2004 Pavement Management Annual Report

Report#: MnDOT/OM-PM--2005-03

May 2005
Office of Materials
Pavement Management Unit

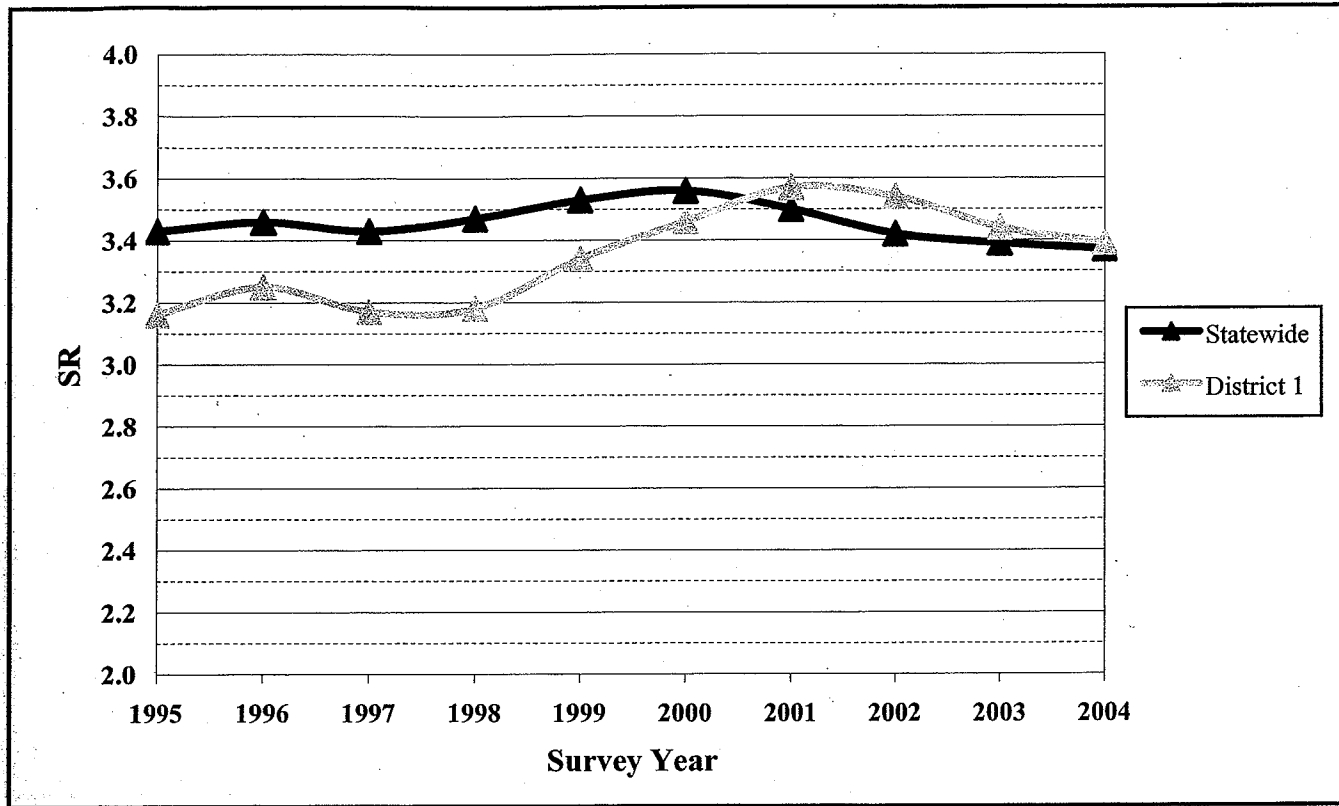
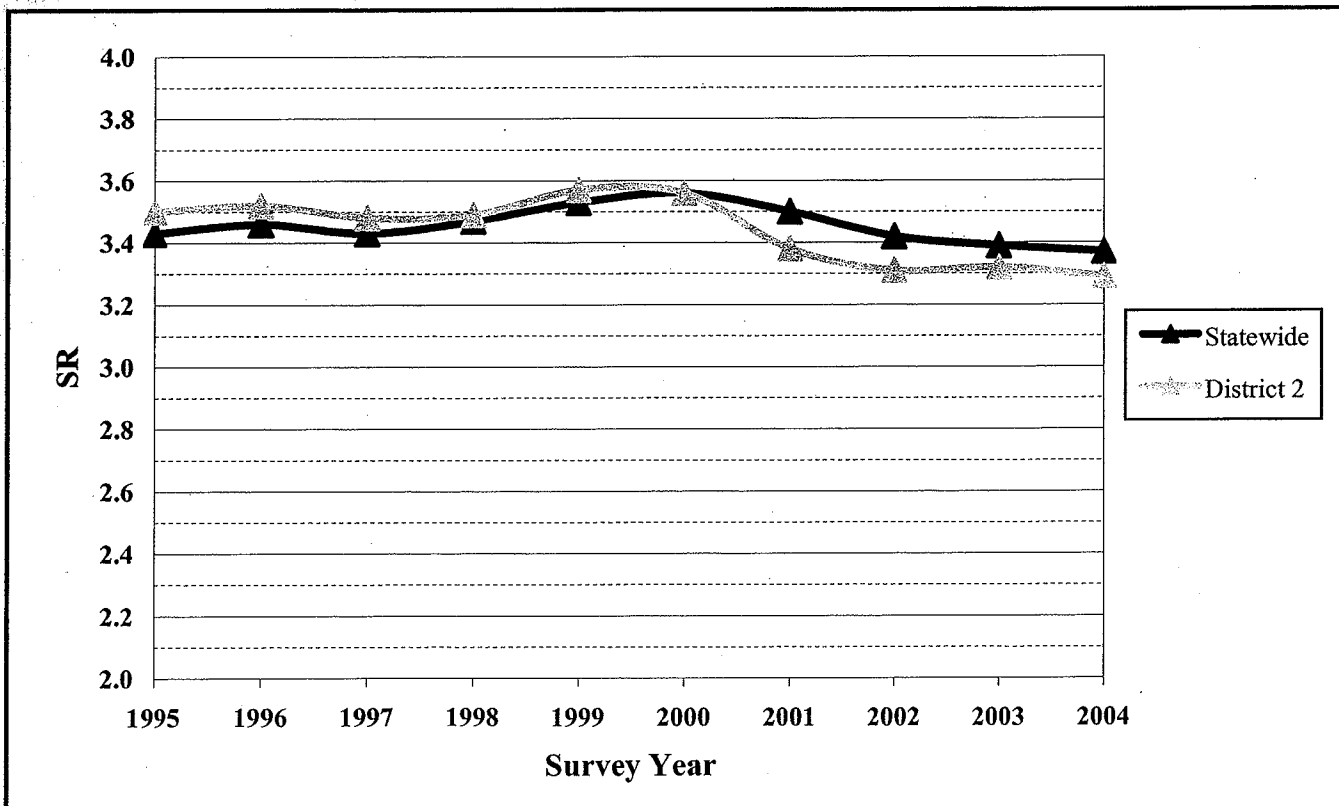
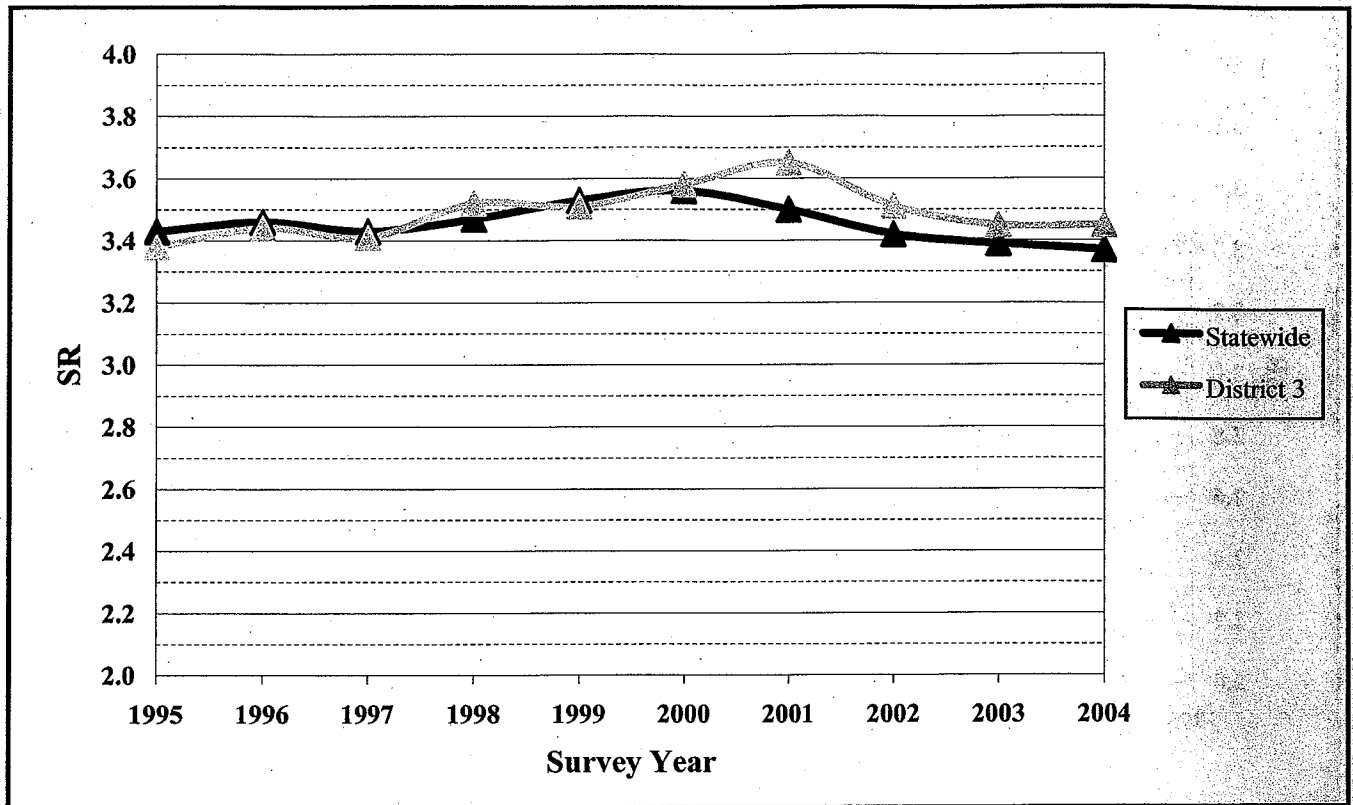
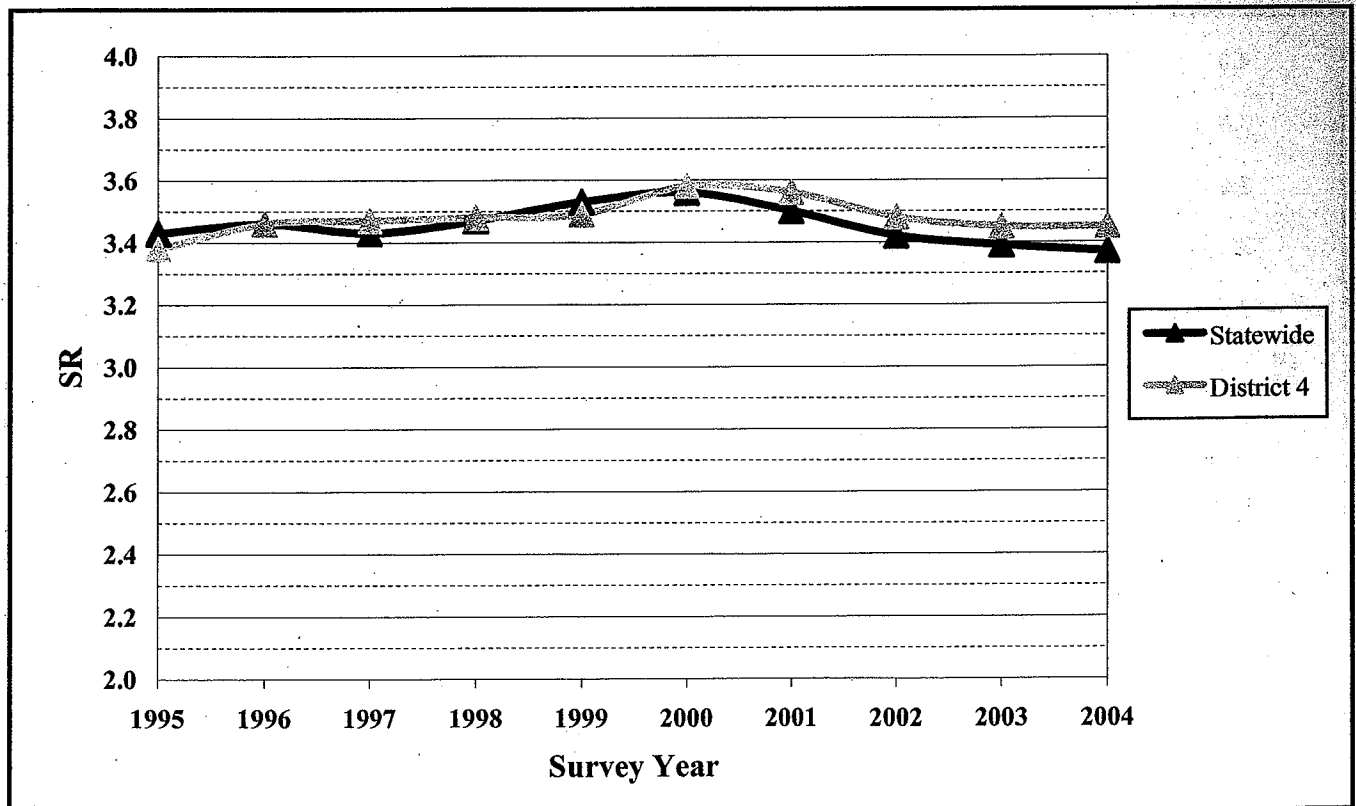
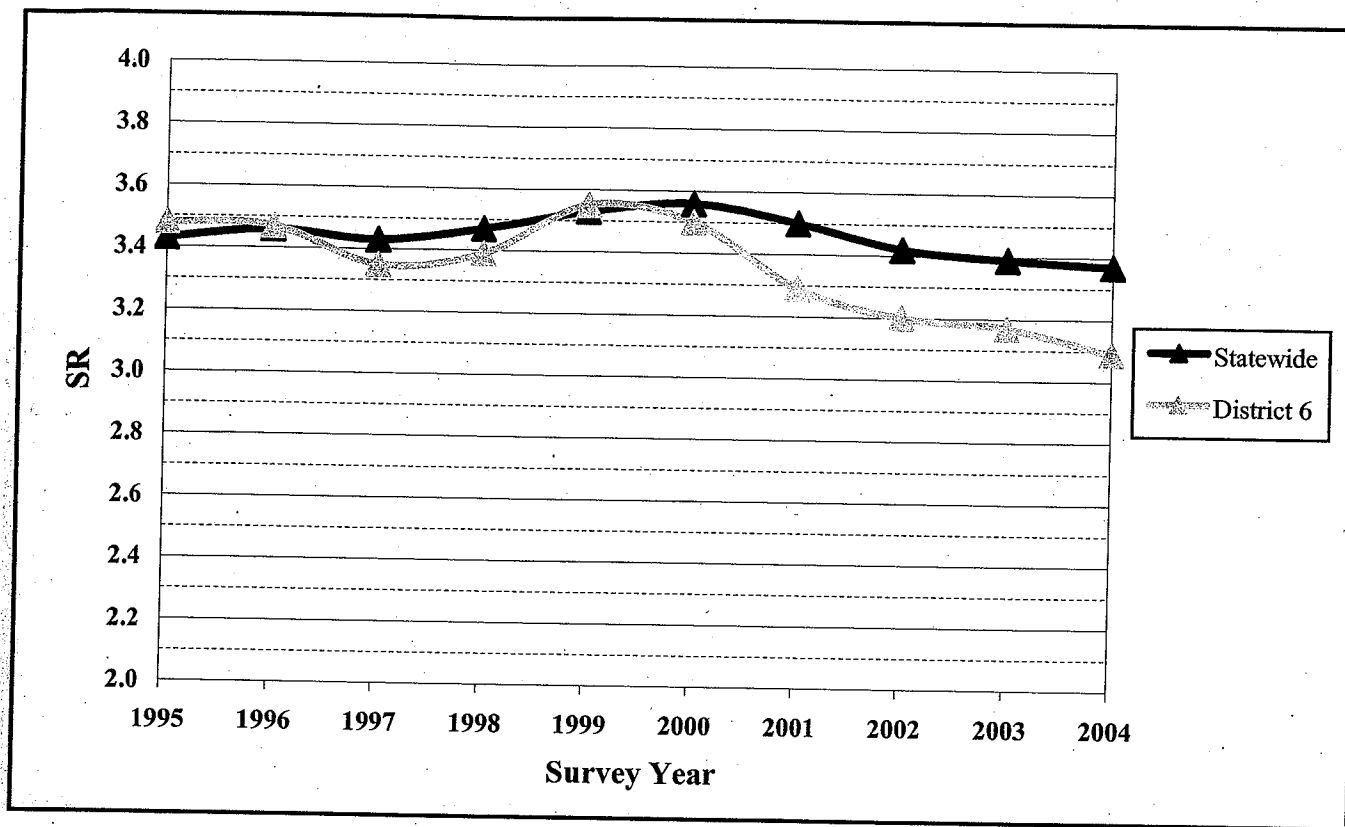
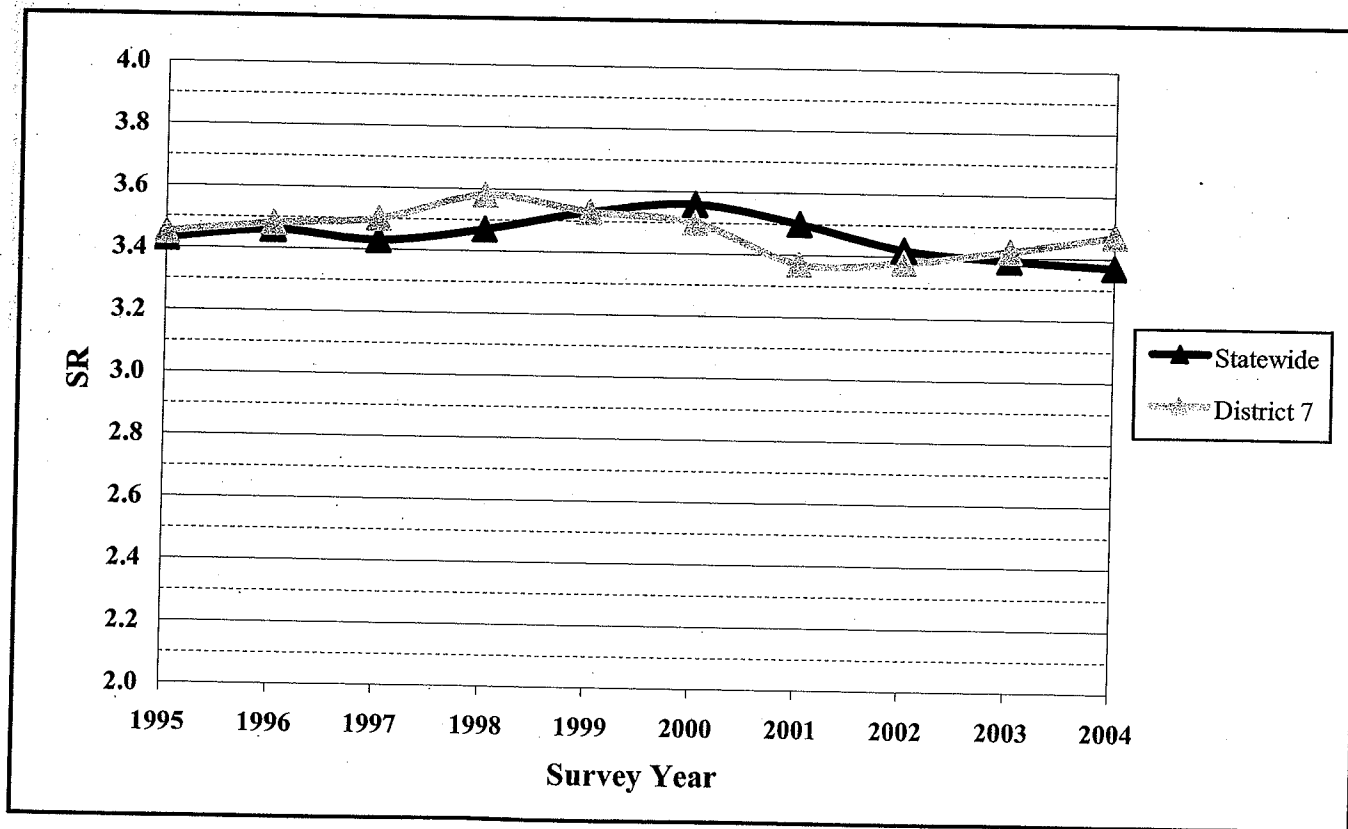
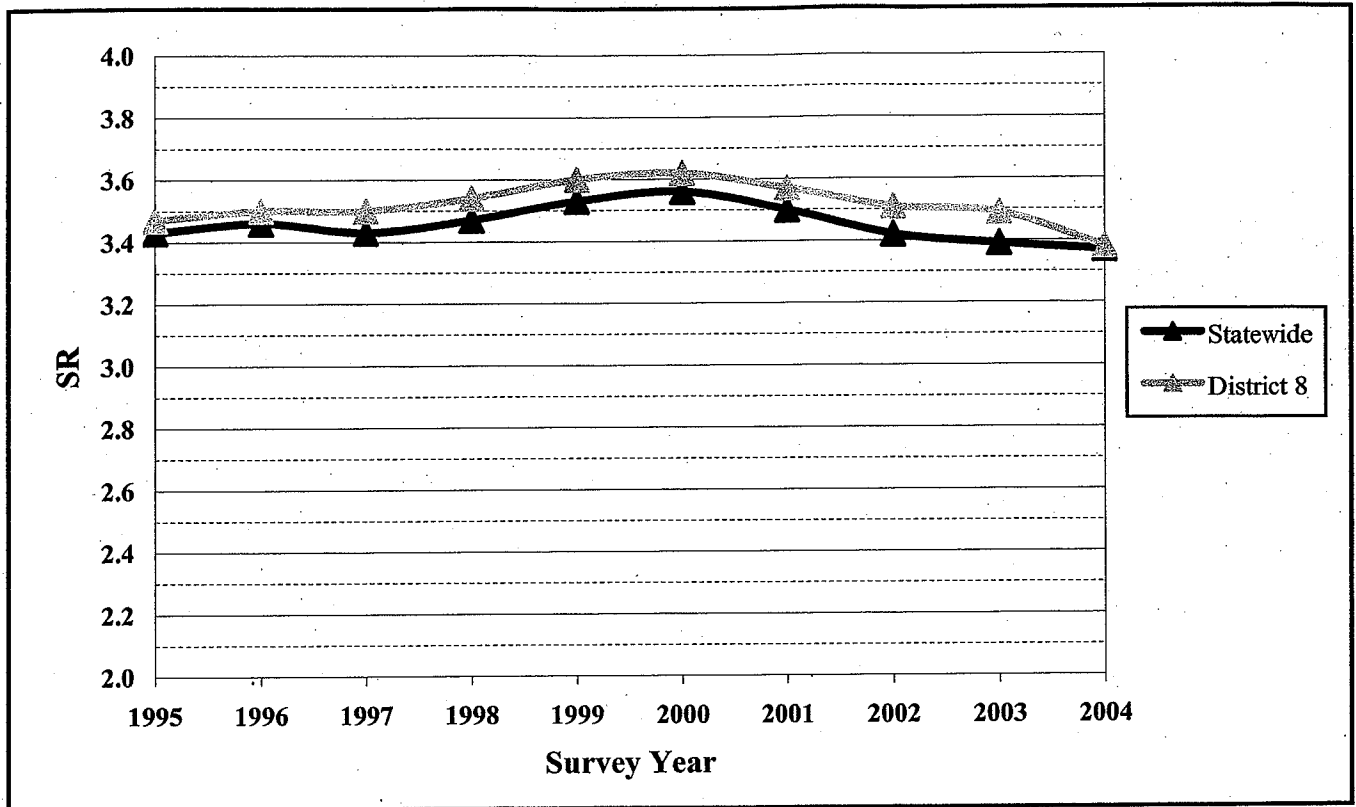
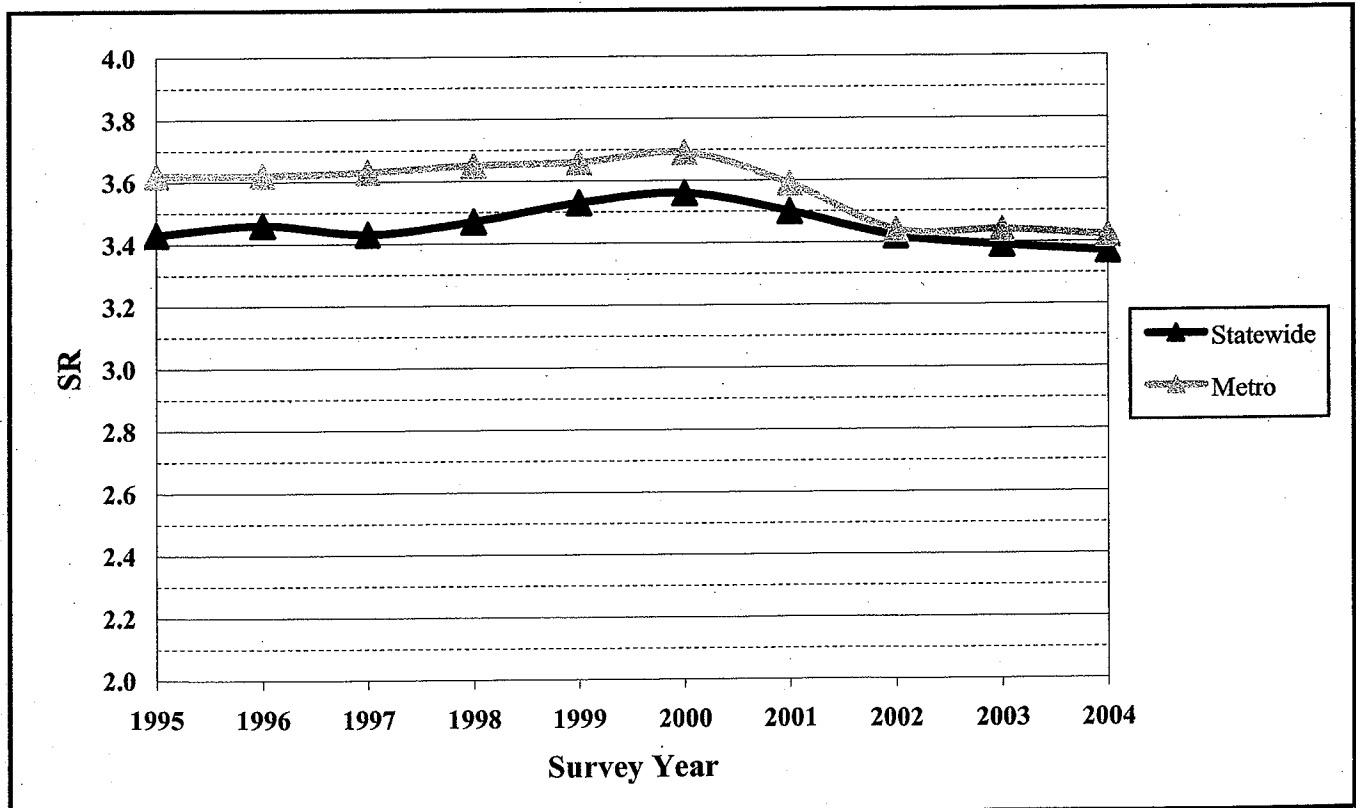
Surface Rating (SR), Figures 6-17 to 6-24

The only district that had an increase in the average SR in 2004 was D-7. This is the third year in a row the average SR has improved in D-7. Since their average SR increased more than their average PSR, much of the increase in SR can likely be attributed to the work of maintenance forces. Districts 2, 3, 4, and Metro remained nearly unchanged. Only D-1, 6, and 8 had any appreciable drop in average SR in 2004. As explained earlier, a drop in SR indicates there are more highways with more total cracking, more severe cracking, or both.

District 7 was the only district to show an increase in the average of all three of the pavement condition indices in 2004 (PQI, PR, SR). Districts 2 and 4 showed an increase in two of the three indices (PQI & PSR). Districts 1 and 6 had a decrease in all three of the indices in 2004.
