# INVESTIGATIVE REPORT TO JOINT COMMITTEE TO INVESTIGATE THE I-35W BRIDGE COLLAPSE

APPENDIX: Volume V

## APPENDIX Volume V

### Additional Documents Cited

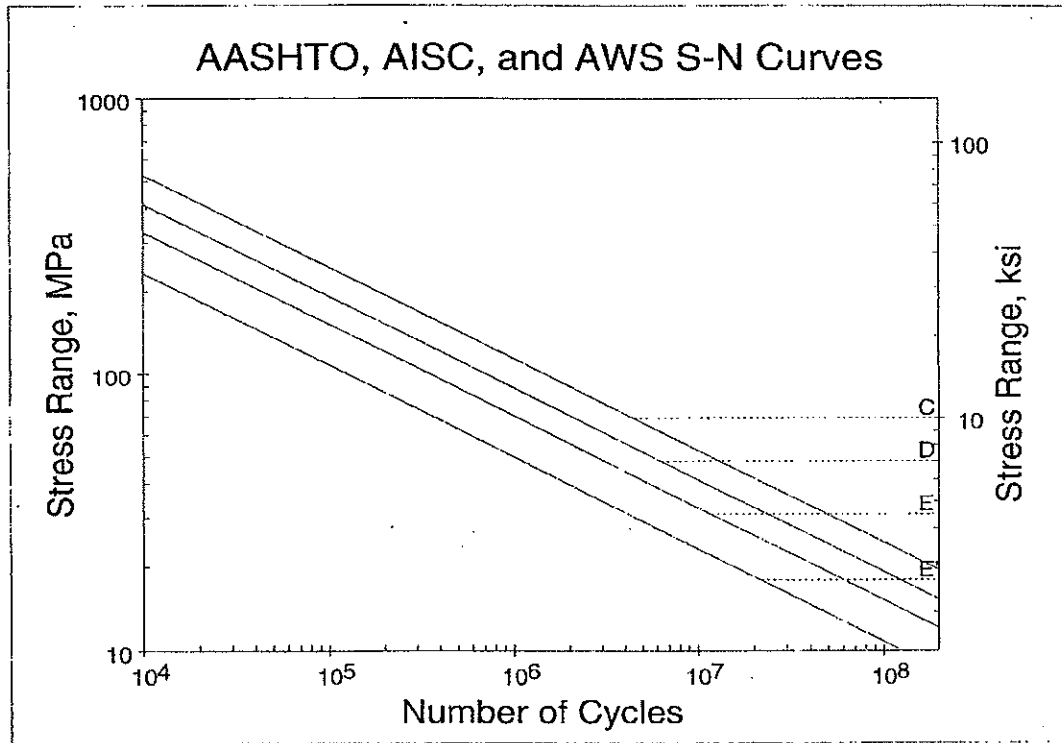
Figure 2: AASHTO Fatigue Resistance Curves

Figure 2 shows the fatigue threshold or constant amplitude fatigue limits (CAFL) for each category as horizontal dashed lines. When constant-amplitude tests are performed at stress ranges below the CAFL, noticeable cracking does not occur. For bridges in service, if almost all the stress ranges are below the CAFL, the fatigue life is considered essentially infinite. The CAFL for Category C, D and E is 69, 48, and 31 MPa, respectively.

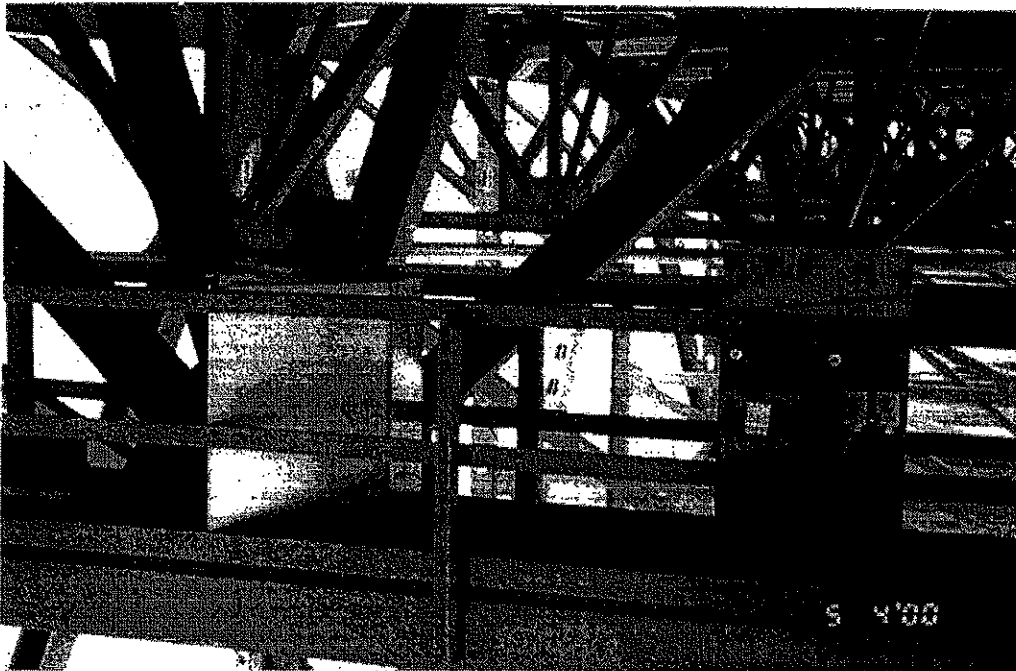
Figure 10: Data Recording Station on Catwalk of Bridge

The wires leading from the gages ran to a central point on the transverse catwalk where they were wired into a data acquisition system housed in a locked electrical box. The box was attached to the catwalk railing using U-bolts. This set up is shown in Figure 10.

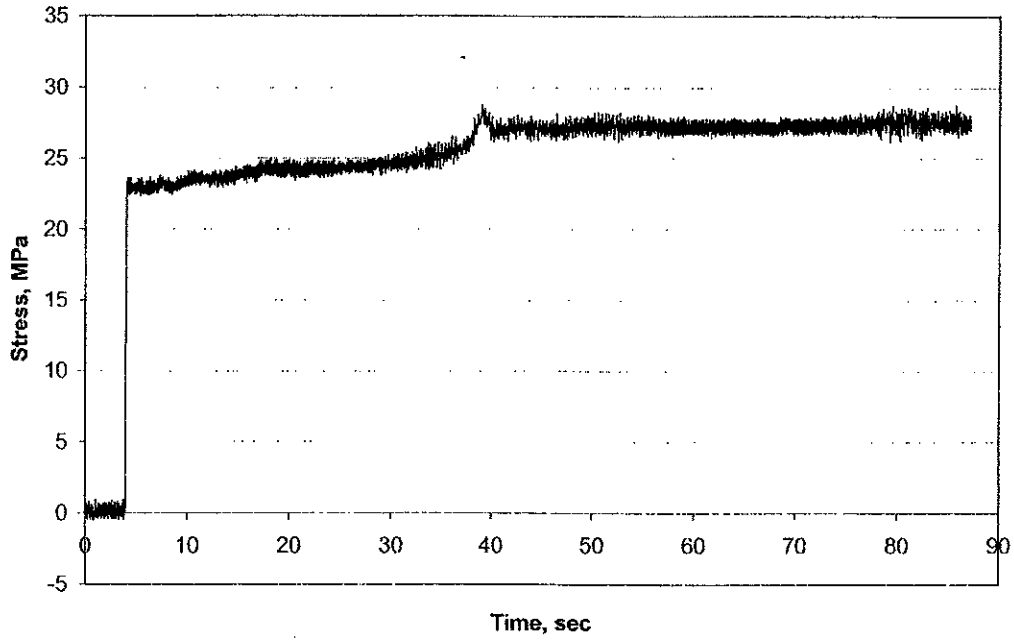
Figure 12: Time History of the Response During Test 1

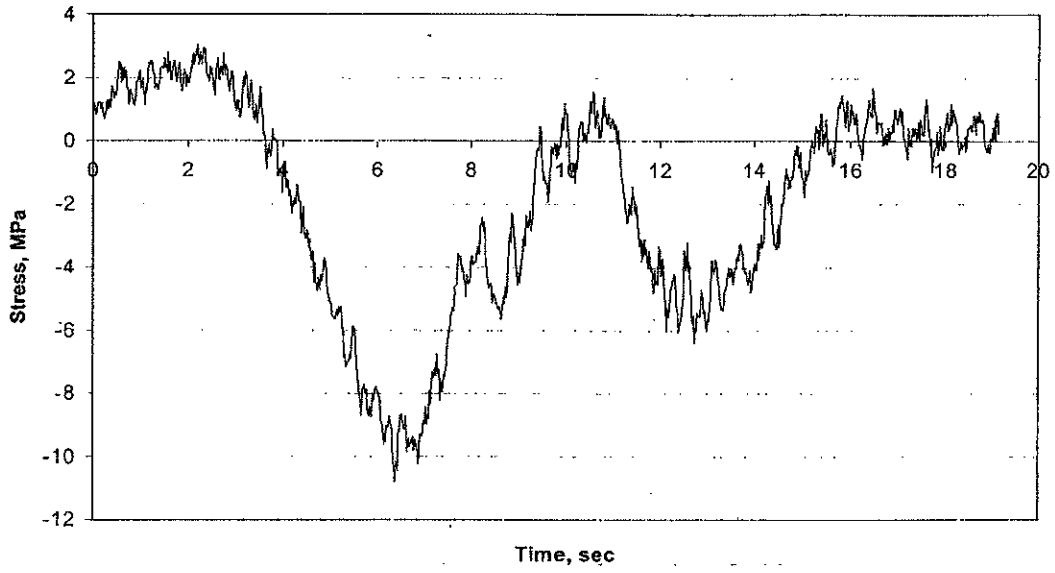
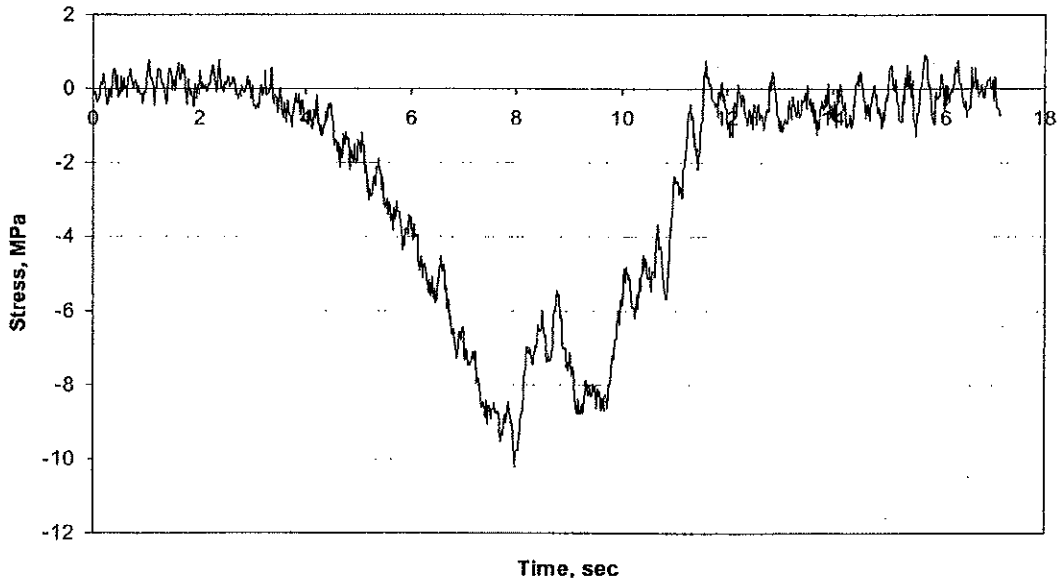
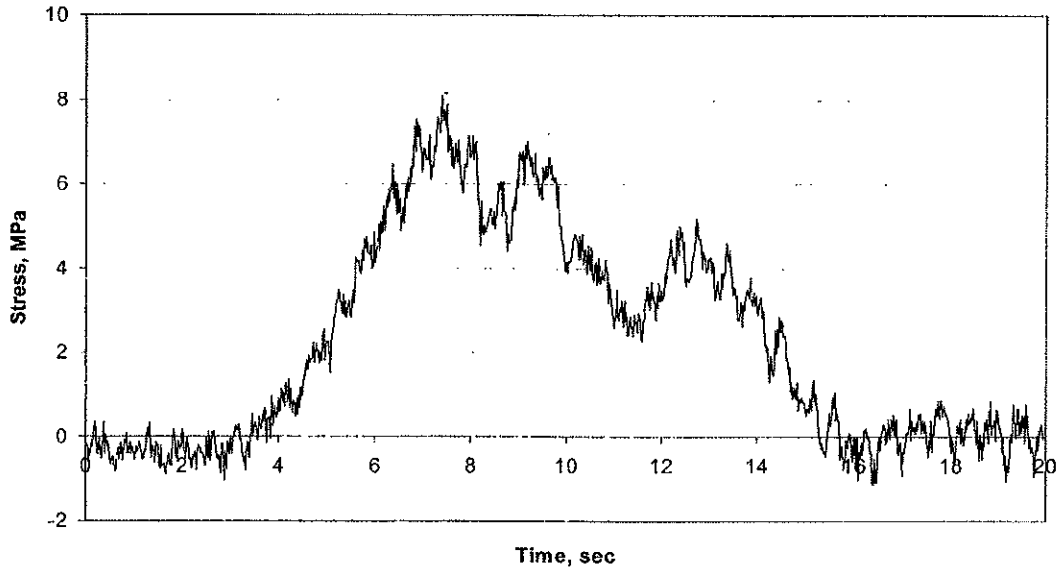
Figure 13: Time Histories of the Response During Test 2

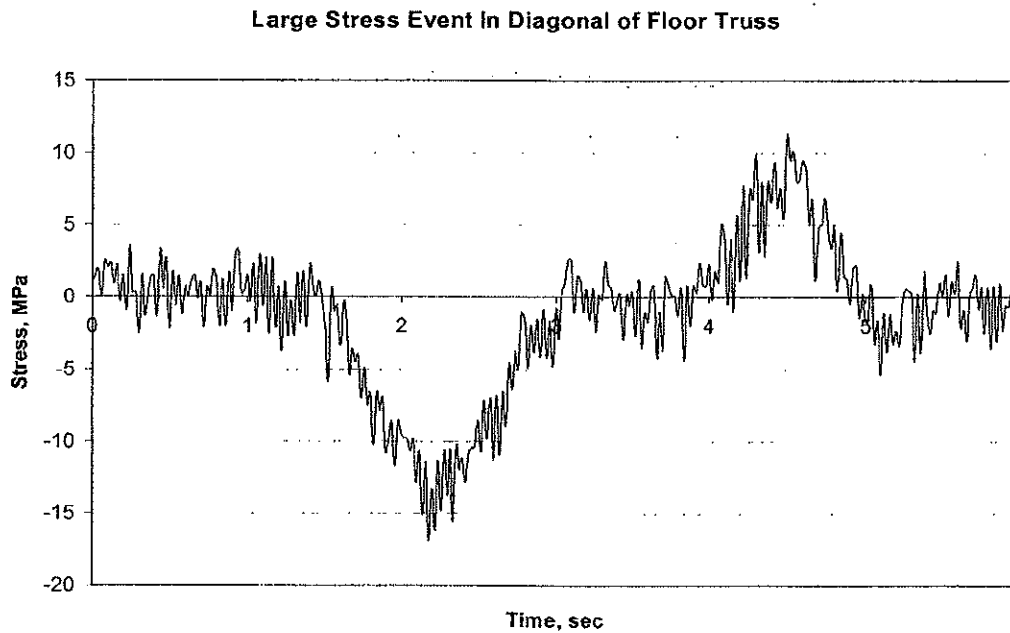
Figure 15: Largest Stress Event Recorded in Open Traffic Conditions

The largest floor truss stress history is presented in Figure 15. The diagonal member is in compression when a load is traveling in the northbound direction, directly over the gaged members, and is in tension when a load is traveling in the southbound direction. Therefore it can be assumed that this large event occurred when two large trucks, each traveling in opposite directions, passed the gaged location within seconds of each other.

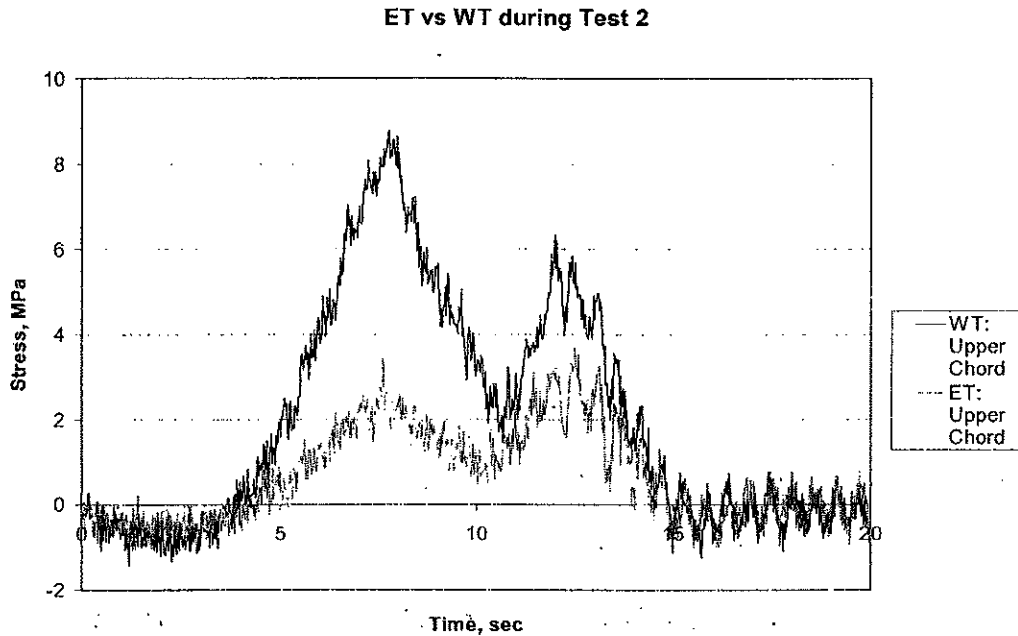
Figure 18: Distribution of Load Across the Bridge Deck

To analyze the results of Test 2, trucks were centered in their lanes as shown in Figure 11b. By measuring the time between peaks in the stress history and estimating the trucks travel speed at 88 kph, it was determined that the following distances for the three rows of trucks was 30.5 and 39.6 meters. Loads were applied to the model with appropriate distances between them and were moved across the length of the bridge.

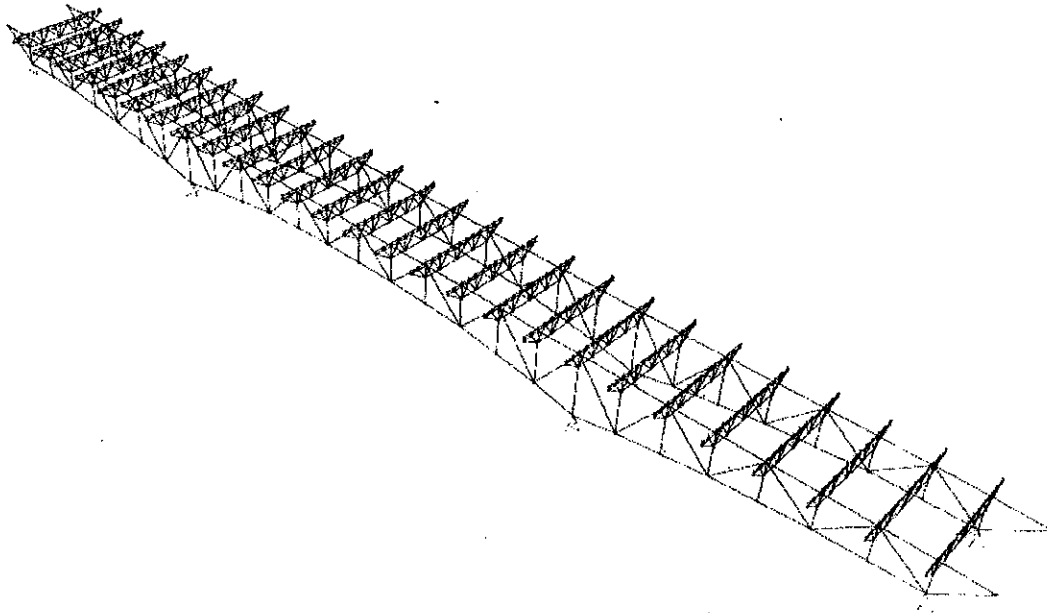
Figure 21: 3-D SAP2000 Model

The stress ranges were more accurate for the upper chord and diagonal, but the stress ranges in the lower chord ranged from worse when the bearings were modeled as rollers to only slightly better with pinned bearings. In the upper chord, the predicted stresses for roller and pinned bearings were 5.2 and 5.4 MPa, respectively, compared to an actual stress range of 5 MPa. The diagonal recorded a stress range of 6 MPa while the analyses predicted 11.4 and 11.7 MPa for the roller and pinned bearings. Lastly, the lower chord recorded a stress range of 8 MPa and analyses predicted 16 and 11.7 MPa for the roller and pinned bearings. The ratio of actual to predicted stress ranges is presented in Table 13.

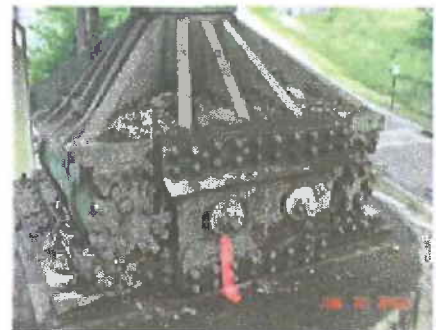
The condition of the deck joints was found to be good except for a few bent fingers in the finger joints. However, the condition of the waterproofing was hard to determine. There was evidence that the deck joints had leaked or were currently leaking as indicated by the concentrated corrosion of the members at or near the deck joints.

Typical Condition of Expansion Bearing at Pier 6 (West Truss)

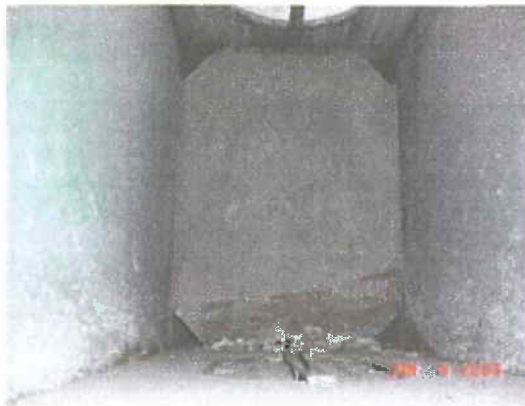
It was difficult to determine if the diaphragm was welded to the truss chord or only to the tabs within the member. Access holes are not located directly adjacent to the diaphragm locations and the diaphragms were visually observed from a distance. There was also an accumulation of debris/dirt around the perimeter of the diaphragms inspected. It appeared that the tabs were attached to the interior of the truss by welding with fillet welds in the longitudinal direction.

Back Side of Internal Diaphragm (Appears Welded)

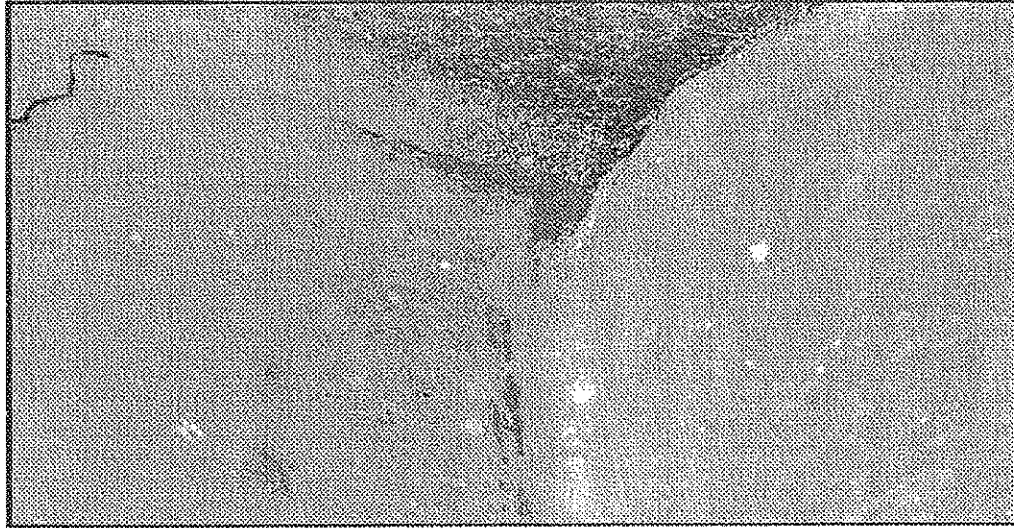
**Br #9340**  
**I-35W Over Mississippi River**  
*Typical Weld Cracks on Top Web/Flange Weld  
And Top Vertical Stiffener/Web Girder*

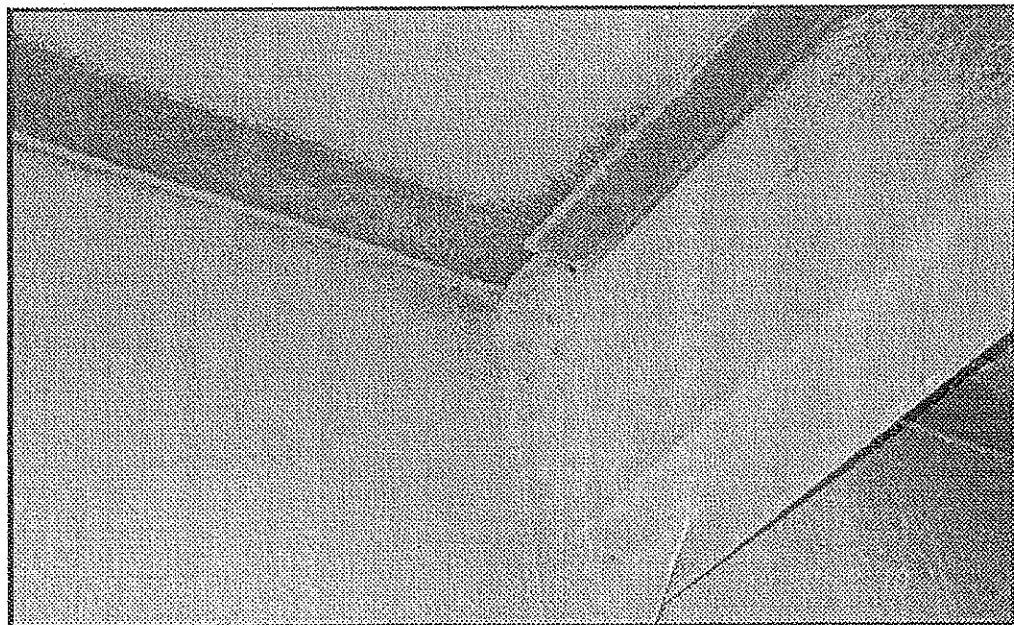
**Br #9340**  
*Girder/Diaphragm Connection*

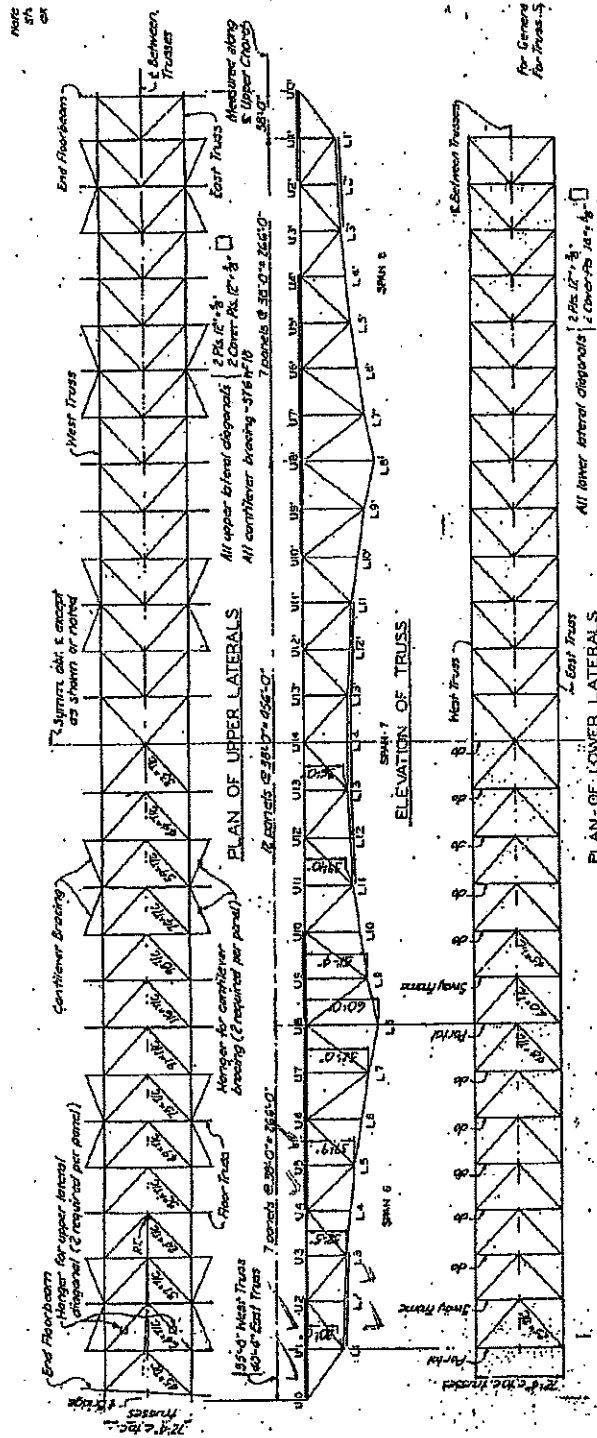
Figure 1: Deck Truss Framing Plan and Elevation from Original Contract Plans  
 (Highlighted Members are Identified Fracture Critical Members)
