May 7, 2015

Robert Jensen  
Director  
Jensen Conservation Services, Inc.  
13515 C Street  
Omaha, NE 68144

## **MINNESOTA CAPITAL QUADRIGA MONUMENT CHARIOTEER SUPPORT ASSESSMENT AND RECOMMENDATIONS REVISION 1**

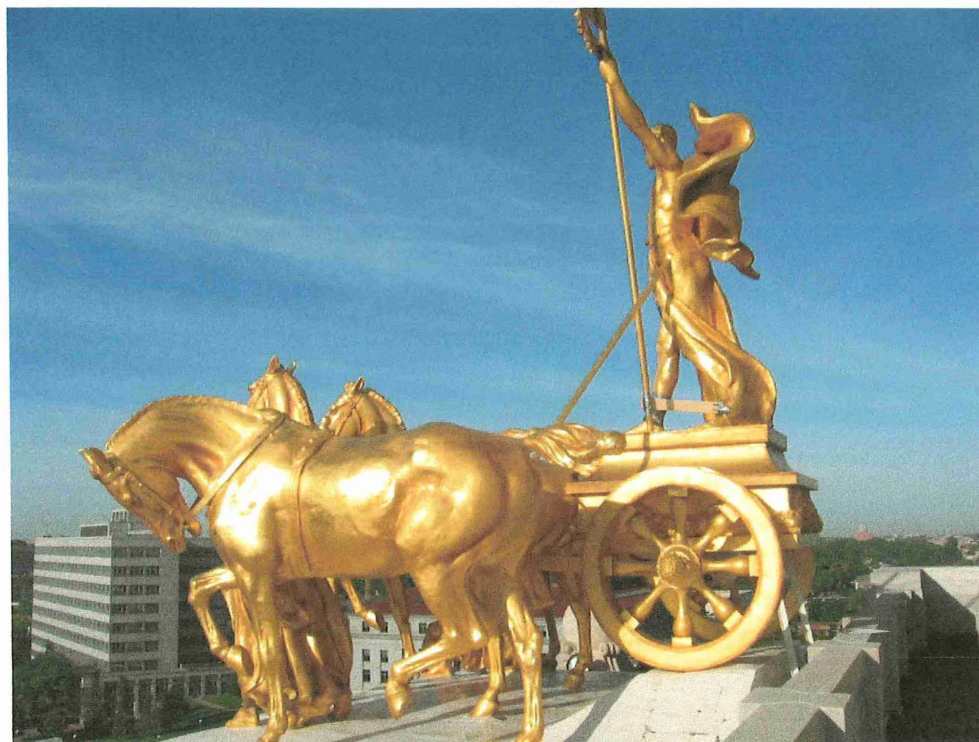
Photo 1: Overall View of the Quadriga

Concerns of corrosion at the Minnesota State Capital quadriga monument prompted the investigation and analysis of the securement of the charioteer statue. LHB assisted with the field measuring and assessment during the recent lowering of the statue from the State Capital roof. See Photo 1 of Appendix A for an overall view of the Quadriga.

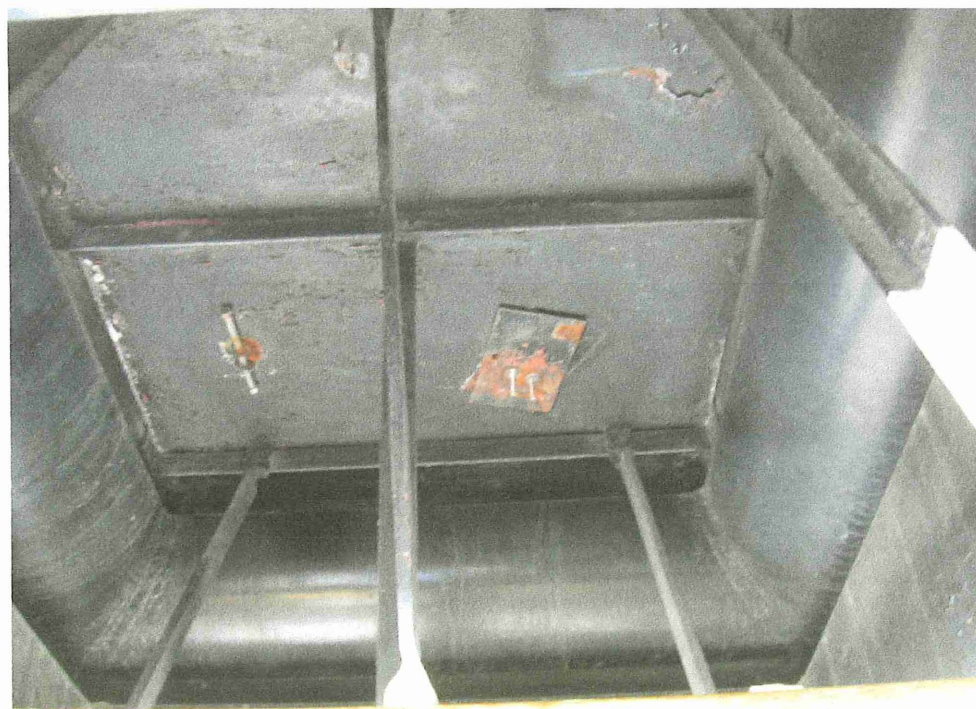
Photo 2: Underside View of Chariot Top

Currently the chariot top is anchored to the chariot axel and building roof with steel straps. See photo 2 for a view of the axel tie downs and photo 3 for a view of the building tie down straps.

LHB recommends replacing the chariot top plate with 316 grade stainless steel plate, 1/8" thick minimum. The original underside L2x2x1/4" reinforcing angles can be reused to support the new stainless steel top plate. Connect the stiffeners to the new top plate using the existing bolt

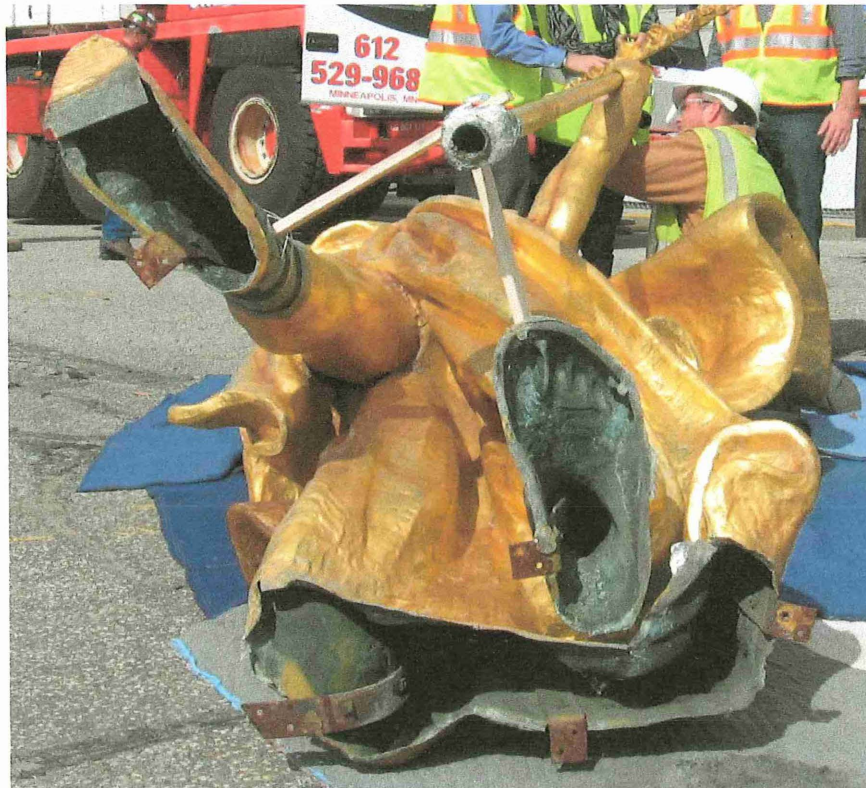
Photo 4: View of Charioteer Bottom

The statue was originally supported on the chariot top which was comprised of a 1/8" thick mild steel top plate reinforced with L2x2x1/4" stiffeners. The statue is secured to the chariot top by five straps, the single pole and two bars laterally to horses. Each strap was bolted to the chariot top with two 1/4" diameter bronze bolts. The mild steel chariot top has extensive corrosion around select statue bolt holes. See Photo 2 for an underside view of the chariot top and auxiliary steel plates added at the bolt locations. The exposed ends of the statue hold down straps have signs of corrosion. See photos 4, 5 and 6 for views of the statue hold down straps and current bolts.

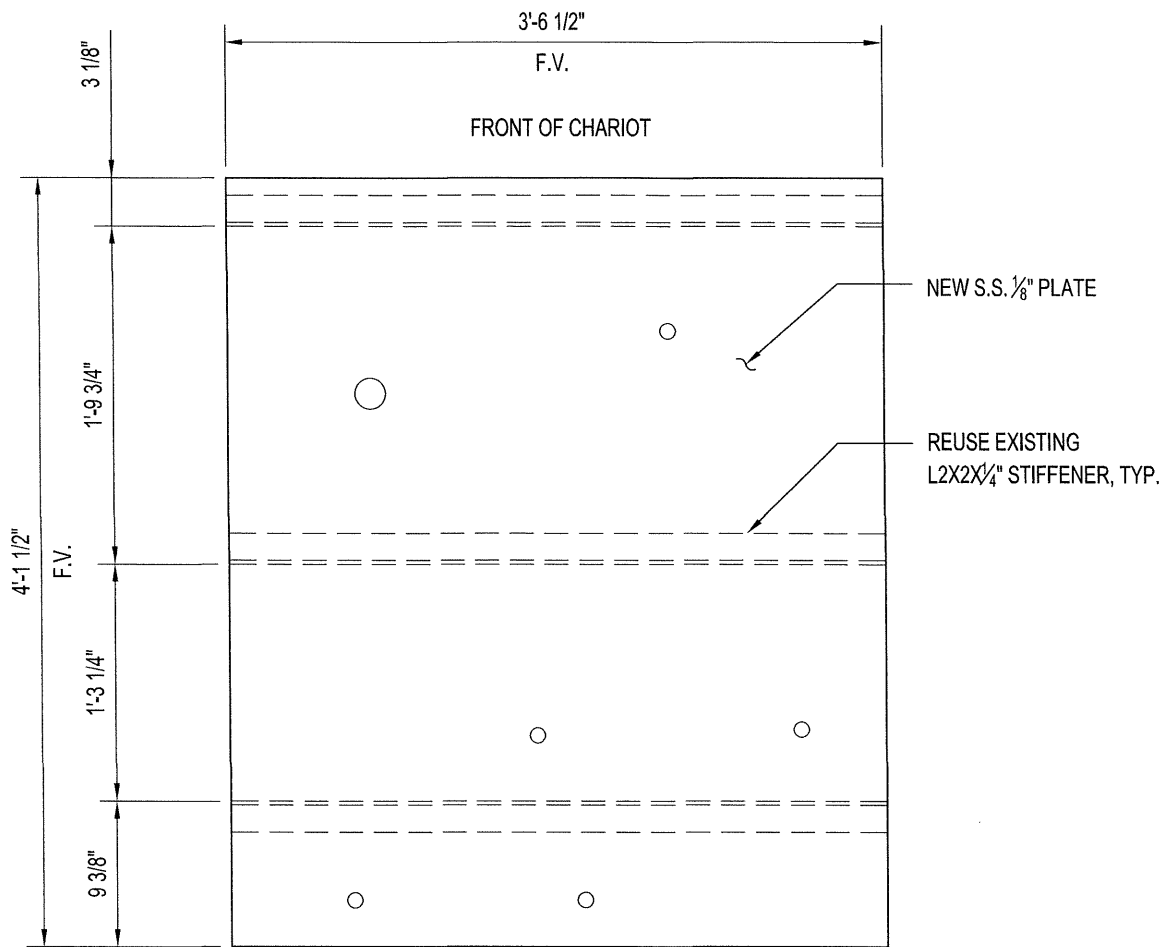
# 1 CHARIOT TOP PLAN VIEW

1. USE ASTM A240 S31600 PLATE, 1/8" THICKNESS FOR THE TOP PLATE.
