**MINNEOPA STATE PARK EVALUATION**

**Client:** Minnesota Department of Natural Resources

**Location:** Minneopa State Park  
54479 Gadwall Road  
Mankato, MN 56001

**Project Description:** Analyze current building performance of Contact Station and Heated Storage/Shop to determine most effective way of reducing overall energy usage of the park by 15%.

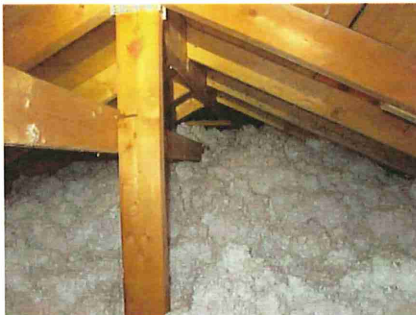
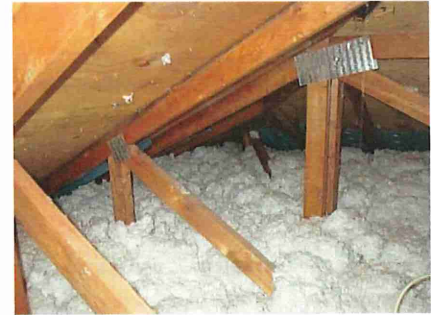
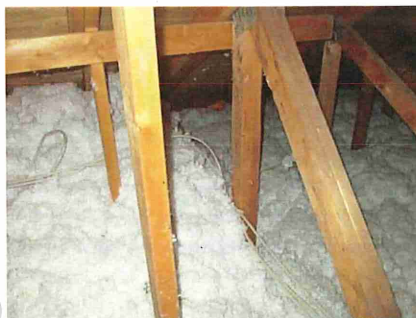
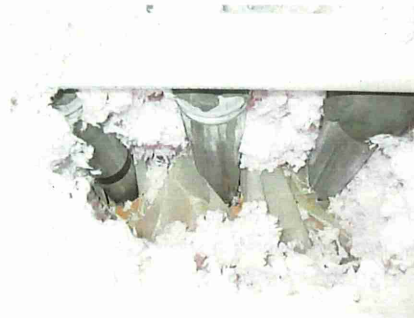
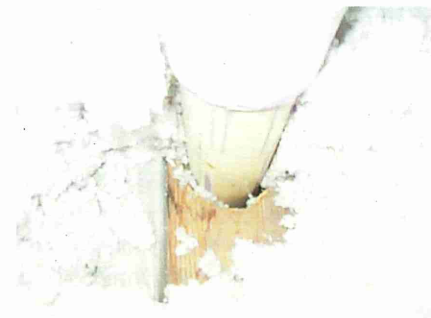
The attic was inspected to assess the amount of insulation (R-value) present. Around 14-20" of blown fiberglass insulation was used. A poly vapor barrier was present under the existing insulation.

CONTACT STATION ATTIC	
Insulation Type	Blown Fiberglass
Existing Insulation Depth	14 – 20"
Average R-value Present	*R-50

These results indicate that the R-value in the attic of the contact station is well above the minimum code requirements for commercial buildings and residential buildings.

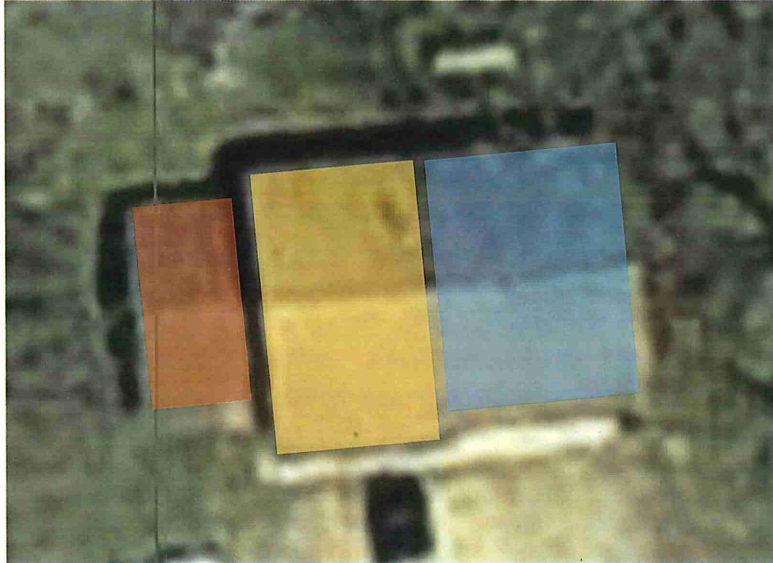
Parts of the storage and shop building are heated to around 50 degrees during the winter and it is only semi-occupied. It was also a candidate for assessing building performance to determine opportunities for increased energy efficiency through building envelope or HVAC improvements.

Break Room

Heated Shop

Typically Unheated Shop
