**Fort Ridgely State Park - Contact Station  
(B40393)**

## Executive Summary

## Fort Ridgely State Park - Chalet (B40080)

## Fort Ridgely State Park - Shop (B40082)

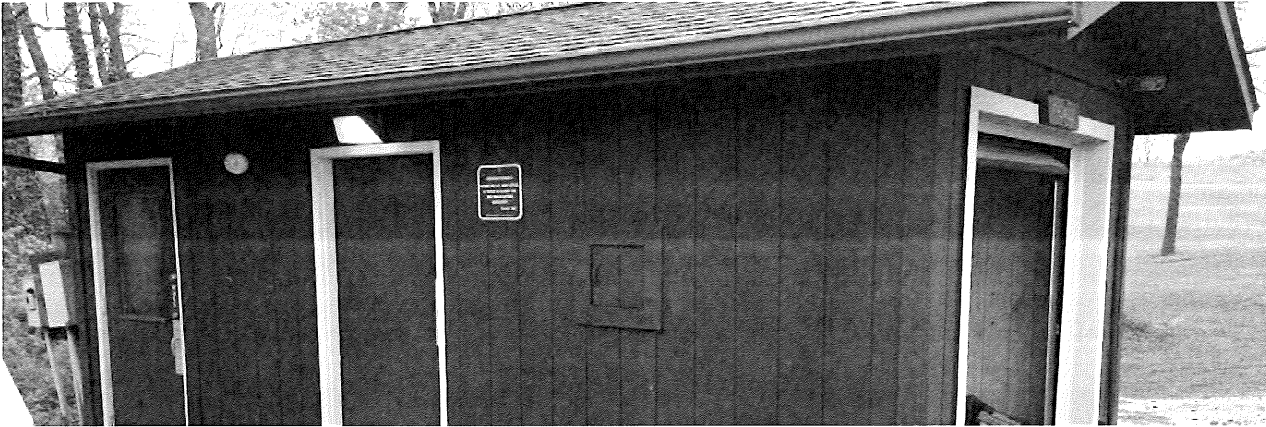
### **Opportunity 1: Install a photocell to ensure exterior lights are shutoff during daytime**

An exterior wallpack was left on and operating during daytime hours. You may want to consider installing a photocell to only allow this fixture to operate during night-time hours. A photocell is a simply a light sensor that turns a circuit on/off depending on light level. Estimated costs are \$50 for a photocell. A rebate may be available through your local utility.

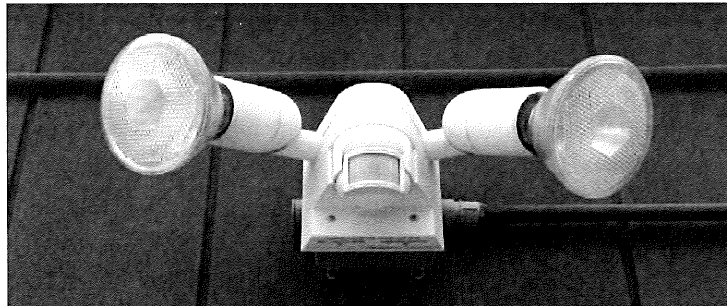
### **Opportunity 3: Replace exterior halogen spots with equivalent LEDs**

The exterior security lights contain (2) halogen lamps. You may want to consider replacing these lamps with LEDs. LED's will last up to 20x longer than your halogen lamps, while using 75% less energy. LED lamps also thrive in cold environments, so their rated life will likely be achieved as this fixture is located outside. Your local utility may incentive this replacement, so please speak to them to find available rebates.

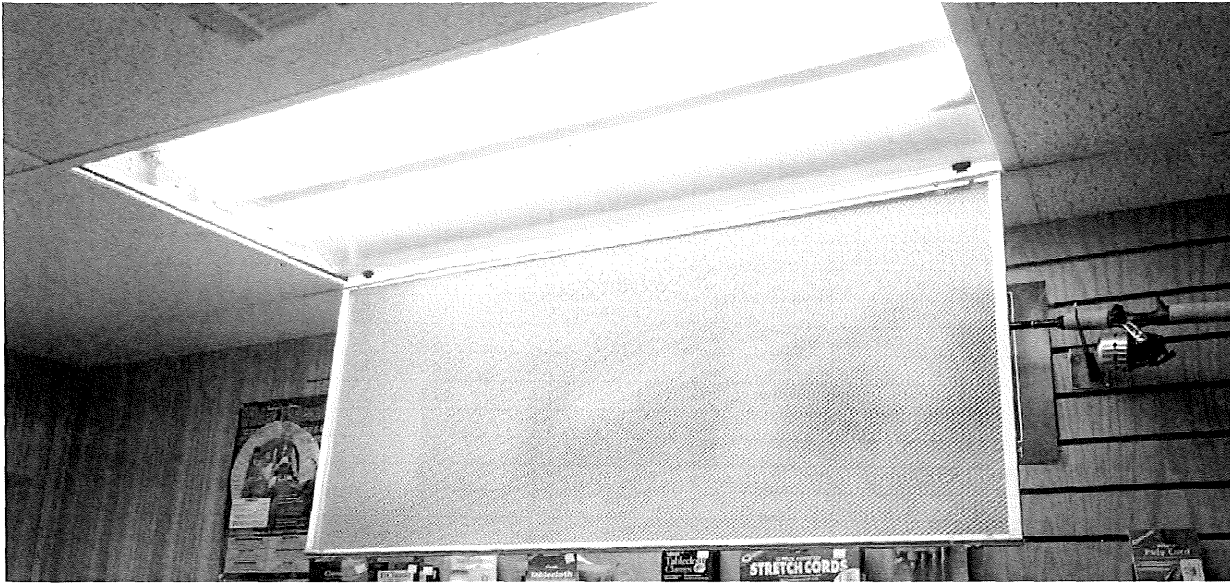
### **Opportunity 4: Replace T12 and T8 fluorescent troffers with LED troffers**

The contact station primarily consists of T12 troffers with a few troffers containing T8 lamps. T12 fluorescent lighting is an outdated technology that has been replaced with T8 fluorescent and LED lighting. Instead of the margin efficiency gains with the retrofit to T8 lamps, you may want to consider replacing all the troffers with LED troffers. LED's offer a better light quality, and last up to 5 longer before needing replacement. Retrofitting troffers costs roughly \$100 per troffer, while a replacement costs roughly \$150. The wattage reduction would be 40-75% per fixture. Incentives may be available through your local utility.

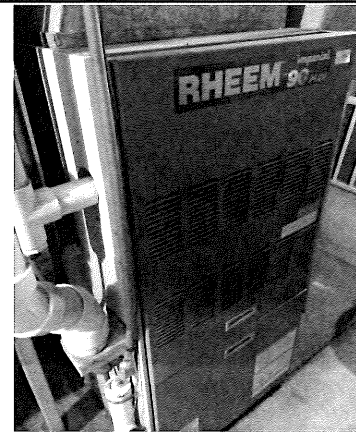
Consider performing a tune-up on your furnace to optimize performance and ensure safe operation of the equipment. By tuning up your furnace, you can see performance gains as great as 5%, and it gives you an easy way to detect future problems. Estimated savings were based upon a tune-up being performed every other year.

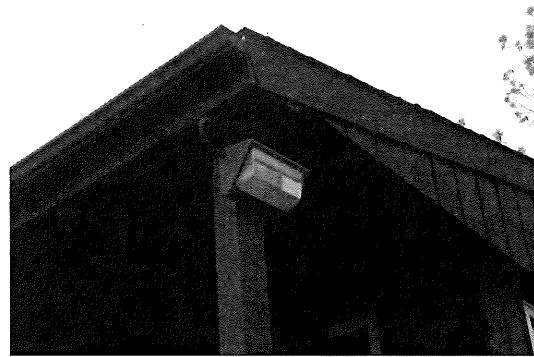
### **Opportunity 2: Replace exterior HID lights with LED lights**

The exterior wallpacks contain high pressure sodium lamps. You may want to consider replacing these fixtures with LED wallpacks. LED wallpacks use roughly 50% less energy, and last up to 3 times longer without lumen degradation. Rebates may be available from your local utility for this project.

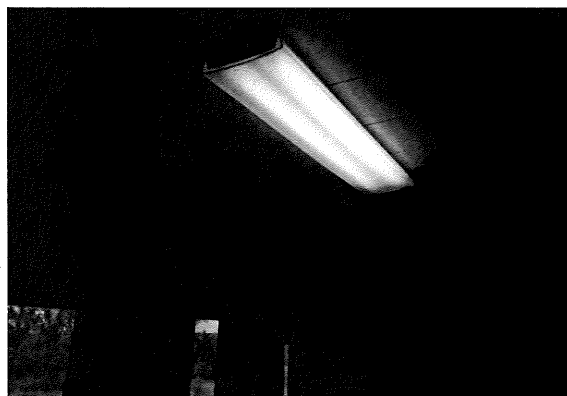
### **Opportunity 3: Replace T12 fluorescent lighting with LED lighting**

The shop consists of T12 fluorescent fixtures. T12 fluorescent lighting is an outdated technology that has been replaced with T8 fluorescent and LED lighting. Instead of the marginal efficiency gains with the retrofit to T8 lamps, you may want to consider replacing all the troffers with LED troffers. LED's offer a better light quality, and last up to 5 longer before needing replacement. Retrofitting troffers costs roughly \$100 per troffer, while a replacement costs roughly \$150. The wattage reduction would be 40-75% per fixture. Incentives may be available through your local utility.

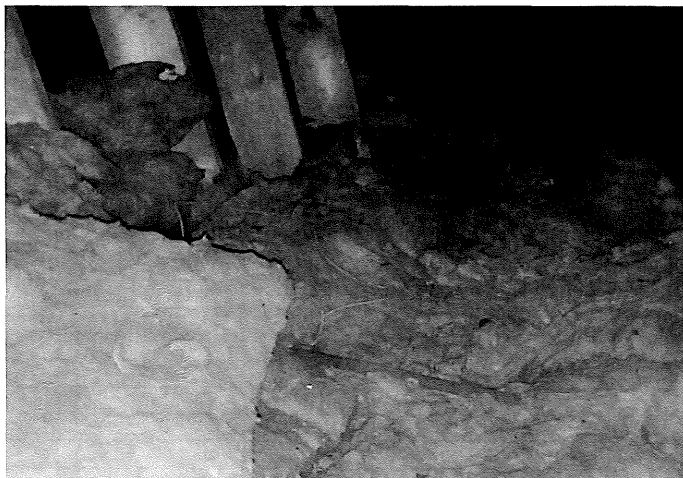
#### **Opportunity 4: Increase insulation in the attic**

The insulation in the attic appears to be about 6-7" and consists of fiberglass batting. The estimated insulation value is R-20. This measure identifies the energy savings that could be realized if additional insulation was added to reach the recommended value of R-49. While there is an upfront cost, the relative ease of adding insulation makes this a worthwhile endeavor.

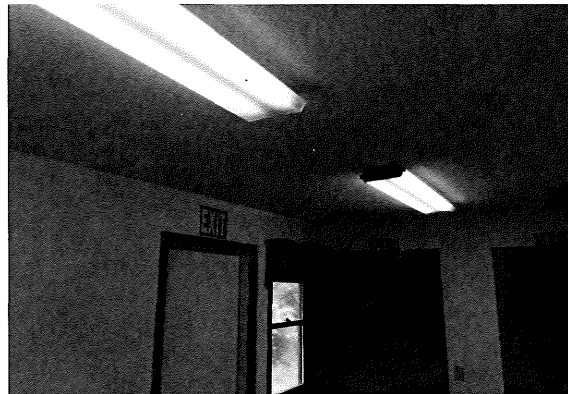
### **Opportunity 3: Replace T12 and T8 fluorescent lighting with LED lighting**

The horse lodge consists of T12 and T8 fluorescent fixtures. T12 fluorescent lighting is an outdated technology that has been replaced with T8 fluorescent and LED lighting. Instead of the marginal efficiency gains with the retrofit to T8 lamps, you may want to consider replacing all the troffers with LED troffers. LED's offer a better light quality, and last up to 5 longer before needing replacement. Retrofitting troffers costs roughly \$100 per troffer, while a replacement costs roughly \$150. The wattage reduction would be 40-75% per fixture. Incentives may be available through your local

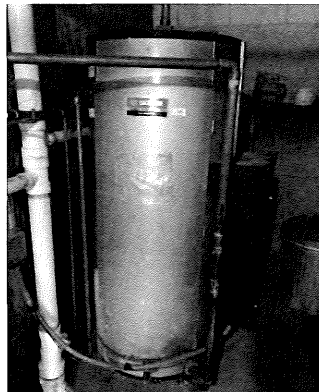
### **Opportunity 3: Replace water heater with on-demand tankless water heater**

Your electric water heater is old and out of date. You may want to consider replacing this unit with an on-demand tankless water heater. This style of water heater will only heat water as needed as opposed to storing water which is beneficial because the occupacny and usage of the horse camp changes throughout the summer. Tankless units are also estimated to last twice as long as conventional units, and do not suffer from standby loss like a tradition unit.

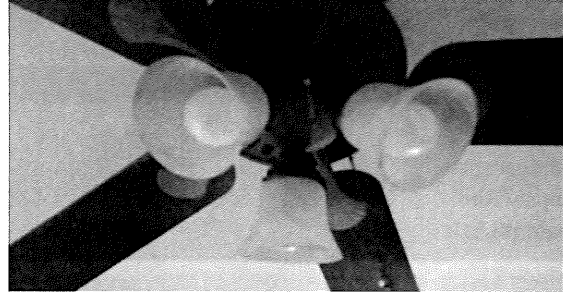
### **Opportunity 1: Replace incandescent lamps with equivalent LEDs**

The interior lights consist of 60 and 75W incandescent lamps. You may want to consider replacing these lamps with LEDs. LED's will last up to 20x longer than your halogen lamp, while using 75% less energy. Your local utility may incentive this replacement, so please speak to them to find available rebates.

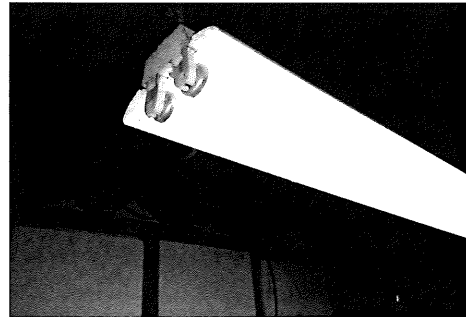
### **Opportunity 2: Replace T12 fluorescent lighting with LED lighting**

The basement of the residence consists of T12 fluorescent fixtures. T12 fluorescent lighting is an outdated technology that has been replaced with T8 fluorescent and LED lighting. Instead of the marginal efficiency gains with the retrofit to T8 lamps, you may want to consider replacing all the troffers with LED troffers. LED's offer a better light quality, and last up to 5 longer before needing replacement. Retrofitting troffers costs roughly \$100 per troffer, while a replacement costs roughly \$150. The wattage reduction would be 40-75% per fixture. Incentives may be available through your local utility.

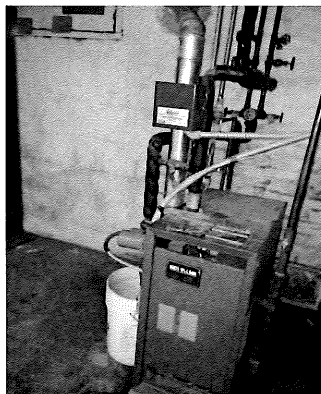
### **Opportunity 3: Upon failure, install new high-efficiency boiler**

Conventional gas combustion boilers generate by-products which are vented out through a chimney, along with a considerable amount of heat. The primary waste products are water vapor and carbon dioxide. Newer designs increase energy efficiency by reducing the amount of heat that escapes and by extracting heat from the flue gas before it is vented. These boilers use much less energy than conventional boilers. You should only consider upgrading to a high-efficiency boiler when near end of life, as it's not cost effective to do so before. Estimated savings were based on upon replacing a 80% efficient propane boiler with a 95% efficient propane boiler.

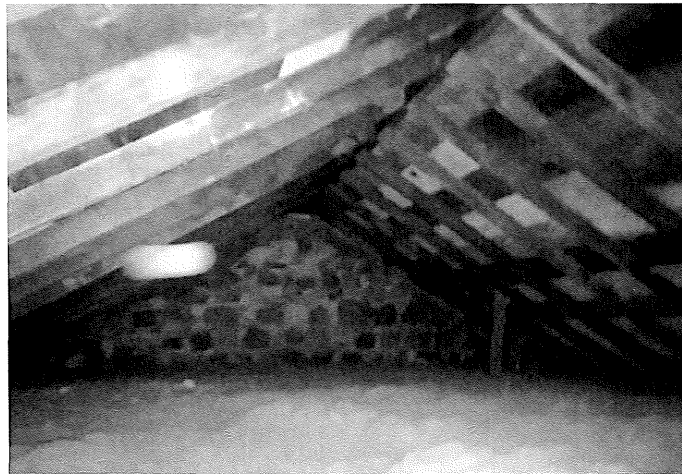
#### **Opportunity 4: Air-seal attic, attic hatch, electrical, plumbing, basement, rim joists, and cracks in foundation**

The house currently uses knob and tube wiring, so this will need to get upgraded before additional insulation is added. It's important to note that insulation and airsealing would improve the energy performance of the house. Air sealing should be performed at all cracks and permiations while insulation should take place in the attic and walls. Be sure to have a second blower door analysis done after insulating and airsealing to ensure ventilation is still met.

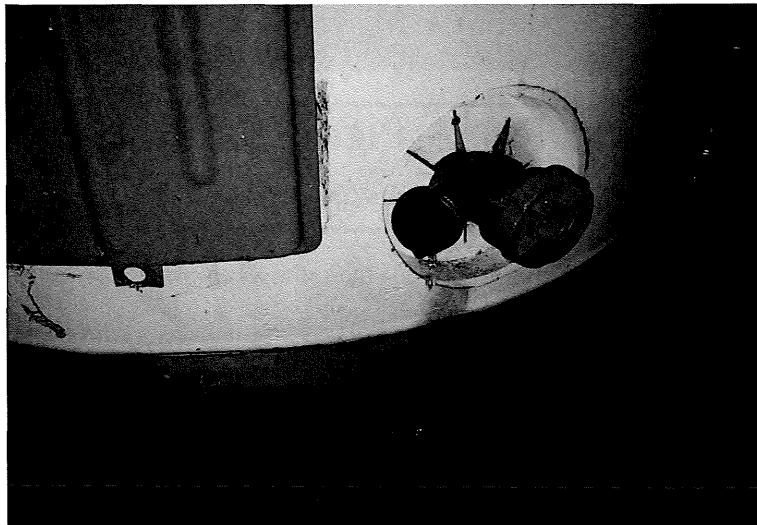
#### **Opportunity 6: Replace leaking water heater**

The water heater was leaking. You may want to replace the unit before it is used again as the intergrity of this tank has likely been compromised. Be sure to look for a high-efficiency or energy-star rated tank for your next purchase

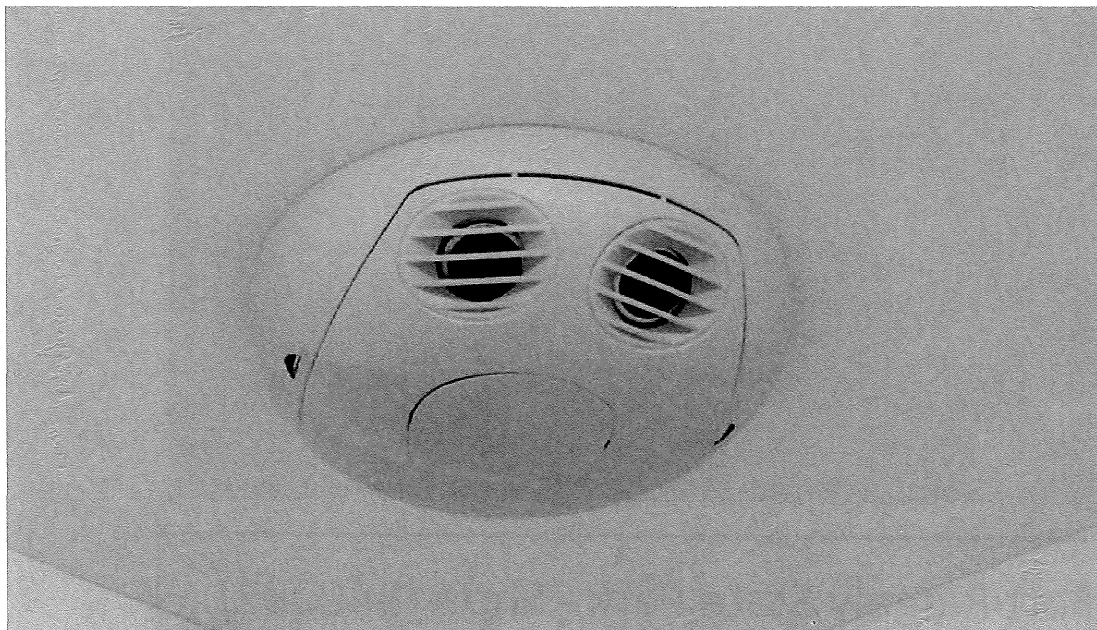
You may want to install Occupancy Sensors to automatically turn lights off in areas such as restrooms, storage rooms, or other rooms where lights could get left on. Occupancy sensors limit the amount of time the lights in each room are left on while unoccupied. Sensors can be purchased fairly inexpensively, for roughly \$20-\$100 each depending on type and style. The savings for installing these sensors varies greatly depending on the quantity of fixtures controlled as well as the amount of human traffic through the room. The typical payback for a break room and restroom installation is under two years. Estimates were conservative assuming that lamp operation is 2,000 hours per year being reduced to 1,000 hours per year.

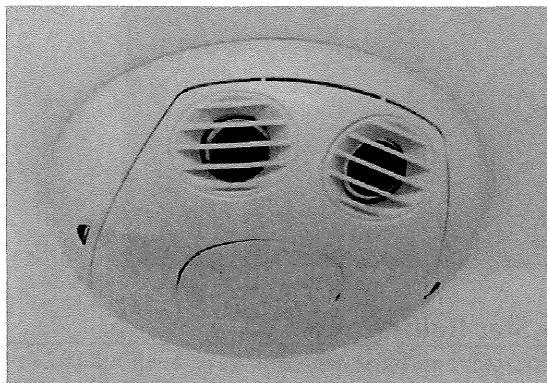
You may want to install Occupancy Sensors to automatically turn lights off in areas such as restrooms, storage rooms, or other rooms where lights could get left on. Occupancy sensors limit the amount of time the lights in each room are left on while unoccupied. Sensors can be purchased fairly inexpensively, for roughly \$20-\$100 each depending on type and style. The savings for installing these sensors varies greatly depending on the quantity of fixtures controlled as well as the amount of human traffic through the room. The typical payback for a break room and restroom installation is under two years. This estimates the savings of installing them on the fixtures inside both the office and shop portions of the building.

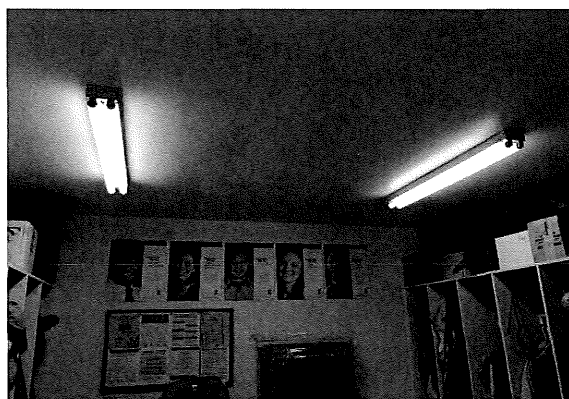
### **Opportunity 3: Replace T12 fluorescent lighting with LED lighting**

The shop consists of T12 fluorescent fixtures. T12 fluorescent lighting is an outdated technology that has been replaced with T8 fluorescent and LED lighting. Instead of the marginal efficiency gains with the retrofit to T8 lamps, you may want to consider replacing all the troffers with LED troffers. LED's offer a better light quality, and last up to 5 longer before needing replacement. Retrofitting troffers costs roughly \$100 per troffer, while a replacement costs roughly \$150. The wattage reduction would be 40-75% per fixture. Incentives may be available through your local utility.

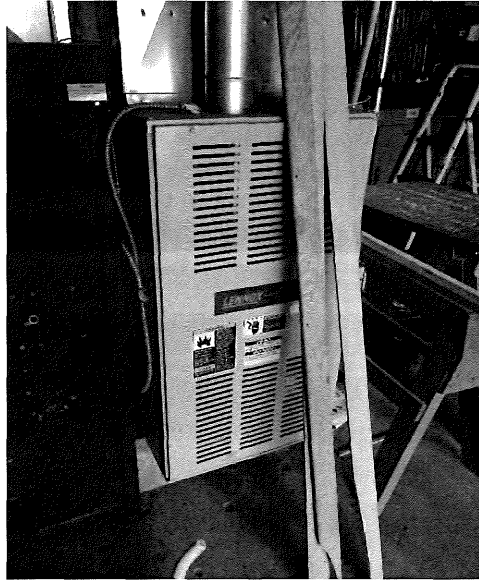
#### **Opportunity 4: Upon failure, install new high-efficiency propane furnace**

Conventional gas combustion furnaces generate by-products which are vented out through a chimney, along with a considerable amount of heat. The primary waste products are water vapor and carbon dioxide. Newer designs increase energy efficiency by reducing the amount of heat that escapes and by extracting heat from the flue gas before it is vented. These furnaces use much less energy than conventional furnaces. You should only consider upgrading to a high-efficiency furnace when near end of life, as it's not cost effective to do so before. Estimated savings were based on upon replacing a 80% efficient propane furnace with a 95% efficient propane furnace.

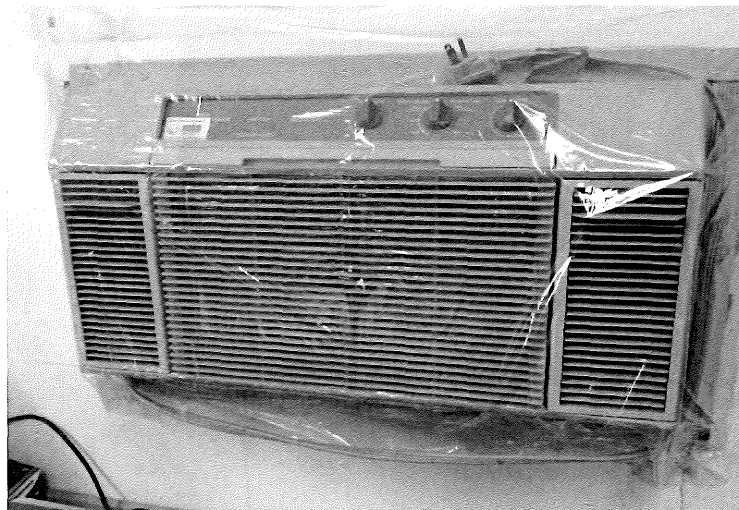
Your air conditioning unit is covered with plastic during the winter to help reduce drafts. This plastic has no insulation value, and is hardly working as an effective air seal. Consider purchasing a true air conditioner cover to properly air seal and insulate the air conditioning unit during winter months.
