***Partridge River Level 2 Rosgen Geomorphic
Survey***

***Rosgen Classification
Partridge River above Dunka Road***

***Prepared for
Poly Met Mining Inc.***

September 2013

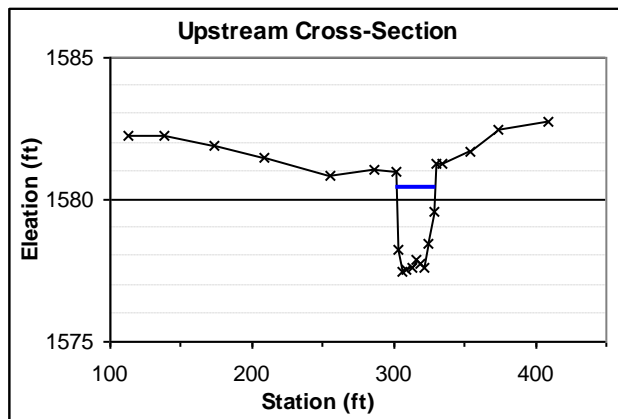
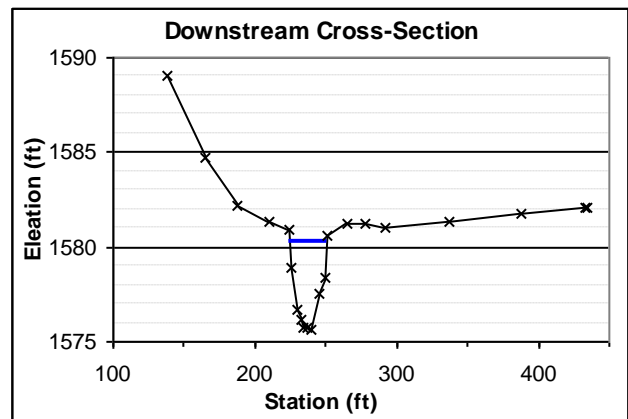
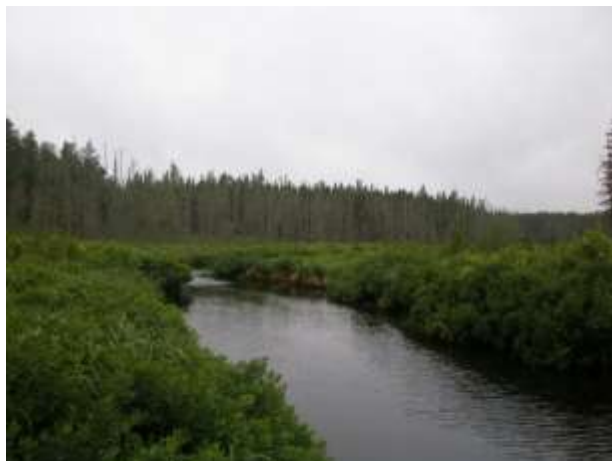
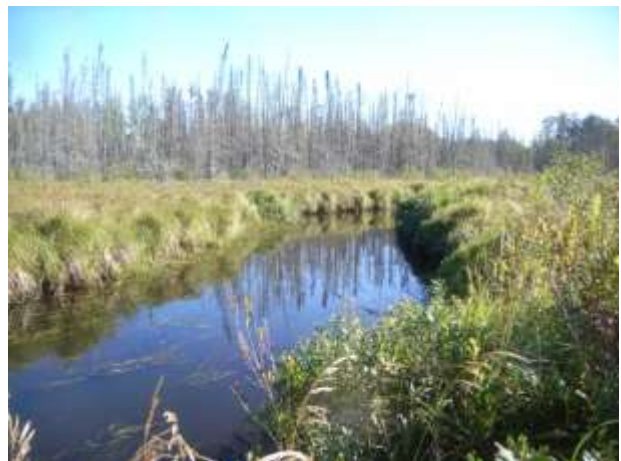
Data Sheet 1. Partridge River East Reach

Parameter	Upstream Cross-Section	Downstream Cross-Section
Bankfull Width	27 ft	27 ft
Bankfull Area	80 ft ²	94 ft ²
Bankfull Mean Depth	2.9 ft	3.5 ft
Bankfull Max. Depth	3.6 ft	4.9 ft
Entrenchment Ratio	19	19
Width/Depth Ratio	9.2	7.7
Floodprone Width	500 ft (est.)	500 ft (est.)
Dominant Bed Material	Peat/Muck	Peat/Muck
Avg. Channel Slope	0.0002	
Sinuosity	1.6	
Channel Type	E6

The East Reach is located north of Dunka Road, approximately 1.25 miles upstream of the road crossing and culvert. The measured parameters, cross-sections and photographs of this reach are shown in Appendix C, Data Sheet 1. In this area, the Partridge River meanders through wetlands with occasional low beaver dams that retard flow and increase water levels without creating large drops. The river is best characterized as a Rosgen Type E stream through this reach. The channel is slightly entrenched and has a low width/depth ratio and a high degree of sinuosity. These characteristics indicate that the stream has an adequate floodplain to dissipate energy during higher-than-bankfull flows. Flows in this portion of the Partridge River are often low (<3 cfs at the time of survey), but bankfull flows are likely near 100 cfs (Table 2a and 3a in Appendix A of Reference (2)).

Bank and floodplain vegetation at the East Reach consists of emergent and wetland grasses and wetland shrubs. In places the shrubs overhang the stream, but there is no evidence of significant

bank undercutting or other erosion on this reach. The shrub wetland along the stream is bordered by a black spruce swamp on both banks, with a strip of dead spruce at the edge of the shrub wetland. Stream bed and bank material is primarily muck and peat, with occasional areas of firmer sand and isolated boulders on the stream bed.

As a Type E6 stream, the East Reach can be sensitive to disturbances of the streambanks or significant changes in stream flow or sediment supply. As indicated in Table A-2 for type E6, the influence of riparian vegetation on channel stability is very high. Because of the well-developed bank vegetation (100% coverage on the banks), this reach is expected to be stable under moderate changes in stream flow and sediment supply. The recovery potential of this channel (should the banks be disturbed) is good.
