# Zim Sod Wetland Mitigation Site

## Wetland Mitigation Plan

Poly Met Mining Inc.

May 2014

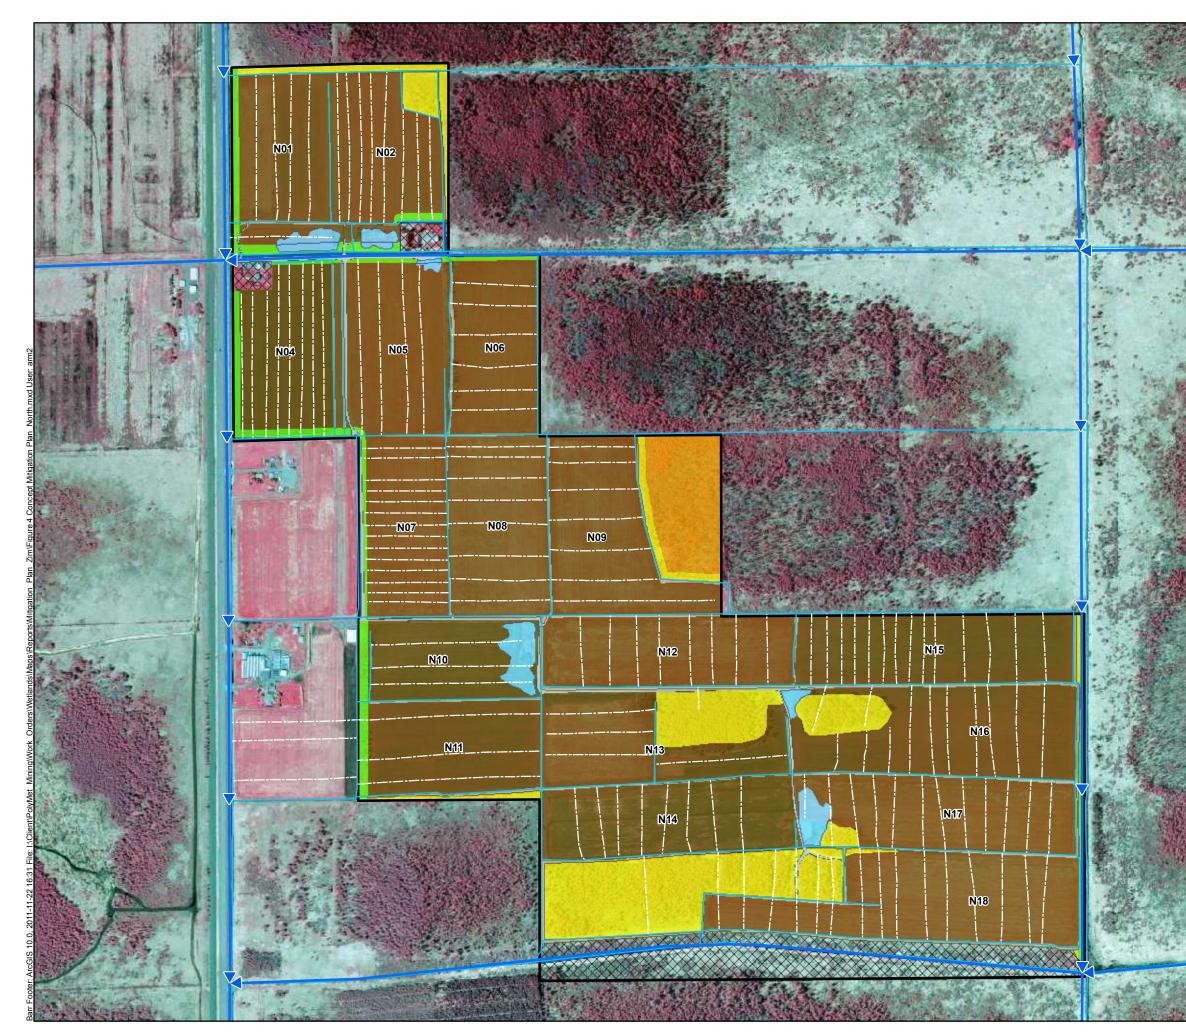
#### Figure 4

NORTH UNIT CONCEPTUAL PLAN CREDIT AREAS NorthMet Project PolyMet Mining, Inc St. Louis County, Minnesota

To the degree feasible, the primary goal of the wetland restoration on the Site is to restore a native wetland plant community. The plan for the restoration will also include an adaptive management plan to account for the natural development and to recognize changing conditions and unpredictable factors contributing to the dynamics of the Site. Restoration methods will be designed to restore a coniferous bog community (Reference (6)); however, developing a bog community is highly dependent on soil and groundwater parameters that are difficult to control. Therefore, a coniferous swamp community will be the contingent community if the soil and groundwater conditions are not adequate for bog regeneration. Coniferous bog or swamp is the target for the majority of the Site, from which 438 forested wetland credits will be established.

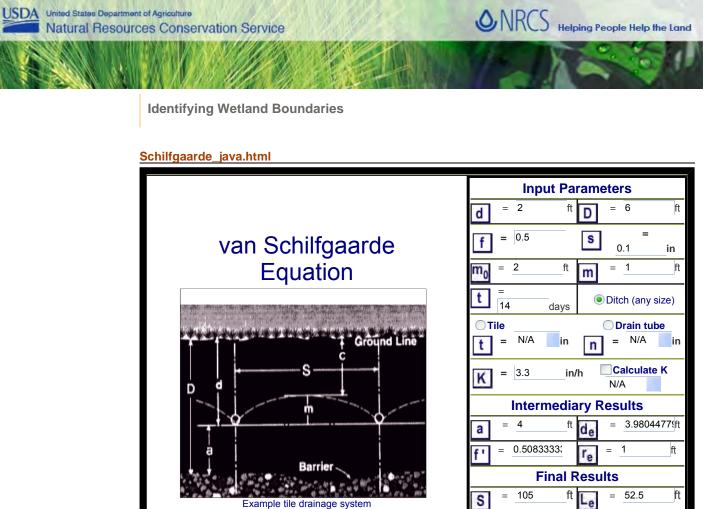
User Name : null	Notes
Reset Name	Greenwood soils, 2 ft deep ditch
Session # : 2	
Time: 13:08	
Date:	
11//index.html16//index.html2011

**Ditch Lateral Effect Calculations**

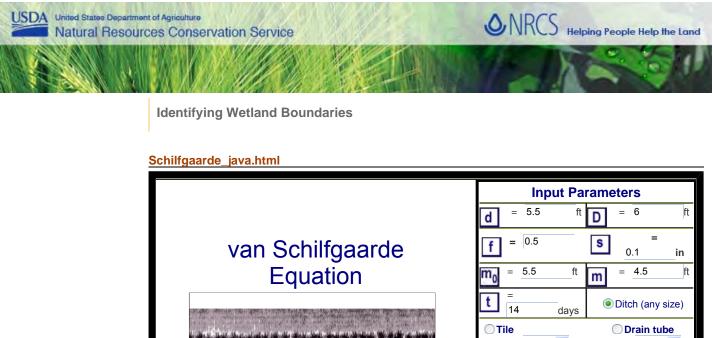
User Name : null	Notes
Reset Name	Gueenwood apila E ft door ditab
Session # : 2	Greenwood soils, 5 ft deep ditch
Time: 13:08	
Date:	
11//index.html16//index.html2011

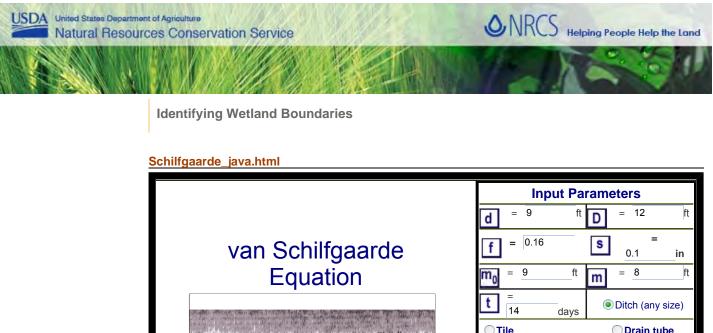
User Name : null	Notes		
Reset Name	Greenwood acila 0 ft door ditch		
Session # : 2	Greenwood soils, 9 ft deep ditch		
Time: 13:08			
Date:			
11//index.html16//index.html2011
