## **2011 Project Abstract**

**PROJECT TITLE:** Restoration Strategies for Ditched Peatland Scientific and Natural Areas

**AFFILIATION:** MN DNR

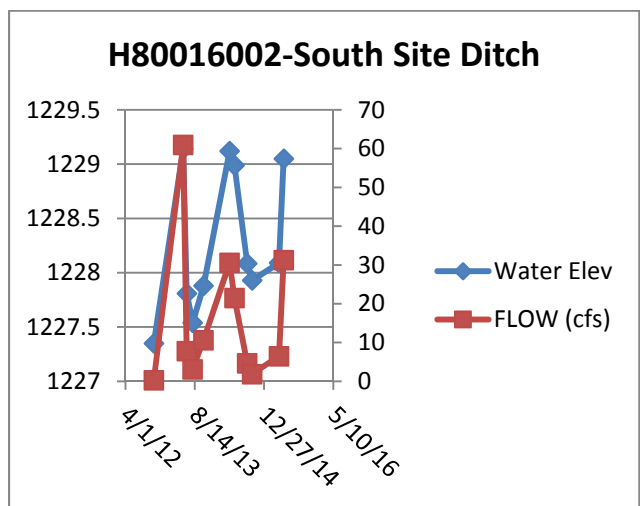
**Figure 10a: Hydrographs of Synoptic Surface Water Sites (Data gaps connected by solid line).**

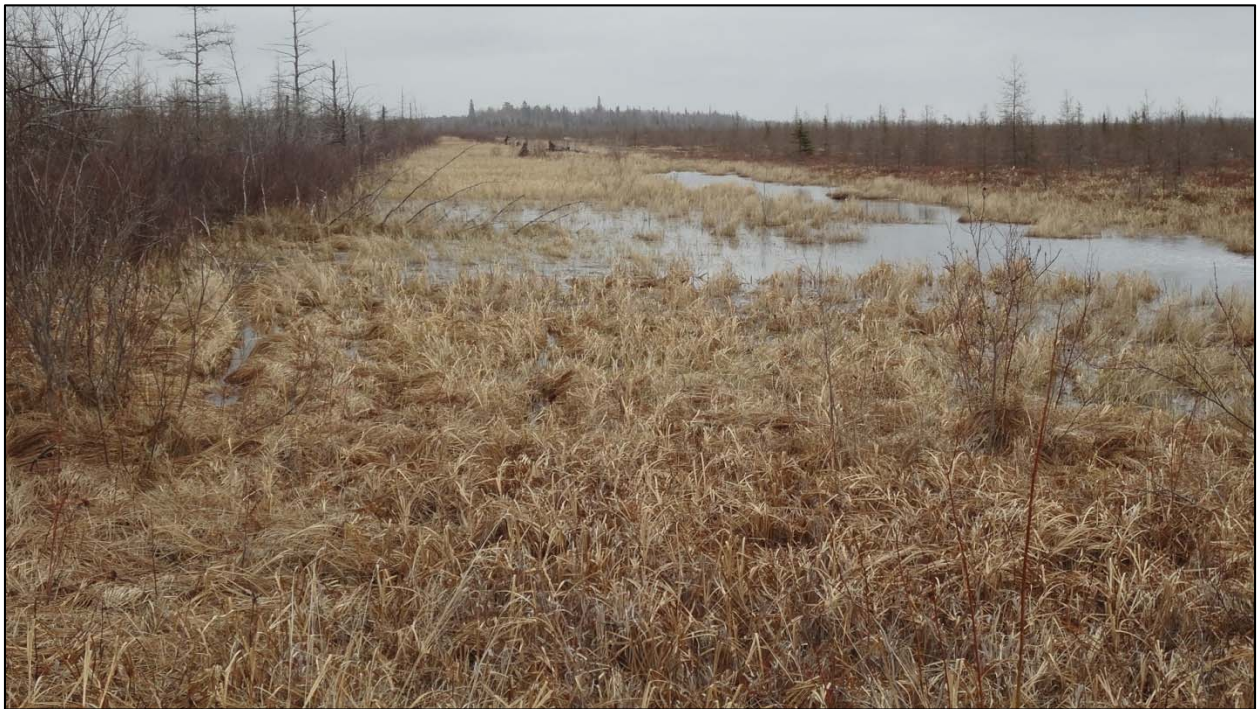
**Figure 2:** Clay core ditch block at the Brown's Lake Peatland Restoration site. May 2014.

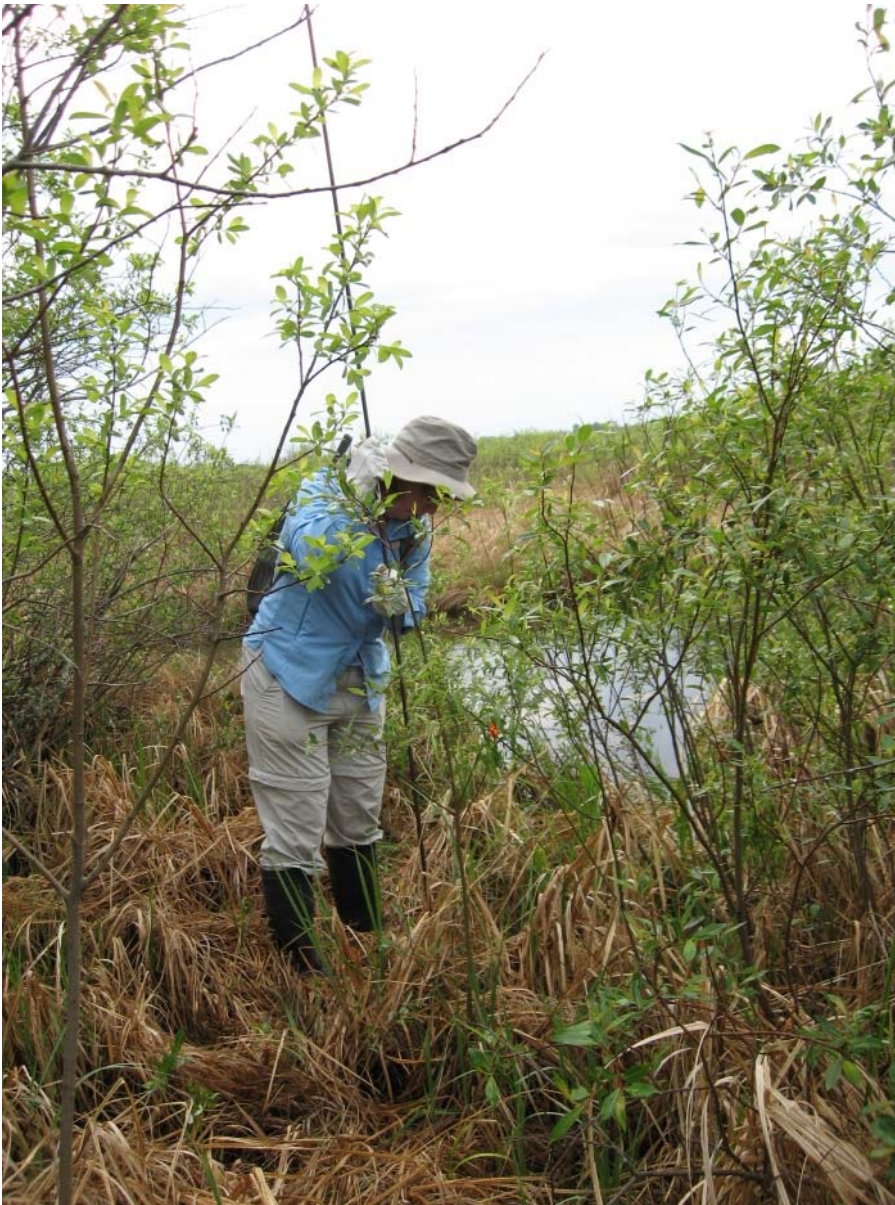
Step 3: Using Re-bar, determine the depth to mineral soil (peat thickness)

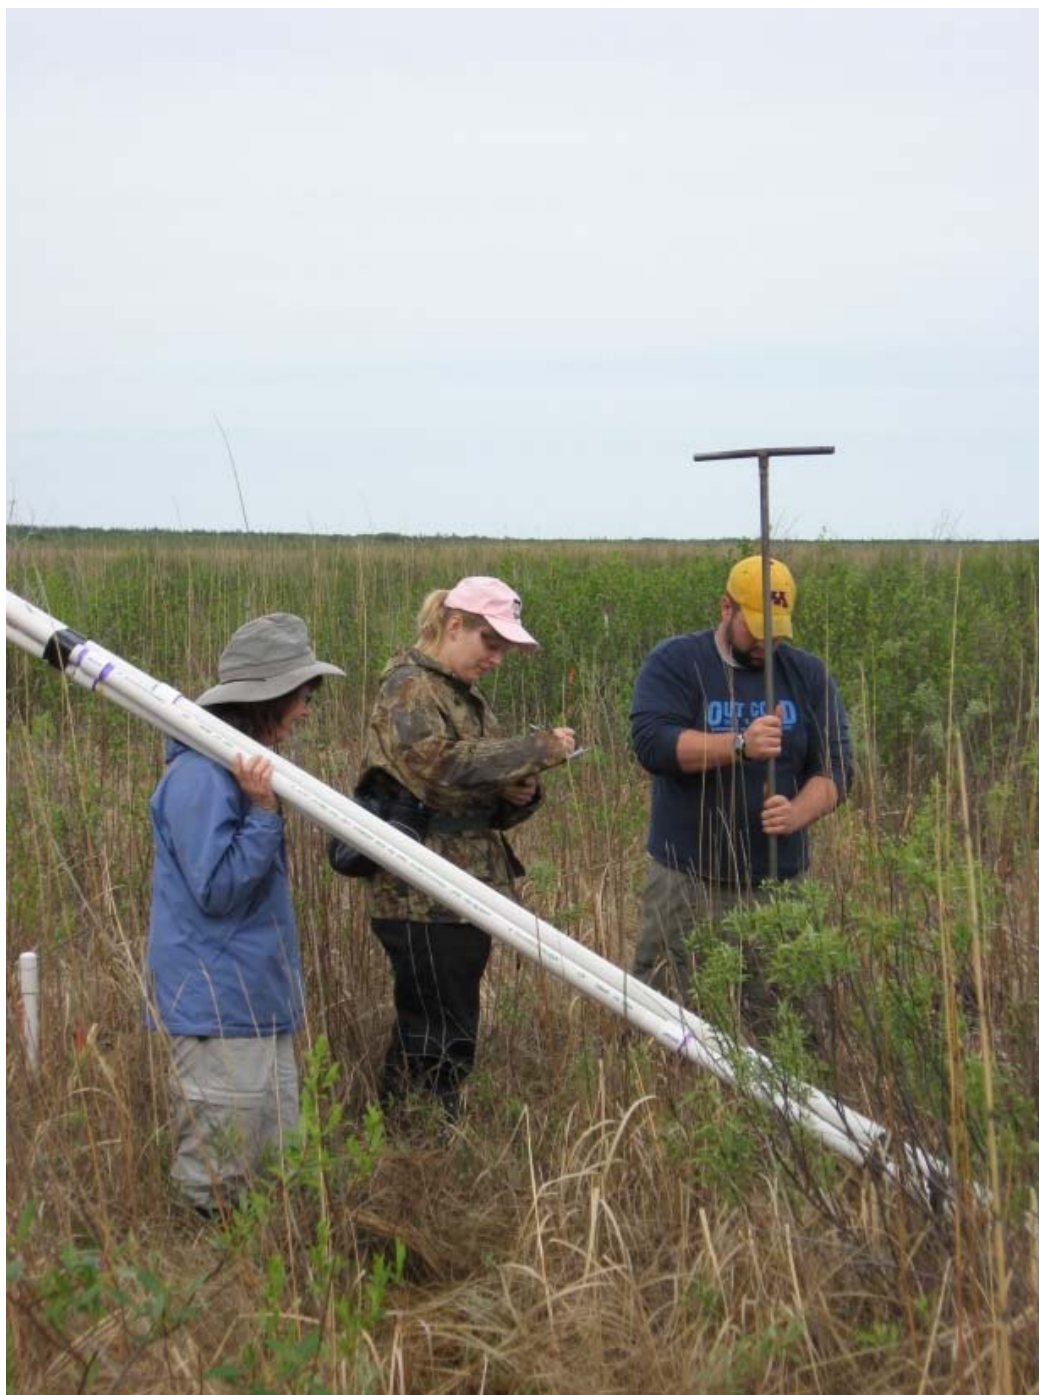
Step 4b: Bring pre-constructed piezometer out to site

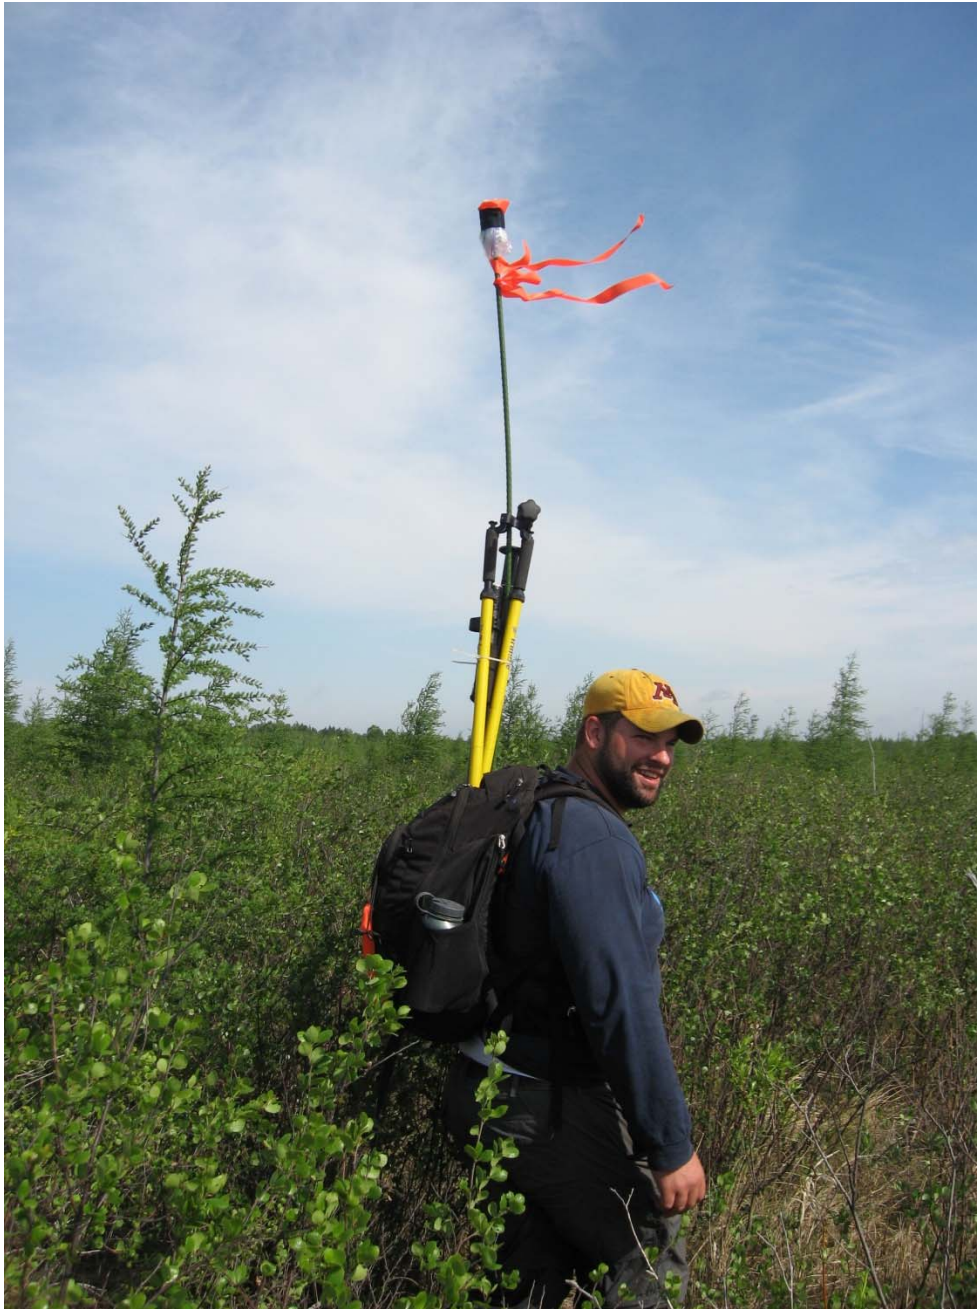
Step 8: Survey well locations and top of casing elevation.
