## **FIELD TEST REPORT**

**PROJECT: Senate / New Legislative Office Building  
St. Paul, Minnesota**

**Report No.: E8666.05-201-43**

**Project Summary:** Architectural Testing, Inc., an Intertek company ("Intertek-ATI"), was contracted to perform on-site testing at the above referenced project. Water penetration test were conducted on six (6) specimens consisting of a Kawneer 1600 UT Curtain Wall System. The specimens tested met the performance requirements listed herein.

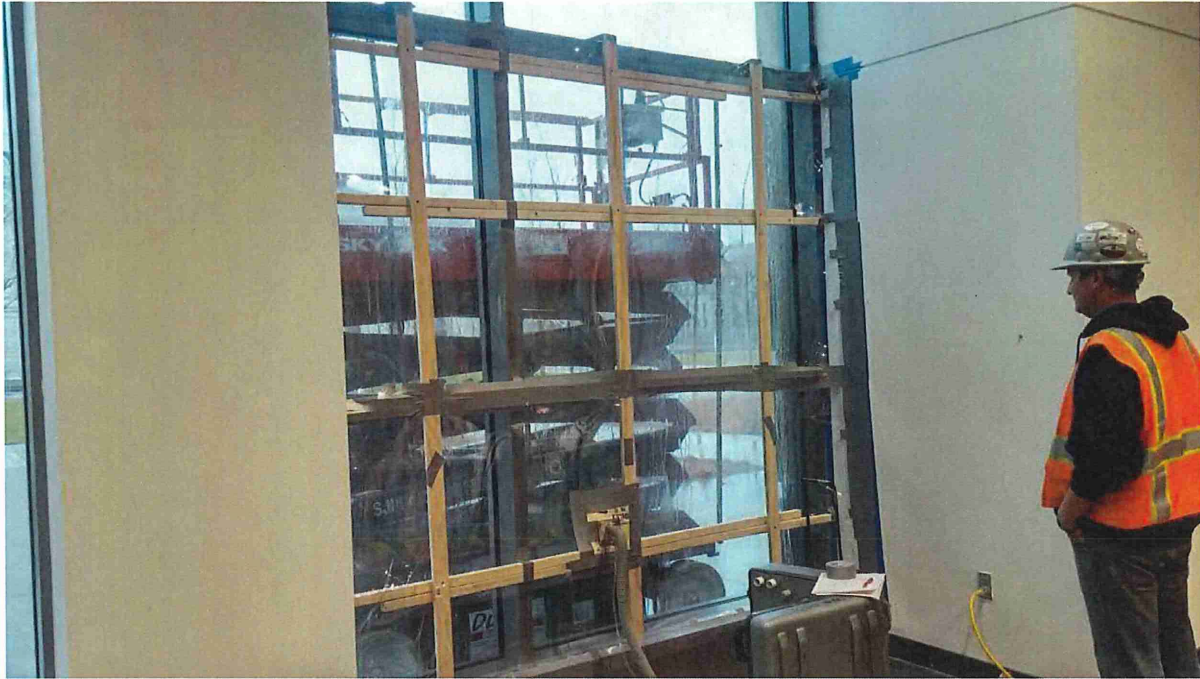
Location: South elevation, first floor, southeast hallway, second bay from the southeast corner of building.

No water leakage

**Photo No. 1 – Test Specimen #1**  
**Interior view with test chamber.**

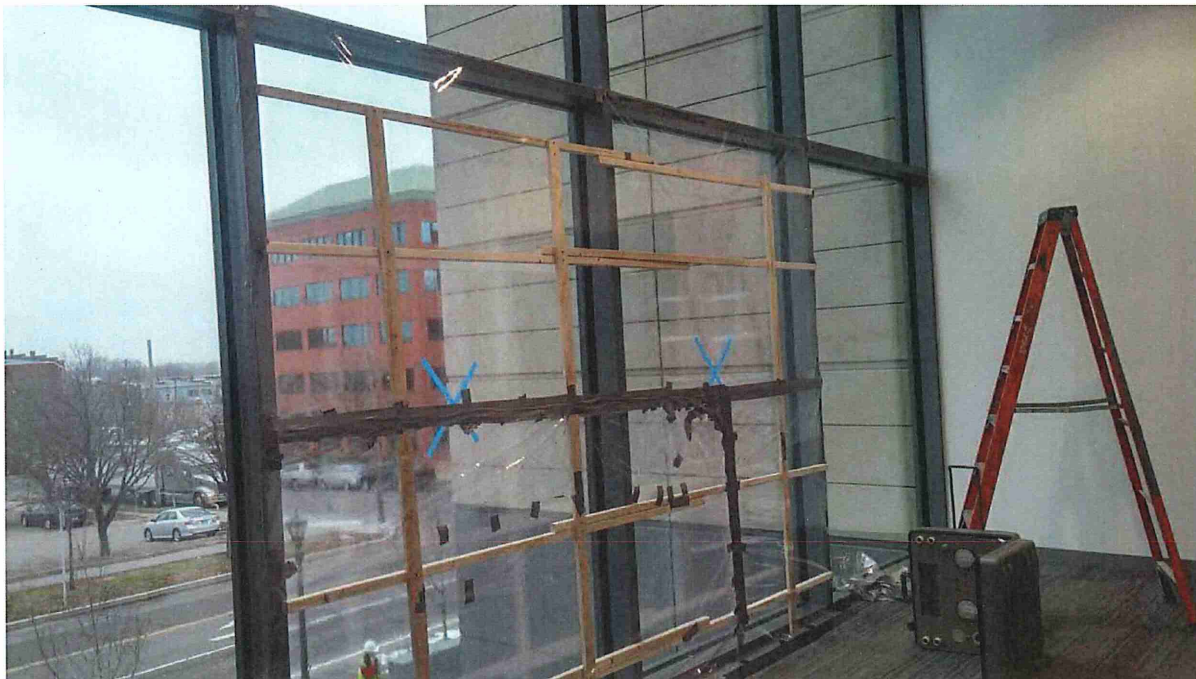
Manufacturer: Kawneer  
Description: 1600 UT series aluminum curtain wall system  
Overall Size: 12' 1/2" wide by 9' 7" high  
Location: West elevation, first floor, south of stair 1, second and third lites from the north.

<u>Title of Test</u>	<u>Test Results</u>	<u>Allowable</u>
Water Penetration @ 15.0 psf	No water leakage	No water leakage

**Photo No. 2 – Test Specimen #4**  
**Interior view with test chamber**

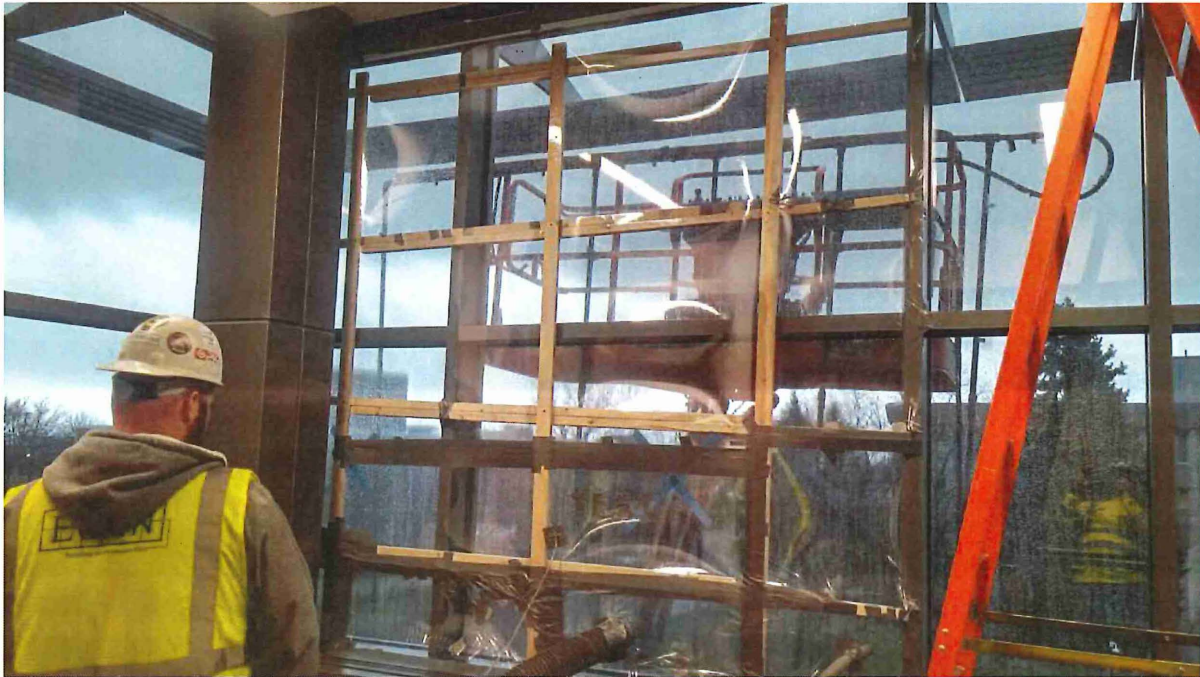
Manufacturer: Kawneer  
Description: 1600 UT series aluminum curtain wall system  
Overall Size: 12' 1/2" wide by 9' 7" high  
Location: East elevation, third floor, room 3133, first and second lites from north.

<u>Title of Test</u>	<u>Test Results</u>	<u>Allowable</u>
Water Penetration @ 15.0 psf	No water leakage	No water leakage

**Photo No. 3 – Test Specimen #6  
Interior view with test chamber.**
