**ST. CROIX CROSSING LOOP TRAIL (PHASE 1)
ARCHAEOLOGICAL CONSTRUCTION MONITORING,
STILLWATER, WASHINGTON COUNTY, MINNESOTA**

**MnDOT Contract No. 04550
State Project No. 8214-114AK
Two Pines Resource Group No. 13-06
OSA License No. 15-63**

**FINAL
January 2016**

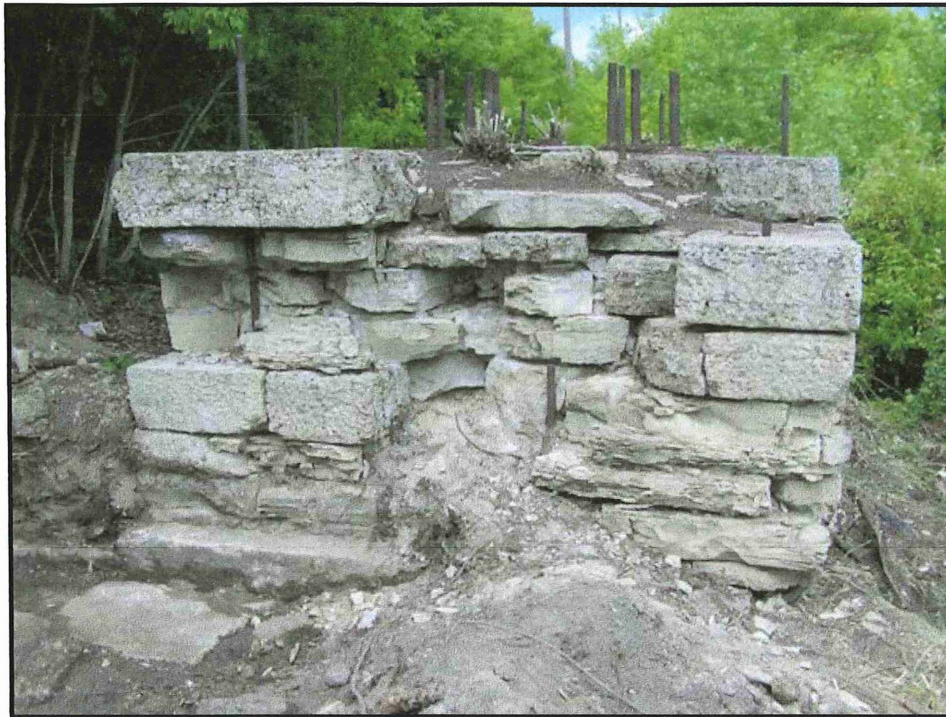
- Sawmill Power House - The footings and foundations of the main sawmill's gang saw (Figure 4), flywheel (Figure 5), and engine. Portions of these features are visible on the surface and others are subsurface.
- Chimney Base – The base of the mill's formerly 30-ft. tall stone chimney is preserved on private property atop the bluff (Figure 6).
- Store/Office Building – The stone foundations of the mill's two-and-a-half story, wood-frame store/office building, which was constructed in 1879, are preserved within a copse of trees. This building was reused and adapted during the twentieth century.
- Retaining Walls– Limestone retaining walls are present along the west edge of the site. These include Walls E and F, and the undesignated wall to the northwest of the store/office building (Figure 7).

FIGURE 4. GANG SAW BASE IN 2004, HERSEY & BEAN LUMBER COMPANY SAWMILL, FACING NORTH

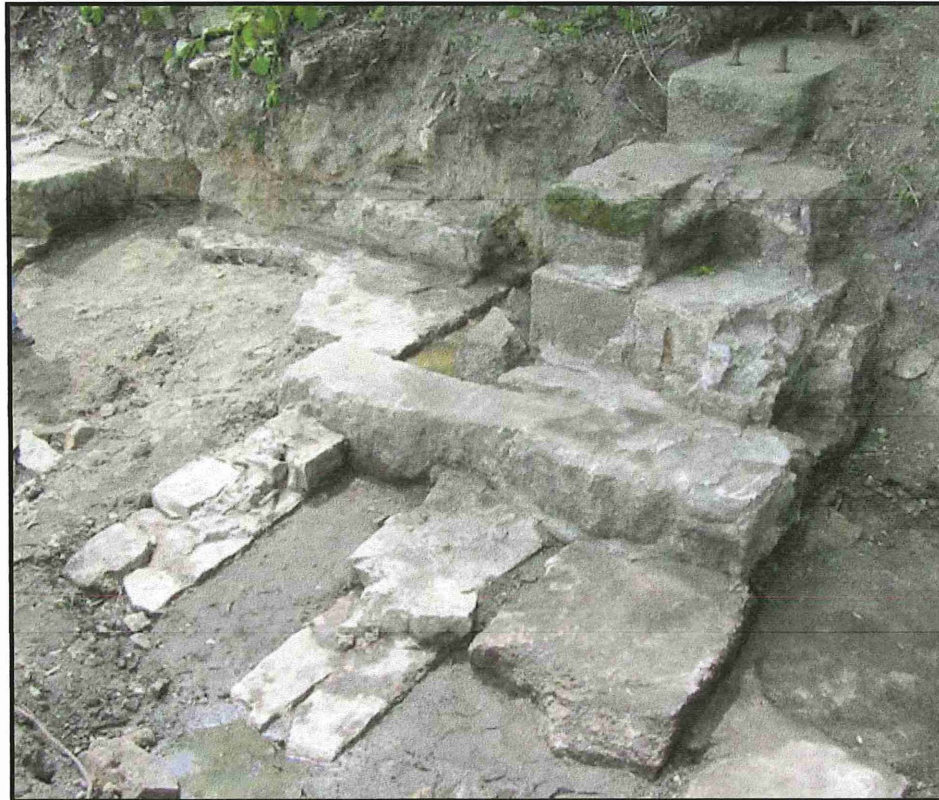
FIGURE 5. FLYWHEEL BASE IN 2004, HERSEY & BEAN LUMBER COMPANY SAWMILL, FACING SOUTH

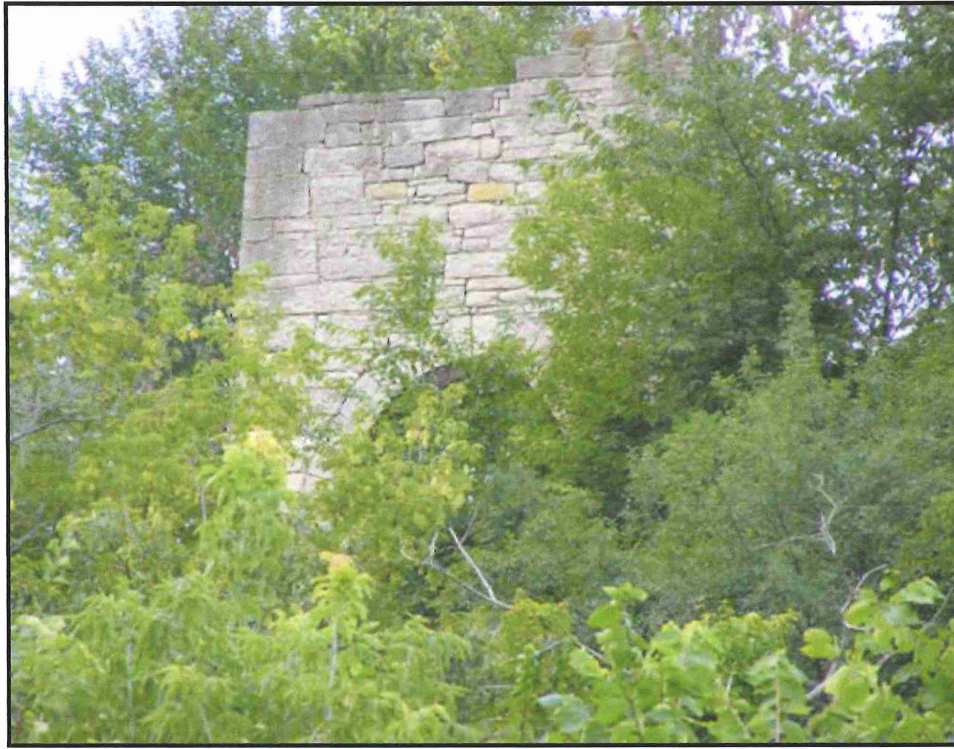
FIGURE 6. CHIMNEY BASE, HERSEY & BEAN LUMBER COMPANY SAWMILL, FACING WEST

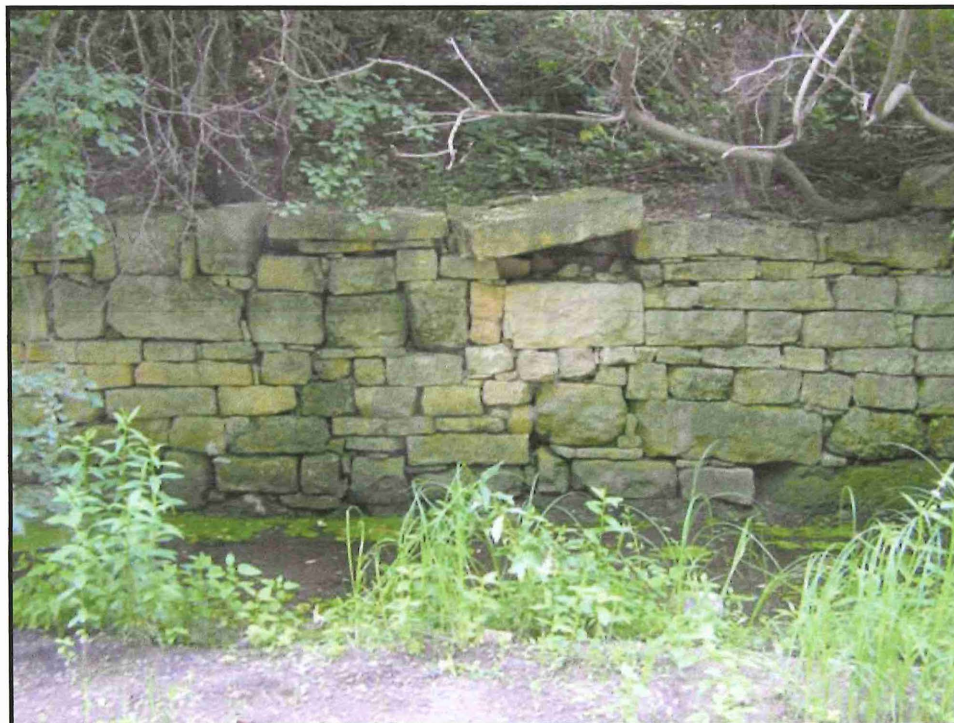
FIGURE 7. SEGMENT OF RETAINING WALL E WITHIN 21WA91

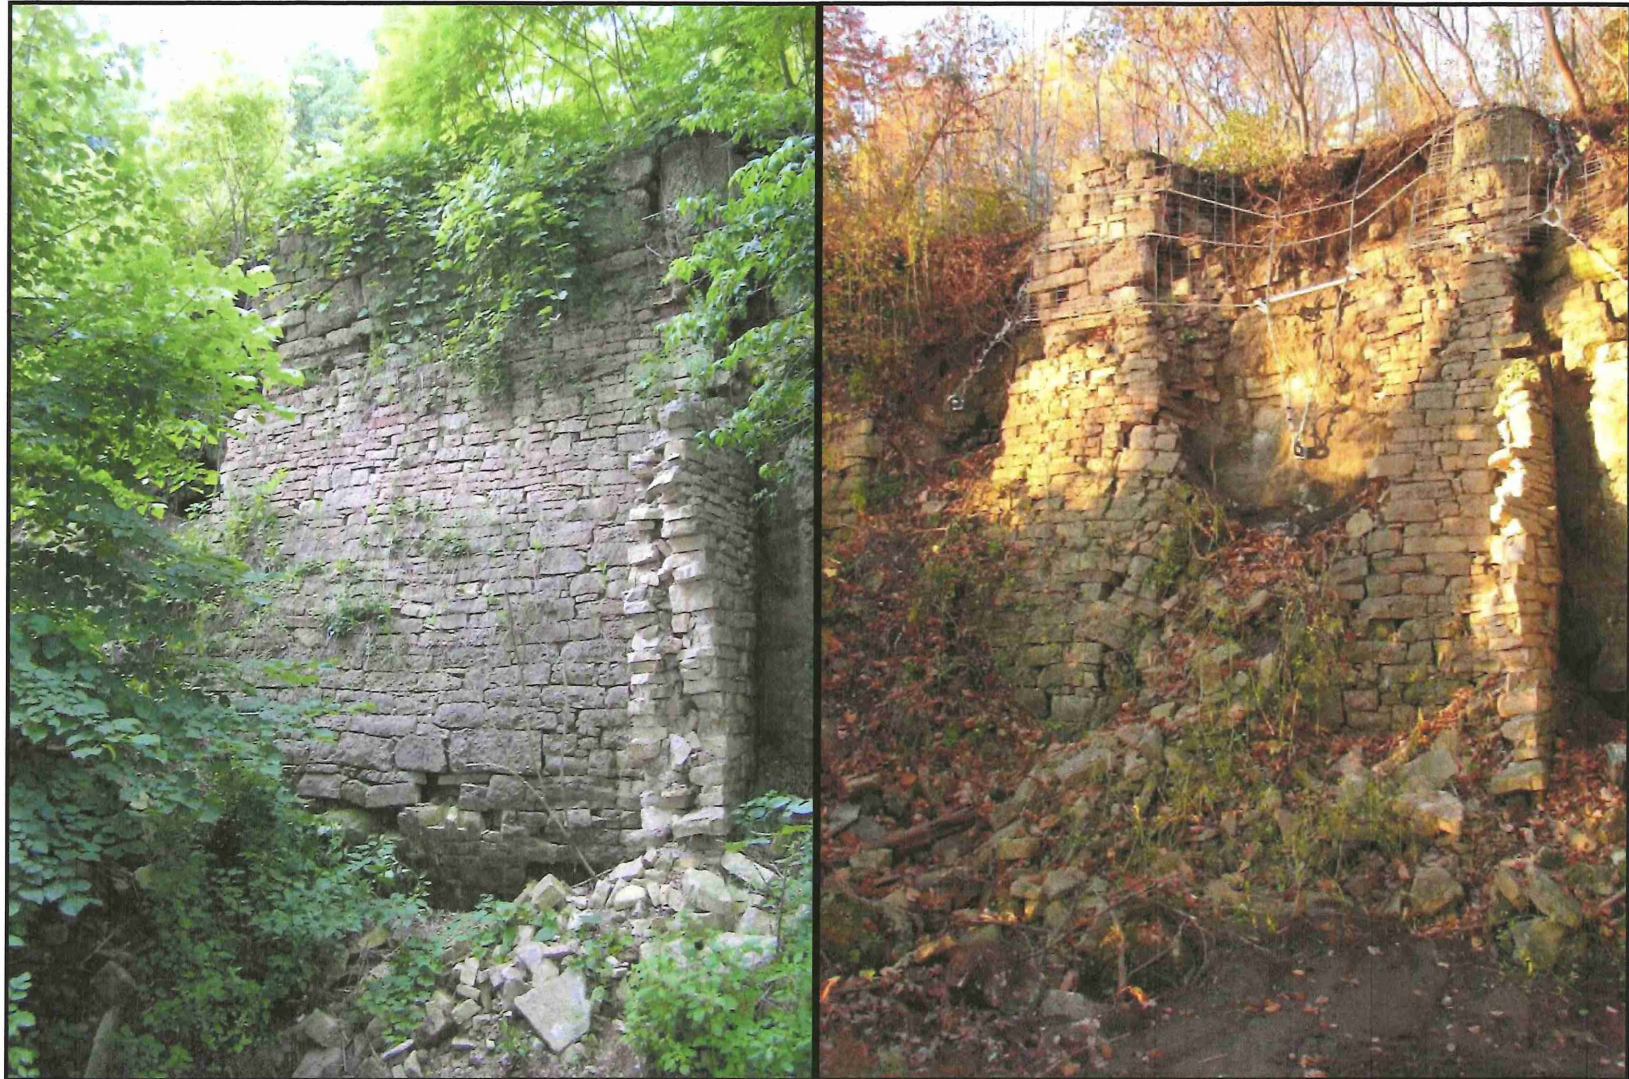
FIGURE 8. WALL D AS IT APPEARED IN 2004 (LEFT) AND AFTER STABILIZATION IN 2015 (RIGHT), VIEW TO SOUTHWEST

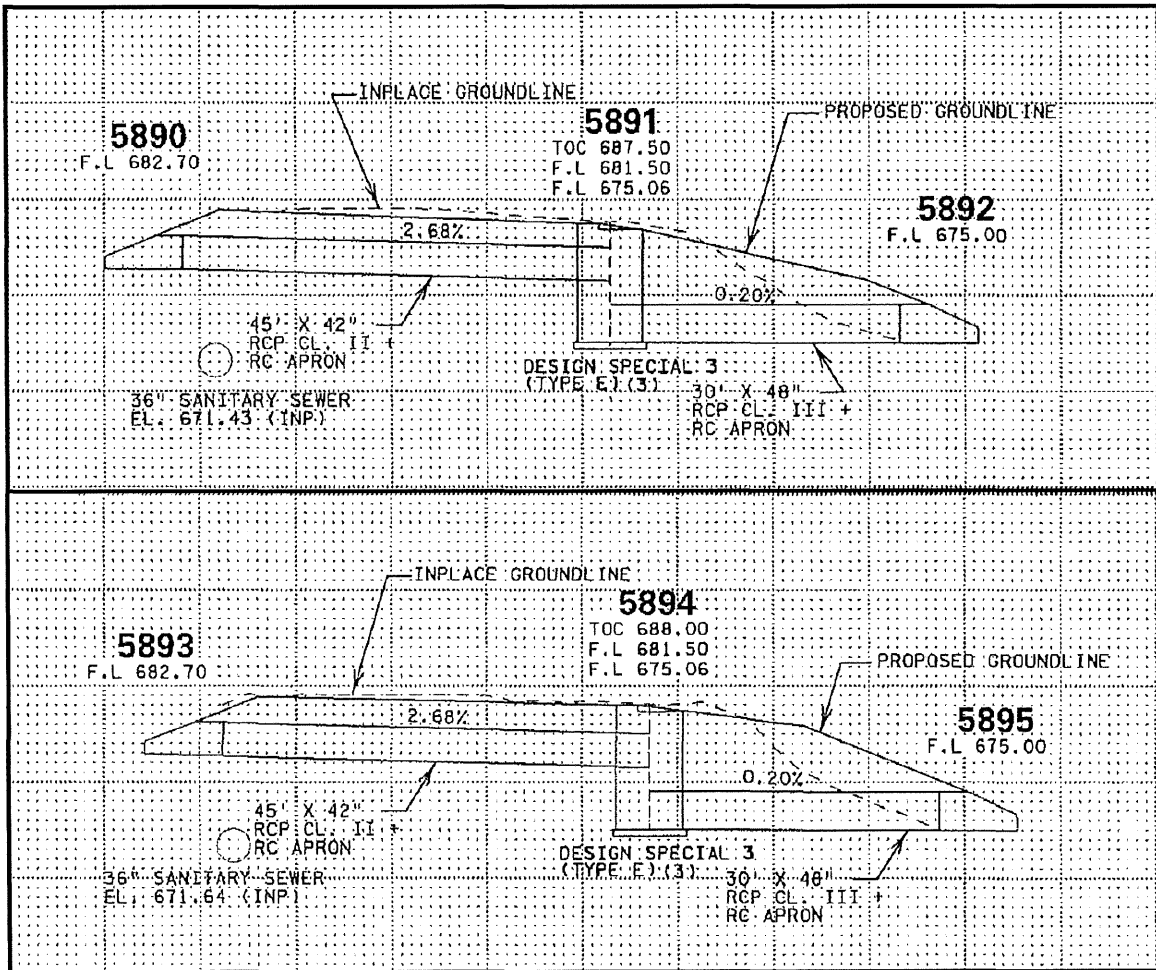
Two parallel storm sewers from Structures 5890 to 5892 and 5893 to 5895 were constructed just outside the south boundary of the District along a section of shoreline that would have been inundated during the operation of the mills (see Figures 9 and 11). The function of these pipes is to carry water from a ditch located at the foot of the exposed limestone bluff to the river. The City of Stillwater's existing 36-in. sanitation line runs north-south beneath these pipe alignments. Examination of the trenches for these approximately 90-ft. long pipe runs confirmed that they were excavated entirely within shoreline fill and no intact archaeological deposits or features were observed within or proximate to their construction limits.

FIGURE 9. PRE-CONSTRUCTION PROFILES OF STORM SEWERS 5890 TO 5892 AND 5893 TO 5895

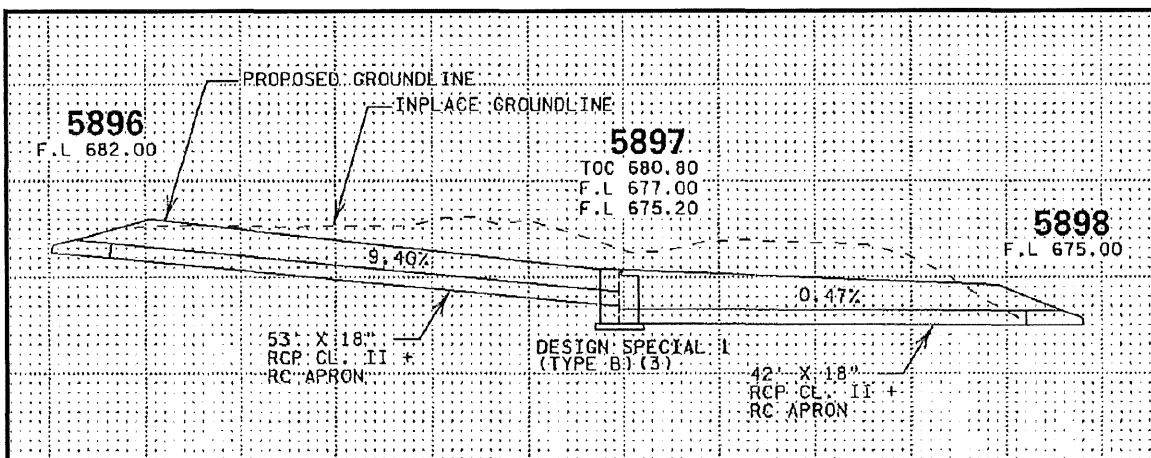
FIGURE 10. PRE-CONSTRUCTION PROFILE OF STORM SEWER 5896 TO 5898

Monitoring of the installation of this pipe run revealed deep deposits of introduced fill to the base of the excavation cut. Observed within the fill were road demolition debris (asphalt, granite and concrete curbing, and paving cobbles) as well as household demolition material (red brick, toilet tank fragments, and porcelain electrical resistors). Within the very west end of the cut for this pipe run and at a depth of approximately 110 cm below the surface (cmbs) a very dark grayish brown (10YR 3/2), silt loam containing numerous wood fragments and a section of an eight inch by ten inch diameter timber was encountered. The apron (Structure 5896) was set atop this horizon. During the subsequent excavation of the swale to the west of Structure 5896, the horizon containing the water-logged wood fragments was revealed to be both above and around the north-south running sanitary sewer line. It is unclear if this material is fill that was introduced to the site during the installation of the sanitary sewer line, or these wood fragments were generated during the mill's period of operation and disturbed and backfilled into the trench at the time the sanitary sewer line was constructed. In either case, the strata with wood fragments encountered within the cut for the storm sewer line between Structures 5896 and 5898 is not a primary deposition due to disturbance from the sanitary sewer installation.

The construction of the storm sewer line between Structures 5896 and 5898 and the excavation of an associated swale took place entirely within shoreline fill or disturbed soils and no intact archaeological deposits or features were observed within, or proximate to, the construction limits.

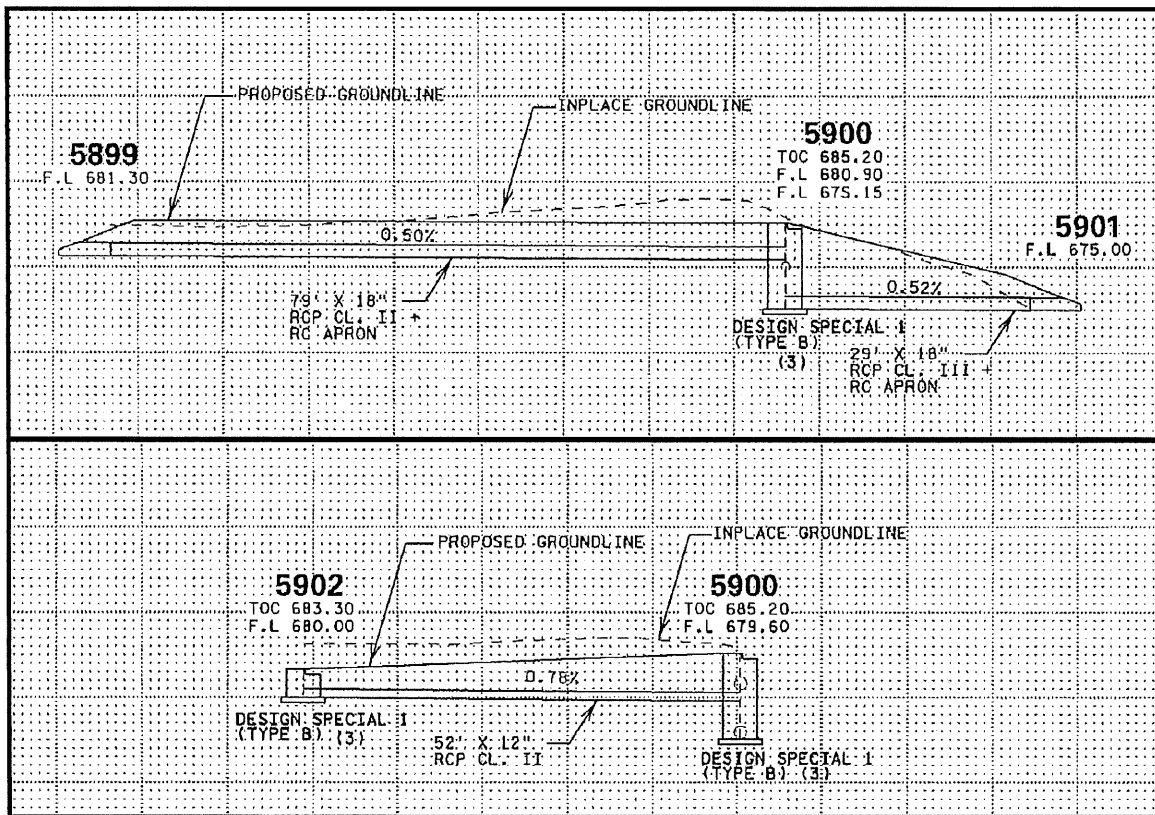
FIGURE 12. PRE-CONSTRUCTION PROFILES OF STORM SEWERS 5899 TO 5901 AND 5900 TO 5902

Monitoring of the installation of these segments of storm sewer revealed a general soil profile consisting of introduced fill overlying thick bands of coal resulting from the stockpiling of coal on the property when it was the Stillwater Municipal Barge Facility (Figure 13). These coal bands overlay earlier fill. Along the shore of the St. Croix River, the approximately 10-ft. deep cut for Structure 5901 was excavated entirely within modern rocky fill. A concrete slab for mooring barges was encountered along the south edge of the cut and left in place. At Structure 5900, where the cut was approximately 12 feet deep, the profile of the trench consisted of modern urban fill containing limestone rubble that capped bands of coal cinders encountered between two and four feet below the surface. These coal bands varied in thickness from 20 to 50 cm. Coal deposits were thicker towards the river than inland. Underlying the coal was additional fill deposits and/or crushed limestone which gave way to a gley subsoil at 7 feet below the current surface. The cut for the storm sewer line between structures 5900 and 5902 encountered the same stratigraphic profile. Three sherds of plain ironstone and two colorless pieces of glass that originated in the fill beneath the coal bands were observed on the backdirt pile.

The construction of the storm sewer lines between Structures 5899 and 5901 and 5900 and 5902, together with the excavation of an associated swale, took place entirely within modern deposits and fill. No intact archaeological deposits or features were observed within, or proximate to, the construction limits.

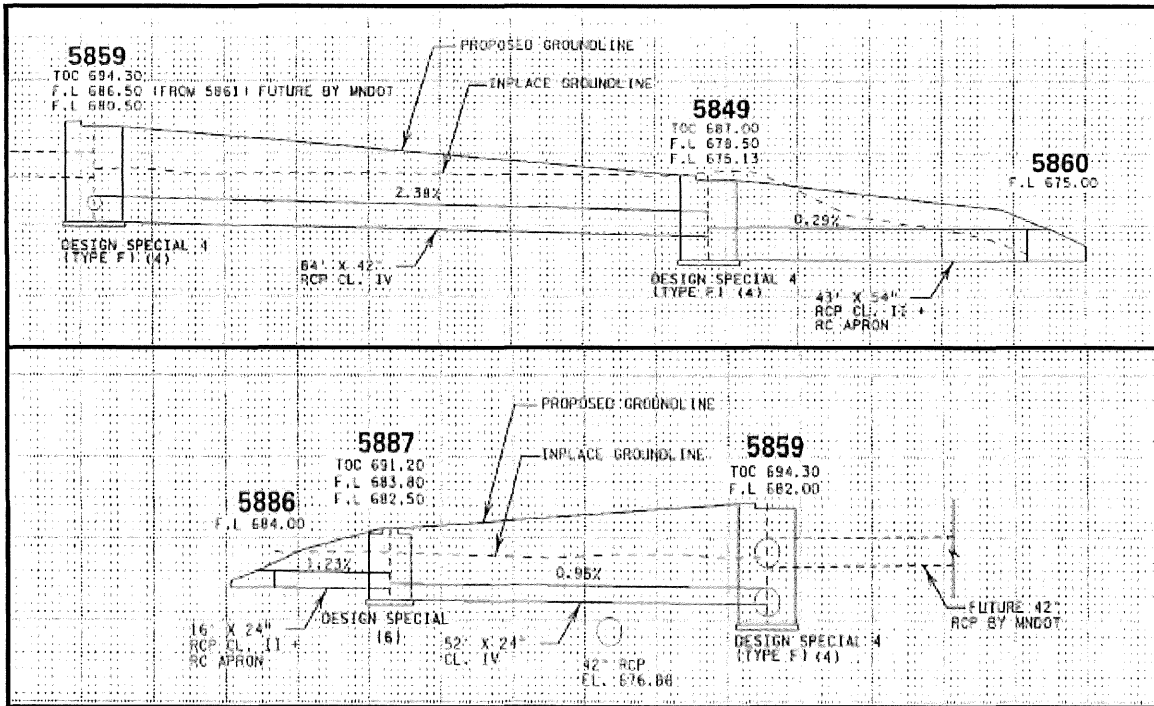
FIGURE 15. PRE-CONSTRUCTION PROFILES OF STORM SEWERS 5859 TO 5860 AND 5859 TO 5886

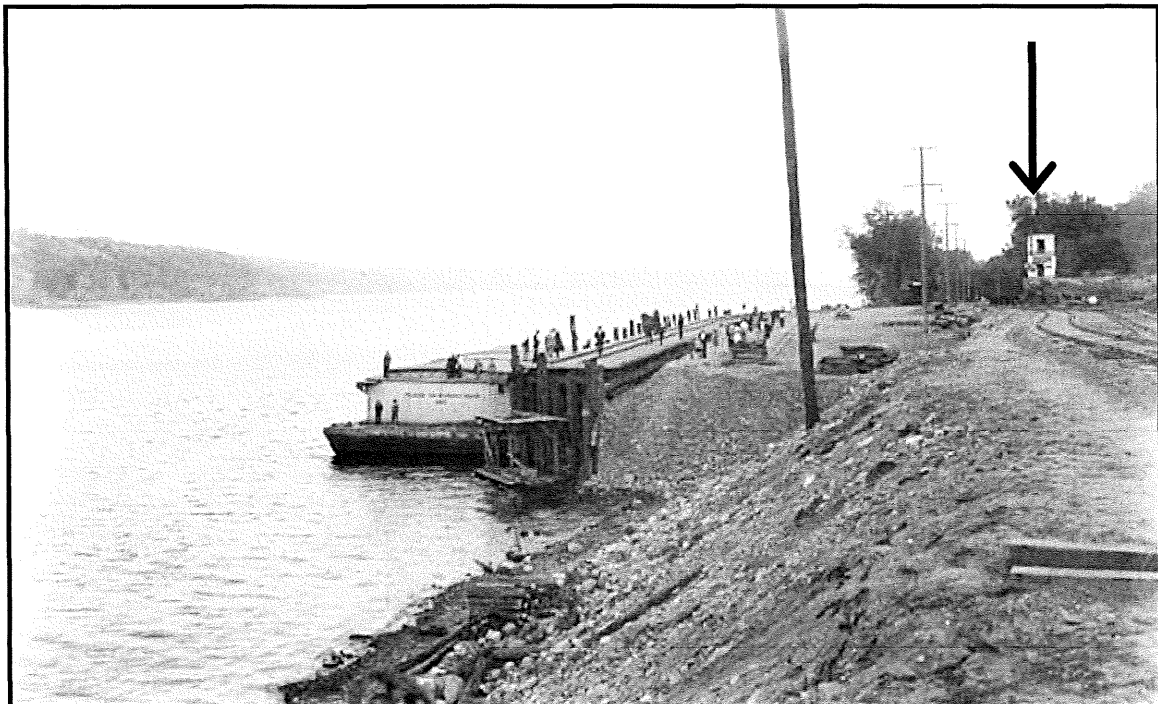
FIGURE 18. SHORELINE FILL IS EVIDENT IN THIS HISTORIC IMAGE OF THE SHODDY MILL SITE AND THE SHODDY MILL POND LOCATION, 1939, VIEW TO SOUTH-SOUTHEAST

The construction of the storm sewer lines to the north of the foundations of the Hersey & Bean Lumber Company's office building encountered deep urban fill deposits along the shoreline to the base of the excavation trench. During the twentieth century, fill was introduced to the site, initially to increase the land area available for the rail yard of the Stillwater Municipal Barge Facility, and later to decrease the likelihood of flooding (Figure 18). Inland, approximately 14 m (46 ft) to the east of the east foundation of the office building, the natural shoreline was encountered at a depth of approximately 2.60 m (8.5 ft.). An accumulation of stumps and wood float like that seen along the river's present shoreline marked this transition. Further inland at approximately 5 m (16 ft.) east of the office building's east foundation a 40-50 cm thick layer of sawdust and slab wood was documented at approximate depths of 2.6 to 3 m (8.5 to 9.8 ft.) (Figure 19). The depth of this horizon of sawdust, which is associated with the operation of the Hersey & Bean Lumber Company, often corresponded to the base of the cut for the pipe installation and followed the natural profile of the shoreline being deeper towards the river (16-18 ft. [4.9-5.5. m] below the surface near Structure 5849) and shallow inland. A single sherd of stoneware was observed within the sawdust horizon. As the trench excavations approached the area to the immediate north of the office building's foundations, a shallow bedrock outcrop was encountered. The eastern edge of the bedrock was located approximately 1-2 m to the east of the alignment of the office's east foundation indicating the office building was constructed atop bedrock.

Note: During this period the foundations of the former lumber company office building have been adapted to serve as switching tower and office (arrow) (MNHS Collections: Runk 2099)

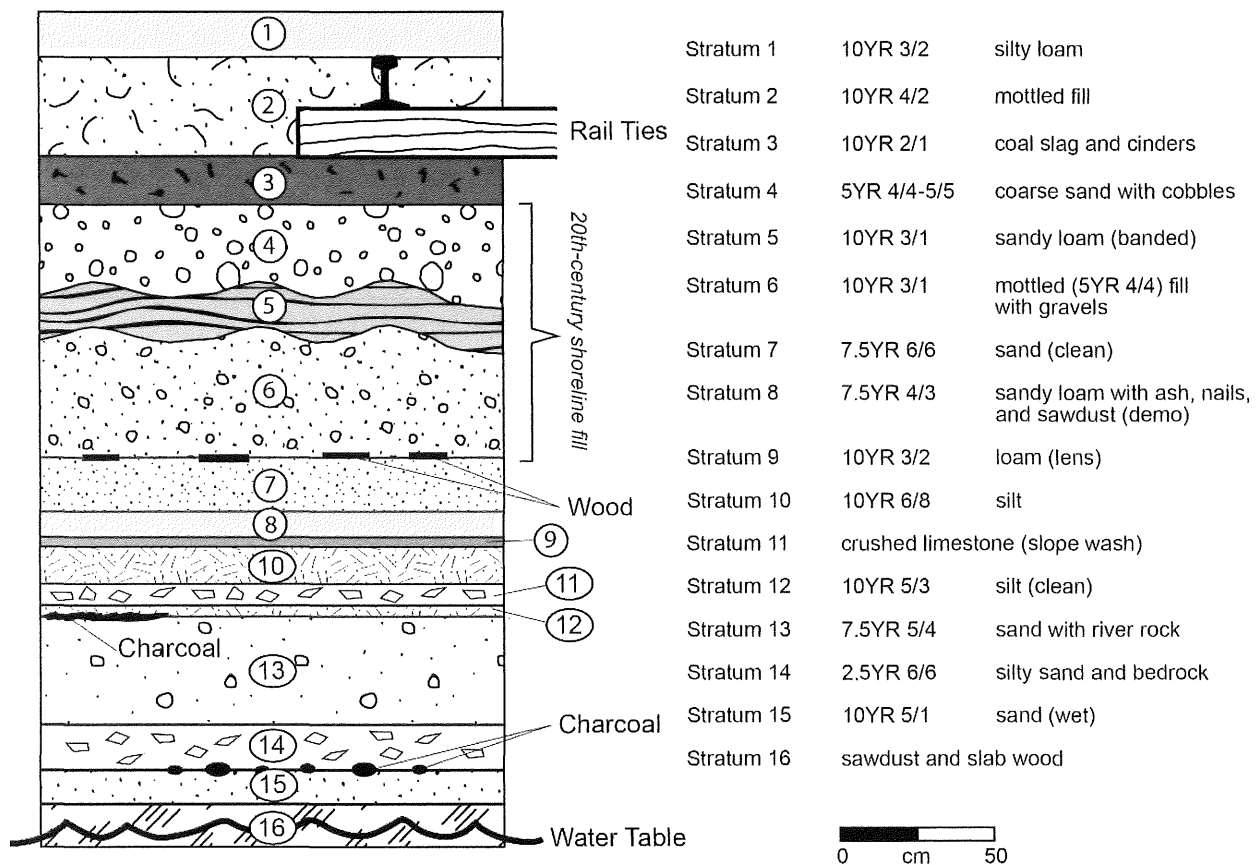
FIGURE 19. GENERAL STRATIGRAPHIC PROFILE 5 METERS EAST OF THE FOUNDATION OF THE OFFICE

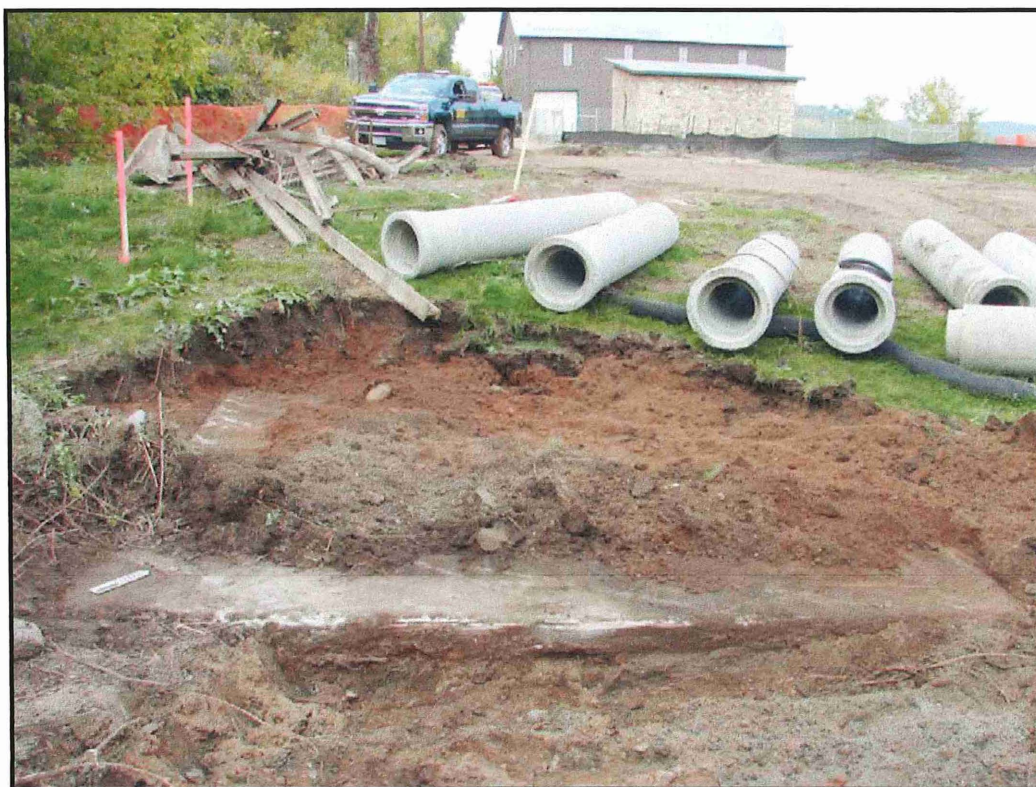
The only feature encountered during the excavation of this drainage system was a concrete slab located to the immediate east of the planned location of Structure 5879. This slab, which was partially visible on the surface, was six inches thick and 12 ft. wide (north-south) by 13 ft. and seven inches long (east-west) (NAD 83, Zone 15, Southeast Corner: 515674.25 E 4988611.16 N; Southwest Corner: 515671.17 E, 4988608.99 N) (Figure 20). This slab was removed to make way for Structure 5879. To its immediate north, this slab abutted another concrete pad that had a thickness of one foot, but the dimensions of which were not exposed. The northernmost slab was left in place. Both slabs were covered by clean sand used to remediate the Terra Terminal site. These slabs were located in the vicinity of the Terra Terminal building's former fertilizer loading facility and apparently formed part of the driveway and/or foundation for that facility (Figure 21).

FIGURE 20. CONCRETE SLAB AT LOCATION OF STRUCTURE 5879, VIEW TO NORTH

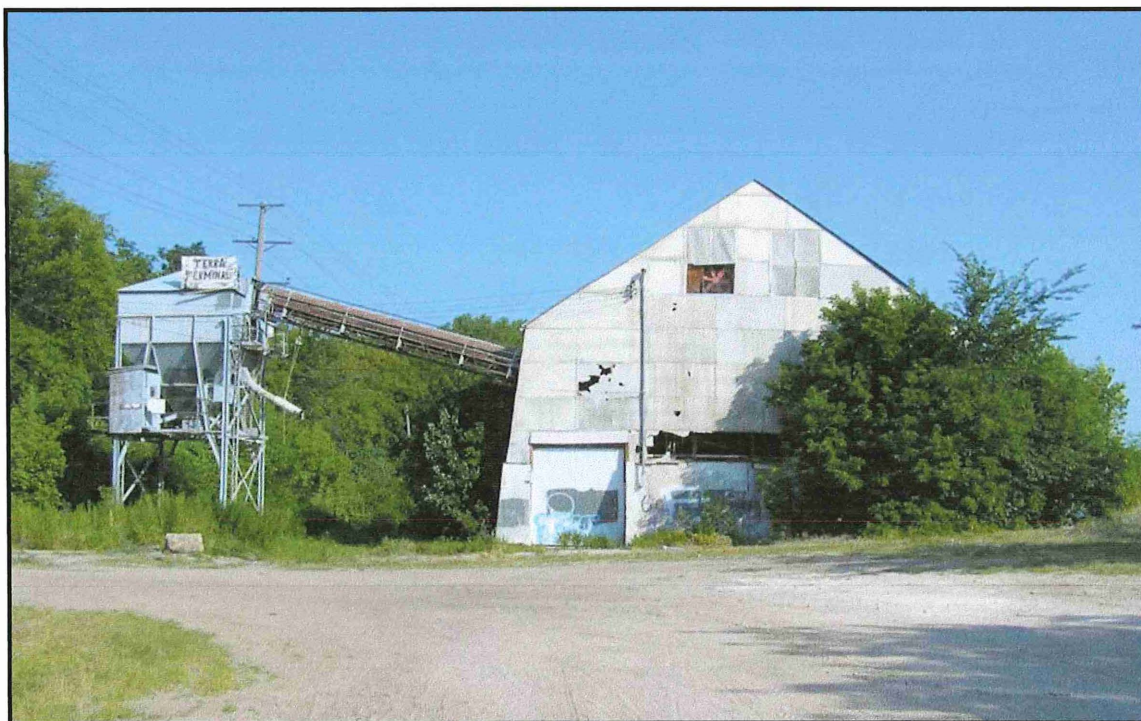
FIGURE 21. TERRA TERMINAL BUILDING IN 2004, LOADING FACILITY ASSOCIATED WITH CONCRETE SLABS AT LEFT, VIEW TO NORTHWEST

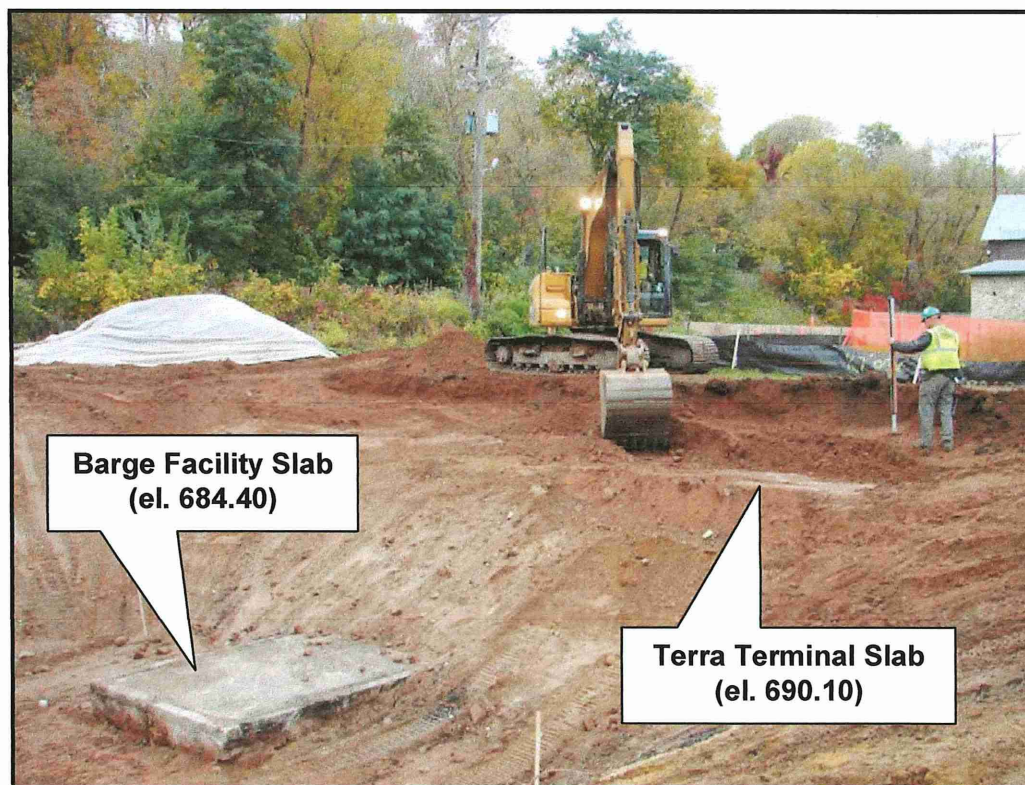
During the excavation of the pond, two twentieth-century concrete features that post-date the Hersey & Bean sawmill were documented. Along the north edge of the pond cut, the southernmost 3 feet of the broken edge of the 1-ft. thick concrete slab of the circa 1960 Terra Terminal building were exposed at a depth of 4 ft. below the surface (el. 690.10; NAD 83, Zone 15, Central Point: 515683.40 E 4999631.62 N) (Figure 23). A second concrete slab was also documented at the north end of the pond cut, but at a lower elevation (el. 684.40) (NAD 83, Zone 15, Southeast Corner: 515686.92 E 4988625.69 N; Southwest Corner: 515685.05 E, 4988624.33 N) (see Figures 23 and 24). This 14-inch thick slab measured 97 in. across (east-west). A slightly (0.5 in.) raised six-inch surround defined a seven-foot wide interior space. The concrete floor of the interior was stained with rust and coal. A single piece of flat glass was observed while the slab was being cleared. Only 10 ft. of the north-south extent of the slab was exposed. Based on the presence of rebar ties centered on the south side and eight feet from the southernmost

FIGURE 23. TERRA TERMINAL AND BARGE FACILITY CONCRETE SLABS, VIEW TO NORTHWEST

edge on the east and west sides, it is surmised that the slab may measure eight by sixteen feet. This slab was constructed after the reddish brown (5YR 4/3) silty sand fill with river rock was introduced to create additional shoreline. The nature of the slab's construction and the accumulation of coal both adjacent to and above the feature suggest it was associated with the operations of the Stillwater Municipal Barge Facility. Both the Terra Terminal and barge facility slabs were left in place.

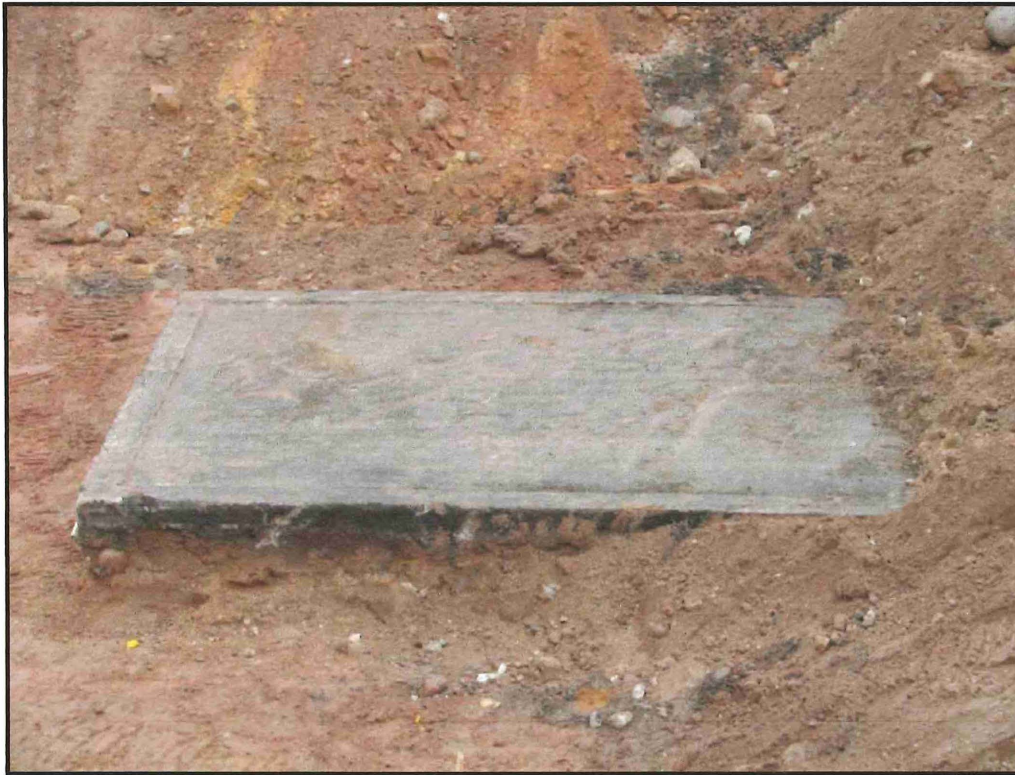
FIGURE 24. BARGE FACILITY CONCRETE SLAB, VIEW TO WEST-SOUTHWEST
