Phase I and II Architectural History Investigations for the
Willmar Connection and Industrial Access Project,
City of Willmar and Willmar Township,
Kandiyohi County, Minnesota

Submitted to:
Minnesota Department of Transportation
395 John Ireland Boulevard
St. Paul, MN 55155

Cultural Services LLC

July 2016

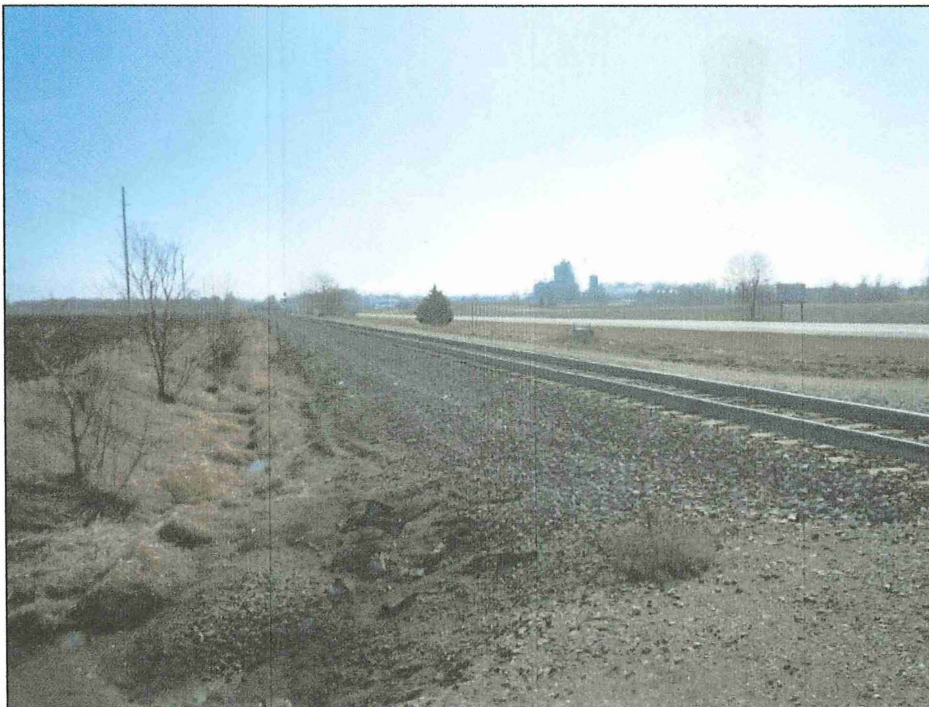
In the project APE, the railroad corridor consists of a railroad roadway, which begins on the east as a double track incorporating wood ties and steel rails supported by a slightly raised rail bed before merging into a single track of the same materials approximately 0.2 mile east of 45th Street NW (Figure 3). The railroad line remains active as part of the BNSF system.

FIGURE 3. ST. PAUL AND PACIFIC RAILROAD MAINLINE AT 45TH STREET NW, LOOKING SE

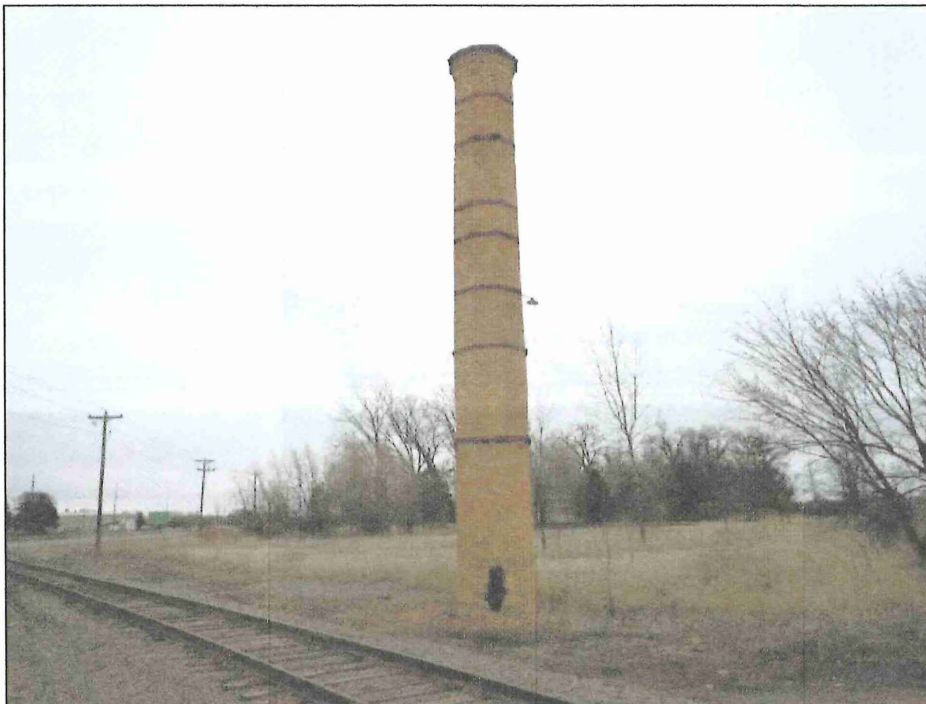
When the Willmar Brick Yard was inventoried in 1985, two kilns, brick smokestacks, a brick farmhouse, and other outbuildings associated with the operations of the Willmar Brick Company were present on the site (Minnesota Historic Properties Inventory Form, KH-WLC-072, on file at the SHPO). Since that time, nearly all of the structures and buildings associated with the Willmar Brick Company have been removed, leaving a single brick smokestack (Figure 4).

FIGURE 4. WILLMAR BRICK YARD SMOKESTACK, LOOKING SE

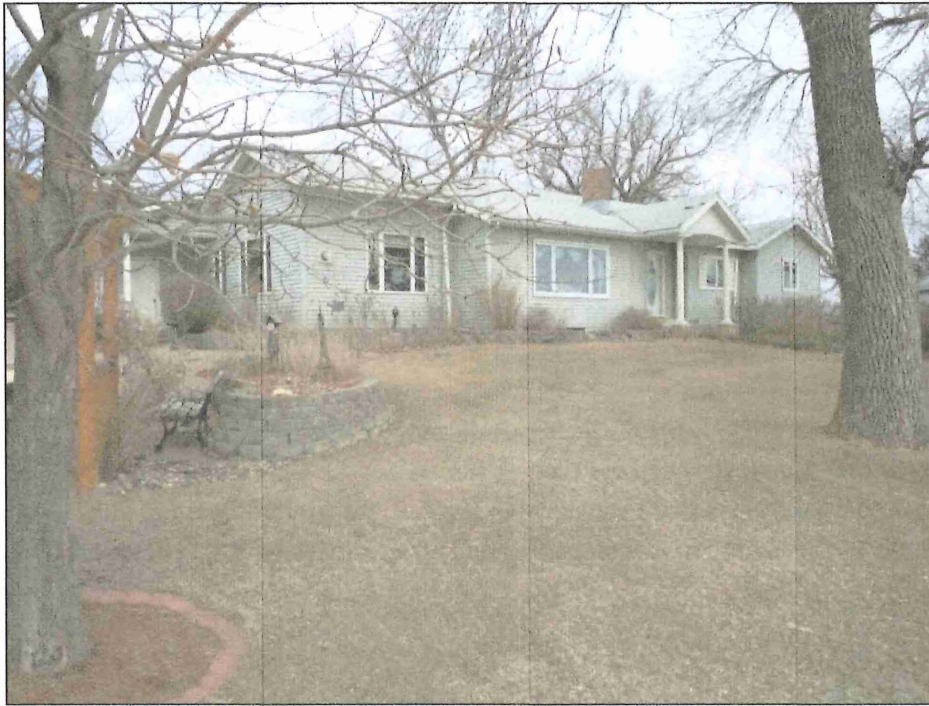
The farmstead includes two houses, a garage, two granaries, a chicken coop, a barn, a silo, a machine shed, a Quonset building, several grain bins, and five additional outbuildings. One of the houses is a large, modern house (Figure 5). The second is a circa-1935, one-story, side-gabled house with a concrete-block foundation. It has been altered with a flat-roofed addition on the north end, fiberboard siding, and replacement windows and doors (Figure 6). Three other buildings and structures along the north edge of the farmstead appear to have been constructed around the same time as this earlier house: a garage, a granary, and a chicken coop (Figures 7 to 9). The single-bay garage has a gabled roof, covered in asphalt shingles, with exposed rafter tails. The walls are wood drop siding, and an original four-light fixed-sash window is located on the rear of the building. The superstructure is raised on wood supports, which either were placed as a measure against deterioration or may indicate that this building was moved from another location.

FIGURE 5. 5090 HIGHWAY 12 NW, MODERN HOUSE, LOOKING NE

Based on the extensive, and in some cases severe, alterations to the buildings and structures on this property, combined with the conspicuous presence of the modern house, this farmstead would not have the integrity to convey any potential historical significance under National Register Criterion A, B, or C. None of the individual elements of the farmstead are especially distinctive examples of architecture or design as required by the Farms Context for significance under Criterion C (Granger and Kelly 2005:7.20). This property is therefore recommended as not eligible for listing in the National Register.

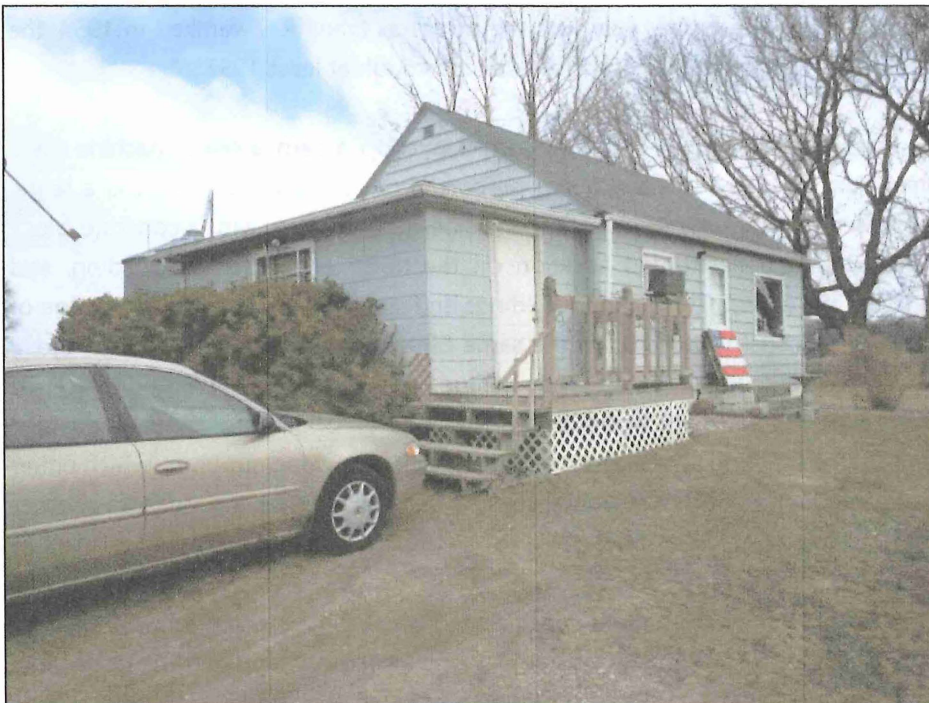
FIGURE 6. 5090 HIGHWAY 12 NW, CIRCA-1935 HOUSE, LOOKING NE

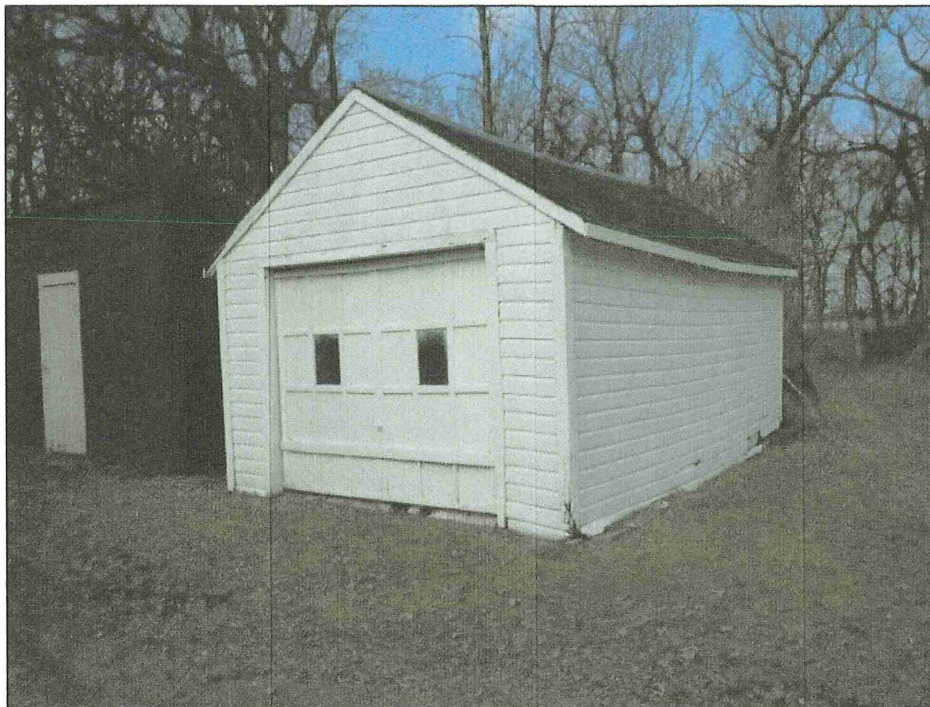
FIGURE 7. 5090 HIGHWAY 12 NW, GARAGE, LOOKING NW

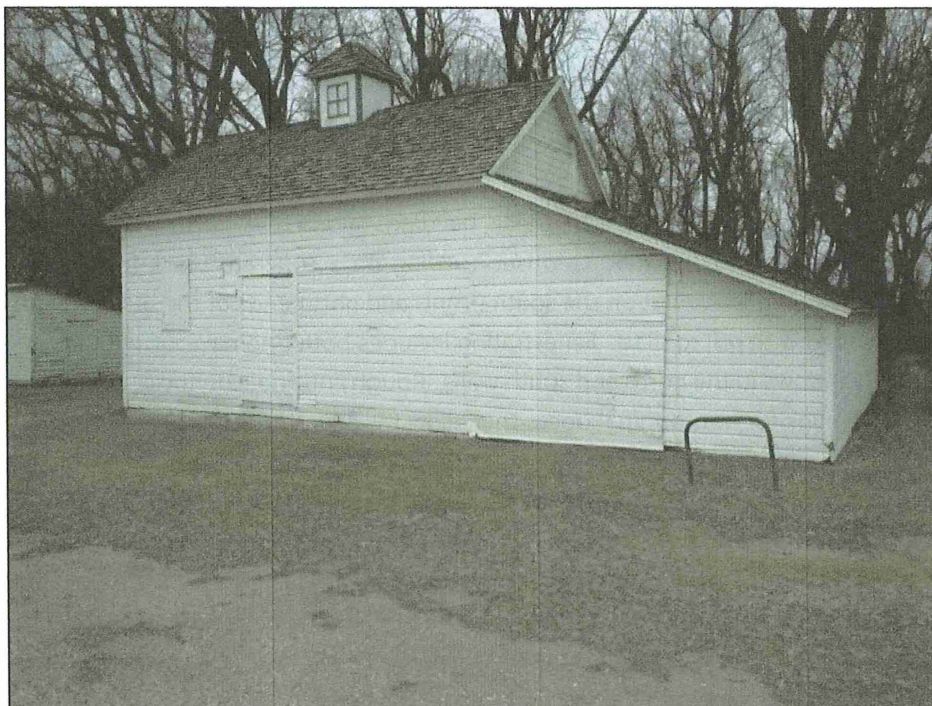
The granary is elevated on concrete skids. It has a gabled roof clad in wood shakes, and a four-light, fixed-sash window is located in the west gable end. Shed wings are located on the east end and the north side, both of which are accessed by sliding doors, the door to the north shed wing located on the west side of the building, and the door to the east shed wing located on the south side of the building. To the west of

FIGURE 8. 5090 HIGHWAY 12 NW, GRANARY, LOOKING NW

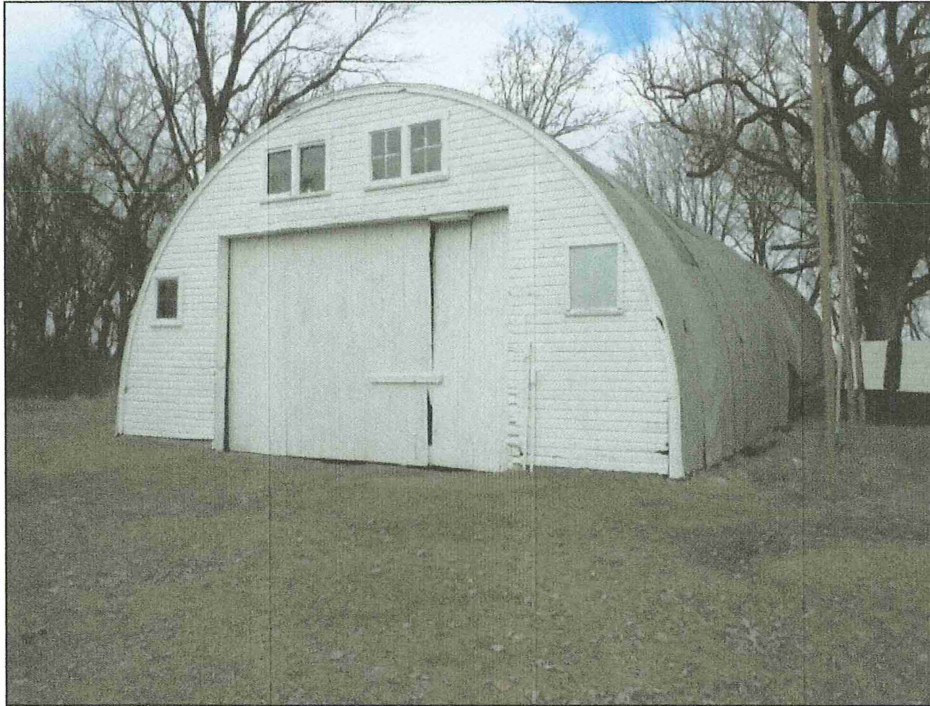
Later additions to the farmstead are interspersed with these buildings along the north edge of the farmstead. To the east of the garage is a circa-1950 Quonset building on a concrete-block foundation (Figure 10). Its original wood drop siding is evident on the south (front) and north ends of the building, but the arched portion has been covered with roll roofing. Fenestration includes both original four-light, fixed-sash windows and replacement windows in the north and south walls. Rough cuts indicate these walls have been altered to create larger openings for non-original doors that allow for drive-through capacity.

FIGURE 10. 5090 HIGHWAY 12 NW, QUONSET BUILDING, LOOKING NW

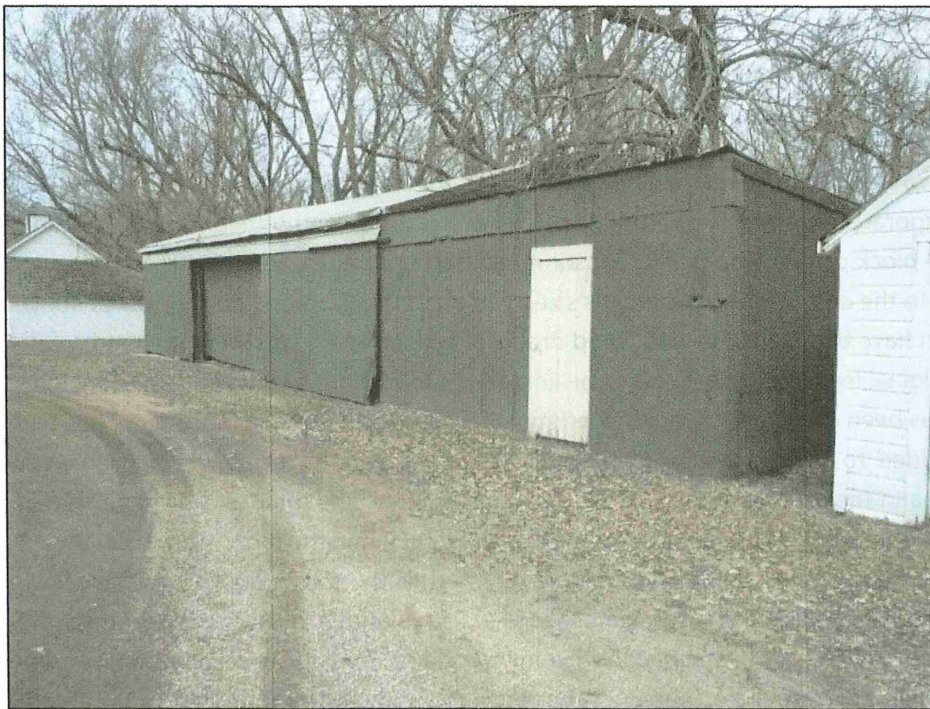
On the west side of the garage is a machine shed covered in corrugated metal sheeting (Figure 11). Aerial photos show a building was placed in this location circa 1960, but any original details of the machine shed are obscured by its cladding. The obscuring of details similarly applies to a later granary with portable elevator located west of the chicken coop (Figure 12). This gable-roofed building is almost entirely covered in sheet metal panels, but original wood drop siding is visible on the north (rear) gable. Exposed rafter tails are visible on both ends of the building. One original six-light, fixed-sash window is present in the south gable, but a second window opening in the same gable is infilled with sheet metal. These visible similarities

FIGURE 11. 5090 HIGHWAY 12 NW, MACHINE SHED, LOOKING NW

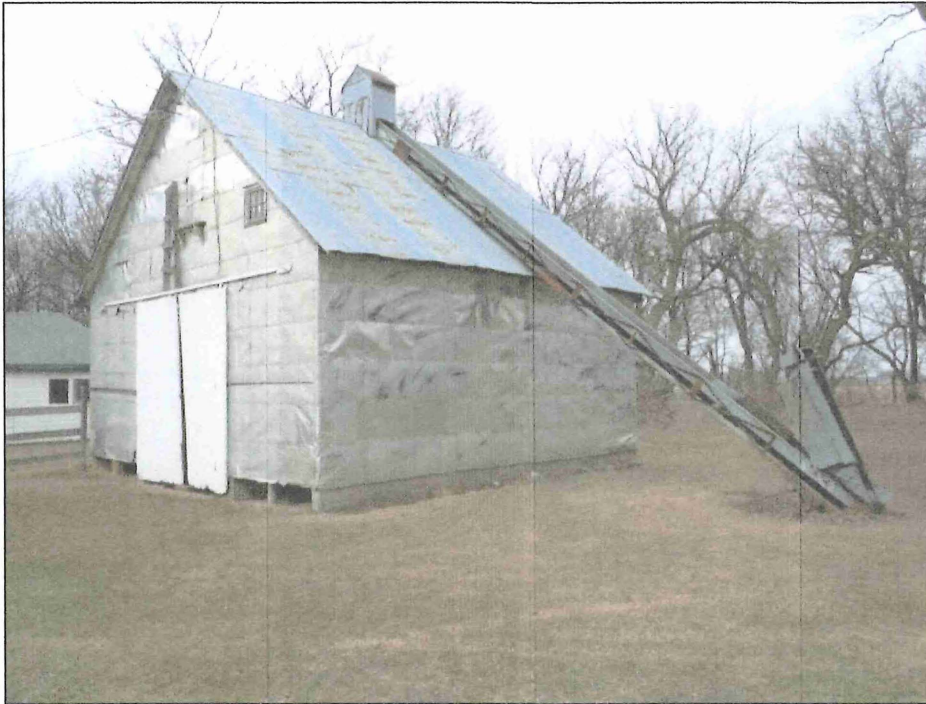
FIGURE 12. 5090 HIGHWAY 12 NW, GRANARY WITH PORTABLE ELEVATOR, LOOKING NW

to the circa-1935 buildings suggest that this building may have been constructed around the same time, but if so, a 1938 aerial photograph indicates that it was moved to this location at a later date. The granary is raised on concrete skids, and it features a sliding door of vertical wood planking on both ends.

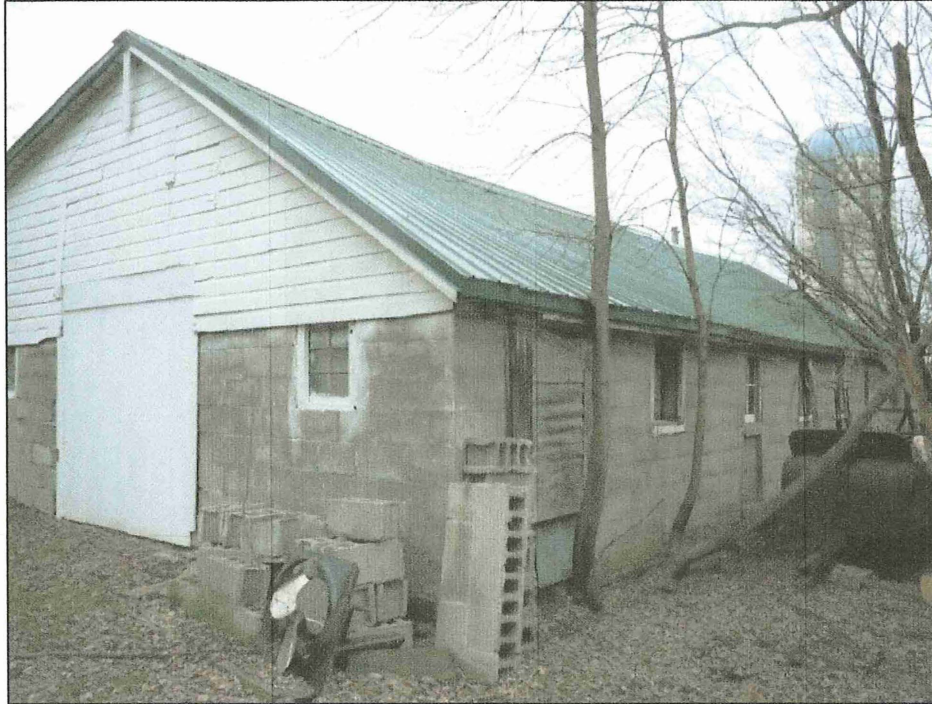
West of the granary are two heavily altered outbuildings that were put into place sometime between 1938 and 1955. The first incorporates original concrete-block walls or portions thereof (Figure 13). A gable evident over the concrete-block portion appears to constitute a later superstructure, and still later was an expansion of the building to the east, nearly doubling its size. The expanded portion and the gables above the concrete-block portion have been covered with wood drop siding, into which cuts were made to create or re-create loft doors. Original fenestration appears to be limited to the six-light fixed sash in the concrete-block portion. The roof has been covered with corrugated metal. The second outbuilding, a barn, has had vertical wood planking added to the north and south ends, which was roughly cut to create doorways (Figure 14). The west side and the roof have been clad in corrugated metal, and the east side has a slatted ventilating wall of horizontal wood planks. A pulley extends from an opening in the mow. To the northwest of the barn is a simple post and beam loafing shed (Figure 15), and to the south is a cement-stave silo (Figure 16). A third outbuilding put up during the period between 1938 and 1955 is located south of the chicken coop (Figure 17). Beyond a small exposure of horizontal wood plank siding, no original architectural details are visible on this gable-roofed building because it has been clad entirely in corrugated metal, except where openings exhibit replacement or added window and doors.

FIGURE 13. 5090 HIGHWAY 12 NW, OUTBUILDING, LOOKING S-SE

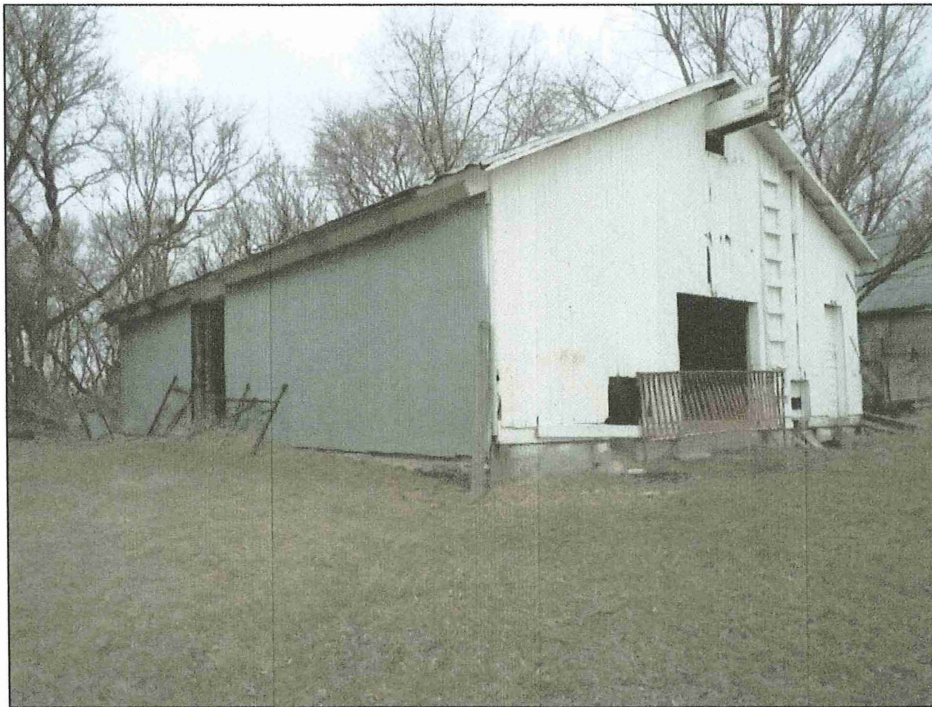
FIGURE 14. 5090 HIGHWAY 12 NW, BARN, LOOKING NE

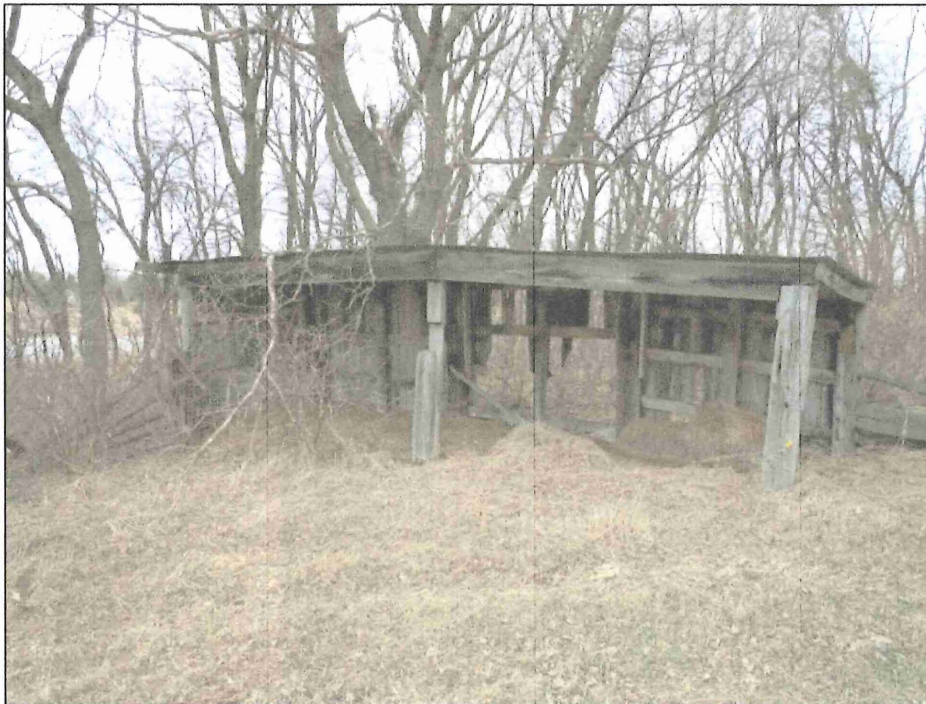
FIGURE 15. 5090 HIGHWAY 12 NW, LOAFING SHED, LOOKING NW

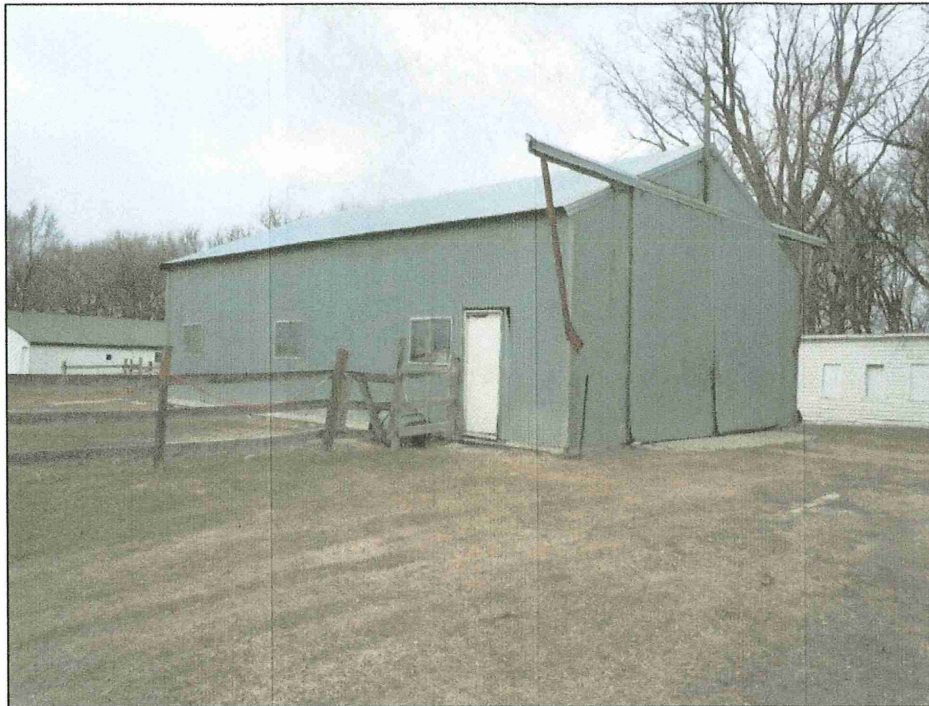
FIGURE 17. 5090 HIGHWAY 12 NW, OUTBUILDING, LOOKING NW

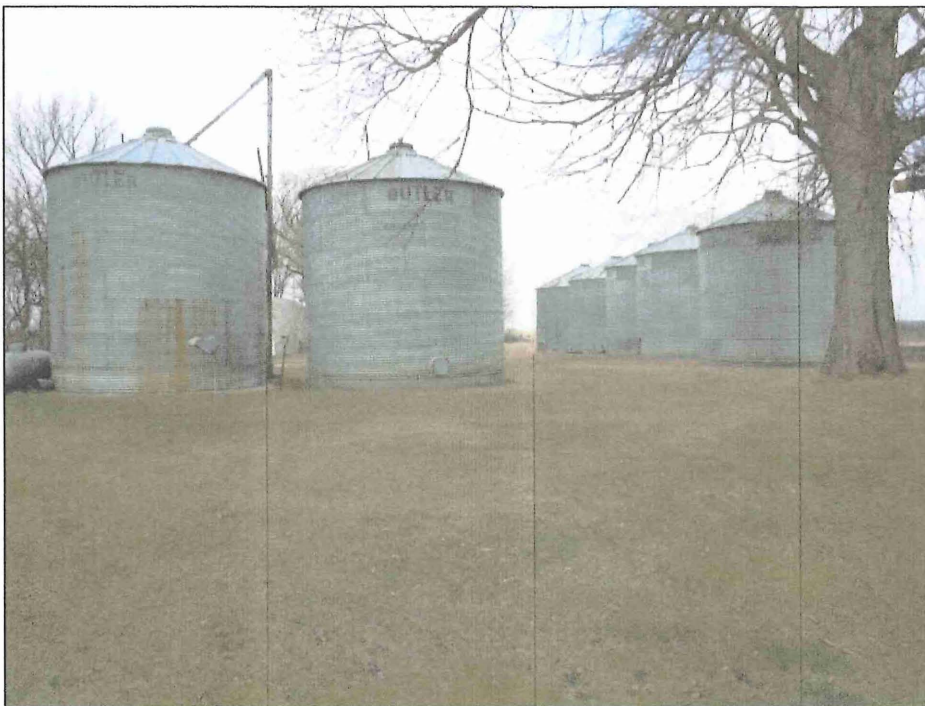
Aerial photographs indicate that additional outbuildings and structures present on the farmstead post-date the period of significance for Minnesota farmsteads. These include several steel grain bins (Figure 18) and a large livestock building (Figure 19) put up on the property during the mid to late 1960s, and two other livestock buildings constructed after 1970 (Figures 20 to 21). The grain bins are located to the north of the circa-1935 house, while the livestock buildings are concentrated in the southeast portion of the farmstead.

FIGURE 18. 5090 HIGHWAY 12 NW, GRAIN BINS, LOOKING N

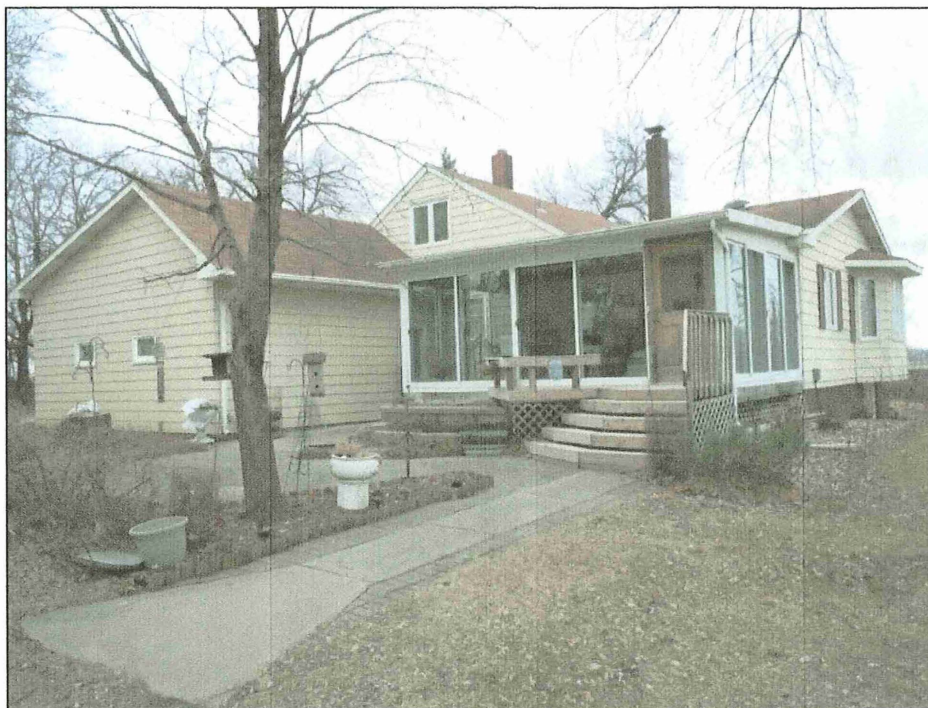
This farmstead includes a house, a barn, a silo, and four additional outbuildings/structures. The house, which appears to have been built as a one-and-a-half-story house with gabled roof has been extensively modified through several additions, including an attached garage and adjoining extension of the house on the south, addition on the east with added bay window, and a sunporch inset in the resultant ell; the installation of vinyl siding and soffits; and the replacement of windows and doors, such that a construction date cannot be discerned (Figure 22).

FIGURE 22. 790 45TH STREET NW, HOUSE, LOOKING NE

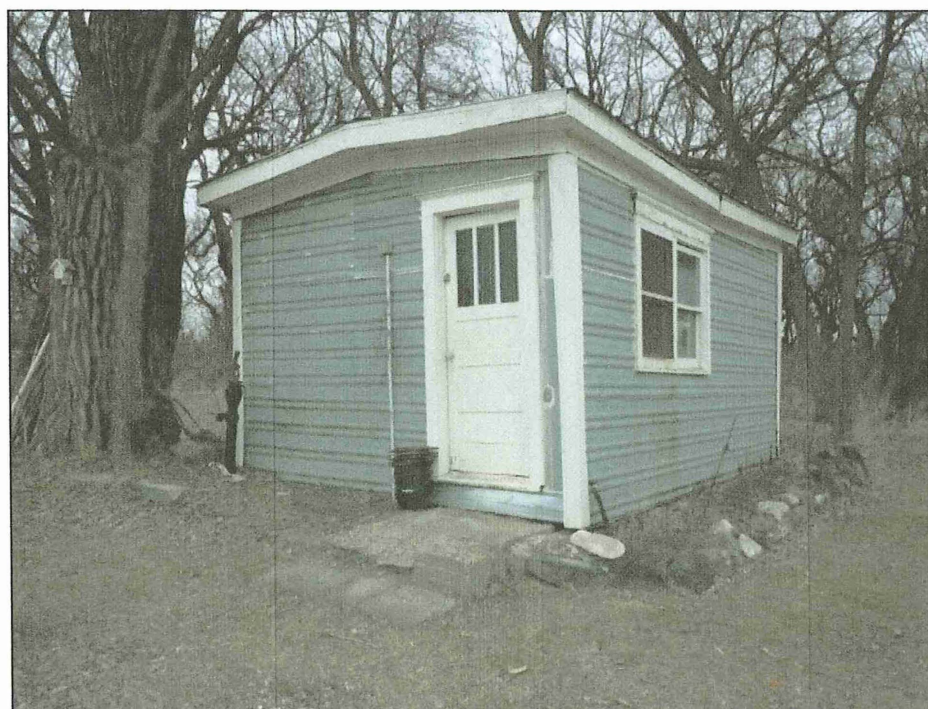
Set somewhat behind the house to the west-southwest is a small, one-story storage building having a low-pitched roof, with walls and roof clad in corrugated metal (Figure 23). Its foundation is not visible. Fenestration appears original, with paired 1/1 double-hung sash windows on the east and two nine-light, fixed-sash windows on the west. What appears to be original wood framing with crown molding surrounds the windows, as well as the single-panel wood pedestrian door on the south end.

FIGURE 23. 790 45TH STREET NW, STORAGE BUILDING, LOOKING NW

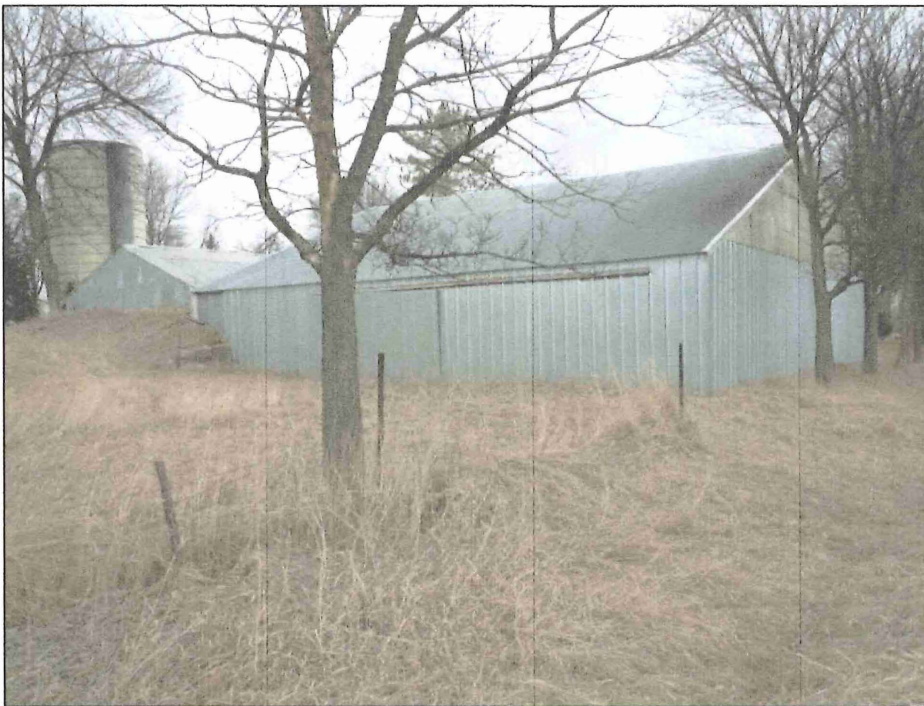
To the south of the storage building and house is a driveway that divides them from the remaining outbuildings and structures. The barn, or former barn, is banked on the north, where an original concrete-faced, mortared fieldstone foundation incorporated into the current building is evident (Figure 24). Beyond this exposure on the north edge, what is assuredly a replacement superstructure is clad in corrugated metal, as is the roof. A larger, post-1963 addition to the building extends in a perpendicular fashion from its south side. Sliding doors are present on the east and west sides of this extension, and a pedestrian door is located on the east side of the extension as well. No windows are present on the building. North of and adjacent to the banked edge is a remnant cement-stave silo (Figure 25).

FIGURE 24. 790 45TH STREET NW, BARN WITH ADDITION IN FOREFRONT, LOOKING NE

Based on the extensive alterations to nearly all of the buildings and structures on this property, this farmstead would not have the integrity to convey any potential historical significance under National Register Criterion A, B, or C. None of the individual elements of the farmstead are especially distinctive examples of architecture or design as required by the Farms Context for significance under Criterion C (Granger and Kelly 2005:7.20). This property is therefore recommended as not eligible for listing in the National Register.

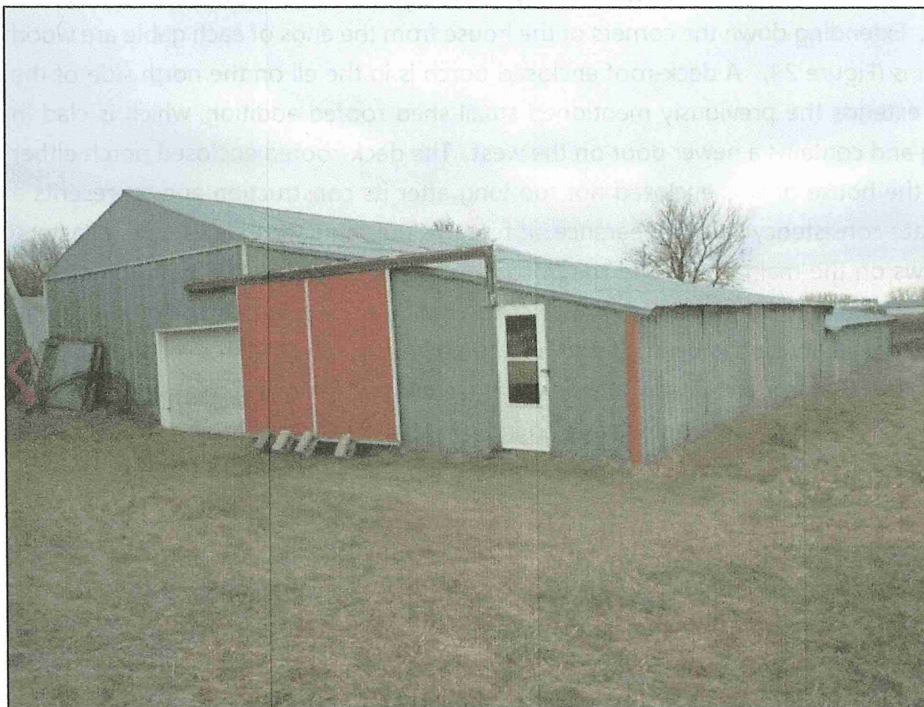
A circa-1960 corrugated metal-clad Quonset building with sliding doors is located northwest of the barn (Figure 26), and a circa-1965 outbuilding, which was subsequently expanded, is to its west (Figure 27). The latter outbuilding also is clad in corrugated metal, with cuts made to accommodate an overhead door and a pedestrian door on the north side, which additionally features a sliding door. A second sliding door is located on the south side.

FIGURE 27. 790 45TH STREET NW, OUTBUILDING, LOOKING SE

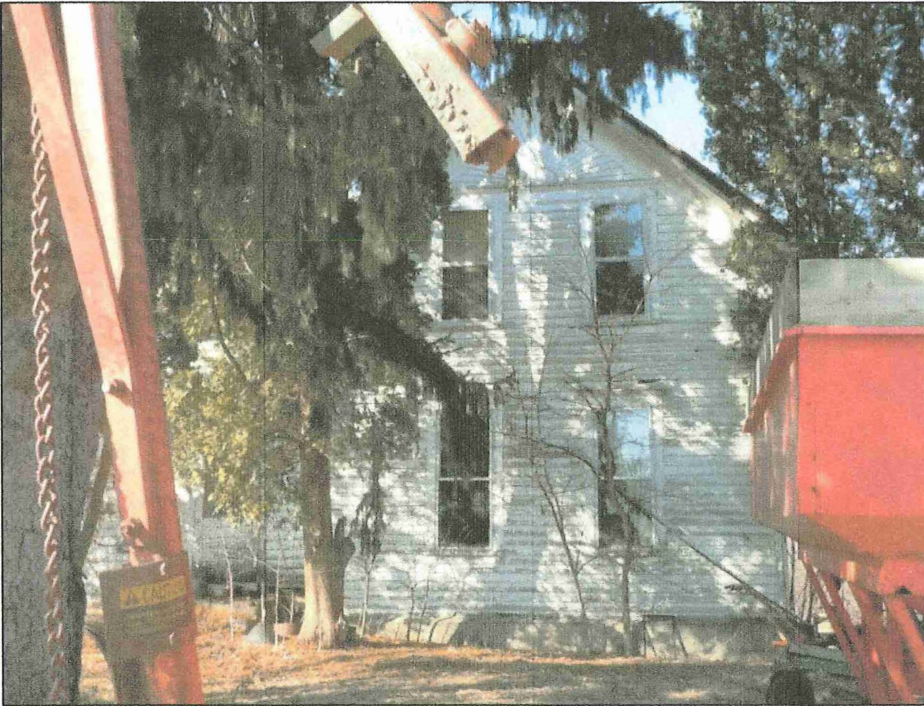
This former farmstead includes a house, barn, remnant silo, possible milk house, machine shed, granary, privy, and one other outbuilding. The circa-1880, one-and-a-half-story, front-gable-and-wing house has a poured-concrete foundation (Figure 28). With the exception of a small shed-roofed addition, the walls are clad in wood lap siding. All gables contain a decorative sunray motif underlined by the crown molding that is over the upper windows. Extending down the corners of the house from the ends of each gable are wood pilasters that mimic columns (Figure 29). A deck-roof enclosed porch is in the ell on the north side of the house; from its west side extends the previously mentioned small shed-roofed addition, which is clad in vertical wood-plank siding and contains a newer door on the west. The deck-roofed enclosed porch either is contemporaneous with the house or was enclosed not too long after its construction and represents a conscientious effort to create consistency in its appearance. It features the same wood lap siding, pilasters, and window style. Windows on the main house and the porch are largely original 1/1 double-hung sash with newer storm windows surrounded by wood frames with crown molding. The window, however, on the lower story of the west end of the house has been altered and contains a 1/1 fixed sash over an inset row of five glass blocks. It exhibits a simple, narrow wood frame with no crown molding. An original wood door is located on the south side of the wing. The roof is covered in asphalt shingles, and original wood soffits and fascia remain intact. An interior brick chimney projects above the peak of the wing.

FIGURE 28. 699 45TH STREET NW, HOUSE, LOOKING N-NW

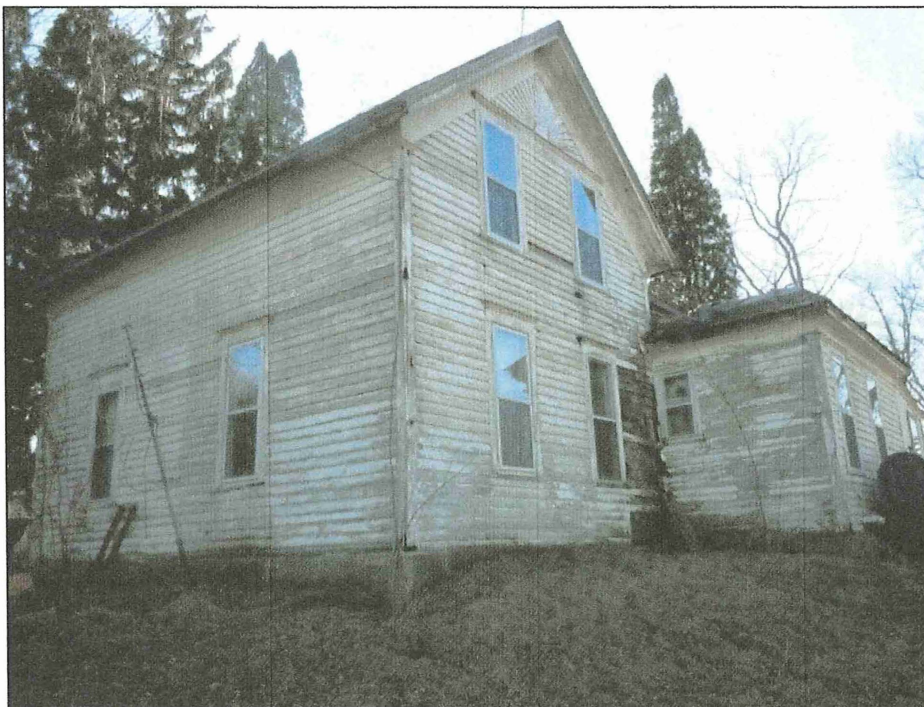
FIGURE 29. 699 45TH STREET NW, HOUSE, LOOKING SW

No evidence could be found to suggest that this farmstead was importantly associated with an event or pattern important to the development of Minnesota farming or agriculture in general and therefore it does not meet National Register Criterion A. No information was found to indicate that anyone in the Rasumusson family was historically significant with regard to agriculture, Willmar Township, or otherwise. The farmstead does not clearly illustrate the pattern of features common to a specific type or period of farming; responses to natural, economic, political, or social forces; or any of the other potential means by which a farmstead would possess the distinctive characteristics of a type, period, or method of construction. It does not represent the work of a master, possess high artistic value, or represent a significant and distinguishable entity whose components may lack individual distinction. It therefore does not meet Criterion C. None of the individual elements are especially distinctive examples of architecture or design as required by the Farms Context for significance under Criterion C (Granger and Kelly 2005:7.20). This property is therefore recommended as not eligible for listing in the National Register.

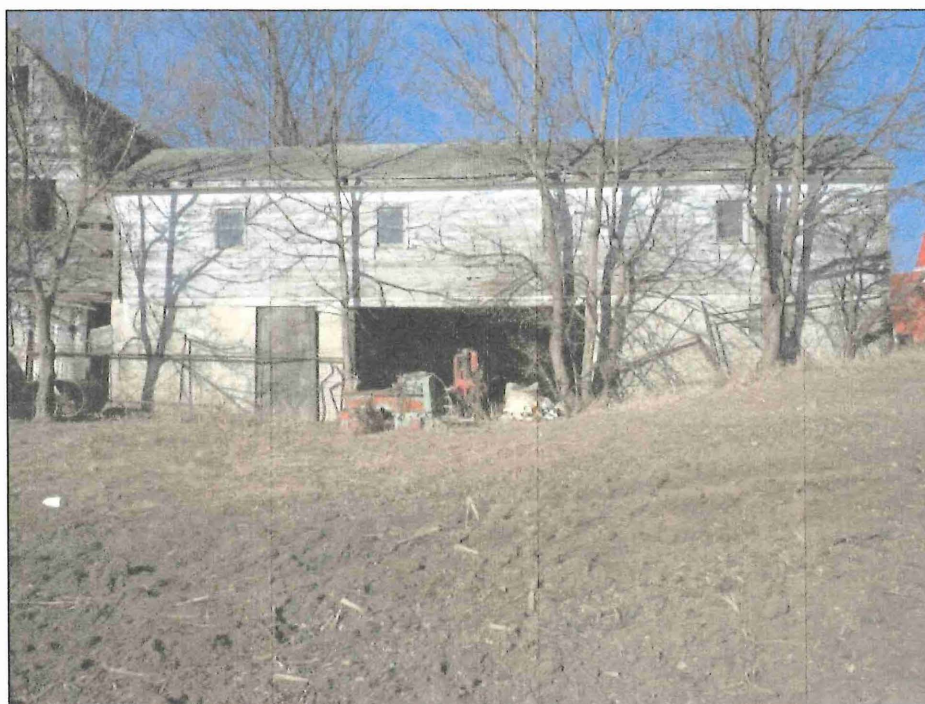
The barn is located on the south edge of the farmstead just above a field edge. It is a circa-1920, gothic-arch, bank barn flanked on both sides by attached wings (Figure 30). The east wing was constructed circa 1965 and has a concrete-block foundation that supports a side-gabled superstructure clad in wood drop siding on the south and in horizontal wood planking on the south and east (Figure 31). Within the foundation on the south side is a central machine-door opening, to the west of which is a wood pedestrian door. These are flanked on both sides by a single glass-block window. In the upper level are regularly

FIGURE 31. 699 45TH STREET NW, EAST WING OF BARN, LOOKING N

spaced 1/1, fixed-sash windows. A pedestrian door opening is present on the east end, while the north side contains two window similar to those on the south. The roof is clad in asphalt shingles. The west wing was constructed at an unknown date (Figure 32). Although a west wing appears on a 1938 aerial photograph of the property, the current truncation of a stone wall near the junction of the barn and wing by a poured-concrete foundation and a superstructure of horizontal wood-plank siding suggest the construction currently present dates to a later period. This wing, which has a flat roof, features regularly spaced openings for four-light, fixed-sash windows, some of which are missing, and a vertical wood-plank pedestrian door on the south side. The rear of this wing is built into the hillside.

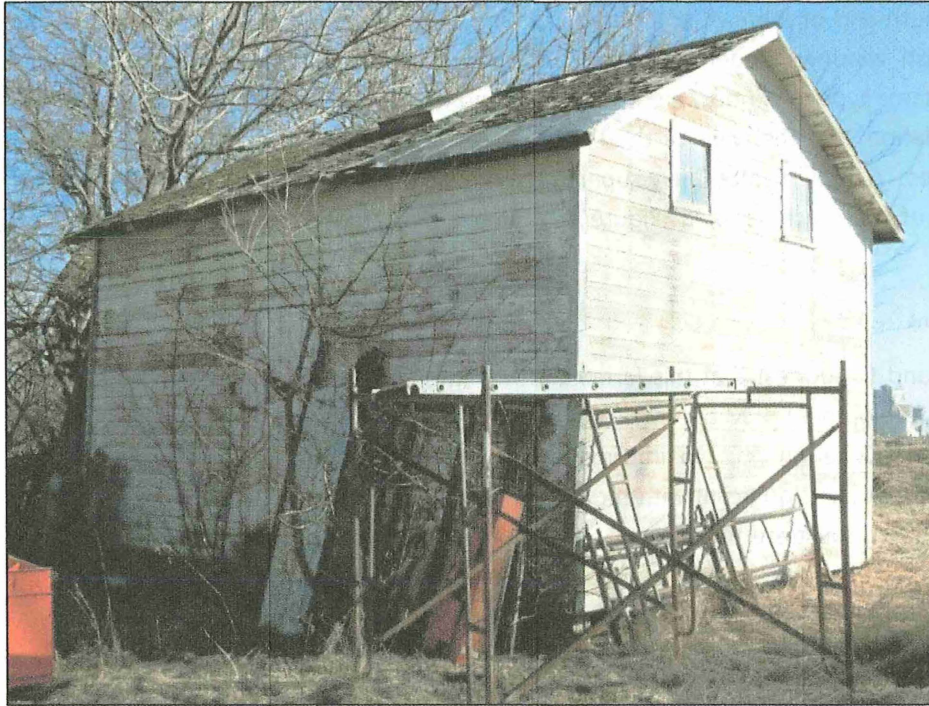
FIGURE 38. 699 45TH STREET NW, GRANARY, LOOKING SE

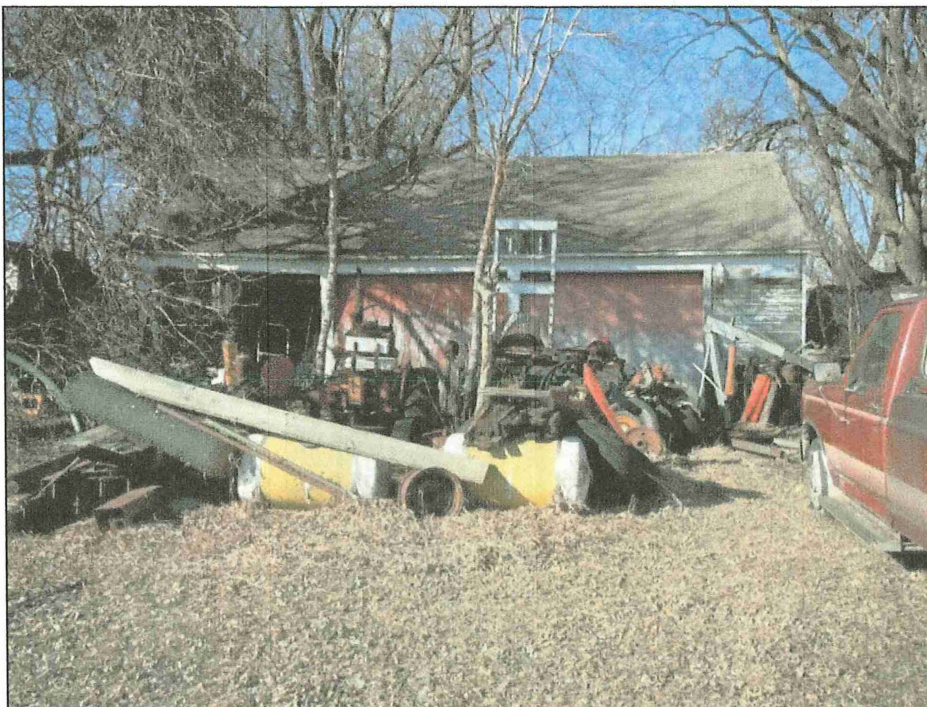
North-northwest of the barn on the north side of the driveway is a side-gabled machine shed with three south-facing bays, each of which holds an overhead door of vertical wood planking (Figure 39). Although this building appears to date to the 1920s or 1930s, aerial photographs indicate that it was not in its current location until sometime after 1963, so it was likely moved from elsewhere on the farmstead. A pedestrian

FIGURE 39. 699 45TH STREET NW, MACHINE SHED, LOOKING N

door is located on the south end of the east end of the building. Centered on the east end is a bank of three four-light, fixed-sash windows underneath a loft door, suggesting that this building has been repurposed. Two of the same type of window are on the west end of the building. The machine shed has a poured-concrete foundation, and the walls of the building are clad in wood drop siding. The roof is covered in asphalt shingles. A gable-roofed privy superstructure clad in wood drop siding is located next to the northwest corner of the machine shed (Figure 40). It has been moved and is used for storing equipment.

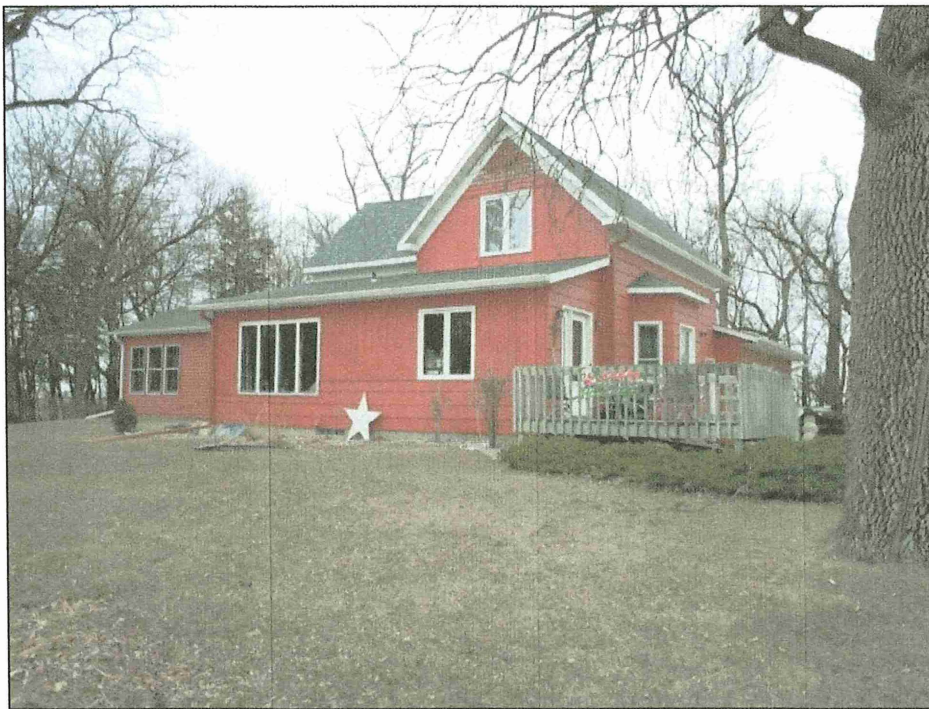
The main house was built circa 1890 (Figure 41). It is one and a half stories in height with a cross-gable roof, and it exhibits a T-plan. What appears to be original wood lap siding is evident, in part, in the north and south gables. Large additions have been made on the north and west sides, the latter a two-bay attached garage, and the front (south) porch has been enclosed. Replacement siding occurs variably as fiberboard, vinyl, and a sheeting that resembles vertical wood planks in the south gable. The roof is covered in asphalt shingles and exhibits vinyl fascia and soffits. All windows and doors are replacement or have been added.

FIGURE 41. 5840 7th AVENUE NW, HOUSE, LOOKING NW

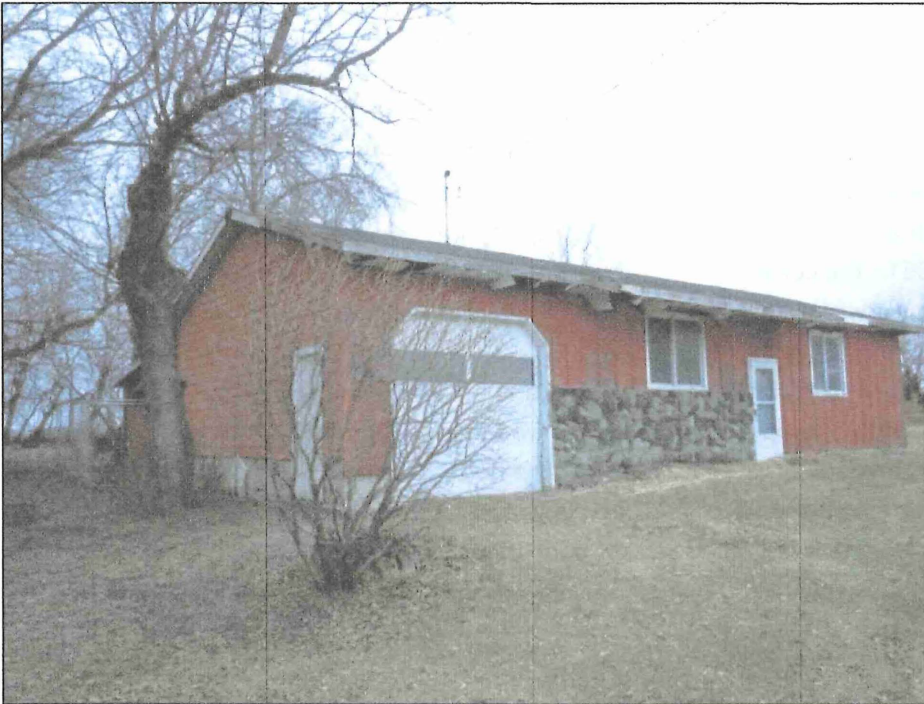
What appears to be a second house, with attached garage, is a side-gabled, converted outbuilding (Figure 42). A sliding machinery door is evident on the east end, where the wall is clad in wood lap siding and a

FIGURE 42. 5840 7TH AVENUE NW, APPARENT SECOND HOUSE, LOOKING NE

concrete-block foundation is visible, as it is on the west. The front (south) of the house has been covered with board and batten siding and a decorative stone treatment between the garage and front door, the latter of which is flanked by added sliding windows. A second pedestrian door is located on the west side of the garage, while a shed-roofed addition is located on the rear of the garage. The roof is clad in asphalt shingles and exhibits vinyl fascia and soffits, which are falling off.

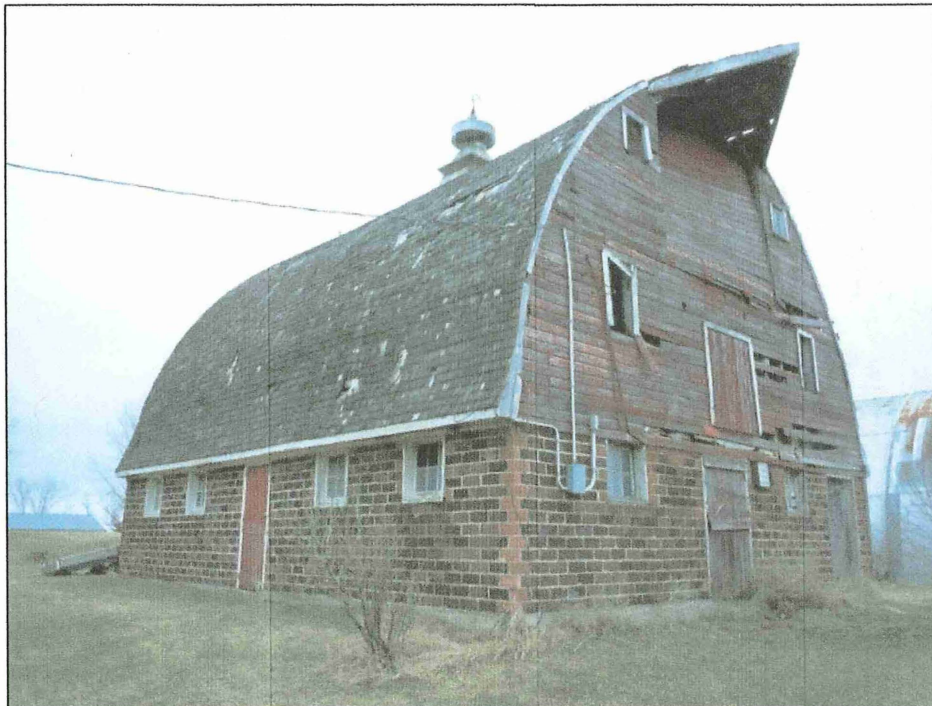
The circa-1945, gothic-arch barn has a poured-concrete foundation (Figure 43). Its lower walls are structural tile, and the walls in the arches are wood siding, the south arch containing drop siding, which is original and deteriorating, and the north arch containing replacement lap siding, which is intact. The roof is covered in wood shakes and features a hay hood over the mow door. Fenestration, where intact, consists largely of original four-light and six-light fixed sash. Some of the windows are no longer present in the south arch, although the openings remain. Dutch doors are located on the east and west sides of the barn, and a pedestrian door is located in the center of the south end. Another pedestrian door opening at the east end of the south end has been infilled with plywood. A sliding door of vertical wood planking is present on the rear of the building.

FIGURE 43. 5840 7TH AVENUE NW, BARN, LOOKING NE
