Phase I and II Architectural History Investigations for the
Willmar Connection and Industrial Access Project,
City of Willmar and Willmar Township,
Kandiyohi County, Minnesota

Submitted to:
Minnesota Department of Transportation
395 John Ireland Boulevard
St. Paul, MN 55155

Cultural Services LLC

July 2016

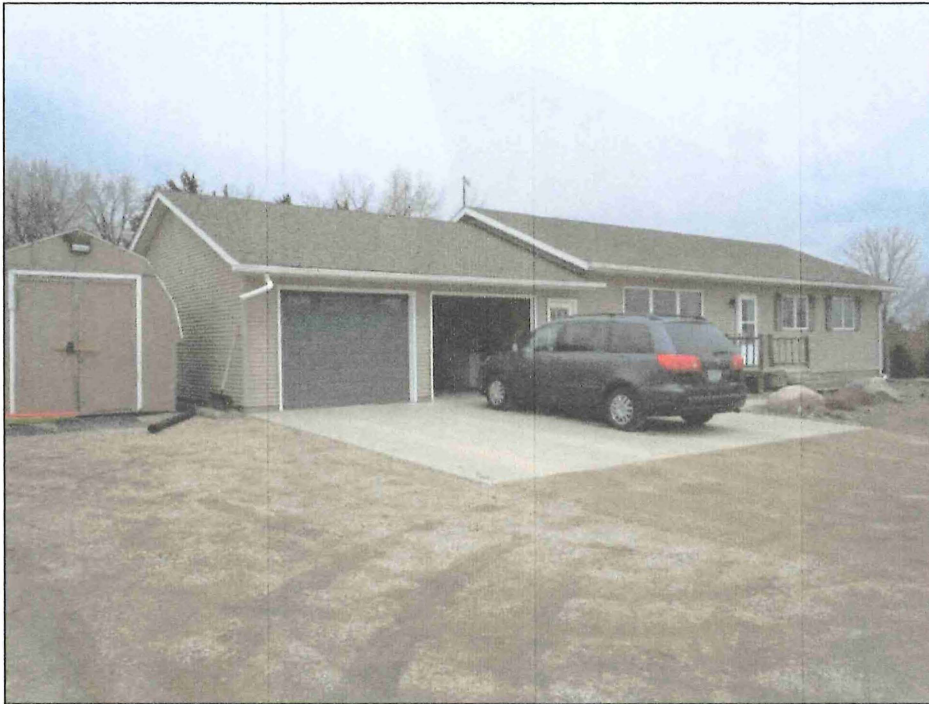
This property, along with the one to the west at 5840 7th Avenue NW, used to constitute a single farmstead, the history of which is provided in Section 4.6. The current property owner at 5812 7th Avenue NW indicated that the original parcel was split the last time it was sold. Buildings located on this parcel include a modern house (Figure 44) and a Quonset barn.

FIGURE 44. 5812 7TH AVENUE NW, MODERN HOUSE, LOOKING NE

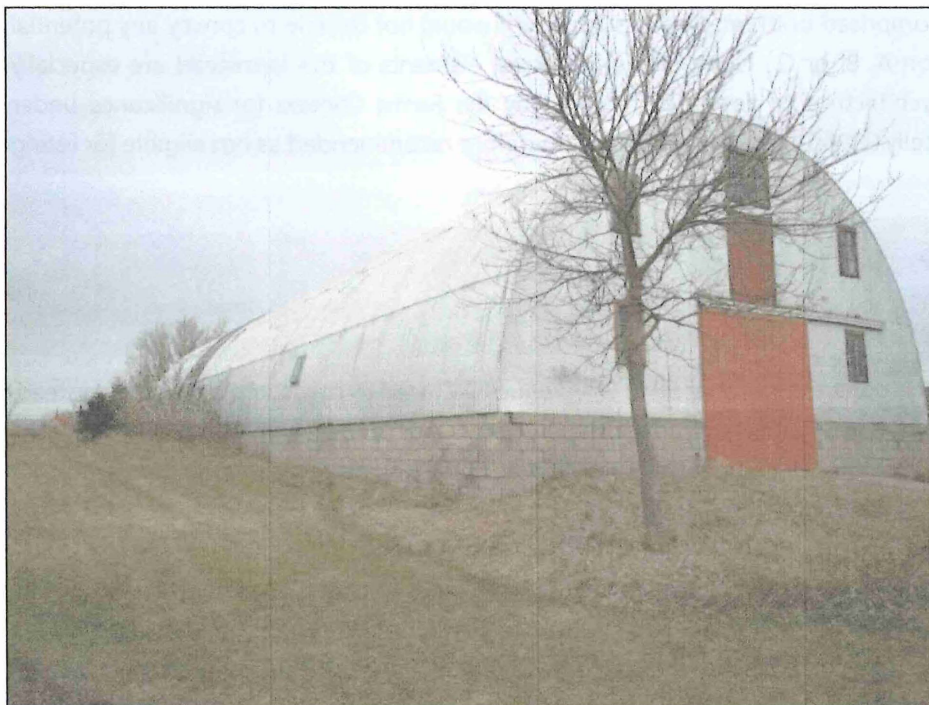
The circa-1945 Quonset building is clad in corrugated metal and has a concrete-block foundation (Figure 45). Fenestration largely consists of original six-light, fixed sash. Skylights on the west and east sides of the building have been covered with corrugated metal. A wood, apparently original, pedestrian door is located on the rear (north) end of the barn, as is a central overhead door. This door replaces a sliding door, for which the rail support is still present. A sliding door sheathed in corrugated metal is present on the front of the barn, underneath a hinged, vertical wood-plank mow door.

FIGURE 45. 5812 7TH AVENUE NW, BARN, LOOKING NE

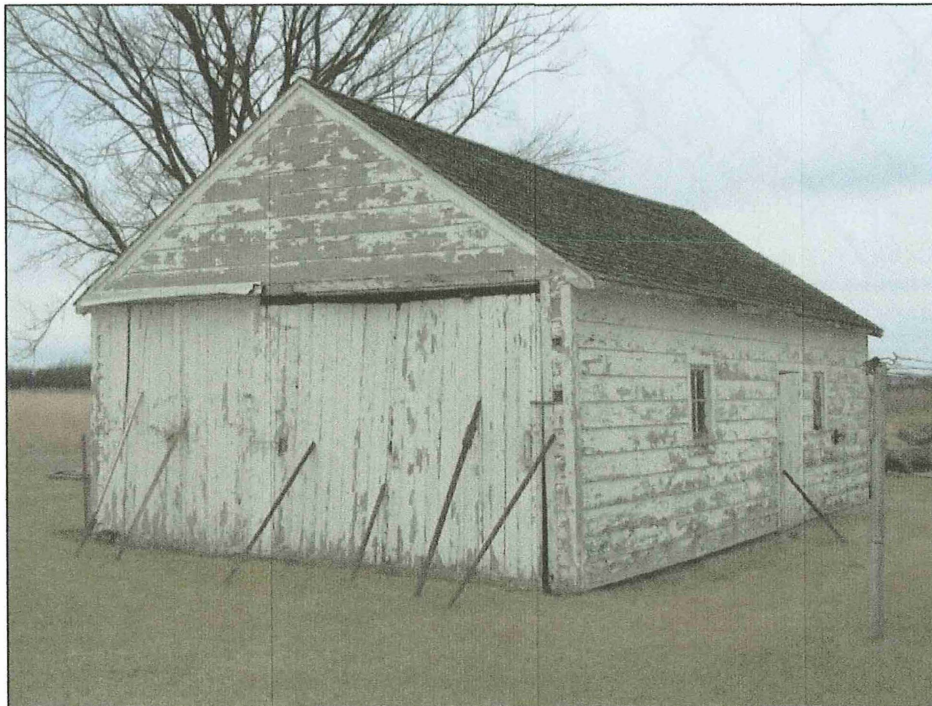
The machine shed is a gable-roofed, wood lap-sided building with a poured-concrete foundation (Figure 48). What was once a sliding door of vertical wood planking on the front (north) of the building is now detached from the rail and is propped up by metal poles, as is the pedestrian door on the west side of the building. Fenestration consists of original four-light, fixed sash on the west and east sides of the building. The roof features exposed rafter tails and is covered in asphalt shingles.

FIGURE 48. 5591 7TH AVENUE NW, MACHINE SHED, LOOKING SE

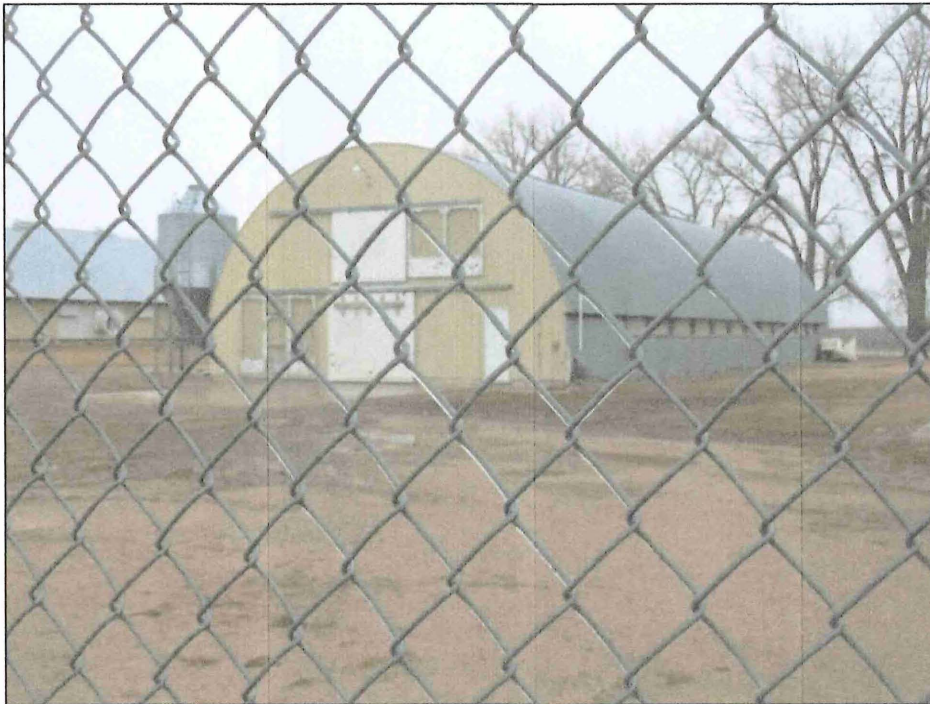
Access to this property was not permitted by the landowner, requiring the survey to be conducted from publicly accessible points. The property is primarily occupied by a poultry processing facility of the Willmar Poultry Company known as the Diamond Farm, the functions for which are housed in two Quonset buildings, a large rectangular-plan, gable-roofed building, and a small, gable-roofed office building, all of which are located inside a chain-link fence, and all of which have are clad in corrugated metal (Figures 49 to 52). Additionally located on the property, outside of the fence, are a house and a garage.

FIGURE 49. DIAMOND FARM, QUONSET BUILDING 1, LOOKING NW

It is possible that this facility is the outgrowth of an earlier one of the farms established by the Willmar Poultry Company beginning during the late 1950s to handle overages in the poult population (see p. 8). No information, however, could be found to substantiate an association between the owner of the property during the late 1950s and early 1960s, Harold Ditmarson, and the Willmar Poultry Company. Even if such a connection could be made, however, only one of the industrial buildings remaining on this property may date prior to 1970, and if it does, it was likely re-clad after that year. The exterior of the house and the garage have been substantially updated in cladding, fenestration, and roofing. For these reasons, the Diamond Farm would not have the integrity to convey any potential significance under Criterion A, B, or C. This property is therefore recommended as not eligible for listing in the National Register.

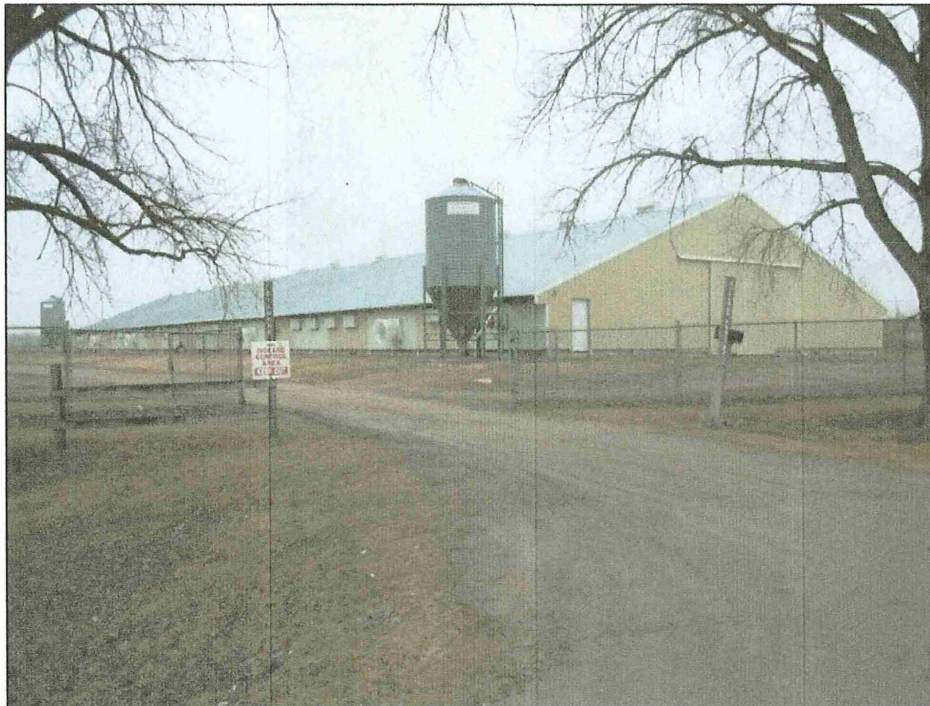
FIGURE 51. DIAMOND FARM, LARGE FACILITY, LOOKING SW

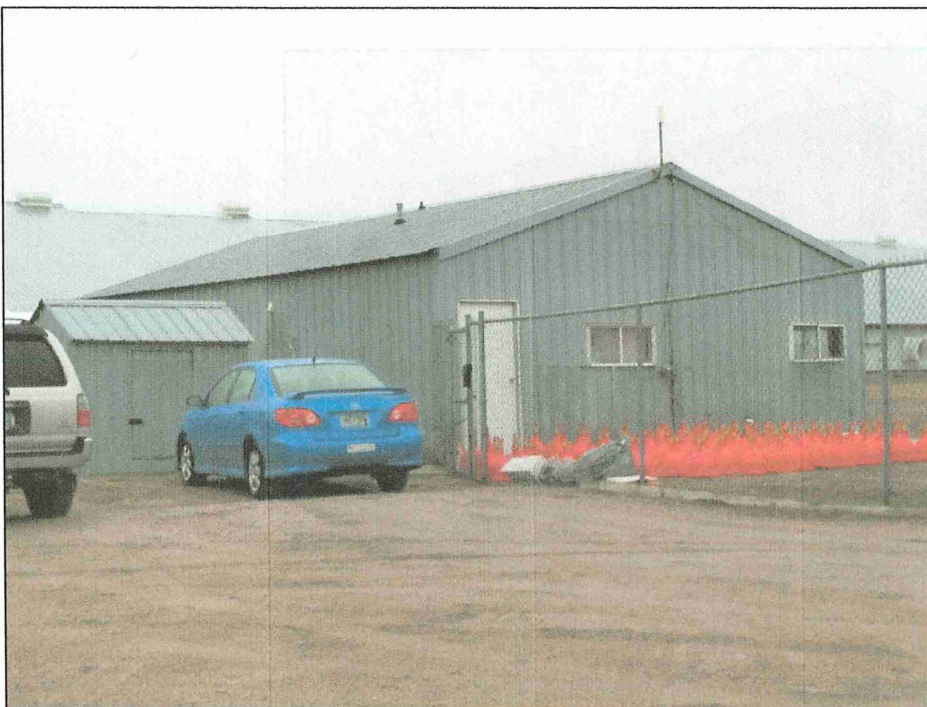
FIGURE 52. DIAMOND FARM, OFFICE, LOOKING W-NW

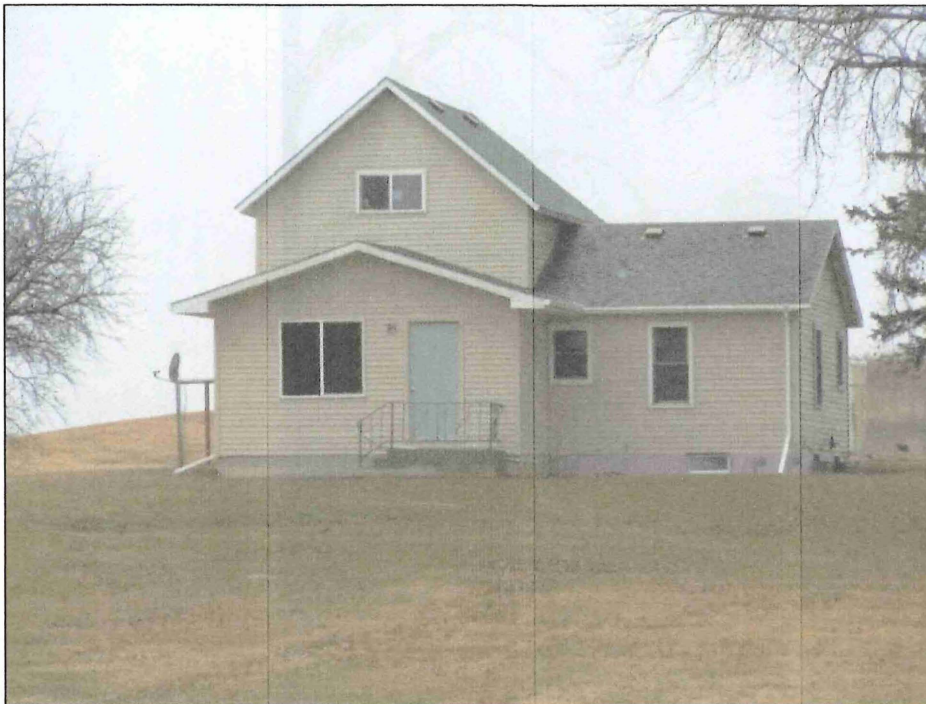
A 1955 aerial photograph shows the property as having been recently graded and a Quonset building present. By 1963, two much longer Quonset buildings flanked it, one each on the east and west, and the house and garage had been built. Sometime between 1970 and 1991, the two longer Quonset buildings were replaced by one of similar size to the first on the east, and the large gable-roofed building on the west. Because the two existing Quonset buildings are identical, it is likely that the circa-1955 Quonset building was replaced with one of similar size, or at least re-clad during the 1970-1991 period. The one-and-a-half-story, L-plan house and gable-roofed, single-bay garage both appear to have recently received replacement siding, windows, and doors, and asphalt-shingle roof with vinyl soffits and fascia (Figures 53 to 54).

FIGURE 53. DIAMOND FARM, HOUSE, LOOKING W

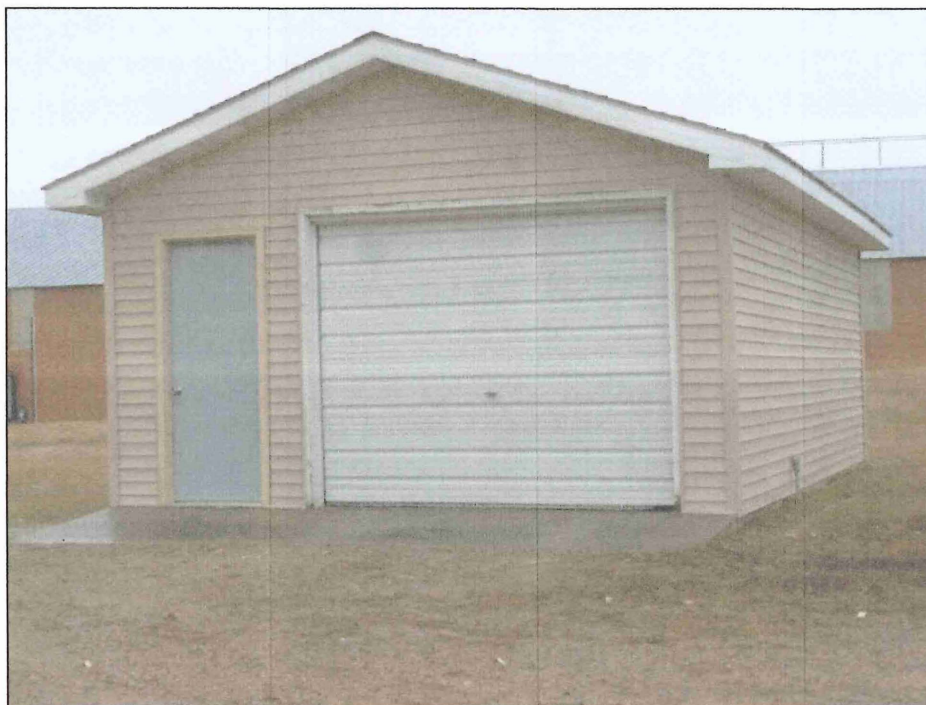
FIGURE 54. DIAMOND FARM, GARAGE, LOOKING SE

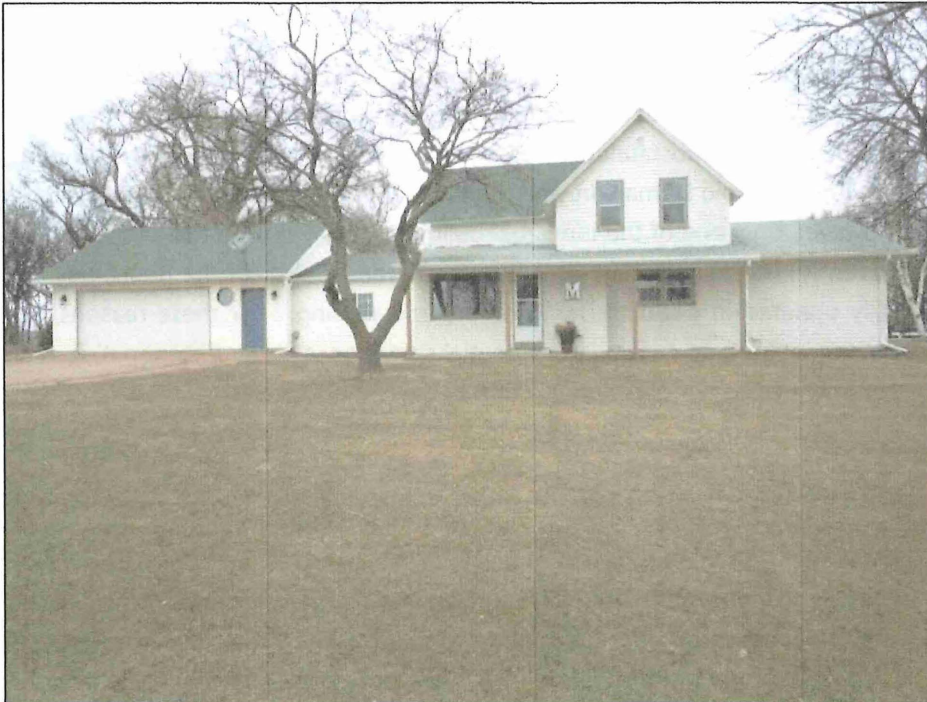
The former farmstead comprises a house, silo, and former granary. The original, circa-1880, T-plan house with cross-gabled roof is two stories in height, but it has been substantially modified through enclosure of the front porch and one-story additions to the east and west ends, the additions on the latter end consisting of an enclosed breezeway and an attached garage (Figure 55). The original construction visible above the additions is clad in wood lap siding, while the newer construction is covered in vinyl siding. Windows are in a multitude of styles and configurations, including a picture window with side casements on the façade; replacement, 1/1 double-hung sash; a bay window on the east end of the east addition; a nine-light fixed-sash window in the breezeway; and a fixed octagonal window in the garage. A newer door is within the front entry. The roof is entirely clad in asphalt shingles, but varying color and condition indicates that portions have been redone more recently than others.

FIGURE 55. 5550 1ST AVENUE W, HOUSE, LOOKING N

Based on the alterations to the house and granary, combined with the removal of the barn and any other historically present outbuildings, this farmstead would not have the integrity to convey any potential historical significance under National Register Criterion A, B, or C. None of the individual elements of the farmstead are especially distinctive examples of architecture or design as required by the Farms Context for significance under Criterion C (Granger and Kelly 2005:7.20). This property is therefore recommended as not eligible for listing in the National Register.

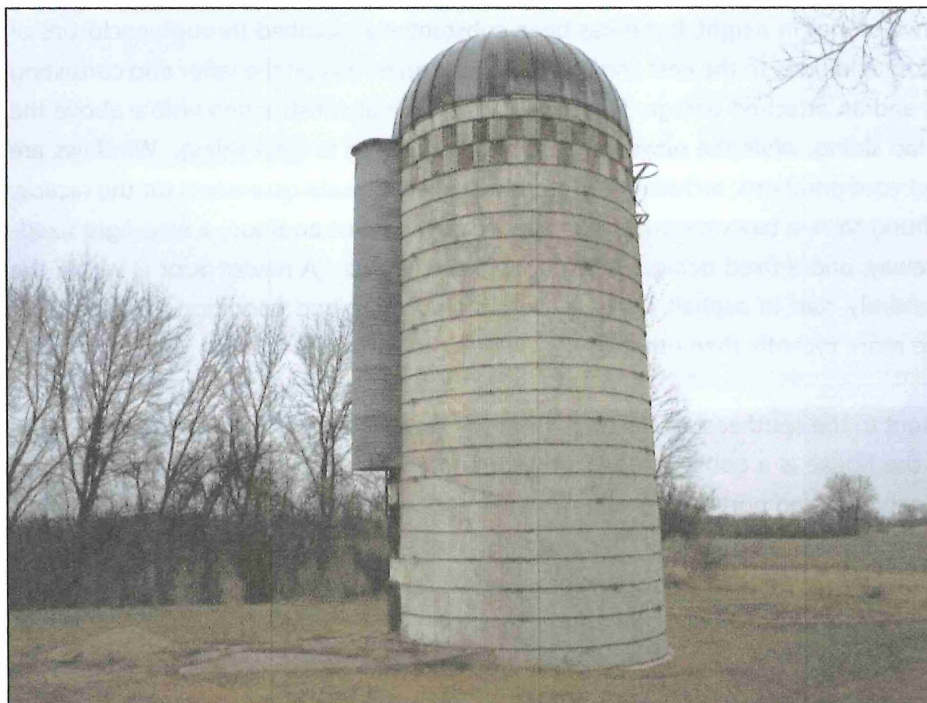
A cement-stave silo is present to the southeast of the house, but the associated barn has been razed (Figure 56). To the southwest of the house is a gable-roofed former granary with shed wing, which is raised on boulders (Figure 57). The gable-roofed portion is clad in wood lap siding on the south and east, and wood drop siding on the north. The shed wing is covered in corrugated metal, as is the roof of the gable-roofed portion. All openings have been infilled with wood planks, except for a 6/6 double-hung sash window on the rear of the building, which appears to have been added, and the pedestrian door on the east side. A dog door has been added to the east side, and this building currently serves as a doghouse. Sliding doors are located on both ends of the shed wing.

FIGURE 56. 5550 1ST AVENUE W, SILO, LOOKING E-SE

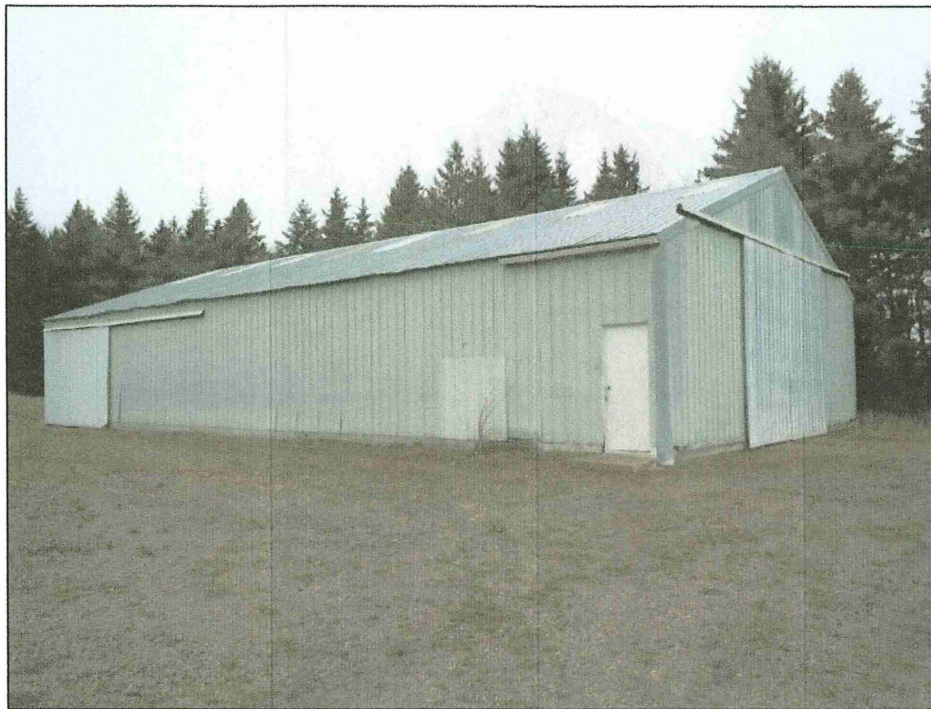
This former farmstead includes a modern house located on the south side of 1st Avenue W (Figure 58), and a barn, root cellar, and post-1970 machine shed (Figure 59) on the north side of the road. The root cellar, of unknown date, is constructed of poured concrete built into an artificially created hill (Figure 60). A deteriorating plywood pedestrian door provides access to it.

FIGURE 59. 4746 1ST AVENUE W, MACHINE SHED, LOOKING NW

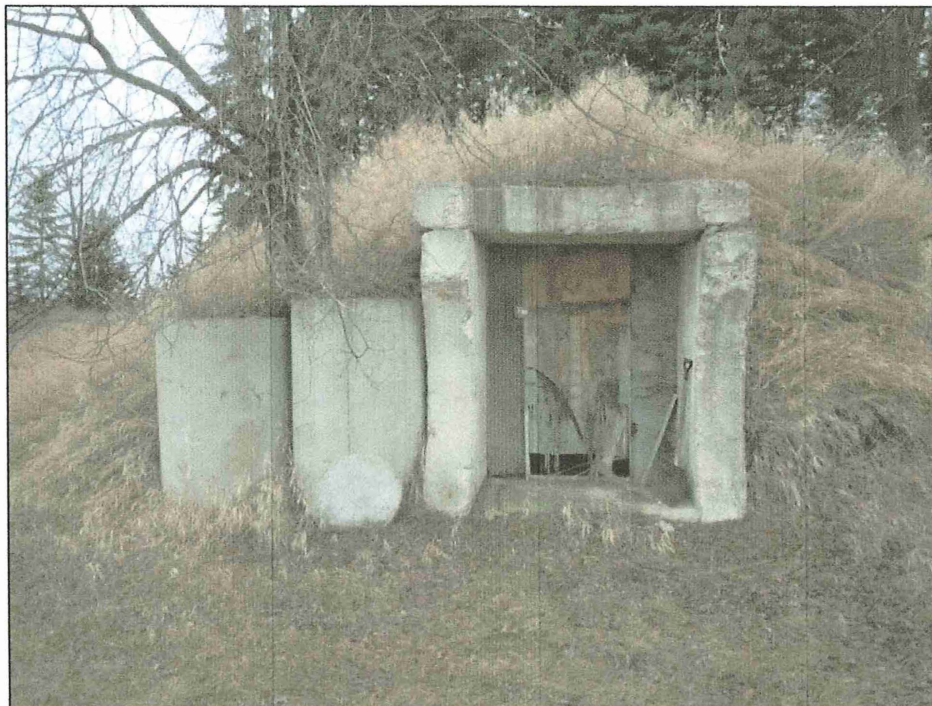
FIGURE 60. 4746 1ST AVENUE W, ROOT CELLAR, LOOKING W

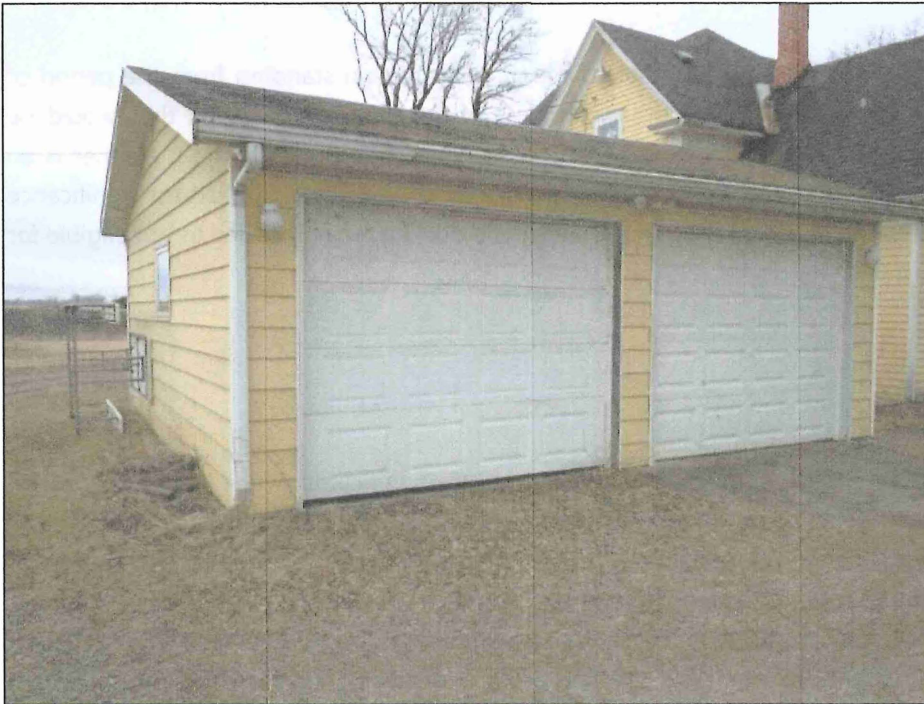
This farmstead property includes a house, garage, two chicken coops, and seven outbuildings. Aerial photographs indicate that the garage, chicken coops, and one of the outbuildings, a modern metal building, were all constructed after 1991, during which period a barn with silo in the vicinity of the metal building was torn down (Figures 63 to 65).

FIGURE 63. 1399 45TH STREET SW, MODERN GARAGE, LOOKING SE

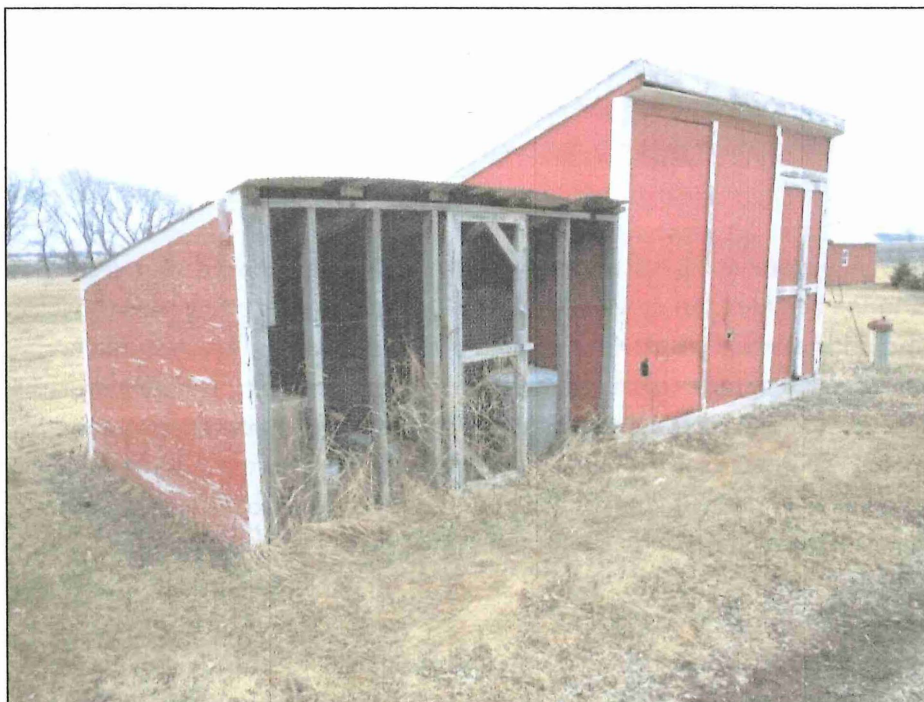
FIGURE 64. 1399 45TH STREET SW, CHICKEN COOPS, LOOKING NE

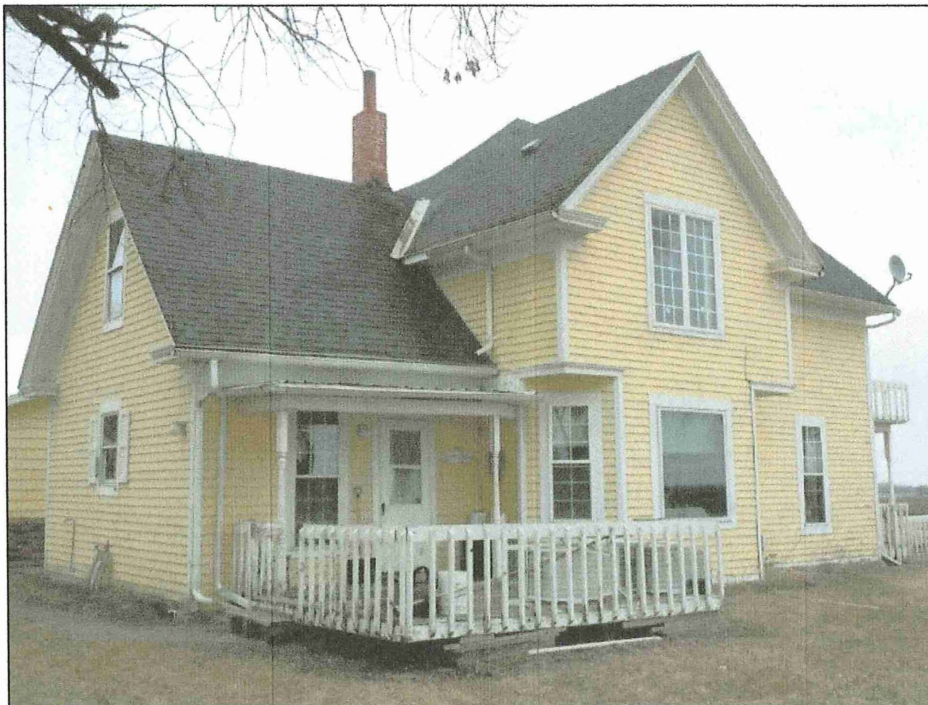
The cross-gabled house is a variable one and a half stories in height, as the gable on the west section of the house does not extend to the height of the others (Figure 66). The upper levels of the higher-gabled sections are incongruous, but original wood window trim around the windows under and near the north-side gable suggests this exterior wall is of the original configuration; the remainder of the upper north wall and the upper walls on the south and east sides either lack fenestration or have newer windows and trim, which along with the incongruity suggests that the upper levels were built up and out from the original configuration on these sides (Figures 67 and 68). The windows on the lower level also have been replaced, with the exception of a stained-glass window located on the east side of the house, which remains above a newer picture window surrounded by the original wood trim. Similarly, the replacement door to its north is within the original wood door frame. This side of the house features an open porch, the roof supported by spindlework posts and situated under a newer balcony. A deck has been built to extend off of the porch. An open porch with similar posts and also extended by a deck is located on the south side of the west

FIGURE 66. 1399 45TH STREET SW, HOUSE, LOOKING NE

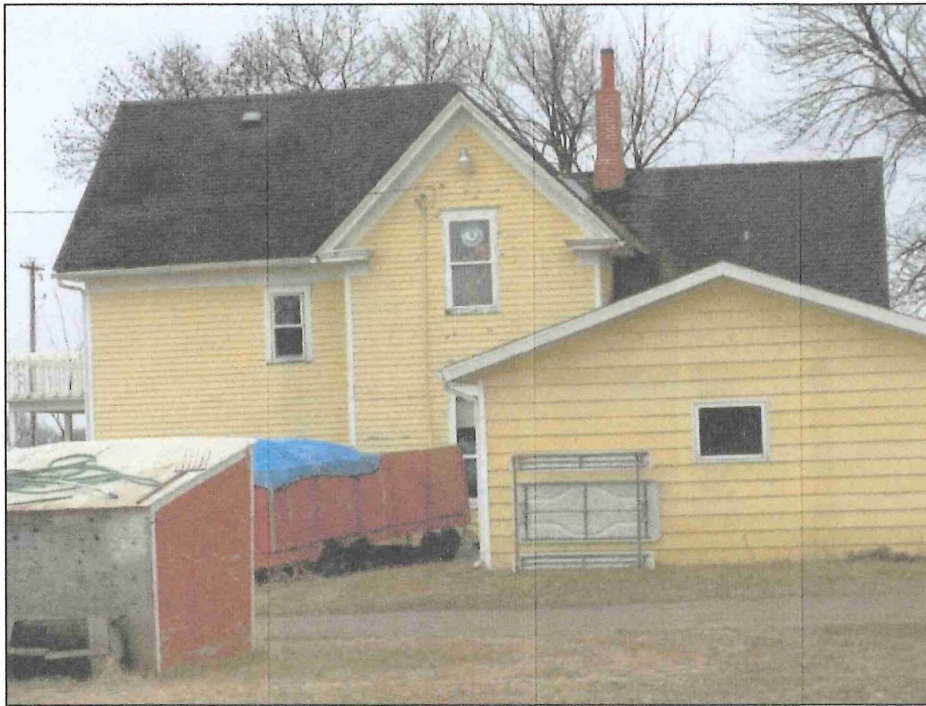
FIGURE 67. 1399 45TH STREET SW, HOUSE, LOOKING S

section, and the wall here contains a replacement window and door. Replacement windows are located on the remaining walls of this section, although those on the north side are surrounded by original wood trim. The walls of the house are wood lap siding and are supported on a stone foundation. The roof is covered in asphalt shingles, and an interior brick chimney projects from its peak above the west section.

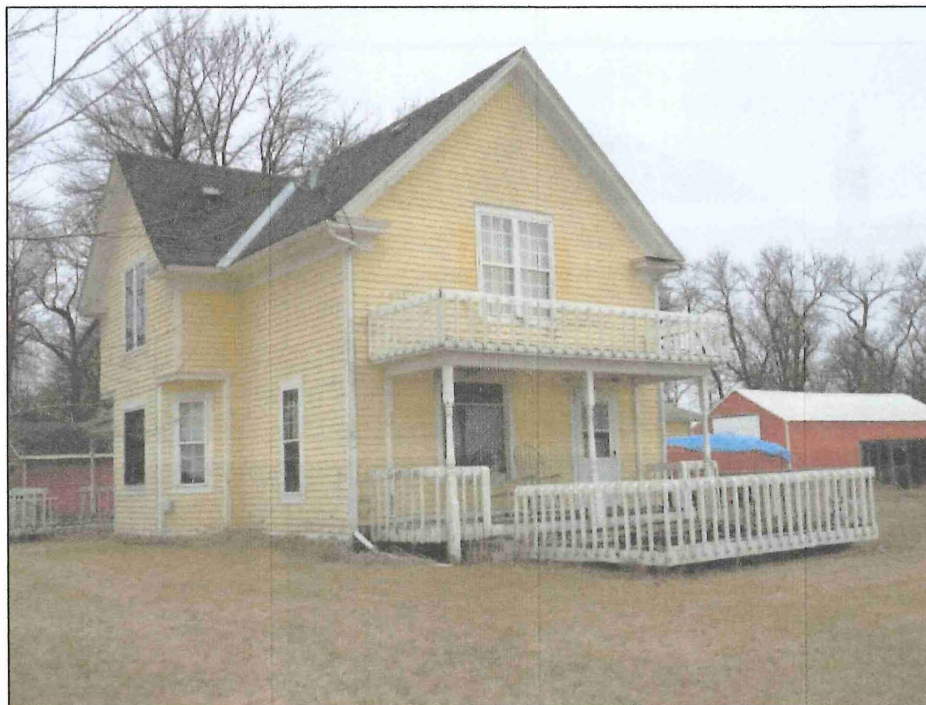
FIGURE 68. 1399 45TH STREET SW, HOUSE, LOOKING W-NW

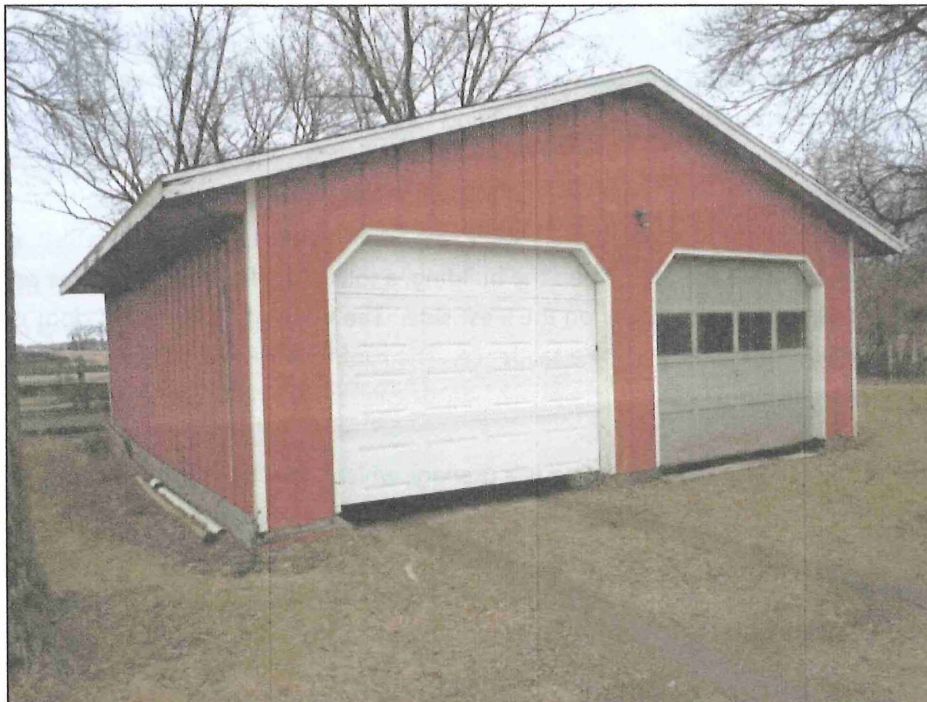
FIGURE 70. 1399 45TH STREET SW, GARAGE-LIKE BUILDING 1, LOOKING SW

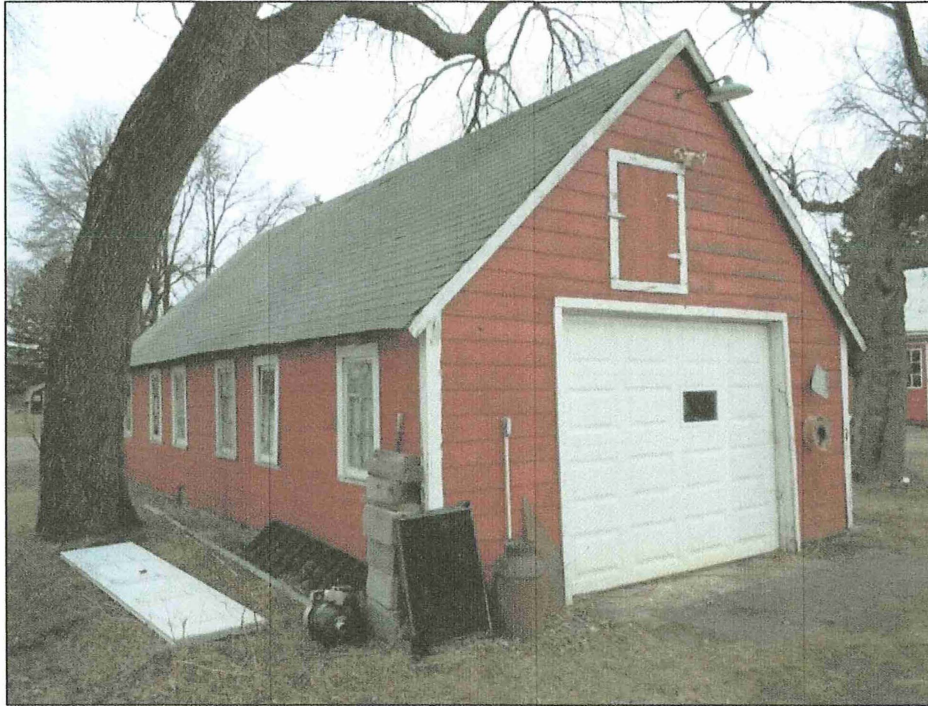
FIGURE 71. 1399 45TH STREET SW, GARAGE-LIKE BUILDING 2, LOOKING NW

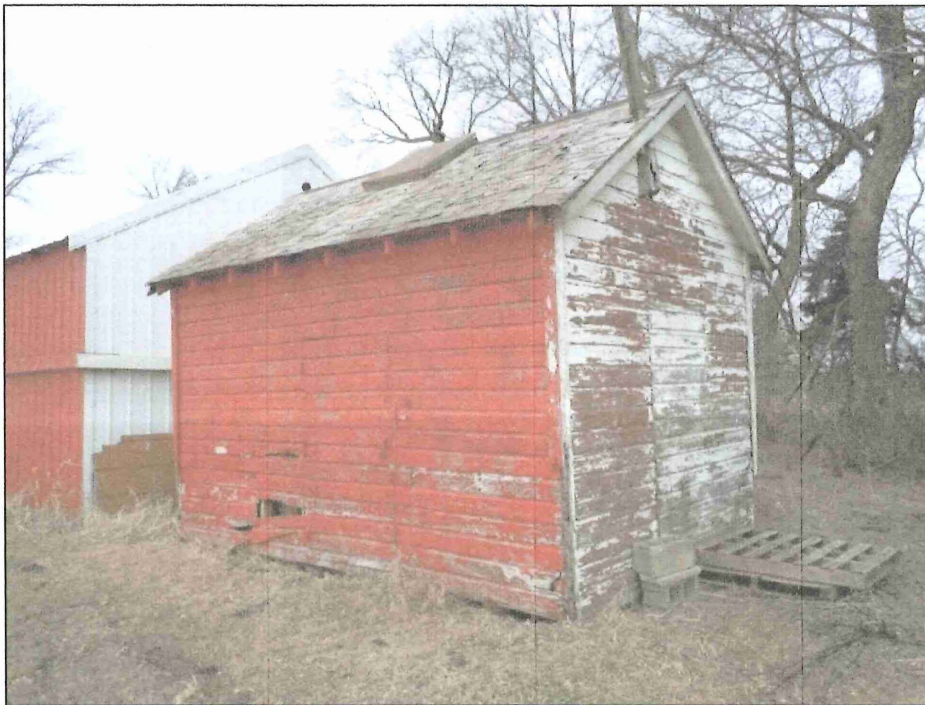
Nearly adjacent to and north of the modern metal building is a granary, which aerial photographs indicate was moved to its current location after 1991 (Figure 74). The circa-1920, gable-roofed granary is raised on wood skids and clad in wood drop siding. A single window opening is present in the south gable, but the window is no longer present. A pedestrian door has been fashioned by making cuts in the siding on the east side. The roof is clad in asphalt shingles and features exposed rafter tails.

FIGURE 74. 1399 45TH STREET SW, GRANARY, LOOKING SW

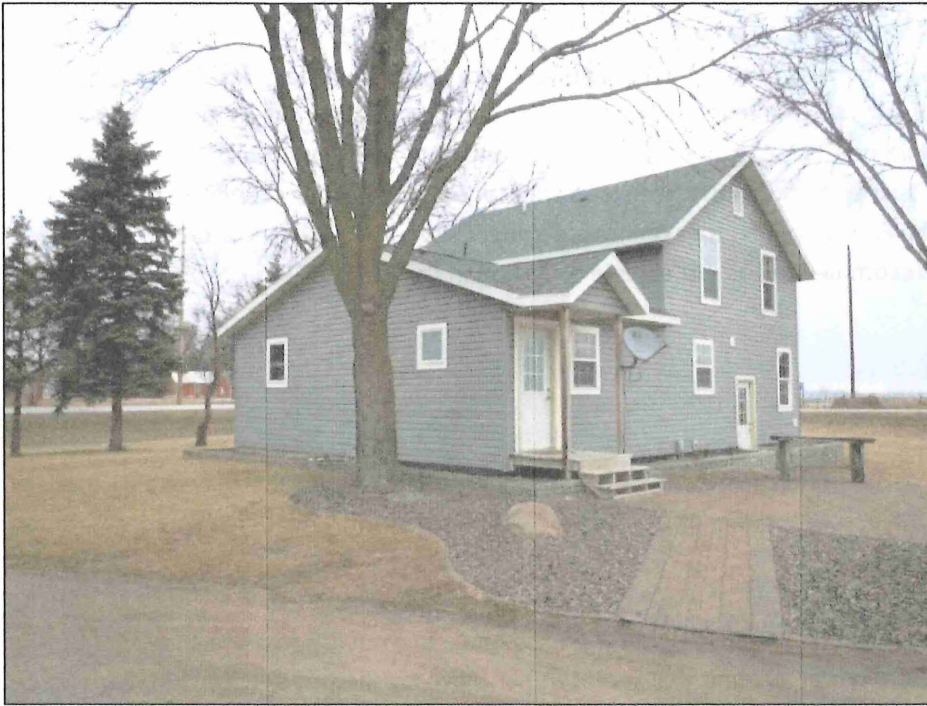
FIGURE 76. 1560 45TH STREET SW, HOUSE, LOOKING NE

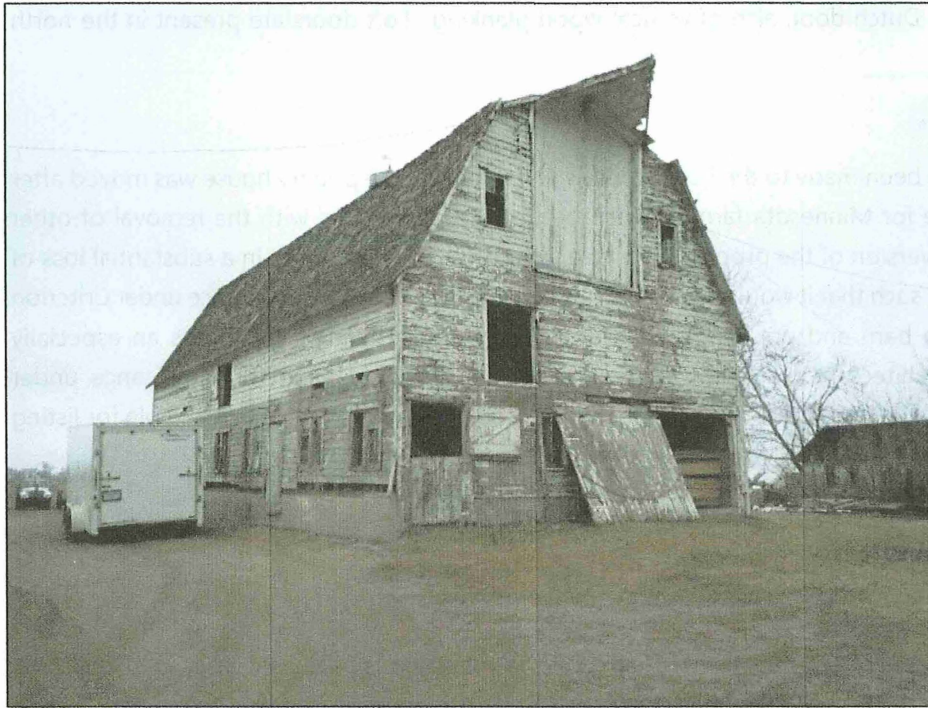
The barn has not been maintained and is in a state of deterioration (Figure 77). It features a poured-concrete foundation and wood drop siding. The gambrel roof is clad in wood shakes and exhibits exposed rafter tails. On the north end, a hay hood extends over the mow door, which is flanked by window openings containing broken six-light, fixed-sash windows. Similarly placed windows have broken out of the south end. What remains of the windows, either broken or infilled, on the lower level of the building indicates that these were also six-light fixed sash. A sliding door at the west end of the north end of the barn has come off the rails and is propped against the wall. At the east end of the north end is a Dutch door. Pedestrian door openings are at both ends of the south wall, the western one of which contains a vertical wood-plank door, and the eastern one of which is empty. A central pedestrian opening is empty and blocked by debris. The remnant of an attached gable and discoloration indicates that this central opening provided a connection between the main barn and a small, gable-roofed extension on its south end.

FIGURE 77. 1560 45TH STREET SW, BARN, LOOKING SW

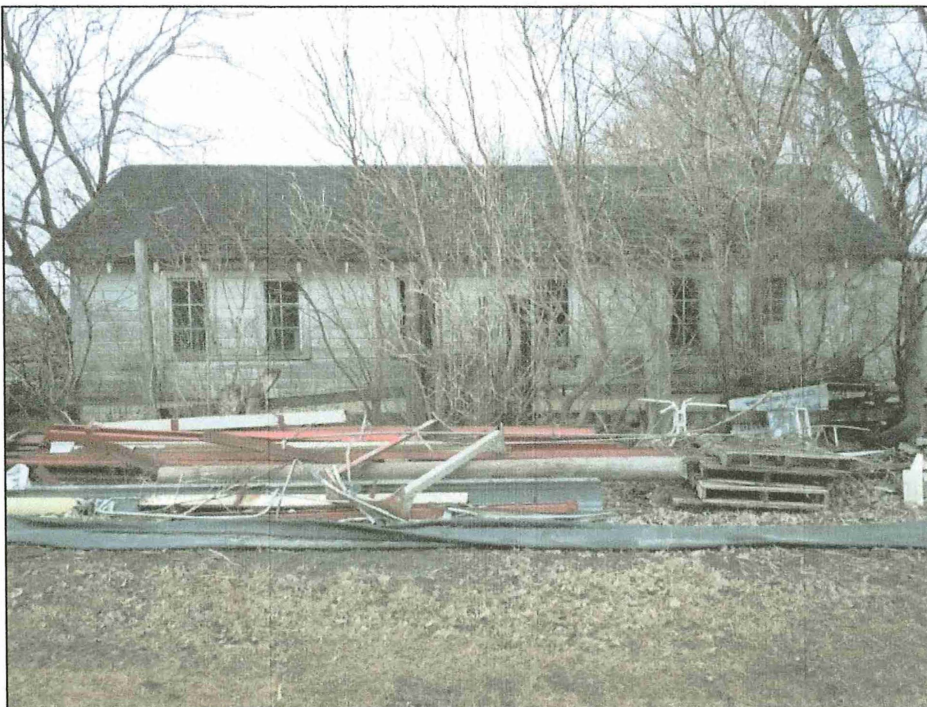
Aerial photographs demonstrate that the poultry house, although likely original to the farmstead, was moved to its current location sometime between 1970 and 1991 (Figure 78). The gabled roof is covered in asphalt shingles and features exposed rafter tails. The building has a poured-concrete foundation and is clad in wood drop siding. Regularly spaced, original six-light, fixed-sash windows are present on the east side of the building, and a single four-light, fixed-sash window is located on the south end. No window openings are present on the north or west side. A sliding door, sheathed in corrugated metal, is located on the north end of the building and a narrow pedestrian door of vertical wood planking is on the east side.

FIGURE 78. 1560 45TH STREET SW, POULTRY HOUSE, LOOKING W

The south end features a Dutch door, also of vertical wood planking. Loft doors are present in the north and south gables.

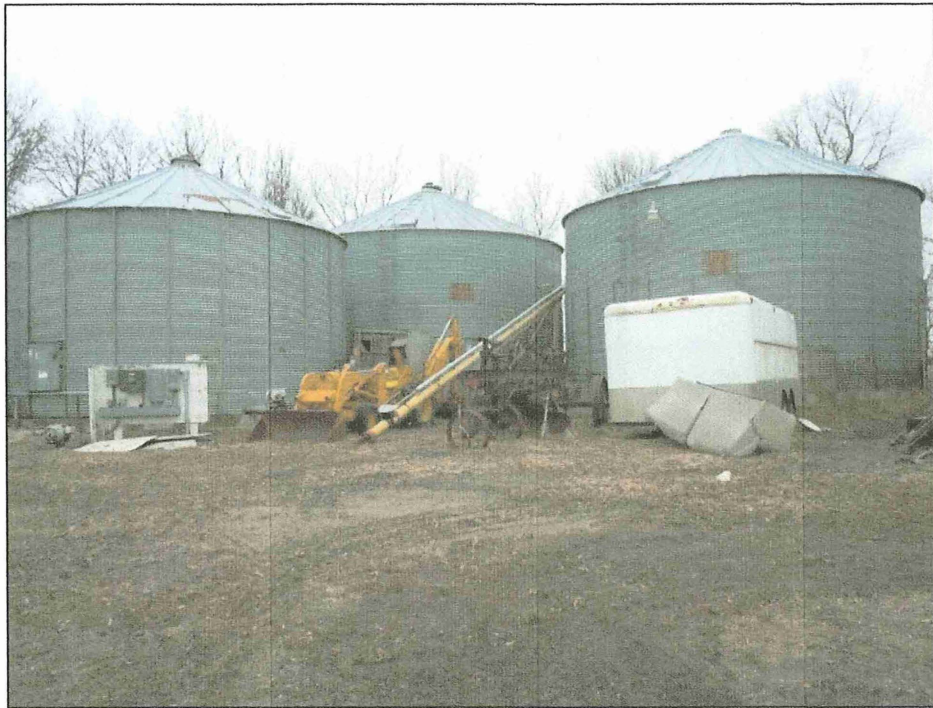
FIGURE 79. 2280 45TH STREET SW, GRAIN BINS, LOOKING NW

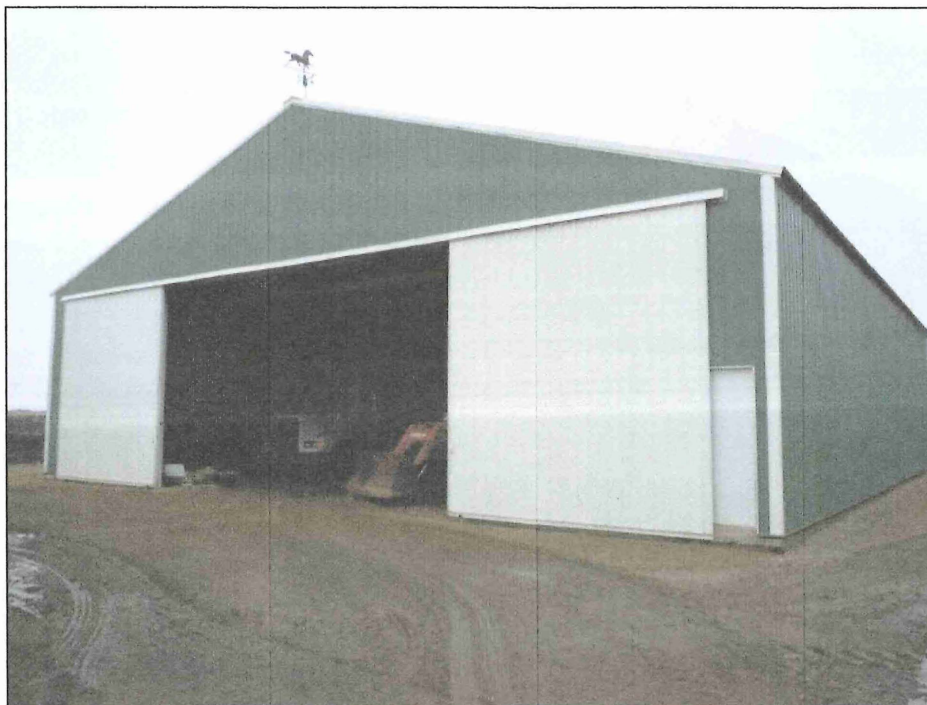
FIGURE 82. 2280 45TH STREET SW, MODERN METAL BUILDING 3, LOOKING SW

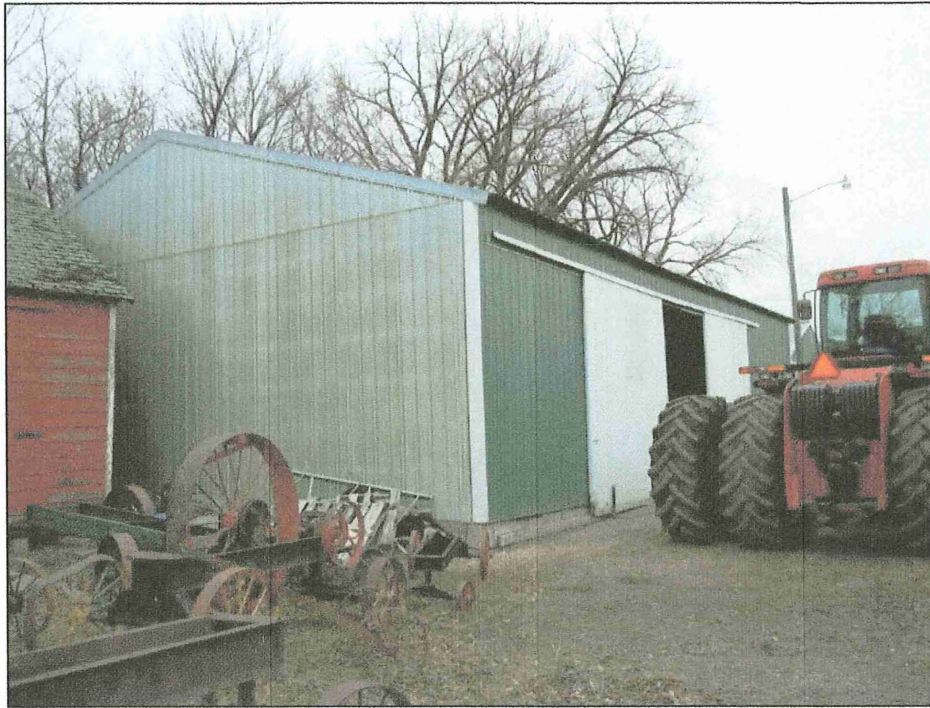
FIGURE 83. 2280 45TH STREET SW, MODERN METAL BUILDING 4, LOOKING NE

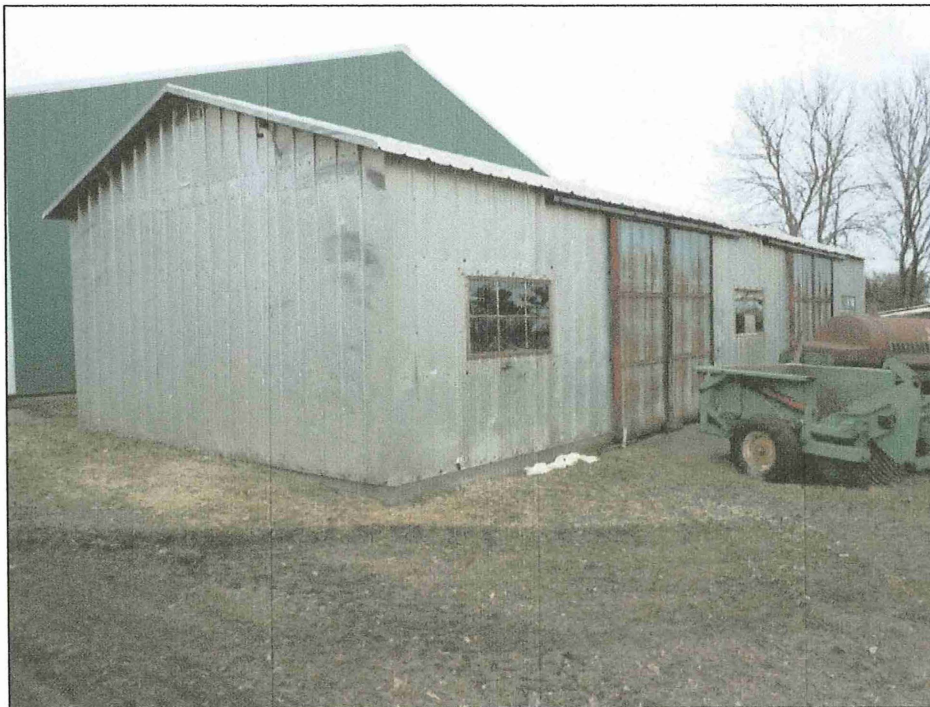
FIGURE 84. 2280 45TH STREET SW, MODERN METAL BUILDING 5, LOOKING SE

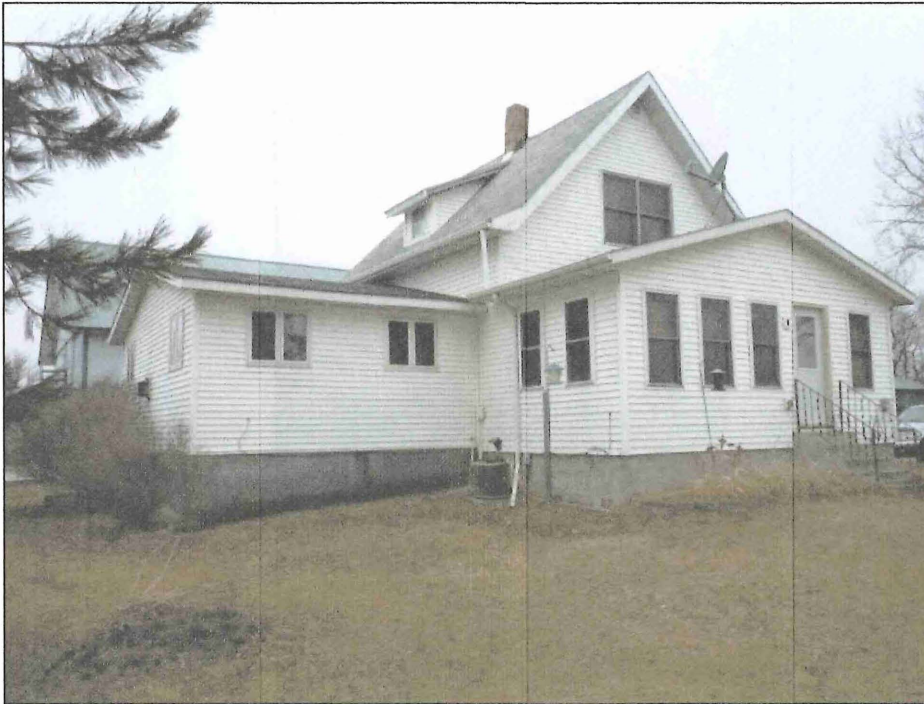
FIGURE 85. 2280 45TH STREET SW, HOUSE, LOOKING NW

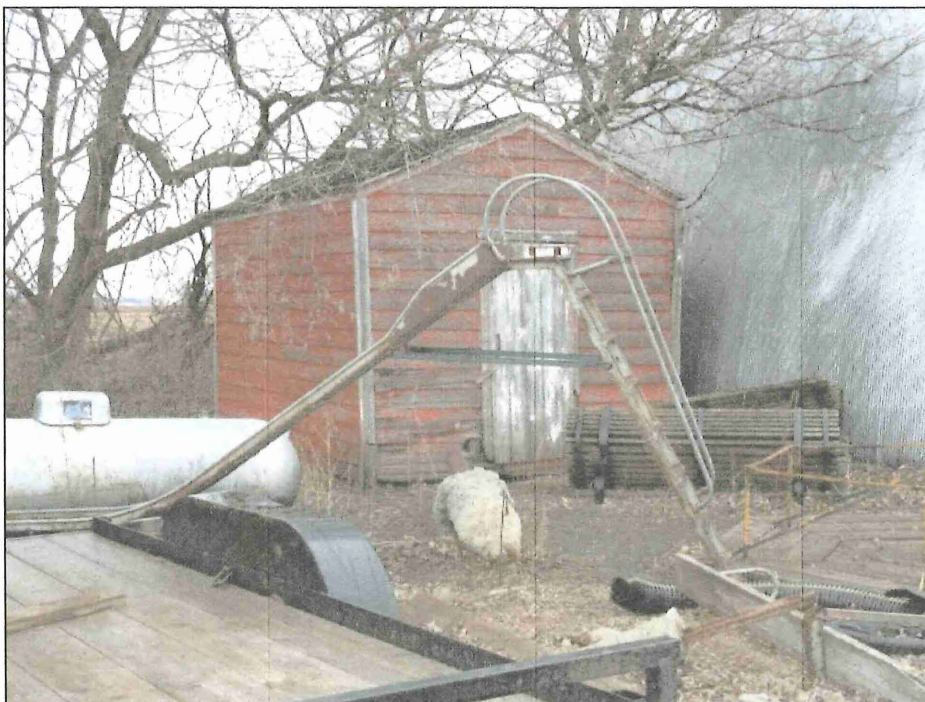
An outbuilding that the current owner's children used as a playhouse, perhaps originally a milk house, is located near the eastern end of the farmstead (Figure 86). It has a low-pitched, gabled roof, wood lap siding, and a single pedestrian door of vertical wood planks. The roof is covered in asphalt shingles.

FIGURE 86. 2280 45TH STREET SW, "PLAYHOUSE," LOOKING NE
