Phase I and II Architectural History Investigations for the
Willmar Connection and Industrial Access Project,
City of Willmar and Willmar Township,
Kandiyohi County, Minnesota

Submitted to:
Minnesota Department of Transportation
395 John Ireland Boulevard
St. Paul, MN 55155

Cultural Services LLC

July 2016

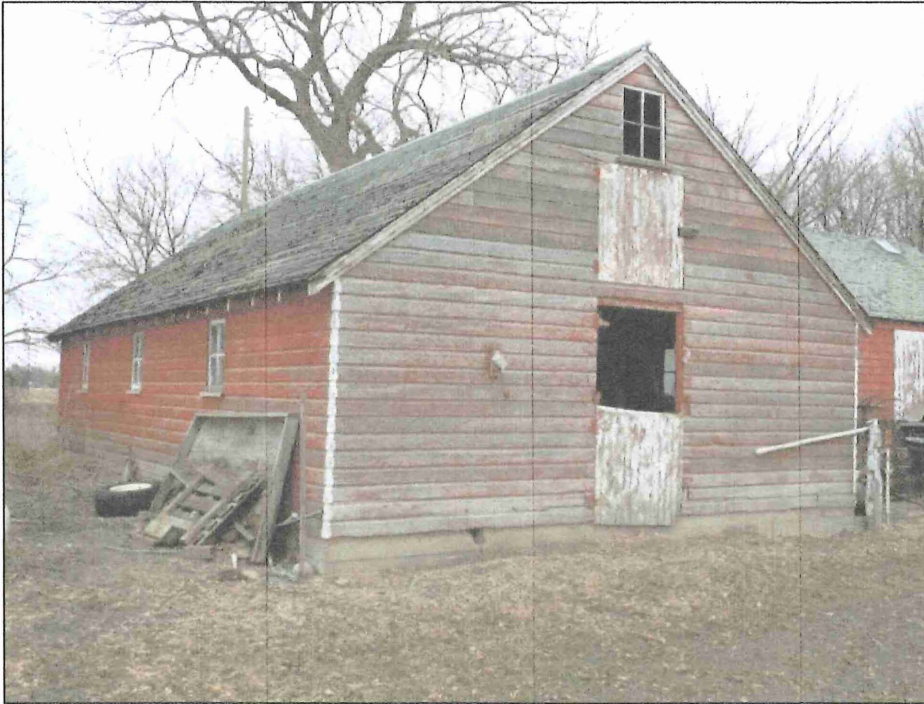
FIGURE 88. 2280 45TH STREET SW, SMALL BARN, LOOKING NE

A bit farther west is the small barn, which has a poured-concrete foundation (Figure 88). Its gable roof is clad in asphalt shingles and has exposed rafter tails, and the walls are clad in wood drop siding. Original four-light, fixed-sash windows are present on the sides and in the south gable, though some of the panes have been broken out. The window in the gable is centered over a loft door, which in turn is over a Dutch door, both doors made of vertical wood planks. Crude openings have been cut into the base of the superstructure on the east side, at least one of which is boarded in.

Extensive alterations have been made to the house, and several massive, modern outbuildings have been constructed on and dominate the visual aspect of this property. The farmstead would therefore be unable to convey any potential significance under Criterion A, B, or C. None of the individual elements of the farmstead are especially distinctive examples of architecture or design as required by the Farms Context for significance under Criterion C (Granger and Kelly 2005:7.20). This property is therefore recommended as not eligible for listing in the National Register.

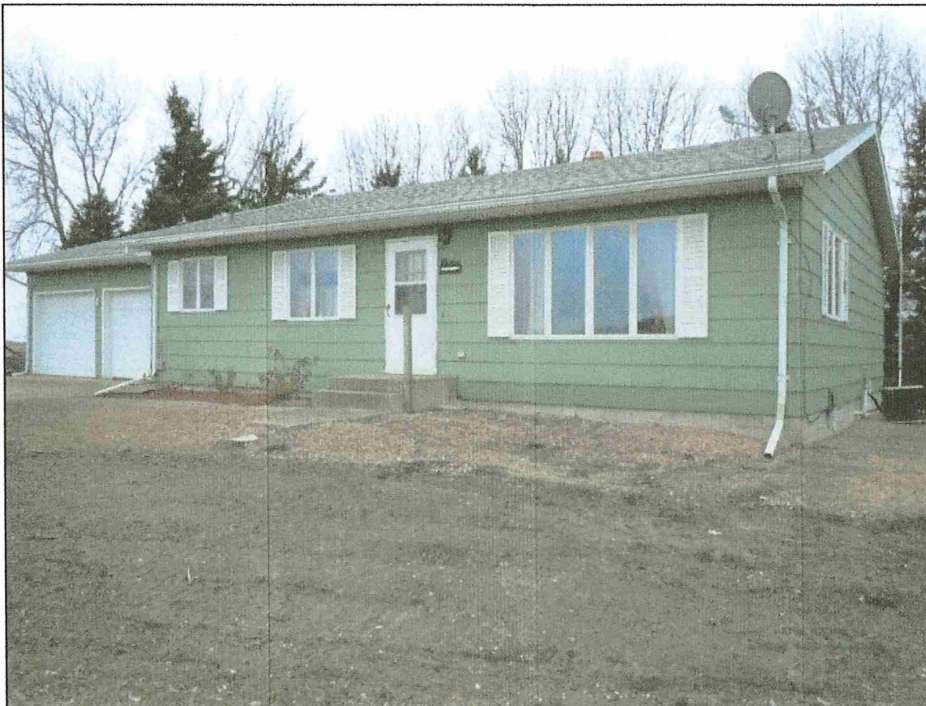
FIGURE 90. 2460 45TH STREET SW, HOUSE, LOOKING SW

This one-story, Ranch-style house with concrete-block foundation and attached two-bay garage was built circa 1965 (Figure 90). The walls are clad in masonite siding and the side-gabled roof in asphalt shingles; the roofing is newer, and the soffits and fascia are vinyl. A brick interior chimney extends above the roof. At the front of the house, poured-concrete steps lead up to a centrally placed door. Fenestration consists primarily of original casement windows, quadrupled to create a picture window on the façade and paired otherwise. Single-pane, fixed-sash windows are located in the garage and at the basement level on the north and west sides of the house. The garage has two replacement overhead doors, next to which on the north is a pedestrian door.

This house has no important associations with historically significant events, patterns, or persons, and it therefore does not meet National Register Criterion A or B. It is a modest, fairly non-descript house that alludes to but does not exhibit any notable architectural hallmarks of the Ranch style; therefore it does not meet Criterion C. This property is therefore recommended as not eligible for listing in the National Register.

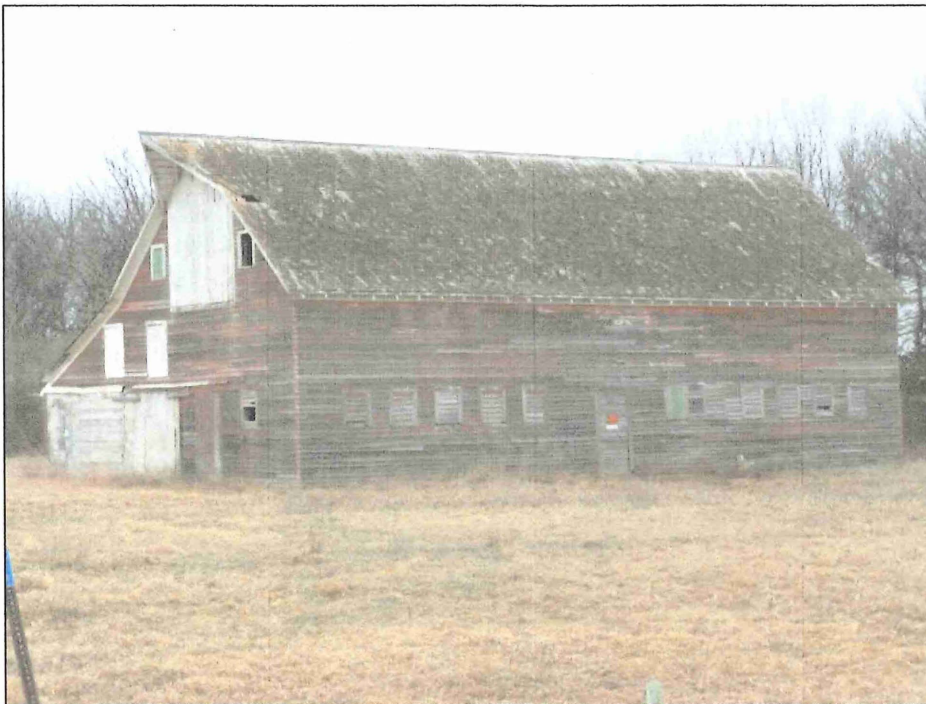
FIGURE 91. BARN, 45TH STREET SW, LOOKING NW

Access to this property was not permitted by the landowner, requiring the survey to be conducted from 45th Street SW. This former farmstead has been reduced by the removal of all other buildings to a single, abandoned barn (Figure 91), which aerial photographs indicate was built in this location sometime between 1938 and 1955. The barn, gable-roofed with a shed wing, has a poured-concrete foundation (Figure 92). The walls are clad in wood lap siding. Window openings have all been infilled, except in two cases on the south side, in which the infill has been broken out. A pedestrian doorway on the east side of the barn also has been infilled. A partially intact Dutch door and a pedestrian door are present on the north side of the building, while a sliding door is located on the south. Two loft doors are located on each end of the barn in positions that mirror each other, near the junction of the main massing and the shed wing, although one on the north end is broken out. The roof of the barn is clad in wood shakes, and it features exposed rafter tails and a hay hood over the mow doors on the south.

With only a barn present, this property would not have the integrity to convey any potential significance of the former farmstead under Criterion A, B, or C. The barn is not an especially distinctive example of architecture or design as required by the Farms Context for significance under Criterion C (Granger and Kelly 2005:7.20). This property is therefore recommended as not eligible for listing in the National Register.

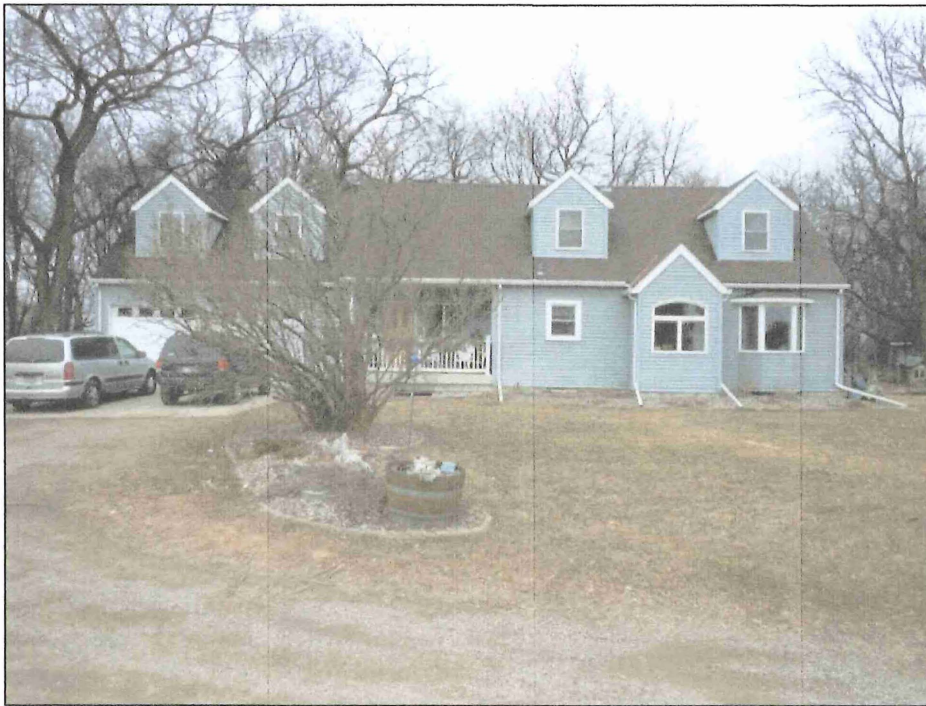
This former farmstead comprises a house, garage, a machine shed, a loafing shed, and two outbuildings. The one-and-a-half-story house with attached garage, if not constructed in the modern era, has been substantially expanded and updated such that any original construction is completely obscured (Figure 93).

FIGURE 93. 3830 COUNTY ROAD 15 SW, HOUSE, LOOKING E

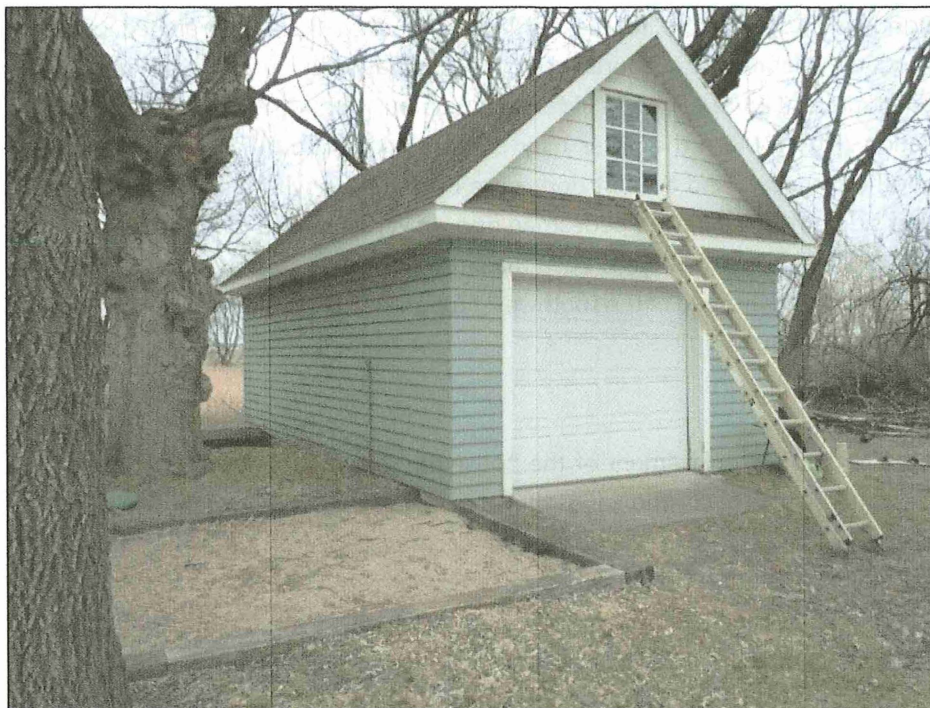
FIGURE 94. 3830 COUNTY ROAD 15 SW, GARAGE-LIKE BUILDING, LOOKING SE

A gable-roofed building with overhead door that appears as a detached garage is located to the east of the house; however, no driveway leads to it, suggesting that it currently serves some other function (Figure 94). The walls are wood lap siding, except in the gable, which may constitute an addition to the original building. The gable contains replacement siding underlined by wood shakes, which angle down and out from the base of the gable to the edges of the eaves, which have vinyl soffits. Within the gable is a nine-light casement window. The gabled roof has vinyl fascia and soffits, and is clad in asphalt shingles.

Based on the extensive alterations to or replacement of the house and the main barn, alterations to the side-gabled outbuilding, and the loss of other outbuildings that are evident in historical aerial photographs, this property would not have the integrity to convey any potential significance of the former farmstead under Criterion A, B, or C. None of the individual elements of the farmstead are especially distinctive examples of architecture or design as required by the Farms Context for significance under Criterion C (Granger and Kelly 2005:7.20). This property is therefore recommended as not eligible for listing in the National Register.

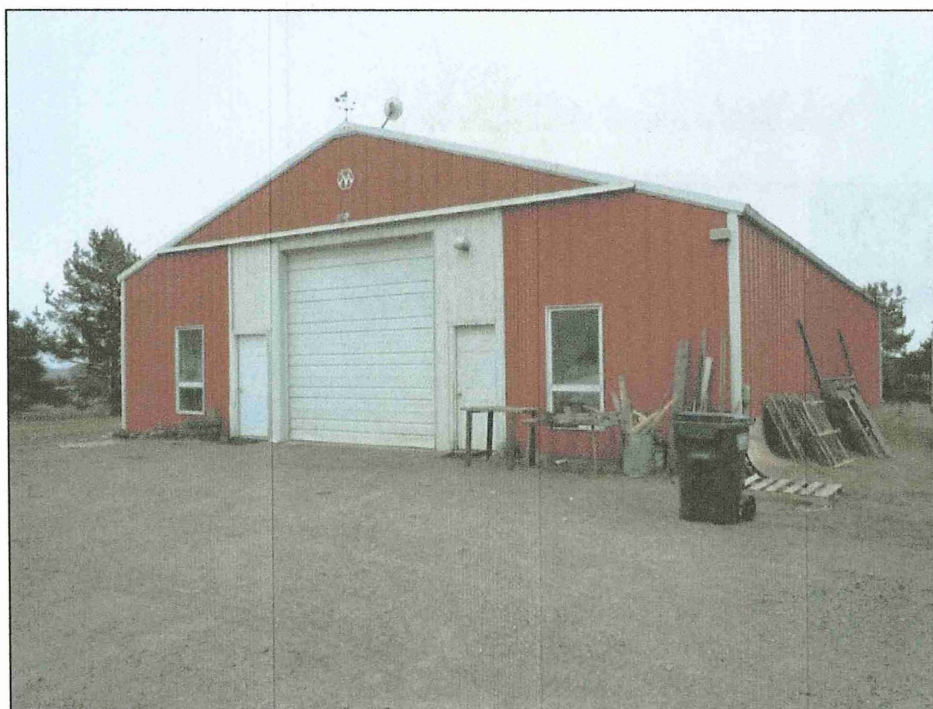
FIGURE 95. 3830 COUNTY ROAD 15 SW, METAL OUTBUILDING, LOOKING SW

Across the driveway from the house to the southwest is a large, gable-roofed outbuilding clad in metal siding (Figure 95). It features a large central overhead door, flanked on either side by newer pedestrian doors and beyond those, new windows. Historical aerial photographs show a large barn in this location, but it is oriented on the opposite axis. This building therefore either represents a post-1963 reconfiguration or post-1963 construction.

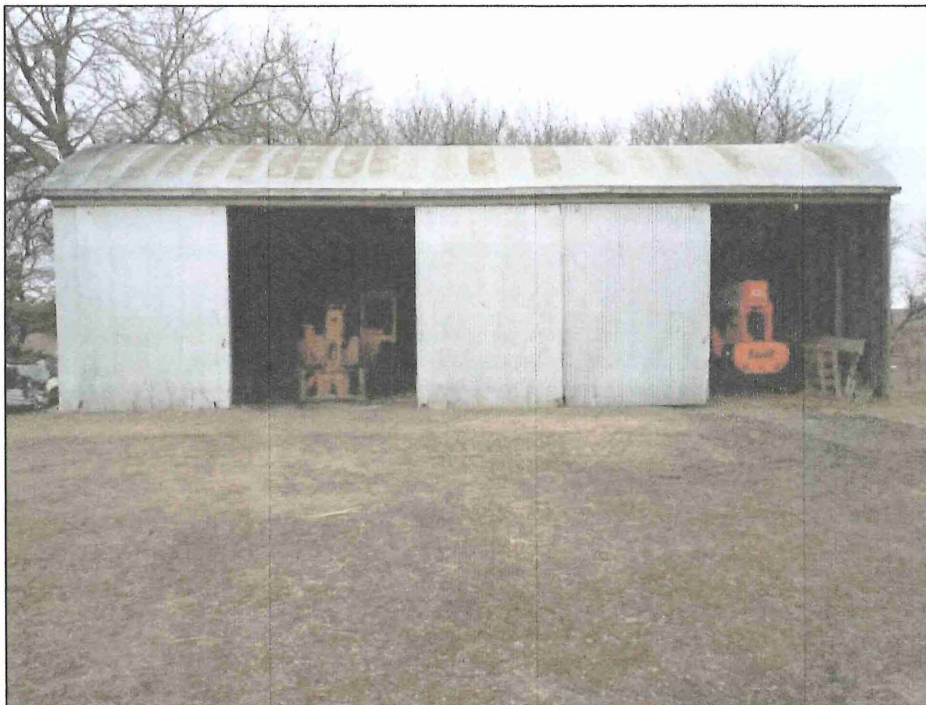
FIGURE 96. 3830 COUNTY ROAD 15 SW, MACHINE SHED, LOOKING N

The remaining outbuildings and structures are to the northwest: a circa-1945, side-arched Quonset machine shed clad in corrugated metal with a poured-concrete foundation (Figure 96); a shed-roofed loafing shed clad in corrugated metal (Figure 97); and a side-gabled outbuilding with wood drop siding and a poured-concrete foundation (Figure 98). The latter may contain original four-light windows in the southeast end, but several other windows and the loft door have been infilled with plywood. Two doors are located on the southwest side of the building, a pedestrian door of vertical wood planking and a wider hinged door of the same. A small, informal shade has been made by extending a corrugated-metal sheet in a shed-roofed fashion from the northwest end of the southwest face of the building to connect to wooden fencing a few feet to its southwest.

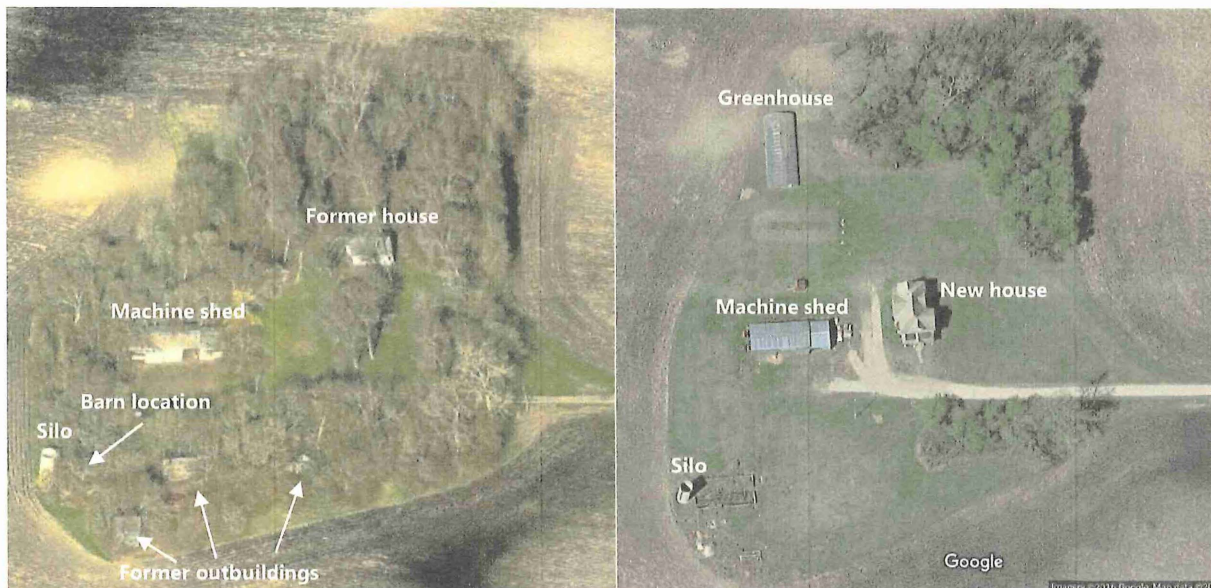
FIGURE 99. 3843 15TH AVENUE SW, RECENT BIRDS' EYE VIEW (LEFT) AND 2016 AERIAL (RIGHT) (NORTH IS TO THE RIGHT)

Access restrictions were placed on the survey of this former farmstead, preventing the obtainment of details on each of the buildings and structures. Comparison, however, of recent aerial photography shows that the house currently present is of very recent construction (Figures 99 and 100), as is a greenhouse to its southwest (Figure 101), all but one outbuilding has been removed, and nearly all trees have been cleared. The only remnants of the farmstead are a partial cement-stave silo (Figure 102) and a corrugated-metal machine shed (Figure 103).

Based on the extensive alterations to this property, it would not have the integrity to convey any potential significance of the former farmstead under Criterion A, B, or C. Neither the silo nor the machine shed is an especially distinctive example of architecture or design as required by the Farms Context for significance under Criterion C (Granger and Kelly 2005:7.20). This property is therefore recommended as not eligible for listing in the National Register.

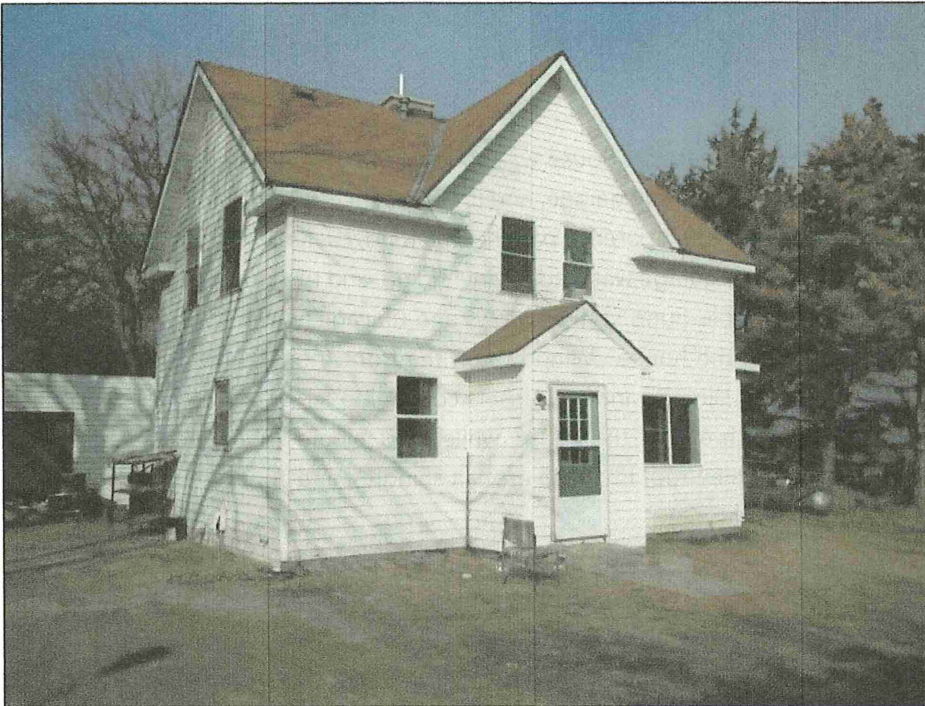
FIGURE 106. 3631 15TH AVENUE SW, HOUSE, LOOKING NW

A second one-and-a-half-story house, this one cross-gabled, is located nearer to the road, and aerial photographs show it was put in place circa 1960 (Figure 106). Based, however, on its appearance, which does not reflect architecture of that era, it was moved from another location. This house similarly is on a concrete-block foundation, has been clad in vinyl siding, and has replacement doors and windows; an asphalt-shingle roof, and vinyl fascia and soffits. The detached two-bay garage off of its southwest corner was built sometime after 1991 (Figure 107).

Given the extensive alterations to this property, both to the buildings and as a whole, it would not have the integrity to convey any potential significance of the former farmstead under Criterion A, B, or C. None of the individual elements are especially distinctive examples of architecture or design as required by the Farms Context for significance under Criterion C (Granger and Kelly 2005:7.20). This property is therefore recommended as not eligible for listing in the National Register.

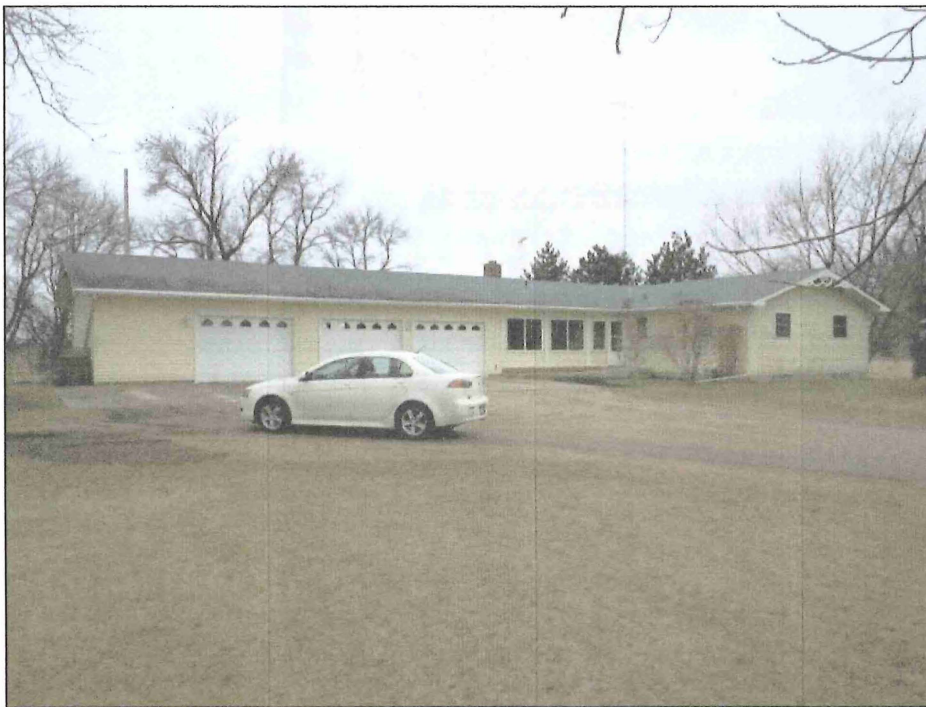
FIGURE 108. 3055 HIGHWAY 12 W, HOUSE, LOOKING SW

Based on a conversation with its current owner, this house was constructed for his parents in 1965. It is a one-story, L-plan house with an attached three-bay garage, and it has a concrete-block foundation (Figure 108). The property owner indicated that upon his parents' passing, the third, easternmost bay of the garage was added on, the entirety of the house and garage was clad in vinyl siding, and the vinyl soffits were added. The house retains several original 1/1 double-hung sash windows and Chicago-style picture windows, the latter located on the back (north) side of the house. Windows on the front (north) of the east ell of the house appear to be added or replacement sliding windows. Insets containing a row of five glass blocks are located in the basement level on the north end of the house, while fixed, single-light windows are in the same level on the west side. The cross-gabled roof is clad in asphalt shingles, and an interior brick chimney extends above the peak of the ell.

This house has no important associations with historically significant events, patterns, or persons, and it therefore does not meet National Register Criterion A or B. It is a modest, fairly non-descript, and modified house that does not exemplify a specific architectural style; therefore it does not meet Criterion C. This property is therefore recommended as not eligible for listing in the National Register.

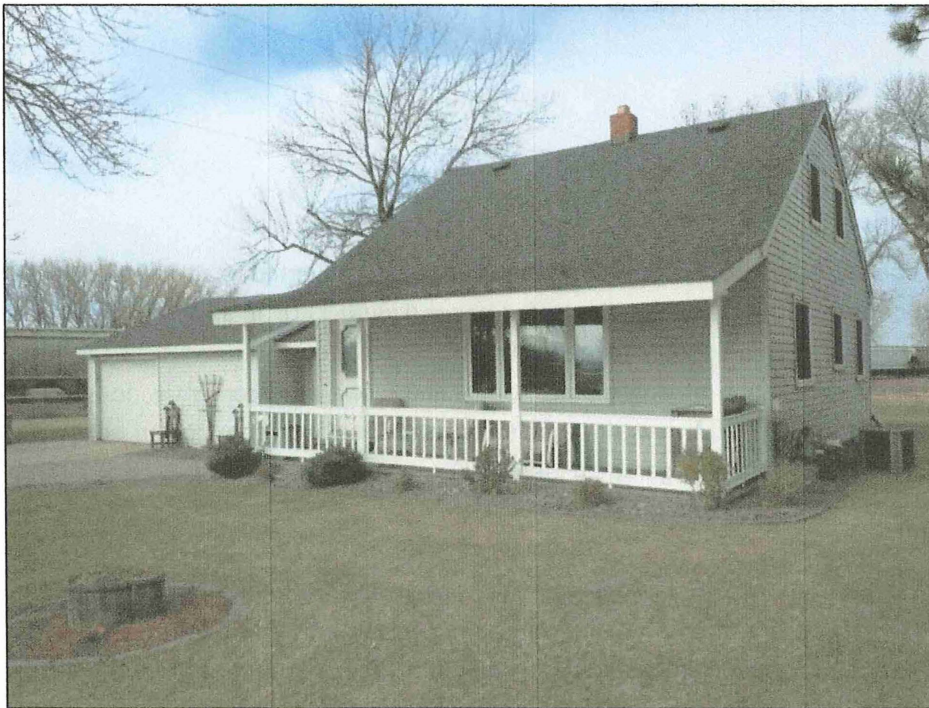
FIGURE 109. 101 33RD STREET NW, HOUSE, LOOKING SW

This one-and-a-half-story, side-gabled house with concrete-block foundation was built in 1957 (Figure 109). The house has been altered with the addition of a shed-wing, open front porch; vinyl siding, soffits, and fascia; and replacement doors and windows. The middle section of the house, which connects to the garage, extends in an incongruous fashion off the rear of the house, suggesting it was expanded or added between the original house and garage prior to the re-siding. The roof is covered in asphalt shingles, and an interior brick chimney rises above the peak. A modern, detached garage/workshop is located to the southeast of the house (Figure 110).

This house has no important associations with historically significant events, patterns, or persons, and it therefore does not meet National Register Criterion A or B. It is a modest, fairly non-descript, and modified house that does not exemplify a specific architectural style; therefore it does not meet Criterion C. This property is therefore recommended as not eligible for listing in the National Register.

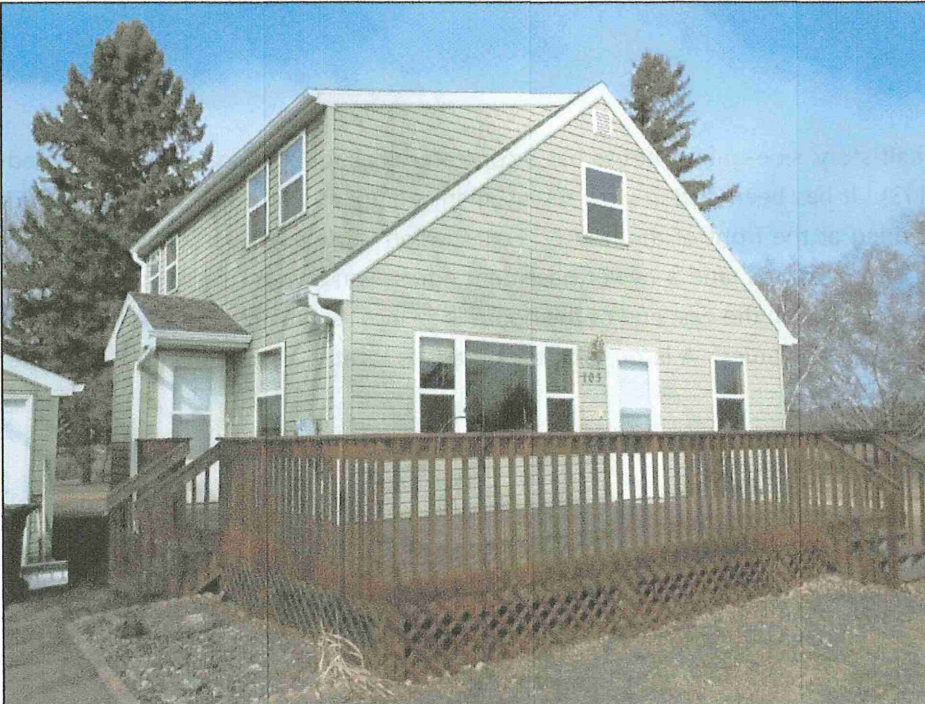
FIGURE 111. 103 33RD STREET NW, HOUSE, LOOKING NW

This circa-1965 house with concrete-block foundation appears to have been converted to a two-story house through a dormer addition on the south side of a gable-roofed house (Figure 111). In all likelihood, it was a side-gabled house that was, like its two neighbors to the north, not oriented toward the road. It has been additionally altered through the installation of vinyl siding, soffits, and fascia, replacement windows and doors, and decks on the east and west ends. A new, side-gabled entrance has been constructed below the dormer addition. Just to its south is a detached garage (Figure 112).

This house has no important associations with historically significant events, patterns, or persons, and it therefore does not meet National Register Criterion A or B. It is a modest, fairly non-descript, and modified house that does not exemplify a specific architectural style; therefore it does not meet Criterion C. This property is therefore recommended as not eligible for listing in the National Register.

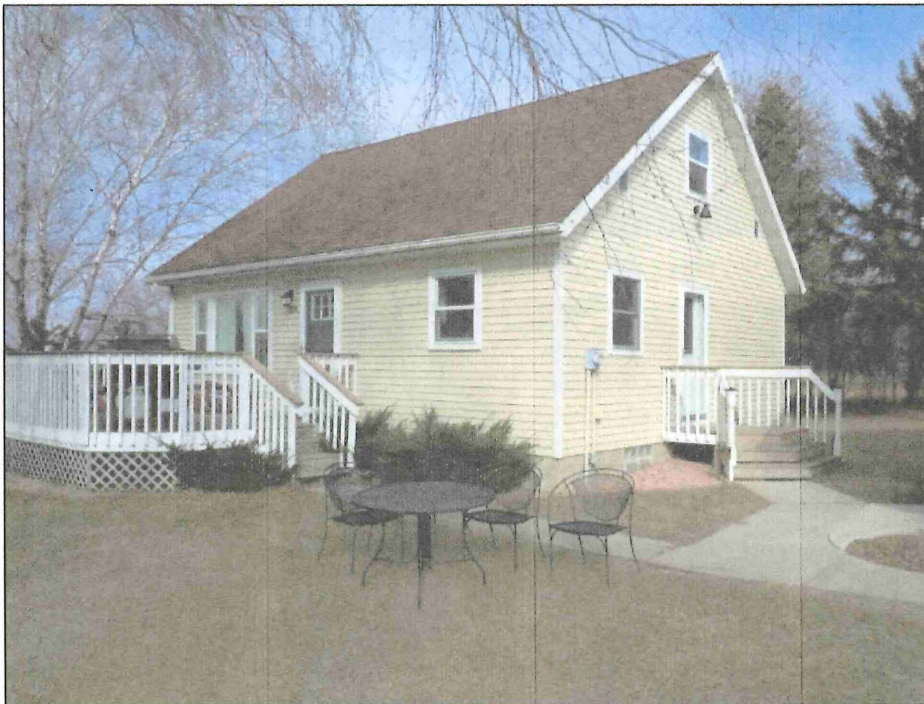
FIGURE 113. 105 33RD STREET NW, HOUSE, LOOKING NW

This circa-1960, one-and-a-half-story, side-gabled house has a concrete-block foundation. It is not oriented toward the road (Figure 113). It has been clad in vinyl replacement siding, and also has vinyl soffits and fascia. A deck has been added at the front of the house. Fenestration includes a Chicago-style picture window, 1/1 double-hung sash windows, and a newer basement egress window on the west end of the house. Opposite the egress window on the east end of the house is an inset containing a row of four glass blocks. The roof is clad in asphalt shingles. A large, modern garage is located east of the house (Figure 114).

This house has no important associations with historically significant events, patterns, or persons, and it therefore does not meet National Register Criterion A or B. It is a modest, fairly non-descript, and modified house that does not exemplify a specific architectural style; therefore it does not meet Criterion C. This property is therefore recommended as not eligible for listing in the National Register.

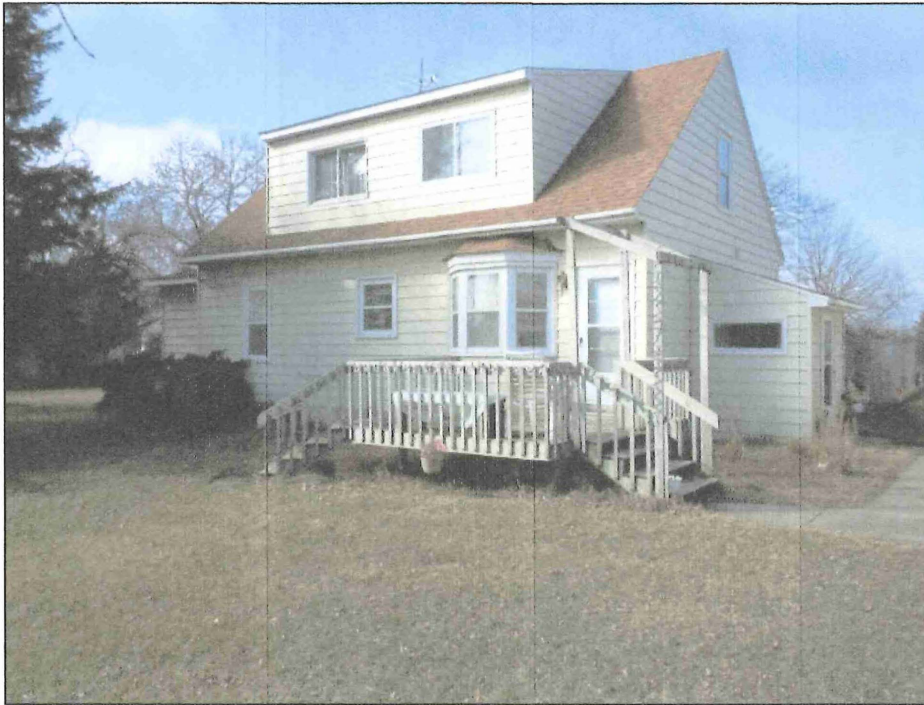
FIGURE 115. 107 33RD STREET NW, HOUSE, LOOKING SW

This circa-1930, front-gabled bungalow with concrete-block foundation is all that remains of a farmstead formerly at this location (Figure 115). It is not oriented toward the road. The house has been altered by the enclosure of the front porch, the addition of shed dormers on both sides of the roof, a shed-roof addition to the back of the house, and the installation of vinyl siding and soffits, replacement windows and doors, and a deck off the west side. A later, vinyl-sided, two-car garage is located north of the house (Figure 116).

This house has no important associations with historically significant events, patterns, or persons, and it therefore does not meet National Register Criterion A or B. It is a modest, fairly non-descript, and modified house that does not exemplify a specific architectural style; therefore it does not meet Criterion C. This property is therefore recommended as not eligible for listing in the National Register.

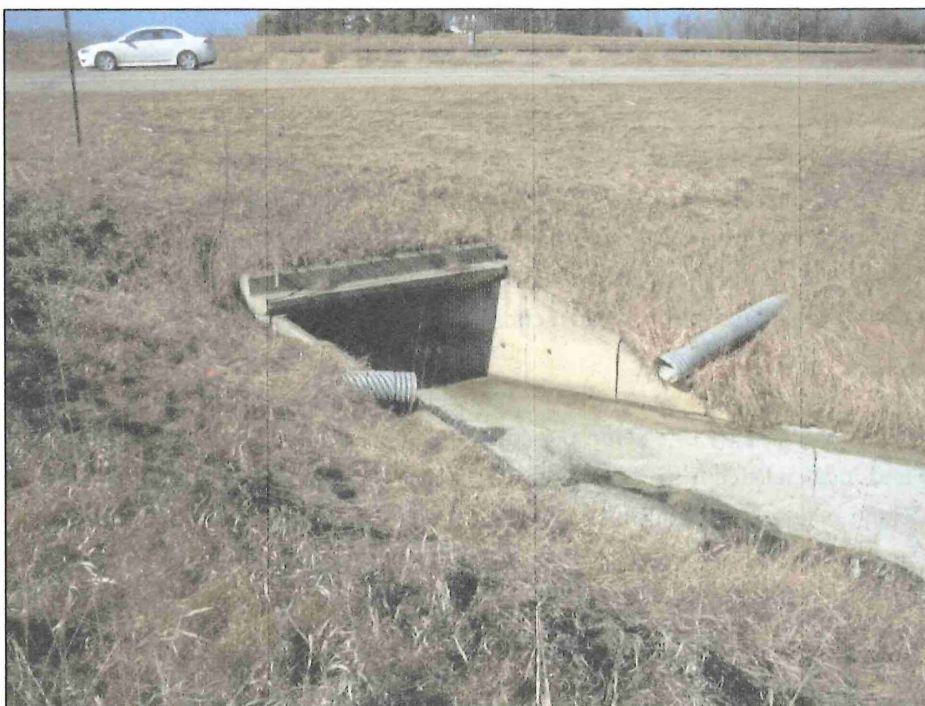
FIGURE 118. COUNTY DITCH NO. 46 AT 19TH AVENUE SW, LOOKING NW

County Ditch No. 46 is an open ditch constructed to be eight feet deep with a one-to-one slope ("General Specifications for the Construction of County Ditch Number 46. Kandiyohi County, Minnesota," Minnesota Division of Waters, County and Judicial Ditch Files, held at the Minnesota Historical Society, St. Paul) (Figure 117). It begins approximately ½ mile east of 30th Street SW, adjacent to the north side of 30th Avenue SW, on the southern edge of Section 21 of T119N, R35W, then extends west for approximately 2-1/4 miles, where it meets County Ditch No. 10 in Section 19 of T119N, R35W, placing approximately one mile of the ditch within the APE. Concrete box culverts carry 19th Avenue SW and CR 55 over the ditch within the APE (Figures 118 to 119).

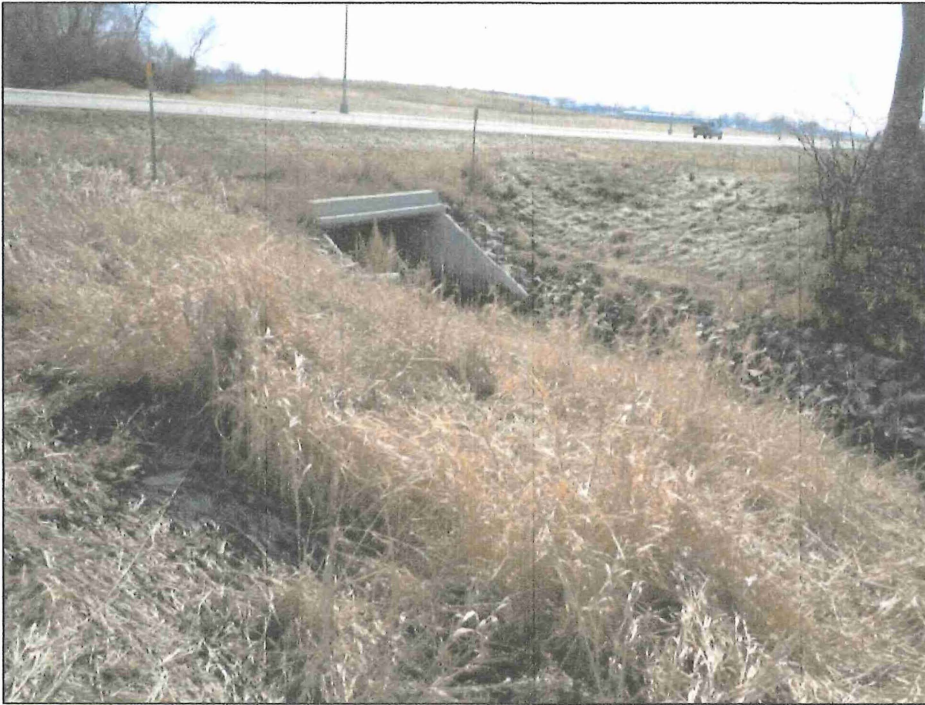
FIGURE 121. COUNTY DITCH NO. 10 AT 30TH STREET NW, LOOKING E-SE

County Ditch No. 10 is an open ditch. Based on the most recent improvement plans, it ranges from 8 to 12 feet deep at the bottom and has a two-to-one slope ("Plans, Improvement C, County Ditch No. 10, Kandiyohi County, Minnesota," available online at http://www.co.kandiyohi.mn.us/departments/drainage/ditch_construction_plans_and_maps.php) (Figure 120). It begins at Foot Lake, then runs west and south, ending at Judicial Ditch 7 in Edwards Township. Comparison of aerial photographs indicates that the ditch follows its originally constructed route, with the exception of a small alteration in Section 17, T119N, R35W, where it was rerouted to accommodate a runway for the first Willmar Airport. Within the APE, concrete box culverts carry TH 12, CSAH 5 (30th Street NW), and CR 55 over the ditch, and the ditch runs under CR 40 (15th Avenue SW) via a corrugated metal pipe culvert (Figures 121 to 123).

have improved surrounding farmland as had intended, no evidence suggests that its impact had a significant effect on the agricultural economy of Willmar. For these reasons, County Ditch No. 10 does not meet Criterion A. The individuals involved in petitioning for County Ditch No. 10 were not significant with regard to agriculture or public drainage history; therefore, the ditch does not meet Criterion B. The ditch, as a basic, open ditch does not employ innovative design, construction, or engineering, and it therefore does not meet Criterion C.

Because it does not meet National Register significance criteria, County Ditch No. 10 is recommended as not eligible for listing in the National Register.

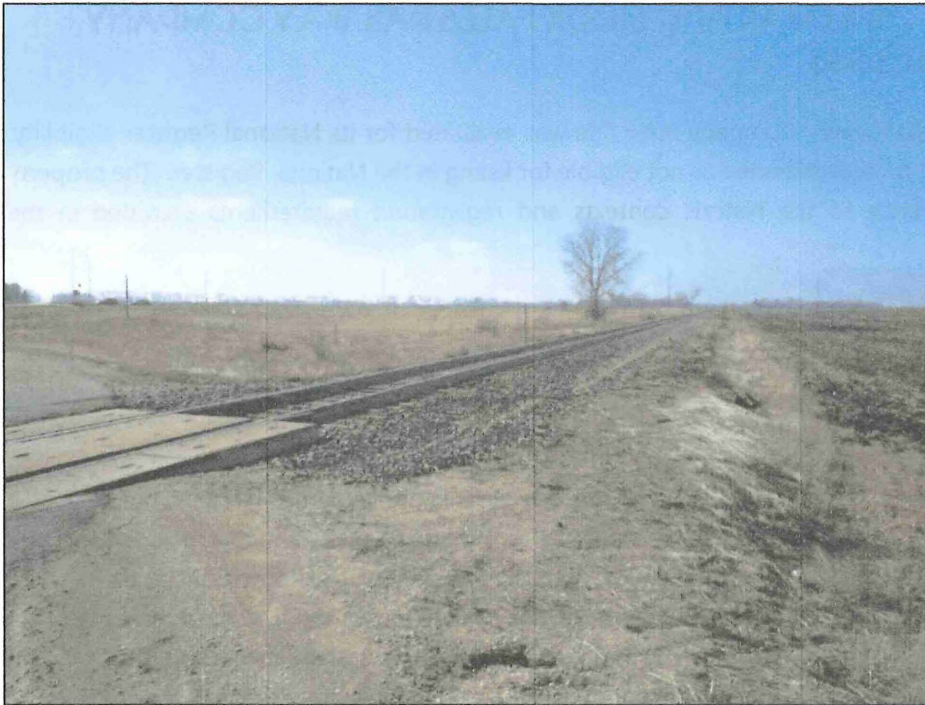
FIGURE 124. WILLMAR AND SIOUX FALLS RAILWAY AT COUNTY ROAD 55, LOOKING SW

Within the project APE, the railroad line consists of a single track incorporating wood ties and steel rails supported by a slightly raised rail bed (Figure 124). The railroad line remains active as part of the BNSF system.

Because the Willmar and Sioux Falls Railway main line does not meet the registration requirements for significance established by the Railroads MPDF, it is recommended as not eligible for listing in the National Register.
