Chicago, Milwaukee and St. Paul Railroad Grade Separation Historic District Reevaluation

Local Historic Bridge Study – Phase 3

**Minnesota Department of
Transportation**

March 2017

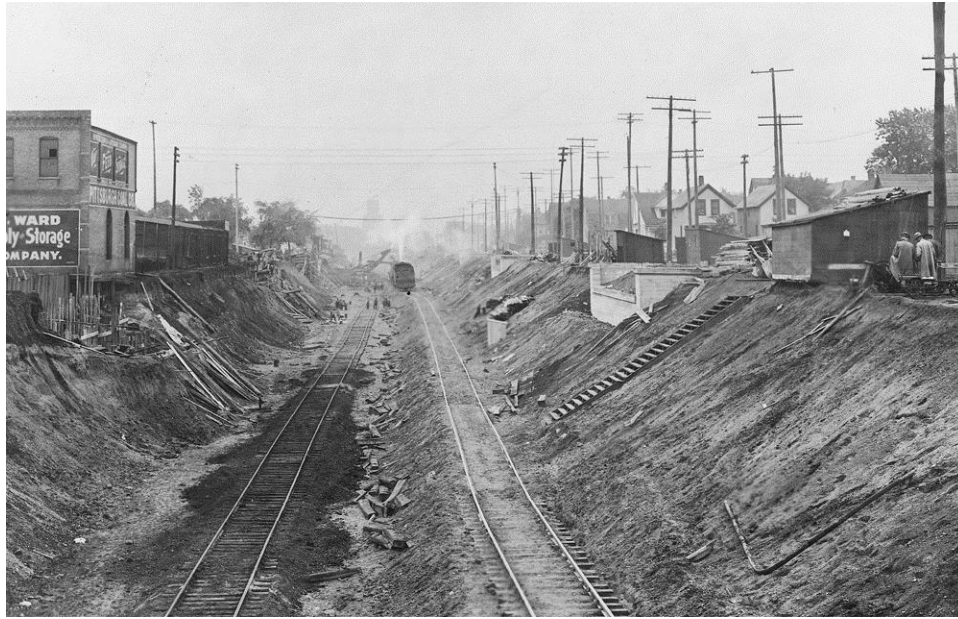
Figure 1. Grade separation trench under construction, view looking west from 1st Avenue (now the location of I-35W). Note bridge abutments under construction. Image from the City of Minneapolis Transportation Department photograph collection, courtesy of Gemini Research.³

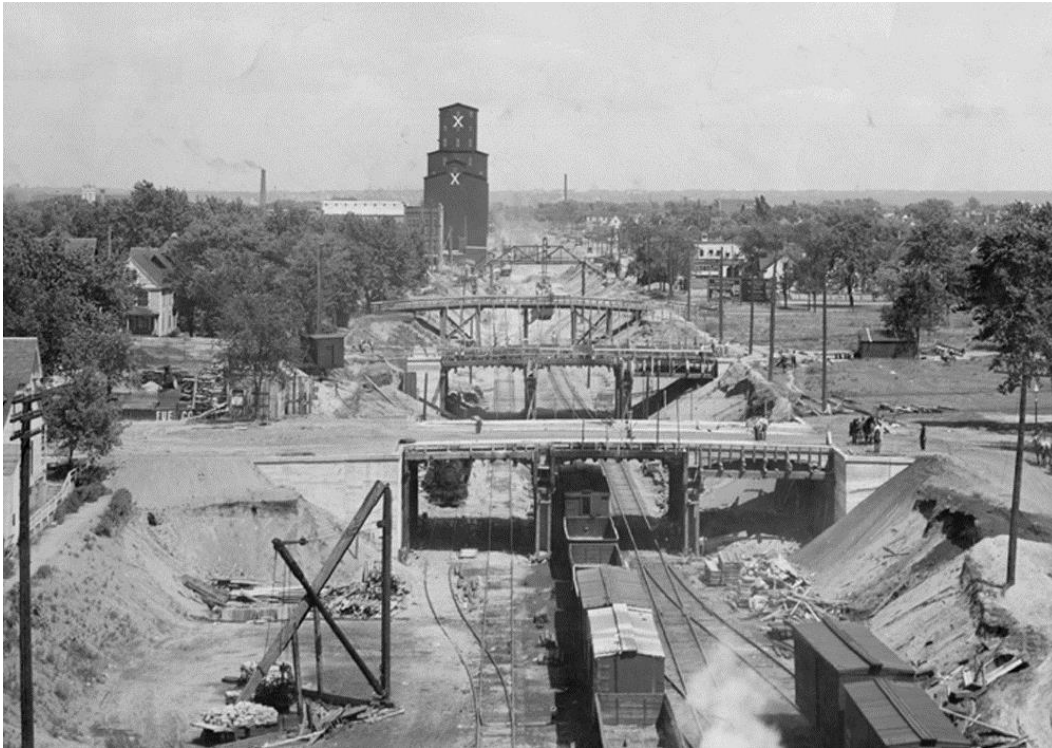
Figure 2. c.1915 image of the grade separation under construction. View from 5th Avenue east toward Portland and Oakland Avenues. Note the Bagley Grain Elevator (later to be replaced by the Stewart Grain Elevator; nonextant) in the background. Photograph by C.J. Hibbard, c.1915, Minnesota Historical Society.

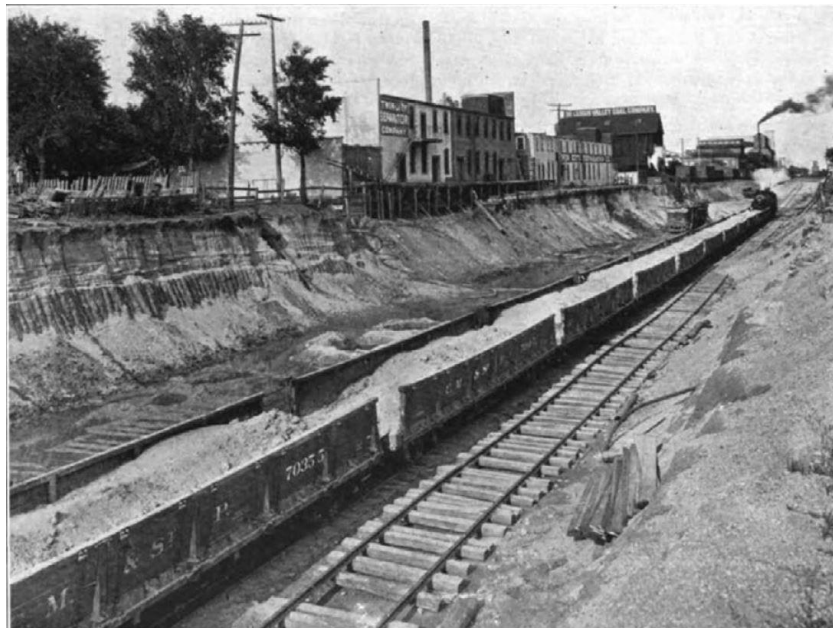
Figure 3. c.1915 photograph of the CM&StP Grade Separation under construction between Dupont and Emerson Avenues. Image from "Track Depression Work of the C.M. & St. P. Ry. at Minneapolis," Railway Review, July 17, 1915, pg. 70.

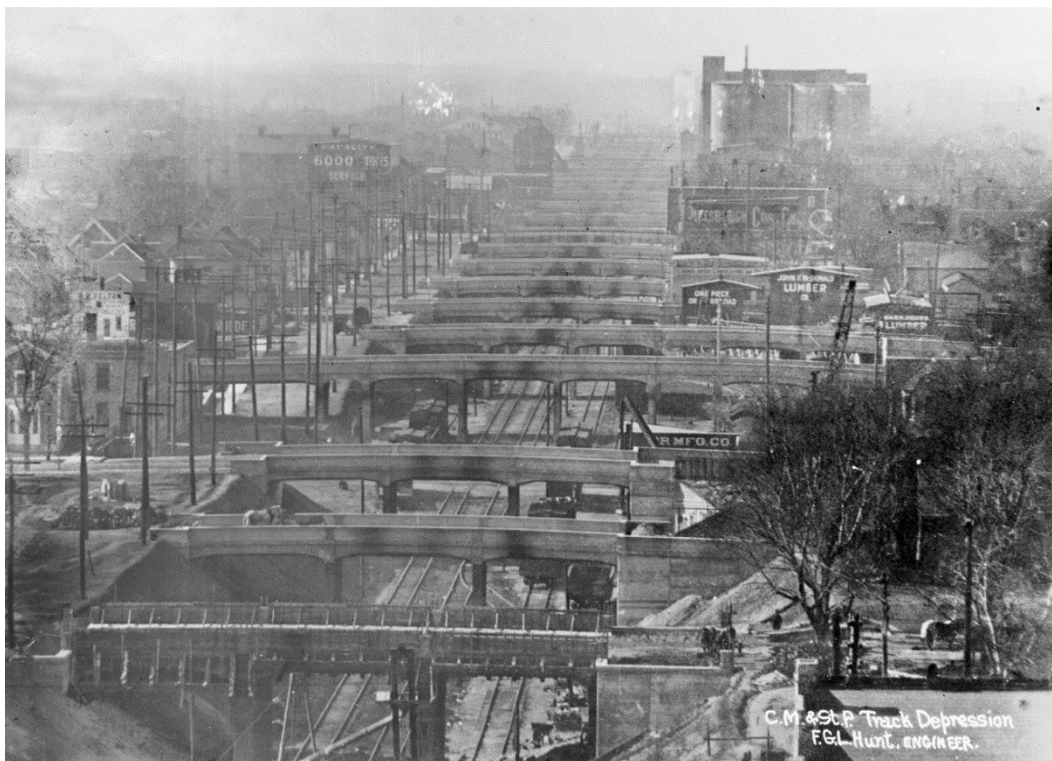
Figure 4. c.1915 image of the corridor nearly finished. View from Park Avenue looking west. Note the industrial uses on the north (right) side of the corridor. Photograph from "Views of the 29th Street Track Depression Construction Project in Minneapolis," annotated photograph album, Minnesota Historical Society.

At its completion, the CM&StP grade separation consisted of a 22-foot-deep trench. The base of the trench measured between 35 and 60 feet while the top of the trench ranged from 110 to 135 feet wide (Figure 4). The base of the trench was flat with a double-track main line running through the center and a series of sidings for both industrial or railroad operations on either side of the main line. Nearing 5th Avenue from the west, the rail line was not depressed, creating the only at-grade crossing. At 5th Avenue the railroad tracks widened out to accommodate a rail yard north of the tracks. The rail line was again depressed as it continued east toward Cedar Avenue. As part of the grade separation construction effort the CM&StP Railroad also reconstructed a portion of 29th Street, between 10th and Cedar Avenues, to accommodate the width of the trench (Figure 5).

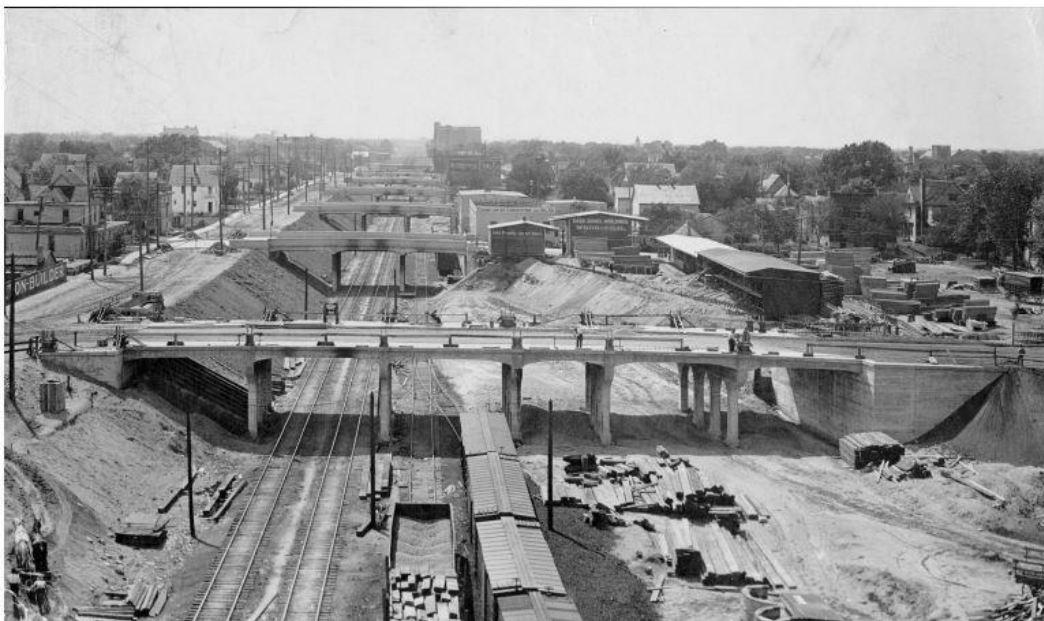
Figure 5. c.1915 photograph showing construction of 29th Street, bridges over the CM&StP Grade Separation, and the rail yard at Clinton Avenue. The Clinton Avenue Bridge is in the foreground followed by the 3rd, 2nd, and Stevens Avenue Bridges (all of which are nonextant). Photograph by C.J. Hibbard, c.1915, Minnesota Historical Society.

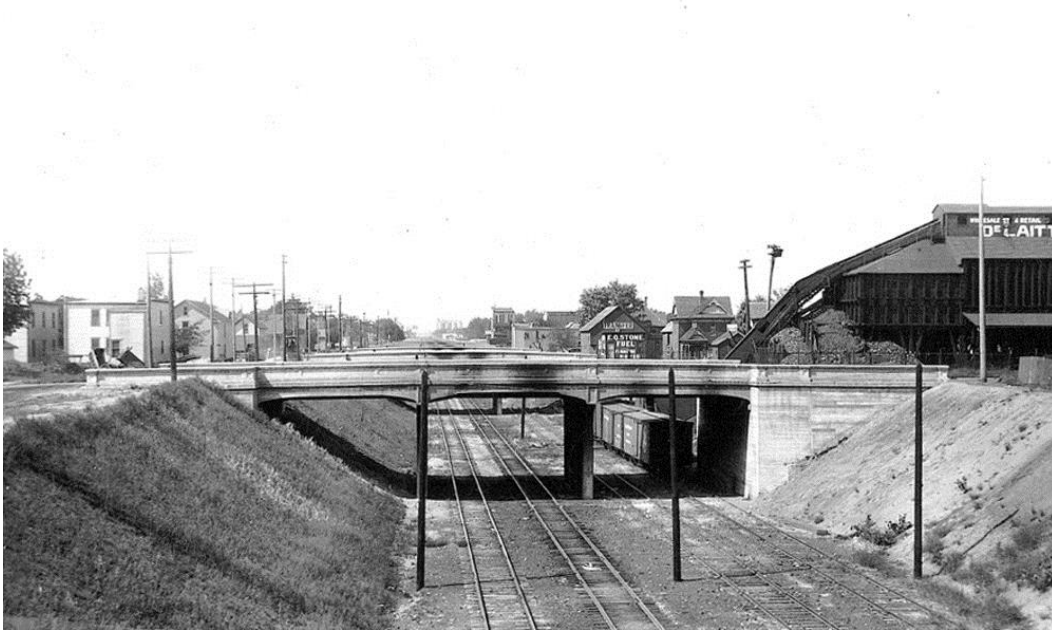
Figure 6. 1917 photograph of the 14th Avenue Bridge looking west with the newly constructed 29th Street to the south (left). Image from the City of Minneapolis Transportation Department photograph collection, courtesy of Gemini Research.

For the majority of the grade separation, the trench walls were comprised of earth, sloped to 1.5:1. The railroad allowed volunteer vegetation to grow along the sloped walls following the trench's completion (Figure 6). In limited areas the railroad constructed concrete retaining walls to stabilize the trench embankment, such as between Pleasant and Nicollet Avenues (Figure 7). During grade separation construction efforts, two companies excavated and expanded lower levels to their existing buildings that were at the new grade of the rail line to provide direct access. One such building was the Western Alloyed Steel Casting Company building, located at 2848 Pleasant Avenue, was reconfigured with a lower level at the base of the trench. As such, the building itself forms the vertical plane of the grade separation trench (Figures 8 and 9).¹¹ The other building was the Twin Cities Separator Company building (nonextant), located at 2841 Dupont Avenue.

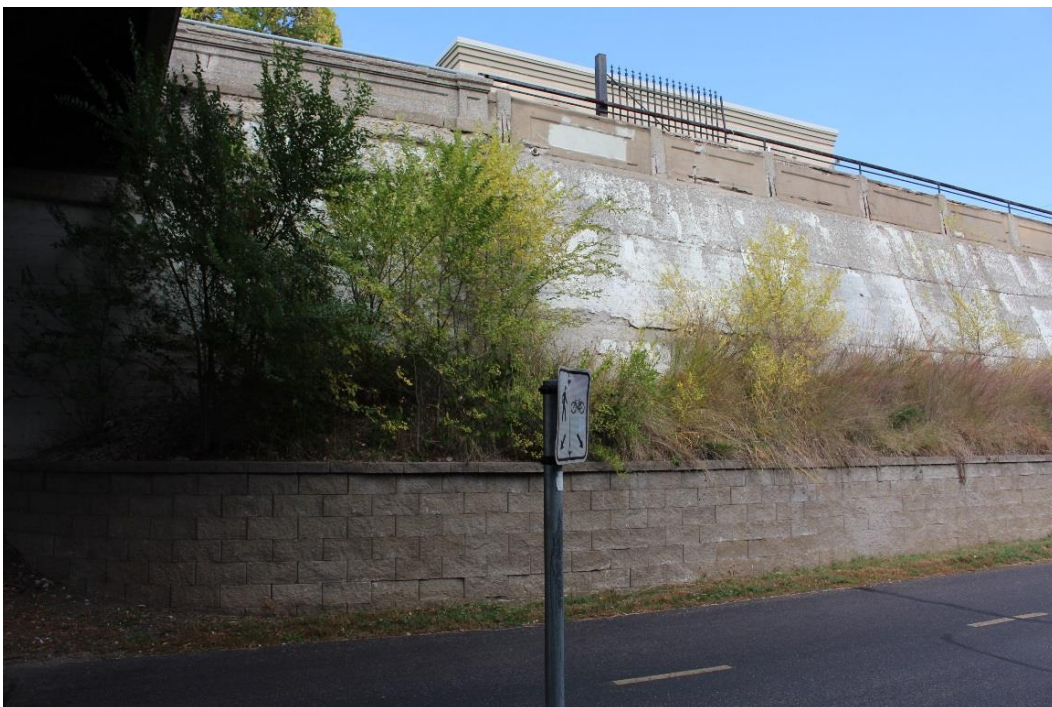
Figure 7. An original trench embankment retaining wall with original concrete parapet in the background and a new ashlar block retaining wall in the foreground, located between Pleasant and Nicollet Avenues. Mead & Hunt, 2015.

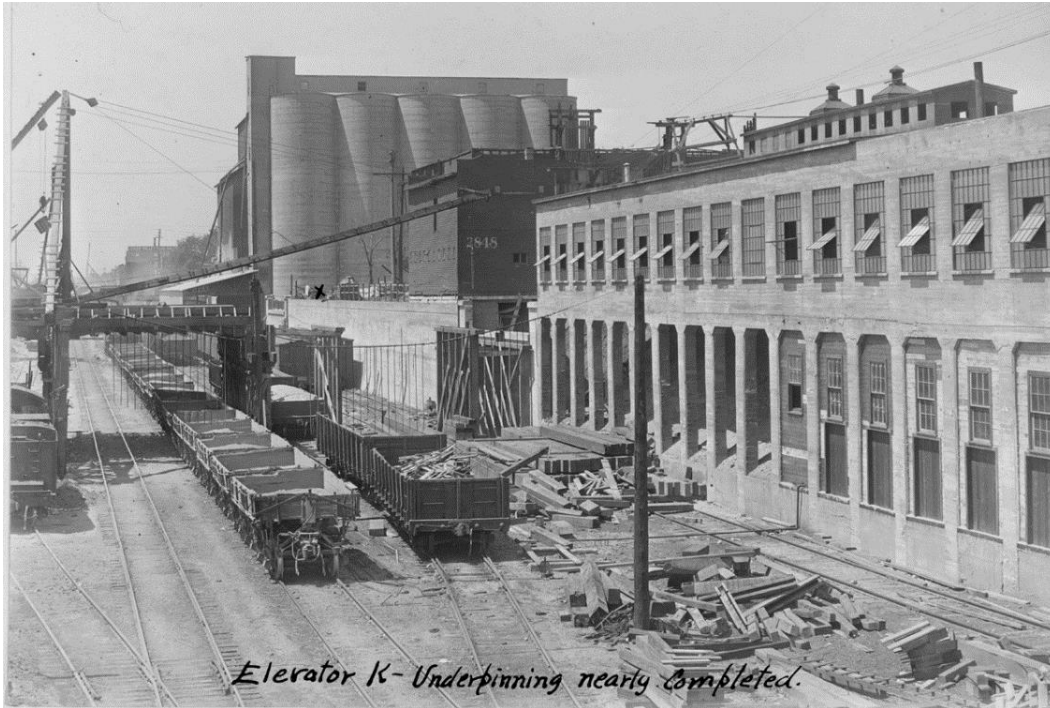
Elevator K- Underpinning nearly completed.

Figure 8. The Western Alloyed Steel Casting Company (foreground) c.1914, looking west toward the Grand Avenue Bridge, under construction. Photograph from "Views of the 29th Street Track Depression Construction Project in Minneapolis," annotated photograph album, Minnesota Historical Society.

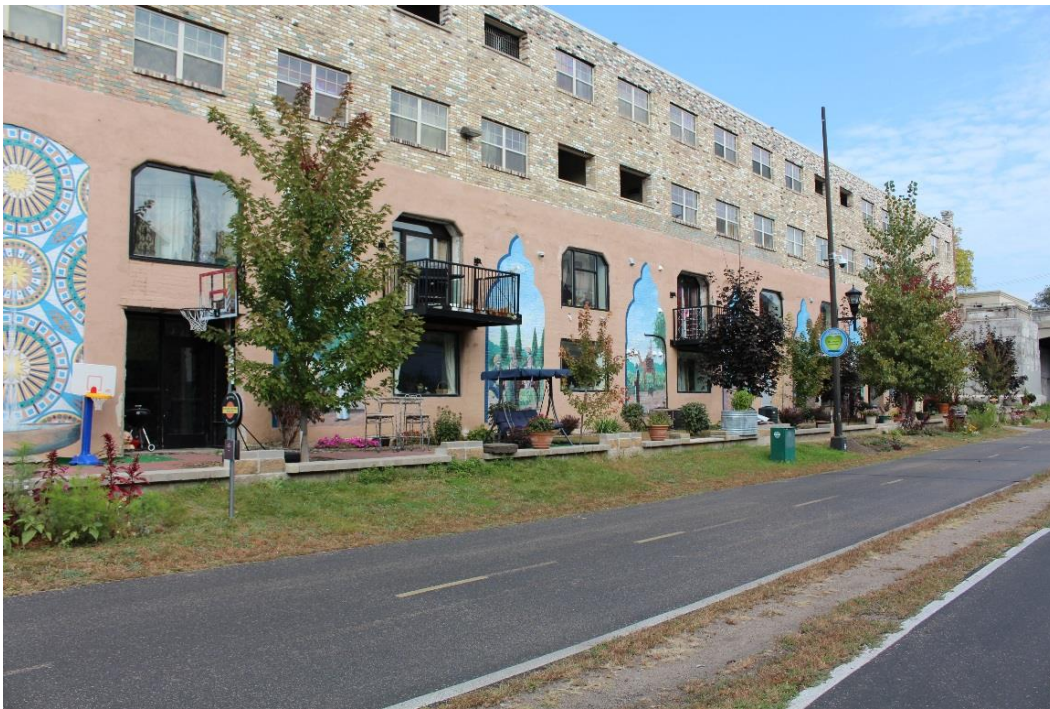
Figure 9. The Western Alloyed Steel Casting Company Building, located at 2848 Pleasant Avenue. Mead & Hunt, 2015.

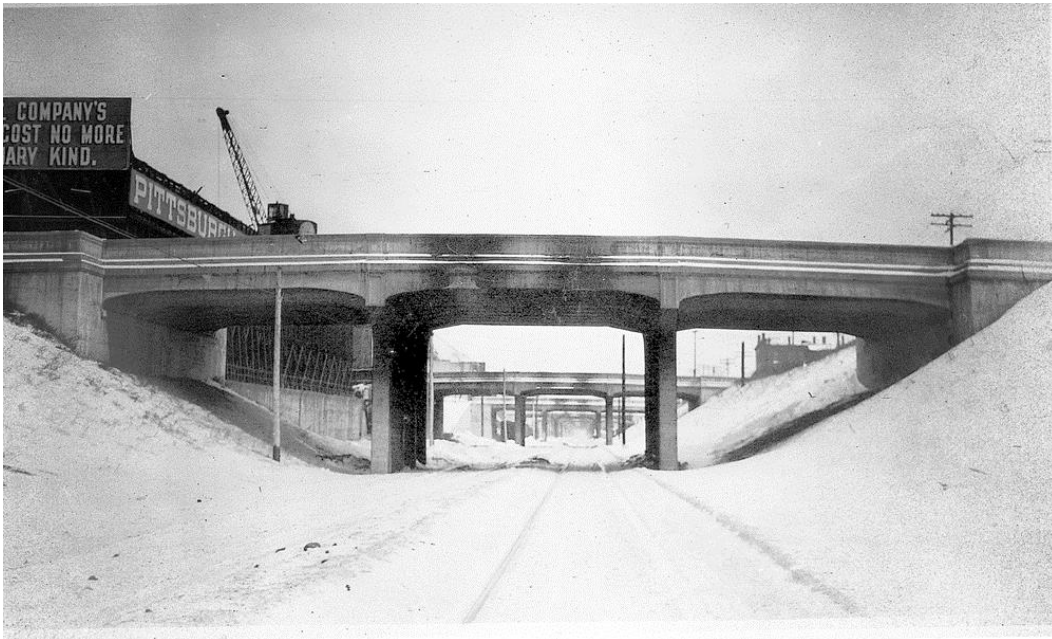
Figure 10. First and Second Avenue Bridges in c.1920 looking east. Image from the City of Minneapolis Transportation Department photograph collection, courtesy of Gemini Research.

To provide for grade separation of vehicular and pedestrian traffic over the rail line, the CM&StP Railroad constructed 37 reinforced-concrete, tee beam bridges; a 38th bridge, located at Hennepin Avenue, was already in place.¹² The bridges were nearly identical in design but specifically engineered for length and abutment wall height at each individual location (Figures 10 and 11). The bridges featured modest Classical Revival-style detailing and included sidewalks and parapet railings. In most cases, bridges were three spans, though a longer bridge was required over the rail yard at 4th Avenue S.

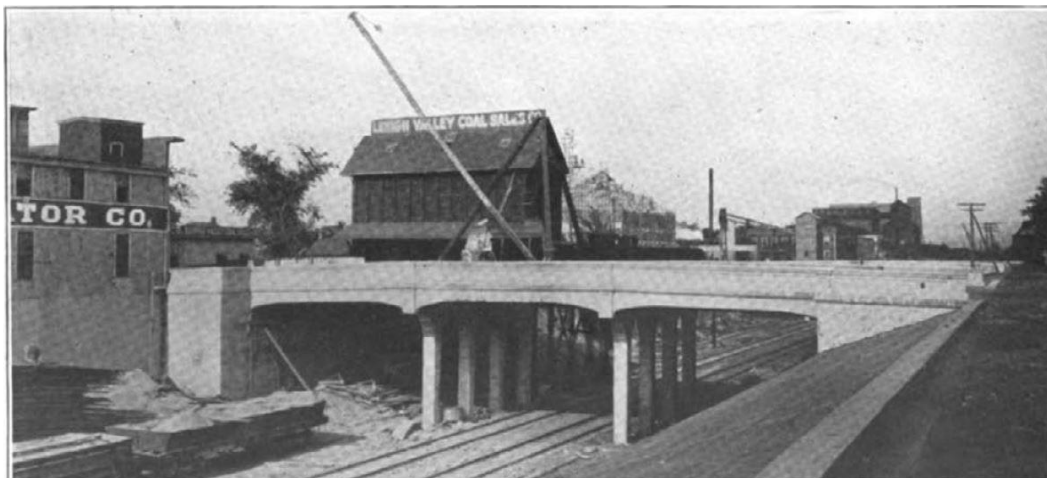
Figure 11. The Colfax Bridge after construction. Note the industrial building on the far right that serves as the embankment wall. Image from "Track Depression Work of the C.M. & St. P. Ry. at Minneapolis," *Railway Review*, July 17, 1915, 72.

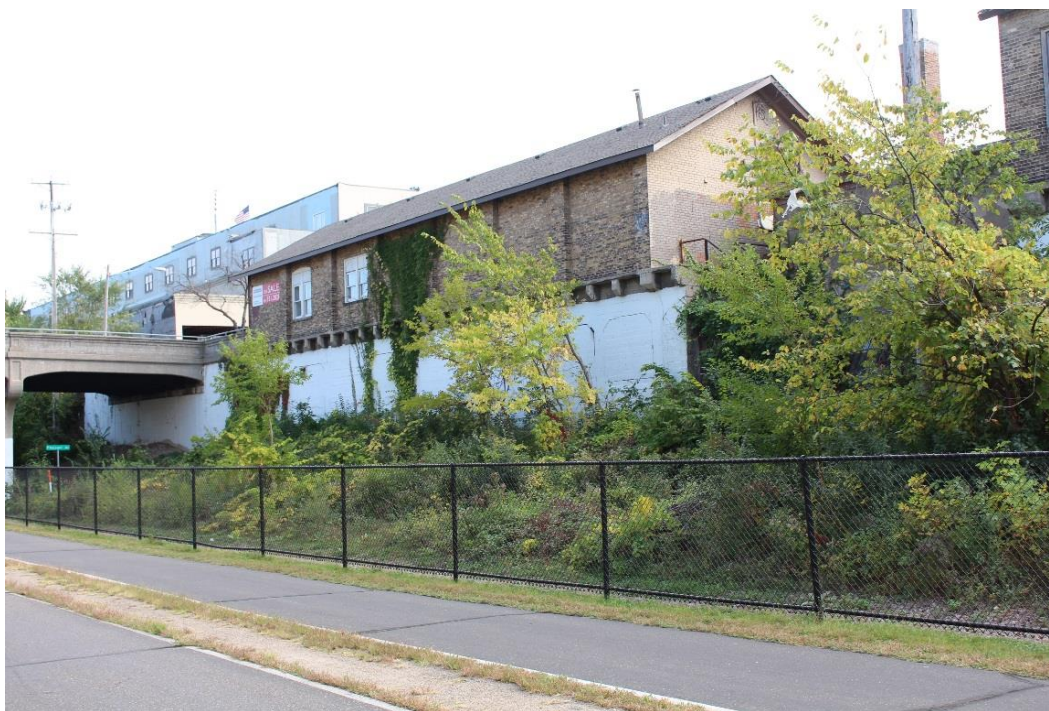
Figure 13. The eastern portion of the Eighth Ward Warehouse, located at 2900 Pleasant Avenue S. Mead & Hunt, 2015.

In the decades following the completion of the grade separation additional industries and commercial businesses were established along and near the rail line. As a result, the area took on even more industrial character. New industrial buildings were constructed adjacent to the line; some were built at the base of the trench with the building itself forming a trench wall. For example, in 1921 the Bruer Bros. Lumber Company constructed a manufacturing building at 2836 Lyndale Avenue, in which the building's lower level was at the railroad grade (Figure 12). In other instances, a company constructing a new building added a retaining wall within the trench. An example of a new building with a trench wall is the Eighth Ward Warehouse at 2900 Pleasant Avenue S (1919; addition 1927, Figure 13).

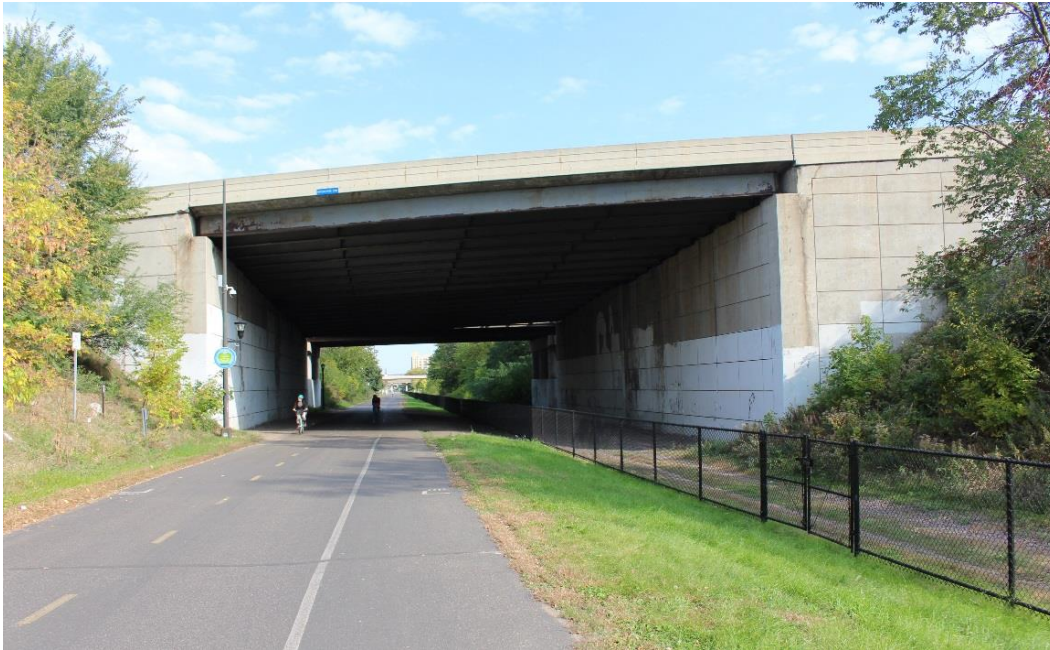
Figure 15. I-35W Bridge (1967). Mead & Hunt, 2015.

¹⁵ MnDOT proposes to replace the I-35W bridge in 2017. Work over the Midtown Greenway includes constructing a wider interstate bridge, an exit ramp, pedestrian bike/trail from the Greenway to Lake Street that runs parallel with Stevens Avenue, and a staircase from Stevens Avenue into the trench.

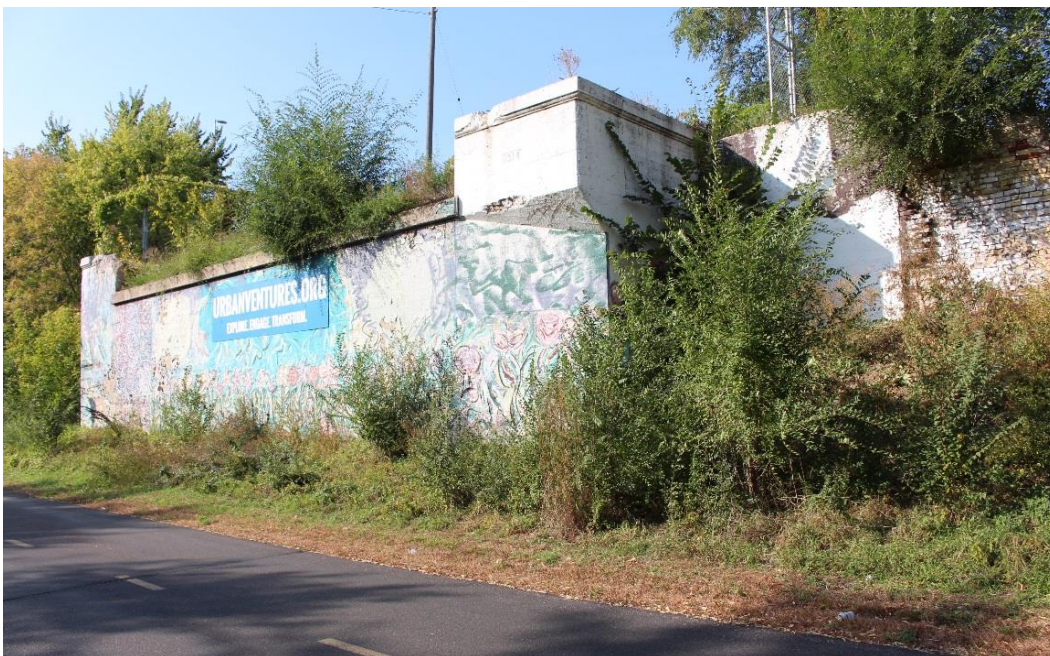
Figure 16. Bridge abutment for the former 3rd Avenue Bridge. Mead & Hunt, 2015.

The district retained its industrial character and remained largely unchanged from the 1930s through the mid-1960s, with few industrial buildings added, expanded, or replaced. The Norris Creameries Building (nonextant) constructed in 1946 at 2828 Emerson Avenue was the last industrial building constructed within the district that also formed a trench wall. The first major alteration to the original design of the grade separation came in 1967, when the state constructed Interstate (I-) 35W over the rail line just west of the 2nd Avenue Bridge. The new bridge was a wide, unadorned, steel structure with massive abutments that visually stood out from the repetition of the original reinforced-concrete bridges (Figure 15).¹⁵ At the same time, all but the bridge abutments of the Clinton and 3rd Avenue Bridges were removed (Figure 16).

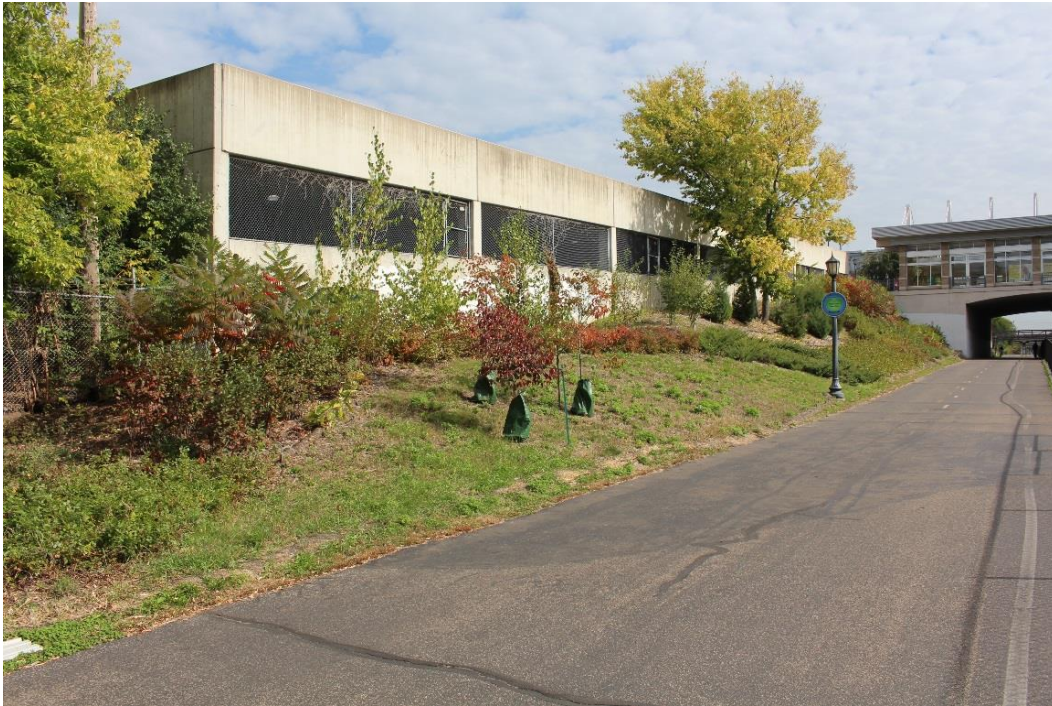
Figure 17. Parking garage adjacent to the CM&StP Historic District, located at 2828 Hennepin Avenue S.
Mead & Hunt, 2015.

In the 1970s a number of new buildings were erected adjacent to the rail line, including a new parking garage (2828 Hennepin Avenue S, Figure 17), a warehouse/storage facility (2837 Oakland Avenue S), and the Sears, Roebuck & Company warehouse addition (2800 10th Avenue S, Figure 18). The Sears, Roebuck & Company warehouse addition originally extended over the trench, essentially creating a block-long tunnel. The addition over the trench was removed in 2005.

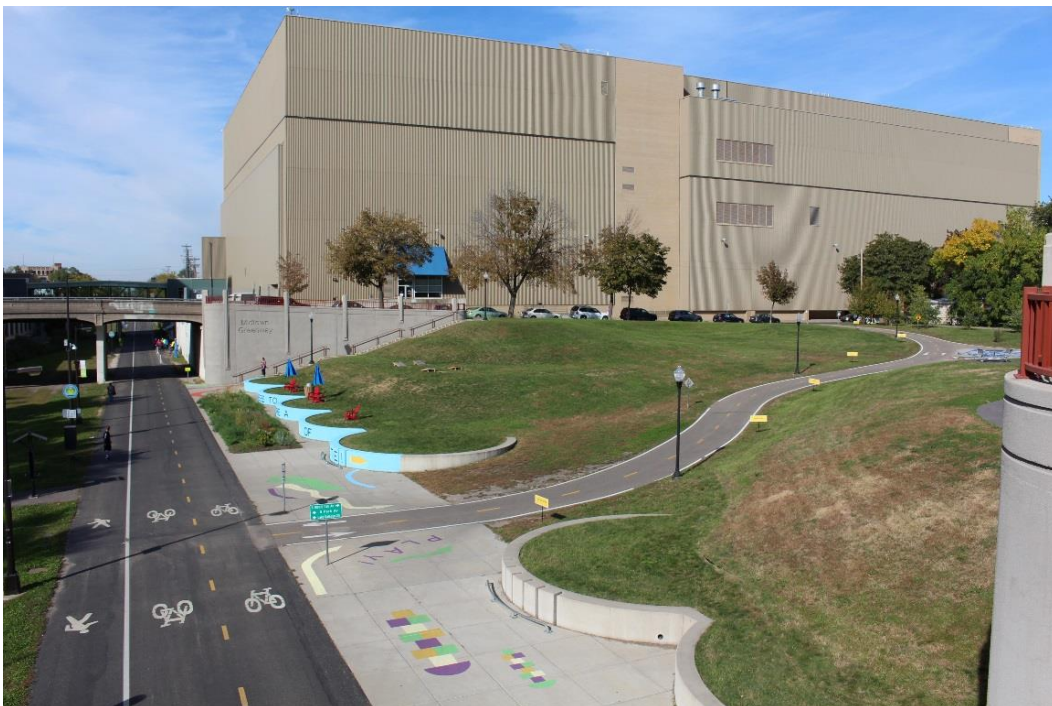
Figure 18. Sears, Roebuck & Company 1970s warehouse (background), with adjacent park (former location of the Stewart Grain Elevator; foreground). Mead & Hunt, 2015.

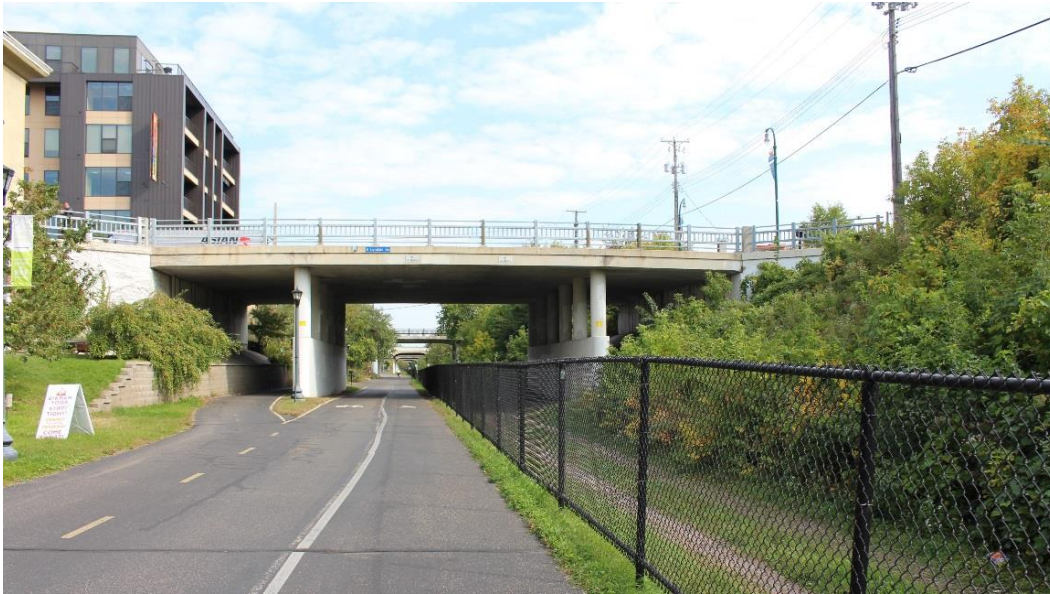
Figure 19. The Lyndale Avenue Bridge (1987). Mead & Hunt, 2015.

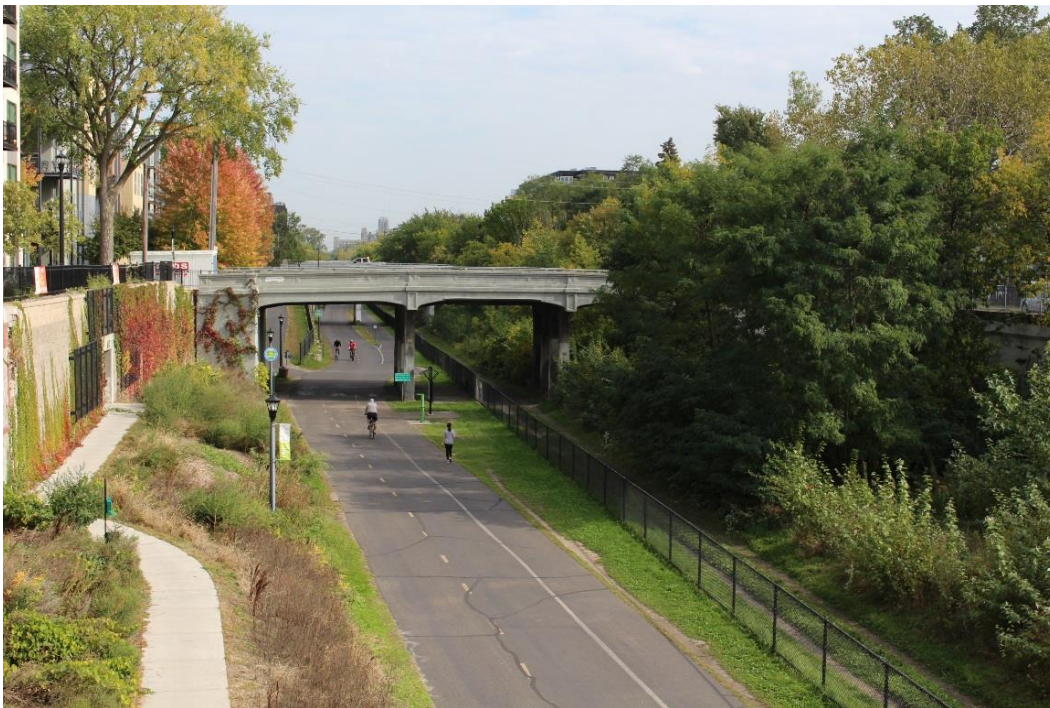
*Figure 20. The Midtown Greenway, looking east from Dupont Avenue towards Colfax Avenue.
Mead & Hunt, 2015.*

- Removal of the rail tracks, sidings, original buildings, trench retaining walls, and concrete slope paving
- Construction of a retaining wall to elevate the trail between Humboldt and Stevens Avenues;
- Installation of a chain-link fence along the length of the constructed elevated trail;
- Erection of seven ashlar and concrete block access ramps to provide access from the street level into the trench; and
- Addition of trail amenities, including staircases, lighting, benches, emergency beacons, and wayfinding signage (Figures 20-22).

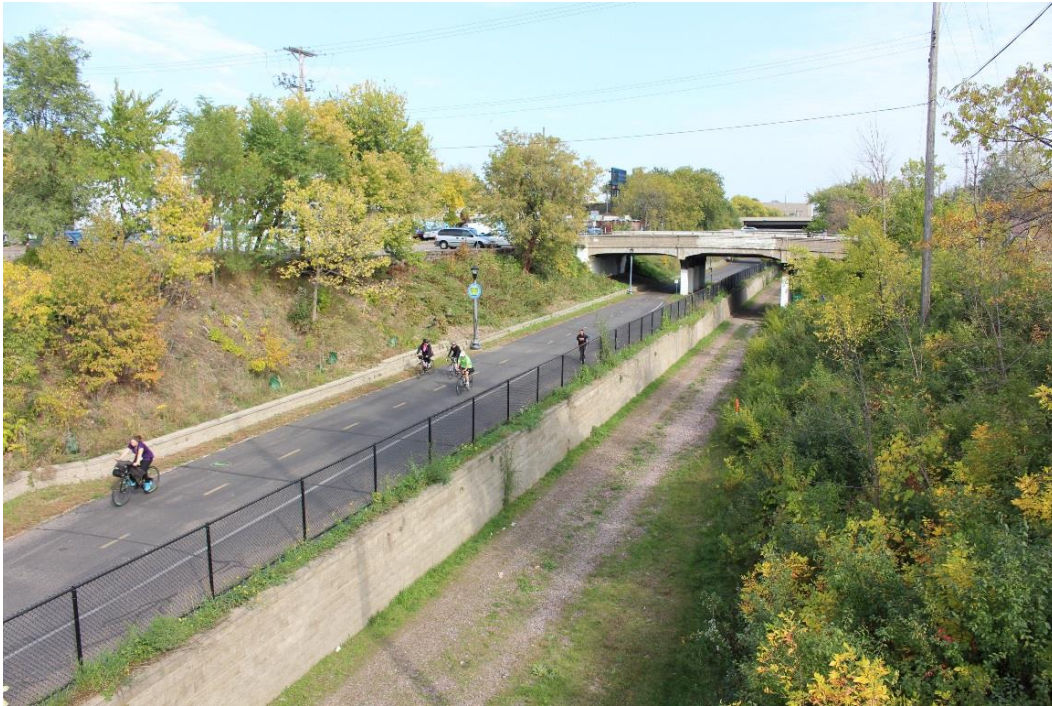
Figure 21. Elevated trail between Nicollet and Stevens Avenues. The use of a retaining wall to elevate the trail significantly alters the original grade of the rail corridor. Mead & Hunt, 2015.

- Alteration to an original bridge, including its removal, replacement, or addition of wingwalls.³⁰
 - Construction of an elevated trail extending between Humboldt and Stevens Avenues, which results in a change to the historic grade separation depth. The elevated trail is comprised of an ashlar block retaining wall, rising up to 15 feet tall, and chain-link fencing.

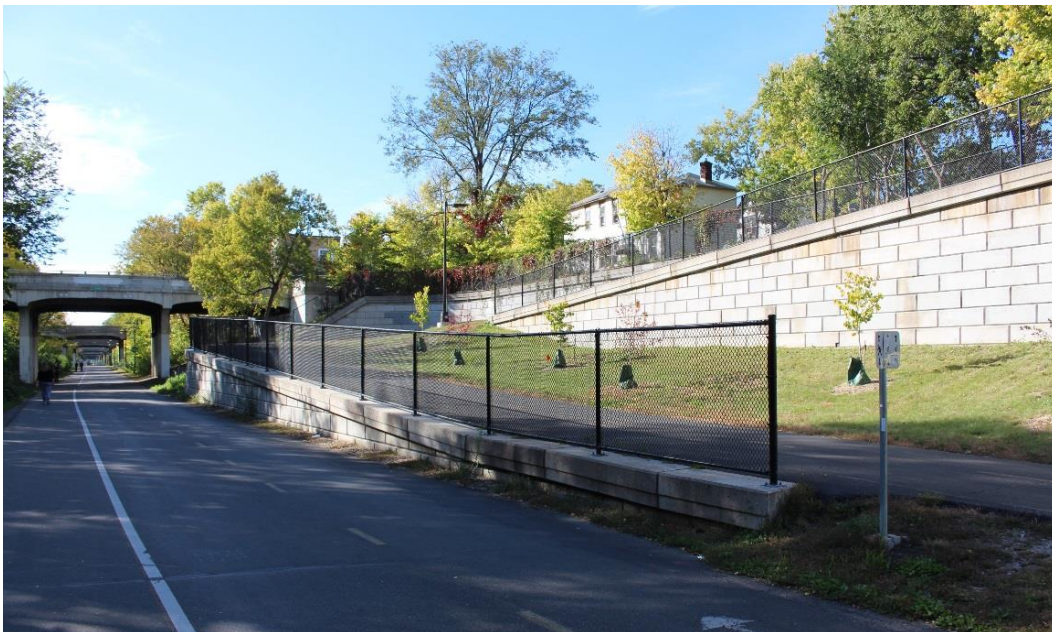
Figure 22. One of seven access ramps from the street into the trench; this one is located between 17th and 18th Avenues. Access ramps like this one extend the length of the block and take up approximately one-third of the trench width. Additionally, the concrete block construction of the access ramp create a new trench wall where there was none historically. Mead & Hunt, 2015.

- Integrity of design is lost within a block when the following occurs:
 - Both original bridges within the block are nonextant.
 - An access ramp extends the length of the block. Access ramps occupy approximately one-third of the trench's width and represent a new or replacement trench wall.

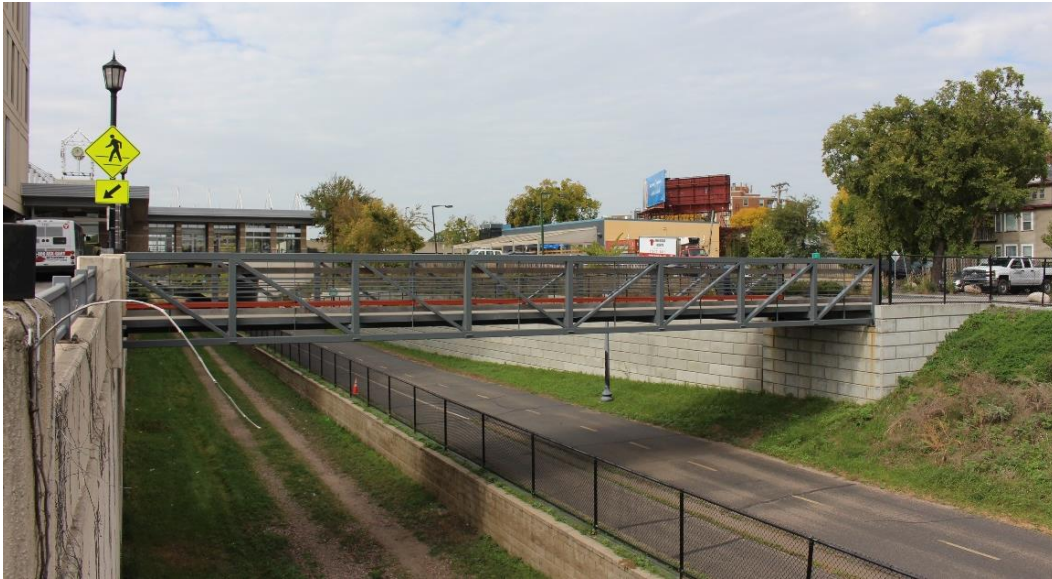
Figure 23. Pedestrian bridge at Girard Avenue (c.2004). Mead & Hunt, 2015.

Additional changes were associated with adjacent land redevelopment. The remaining grain elevator, located between 10th and 11th Avenues, was demolished in 2004 (replaced with a public open space c.2007). Two pedestrian bridges were added by private developers in 2004: one at Girard Avenue and one between Elliot and 10th Avenues (Figure 23).

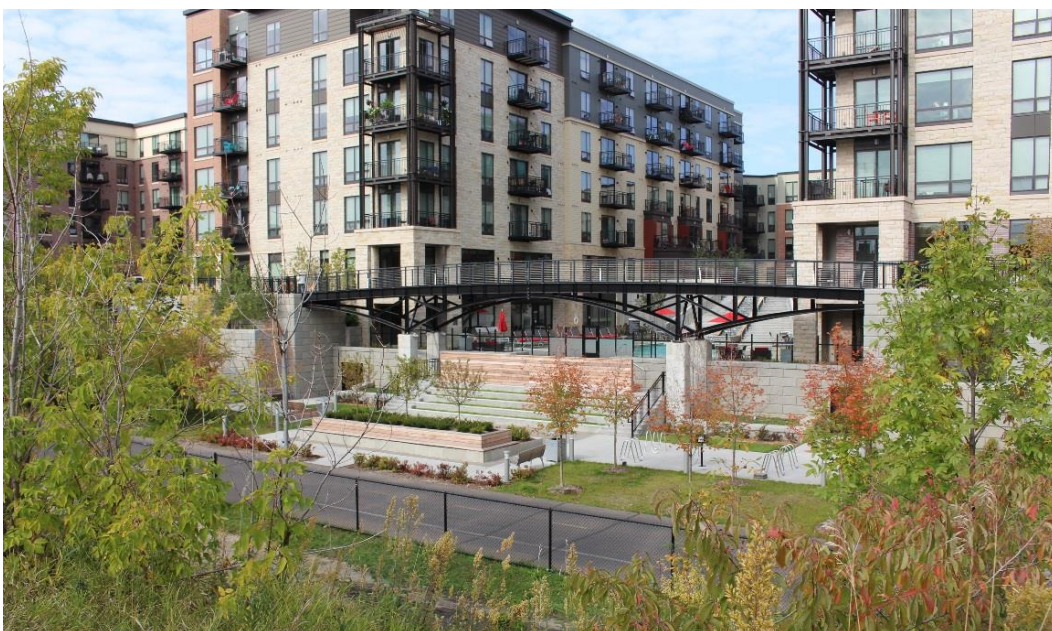
Figure 24. The terrace between Emerson and Dupont Avenues, completed 2015, is located inside the district boundary. The multi-story apartment complex in the background is directly adjacent to the district. Mead & Hunt, 2015.

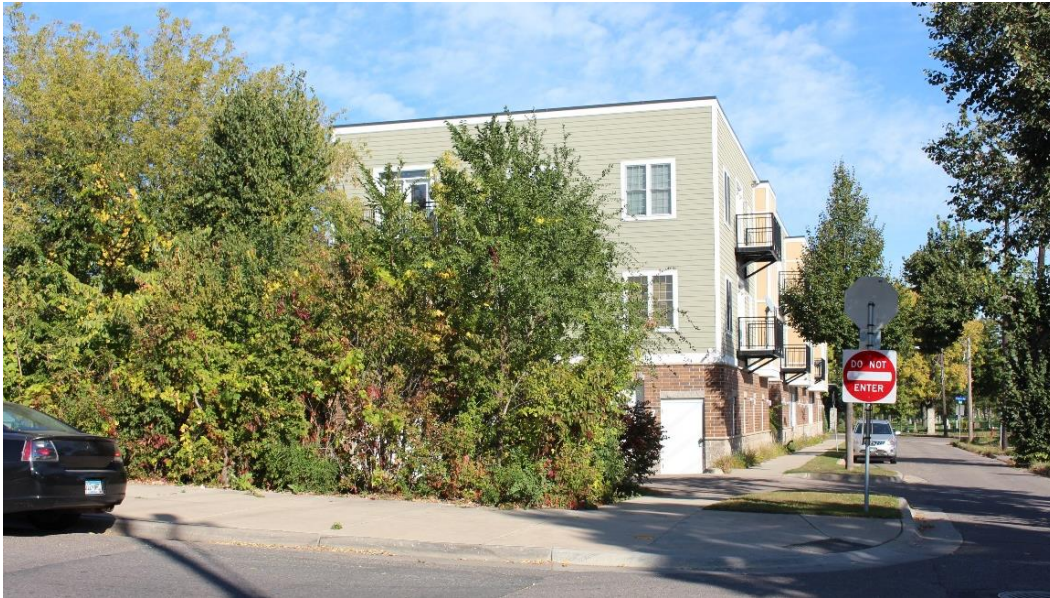
Figure 25. 2005 apartment complex located within the CM&StP Historic District boundary at 2850 Cedar Avenue. Mead & Hunt, 2015.

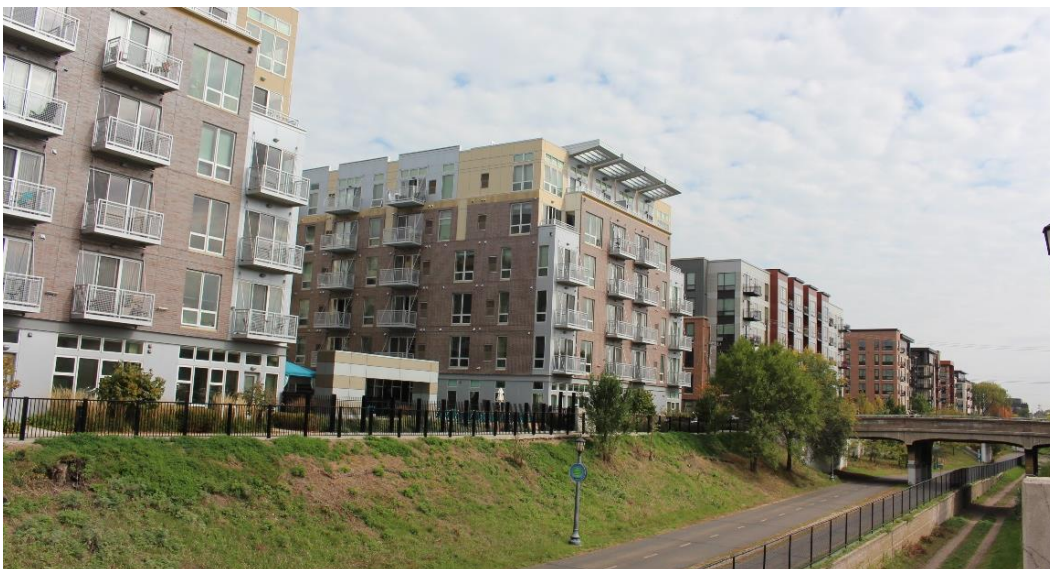
Figure 26. View of the north side of the trench between Girard and Emerson Avenues with newly constructed apartment complexes where industrial buildings once stood. Mead & Hunt, 2015.

The popularity of the trail has resulted in the redevelopment of lots adjacent to the district. A number of the historic industrial buildings and residential homes located within the western portion of the district and directly adjacent to Midtown Greenway have been demolished and replaced with five- to seven-story apartment/condominium or hotel buildings (Figures 26 and 27). The majority of these buildings were erected between 2007 and 2015. In some instances, the new building removed original trench walls or added a new wall where one had not historically been.

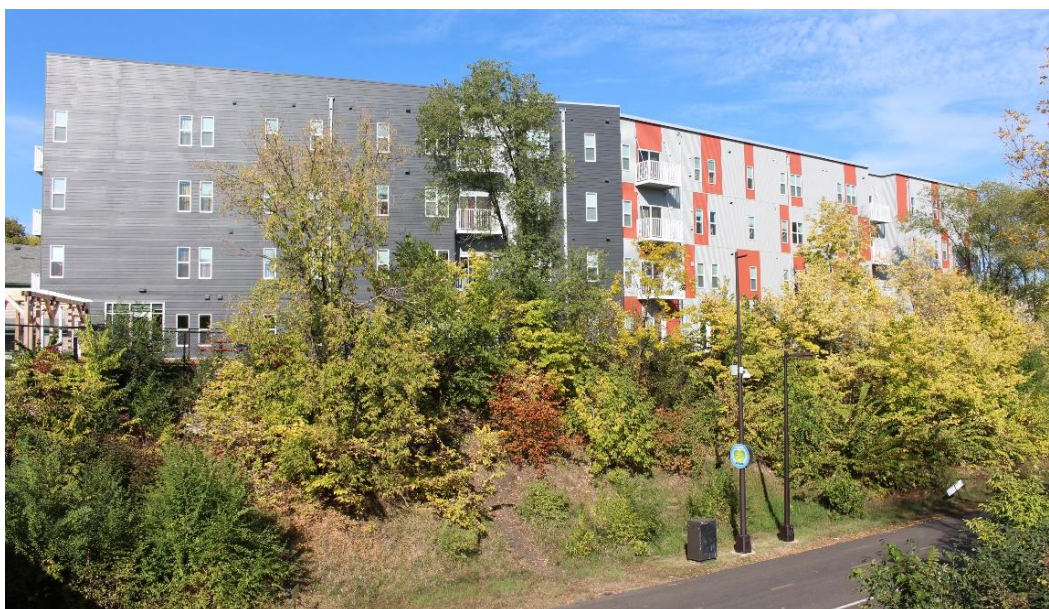
Figure 27. New apartment complex between Bloomington and 16th Avenues. Mead & Hunt, 2015.

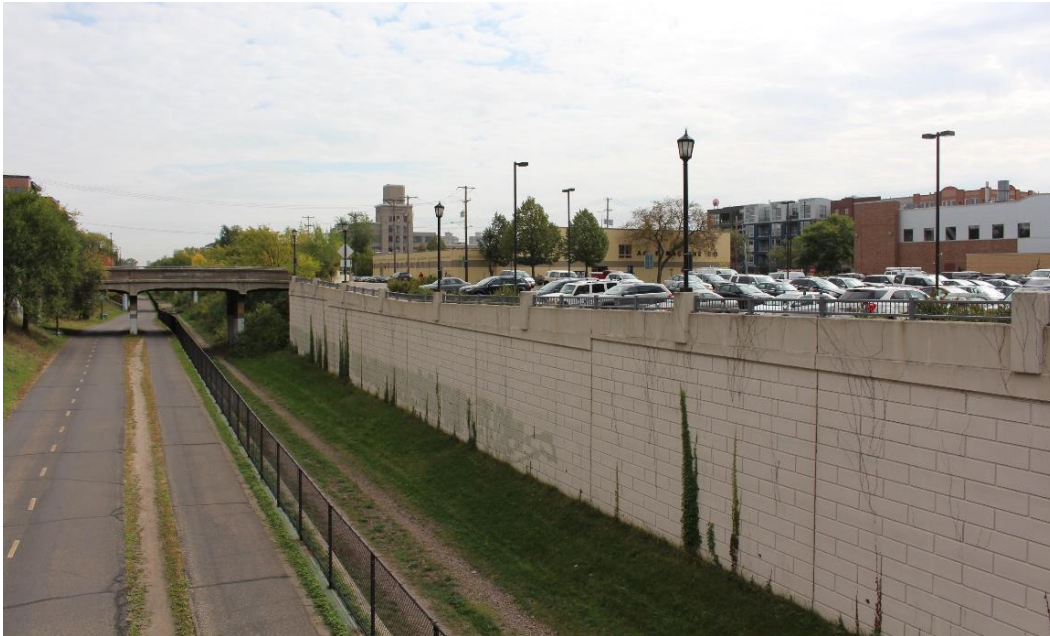
Figure 28. Example of a new trench retaining wall where none was historically, located between Hennepin and Freemont Avenues. Mead & Hunt, 2015.

- Newly constructed trench retaining walls, where none were historically, were included as one structure (Figure 28).
- Former rail yard, spanning from 3rd to 5th Avenues, was included as one site.

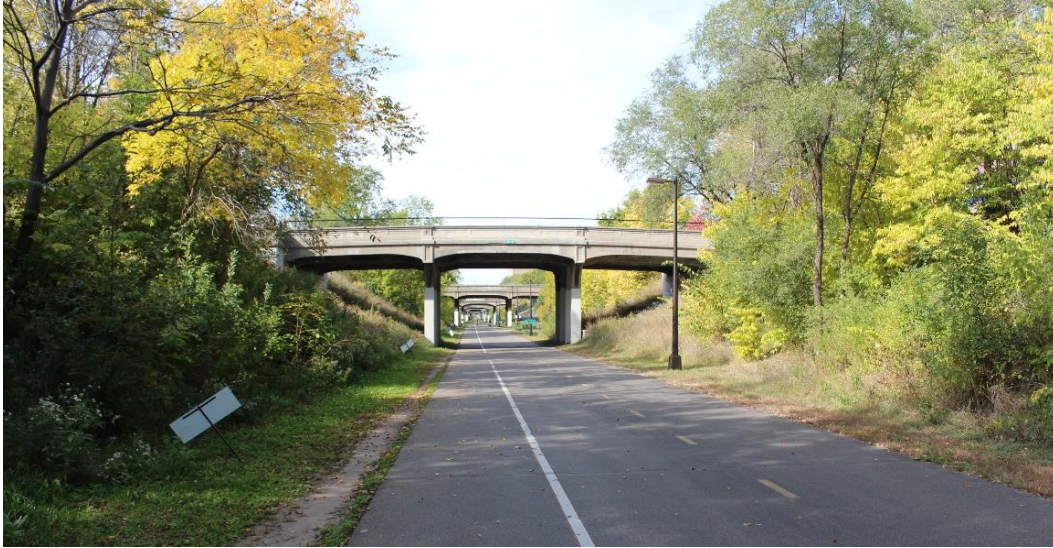
Figure 29. The grade-separation structures and sloped embankment walls are essential physical features. Mead & Hunt, 2015.
