Chicago, Milwaukee and St. Paul Railroad Grade Separation Historic District Reevaluation

Local Historic Bridge Study – Phase 3

**Minnesota Department of
Transportation**

March 2017

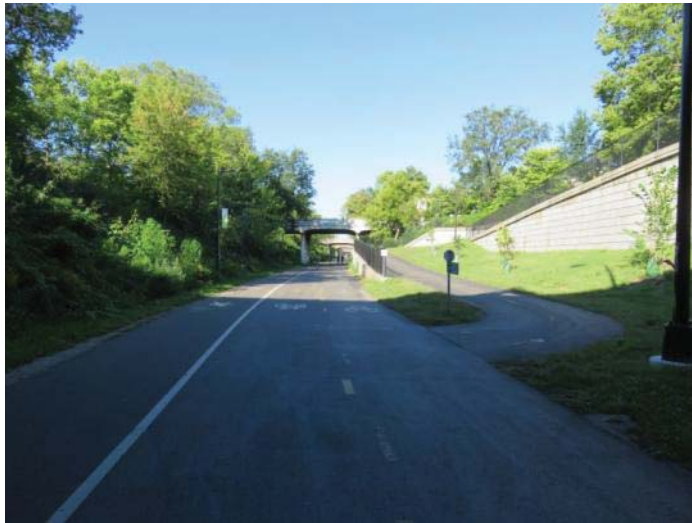
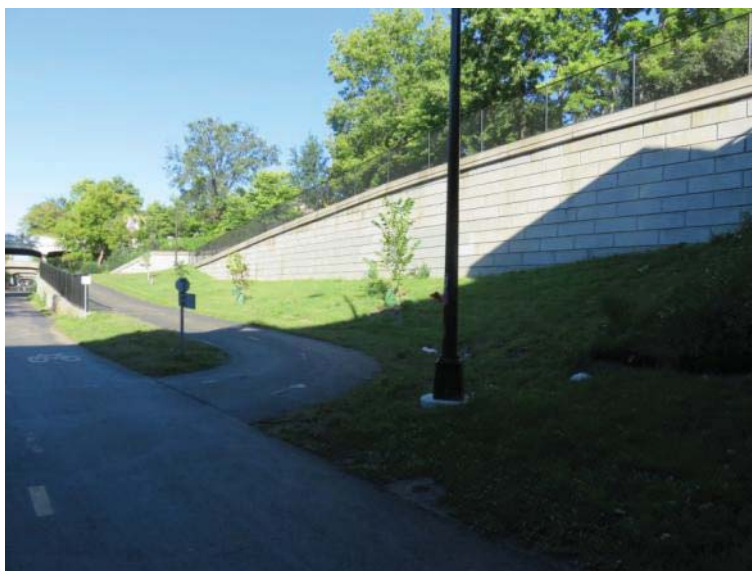
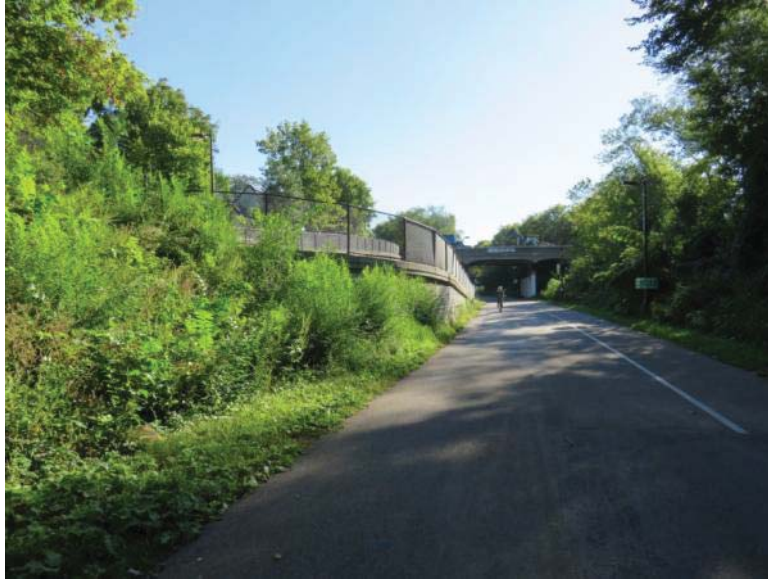
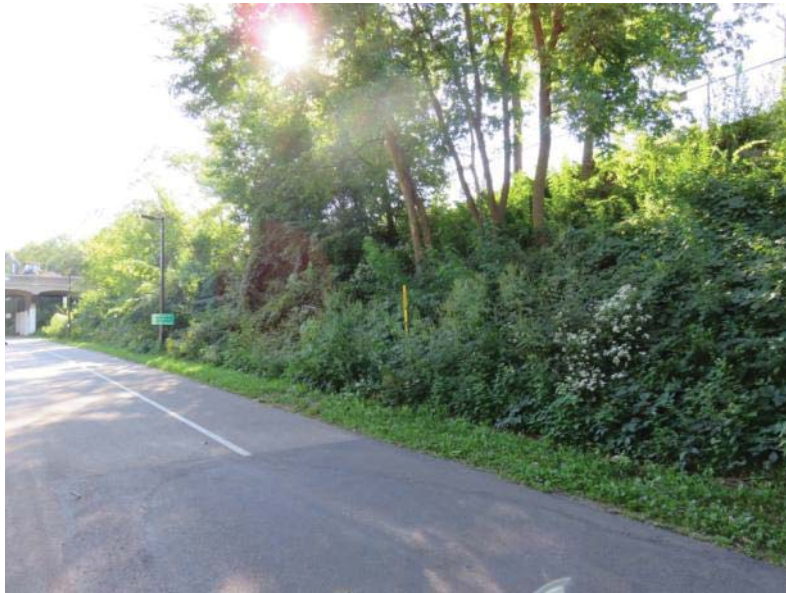
Segment No. 40 (Between 18th and 17th Ave. S.)

Photo 1: looking west

Photo 2: looking northwest at ramp.

Photo 3: looking east. Ramp at left.

Photo 4: looking southeast. South elevation of trench.

Segment 40 Comments: the principal features of this segment of the district remain, including the trench and the two historic bridges that define its east and west boundary. The MnDOT may have concluded that this segment is non-contributing because a bike ramp exists in the trench. However, the historical record notes that bike ramps, the bike/walking trail, non-original retaining walls, and light standards were in place within the trench at the time the Historic District was listed in the National

Register in 2005. Given this information, it is unclear why this segment was determined non-contributing.

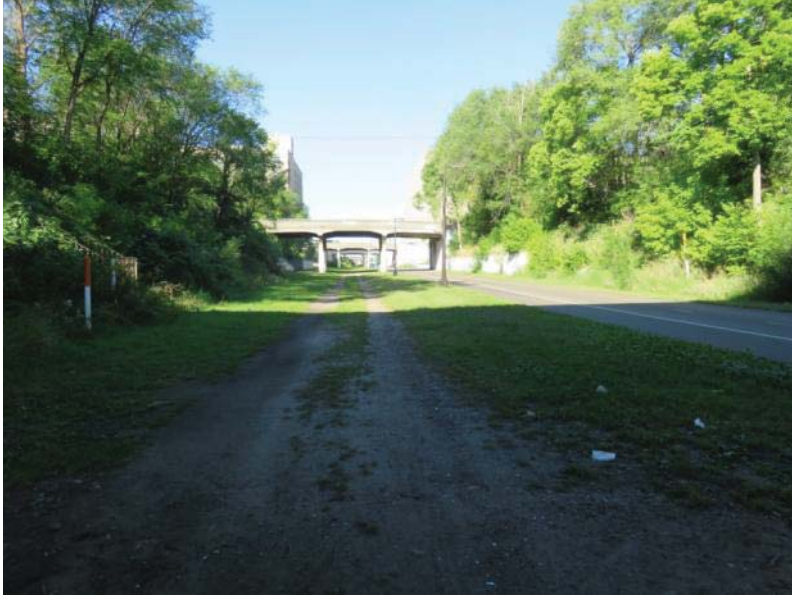
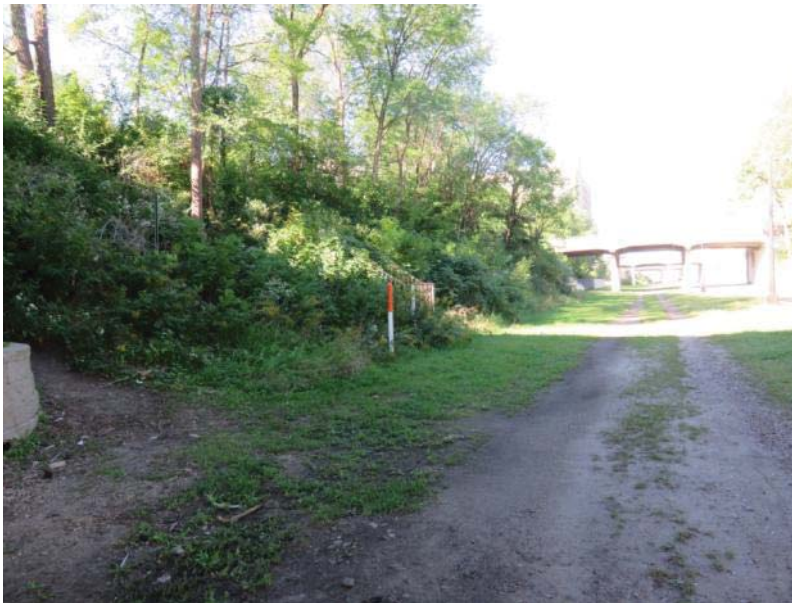
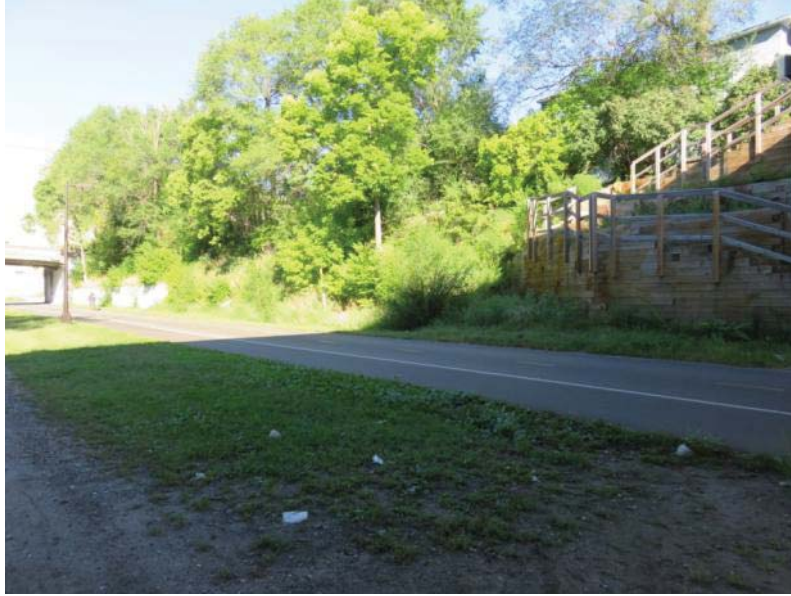
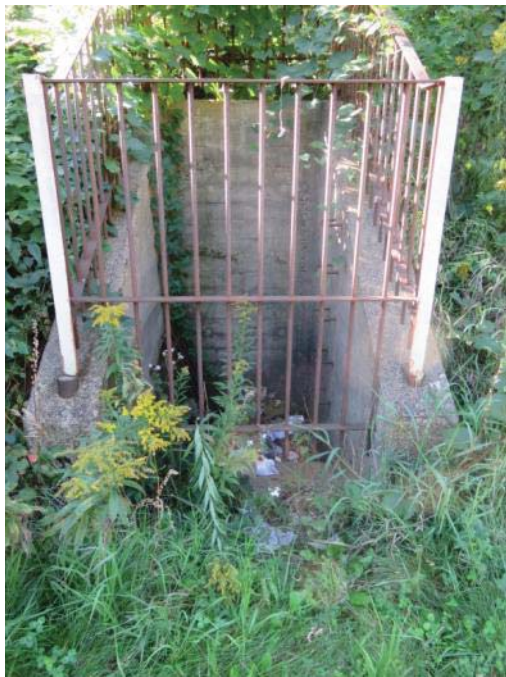
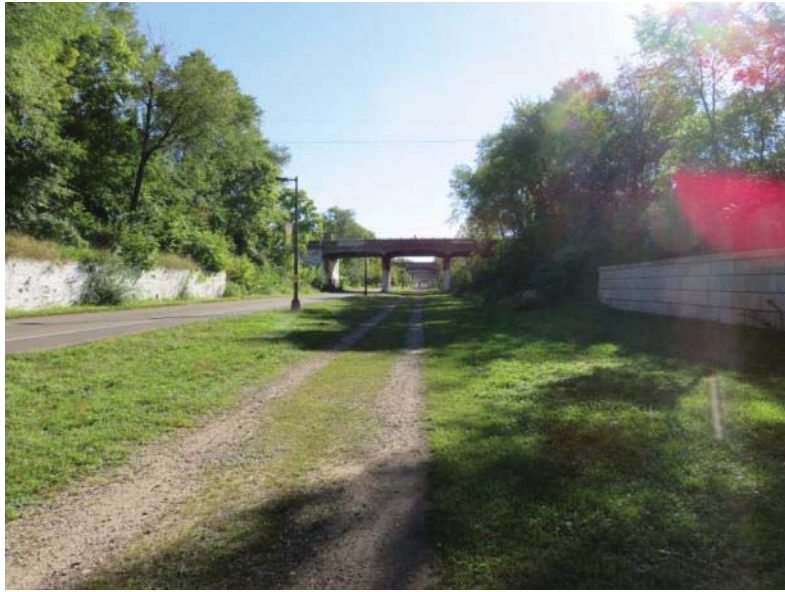
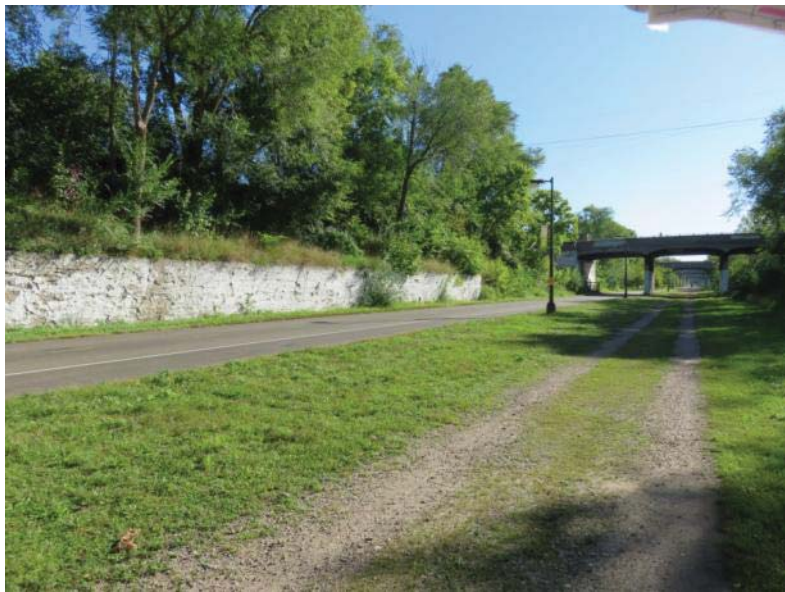
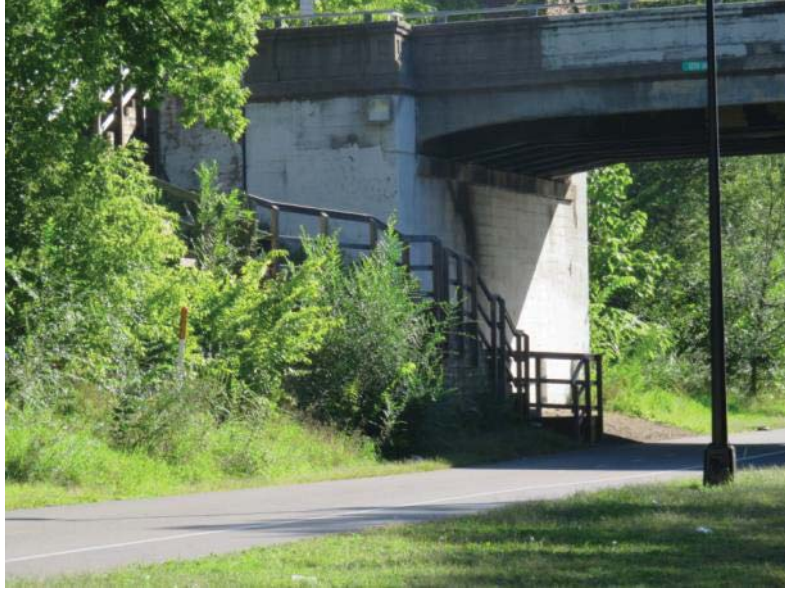
Segment No. 33 (Between 12th and 11th Ave. S.)

Photo 5: looking west.

Photo 6: looking southwest at south elevation of trench.

Photo 7: looking northwest. Stairway at right.

Photo 8: looking south. Access to below ground tunnel.

Photo 9: looking east.

Photo 10: looking northeast at north elevation of trench.

Photo 11: looking northeast at stairway.

Segment 33 Comments: the principal character-defining features of the segment are apparent, the trench and the bridges that define the east and west boundary of the segment. A section of non-original retaining wall is at the south side of the trench, although the historical record explains that many of these structure-types were in place at the time of listing. Perhaps the MnDOT concluded that the segment was non-contributing because a stairway is located in the northeast corner of the segment. However, when viewing the segment as a whole, the intrusiveness of the stairway is relatively minor.

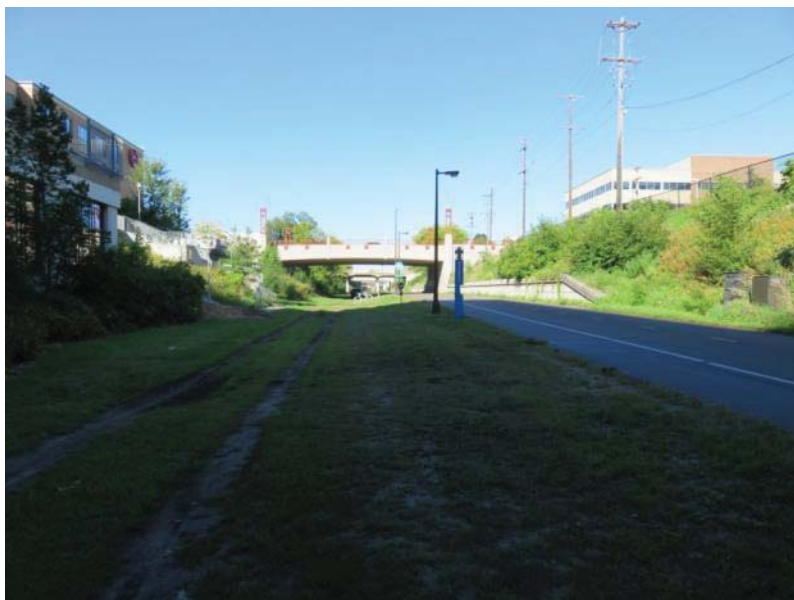
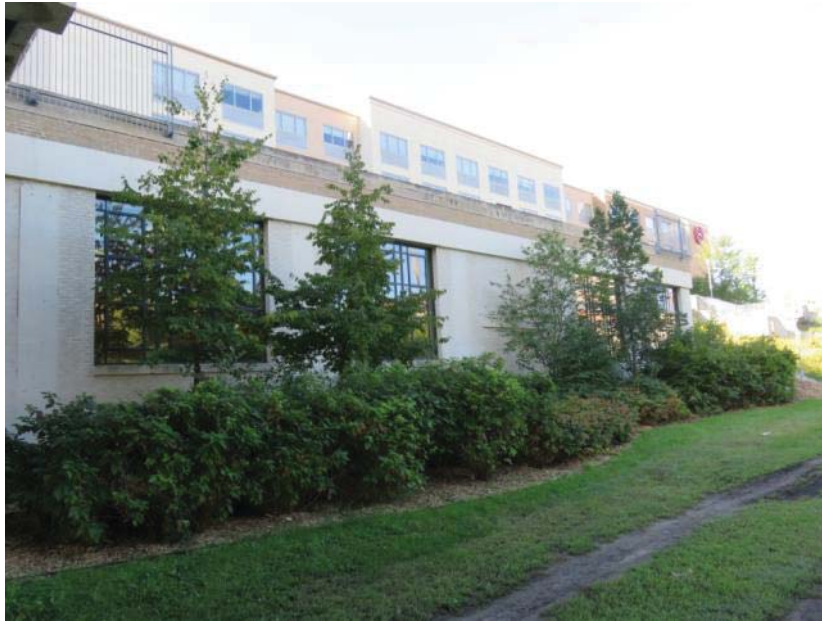
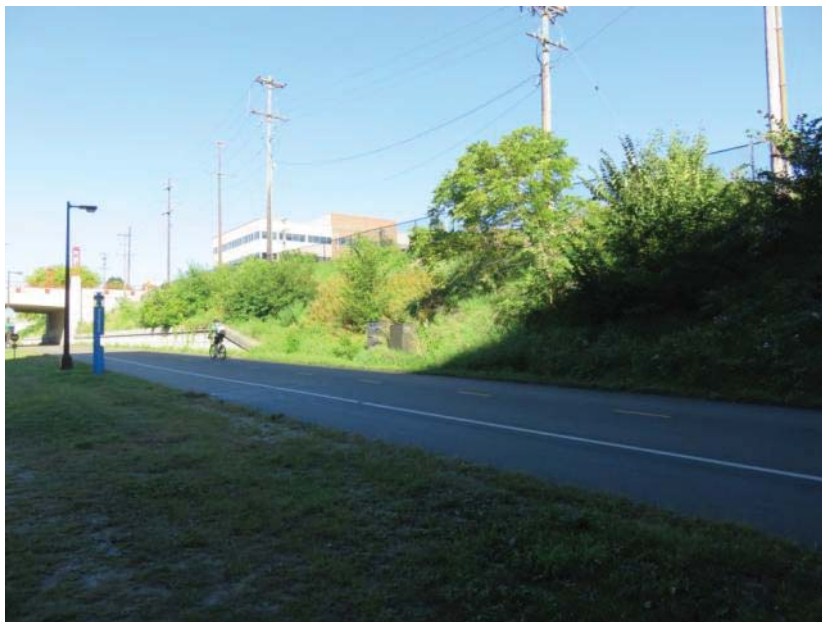
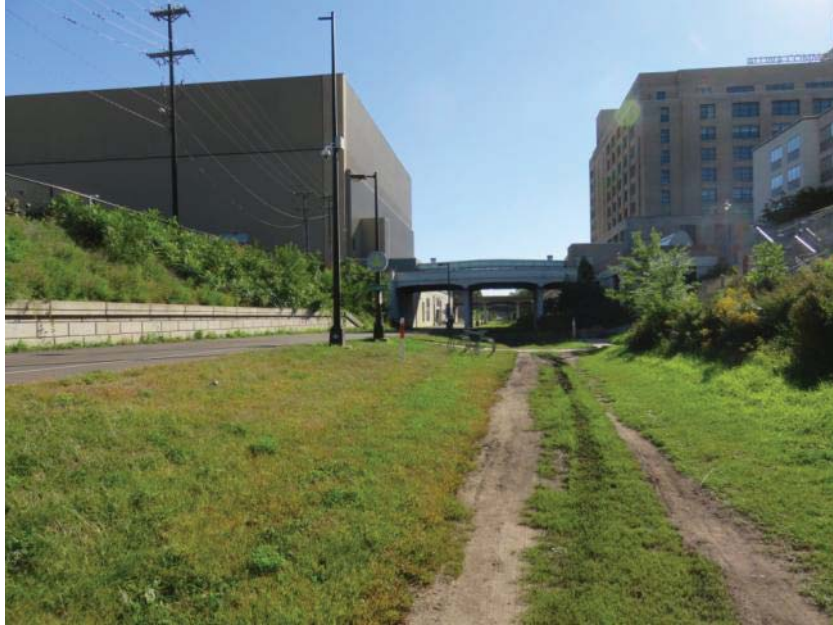
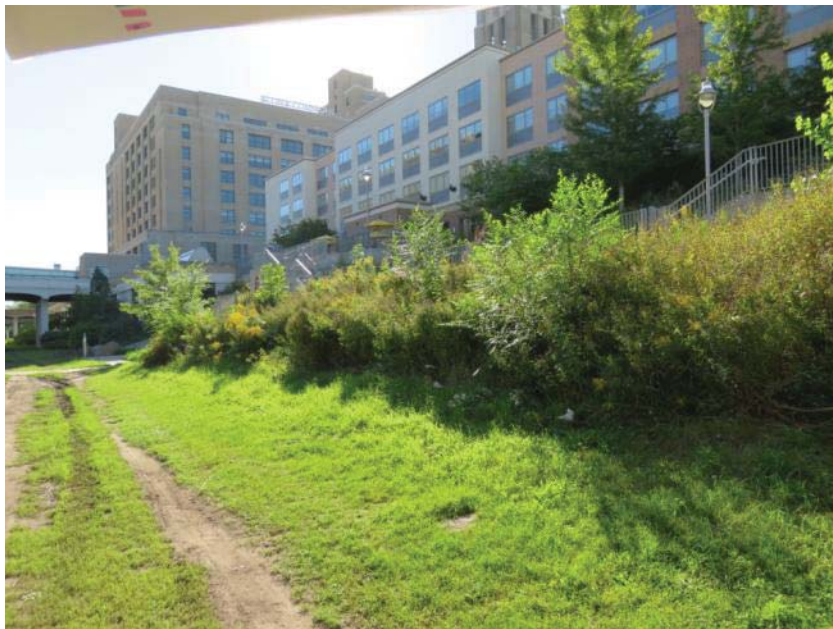
Segment 30 (Between Elliot and Chicago Avenues)

Photo 12: looking west.

Photo 13: looking southwest at south side of trench.

Photo 14: looking northwest at north side of trench.

Photo 15: looking east.

Photo 16: looking southeast at south side of trench.

Segment 30 comments: the trench and the original bridge marking the east boundary remain. A post-2005 bridge carries Chicago Avenue over the trench at the west boundary of the segment. At the time this Chicago Avenue replacement bridge was reviewed by the MnHPO, it was determined that the new bridge had been designed in conformance with the Secretary of the Interior's Standards for Rehabilitation, a conclusion that indicates the new bridge was compatible with the Historic District and protected the historic integrity of the property. The retaining wall at the north likely was in place at the time of listing. Documentation regarding construction at the south side of the trench does not note that it is new. Installation of a new bridge at Chicago Avenue does not make the entire segment non-contributing.

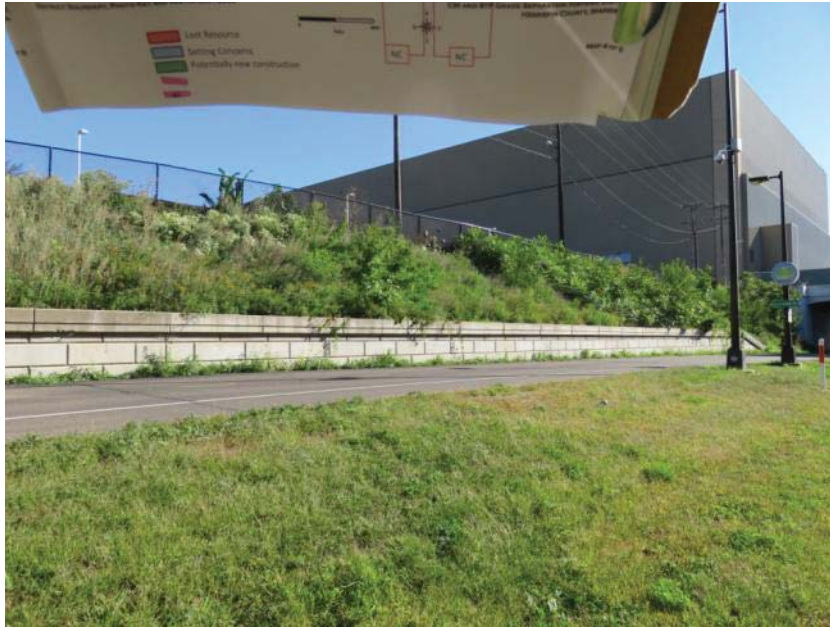
Photo 18: looking northeast at north side of trench.

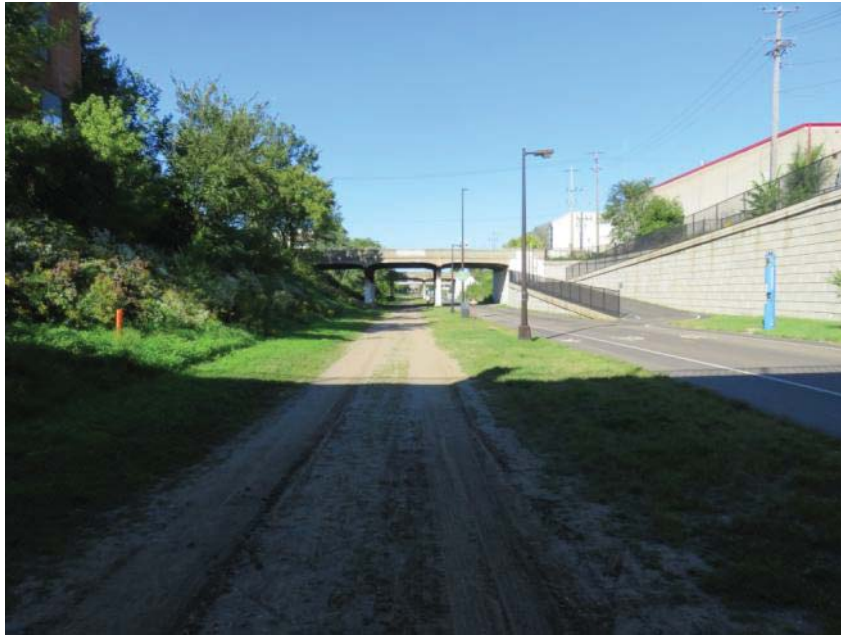
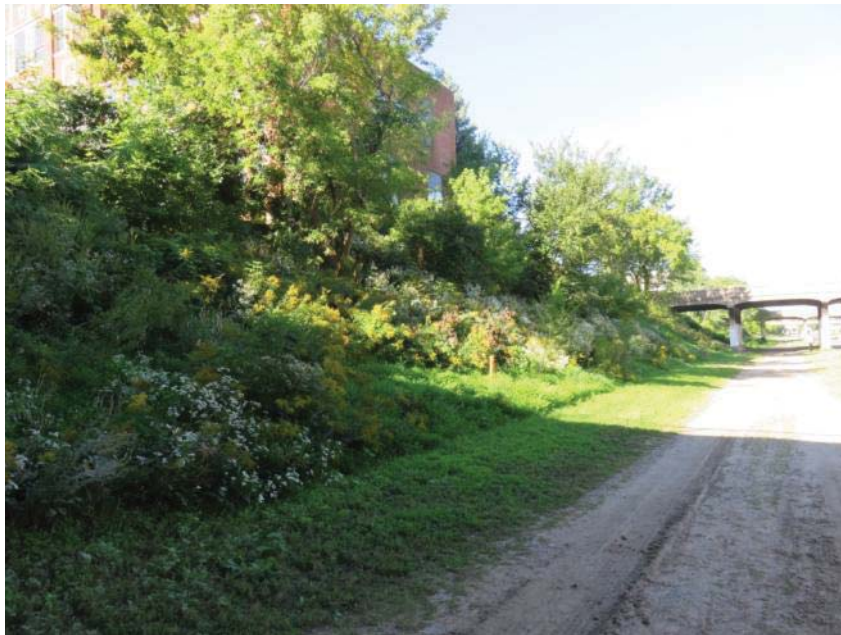
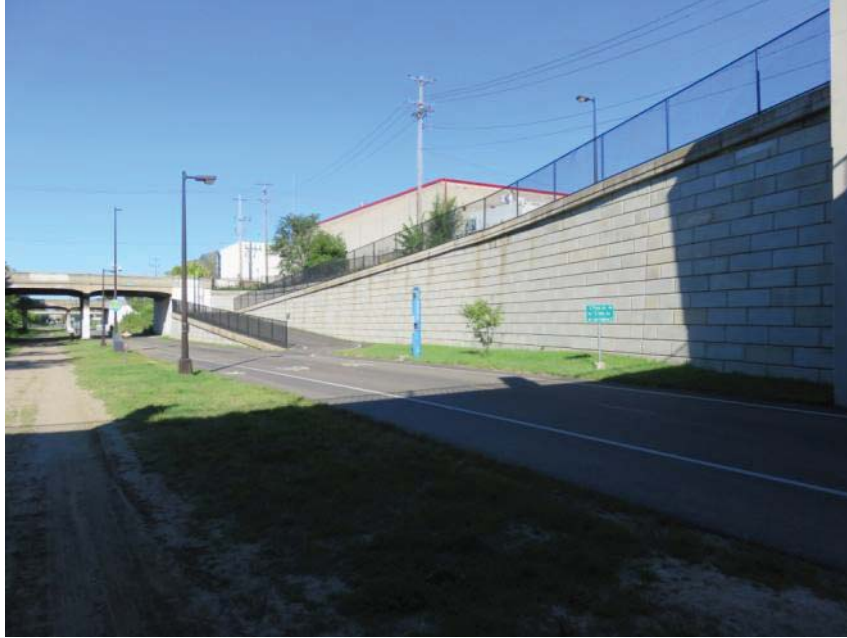
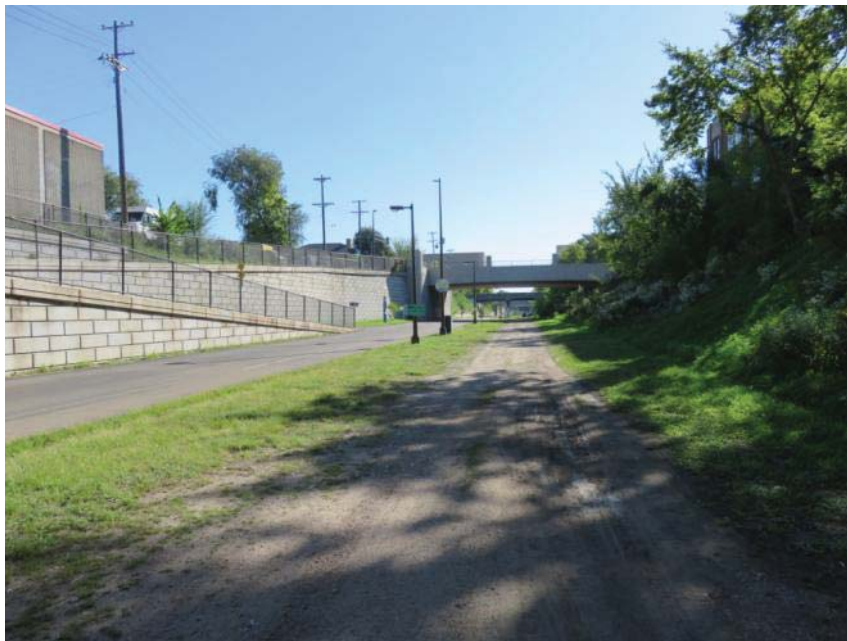
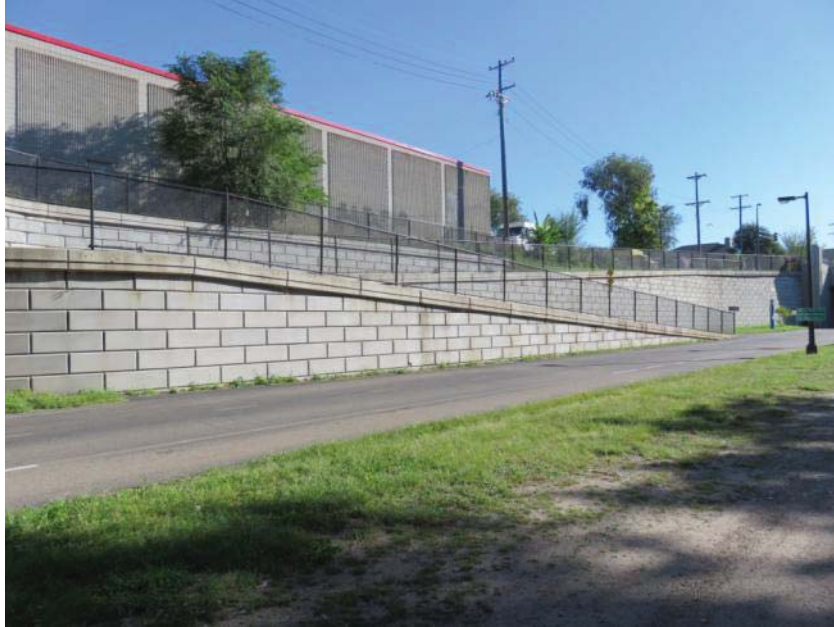
Segment No. 27 (Between Park and Oakland Avenues)

Photo 19: looking west.

Photo 20: looking southwest at south side of trench.

Photo 21: looking northwest at ramp north side of trench.

Photo 22: looking east.

Photo 23: looking northeast at ramp.

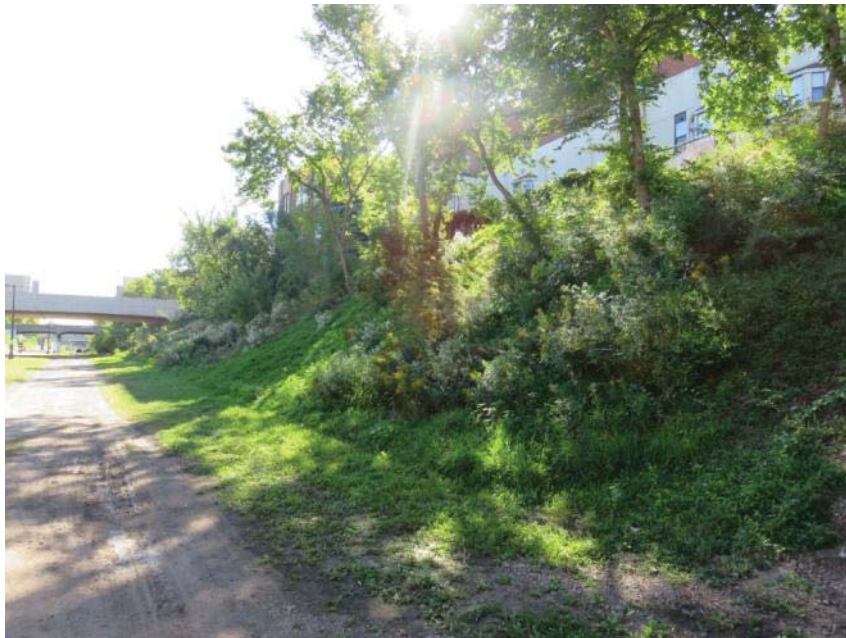
Photo 24: looking southeast at south side of trench.

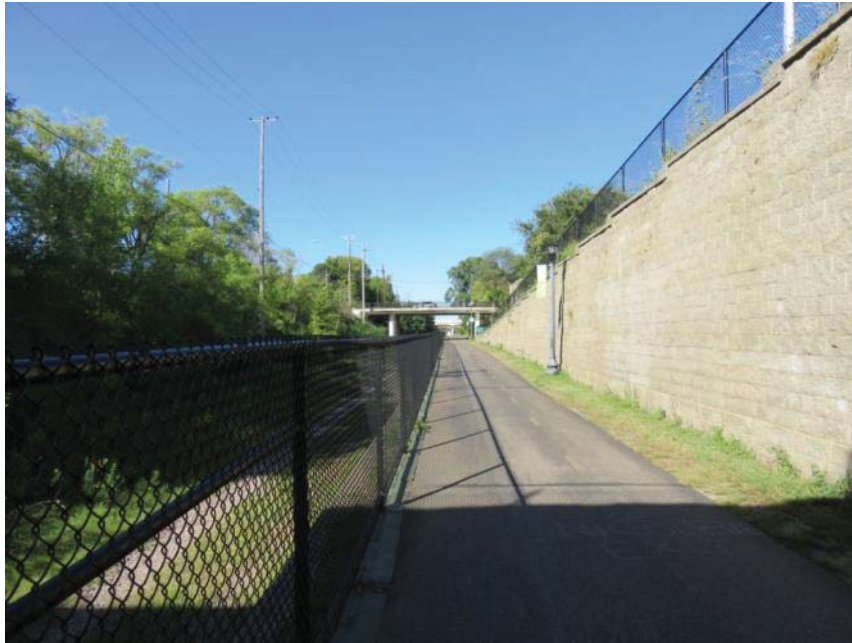
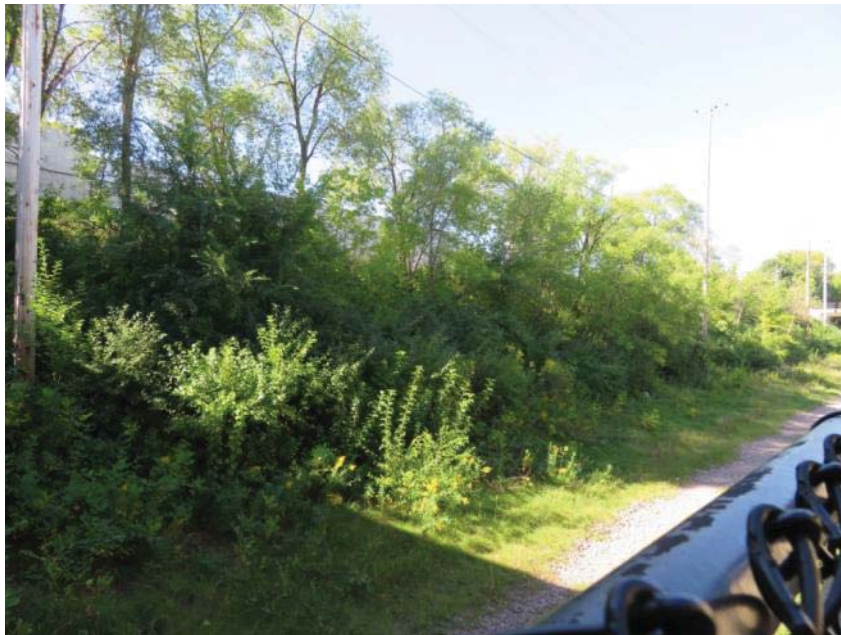
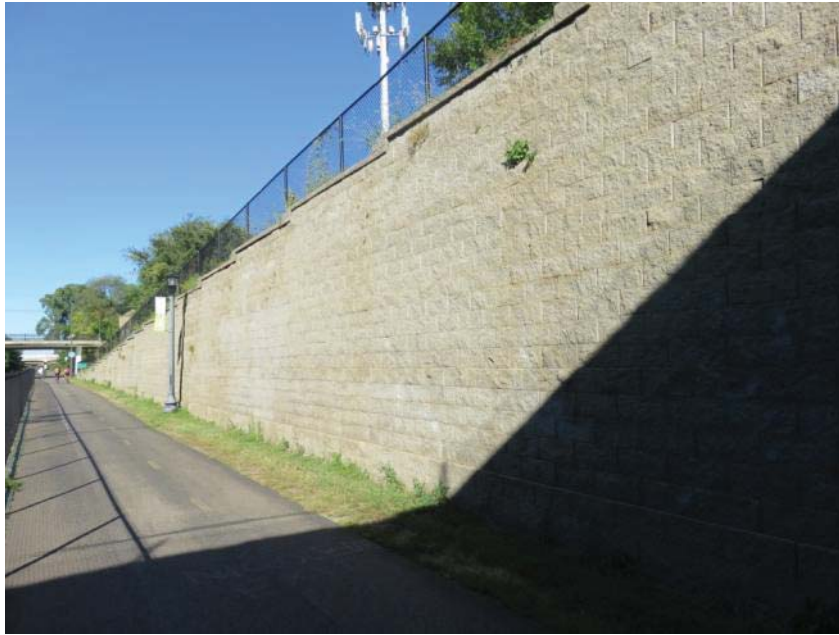
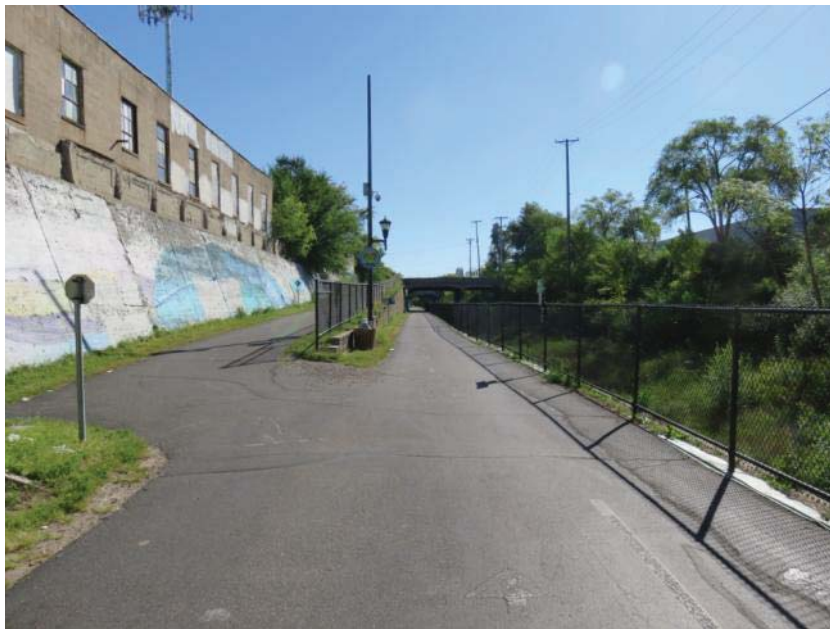
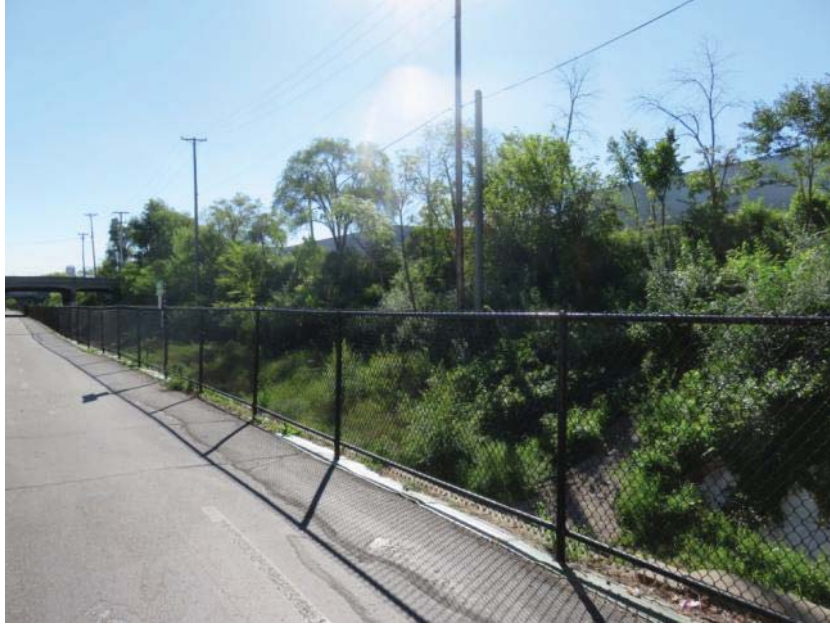
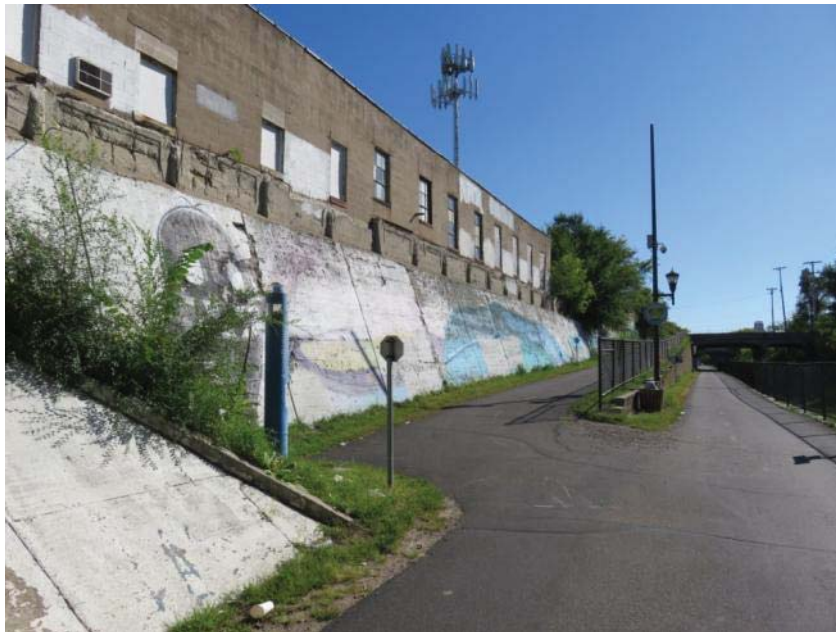
Segment No. 17 (Between Nicollet and Blaisdell Avenues)

Photo 25: looking west.

Photo 26: looking southwest at south side of trench.

Photo 27: looking northwest at ramp at north side of trench.

Photo 28: looking east.

Photo 29: looking southeast at south side of trench.

Photo 30: looking northeast at ramp north side of trench.

Segment 17 Comments: the trench remains, as does the original bridge defining the east end of the segment. A non-contributing bridge defines the west end of the segment. A bike ramp is at the north side of the trench, while a metal, chain-link fence runs through the middle of the segment. The ramp was likely in place at the time the property was listed, as was the chain-link fence. The bridge predates 2005. It is unclear why this segment was determined non-contributing.

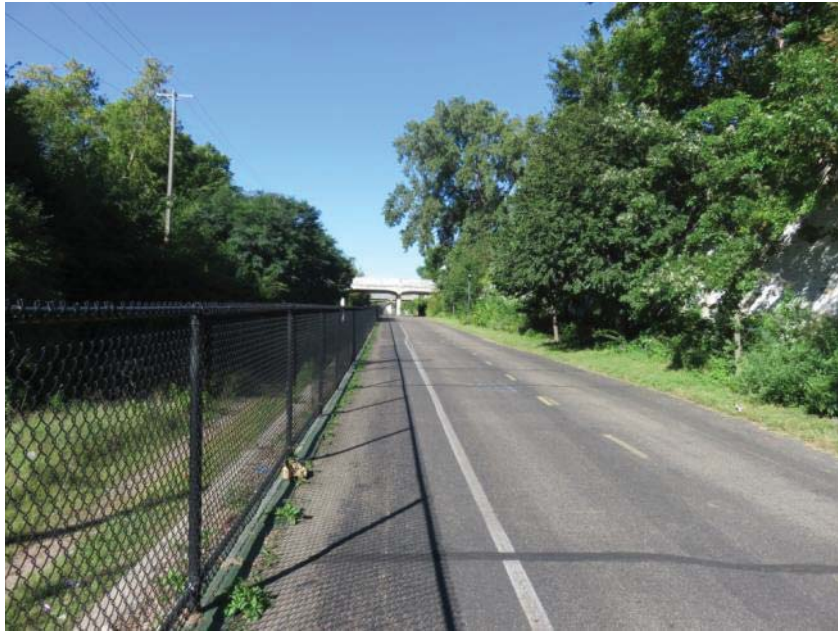
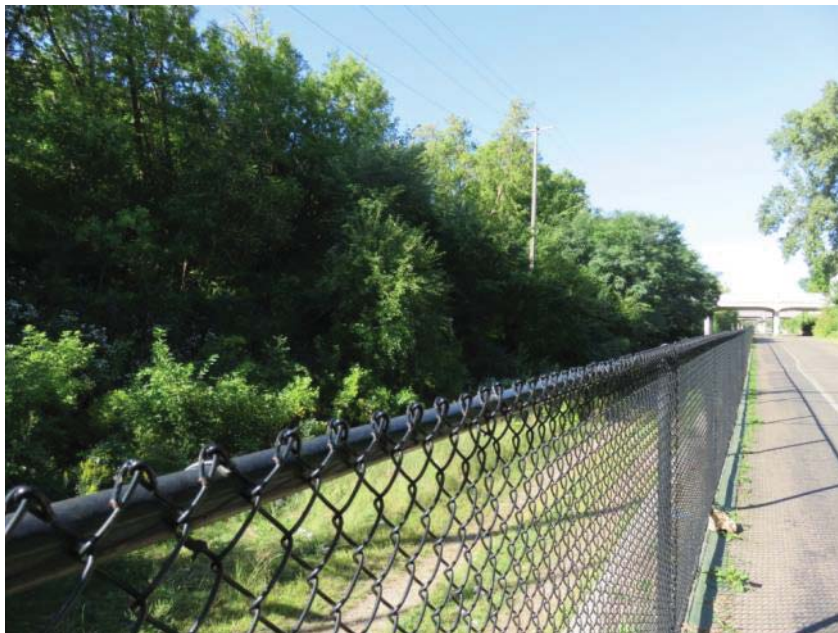
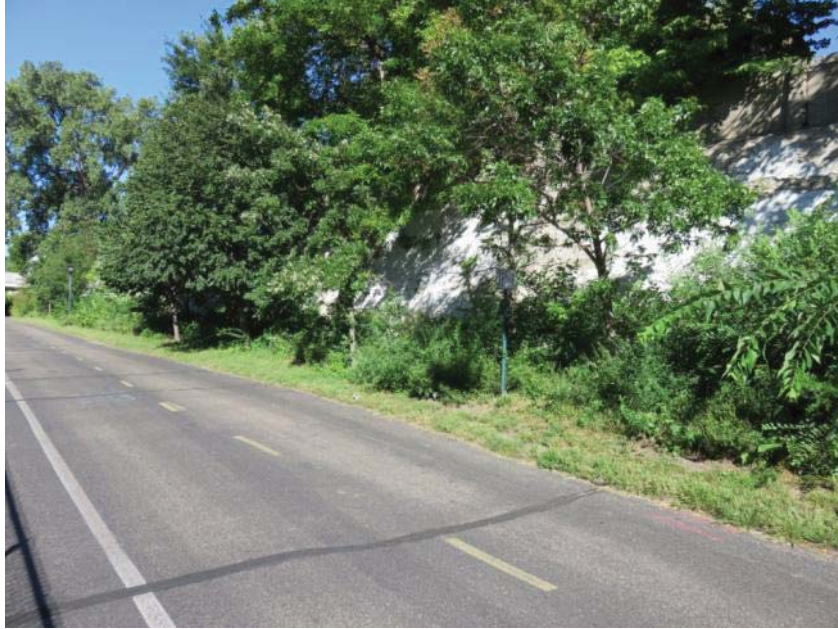
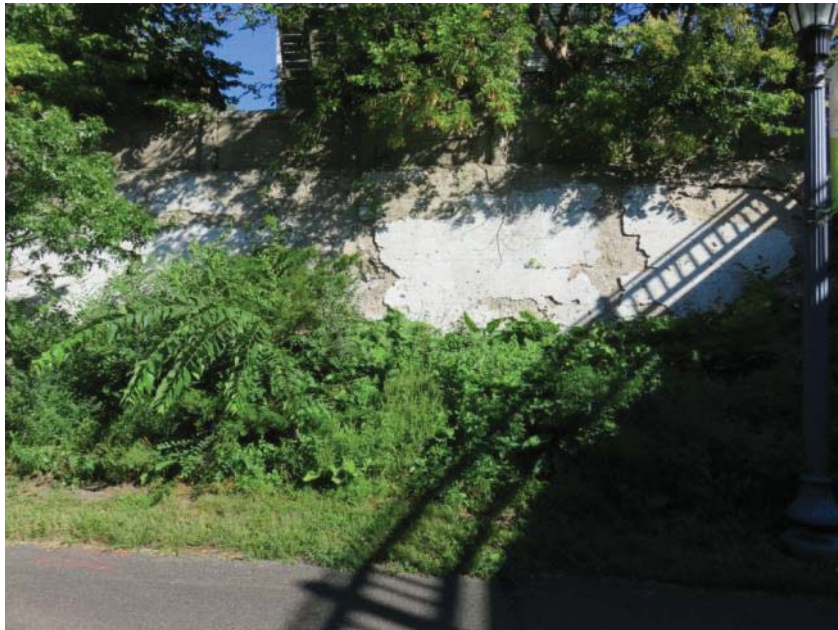
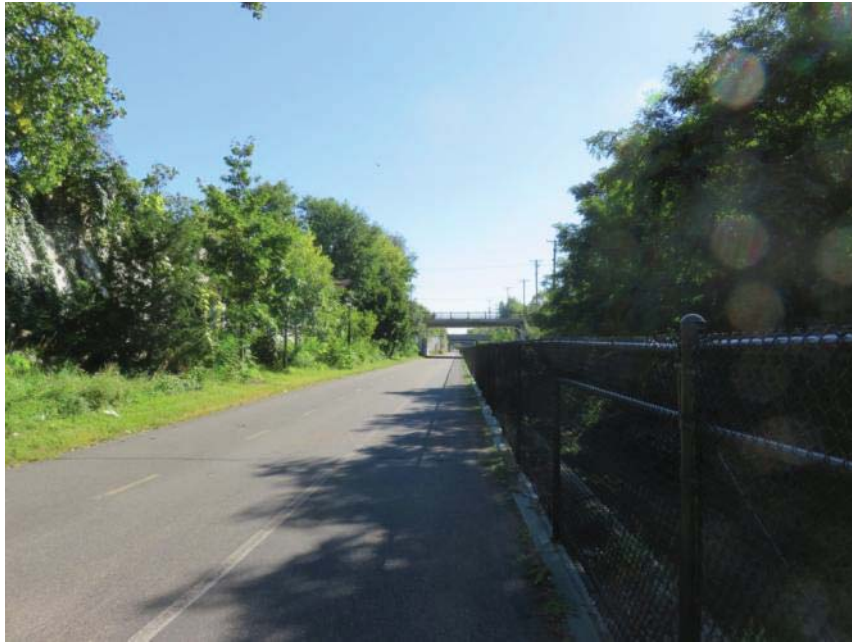
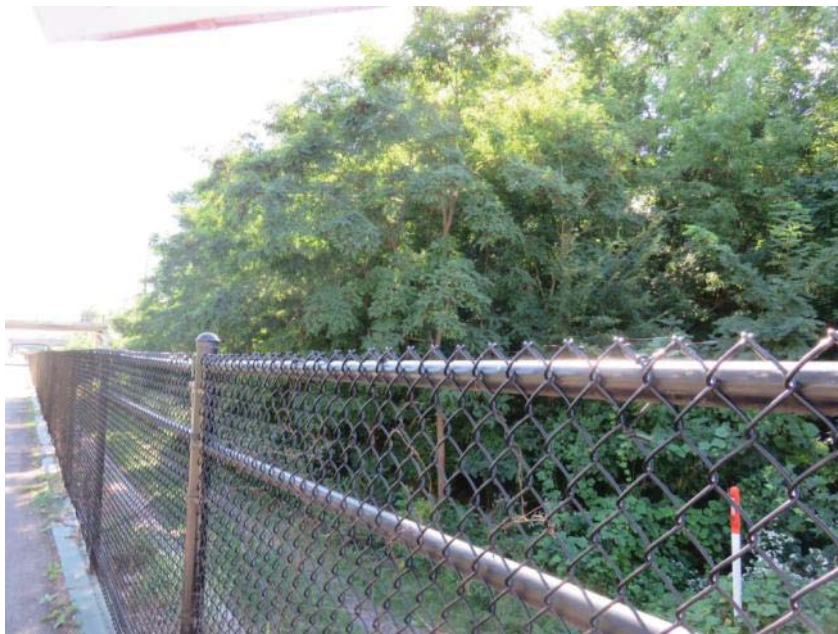
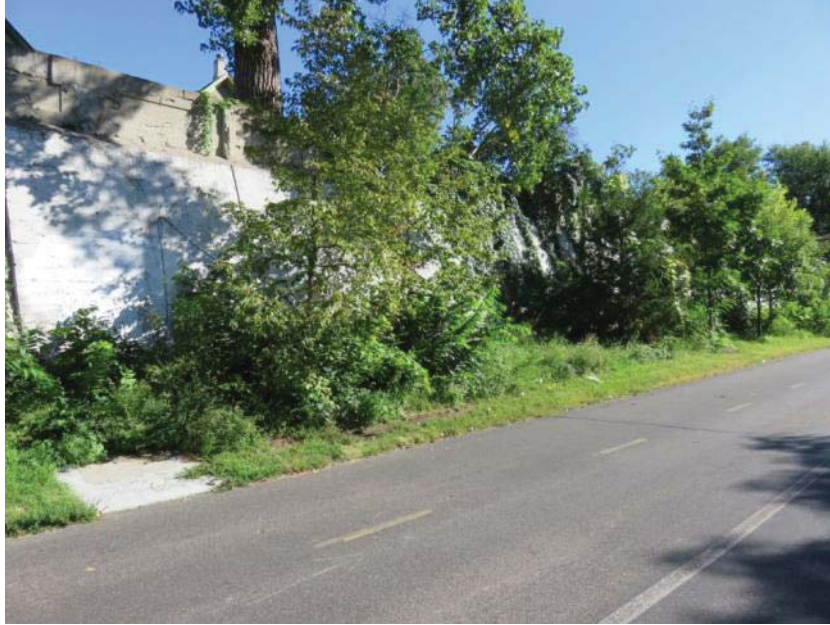
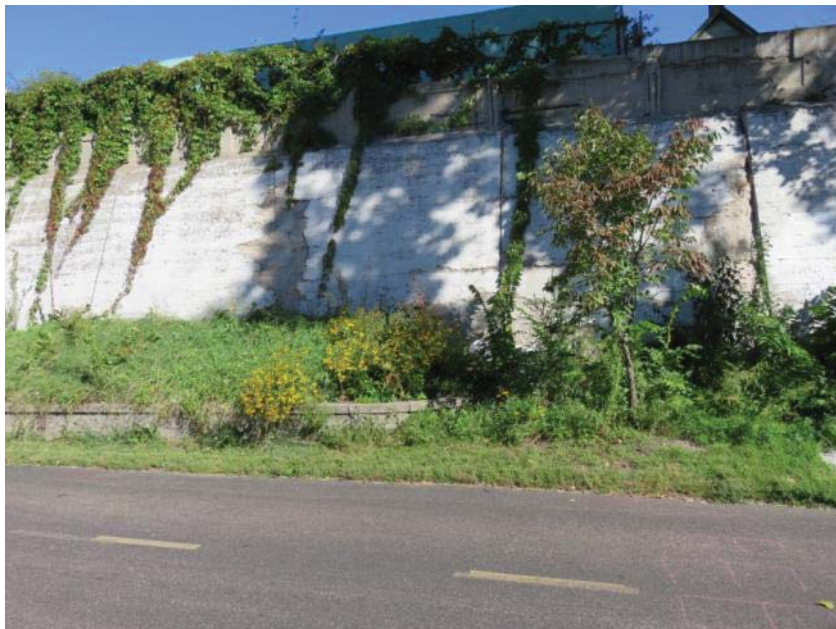
Segment No. 16 (Between Blaisdell and Pillsbury Avenues)

Photo 31: looking west.

Photo 32: looking southwest at south side of trench.

Photo 33: looking northwest at north side of trench.

Photo 34: looking north at north side of trench.

Photo 35: looking east.

Photo 36: looking southeast at south side of trench.

Photo 37: looking northeast at north side of trench.

Photo 38: looking north at north side of trench.

Segment 16 Comments: the trench remains, as does the original bridge defining the west side of the segment. A non-original bridge marks the east boundary. A metal, chain-link fence runs through the middle of the segment. The non-original bridge was in place prior to listing, as was the chain-link fence. It is unclear why this segment was determined non-contributing.
