Chicago, Milwaukee and St. Paul Railroad Grade Separation Historic District Reevaluation

Local Historic Bridge Study – Phase 3

**Minnesota Department of
Transportation**

March 2017

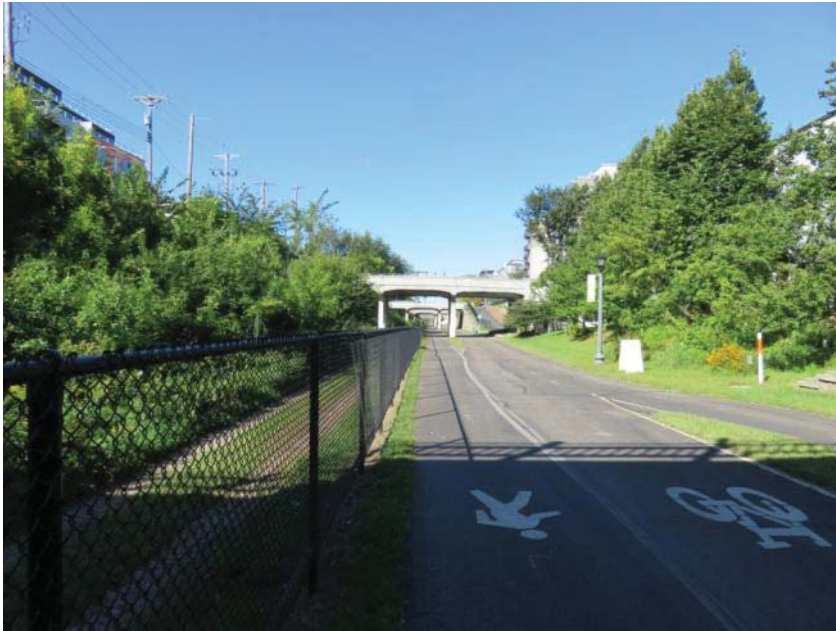
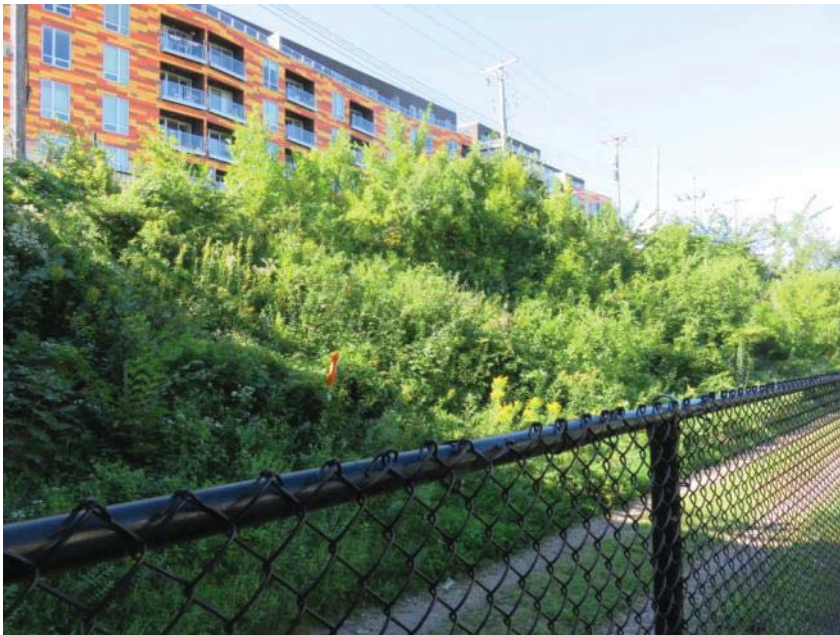
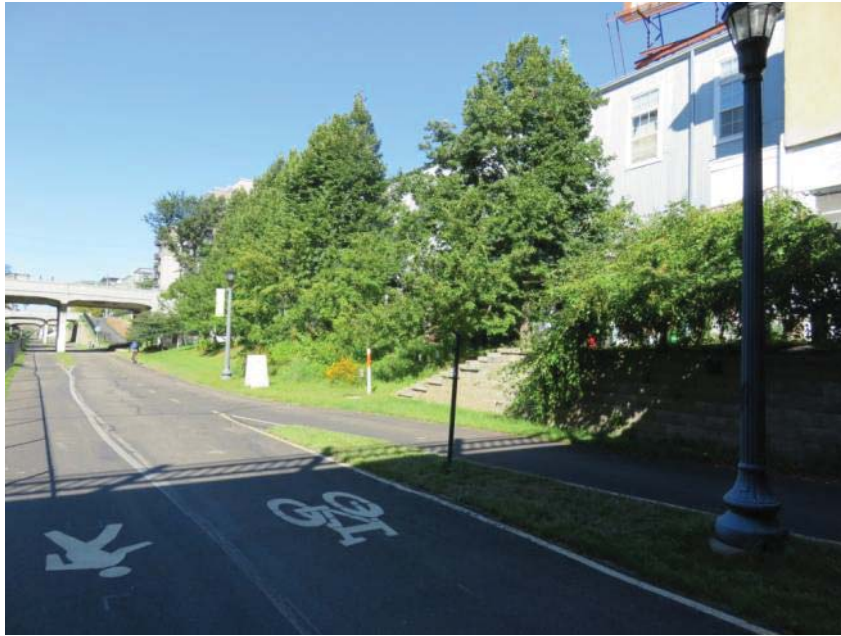
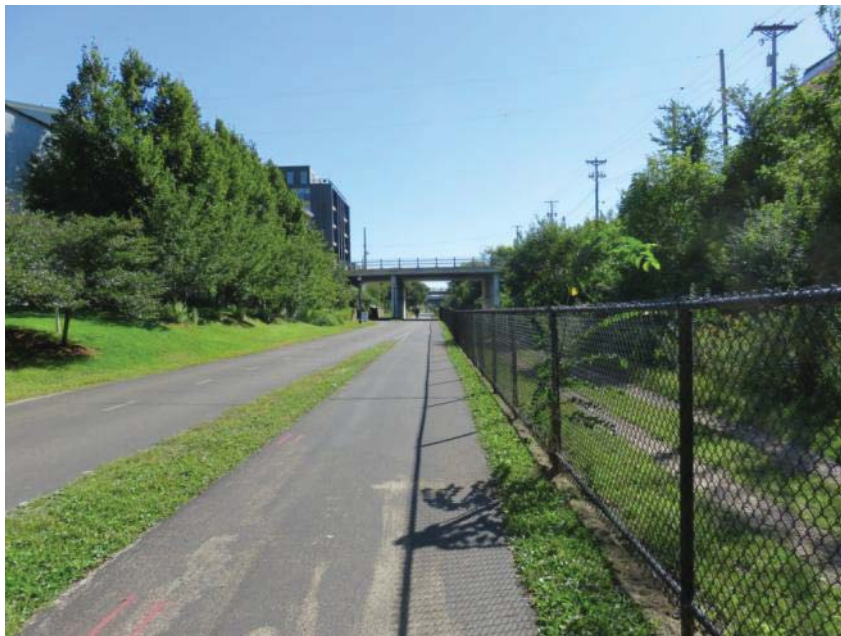
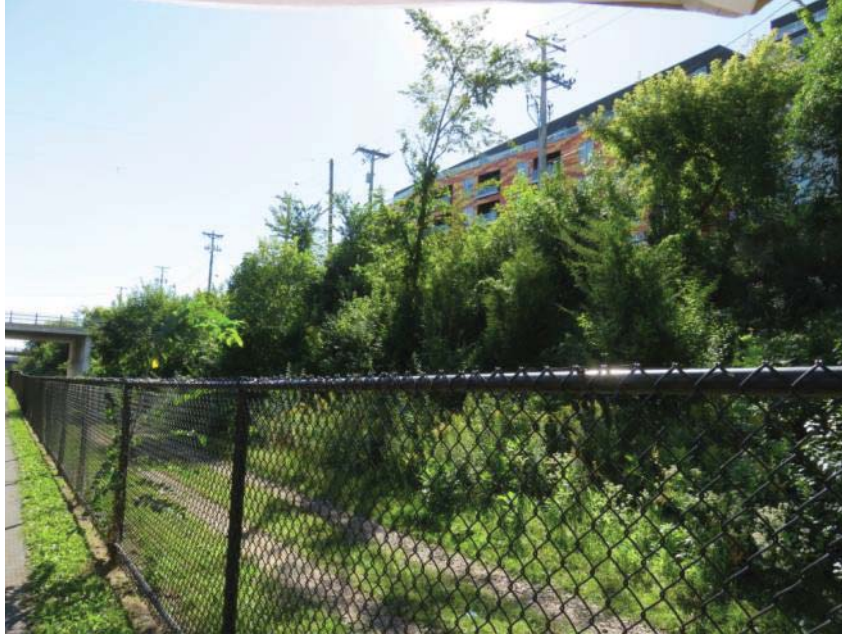
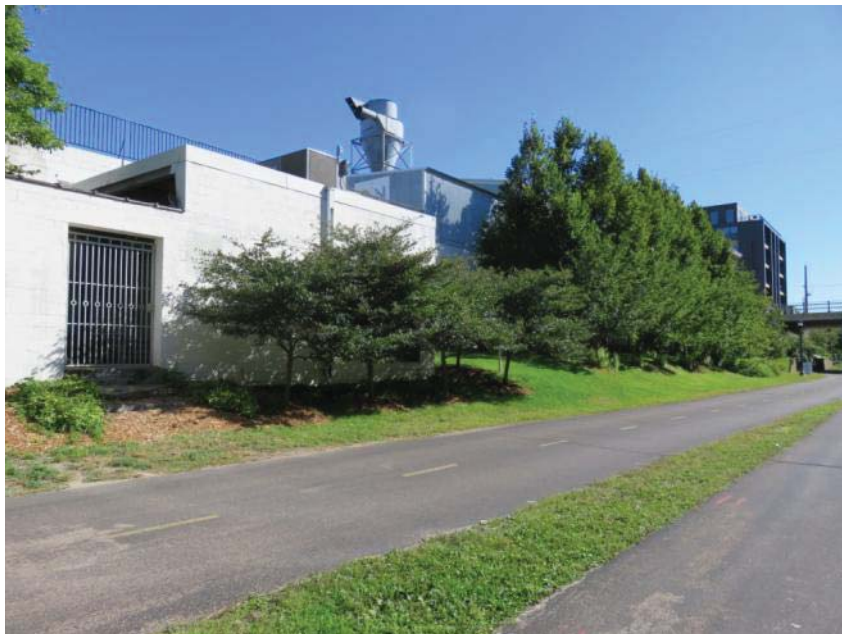
Segment No. 10 (Between Lyndale and Aldrich Avenues)

Photo 39: looking west.

Photo 40: looking southwest at south side of trench and residential units.

Photo 41: looking northwest at north side of trench and commercial building?

Photo 42: looking east.

Photo 43: looking southeast at south side of trench. Residential units in background.

Photo 44: looking northeast at east side of trench and commercial structures/buildings?

Segment 10 Comments: the trench remains, as does the original bridge marking the west boundary of the segment. Non-contributing construction is at the north side of the trench. Residential construction is beyond the property boundary near the south side of the trench. The non-contributing construction to the north predates 2005. The non-contributing construction to the south of the trench is outside of the property boundary but nevertheless influences integrity of setting. While setting is undermined by this construction, troubling setting alone does not perfunctorily make the segment non-contributing.

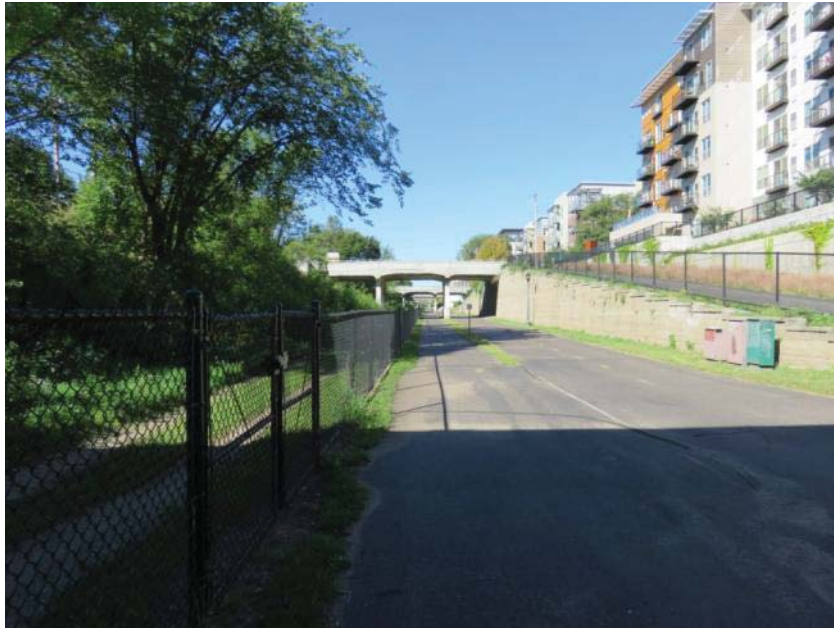
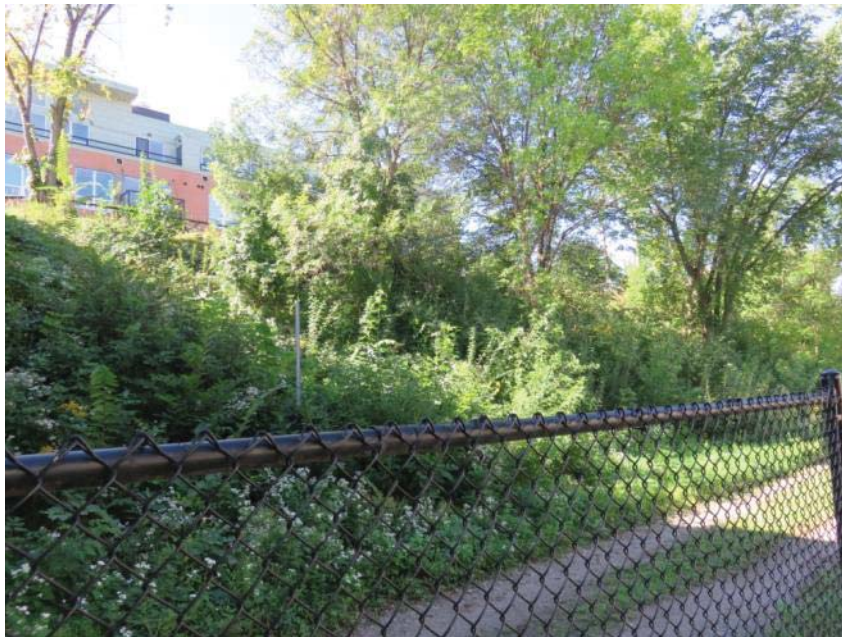
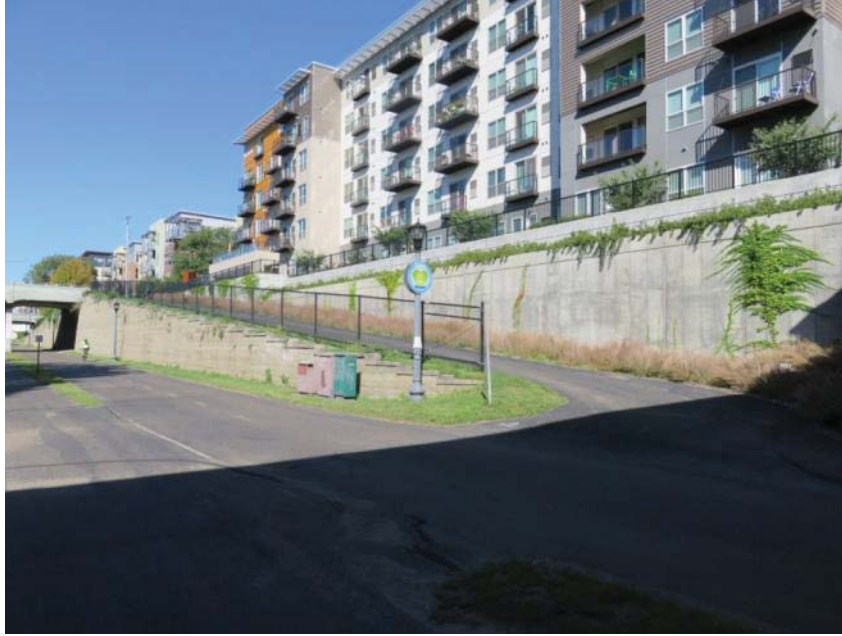
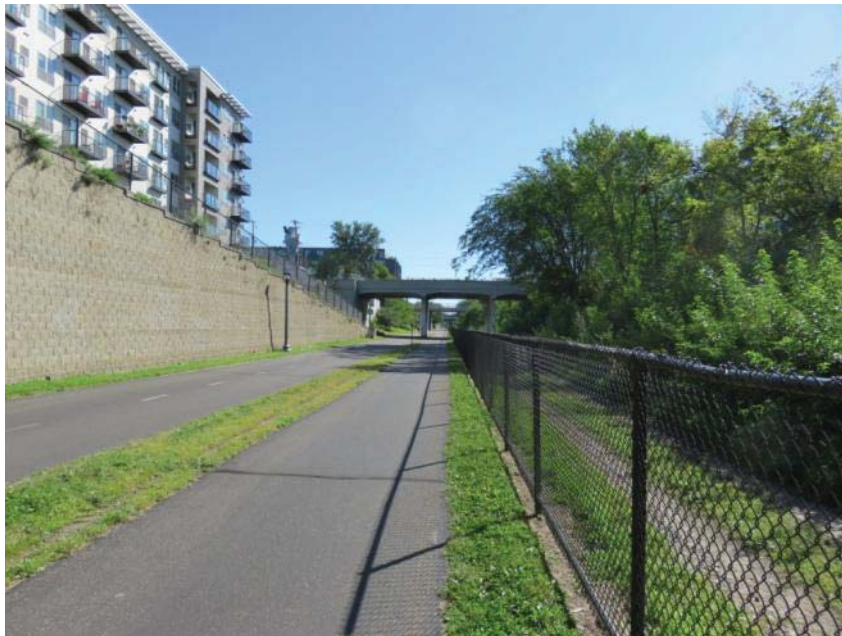
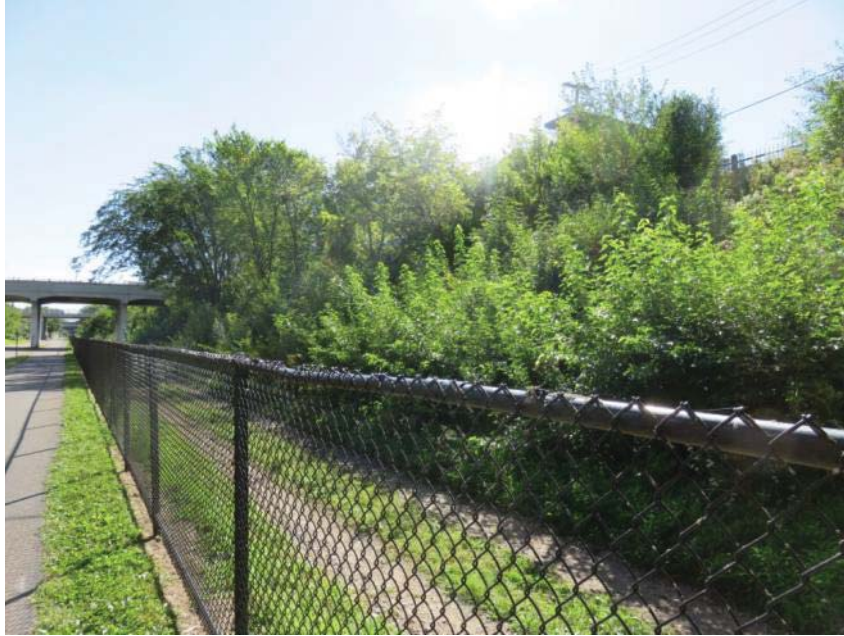
Segment No. 9 (Between Aldrich and Bryant Avenues)

Photo 45: looking west.

Photo 46: looking southwest at south side of trench. Background is residential building?

Photo 47: looking northwest at north side of trench and residential units.

Photo 48: looking east.

Photo 49: looking southeast at south side of trench.

Segment 9 Comments: the trench remains, as do the original bridges marking the east and west end of the segment. A bike ramp is at the north side of the trench and a chain-link fence runs through the segment. The ramp was likely in place at the time of listing, as was the chain-link fence. New residential construction is outside the property boundary near the north side of the trench. Like the previous segment, integrity of setting is compromised by this construction, but the troubling setting north of the boundary by itself does not warrant determining the entire segment non-contributing.

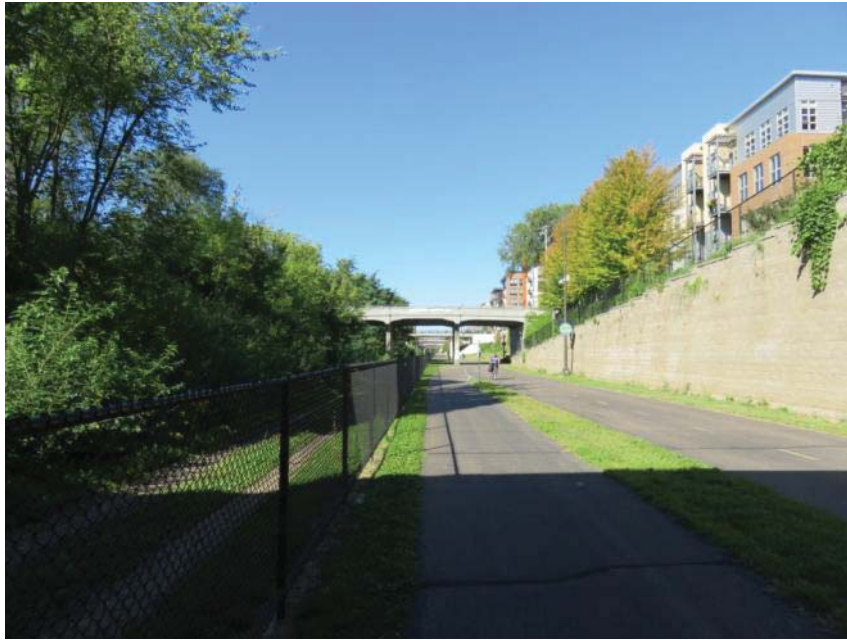
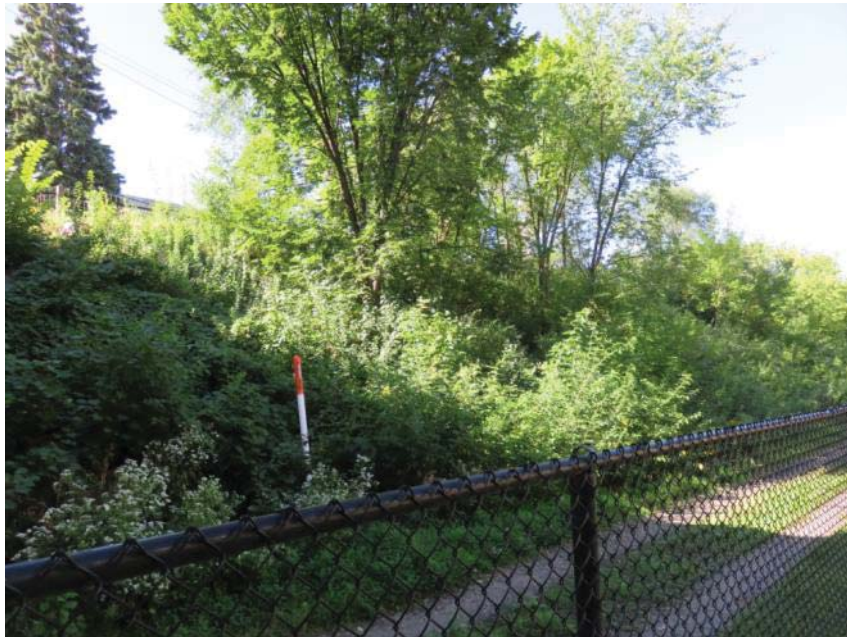
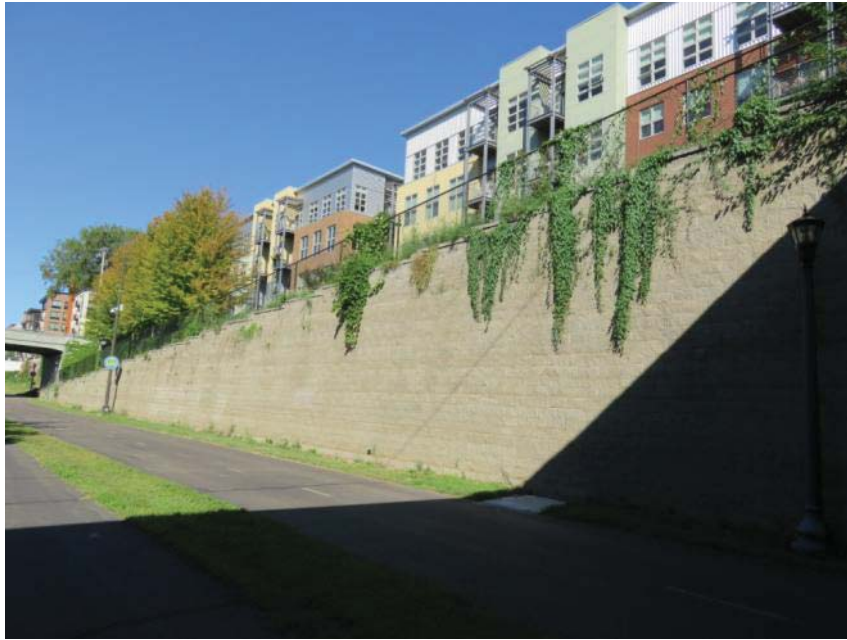
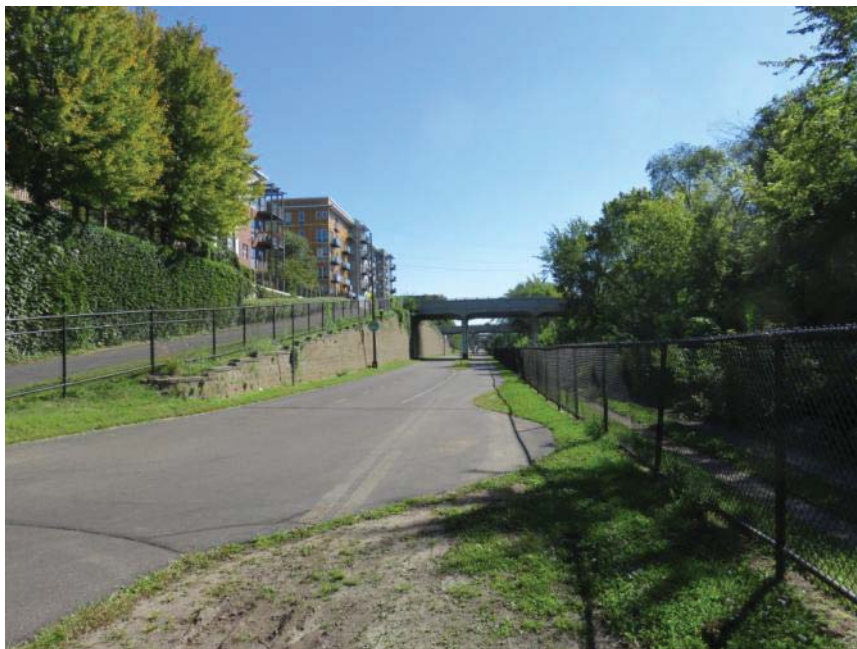
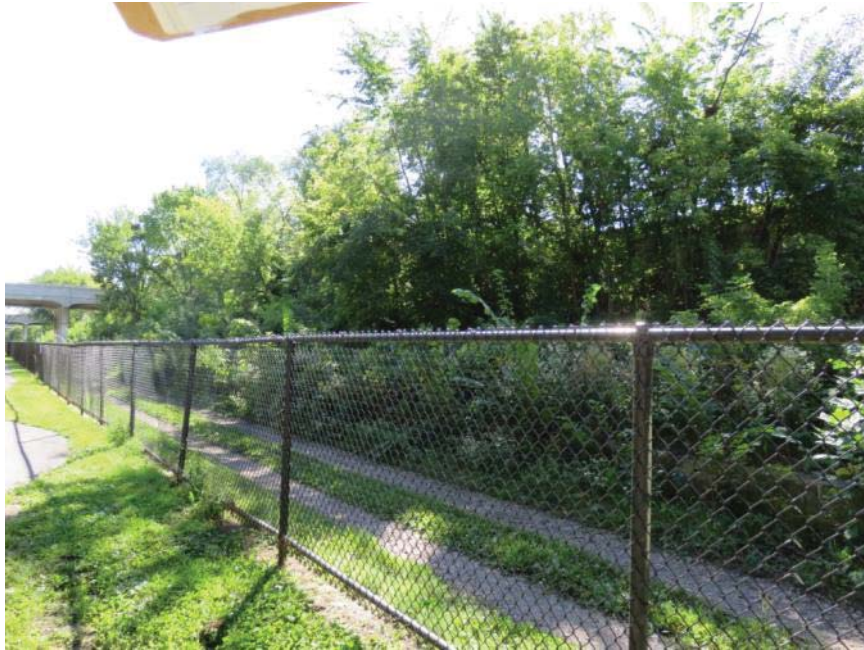
Segment No. 8 (Between Bryant and Colfax Avenues)

Photo 51: looking west.

Photo 52: looking southwest at west side of trench.

Photo 53: looking northwest at ramp and residential units north side of trench.

Photo 54: looking east.

Photo 55: looking southeast at south side of trench.

near the property line. Like the previous segment, integrity of setting is compromised by this new construction, and the addition of new foliage further unsettles integrity of setting. However, it is out of sorts to conclude that the setting failings at the north side of the boundary outweigh the principal character-defining features of the segment.

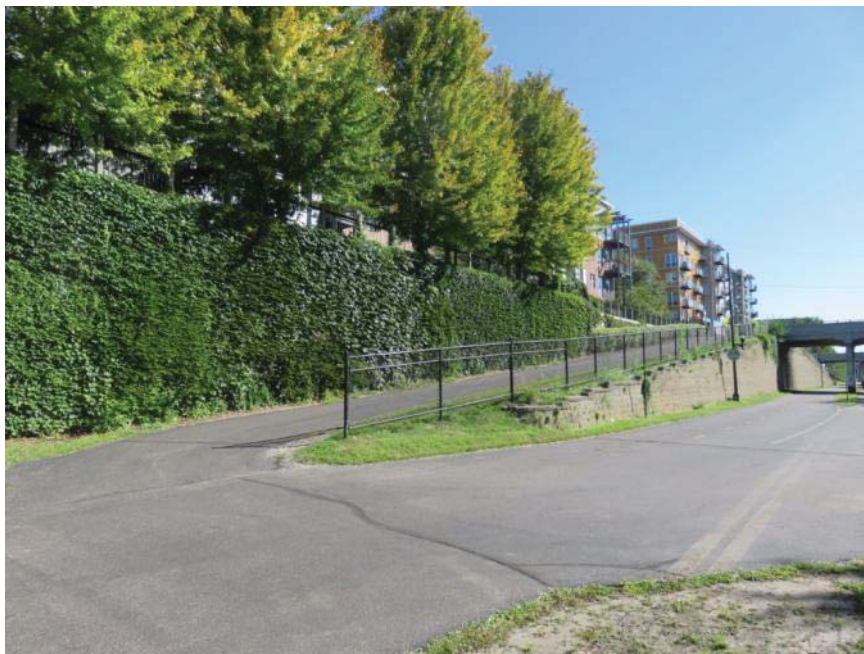
Photo 56: looking northeast at ramp and residential units north side of trench.

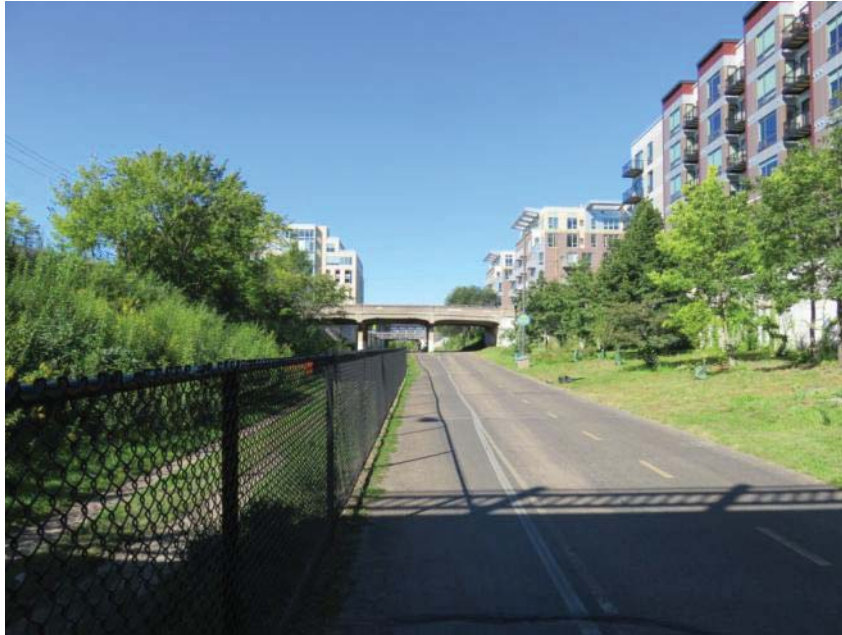
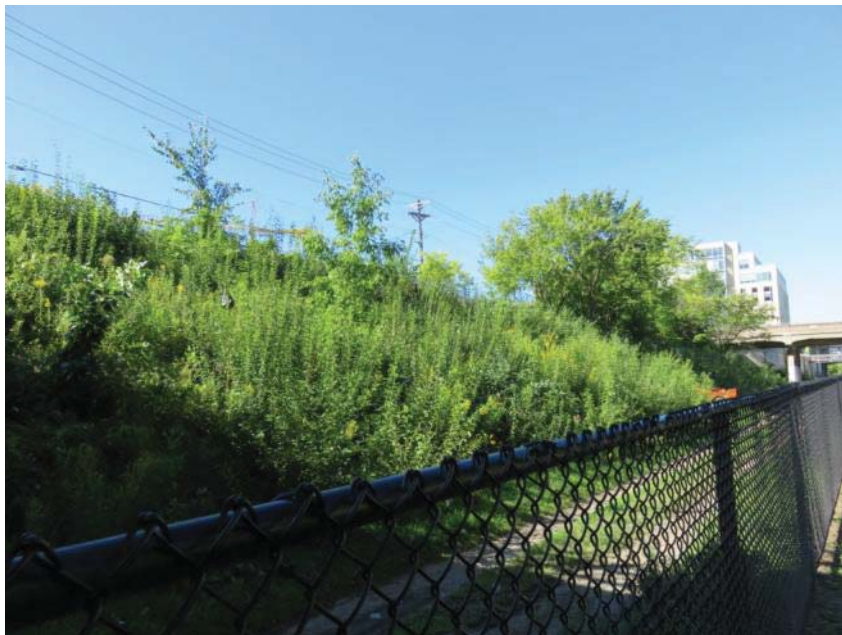
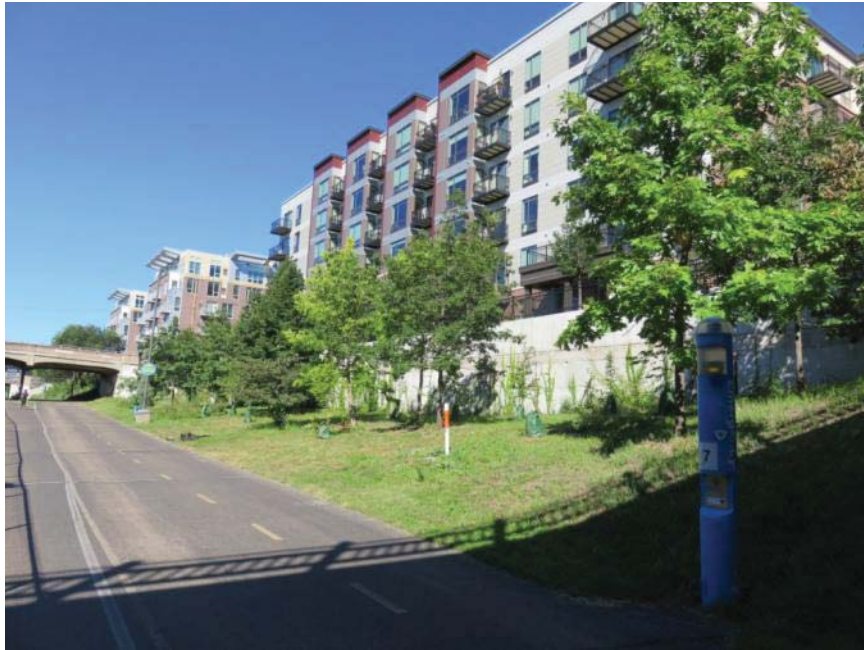
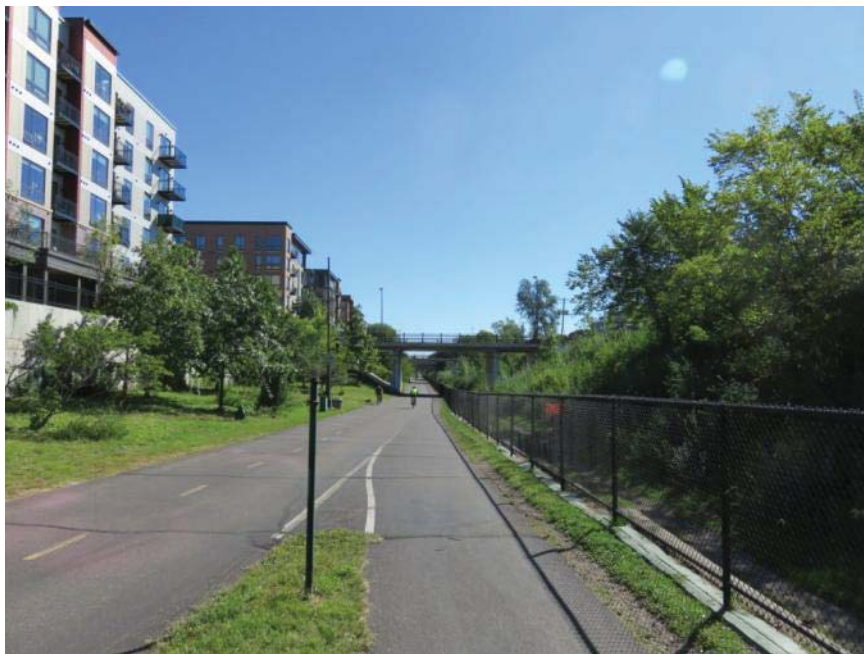
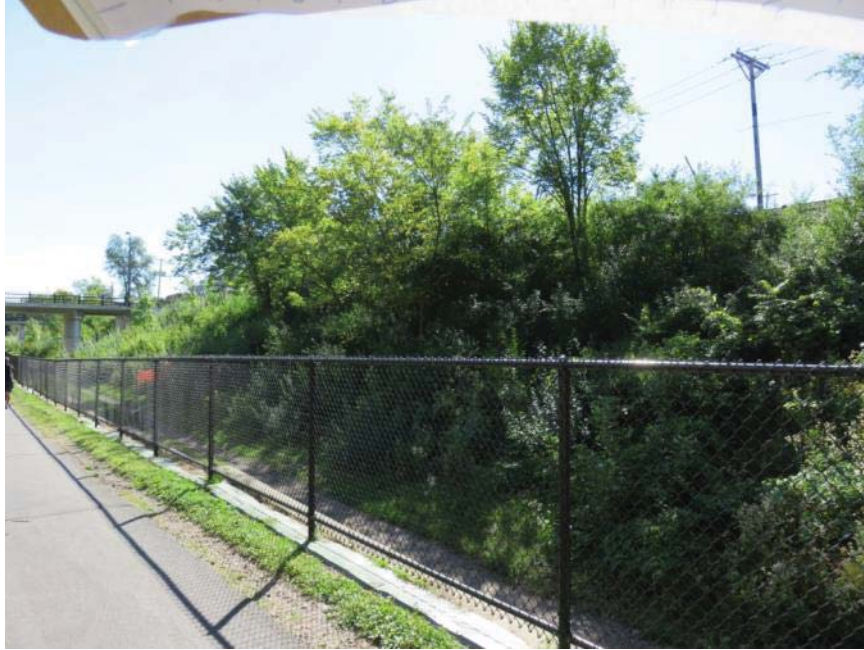
Segment No. 5 (Between Emerson and Freemont Avenues)

Photo 57: looking west.

Photo 58: looking southwest at south side of trench.

Photo 59: looking northwest at north side of trench and residential units.

Photo 60: looking east.

Photo 61: looking southeast at south side of trench.

previously-noted segment, integrity of setting is compromised by the residential construction beyond the property boundary near the north side of the trench. Newly-planted trees just inside the boundary at this side negatively affect the segment. Nevertheless, concluding that these things supersede all else in the segment is not convincing.

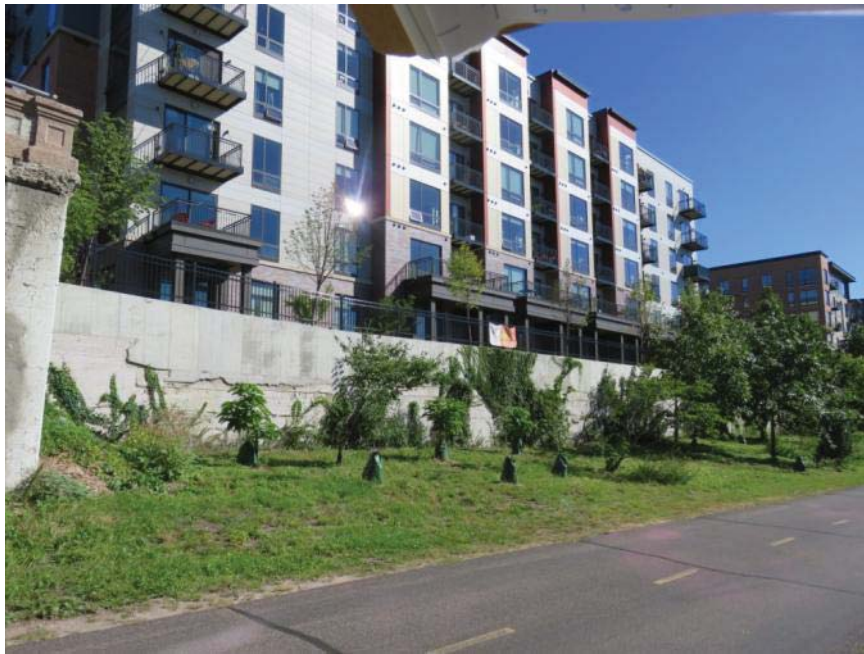
Photo 62: looking northeast at north side of trench and residential units.
