**Minnesota Department of Natural Resources**  
**Minnesota Board of Water and Soil Resources**

## **Project Evaluations**

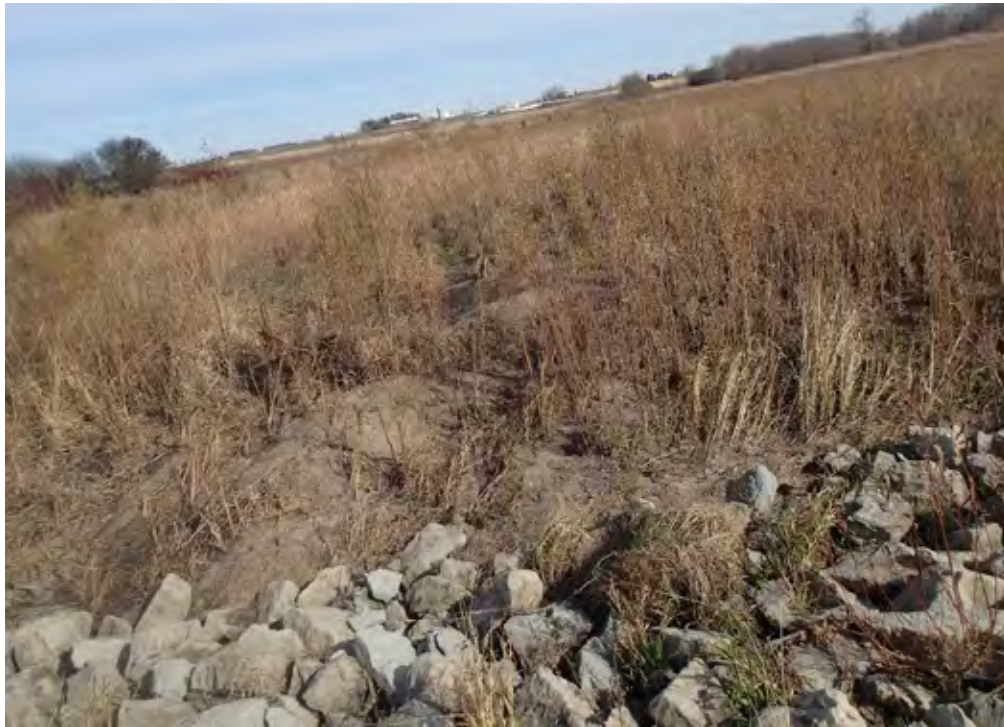
**Photo 3-3** Sediment capture observed at bottom of inlet spillway, 10/24/18.

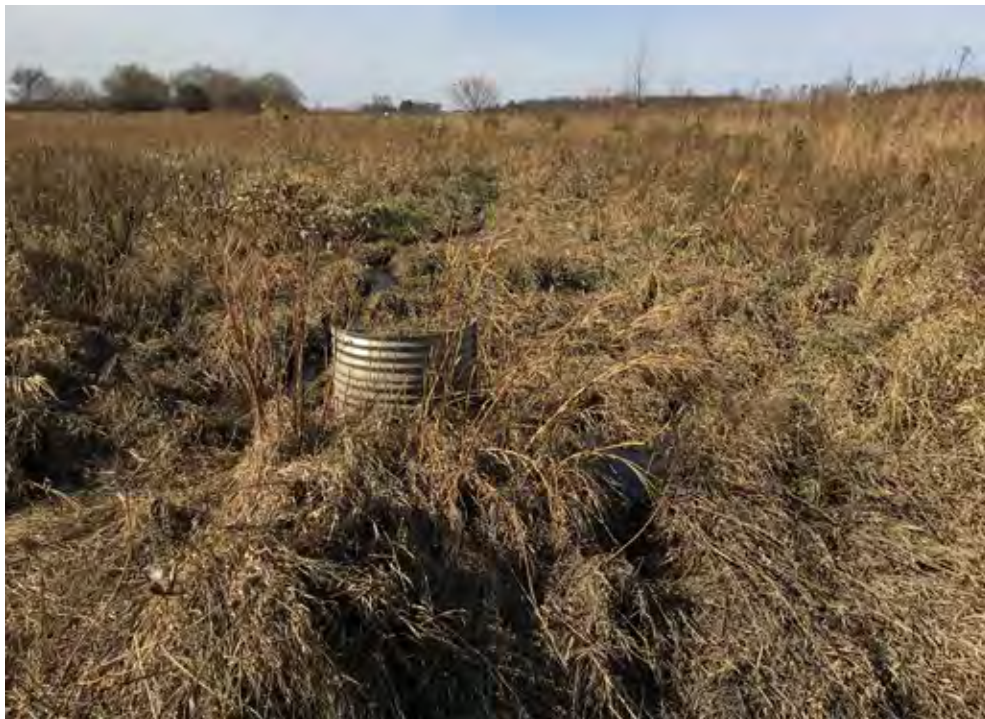
**Photo 3-4** Outlet structure of Geomaat retention wetland, 10/24/2018.

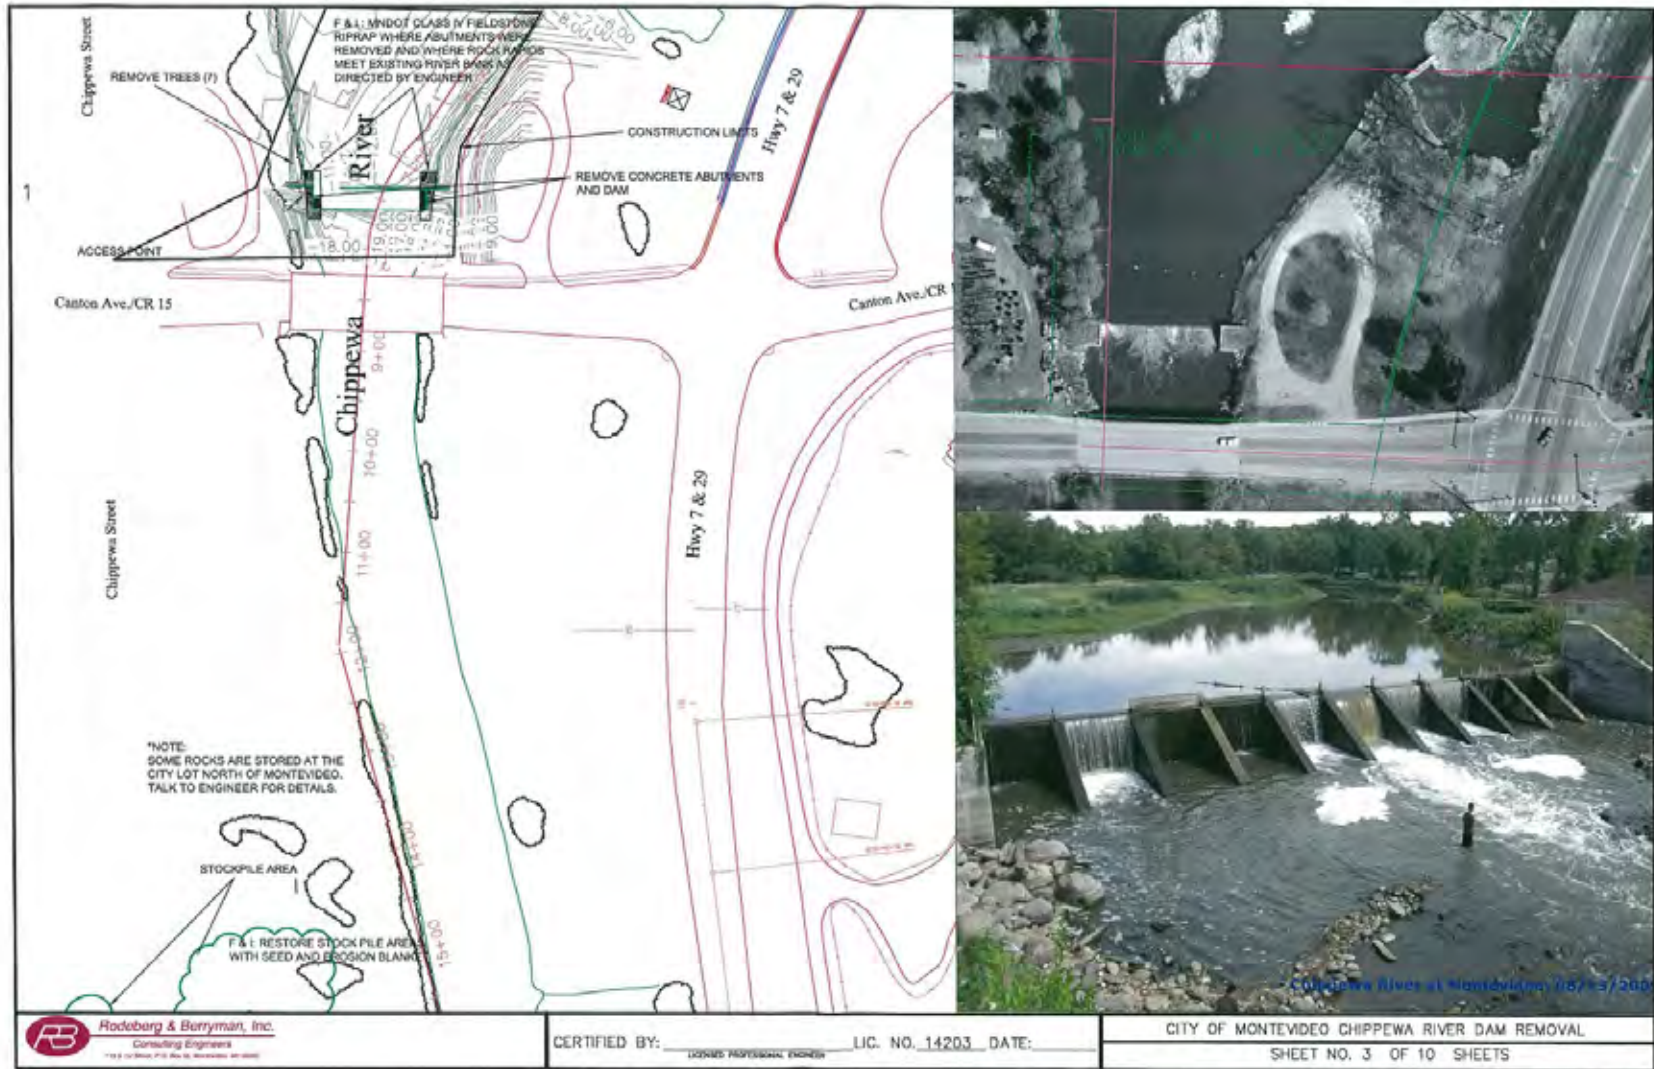
Figure 4-2 Construction plan set sheet 3 of 10, existing conditions.

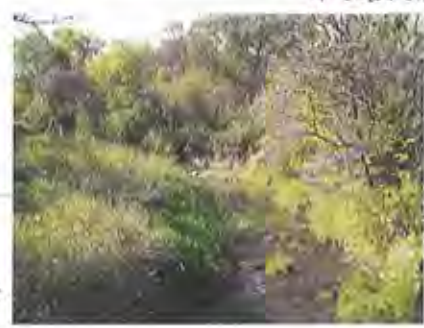
Figure 6-15 Comments from DNR on design, page 3 of 5. Most of this work, from station 6+50 to 72+25, was eliminated from the final design.

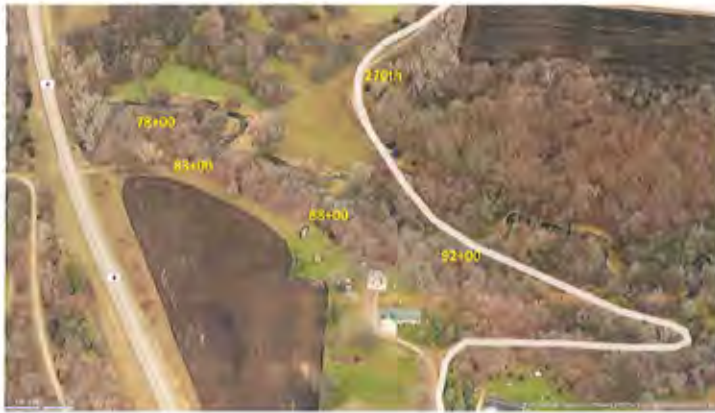
Spring Creek, MN Hwy 4 - abandoned 270<sup>th</sup>

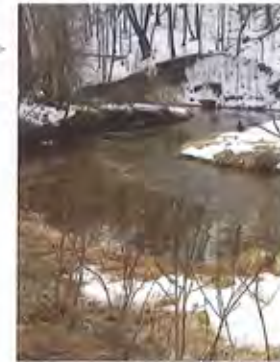
**Figure 6-16** Comments from DNR on design, page 4 of 5. The DNR recommended toe protection for a large valley wall at 83+00, no protection was included in the final design

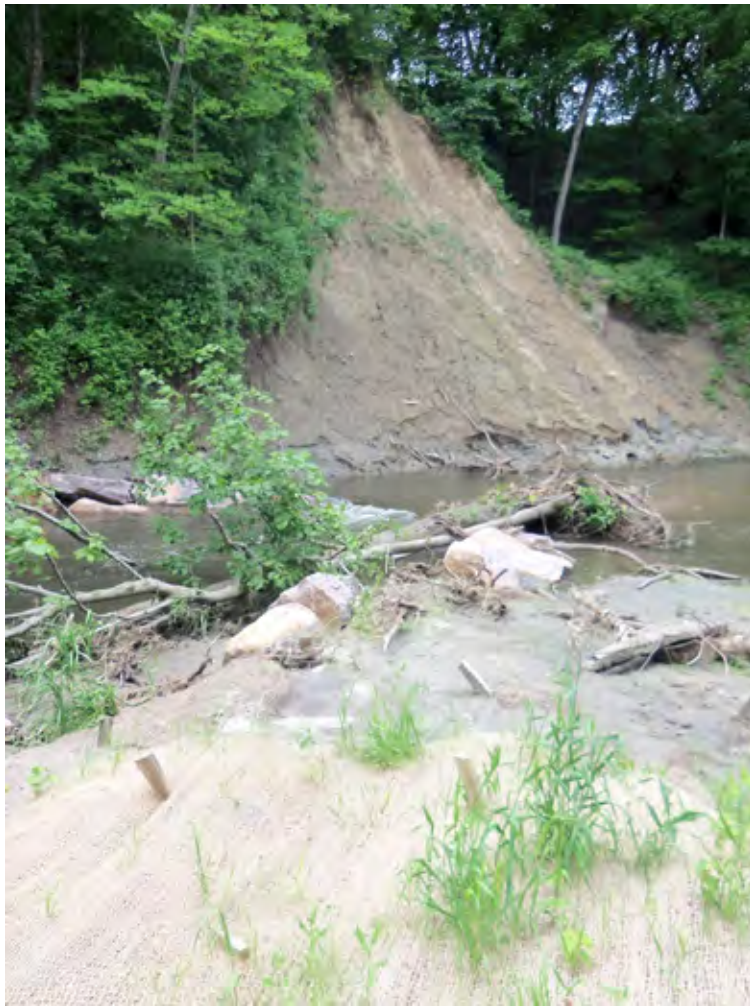
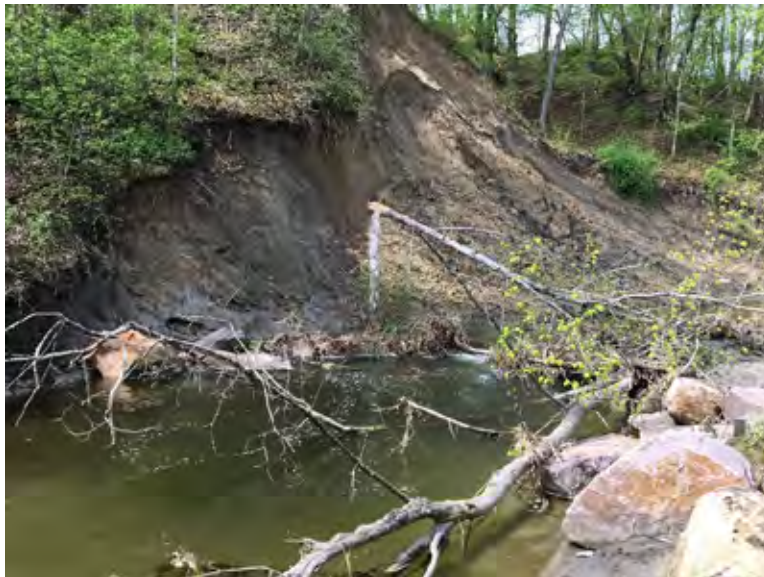
**Photo 6-5** Top photo taken 6/6/16 during CPL monitoring site visit, compare to same bank in photo below taken 5/14/18. Significant bank failure and erosion between photos, no structures or stabilizing treatments were applied directly to this bank.

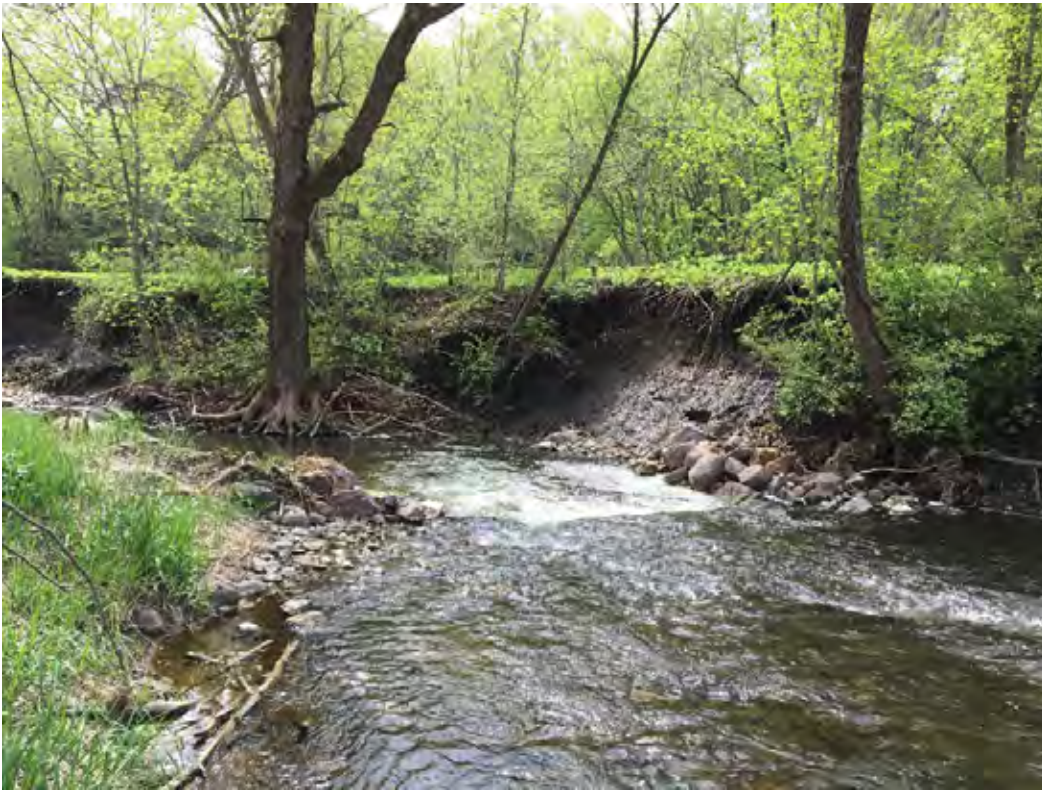
**Photo 6-6** Vane creating pool and fish habitat but constructed at wrong angle and directing flow into the bank. 5/14/18.

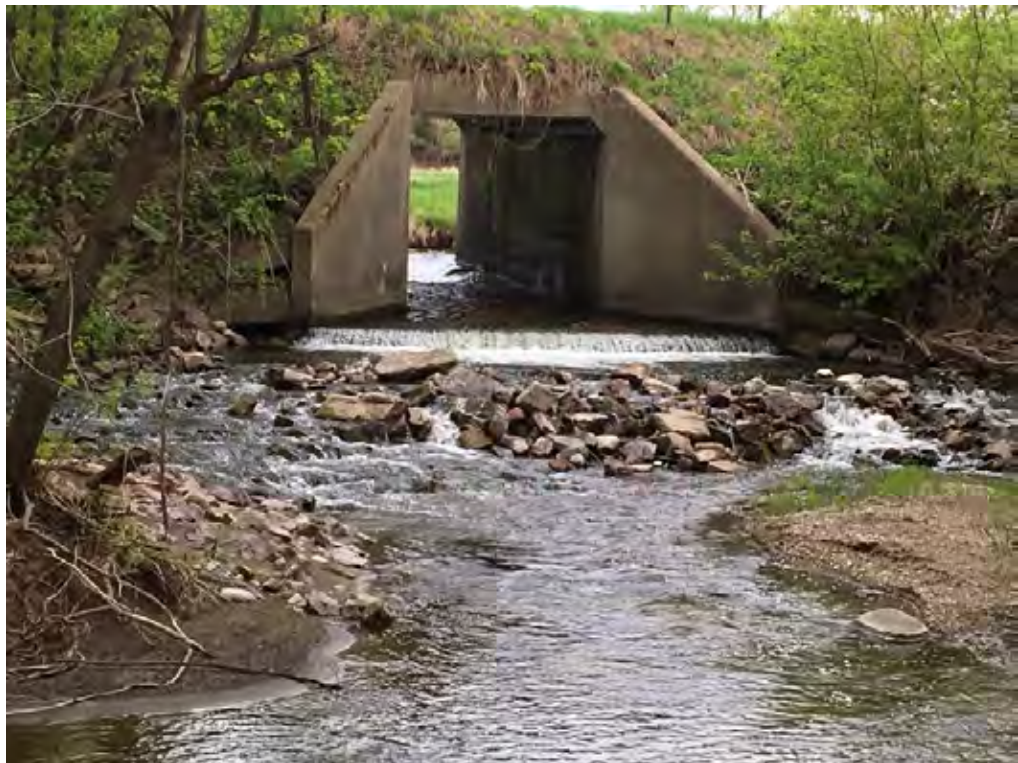
**Photo 6-13** Partial failure of fish passage riffle at 280<sup>th</sup> Ave culvert, fish passage is still possible. 5/14/18.

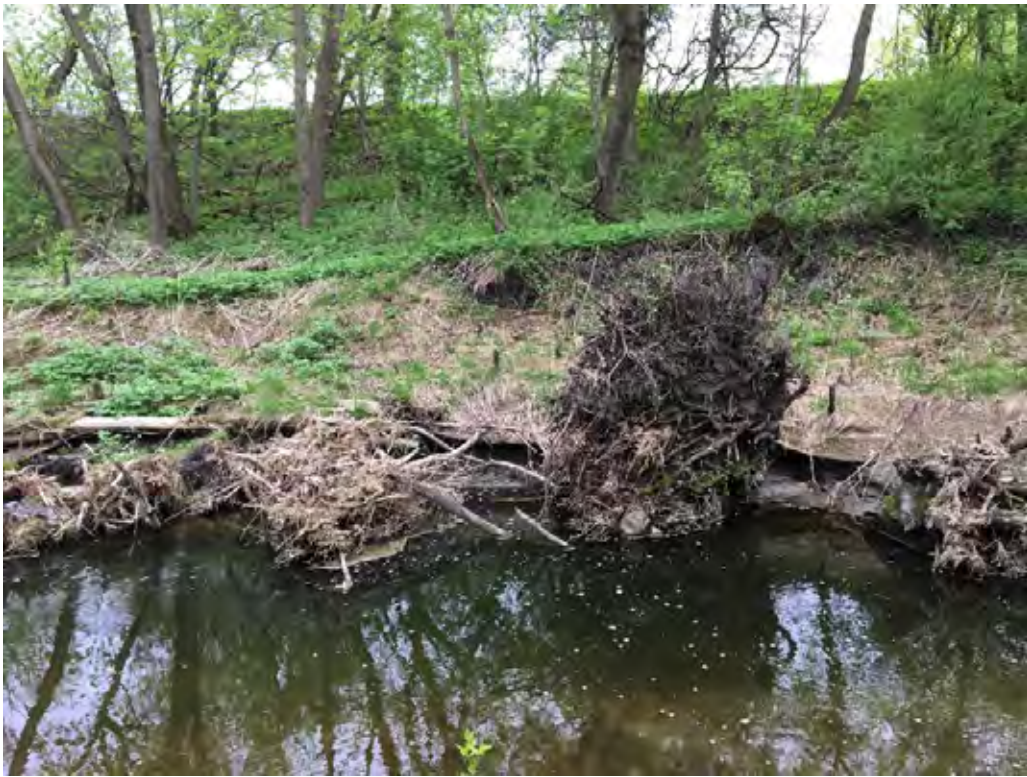
**Photo 6-14** Toe wood sticking well out of the water and higher than neighboring pieces possibly causing the erosion in-between the root wads. 5/14/18.

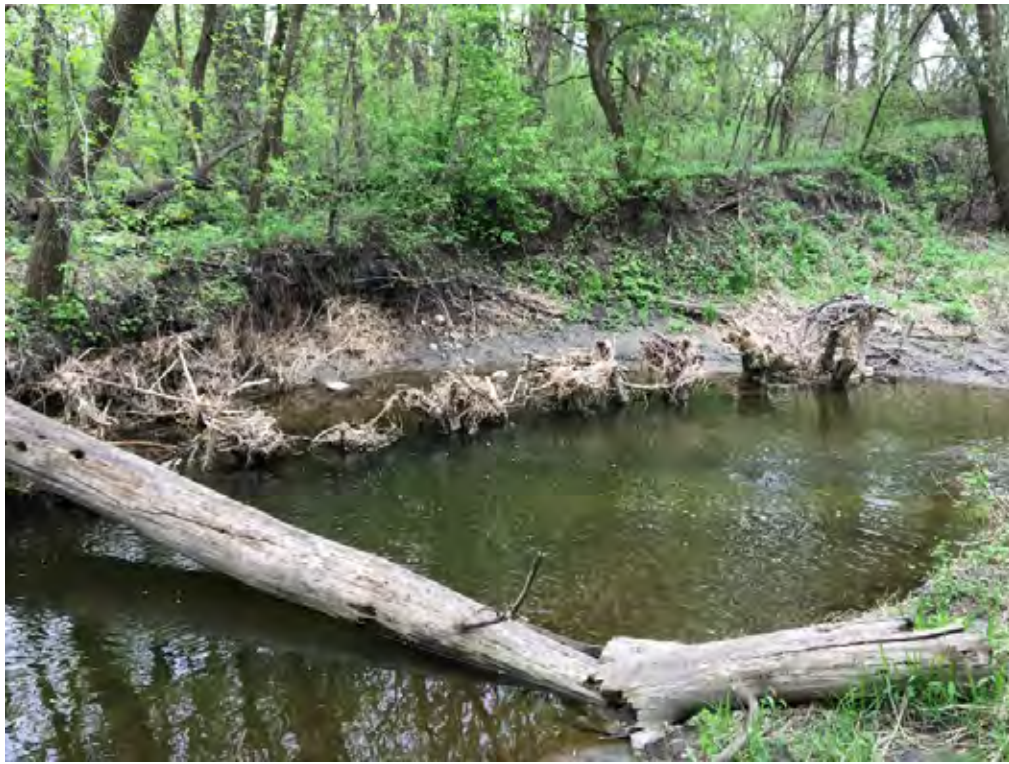
**Photo 6-16** Failed tree pin structure. 5/14/18.

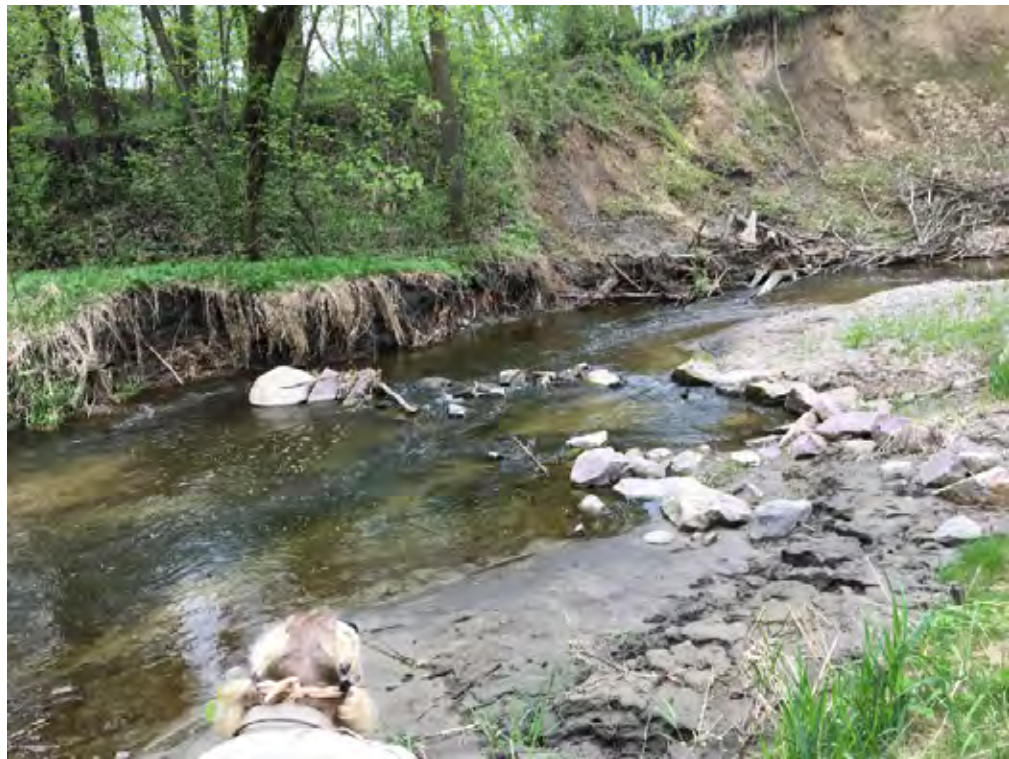
**Photo 6-17** Failed vane structure causing bank erosion on left side of photo. 5/14/18.

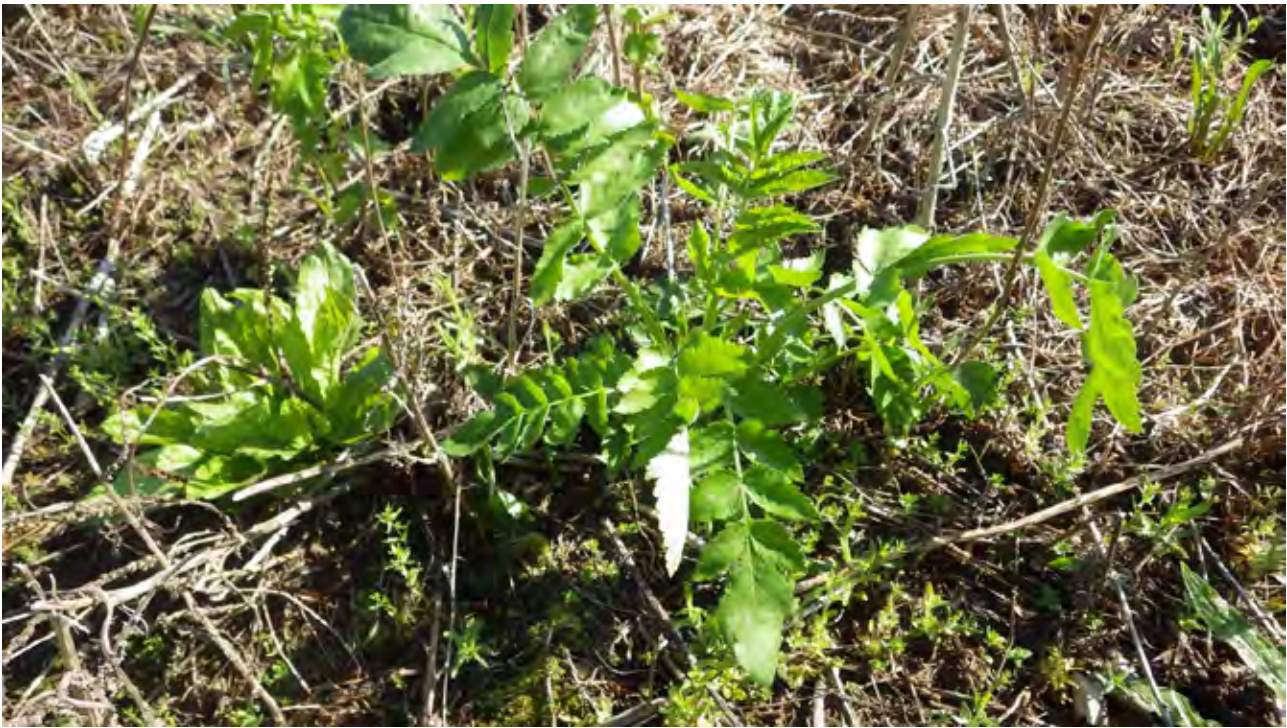
**Photo 9-3** Wild parsnip found in relatively low density.

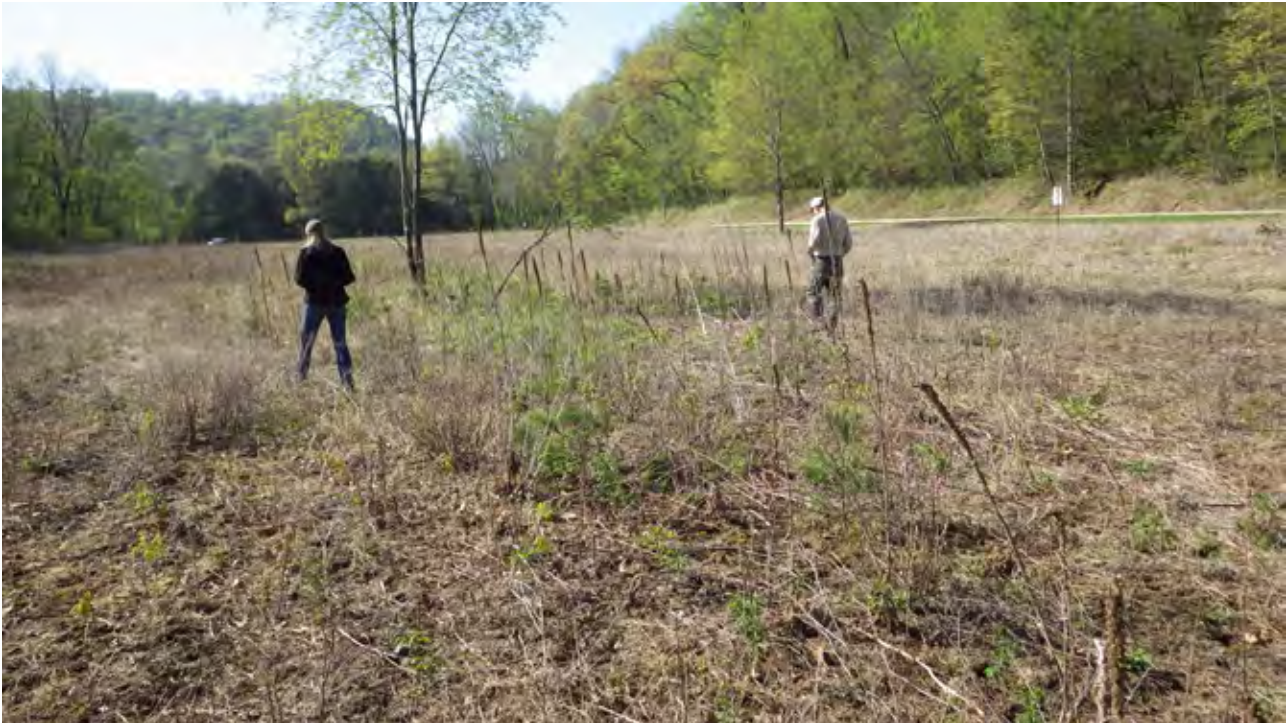
**Photo 9-4** White pine seedlings found near lone mature cherry tree.

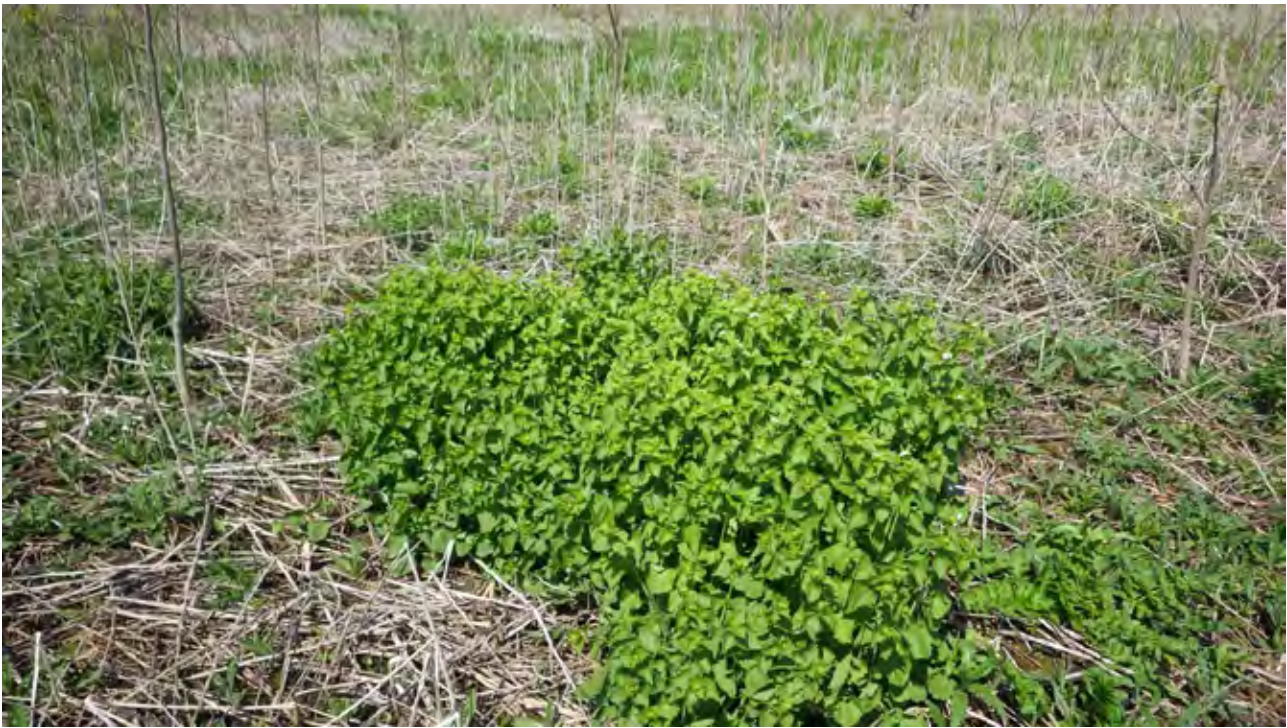
**Photo 10-3** Garlic mustard patches found scattered throughout site.

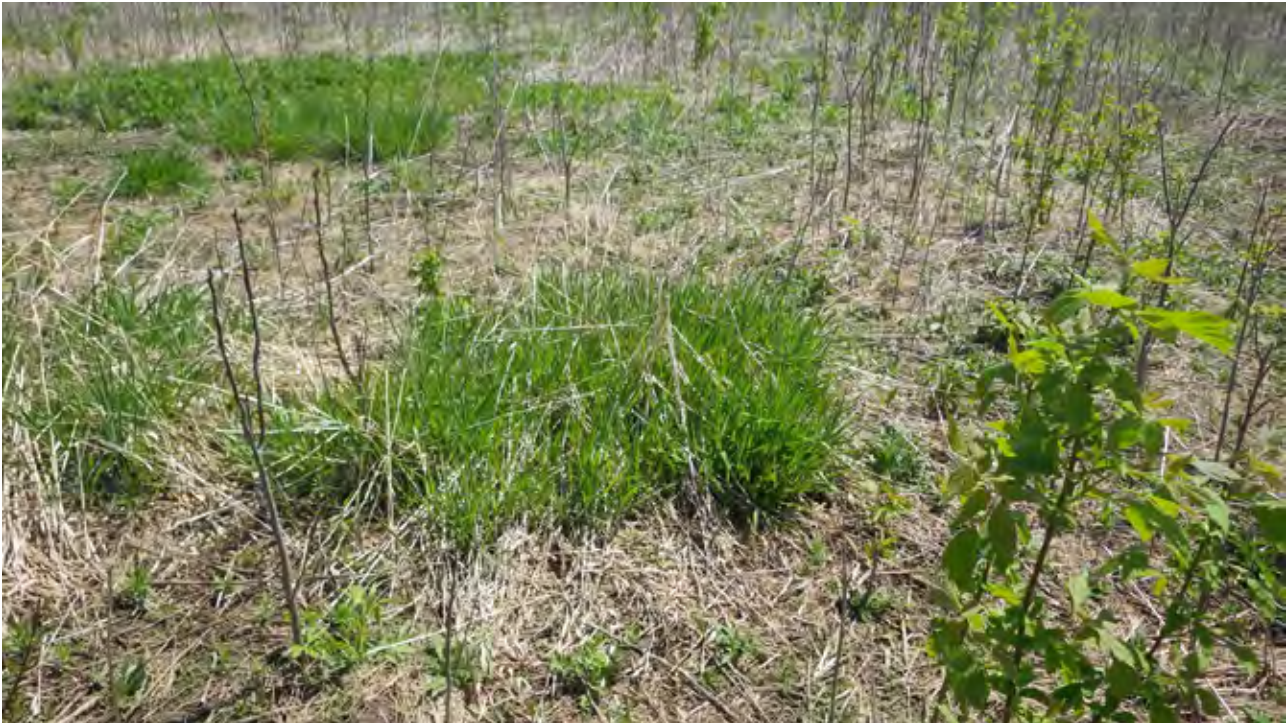
**Photo 10-4** Reed canary grass patches found scattered mostly on west portion of site.

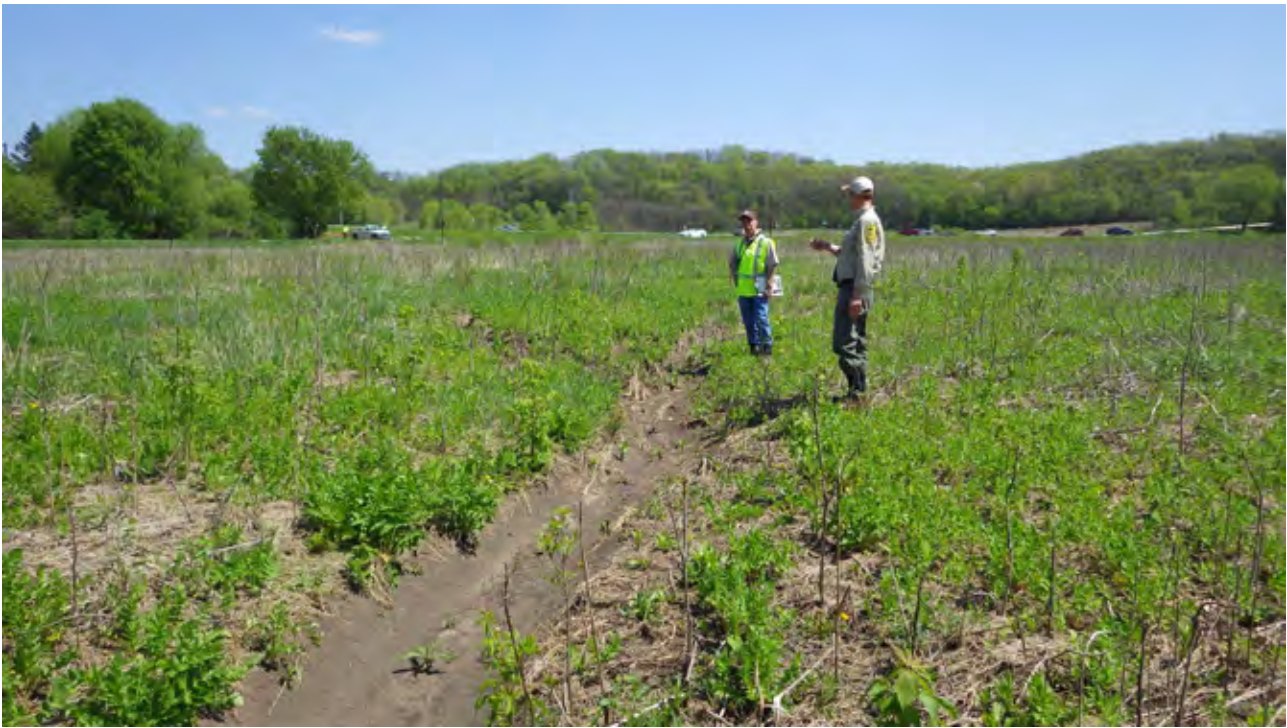
**Photo 10-5** Scour caused by excessive stormwater drainage crossing the west portion of site.

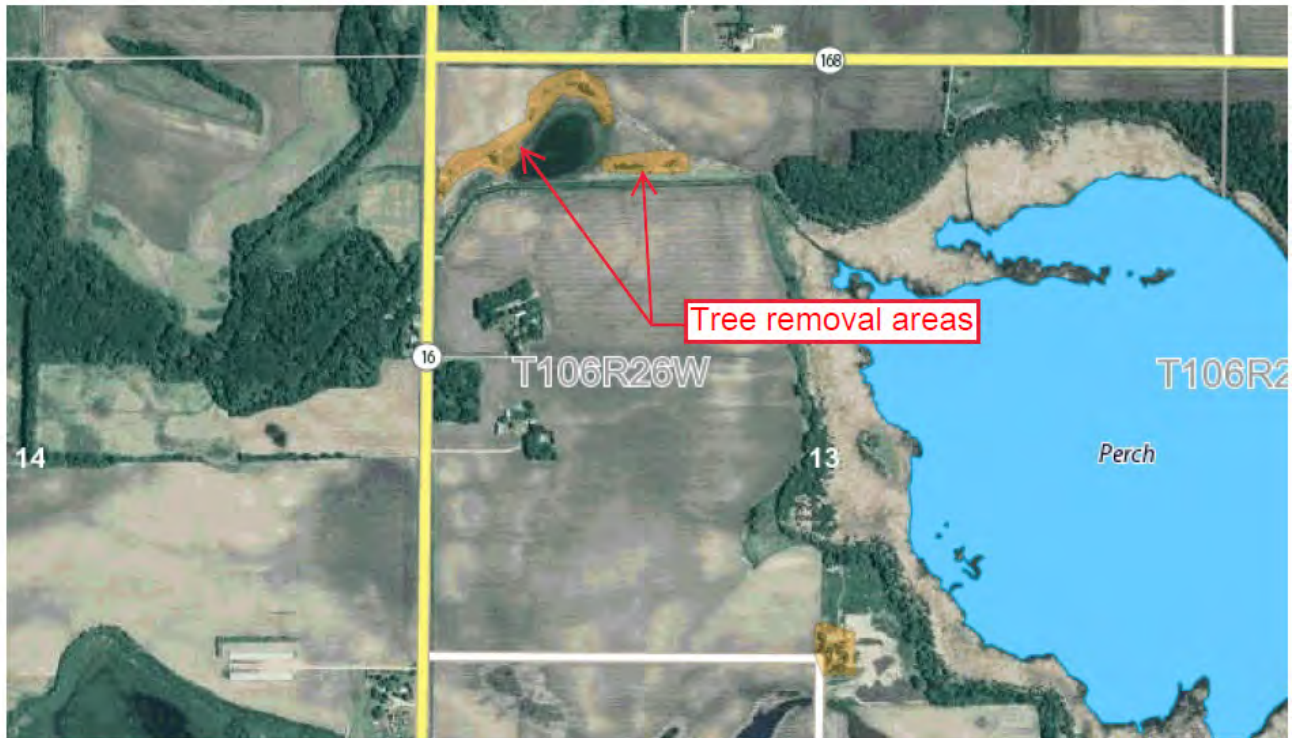
Figure 11-1 Soils map of project area showing approximate wetland fringe tree removal area on

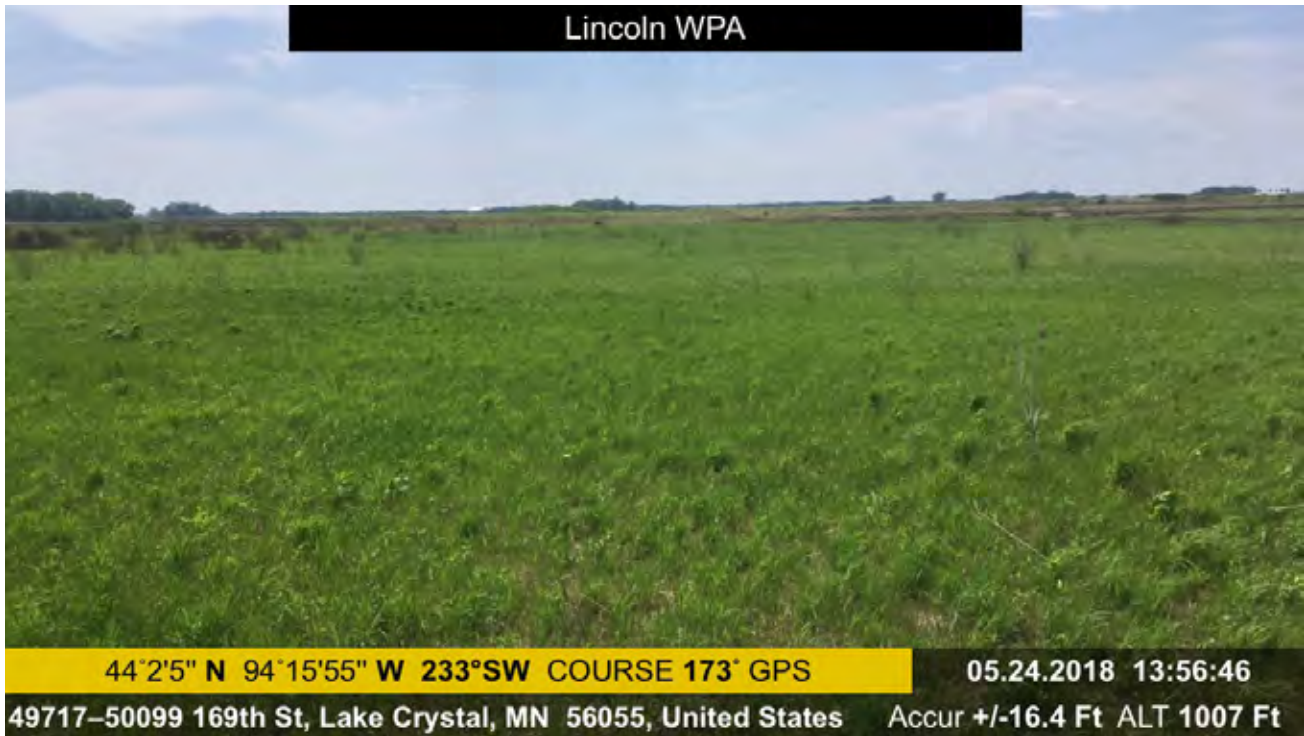
Photo 13-8 South Meixell Unit view, looking south over area burned in spring 2018

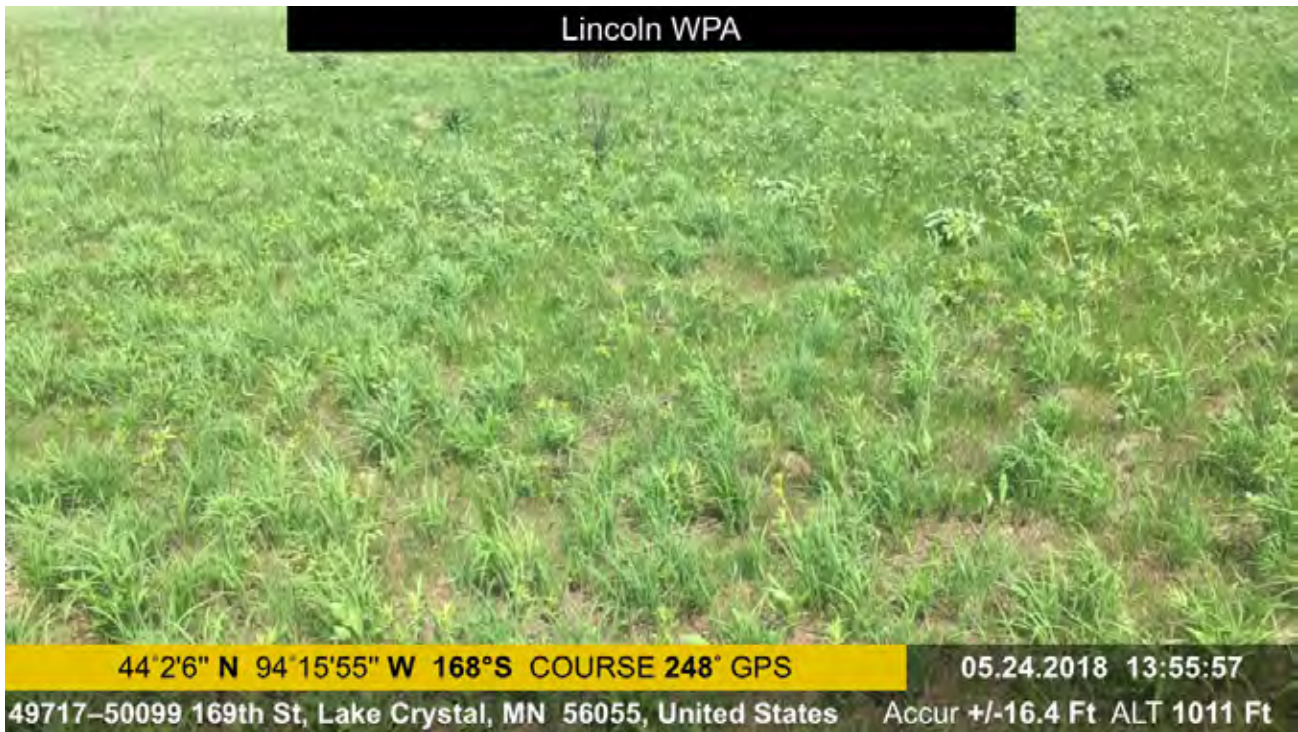
**Photo 13-9** Drier portion of upland prairie, south Meixell Unit burned in spring 2018

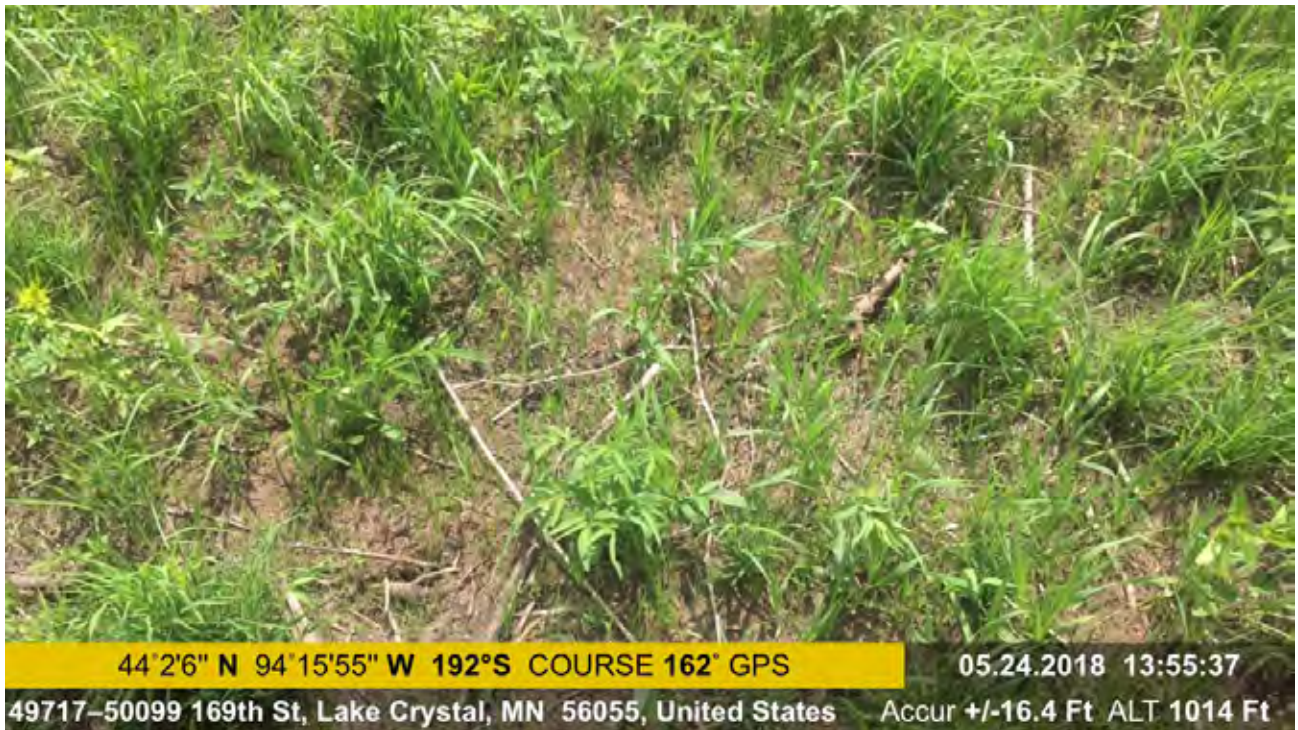
**Photo 13-10** Native plant density is good in drier portion of upland prairie, south Meixell Unit burned in spring 2018

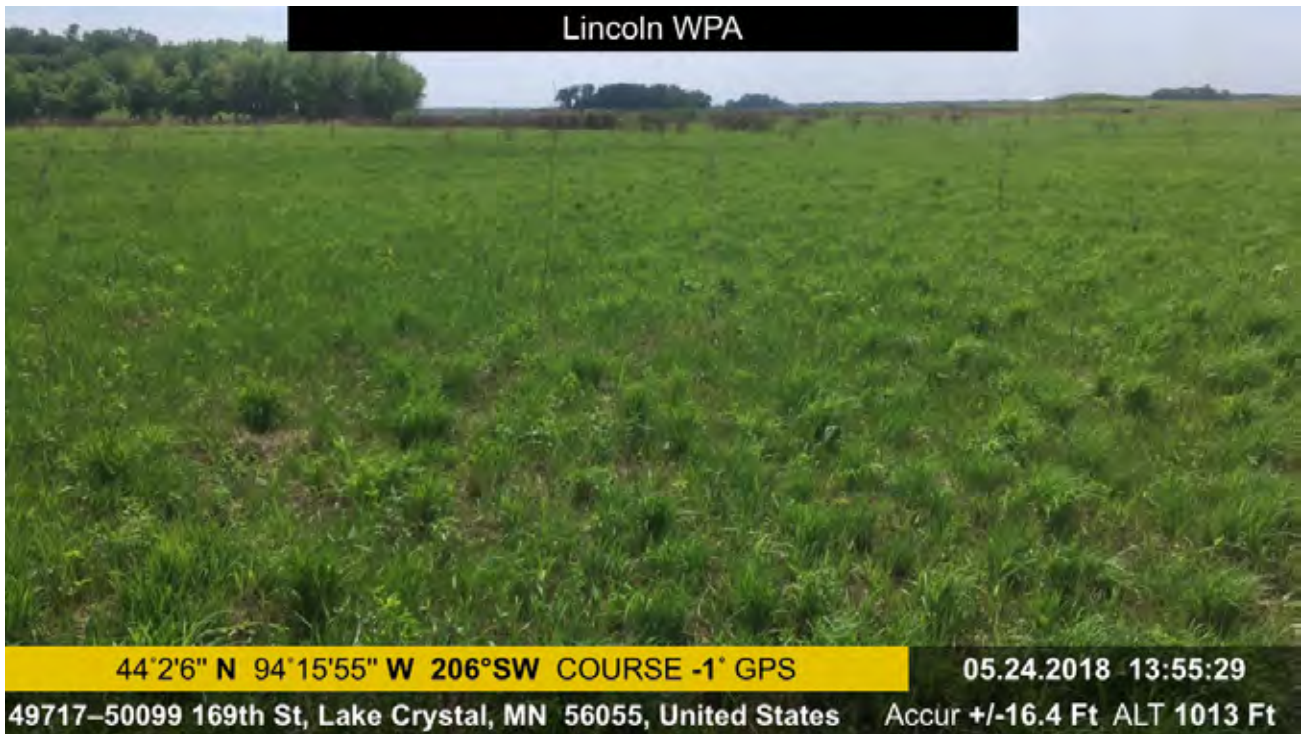
Photo 13-11 Mesic to wet-mesic prairie, south Meixell Unit burned in spring 2018

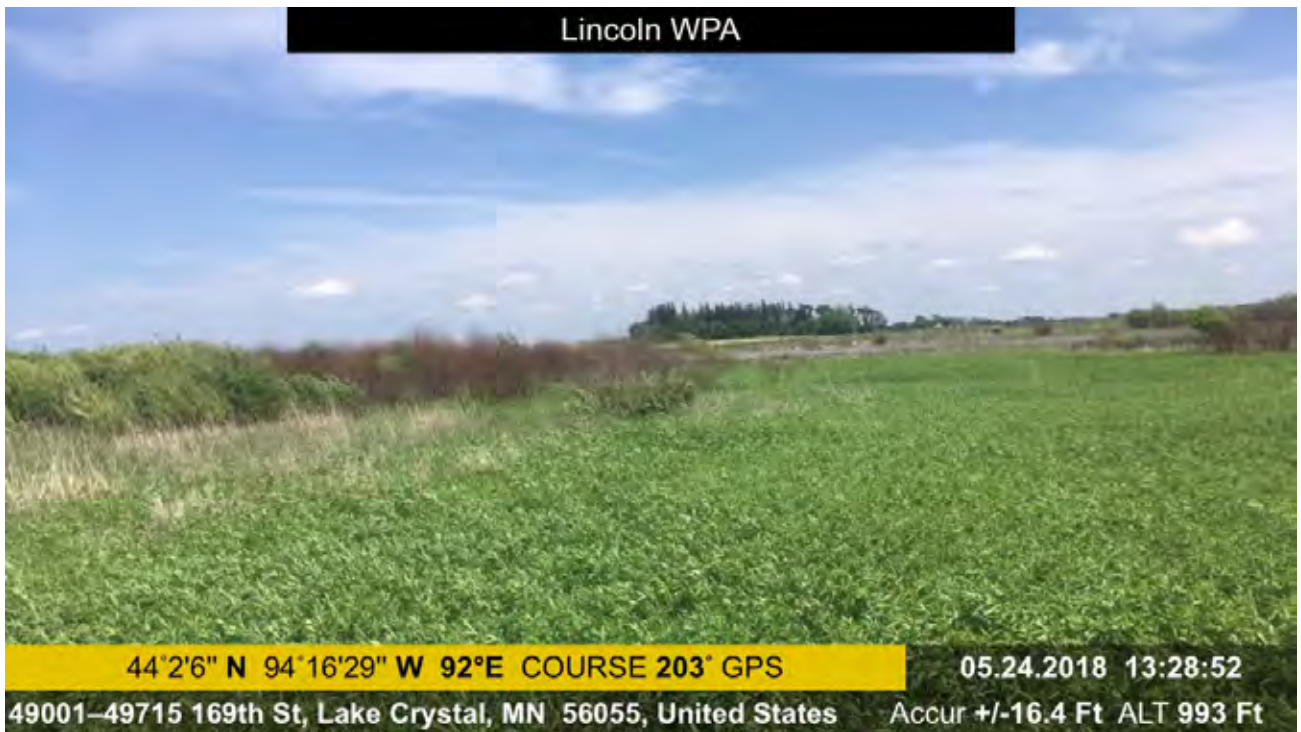
Photo 13-12 Wet meadow, south Meixell Unit burned in spring 2018

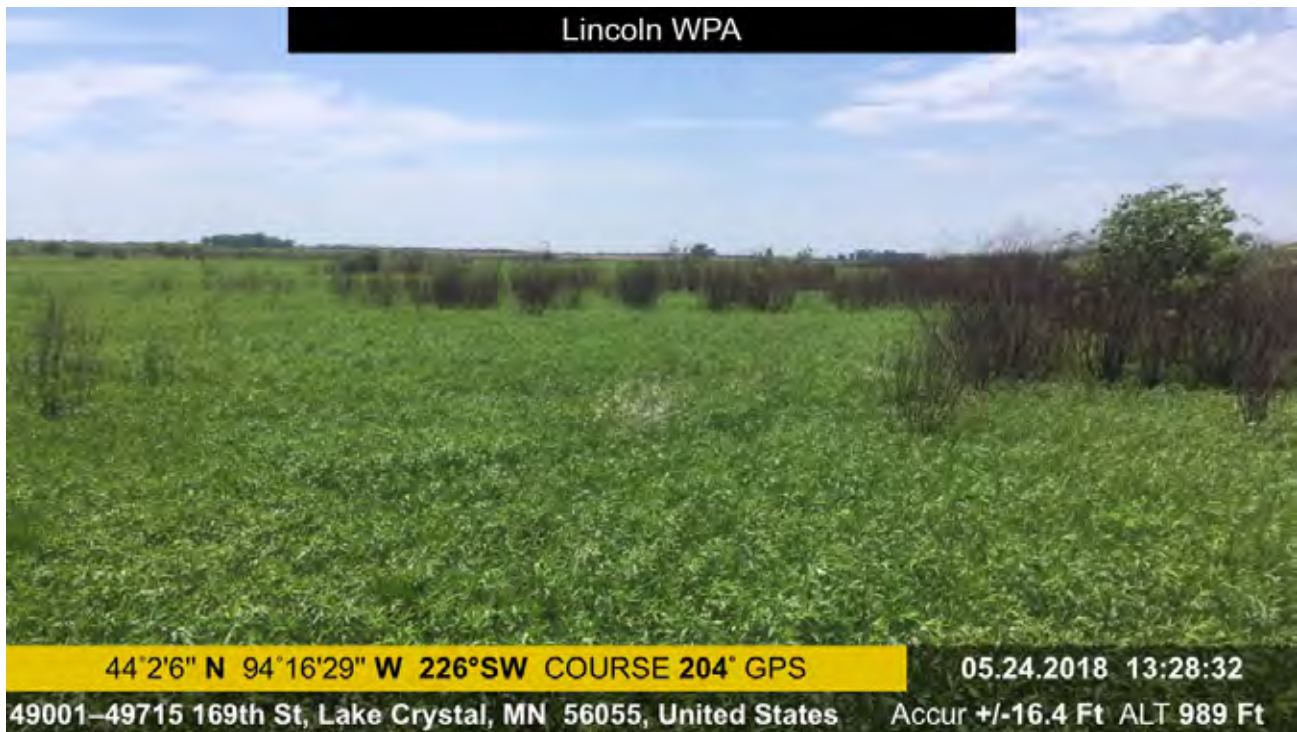
**Photo 13-13** Wet meadow, south Meixell Unit burned in spring 2018

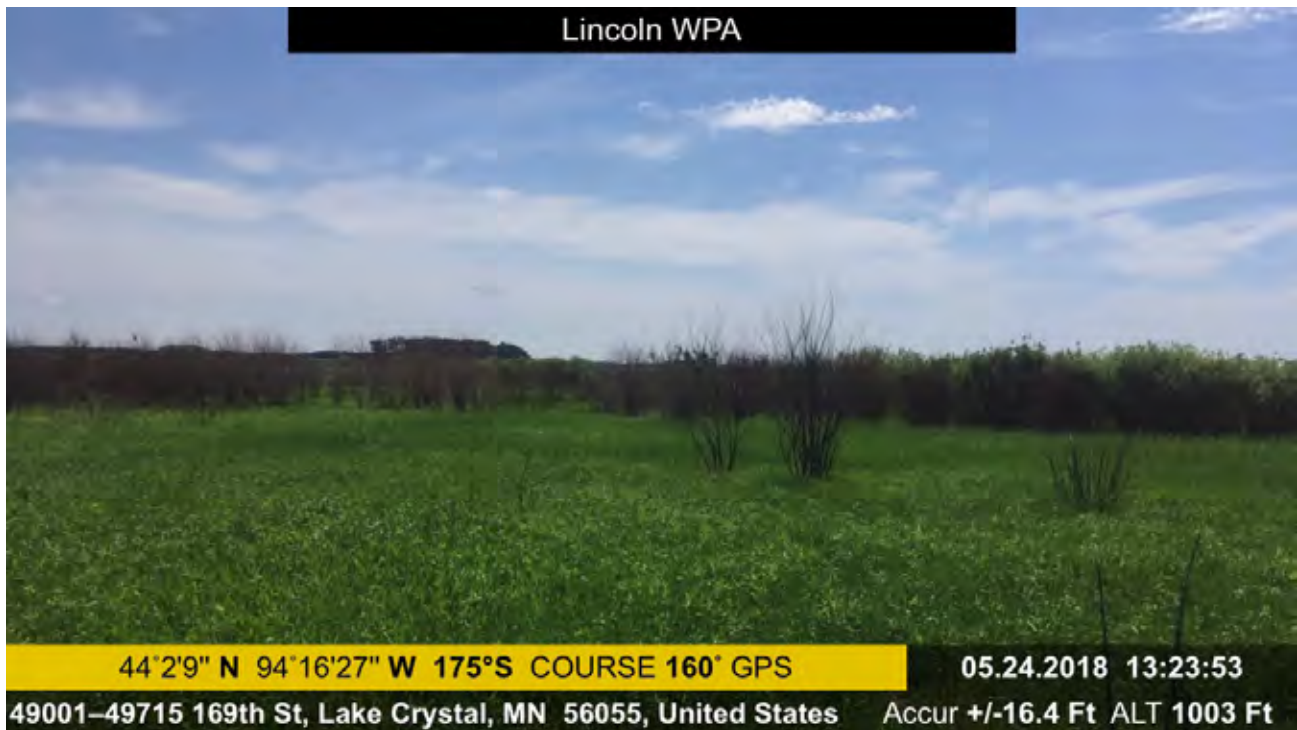
**Photo 13-14** Wet meadow, south Meixell Unit burned in spring 2018
