**Minnesota Department of Natural Resources**  
**Minnesota Board of Water and Soil Resources**

## **Project Evaluations**

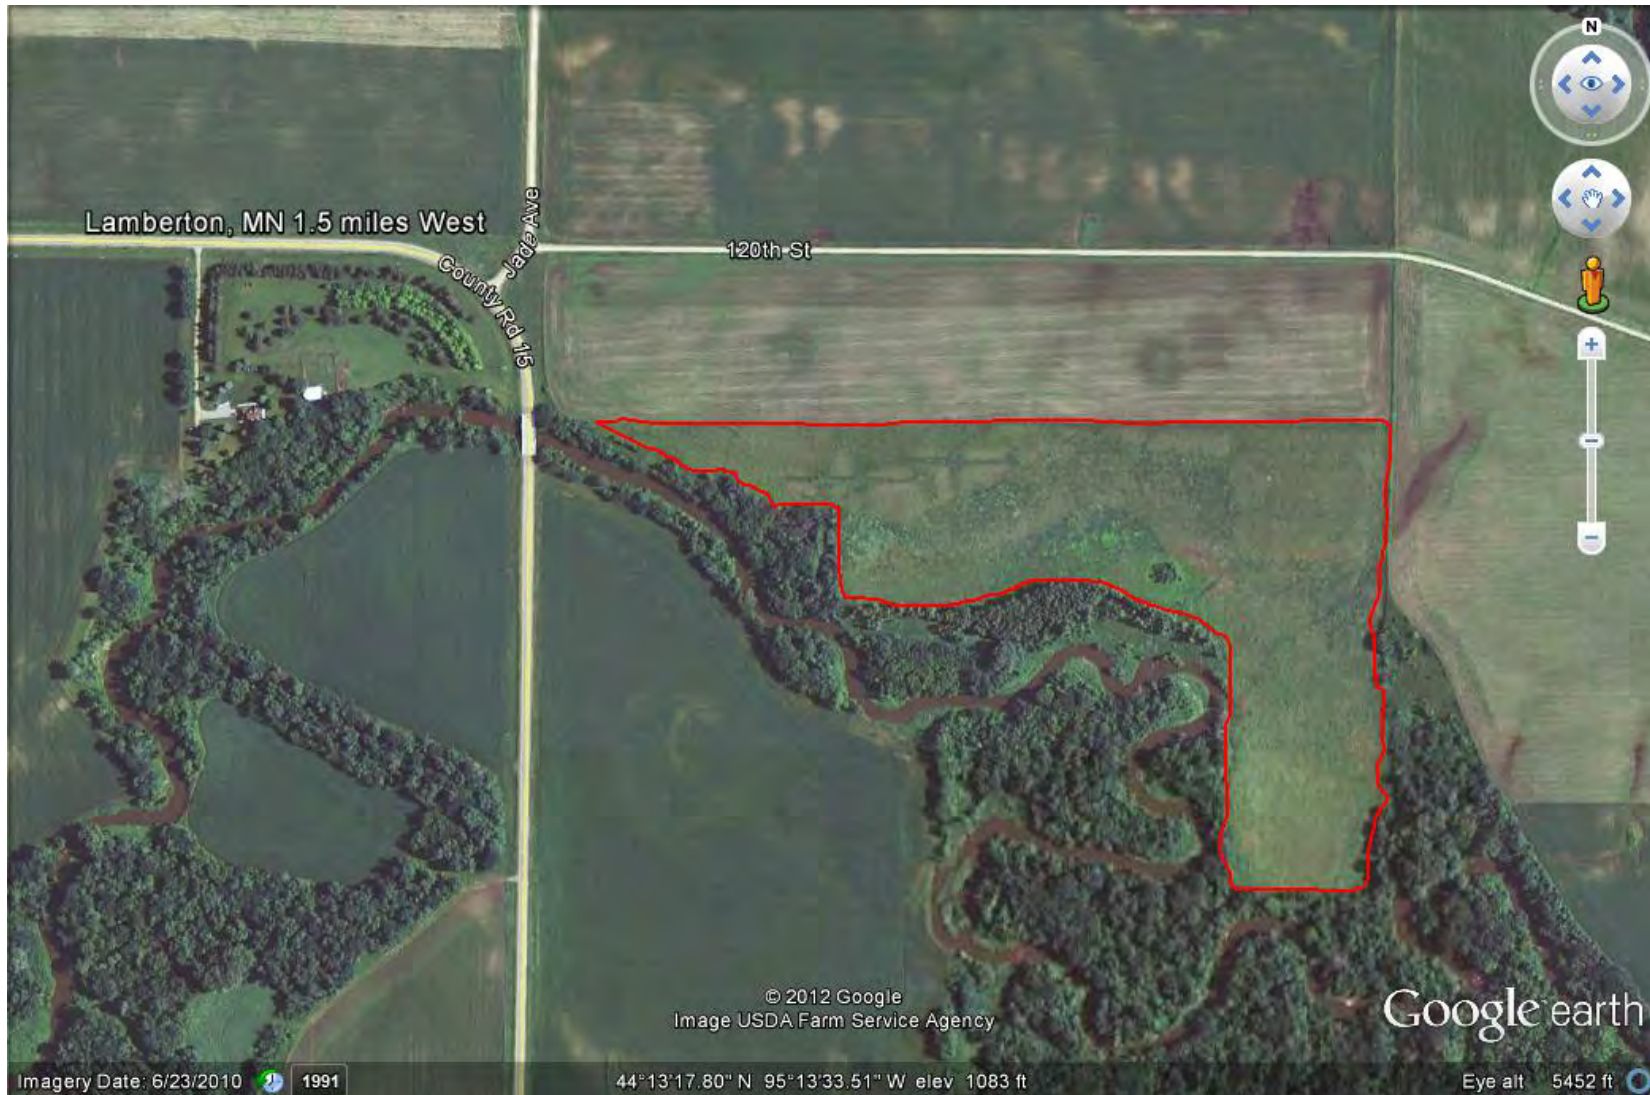
Figure 14-1 Location of prescribed burn and forb enrichment seeding (Source: MN DNR).

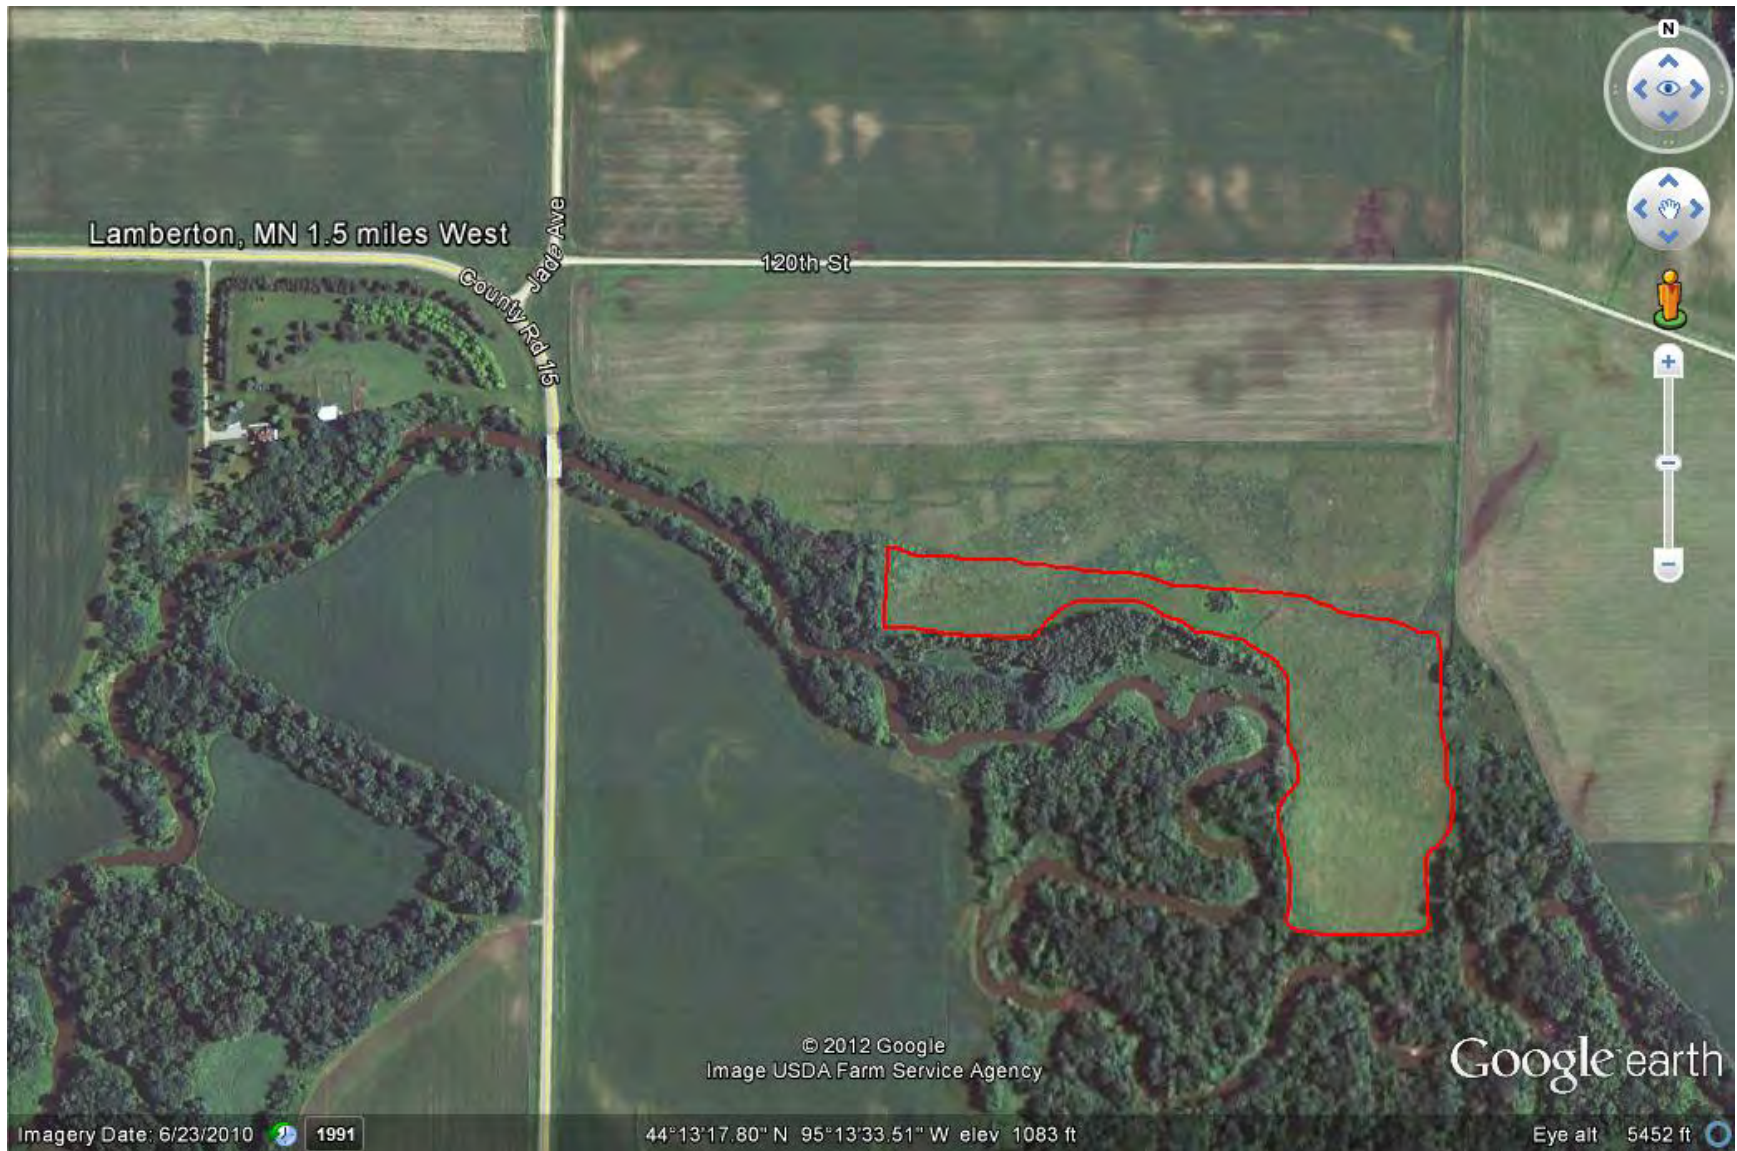
Figure 14-2 Tree and shrub seedling installation location.

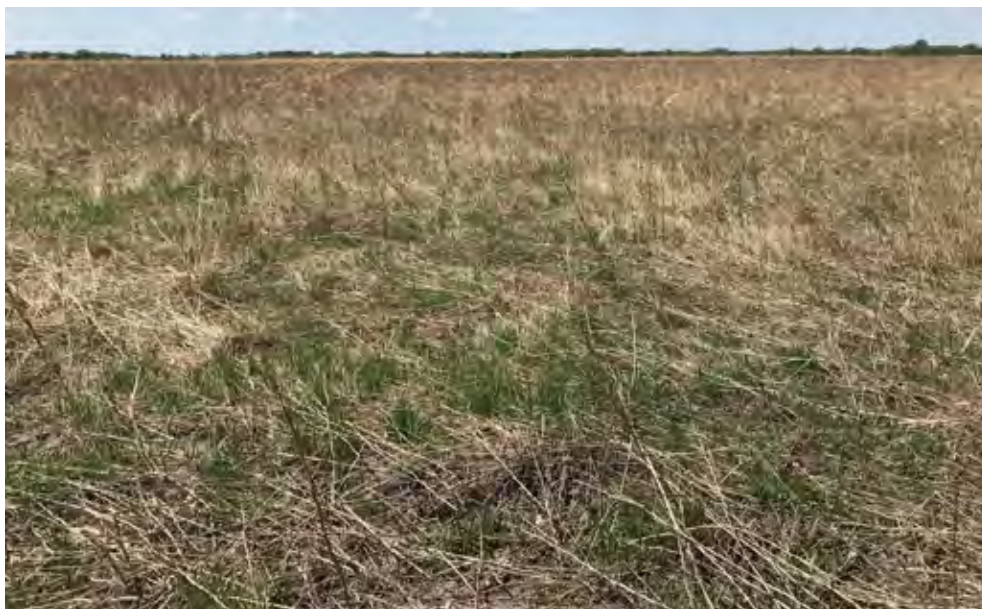
**Photo 17-1** Prairie restoration at Artichoke Lake WPA. View from the northeast corner looking southwest. Photo was taken May 16, 2018.

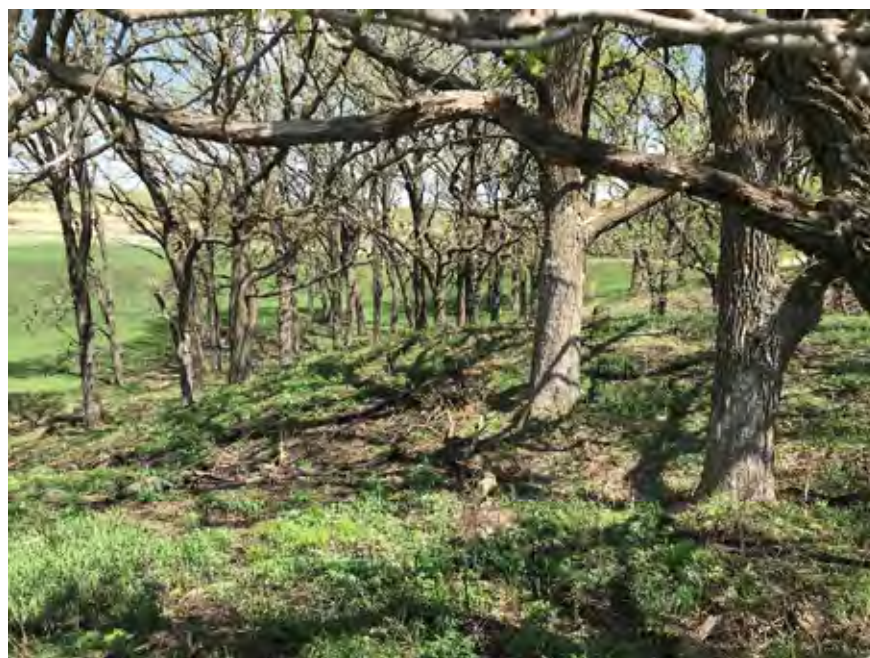
**Photo 18-1** North slope in Unit B with bur oak canopy and patchy herbaceous layer. Photo was taken May 16, 2018, about two weeks after a prescribed burn.

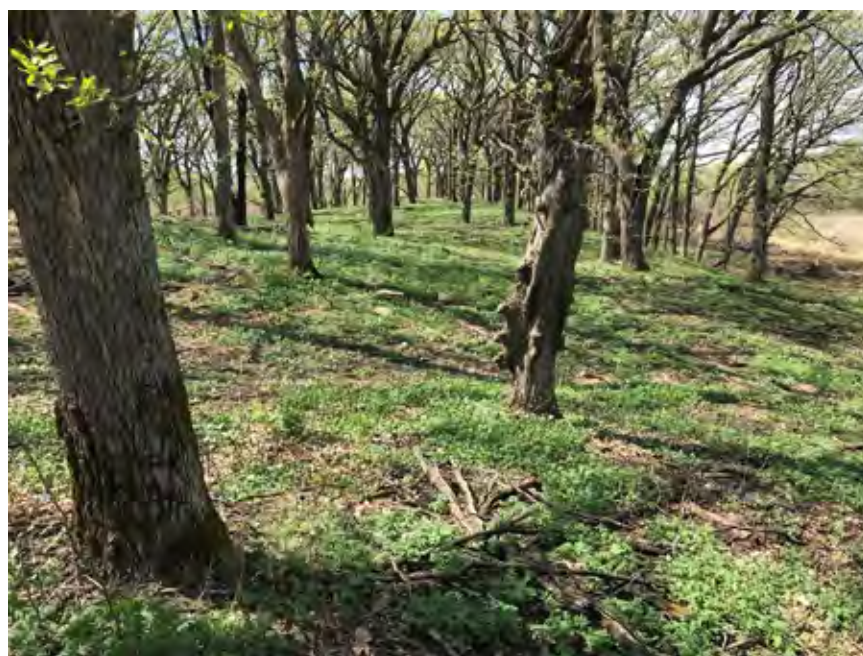
**Photo 18-2** Bur oak canopy and example of nearly continuous native herbaceous layer cover along a ridgeline in Unit B. Photo was taken May 16, 2018, about two weeks after a prescribed burn.

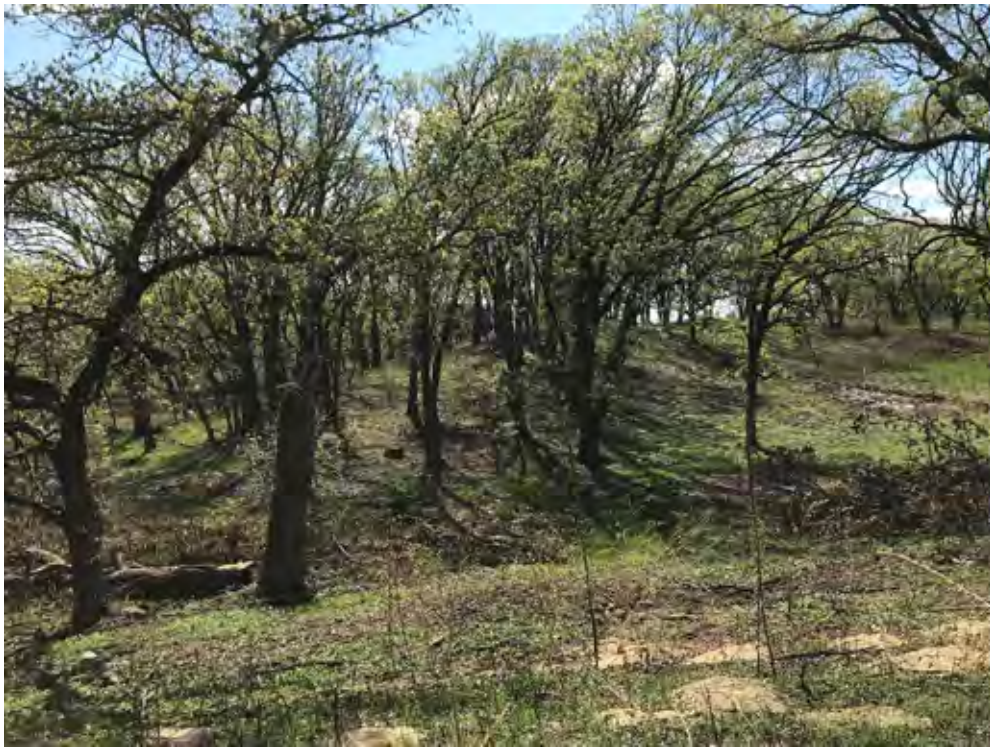
**Photo 18-3** View west across the west end of Unit B. Photo was taken May 16, 2018, about two weeks after a prescribed burn.

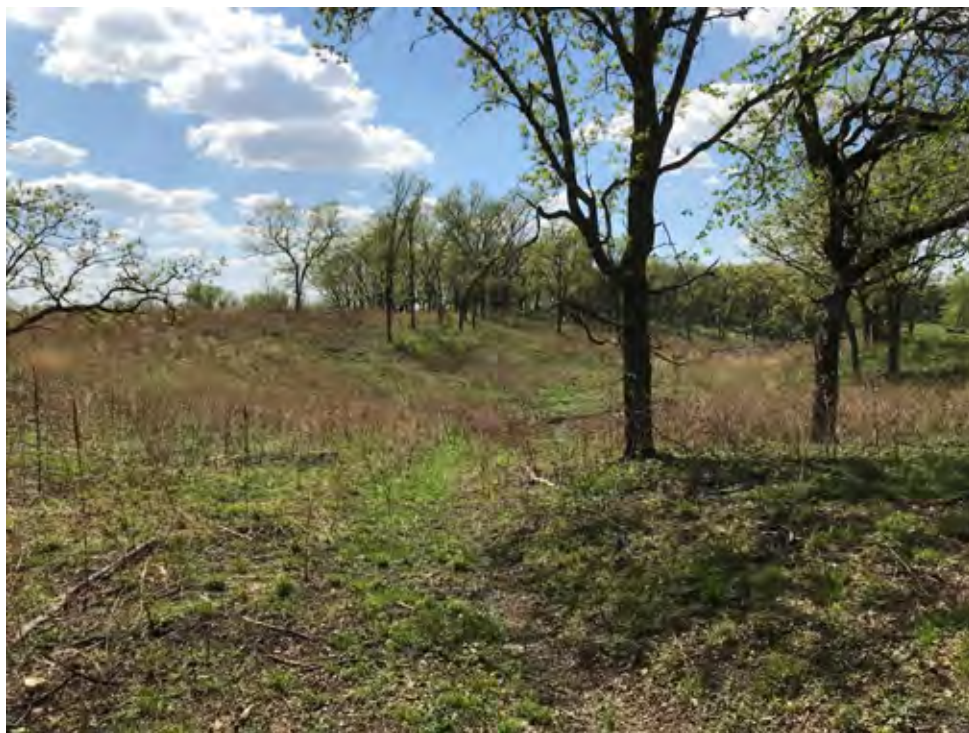
**Photo 18-4** View west across a valley in Unit A. Burdock fruiting stems from 2017 are dense throughout. Photo taken May 16, 2018, about two weeks after a prescribed burn.

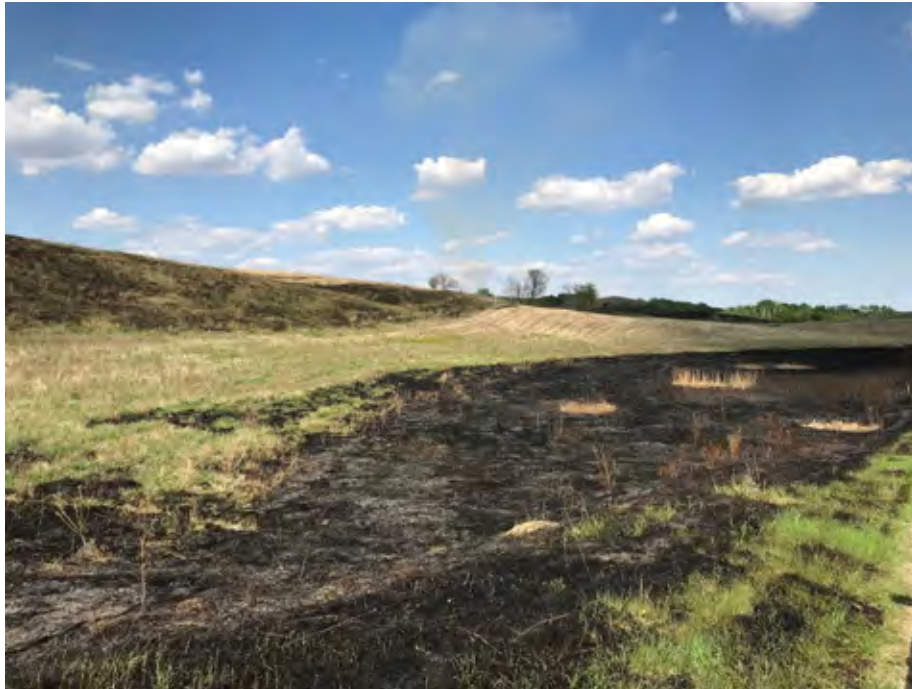
**Photo 19-1** View west across the prairie restoration showing a recently burned portion of the prairie restoration. Photo taken May 16, 2018.

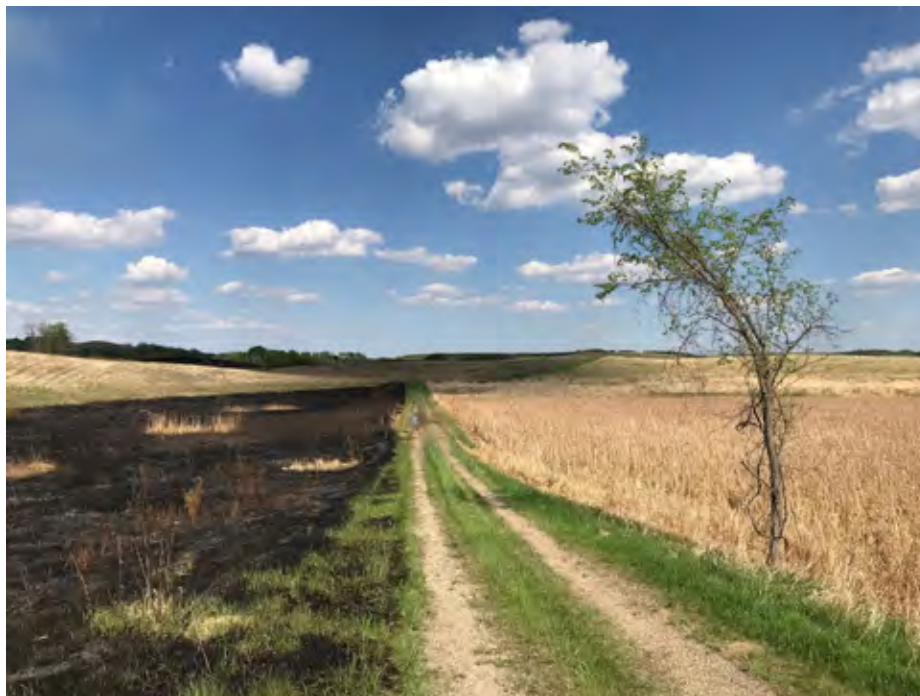
**Photo 19-2** View west across the prairie restoration showing a recently burned portion of the prairie restoration at left. Photo taken May 16, 2018.

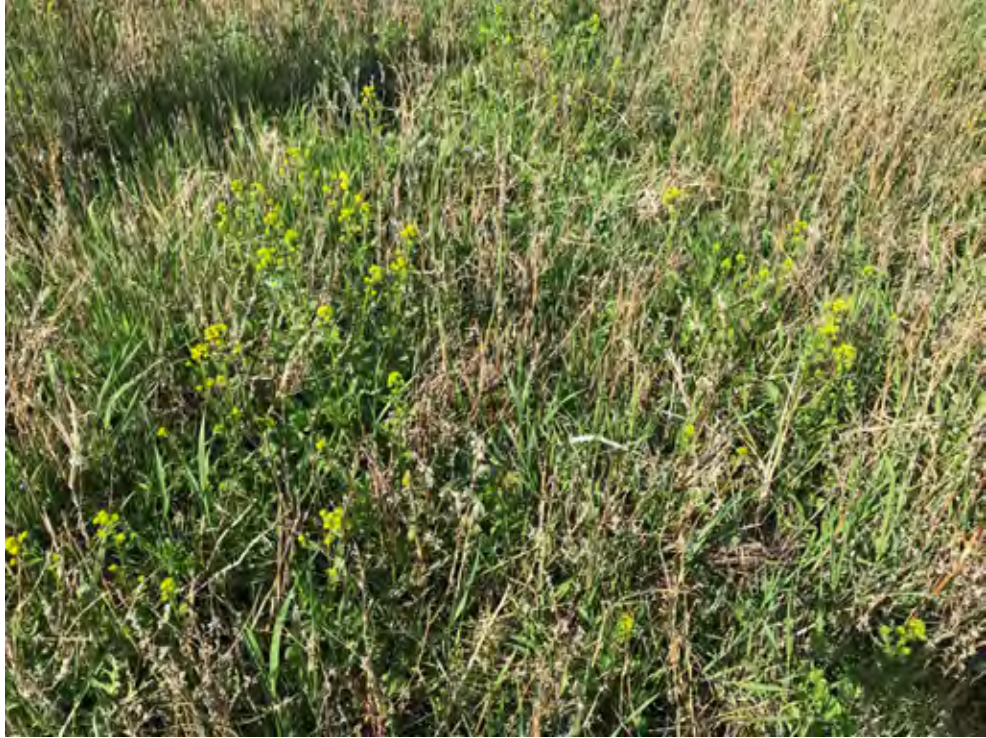
**Photo 19-3** Example vegetation cover in a portion of the south field of the restoration that did not burn. Photo take May 16, 2018.

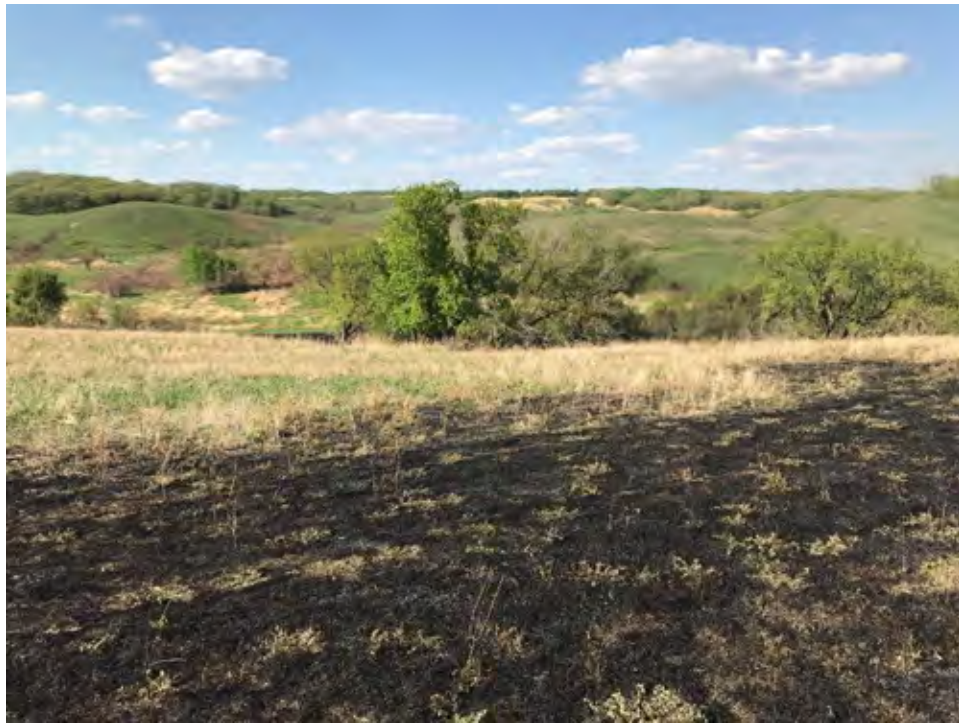
**Photo 19-4** View towards the northeast of burned and unburned portions in the north field of the prairie restoration on May 16, 2018.

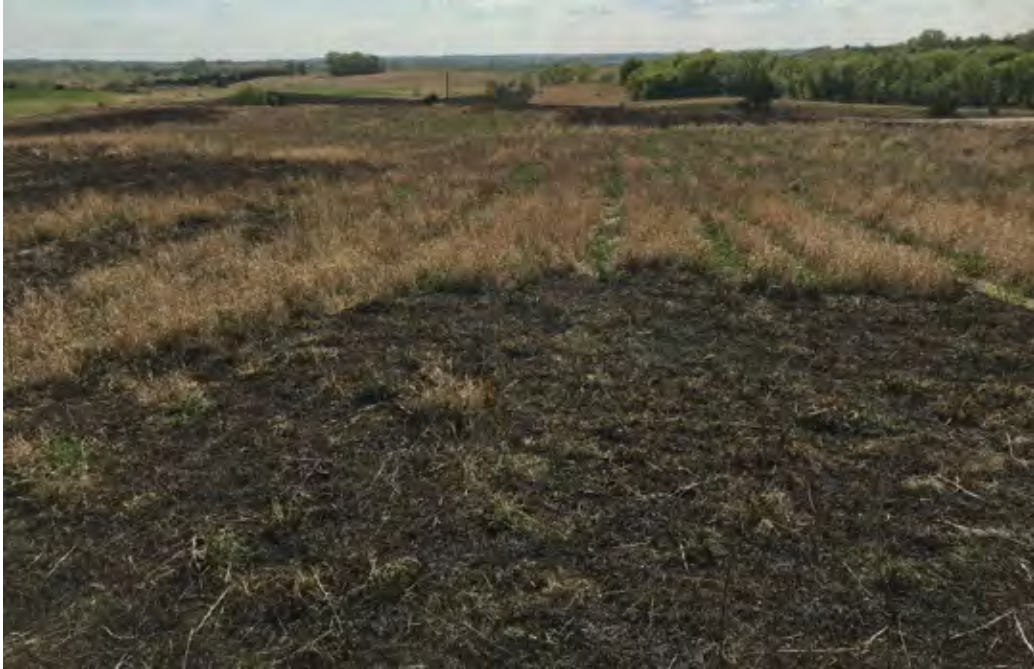
**Photo 19-5** View towards the west of burned and unburned portions in the north field of the prairie restoration on May 16, 2018.

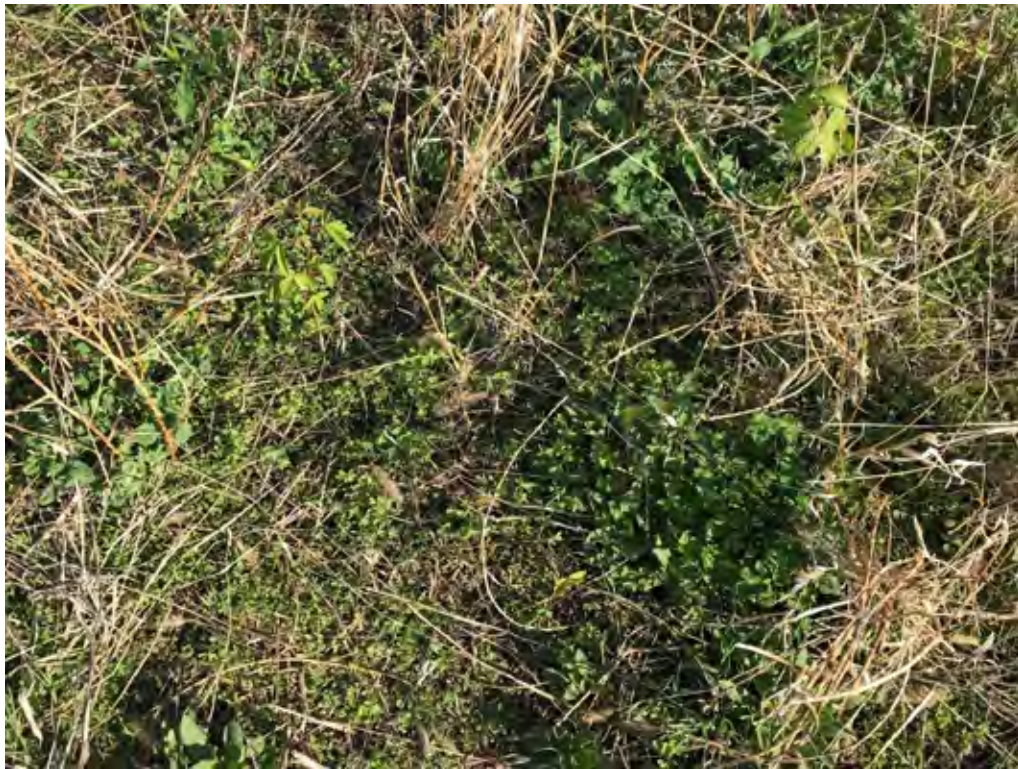
**Photo 19-6** Example vegetation cover in the north field of the prairie restoration on May 16, 2018.

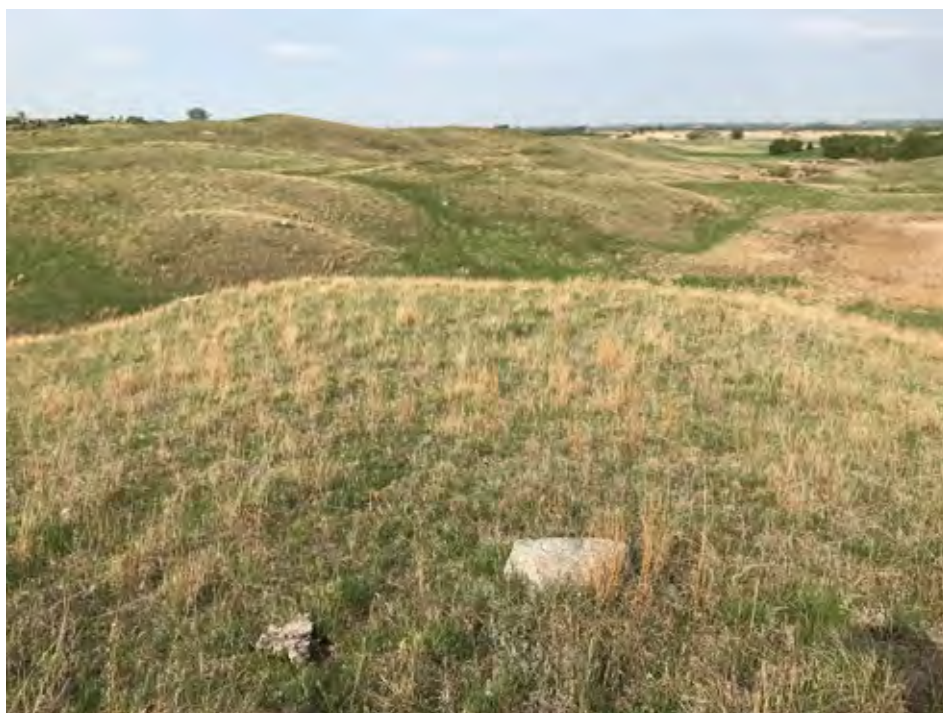
**Photo 21-1** Landscape photo of the woody removal area at the Stadsvold USFWS conservation easement. Photo taken on May 17, 2018.

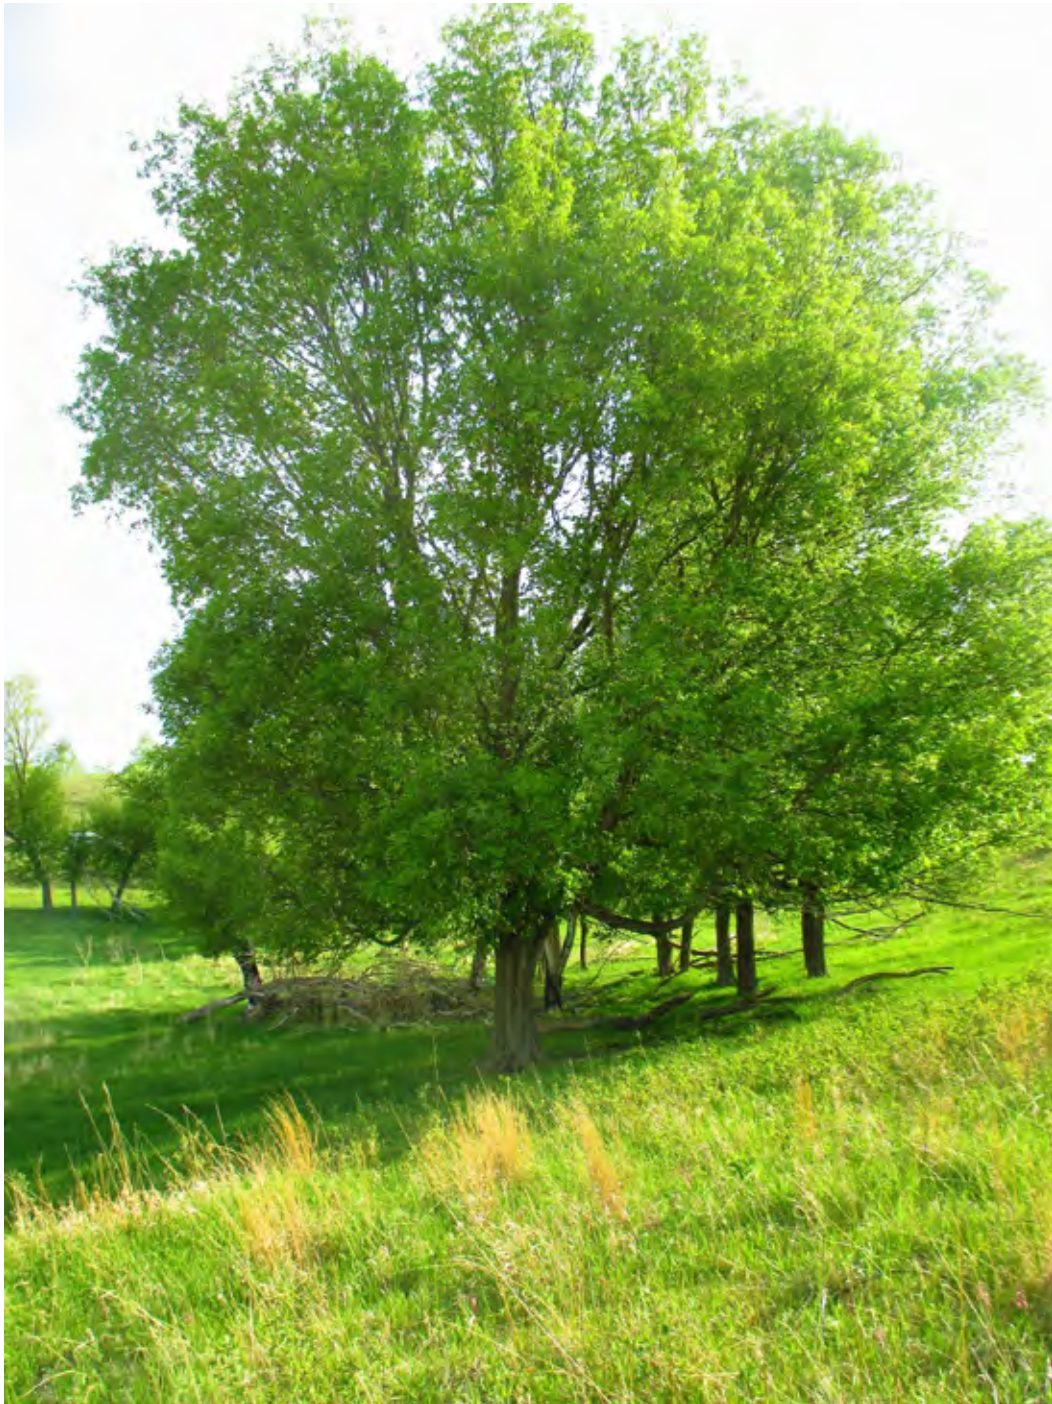
**Photo 21-3** Boxelder trees left on north east corner of the easement. The project manager noted that the property owner indicated they would be open to discussing removal if seedling recruitment became an issue in the future.

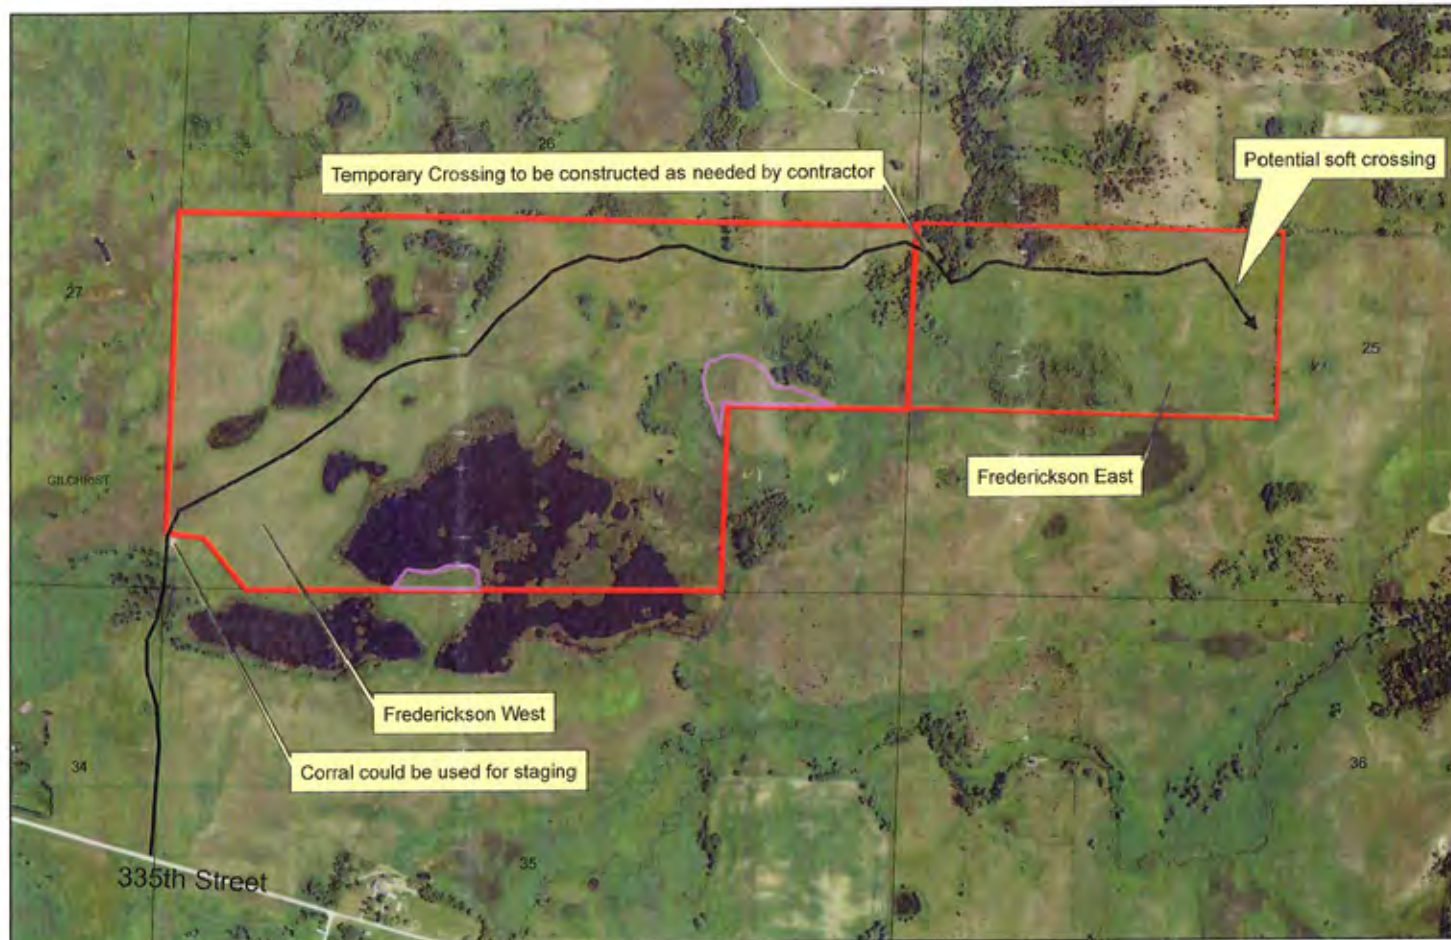
Ordway WLI Proposed Invasive Tree Removal (red boundaries) -Frederickson East and West

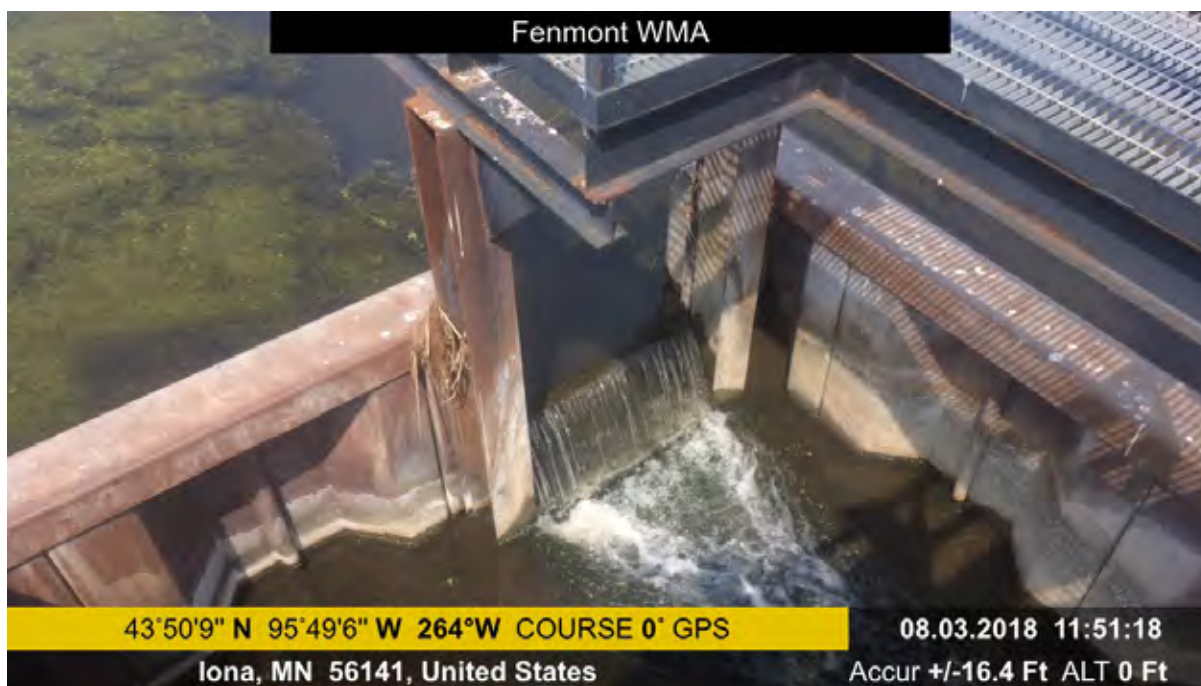
**Photo 23-1** View of control structure with sheet piling and stop log structure. Most stoplogs were removed at the time of the field visit to mimic a summer drawdown intended to stimulate vegetation in mud flat conditions.

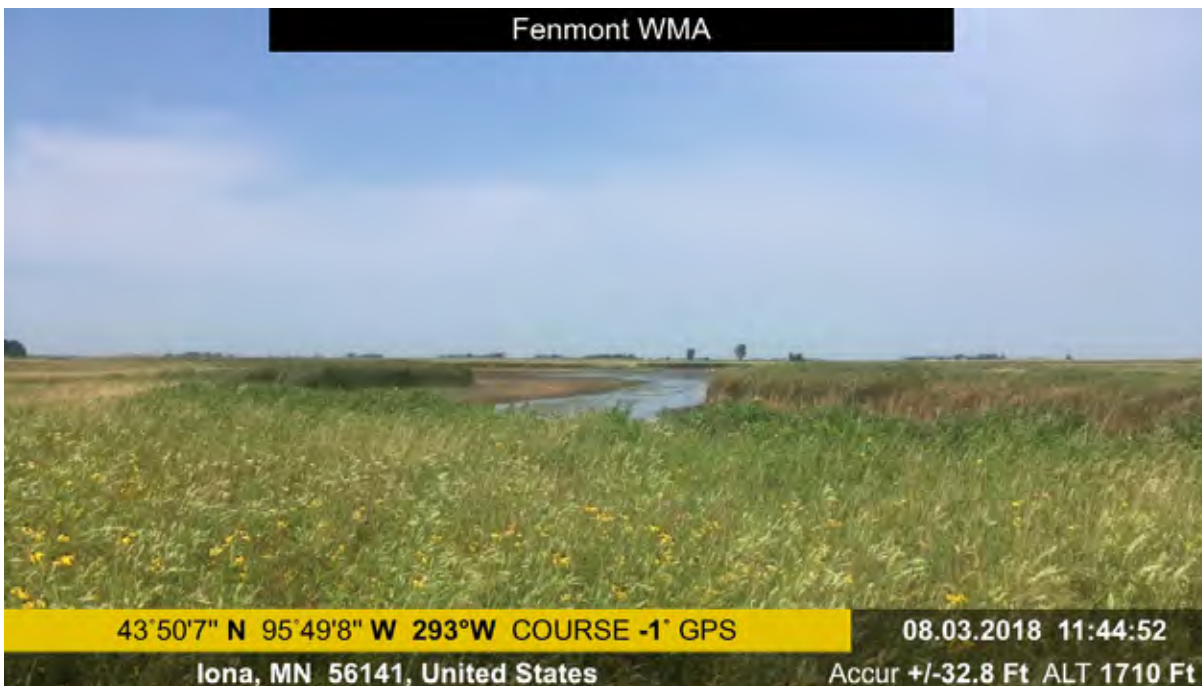
**Photo 23-2** View looking northwest from the berm near the wetland outlet structure, showing the wetland during draw down condition.

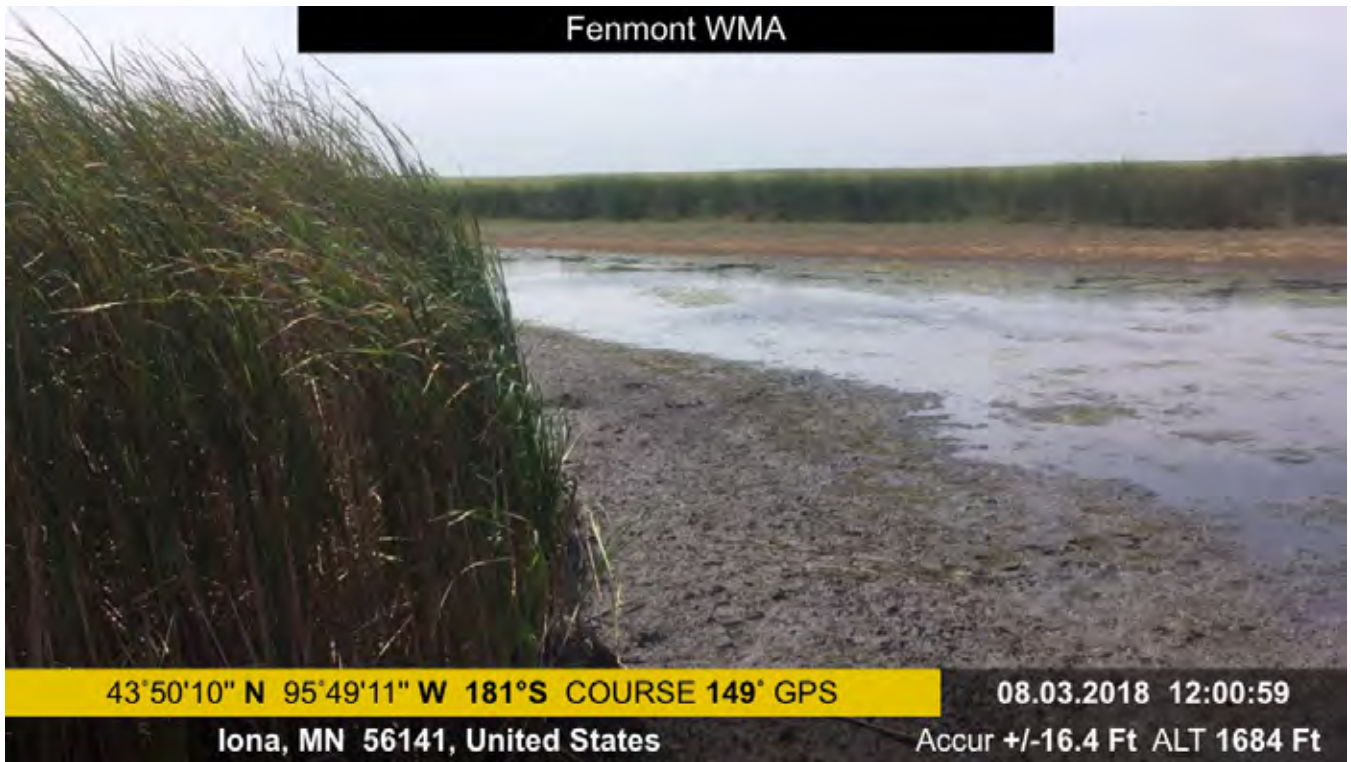
Photo 23-3 View of mudflat looking southeast toward wetland outlet.

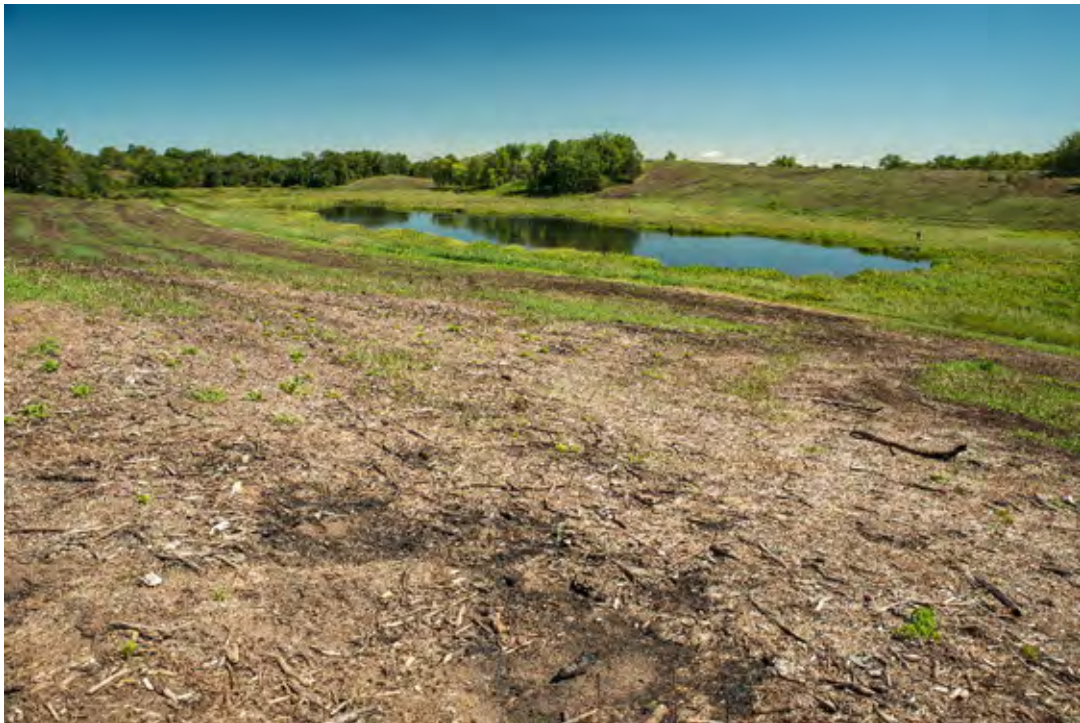
**Photo 25-3** Ferrian site in August 2015 after herbicide application and prescribed burn for site prep. Photo taken 8/20/2015.

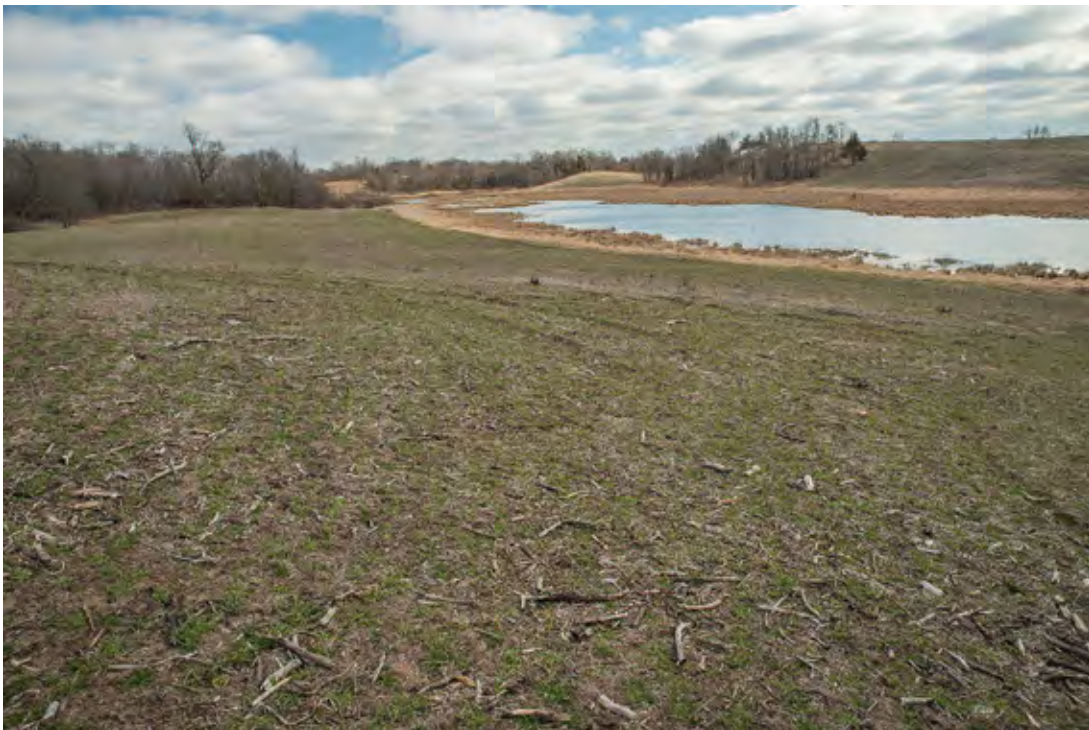
**Photo 25-4** Ferrian site in April 2016. The site had been drill seeded the previous fall. Photo taken 4/10/2016.

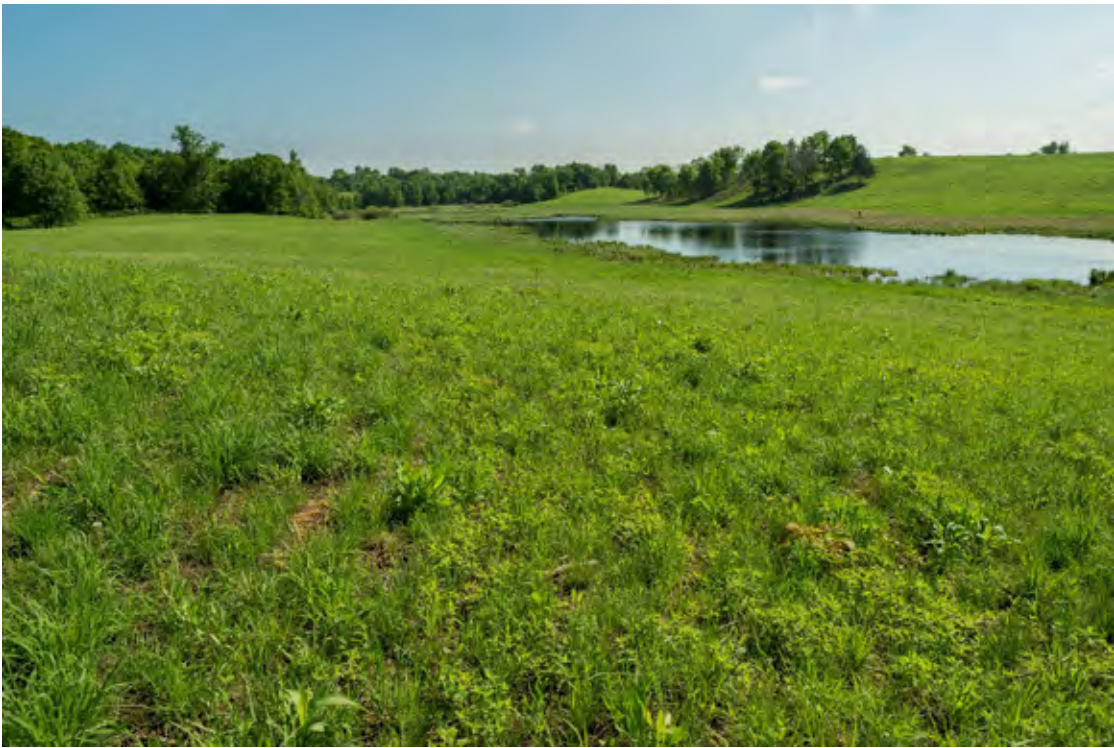
**Photo 25-9** Ferrian site June 2018. Now that the vegetation has been established the site will be incorporated into a burn cycle. Photo taken 5/30/2018.

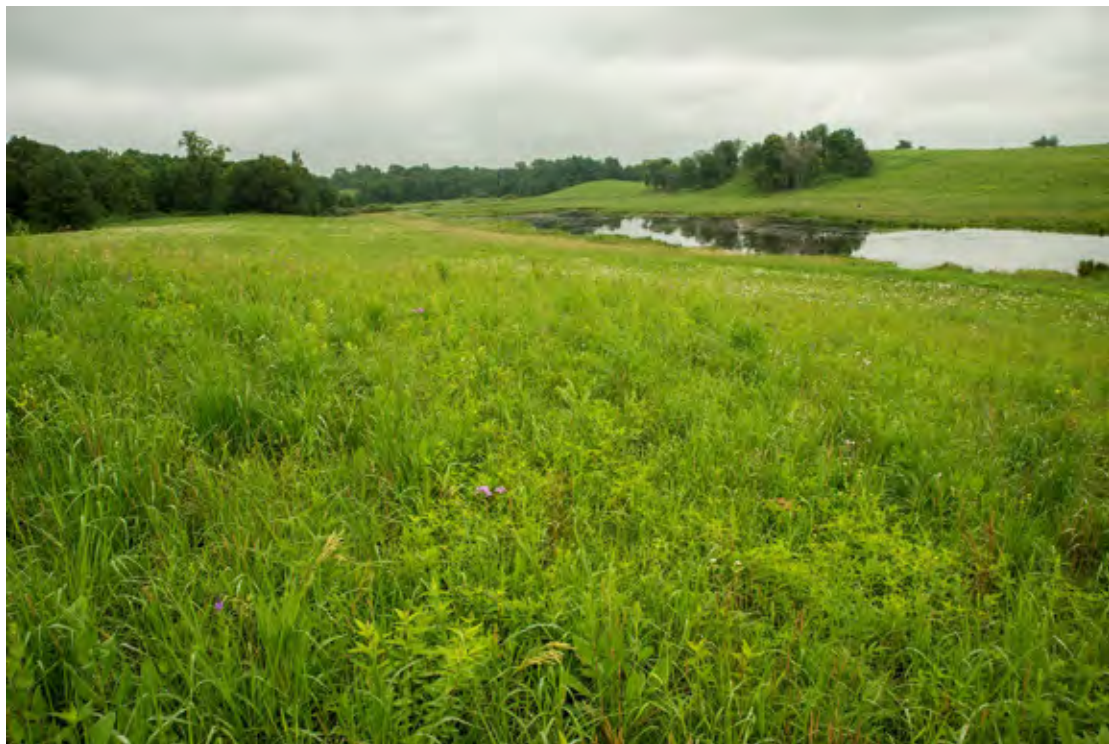
**Photo 25-10** Ferrian site July 2018. Photo taken 6/26/2018.

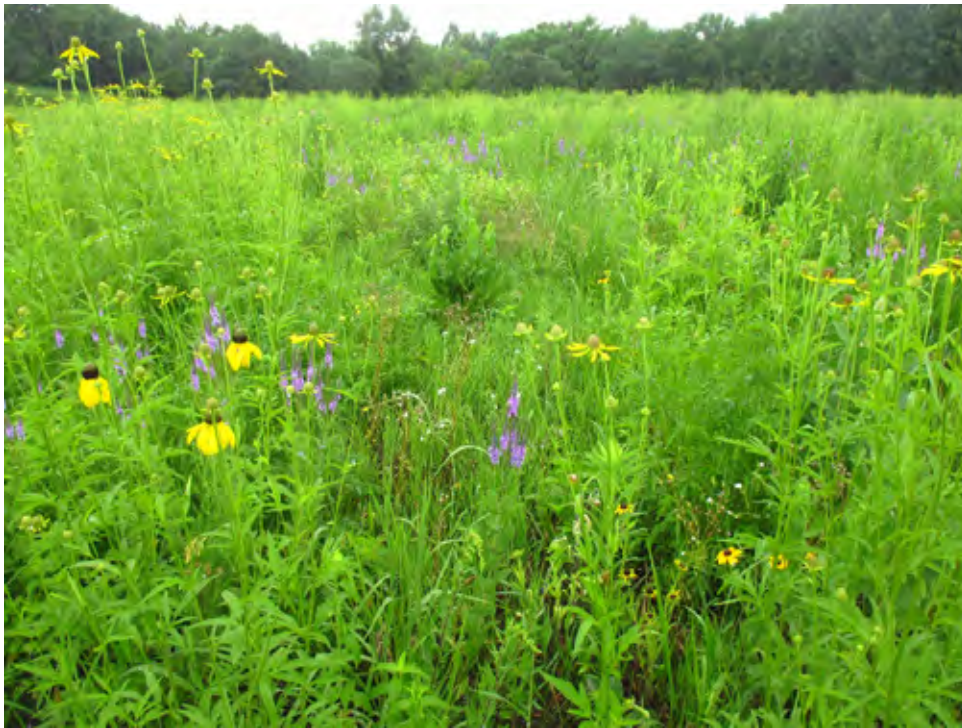
**Photo 25-11** Well established forb and grass mix growing after spring burn at the meander site in the west unit of the prairie complex. Photo taken 7/3/2018.

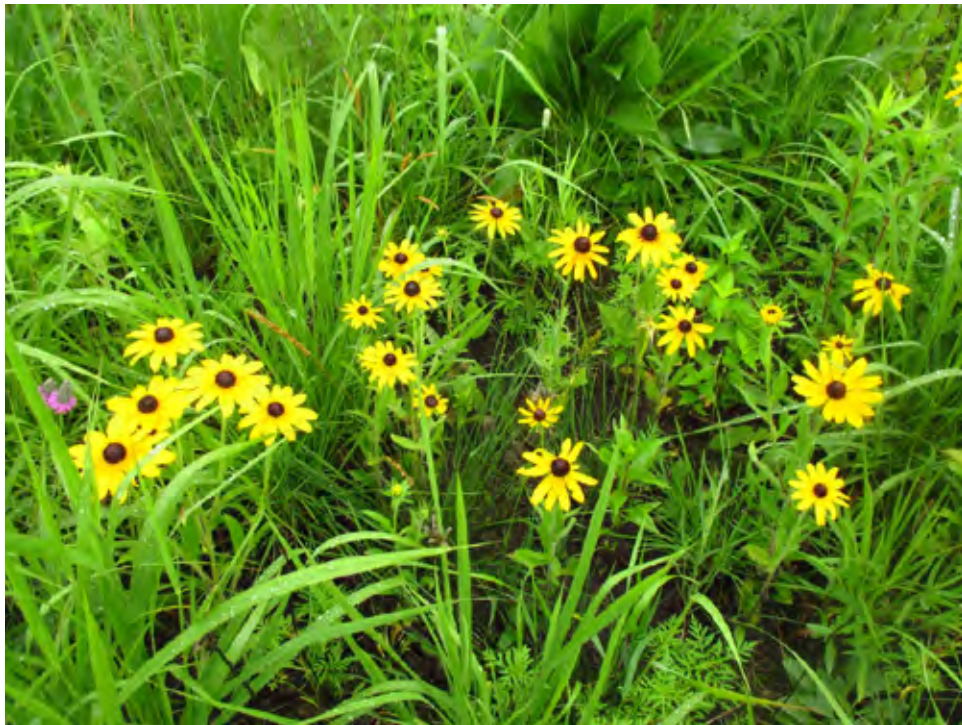
**Photo 25-12** Forb and grass mix growing over patches of bare ground and emerging seedlings at the meander site in the west unit of the prairie complex. Photo taken 7/3/2018.
