**Minnesota Department of Natural Resources**  
**Minnesota Board of Water and Soil Resources**

## **Project Evaluations**

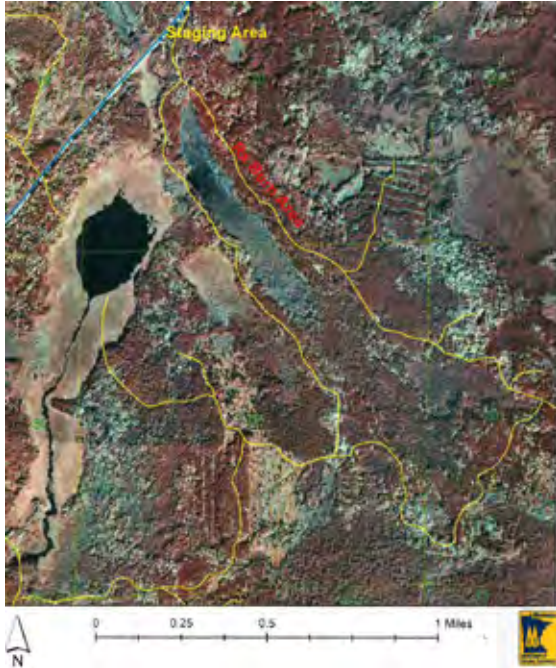
Study area: 27 acres of FDn33 in Chippewa Plains subsection. Harvest and burn treatments were applied to 10 acres. An unburned control area was established.

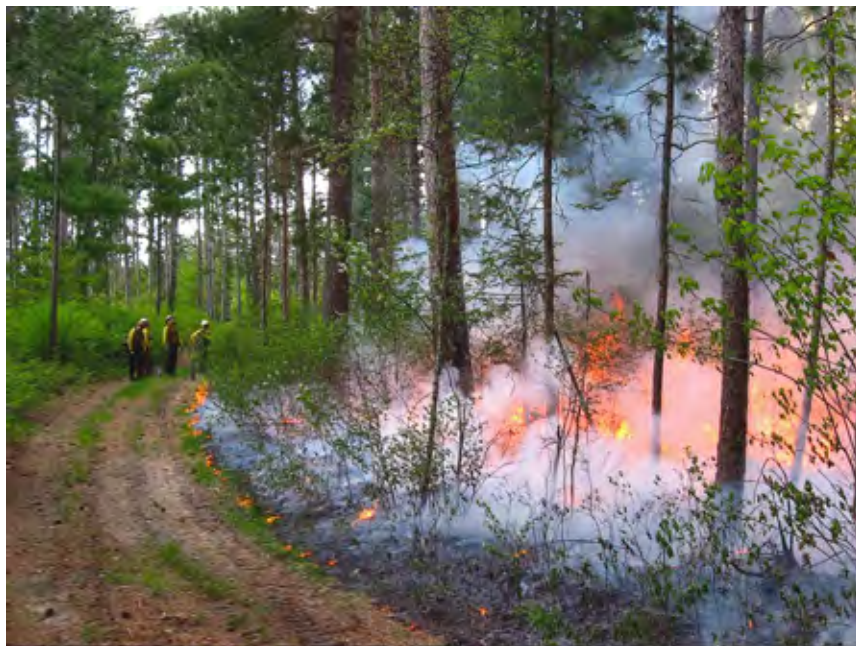
**Figure 28-3** A photo provided by MN DNR taken during the prescribed burn at either Unit 1 or Unit 2 in 2013.

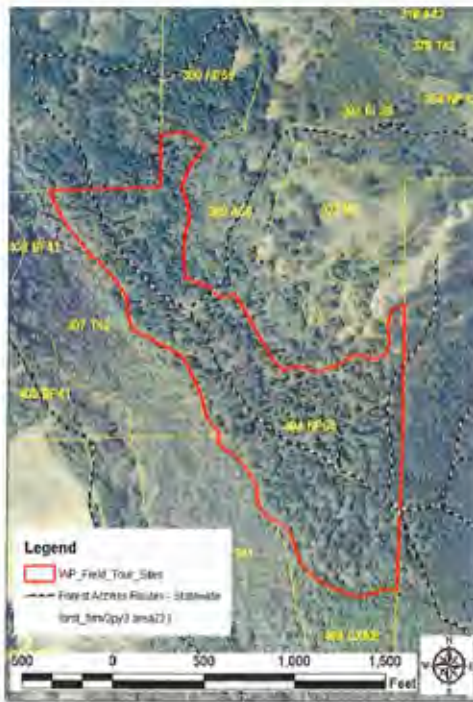
**Site 1 AFMP Prescribed Burn**

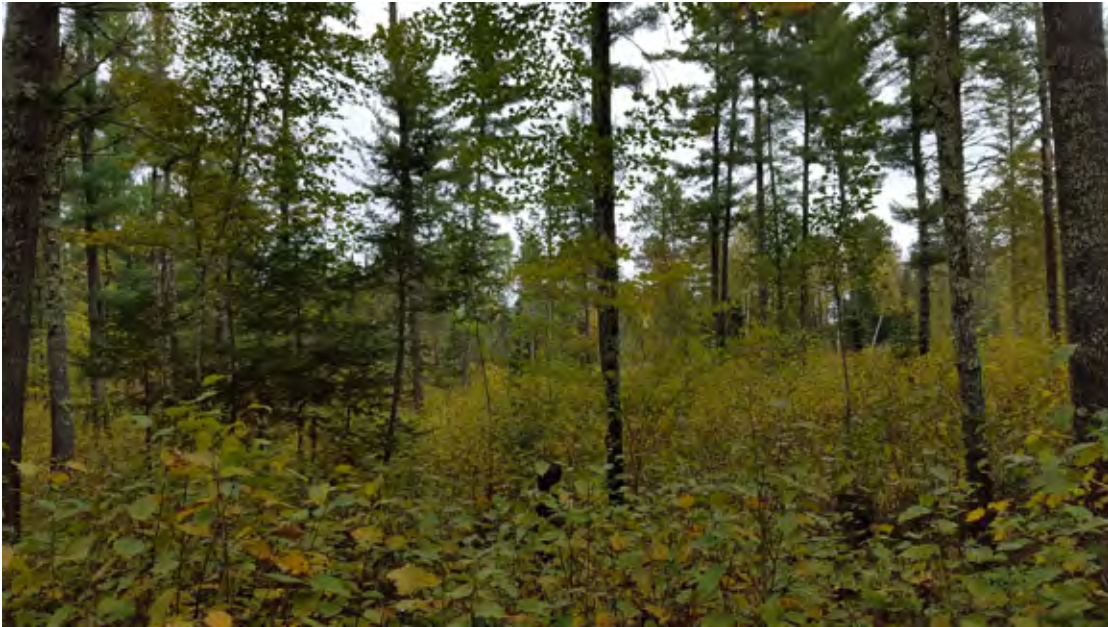
**Photo 28-1** Example of the understory consisting of beaked hazelnut, subcanopy of balsam fir, and remaining reserve white pine canopy trees in Unit 1, Two Mile Prescribed Burn project site, Bowstring State Forest. Photo illustrates how canopy gaps were created using a forest harvest and the shrub layer was reduced through prescribed fire. White pines, in particular, need larger gaps to establish. Photo taken by Mark Pranckus, Cardno 9/25/18.

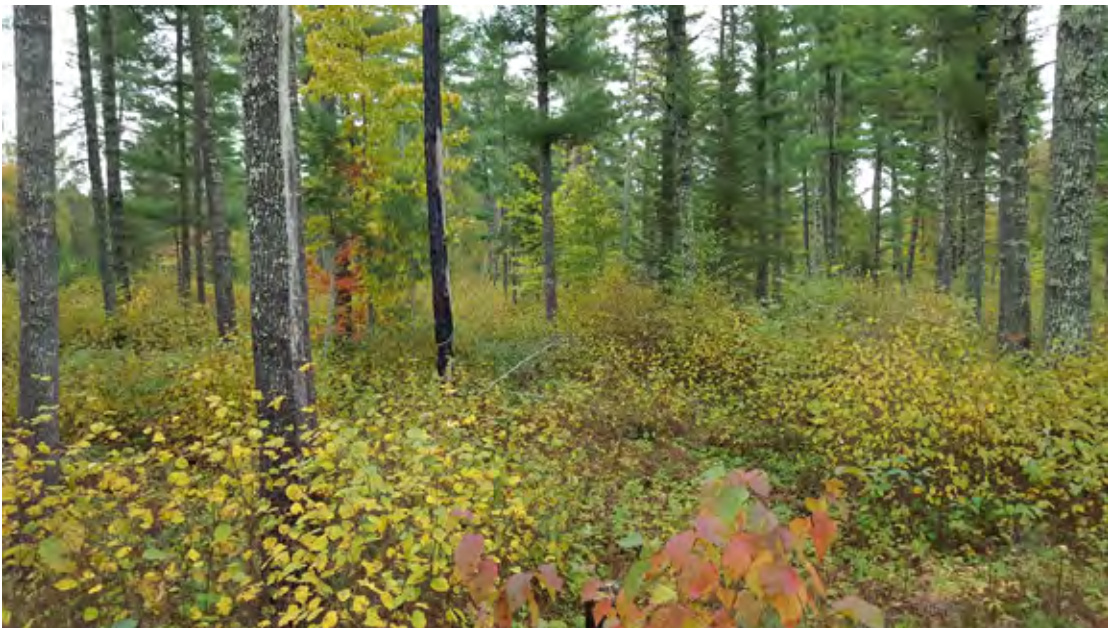
**Photo 28-2** Example of a reduced beaked hazelnut shrub layer in Unit 1, Two Mile Prescribed Burn project site, Bowstring State Forest. A fire scar from the prescribed burn in either 2009 or 2013 is present on the dark tree in the center of the photo. Remaining balsam firs and aspens provide subcanopy diversity and structure. Photo taken by Mark Pranckus, Cardno 9/25/18.

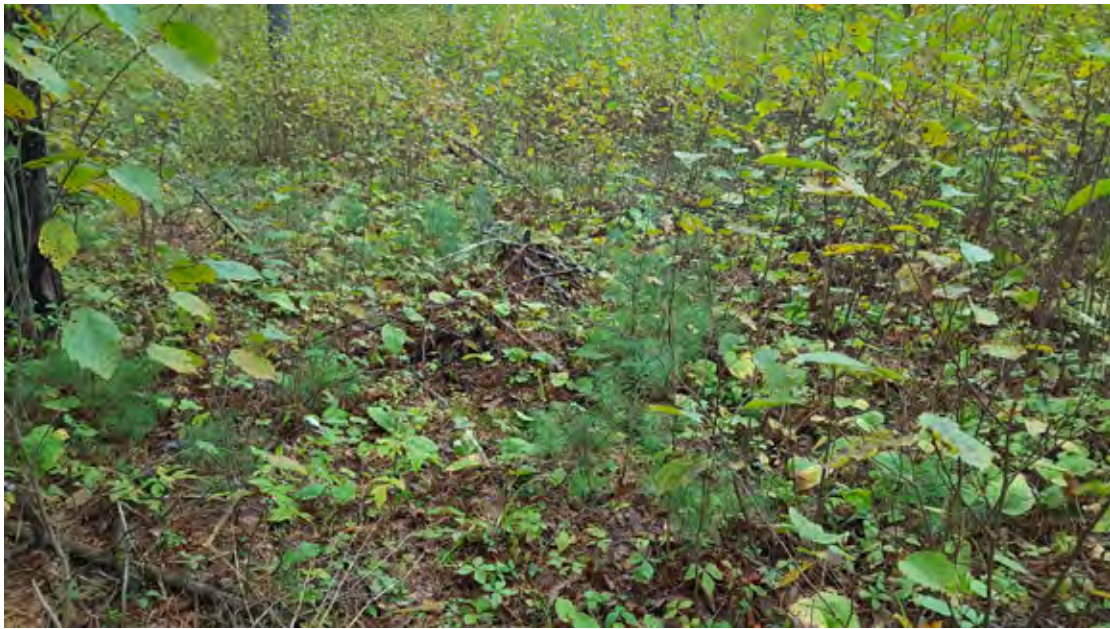
**Photo 28-3** Example of white pine seedling establishment in Unit 1, Two Mile Prescribed Burn project site, Bowstring State Forest. In the center of the photo, several seedlings can be seen ranging in ages. In the background, beaked hazelnut that is regenerating following the prescribed fire in 2013. Photo taken by Mark Pranckus, Cardno 9/25/18.

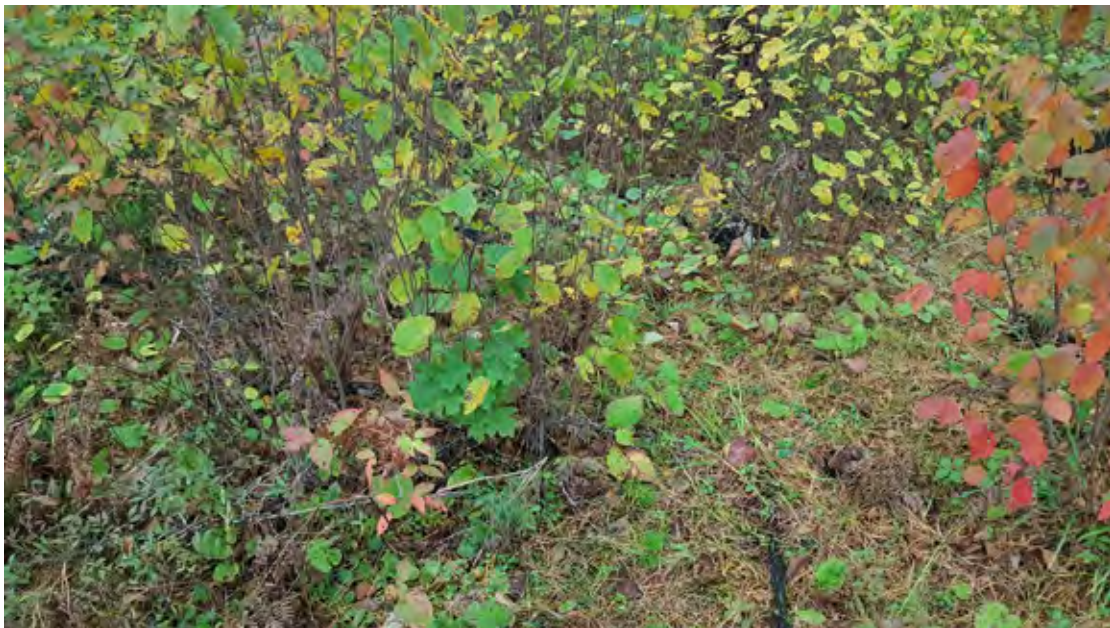
**Photo 28-4** Example of an oak seedling getting established in in Unit 1, Two Mile Prescribed Burn project site, Bowstring State Forest. In the center of the photo is a small oak seedling growing within a beaked hazelnut shrub. Future management may look to hand-release this seedling and other oaks, birch, and pines to increase the growth rate and promote a diverse mixed-age pine stand. In the foreground, an example of the ground cover and duff layer 5 years after the prescribed burn. Photo taken by Mark Pranckus, Cardno 9/25/18.

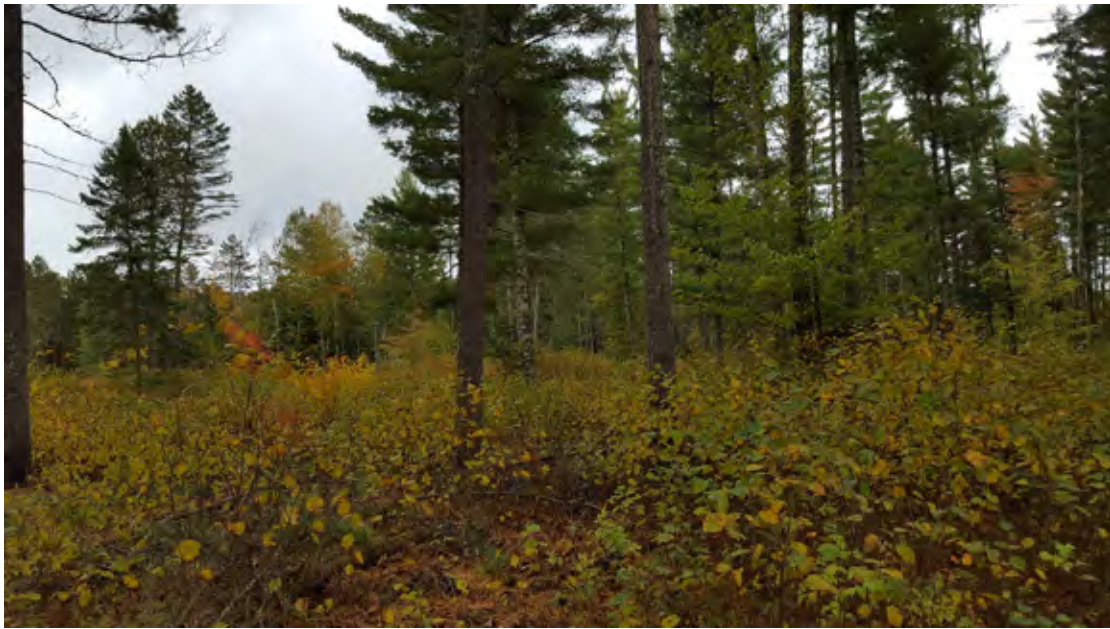
**Photo 28-5** Example of the shrub and remaining reserve canopy layer in Unit 2, Two Mile Prescribed Burn project site, Bowstring State Forest. In this photo, the subcanopy of trees remaining after the burn and harvest in 2013 are fairly sparse. Photo taken by Mark Pranckus, Cardno 9/25/18.

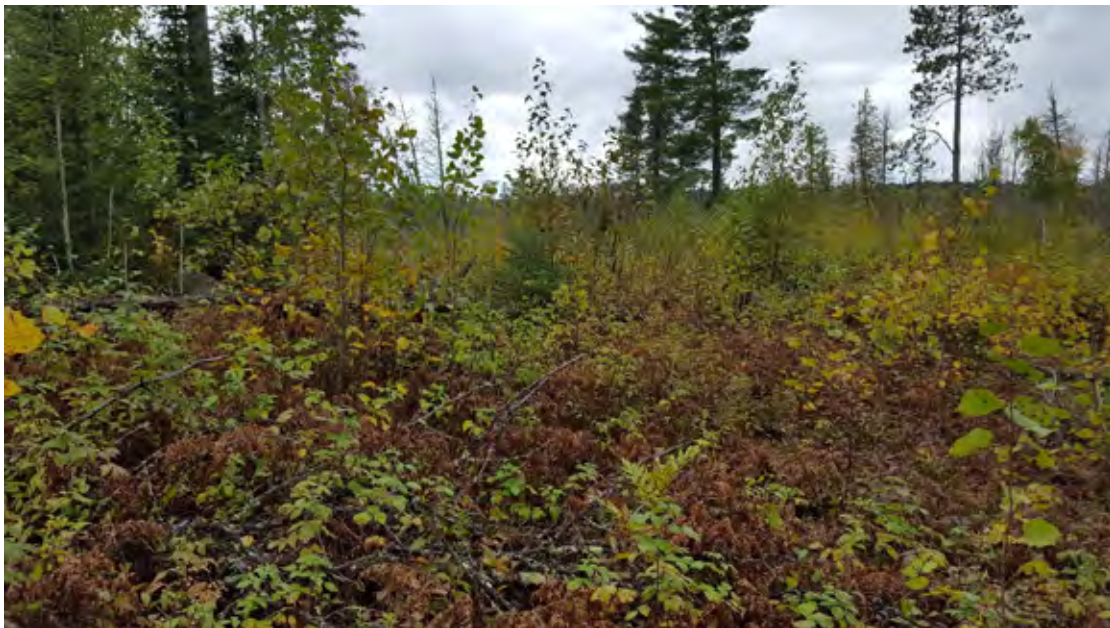
**Photo 28-6** Example of the shrub and remaining reserve canopy layer in Unit 2, Two Mile Prescribed Burn project site, Bowstring State Forest. In portions of Unit 2, the remaining reserve canopy trees were less dense than in other areas within the unit. The shrub layer and canopy layer is also more varied than in other parts of the unit. Photo taken by Mark Pranckus, Cardno 9/25/18.

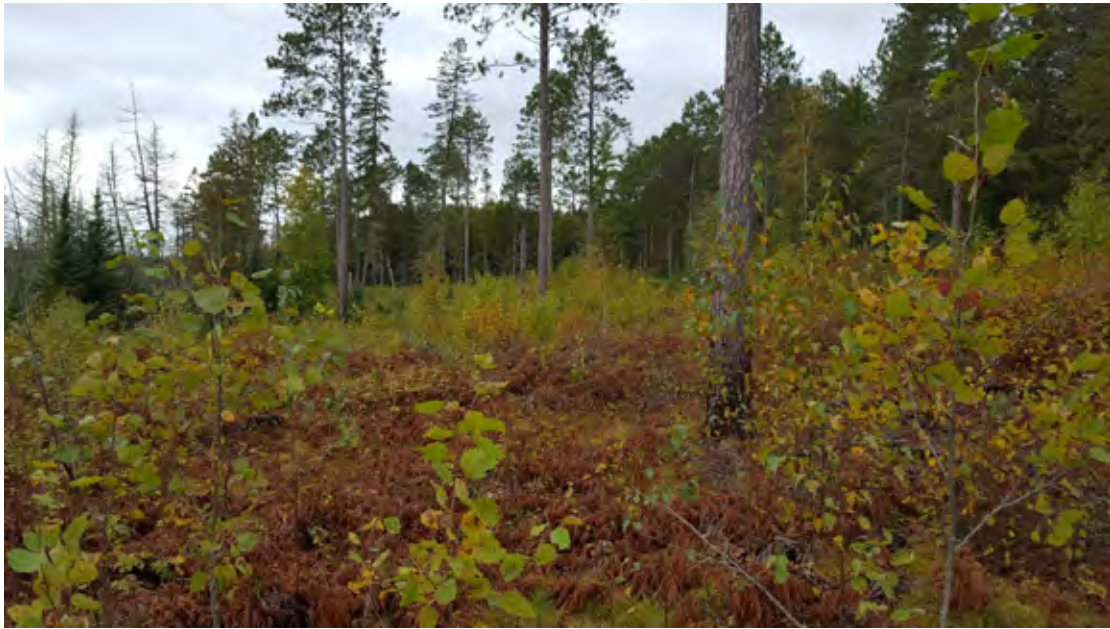
**Photo 28-7** In the center and foreground, an example of areas within Unit 2 where the regeneration of the shrub layer following the 2013 prescribed fire has been reduced compared to other areas. This may be due to the fire burning hotter than in other areas killing shrubs and temporarily sterilizing soil. This creates habitat diversity within the forest stand, but by require a longer time period for pine seedlings to establish. Photo taken at the Two Mile Prescribed Burn project site, Bowstring State Forest on 9/25/18 by Mark Pranckus, Cardno.

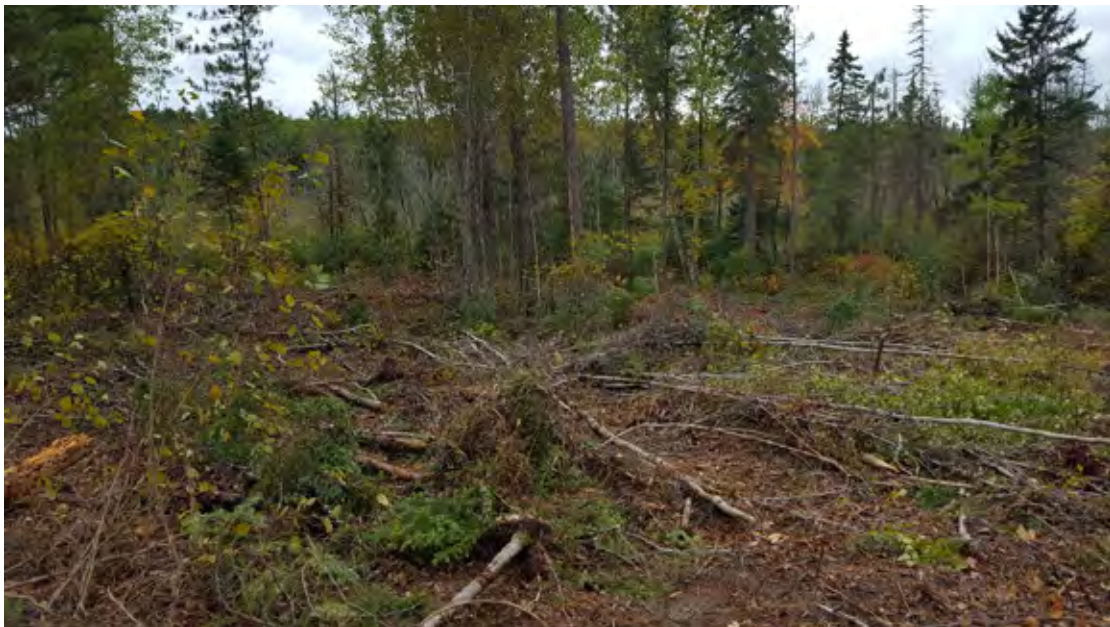
**Photo 28-8** Example for a recent tree harvest during 2018 in Unit 3, which is adjacent to Unit 1 and 2. Unit 3 did not receive a prescribed burn prior to tree harvest so it will provide a reference to the effects of burning as a means to enhance seed bed preparation and improve seed establishment. Photo taken at the Two Mile Prescribed Burn project site, Bowstring State Forest on 9/25/18 by Mark Pranckus, Cardno.

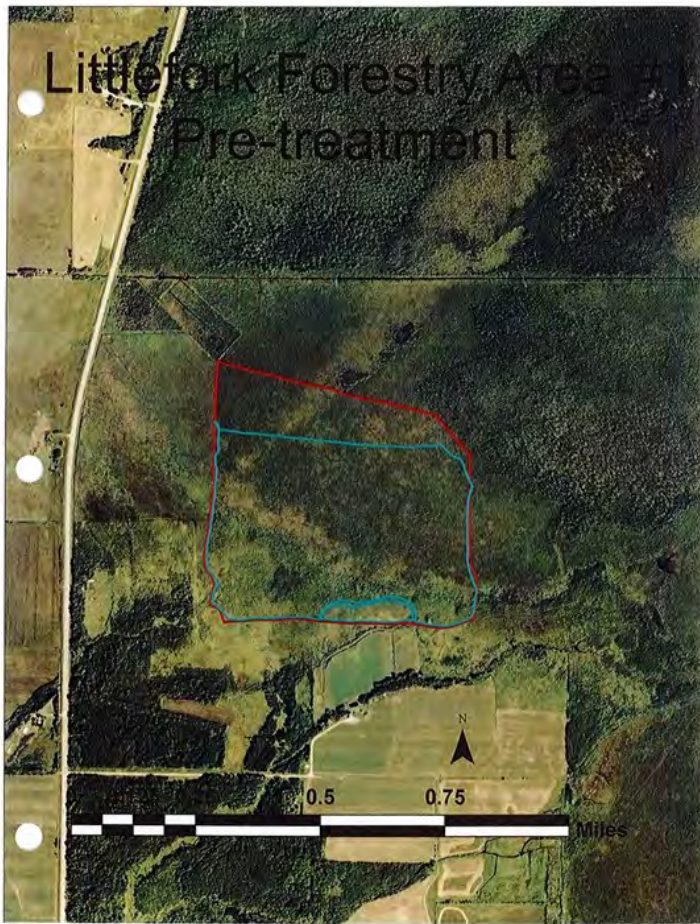
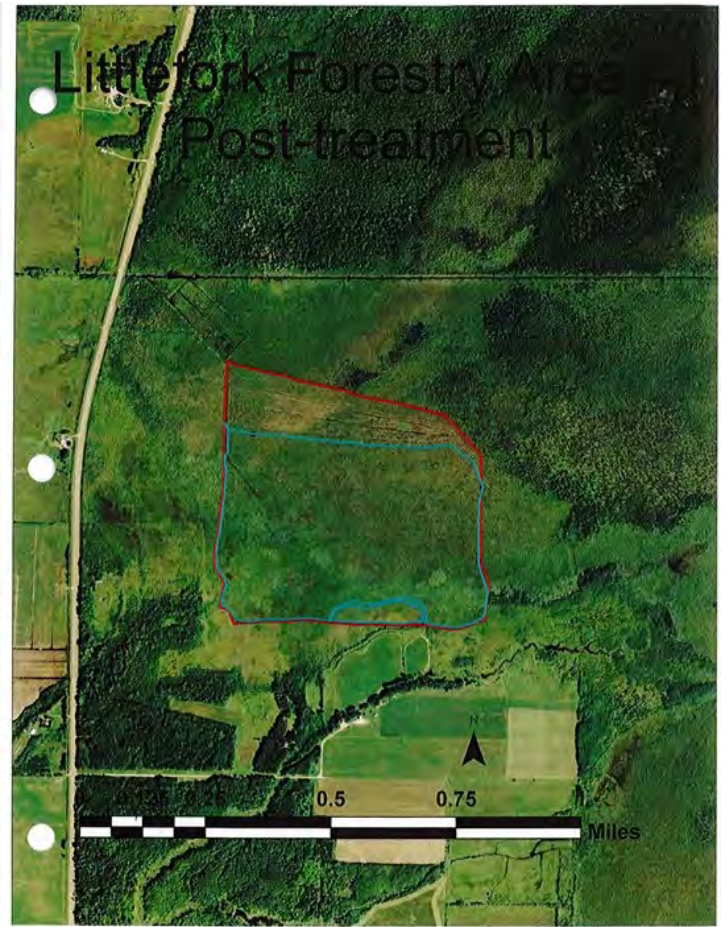
**Figure 29-4** Aerial maps showing pre-project and post-project conditions at the Littlefork 150 acre brushland management site. The “red” line indicates the overall project boundary. The “blue” line indicates work that occurred after the project was suspended due to poor field conditions.

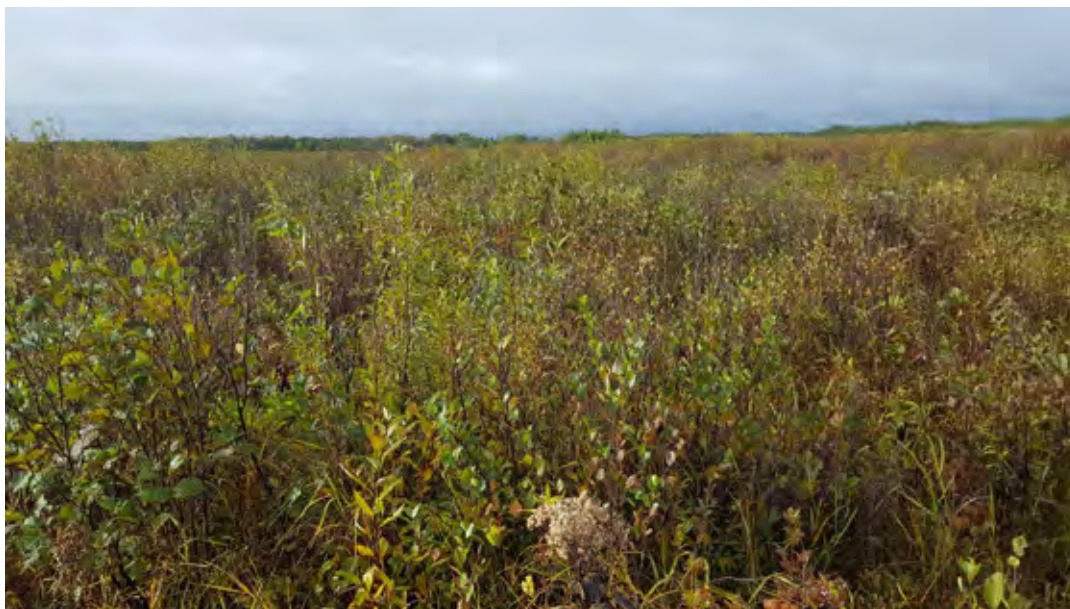
**Photo 29-1** Example of the existing shrub community following mechanical shearing in 2013 and an attempted prescribed burn in 2017. All shrubs were typically less than 6 feet in height. Photo taken on 9/28/18 at the Pelland Brushland Management – Unit B site by Mark Pranckus, Cardno.

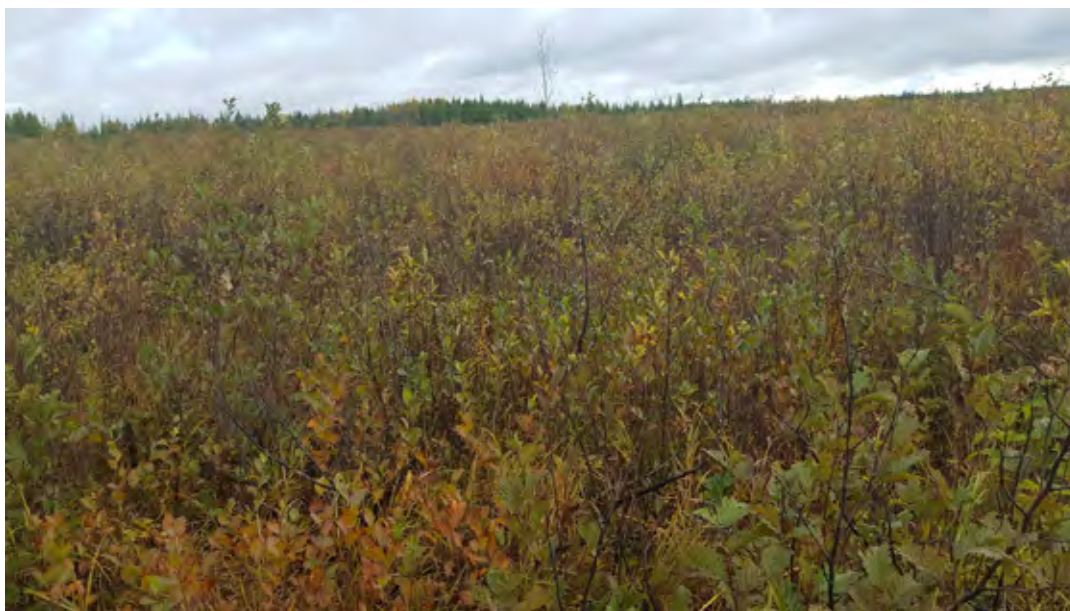
**Photo 29-2** Example of the existing shrub community following mechanical shearing in 2013 and an attempted prescribed burn in 2017. All shrubs were typically less than 6 feet in height. Photo taken on 9/28/18 at the Pelland Brushland Management – Unit B site by Mark Pranckus, Cardno.

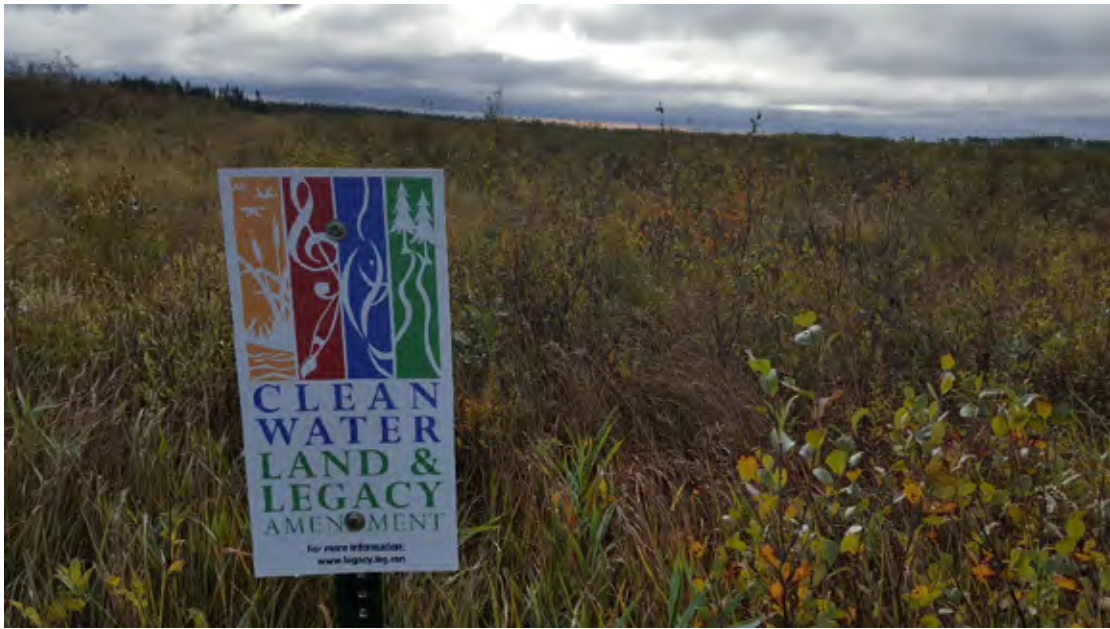
**Photo 29-3** Example of the OHF sign posted at the northwestern corner of the site. Surrounding vegetation was not much taller than the sign and post because of the 2013 mechanical shearing project and follow up prescribed burn in 2017. Photo taken on 9/28/18 at the Pelland Brushland Management – Unit B site by Mark Pranckus, Cardno.

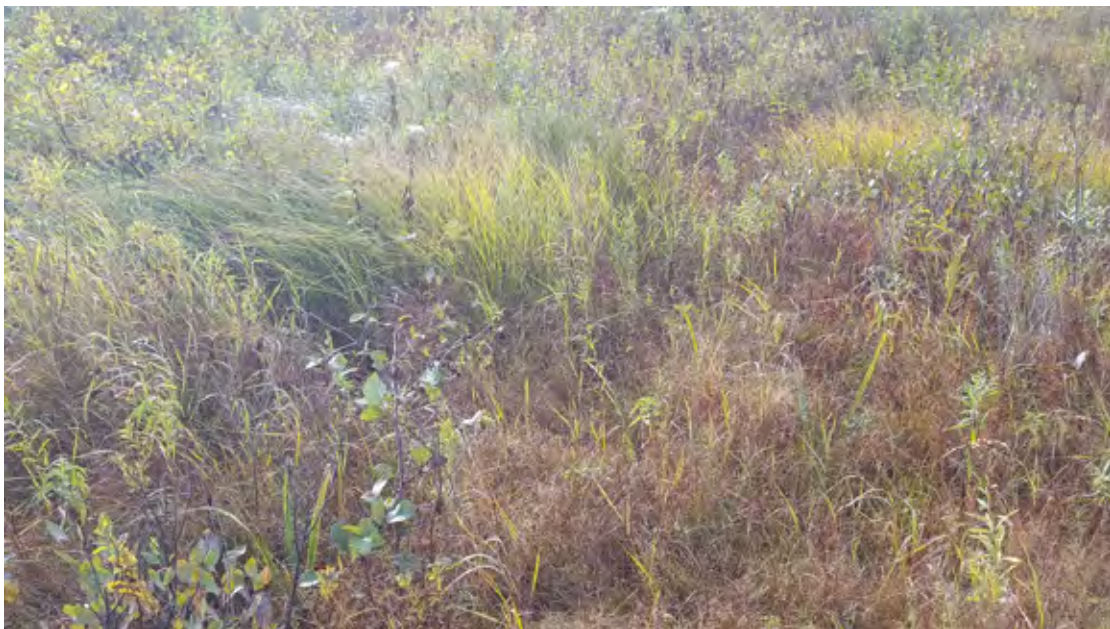
**Photo 29-4** Example of the well-developed ground layer vegetation present on the site. Photo was taken in a location where shrub regeneration was not very dense. Open areas within the shrub re-growth are important feeding areas for wildlife species such as sharp-tailed grouse. Photo taken on 9/28/18 at the Pelland Brushland Management – Unit B site by Mark Pranckus, Cardno.

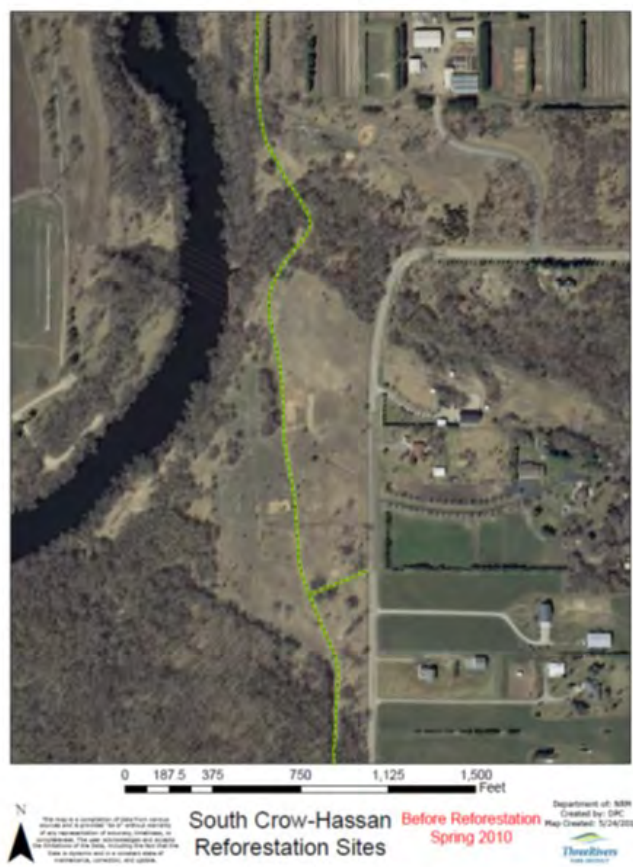
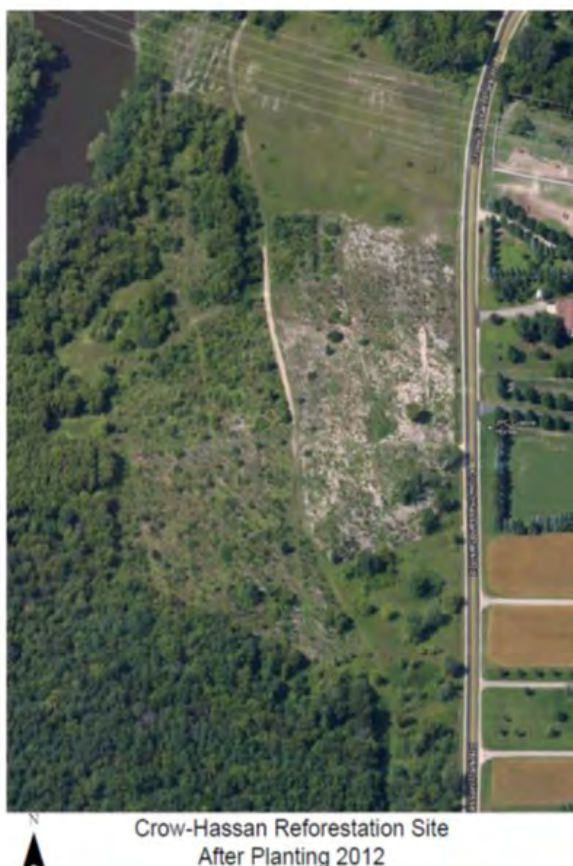
**Figure 31-1** Time series of aerial photos of the site of the Crow-Hassan Reforestation project. The images from before restoration (spring 2010) and after planting (2012) were provided by Three Rivers Park District. The 2015 image was obtained in Google Earth Pro.

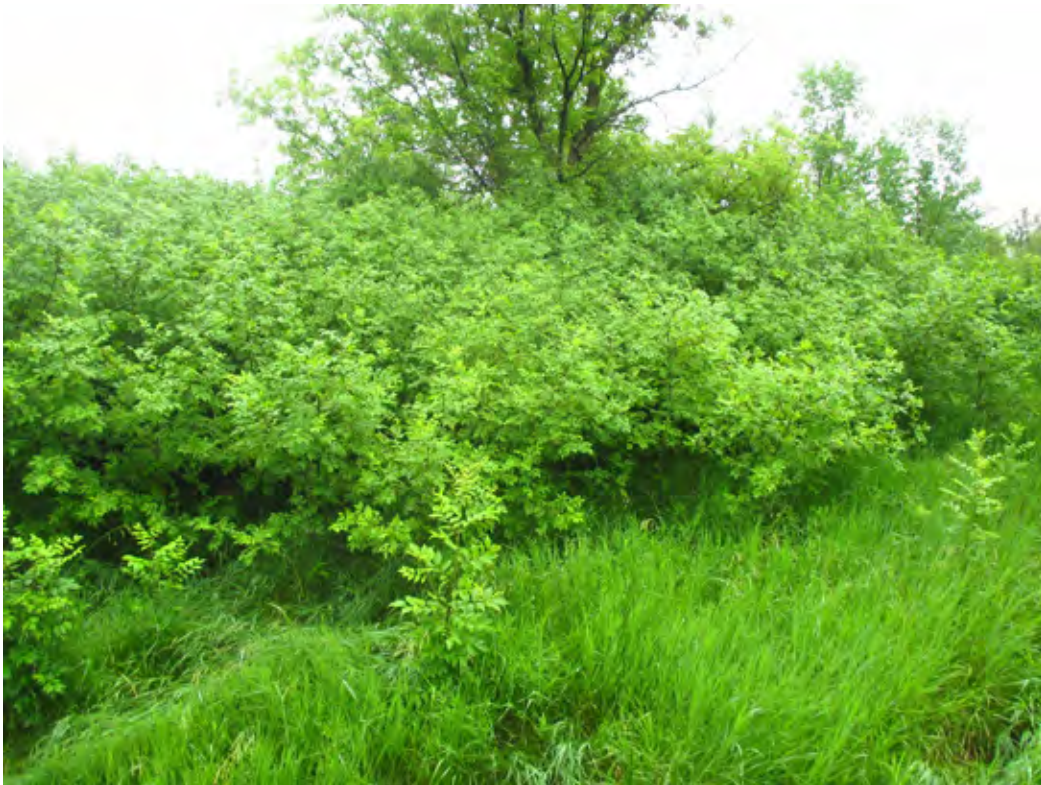
**Photo 31-3** Prickly ash regenerating in the planting area. Staff noted challenges in growing prickly ash stock because of the phototoxicity of the seeds but the species seems to have taken in this planting. (Photo taken during site visit 7/3/2018).

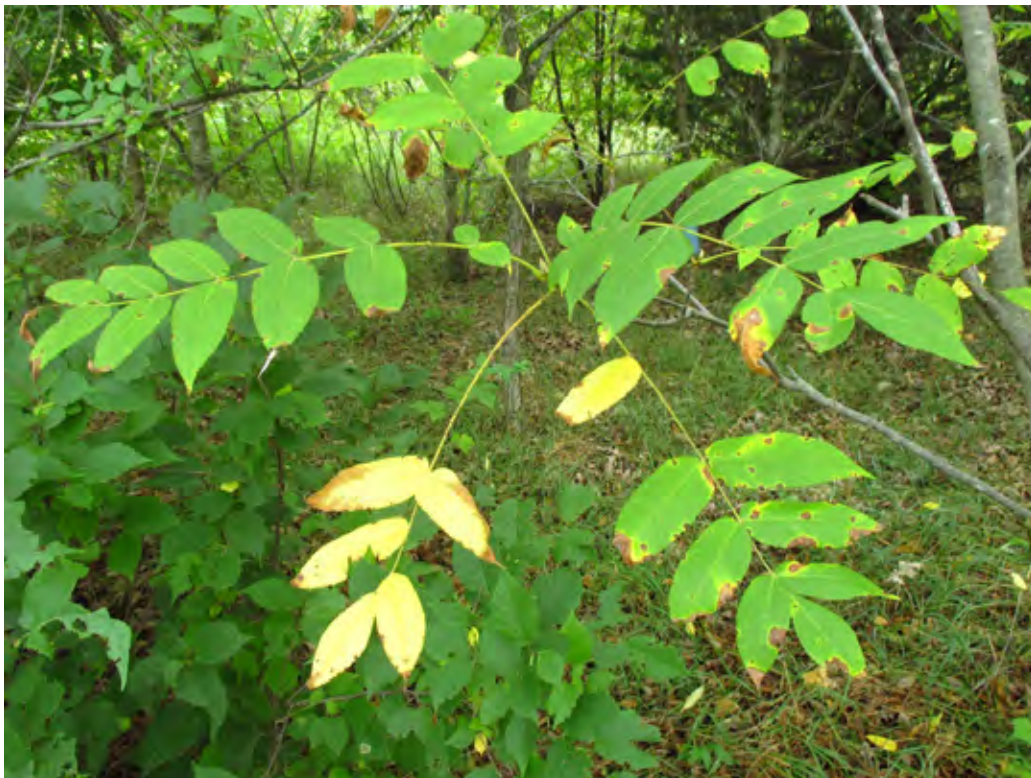
**Photo 31-4** Butternut canker observed on a planted Butternut tree. (Photo taken 8/31/2018).

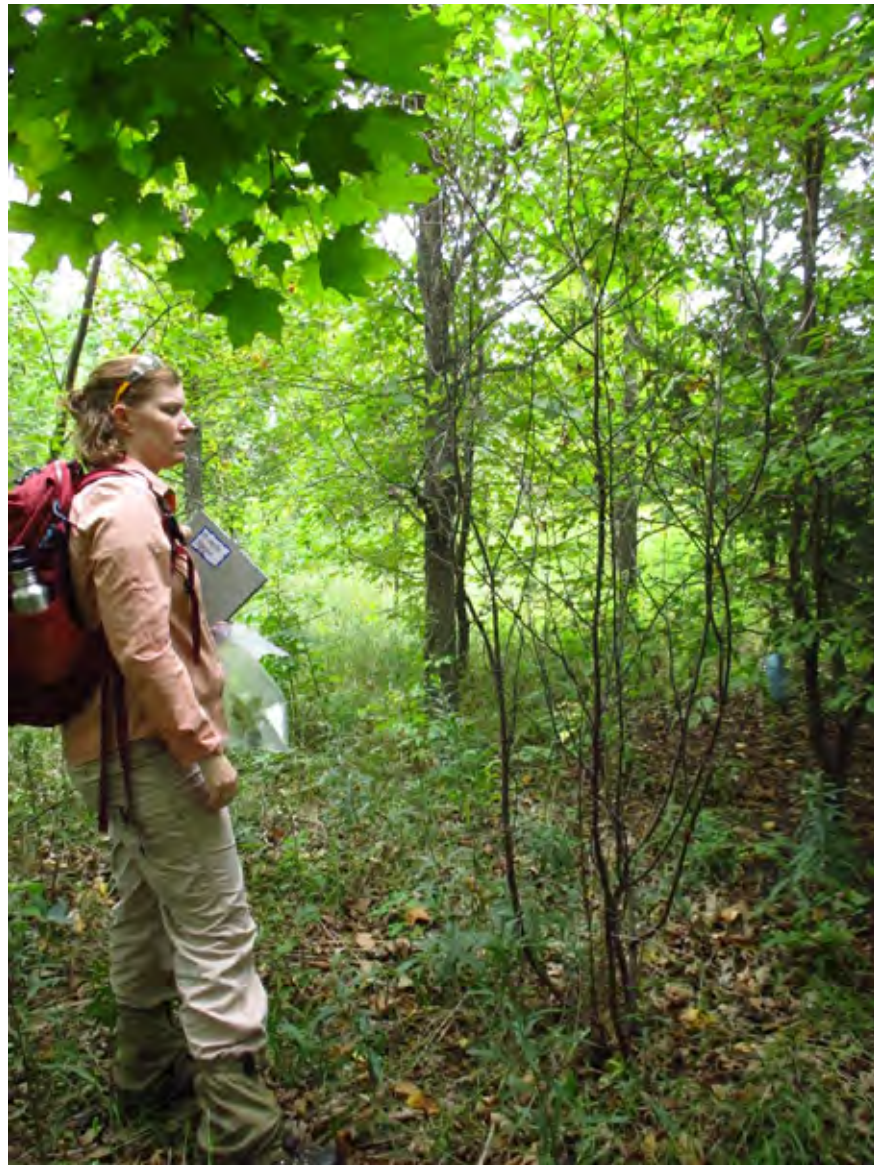
**Photo 31-5** Michelle Martin standing near a Bog Birch. This particular tree appeared to be dying, but others were larger and appeared to be doing well in the planting. (Photo taken 8/31/2018).

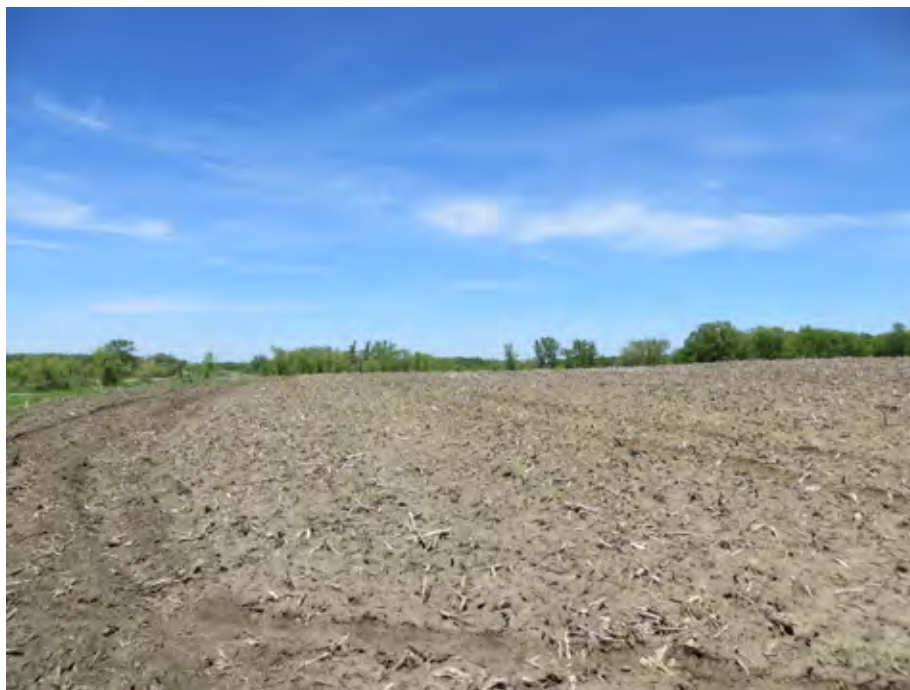
**Photo 32-1** Site condition looking north, prior to restoration. May 29, 2014 (Photo courtesy of Molly Tranel Nelson).

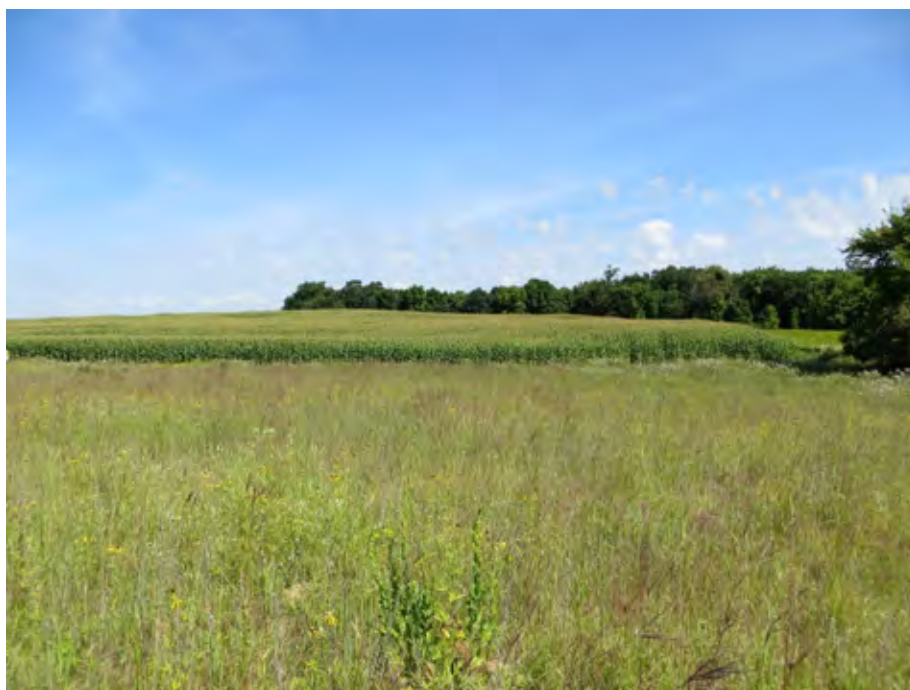
**Photo 32-2** Site condition looking north, prior to restoration. Corn in background is site. CRP in foreground is adjacent land. August 14, 2013 (Photo courtesy of Molly Tranel Nelson).

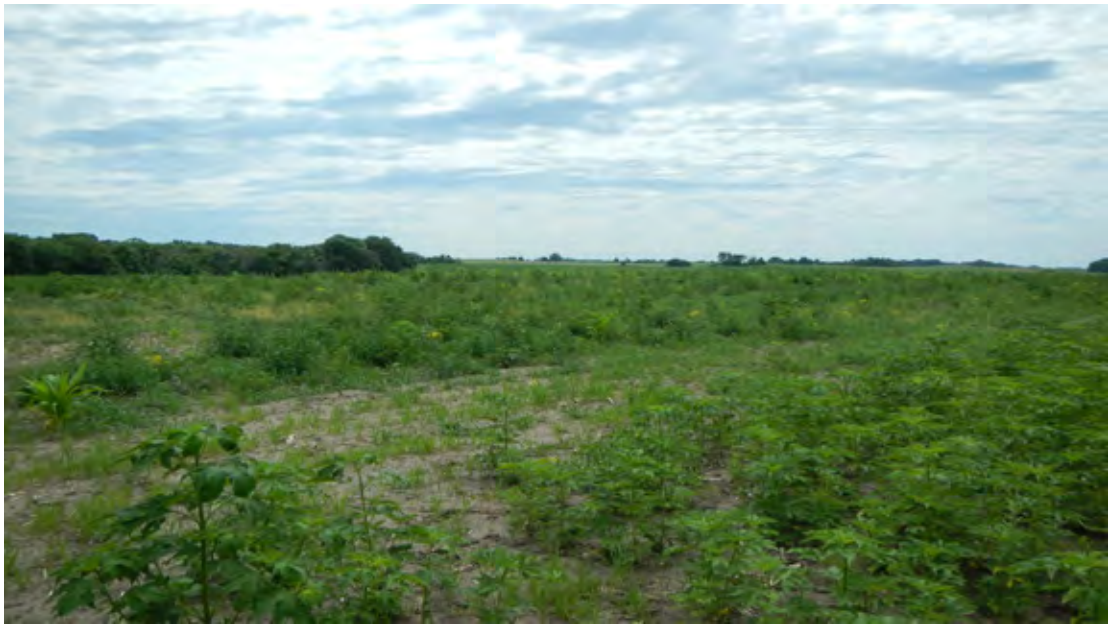
**Photo 32-3** Site on July 7, 2014. Photo taken from 640th Ave looking southeast (Photo courtesy of Molly Tranel Nelson).

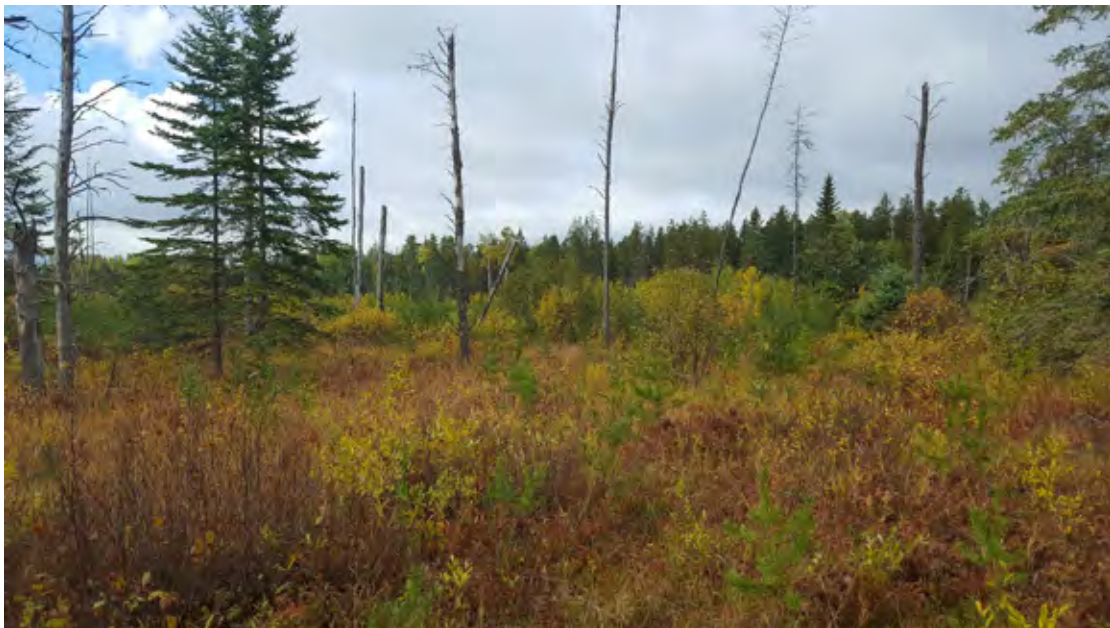
**Photo 35-4** Example of jack pine regeneration on the northwestern portion of the project site, Hayes Lake State Park. Jack pine present in the central portion of the photo were likely regeneration trees from on-site seed sources. Trees in this portion of the site were smaller than in other areas likely due to local differences in soil and growing conditions, but adding to the overall structural diversity of the site. Photo taken on 9/27/18 by Mark Prankus, Cardno.

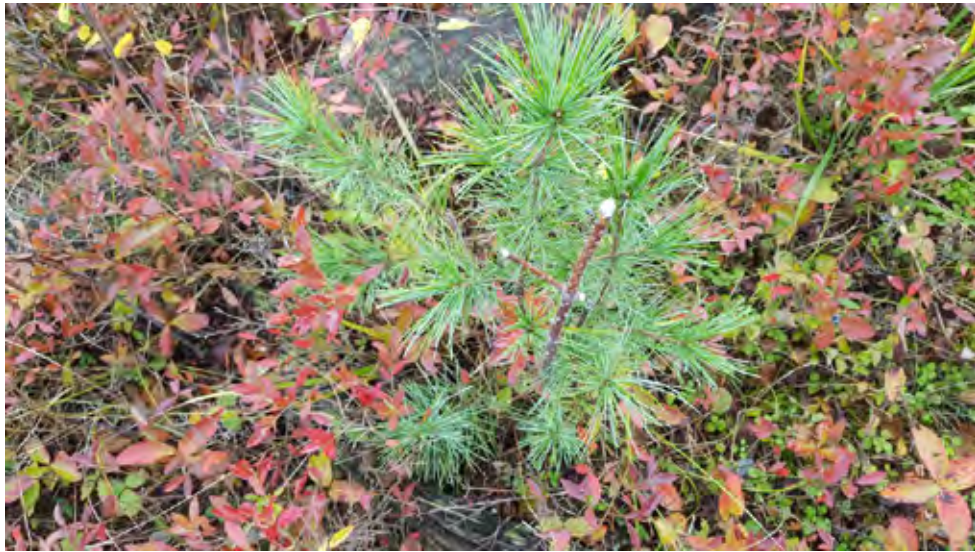
**Photo 35-5** Example of deer browse present on the site. The top of this small sapling was browsed by deer, which reduces growth rate and can, in cases, kill the tree. Deer browse like this was present on the site, but not prevalent. A significant percentage of trees have grown to a height that they are now more resistant to browse damage as the local deer herd recovers from herd reduction related to bovine tuberculosis management. Photo taken on 9/27/18 at the 19-acre jack pine restoration site in Hayes Lake State Park by Mark Pranckus, Cardno.

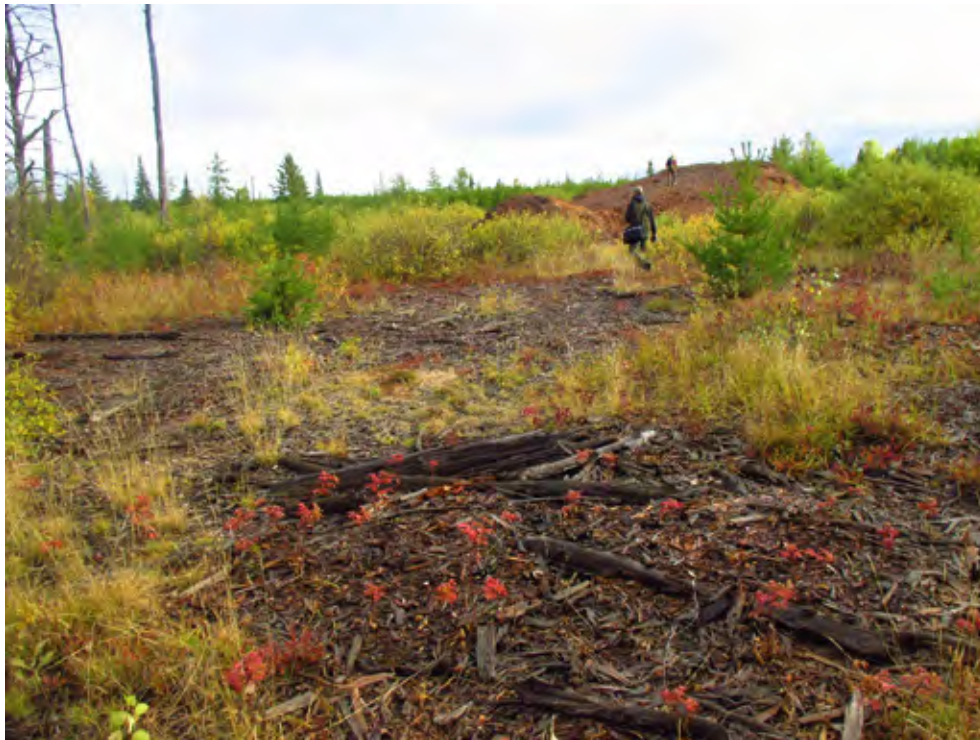
**Photo 35-6** Example of the mulch pile that remains on-site following the project in 2010. Harvested trees were stockpiled here and processed into mulch. Future projects would look to make sure excess material like this gets removed as part of the original project scope.
