# Timber Harvesting and Forest Management Guidelines on Public and Private Forest Land in Forested Watersheds in Minnesota

## 2018 Monitoring Implementation Results

A report by the Minnesota Department of Natural Resources,  
Forest Management Guideline Implementation Monitoring Program  
Respectfully submitted to the Minnesota Forest Resources Council

Monitoring for Implementation 2018

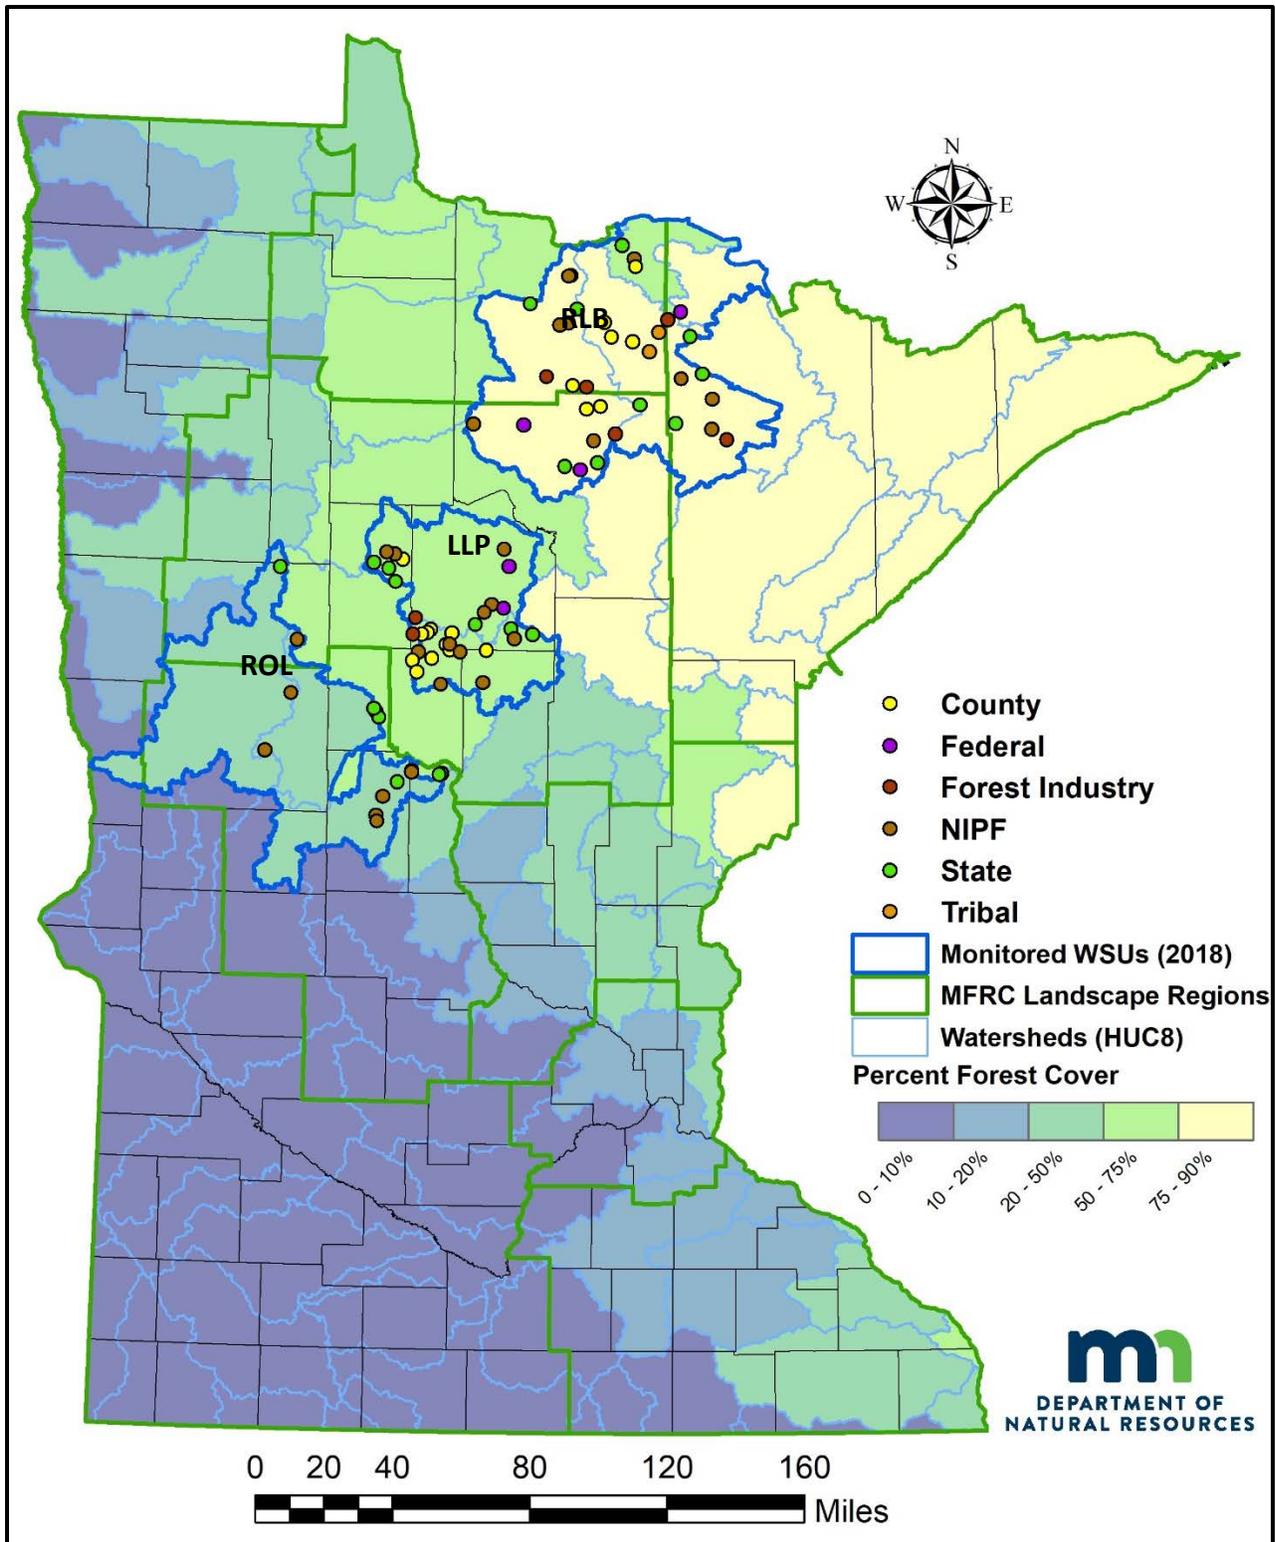
Figure 1. Watersheds and sites where guideline implementation monitoring occurred in 2018. Site locations are displayed by land ownership category. In total, 83 sites were sampled. Percent forest cover by HUC-8 watershed is displayed as blue (less forest cover – in the southwest) to yellow (nearly full forest cover – in the northeast) shading.

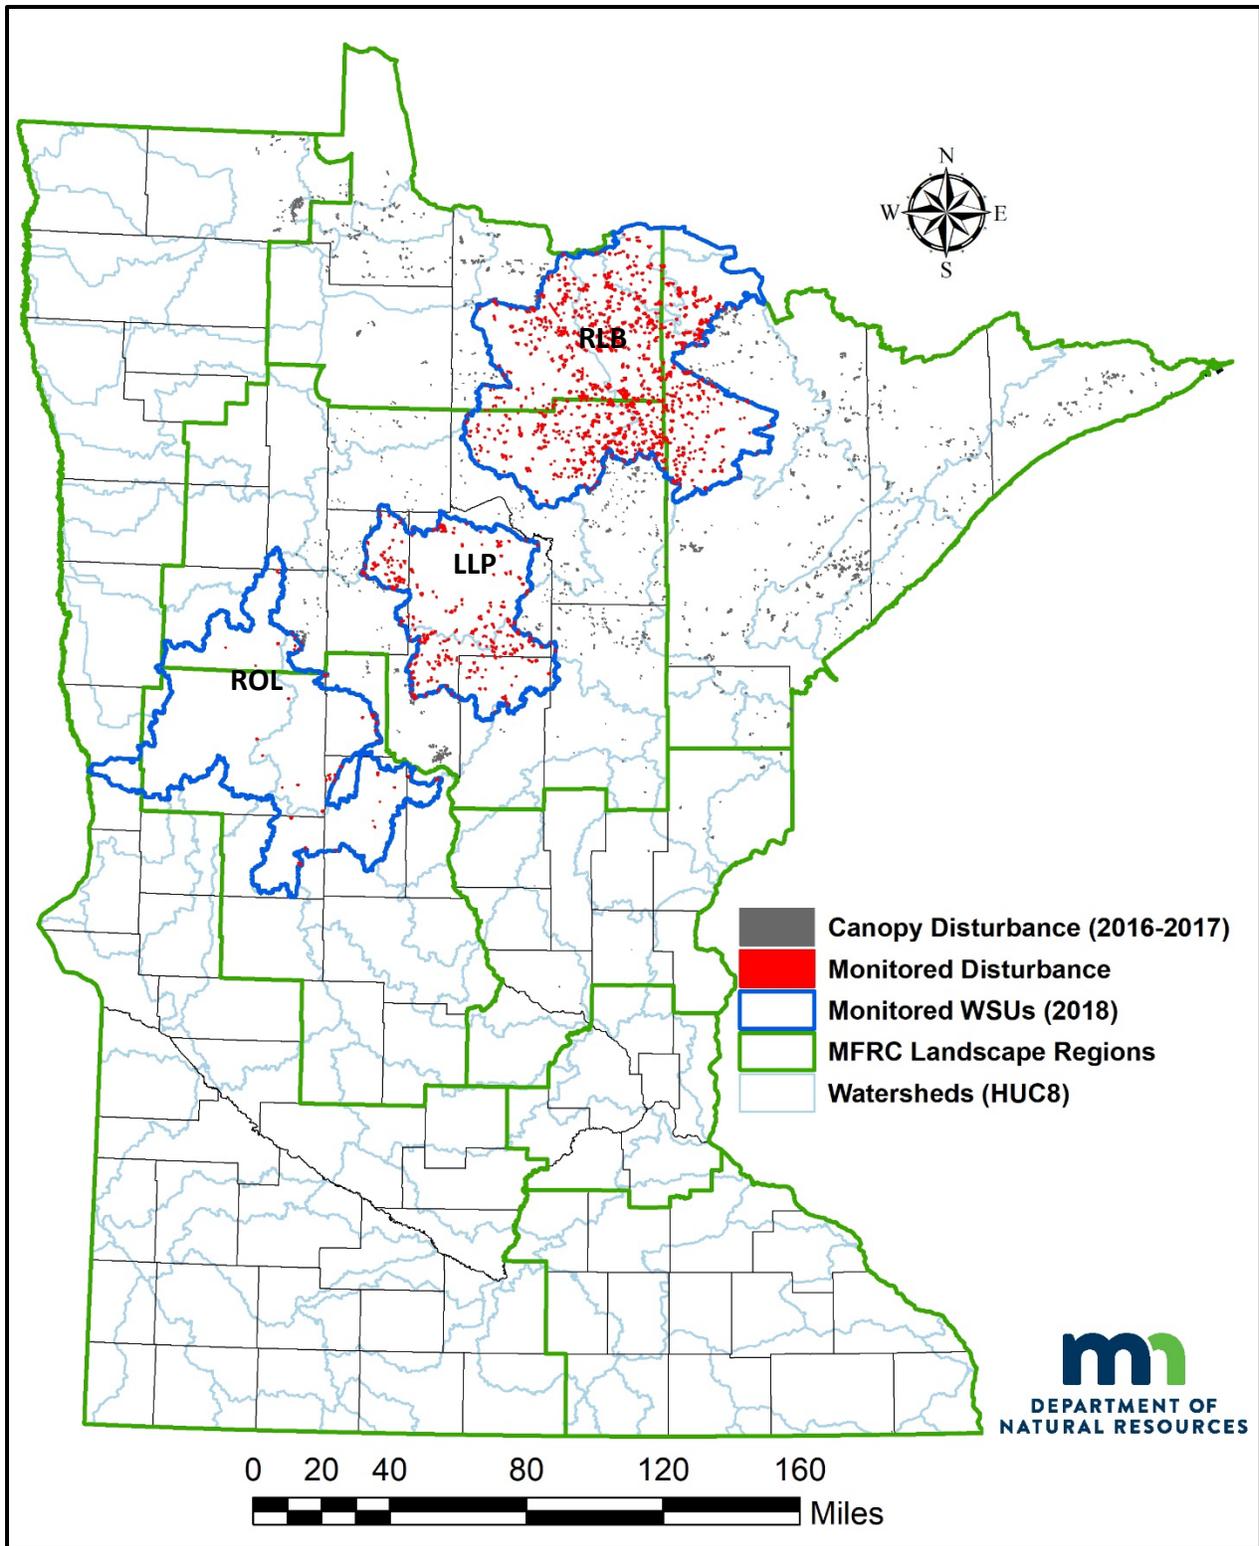
Figure 2. Two-year forest canopy disturbance map. Statewide, canopy disturbance observed between 2016 and 2017 is shown as gray patches. Within watershed sample units monitored in 2018, canopy disturbance is shown as red patches. Note the concentration of canopy disturbance in the RLB unit.

Changes detected between summers 2016 and 2017 were used to identify sites sampled in 2018. Disturbance estimates are depicted visually in Figure 2 and as annual averages in Table 2. Of the three WSUs sampled in 2018, RLB (12.5 million acres) had the highest number of disturbed sites (676 annually) and the highest percent of forest cover disturbed (1.1% annually), though the average disturbance size was small (33.9 acres). Such high levels of harvest are consistent with the predominantly aspen forest type present in the RLB unit (36%), and increased harvests of tamarack and black ash related to recent insect outbreaks in the region. The ROL watershed unit (2.36 million acres) had the lowest number of disturbances and the lowest percent of forest cover disturbed (0.15%). The LLP watershed unit (1.36 million acres)

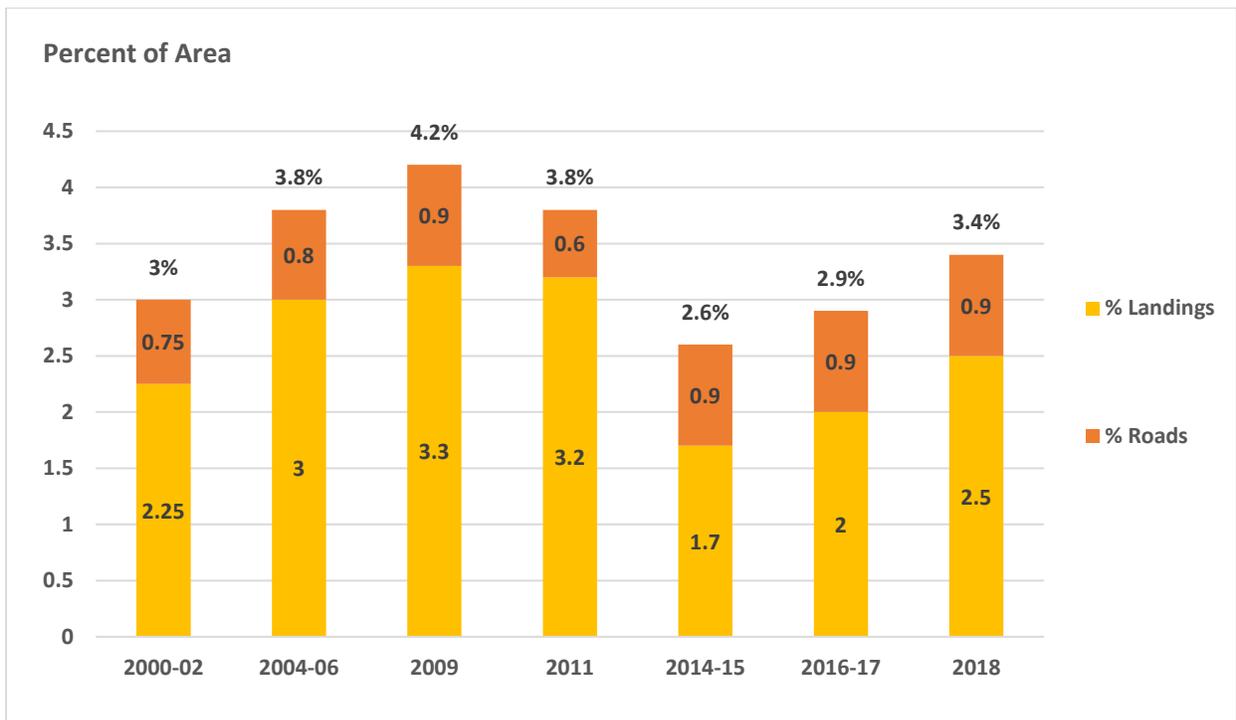
Figure 3. Mean percent infrastructure by reporting period.

Overall, 74% of sites monitored in 2018 met the recommended infrastructure amounts based on 2012 guidelines (Table 12). This is lower than the 2016-2017 report (77%) but considerably higher than previous reports. When comparing on-site infrastructure with site size, compliance was highest for sites averaging 47 acres or more. Compliance was lowest for sites less than 24 acres. Mean site size (40 acres) was smaller for watersheds in this report compared to the long-term average of 55 acres, but overall compliance was similar.
