Operation and Maintenance Report – July 2021
Albert Closed Landfill
Albert Lea, Minnesota

GHD is pleased to provide this Operation and Maintenance (O&M) Report for site activities conducted in July 2021 at the Albert Lea Closed Landfill in Albert Lea, Minnesota (Site).

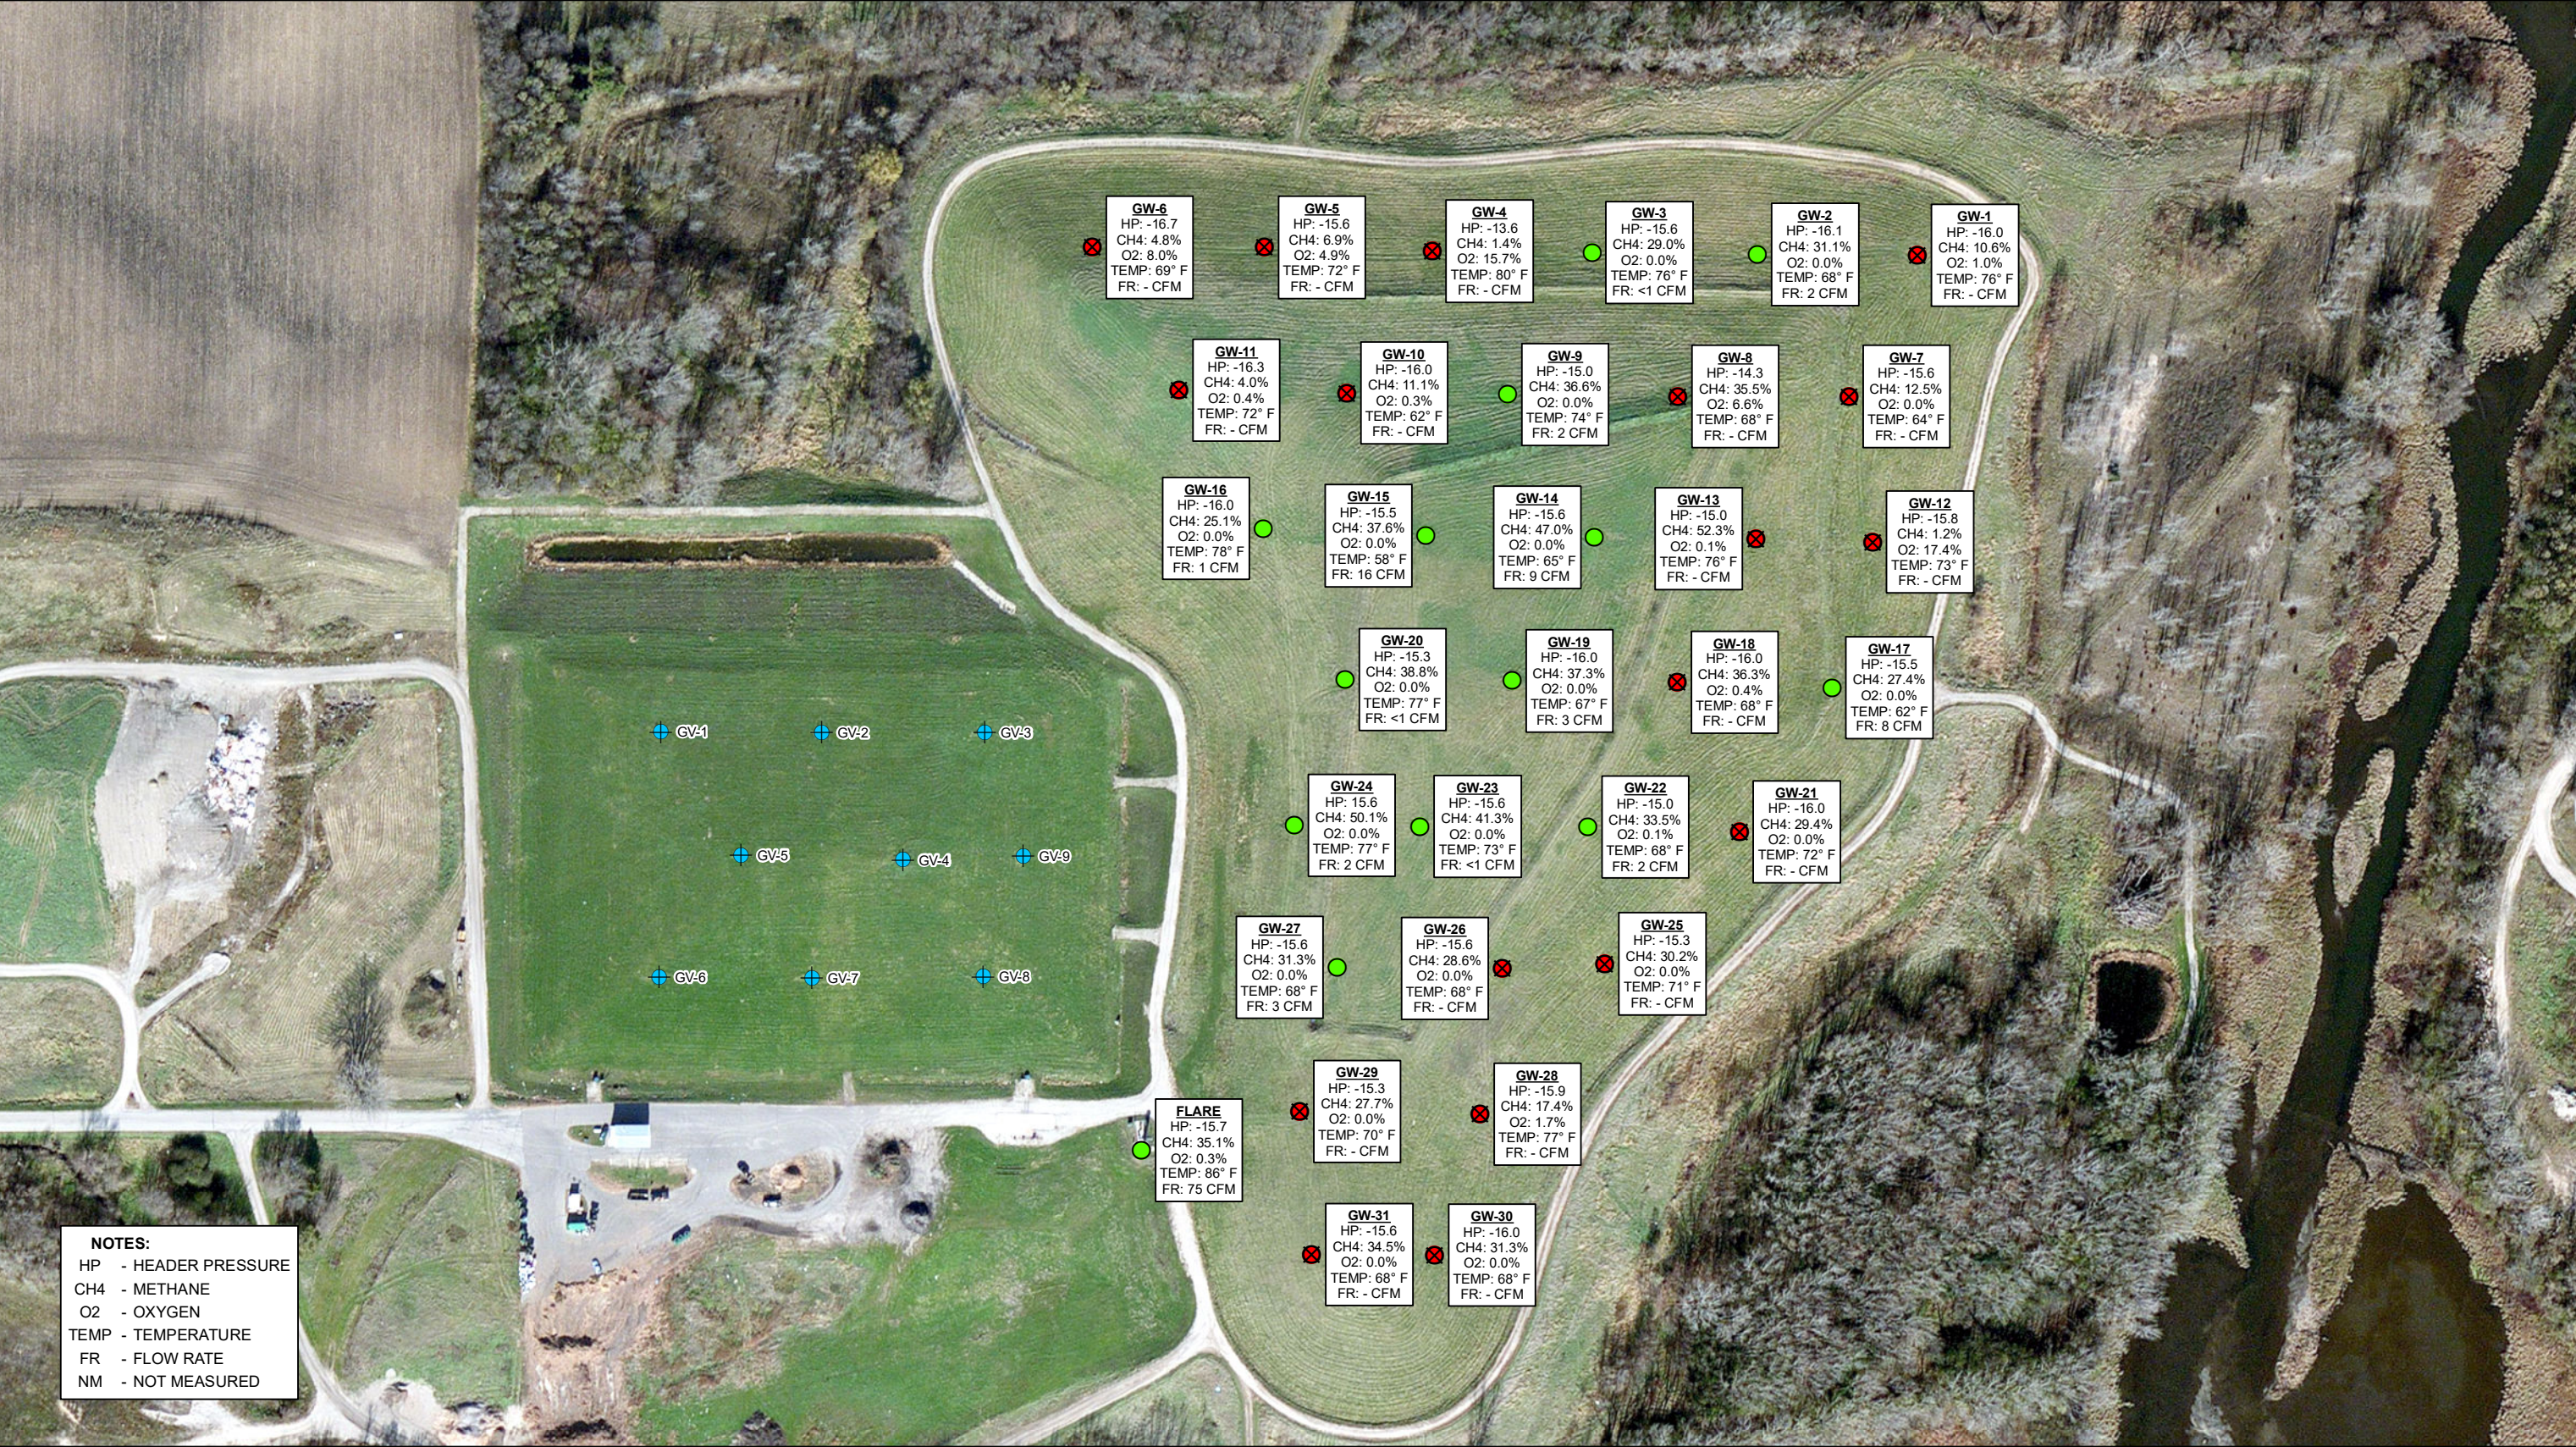
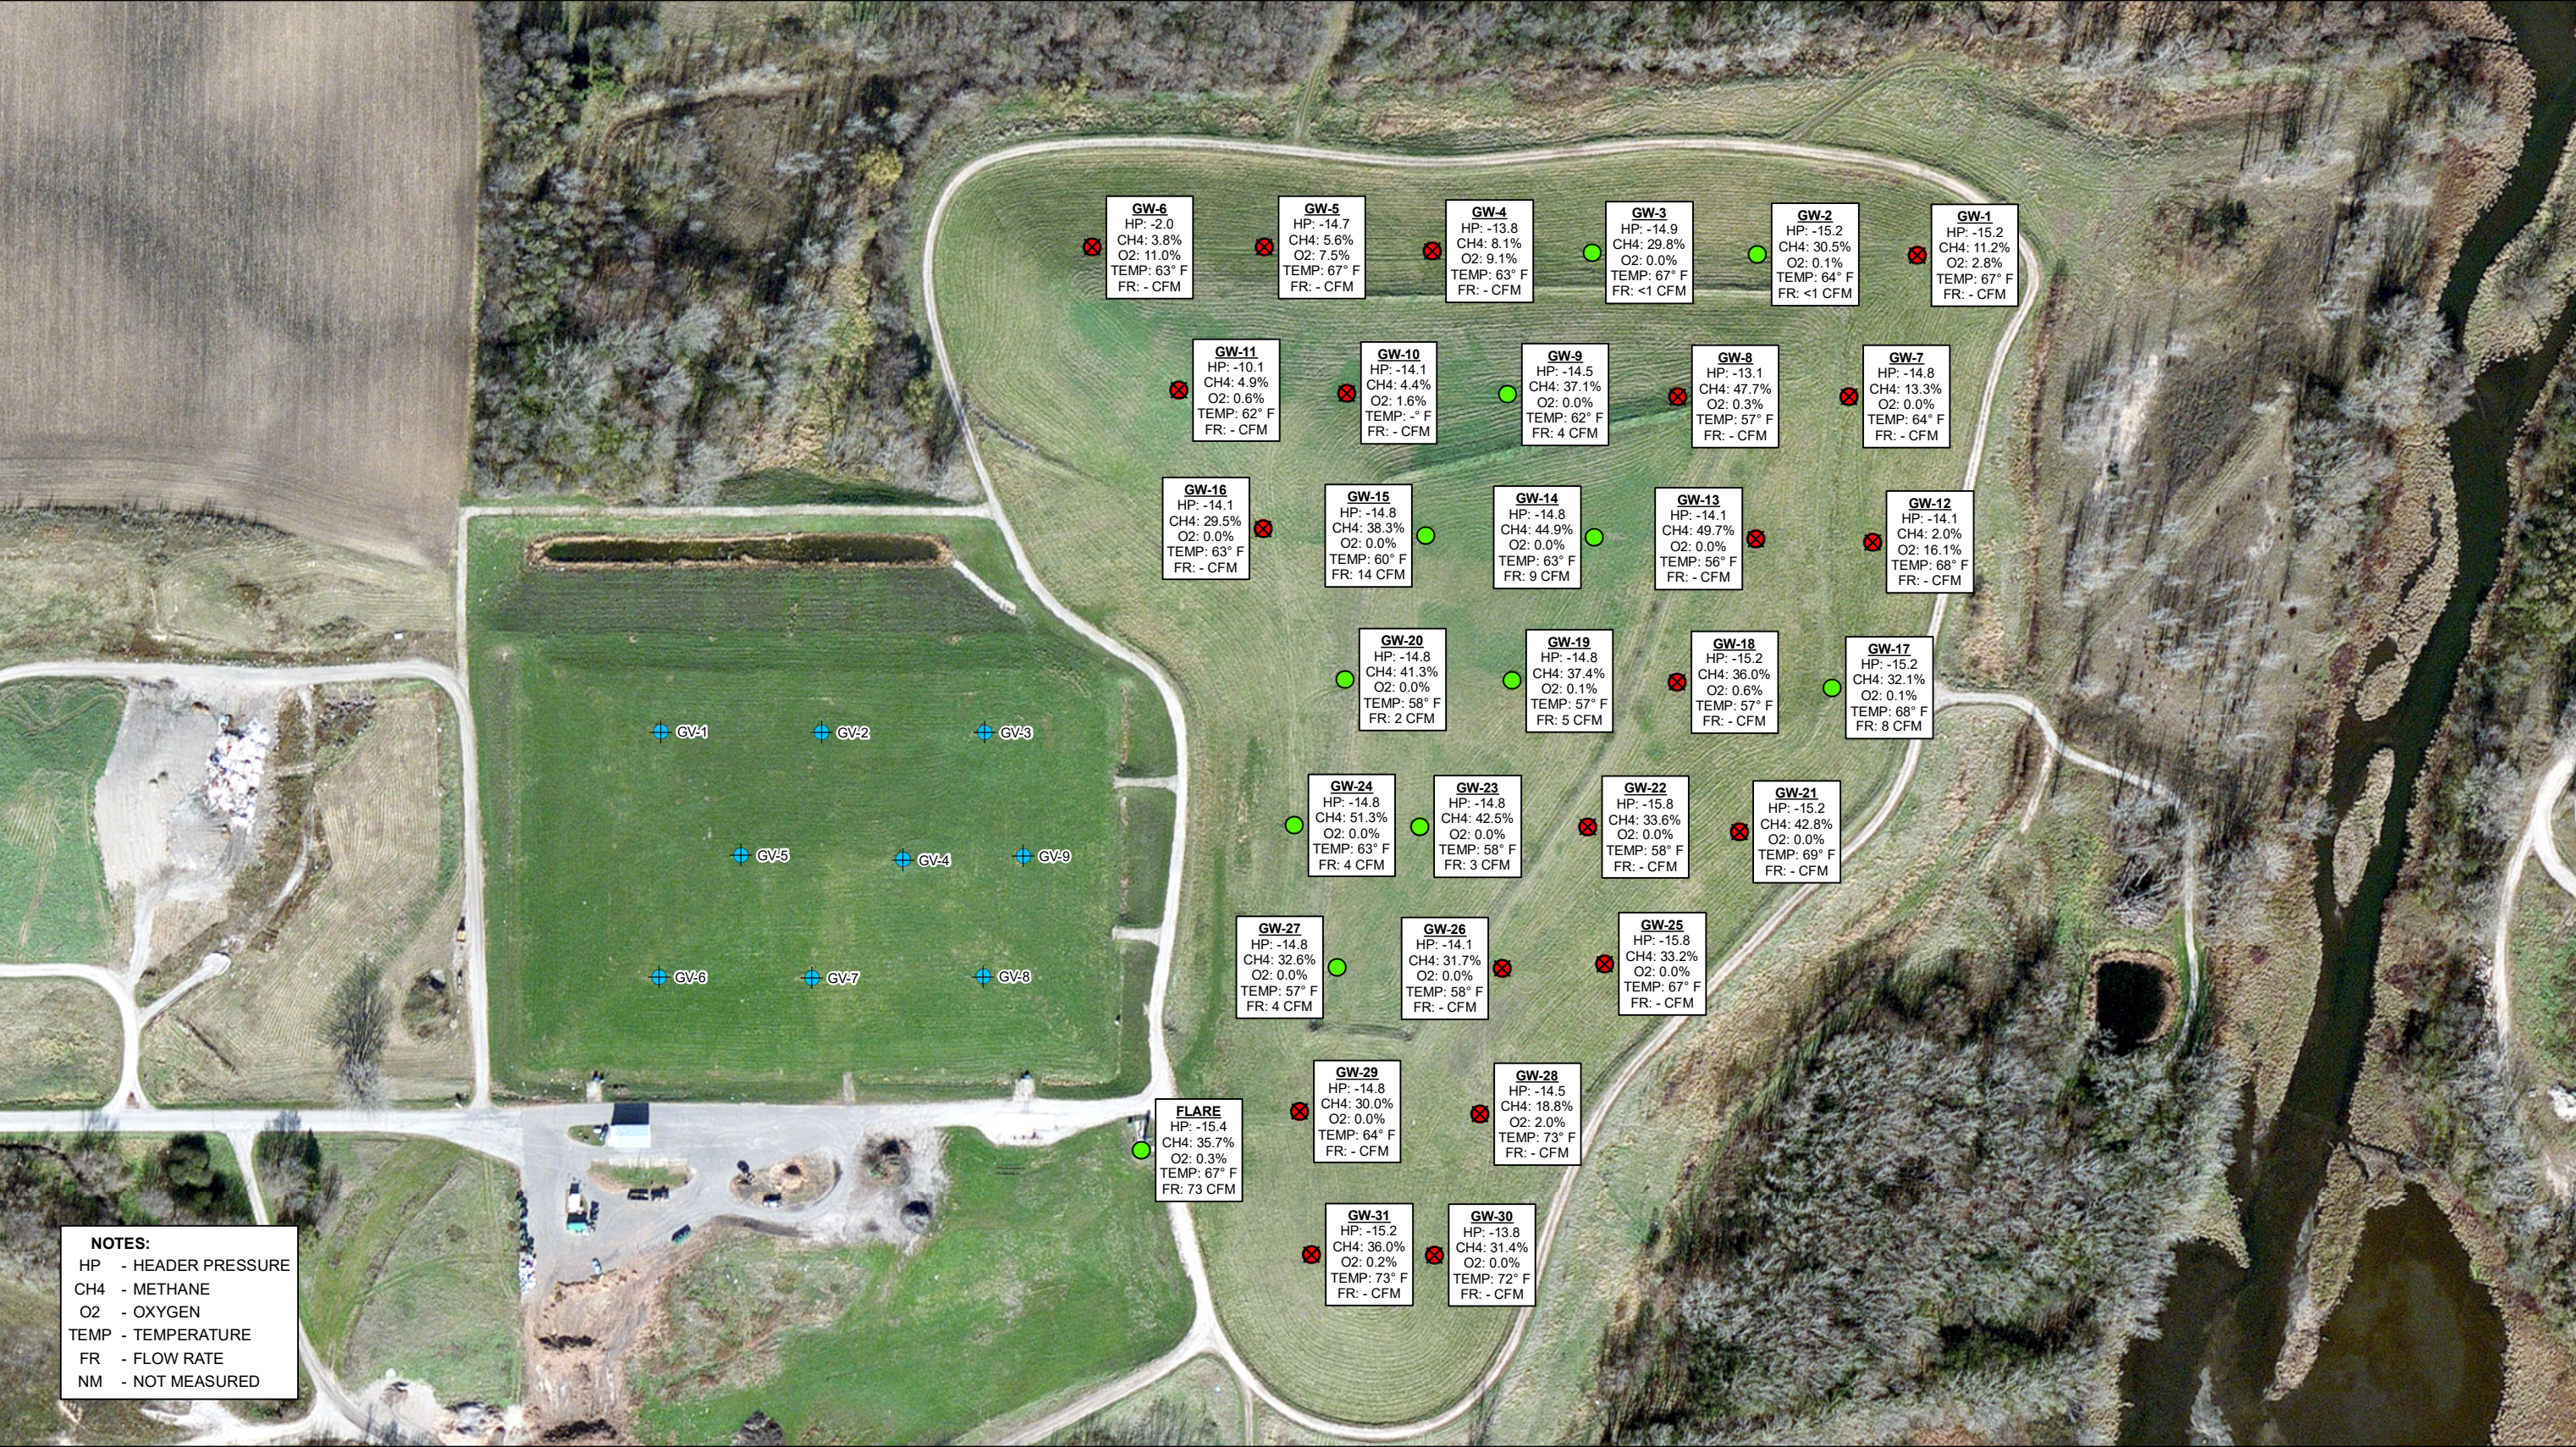
Gas extraction well monitoring was conducted during the reporting period on July 16 and 30, 2021. Figures 2A and 2B show a Site plan with gas monitoring data for the individual gas extraction wells and flare station for the July 2021 monitoring events. Gas extraction well and flare station gas data collected during the reporting period are presented in Table 1.

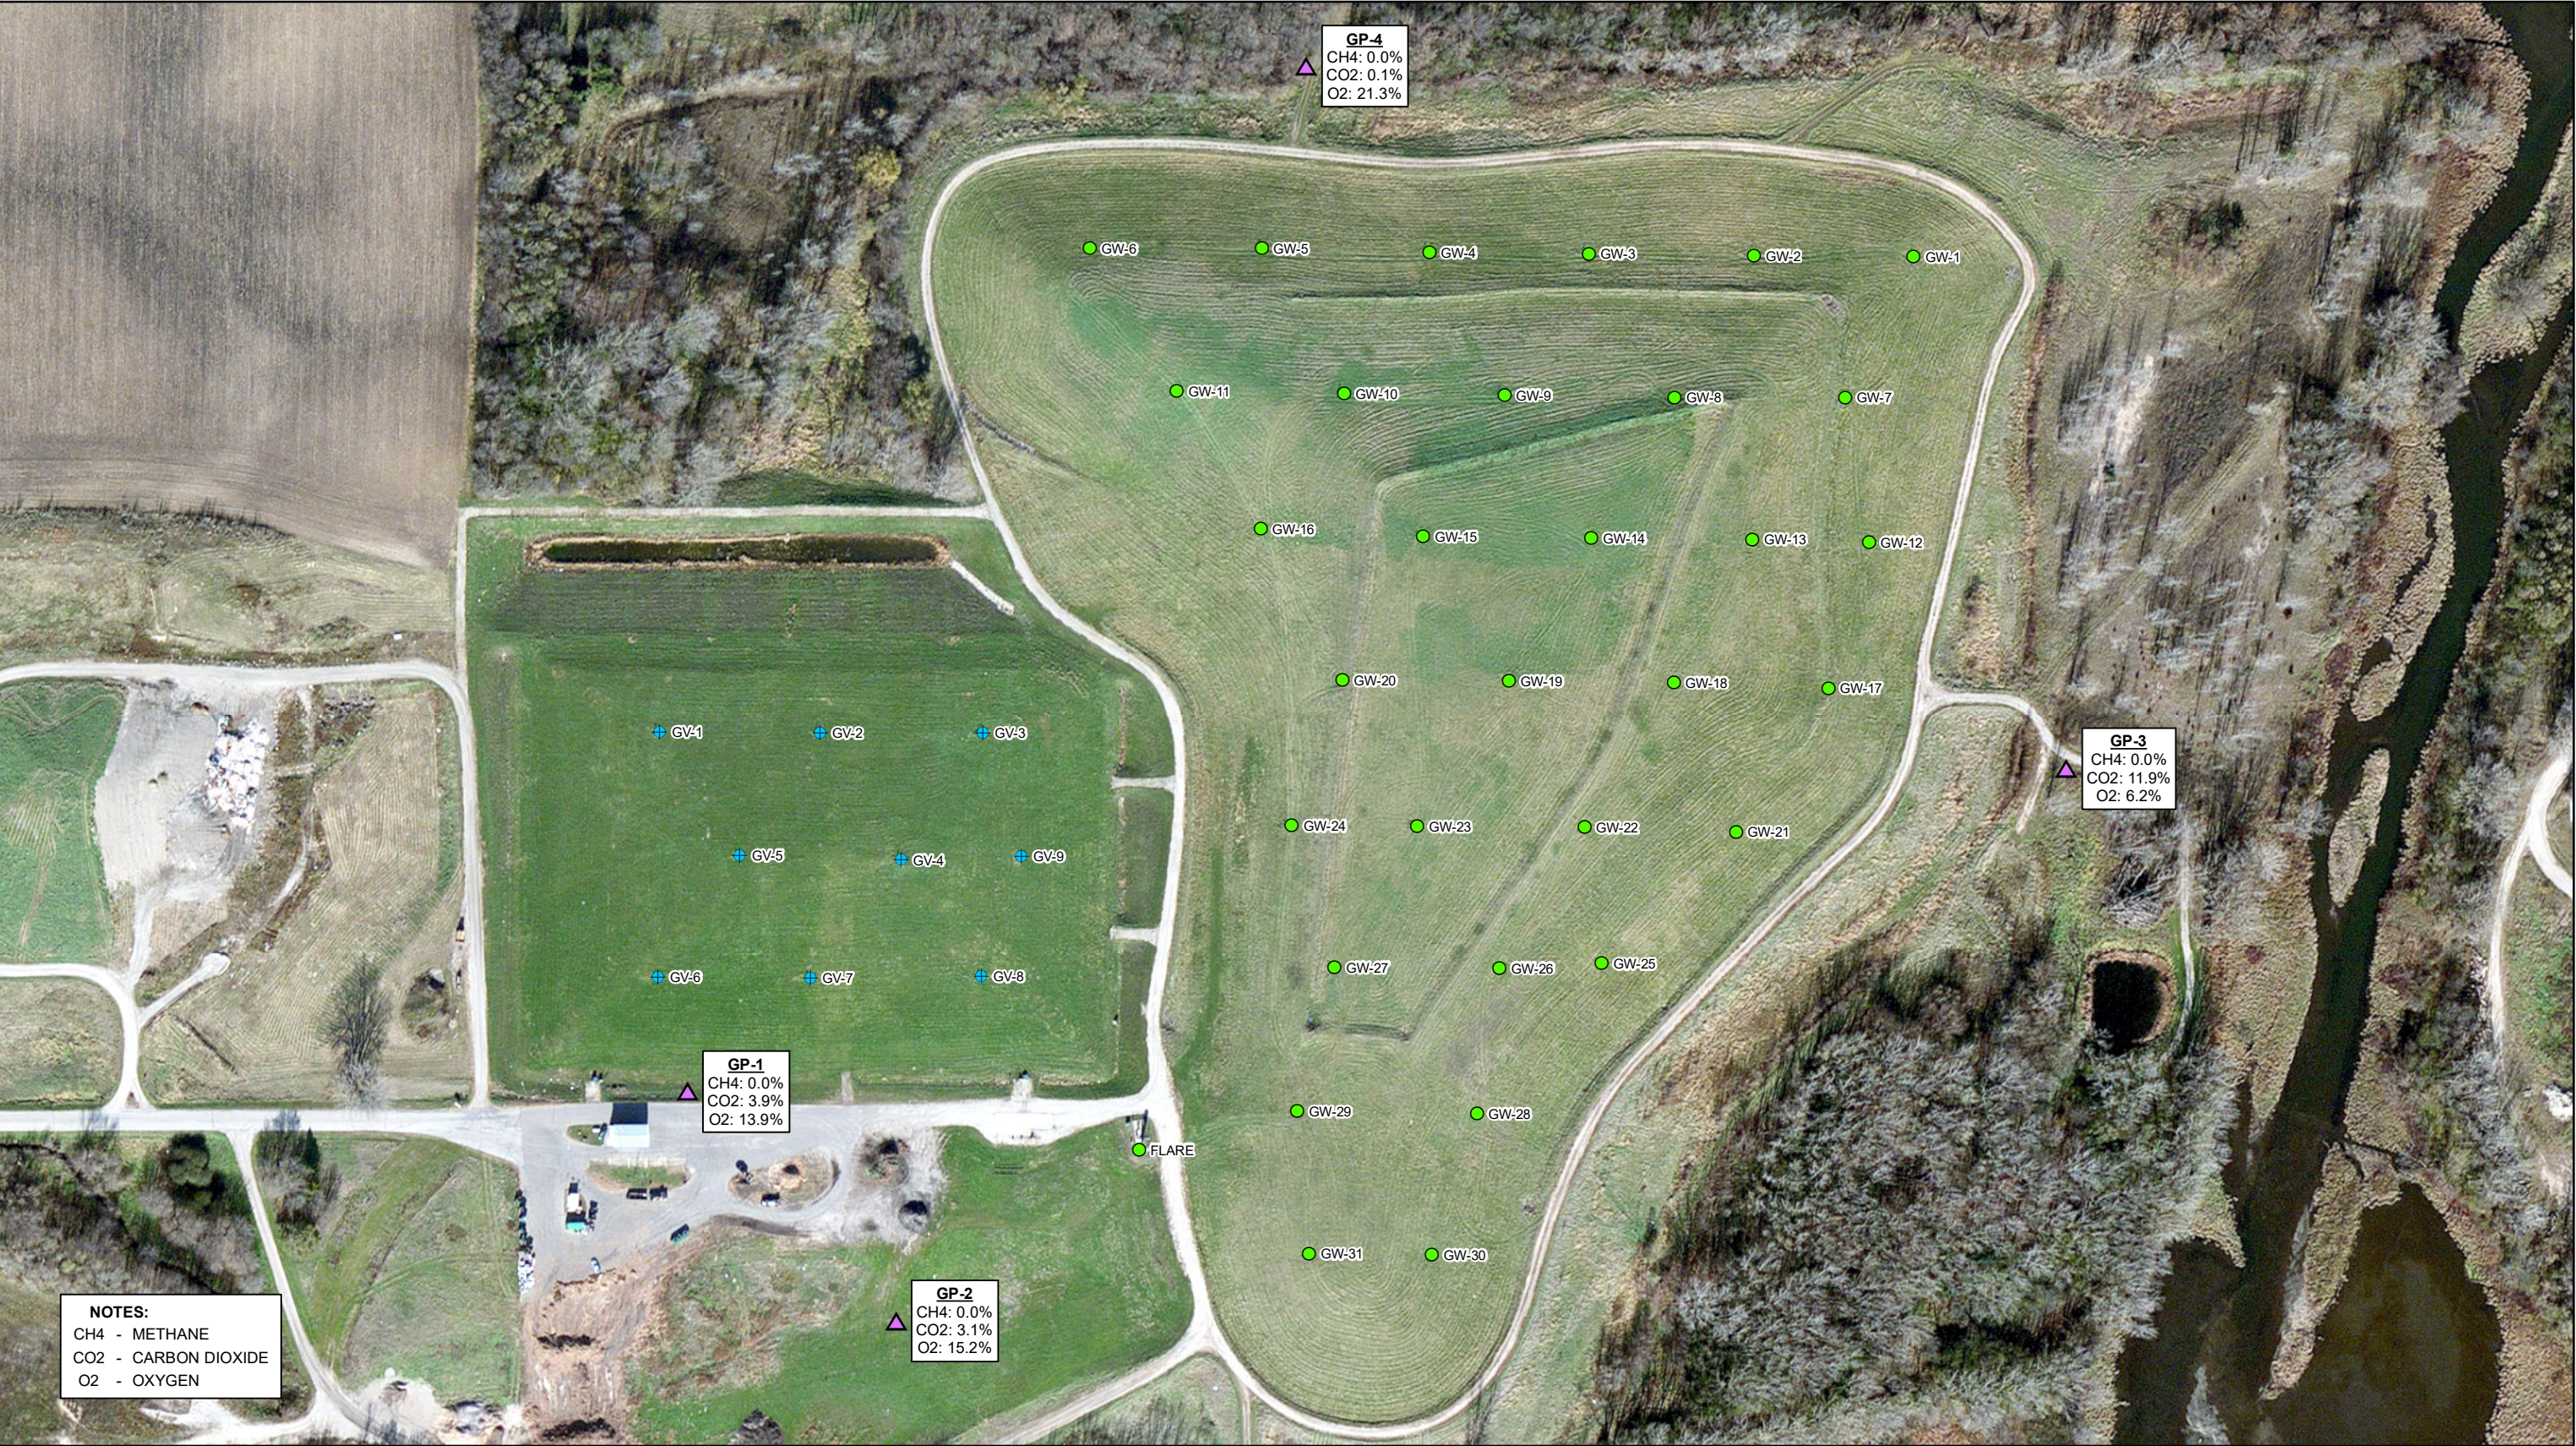
Methane was non-detect at all Site gas probes in the July 16, 2021 monitoring event. Gas probe data collected in the July 2021 monitoring round is shown on Figure 4 and provided in Table 4.
