Evaluation of the Effectiveness of Stop Lines in Increasing the Safety of Stop-Controlled Intersections

Minnesota Traffic Observatory

Research Project

Final Report 2020-17

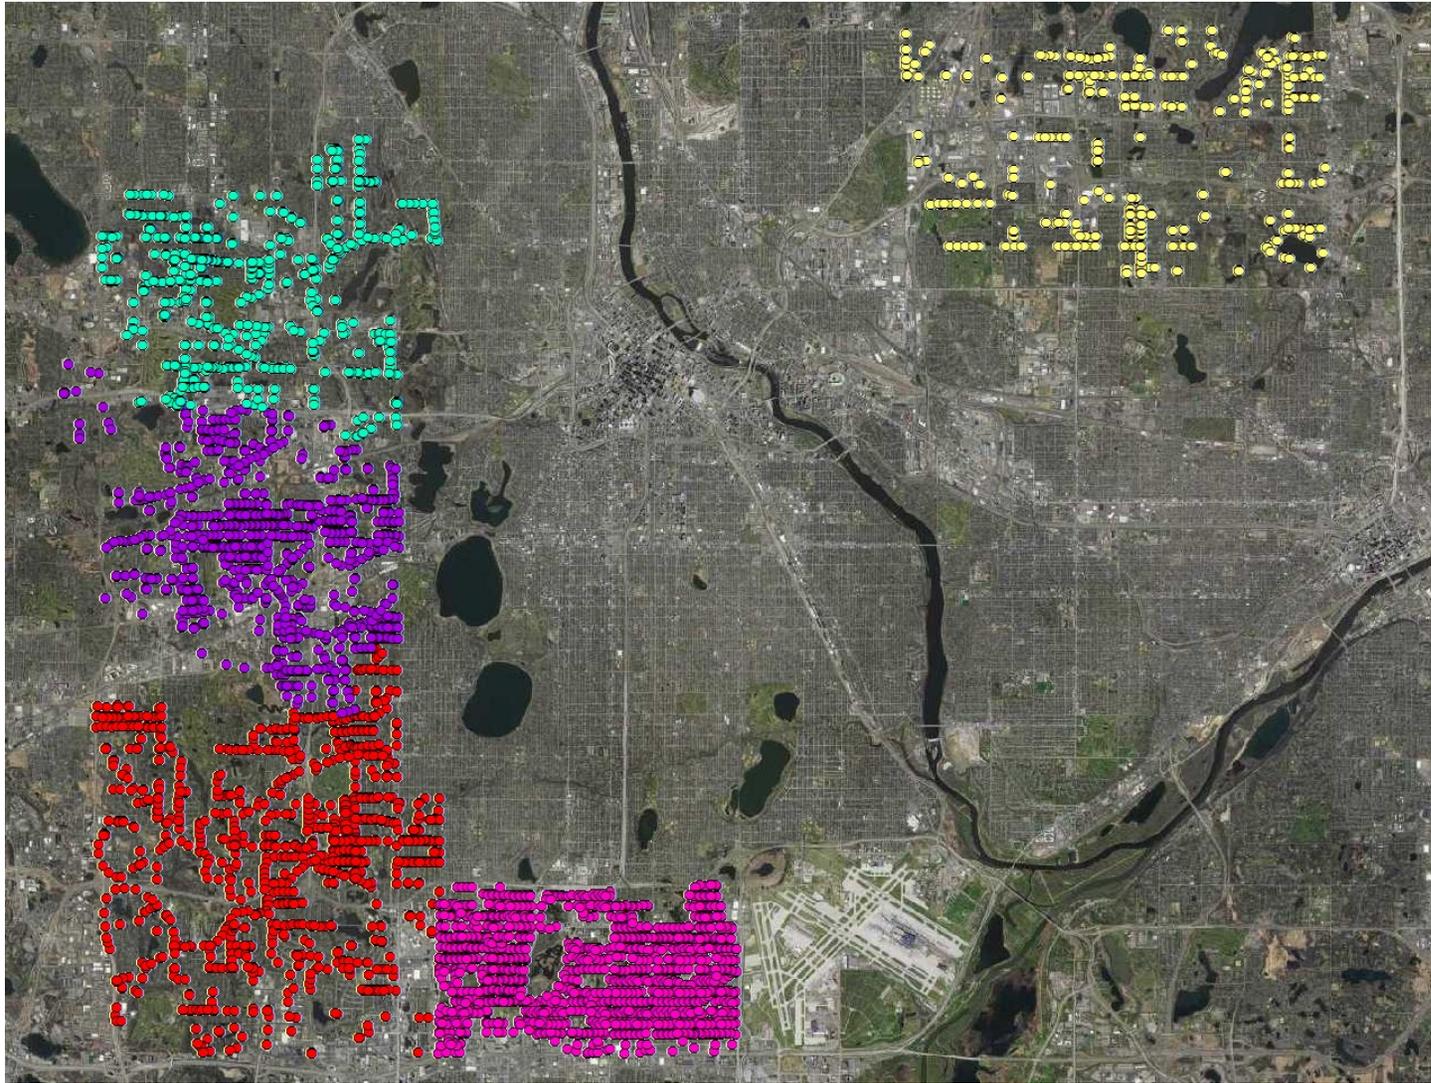
Figure 2.1 Stop sign markers for the five cities that provided data (clockwise from upper right: Roseville, Richfield, Edina, St. Louis Park, and Golden Valley)

Manual adjustments were made to the stop sign and intersection pins to improve the accuracy of the approach identification process. Adjustments of intersection pins consisted of moving the pins to be closer to the center of the intersection (according to the 2016 MnGeo aerial imagery) and adding or removing pins that were erroneously included or omitted during the site identification process. Cases of accidental inclusion or omission commonly involved private driveways that resembled public roads or one-way roads that resembled two-way roads. Adjustments to the stop sign markers consisted of deleting duplicates, adding missing markers, and moving existing markers to their positions relative to the intersection of the polylines on the road layer. The vector from the intersection node to the intersection pin was used later to translate other objects at the intersection.

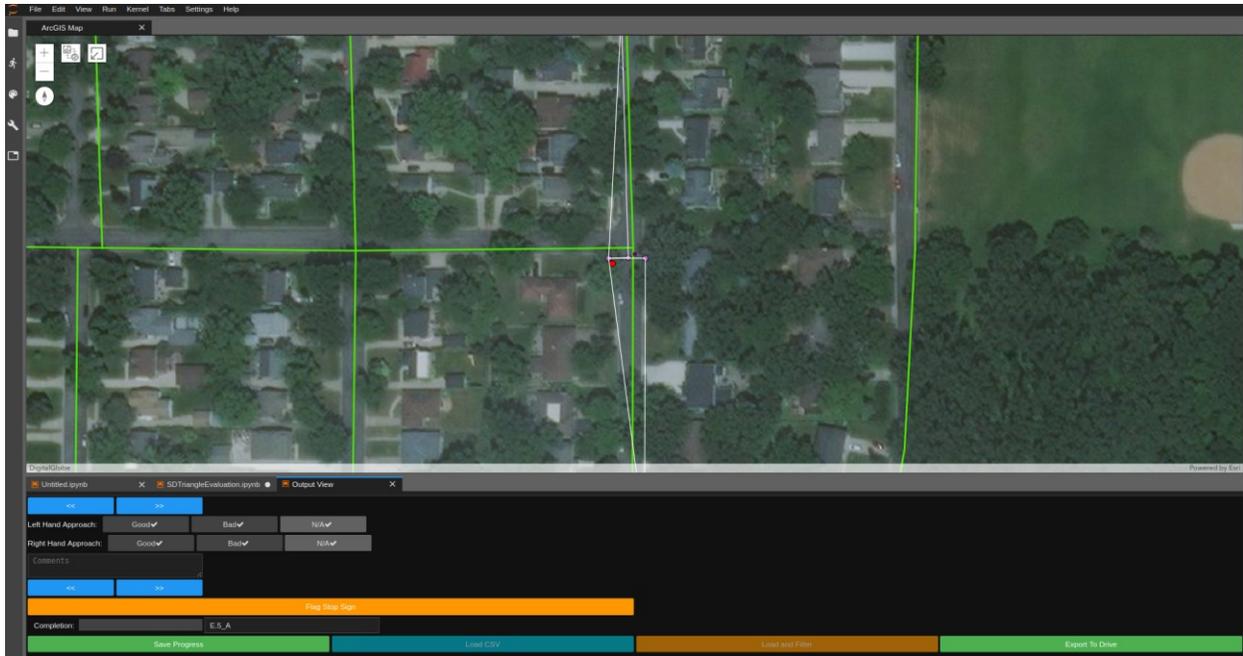
Figure 2.4 User interface of the program used to estimate the adequacy of the sight distances at each site

create the sight triangles is included in Appendix B. Required sight distance triangles were calculated for both the LHM and RHM approaches from the perspective of a driver stopped next to the stop sign. The required sight distance triangles were plotted on the MnGeo 2016 aerial imagery with the Streetnames layer polylines for reference (see Figure 2.4). The 2016 imagery was used because it was the highest quality imagery available that was taken when trees had leaves – a necessary condition for incorporating the impact of vegetation on visibility. A single member of the research team used the aerial images with the overlays to estimate whether the available sight distance for each existing major road approach was sufficient.

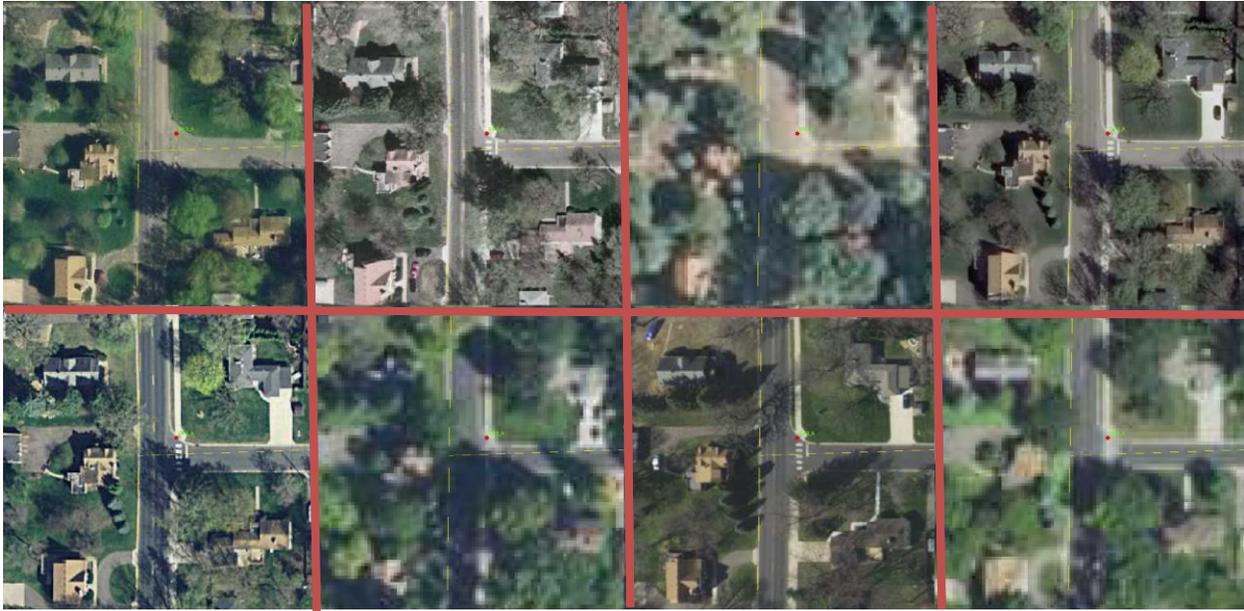
Figure 2.5 Aerial imagery mosaic (left to right, top: 2004, 2006, 2008, 2010; bottom: 2012, 2015, 2016, 2017)

To streamline the review of the MnGeo imagery, the research team created a program to take eight screenshots centered on each intersection in ArcMap – one for each of the available years of imagery. Street polylines and labelled stop sign markers were included to help identify each approach. The eight screenshots were then arranged in chronological order to form a mosaic like the example shown in Figure 2.5. For every approach, the presence of a stop line and the presence of a crosswalk on the near side of the major road was noted for each of the eight years shown in the mosaics. In some cases, the reviewer was unable to determine whether an image showed a crosswalk and/or a stop line due to an obstruction or low image quality. In those cases, the reviewer would look at the preceding and following images and determine whether the presence or lack of a stop line or crosswalk remained the same on either side of the year with the unclear stop sign and/or crosswalk presence. If there was no change on either side, the unclear stop sign and/or crosswalk presence was assumed to have remained constant, otherwise, the approach-year was flagged for further review using the Google imagery. Similarly, the presence of a stop line and/or crosswalk during the years not pictured in the mosaics was interpolated if possible and if not possible, the year was flagged for further review using the Google imagery. For example, the imagery from 2008 (top row, third from the left) in Figure 2.5 is too blurry to clearly see whether a stop line is present. The images from 2006 and 2010 (top row, second and fourth from the left, respectively) both show a stop line at the approach so it is assumed that a stop line would be present in 2008 as well. In 2004, the approach does not have a crosswalk or stop line but it does in 2006. As such, 2005 is flagged for further review.

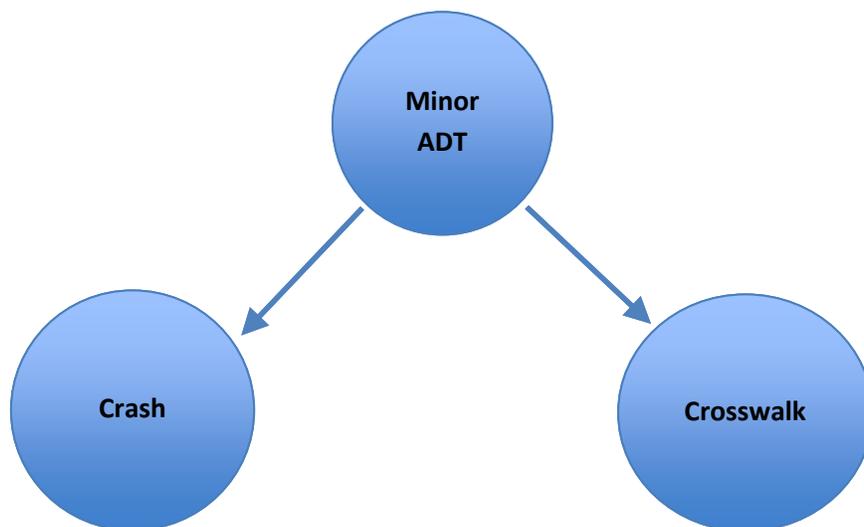
Figure 2.6 Example Causal Structure

As noted earlier, this study uses an observational, cross-sectional design. This type of design can identify correlations between an outcome measure (crash risk) and observed input measure, such as AADT or sight distance, but it cannot do by itself determine if the observed correlations indicate causal connections. For this, additional information, beyond what it is in the study, would be needed. In particular, a correlation between presence of crosswalks and crash occurrence cannot by itself be interpreted as indicating a causal effect. One definite possibility is that crosswalks tend to be installed at intersections having higher minor road traffic volumes. That is, the underlying causal pattern is given by Figure 2.6. Since intersections with more traffic on their minor roads create more opportunities for angle crashes than do those with low minor road volumes they will also tend to show higher crash frequencies, whether or not they have crosswalks. In this case the presence of crosswalk could simply be an indicator that that an intersection has higher minor road traffic.

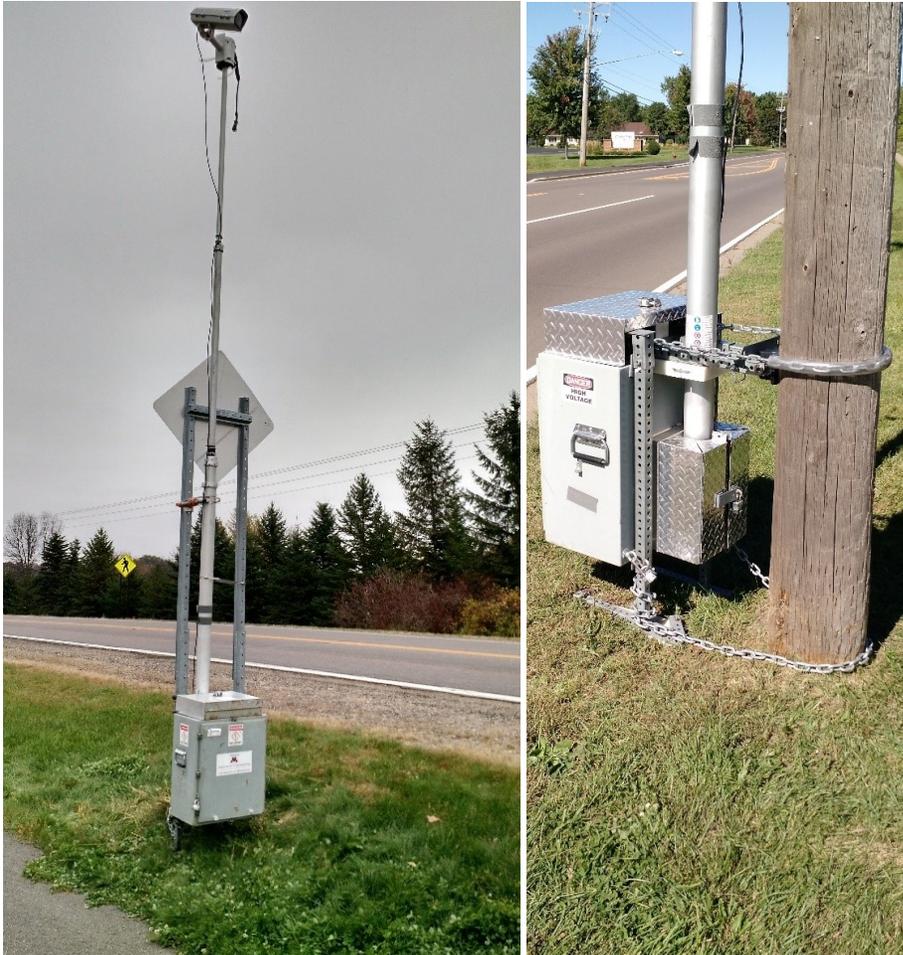
Figure 3.2 MTO camera systems braced on sign post (left) and utility pole (right)

The MTO used nine custom-built camera systems to collect video at the 15 intersections included in the study. The camera systems (shown in Figure 3.2) are self-contained systems include a high-resolution camera mounted to an extendable mast or directly to existing infrastructure via non-invasive steel bands. A weatherproof steel container houses recording equipment and independent battery power. The entire system attaches non-invasively to any conveniently placed pole or tree.

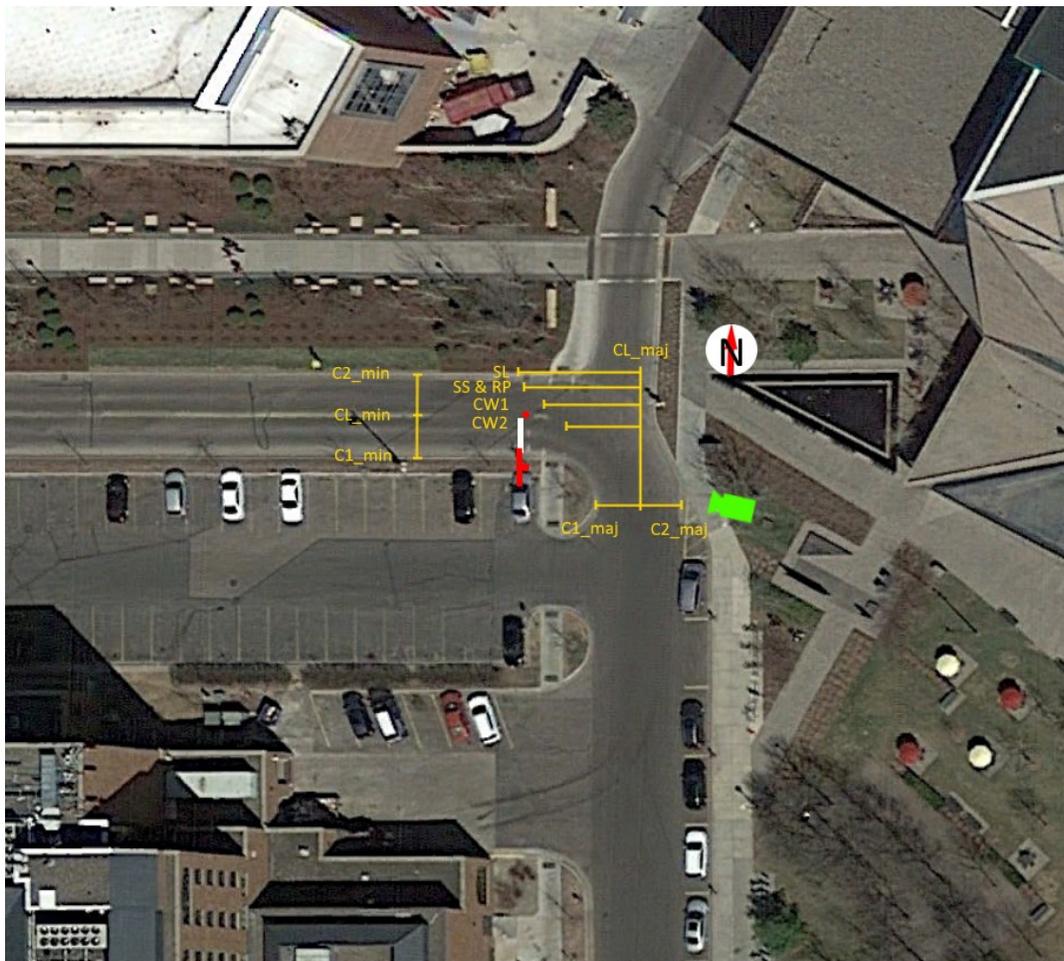
Figure 3.10 Aerial view of the intersection of Walnut St SE and Beacon St SE with measurements marked

The intersection of Walnut St SE and Beacon St SE is a T-intersection located in Minneapolis, on the University of Minnesota campus. Figure 3.10 shows an aerial view of the intersection annotated with key measurements. Figure 3.11 shows the camera view for the site. The site is somewhat unique in that Walnut St is a one-way road (NB) to the north of the intersection. Beacon St had a faded stop line and faded crosswalk prior to this project. Both Walnut St and Beacon St have observed ADTs of approximately 1000 vehicles. This site was chosen because of its unique geometry and proximity to the MTO, which allowed for it to be a testing ground for methods and equipment. The righthand available sight distance was adequate, unless vehicles occupied the parking lot immediately to the right of the intersection, in which case it fell short as seen in Figure 3.12.

Measurements noted on Figure 3.10 are listed in Table 3.11.

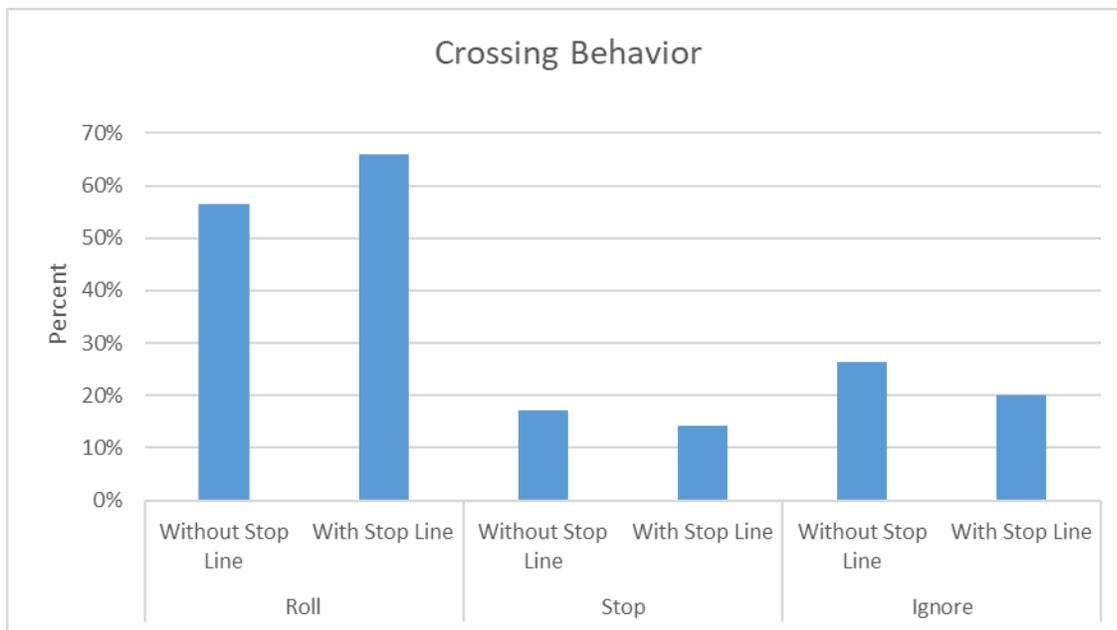
Figure 3.13 EB Beacon St SE distribution of driver crossing behavior as a percentage of all events pre- vs with-stop line

Following the addition of a stop line, EB Beacon St experienced an increase in roll events and decreases in stop and ignore events, as seen in Figure 3.13. Because the majority of drivers roll at this intersection, the impact of the stop line appears minimal. Additionally, the number of drivers ignoring the stop line is high as compared to other locations as well as an expected violation rate of ~5%. Additional information on the roll and ignore events captured by the UGRAs is presented in Figure 3.16.

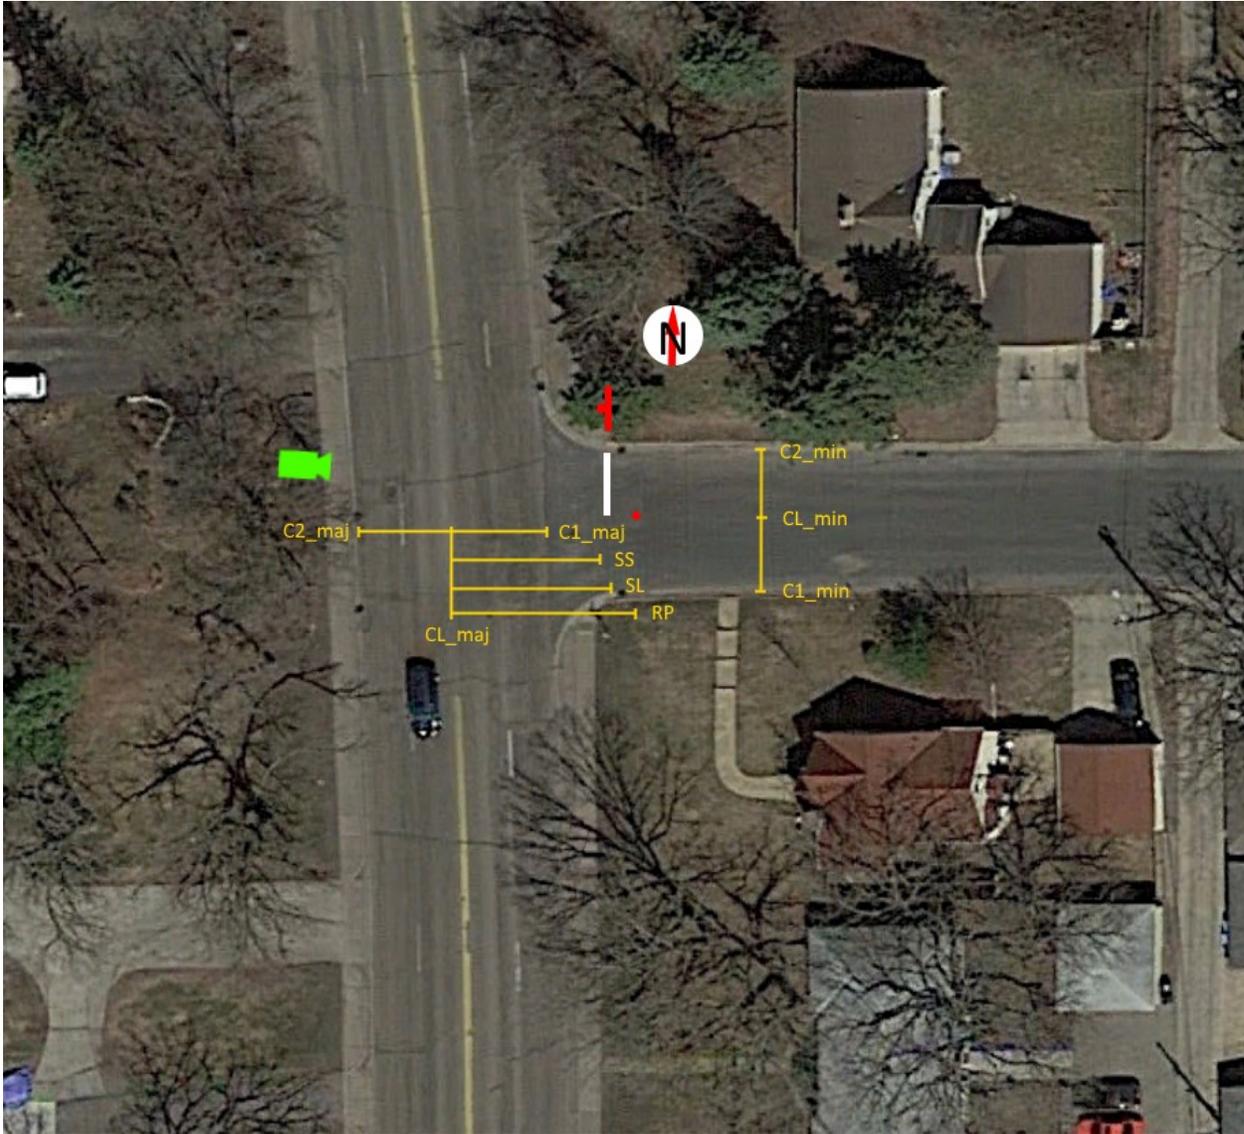
Figure 3.17 – Aerial view of the intersection of Lyndale Ave S and W 72nd St with measurements marked

Measurements noted on Figure 3.17 are listed in Table 3.12.

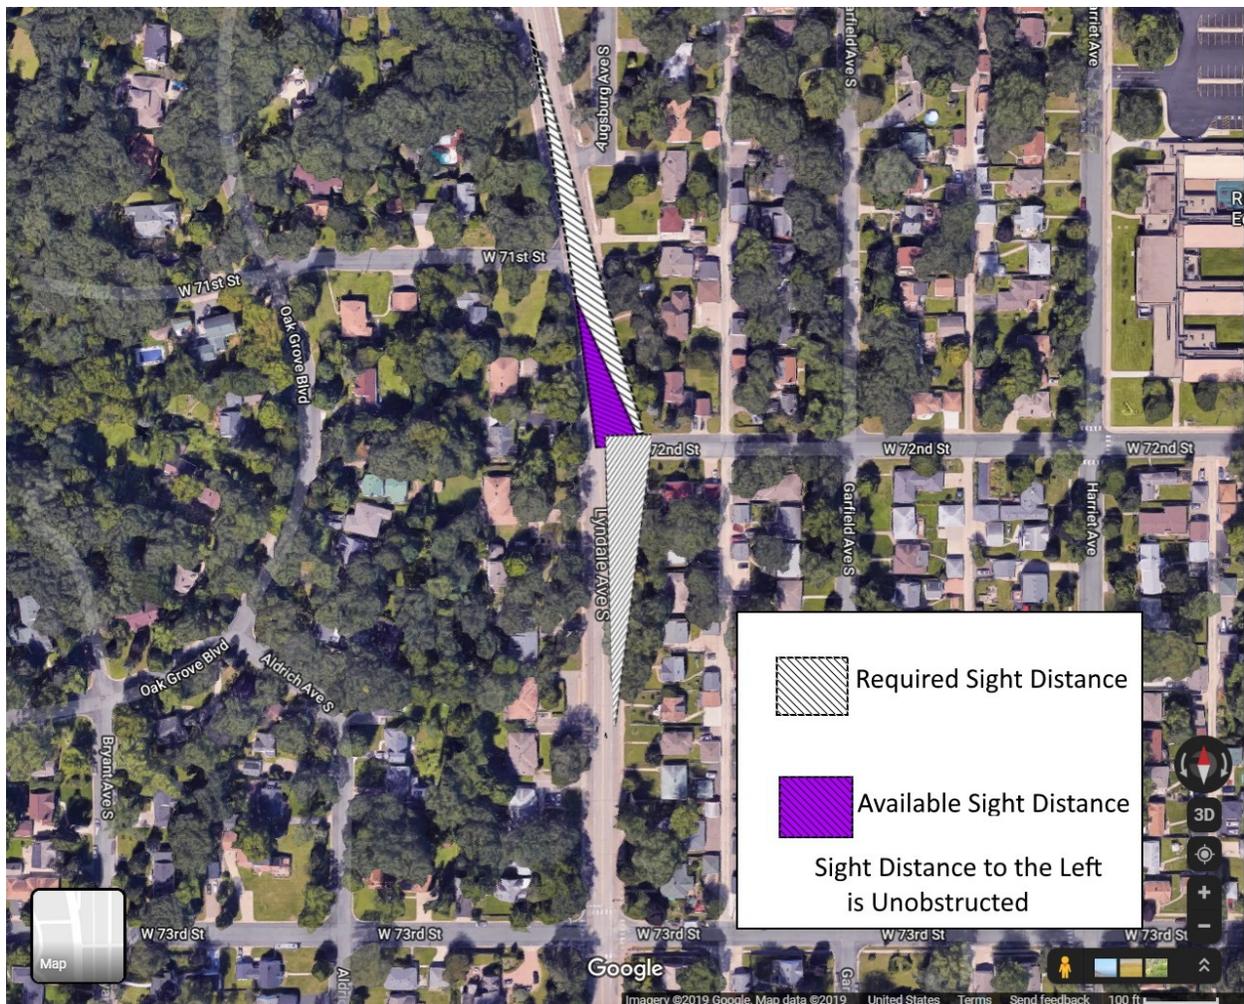
Figure 3.19 Available sight distance and required sight distance at Lyndale Ave S and W 72nd St

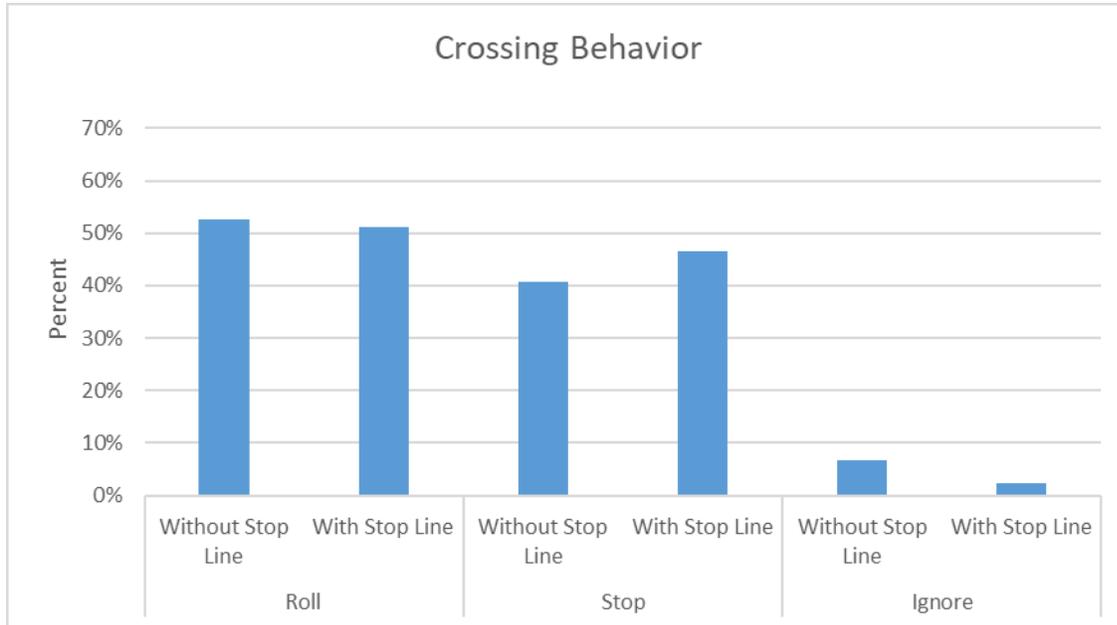
Figure 3.20 EB W 72nd St distribution of driver crossing behavior as a percentage of all events without vs with stop line

decrease in roll and ignore events and a minor increase in stop events, as seen in Figure 3.20. This is expected, as Lyndale Ave is a high AADT road, which forces drivers on 72nd St to stop and wait for a gap to make their movement. The poor visibility to the right also gives drivers a reason to stop. The number of drivers that ignore the stop sign is at generally accepted levels.

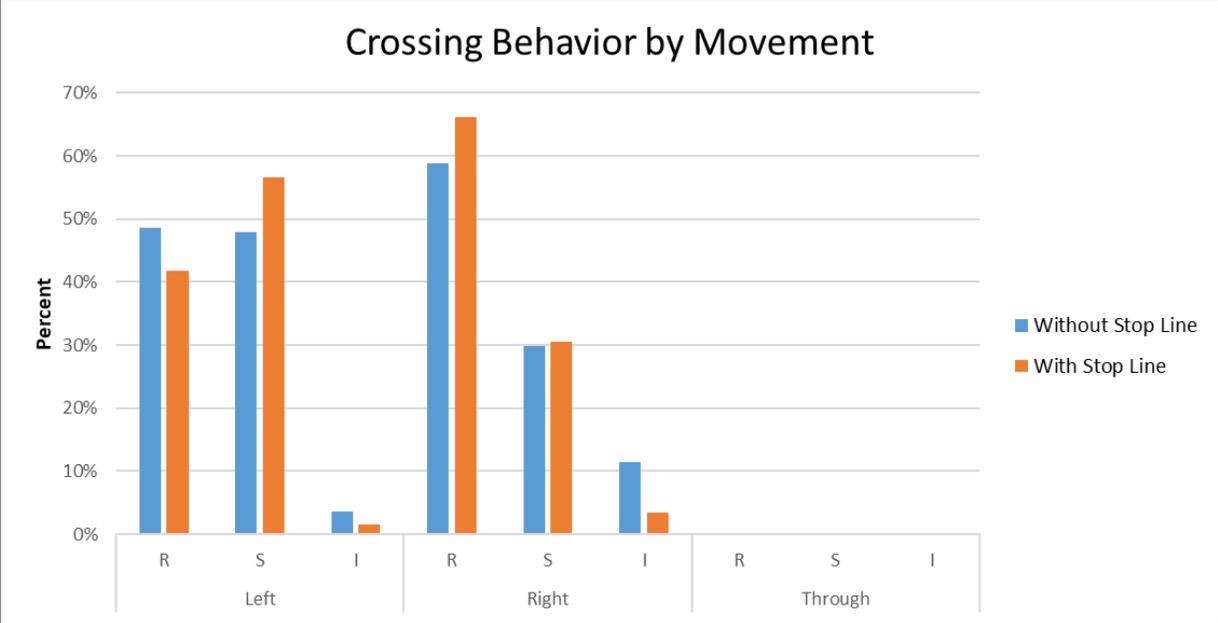
Figure 3.21 EB W 72nd St distribution of driver crossing behavior as a percentage of all events without- vs with - stop line, by driver movement

In difference, in left turning movement, which has a substandard sight distance to the right, the stop line seems to have made a change towards increasing the fraction of drivers that stop by reducing both rolls and ignores. These observations suggest a strong relationship between the effect of the stop line and the available sight distances.

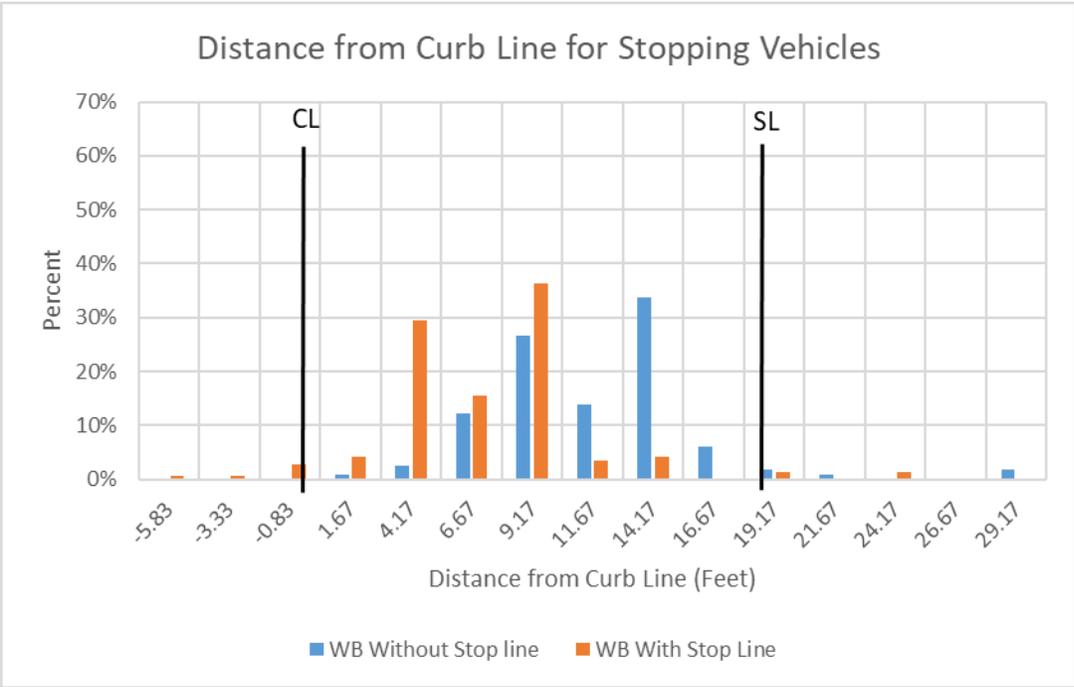
Figure 3.22 Lyndale Ave S and W 72nd St Distribution of Stopping Distance During Stop Events

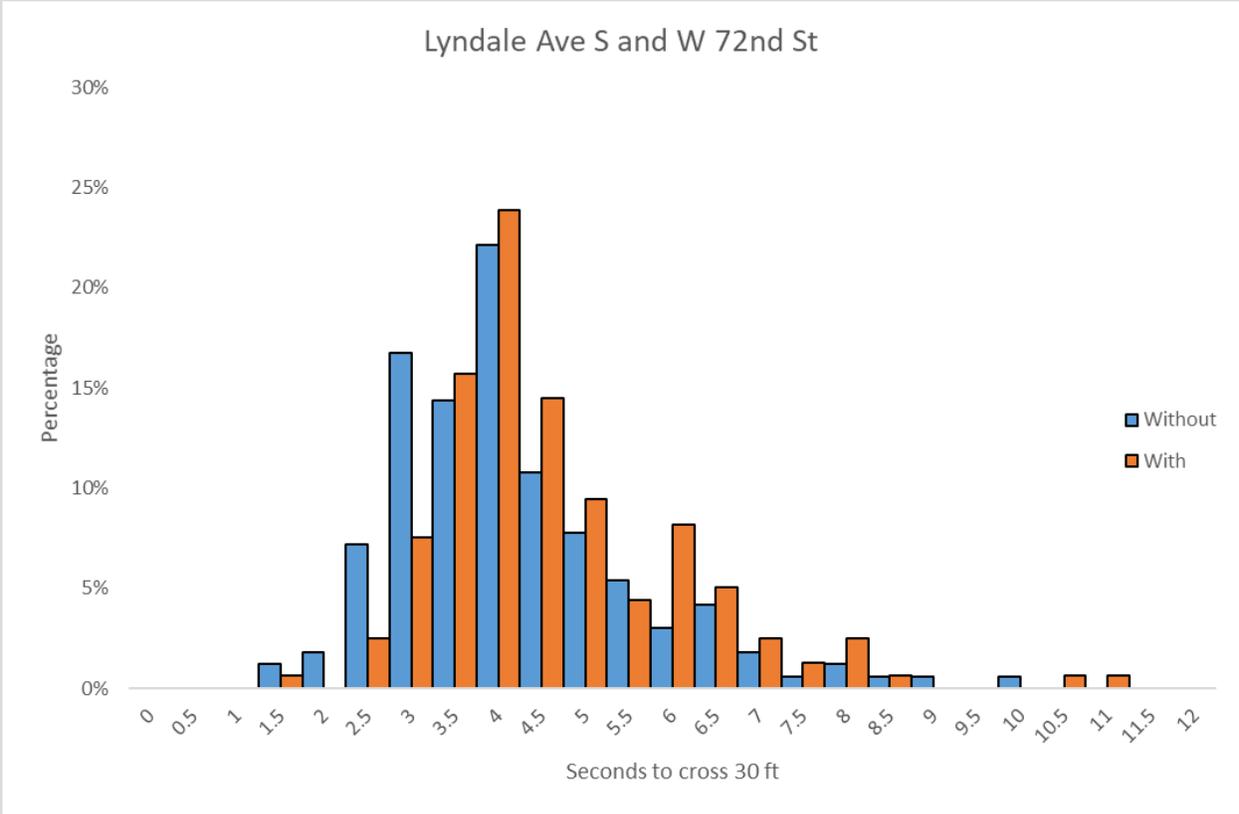
Figure 3.23 Lyndale Ave S and W 72nd St Histogram of Roll and Ignore behaviors, in seconds to travel 30 ft

Regardless, the suggestion here is that the stop line is in the wrong place since, at least from the driver's point of view, there is no satisfactory sight distance if they stop at the correct place. In addition, it may act as a visual cue to the driver to pull forward further towards the intersection, and further toward the point of collision. That said, the stop line did convince more left turning drivers to stop rather than roll and reduced the violations in right turning vehicles. This is further supported in Figure 3.23, where the average time to travel 30 feet increased by about 1 second after the placement of the stop line, meaning although drivers are continuing to roll through or ignore the stop line, they are slowing down more as they pass through the intersection. In the same figure we also see a large reduction in the smallest travel times, supporting the observation of the shift from ignores to rolls for right-turning vehicles.

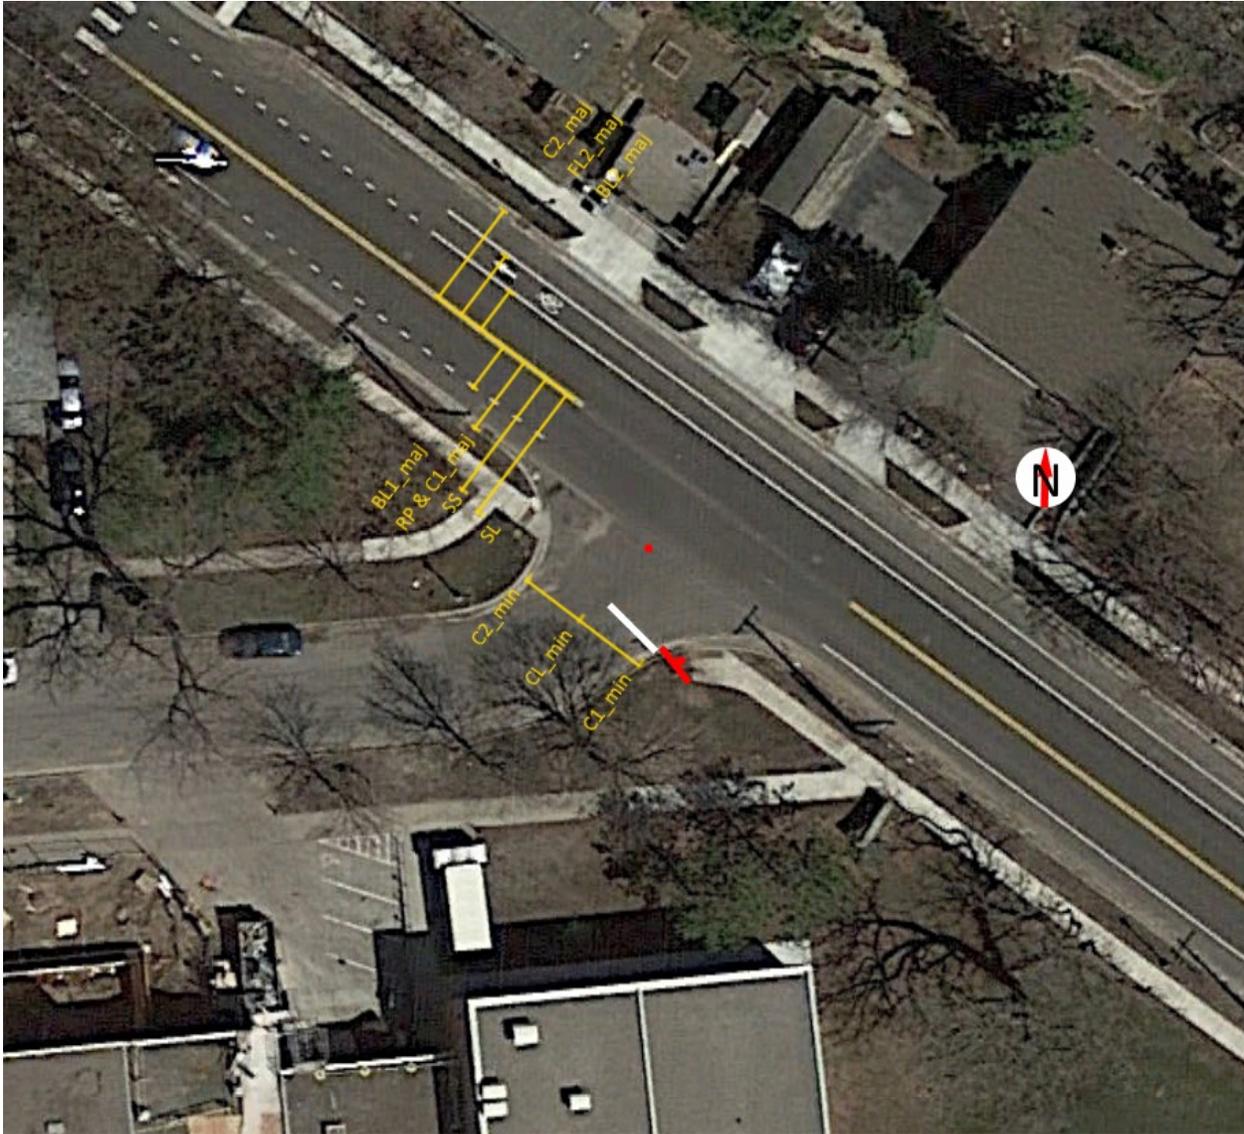
Figure 3.24 Aerial view of the intersection of Como Ave and Knapp St with measurements marked

An aerial view of the site is provided in Figure 3.24. A camera view with overlay lines marked is shown in Figure 3.25. During the summer months, sight distance to the left is obscured by foliage, and sight distance to the right is limited due to the upward grade on Como Ave, as seen in Figure 3.26.

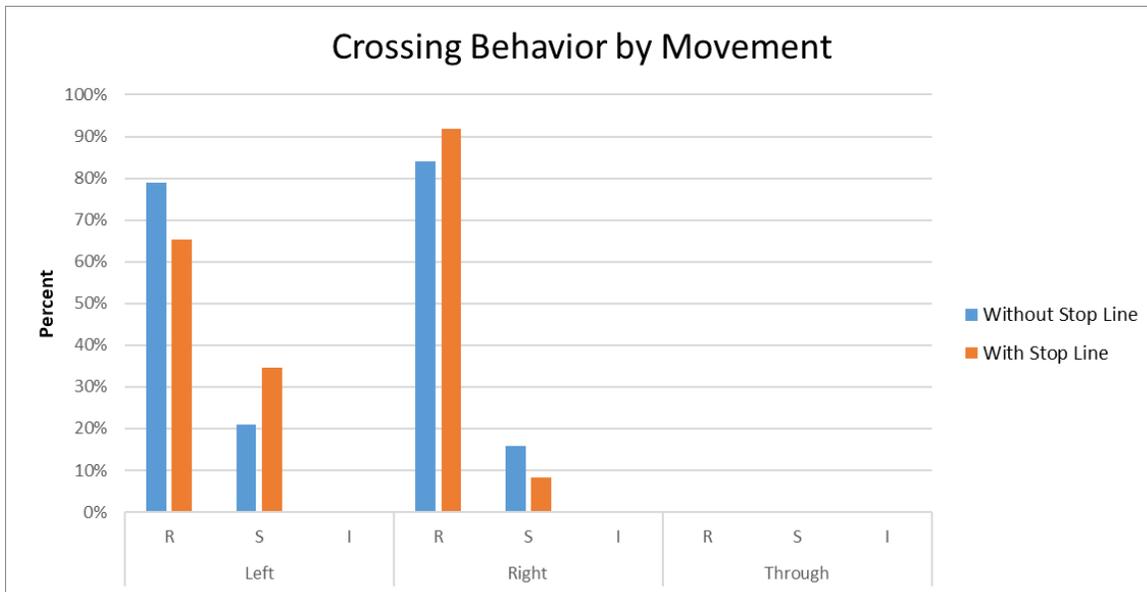
Figure 3.28 EB Knapp St distribution of driver crossing behavior as a percentage of all events without- vs with-stop line, by driver movement

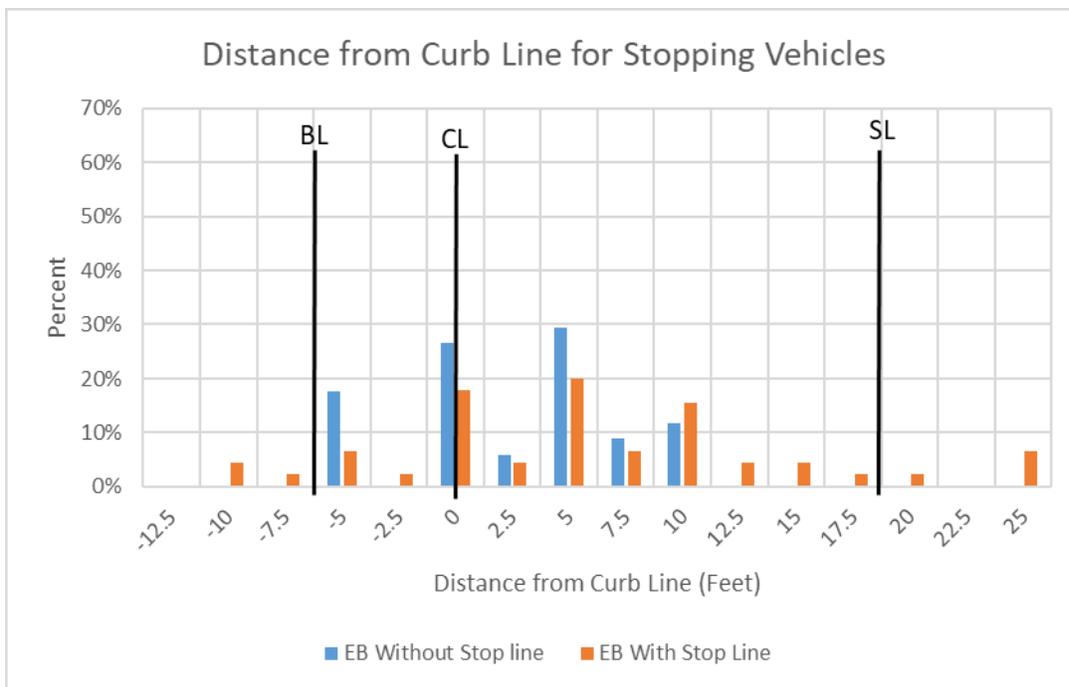
Figure 3.29 Como Ave and Knapp St Distribution of Stopping Distance During Stop Events

As seen in Figure 3.29, without the stop line, most drivers stopped at the curb line or even more toward the centerline, with their front tires into the bike lane. After the placement of the stop line, the distribution of stop locations flattened, and drivers appear to be stopping farther behind the curb line. It is important to highlight here that, given that the vast majority of the rolls over the stops, this graph is based only on an approximately 15% of the observations, predominantly left turning movements. This differs from the earlier site, where the ratio between rolls and stops was closer to 1.

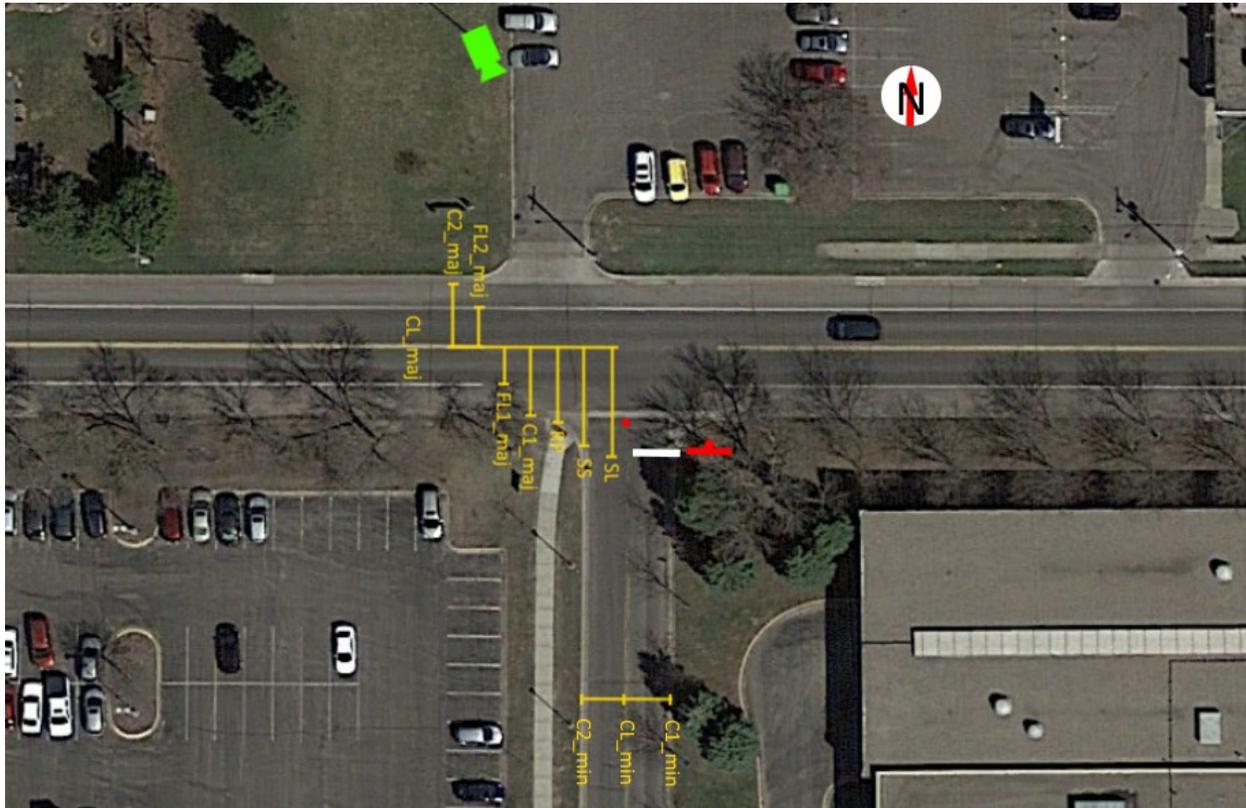
Figure 3.31 Aerial view of the intersection of Woodhill Dr and Civic Center Dr with measurements marked

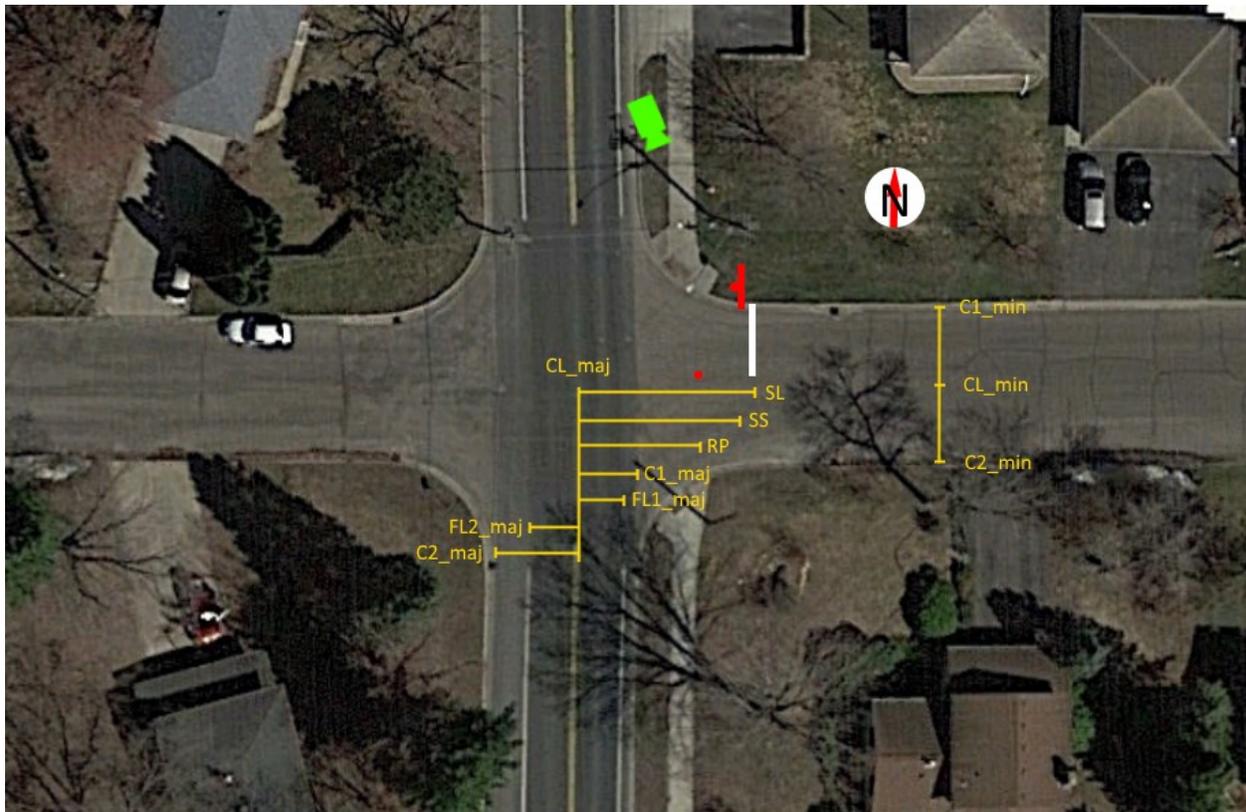
Figure 3.38 Aerial view of the intersection of Dale St N and Iona Ln with measurements marked

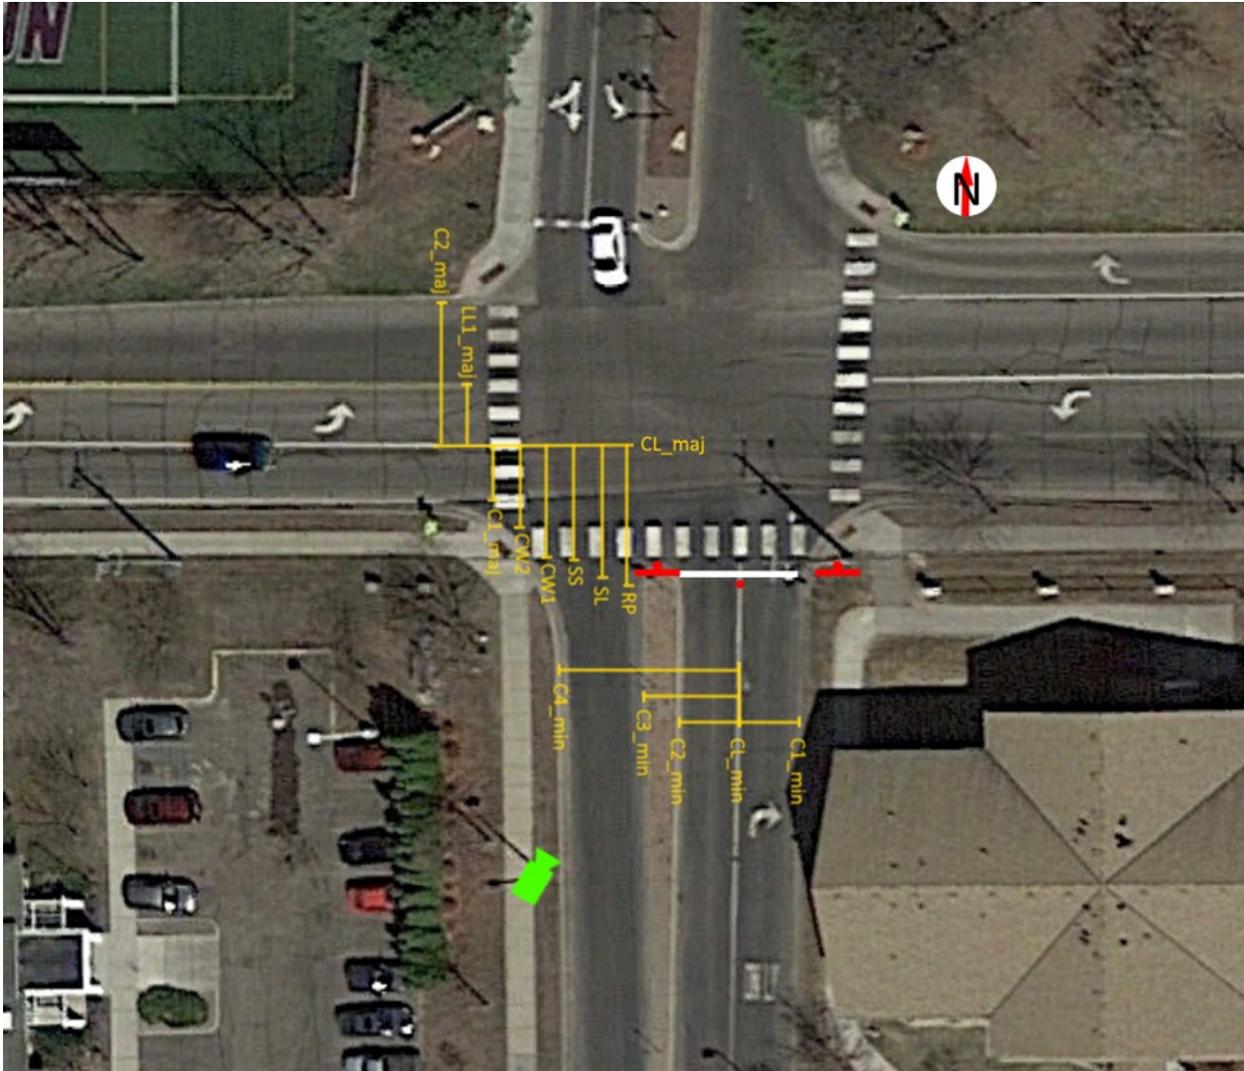
Figure 3.45 Aerial view of the intersection of Lincoln Dr and Lydia Ave W with measurements marked

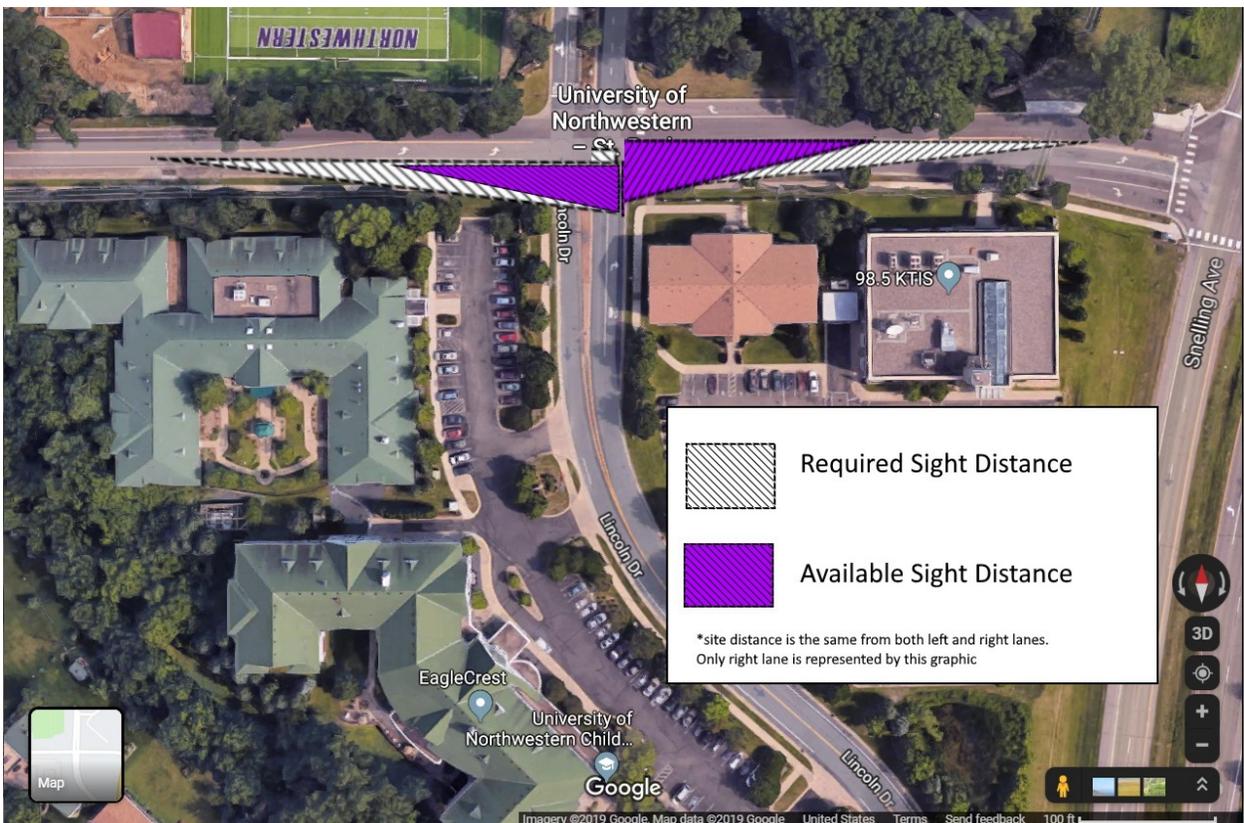
Figure 3.47 Available sight distance and required sight distance at Lincoln Dr and Lydia Ave W, for both left and right lane
