Evaluation of the Effectiveness of Stop Lines in Increasing the Safety of Stop-Controlled Intersections

Minnesota Traffic Observatory

Research Project

Final Report 2020-17

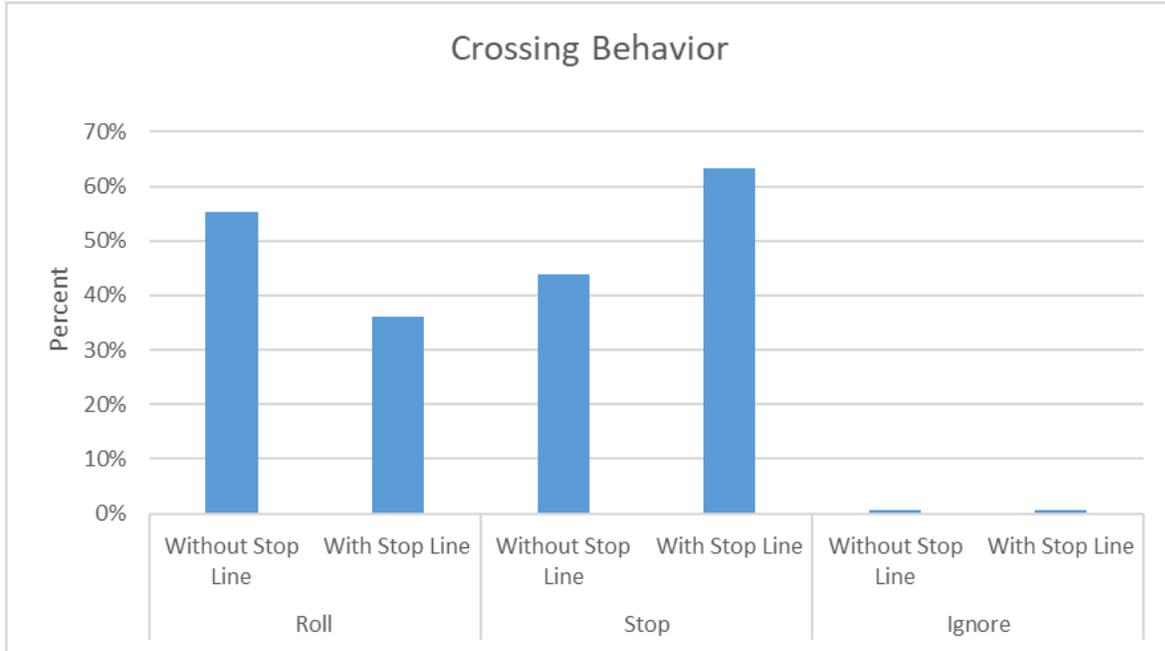
Figure 3.48 Lincoln Dr Left Lane distribution of driver crossing behavior as a percentage of all events without- vs with-stop line

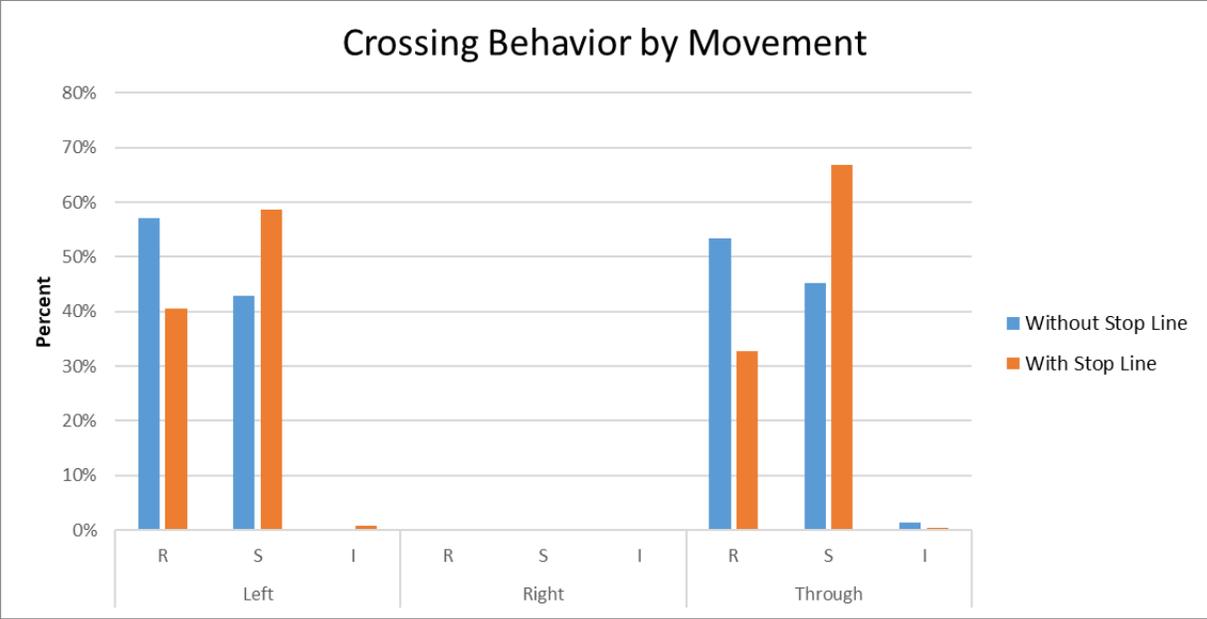
Figure 3.49 Lincoln Dr Left Lane distribution of driver crossing behavior as a percentage of all events without- vs with-stop line, by driver movement

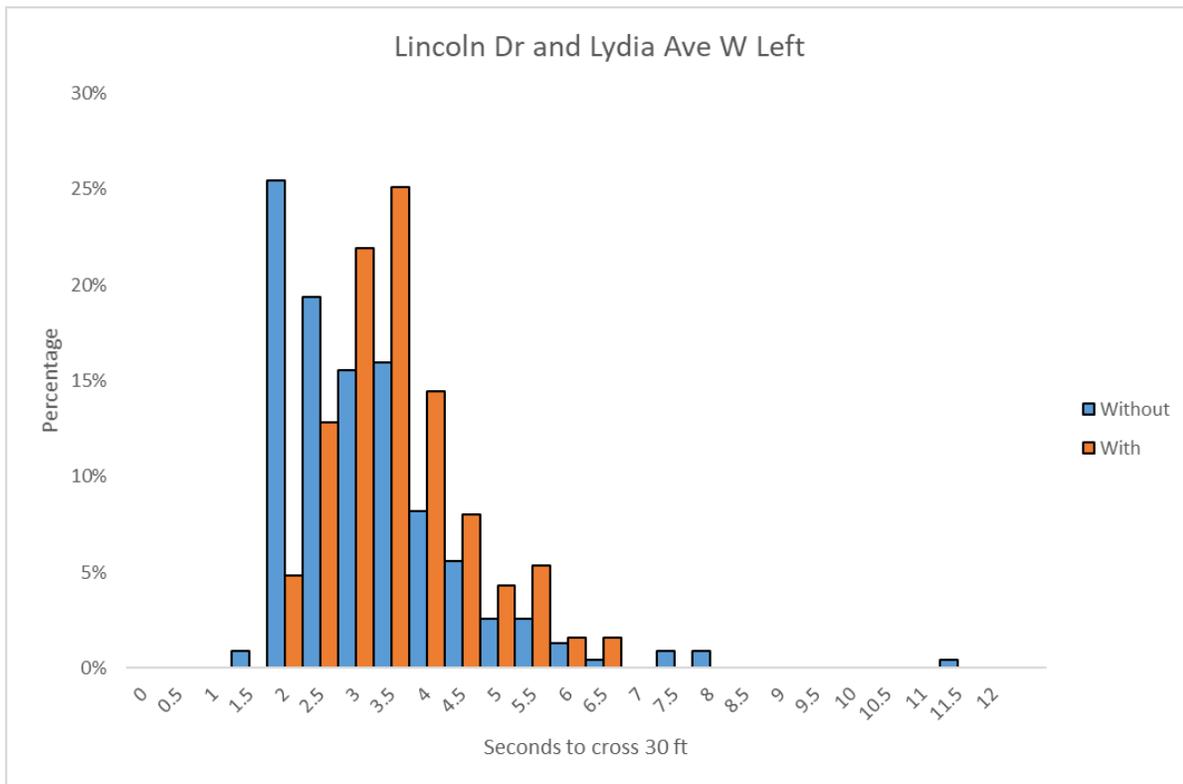
Figure 3.51 Lincoln Dr Left Lane Histogram of Roll and Ignore behaviors, in seconds to travel 30 ft

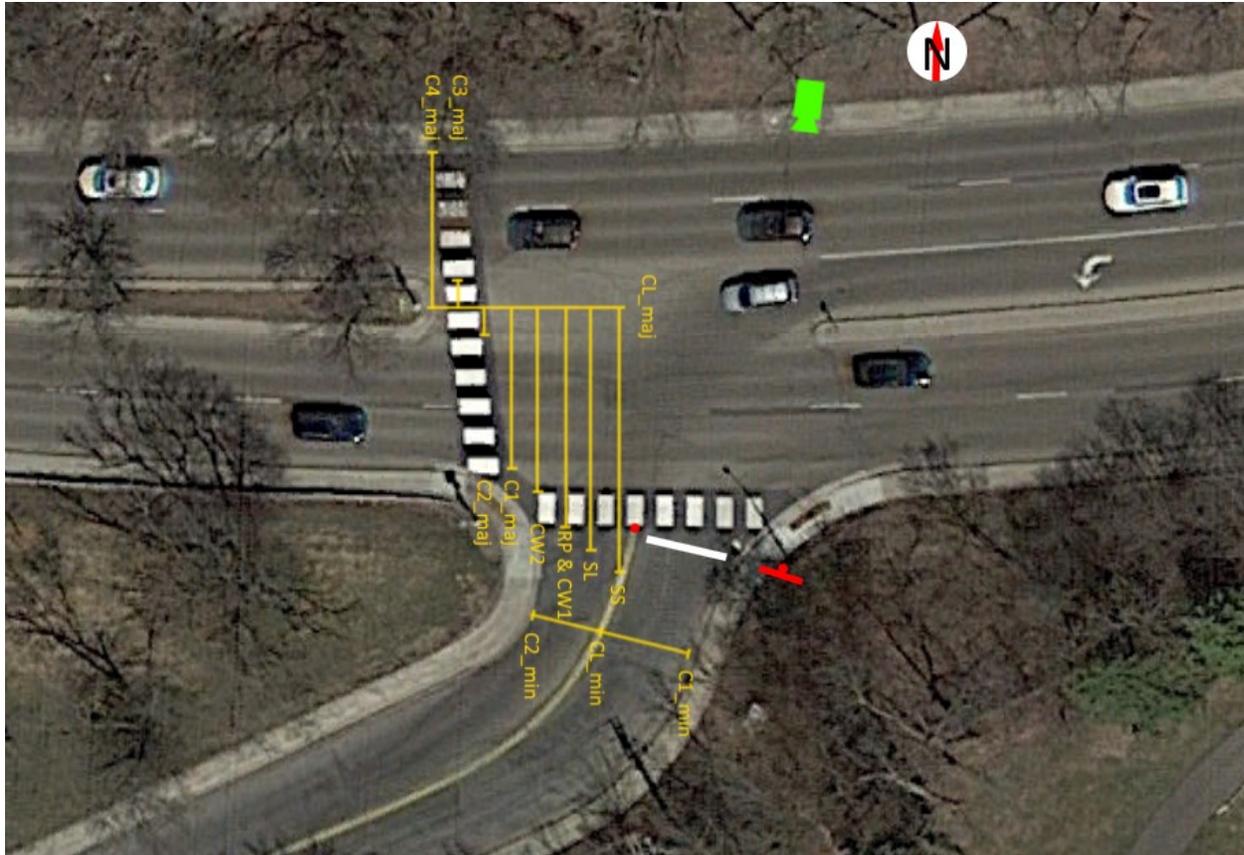
Figure 3.55 Aerial view of the intersection of 50th St W and Eden Ave with measurements marked

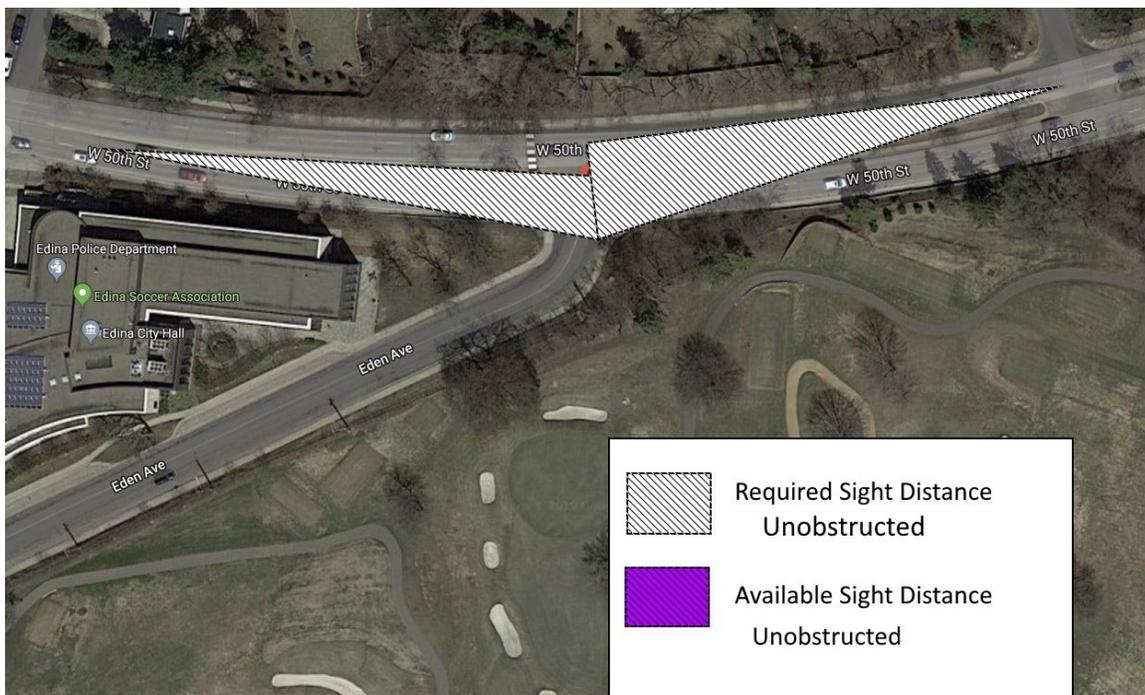
Figure 3.57 Available sight distance and required sight distance at 50th St W

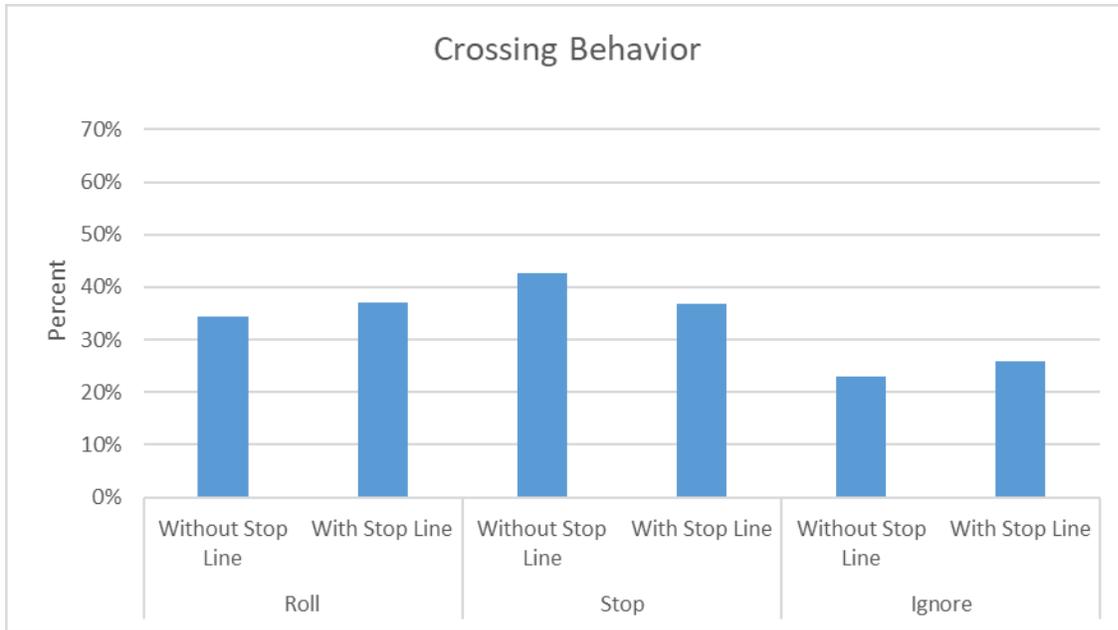
Figure 3.58 50th St W and Eden Ave distribution of driver crossing behavior as a percentage of all events without- vs with-stop line

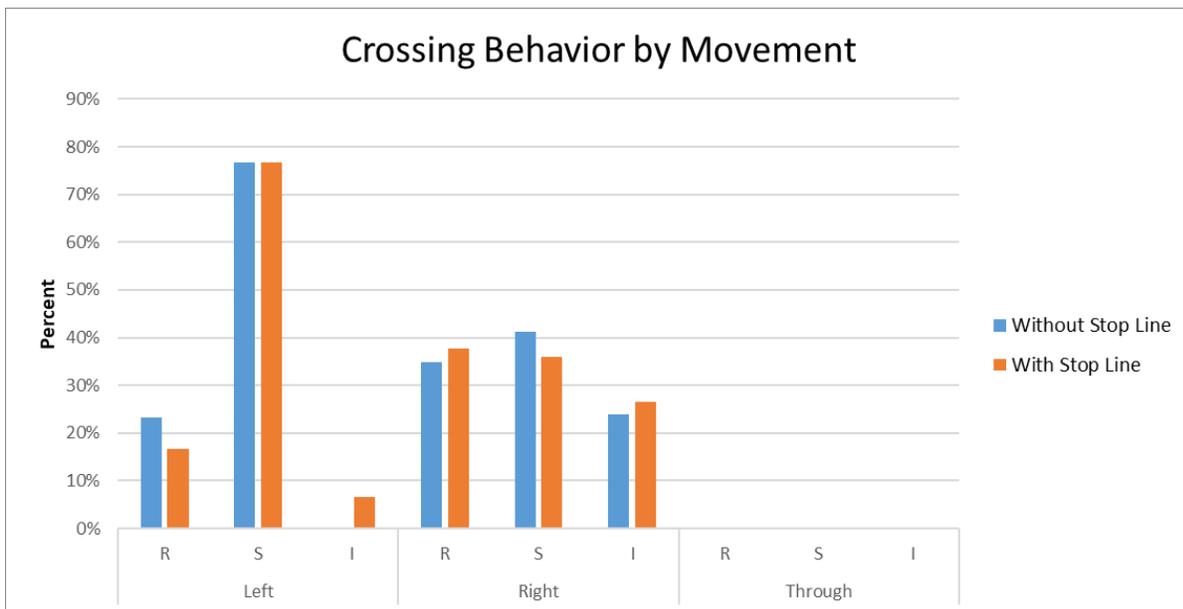
Figure 3.59 50th St W and Eden Ave distribution of driver crossing behavior as a percentage of all events without- vs with-stop line, by driver movement

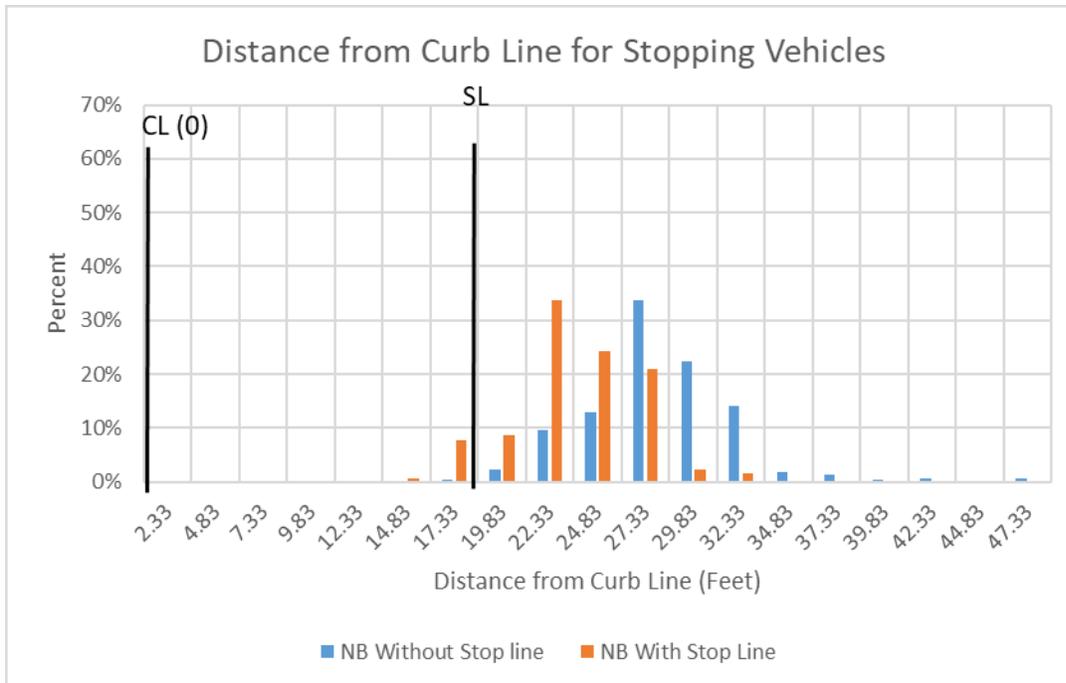
Figure 3.60 50th St W and Eden Ave Distribution of Stopping Distance During Stop Events

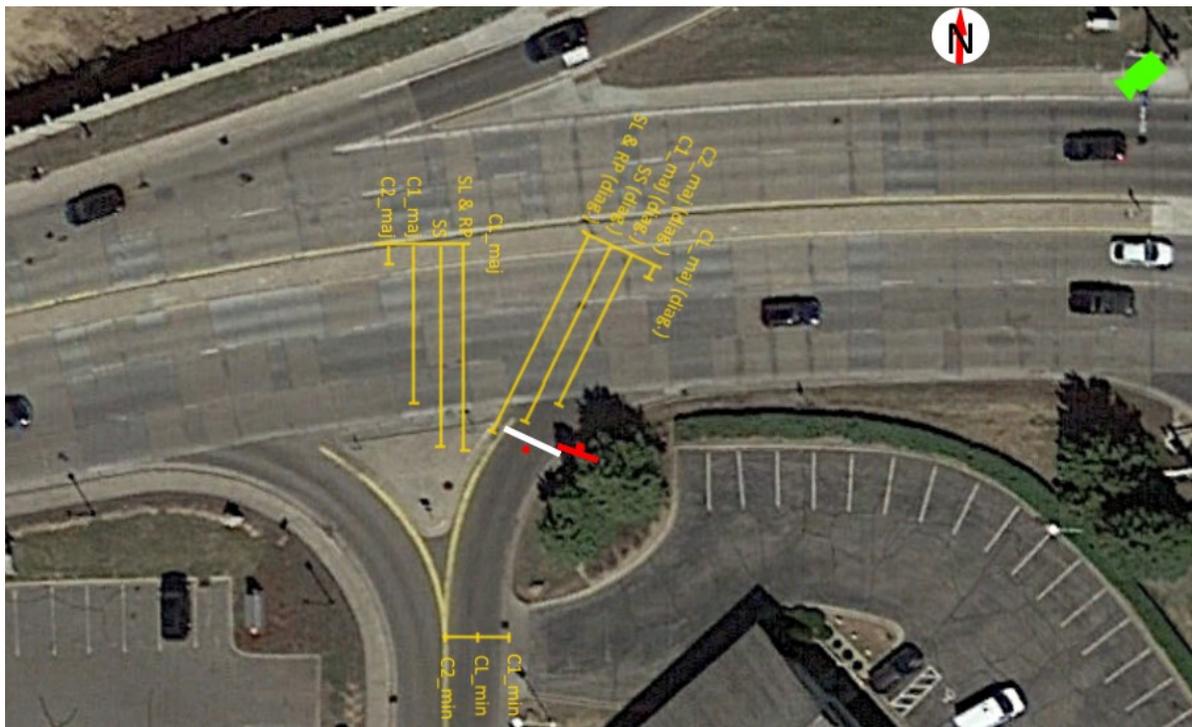
Figure 3.62 Aerial view of the intersection of Vernon Ave S and Arcadia Ave with measurements marked

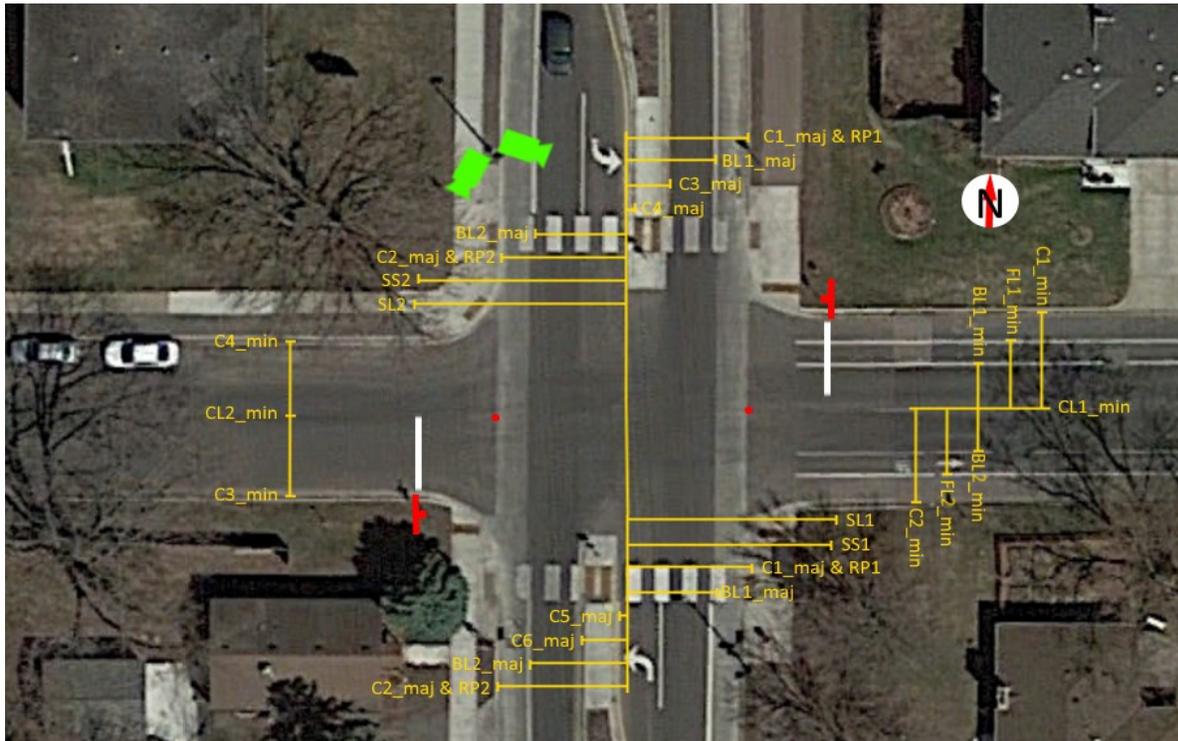
Figure 3.68 Aerial view of the intersection of Portland Ave and E 73rd St with measurements marked

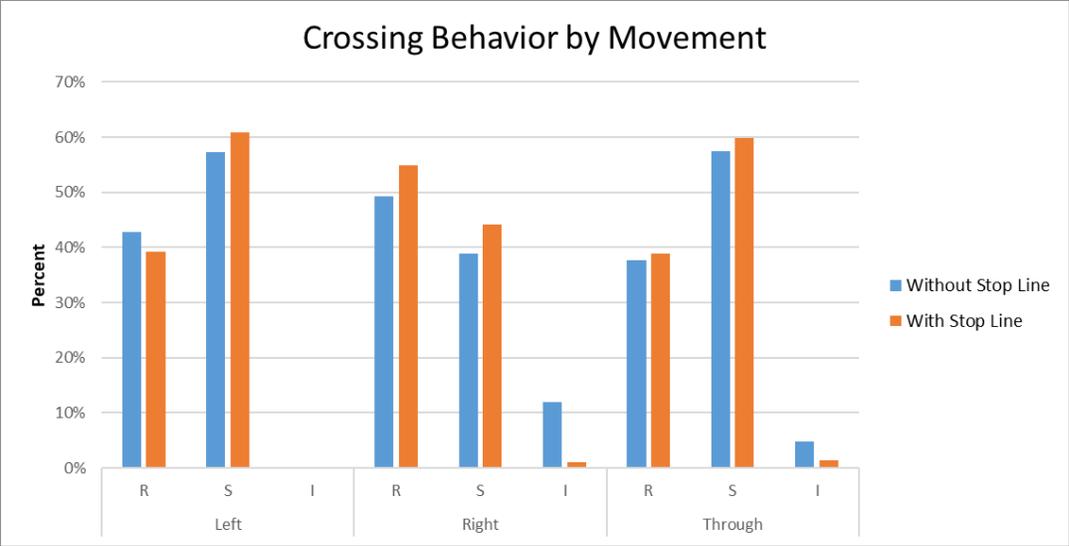
Figure 3.72 Portland Ave and 73rd St EB distribution of driver crossing behavior as a percentage of all events without- vs with-stop line, by driver movement

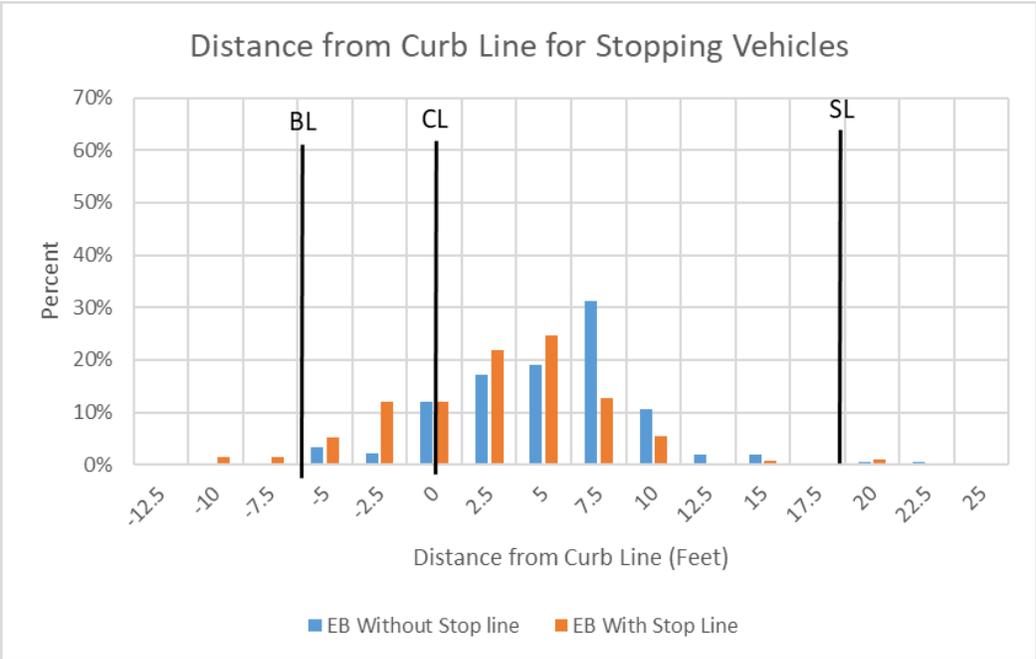
Figure 3.73 Portland Ave and E 73rd St EB Distribution of Stopping Distance During Stop Events

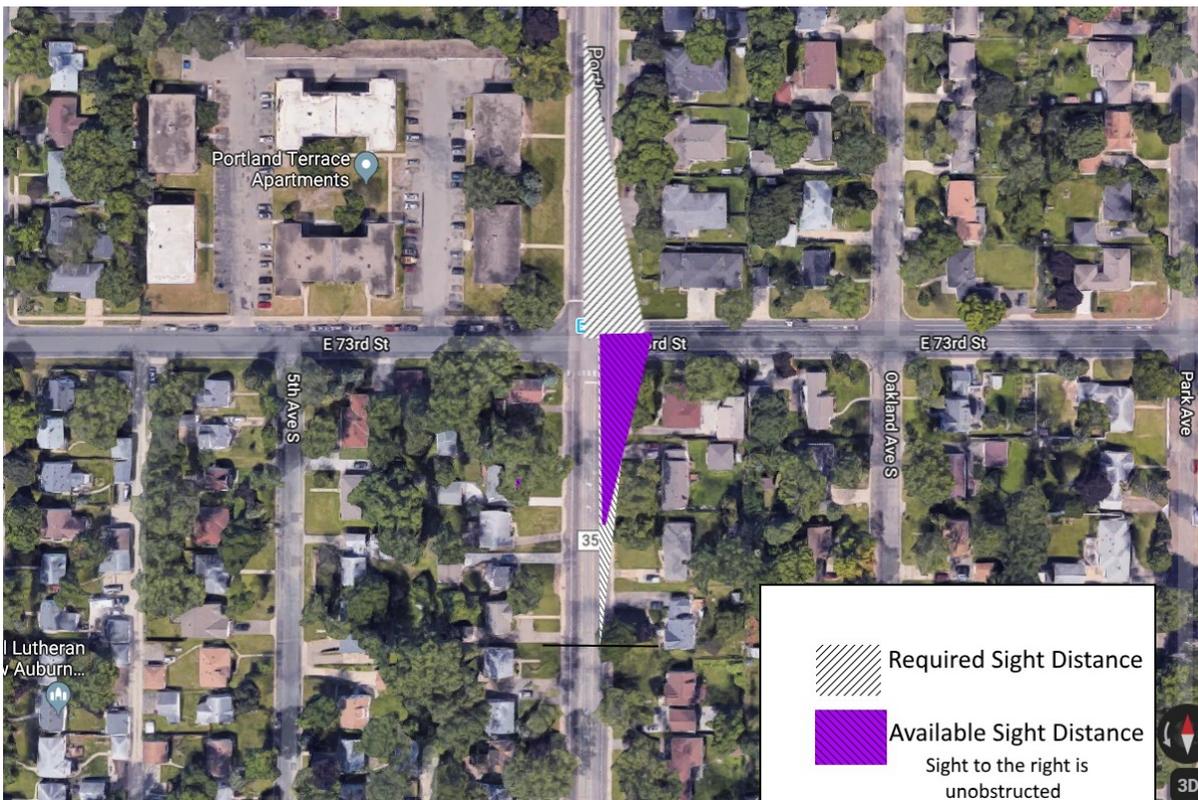
Figure 3.76 Available sight distance and required sight distance at Portland Ave and E 73rd St WB

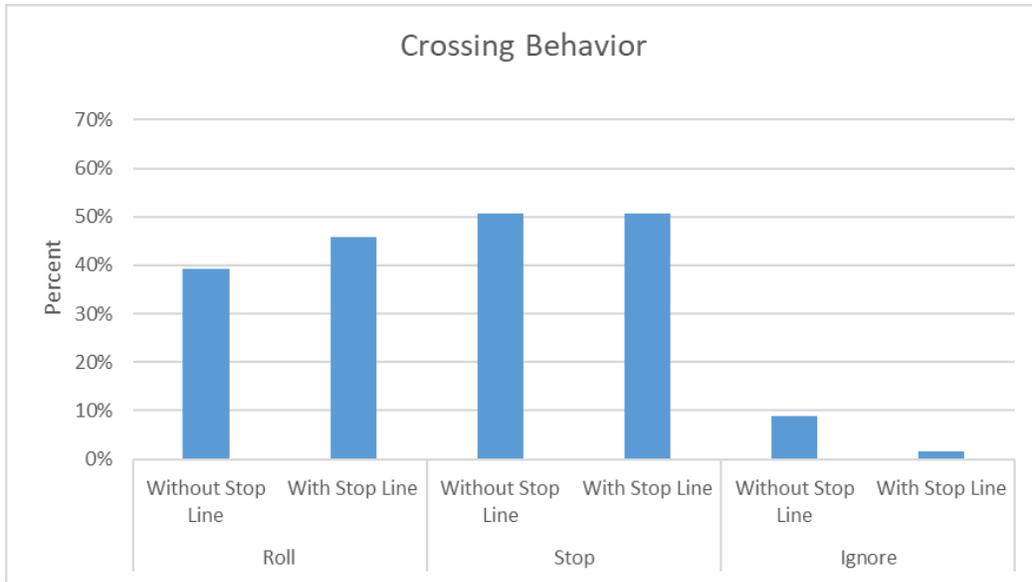
Figure 3.77 Portland Ave and 73rd St WB distribution of driver crossing behavior as a percentage of all events without- vs with-stop line

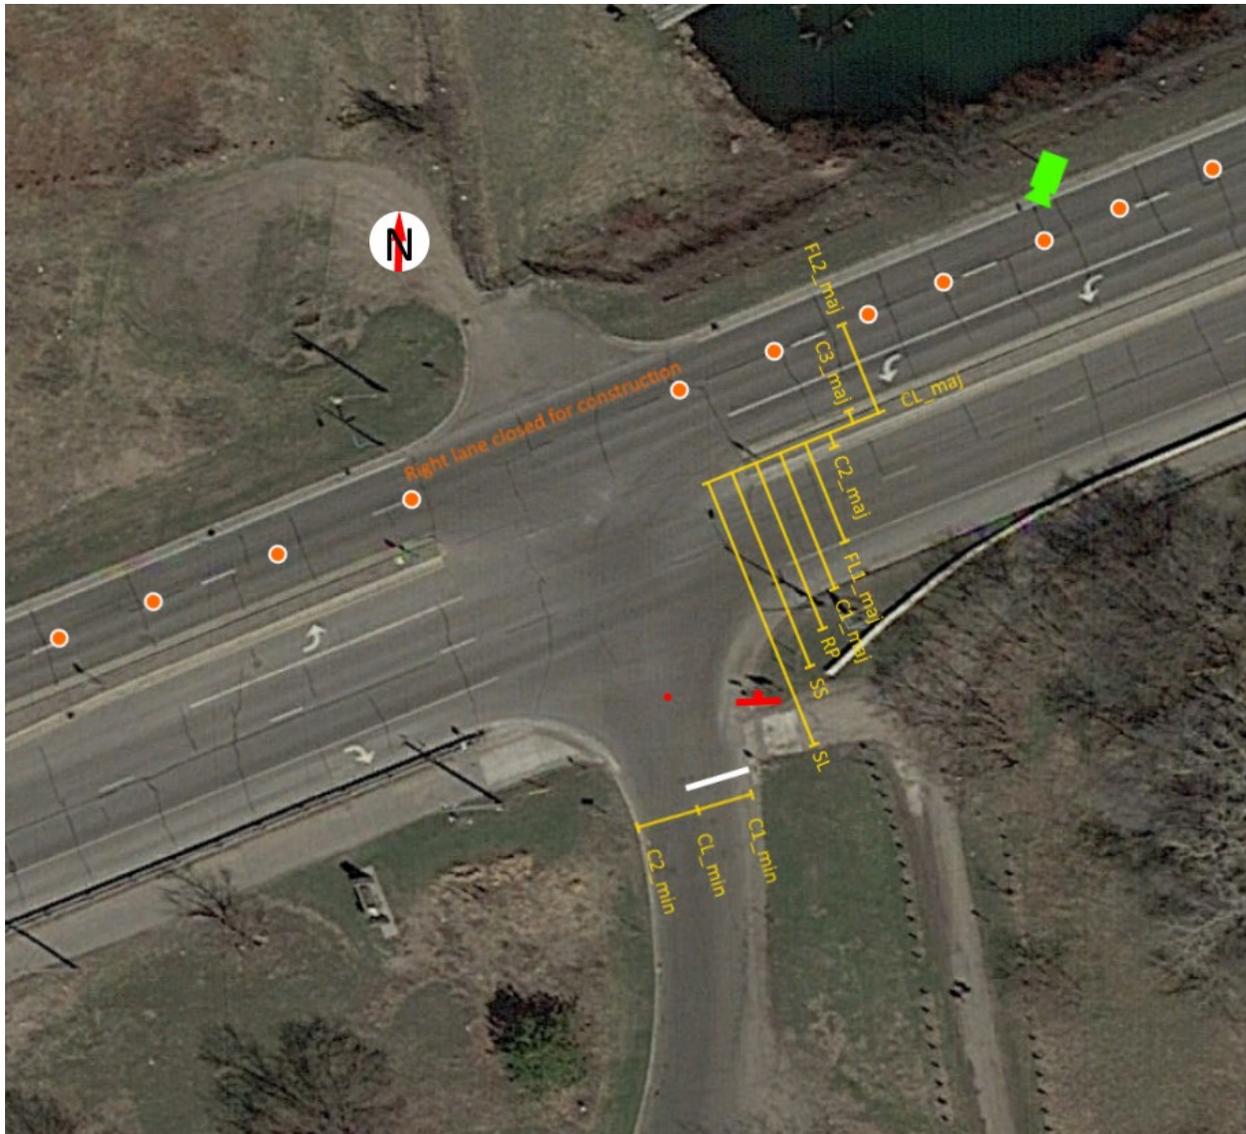
Figure 3.81 Aerial view of the intersection of Warner Rd and Fish Hatchery Rd N with measurements marked

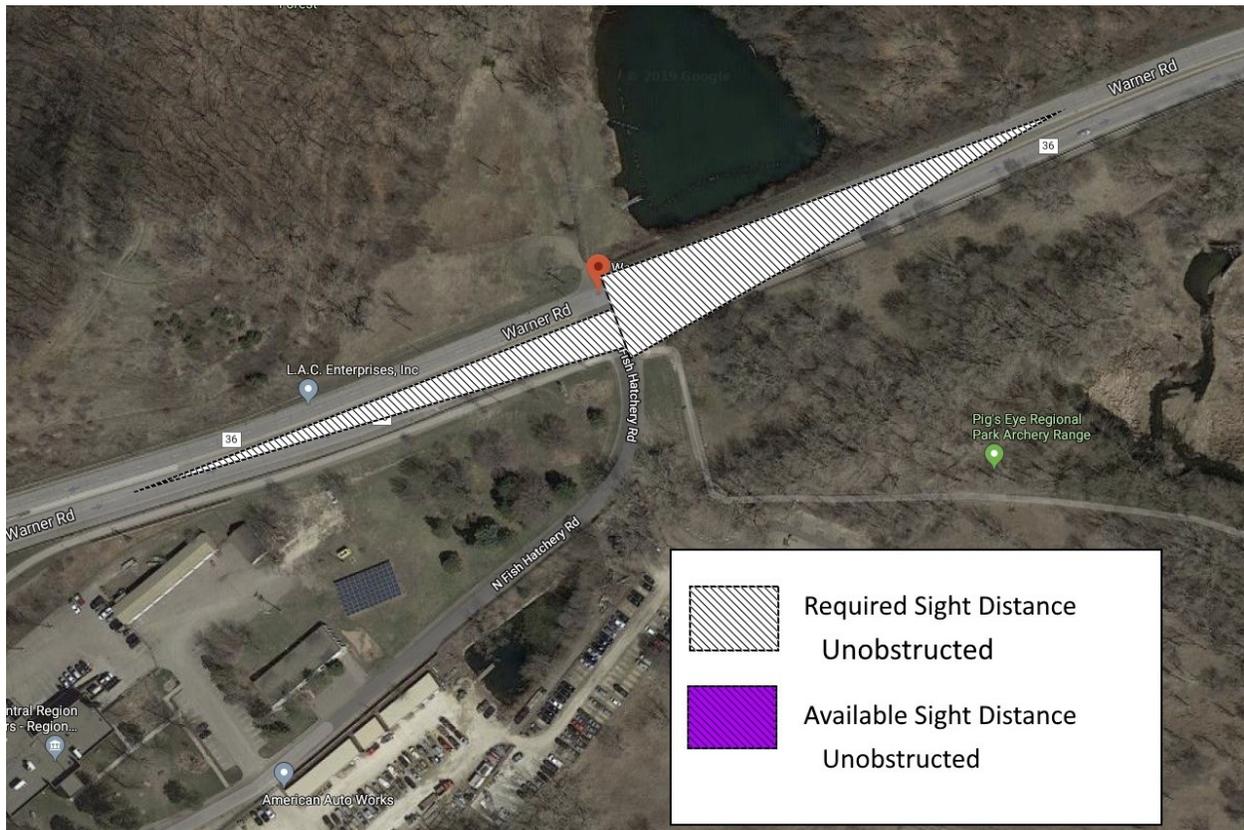
Figure 3.83 Available sight distance and required sight distance at Warner Rd and Fish Hatchery Rd N

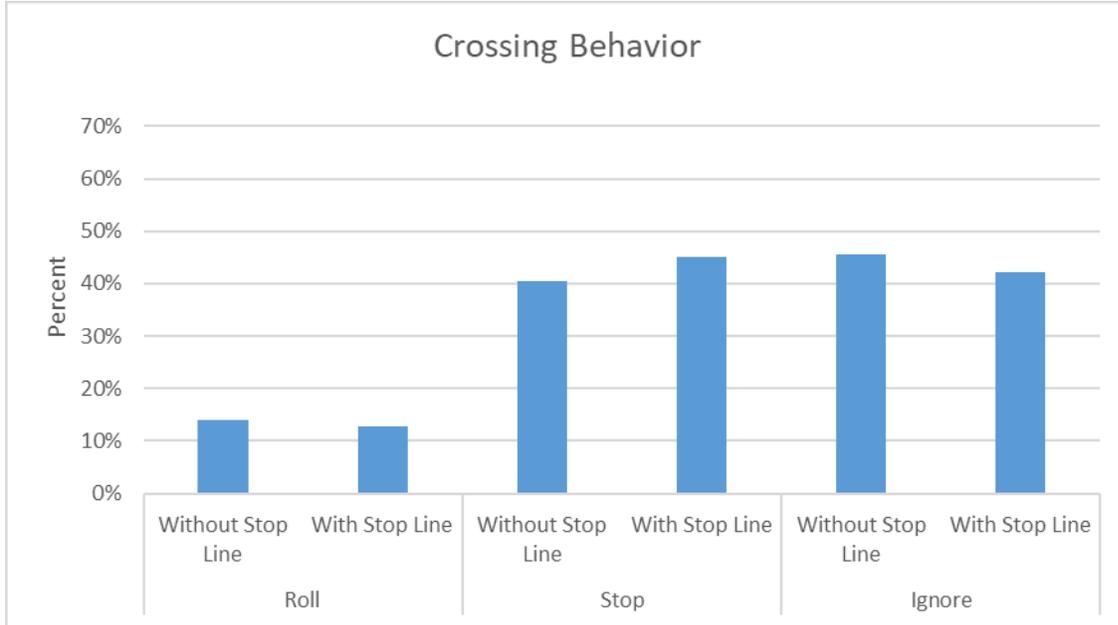
Figure 3.84 Warner Rd and Fish Hatchery Rd N distribution of driver crossing behavior as a percentage of all events without- vs with-stop line

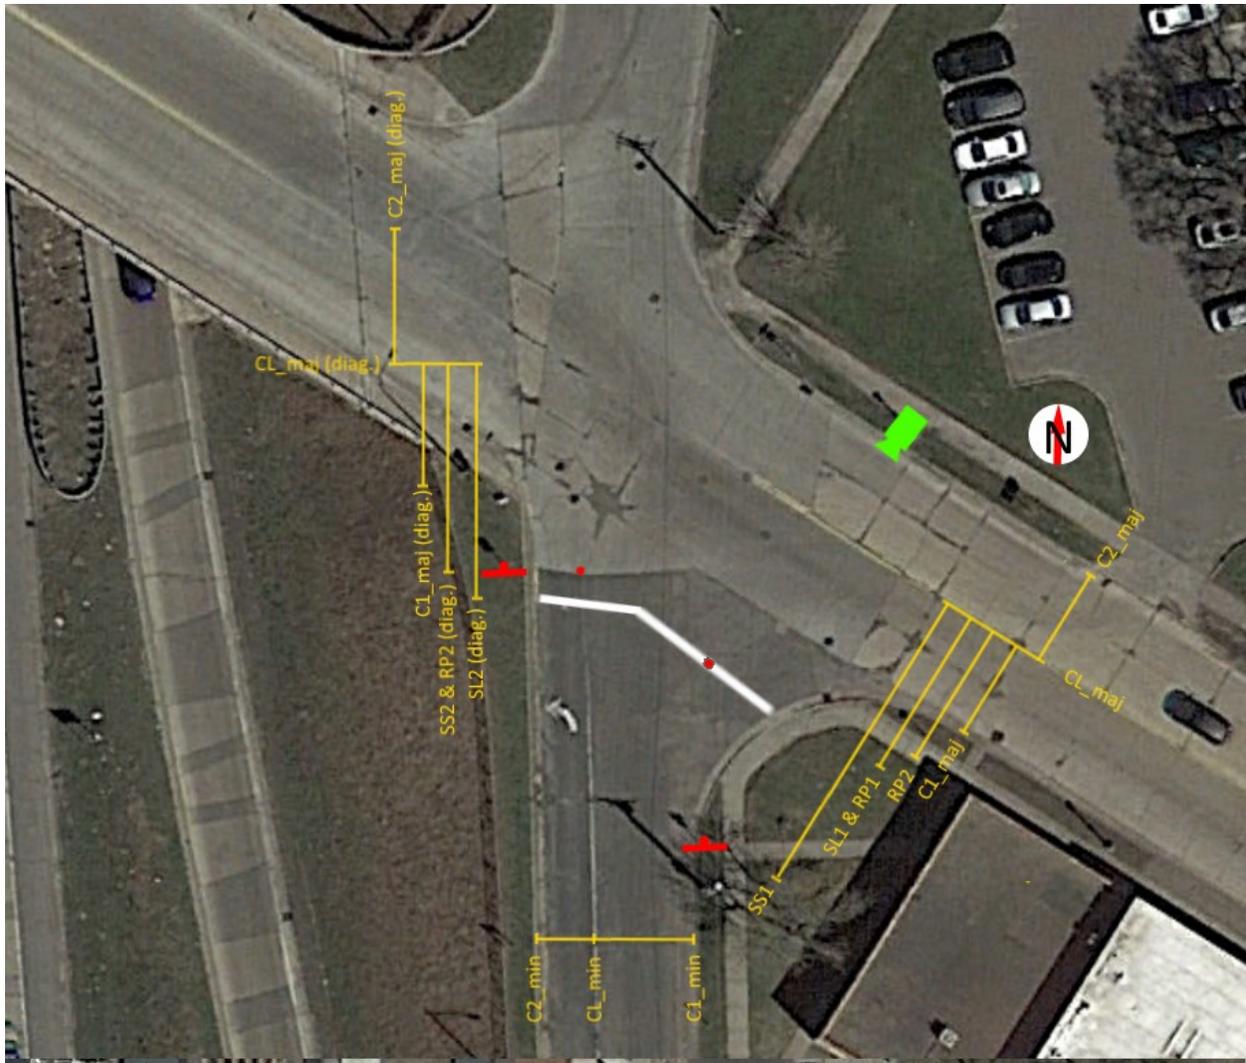
Figure 3.88 Aerial view of the intersection of W Territorial Rd and Cromwell Ave with measurements marked

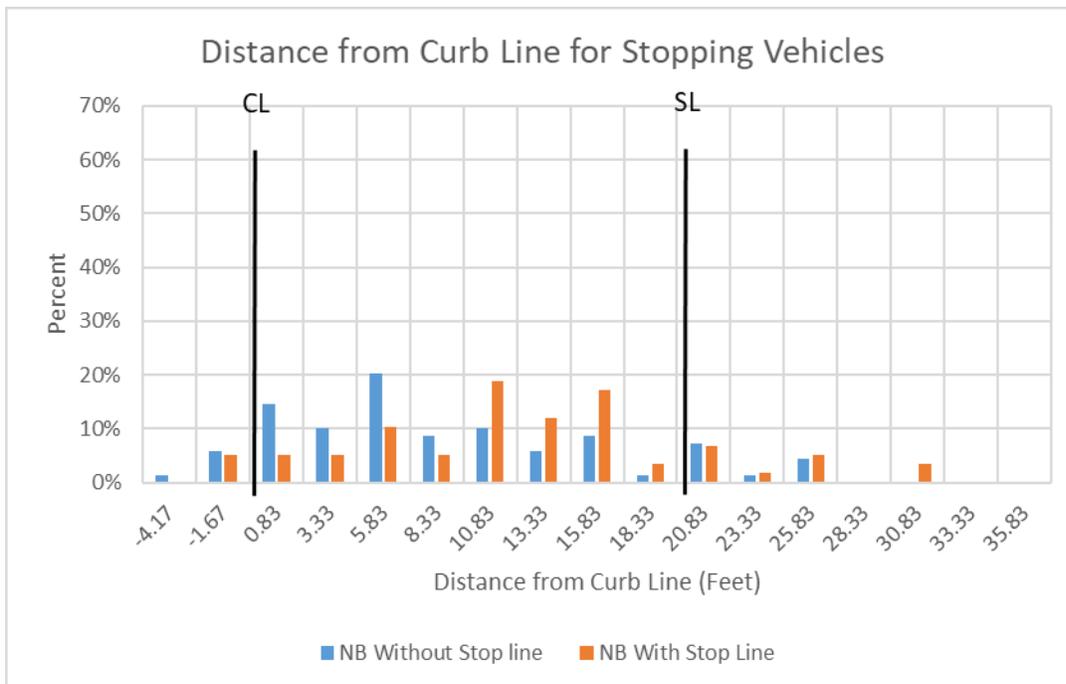
Figure 3.92 W Territorial Rd and Cromwell Ave N (Right) Distribution of Stopping Distance During Stop Events

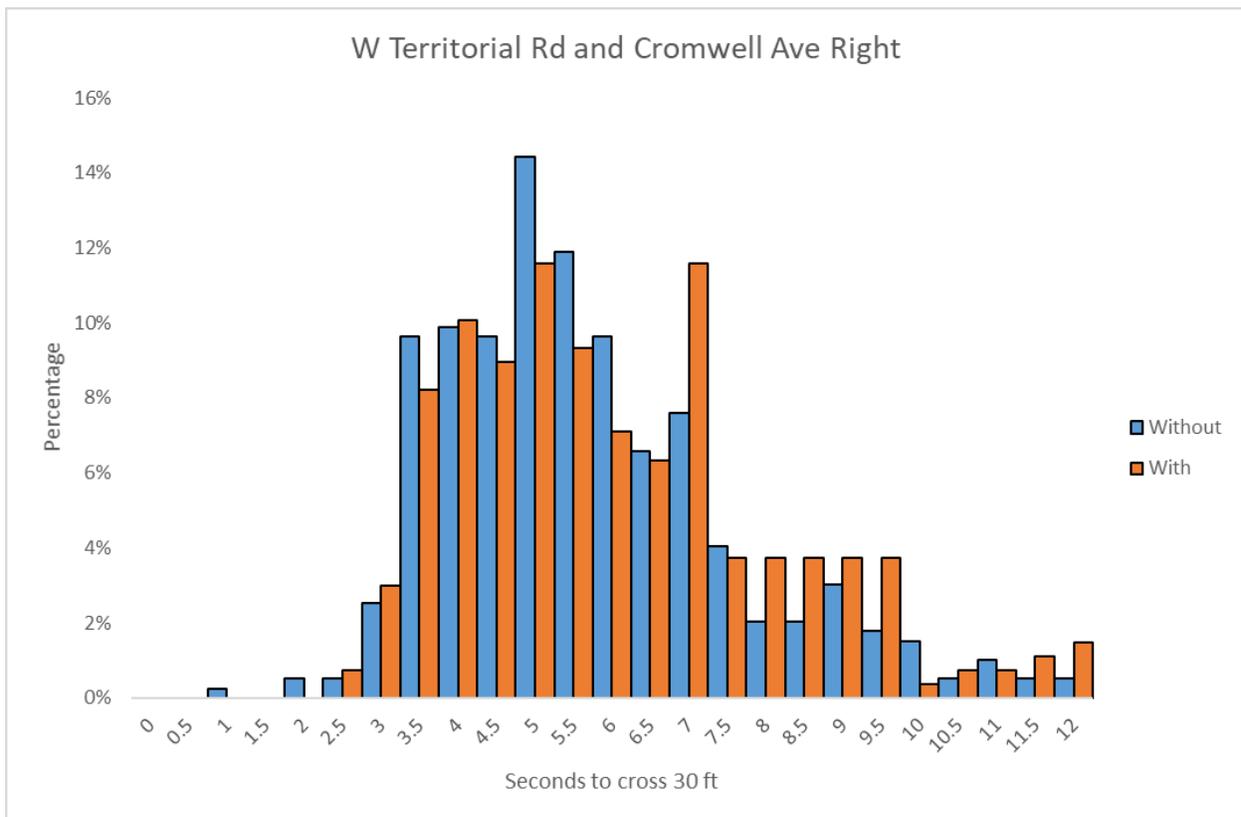
Figure 3.93 W Territorial Rd and Cromwell Ave N (right) Histogram of Roll and Ignore behaviors, in seconds to travel 30 ft

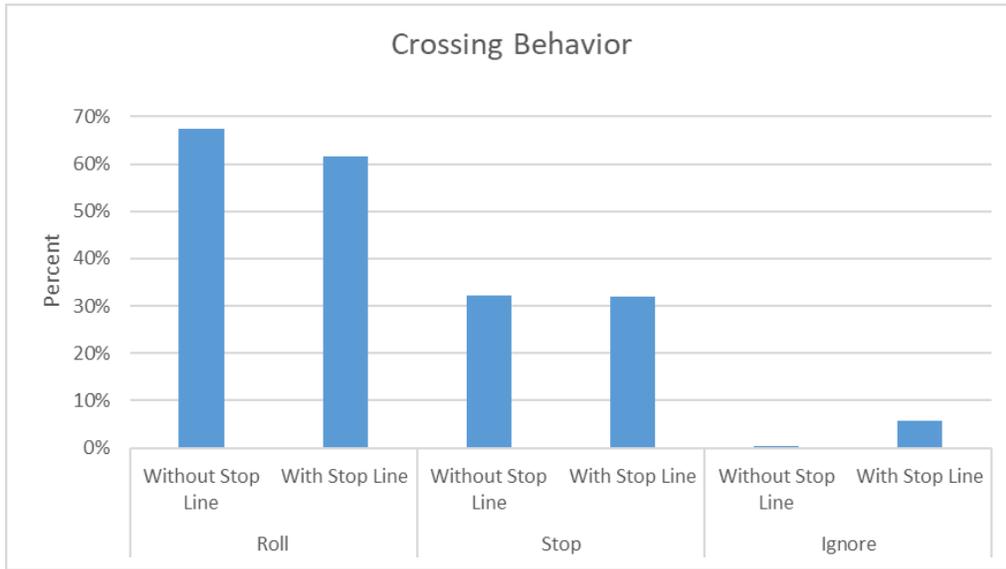
Figure 3.94 W Territorial Rd and Cromwell Ave N (through) distribution of driver crossing behavior as a percentage of all events without- vs with-stop line

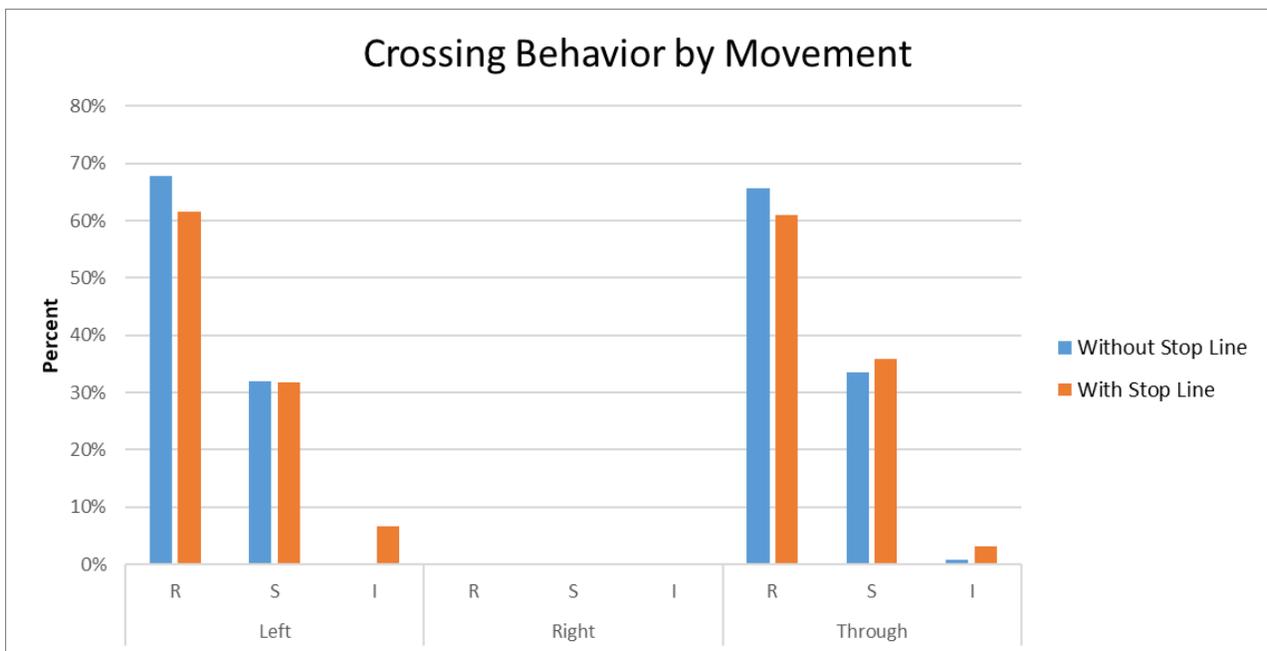
Figure 3.95 W Territorial Rd and Cromwell Ave N (through) distribution of driver crossing behavior as a percentage of all events without- vs with-stop line, by driver movement

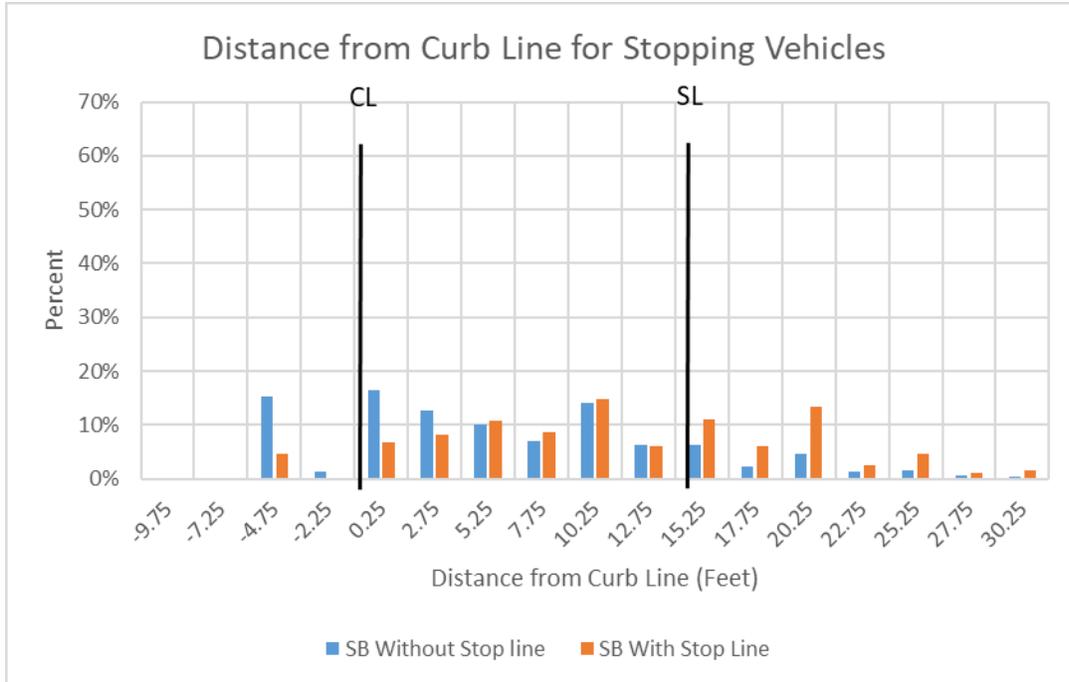
Figure 3.96 W Territorial Rd and Cromwell Ave N (through) Distribution of Stopping Distance During Stop Events

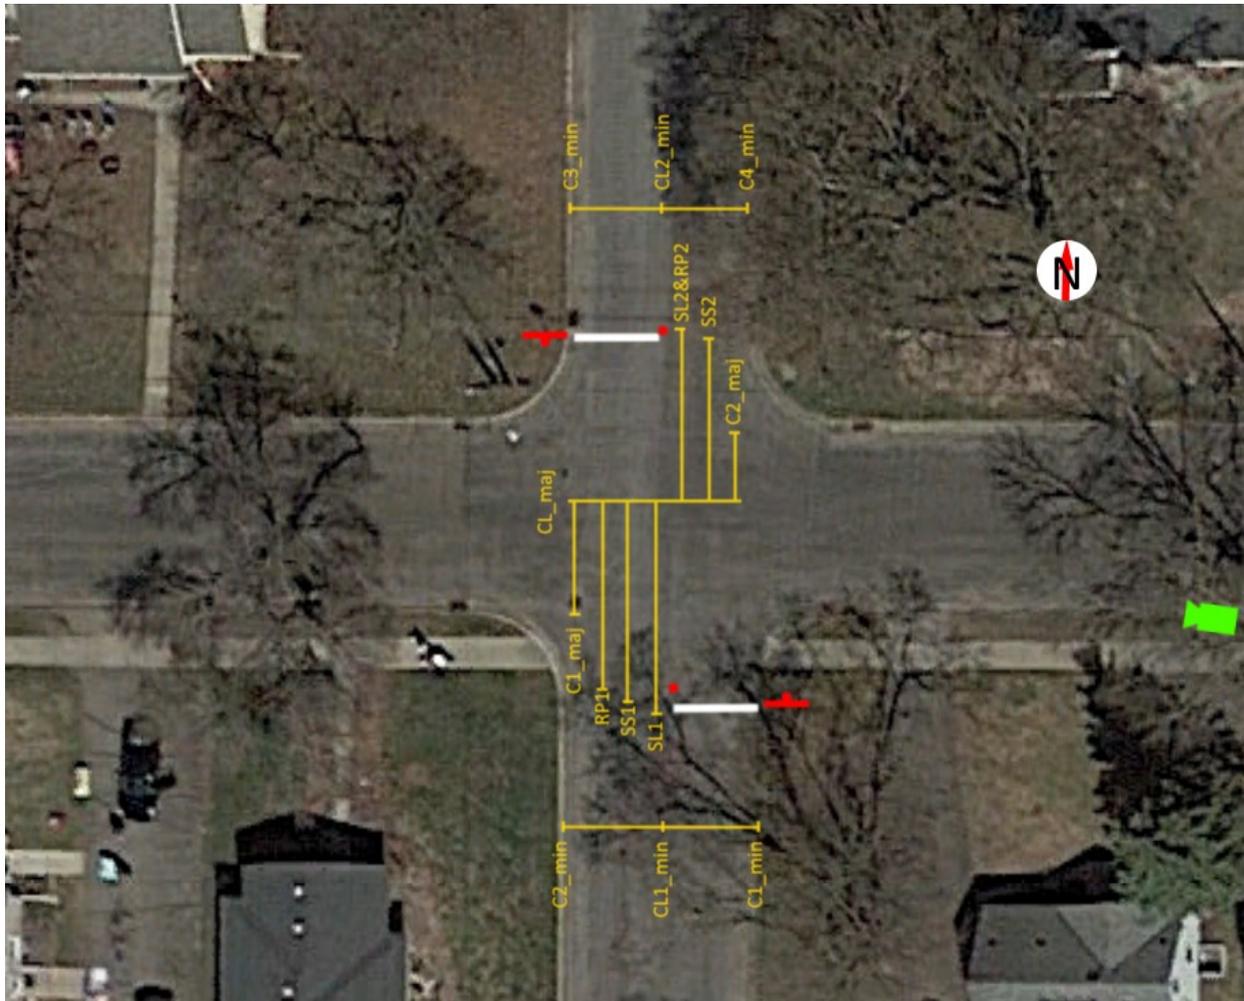
Figure 3.98 Aerial view of the intersection of Raleigh Ave and W 28th St with measurements marked

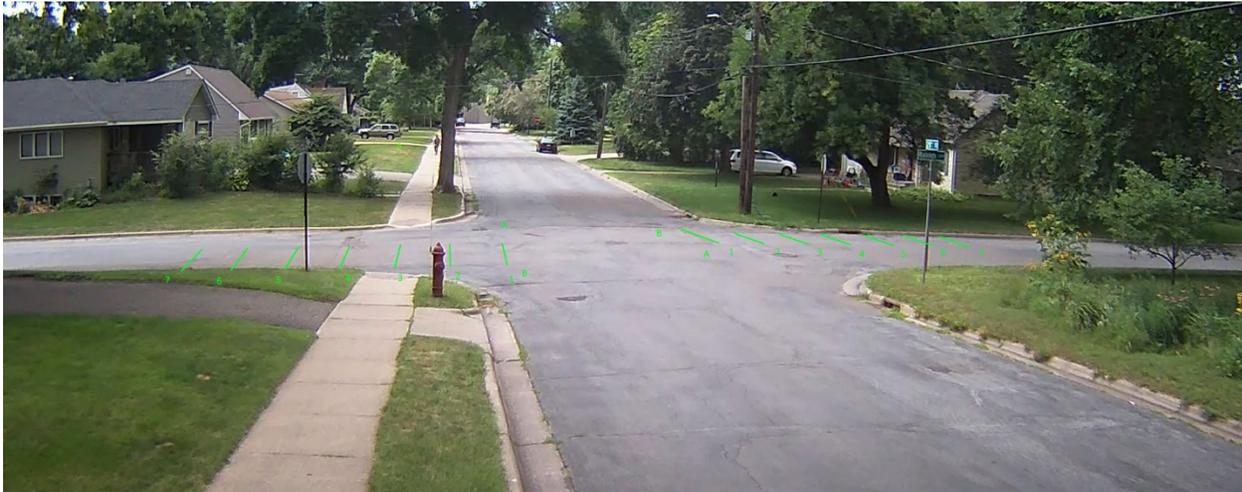
Figure 3.99 Camera view of the intersection of Raleigh Ave and W 28th St with 5-ft overlay lines marked

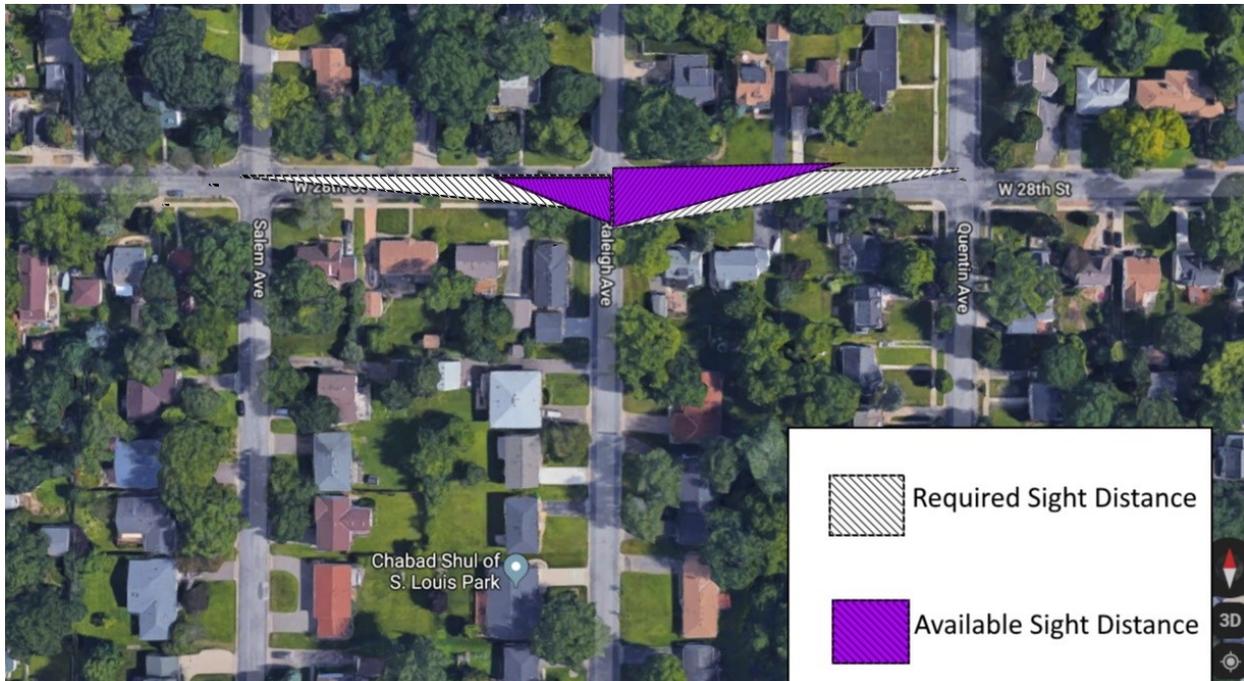
Figure 3.100 Available sight distance and required sight distance at Raleigh Ave and W 28th St NB
