Evaluation of the Effectiveness of Stop Lines in Increasing the Safety of Stop-Controlled Intersections

Minnesota Traffic Observatory

Research Project

Final Report 2020-17

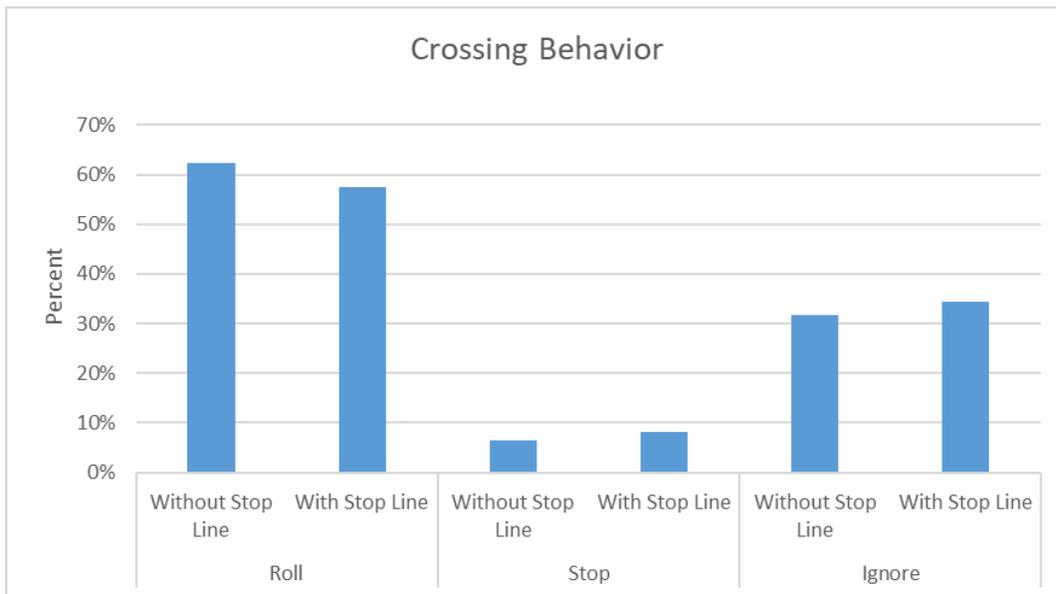
Figure 3.101 Raleigh Ave NB distribution of driver crossing behavior as a percentage of all events without- vs with-stop line

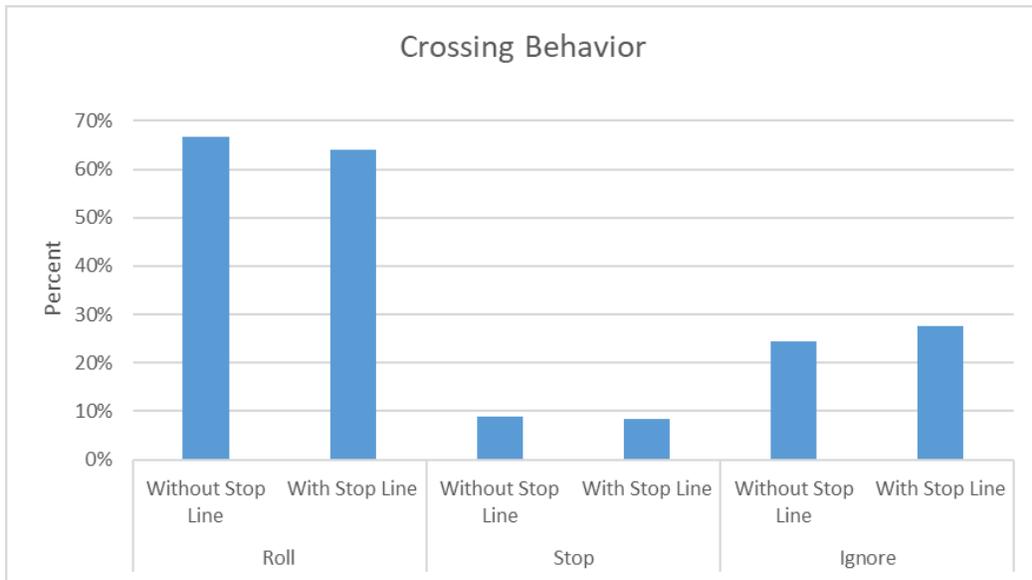
Figure 3.106 Raleigh Ave SB distribution of driver crossing behavior as a percentage of all events without- vs with-stop line

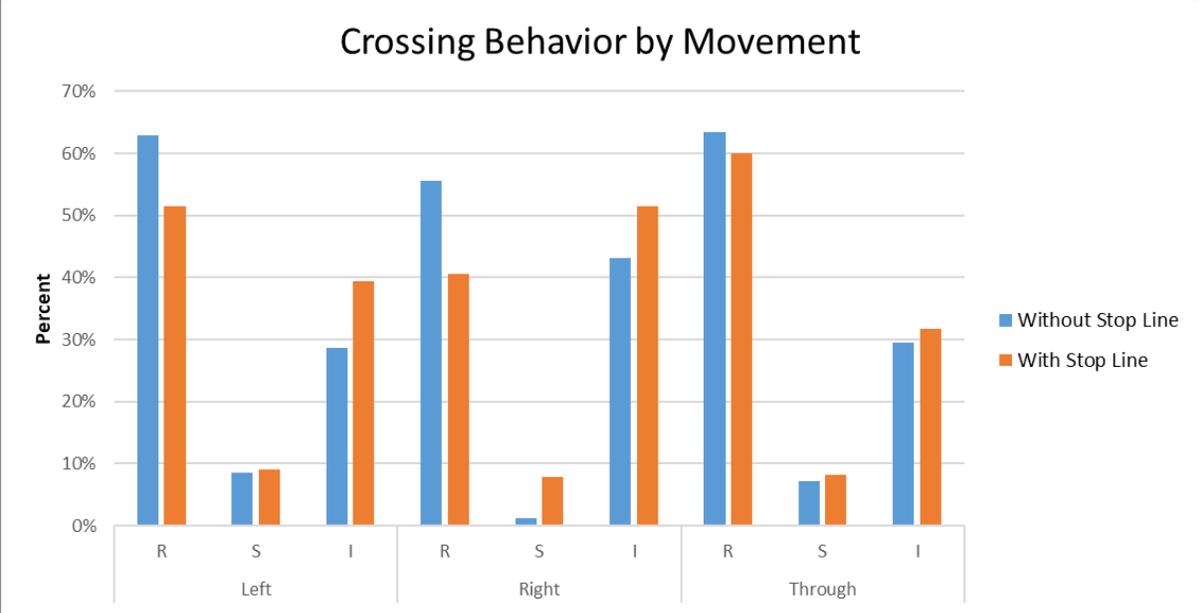
Figure 3.107 Raleigh Ave SB distribution of driver crossing behavior as a percentage of all events without- vs with-stop line, by driver movement

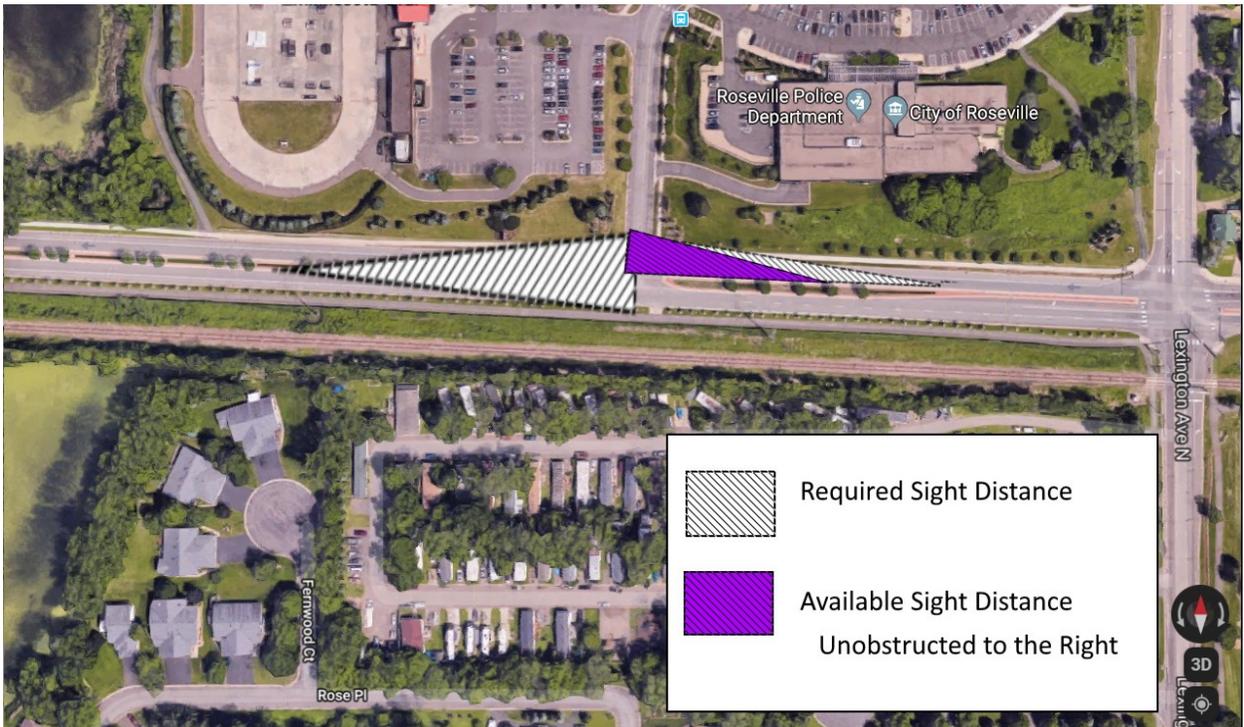
Figure 3.112 Available sight distance and required sight distance at County Rd C W and Civic Center Dr

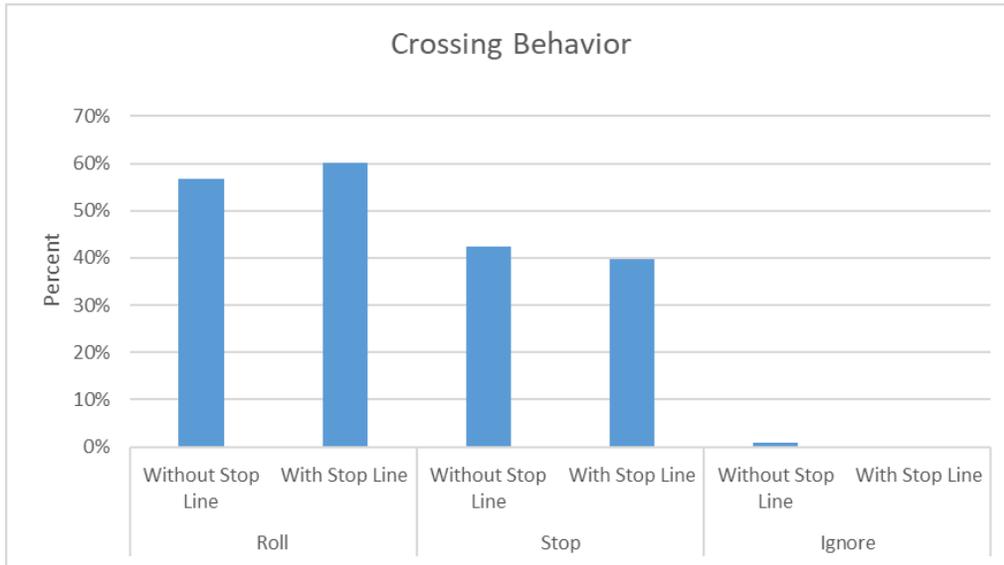
Figure 3.113 County Rd C W and Civic Center Dr distribution of driver crossing behavior as a percentage of all events without- vs with-stop line

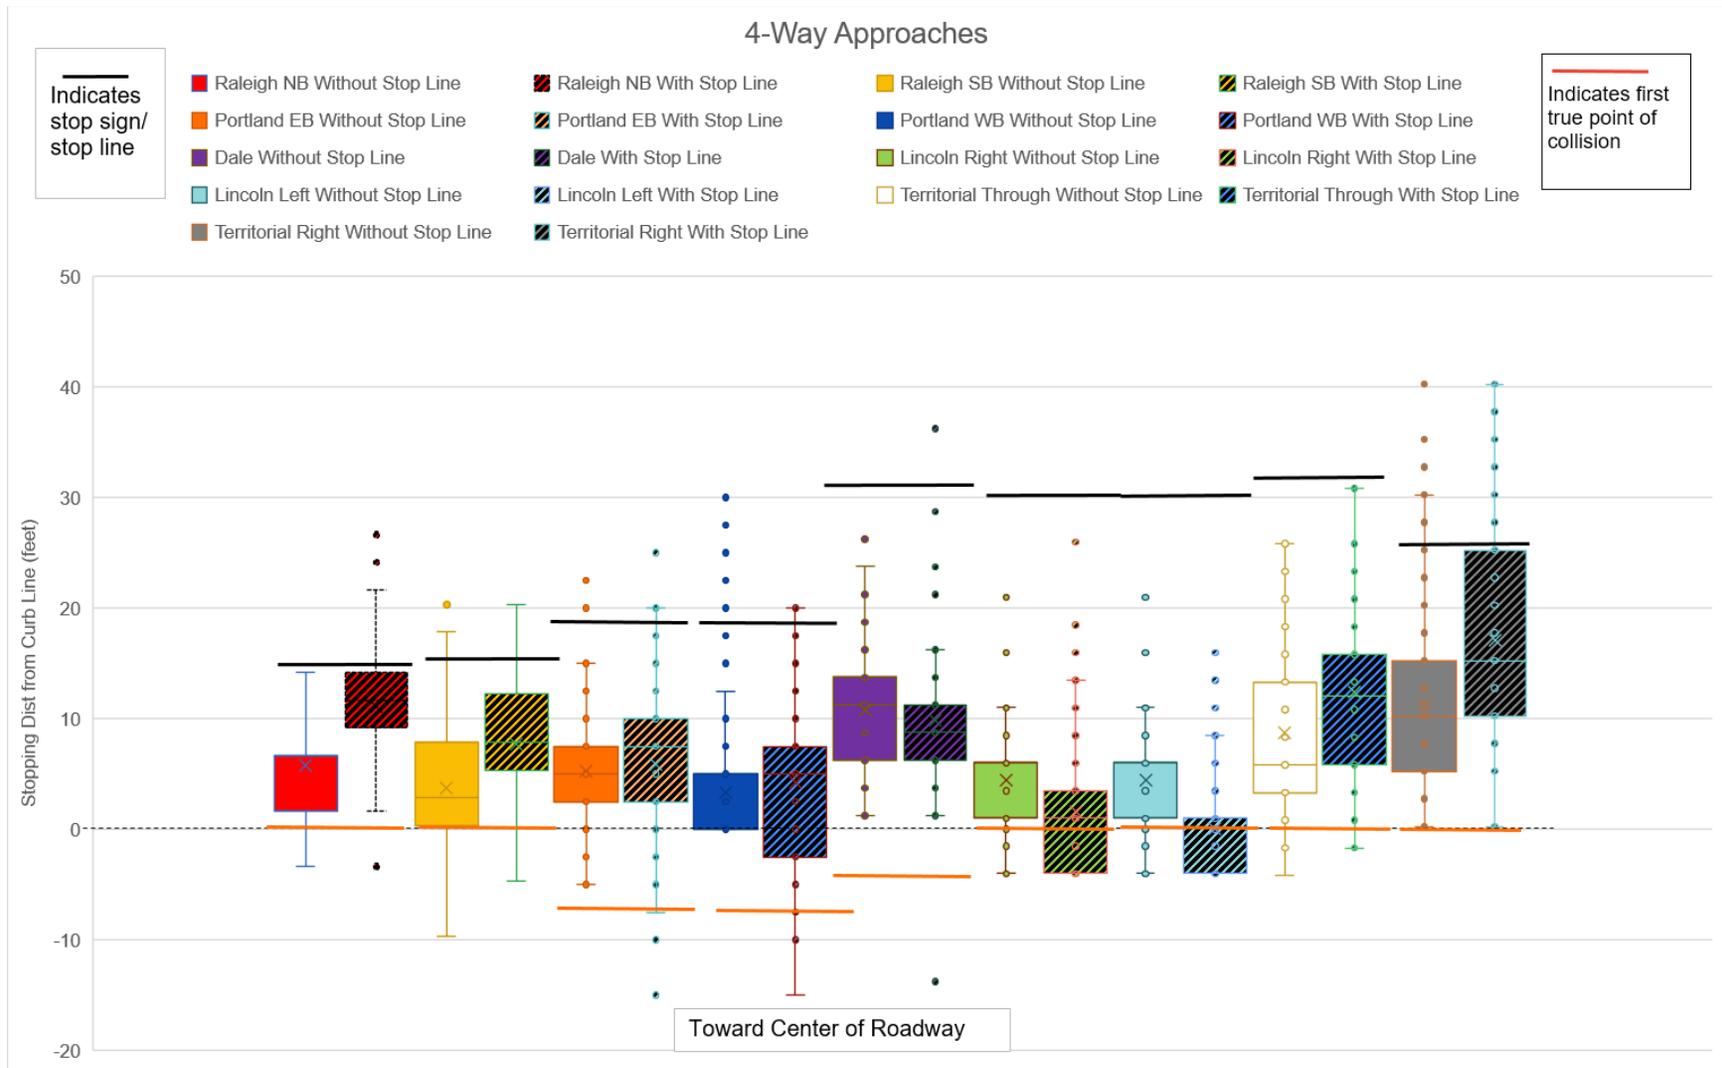
Figure 3.117 Overall Stop Location Distances on 4-way intersections

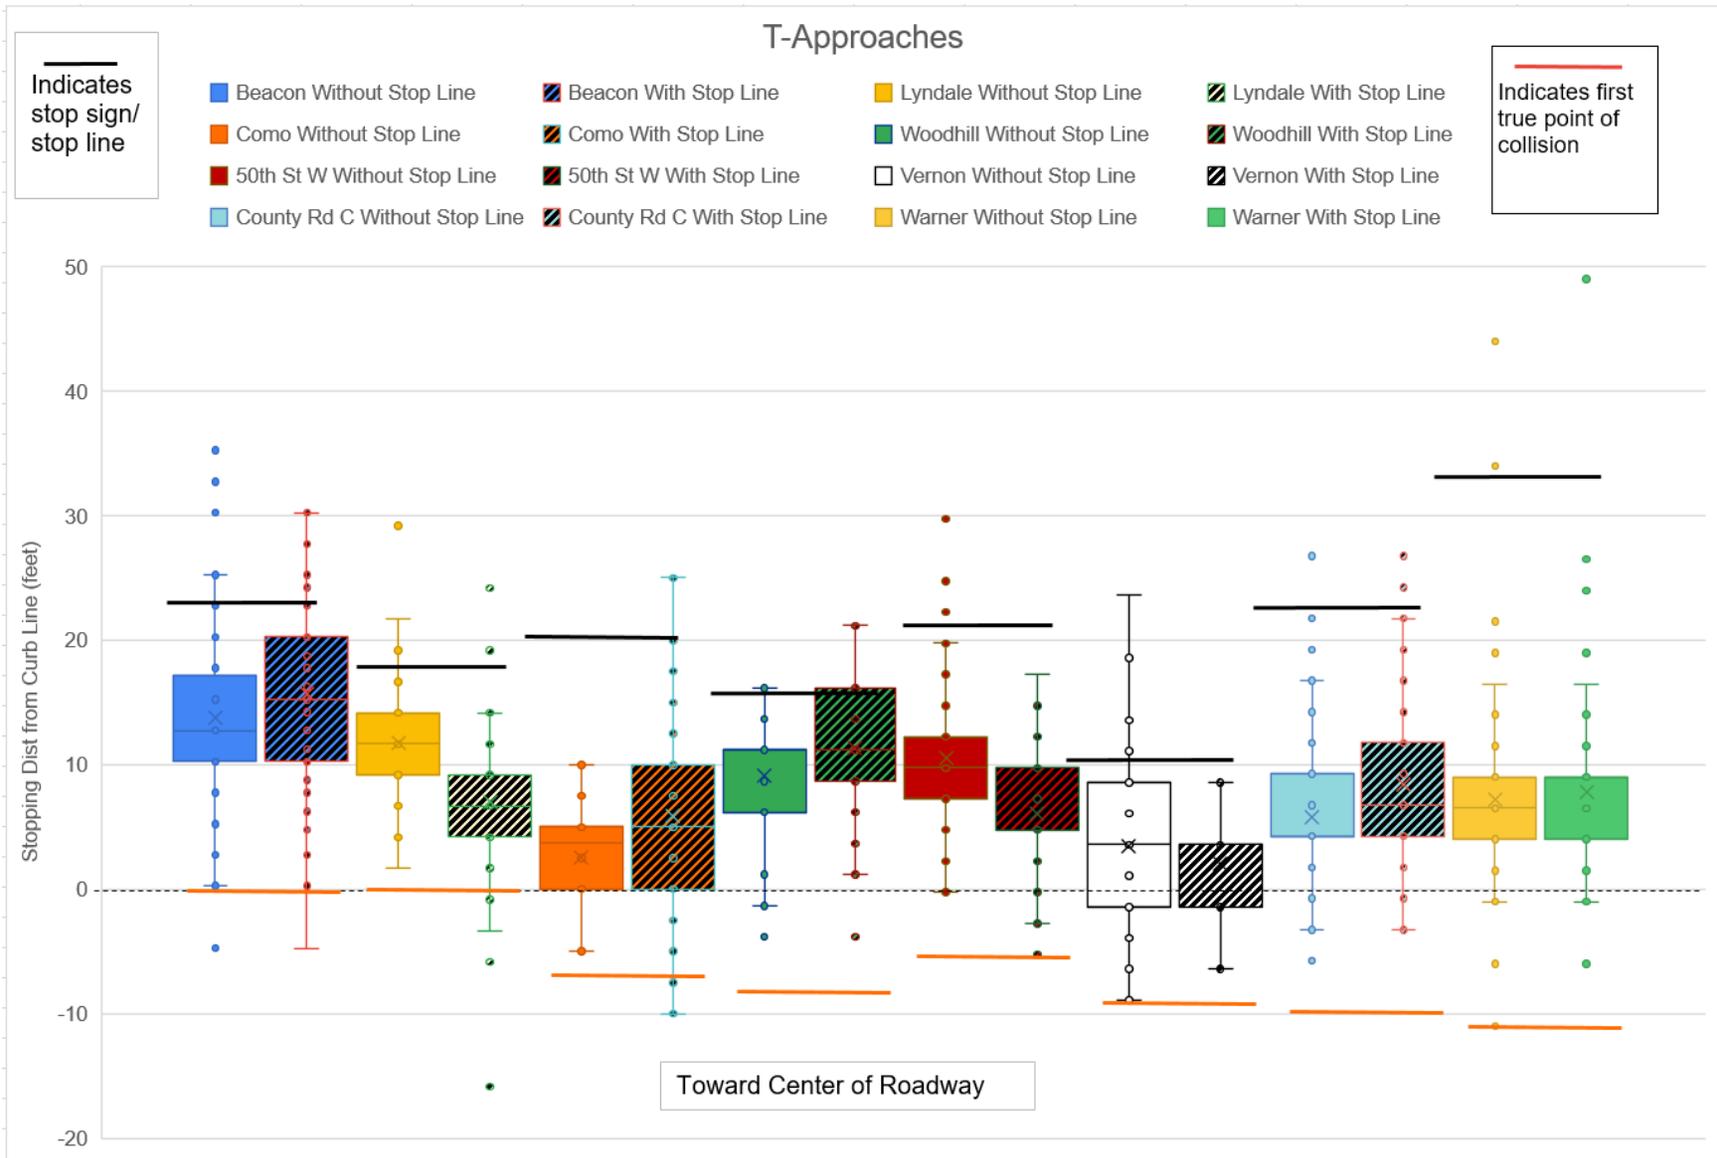
Figure 3.118 Overall Stop Location Distances on T intersections

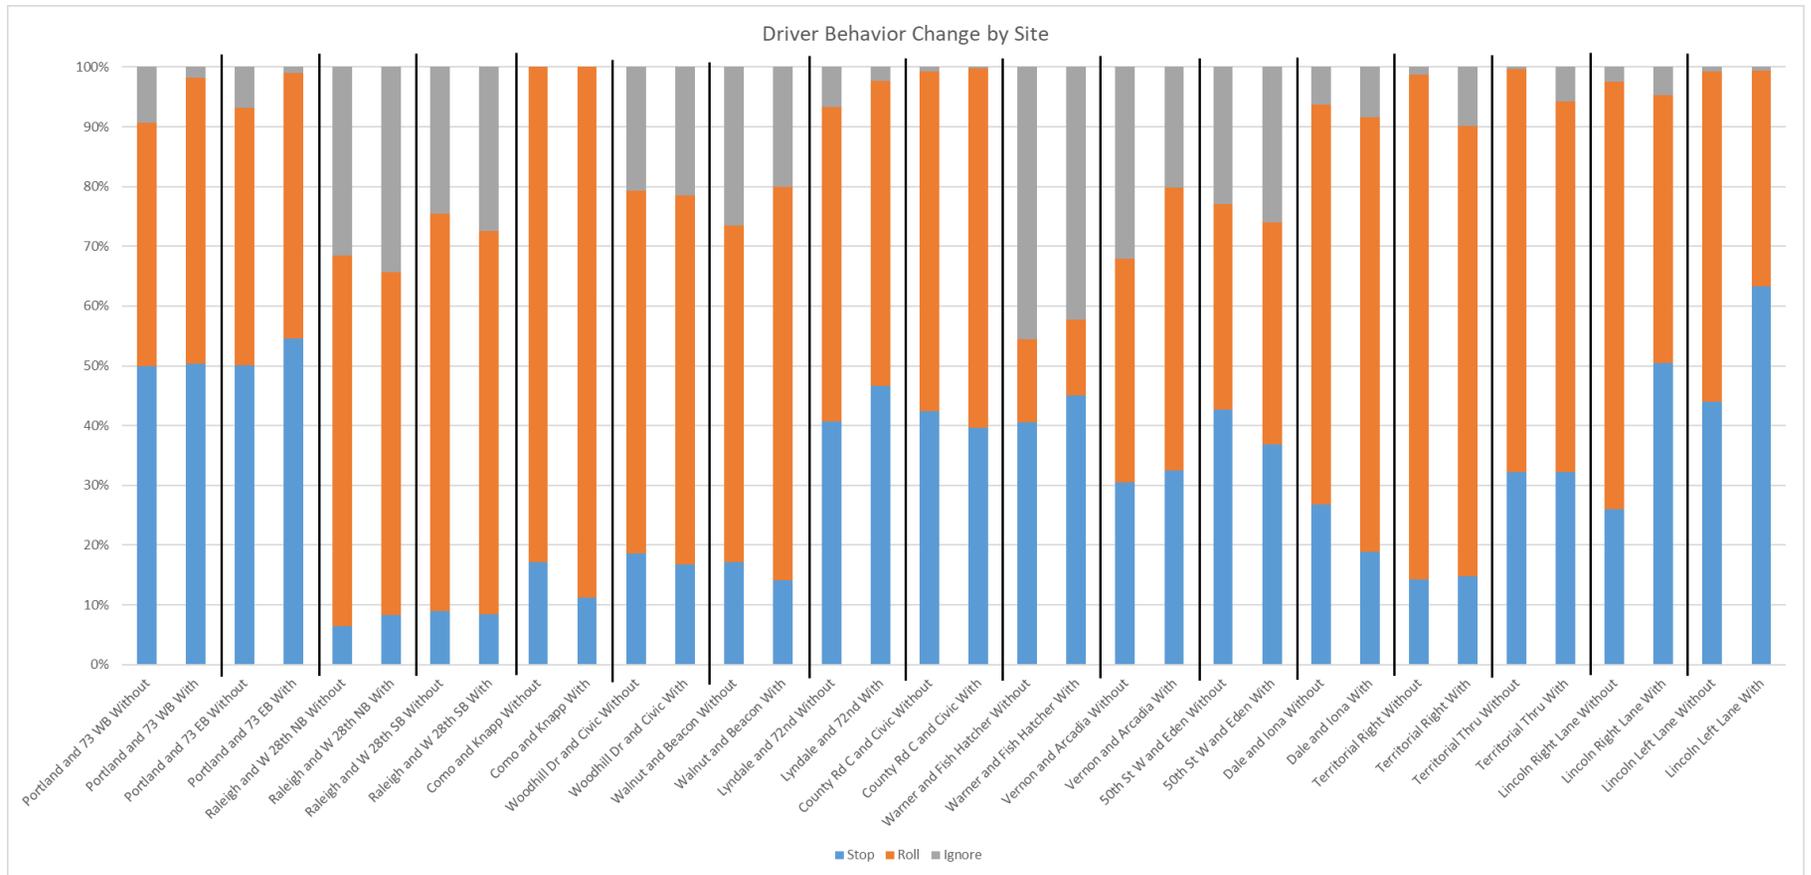
Figure 3.119 Overall Crossing Behaviors before and after the Stop Line installation

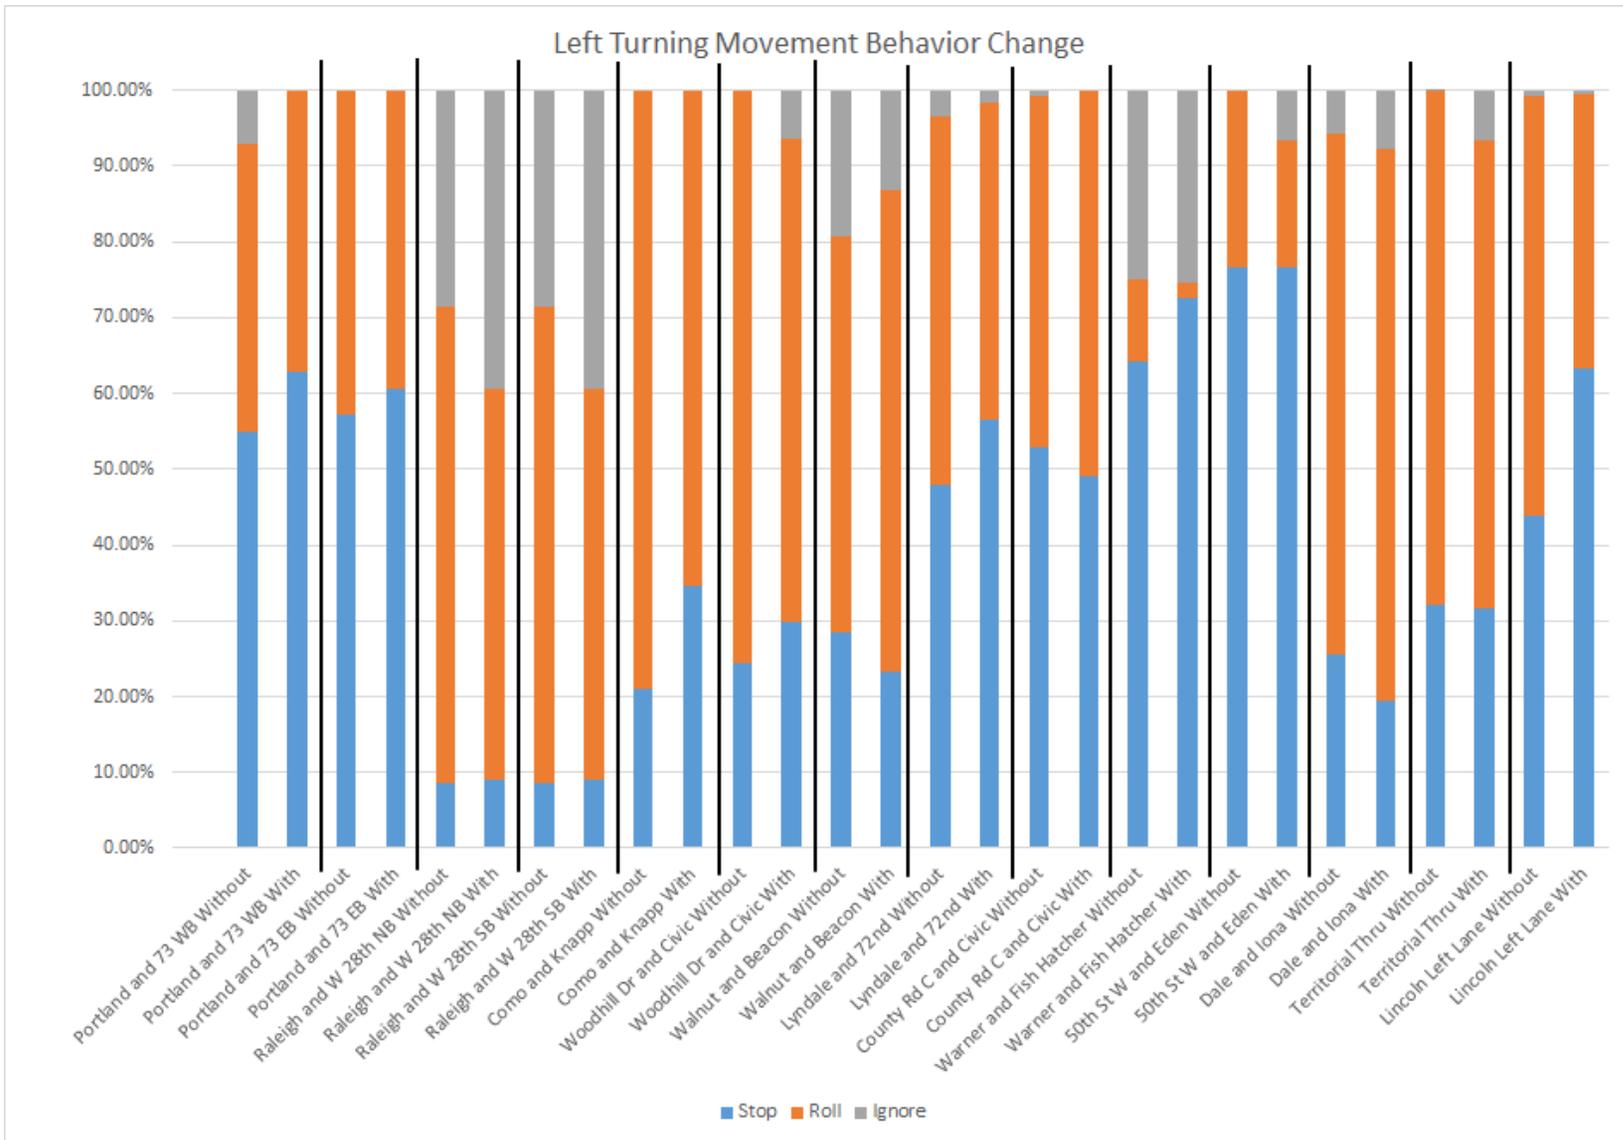
Figure 3.120 Left Turning Movement Crossing Behaviors before and after the Stop Line installation

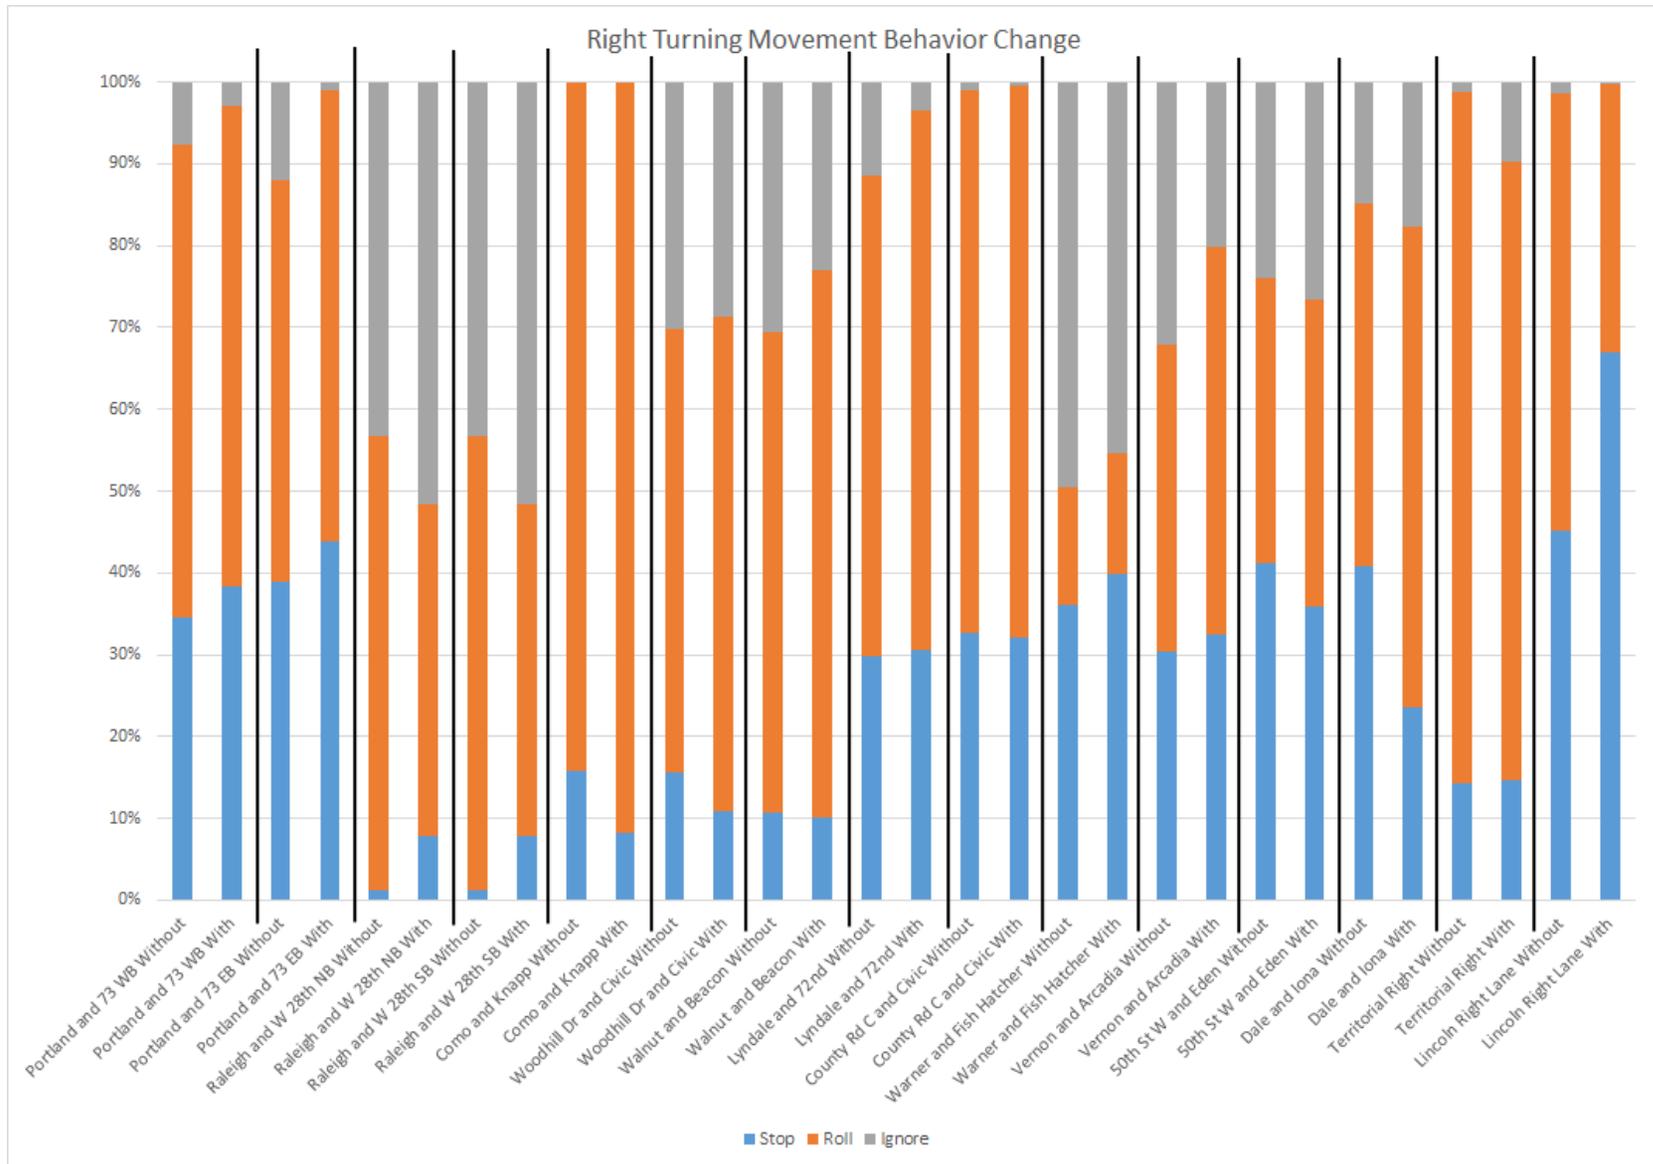
Figure 3.121 Right Turning Movement Crossing Behaviors before and after the Stop Line Installation

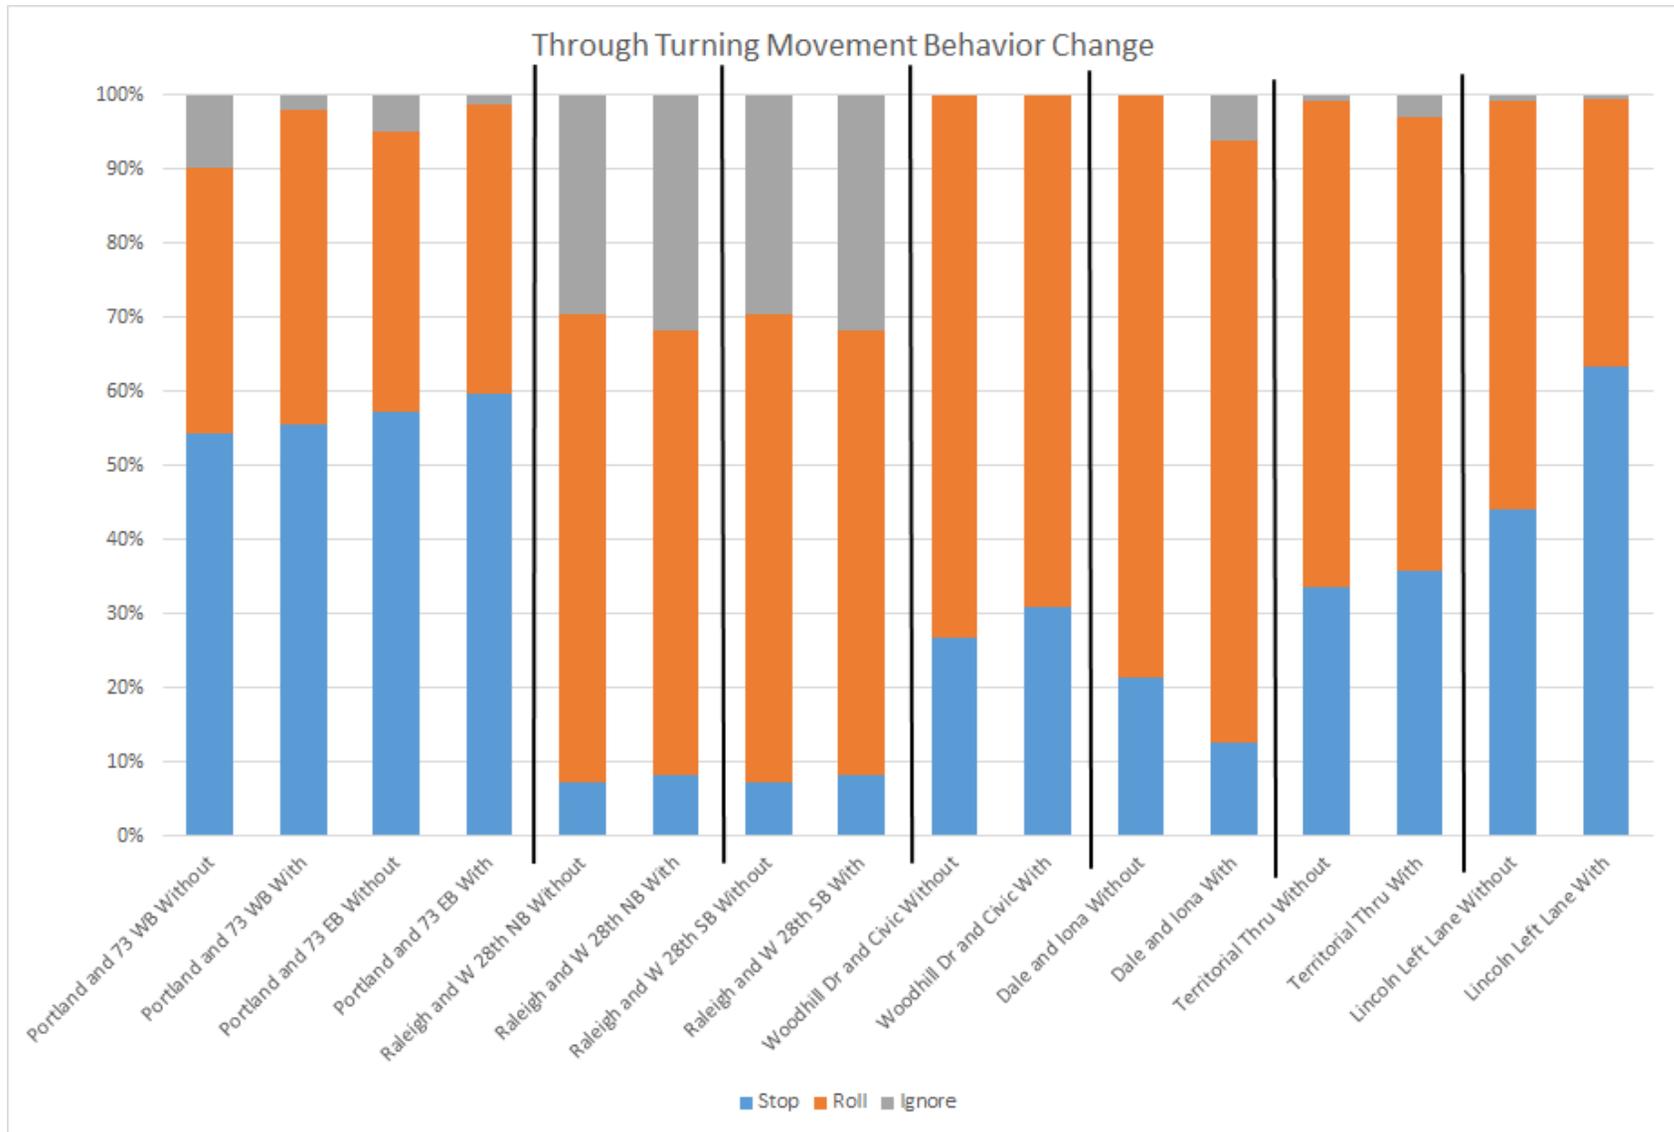
Figure 3.122 Through Movement Crossing Behaviors before and after the Stop Line installation

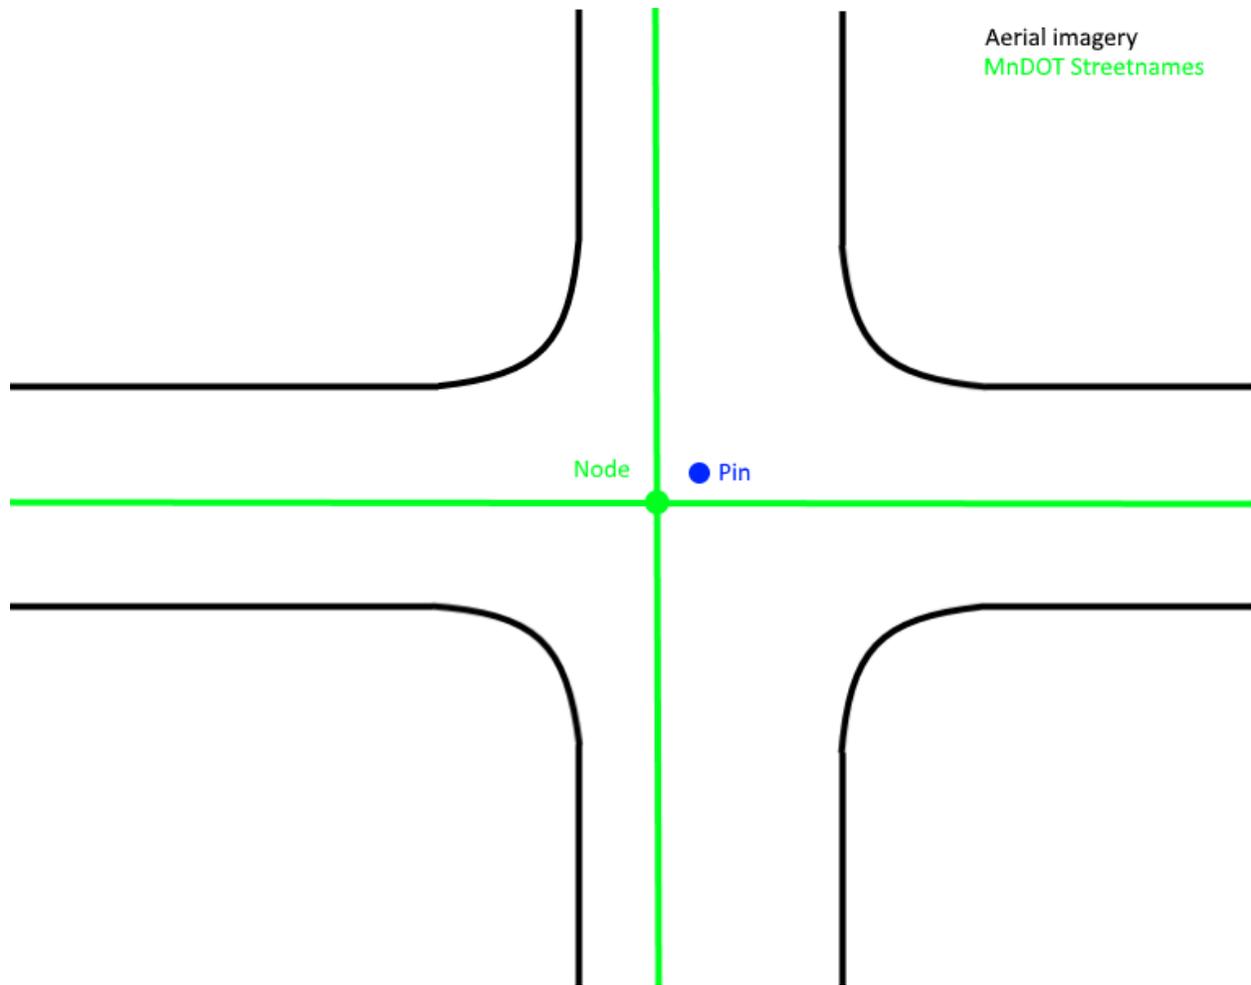
Figure A-0.1 Identification and assignment of approaches – Step 1

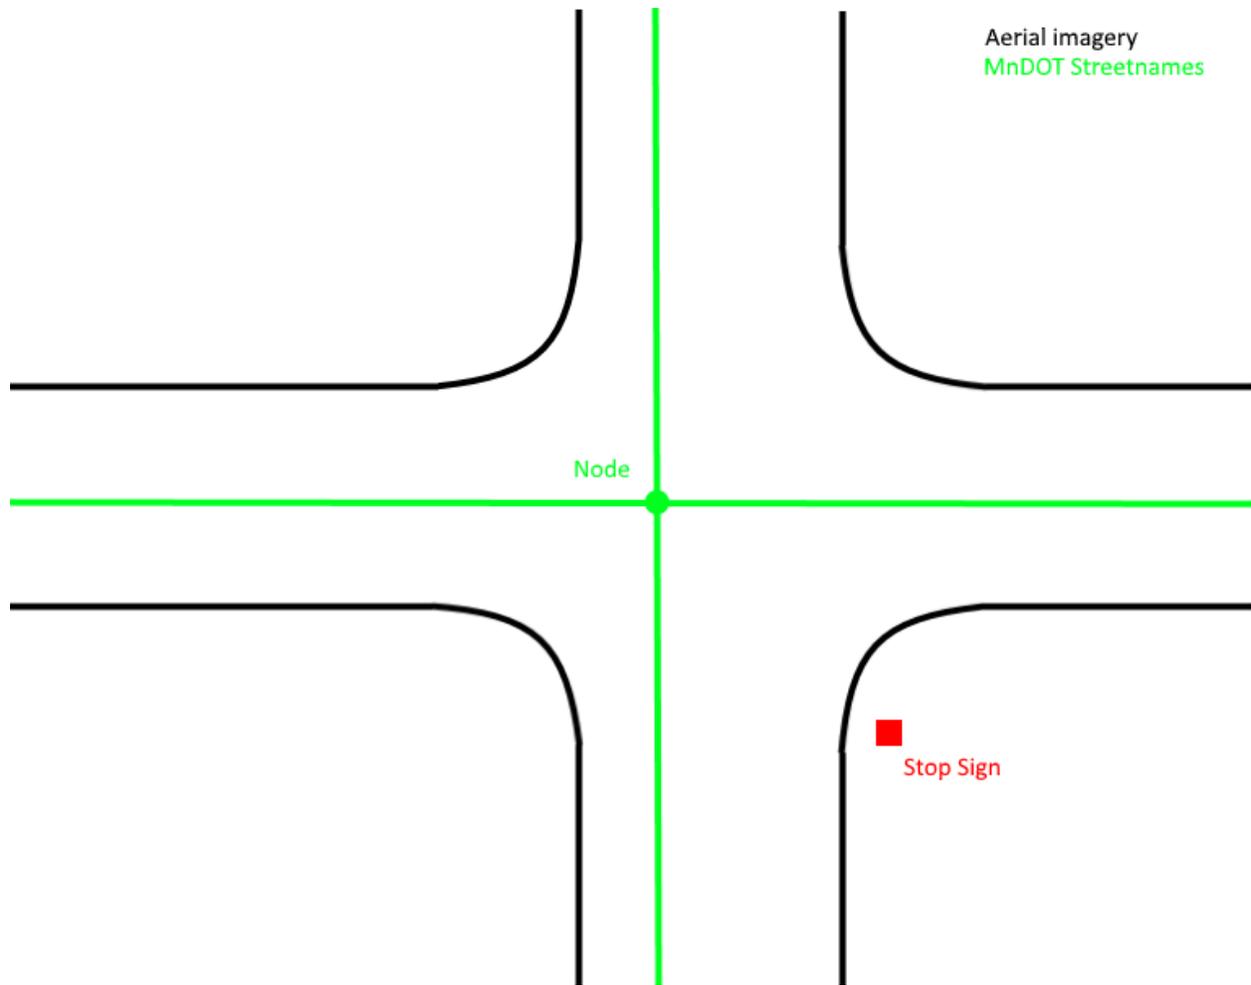
Figure A-0.2 Identification and assignment of approaches – Step 2

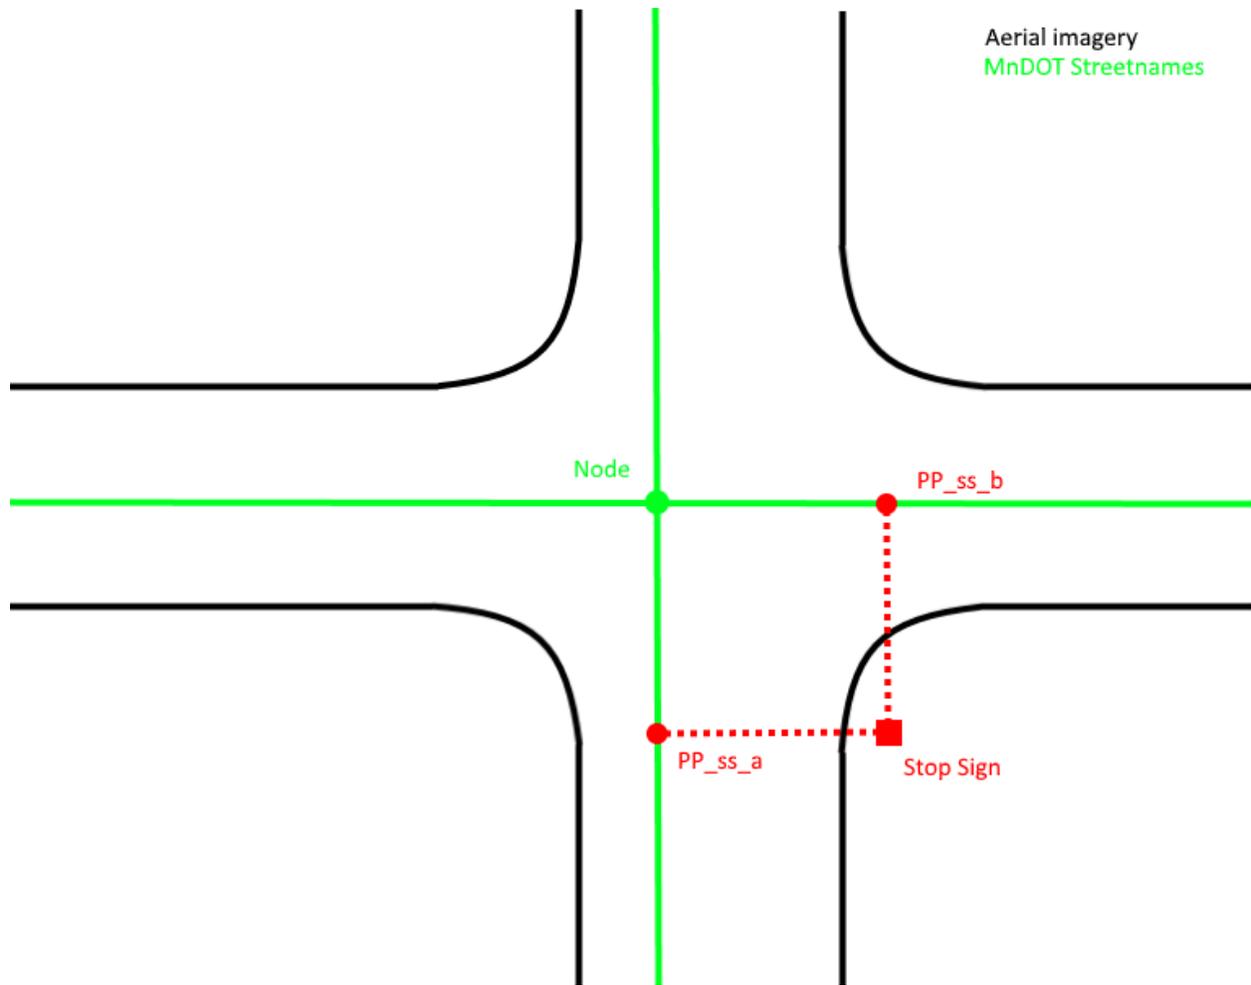
Figure A-0.3 Identification and assignment of approaches – Step 3

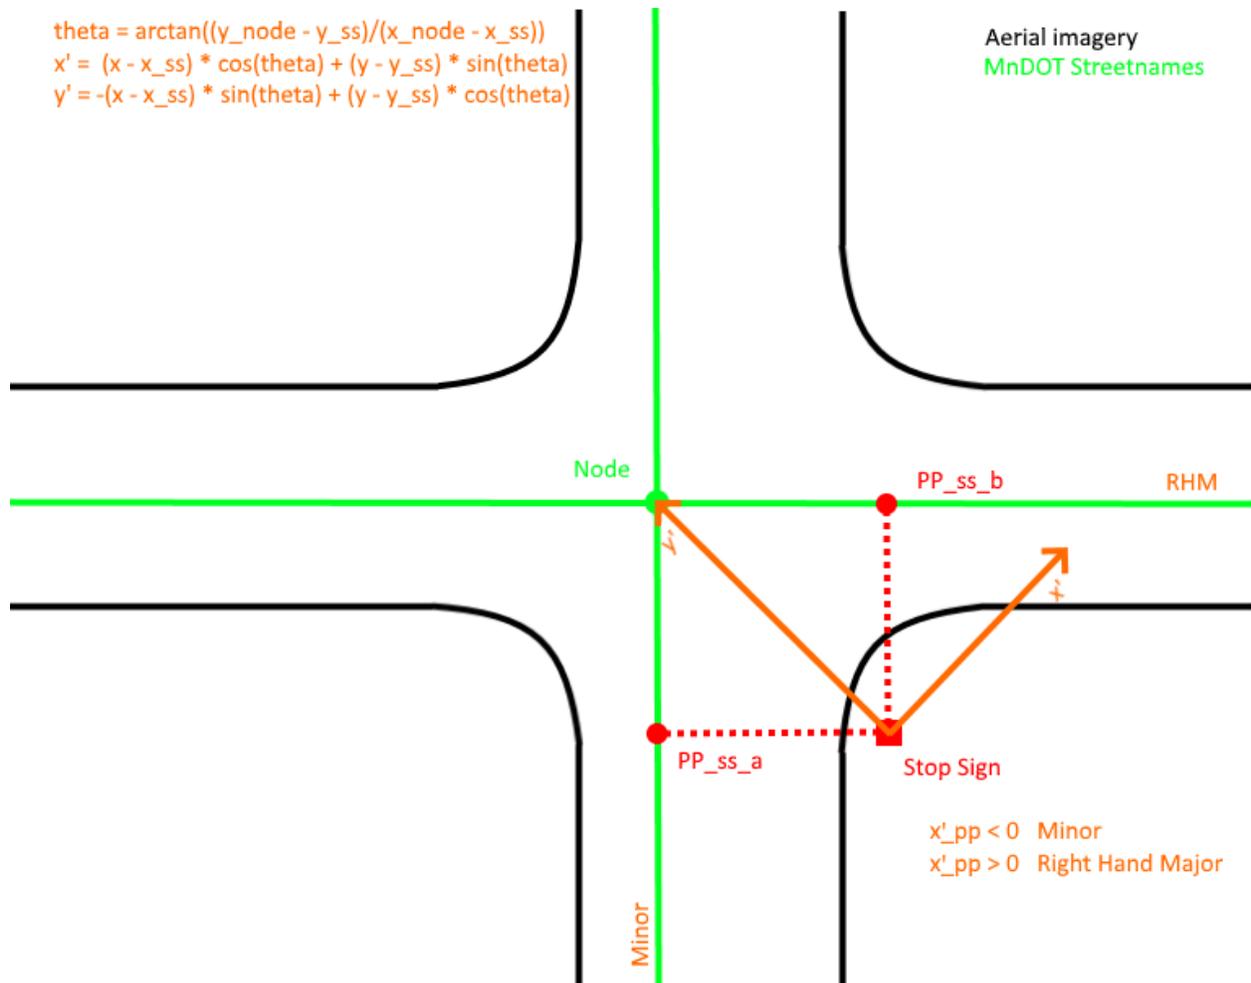
Figure A-0.4 Identification and assignment of approaches – Step 4

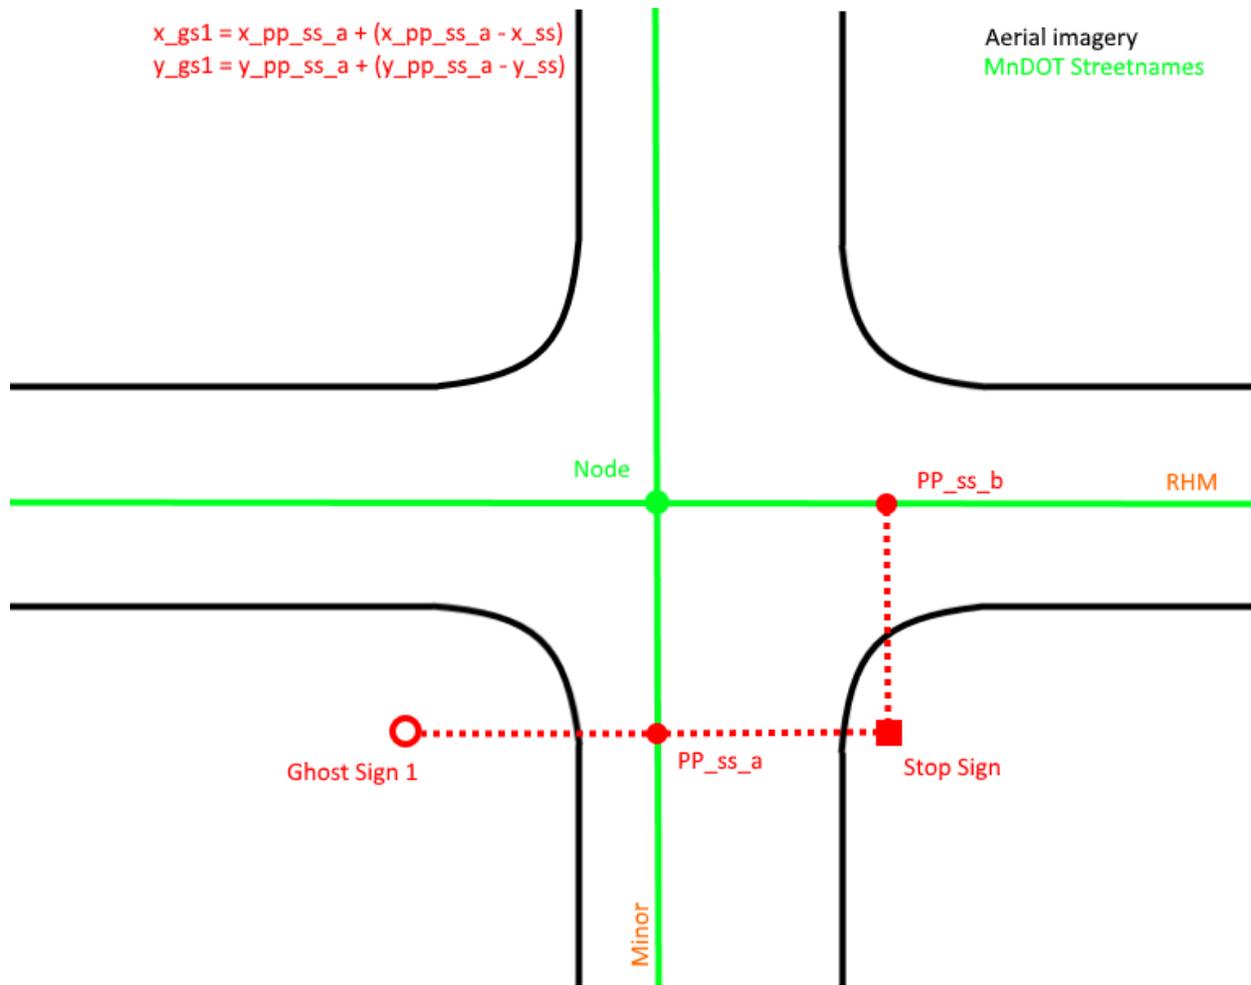
Figure A-0.5 Identification and assignment of approaches – Step 5

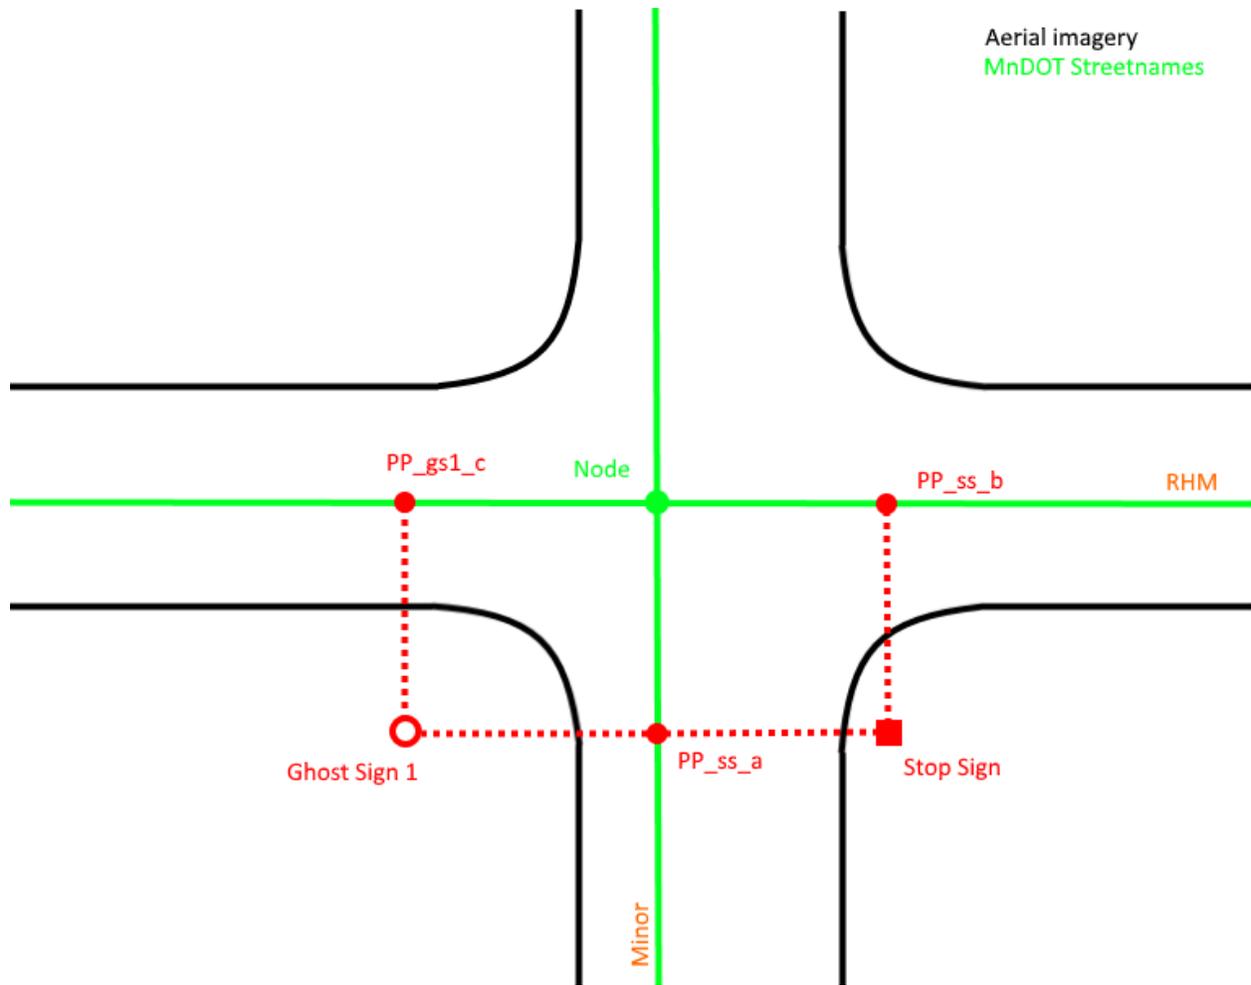
Figure A-0.6 Identification and assignment of approaches – Step 6
