Evaluation of the Effectiveness of Stop Lines in Increasing the Safety of Stop-Controlled Intersections

Minnesota Traffic Observatory

Research Project

Final Report 2020-17

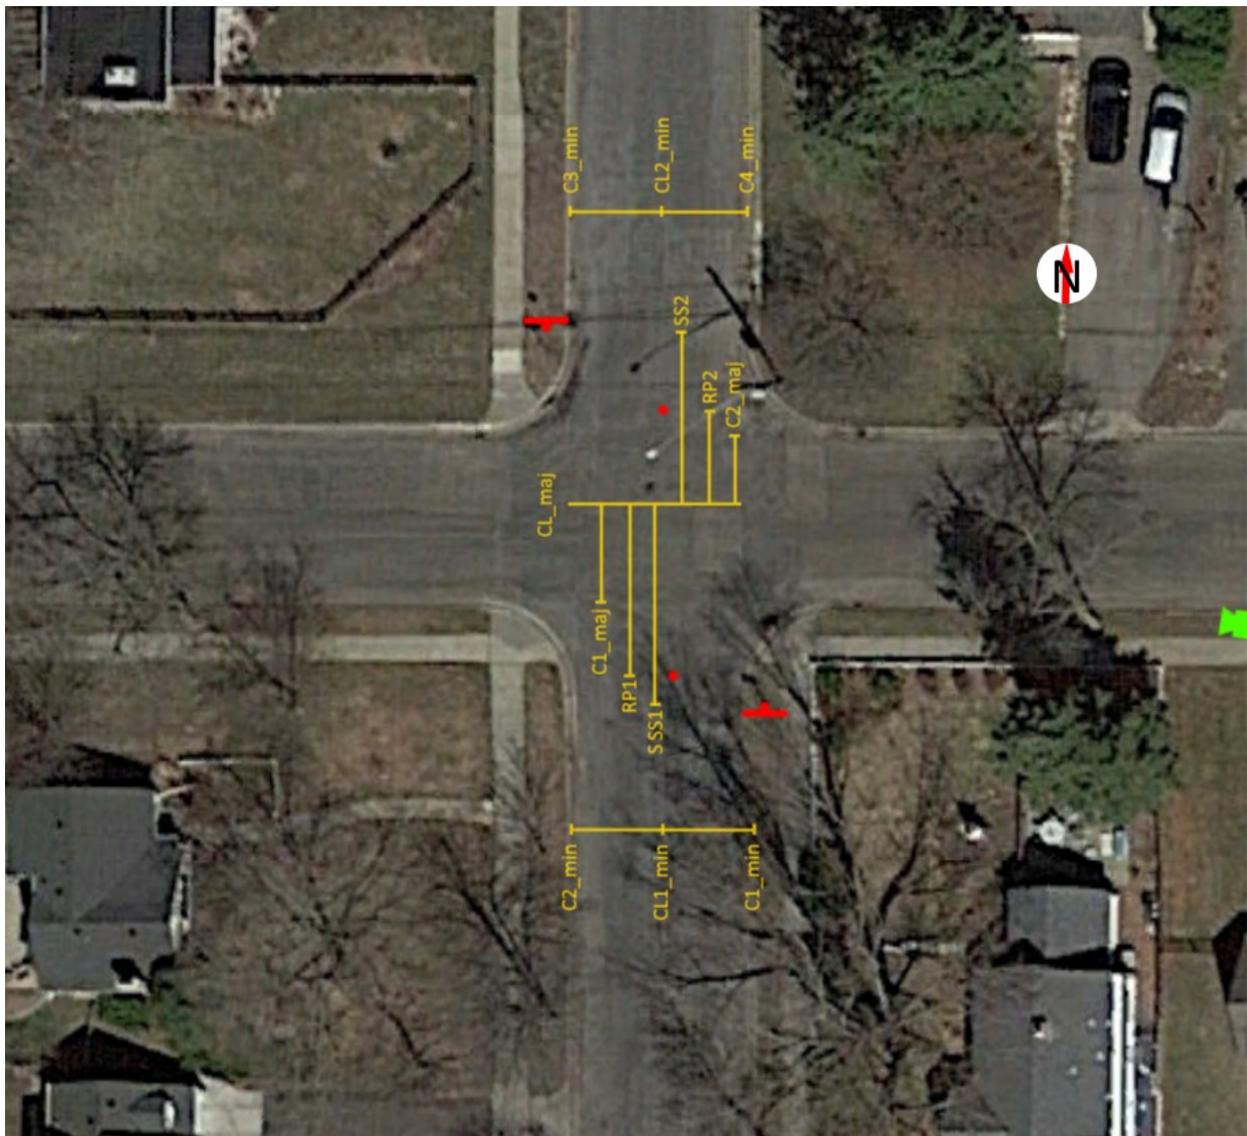
Figure C-0.5 Aerial view of Quentin Ave NB and SB with measurements

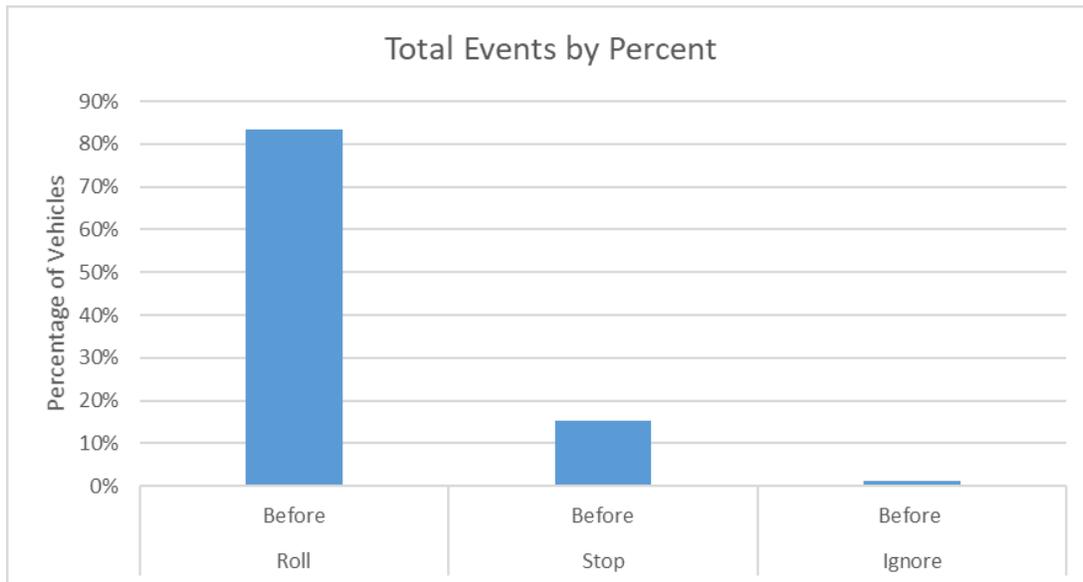
Figure C-0.6 Quentin Ave NB distribution of driver crossing behavior

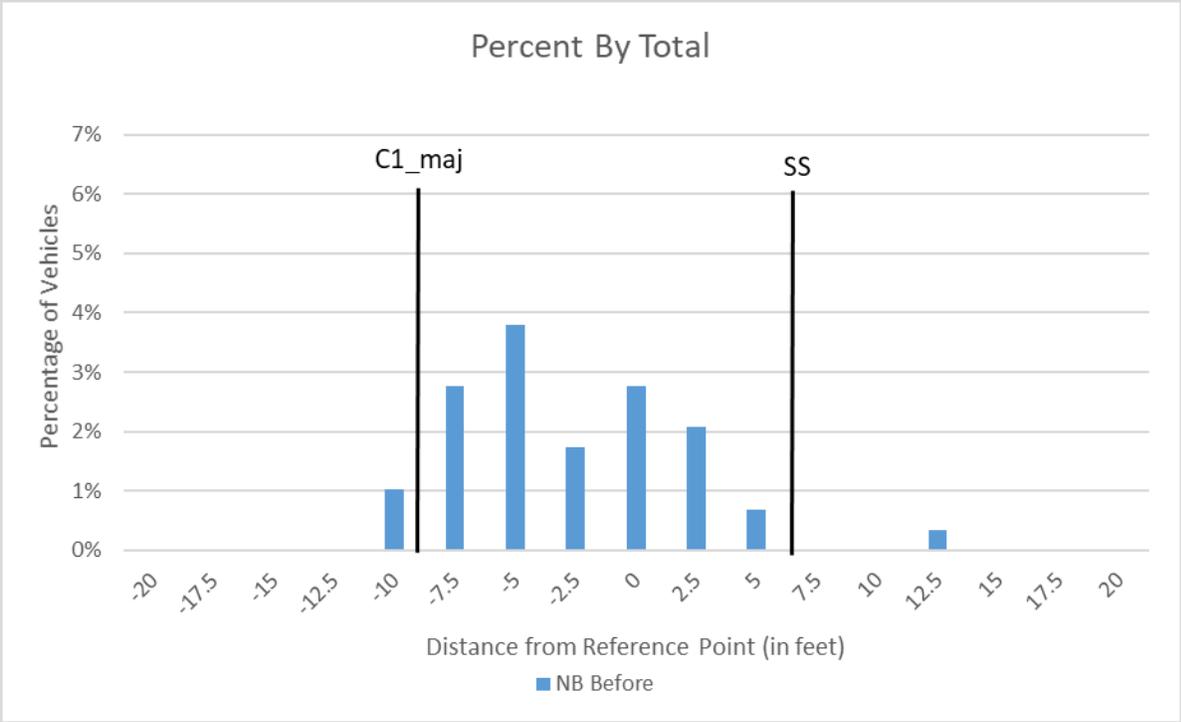
Figure C-0.7 Quentin Ave NB Distribution of Stopping Distance During All Events

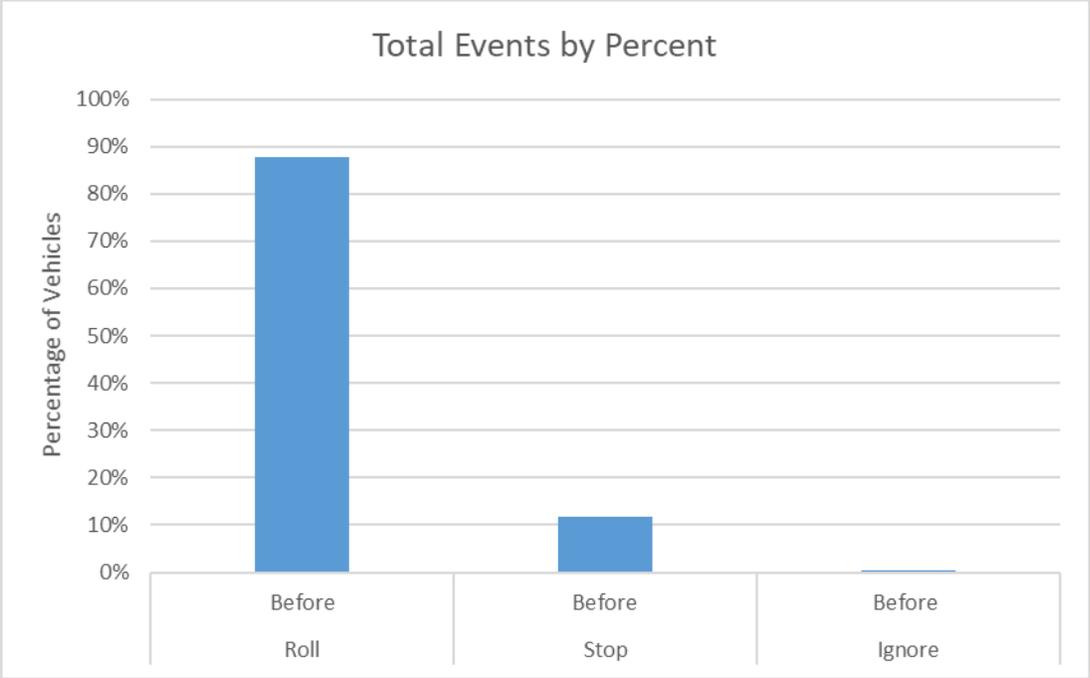
Figure C-0.12 Quentin Ave SB distribution of driver crossing behavior

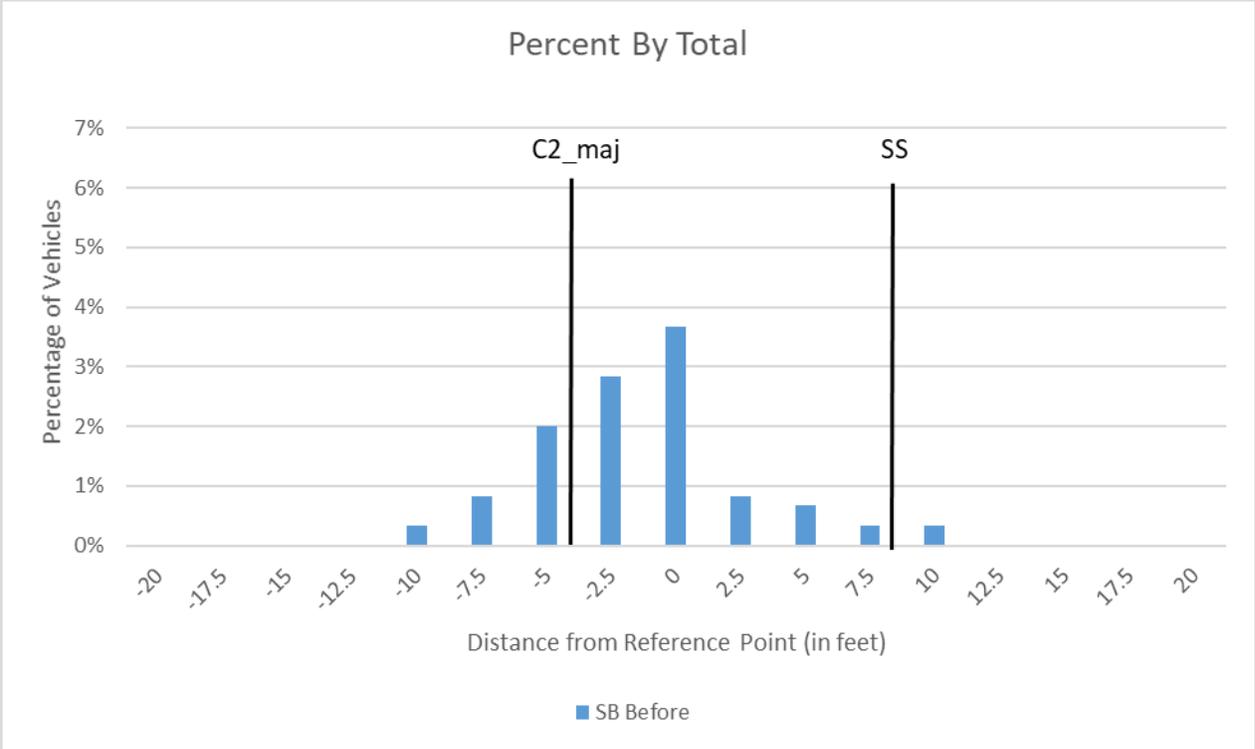
Figure C-0.13 Quentin Ave SB Distribution of Stopping Distance During All Events

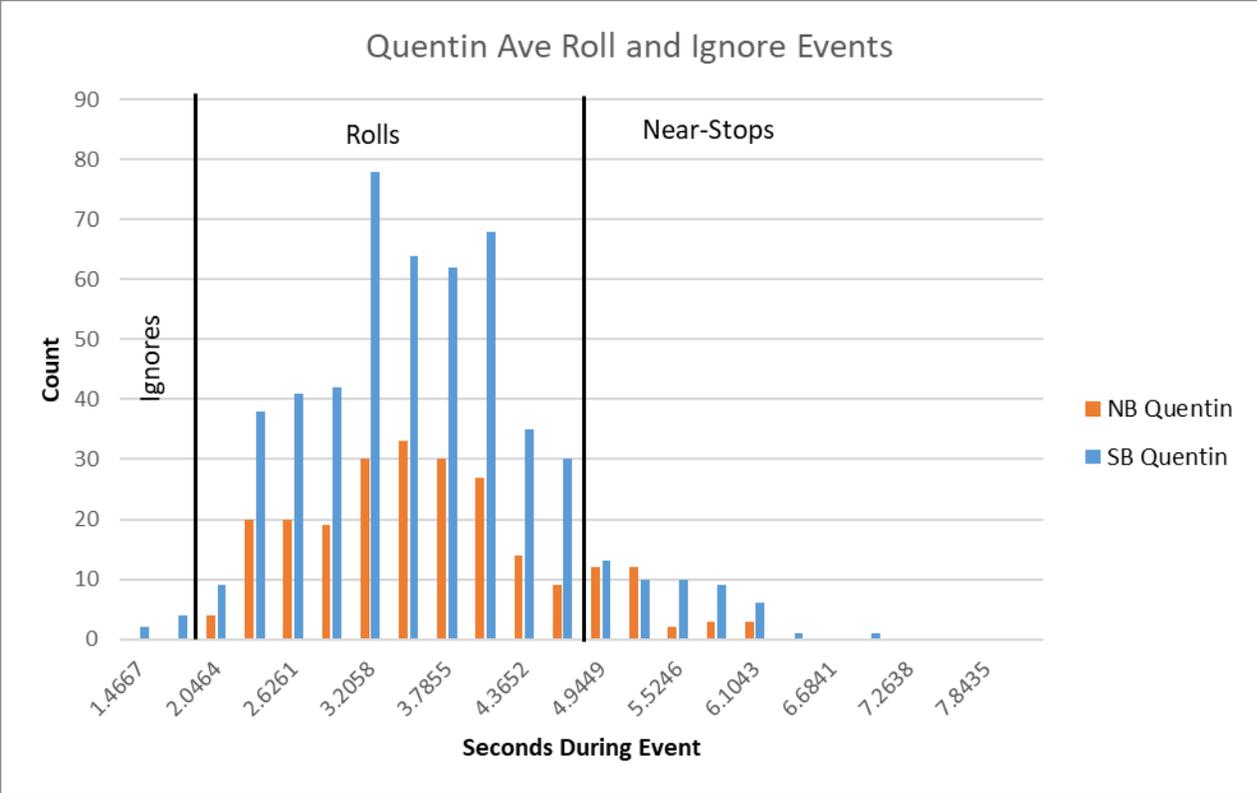
Figure C-0.18 Histogram of time drivers spent at stop sign during roll and ignore events
