DRAFT REPORT

FATIGUE EVALUATION AND REDUNDANCY ANALYSIS

**BRIDGE NO. 9340
I-35W OVER MISSISSIPPI RIVER**

URS Corporation
700 South Third Street, Suit 600
Minneapolis, MN 55416
Project No. 31809166.01201

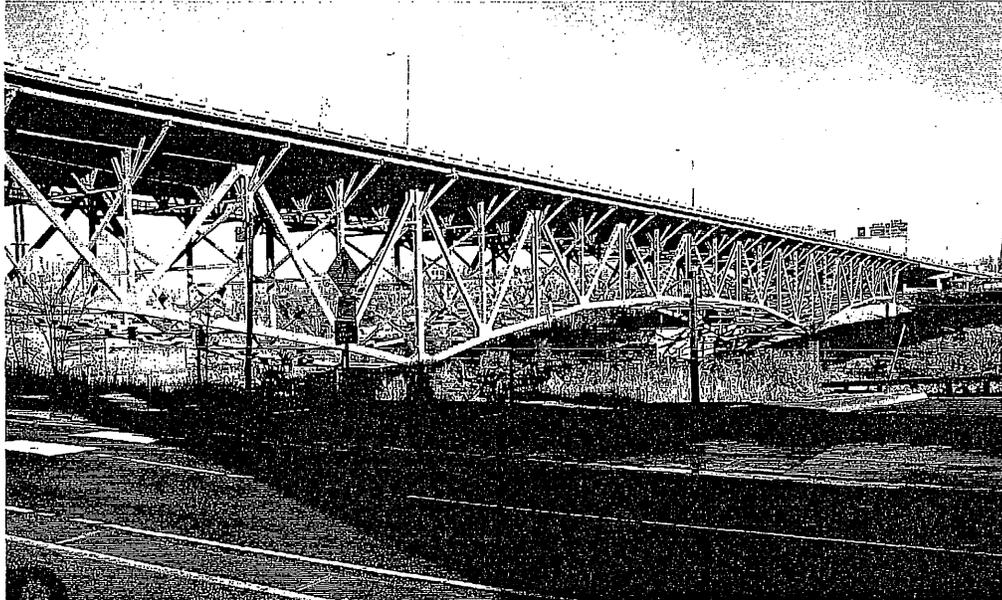
Figure 1-3. Bridge 9340 Overview Looking North-West

Figure 1-1 shows the general plan and elevation of the bridge; and **Figure 1-2** depicts the framing plan of the deck truss, both extracted from the 1965 original plans of contract B. **Figure 1-3** shows an overview of the bridge looking north-west, and **Figure 1-4** is a view above the bridge deck looking north.

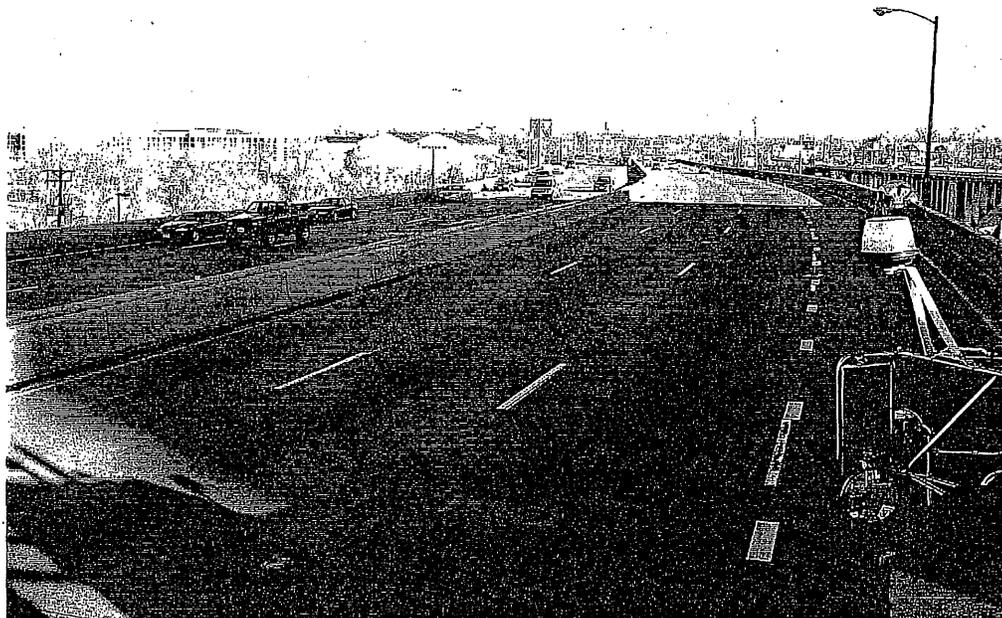
Figure 1-4. Bridge 9340 Deck View Looking North
