# User-Centered Smart Traffic Sign Development Implementation Study

**March 2026**

Research Report  
Final Report 2026-10

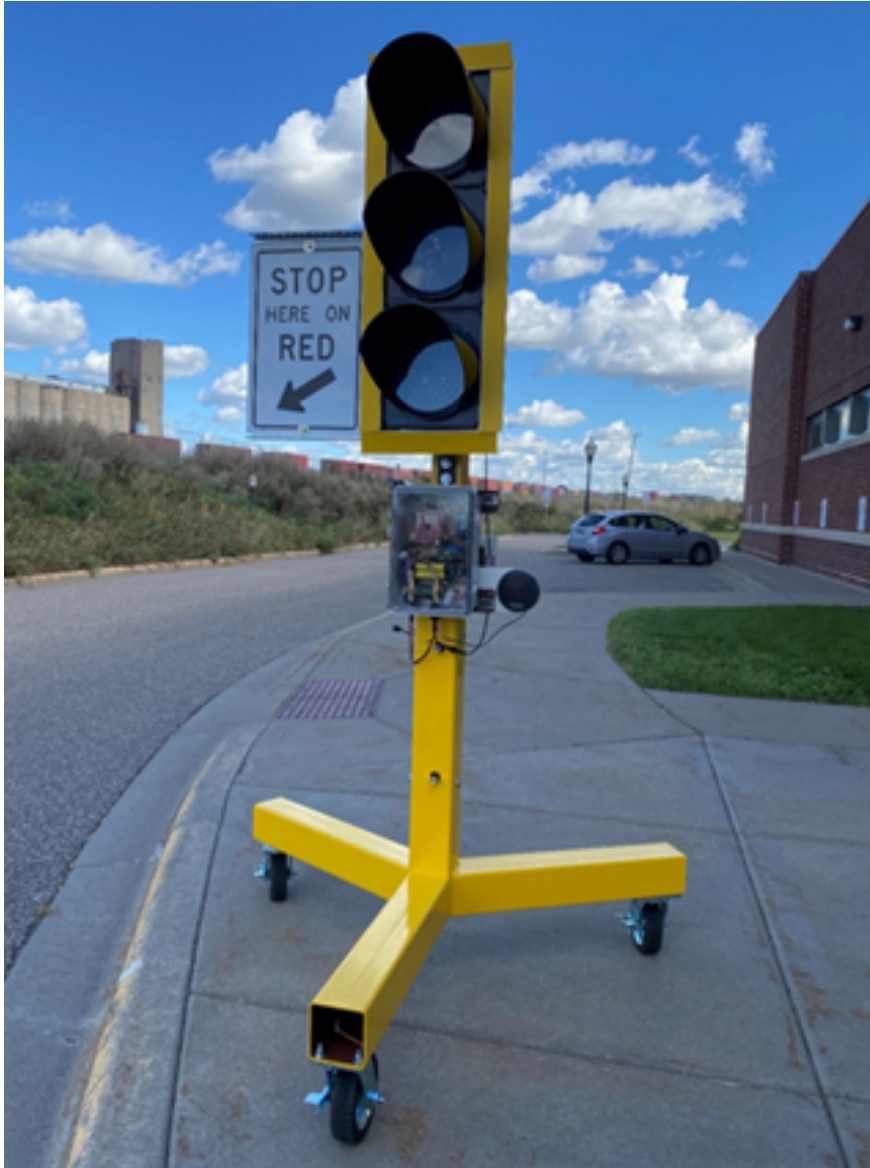
Figure 1.1: Photograph of the implemented smart work zone traffic signal from Phase 1.

Phase 1 of the study focused on the development of a user-centered smart traffic sign both in regard to testing the overall proposed sign design in a simulator from a driver behavior perspective and the sensing capabilities to detect and track oncoming traffic using low-cost sensors. Through this work a modified traffic signal was constructed capable of being operated via handheld remote. The modified traffic signal included a sensing system that would monitor vehicles that were either approaching the work zone at dangerous speeds or entering the work zone when the traffic signal was indicating for the driver to wait. Usability testing of the modified traffic signal in a driving simulation found lower expectancies and stopping rates of the traffic signal-based alarm system compared to a traditional flagger but did demonstrate evidence that drivers may be less likely to stop and remain stopped with the flagger STOP sign than the red ball indicator of the traffic signal. A follow up test found that the addition of the sensor audiovisual alarm system to a more traditional stop/slow flagger paddle saw improved performance. Based on these findings from phase 1 of the study, the proposed work to be accomplished within phase 2 is aimed toward field validation testing of the flagger style smart traffic signal prototype in regard to sensing capabilities, usability from the perspective of the workers, and resulting driver behavior.

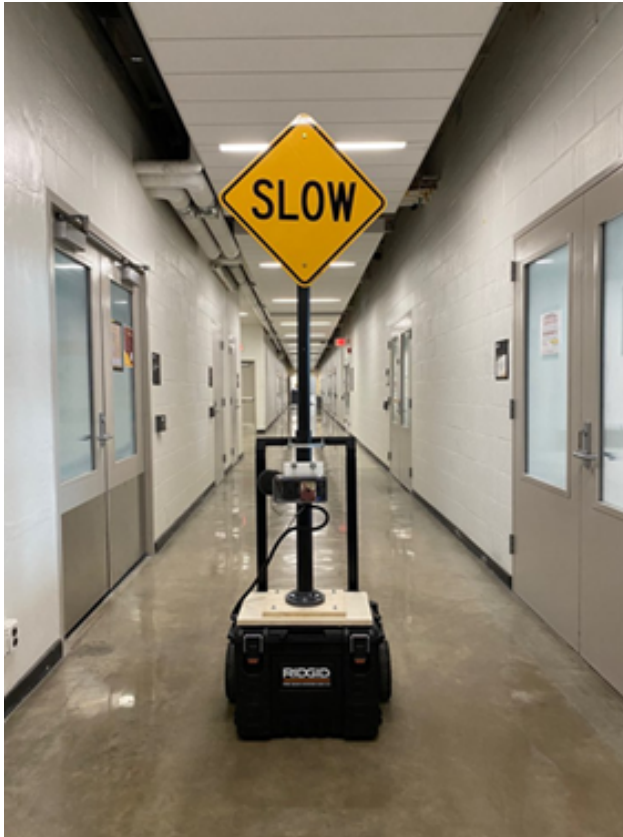
Figure 2.2 Photograph of instrumented sign being used with a taller height, showing adjustability of desired height

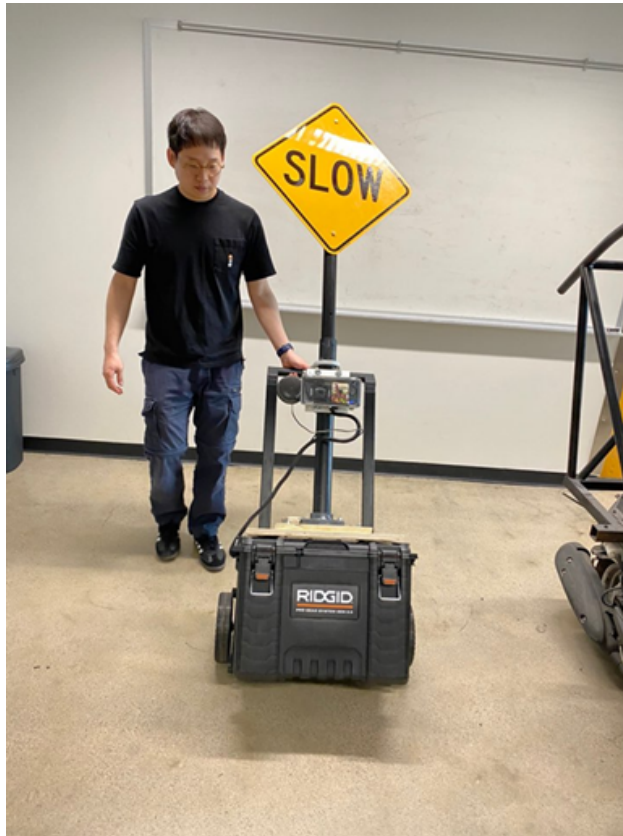
Figure 2.4 Photograph showing that the portable device can be easily wheeled over a concrete floor

The developed sign is portable and can be easily wheeled, as shown by one of the co-authors of this report in Fig.2.4.

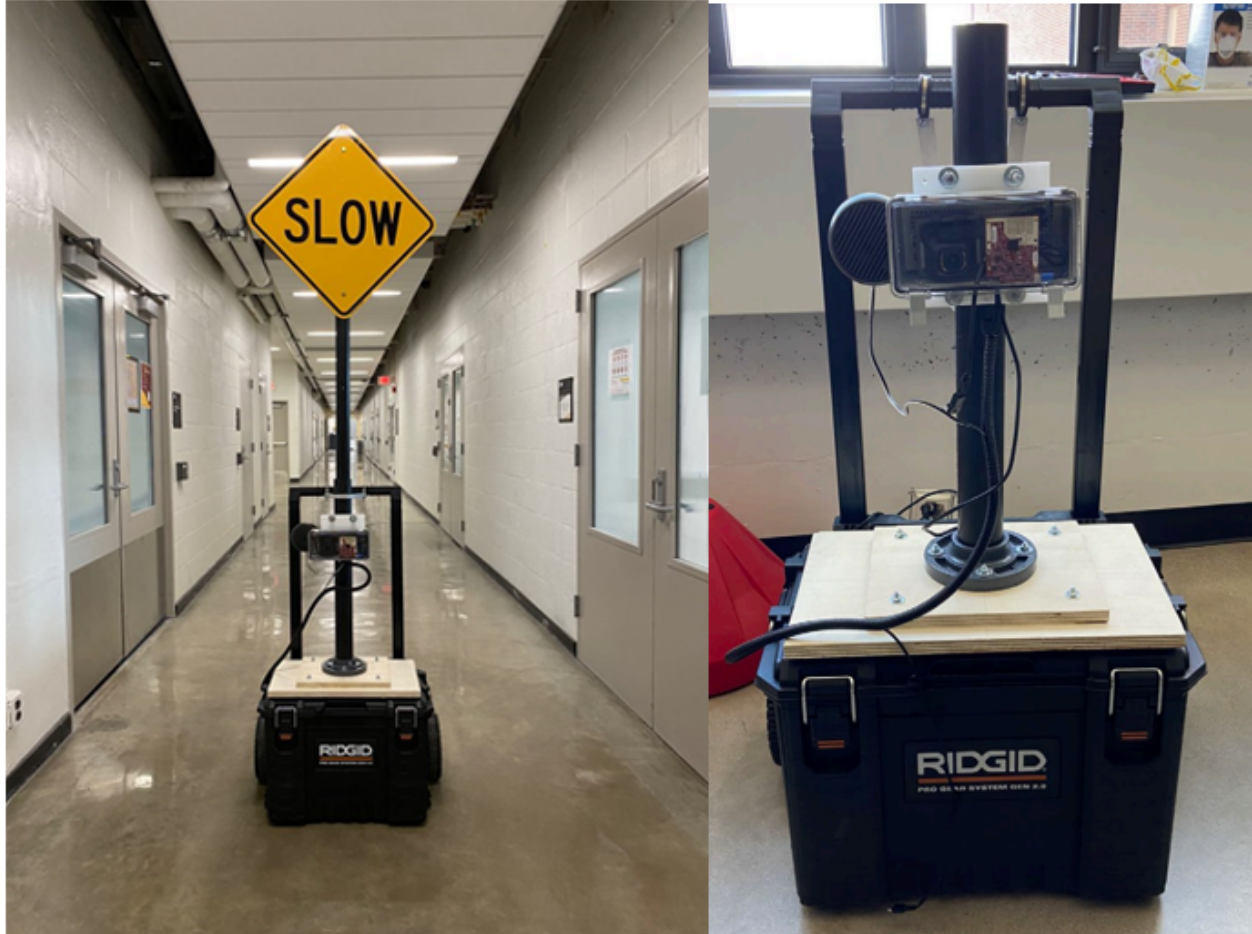
Figure 3.2 (a) Gen 2 prototype developed in Task 2; (b) radar and electronics decoupled from the STOP/SLOW sign.

The Gen 2 prototype consists of a STOP/SLOW sign on a wheeled box with rugged wheels (Fig. 3.2). Electronics and a heavy battery are housed inside the box; their weight helps prevent toppling in strong winds. A dual telescoping pole mounts to the box. The upper pole rotates to present STOP or SLOW and locks in place; it can be removed and stored separately for transport. A radar chip and antenna, Raspberry Pi, loud-speaker, and ancillary electronics are mounted on the lower (non-rotating) pole, keeping the radar oriented toward oncoming traffic.

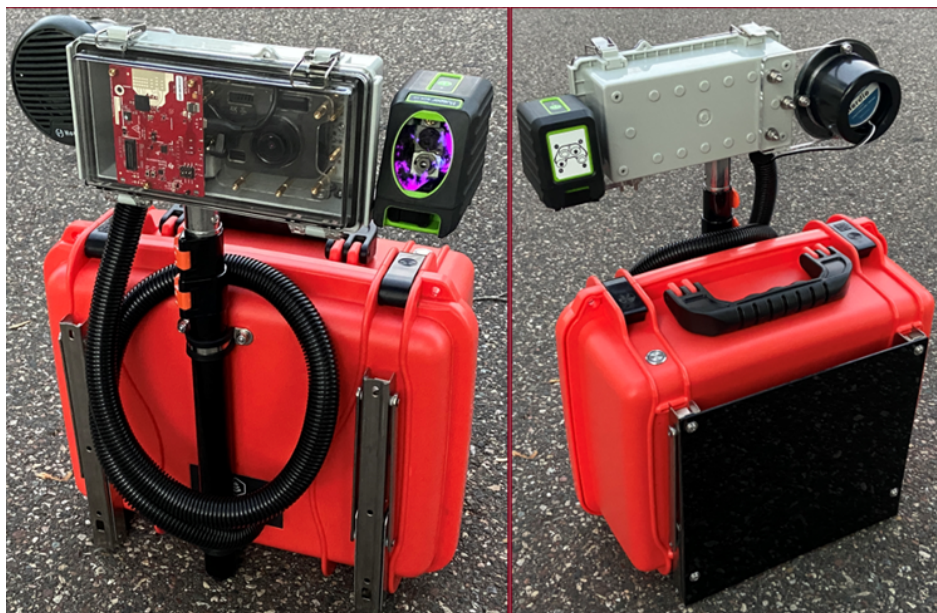
Figure 3.5 Front view of Gen 3 prototype (left) and rear view (right).

The Gen 3 prototype is a waterproof box containing the radar sensor and dash-cam. It collapses into a compact case for transport and expands for operation. A telescoping pole raises the radar to the needed height; folding shelf brackets stabilize the case against wind.

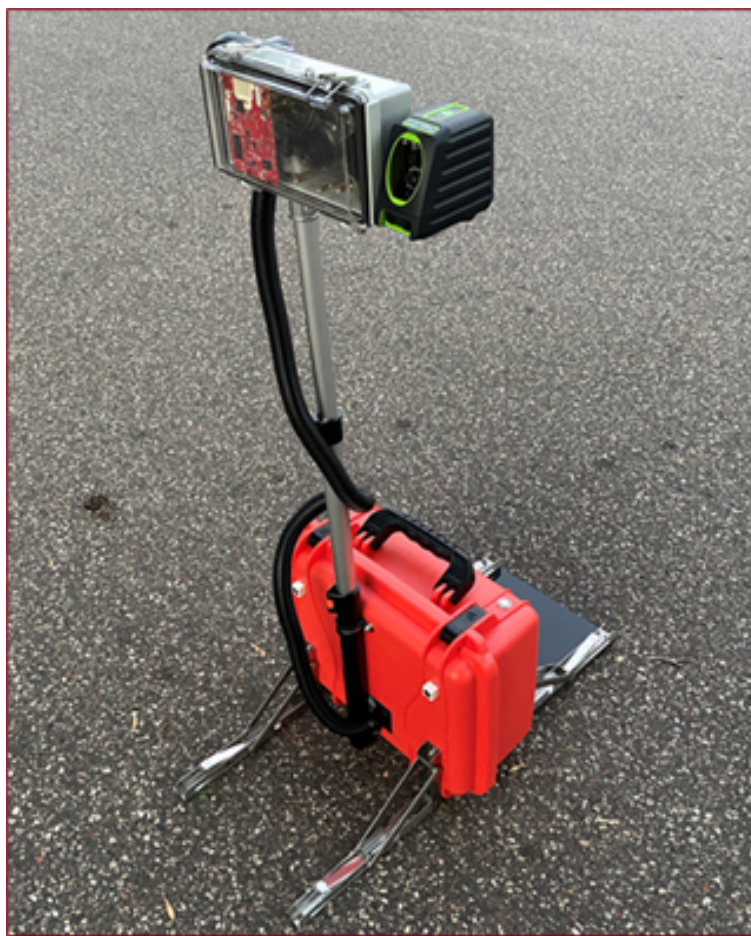
Figure 3.6 Expanded Gen 3 prototype ready for deployment.

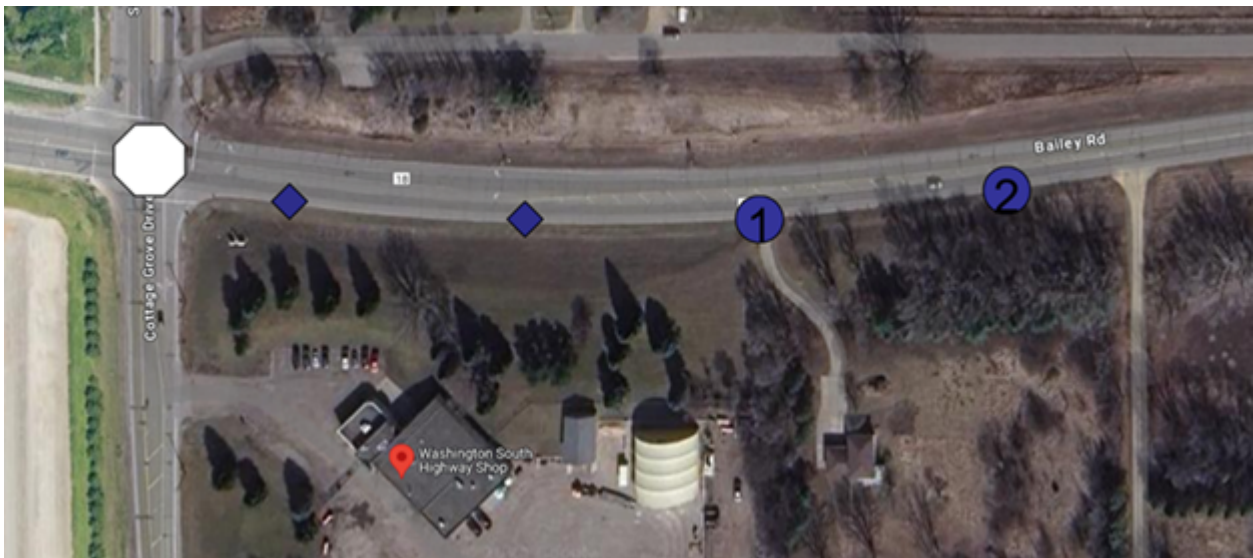
Figure 3.10 Locations of the pilot test.

Data from Device 2 (Fig. 3.10) were used for analysis; its placement farther from the four-way stop let

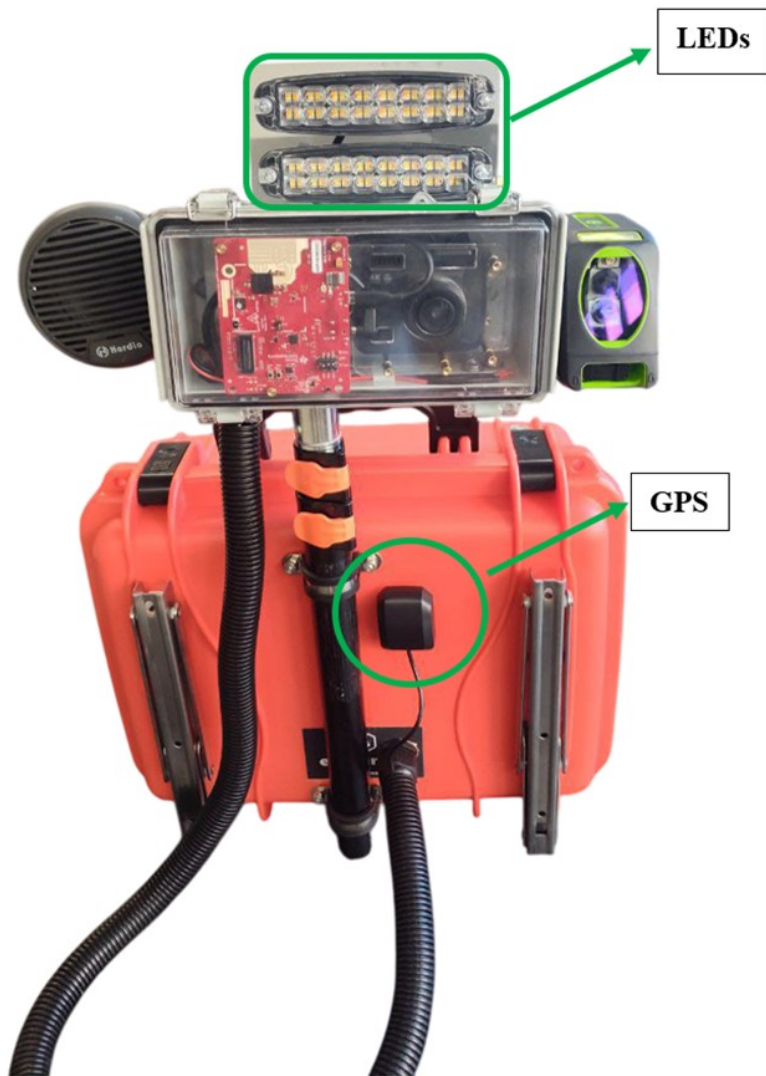
Figure 4.1 Component configuration.

GPS tracking capability was added to the revised system to accommodate feedback from workers to measure the distance between the two devices. This tracking system would allow for the primary device to measure its distance from the secondary device, a proxy measure of the distance to the flagger. A GPS module that provides updates with a frequency of 10 Hz has been integrated into each device to enable real-time reporting of their geographic coordinates. As illustrated in Fig. 4.1, the module is mounted on the back of the case. Wireless communication between devices is facilitated by a radio frequency (RF) module (detailed in the following section), allowing multiple devices to exchange GPS coordinates. This functionality is potentially beneficial for tuning the intrusion detection algorithm parameters, especially in dynamic construction zone scenarios where the relative distance of the upstream and downstream warning devices can change. Adjusting the algorithm of the target speed of approaching vehicles based on their distance to the flagger was suggested as an important feature to reduce false alarms of vehicles traveling at higher speeds further from the work zone and elevate warnings for vehicles quickly approaching the work zone at shorter distances.
