# Evaluating Minnesota Homes Final Report

Prepared for:  
**The Minnesota Department of Commerce**

By:  
**Sheltersource, Inc.**

June 30, 2002

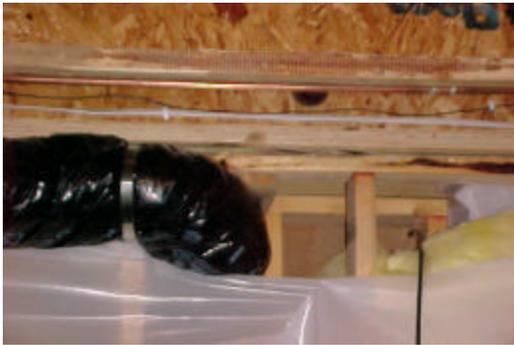
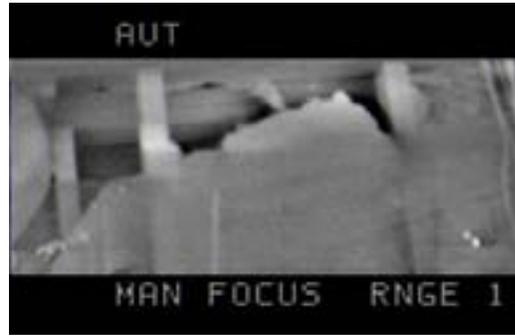
The above images illustrate an obvious void and serve as a good example of what can be found with infrared imaging. The dark areas in the infrared image correspond to the cold surfaces caused by the missing insulation. This was in a 1998 home where a ventilation system was retrofit. The insulation was not put back in place properly after the exterior hood and flex duct for the ventilation system were installed.

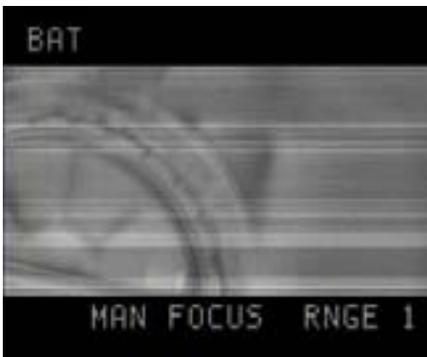
This infrared image shows an insulation void in the corner of the arched window in this 1998 home. This is a typical scenario for this detail due to the amount of framing members necessary to support this window and the small amount of space left to provide insulation, but this image would indicate that there is no insulation placed in that cavity.

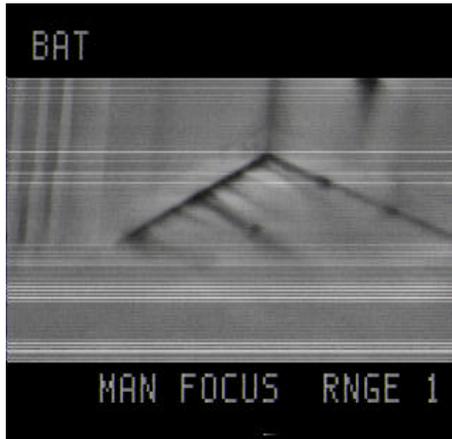
## Bottom Plate Leakage

These pictures show air leakage from the crack between a sub-floor and bottom plate. Typically the leakage is greater in exterior corners of the floor due to the complex connection of the adjoining walls and the physical properties of wood to expand and contract with slight changes in moisture and temperatures. Using a plate gasket in between the sub-floor and the bottom plate or caulking the bottom plate to the sub-floor are two common ways of preventing this air leakage pathway.

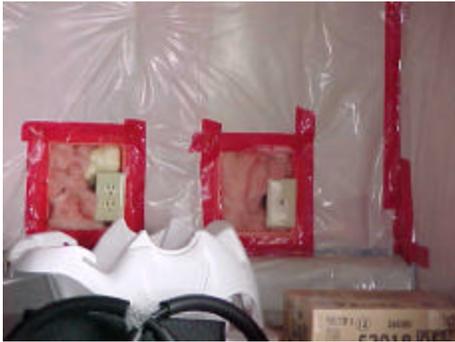
## Exterior outlets

Leakage from exterior electrical penetrations was expected to be more of a problem in the 1994 and 1998 homes than the year 2000 stock due to the increased use of sealed exterior outlet boxes. This was the case, but not to the degree expected. Some of the installations were well sealed; others leaked as much as regular boxes. Attention to detail is essential to the success of airsealing at this assembly.

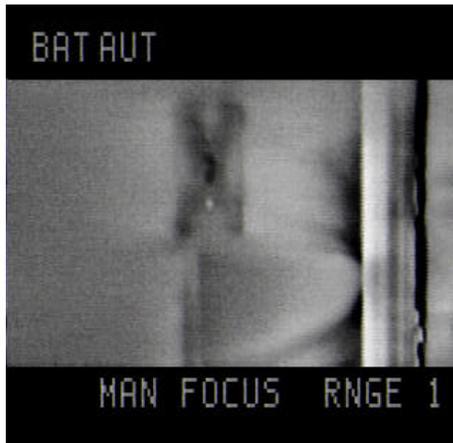
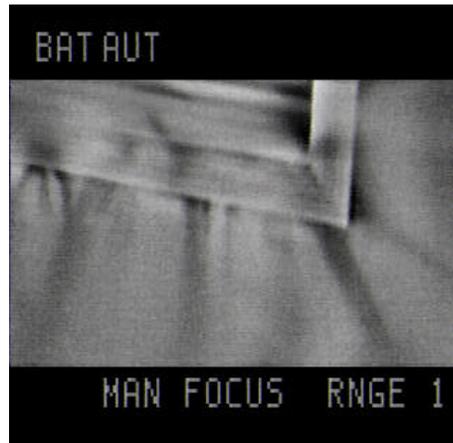
## Doors and windows

Leakage around doors and windows can occur when the interior poly or sheetrock is not sealed to the rough openings. The leakage may go unnoticed by the homeowner because of the nature of the leak. Many occupants may simply think that the leak is from an improper seal at the door or window, not the installation. Sealing the vapor barrier or sheetrock to the rough opening of the door or window, insulating the cavity between the rough opening and the door or window, and properly sealing the exterior of the door or window frame to the exterior air barrier greatly reduces the potential for drafts at the doors and windows.

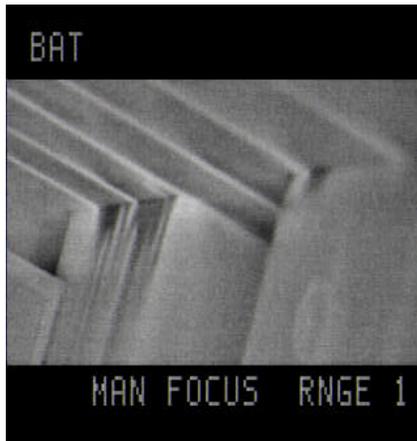
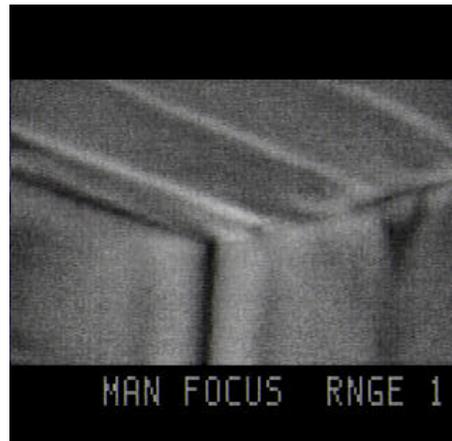
These are shots of air leakage from floor cavities situated over attached garages. Both of the pictures are observed from adjacent kitchens. Note that the floor trusses are white because they retain heat longer than the un-insulated cavities around them that are getting washed with cold air. This was noticed in homes of all code types.

None of the homeowners in our study mentioned comfort issues that could be traced to this situation, but many homeowners believe that the cold feeling from this room in the winter is natural and to be expected because the room is over the garage. Sealed blocking above the garage common wall would reduce the amount of air drawn into the wall and floor cavities and isolate leakage from the cantilevered floor if it occurred.

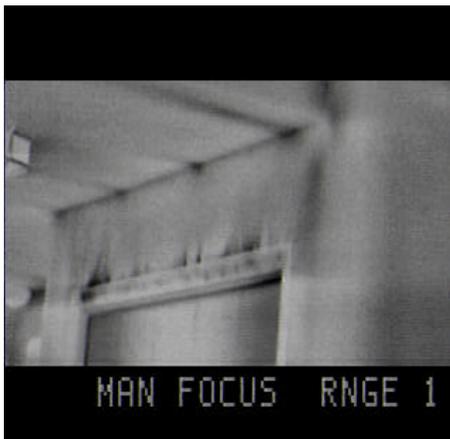
The leakage shown here was observed from an unsealed rim joist in a Category 2 home. There are also air leaks noticeable above the patio door.

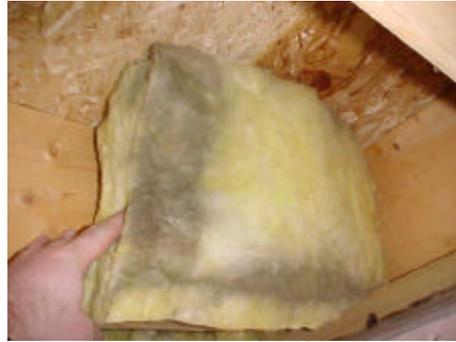
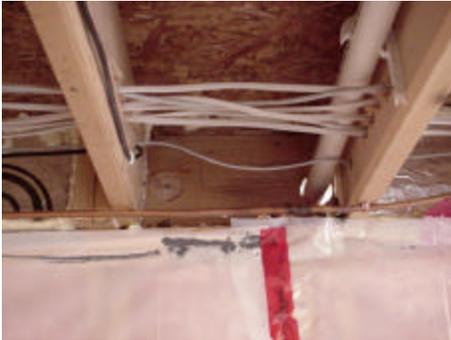
This staining is a common visual indication of rim leakage in a main floor rim of a 1994 home. The batt of insulation has been filtering infiltration for some time. Again, the proper sealing of the rim joist would prevent the air leakage from spilling into the basement.

This is a main floor rim joist in a year 2000 home. Notice the light coming in around the PVC pipe. The majority of the rim is well sealed with rigid foam and integrated with the polyethylene air/vapor barrier below it, but this penetration is a weak point.

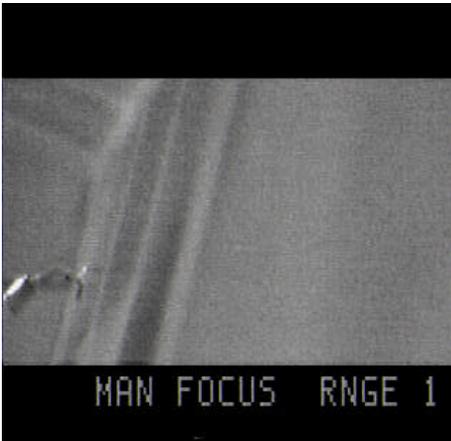
This is a second floor shower stall that is adjacent to an exterior wall and below an unconditioned attic. The object on the left of the picture is a showerhead. The white lines are warm studs, which are highlighted in black because of cold air filling the cavity.

As easily as the air can enter the wall cavity under test conditions, warm moist air can travel in the opposite direction during the winter. When this happens, accumulation of water in the wall cavity may occur due to condensation, challenging the systems durability.

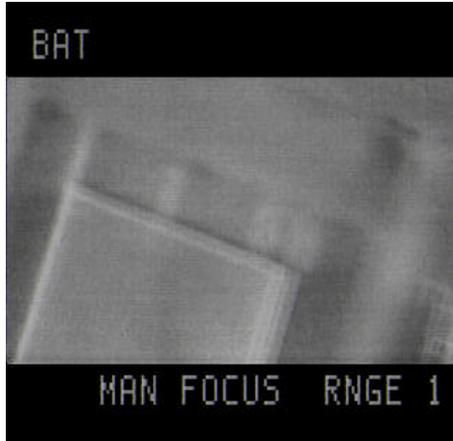
Both of these pictures are framed fireplace cavities on exterior walls. Just as with the plumbing wall, the interior studs of these cavities appear warm when compared to the adjacent sheetrock. Had the cavity been sealed from exterior leakage, there would not be as significant a temperature difference and the dark areas would not be as evident.

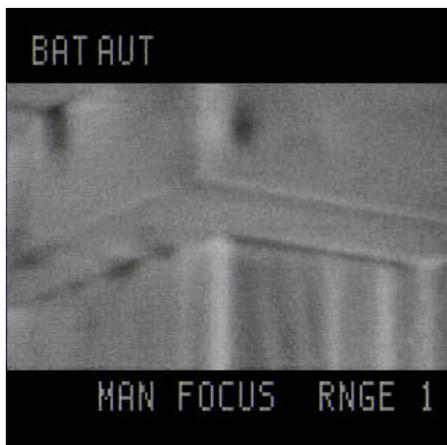
This is a dropped soffit in the basement of a 1998 home with an air leakage signature similar to those of the framing cavities above.

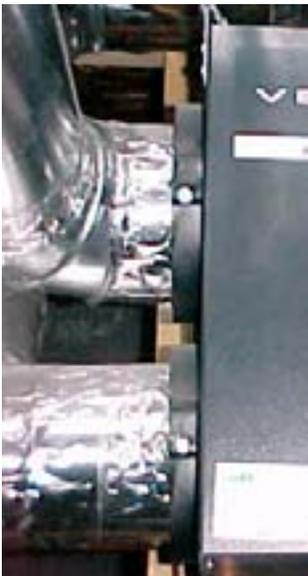
This is a picture of the warm side duct collars on a properly balanced HRV. Notice the dampers are screwed in place at the collar attachments and the metal ducts are sealed to the unit.

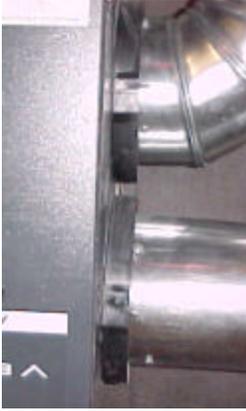
This picture shows the intake and exhaust balancing dampers on the duct collars where the metal ductwork is attached to the unit. Notice there are no screws in the dampers. These dampers could be accidentally adjusted and affect the operation of the ventilation system. Notice that there is a balancing sticker attached in the upper right corner although the system was never actually balanced.

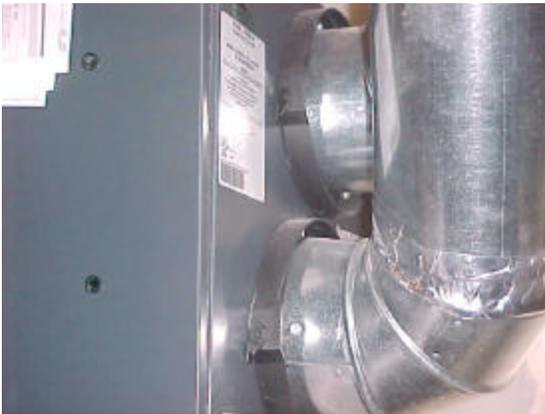
This picture shows the balancing dampers on a year 2000 system as they were found - completely shut and reducing airflow and system effectiveness. No attempt was ever made to ensure that this unit operated properly after it was roughed in.

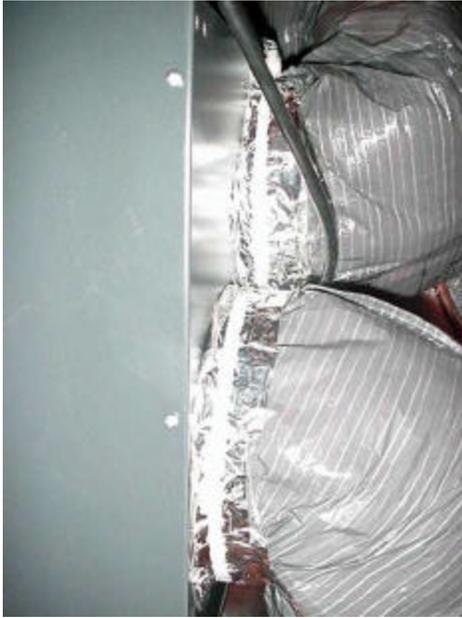
This picture is a good example of properly installed flex duct on the cold side of an HRV installation. The exterior of the flex is taped and tie-strapped to the outside of the duct collar. It can only be assumed that the interior of the flex duct is attached to the interior of the collar in a similar manner. The sharp bends in the flex duct will reduce the overall system flow rate and would benefit from getting at least 12” of straight duct length prior to the bend.

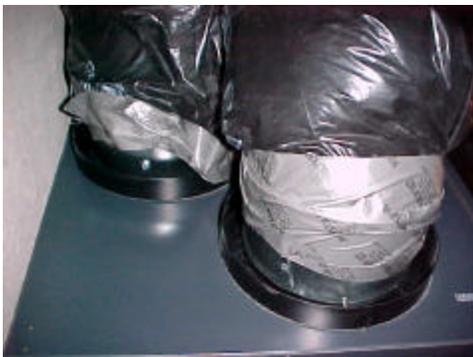
This installation left exposed metal ductwork on the cold side of the system. It is important that the insulation in the flex duct extends all of the way to the collar and that the flex/collar connection is sealed properly. If this does not occur, it is possible that condensation will occur throughout the winter at this connection.

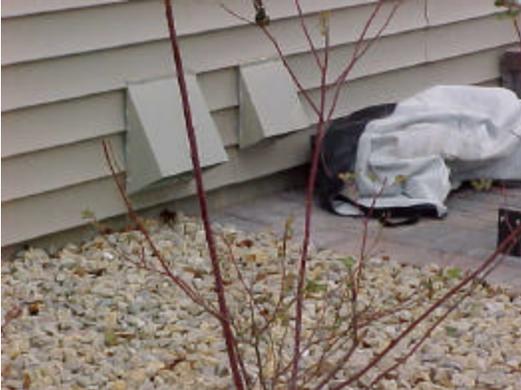
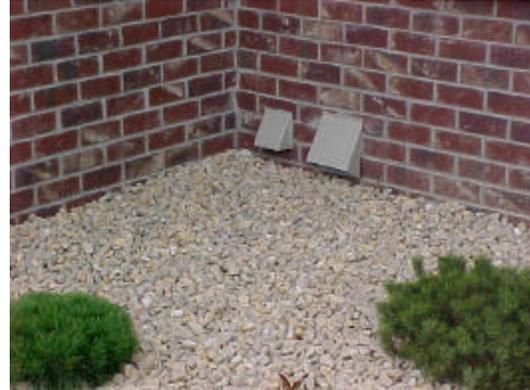
These are shots of the intake and exhaust hood locations of the other installation. The ventilation and dryer exhaust hoods on the right are about 4" of the landscape rock. The intake and combustion air hoods on the left are approximately 6" above the rock.

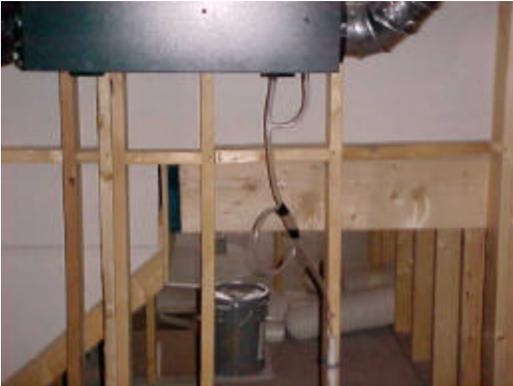
This is a properly trapped condensate tube.

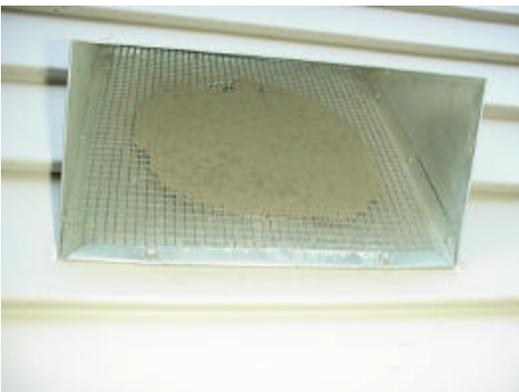
This is a typical plugged hood. Very little intake air is able to make it through the ¼” screen. The system will now have more exhaust capacity and could depressurize the structure.

Similar flow issues can arise if the filters and the heat recovery cores of these systems are not cleaned on a regular basis. Plugged intake hoods and dirty filters seem to go hand-in-hand and are part of an overall misunderstanding of proper maintenance procedure. The three systems above with the largest difference between exhaust flow and intake flow also had dirty filters. Just as a furnace filter needs to be replaced regularly to ensure the proper operation of the heating and cooling system, ventilation units need regular maintenance to maintain their ability to deliver fresh air.

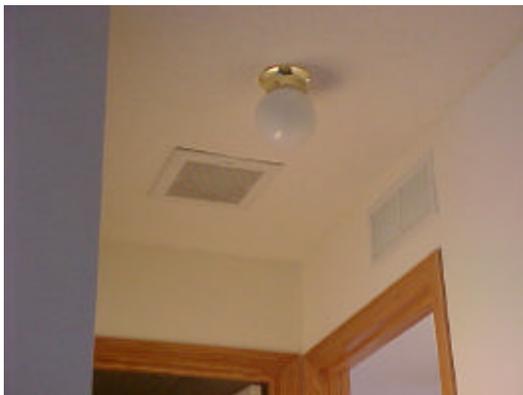
The three exhaust-only systems had the people ventilation fan installed centrally in a 2<sup>nd</sup> floor hallway. Each of the homes had open staircases that allowed for air movement from the main floor.

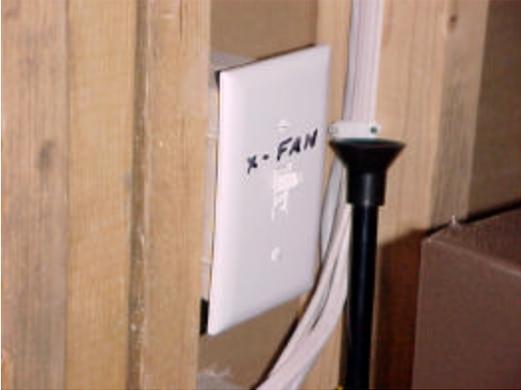
Each of the systems had a labeled people fan switch similar to this installed in the basement.

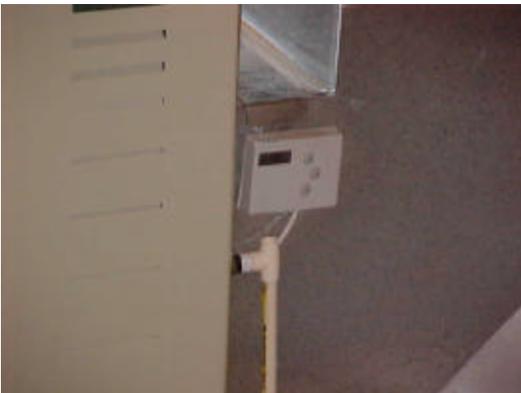
Each of the systems had a control to operate the air handler on the furnace at periodic intervals to distribute fresh air throughout the house.
