# BEEBE LAKE

## HIGH WATER INVESTIGATION MITIGATION STRATEGIES

HIGH WATER INVESTIGATION  
AND  
MITIGATION STRATEGIES  
FOR  
BEEBE LAKE  
BASIN #86-23  
WRIGHT COUNTY

Minnesota Department of Natural Resources  
Division of Waters

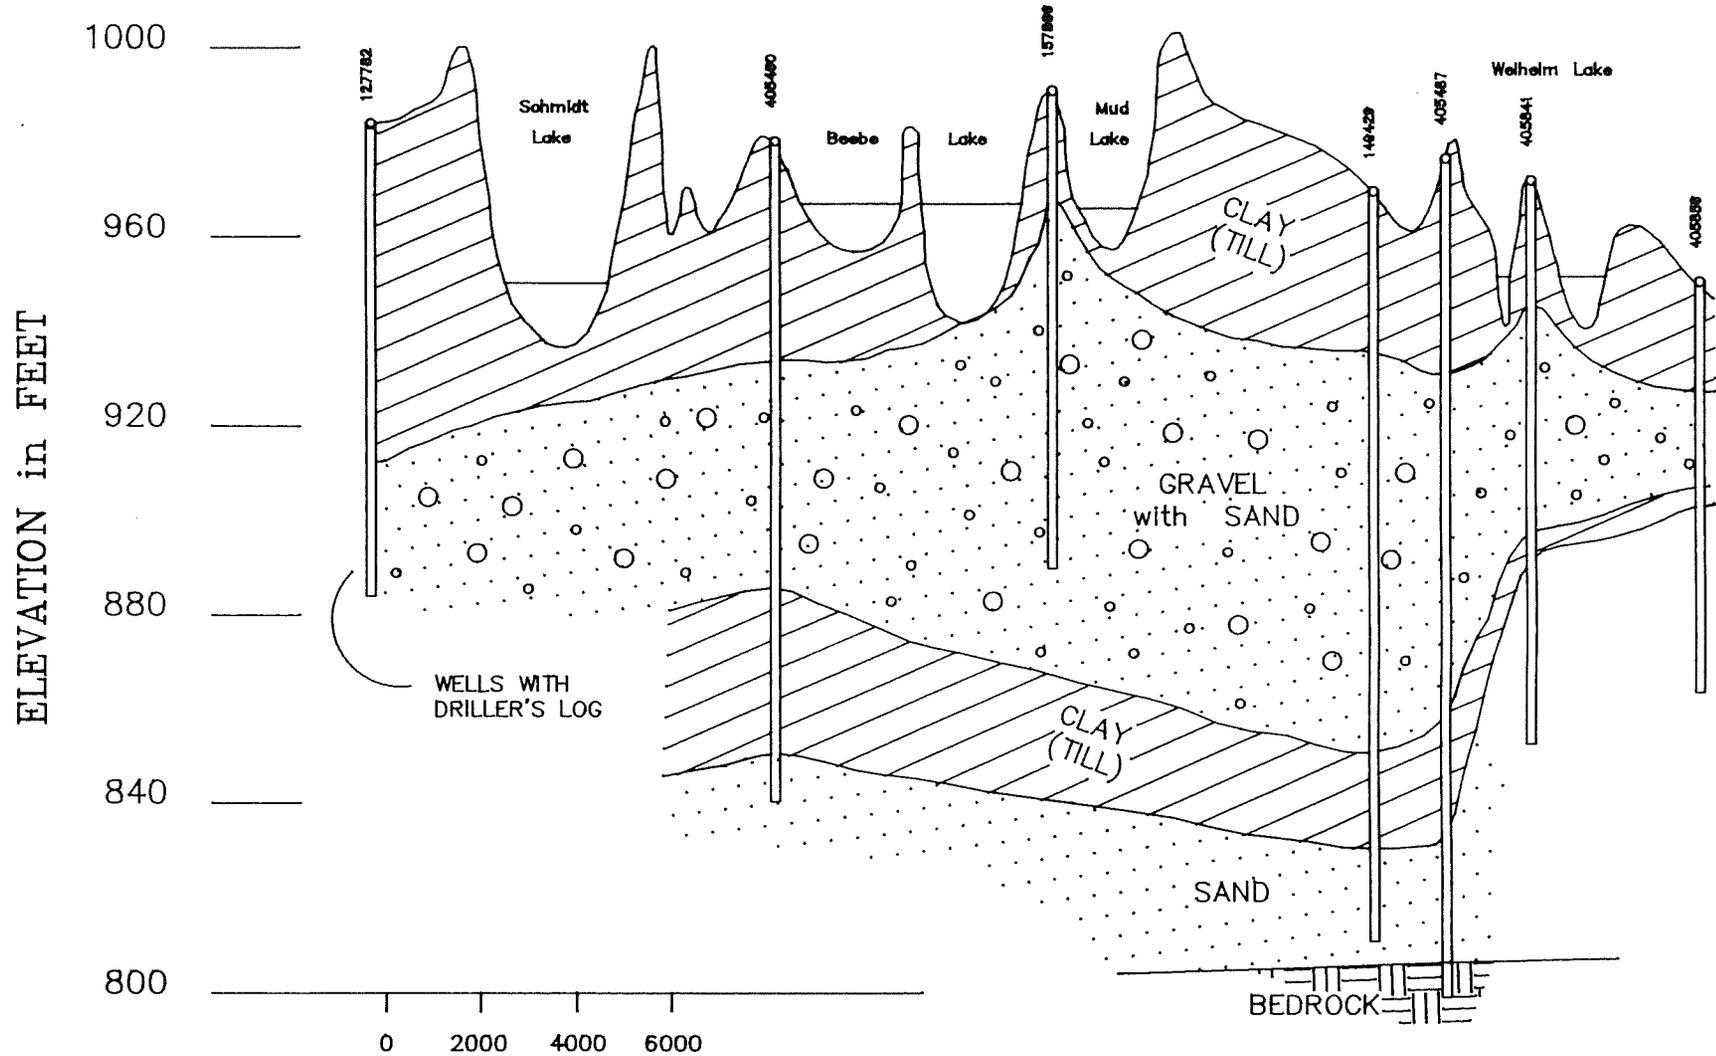
PLATE 2 : STRATIGRAPHY of GLACIAL DRIFT DEPOSITS in the BEEBE LAKE AREA (Information from drillers's logs).

The primary water-bearing units in the area are buried sands and gravels within the till. Wells in the area obtain water from these deposits. The regional direction of ground water flow in the deeper (100 ft.) buried drift aquifers and in the underlying bedrock aquifers is to the southeast toward the Crow River. Local flow systems with different ground water flow directions may exist around the lake. The lake is in contact with glacial till, implying rather slow rates of ground water seepage into and out of the lake. If the buried gravel deposit does intersect the lake bottom, a more direct connection between the ground water system and the lake would exist. However, even at the slower rates of seepage through glacial till, the contribution to the lakes water budget can be significant, especially if a ground water mound develops on the down-gradient side of the lake and blocks outflow to the ground water system.

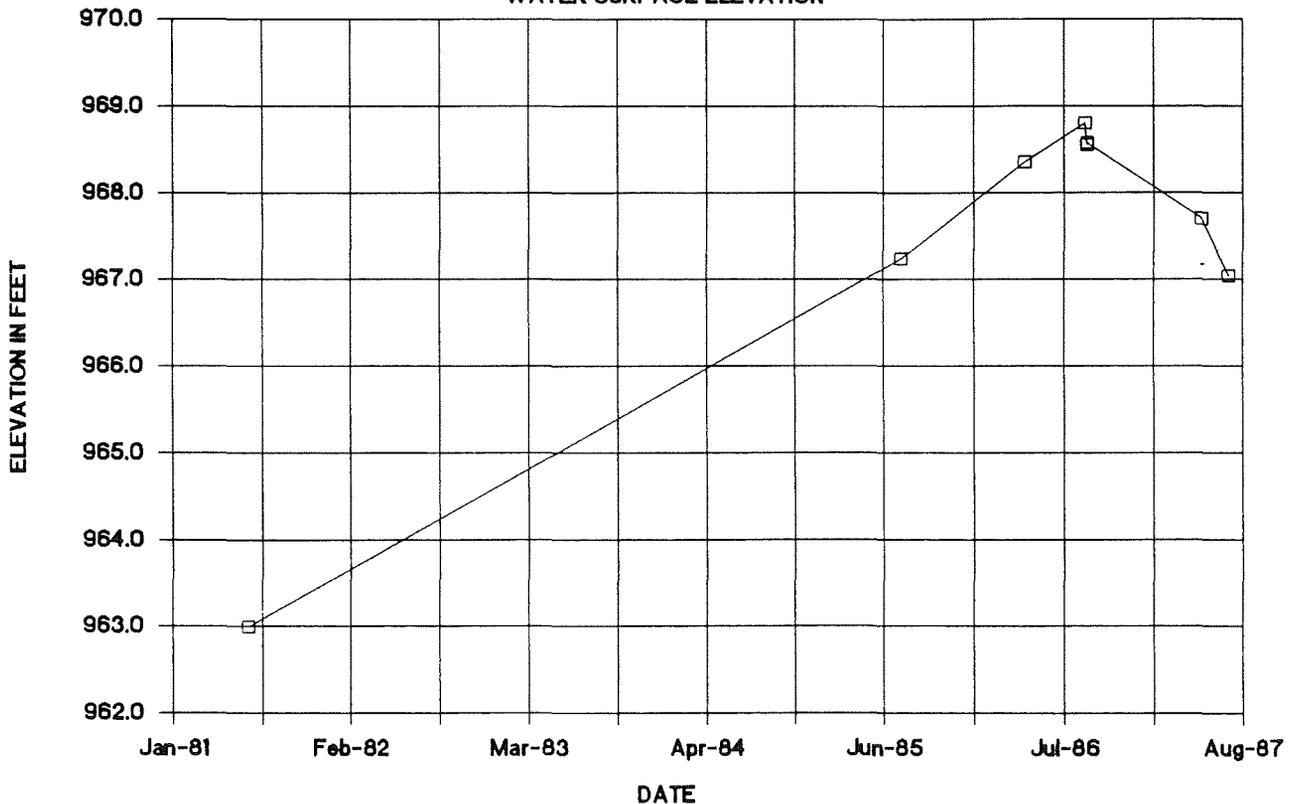
### BEEBE LAKE - WRIGHT CO.

#### WATER SURFACE ELEVATION

The Department of Natural Resources' Beebe Lake file contains eight fairly reliable surface water elevations dated from October 27, 1959 through May 8, 1987 (see Chart 1 and Table 1 below). The available precipitation and lake level data indicate a correlation between the area's annual precipitation and the lake's water level. From 1982 through 1986 (last five years), the area received an additional 28.94 inches of precipitation over the normal annual precipitation of 29.03 inches. The water level of the lake (968.8') on August 22, 1986 was within 0.8' of the lake's Natural Ordinary High Water Mark (969.6') and was presumably due to several years of above normal precipitation.

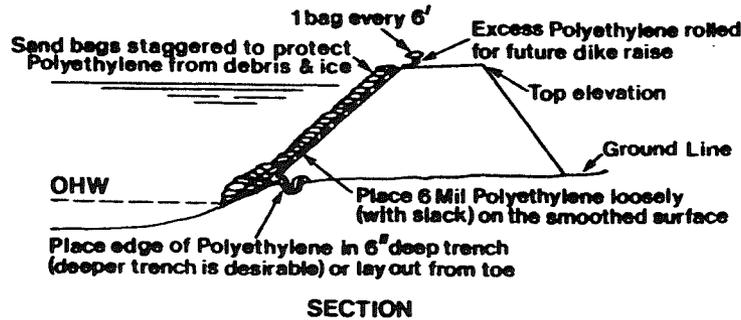
### EARTHEN LEVEE

SECTION

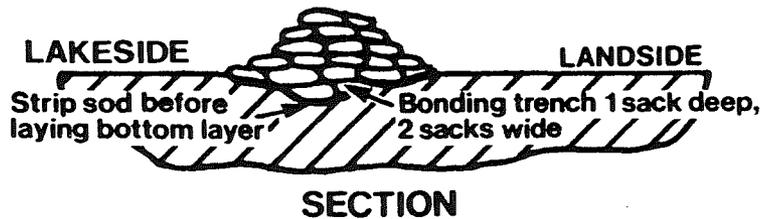
### SANDBAGGING

A sandbag levee provides temporary protection from short term rises in lake elevations.

- Seepage Barrier: Polyethylene sheeting may be incorporated into the lakeward face of the levee to reduce seepage. Placement is similar to placement on an earthen levee.
- Interior Drainage: Pumping will be required for removal of seepage and rainfall behind the levee. Sandbag levees will seep more than earthen levees, as the material is pervious and the cross section is not as wide.
- Placement in Water: If the levee is placed in the water, it is important to monitor the levee for settlement, erosion under the levee and excessive seepage.

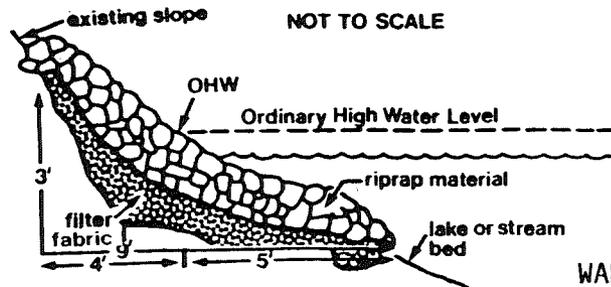
### RIPRAP: NATURAL SHORELINE OR FILL EMBANKMENT PROTECTION

- Natural rock riprap 12" in diameter or larger
- Finished side slope no steeper than 3:1 (3' horizontal to 1' vertical)
- A transitional layer of filter fabric is required to be placed between the slope or embankment material and the riprap.

WARNING: Fill placed below the Ordinary High Water Level may require a permit.

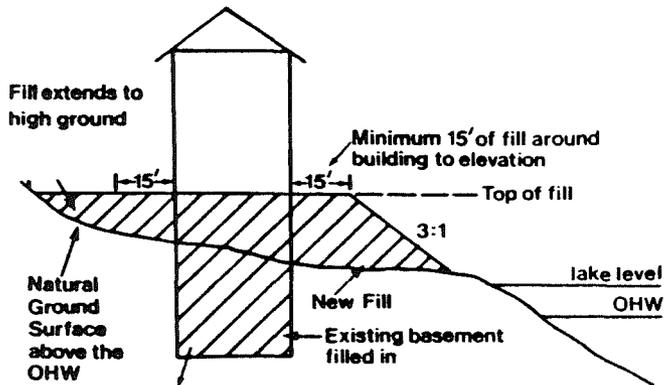
#### ELEVATED STRUCTURE (PERMANENT)

NOTE: Enclosed areas below the lake level intentionally kept dry by pumping are subject to wall and floor collapse.

- Stabilized fill elevation underneath and 15' around the structure
- Fill selection and placement shall recognize the effects of saturation from flood waters on slope stability, uniform and differential settlement and scour/wave action.
- Fill material would be preferably granular and free-graining, placed in compacted layers.
- The minimum distance from any point of the building perimeter to the top of the edge of the fill slope shall be 15'.
- Side slope sections of fill areas should be anticipated to experience wave action and must be properly riprapped or otherwise protected.
- The area to be filled shall be properly cleared of trees, brush, debris or other growth which the building officials considers unstable as a foundation material.

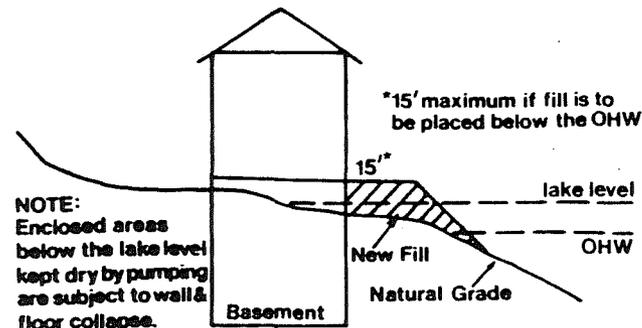
#### PERMANENT FILLING AROUND STRUCTURE

- The side slope of the fill area shall be properly protected by a method of protection as outlined above.
- Pumping lower level enclosed areas may result in hydrostatic pressure levels being higher on the outside of the walls as compared to the inside of the walls. This pressure differential can cause walls to collapse or floors to buckle.

WARNING: Fill placed below the Ordinary High Water Level may require a permit.

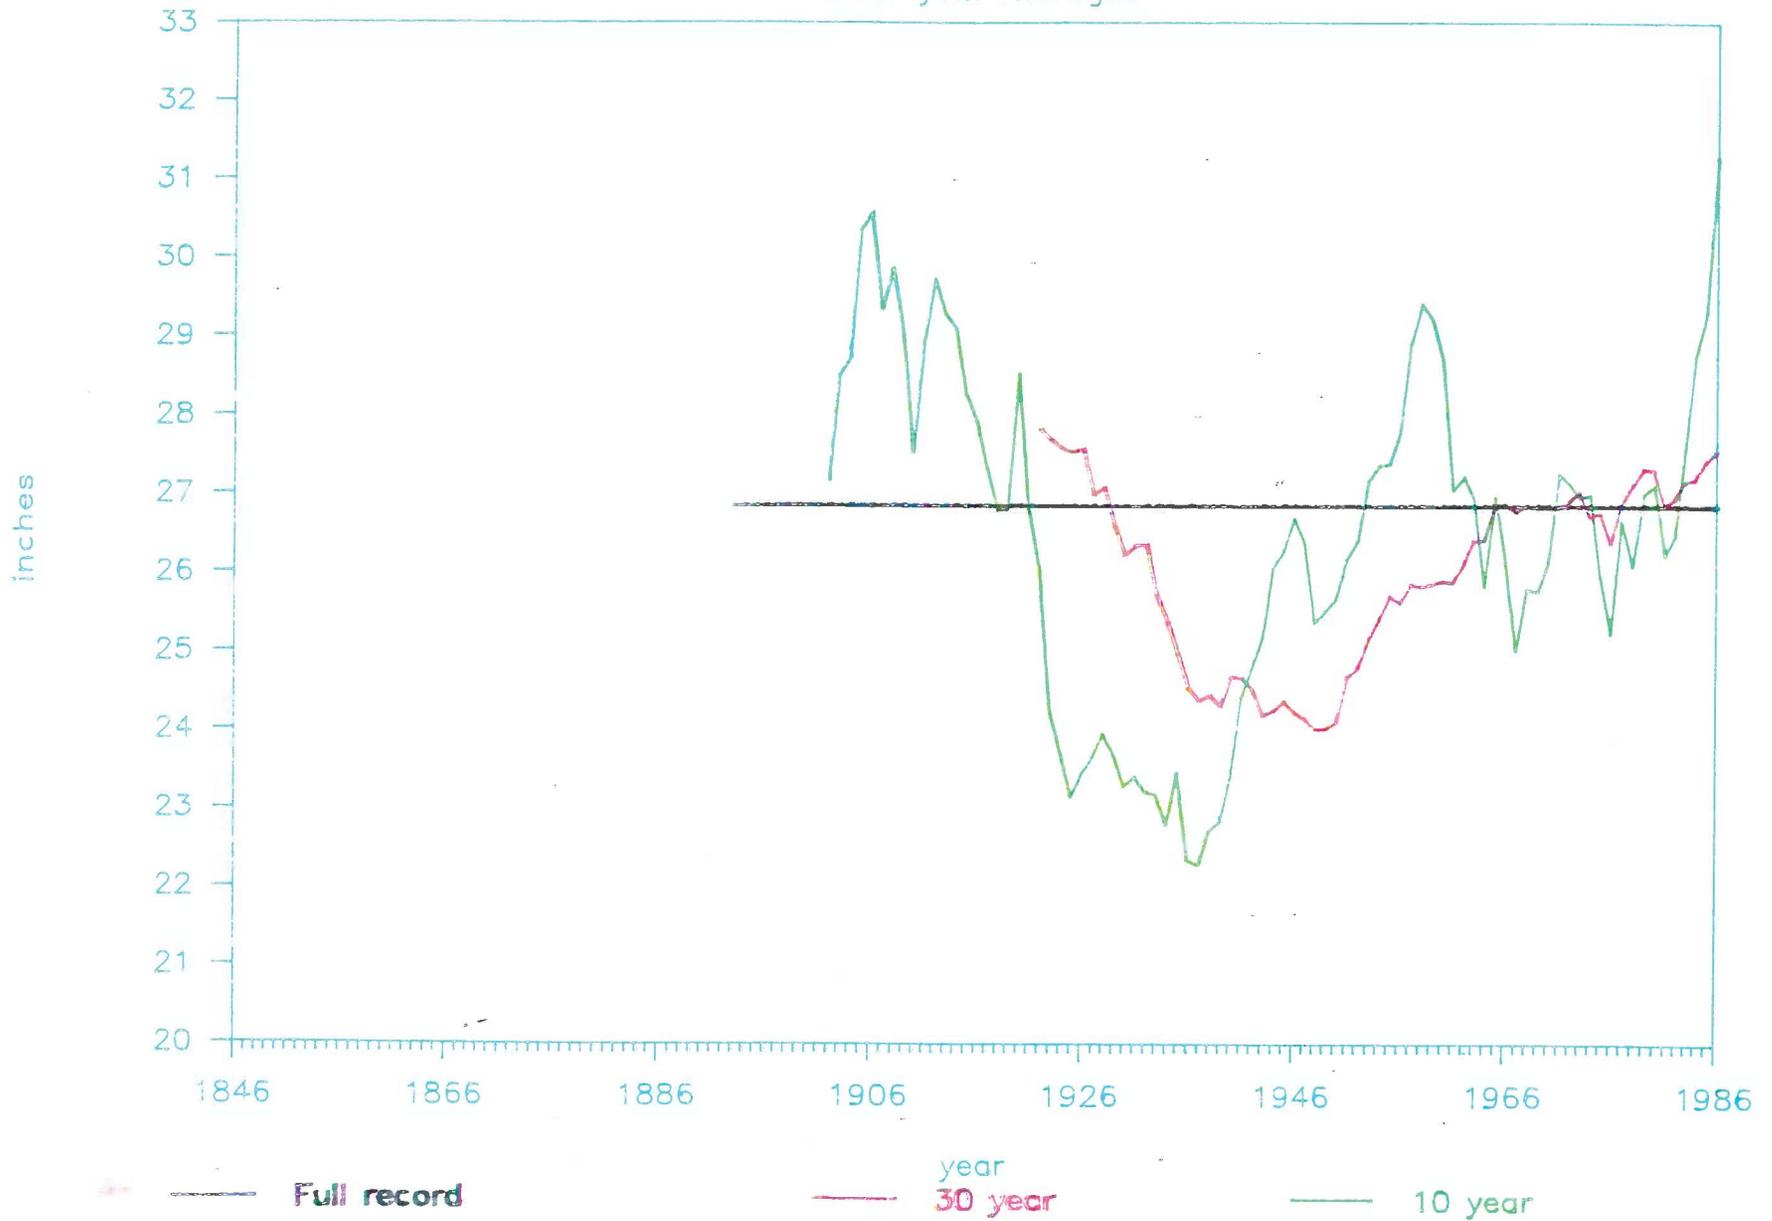
# St. Cloud Annual Precipitation

Multi-year Averages

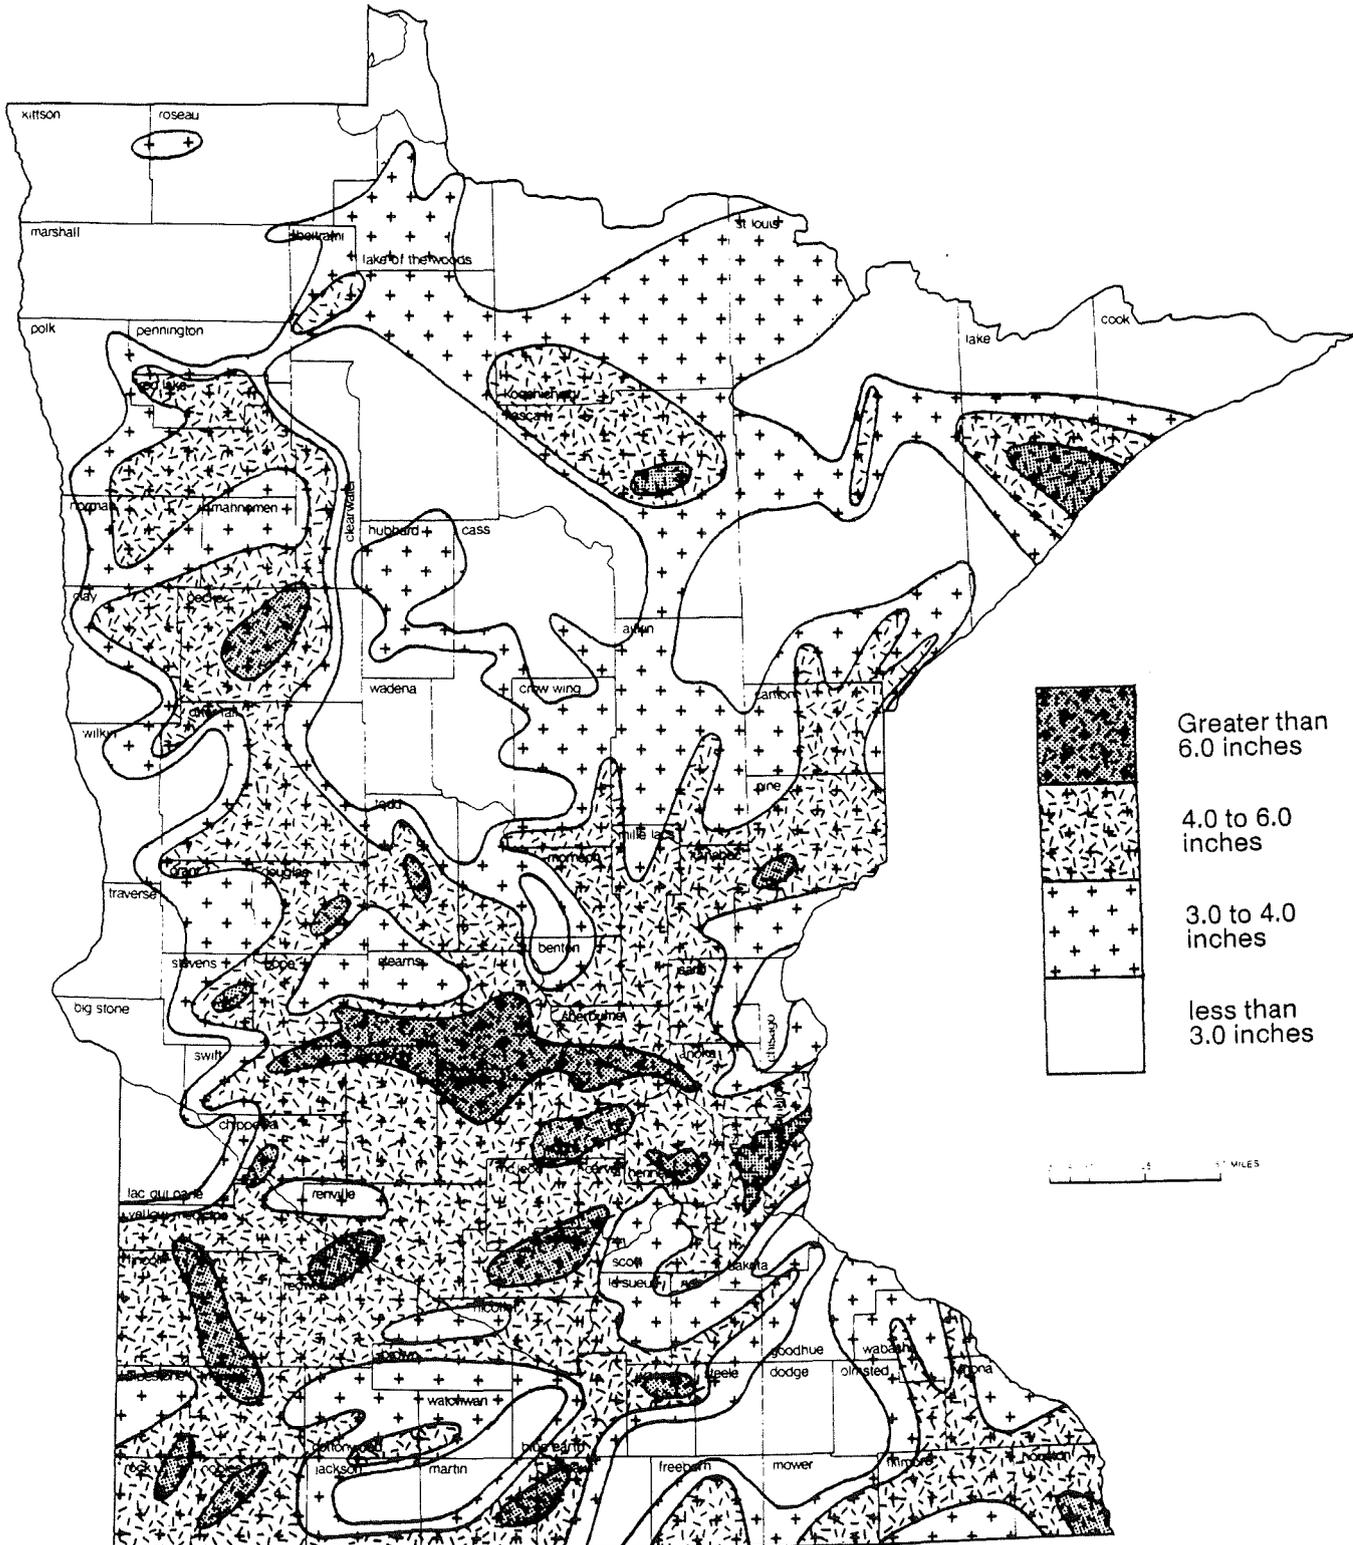
# AVERAGE ANNUAL DEPARTURE FROM NORMAL PRECIPITATION FOR 1977 - 1986 (10 YEARS)

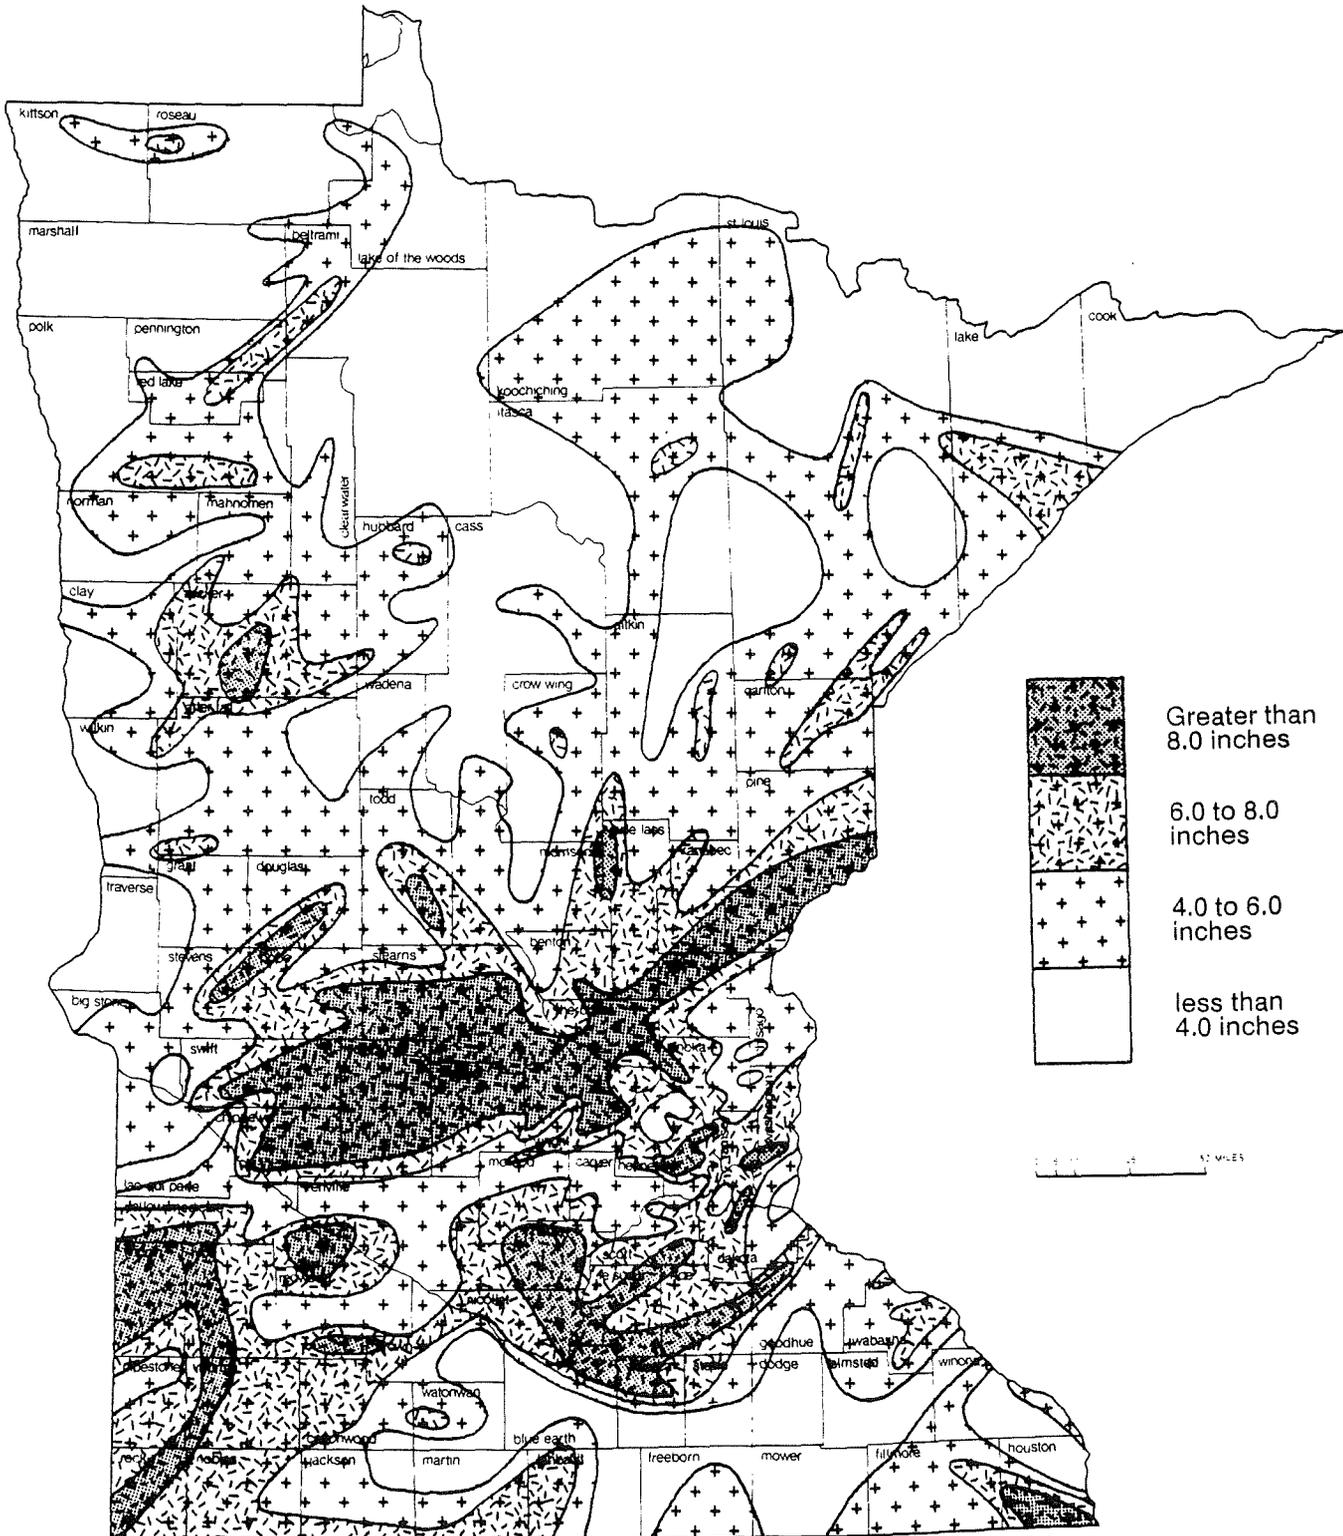
# AVERAGE ANNUAL DEPARTURE FROM NORMAL PRECIPITATION FOR 1982 - 1986 (5 YEARS)

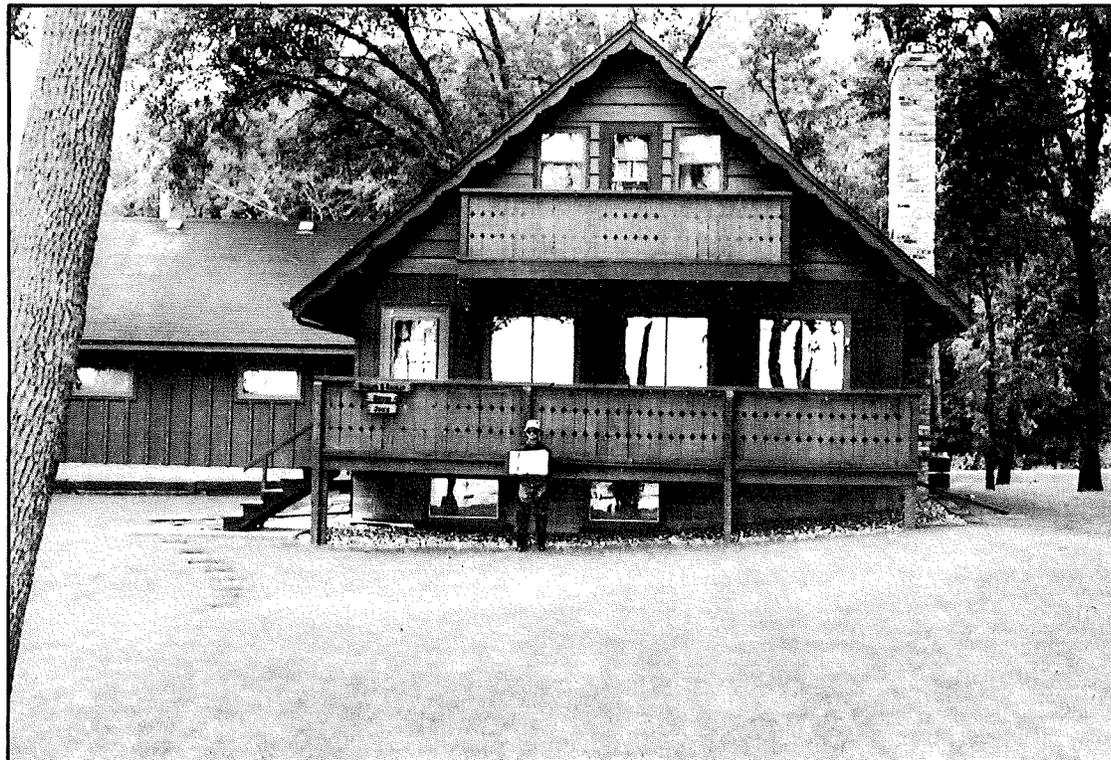
Structure Number : 17  
Name : Moen, Dale H. and Carole  
Address : 1565 Hansack Avenue N.E.  
St, Michael, MN 55376

<sup>6</sup> Twenty-five percent additional damages will occur when water enters any structure with a second level above elevation 976.57'. The first structure where this would occur is #17 at elevation 977.20'. See column "First Floor Level".
