HIGH WATER INVESTIGATION MITIGATION STRATEGIES

HIGH WATER INVESTIGATION
AND
MITIGATION STRATEGIES
FOR
CANTLIN LAKE
BASIN #71-41
SHERBURNE COUNTY

Minnesota Department of Natural Resources
Division of Waters

April 1987

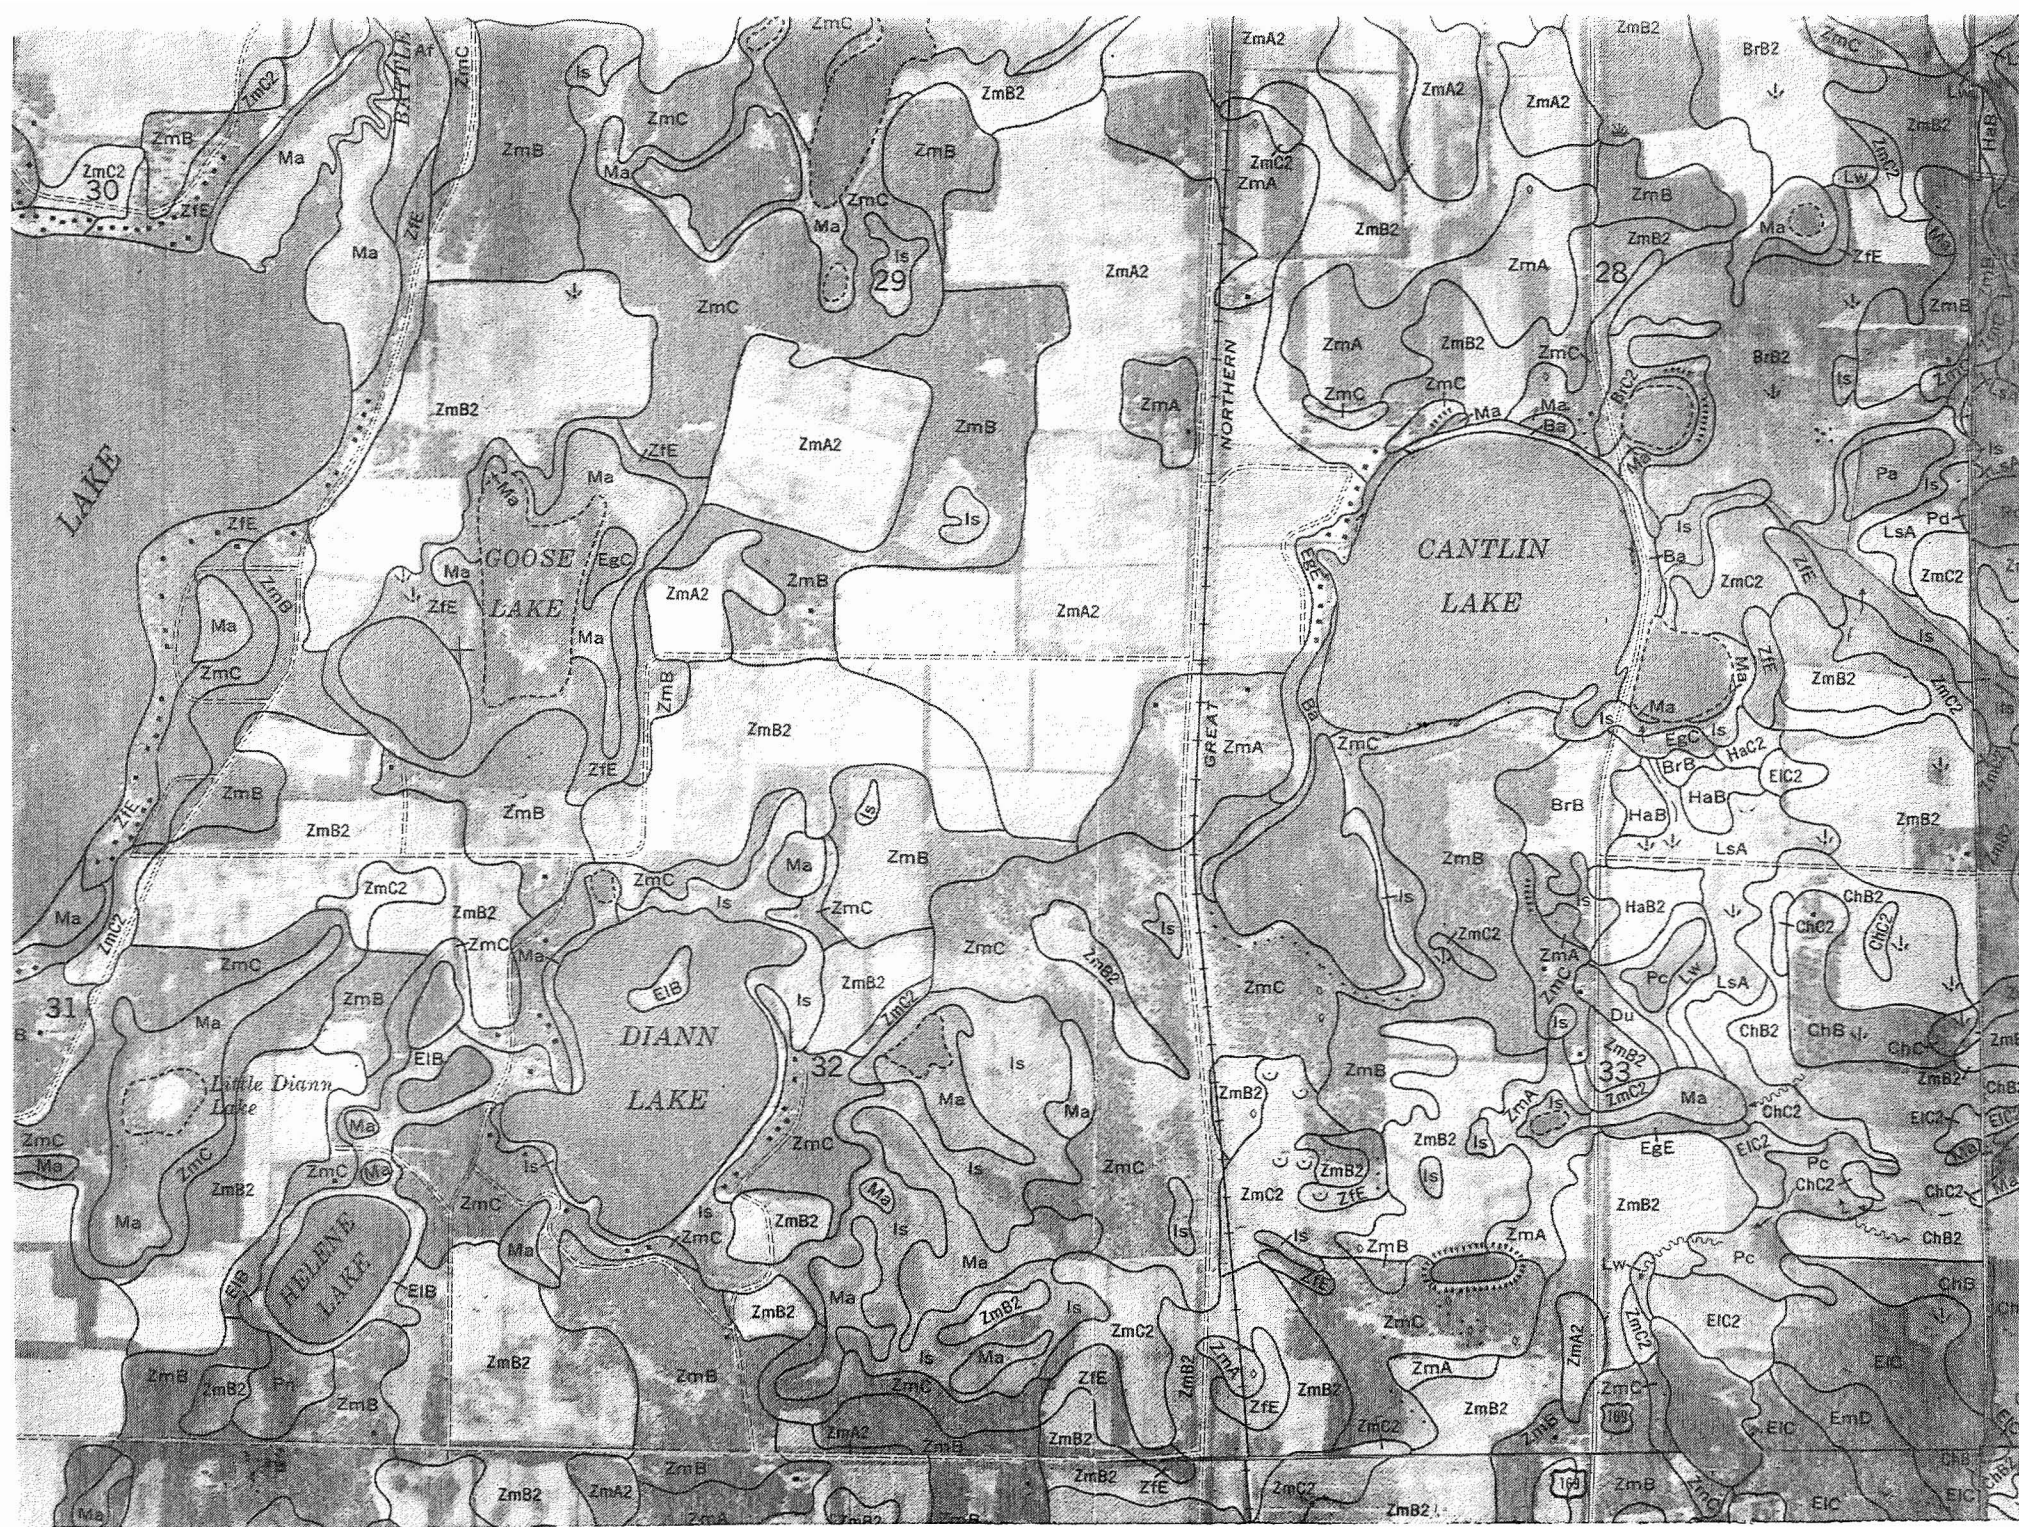
SOIL SURVEY FOR CANTLIN, DIANN, AND HELENE LAKES

MAP SYMBOL	SOIL CLASSIFICATION	% SLOPE
Af	Alluvial land, frequently flooded	
Ba	Beach sand	
BrB	Braham loamy fine sand	2-6
BrB2	Braham loamy fine sand, eroded	2-6
BrC2	Braham loamy fine sand, eroded	6-12
ChB	Chetek sandy loam	2-6
ChB2	Chetek sandy loam, eroded	2-6
ChC	Chetek sandy loam	6-12
ChC2	Chetek sandy loam, eroded	6-12
Du	Dundas loam	
EgC	Emmert gravelly loamy sand	6-12
EgE	Emmert gravelly loamy sand	12-35
EIB	Emmert loamy sand	2-6
EIB2	Emmert loamy sand, eroded	2-6
EIC	Emmert loamy sand	6-12
EIC2	Emmert loamy sand, eroded	6-12
EIC3	Emmert loamy sand, severely eroded	6-12
EmD	Emmert and Chetek soils	12-18
HaB	Hayden fine sandy loam	2-6
HaB2	Hayden fine sandy loam, mod. eroded	2-6
Is	Isanti loamy fine sand	
LsA	Lino loamy fine sand, loam substratum	0-2
Lw	Loamy wet land	
Ma	Marsh	
Pa	Peat and muck, deep	
Pc	Peat and muck, shallow, over loam	
Pd	Peat and muck, shallow, over sand	
Pn	Peat-Lino complex	
ZfE	Zimmerman fine sand

The area surrounding Cantlin Lake, as well as area which is now flooded by lake water but was mapped by the Soil Conservation Service, is covered almost entirely by sandy soils of the Zimmerman Series. The soils were developed from outwash sands that have been sorted by wind and water action. The soils are very permeable, and have poor moisture holding capacity. There are also a few small areas of marsh soils and peat.
