# SANDY LAKE

(Sherburne County, 71-40)

## HIGH WATER INVESTIGATION MITIGATION STRATEGIES

HIGH WATER INVESTIGATION  
AND  
MITIGATION STRATEGIES  
FOR  
SANDY LAKE  
BASIN #71-40  
SHERBURNE COUNTY

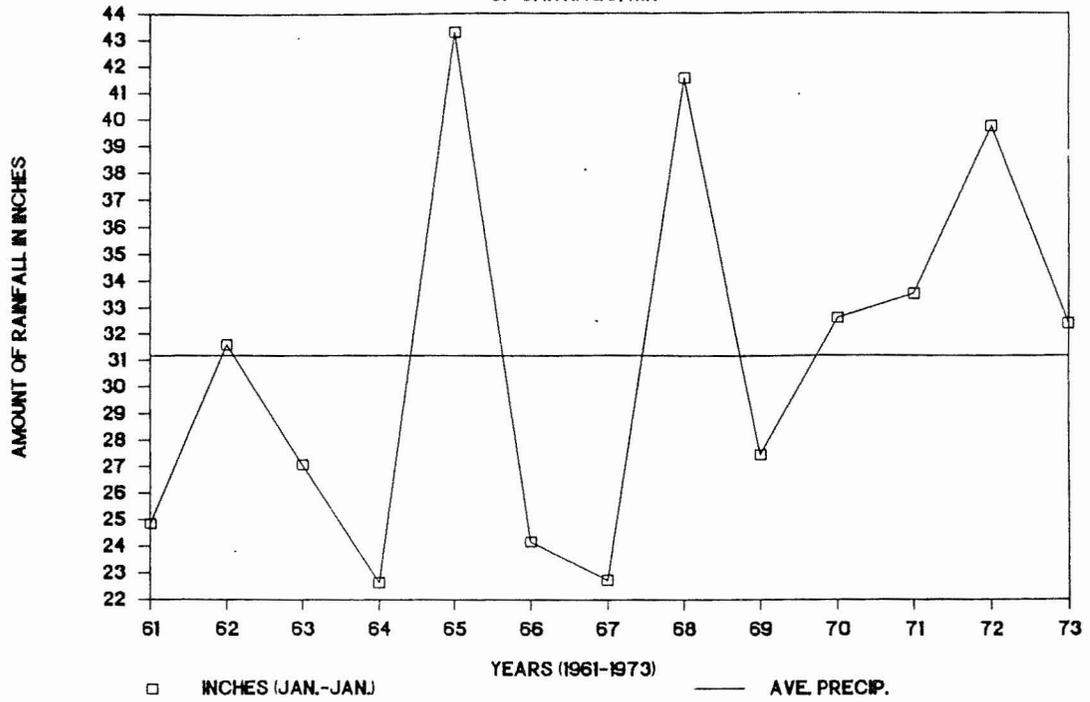
**ANNUAL PRECIPITATION**

OF SANTIAGO, MN

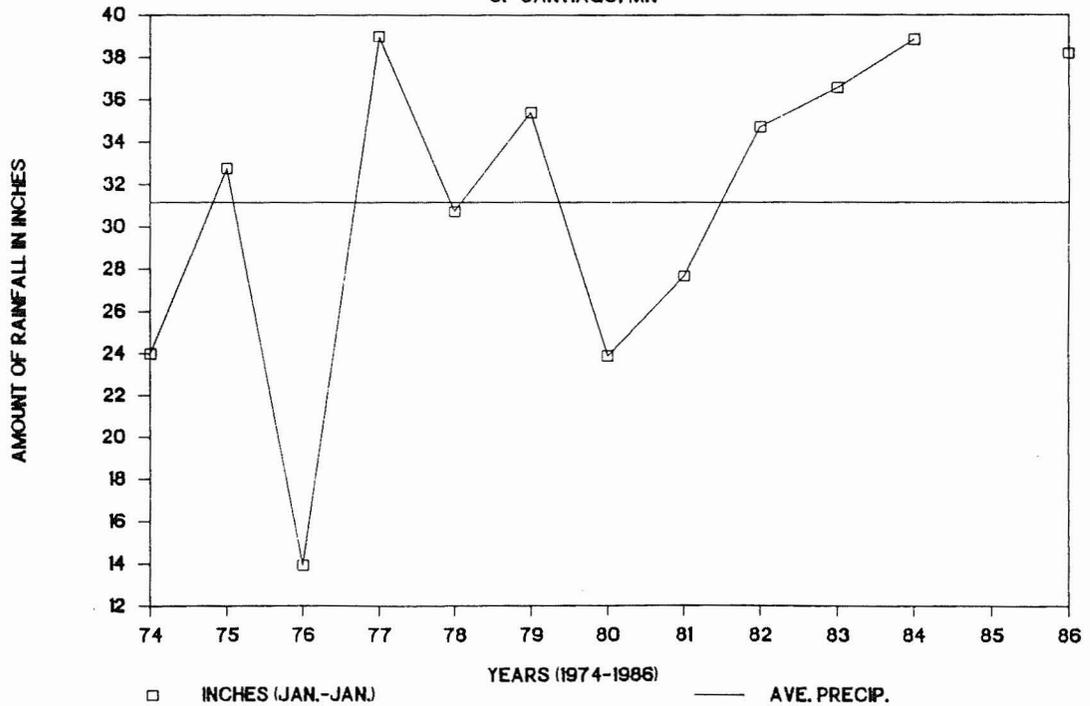
**PLATE 3**

**ANNUAL PRECIPITATION**

OF SANTIAGO, MN

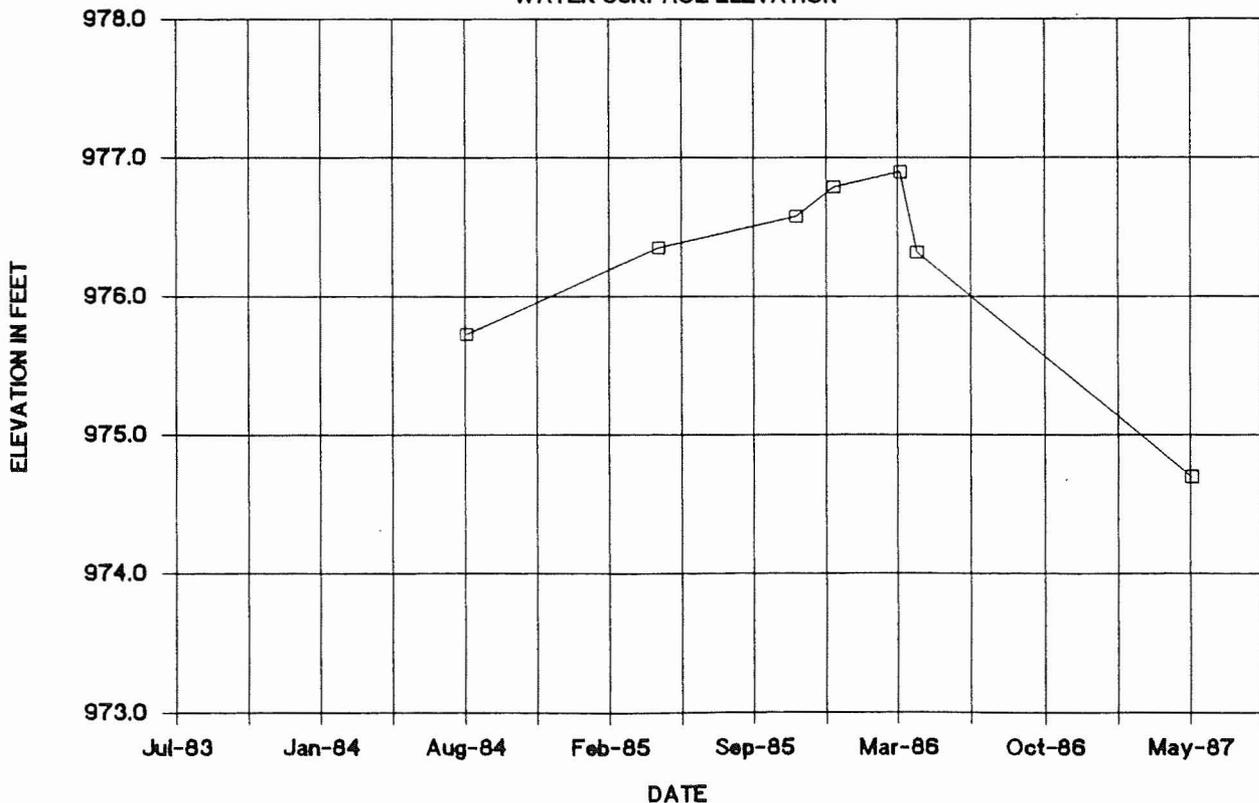
CHART 1  
SANDY LAKE - SHERBURNE CO.  
WATER SURFACE ELEVATION

The Department of Natural Resources' Sandy Lake file contains nine fairly reliable surface water elevations dating from 1961 through March 5, 1987 (see Chart 1 and Table 1 below). The available precipitation and lake level data indicate a correlation between the area's annual precipitation and the lake's water level. From 1982 through 1986 (last 5 years), the area has received an additional 25.80 inches of precipitation over the normal precipitation. The water level of the lake in April, 1986 (976.9') was about 0.5' above the lake's Natural Ordinary High Water mark (976.4') and is due to the several years of above normal precipitation.

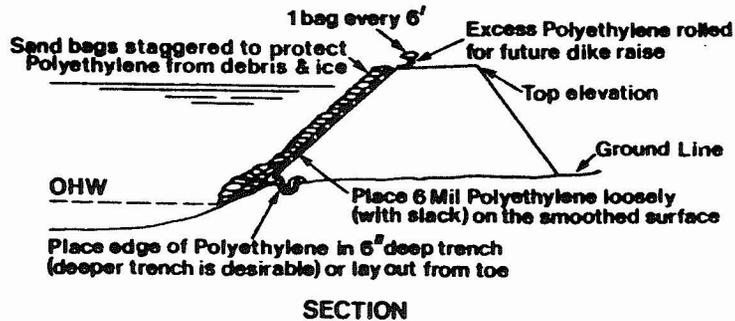
### EARTHEN LEVEE

These criteria are guidelines for construction of temporary levees. The criteria are not for permanent protection and not intended for long term exposure to high water.

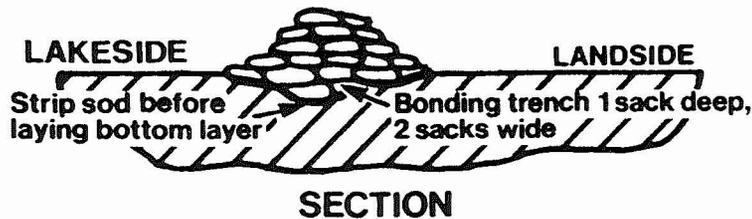
### SANDBAGGING

A sandbag levee provides temporary protection from short term rises in lake elevations.

- Site Preparation: Remove topsoil and vegetation. Dig a bonding trench to key in the levee to the foundation.
- Construction Materials and Placement: Sand or predominantly sandy or gravelly material should be used. Woven plastic sandbags are preferred if the levee is long term, as burlap bags will deteriorate over time. Bags should be filled ½ full, lapped when placed, and tamped tightly in place. The bags should be staggered when placing to prevent gaps through the levee.
- Cross Section: The base width should be 3 times the height, as a minimum. The top width should be sufficient to add additional bags to raise the levee if needed. A maximum height of 3 feet is recommended.

- Seepage Barrier: Polyethylene sheeting may be incorporated into the lakeward face of the levee to reduce seepage. Placement is similar to placement on an earthen levee.
- Interior Drainage: Pumping will be required for removal of seepage and rainfall behind the levee. Sandbag levees will seep more than earthen levees, as the material is pervious and the cross section is not as wide.
- Placement in Water: If the levee is placed in the water, it is important to monitor the levee for settlement, erosion under the levee and excessive seepage.

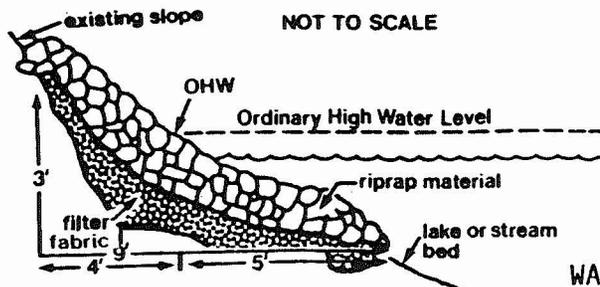
### RIPRAP: NATURAL SHORELINE OR FILL EMBANKMENT PROTECTION

- Natural rock riprap 12" in diameter or larger
- Finished side slope no steeper than 3:1 (3' horizontal to 1' vertical)
- A transitional layer of filter fabric is required to be placed between the slope or embankment material and the riprap.

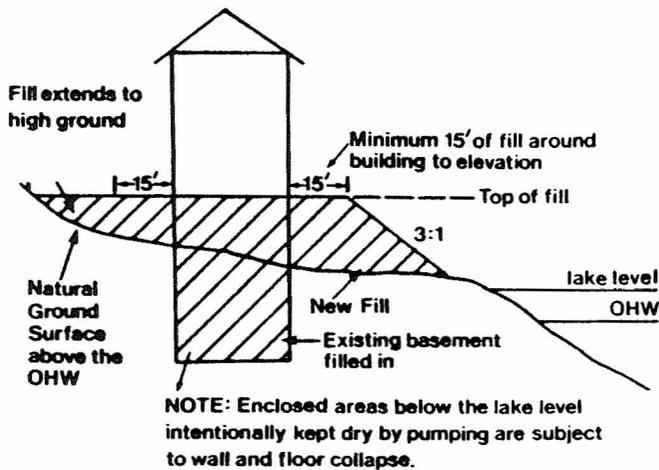
#### ELEVATED STRUCTURE (PERMANENT)

- Stabilized fill elevation underneath and 15' around the structure
- Fill selection and placement shall recognize the effects of saturation from flood waters on slope stability, uniform and differential settlement and scour/wave action.
- Fill material would be preferably granular and free-graining, placed in compacted layers.
- The minimum distance from any point of the building perimeter to the top of the edge of the fill slope shall be 15'.
- Side slope sections of fill areas should be anticipated to experience wave action and must be properly riprapped or otherwise protected.
- The area to be filled shall be properly cleared of trees, brush, debris or other growth which the building officials considers unstable as a foundation material.

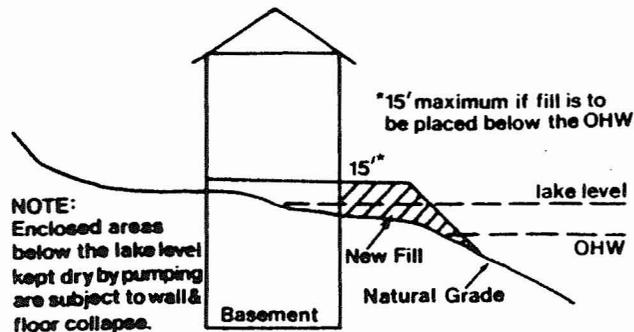
#### PERMANENT FILLING AROUND STRUCTURE

- The side slope of the fill area shall be properly protected by a method of protection as outlined above.
- Pumping lower level enclosed areas may result in hydrostatic pressure levels being higher on the outside of the walls as compared to the inside of the walls. This pressure differential can cause walls to collapse or floors to buckle.
