FRACTURE CRITICAL BRIDGE INSPECTION

In-Depth Report

BRIDGE # 9340 (SQUIRT BRIDGE)

I-35W over the Mississippi River at Minneapolis, MN

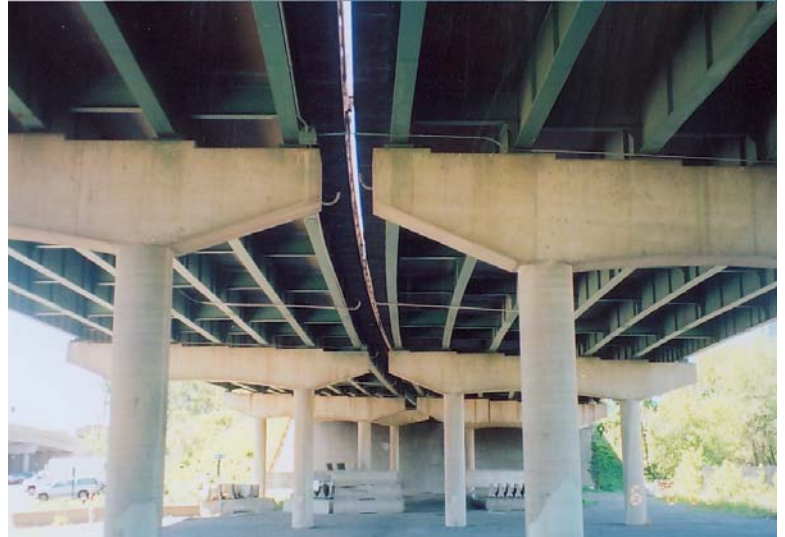
Multi-beam Spans Looking South

Water Saturation NBL Bays 2, 3 & 4

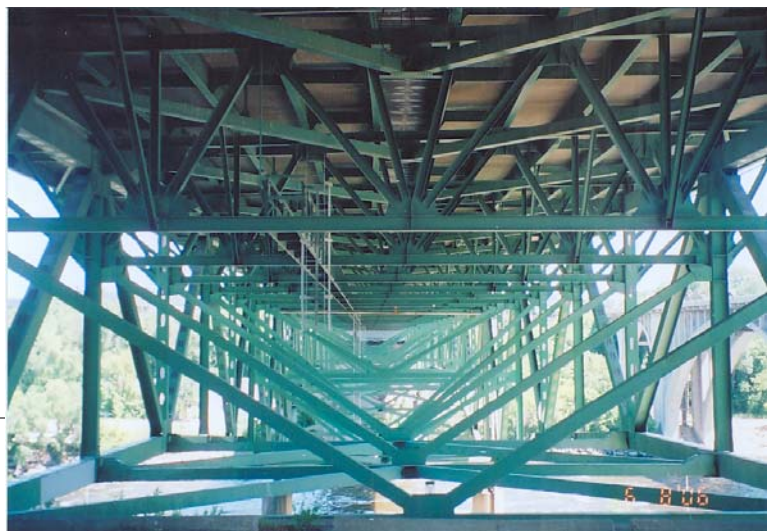
Deck Truss Looking North

Rubber "skirts" installed below the finger joint. [2000] Rubber trough above rocker bearings filled with debris; needs to be flushed. [2002] Panel points 0 to 1 there is water saturation between stringers 2 thru 4. [2005] Stringers 2 & 3 have flaking & surface rust.

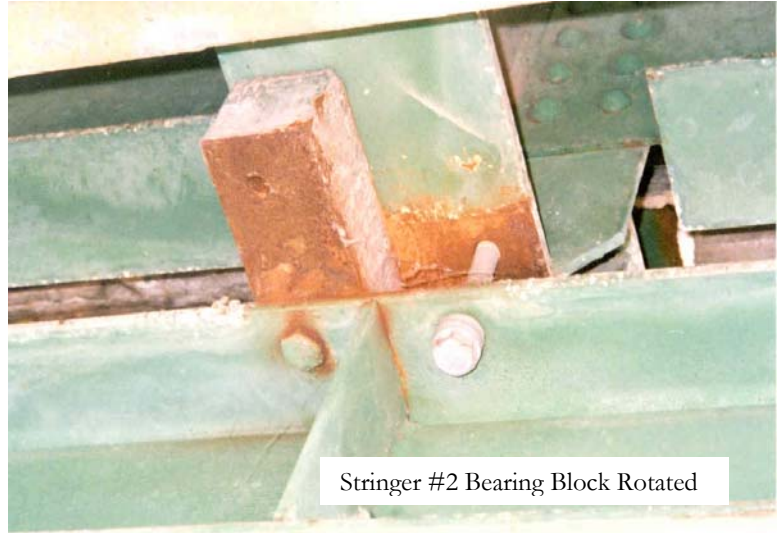
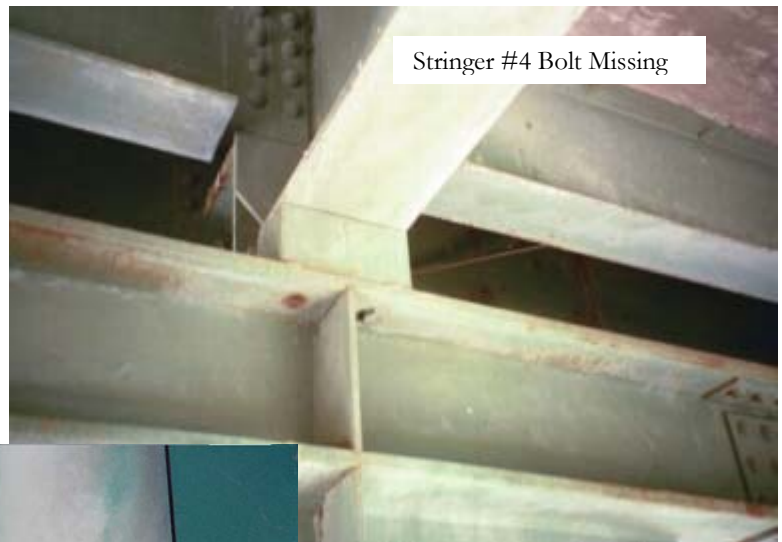
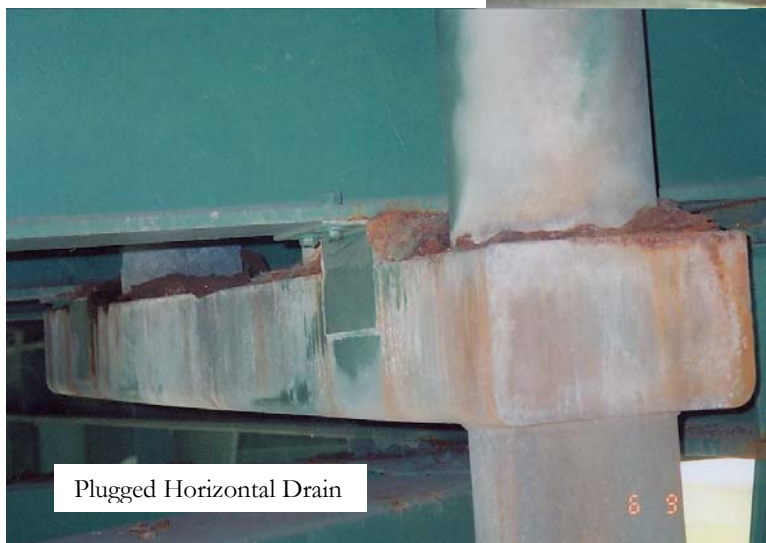
Panel Point #8 (East Truss Pier #6 Stringer Joint):

Type H: strip seal and deck drain above. [1999] Missing bolt replaced. Vertical truss member has pitting, section loss, moderate flaking rust. Floorbeam bottom chord & middle bracing connection plate has pitting, moderate section loss, severe flaking rust. Middle bracing connection plate has 1/2" spread from pack rust. Underside of the deck has 50 SF of water saturation. [94/2003] Joint is leaking, small hole & membrane has pulled out. Stringer #4: one bolt broken off at south floorbeam connection. Stringer #2 (south side): bearing block has rotated 90°.

- Four-stringer connection bolts, all in the NBL, need replacement. At panel point #8, stringer #2 has 2 loose bolts, and the bearing block has rotated. This will likely require jacking the superstructure. Stringer bolts also need replacement at panel point #8, stringer #4, south side, and at panel point #11, stringer #3.

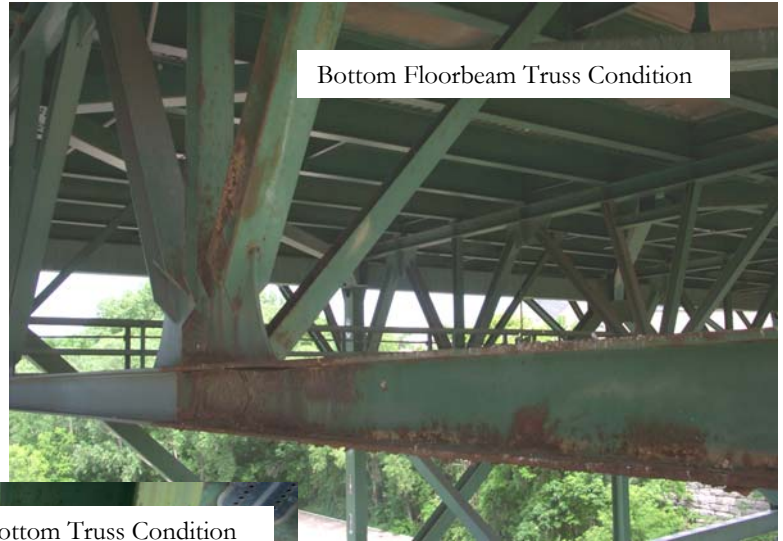
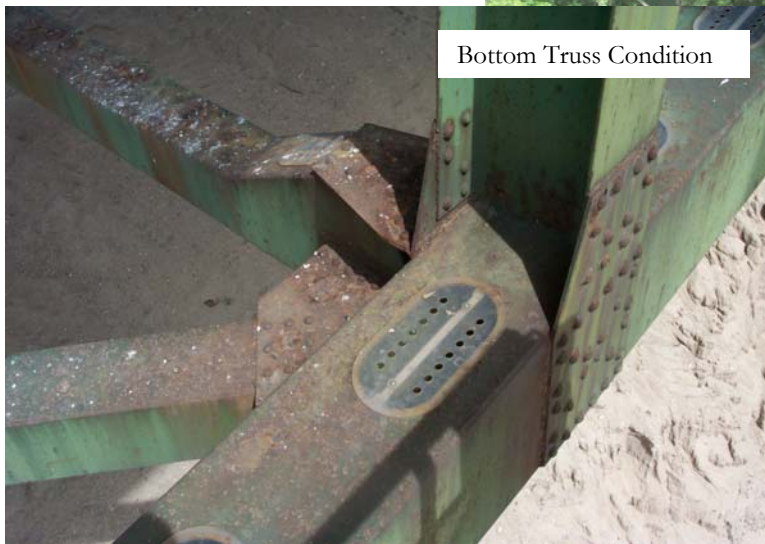
Bottom Floorbeam Truss Condition

Center lane has road sensors on the deck surface. Top chord of the floorbeam truss has an “incomplete” weld along the top edge of the web reinforcement plate.

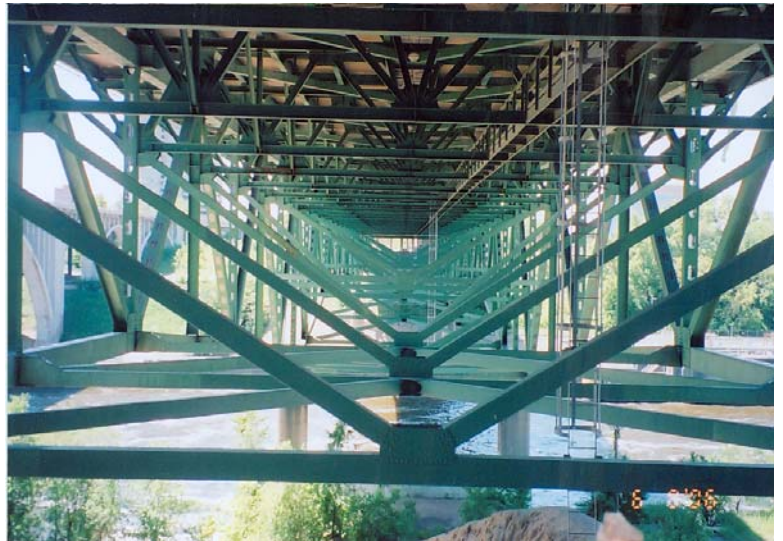
Deck Truss Looking South

Joint has open finger joint above. [1998] Drain troughs removed. [1999] Rubber “skirts” installed below the finger joint. [2000] Rubber trough above rocker bearings filled with debris, need to be flushed. [1998/99] Floorbeam re-painted, side facing finger joint has section loss with holes in web stiffeners. [1998] North face, directly above east rocker bearing, has two horizontal welds between stiffener plates. They have cracked through entirely. [2004] Finger joint in the SB right lane and shoulder has been ground down to prevent the snow plows catching on the joint.

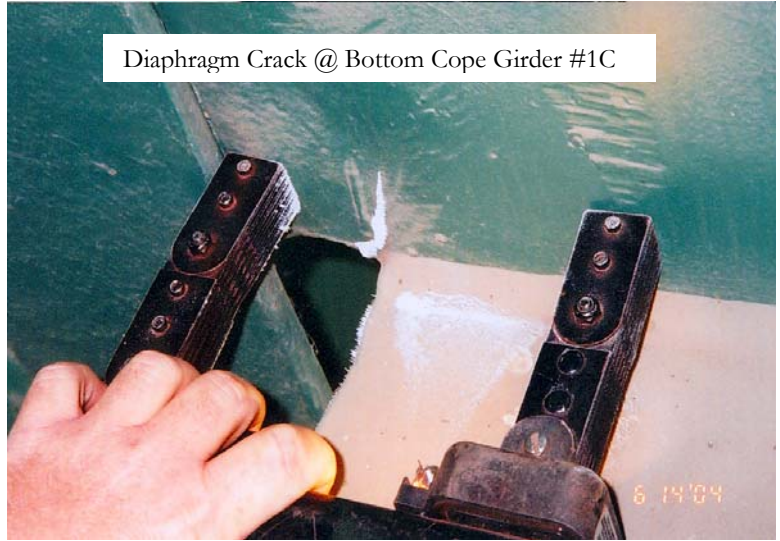
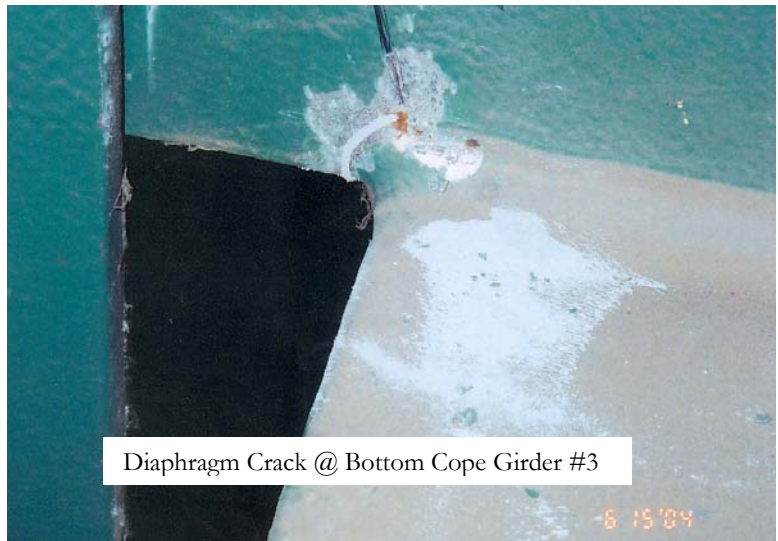
Span #9 (Multi-beam):

Span is 168 FT long with one floorbeam truss at pier #8, fifteen 48" deep welded plate girders bolted onto the crossbeam. Multi-beam spans resume. NB has 8 girders. SB has 7 girders. There are two active railroad tracks below. [1999] Refer to Appendix "A" **First Diaphragm South of Pier #9** graph for crack locations, description & repair to the diaphragm line. Girders 6, 7, 8, 9, & 10 are re-painted. Lateral bracing welded to web & stiffener. [2003] Bottom of deck has conduit on the east side. [2004] Girder 1C (NBL), crack at the diaphragm bottom cope, NE side measures 2" ("front face") and NW side measures 2-1/2" ("Back face"). Girder 3 (NBL), crack at the diaphragm bottom cutout, measures 1-1/2" (both sides). [1998/2004] Girder #3 has a "tear" in the girder's web at the diaphragm girder connection. The "tear" measured 42" long on one side and 12" long on the other, was caused by out of plane bending between the diaphragm and the girder. Girder Connection Lowered & Girder Web Repaired with Splice Plate. [2002/06] Underside of deck has 260 SF of water saturation, & 4 SF of delamination. [2006] Girder #12 has paint failure from leaking de-icing system.
