INVESTIGATIVE REPORT TO JOINT COMMITTEE TO INVESTIGATE THE I-35W BRIDGE COLLAPSE

APPENDIX: Volume II

MAY 2008

Appendix Volumes II and III

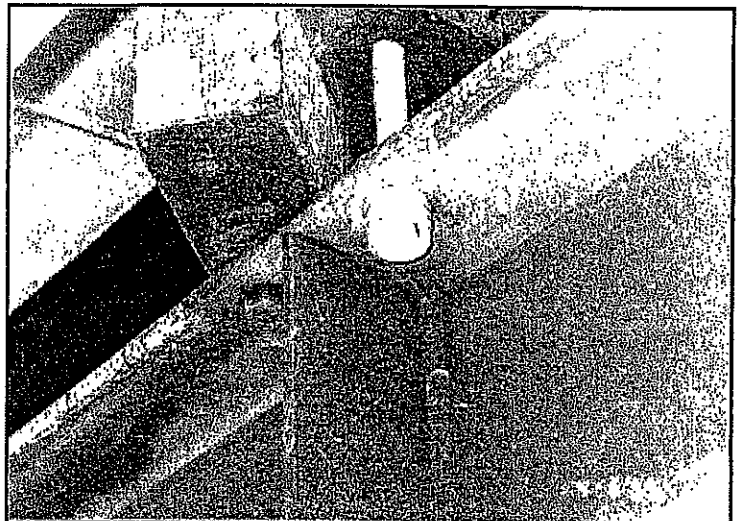
Panel Point #8, Stringer #2

Panel Point #8 (East Truss, Pier #6, Stringer Joint): Strip seal and deck drain above. [1999] Joint is leaking. [1998] Stringer #4: bolt missing at south floorbeam connection. [1994] Stringer #2 (south side): one bolt is missing and the nut is missing from the other bolt - the bearing block has rotated. [2000] Missing bolt was replaced in 1999, but the bearing block was not returned to it's proper position – now bolt bolts are loose, needs repair (photos).

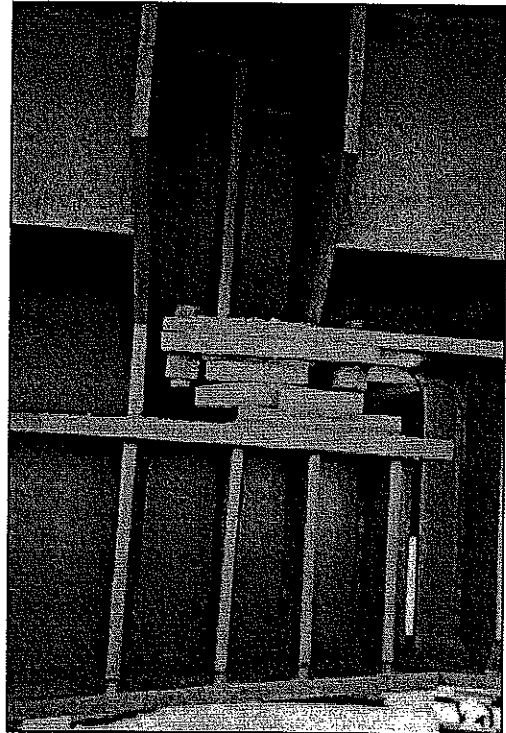
Hinge Bearing Sole Plate

Hinge joint has open finger joint above. [94/2002] Hinge assemblies are expanded beyond tolerance; sliding plates extend 4" beyond the base plates, reducing bearing capacity. At beam #10, the sliding plate has tipped, falling off the base plate, and is preventing the joint from opening. [1999] Hinge area re-painted. [2000] Beam-ends have section loss, moderate surface pitting; debris has begun to build up on hinge area. Additionally, the tops of the beam-ends are contacting at the top flange or at the web along this joint.

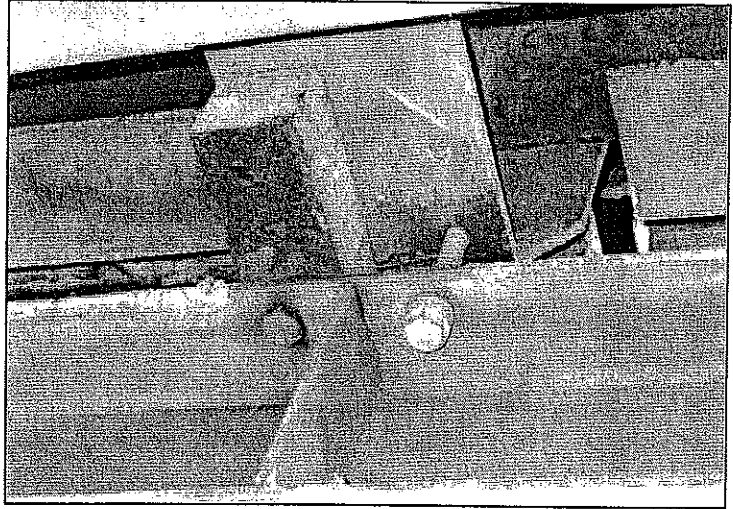
Strip seal and deck drain above. [94/2003] Joint is leaking, small hole & membrane has pulled out. Stringer #4: one bolt broken off at south floorbeam connection. Deck drain is plugged solid. Stringer #2 (south side): one bolt is missing and the nut is missing from the other bolt. The bearing block has rotated 90°. [1999] Missing bolt replaced. [2000] Bolts are loose, needs repair. Vertical truss member has section loss, moderate flaking rust. Floorbeam bottom chord & middle bracing connection plate has moderate section loss, severe flaking rust. Middle bracing connection plate has 1/2" spread from pack rust. Underside of the deck has 50 SF of water saturation.

Stringer 2 Bearing Block Rotated

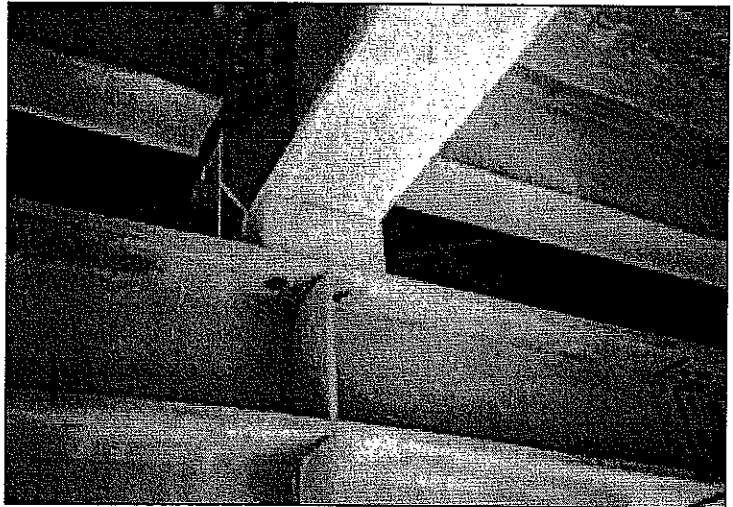
Stringer 4 Bolt Missing

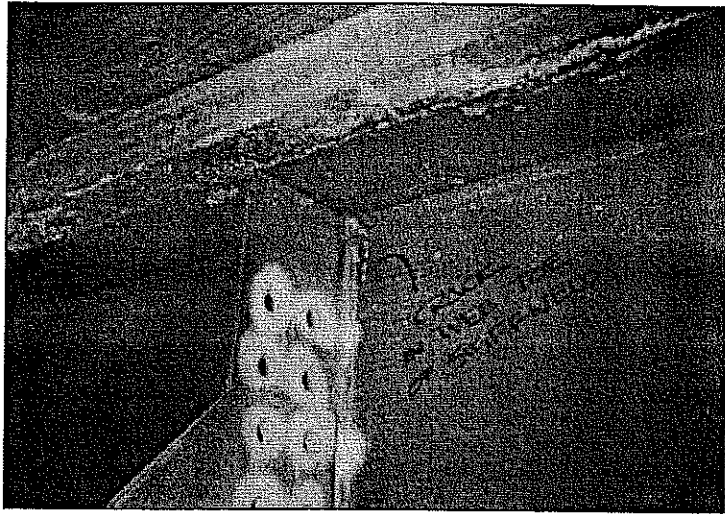
Diaphragm Crack Locations North of Pier #9	
Girder Location	Crack Description and or Repair Description
G1 (East Fascia NB)	
G1B (NB)	Stiffeners are welded to the top flange (positive moment).
G3 (NB)	
G1D (NB)	Stiffeners are welded to the top flange (positive moment)
G2 (NB)	
G3 (NB)	
G4 (NB)	* [2000] Two 2" holes drilled in web. Crack contained.
G5 (NB)	* [2000] Two 2" holes drilled in web. Crack contained.
G6 (NB)	
G7 (NB)	
G8 (SB)	
G9 (SB)	* [98/2000] Crack in top flange/web weld & top of stiffener weld (west side). [2003] No change.
G10 (SB)	* [2000] Crack in top flange/ web weld (east side) This crack has grown; see photos.
G11 (SB)	* [2000] Two 2" holes drilled in web. Crack contained.
G12 (SB)	* [2000] Two 2" holes drilled in web. Crack contained.
G13 (SB)	
G14 (West Fascia SB)

Girder #10 Vertical Stiffener/Girder Web

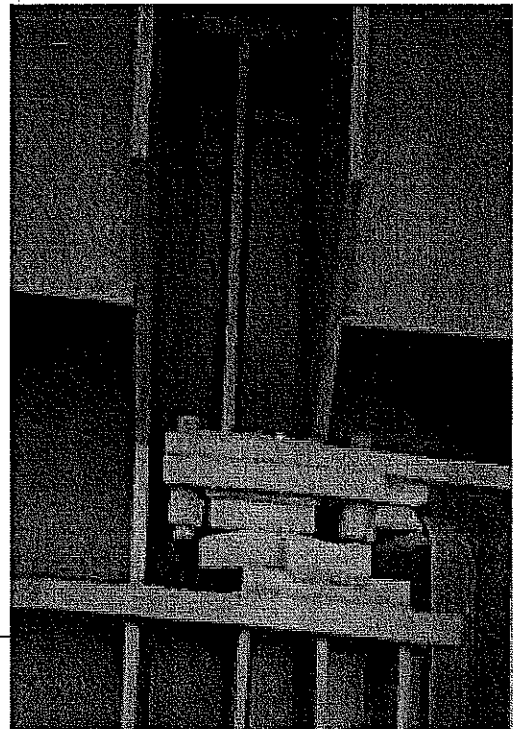
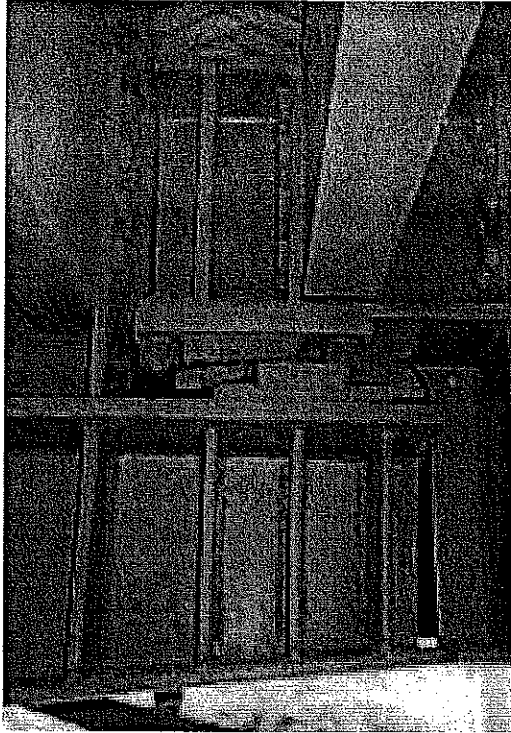
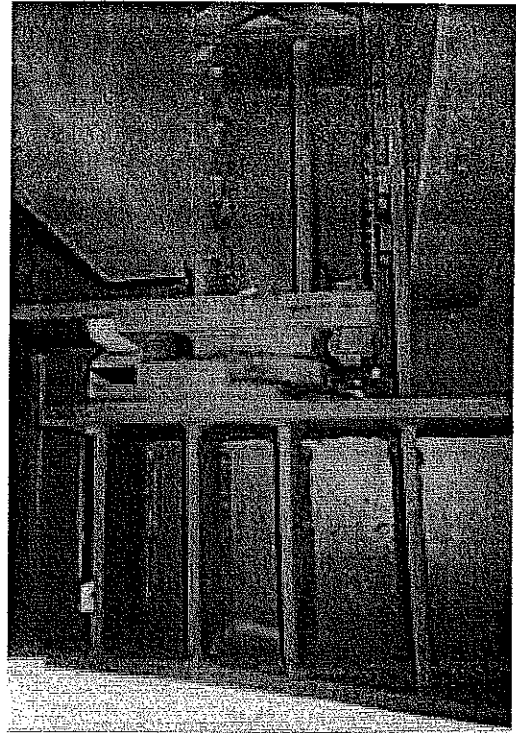
Hinge joint has open finger joint above. [1999] Hinge area re-painted. [2000] Beam-ends have section loss, moderate surface pitting; debris has begun to build up on hinge area. Additionally, the tops of the beam ends are contacting at the top flange or at the web along this joint. [94/2005] All hinge assemblies are expanded beyond tolerance; sliding plates extend 4" or more beyond the base plates, reducing bearing capacity. At beam #10, the sliding plate has tipped, falling off the base plate, and is preventing the joint from opening. [2005] Hinges should be flushed.

Sliding Plate @ West Fascia

Sliding Plate @ Beam 5 NBL

Sliding Plate @ Beam 6 NBL

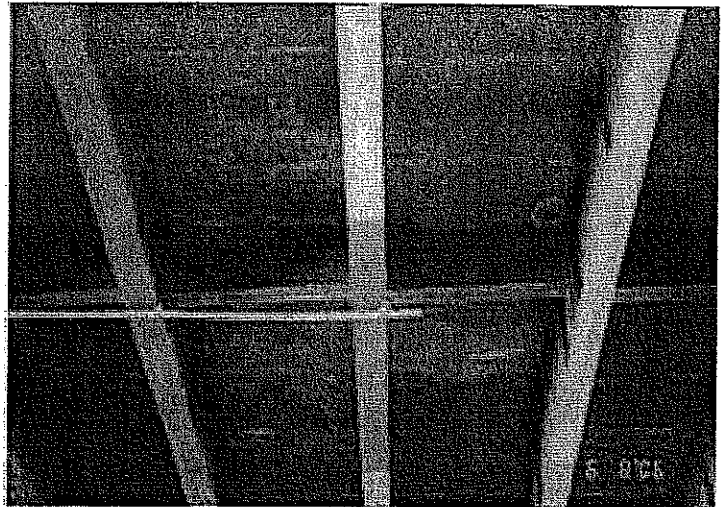
Over contract parking lot (no access) & Bluff St. Span is 110 FT long with fourteen 48" deep welded plate beams. [1978] Second & third bays from the east have full depth deck repairs. [1998] Underside of deck has 200 LF of transverse leaching cracks, 200 SF of spall with exposed rebar below a transverse poured joint, full width of deck. [1999] Beams 6, 7, 8, & 9 were re-painted. Diaphragms lowered, even though the connections have a "positive moment" configuration. Stiffeners are welded to the top flange. Refer to Appendix "A" **First Diaphragm North of Pier #3** graph for crack locations, description & repair to the diaphragm line. [1998/99] Diaphragms lowered with strain gauges placed on beams #2 & 6 (**first diaphragm Line South of Pier #4**). [2000] Fourth bay from west has 20 SF of severe leaching. [2005] East fascia beam has section loss, flaking & surface rust on bottom flange.

Water Saturation SBL Bays 9 & 10

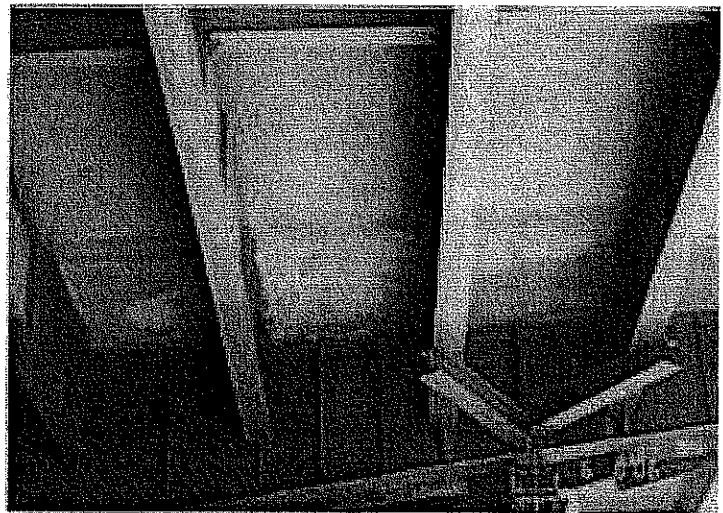
Over contract parking lot; span is 109 FT long with fourteen, 48" deep welded plate beams bolted onto the crossbeam. [1978] Underside of deck is leaching at the finger joint, has two full depth patches in the west bays. [1996] 4 conduit clamps missing on NB fascia beam. Median girder has impact damage from parking lot below. [1998] Bay just east of median has severe spalling on "stool" and the adjacent deck is cracked. [1999] Beams 6, 7, 8, & 9 were re-painted. Refer to Appendix "A" **First Diaphragm North of Pier #4** graph for crack locations, description & repair to the diaphragm line.

Water Saturation NBL Bays 2, 3 & 4

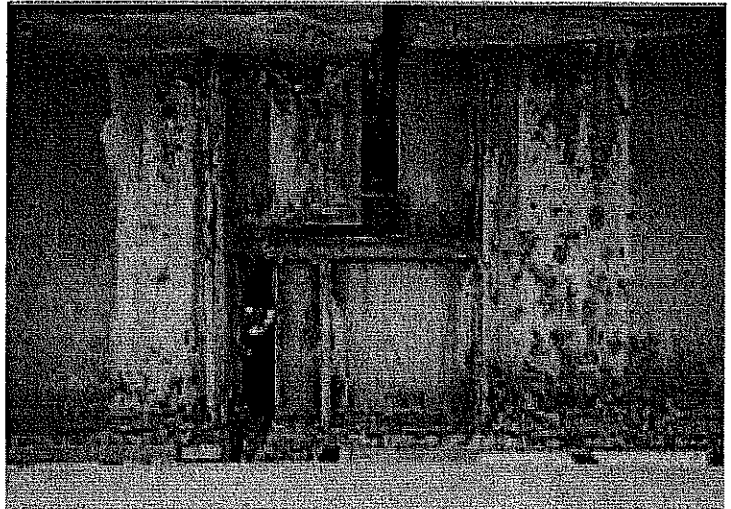
Type H; strip seal deck joint above. [1996] Floorbeam truss bottom chord/vertical member connection gusset plate has a weld overlap. [1999] Gland has 1 LF of gland pulled out at centerline. Junction box cover is missing at catwalk. [2000] Joint gland at east end has concrete in. [2005] Pitting, flaking & surface rust exterior east truss.

Flaking & Surface Rust Exterior East Truss

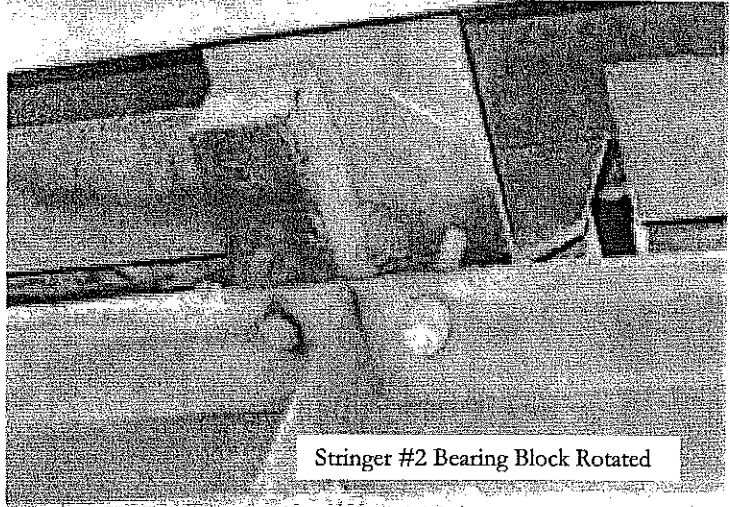
Type H: strip seal and deck drain above. [1999] Missing bolt replaced. Vertical truss member has pitting, section loss, moderate flaking rust. Floorbeam bottom chord & middle bracing connection plate has pitting, moderate section loss, severe flaking rust. Middle bracing connection plate has 1/2" spread from pack rust. Underside of the deck has 50 SF of water saturation. [94/2003] Joint is leaking, small hole & membrane has pulled out. Stringer #4: one bolt broken off at south floorbeam connection. Stringer #2 (south side): bearing block has rotated 90°.

Stringer #2 Bearing Block Rotated

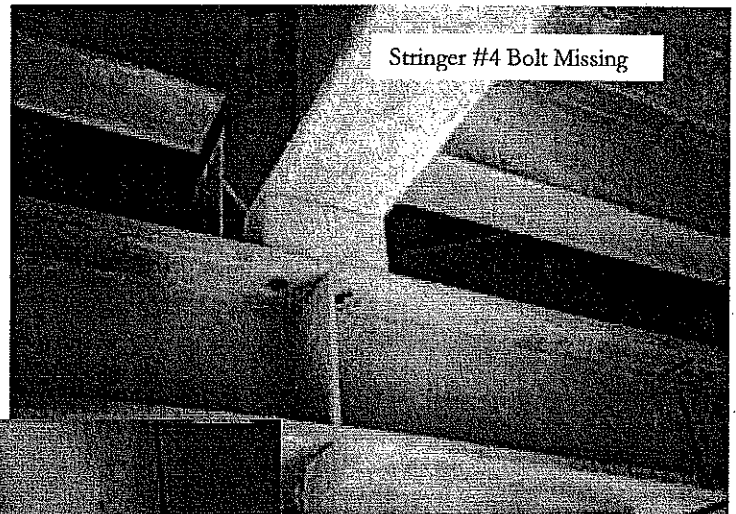
Stringer #4 Bolt Missing

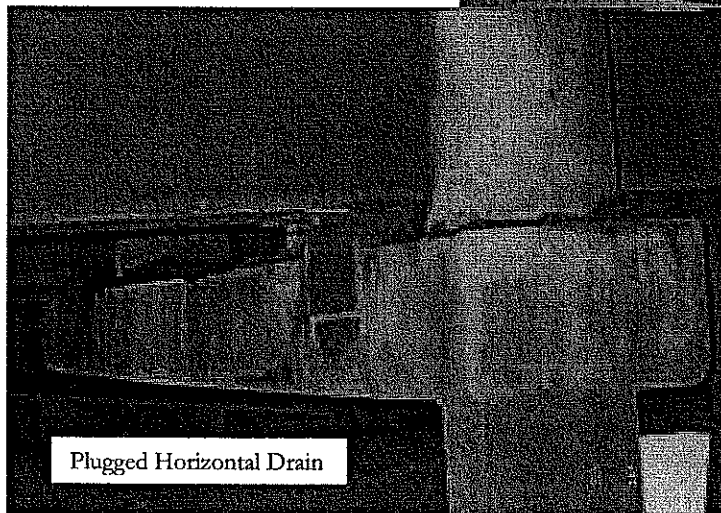
Plugged Horizontal Drain

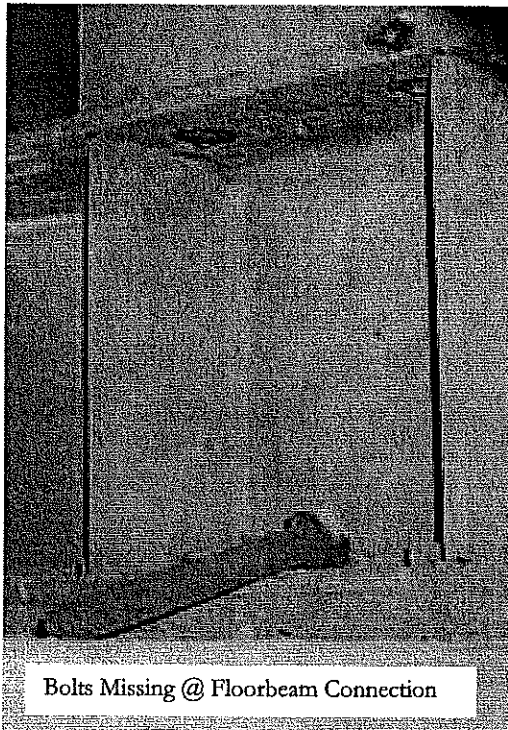
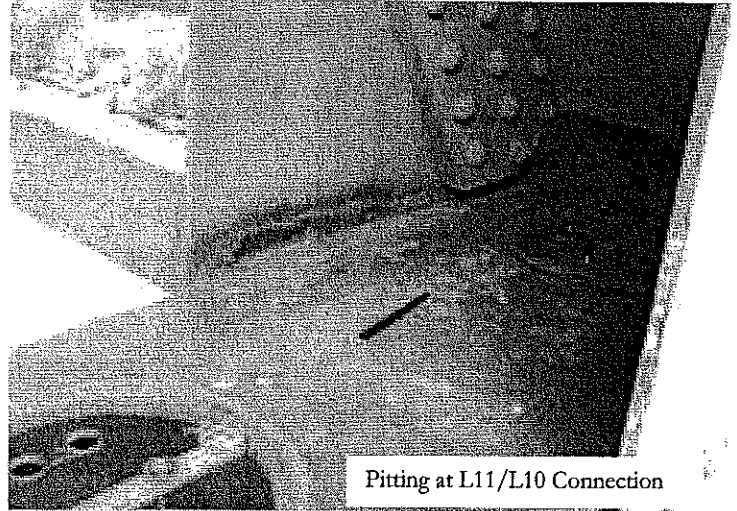
Panel Point #11 (East Truss):

Section loss: at gusset plate bottom chord. [2004] Pitting: inside gusset plate connection at L11 toward L10. [2000/05] Stringer #3 has two bolts missing at the floorbeam connection.

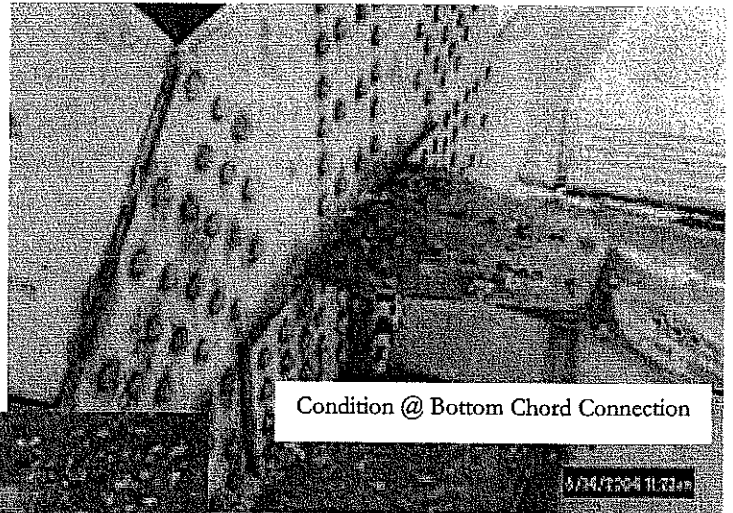
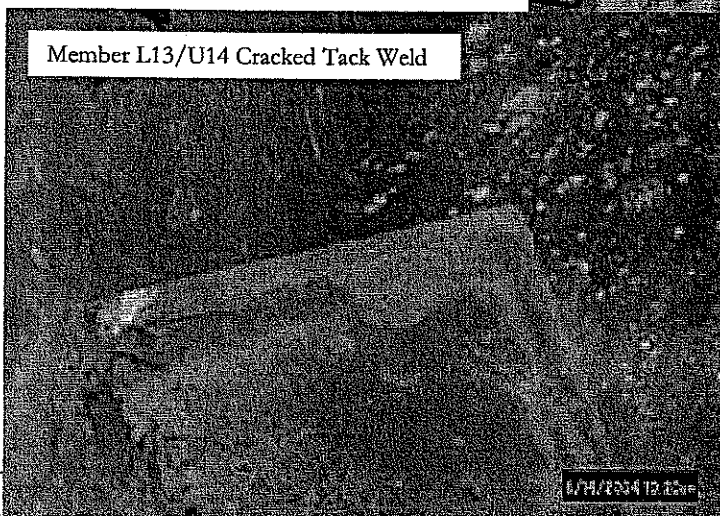
Panel Point #13 (East Truss):

Water from deck drains fall directly into river. [1999] Truss bottom chord member L13/L14 has cracked tack welds at two interior stiffeners. [99/2002] Bottom chord gusset plate has section loss, flaking & pack rust. [2004] Bottom chord member L13/L14 has cracked tack weld at diaphragm tab. Cracked tack weld at diaphragm tab member L13/U14. See photos. [2006] Bottom chord member L13/L14 has a missing bird cover.

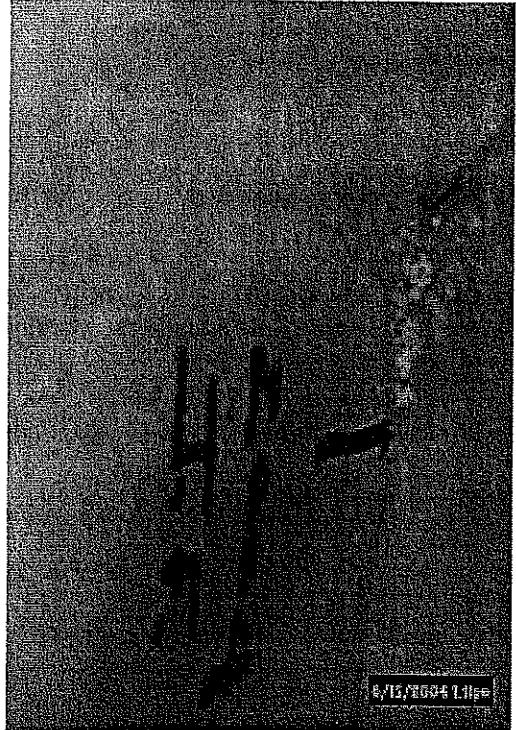
Strip seal expansion joint on the deck. Sway frame rusty. [1999] Truss bottom chord member L14/L13' has a cracked tack weld at an interior stiffener. [2002/03] Floorbeam bottom chord & middle bracing connection plate has 1/2" pack rust. Underside of the deck has 4 SF of delamination. [2004] Bottom chord member L14/L13' cracked tack weld at diaphragm tab.

Member L14/L13' Cracked Tack Weld

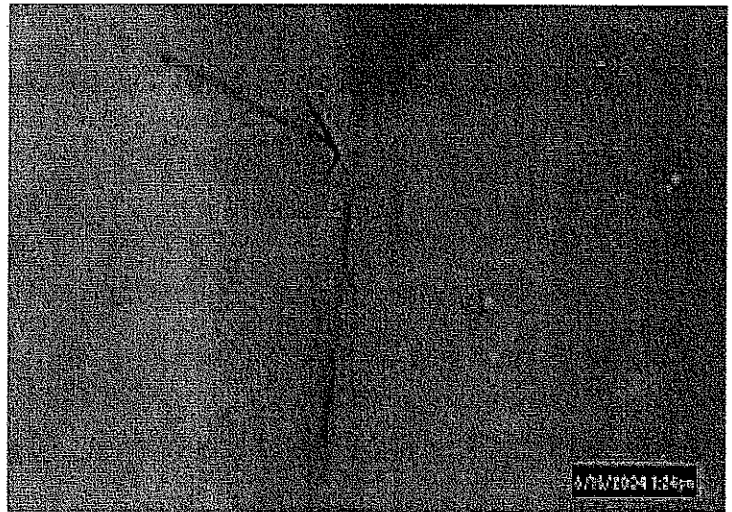
Floorbeam truss top chord has a ground out spot near stringer #4. [1996] Truss bottom chord member L13'/L12' has a cracked tack weld at an interior stiffener. [2003] Truss bottom chord connection plate has 1/2" pack rust. Underside of the deck has 20 SF of water saturation. [2004] Bottom chord member L13'/L12' has cracked tack weld at diaphragm tab.

Member L13'/L12' Cracked Tack Weld

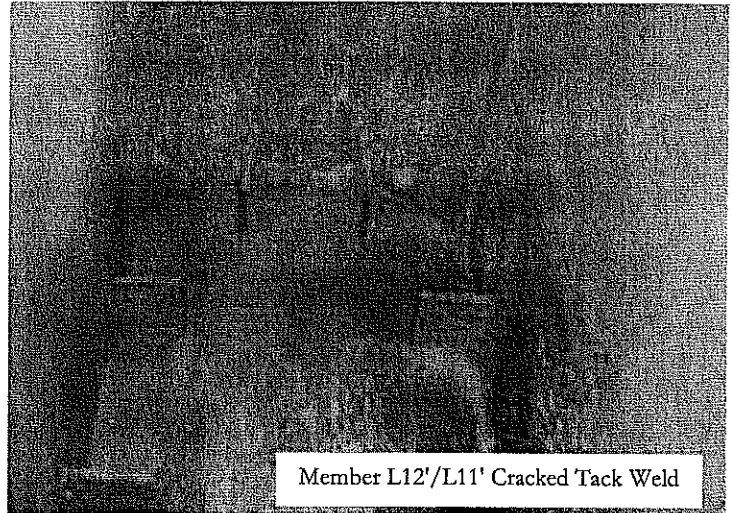
[1998] Truss bottom chord member L12'/L11' has a cracked tack weld at an interior stiffener.
[99/2003] Underside of the deck has 65 SF of water saturation. [2004] Bottom chord member L12'/L11' two cracked tack weld at diaphragm tab.

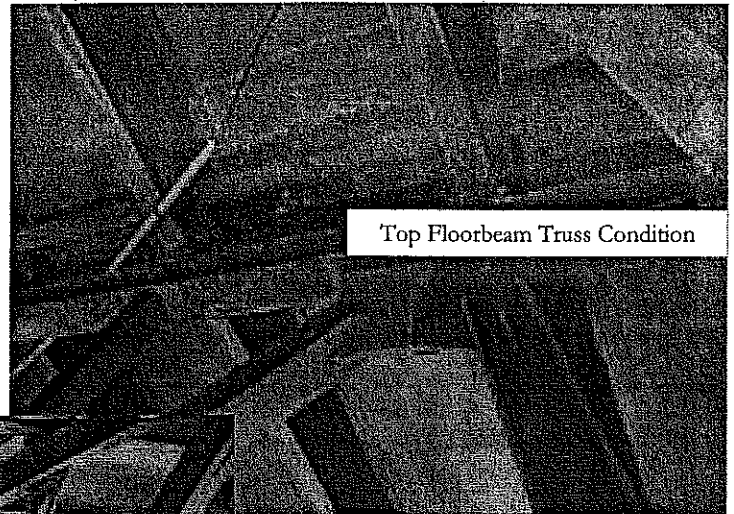
Type H: strip seal expansion joint on the deck. Truss diagonal member U4'/L3' has backer bars along the interior edges. [01/04] Strip seal has 3 LF of gland pulled out. Truss connection plates, the top chord, and floorbeam have moderate section loss, severe flaking rust. Bottom connection plates have 1/2" pack rust.

Top Floorbeam Truss Condition

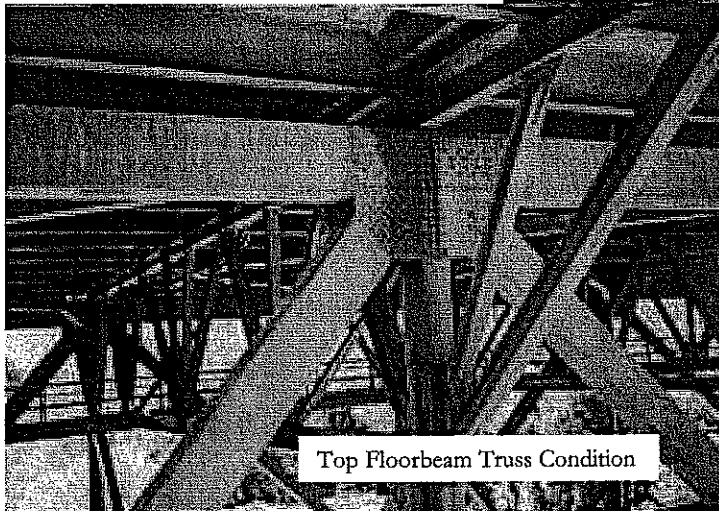
Top Floorbeam Truss Condition

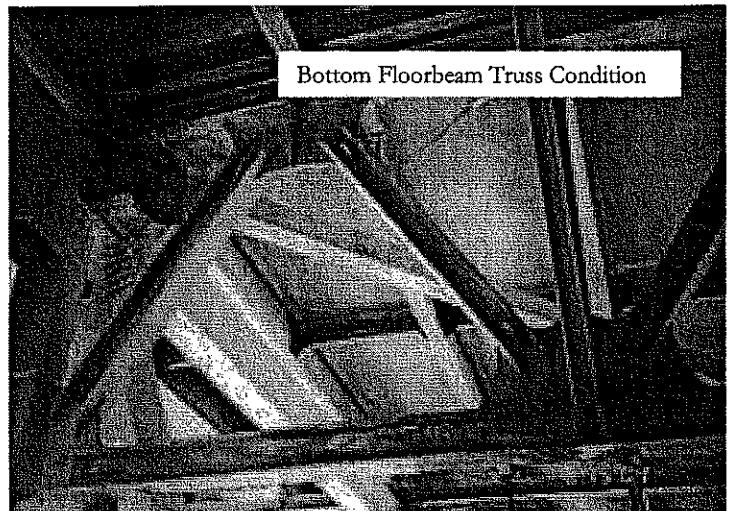
Bottom Floorbeam Truss Condition

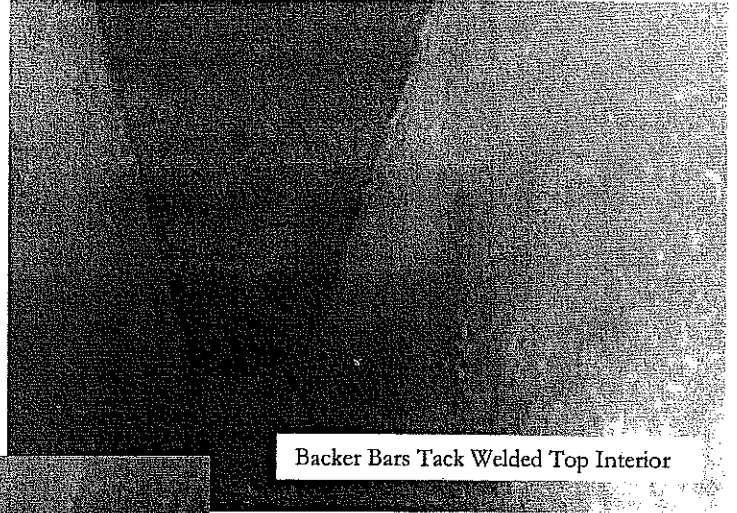
[2004] Truss bottom chord L2/L3 has a nick. Top chord U3/U4 has backer bars tack welded along the top interior corners of member. See photo. Bottom chord L4/L5 has no diaphragm tabs, full weld on side & tack welds on other. See photo. Diagonal member L3/U4 has 4 diaphragms with tabs. See photo.

Backer Bars Tack Welded Top Interior

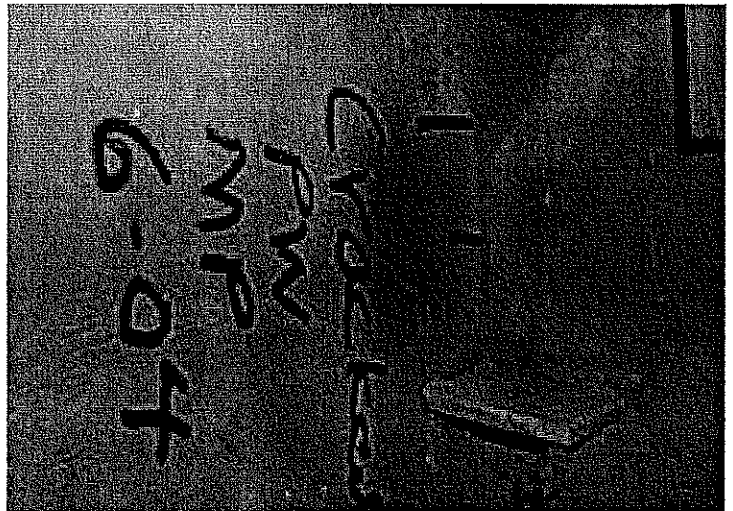
[1996] Bottom chord member L12/L13 has a cracked tack weld at the internal stiffener. [2004] Bottom chord member L12/L13 has a cracked tack weld (diaphragm #2), (not at diaphragm tab). See photo.

Cracked Tack Weld @ Diaphragm #2

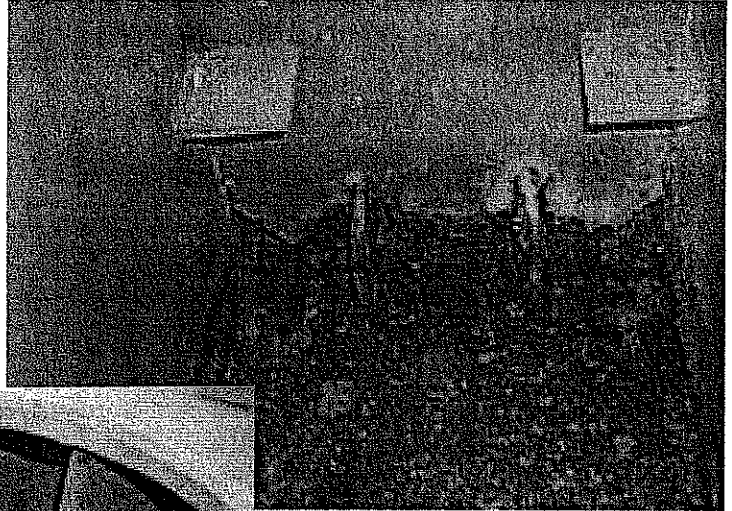
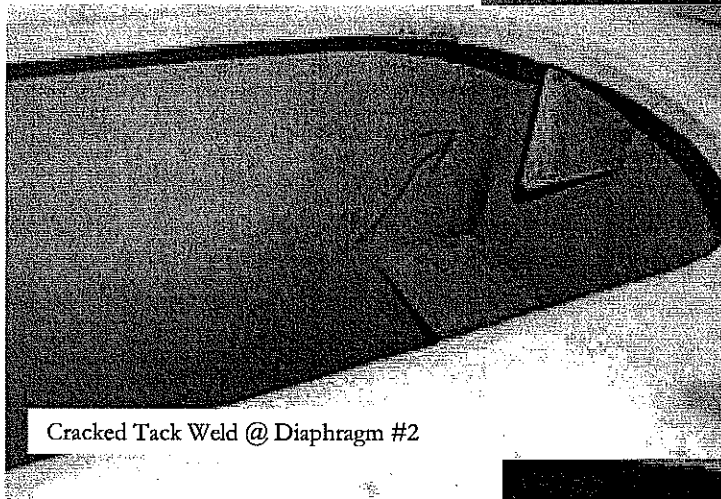
[1996/99] Bottom chord member L13/L14 has cracked tack welds at two internal stiffeners [1999] Truss bottom chord/sway frame connection plates have 3/4" pack rust. [2004] Diagonal L13/U14 has corrosion from deck drain. Cracked tack weld (not at diaphragm tab). Cracked tack weld: (diaphragm #3), (not at diaphragm tab), (entire tack weld broken cleanly).

L13/U14 Corrosion @ Diaphragm

Cracked Tack Weld @ Diaphragm #2

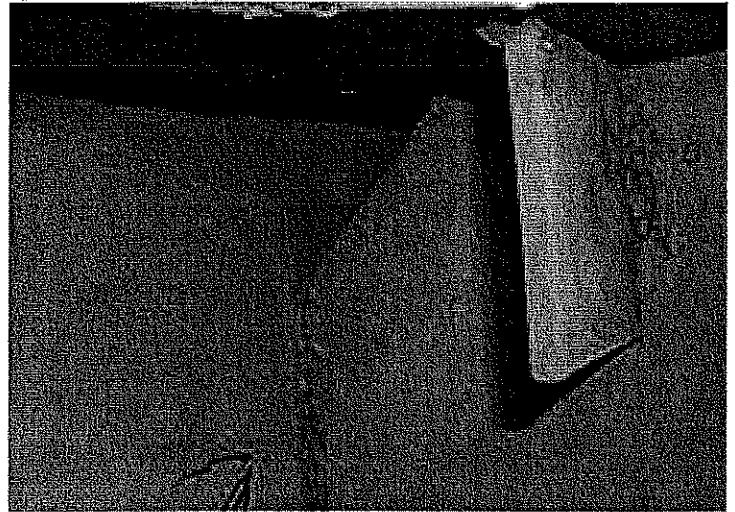
Cracked Tack Weld @ Diaphragm #2

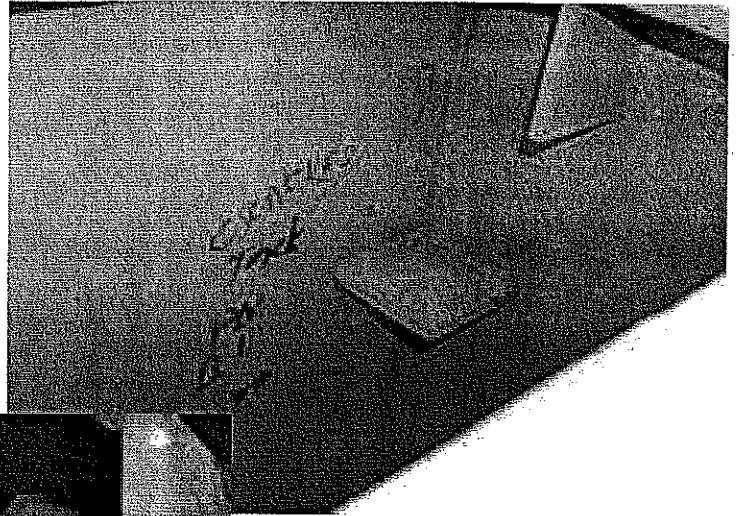
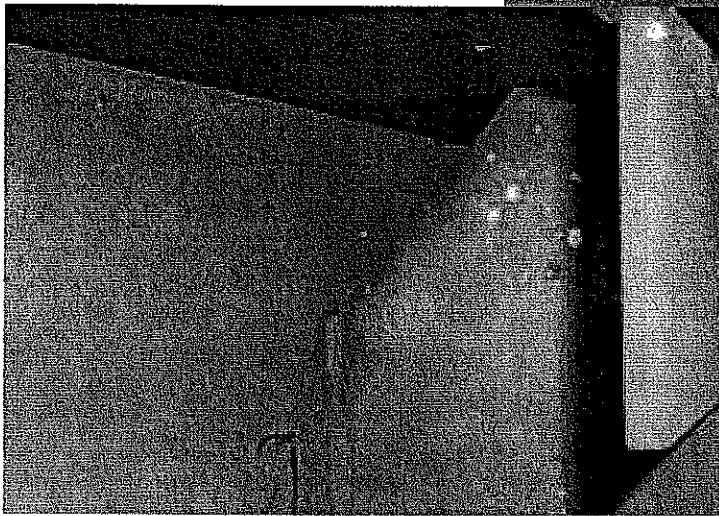
Cracked Tack Weld @ Diaphragm #3

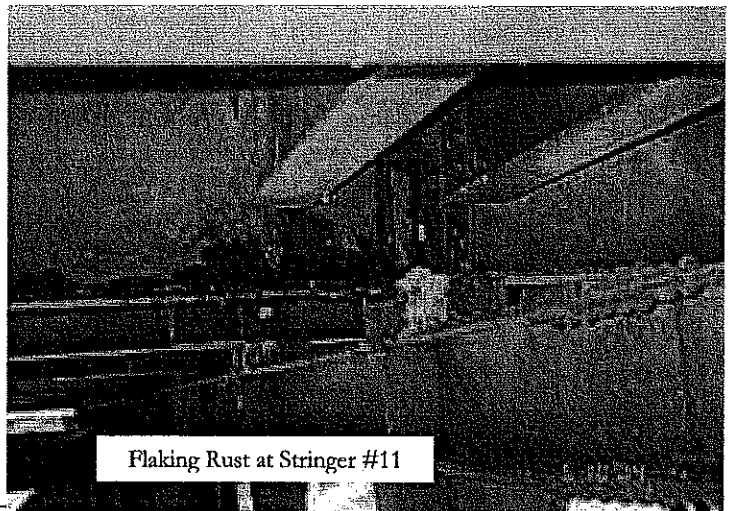
Type H: strip seal deck joint above. Deck drains on both sides. [1994] Stringer #11 has section loss, flaking rust near the joint from gland pulled out above. Tack welds along the sway frame/truss,

Flaking Rust at Stringer #11

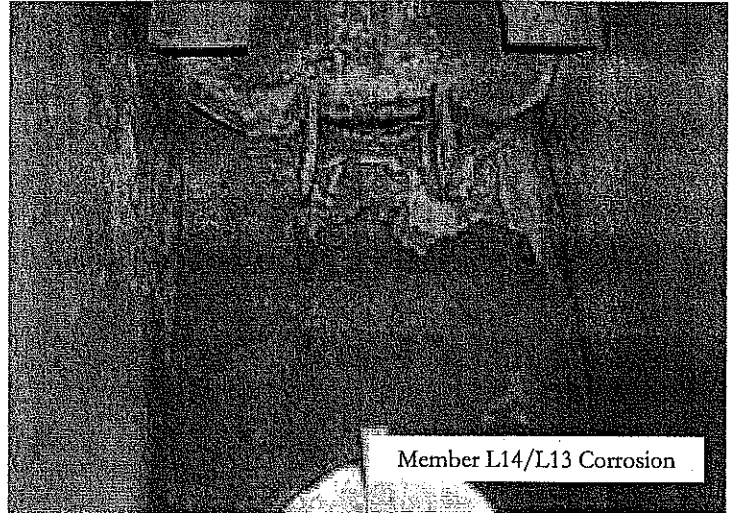
[2004] Bottom chord member L14/L13' has internal tack welds (full length) at interior diaphragm. Upper chord member U14/U13' has corrosion from deck drain. See photo.

Member L14/L13 Corrosion

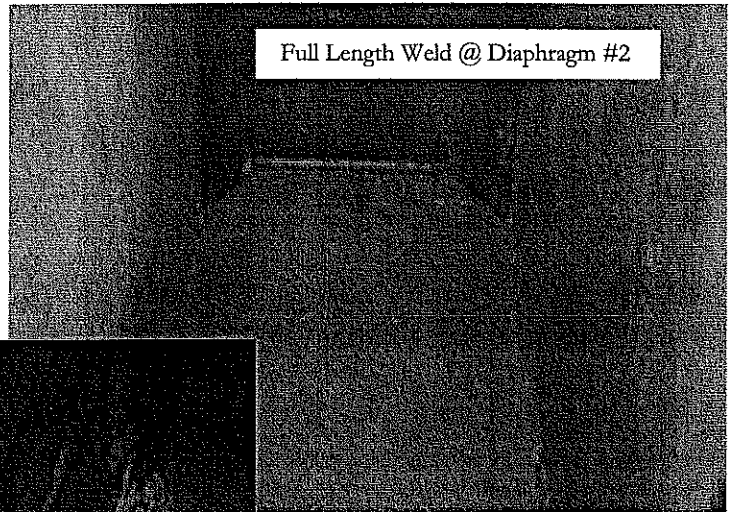
[2004] Upper chord member U13'/U12' (diaphragm #2) has no tabs, diaphragm is welded (full length) one side only. Bottom chord member L13'/L12': cracked tack weld (diaphragm #1), (not at diaphragm tab), (clean break). See photo #2.

Full Length Weld @ Diaphragm #2

[2004] Upper chord member U13'/U12' (diaphragm #2) has no tabs, diaphragm is welded (full length) one side only see photo #1. Bottom chord member L13'/L12' cracked tack weld (diaphragm #1), (not @ diaphragm tab), (clean break) see photo #2.

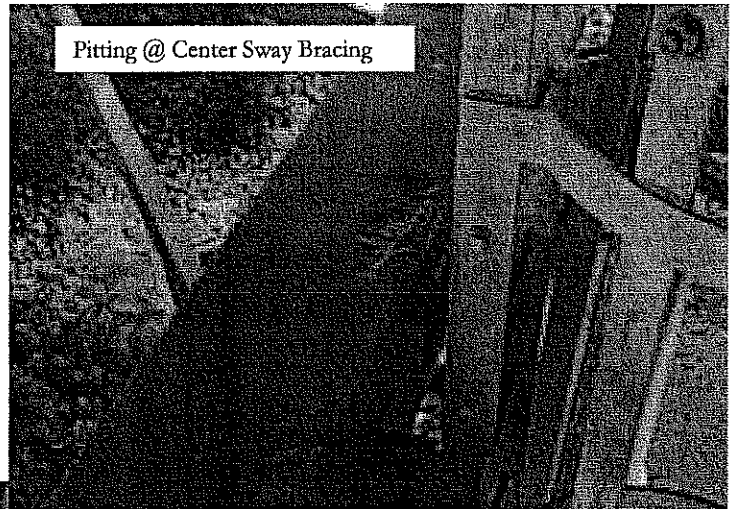
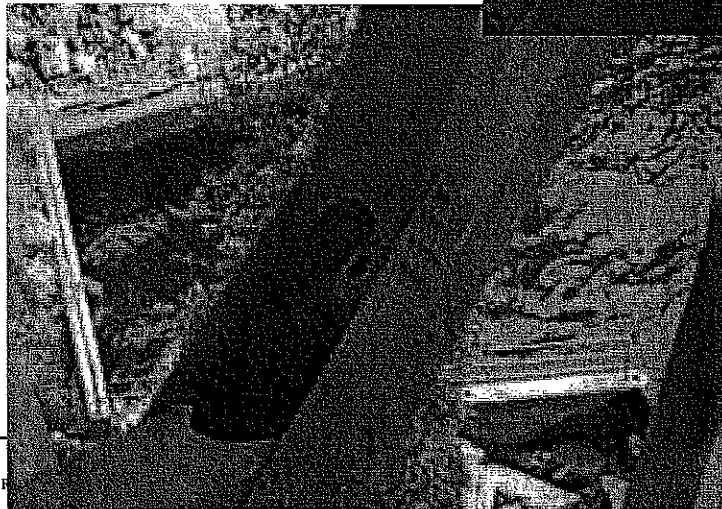
Type H: strip seal deck joint above. [1996] Below stringer #13, the diagonal brace between top and bottom chord of the floorbeam truss is bent, from original construction. [1998] Stringer #11: bolt replaced at floorbeam truss connection. [2001] Truss bottom chord/sway frame connection (gusset plates) has section loss with heavy flaking rust. [2002] Truss bottom chord, L8'/L9', has section loss with heavy flaking rust. [2004/05] Sway bracing center horizontal has 3" x 8" severe pitting & ½" diameter hole; bottom sway bracing has a 2" x 3" hole between stringer #11 & stringer #10. See photos. [2005] Strip seal gland has 5 LF pulled out & is leaking onto the crossbeam below, between stringer 10 & 11.

Hole in Bottom Member of Sway Bracing

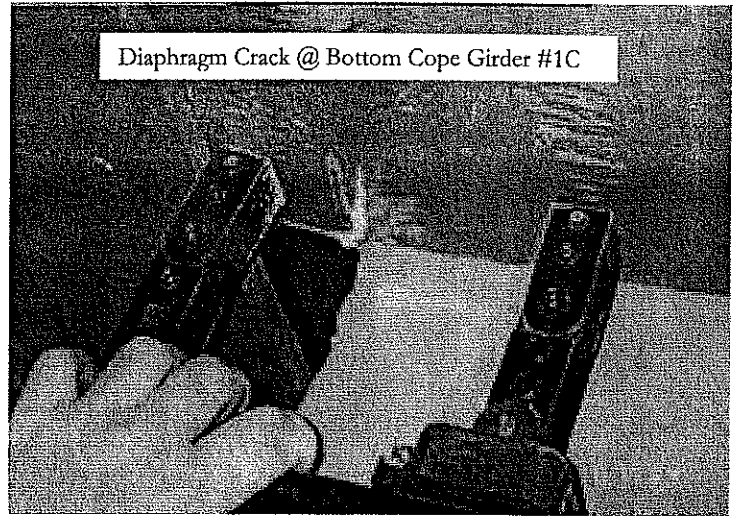
Diaphragm Crack @ Bottom Cope Girder #1C

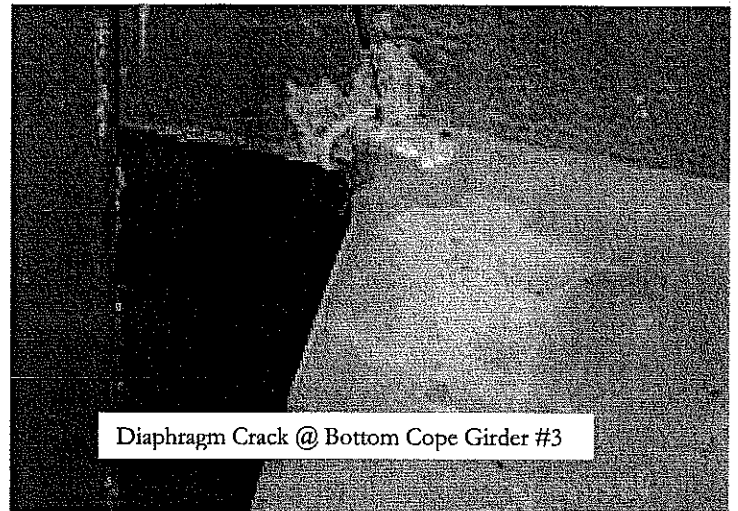
Diaphragm Crack @ Bottom Cope Girder #3

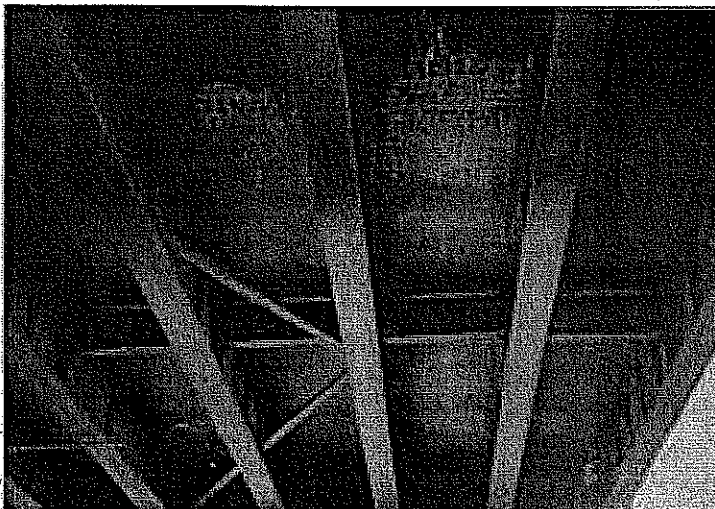
Water Saturation SB Bays 12, 13 & 14

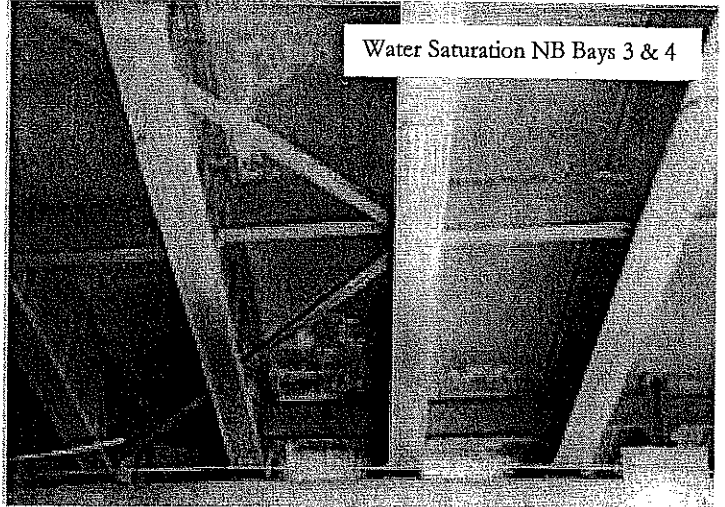
Water Saturation NB Bays 3 & 4

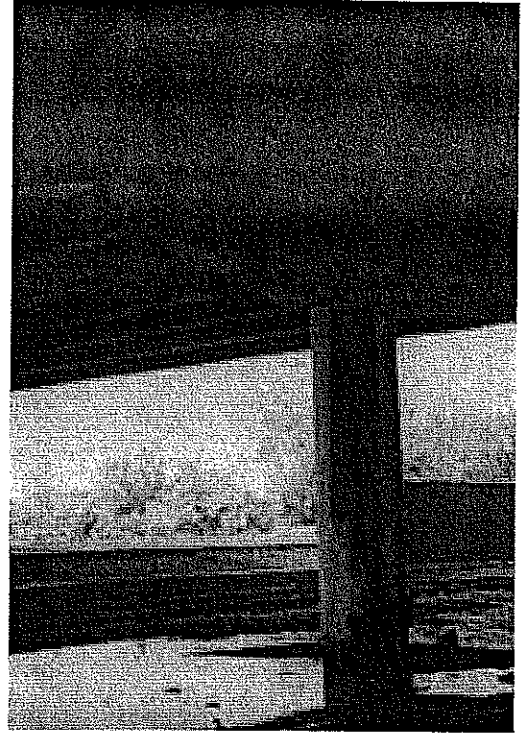
Plate bearing assemblies have 13 fixed, and four sliding. Pier consists of four columns and cap, with a railroad crash strut between the columns. 2 Deck drain: downspouts. [1969] East column damaged by train derailment: the column has minor scrapes and spalls, downspout had to be reconnected. [1999] Bearings 9, 10, 11, &. 12 were re-painted. [2004/05] West vertical & median deck drain plugged.

Median Drain Plugged Pier 9

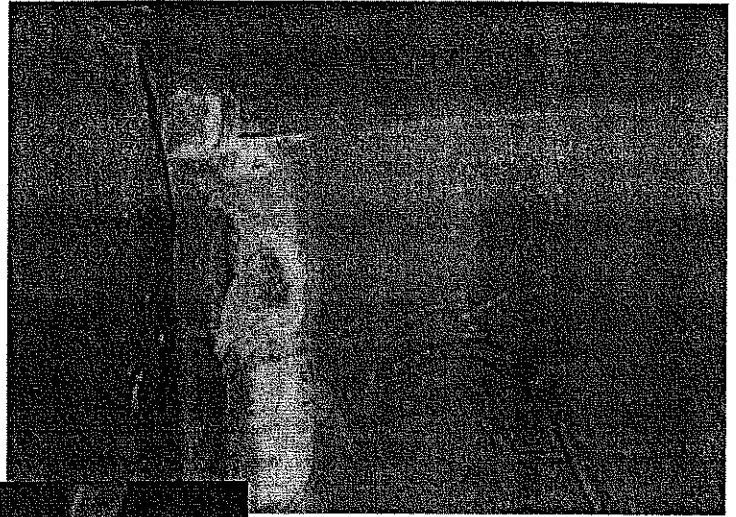
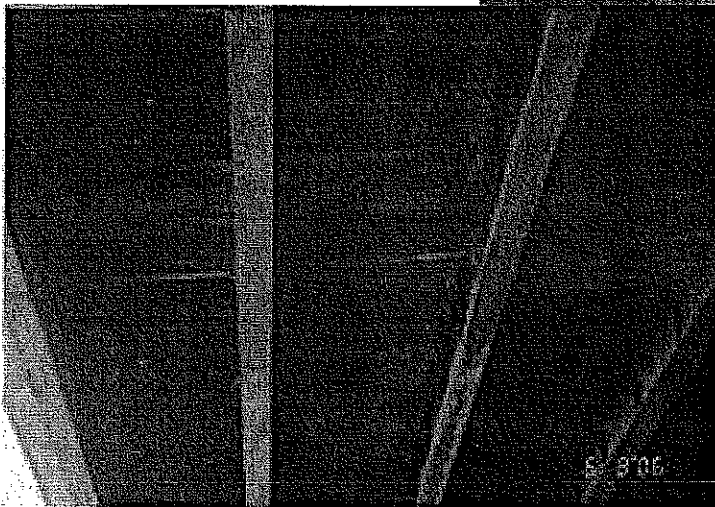
Water Saturation SB Bays 12, 13 & 14

Water Saturation NB Bays 5, 6 & 7

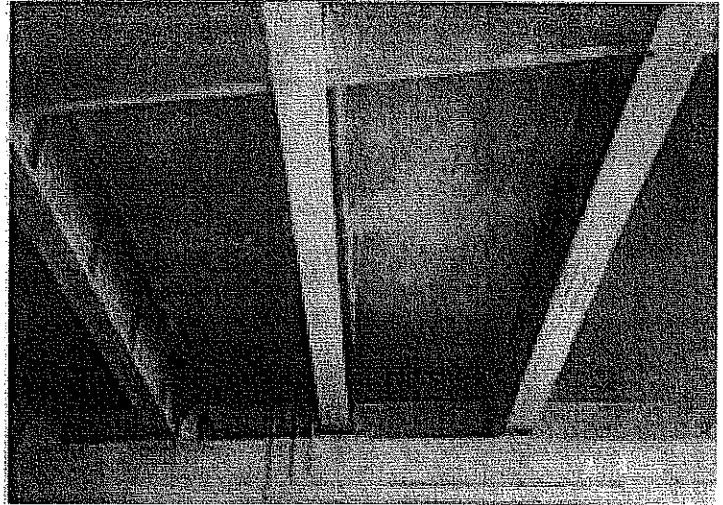
Span is 68 ft. long with 18 steel beams. Northbound has 11 beams; southbound has 7 beams, and the parking lot below. [1999] Beams 9, 10, 11, & 12 were re-painted. Connections welded to top flange. Diaphragms were inverted & lowered, even though the beam connections have "positive moment" configuration. [2003] Conduit: east side bottom of deck. [2004] 50 SF of water saturated deck underneath.

Water Saturation SB bays 15 & 16

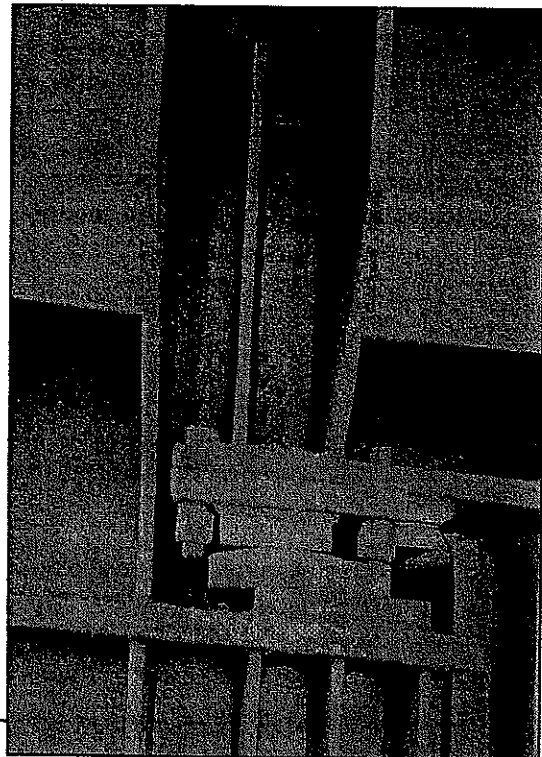
West Fascia SBL Hinge
Bearing Sole Plate

Hinge joint has open finger joint above. [94/2005] All hinge assemblies are expanded beyond tolerance; sliding plates extend 4" or more beyond the base plates, reducing bearing capacity. At beam #10, the sliding plate has tipped, falling off the base plate, and is preventing the joint from opening. [1999] Hinge area re-painted. [2000] Beam-ends have section loss, moderate surface pitting; debris has begun to build up on hinge area. Additionally, the tops of the beam ends are contacting at the top flange or at the web along this joint. [2005] Hinges should be flushed.

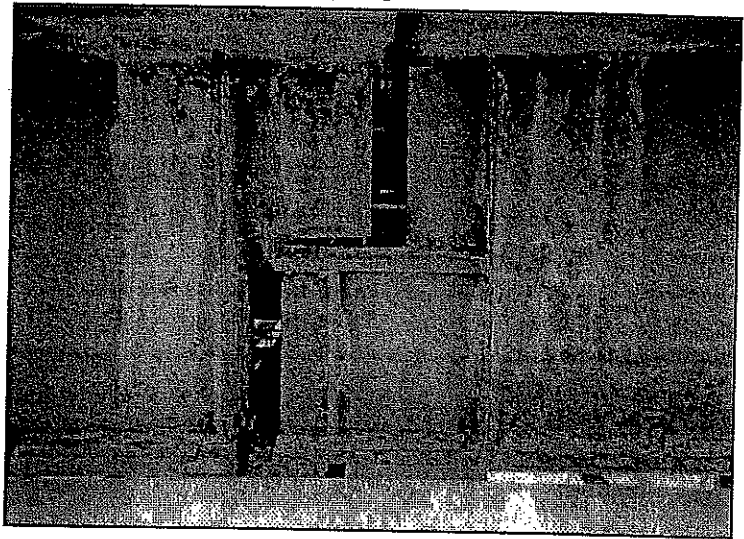
Strip seal deck joint above. [1999] 1 ft. of gland pulled out at centerline. [1996] Floorbeam truss bottom chord/vertical member connection gusset plate has a weld overlap. [1999] Junction box cover is missing at catwalk. [2000] Concrete in joint at east end. [2005] Flaking & surface rust exterior east truss.

Flaking & Surface Rust Exterior East Truss

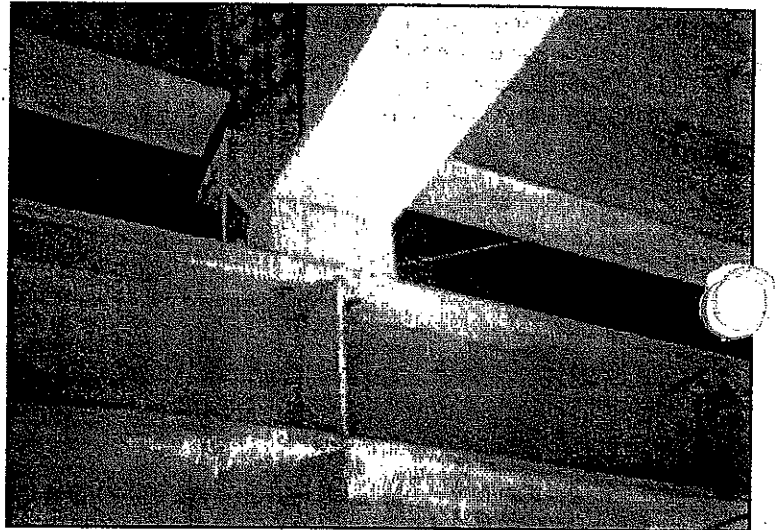
- The rubber "skirts" sections above the truss end rockers, installed in 1999, tend to fill with debris. These should be flushed out annually. The horizontal drain troughs at pier #6 have inadequate slope, and are clogged.

Plugged Horizontal Drain Trough

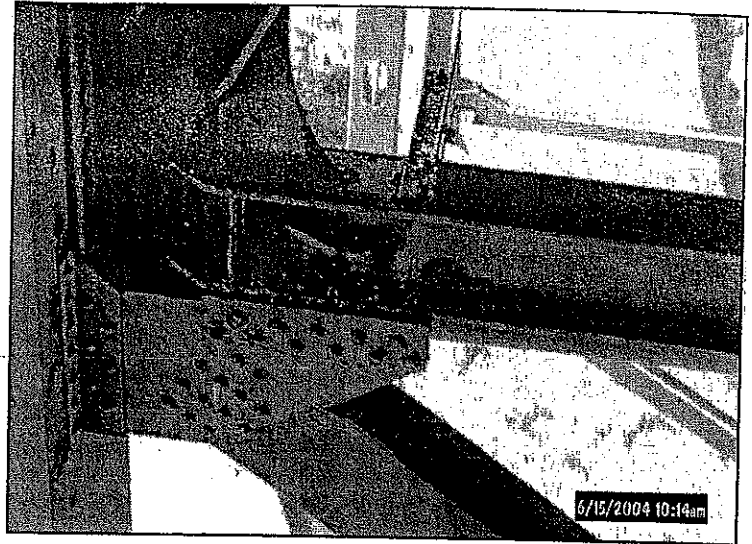
[2004] Typical condition & rust at floorbeam connection near deck drain at connection U8.

Floorbeam Condition.

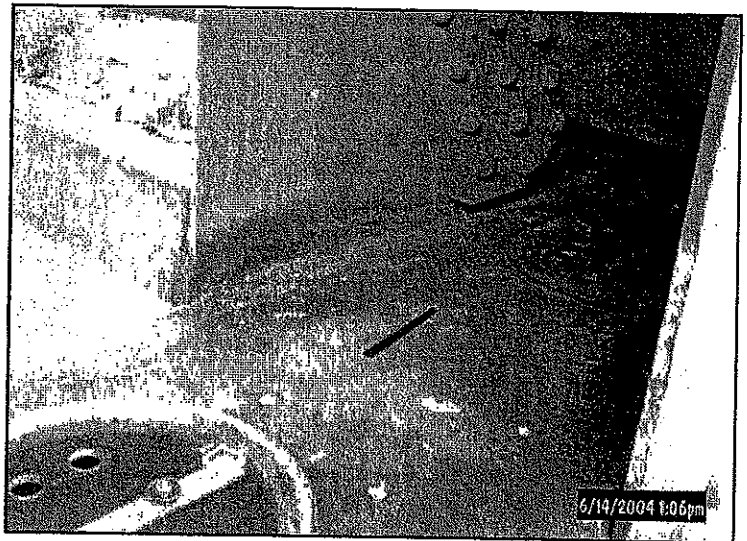
Section loss: at gusset plate bottom chord. [2000/05] Stringer #3 has two bolts missing at the floorbeam connection. [2004] Pitting inside gusset plate connection at L11 toward L10

Pitting @ L11/L10 Connection

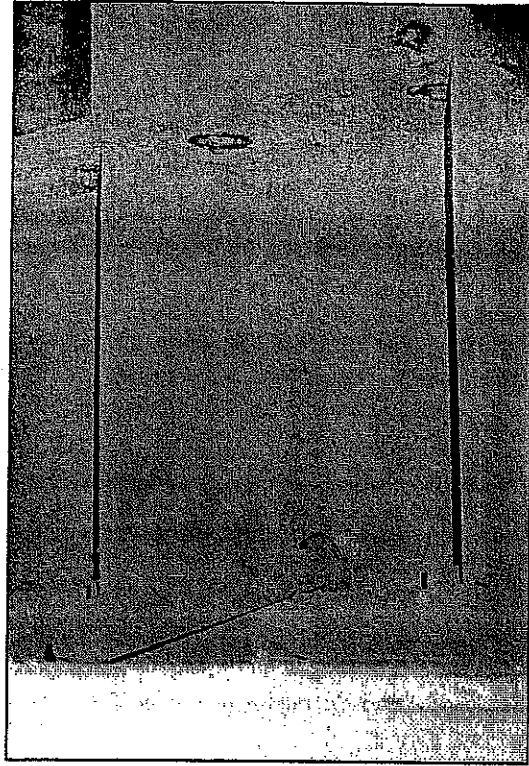
Bolts Missing @ Floorbeam Connection

- Four-stringer connection bolts, all in the NBL, need replacement. At panel point #8, stringer #2 has 2 loose bolts, and the bearing block has rotated. This will likely require jacking the superstructure. Stringer bolts also need replacement at panel point #8, stringer #4, south side, and at panel point #11, stringer #3.
