INVESTIGATIVE REPORT TO JOINT COMMITTEE TO INVESTIGATE THE I-35W BRIDGE COLLAPSE

APPENDIX: Volume II

MAY 2008

Appendix Volumes II and III

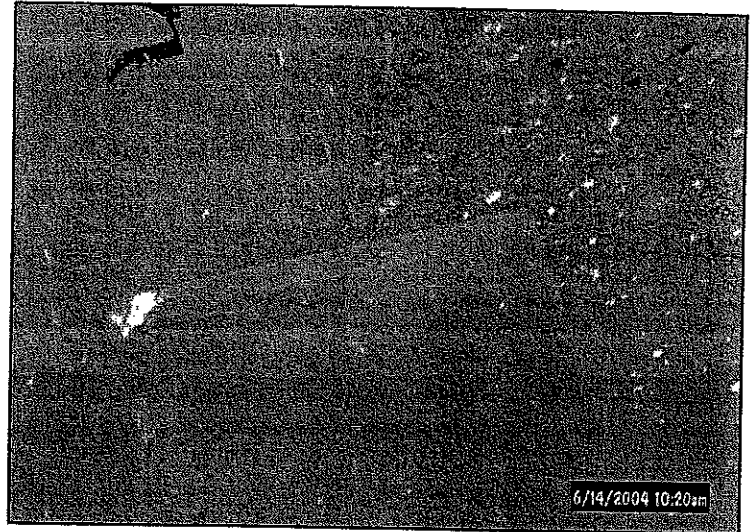
Panel Point #13 (East Truss):
Water from deck drains fall directly into river. [99/2002] Bottom chord gusset plate has section loss, flaking & pack rust. [1999] Truss bottom chord member L13/L14 has cracked tack welds at two interior stiffeners. [2004] Bottom chord member L13/L14 cracked tack weld @ diagram tab (diagram #1?). Cracked tack weld @ diagram tab member L13/U14 see photos.

Member L13/U14 Cracked Tack Weld

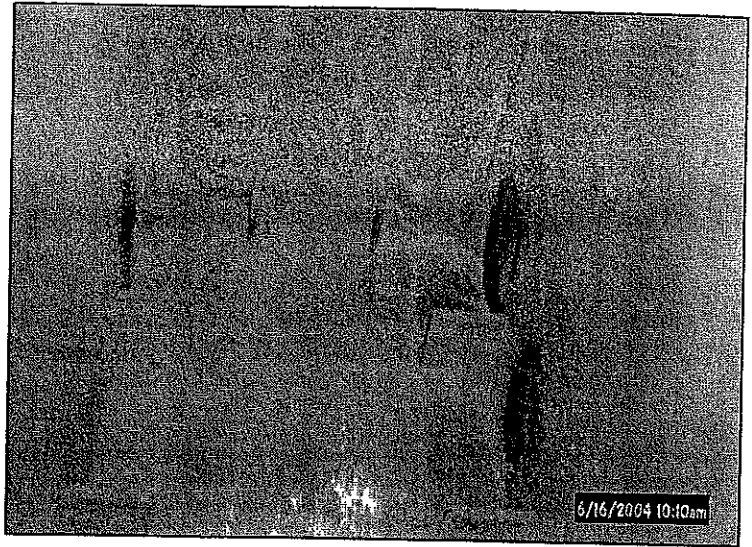
[99/2003] Underside of the deck has 65 SF of water saturation. [1998] Truss bottom chord member L12'/L11' has a cracked tack weld at an interior stiffener. [2004] Bottom chord member L12'/L11' two cracked tack weld @ diagram tab (diagram #3?) see photo.

Member L12'/L11' Cracked Tack Weld

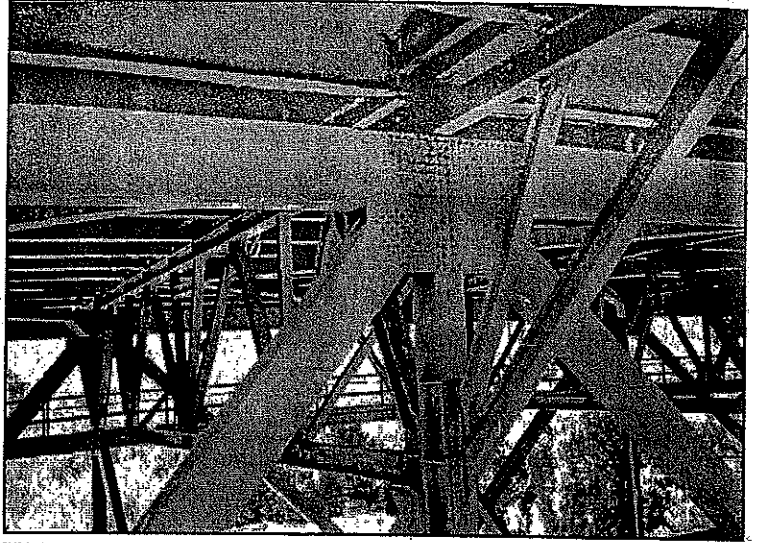
Strip seal expansion joint on the deck. Truss diagonal member U4'/L3' has backer bars along the interior edges. [01/04] Strip seal has 3 LF of gland pulled out. Truss connection plates, the top chord, and floorbeam have moderate section loss, severe flaking rust. Bottom connection plates have 1/2" pack rust.

Top Floorbeam Truss Condition

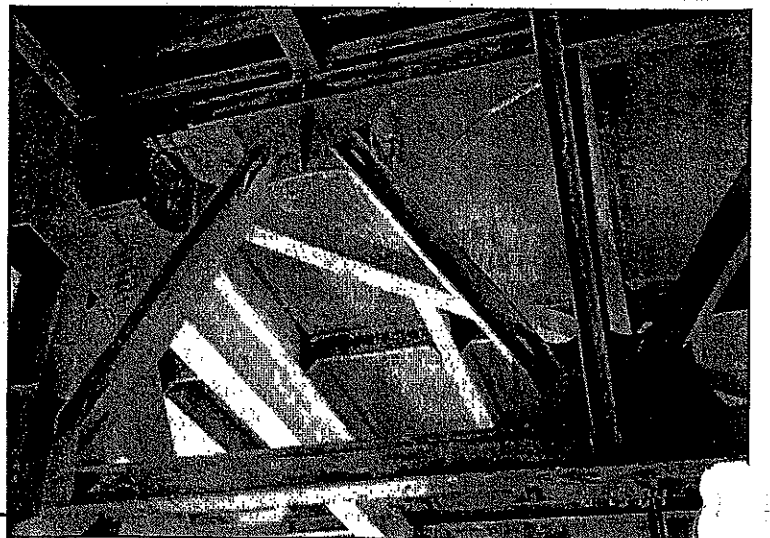
Bottom Floorbeam Truss Condition

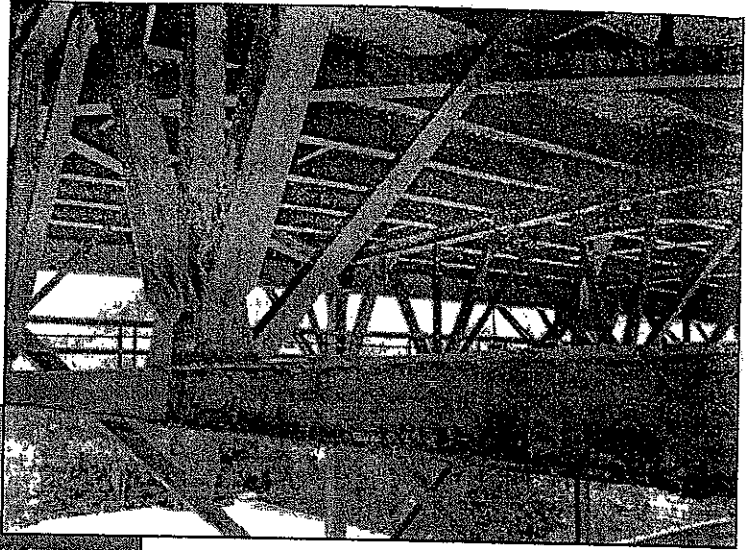
Bottom Truss Condition

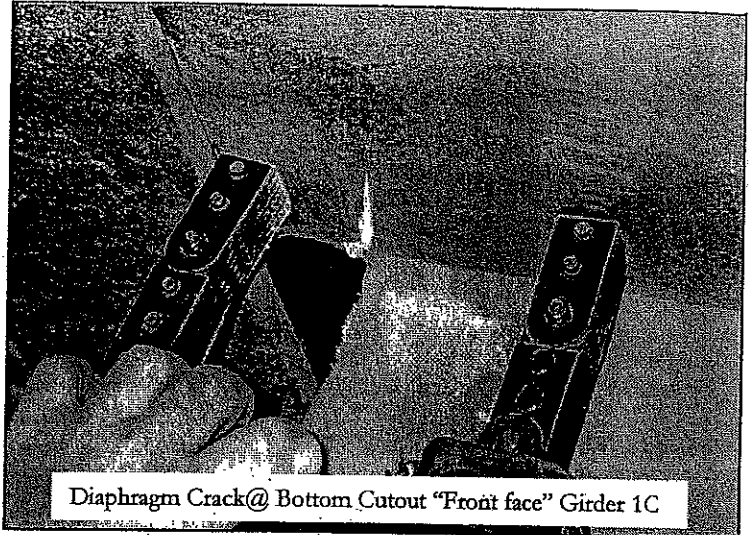
- Fatigue cracks at girder #1C (NBL), crack at the diaphragm bottom cutout, NE side measures 2" ("front face") and NW side measures 2-1/2" ("back face"). Fatigue cracks a girder #3 (NBL), crack at the diaphragm bottom cutout, measures 1-1/2" (both sides). The cracks are located in negative moment regions where the diaphragm web stiffener was not welded to the top flange and were pervious fatigue cracks occurred and were repaired in 1998 and 1999. These areas should be inspected next year for any lengthening of the cracks and drilling of possible stress relief holes.

Diaphragm Crack@ Bottom Cutout "Front face" Girder 1C

- Fatigue cracks at girder #1C (NBL), crack at the diaphragm bottom cutout, NE side measures 2" ("front face") and NW side measures 2-1/2" ("back face"). Fatigue cracks a girder #3 (NBL), crack at the diaphragm bottom cutout, measures 1-1/2" (both sides). The cracks are located in negative moment regions where the diaphragm web stiffener was not welded to the top flange and were pervious fatigue cracks occurred and were repaired in 1998 and 1999. These areas should be inspected next year for any lengthening of the cracks and drilling of possible stress relief holes.

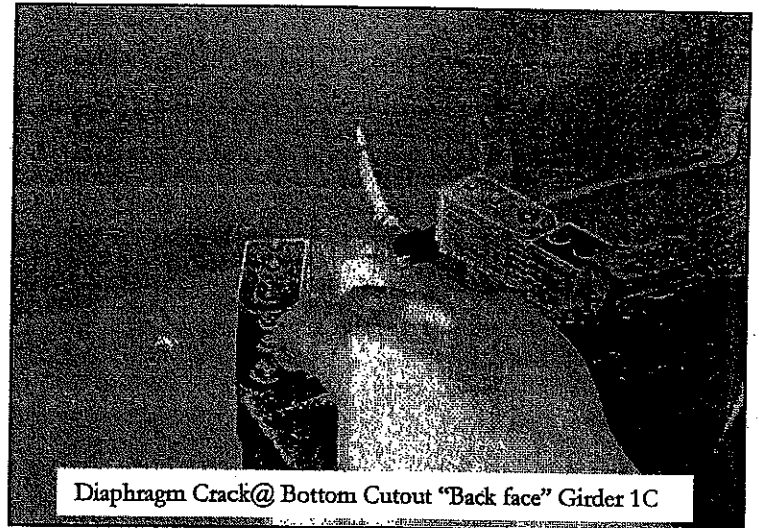
Diaphragm Crack@ Bottom Cutout "Back face" Girder 1C

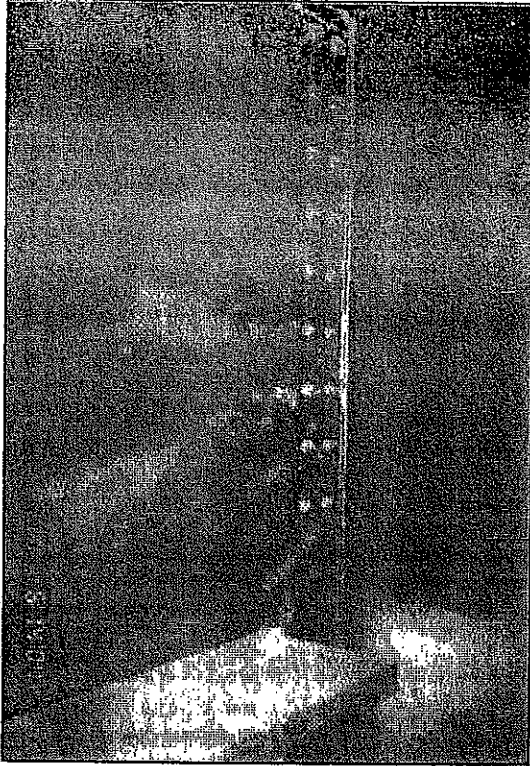
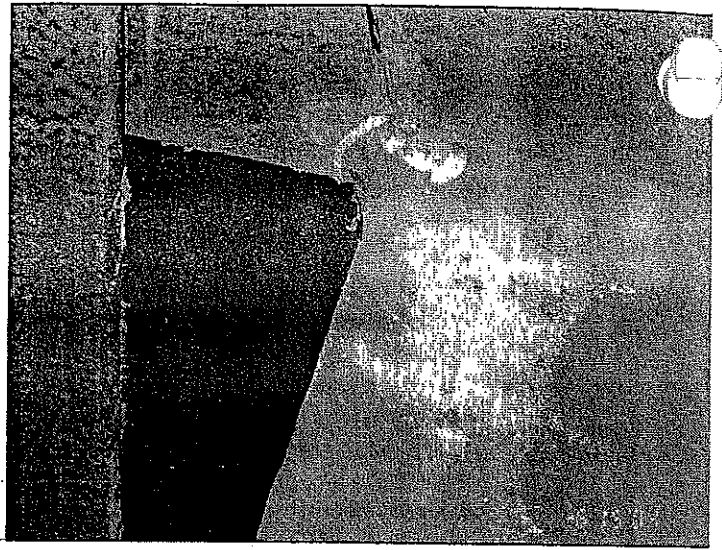
Diaphragm Crack @ Bottom Cutout "Back face" Girder 3

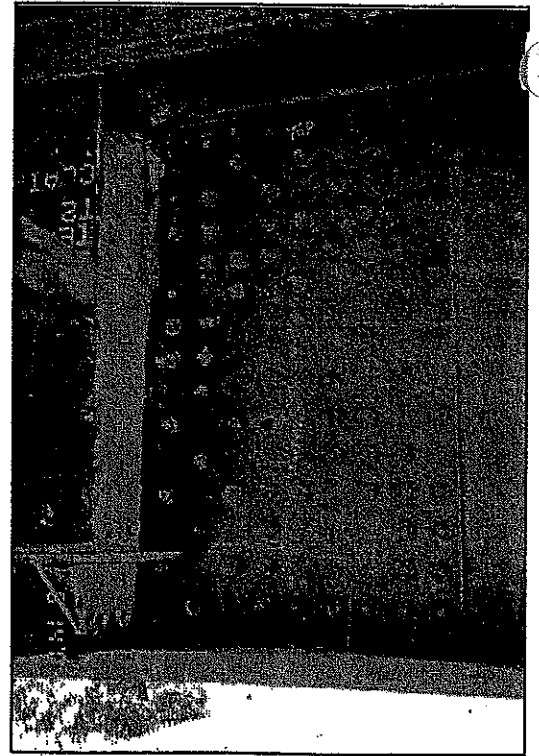
Web "Tear" G # 3 @ Diaphragm Looking West

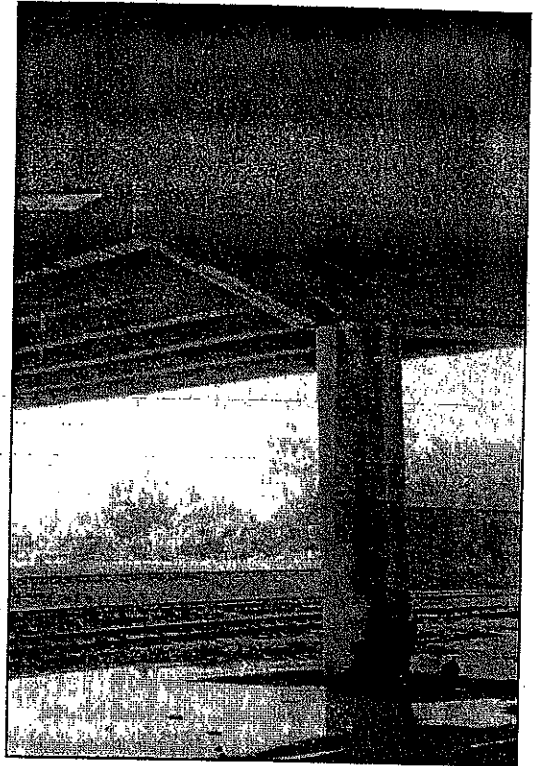
Plate bearing assemblies have 13 fixed, and four sliding. Pier consists of four columns and cap, with a railroad crash strut between the columns. Deck drain: downspout. [1969] East column damaged by train derailment - the column has minor scrapes and spalls. Downspout had to be reconnected. [1999] Bearings 6, 7, 8, & 9 were re-painted. [2004/05] West vertical & median deck drain plugged.

Median Drain Plugged Pier 9

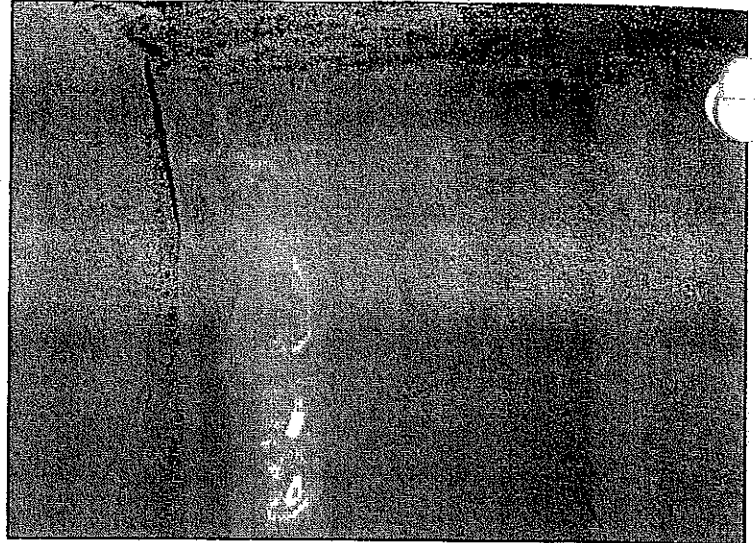
Span is 94 FT long with 17 steel beams. NB has 10 beams; SB has 7 beams (the welded beams transition from 48" to 33" depth just north of pier) with active railroad tracks below. One track splits into two. Refer to Appendix A **First Diaphragm North of Pier #9** graph for crack locations, description & repair to the diaphragm line. [1999] Beams 6, 7, 8, & 9 were re-painted. Diaphragms were inverted & lowered, even though the beam connections have a "positive moment" configuration. Connections welded to top flange. [2003] Conduit: at east side bottom of deck. [2000] Beam #6 appears to be "working" at the top connection. [2004] 250LF of leaching cracks underneath

Girder #10 Vertical Stiffener/Girder Web

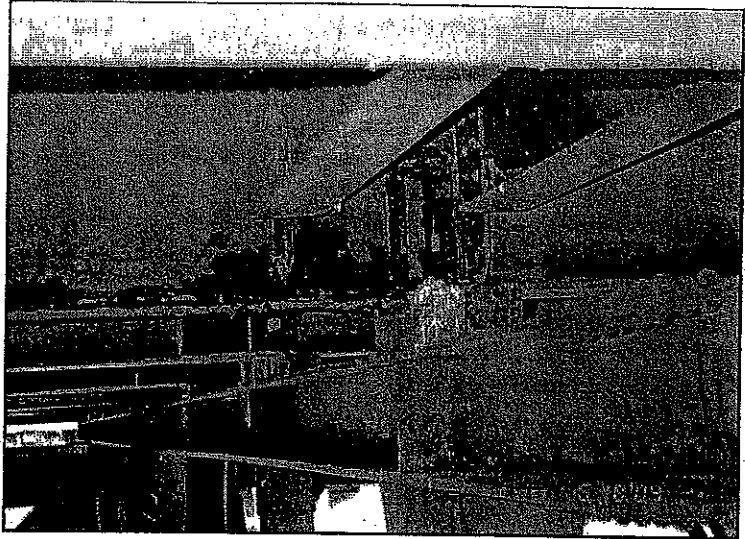
Strip seal deck joint above. [2005] 10 LF of strip gland pulled out. Deck drains on both sides. [1994] Stringer #11 has section loss, flaking rust near the joint from gland pulled out above. Tack welds along the sway frame/truss, bottom chord, and gusset plate. [1999] Bottom chord member L14/L13' has a cracked tack weld at an interior stiffener. [2003] Stringer #14 connection, south side of the floorbeam, has a cracked tack weld. [2004] Upper chord member U14/U13' has internal tack welds (full length) at interior diaphragm. Bottom chord member L14/L13' has corrosion from deck drain (?) see photo.

Flaking Rust @ Stringer #11

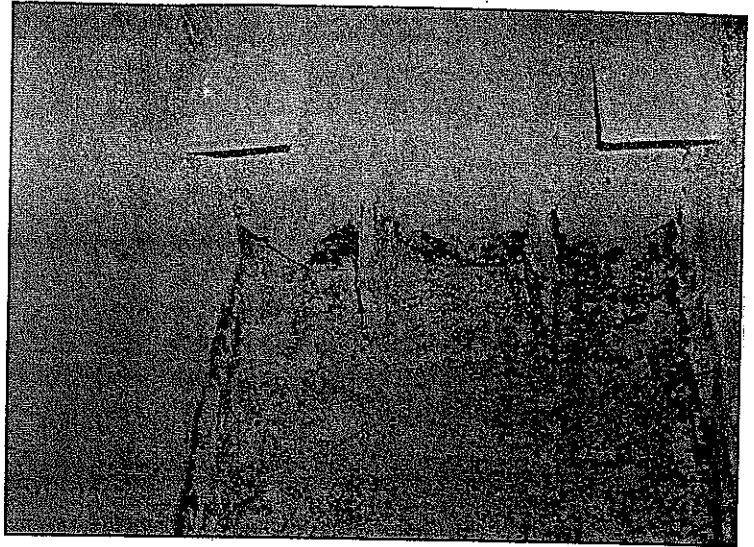
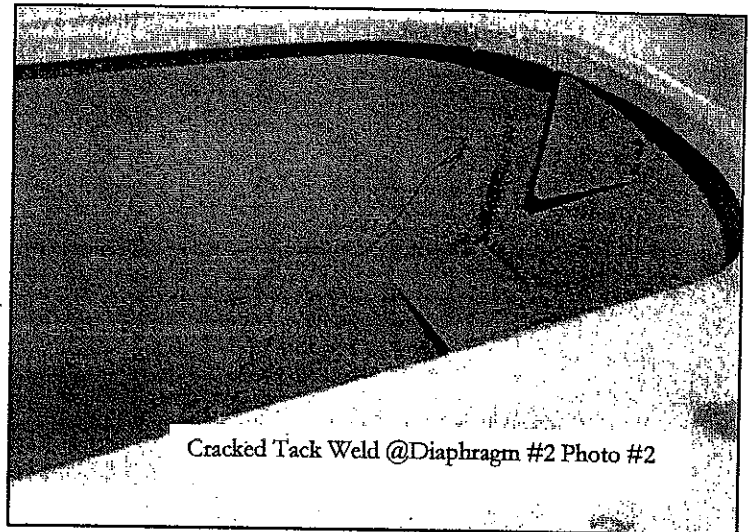
Panel Point #13 (West Truss):
[1999] Truss bottom chord/sway frame connection plates have 3/4" pack rust.
[1996/99] Bottom chord member L13/L14 has cracked tack welds at two internal stiffeners. [2004] Diagonal L13/U14 has corrosion from deck drain (diaphragm #1). Cracked tack weld (diaphragm #2) (not @ diaphragm tab) see photo #2 & #3. Cracked tack weld (diaphragm #3), (not @ diaphragm tab), (entire tack weld broken cleanly) see photo #4 & #5.

L13/U14 Corrosion @Diaphragm

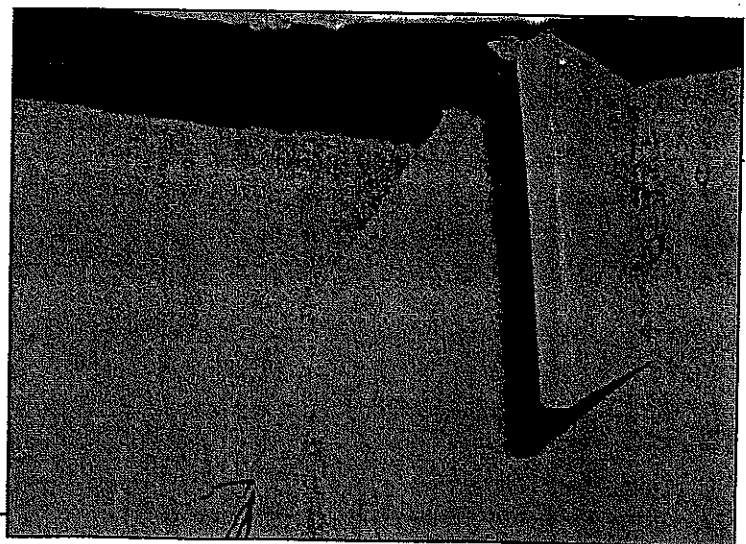
Cracked Tack Weld Diaphragm #2
Photo #3

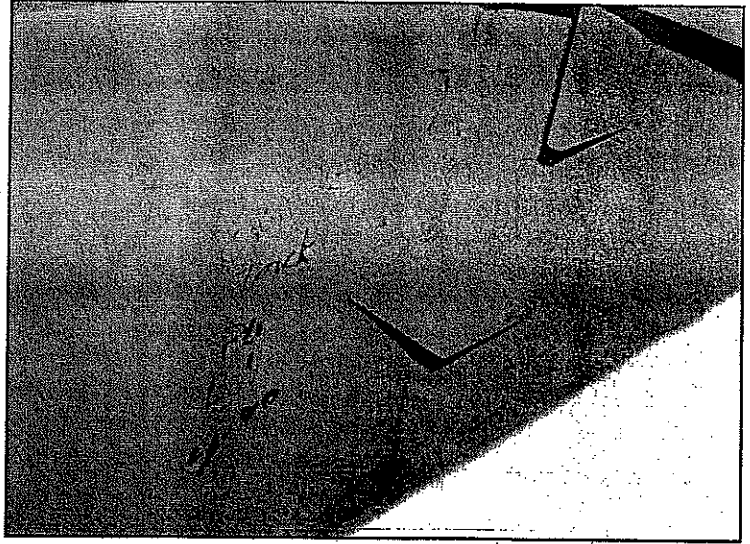
Cracked Tack Weld Diaphragm #3
Photo #4

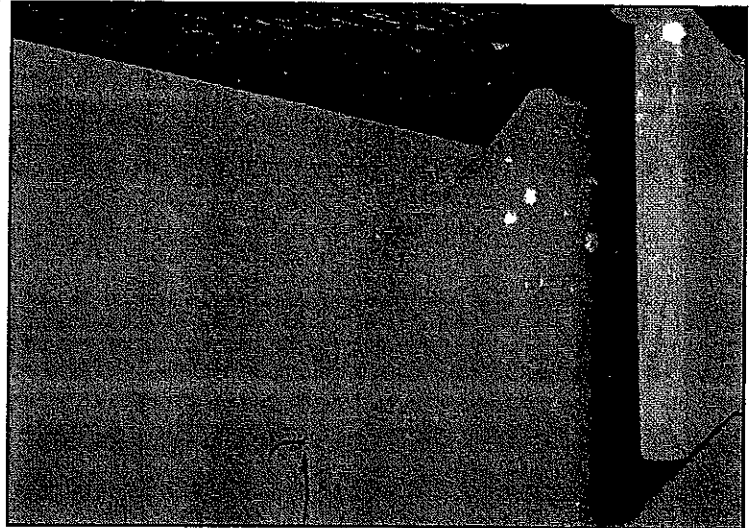
Cracked Tack Weld Diaphragm #3
Photo #5

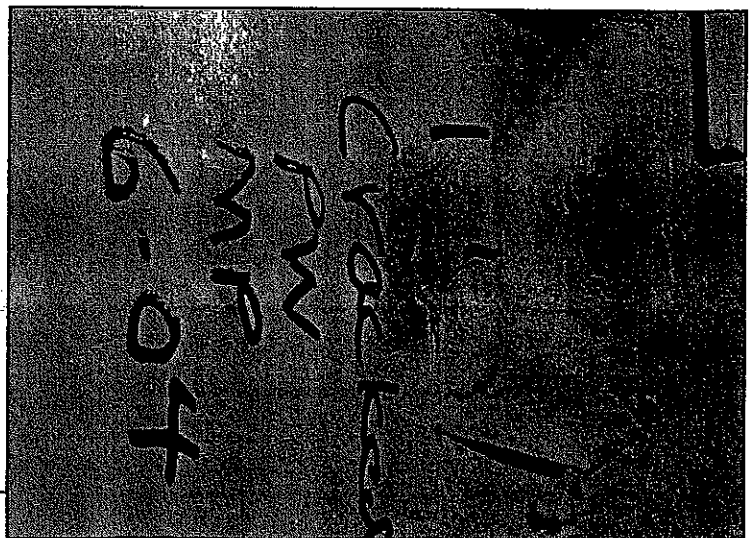
Panel Point #12 (West Truss):
[1996] Bottom chord member L12/L13 has a cracked tack weld at the internal stiffener. [2004] Bottom chord member L12/L13 has a cracked tack weld (diagram #2), (not @ diaphragm tab) see photo.

Member L12/L13 Cracked Tack Weld
Diaphragm #2

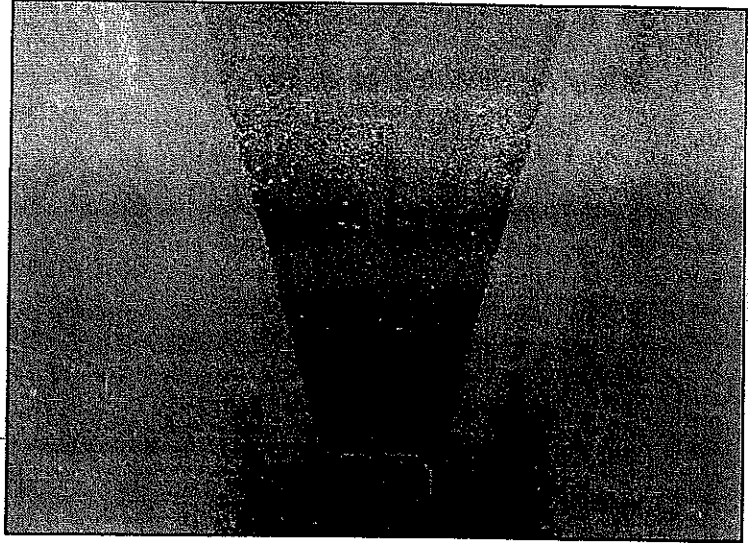
Backer Bars Tack Welded Along Top Interior

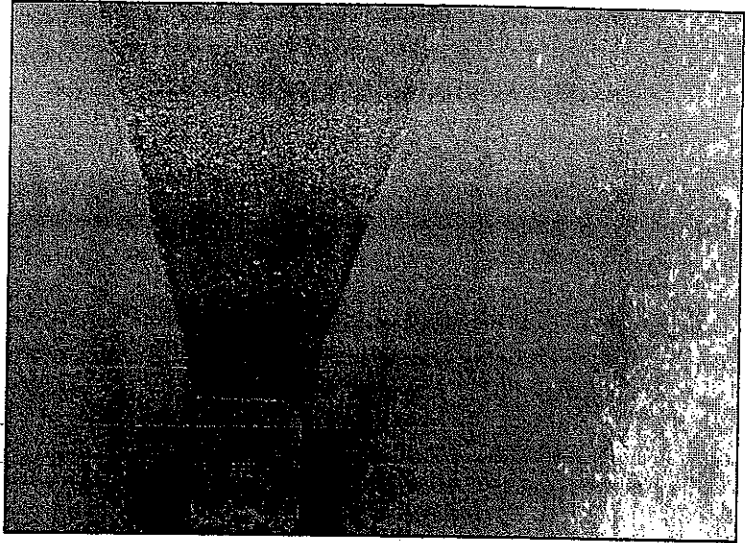
Truss bottom chord L2/L3 has a nick. Top chord U3/U4 has backer bars tack welded along the top interior corners of member see [2004] photo. Bottom chord L4/L5 has no diaphragm tabs, full weld on side and tack welds on other see [2004] photo. Diagonal member L3/U4 has 4 diaphragms with tabs see [2004] photo.

Backer Bars Tack Welded Along Top Interior

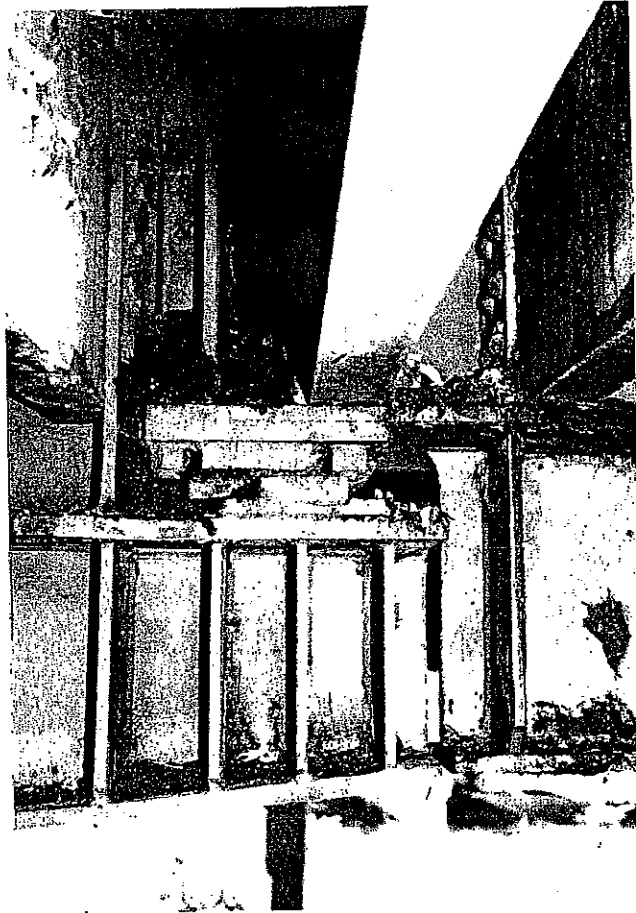
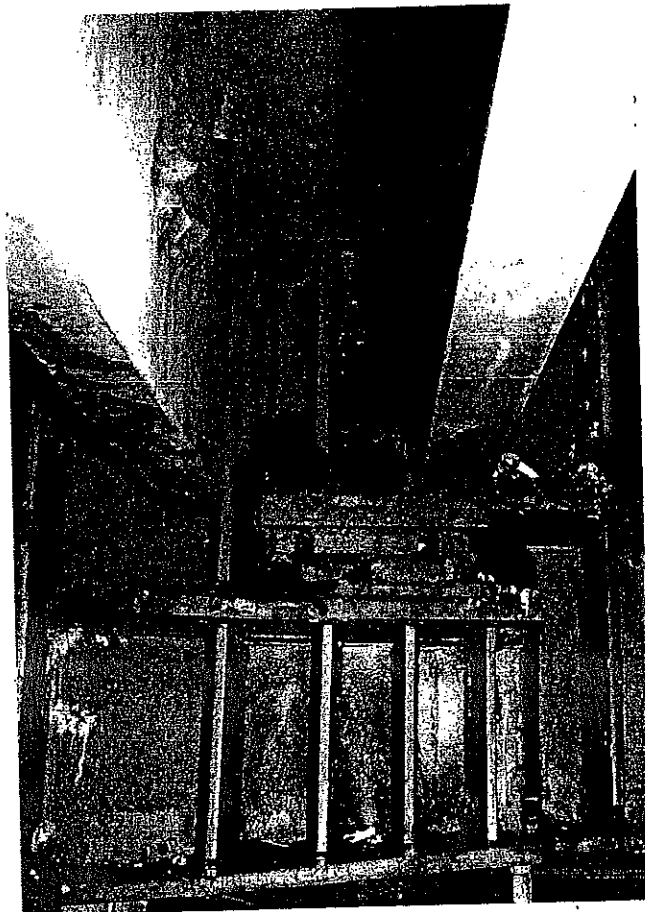
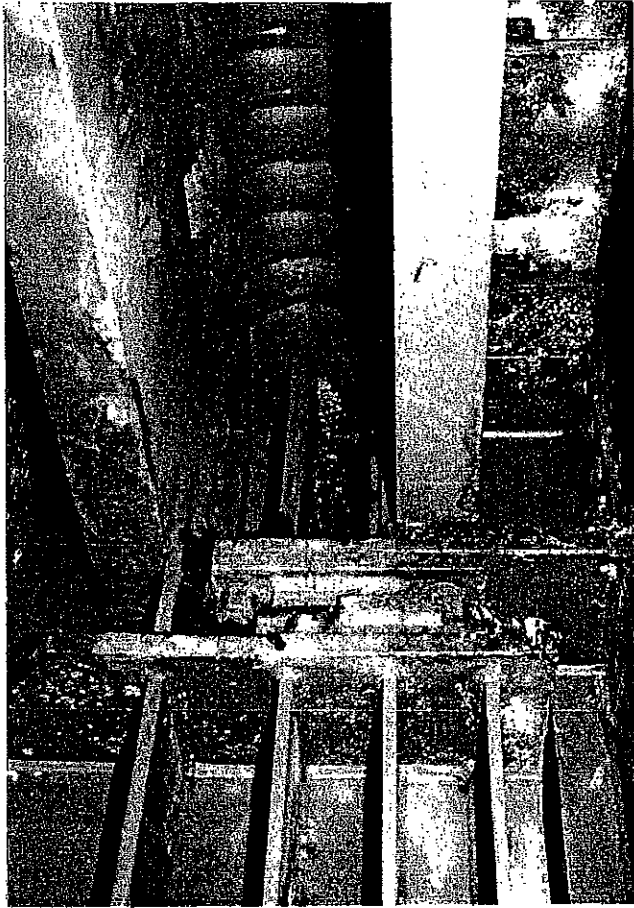
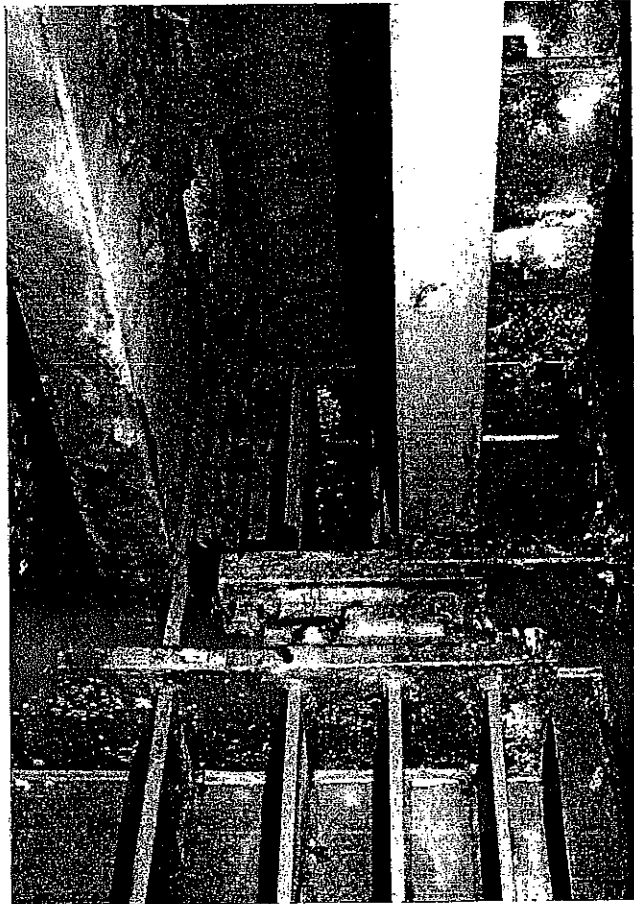
SPAN 2: Typical at this expansion joint. See picture #1, #2, #3, #4. The hinged expansion bearings are inoperative. They have expanded beyond their design limit and are unable to move apart. The ends of the beams are in contact allowing no additional expansion. These two situations combine with the result of a completely frozen joint.

Picture #1
Hinge @ Span #2
No. B'nd.

Picture #2
Hinge @ Span #2
No. B'nd.

Picture #3
Hinge @ Span #2
No. B'nd.

Picture #4
Hinge @ Span #2
No. B'nd.

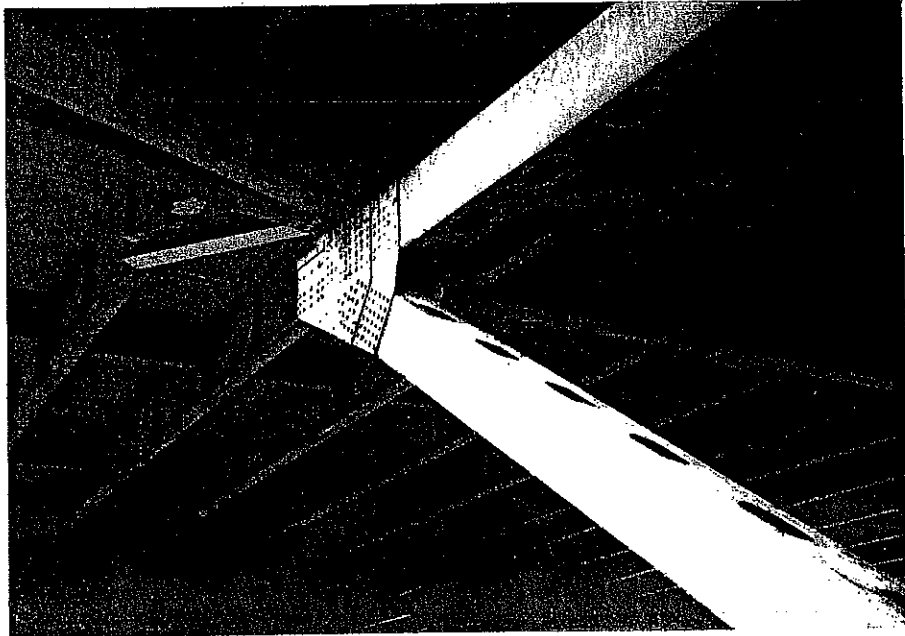
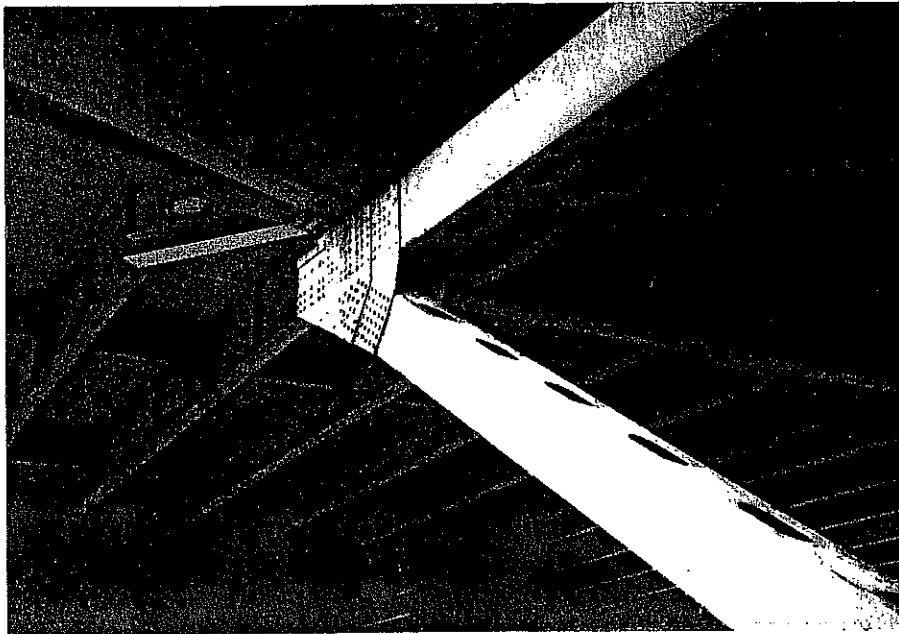
PANEL POINT U0: Finger joint in the deck. Floor beam rusty. Rusty gusset plate, deck truss #2. See picture #6.

Picture #6
Deck Truss #2
Span #4, P/P-U0, No. B'nd.

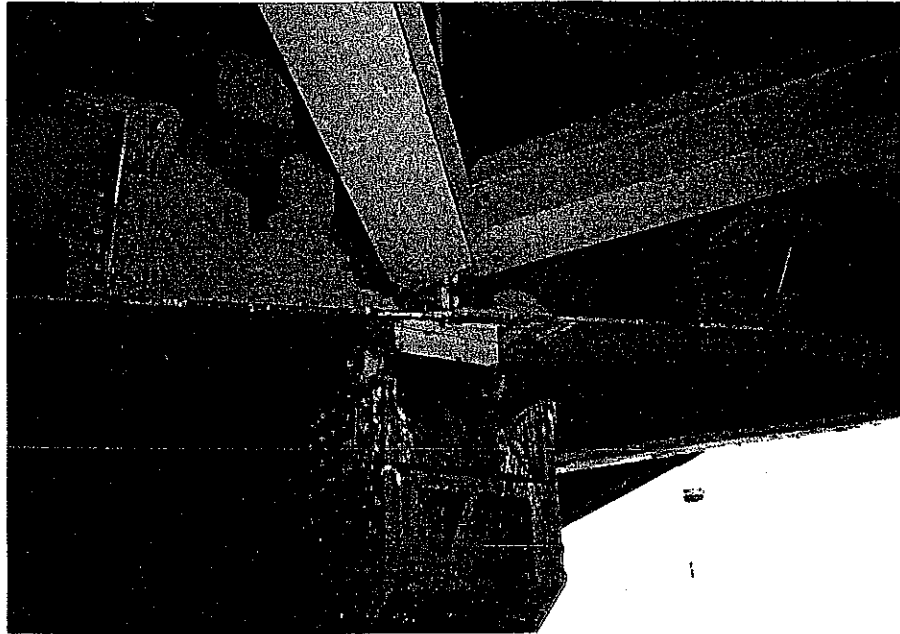
SPAN 5: First 71' steel multi-beam, last 38' deck truss. Repair work at the north floor beam, end of the steel multi-beam span, south end of the bridge. See picture #5. Two corroded rocker bearings support the multi beam span on to the truss. Patches in the overlay at the finger joint.

Picture #5
Repair to Floorbeam @ End of Multi-Beam Span
No. B'nd., Span #5, Deck Truss #2

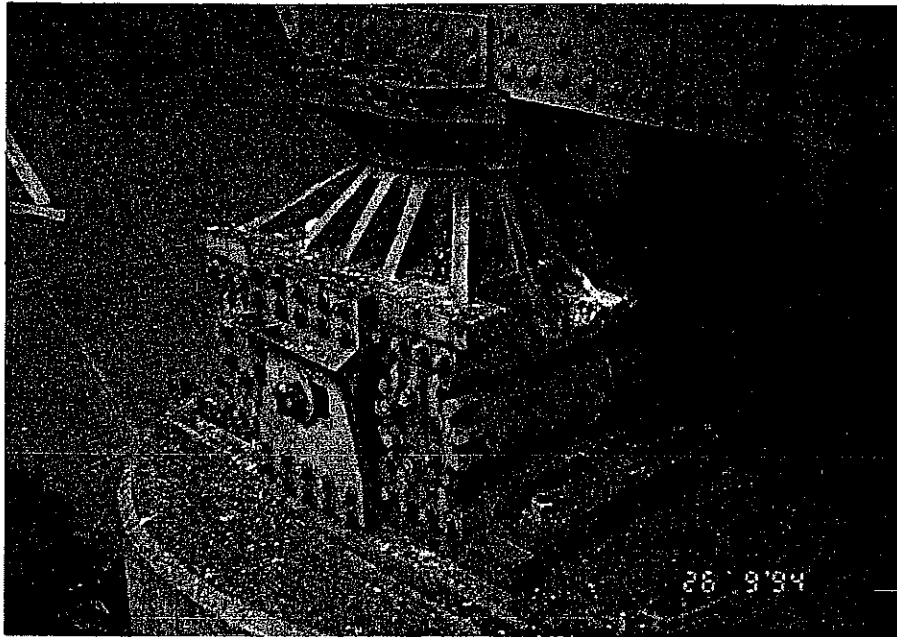
PANEL POINT U1, PIER 5: Picture of the moveable bearing, deck truss #2. See picture #7. Picture of the floor beam truss. See picture #8.

Picture #7
Expansion Bearing
Pier #3, No. B'nd.

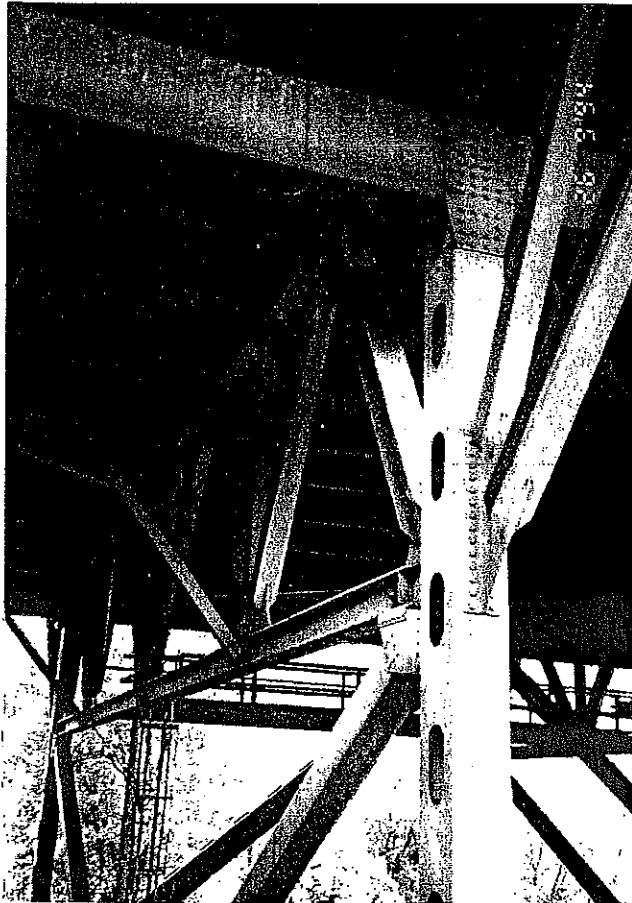
Picture #8
Floor Beam Truss #1
Span #5, P/P-U1
No. B'nd.

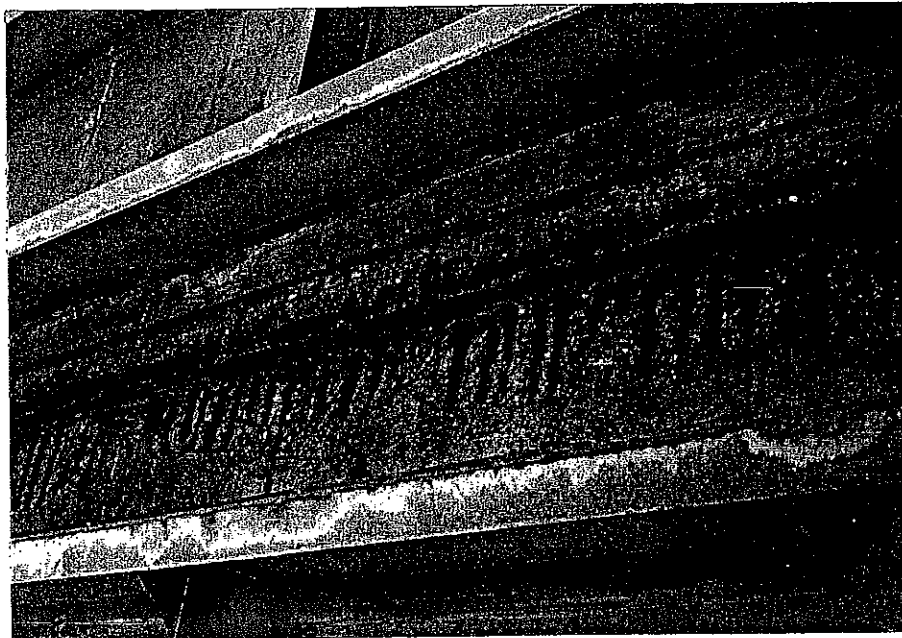
PANEL POINT U14: Strip seal joint in the deck. Sway frame rusty. Pictures of chipped concrete coping at the median (midspan). See picture #13, #14.

Picture #14
Chipped Concrete - Underside of Deck @ Median
Span #7, P/P-U14(midspan), No. B'nd.

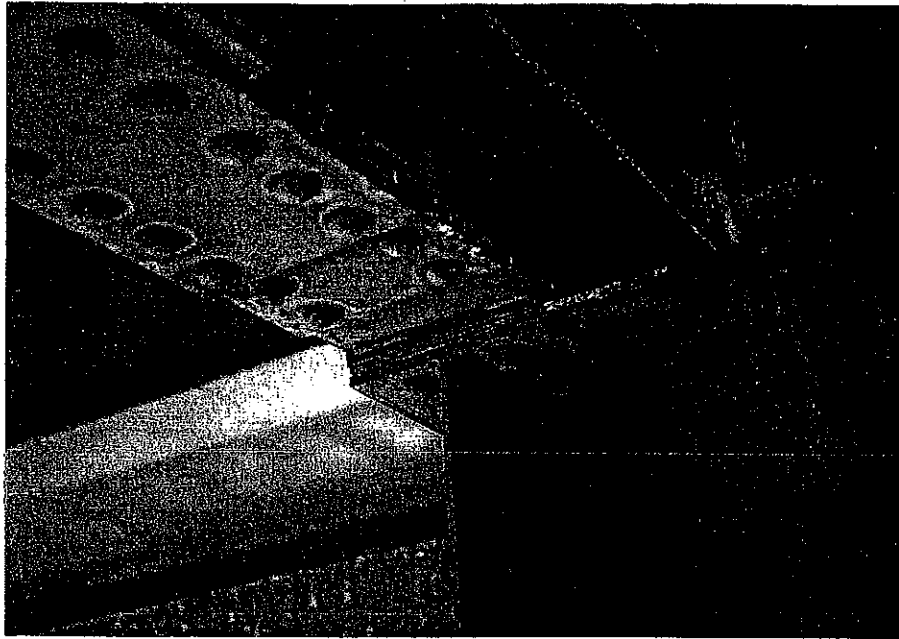
PANEL POINT U13' (15): Bad detail, 2" - 2 1/2" tack welds in maximum tension area, floor beam truss over the main truss. See picture #15, interior #16, exterior. (typical)

Picture #15
Bad Detail - 2" to 2 1/2" Tack Welds
Max. Tension in Floor Truss over Deck Truss
Span #7, P/P-U13', No. B'nd.

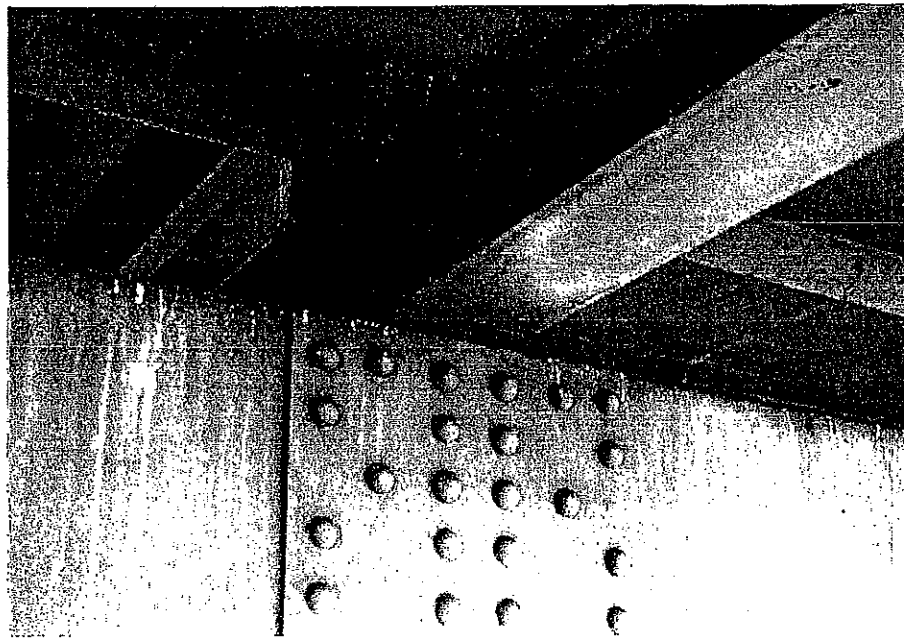
Picture #16
Bad Detail - 2" to 2 1/2" Tack Welds
Max. Tension in Floor Truss over Deck Truss
Span #7, P/P-U13', No. B'nd.

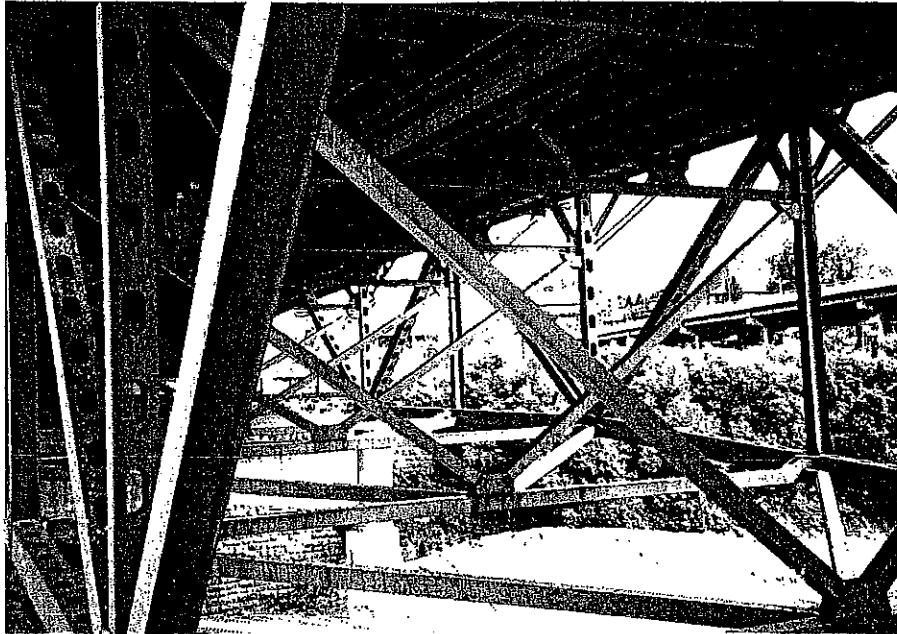
Picture #33
General View of Sway Framing
Looking North, Span #8, P/P-U6', So. B'nd.

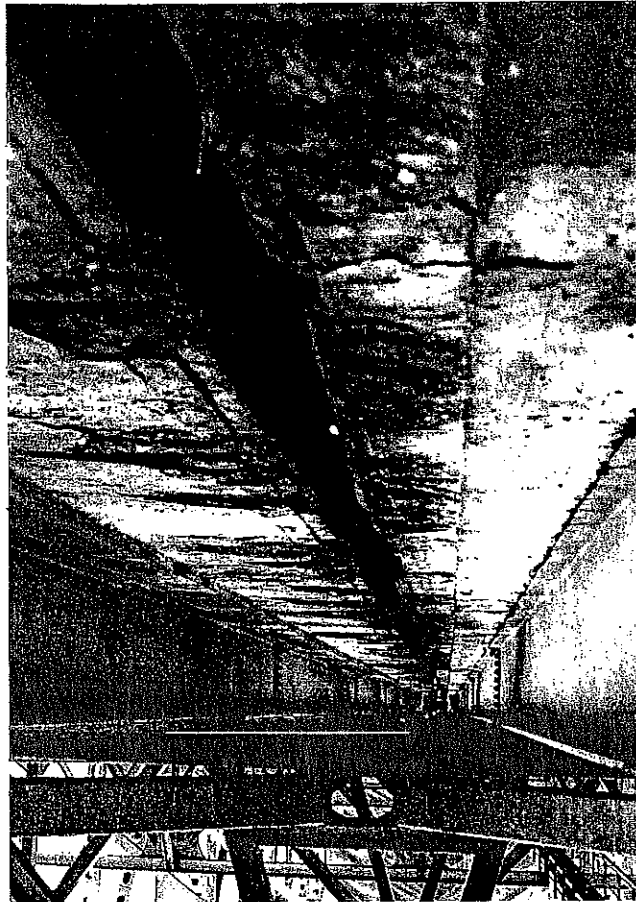
PANEL POINT U9' (19): Sway frame and gusset plate connection, some rivets rusty in the median area. View south under median. See picture #36.

Picture #36
Looking South
Under Median
Span #7, P/P-U9'
So. B'nd

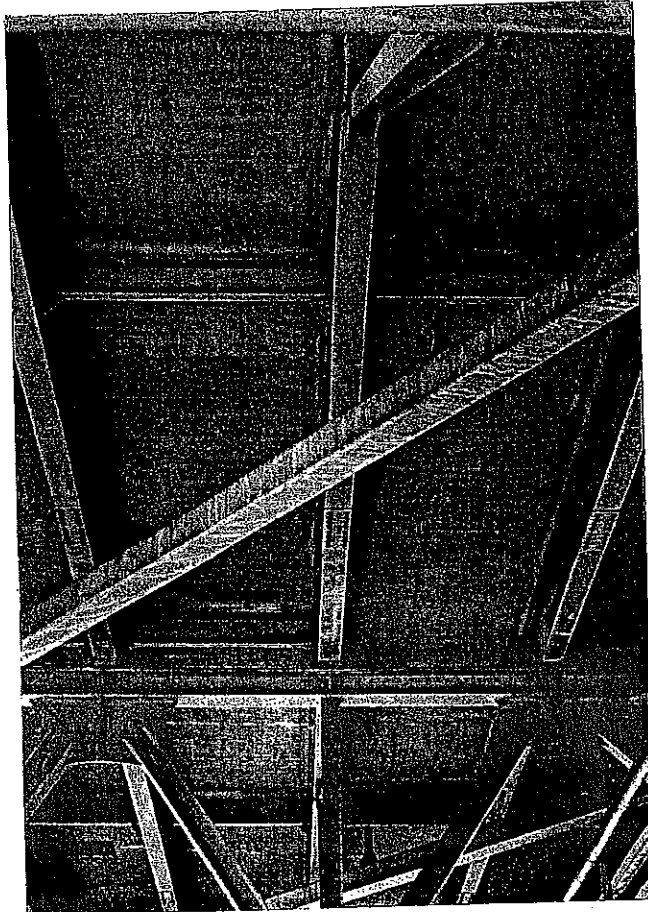
PANEL POINT U11' (17): Typical views of underside of the deck. See picture #38, #39.

Picture #38
Typical View of
Underside of Deck
Span #7, P/P-11'
So. B'nd.

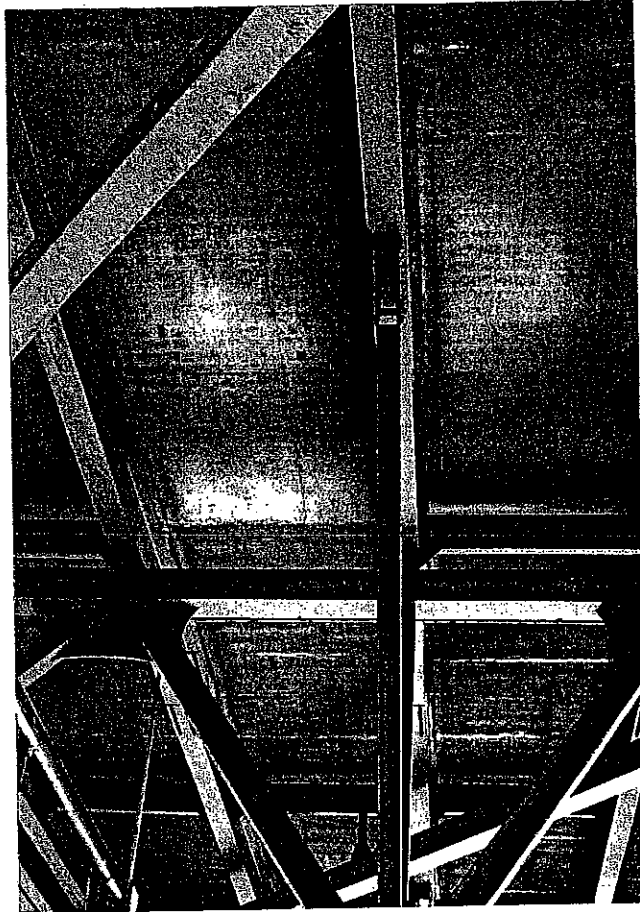
Picture #39
Typical View of
Underside of Deck
Span #7, P/P-11'
So. B'nd.

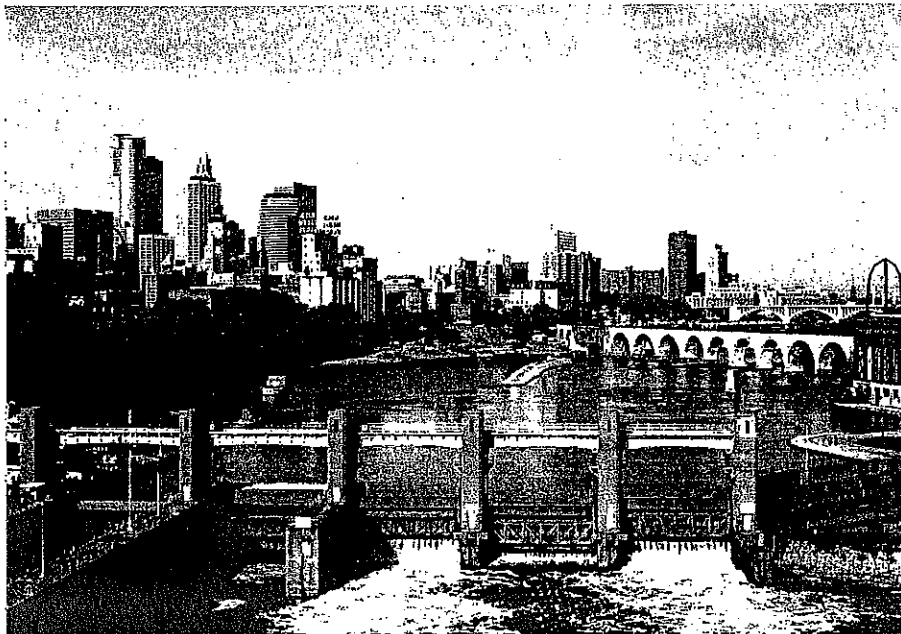
PANEL POINT U13' (15): Looking west at downtown Minneapolis. See picture #40.

Picture #40
View from Under the Bridge
Looking West at Downtown Minneapolis

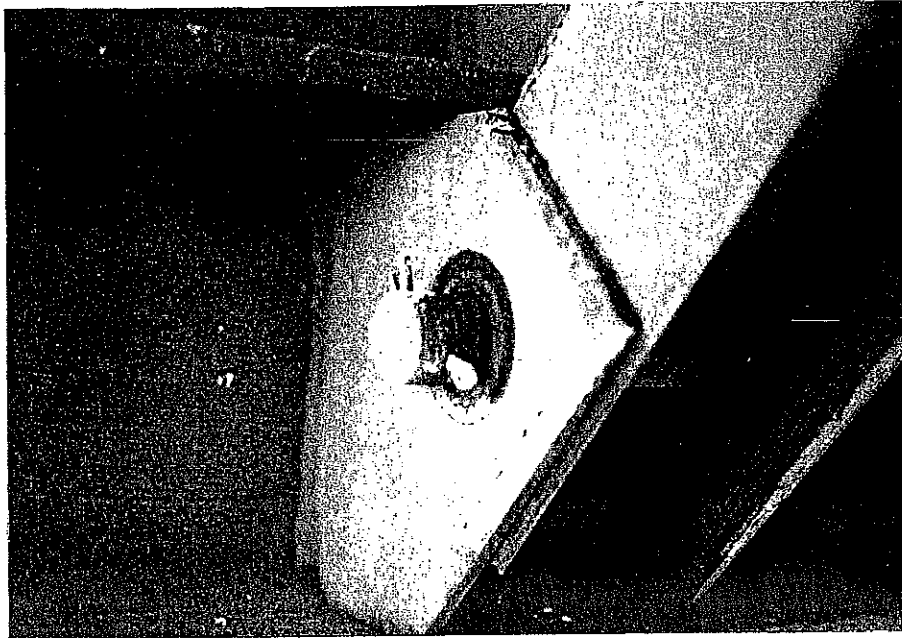
PANEL POINT U7: Pin rotating, vertical brace at the bottom chord of the floor beam truss (U7 - L7). See picture #44.

Picture #44
Pin Rotating - Vertical Brace @ Bottom Chord of Floor Truss
Span #6, P/P-U7, So. B'nd.

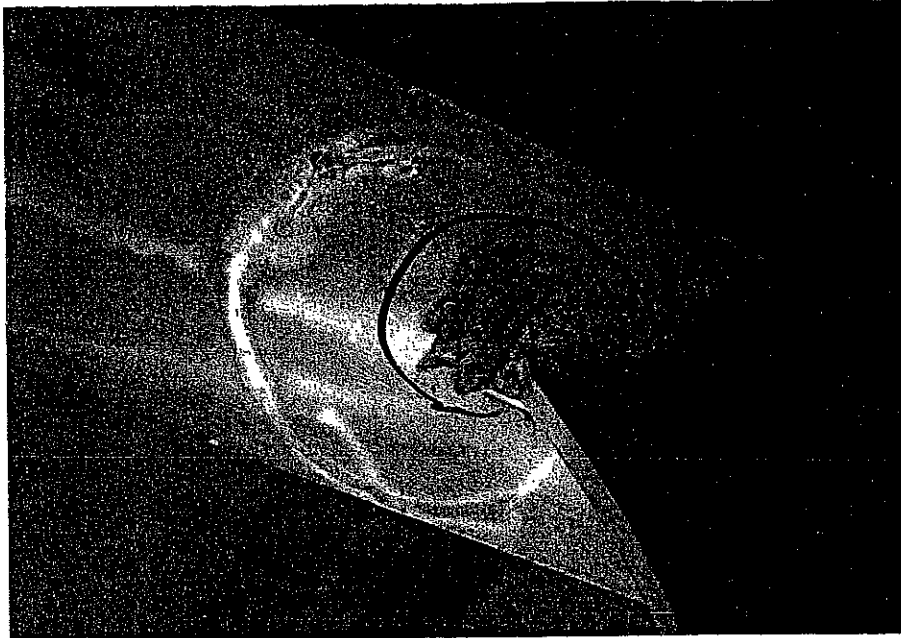
PANEL POINT U6: Gouges from construction, top flange of floor beam truss (U5 - U4). See picture #45. Overhead sign. Three ground out spots on the lower chord floor beam truss.

Picture #45
Gouges in Top Chord of Floor Truss
Span #6, P/P-U6, So. B'nd.

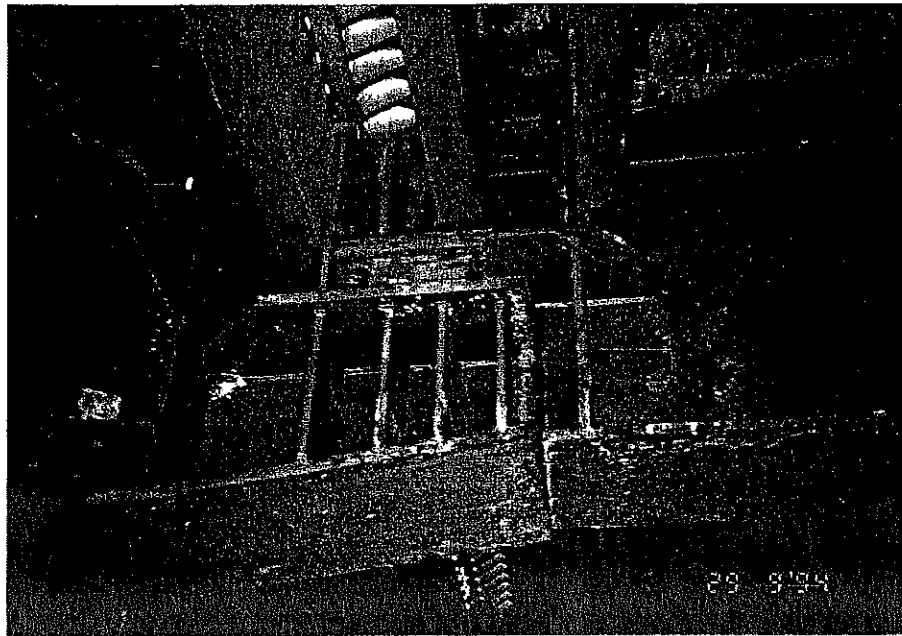
SPAN 2: Hinge 12' south of pier #2. The bottom flange of beams #1, #5 were tight. At beam #5, see picture #49. Picture #50, below finger joint at beam #5. At hinge and beam #4, picture of the debris. See picture #51. At hinge and beam #1, outside coping west side, see picture #52. 10 SF of spall in overlay at the finger joint. Expansion plate missing, both sides of south bound.

Picture #50
Hinge in Beam #5 - Ends of Beam Touching
Span #2, So. B'nd.
