INVESTIGATIVE REPORT TO JOINT COMMITTEE TO INVESTIGATE THE I-35W BRIDGE COLLAPSE

APPENDIX: Volume II

MAY 2008

Appendix Volumes II and III

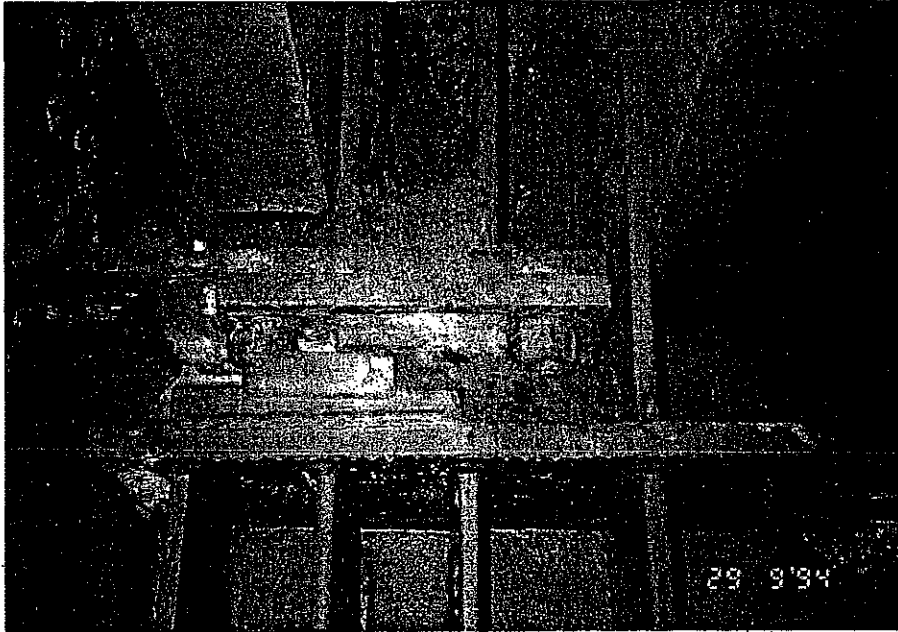
SPAN 2: Hinge 12' south of pier #2. The bottom flange of beams #1, #5 were tight. At beam #5, see picture #49. Picture #50, below finger joint at beam #5. At hinge and beam #4, picture of the debris. See picture #51. At hinge and beam #1, outside coping west side, see picture #52. 10 SF of spall in overlay at the finger joint. Expansion plate missing, both sides of south bound.

Picture #51
Hinge in Beam #4 - Debris Below Finger Joint
Span #2, So. B'nd.

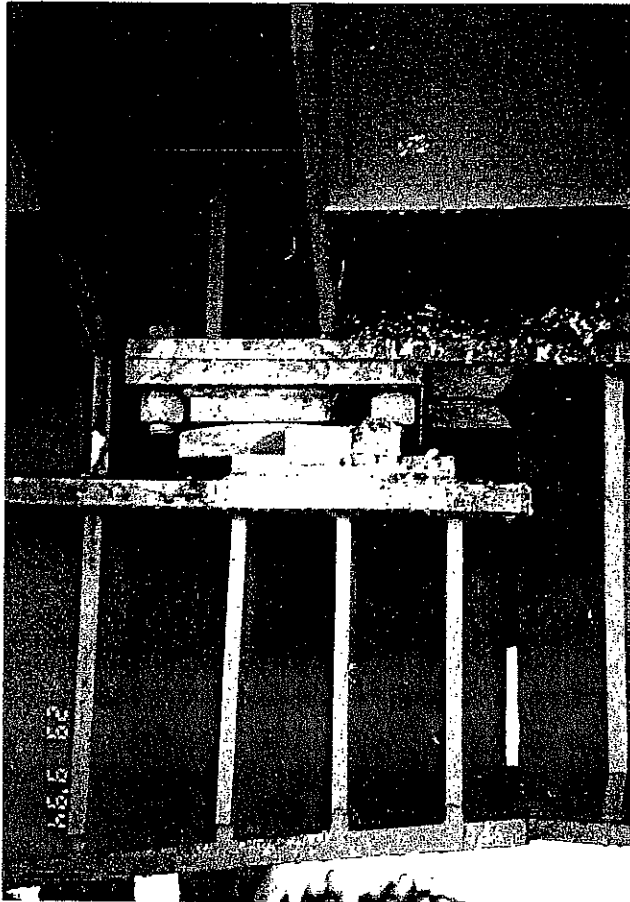
Picture #52
Hinge in B'm #1
Span #2,
So. B'nd.
