# **INVESTIGATIVE REPORT TO JOINT COMMITTEE TO INVESTIGATE THE I-35W BRIDGE COLLAPSE**

**APPENDIX: Volume IV**

### Bridge Inspection Reports

*Bridge # 9340  
I-35W over the Mississippi River  
(Downtown Minneapolis)*

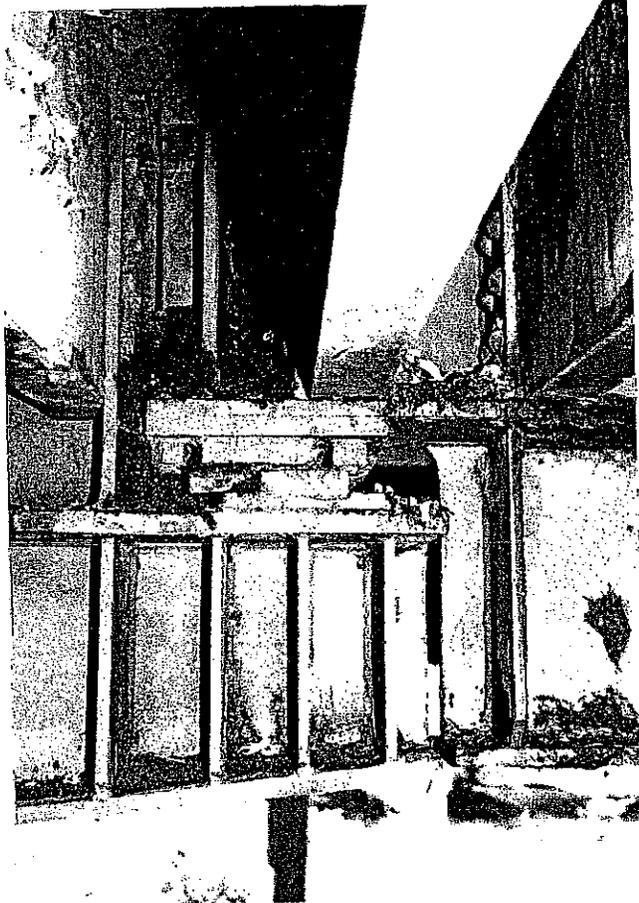
Picture #1  
Hinge @ Span #2  
No. B'nd.

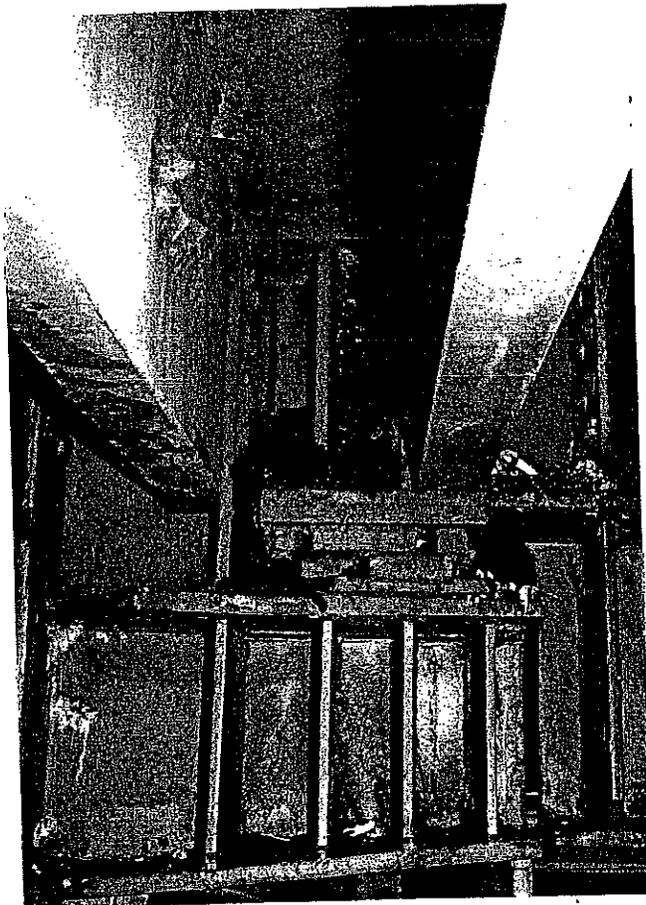
Picture #2  
Hinge @ Span #2  
No. B'nd.

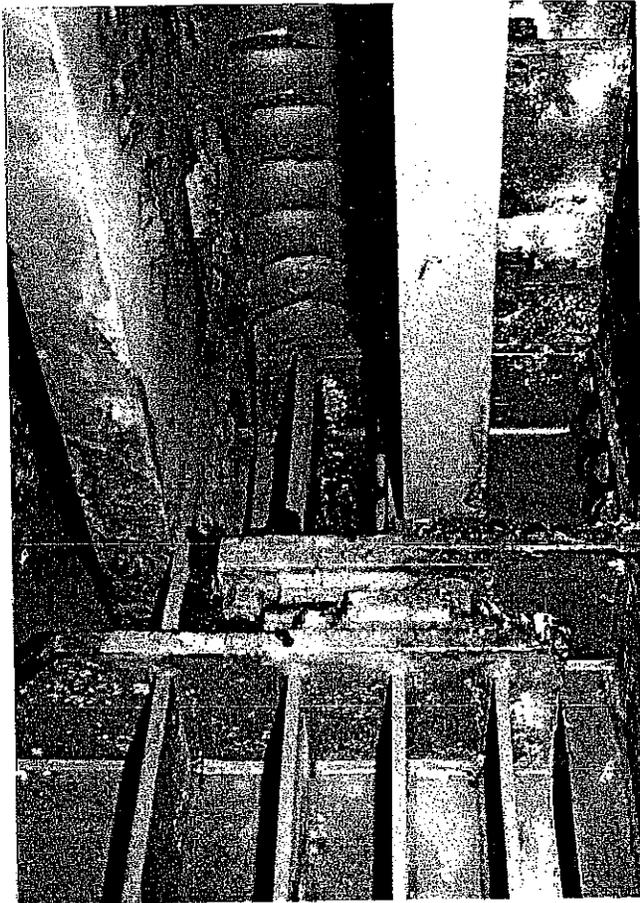
Picture #3  
Hinge @ Span #2  
No. B'nd.

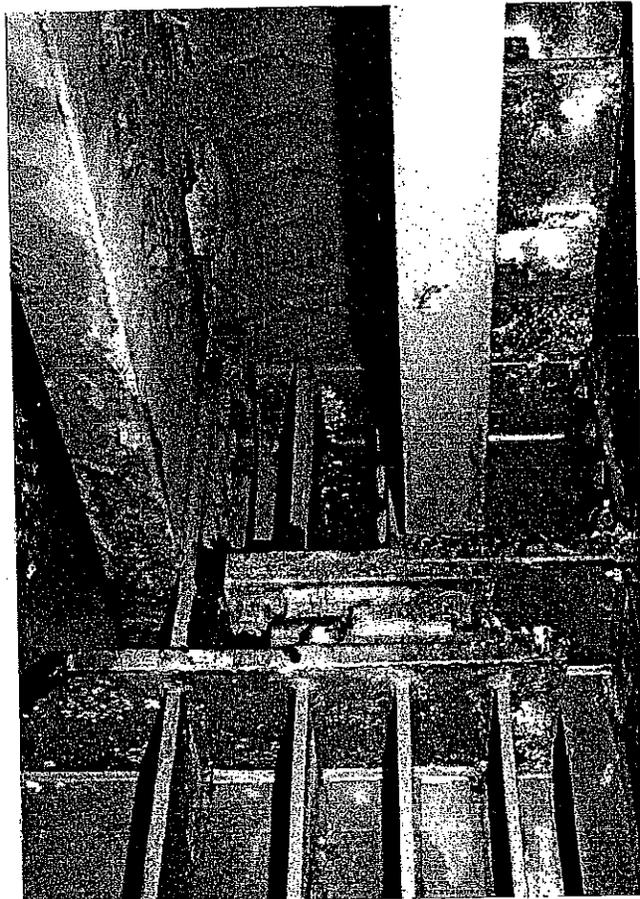
Picture #4  
Hinge @ Span #2  
No. B'nd.

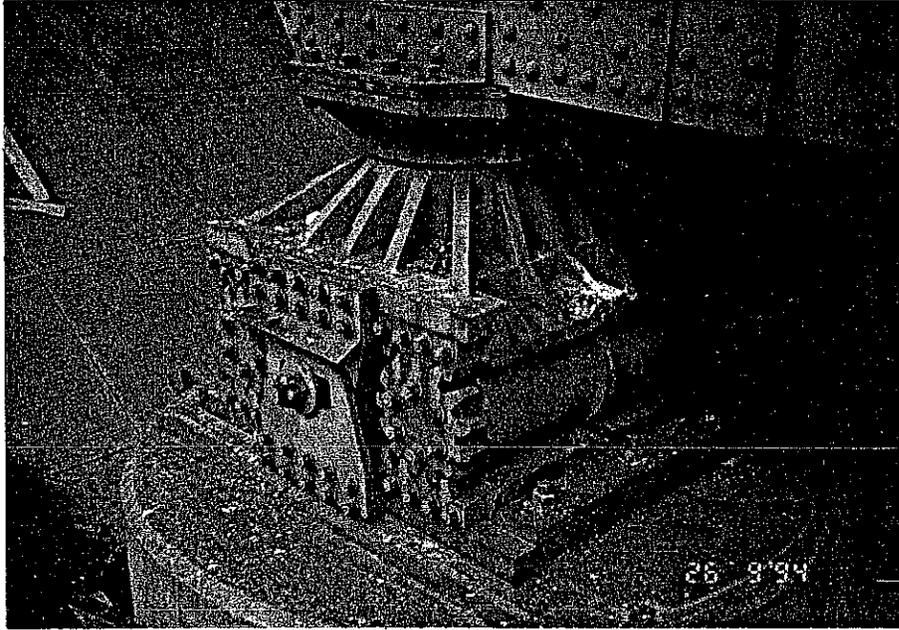
**PANEL POINT U1, PIER 5:** Picture of the moveable bearing, deck truss #2. See picture #7. Picture of the floor beam truss. See picture #8.

Picture #7  
Expansion Bearing  
Pier #3, No. B'nd.

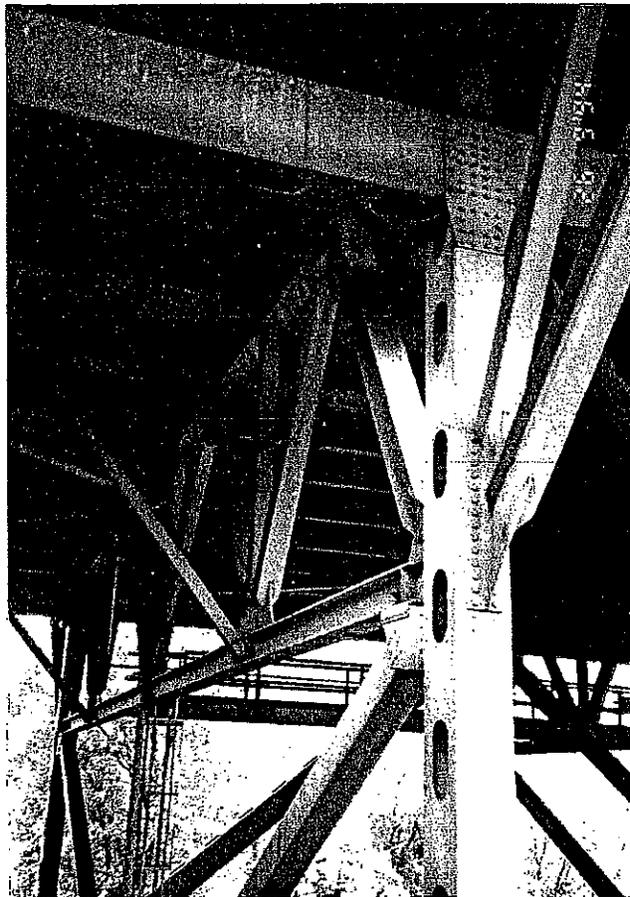
Picture #8  
Floor Beam Truss #1  
Span #5, P/P-U1  
No. B'nd.

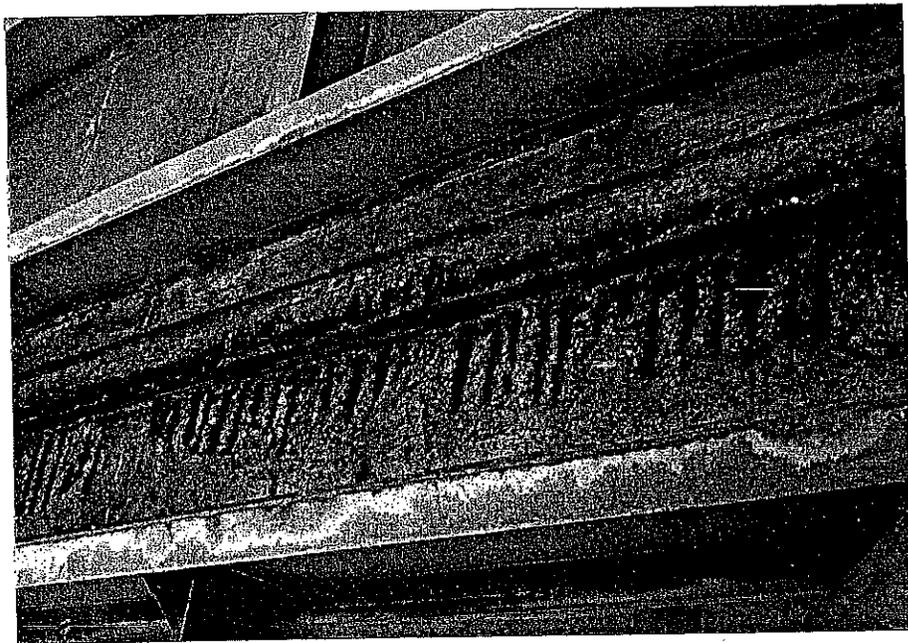
**PANEL POINT U14:** Strip seal joint in the deck. Sway frame rusty. Pictures of chipped concrete coping at the median (midspan). See picture #13, #14.

Picture #14  
Chipped Concrete - Underside of Deck @ Median  
Span #7, P/P-U14 (midspan), No. B'nd.

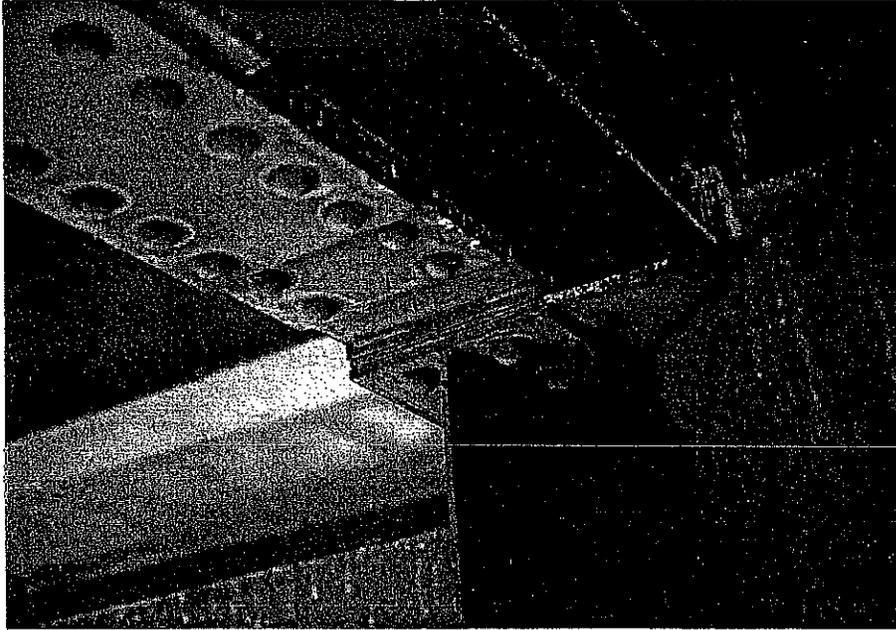
**PANEL POINT U13' (15):** Bad detail, 2" - 2 1/2" tack welds in maximum tension area, floor beam truss over the main truss. See picture #15, interior #16, exterior. (typical)

Picture #15  
Bad Detail - 2" to 2 1/2" Tack Welds  
Max. Tension in Floor Truss over Deck Truss  
Span #7, P/P-U13', No. B'nd.

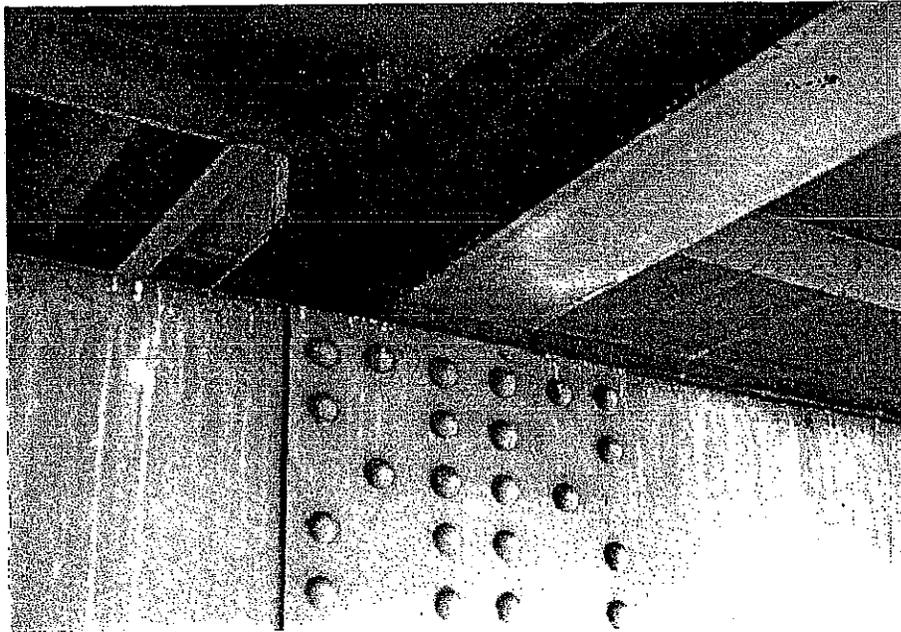
Picture #16  
Bad Detail - 2" to 2 1/2" Tack Welds  
Max. Tension in Floor Truss over Deck Truss  
Span #7, P/P-U13', No. B'nd.

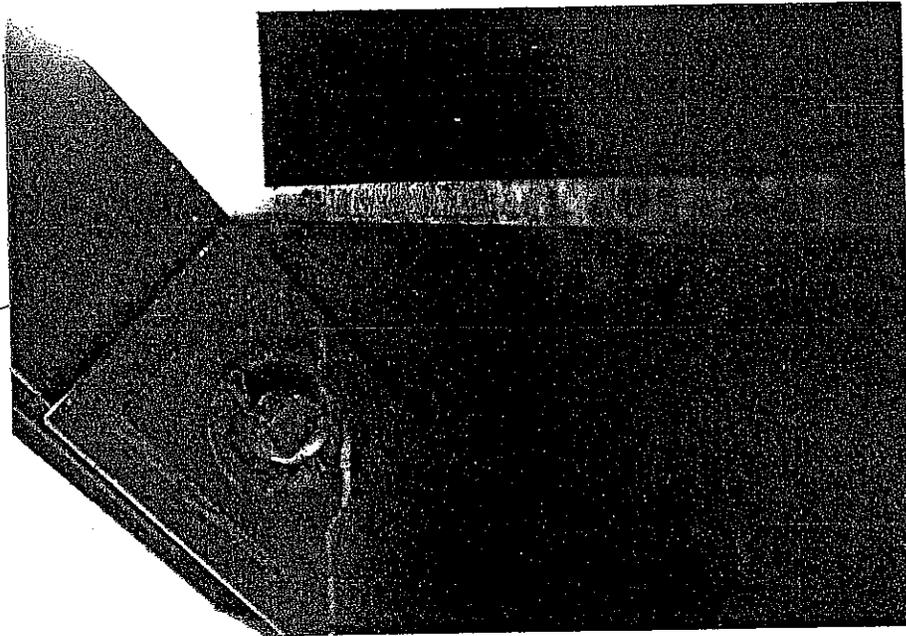
**PANEL POINT U1' (27), PIER 8:** Pin rotating in east vertical, angle brace connection to the bottom chord of floor truss. See picture #24.

Picture #24  
Pin Rotating Angle Brace to Bottom Chord of Floor Truss  
Span #8, P/P-U1', No. B'nd.

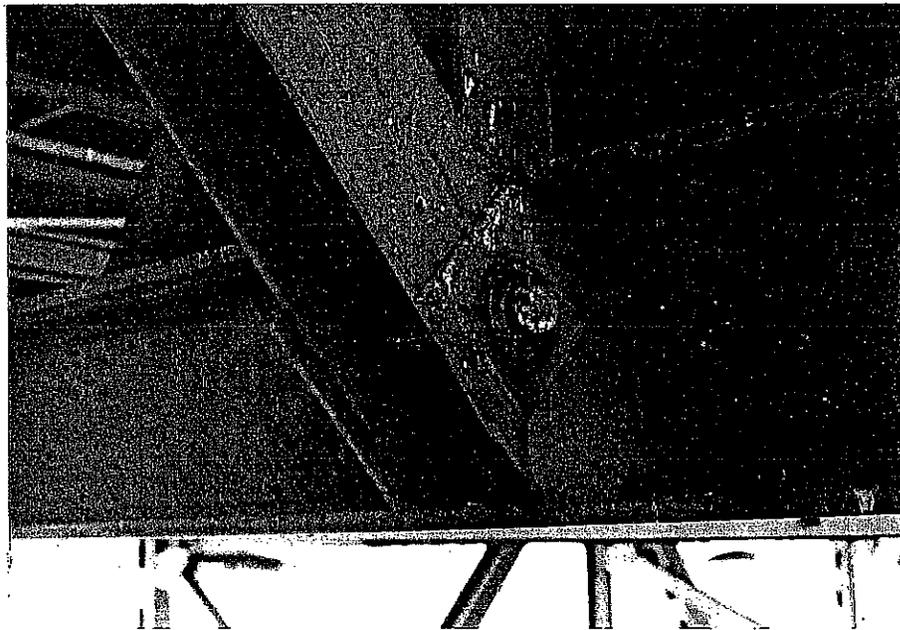
**PANEL POINT U4' (24):** Rotating pin in vertical brace (U10 - L10) of the floor beam truss. See picture #30. Strip seal joint in the deck.

Picture #30  
Rotating Pin in Vertical Brace (U10-L10) of Floor Truss  
Span #8, P/P-U4', So. B'nd.

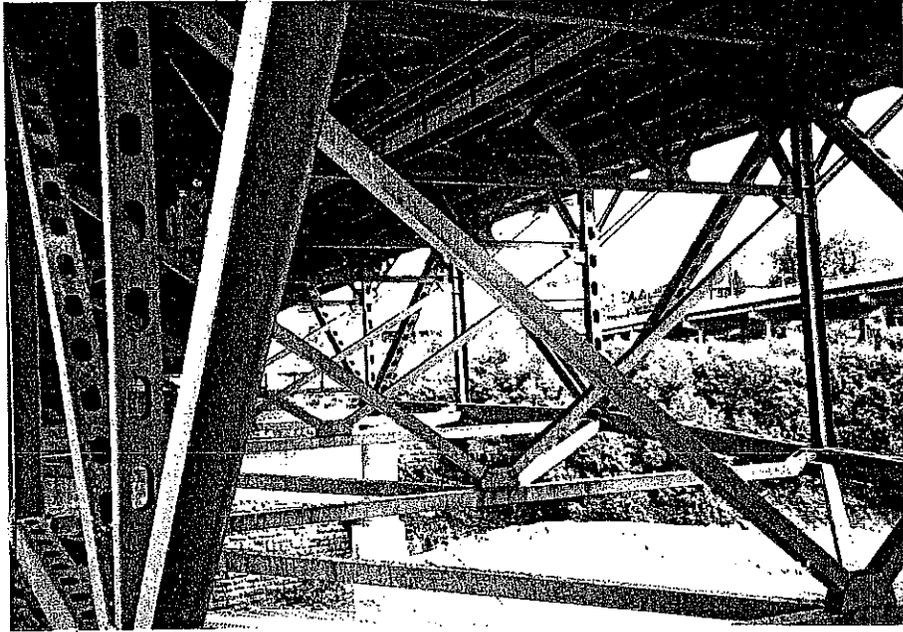
Picture #33  
General View of Sway Framing  
Looking North, Span #8, P/P-U6', So. B'nd.

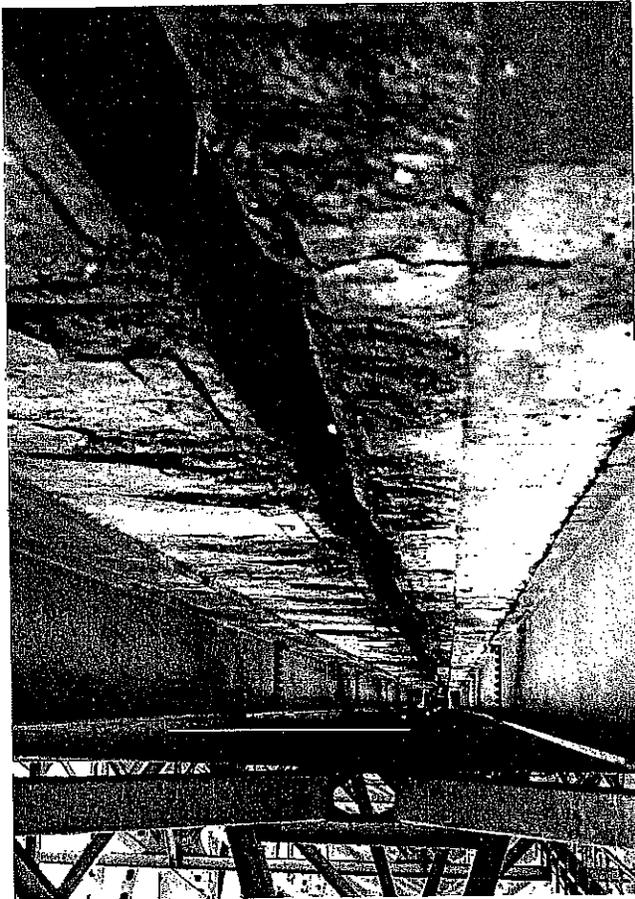
**PANEL POINT U9' (19):** Sway frame and gusset plate connection, some rivets rusty in the median area. View south under median. See picture #36.

Picture #36  
Looking South  
Under Median  
Span #7, P/P-U9'  
So. B'nd

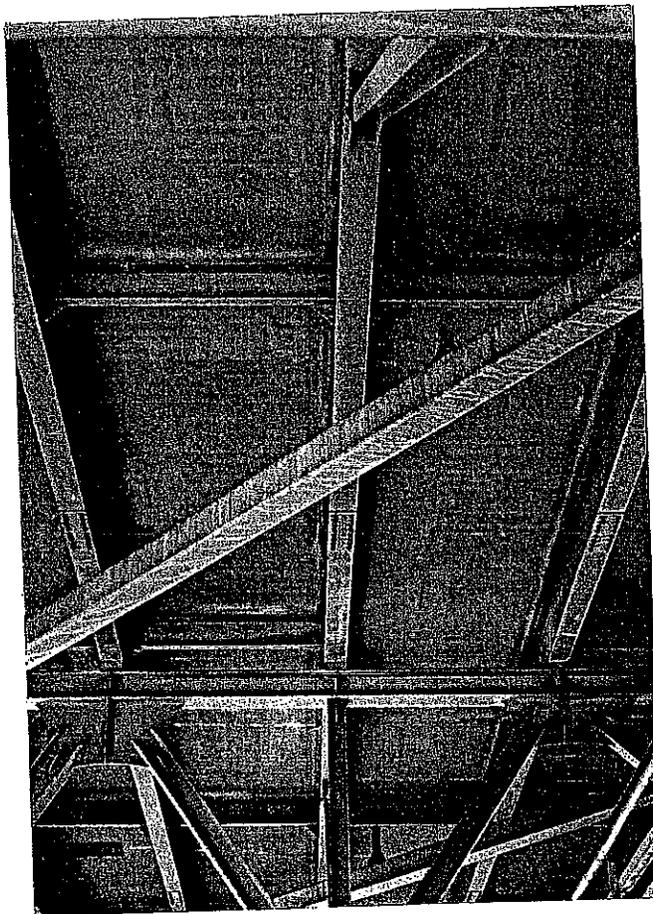
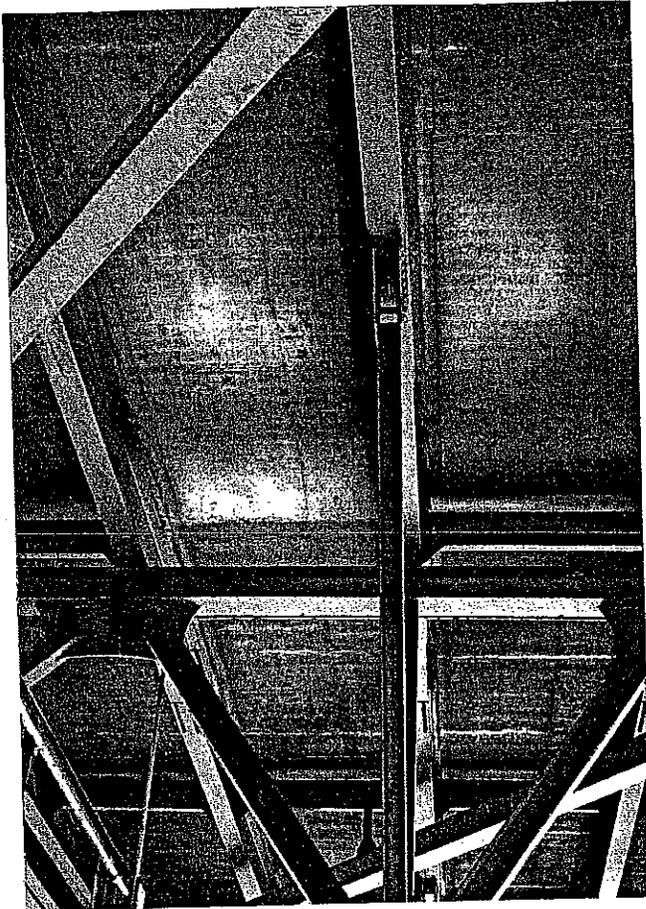
Picture #38  
Typical View of  
Underside of Deck  
Span #7, P/P-11'  
So. B'nd.

Picture #39  
Typical View of  
Underside of Deck  
Span #7, P/P-11'  
So. B'nd.

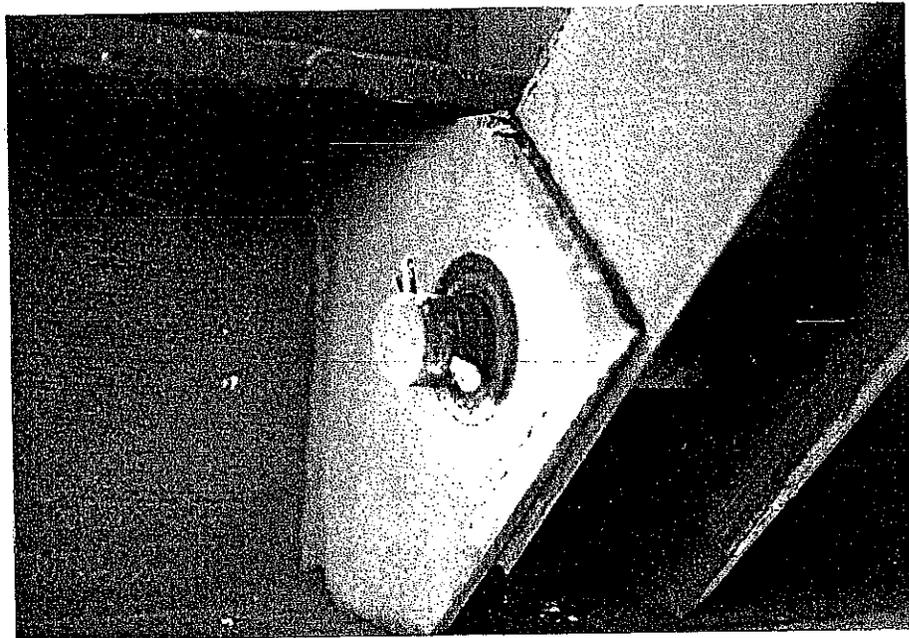
**PANEL POINT U7:** Pin rotating, vertical brace at the bottom chord of the floor beam truss (U7 - L7). See picture #44.

Picture #44  
Pin Rotating - Vertical Brace @ Bottom Chord of Floor Truss  
Span #6, P/P-U7, So. B'nd.

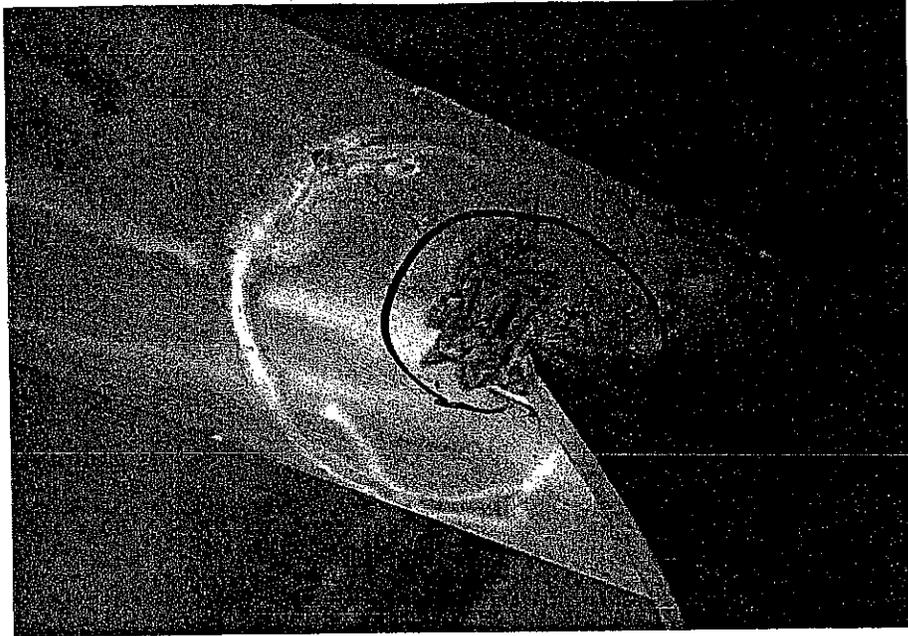
**PANEL POINT U6:** Gouges from construction, top flange of floor beam truss (U5 - U4). See picture #45. Overhead sign. Three ground out spots on the lower chord floor beam truss.

Picture #45  
Gouges in Top Chord of Floor Truss  
Span #6, P/P-U6, So. B'nd.

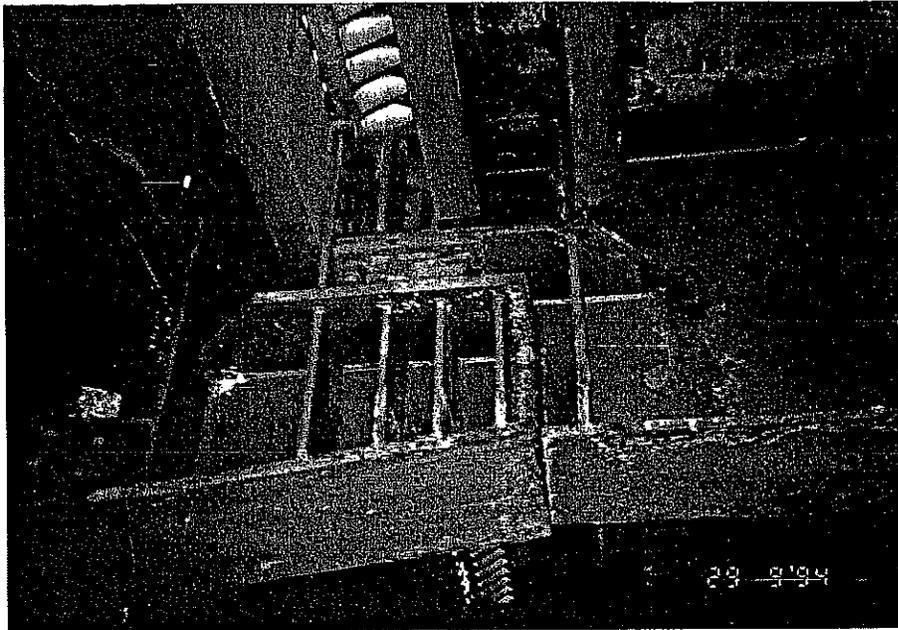
**SPAN 2:** Hinge 12' south of pier #2. The bottom flange of beams #1, #5 were tight. At beam #5, see picture #49. Picture #50, below finger joint at beam #5. At hinge and beam #4, picture of the debris. See picture #51. At hinge and beam #1, outside coping west side, see picture #52. 10 SF of spall in overlay at the finger joint. Expansion plate missing, both sides of south bound.

Picture #50  
Hinge in Beam #5 - Ends of Beam Touching  
Span #2, So. B'nd.

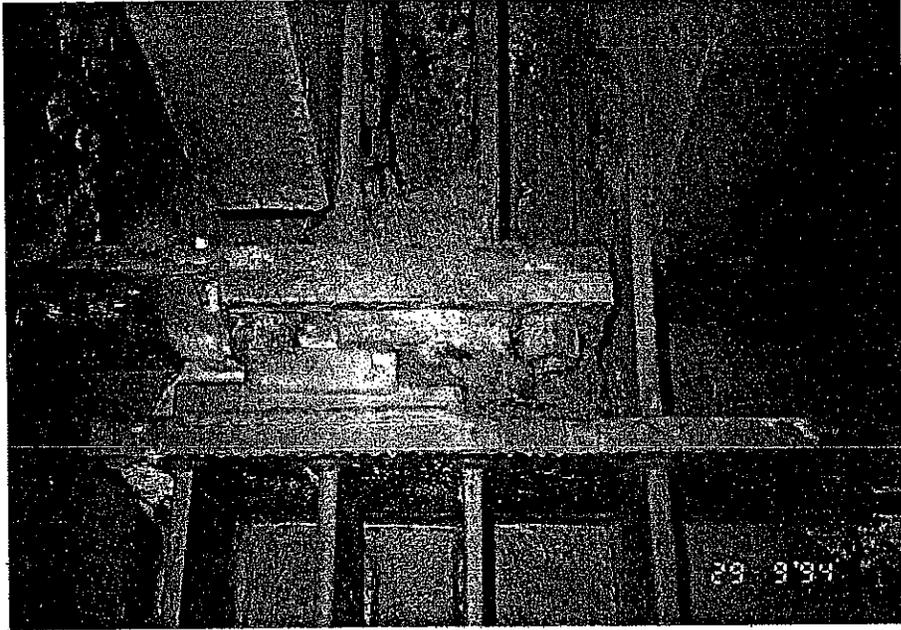
Picture #51  
Hinge in Beam #4 - Debris Below Finger Joint  
Span #2, So. B'nd.

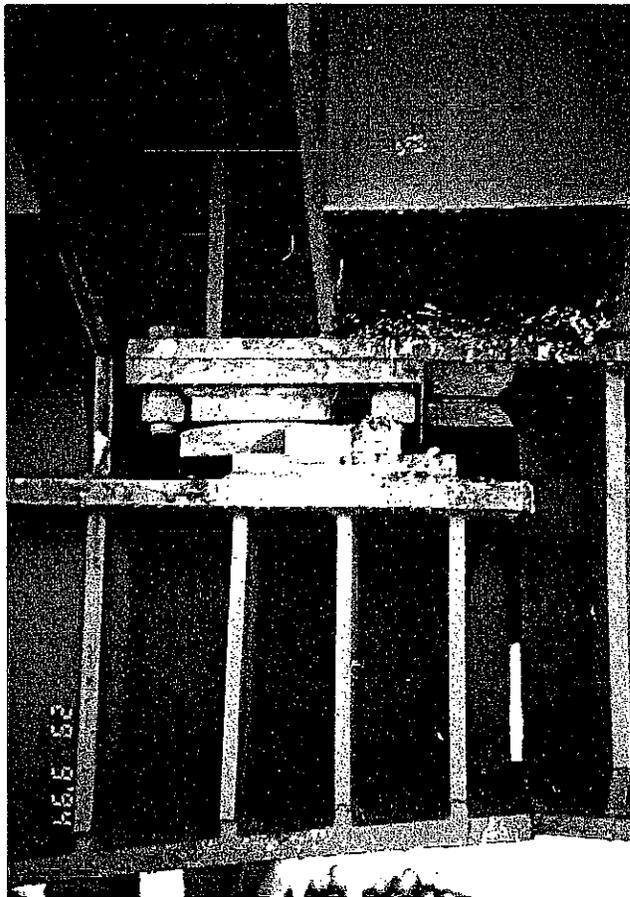
Picture #52  
Hinge in B'm #1  
Span #2,  
So. B'nd.

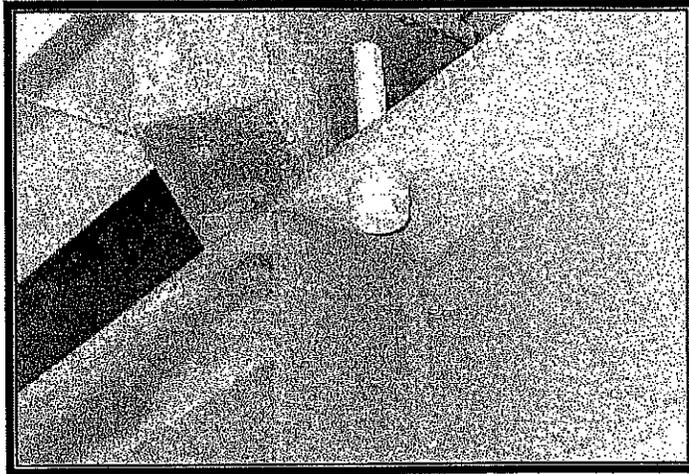
Panel Point #8 East Truss Stringer #2

**Panel Point #8 (East Truss, Pier #6, Stringer Joint):** Strip seal and deck drain above. [1999] Joint is leaking. [1998] Stringer #4: bolt replaced at south floorbeam connection. [1994] Stringer #2 (south side): one bolt is missing and the nut is missing from the other bolt - the bearing block has rotated. [1999] Missing bolt replaced (bearing block still rotated) - photo.

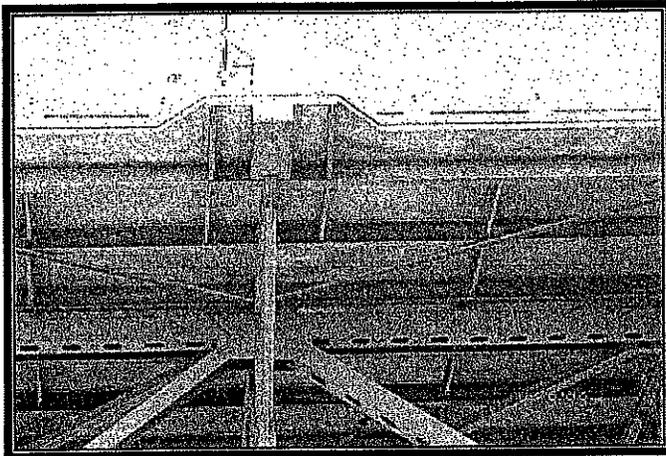
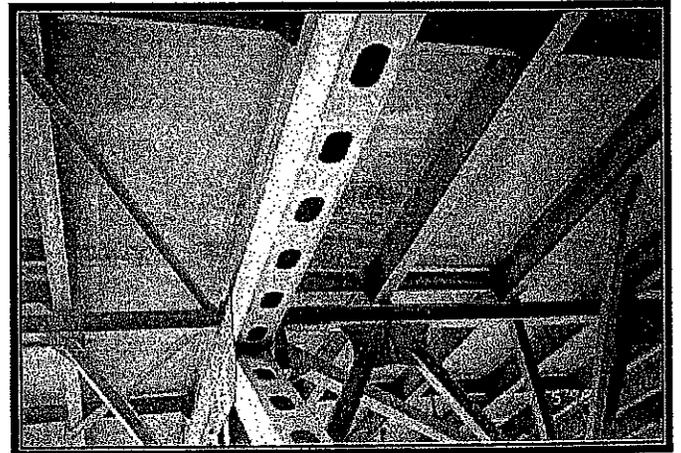
Deck Deterioration Panel Point #2

**Panel Point #2' (East Truss):** Overhead Sign. [1999] Deck in Bay #3 has 100 SF of water saturation (photos).

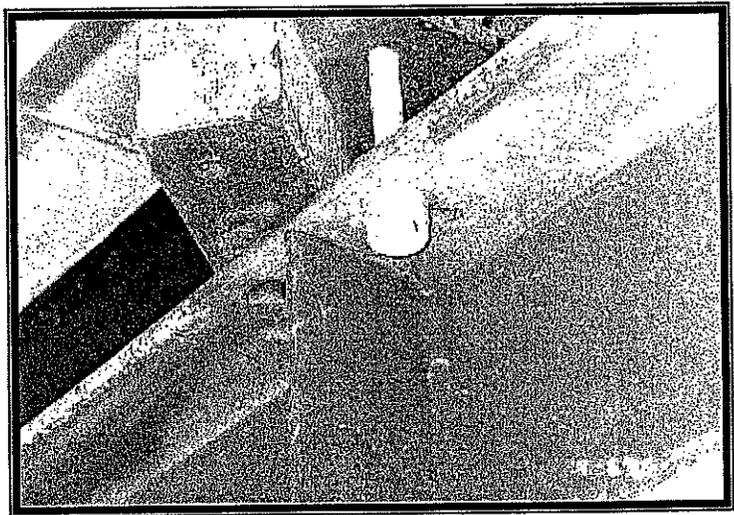
Panel Point #8, Stringer #2

**Panel Point #8 (East Truss, Pier #6, Stringer Joint):** Strip seal and deck drain above. [1999] Joint is leaking. [1998] Stringer #4: bolt missing at south floorbeam connection. [1994] Stringer #2 (south side): one bolt is missing and the nut is missing from the other bolt - the bearing block has rotated. [2000] Missing bolt was replaced in 1999, but the bearing block was not returned to it's proper position – now bolt bolts are loose, needs repair (photos).

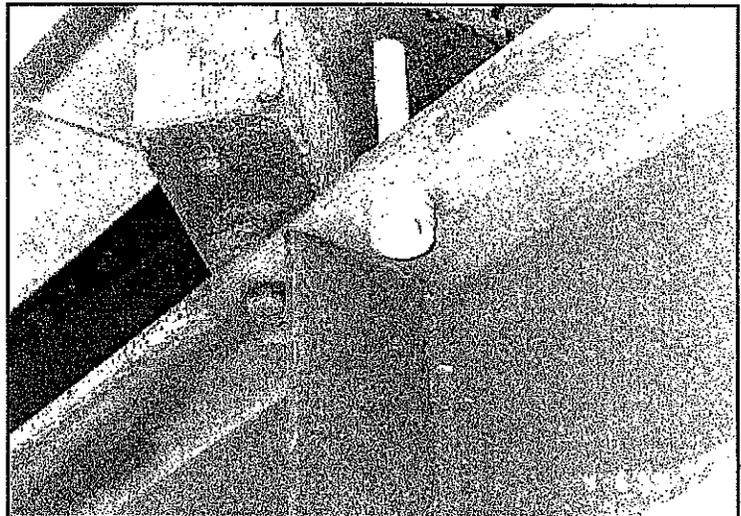
Panel Point #8, Stringer #2

**Panel Point #8 (East Truss, Pier #6, Stringer Joint):** Strip seal and deck drain above. [1999] Joint is leaking. [1998] Stringer #4: bolt missing at south floorbeam connection. [1994] Stringer #2 (south side): one bolt is missing and the nut is missing from the other bolt - the bearing block has rotated. [2000] Missing bolt was replaced in 1999, but the bearing block was not returned to it's proper position – now bolt bolts are loose, needs repair (photos).

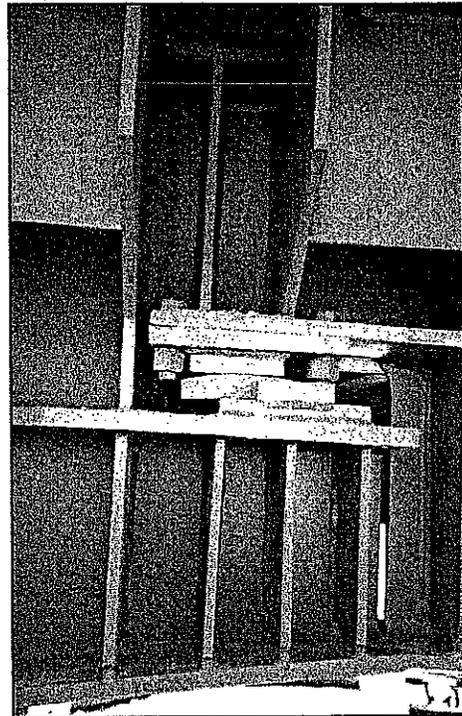
**Hinge Joint (12 ft. South of Pier #2:**

Open finger joint above. [1994] The hinge assemblies are expanded beyond tolerance (the sliding plates extend 1-3/4" beyond the base plates). At Beam #10, the sliding plate has tipped (falling off the base plate) and is preventing the joint from opening. [1999] Hinge area re-painted. [2000] Beam-ends have moderate surface pitting; debris has begun to build up on hinge area. [2002] The sole plate & bearing surfaces have "moved" 4" off of the masonry plate allowing for an approximate 50% reduction in bearing capacity? This condition has existed since 1994. Additionally, the tops of the beam-ends are contacting at the top flange or at the web along this joint.

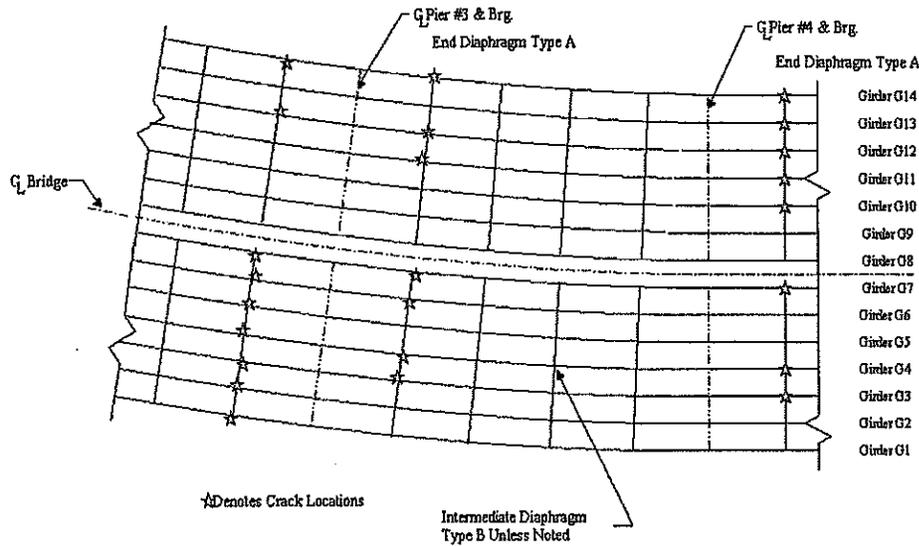
**Diaphragm Line South of Pier #3:**

Refer to chart titled **Diaphragm Crack Locations South of Pier #3** for crack locations, crack description/repair description. [1999] Diaphragms lowered.

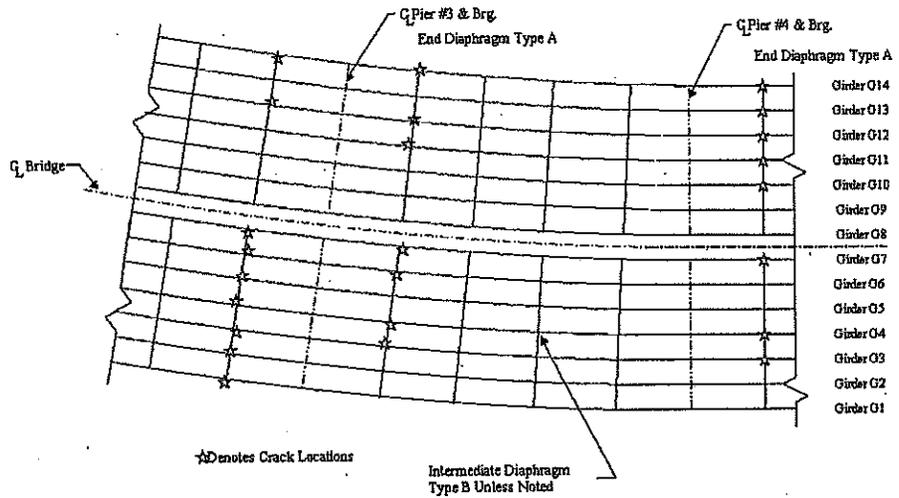
**Diaphragm Line North of Pier #3:**

Refer to chart titled **Diaphragm Crack Locations North of Pier #3** for crack locations, crack description/repair description. [1998/99] Diaphragms lowered (strain gauges placed on beams #2 & 6). \*Denotes locations where cracks were found in 1998.

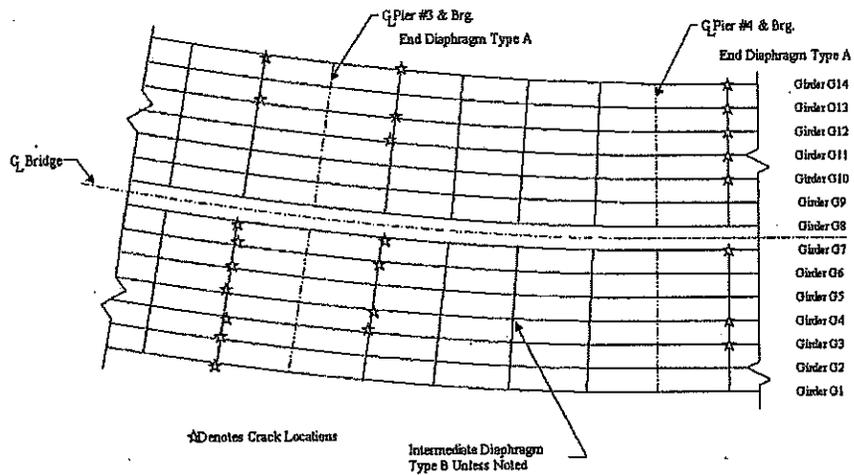
**Diaphragm Line North of Pier #4:**

Refer to chart titled **Diaphragm Crack Locations North of Pier #4** for crack locations, crack description/repair description.

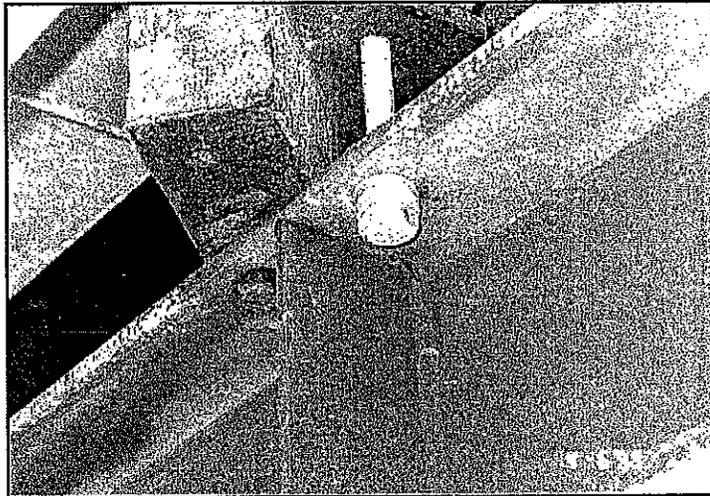
Strip seal and deck drain above. [2002] Joint is leaking, small hole. Stringer #4: bolt broken off at south floorbeam connection. There is corrosion and flaking rust on the vertical truss member. [1994] Stringer #2 (south side): one bolt is missing and the nut is missing from the other bolt - the bearing block has rotated. [2000] Missing bolt was replaced in 1999, but the bearing block was not returned to it's proper position – now bolt bolts are loose, needs repair (photos).

- 1) Four-stringer connection bolts need replacement (all in the NBL). At Panel Point #8, Stringer #2 has 2 loose bolts, and the bearing block has rotated (this will likely require jacking the superstructure). Stringer bolts also need replacement at Panel Point #8, Stringer #4 (south side), and at Panel Point #11, Stringer #3.

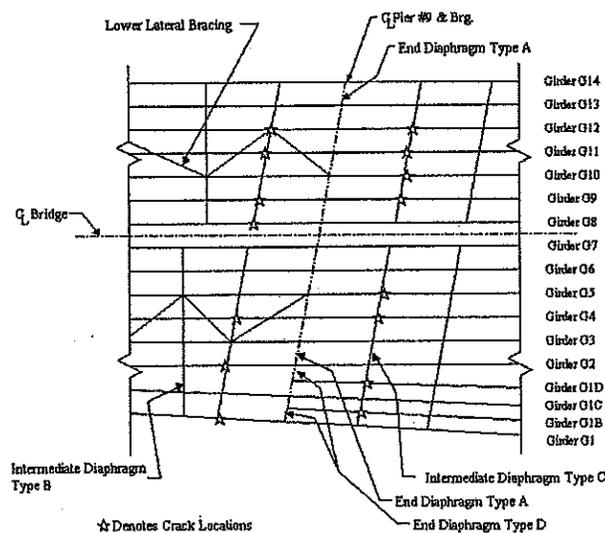
**Diaphragm Line South of Pier #9:**

Refer to chart titled **Diaphragm Crack Locations south of Pier #9** for crack locations, crack description/repair description. [1999] Diaphragms lowered.

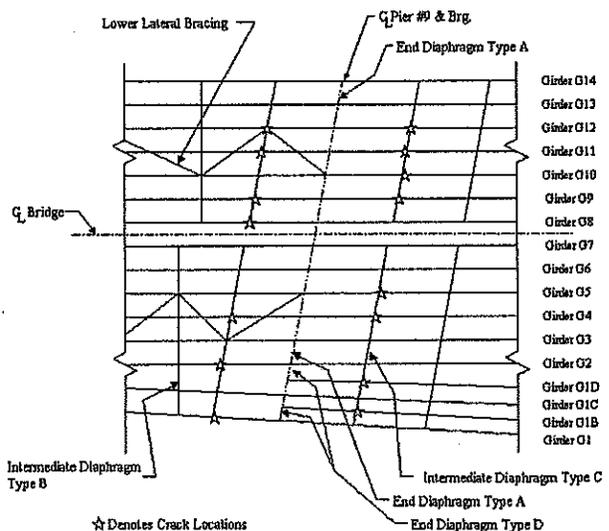
#### Diaphragm Line North of Pier #9:

Refer to chart titled **Diaphragm Crack Locations North of Pier #9** for crack locations, crack description/repair description. [1999] Diaphragms lowered.

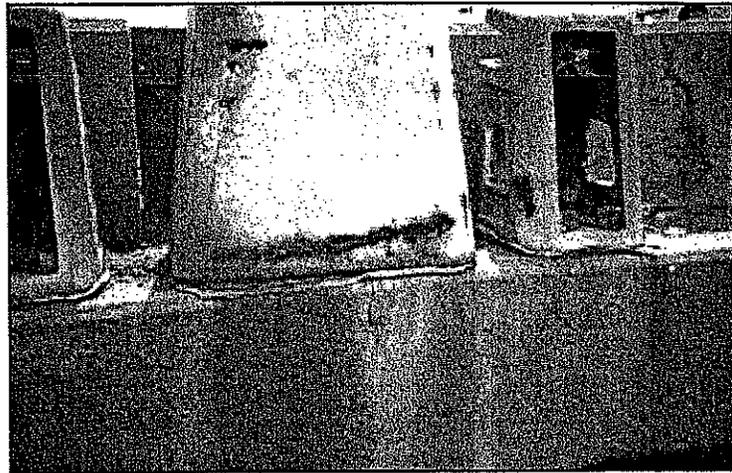
**Panel Point #1' (West Truss Pier #8):**

Light pole base rusted through @ two faces. Pole feed point number (W5L8?).

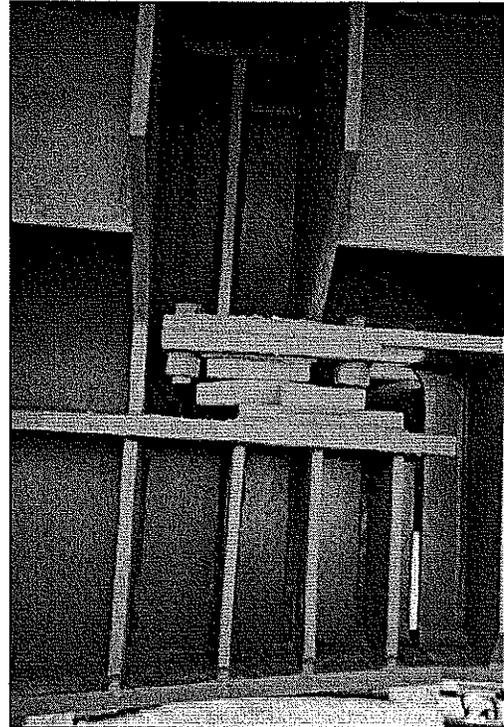
Hinge Bearing Sole Plate

**Hinge Joint (12 ft. South of Pier #2):**

Hinge joint has open finger joint above. [94/2002] Hinge assemblies are expanded beyond tolerance; sliding plates extend 4" beyond the base plates, reducing bearing capacity. At beam #10, the sliding plate has tipped, falling off the base plate, and is preventing the joint from opening. [1999] Hinge area re-painted. [2000] Beam-ends have section loss, moderate surface pitting; debris has begun to build up on hinge area. Additionally, the tops of the beam-ends are contacting at the top flange or at the web along this joint.

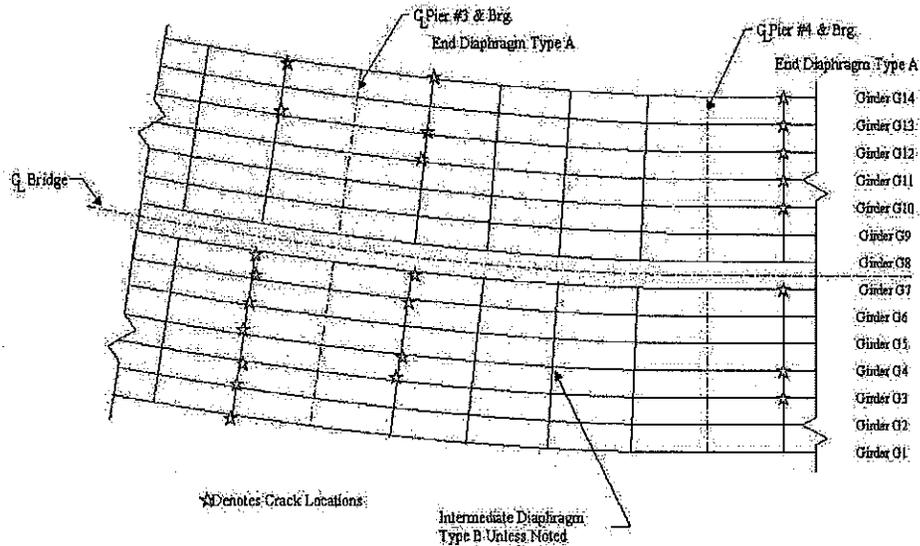
**Diaphragm Line South of Pier #3:**

Refer to chart titled **Diaphragm Crack Locations South of Pier #3** for crack locations, description & repair. [1999] Diaphragms lowered.

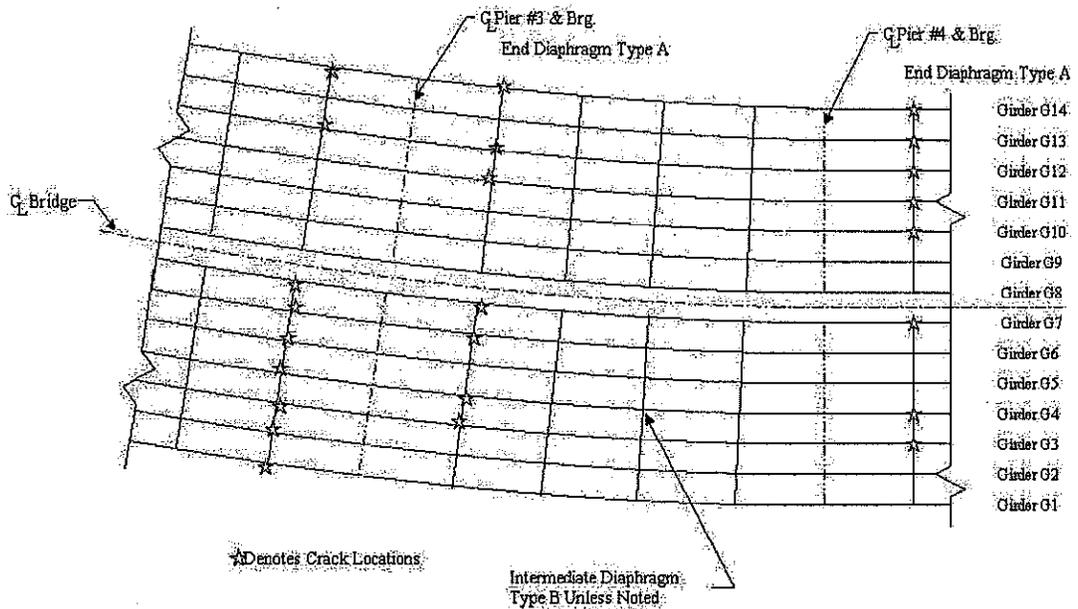
**Diaphragm Line North of Pier #3:**

Refer to chart titled **Diaphragm Crack Locations North of Pier #3** for crack locations, description & repair. [1998/99] Diaphragms lowered with strain gauges placed on beams #2 & 6. \*Denotes locations where cracks were found in 1998.

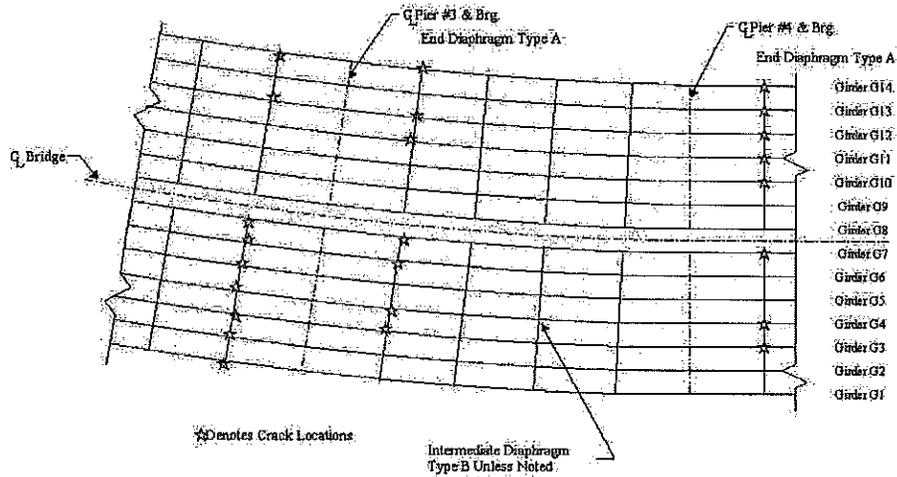
**Diaphragm Line North of Pier #4:**

Refer to chart titled **Diaphragm Crack Locations North of Pier #4** for crack locations, description & repair.

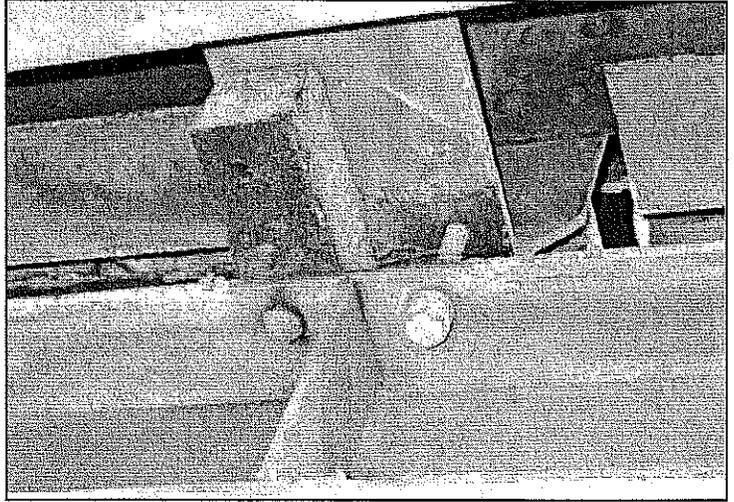
Strip seal and deck drain above. [94/2003] Joint is leaking, small hole & membrane has pulled out. Stringer #4: one bolt broken off at south floorbeam connection. Deck drain is plugged solid. Stringer #2 (south side): one bolt is missing and the nut is missing from the other bolt. The bearing block has rotated 90°. [1999] Missing bolt replaced. [2000] Bolts are loose, needs repair. Vertical truss member has section loss, moderate flaking rust. Floorbeam bottom chord & middle bracing connection plate has moderate section loss, severe flaking rust. Middle bracing connection plate has 1/2" spread from pack rust. Underside of the deck has 50 SF of water saturation.

Stringer 2 Bearing Block Rotated

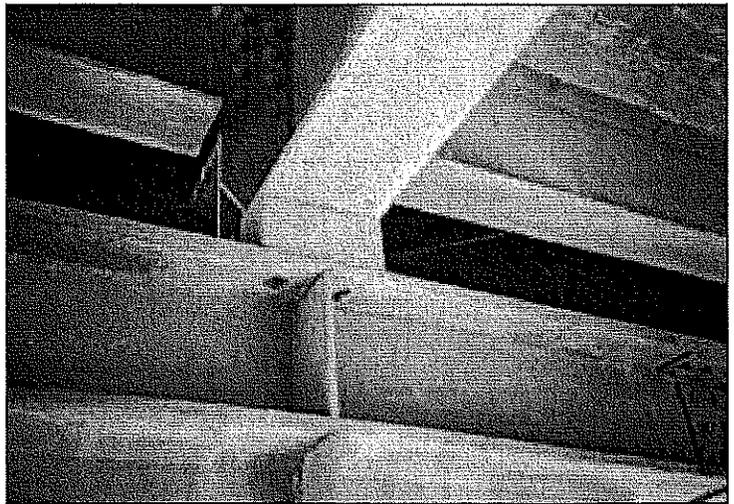
Stringer 4 Bolt Missing

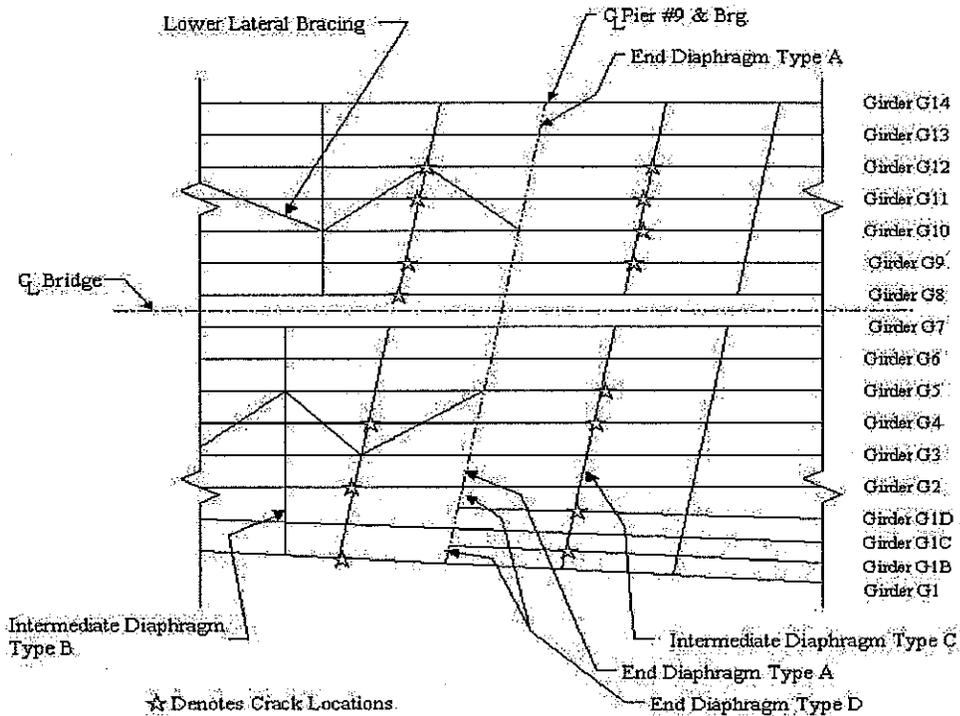
**Diaphragm Line South of Pier #9:**

Refer to chart titled **Diaphragm Crack Locations South of Pier #9** for crack locations, description & repair. [1999] Diaphragms lowered.

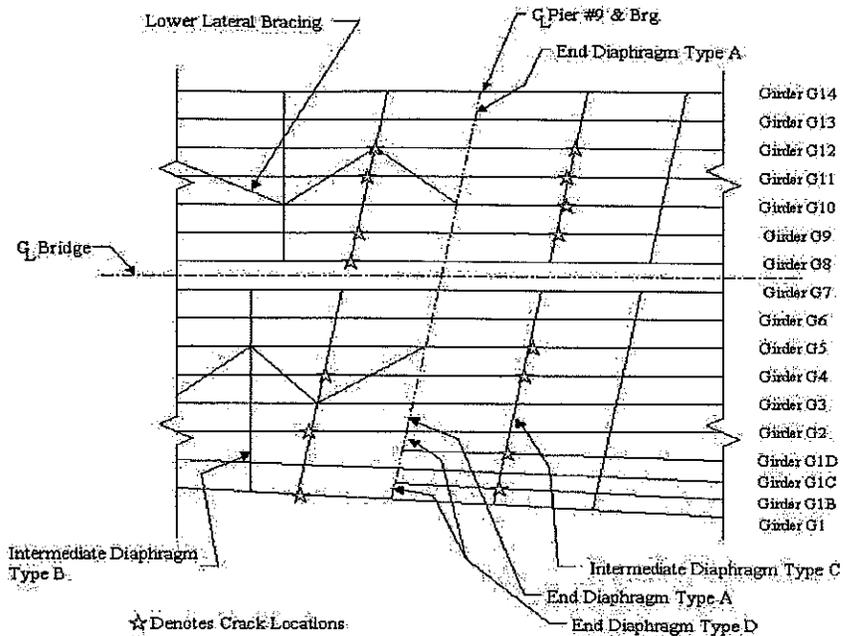
**Diaphragm Line North of Pier #9:**

Refer to chart titled **Diaphragm Crack Locations North of Pier #9** for crack locations, description & repair. [1999]  
Diaphragms lowered.
