# **INVESTIGATIVE REPORT TO JOINT COMMITTEE TO INVESTIGATE THE I-35W BRIDGE COLLAPSE**

**APPENDIX: Volume IV**

### Bridge Inspection Reports

*Bridge # 9340  
I-35W over the Mississippi River  
(Downtown Minneapolis)*

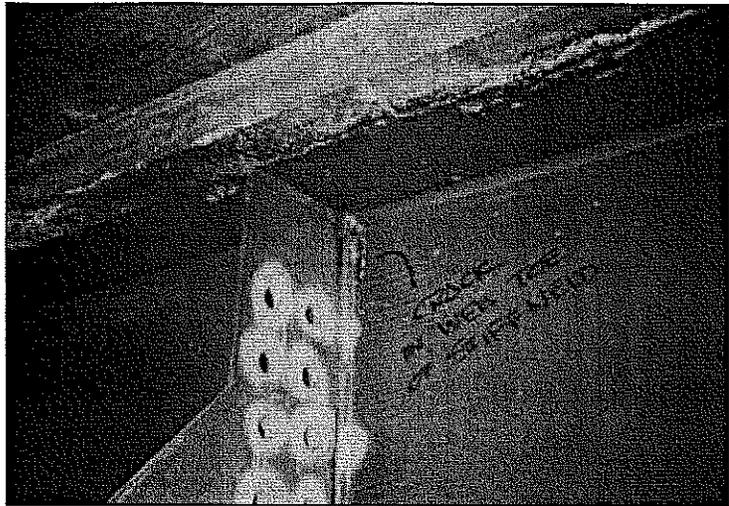
Girder #10 Vertical Stiffener/Girder Web

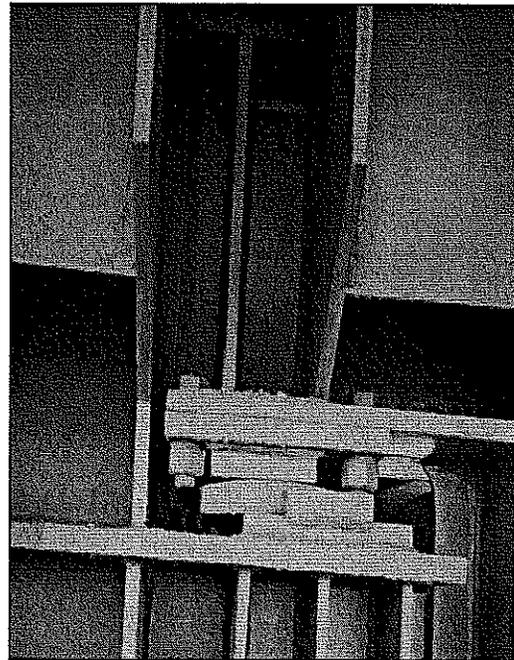
Hinge Bearing Sole Plate

Hinge joint has open finger joint above. [94/2002] Hinge assemblies are expanded beyond tolerance; sliding plates extend 4" beyond the base plates, reducing bearing capacity. At beam #10, the sliding plate has tipped, falling off the base plate, and is preventing the joint from opening. [1999] Hinge area re-painted. [2000] Beam-ends have section loss, moderate surface pitting; debris has begun to build up on hinge area. Additionally, the tops of the beam-ends are contacting at the top flange or at the web along this joint.

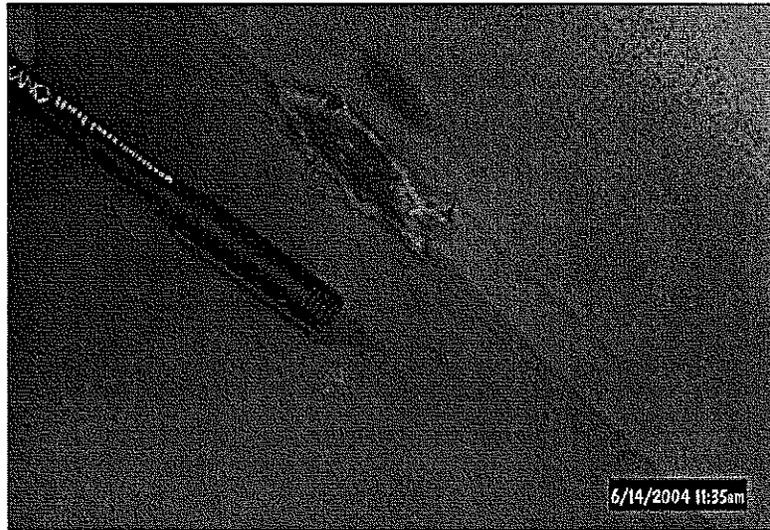
**Panel Point #12 (East Truss):**

[1999] Truss bottom chord  
member L12/L13 has a  
cracked tack weld at an  
interior stiffener. [2004]  
Ground out pit from past  
inspection when???

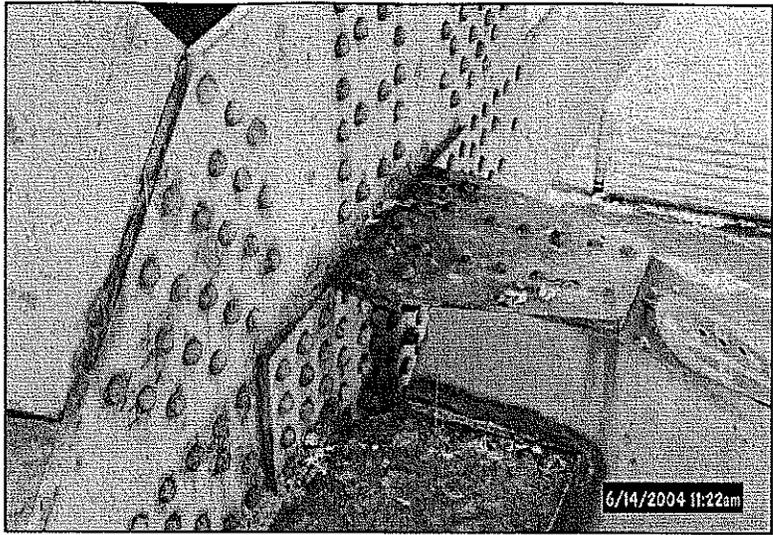
Water from deck drains fall directly into river. [99/2002] Bottom chord gusset plate has section loss, flaking & pack rust. [1999] Truss bottom chord member L13/L14 has cracked tack welds at two interior stiffeners. [2004] Bottom chord member L13/L14 cracked tack weld @ diagram tab (diagram #1?). Cracked tack weld @ diagram tab member L13/U14 see photos.

Bottom Chord Connection Condition

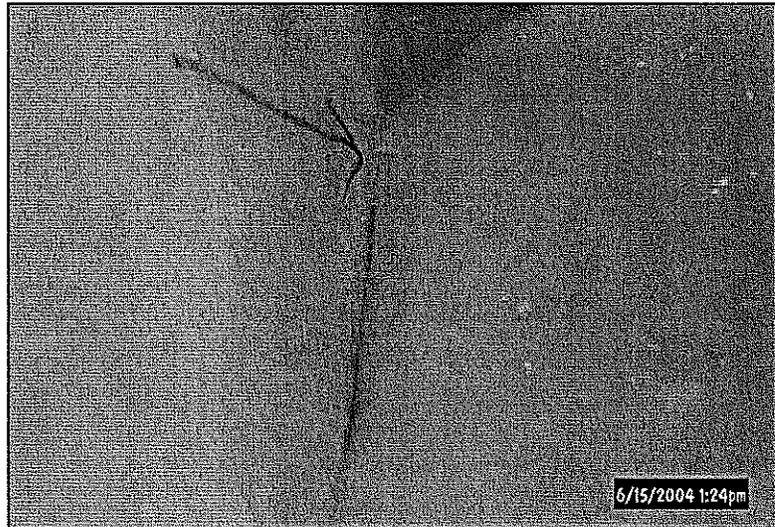
Floorbeam truss top chord has a ground out spot near stringer #4. [1996] Truss bottom chord member L13'/L12' has a cracked tack weld at an interior stiffener. [2003] Truss bottom chord connection plate has 1/2" pack rust. Underside of the deck has 20 SF of water saturation. [2004] Bottom chord member L13'/L12' cracked tack weld @ diagram tab (diagram #3?) see photo.

Member L13'/L12' Cracked Tack Weld

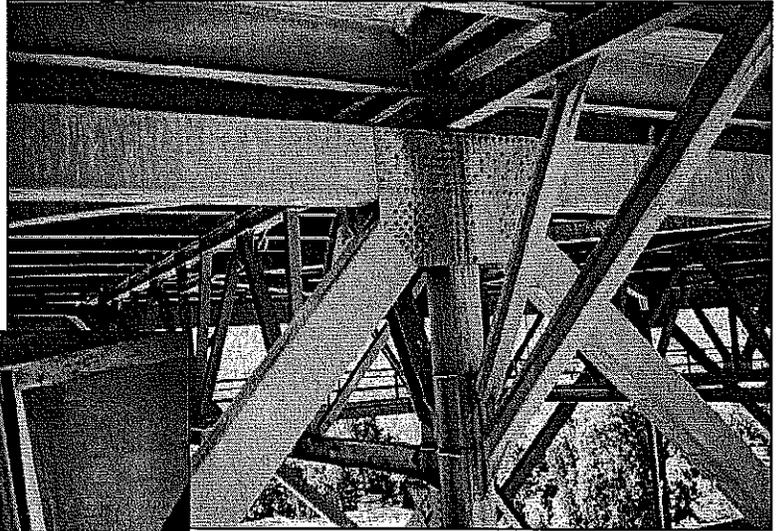
Strip seal expansion joint on the deck. Truss diagonal member U4'/L3' has backer bars along the interior edges. [01/04] Strip seal has 3 LF of gland pulled out. Truss connection plates, the top chord, and floorbeam have moderate section loss, severe flaking rust. Bottom connection plates have 1/2" pack rust.

Top Condition of Floorbeam Truss

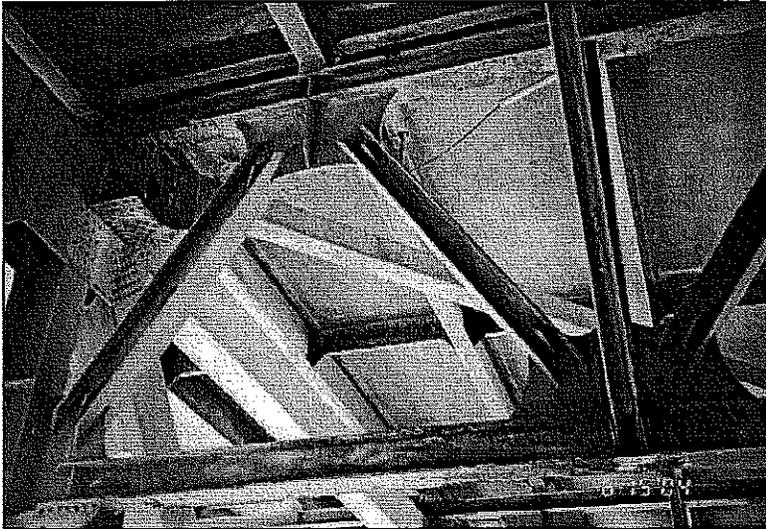
Bottom Condition of Floorbeam Truss

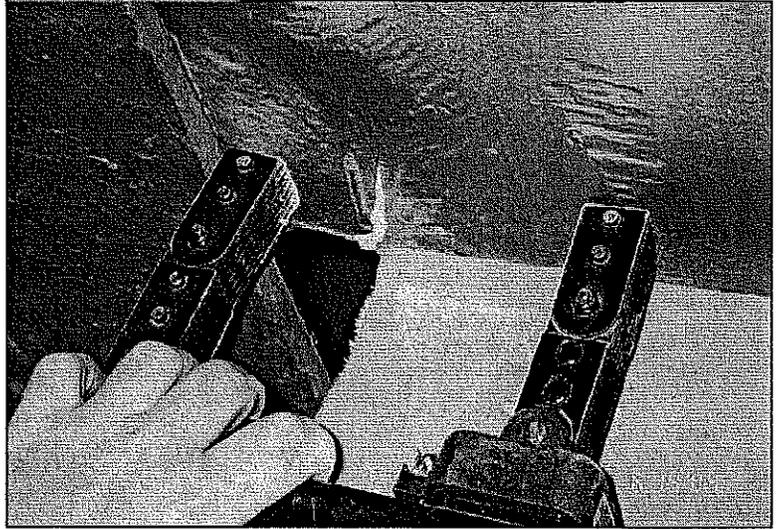
Diaphragm Crack@ Bottom Cutout "Front face" Girder 1C

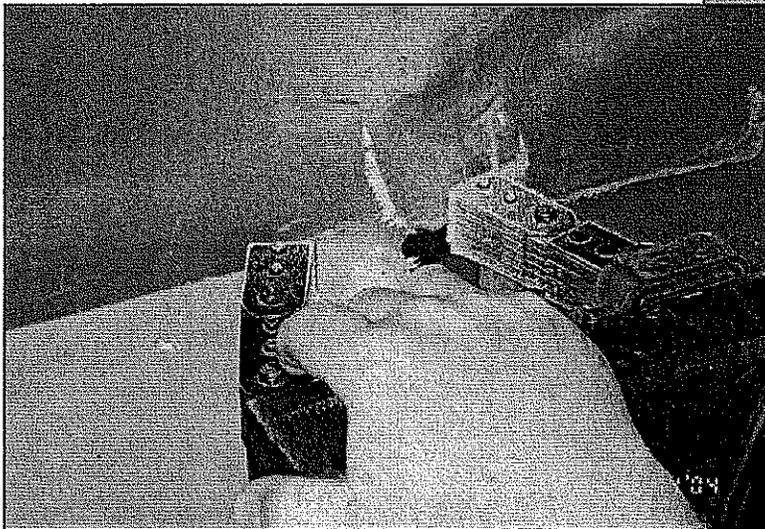
Diaphragm Crack@ Bottom Cutout "Back face" Girder 1C

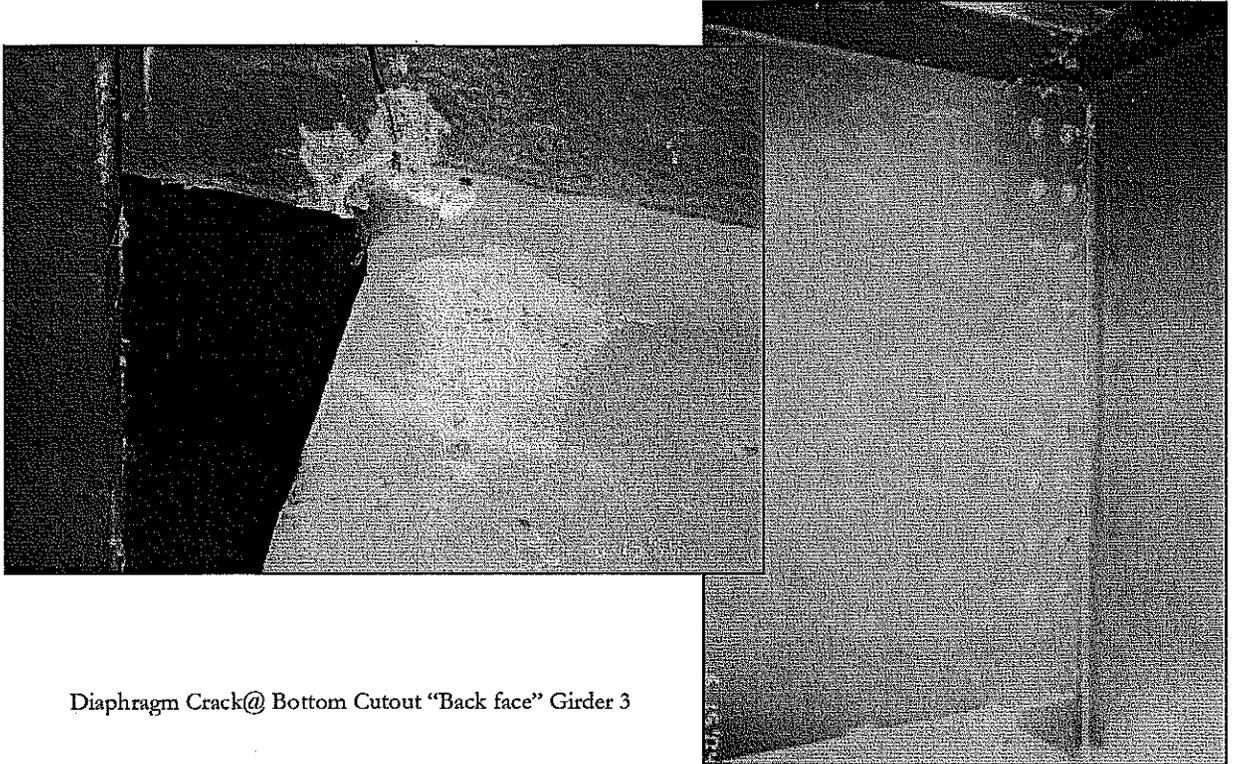
Diaphragm Crack @ Bottom Cutout "Back face" Girder 3

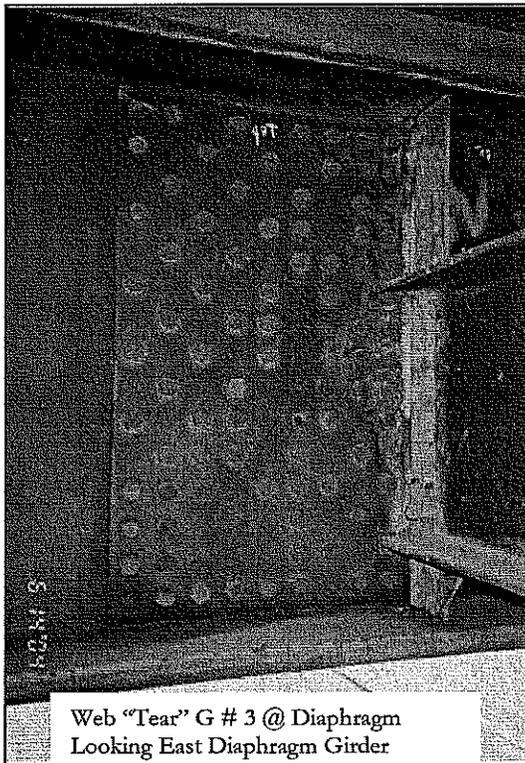
Web "Tear" G # 3 @ Diaphragm  
Looking East Diaphragm Girder

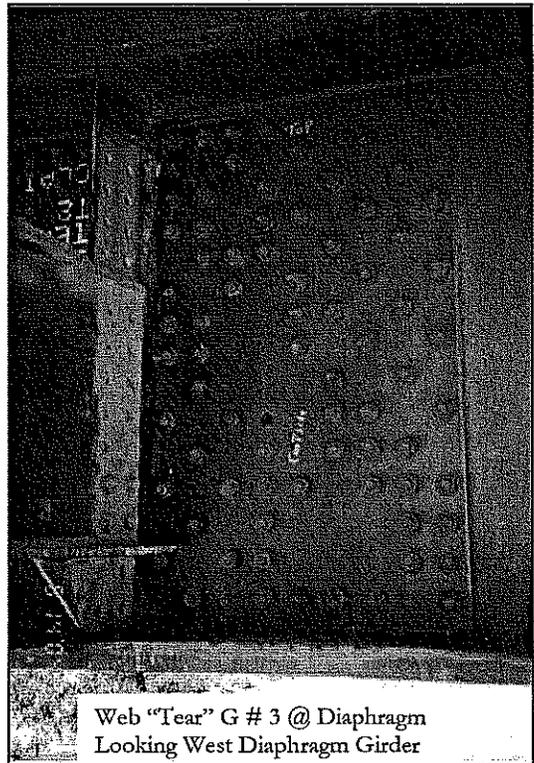
Web "Tear" G # 3 @ Diaphragm  
Looking West Diaphragm Girder

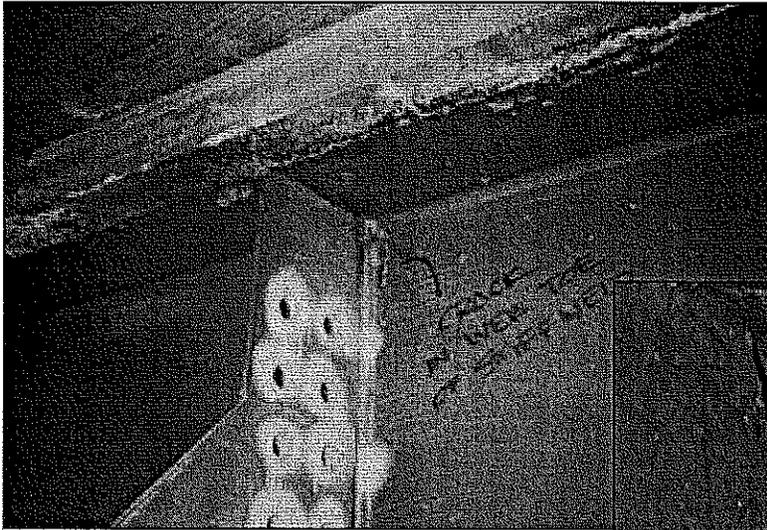
| Girder Location | First Diaphragm North of Pier #9<br>*Denotes original 1998 crack locations |
|---|---|
| G10 (SB) | * [2000] Crack in top flange/ web weld (east side) This crack has grown; see photos. |

Girder #10 Vertical Stiffener/Girder Web

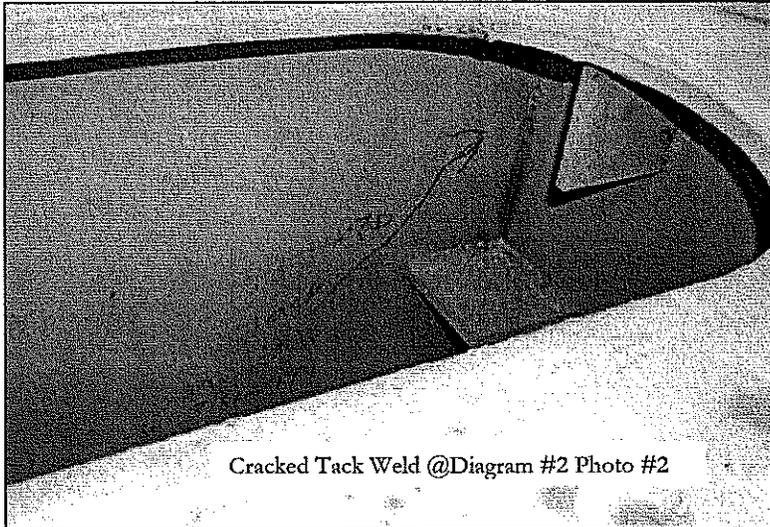
**Panel Point #13 (West Truss):**  
 [1999] Truss bottom chord/sway frame connection plates have 3/4" pack rust. [1996/99] Bottom chord member L13/L14 has cracked tack welds at two internal stiffeners. [2004] Bottom chord member L13/L14 has corrosion from deck drain (P), (diagram #1). Cracked tack weld (diagram #2) (not @ diagram tab) see photo #2 & #3. Cracked tack weld (diagram #3), (not @ diagram tab), (entire tack weld broken cleanly) see photo #4 & #5.

Cracked Tack Weld @Diagram #2 Photo #2

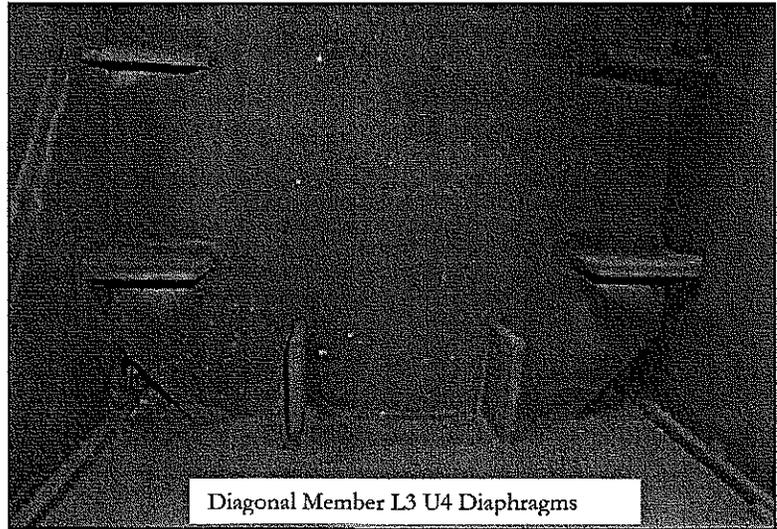
Diagonal Member L3 U4 Diaphragms

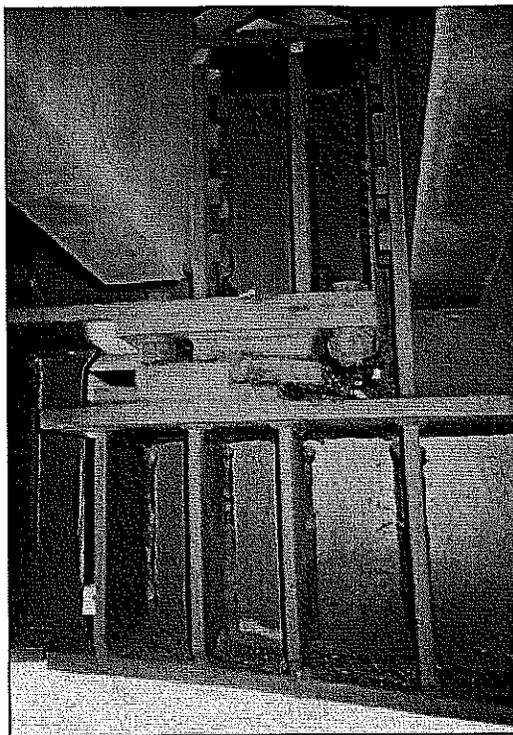
Hinge joint has open finger joint above. [94/2005] All hinge assemblies are expanded beyond tolerance; sliding plates extend 4" or more beyond the base plates, reducing bearing capacity. At beam #10, the sliding plate has tipped, falling off the base plate, and is preventing the joint from opening. [1999] Hinge area re-painted. [2000] Beam-ends have section loss, moderate surface pitting; debris has begun to build up on hinge area. Additionally, the tops of the beam ends are contacting at the top flange or at the web along this joint. [2005] Hinges should be flushed.

Beam 6 NBL @ Hinge

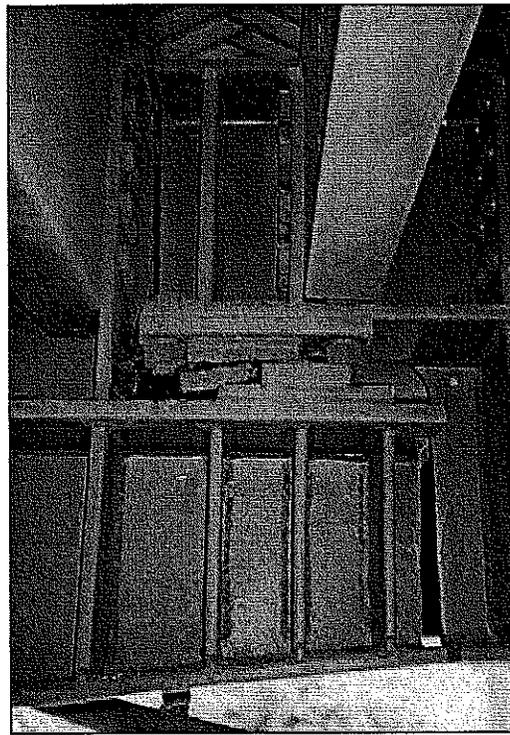
Beam 5 NBL @ Hinge

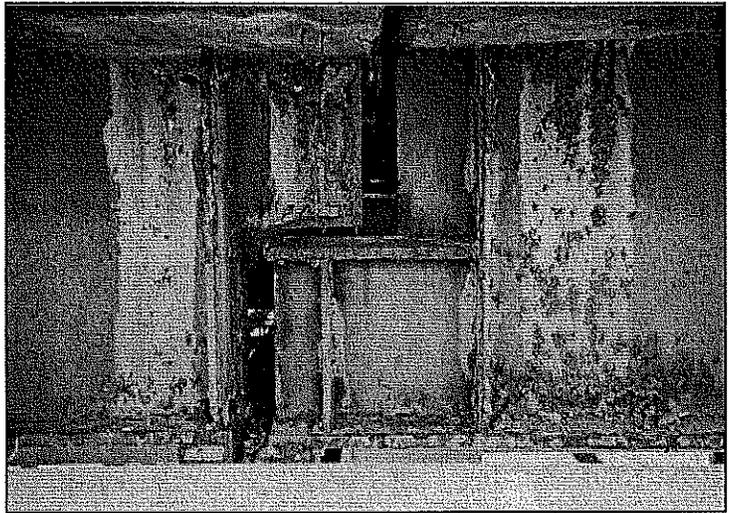
Strip seal deck joint above. [1999] 1 ft. of gland pulled out at centerline. [1996] Floorbeam truss bottom chord/vertical member connection gusset plate has a weld overlap. [1999] Junction box cover is missing at catwalk. [2000] Concrete in joint at east end. [2005] Flaking & surface rust exterior east truss.

Flaking & Surface Rust Exterior East Truss

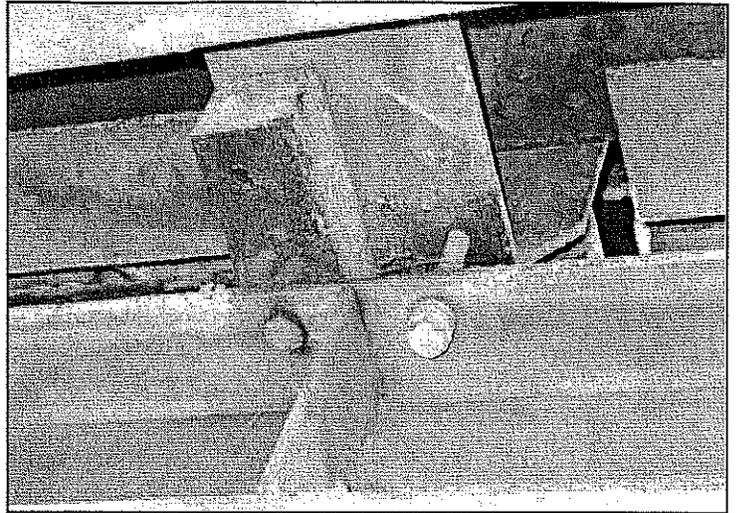
Strip seal and deck drain above. [94/2003] Joint is leaking, small hole & membrane has pulled out. Stringer #4: one bolt broken off at south floorbeam connection. Deck drain is plugged solid. Stringer #2 (south side): one bolt is missing and the nut is missing from the other bolt. The bearing block has rotated 90°. [1999] Missing bolt replaced. [2000] Bolts are loose, needs repair. Vertical truss member has section loss, moderate flaking rust. Floorbeam bottom chord & middle bracing connection plate has moderate section loss, severe flaking rust. Middle bracing connection plate has 1/2" spread from pack rust. Underside of the deck has 50 SF of water saturation.

Stringer #2 Bearing Block Rotated

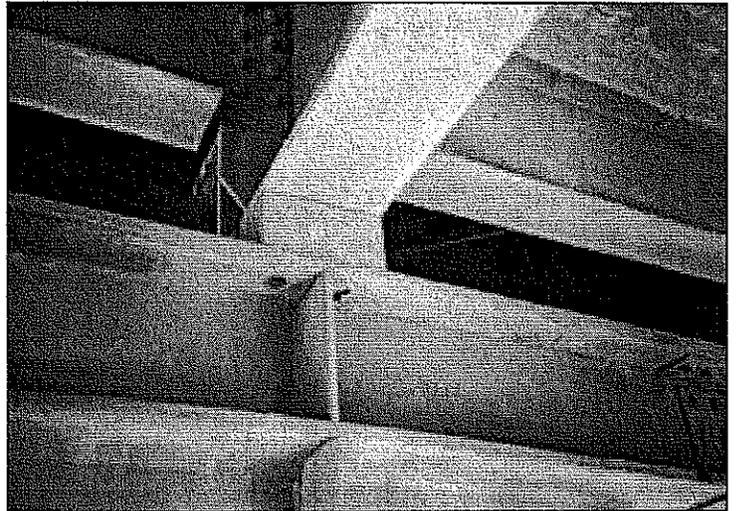
Stringer #4 Bolt Missing

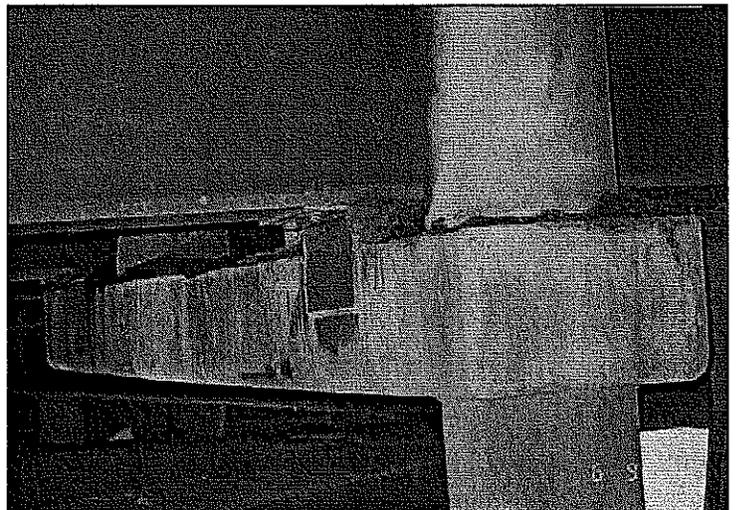
Plugged Horizontal Drain Trough

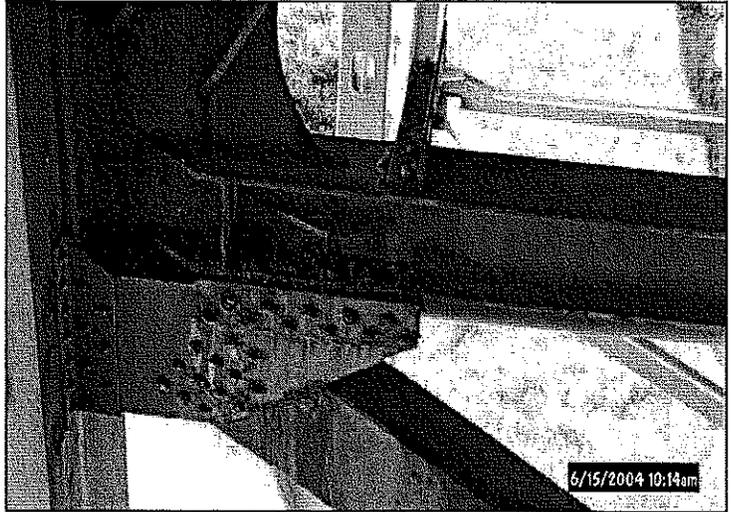
[2004] Typical condition & rust at floorbeam connection near deck drain at connection U8.

Floorbeam Condition

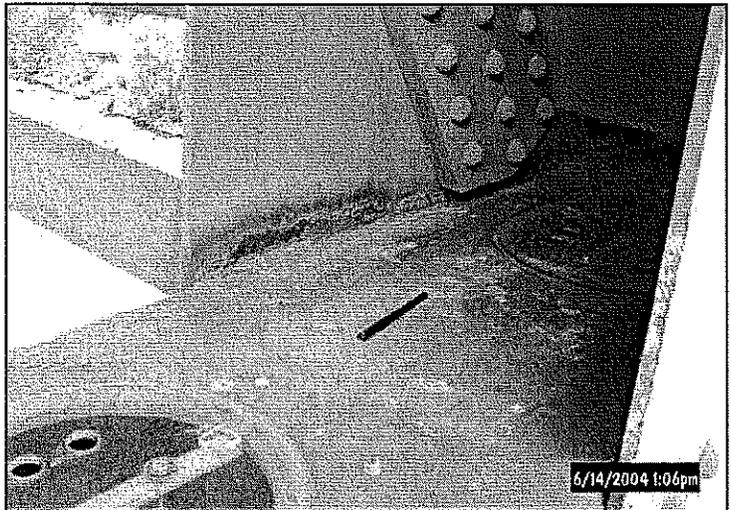
Section loss: at gusset plate bottom chord. [2000/05] Stringer #3 has two bolts missing at the floorbeam connection. [2004] Pitting inside gusset plate connection at L11 toward L10

Pitting @ L11/L10 Connection

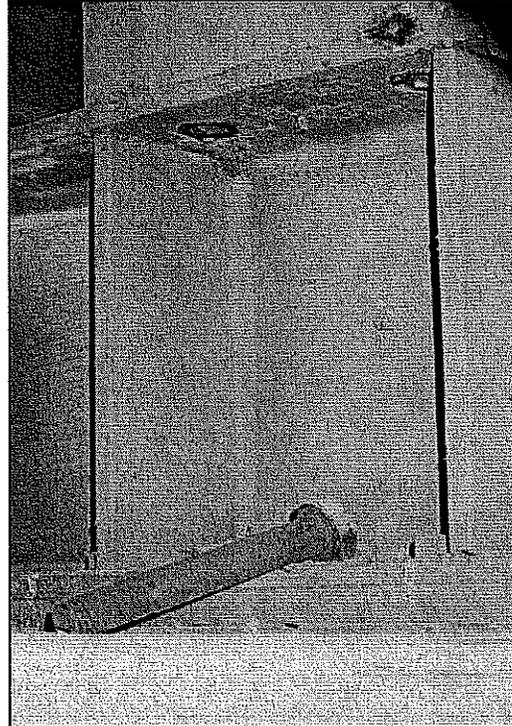
Bolts Missing @ Floorbeam Connection

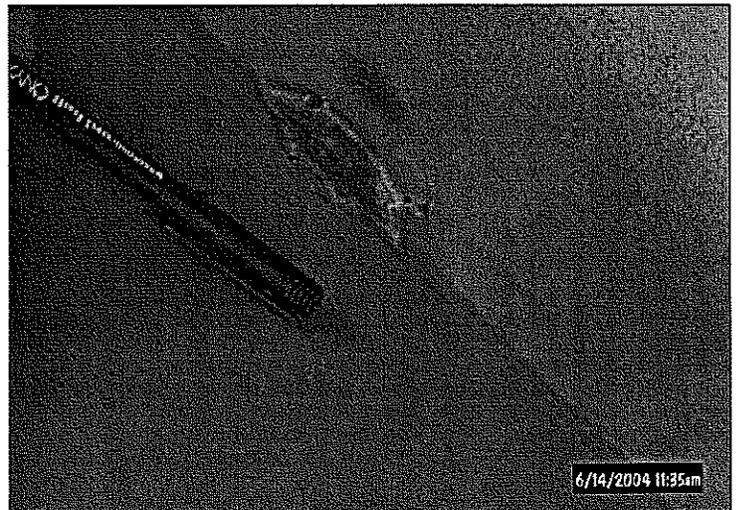
[1999] Truss bottom chord member L12/L13 has a cracked tack weld at an interior stiffener. [2004]  
Ground out pit from past inspection when???

Weld Ground Out When?

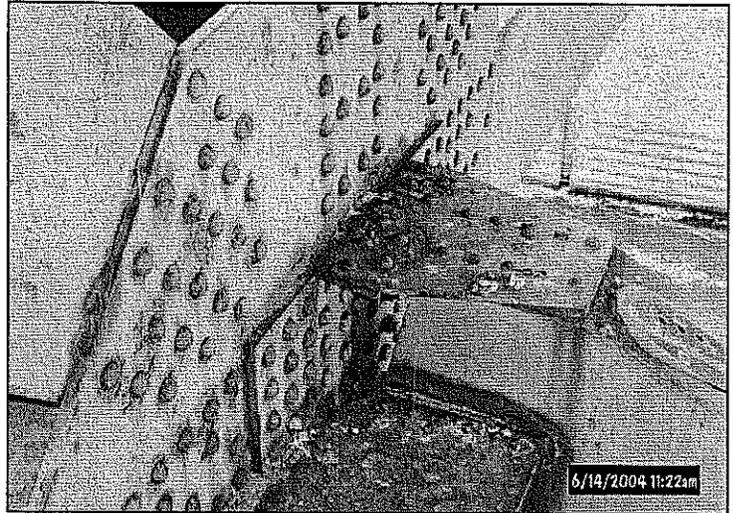
Water from deck drains fall directly into river. [99/2002] Bottom chord gusset plate has section loss, flaking & pack rust. [1999] Truss bottom chord member L13/L14 has cracked tack welds at two interior stiffeners. [2004] Bottom chord member L13/L14 cracked tack weld @ diagram tab (diagram #1?). Cracked tack weld @ diagram tab member L13/U14 see photos.

Condition @Bottom Chord Connection

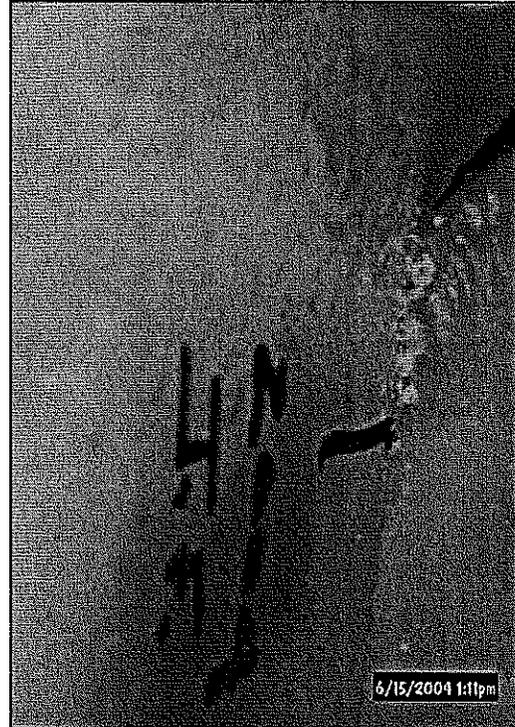
Strip seal expansion joint on the deck. Sway frame rusty. [1999] Truss bottom chord member L14/L13' has a cracked tack weld at an interior stiffener. [2002/03] Floorbeam bottom chord & middle bracing connection plate has 1/2" pack rust. Underside of the deck has 4 SF of delamination. [2004] Bottom chord member L14/L13' cracked tack weld at diagram tab (diagram #3?) see photo.

Member L14/L13' Cracked Tack Weld

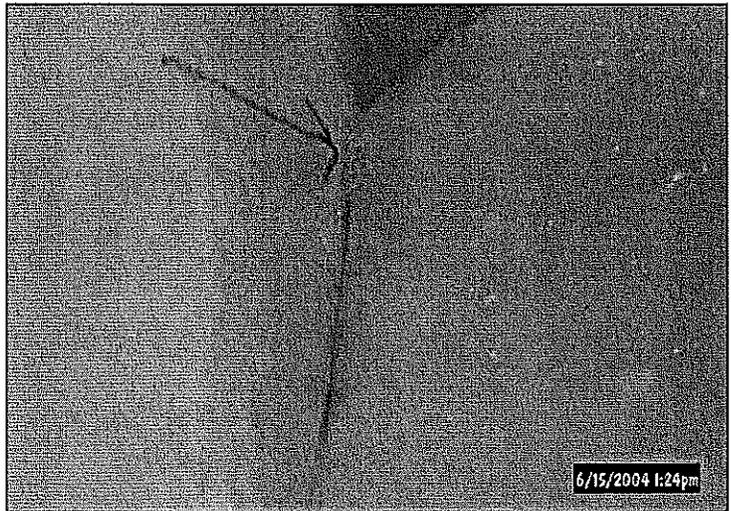
Floorbeam truss top chord has a ground out spot near stringer #4. [1996] Truss bottom chord member L13'/L12' has a cracked tack weld at an interior stiffener. [2003] Truss bottom chord connection plate has 1/2" pack rust. Underside of the deck has 20 SF of water saturation. [2004] Bottom chord member L13'/L12' cracked tack weld @ diagram tab (diagram #3?) see photo.

Member L13'/L12' Cracked Tack Weld

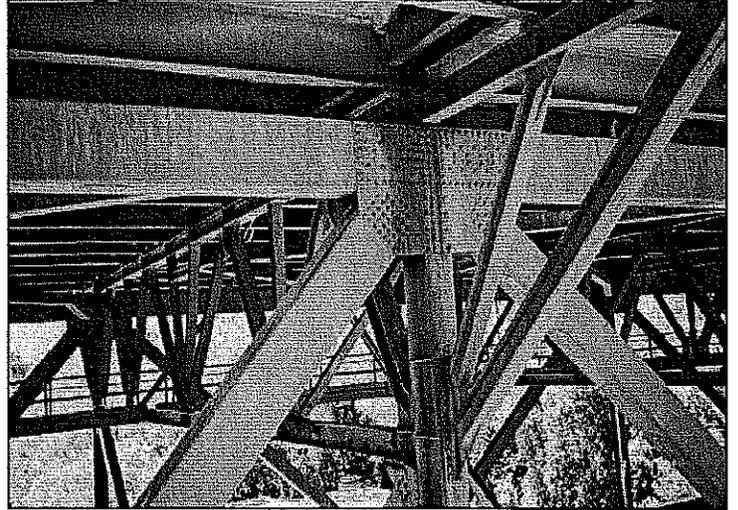
Strip seal expansion joint on the deck. Truss diagonal member U4'/L3' has backer bars along the interior edges. [01/04] Strip seal has 3 LF of gland pulled out. Truss connection plates, the top chord, and floorbeam have moderate section loss, severe flaking rust. Bottom connection plates have 1/2" pack rust.

Top Floorbeam Truss Condition

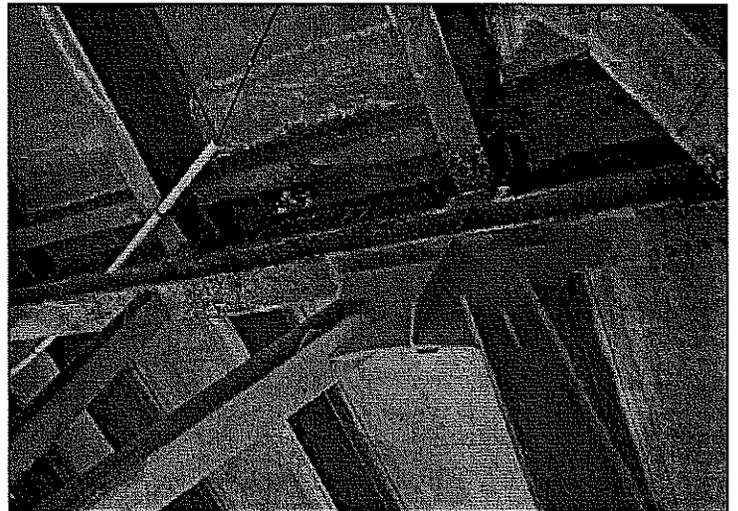
Top Floorbeam Truss Condition

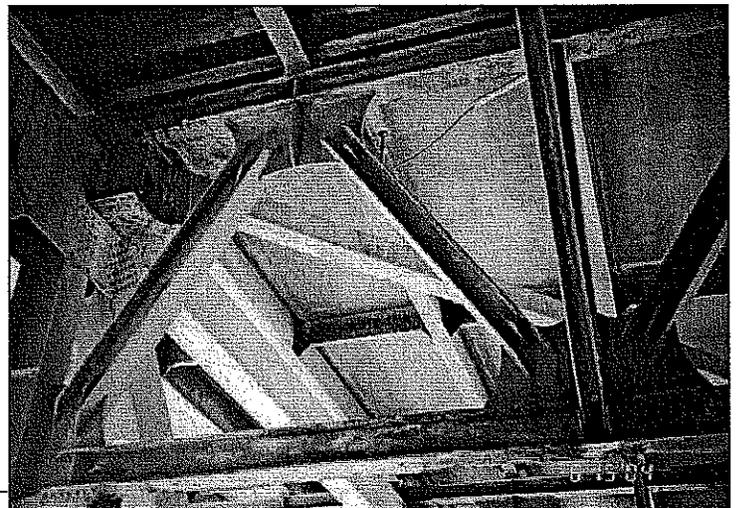
Bottom Floorbeam Truss Condition

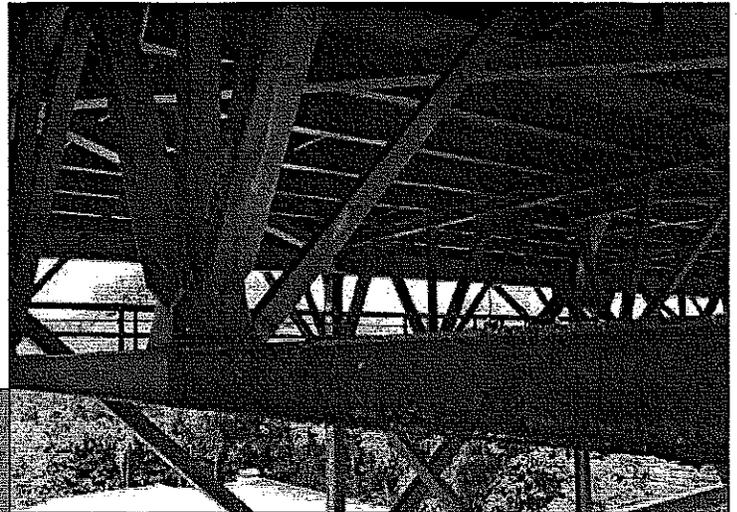
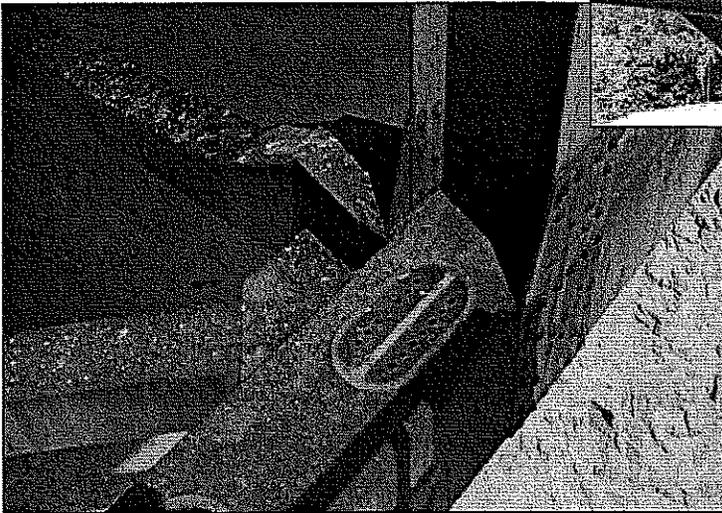
Bottom Floorbeam Truss Condition

Bottom Truss Condition

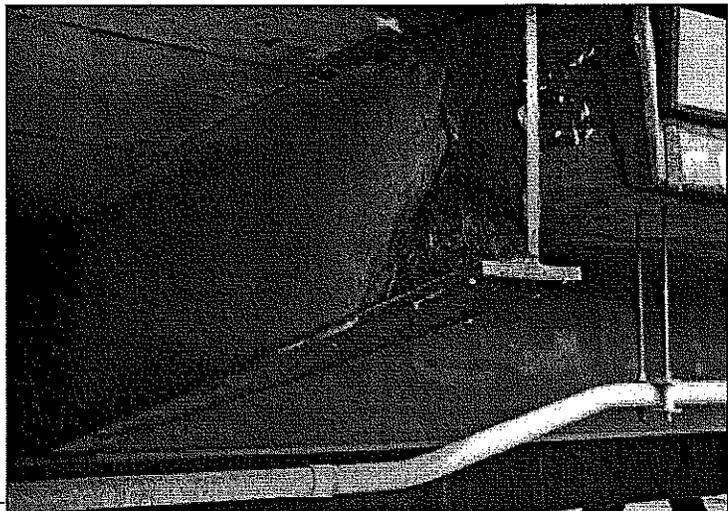
Overhead sign mounted on exterior railings. [1999] Deck in bay #3 has 100 SF of water saturation. [2003] Bottom connection plates have flaking rust. [2004] Area underneath overhead sign has 100 SF of water saturation. [2005] North support beam (stringer ?) has severe section loss at end.

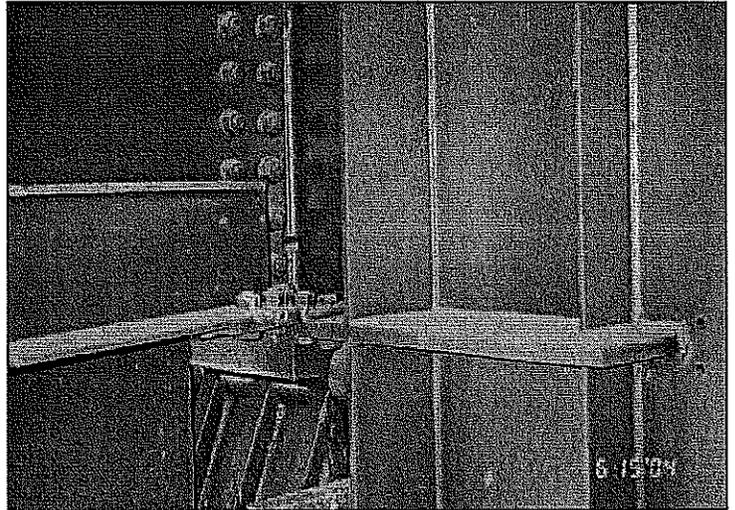
[1998/99] Crossbeam re-painted. Side facing finger joint has section loss, with pitting at base of stiffeners. [1992] North face has crack in the crossbeam web stiffener, above the rocker at the beam #12 connection. This was drilled out. [1997/98] North face: weld above east rocker bearing, between the horizontal & center vertical stiffener, has cracked through entirely. Weld end at the crossbeam web was partially drilled out. [1998] North face has cracks at both ends of the horizontal stiffener, above rocker bearing. They were drilled out with two small holes drilled in crossbeam web at each location. [1998] Bracing installed between crossbeam, above east rocker, and beams #3 & 5. *\*\* [2000] Gap between crossbeam & floorbeam (at rocker bearing) was 3-5/8" at 40° F.* [2005] Movement at east bearing.

Web Stiffener Crack Northwest Side

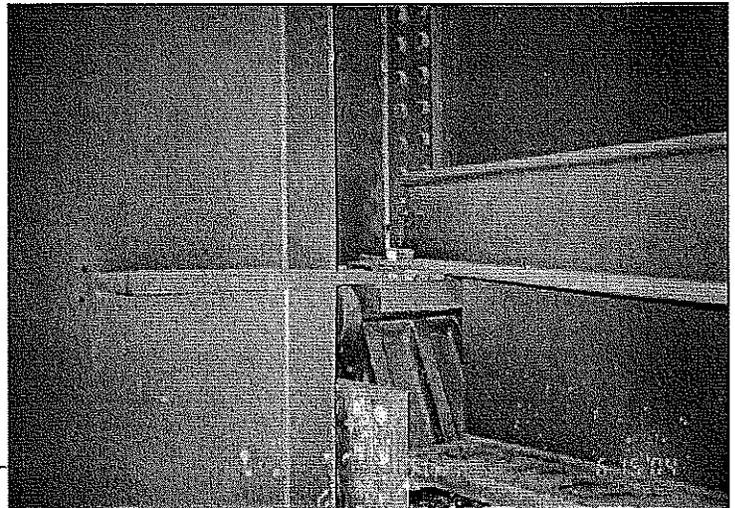
Web Stiffener Crack Northeast Side

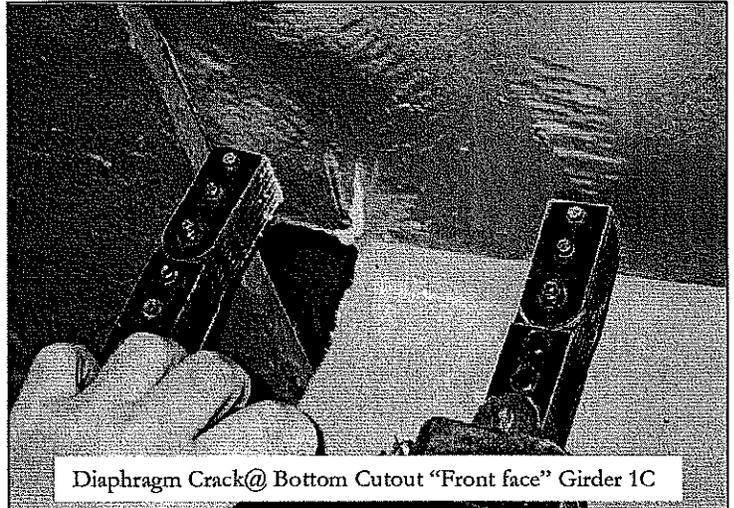
Span is 168 FT long with one floorbeam truss at pier #8, fourteen 48" deep welded plate beams bolted onto the crossbeam. Multi-beam spans resume. NB has 8 girders. SB has 7 girders. There are two active railroad tracks below. Refer to Appendix A **First Diaphragm South of Pier #9** graph for crack locations, description & repair to the diaphragm line. [1999] Girders 6, 7, 8, & 9 are re-painted. Lateral bracing welded to web & stiffener. [2003] Conduit: at east side bottom of deck. [2002/04] Underside of deck at the south end, in NBL, has 150 SF of water saturation near the spray head. The 2<sup>nd</sup> & 3<sup>rd</sup> bays from west (southbound) have 250 SF of salt and water saturation. [2004] Girder 1C (NBL), crack at the diaphragm bottom cutout, NE side measures 2" ("front face") and NW side measures 2-1/2" ("Back face"). Girder 3 (NBL), crack at the diaphragm bottom cutout, measures 1-1/2" (both sides). [1998??] Girder #3 has a "tear" in the girder's web at the diaphragm girder connection. The "tear" measured 42" long on one side and 12" long on the other, was caused by out of plane bending between the diaphragm and the girder. Girder Connection Lowered & Girder Web Repaired with Splice Plate

Diaphragm Crack@ Bottom Cutout "Front face" Girder 1C

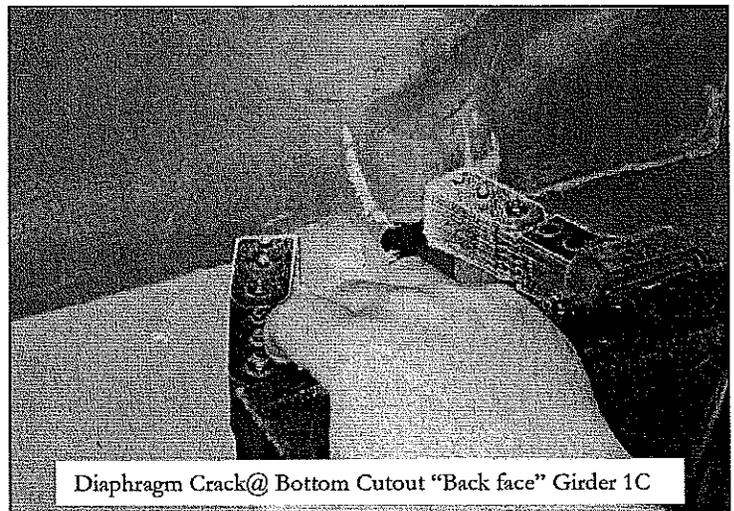
Diaphragm Crack@ Bottom Cutout "Back face" Girder 1C

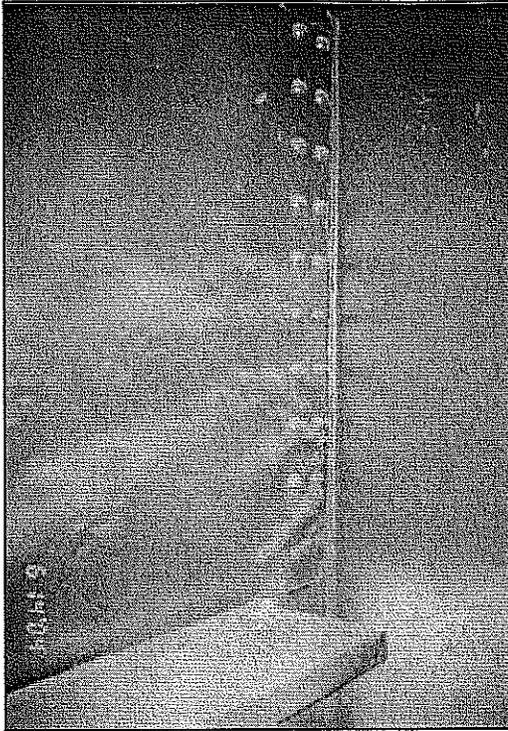
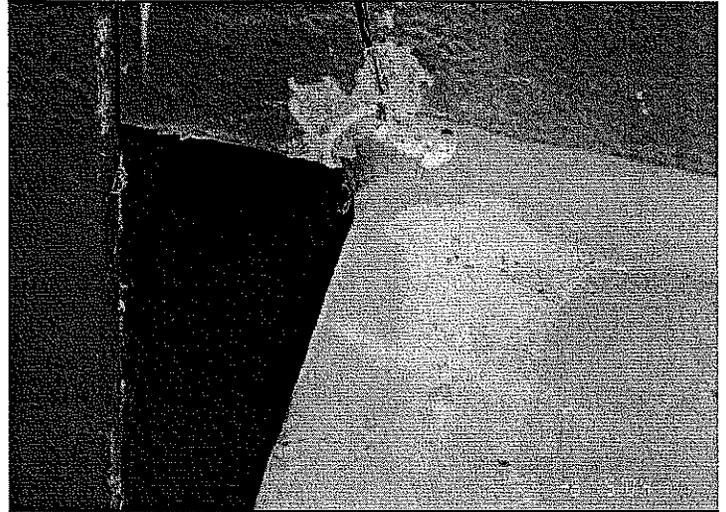
Diaphragm Crack @ Bottom Cutout "Back face" Girder 3

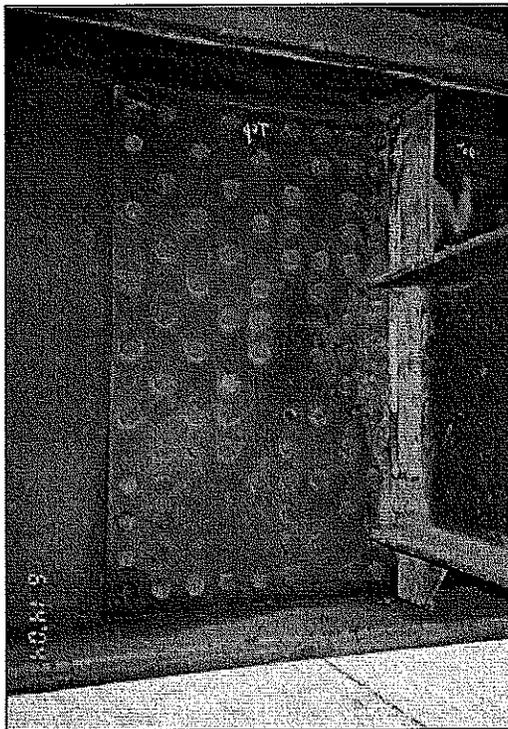
Web "Tear" G # 3 @ Diaphragm Looking East

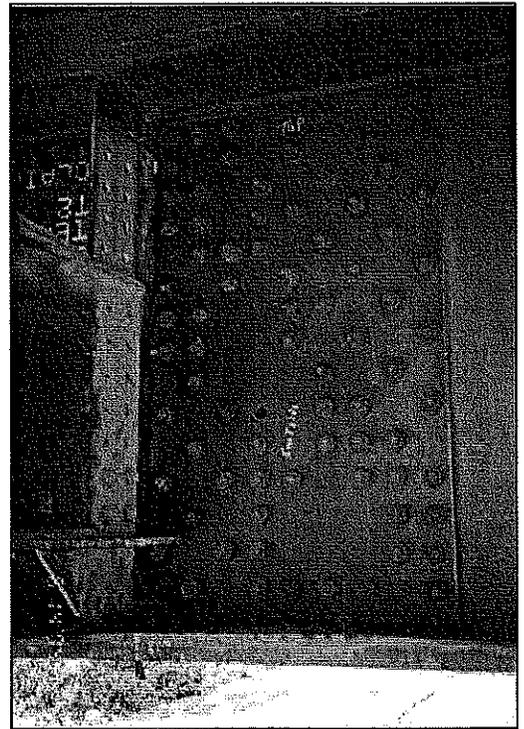
Web "Tear" G # 3 @ Diaphragm Looking West

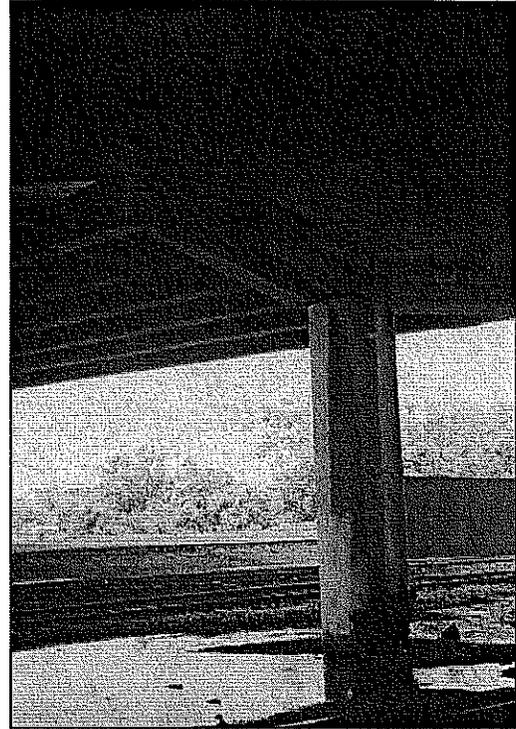
Plate bearing assemblies have 13 fixed, and four sliding. Pier consists of four columns and cap, with a railroad crash strut between the columns. Deck drain: downspout. [1969] East column damaged by train derailment - the column has minor scrapes and spalls. Downspout had to be reconnected. [1999] Bearings 6, 7, 8, & 9 were re-painted. [2004/05] West vertical & median deck drain plugged.

Median Drain Plugged Pier 9

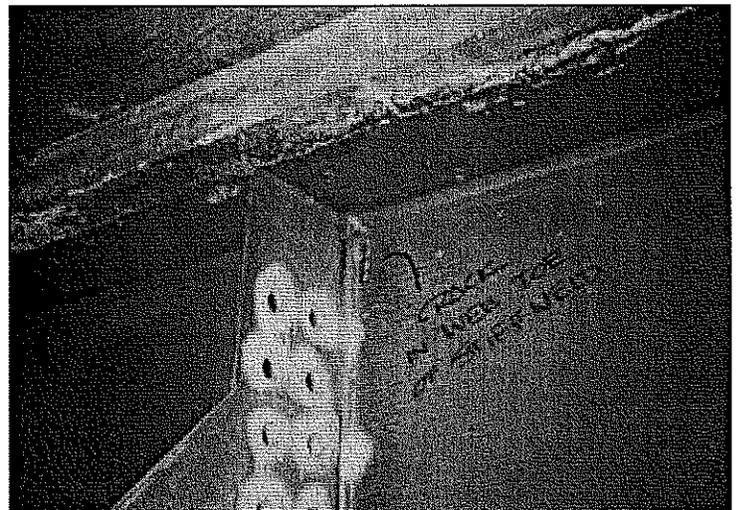
Girder #10 Vertical Stiffener/Girder Web

Span is 94 FT long with 17 steel beams. NB has 10 beams; SB has 7 beams (the welded beams transition from 48" to 33" depth just north of pier) with active railroad tracks below. One track splits into two. Refer to Appendix A **First Diaphragm North of Pier #9** graph for crack locations, description & repair to the diaphragm line. [1999] Beams 6, 7, 8, & 9 were re-painted. Diaphragms were inverted & lowered, even though the beam connections have a "positive moment" configuration. Connections welded to top flange. [2003] Conduit: at east side bottom of deck. [2000] Beam #6 appears to be "working" at the top connection. [2004] 250LF of leaching cracks underneath

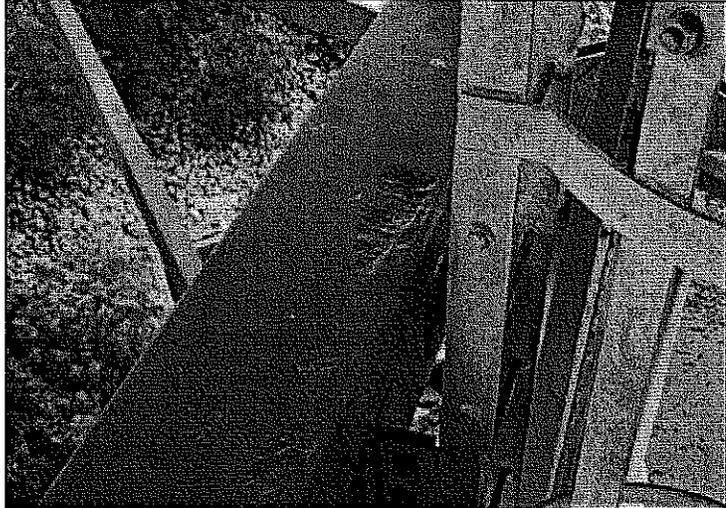
[2004/05] Sway bracing center horizontal has 3" x 8" severe pitting & 1/2" diameter hole; bottom sway bracing has a 2" x 3" hole between stringer #11 & stringer #10 see photos. [2002] Section loss: heavy flaking rust on truss bottom chord, L8'/L9'.

Center Sway Bracing

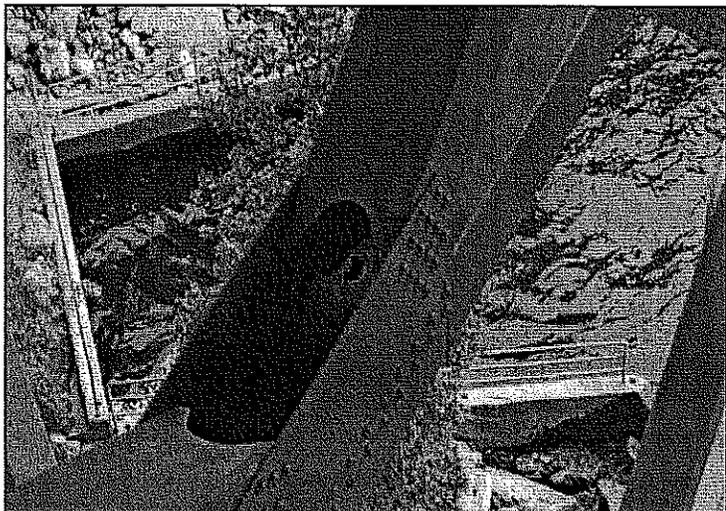
Hole in Bottom Member of Sway Bracing

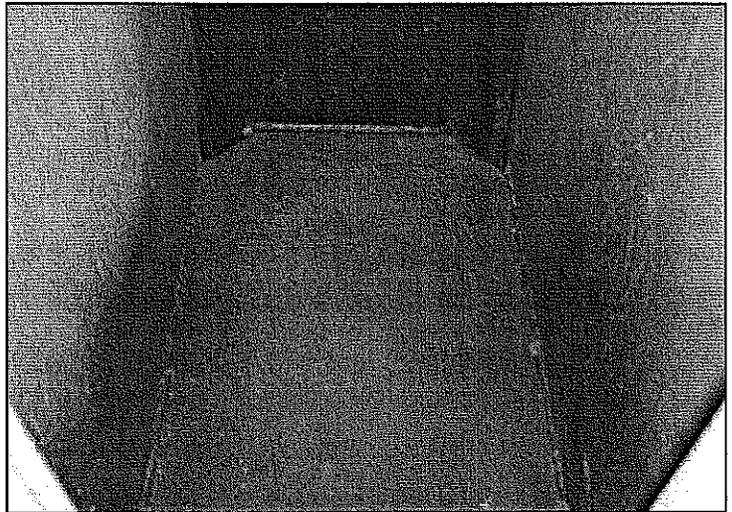
U13'/U12' (Diaphragm #2) Photo #1

[2004] Upper chord member U13'/U12' (diaphragm #2) has no tabs, diaphragm is welded (full length) one side only see photo #1. Bottom chord member L13'/L12' cracked tack weld (diaphragm #1), (not @ diaphragm tab), (clean break) see photo #2.

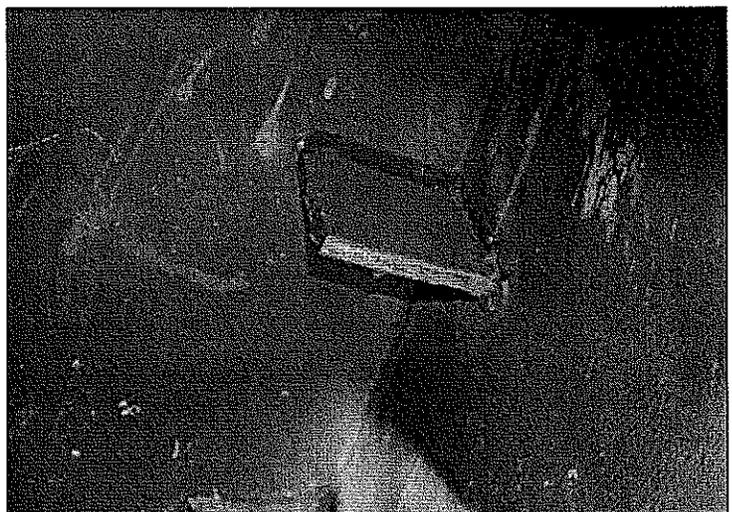
U13'/U12' (Diaphragm #1) Photo #2

[2004] Upper chord member U13'/U12' (diaphragm #2) has no tabs, diaphragm is welded (full length) one side only. Bottom chord member L13'/L12': cracked tack weld (diaphragm #1), (not at diaphragm tab), (clean break). See photo #2.

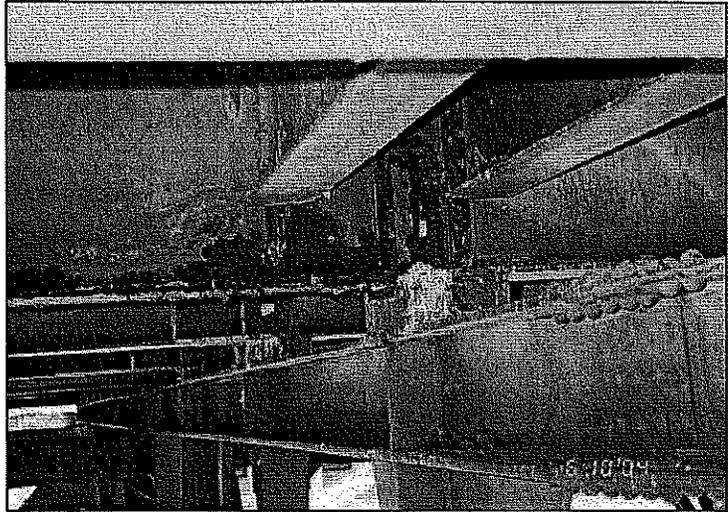
Strip seal deck joint above. [2005] 10 LF of strip gland pulled out. Deck drains on both sides. [1994] Stringer #11 has section loss, flaking rust near the joint from gland pulled out above. Tack welds along the sway frame/truss, bottom chord, and gusset plate. [1999] Bottom chord member L14/L13' has a cracked tack weld at an interior stiffener. [2003] Stringer #14 connection, south side of the floorbeam, has a cracked tack weld. [2004] Upper chord member U14/U13' has internal tack welds (full length) at interior diaphragm. Bottom chord member L14/L13' has corrosion from deck drain (?) see photo.

Flaking Rust @ Stringer #11
