# **INVESTIGATIVE REPORT TO JOINT COMMITTEE TO INVESTIGATE THE I-35W BRIDGE COLLAPSE**

**APPENDIX: Volume IV**

### Bridge Inspection Reports

*Bridge # 9340  
I-35W over the Mississippi River  
(Downtown Minneapolis)*

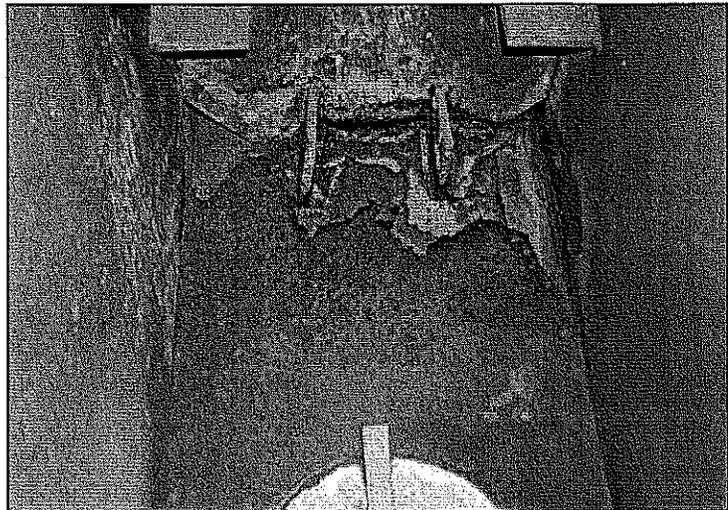
Strip seal deck joint above. [2005] 10 LF of strip gland pulled out. Deck drains on both sides. [1994] Stringer #11 has section loss, flaking rust near the joint from gland pulled out above. Tack welds along the sway frame/truss, bottom chord, and gusset plate. [1999] Bottom chord member L14/L13' has a cracked tack weld at an interior stiffener. [2003] Stringer #14 connection, south side of the floorbeam, has a cracked tack weld. [2004] Upper chord member U14/U13' has internal tack welds (full length) at interior diaphragm. Bottom chord member L14/L13' has corrosion from deck drain (?) see photo.

Member L14/L13' Corrosion

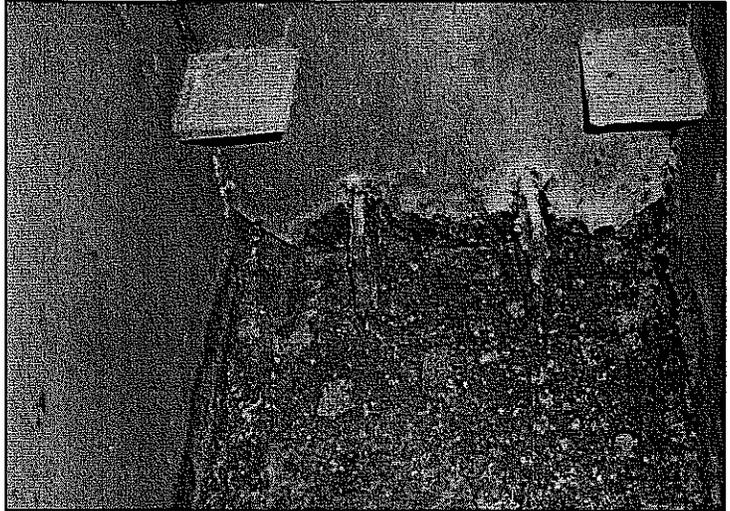
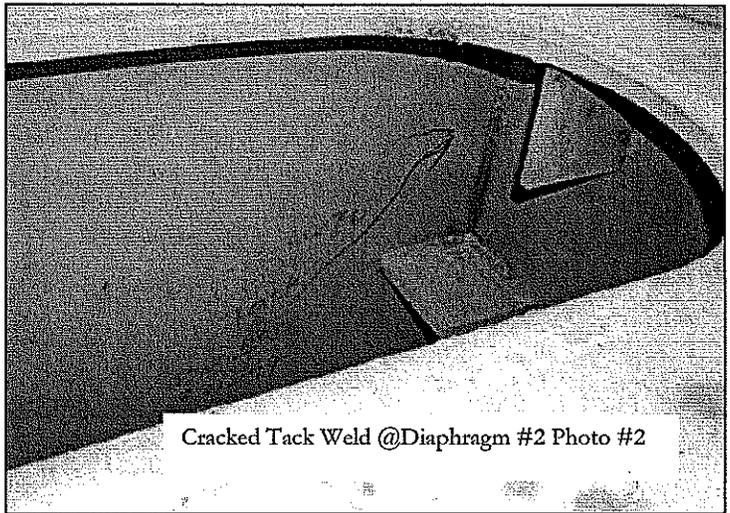
[1999] Truss bottom chord/sway frame connection plates have 3/4" pack rust.  
[1996/99] Bottom chord member L13/L14 has cracked tack welds at two internal stiffeners. [2004] Diagonal L13/U14 has corrosion from deck drain (diaphragm #1). Cracked tack weld (diaphragm #2) (not @ diaphragm tab) see photo #2 & #3. Cracked tack weld (diaphragm #3), (not @ diaphragm tab), (entire tack weld broken cleanly) see photo #4 & #5.

L13/U14 Corrosion @Diaphragm

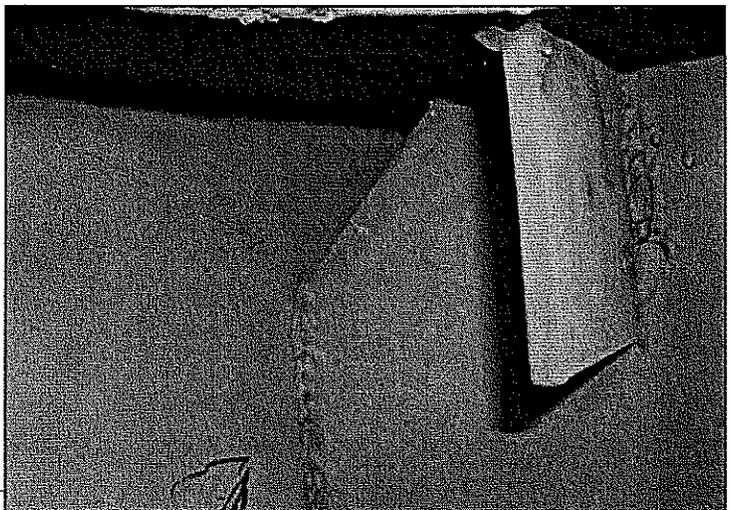
Cracked Tack Weld Diaphragm #2  
Photo #3

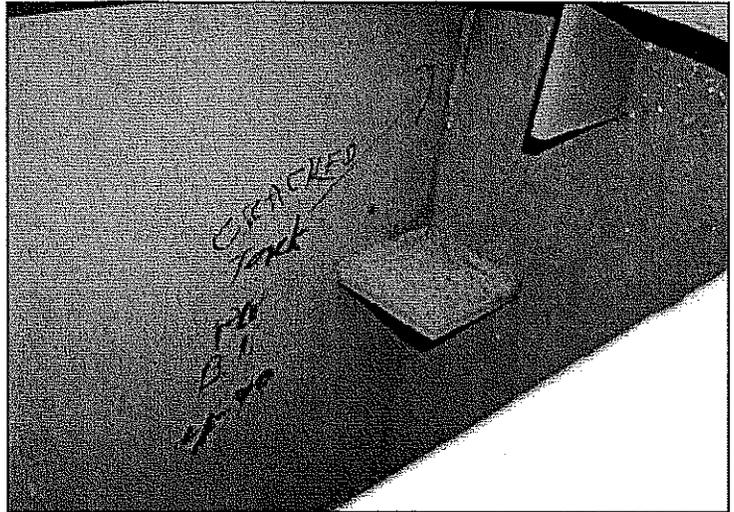
Cracked Tack Weld Diaphragm #3  
Photo #4

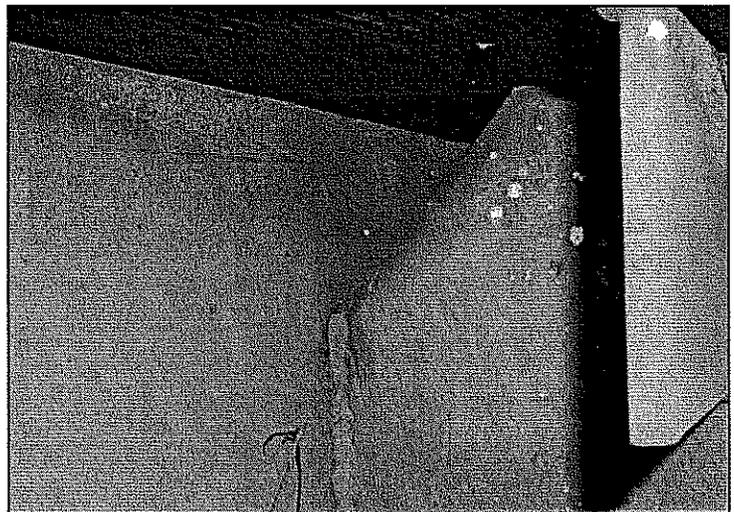
Cracked Tack Weld Diaphragm #3  
Photo #5

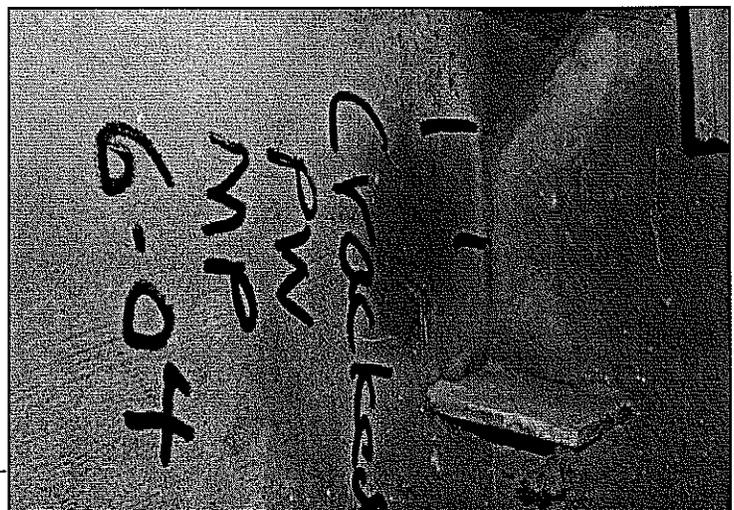
**Panel Point #12 (West Truss):**  
[1996] Bottom chord member L12/L13 has a cracked tack weld at the internal stiffener. [2004] Bottom chord member L12/L13 has a cracked tack weld (diagram #2), (not @ diaphragm tab) see photo.

Member L12/L13 Cracked Tack Weld  
Diaphragm #2

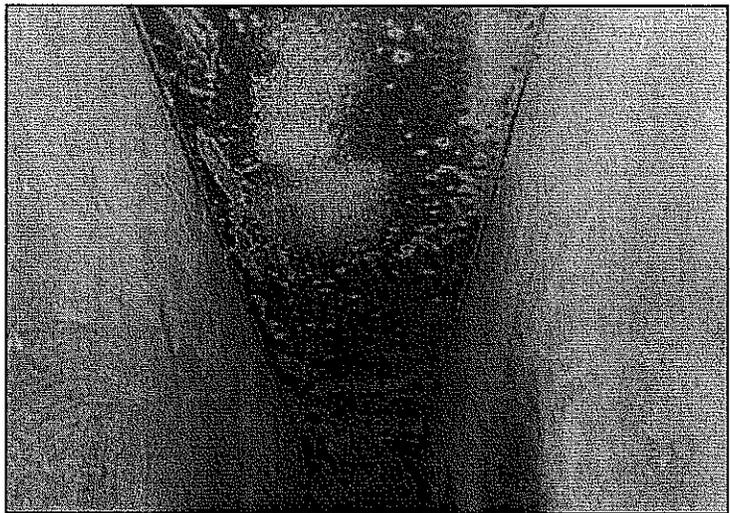
Top chord U5/U6 has backer bars tack welded along the top interior corners of member see photo.

Backer Bars Tack Welded Along Top Interior

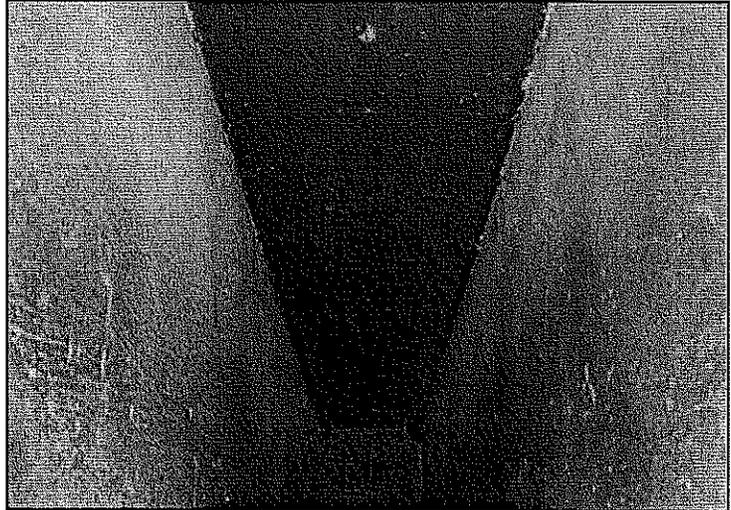
Backer Bars Tack Welded Along Top Interior

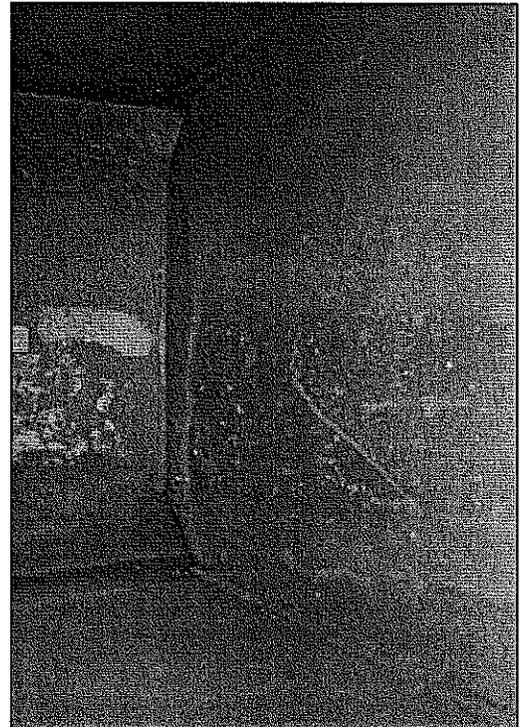
Bottom Chord Full Weld on Diaphragm

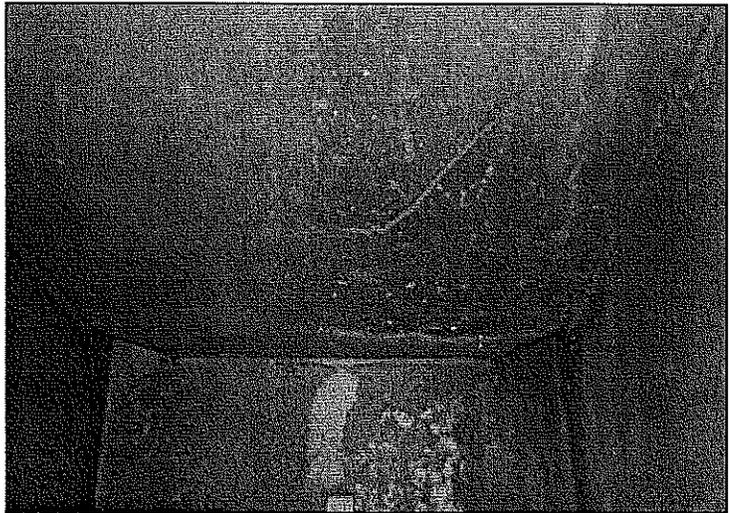
Truss bottom chord L2/L3 has a nick. Top chord U3/U4 has backer bars tack welded along the top interior corners of member see [2004] photo. Bottom chord L4/L5 has no diaphragm tabs, full weld on side and tack welds on other see [2004] photo. Diagonal member L3/U4 has 4 diaphragms with tabs see [2004] photo.

Diaphragm @ Member L3 U4

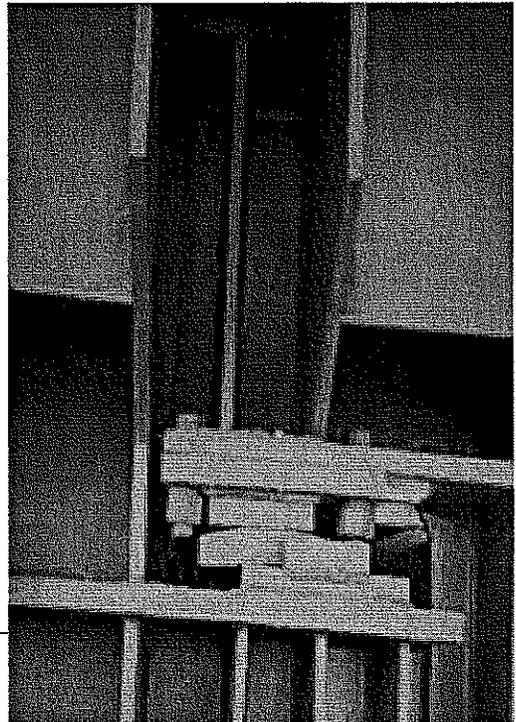
Sliding Plate @ West Fascia

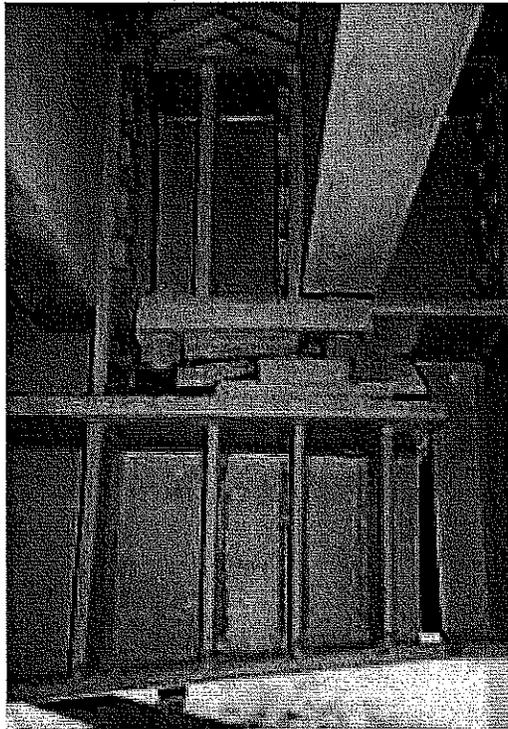
Sliding Plate @ Beam 5 NBL

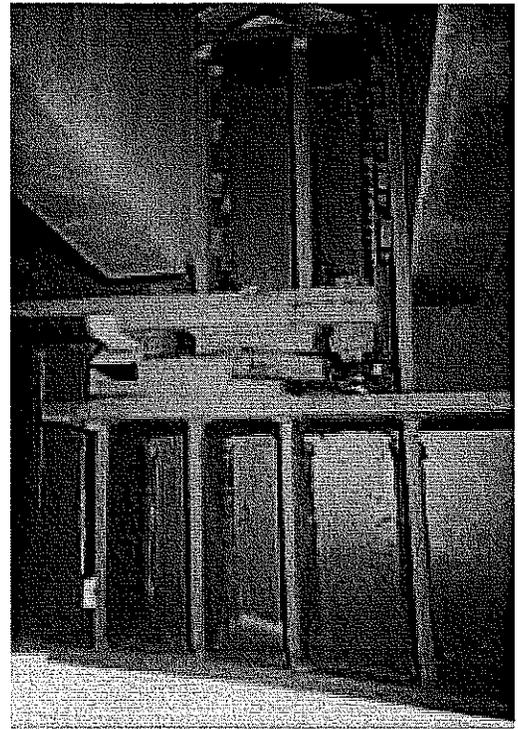
Sliding Plate @ Beam 6 NBL

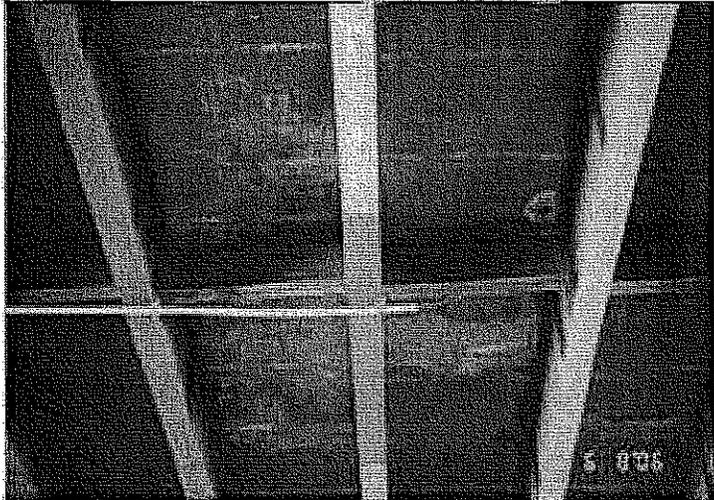
Over contract parking lot (no access) & Bluff St. Span is 110 FT long with fourteen 48" deep welded plate beams. [1978] Second & third bays from the east have full depth deck repairs. [1998] Underside of deck has 200 LF of transverse leaching cracks, 200 SF of spall with exposed rebar below a transverse poured joint, full width of deck. [1999] Beams 6, 7, 8, & 9 were re-painted. Diaphragms lowered, even though the connections have a "positive moment" configuration. Stiffeners are welded to the top flange. Refer to Appendix "A" **First Diaphragm North of Pier #3** graph for crack locations, description & repair to the diaphragm line. [1998/99] Diaphragms lowered with strain gauges placed on beams #2 & 6 (*first diaphragm line south of Pier #4*). [2000] Fourth bay from west has 20 SF of severe leaching. [2005] East fascia beam has section loss, flaking & surface rust on bottom flange.

Water Saturation SBL Bays 9 & 10

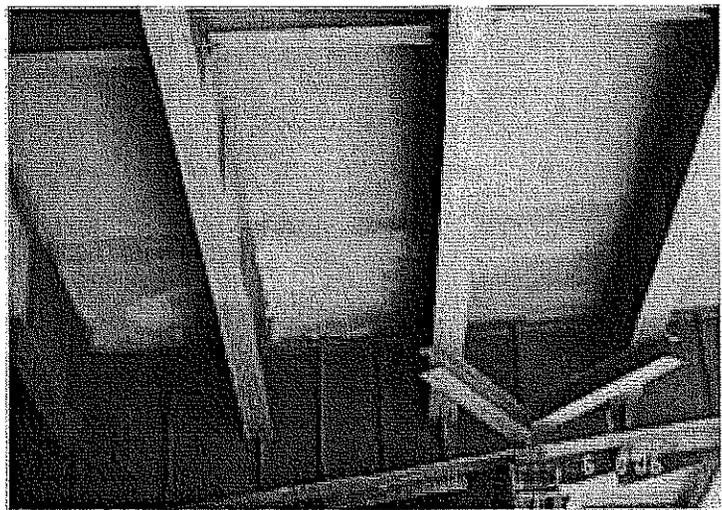
Over contract parking lot; span is 109 FT long with fourteen, 48" deep welded plate beams bolted onto the crossbeam. [1978] Underside of deck is leaching at the finger joint, has two full depth patches in the west bays. [1996] 4 conduit clamps missing on NB fascia beam. Median girder has impact damage from parking lot below. [1998] Bay just east of median has severe spalling on "stool" and the adjacent deck is cracked. [1999] Beams 6, 7, 8, & 9 were re-painted. Refer to Appendix "A" **First Diaphragm North of Pier #4** graph for crack locations, description & repair to the diaphragm line.

Water Saturation NBL Bays 2, 3 & 4

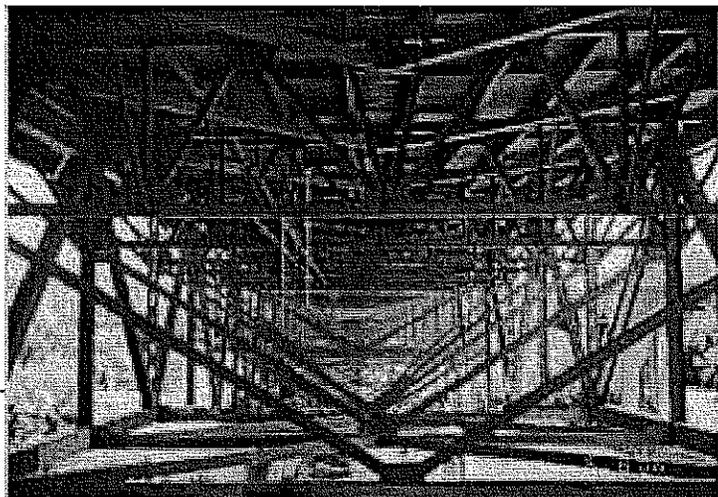
Rubber "skirts" installed below the finger joint. [2000] Rubber trough above rocker bearings filled with debris; needs to be flushed. [2002] Panel points 0 to 1 there is water saturation between stringers 2 thru 4. [2005] Stringers 2 & 3 have flaking & surface rust.

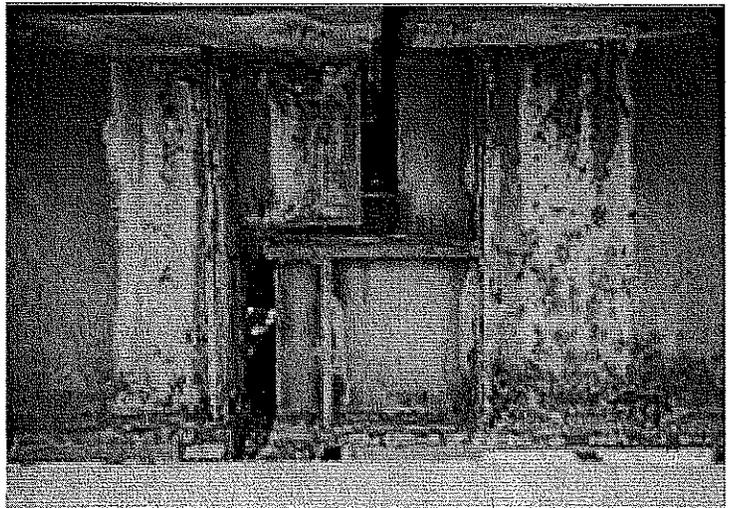
Type H: strip seal deck joint above. [1996] Floorbeam truss bottom chord/vertical member connection gusset plate has a weld overlap. [1999] Gland has 1 LF of gland pulled out at centerline. Junction box cover is missing at catwalk. [2000] Joint gland at east end has concrete in. [2005] Pitting, flaking & surface rust exterior east truss.

Flaking & Surface Rust Exterior East Truss

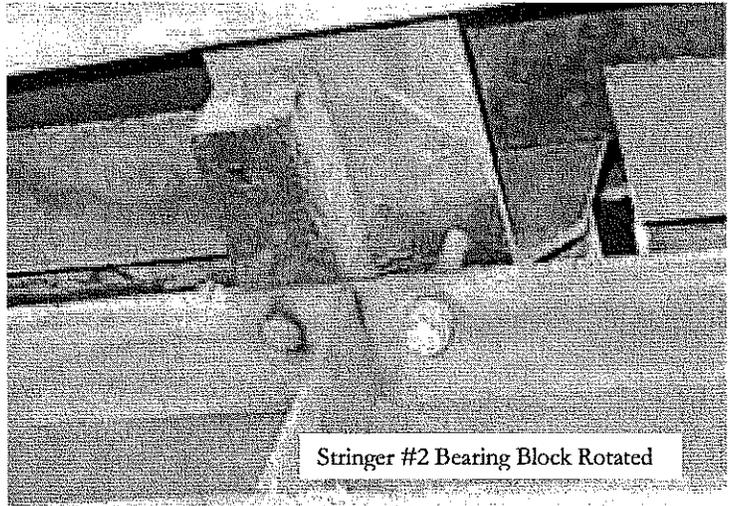
Type H: strip seal and deck drain above. [1999] Missing bolt replaced. Vertical truss member has pitting, section loss, moderate flaking rust. Floorbeam bottom chord & middle bracing connection plate has pitting, moderate section loss, severe flaking rust. Middle bracing connection plate has 1/2" spread from pack rust. Underside of the deck has 50 SF of water saturation. [94/2003] Joint is leaking, small hole & membrane has pulled out. Stringer #4: one bolt broken off at south floorbeam connection. Stringer #2 (south side): bearing block has rotated 90°.

Stringer #2 Bearing Block Rotated

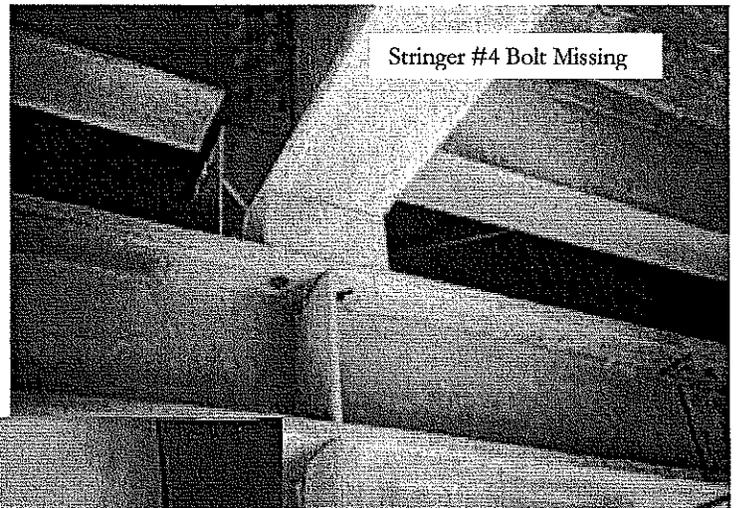
Stringer #4 Bolt Missing

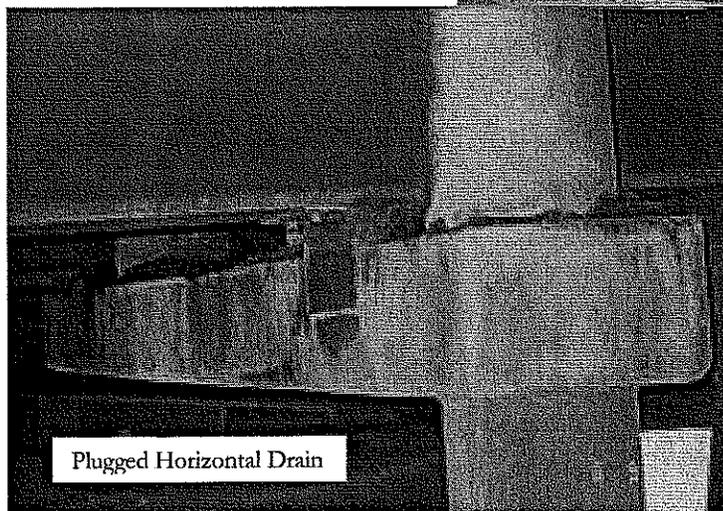
Plugged Horizontal Drain

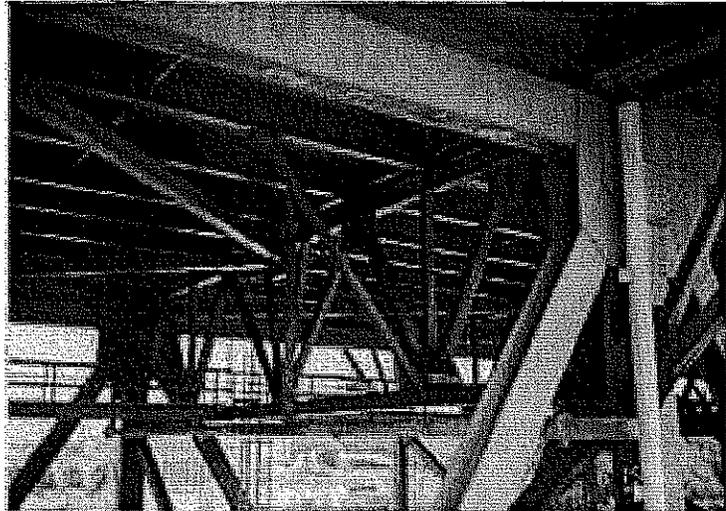
Median Drain Plugged

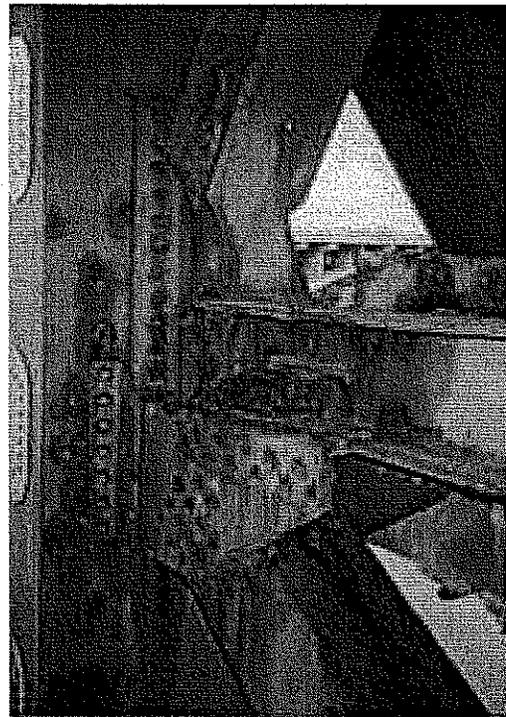
Pier consists of two concrete columns with a pier wall at the base, two “rollernest” bearing assemblies. [1997] Bearings have surface rust, moderate corrosion and show no signs of movement. Deck drain downspouts are clogged, top & bottom at median. [2004] Typical condition & rust at floorbeam connection near deck drain at connection L8.

Floorbeam Truss Condition

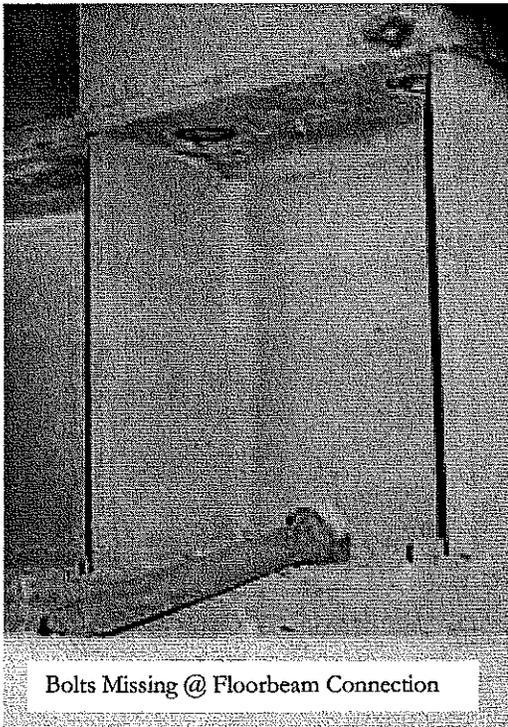
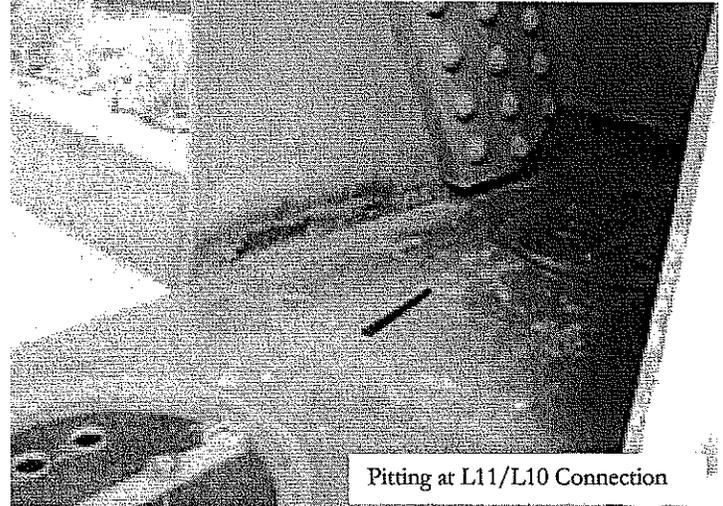
Section loss: at gusset plate bottom chord. [2004] Pitting: inside gusset plate connection at L11 toward L10. [2000/05] Stringer #3 has two bolts missing at the floorbeam connection.

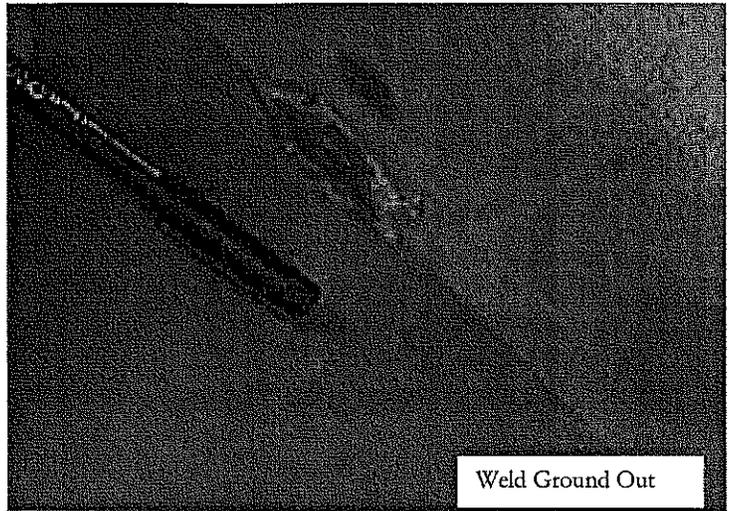
[1999] Truss bottom chord member L12/L13 has a cracked tack weld at an interior stiffener. [2004] Ground out pit from past inspection.

Weld Ground Out

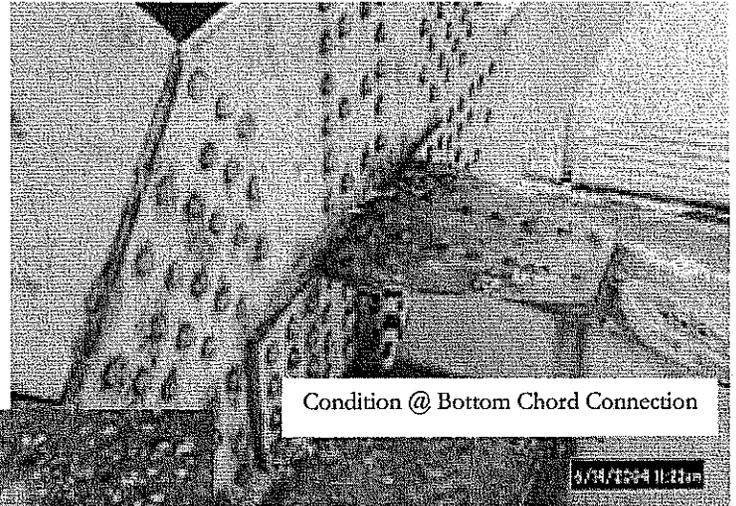
Water from deck drains fall directly into river. [1999] Truss bottom chord member L13/L14 has cracked tack welds at two interior stiffeners. [99/2002] Bottom chord gusset plate has section loss, flaking & pack rust. [2004] Bottom chord member L13/L14 has cracked tack weld at diaphragm tab. Cracked tack weld at diaphragm tab member L13/U14. See photos. [2006] Bottom chord member L13/L14 has a missing bird cover.

Condition @ Bottom Chord Connection

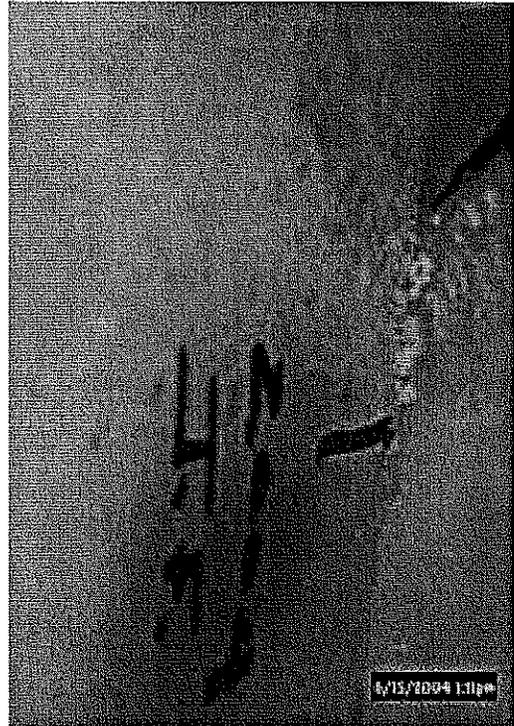
Strip seal expansion joint on the deck. Sway frame rusty. [1999] Truss bottom chord member L14/L13' has a cracked tack weld at an interior stiffener. [2002/03] Floorbeam bottom chord & middle bracing connection plate has 1/2" pack rust. Underside of the deck has 4 SF of delamination. [2004] Bottom chord member L14/L13' cracked tack weld at diaphragm tab.

Member L14/L13' Cracked Tack Weld

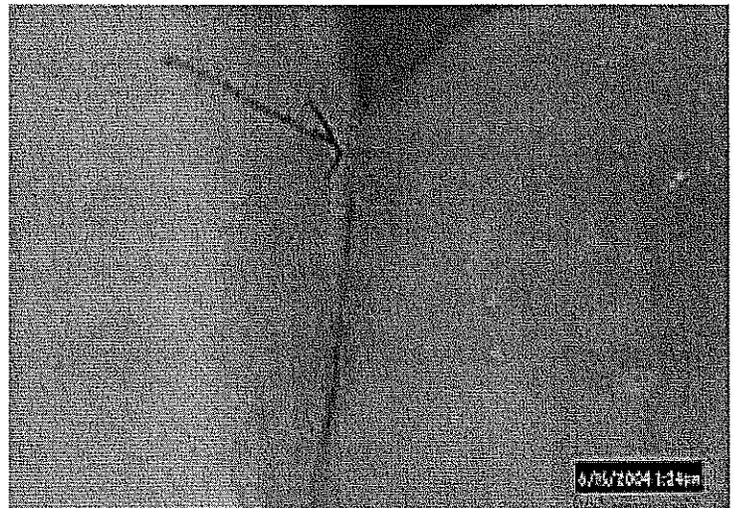
Floorbeam truss top chord has a ground out spot near stringer #4. [1996] Truss bottom chord member L13'/L12' has a cracked tack weld at an interior stiffener. [2003] Truss bottom chord connection plate has 1/2" pack rust. Underside of the deck has 20 SF of water saturation. [2004] Bottom chord member L13'/L12' has cracked tack weld at diaphragm tab.

Member L13'/L12' Cracked Tack Weld

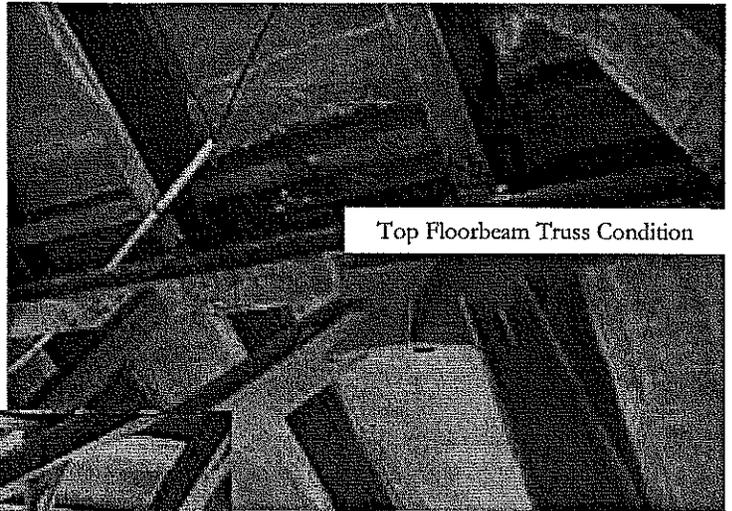
Type H: strip seal expansion joint on the deck. Truss diagonal member U4'/L3' has backer bars along the interior edges. [01/04] Strip seal has 3 LF of gland pulled out. Truss connection plates, the top chord, and floorbeam have moderate section loss, severe flaking rust. Bottom connection plates have 1/2" pack rust.

Top Floorbeam Truss Condition

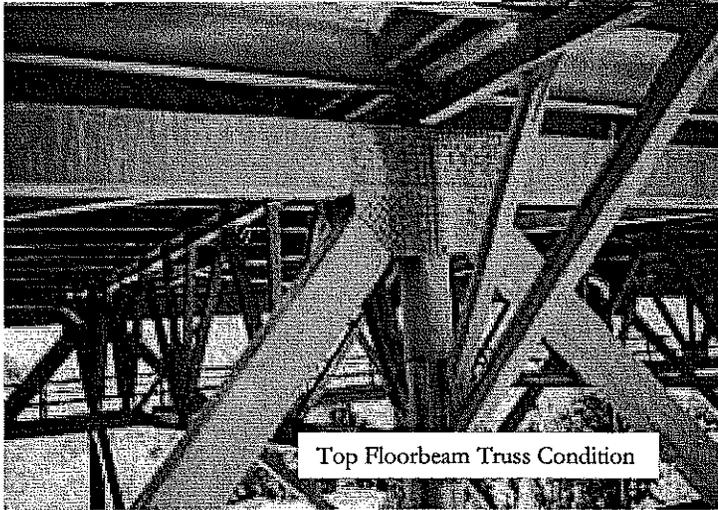
Top Floorbeam Truss Condition

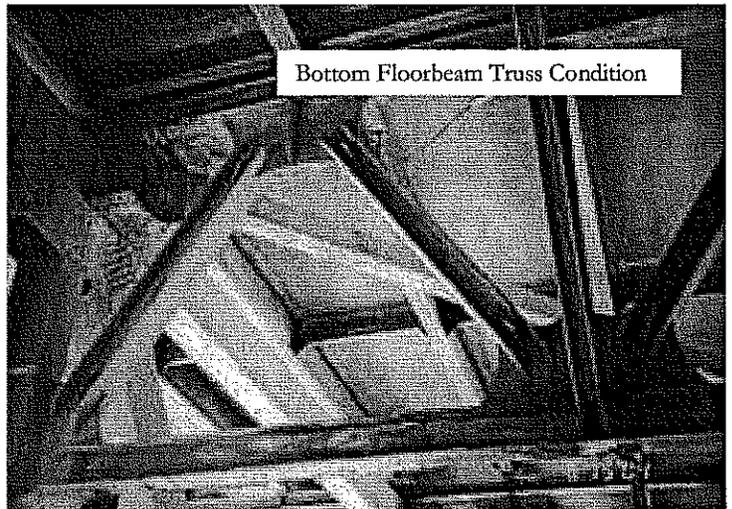
Bottom Floorbeam Truss Condition

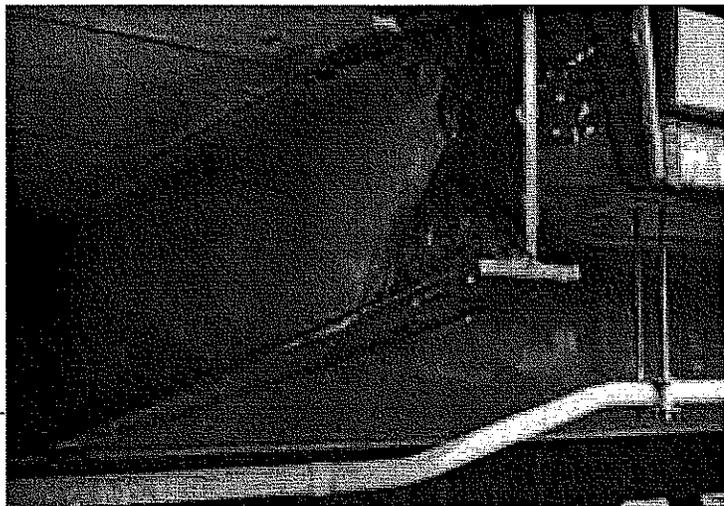
Overhead sign mounted on exterior railings. [1999] Deck in bay #3 has 100 SF of water saturation. [2003] Bottom connection plates have flaking rust. [2004] Area underneath overhead sign has 100 SF of water saturation. [2005] North support beam stringer has severe section loss at end.

North Support Beam Stringer

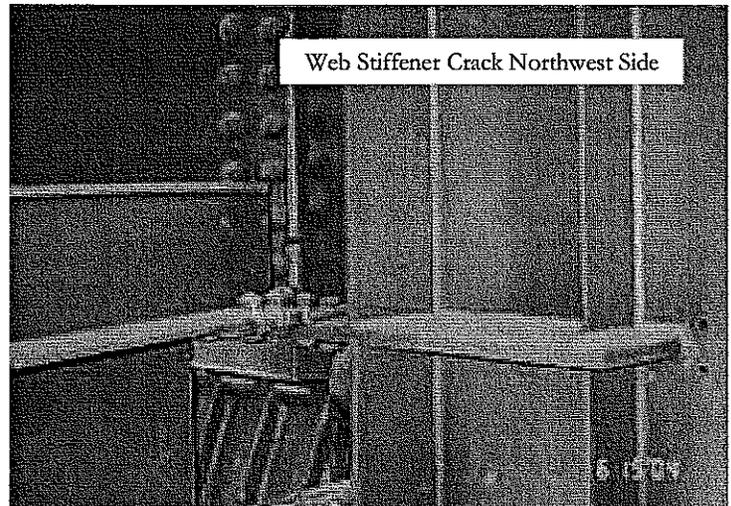
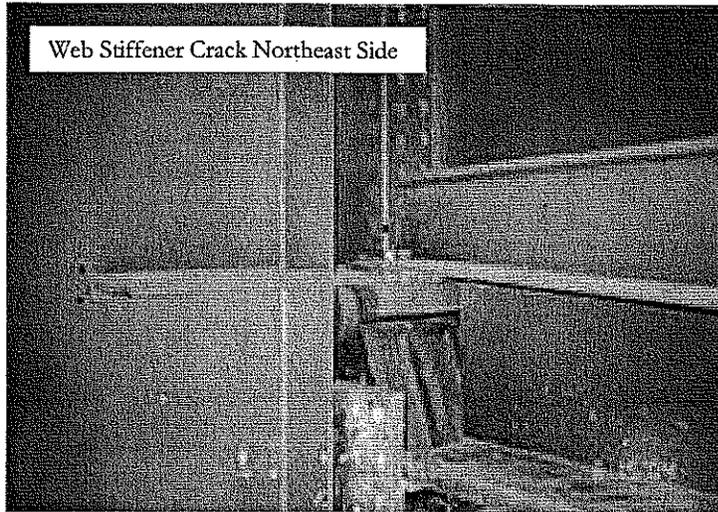
[1992] North face has crack in the crossbeam web stiffener, above the rocker at the beam #12 connection. This was drilled out. [1997/98] North face: weld above east rocker bearing, between the horizontal & center vertical stiffener, has cracked through entirely. Weld end at the crossbeam web was partially drilled out. [1998] North face has cracks at both ends of the horizontal stiffener, above rocker bearing. They were drilled out with two small holes drilled in crossbeam web at each location. Bracing installed between crossbeam, above east rocker, and beams #3 & 5. [1998/99] Crossbeam re-painted. Side facing finger joint has section loss, with pitting at base of stiffeners. [1999] Bolted connection between beam #12 and the crossbeam was re-tensioned. Connection had been “working” \*\* [2000] Gap between crossbeam & floorbeam (at rocker bearing) was 3-1/8" at 40° F. [2001003] Gap between crossbeam & floorbeam (at rocker bearing) was 3-1/2". [2005] Movement at east bearing.

Web Stiffener Crack Northeast Side

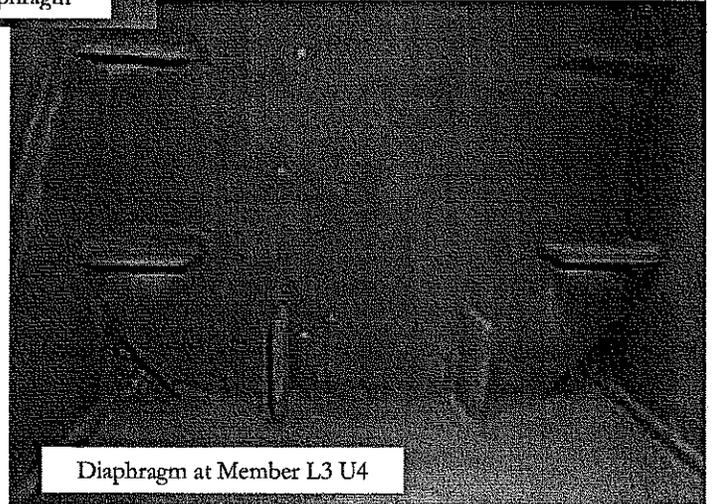
Diaphragm at Member L3 U4

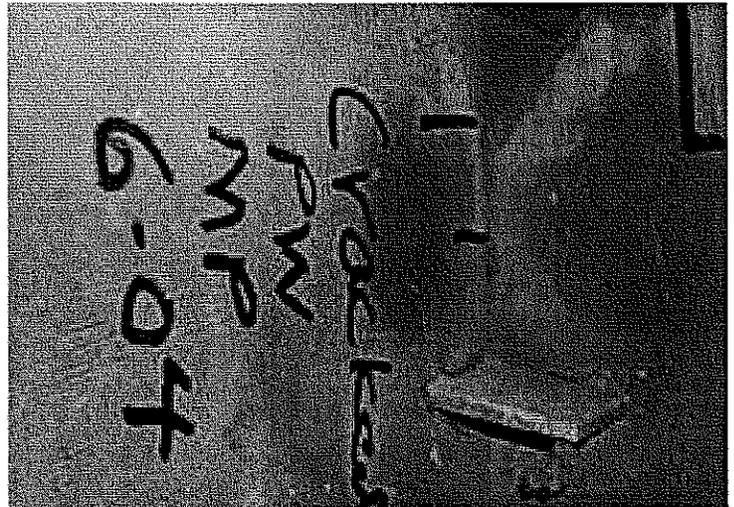
**Panel Point #12 (West Truss):**

[1996] Bottom chord member L12/L13 has a cracked tack weld at the internal stiffener. [2004] Bottom chord member L12/L13 has a cracked tack weld (diaphragm #2), (not at diaphragm tab). See photo.

Cracked Tack Weld @ Diaphragm #2

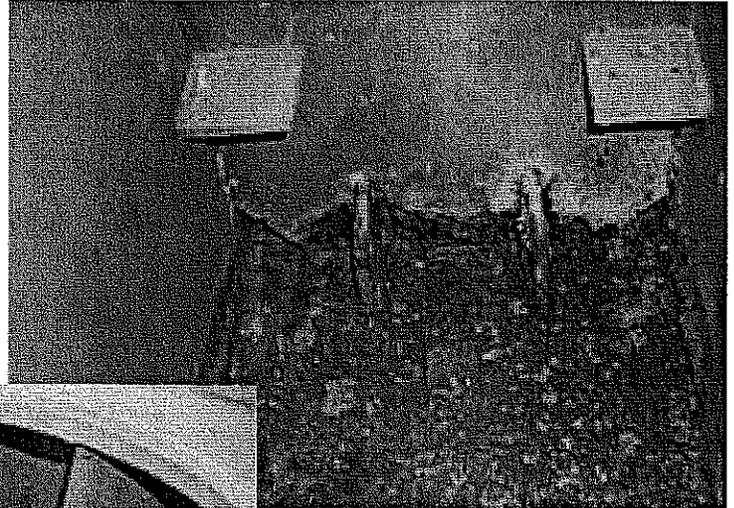
[1996/99] Bottom chord member L13/L14 has cracked tack welds at two internal stiffeners [1999] Truss bottom chord/sway frame connection plates have 3/4" pack rust. [2004] Diagonal L13/U14 has corrosion from deck drain. Cracked tack weld (not at diaphragm tab). Cracked tack weld: (diaphragm #3), (not at diaphragm tab), (entire tack weld broken cleanly).

L13/U14 Corrosion @ Diaphragm

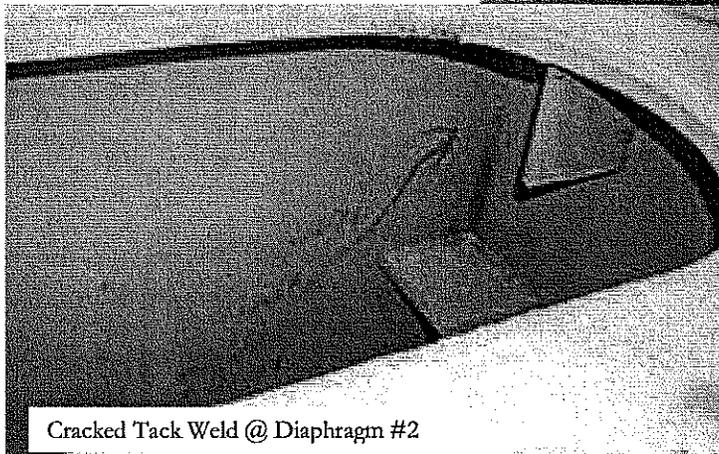
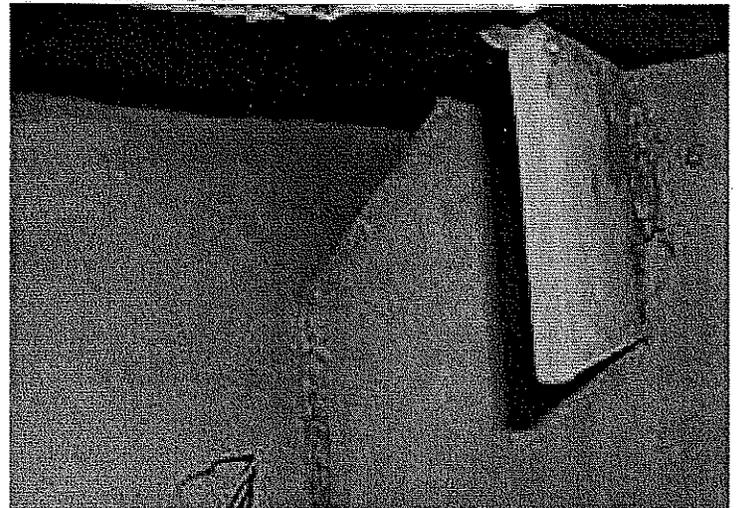
Cracked Tack Weld @ Diaphragm #2

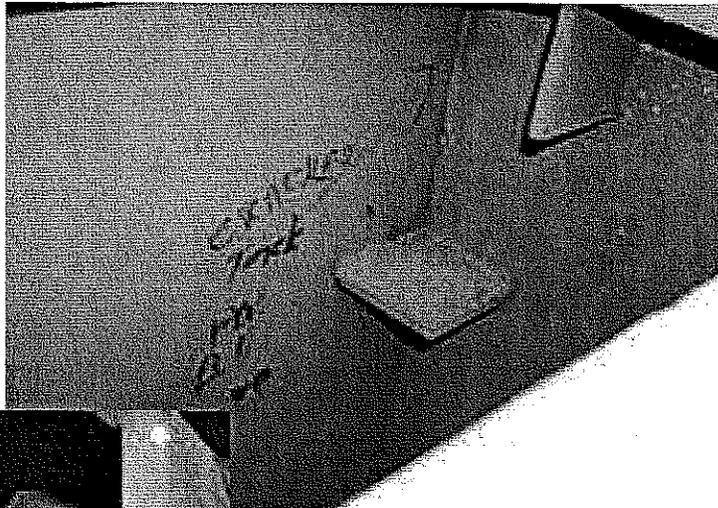
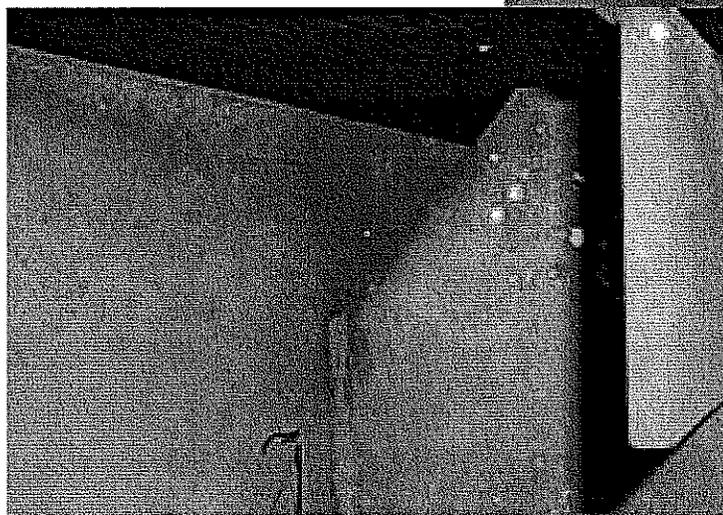
Cracked Tack Weld @ Diaphragm #3

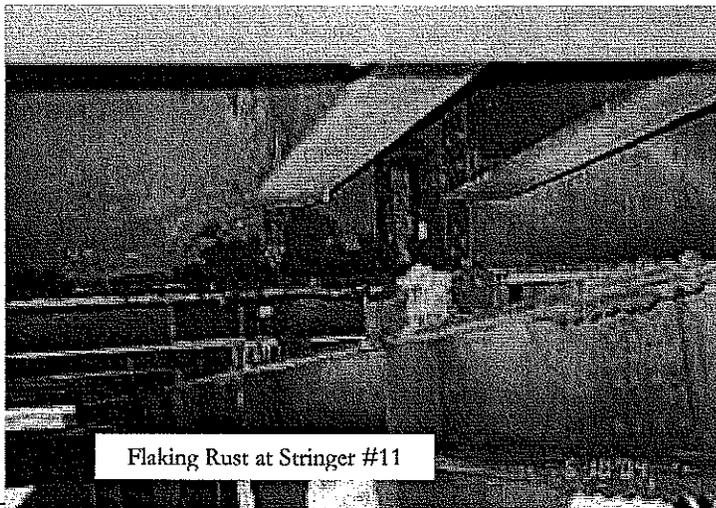
**Panel Point #14 (West Truss Midspan Stringer Joint):**

Type H: strip seal deck joint above. Deck drains on both sides. [1994] Stringer #11 has section loss, flaking rust near the joint from gland pulled out above. Tack welds along the sway frame/truss, bottom chord, and gusset plate. [1999] Bottom chord member L14/L13' has a cracked tack weld at an interior stiffener. [2003] Stringer #14 connection, south side of the floorbeam, has a cracked tack weld. [2004] Bottom chord member L14/L13' has internal tack welds (full length) at interior diaphragm. Upper chord member U14/U13' has corrosion from deck drain. See photo. [2005] Strip seal gland has 10 LF pulled out. [2006] Reversible diagonal member U14/L13 has section loss with severe flaking rust.

Flaking Rust at Stringer #11

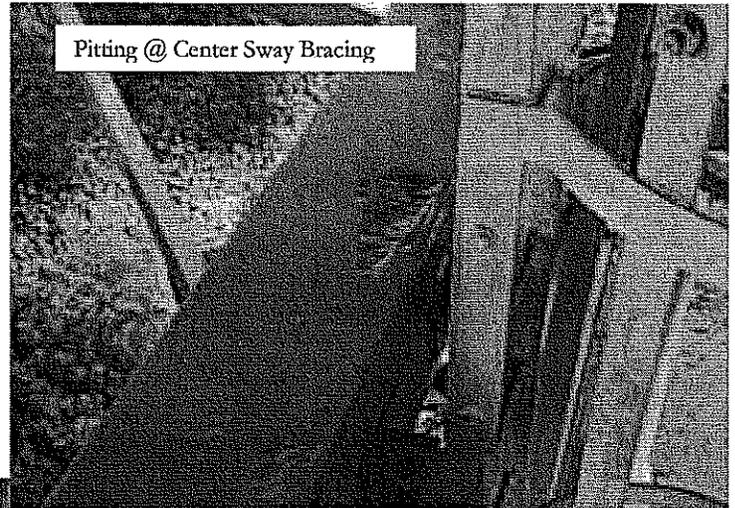
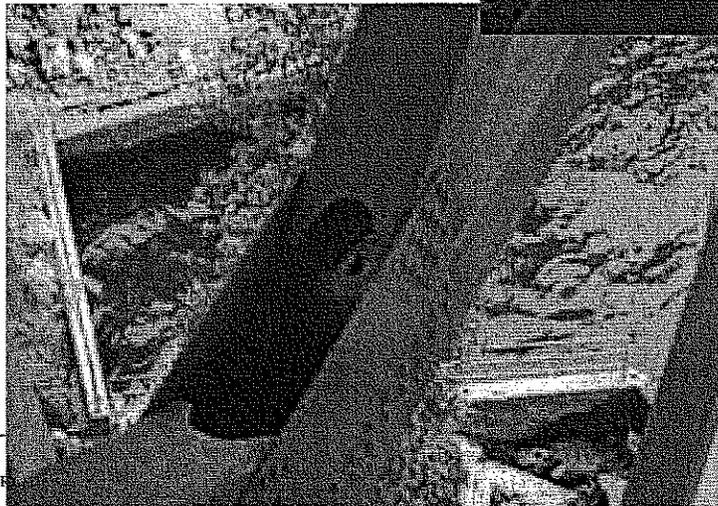
**Panel Point #8' (West Truss Pier #7 Stringer Joint):**

Type H: strip seal deck joint above. [1996] Below stringer #13, the diagonal brace between top and bottom chord of the floorbeam truss is bent, from original construction. [1998] Stringer #11: bolt replaced at floorbeam truss connection. [2001] Truss bottom chord/sway frame connection (gusset plates) has section loss with heavy flaking rust. [2002] Truss bottom chord, L8'/L9', has section loss with heavy flaking rust. [2004/05] Sway bracing center horizontal has 3" x 8" severe pitting & 1/2" diameter hole; bottom sway bracing has a 2" x 3" hole between stringer #11 & stringer #10. See photos. [2005] Strip seal gland has 5 LF pulled out & is leaking onto the crossbeam below, between stringer 10 & 11.

Hole in Bottom Member of Sway Bracing

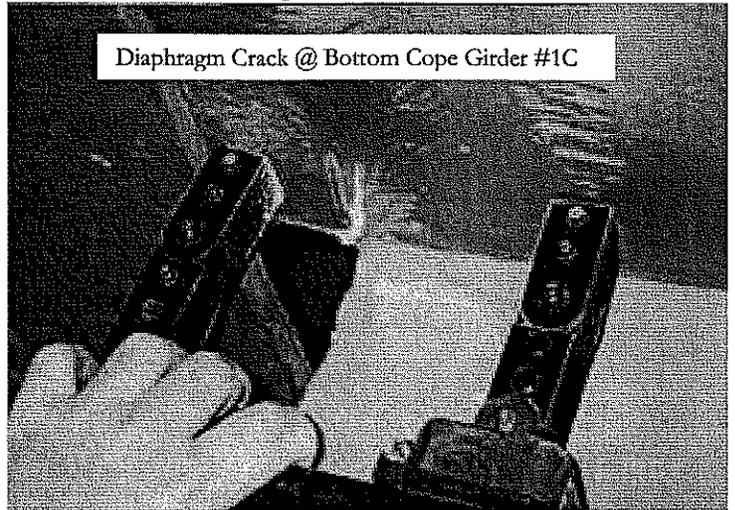
Diaphragm Crack @ Bottom Cope Girder #1C

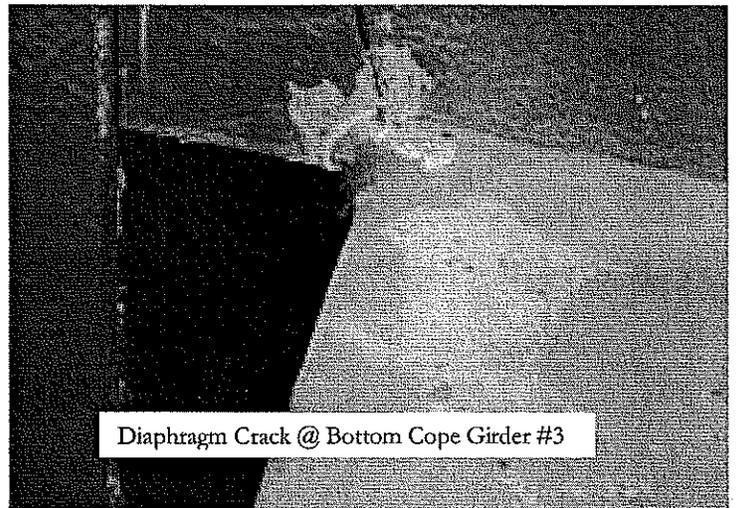
Diaphragm Crack @ Bottom Cope Girder #3

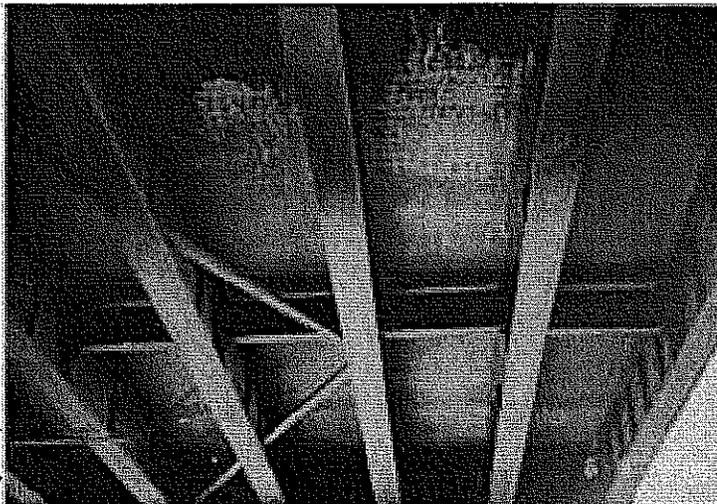
Water Saturation SB Bays 12, 13 & 14

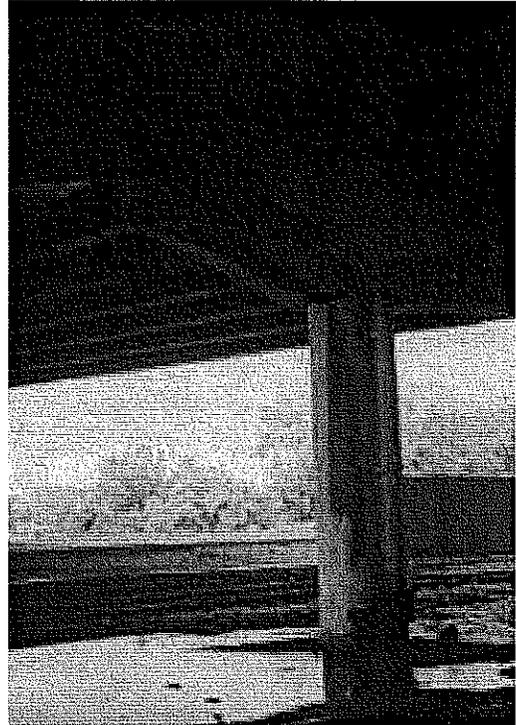
**Pier #9:**

Plate bearing assemblies have 13 fixed, and four sliding. Pier consists of four columns and cap, with a railroad crash strut between the columns. 2 Deck drain: downspouts. [1969] East column damaged by train derailment: the column has minor scrapes and spalls, downspout had to be reconnected. [1999] Bearings 9, 10, 11, &. 12 were re-painted. [2004/05] West vertical & median deck drain plugged.

Median Drain Plugged Pier 9

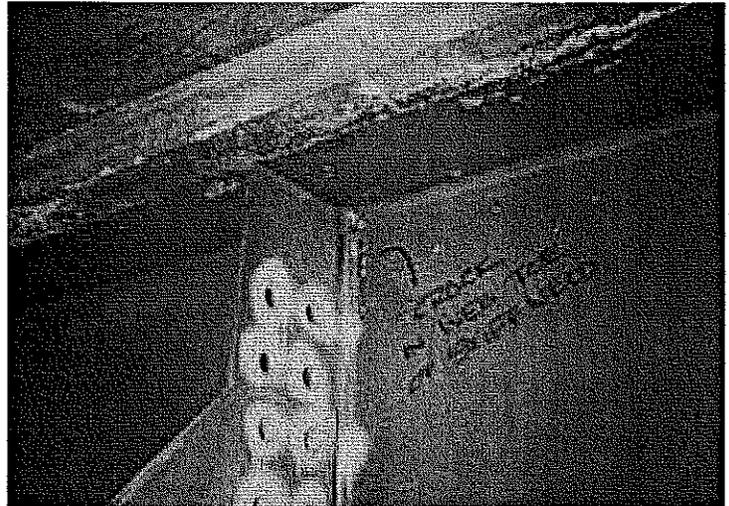
Girder #10 Vertical Stiffener/Girder Web

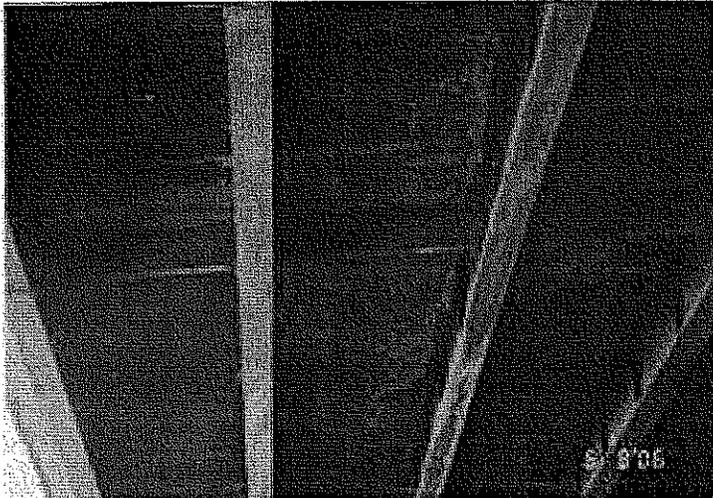
Water Saturation NB Bays 5, 6 & 7

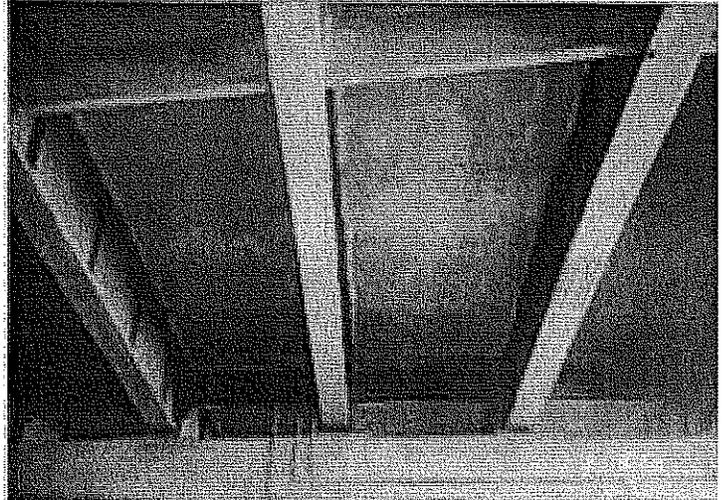
Span is 68 ft. long with 18 steel beams. Northbound has 11 beams; southbound has 7 beams, and the parking lot below. [1999] Beams 9, 10, 11, & 12 were re-painted. Connections welded to top flange. Diaphragms were inverted & lowered, even though the beam connections have "positive moment" configuration. [2003] Conduit: east side bottom of deck. [2004] 50 SF of water saturated deck underneath.

Water Saturation SB bays 15 & 16
