LEGACY FUND RESTORATION EVALUATION REPORT

Technical Panel Findings and Recommendations—Fiscal Year 2015

Report to the Legislature

October 2016

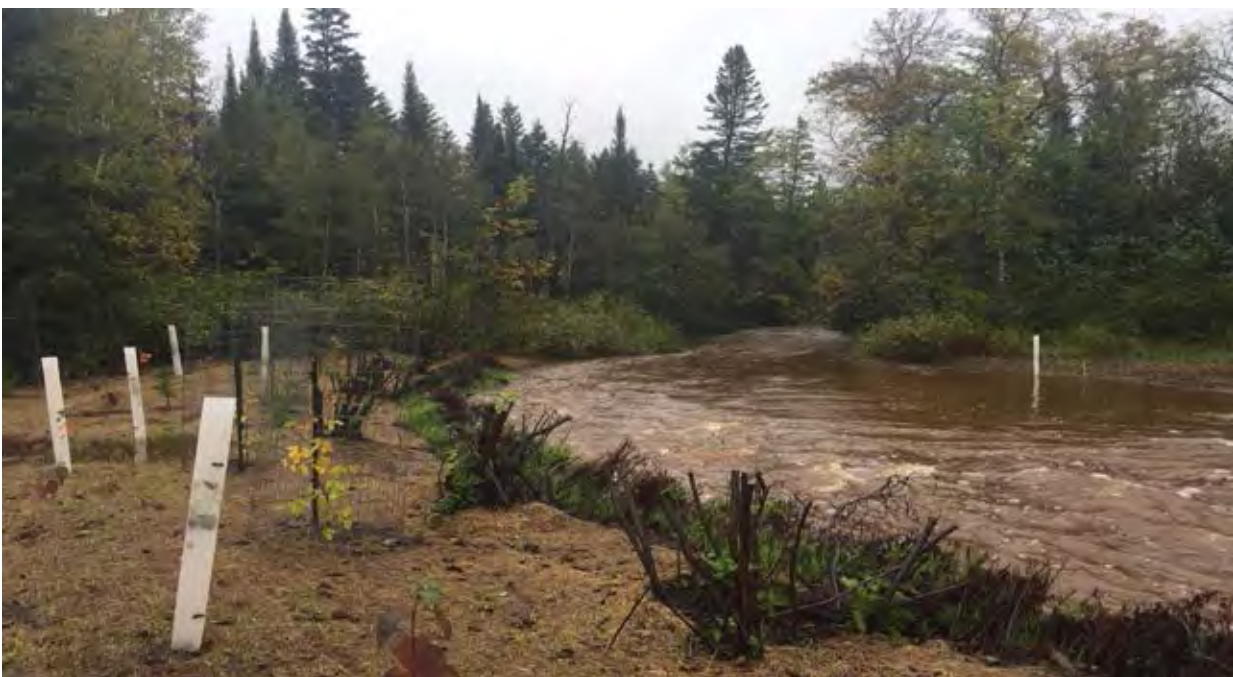
Figure 4 - Representative image of toe wood (near bank) and onsite transplants (near bank) along with the tree and shrub plantings with browse protection.

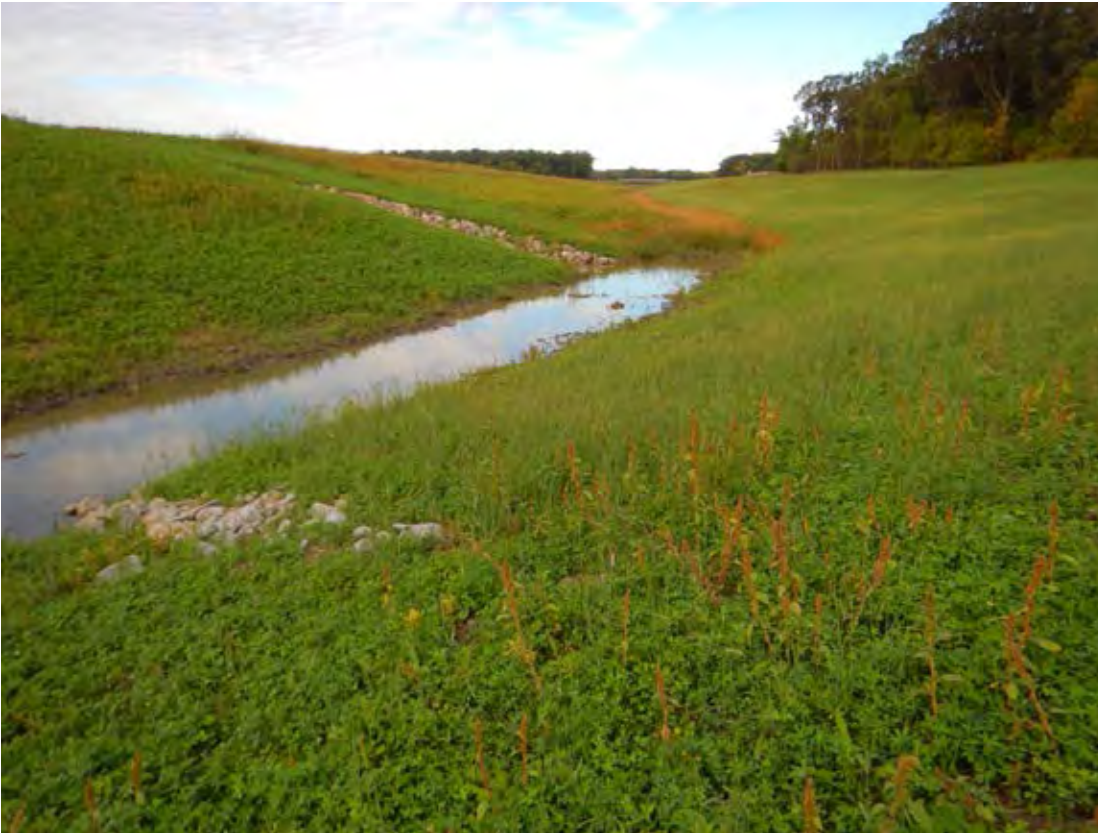
CC Photo 1: Stabilized slopes immediately south of Diversion Structure.

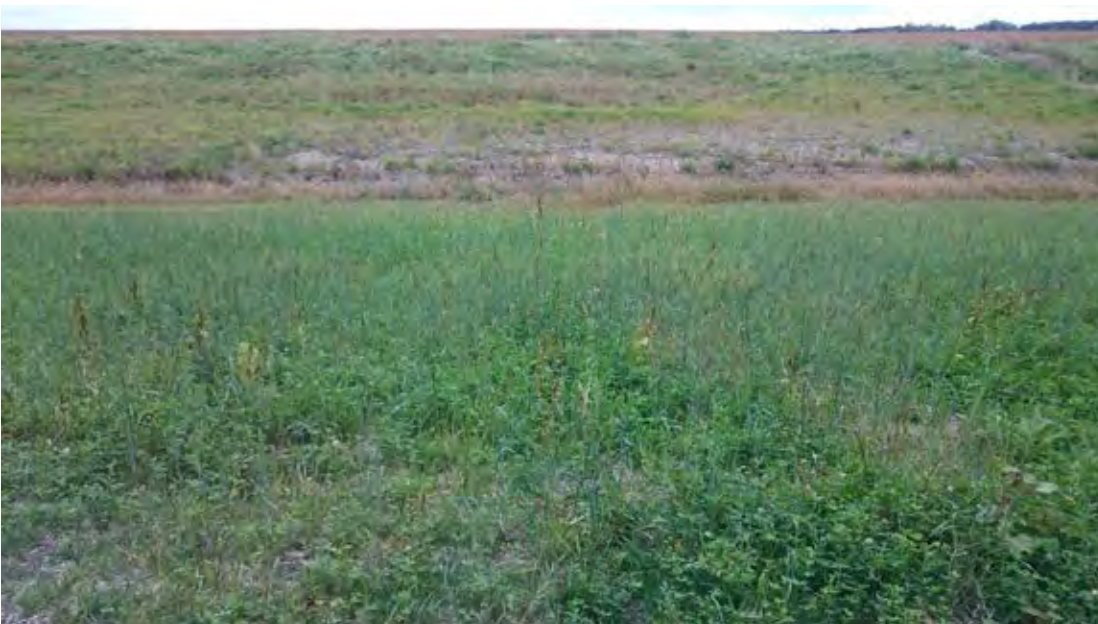
CC Photo 2: Stabilized slopes along upper channel. Note erosion at lower elevations near water level.

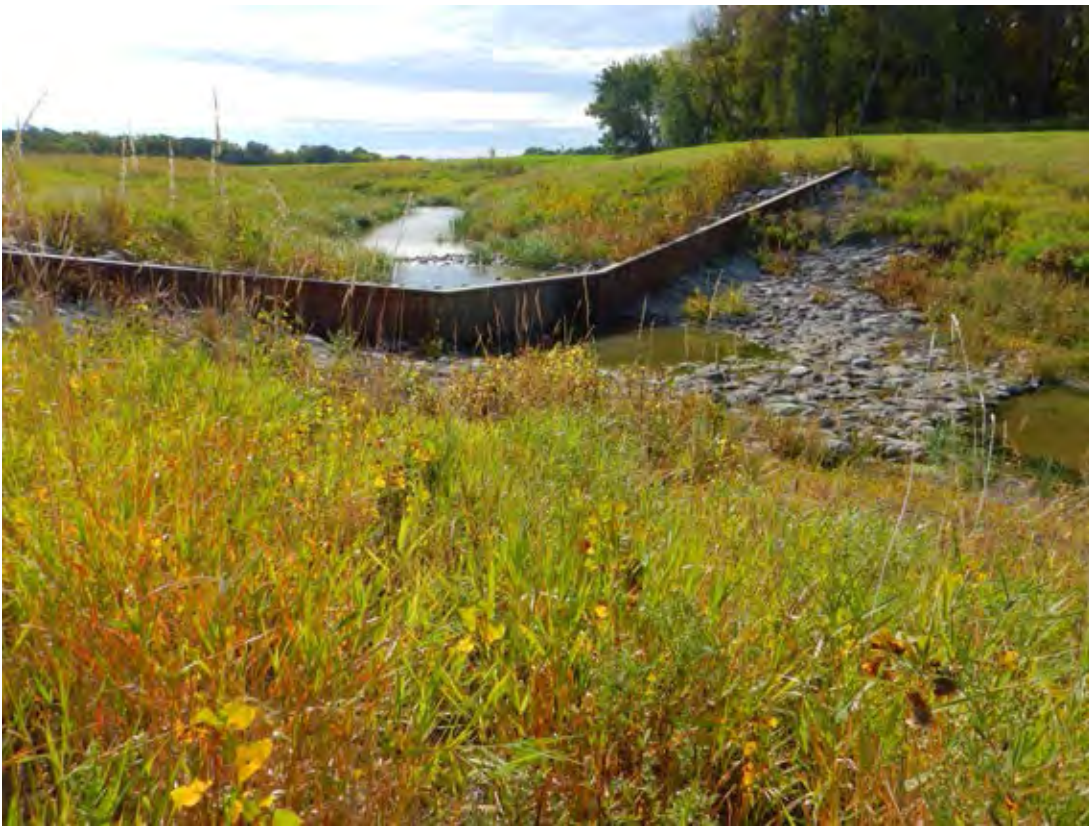
CC Photo 4: Upper grade control structure.

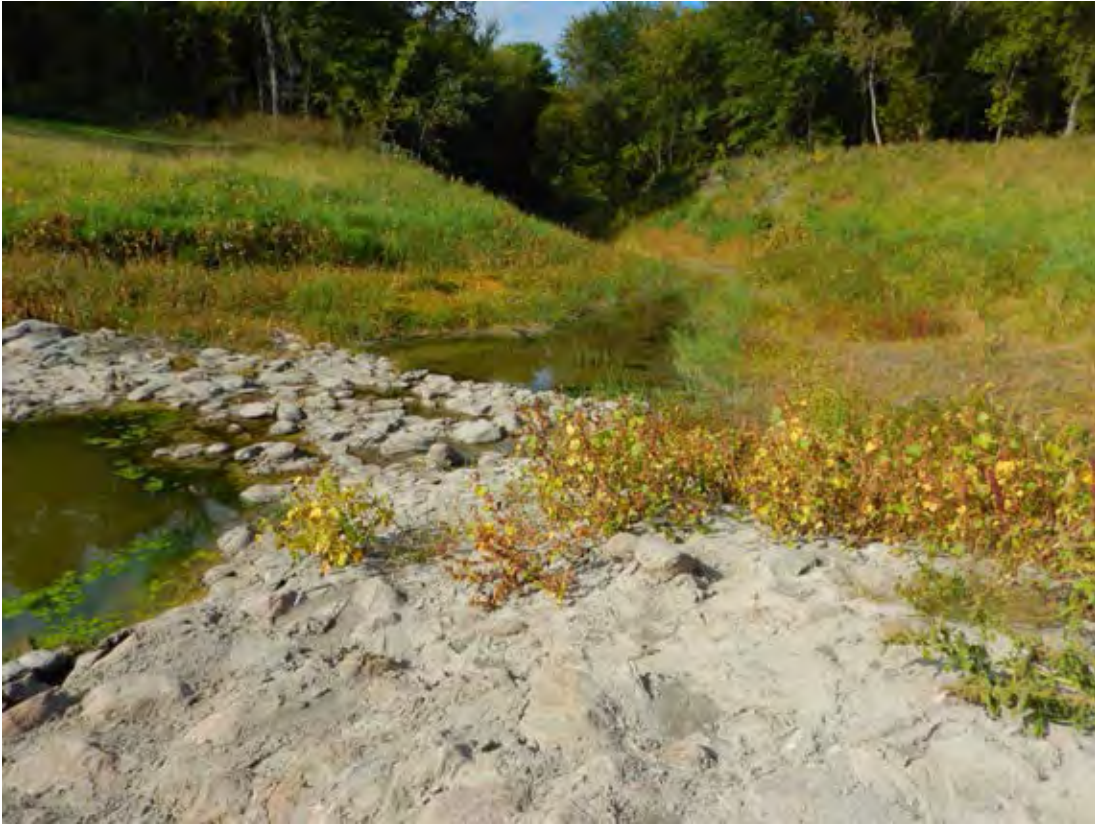
CC Photo 5: Immediately downstream of upper grade control structure.

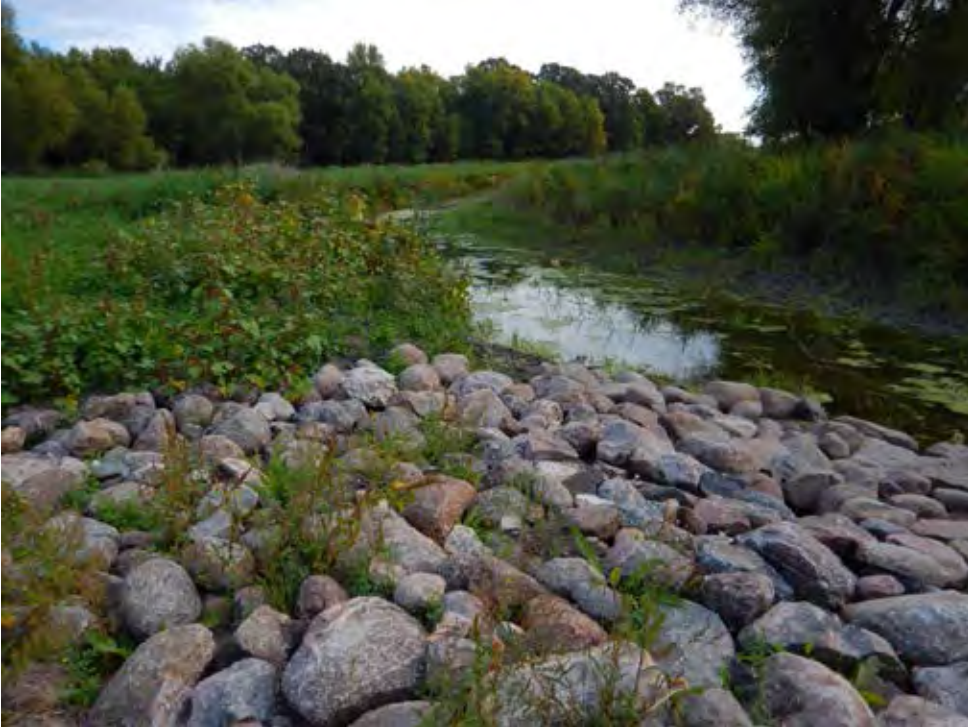
SR Photo 1: Grand Marais Creek at location of Diversion Structure.

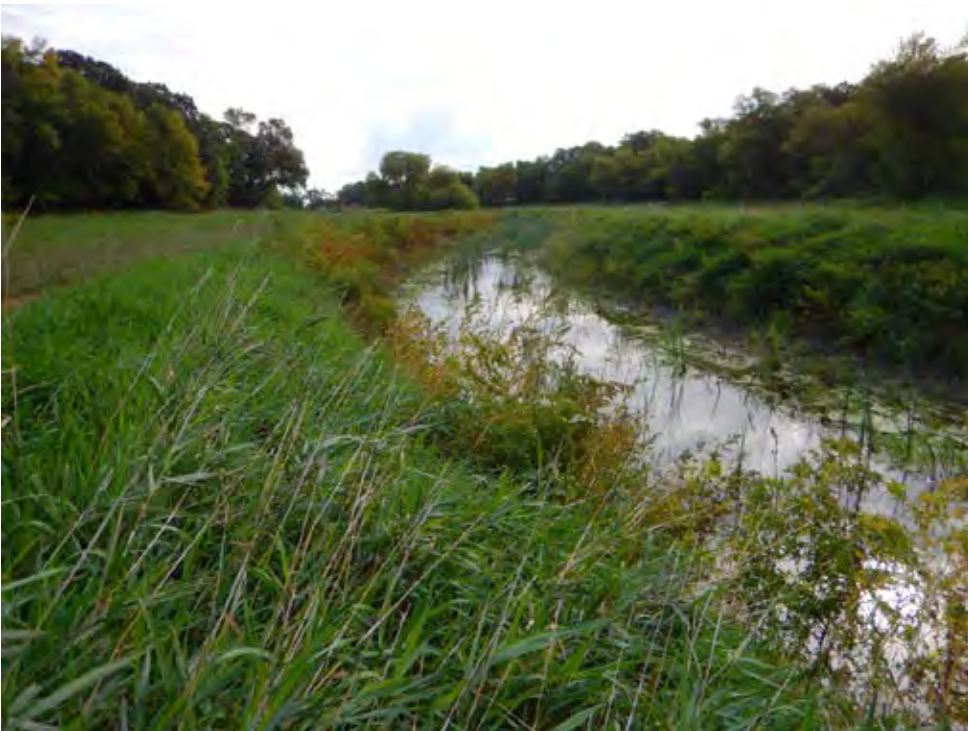
SR Photo 2: Vegetated slopes in upper project area immediately downstream of Diversion Structure.

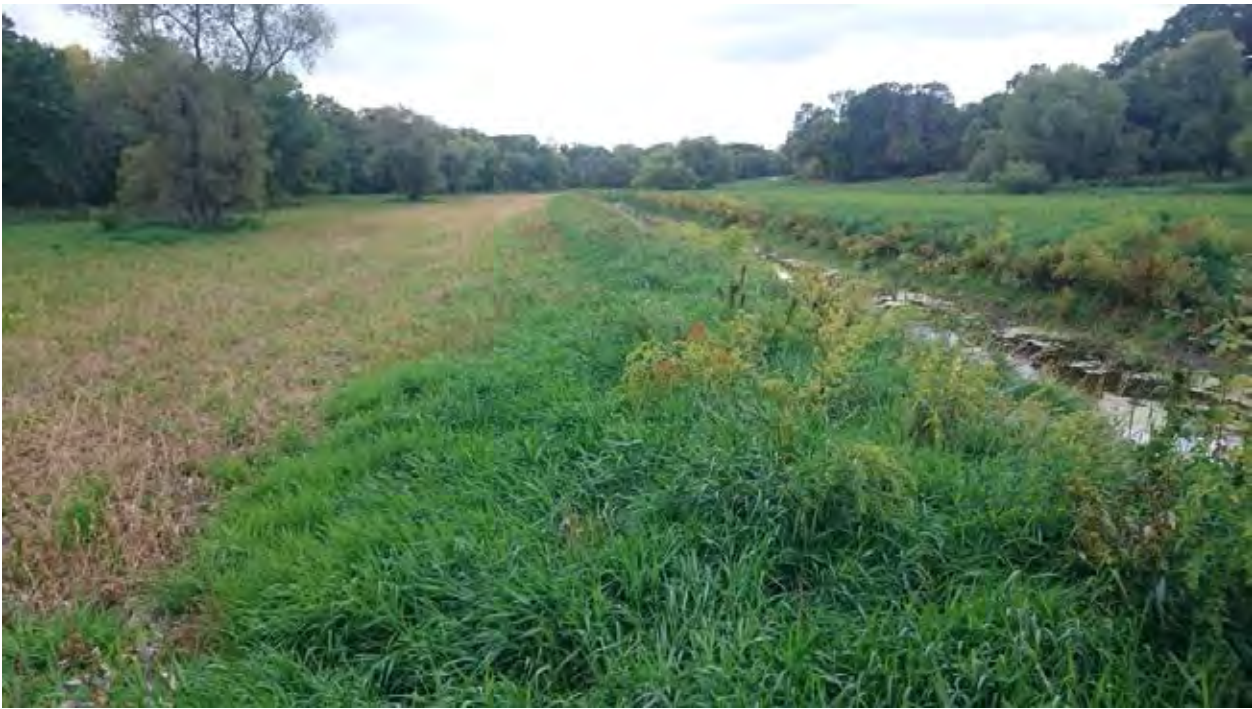
SR Photo 4: East bank immediately downstream of Diversion Structure.

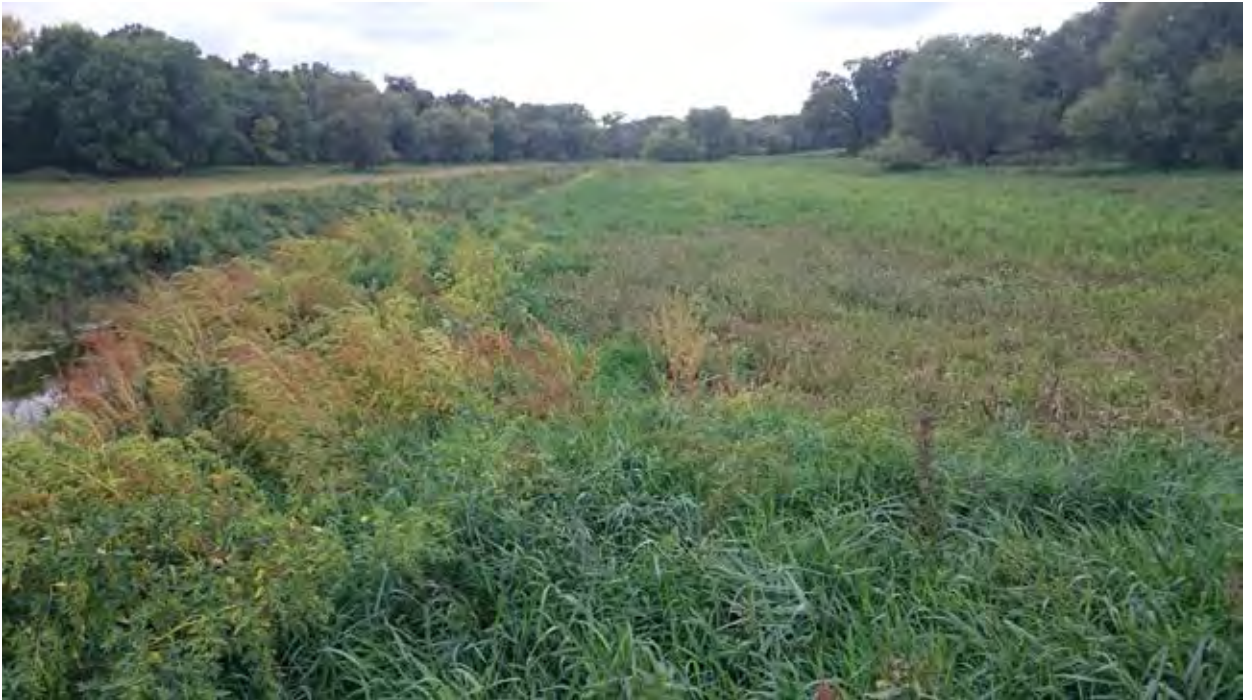
SR Photo 5: West bank immediately downstream of Diversion Structure.

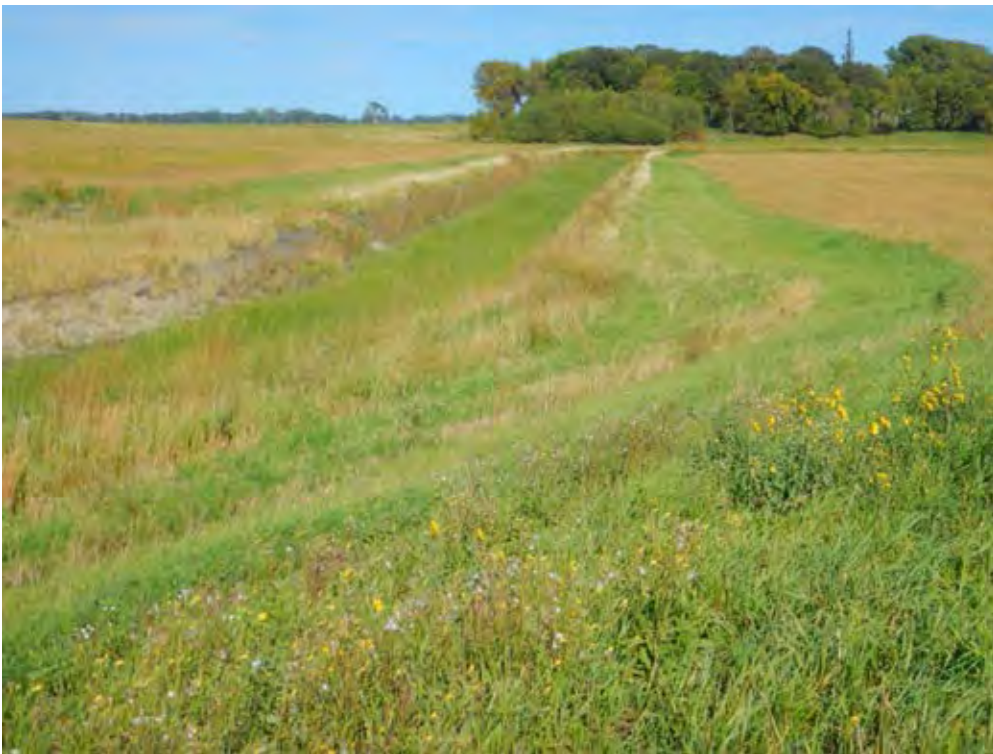
SR Photo 6: Constructed Channel. Upper areas seeded to “Special Seed Mix.” Lower slopes not seeded, channel dominated by Hybrid Cattail.

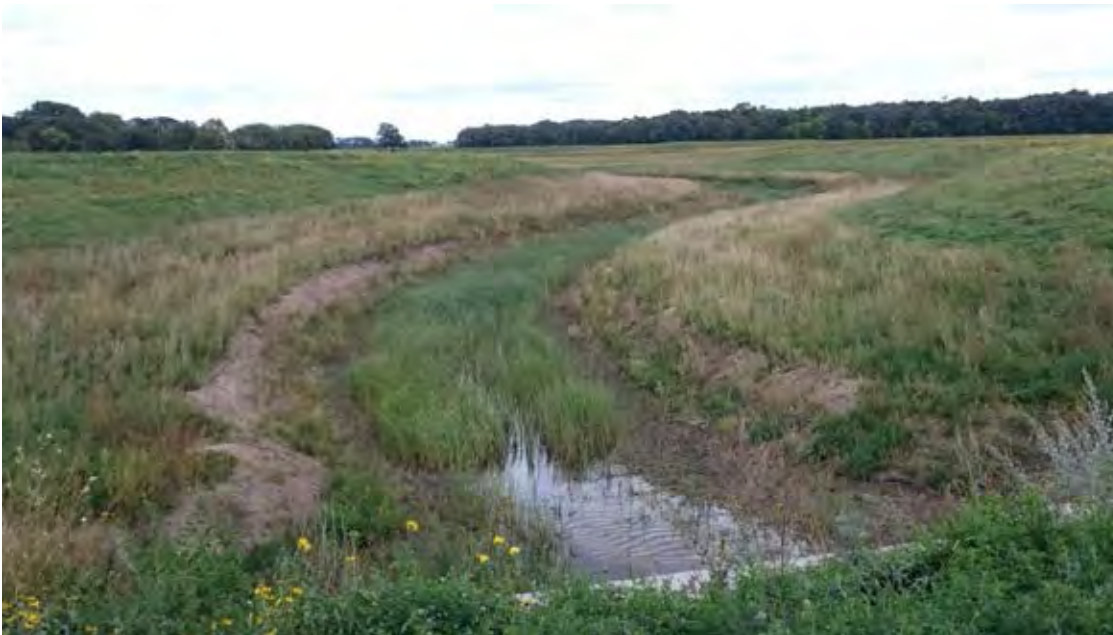
SR Photo 8: Constructed Channel looking east from 470th Avenue NW. Seeded upland, unseeded channel.

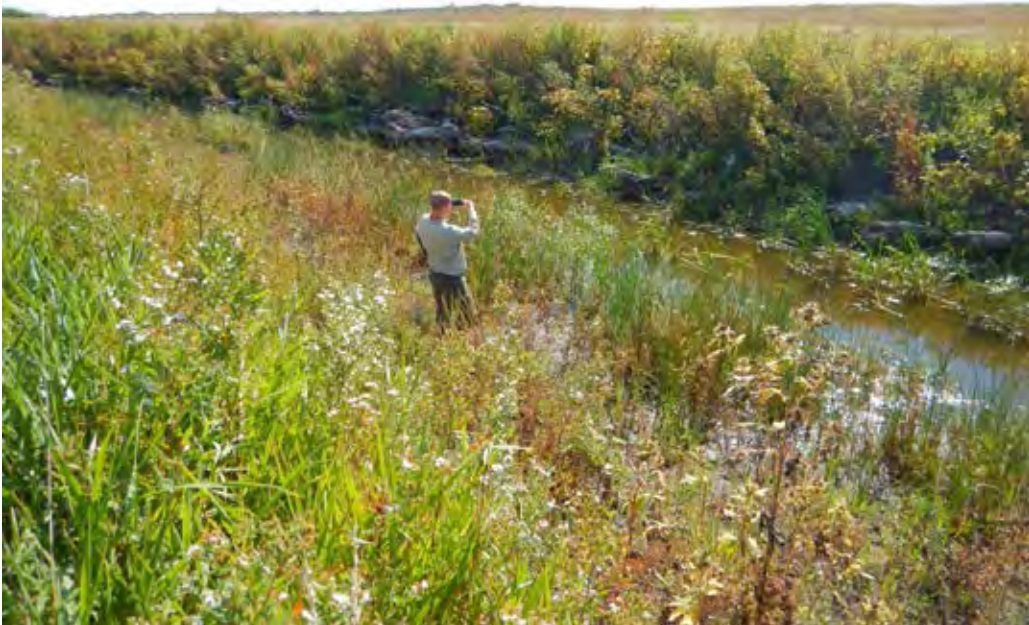
SR Photo 10: Constructed Channel. Toe wood treatment on opposite bank.

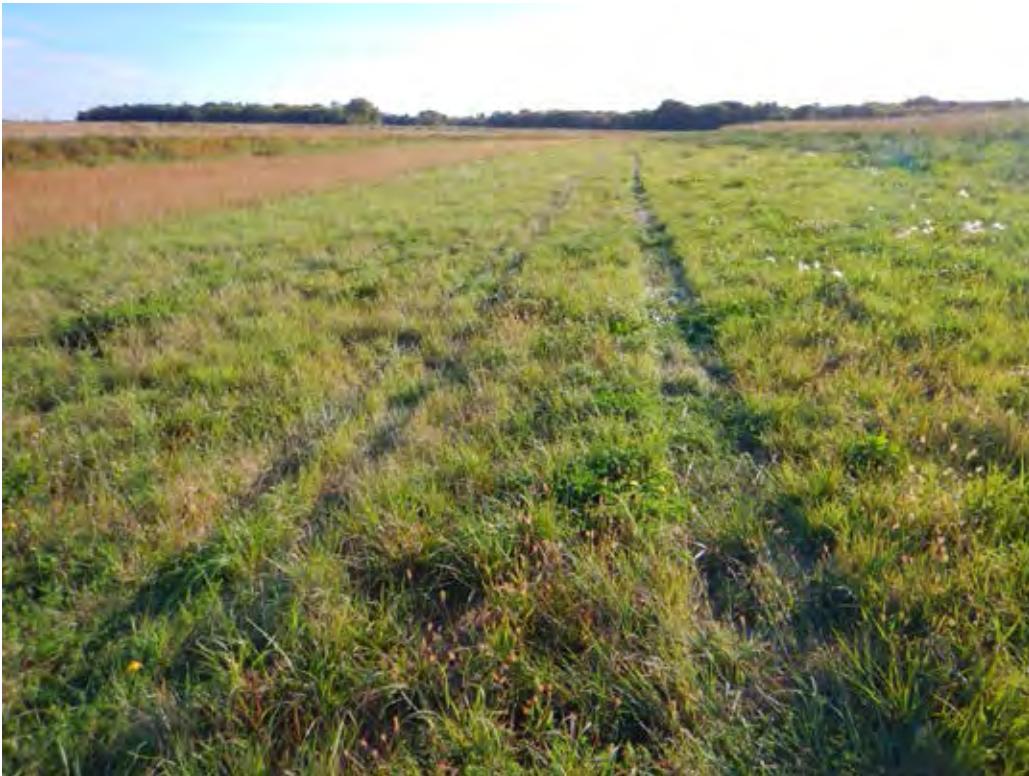
SR Photo 11: Seeding areas above the channel restoration. Note three zones of seeding. Appears to have been seeded at different times with very different species composition.

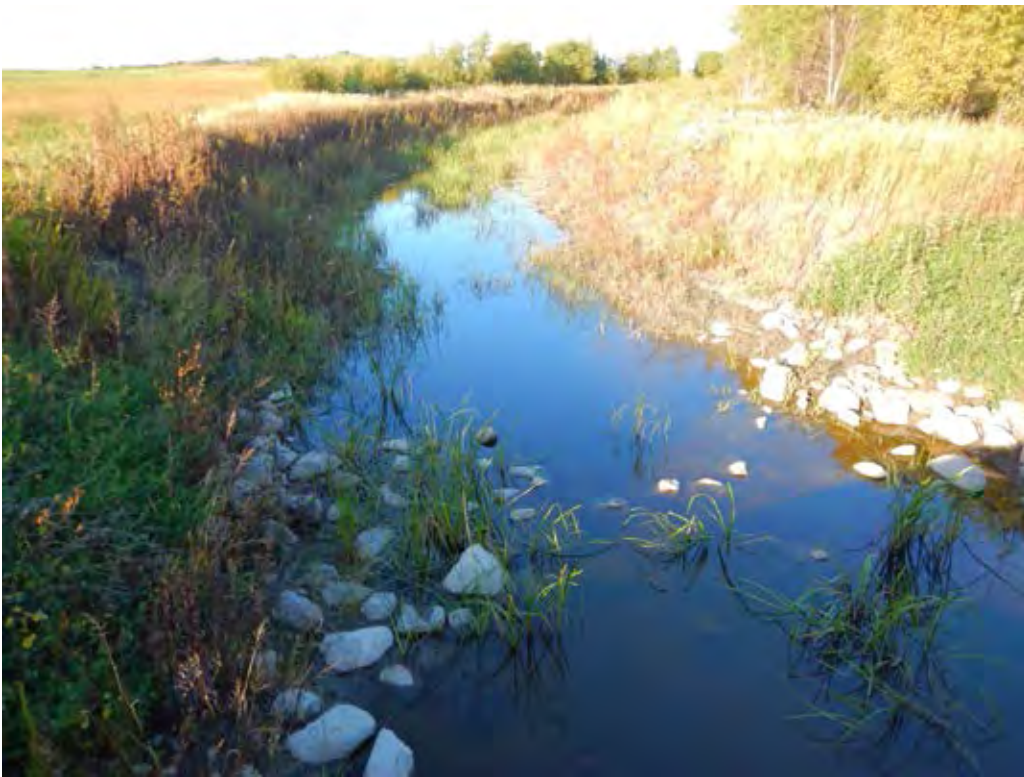
SR Photo 12: Ellipse Channel Riffle at 171+25. Vegetation is volunteer.

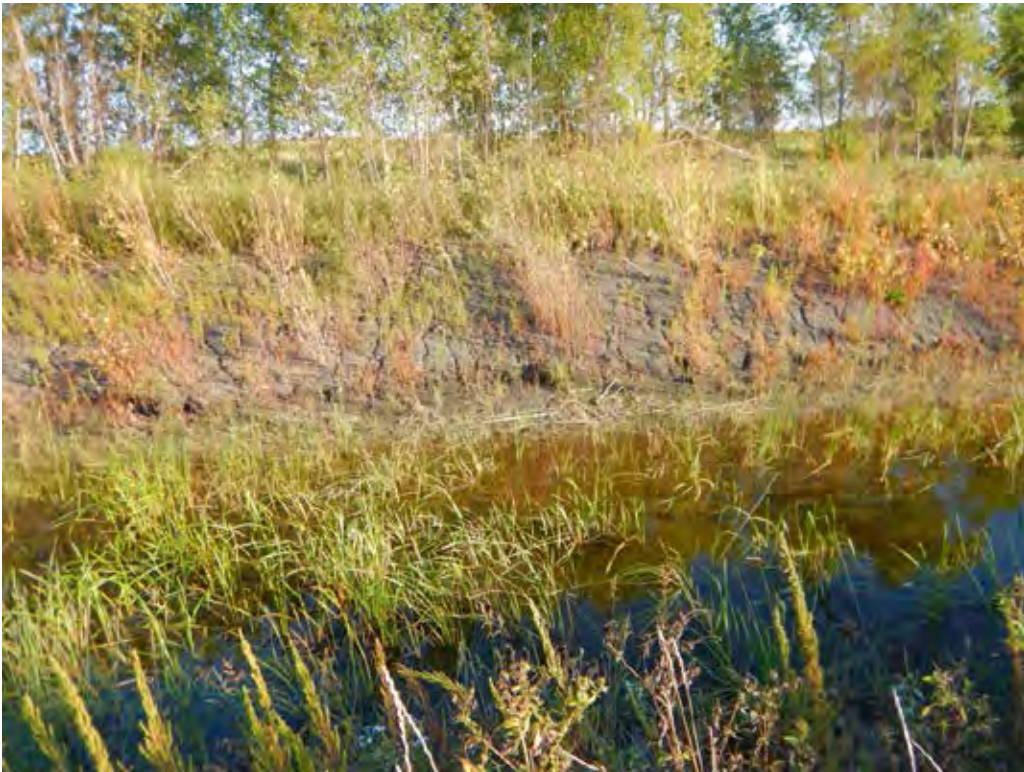
SR Photo 13: Unseeded slope at excavated channel.

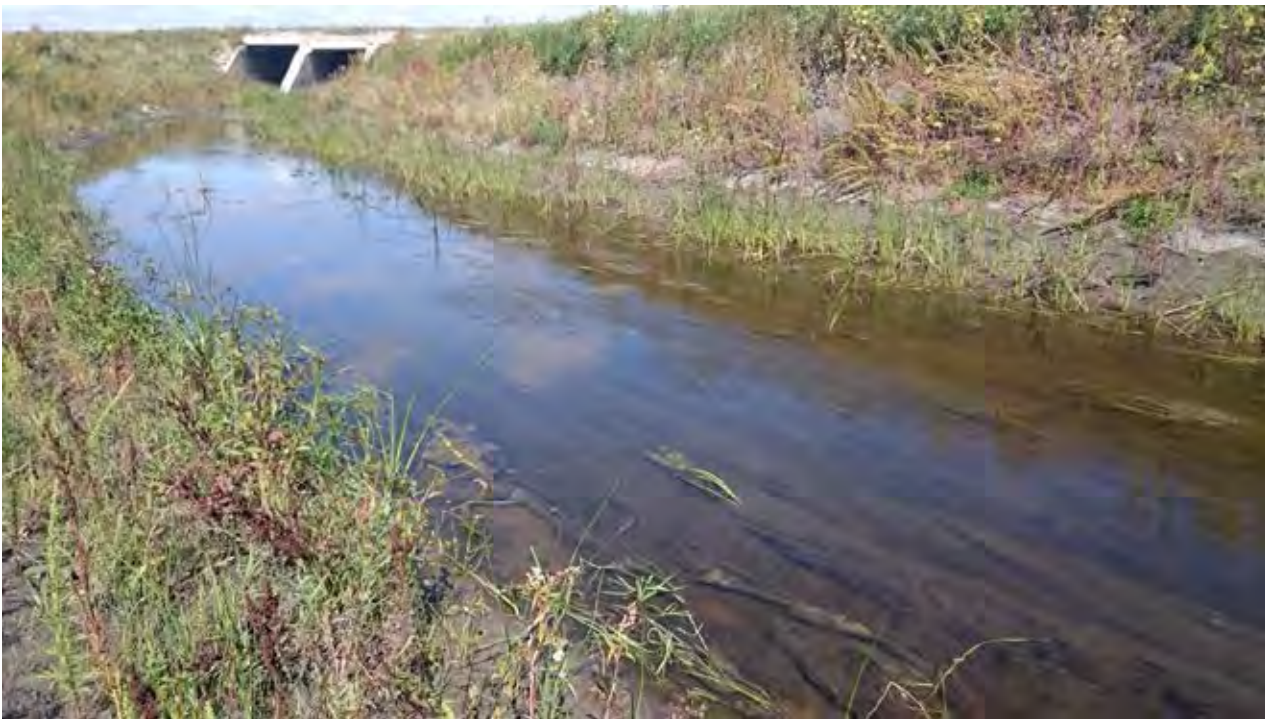
SR Photo 18: Stream channel upstream of the road crossing at 130th St. NW.

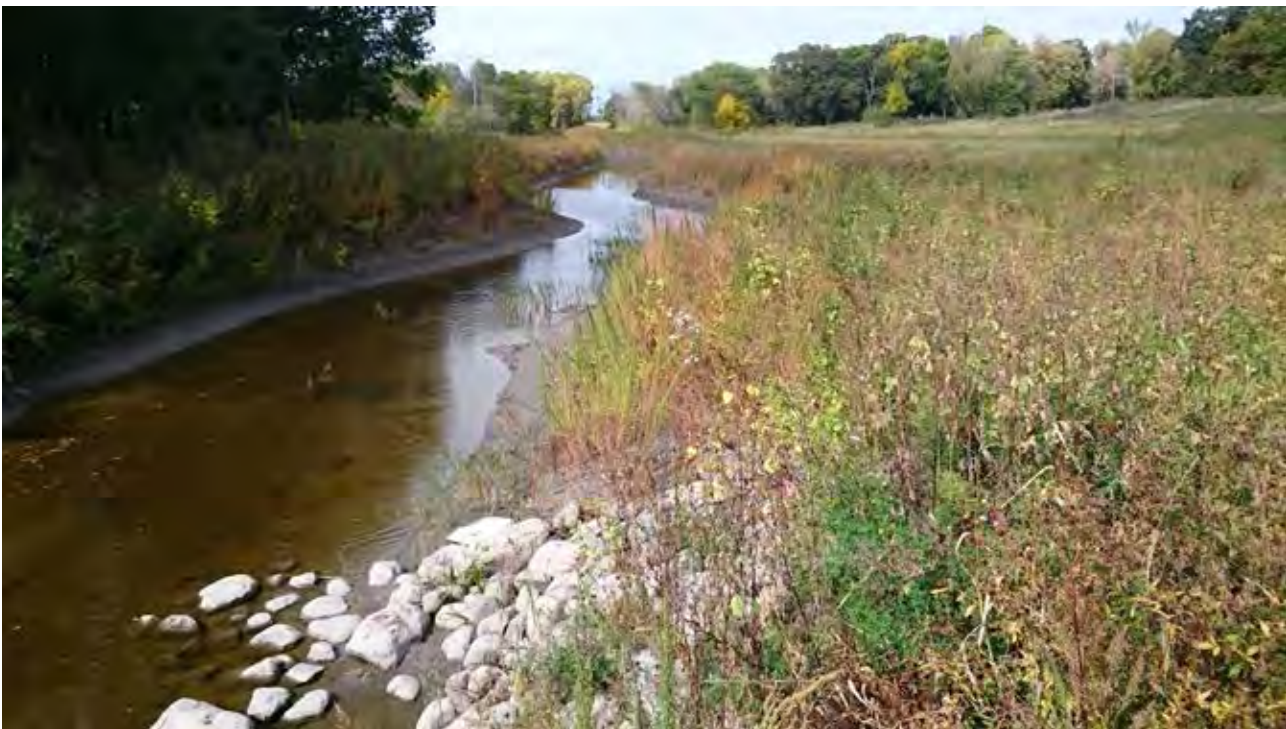
SR Photo 23: Riffle Boulder Vane below railroad car bridge.

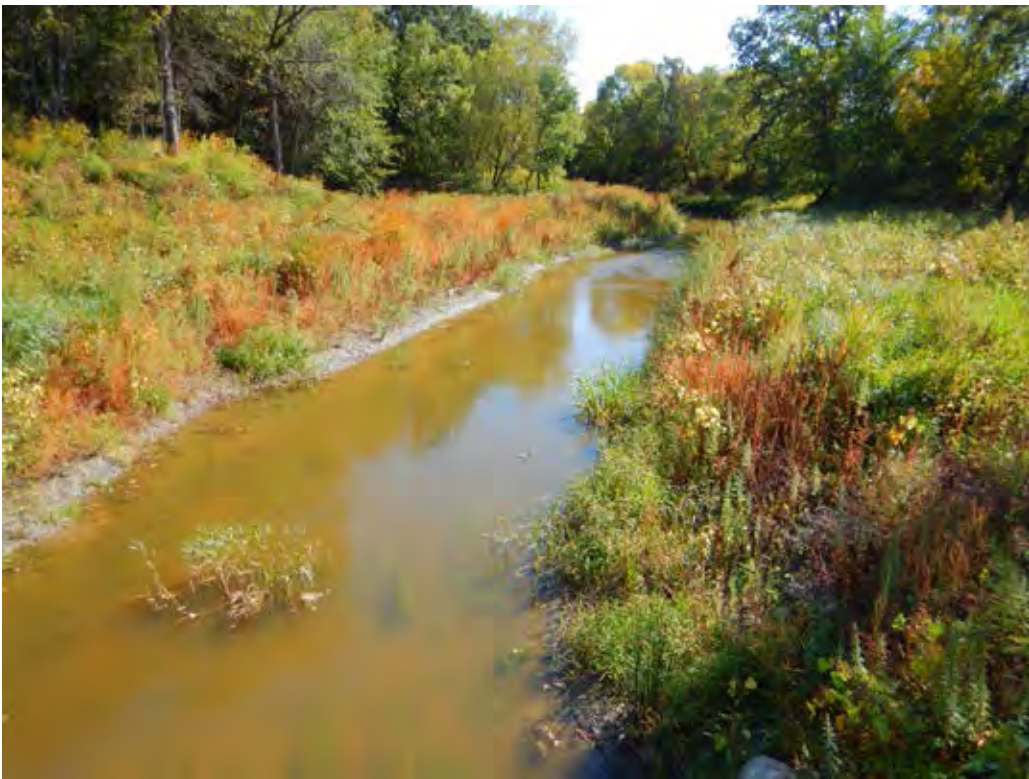
SR Photo 26: Graded channel in cleared woods. Annual pioneer species dominate.

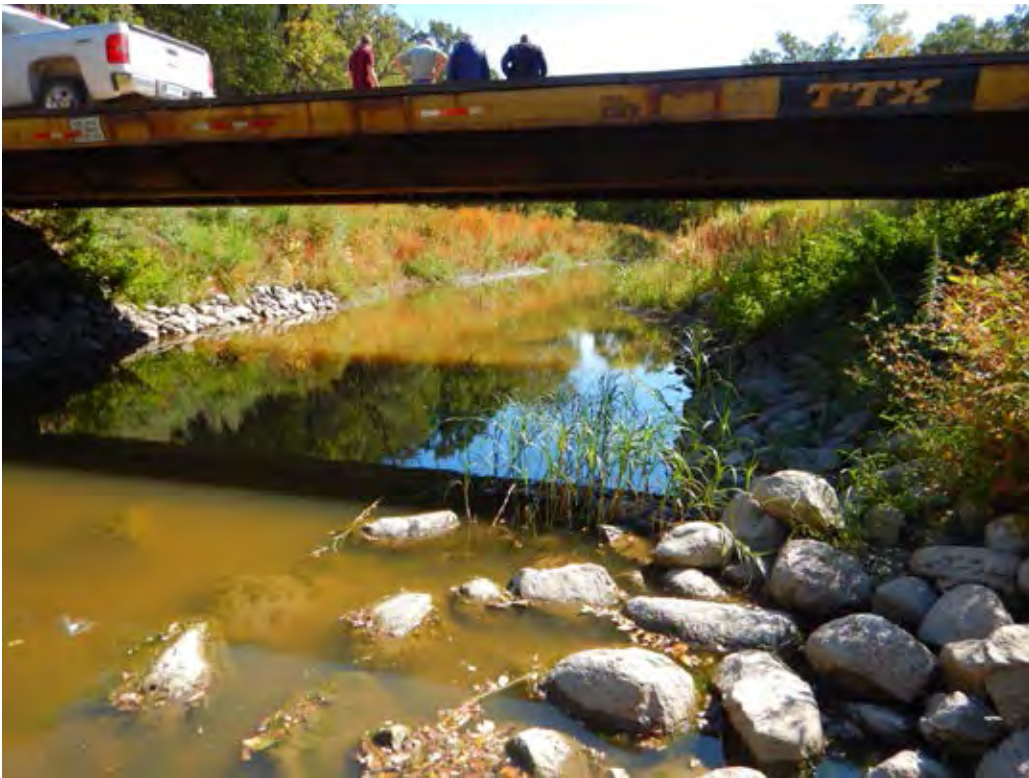
SR Photo 27: Railroad car bridge with Boulder Vane in channel below.

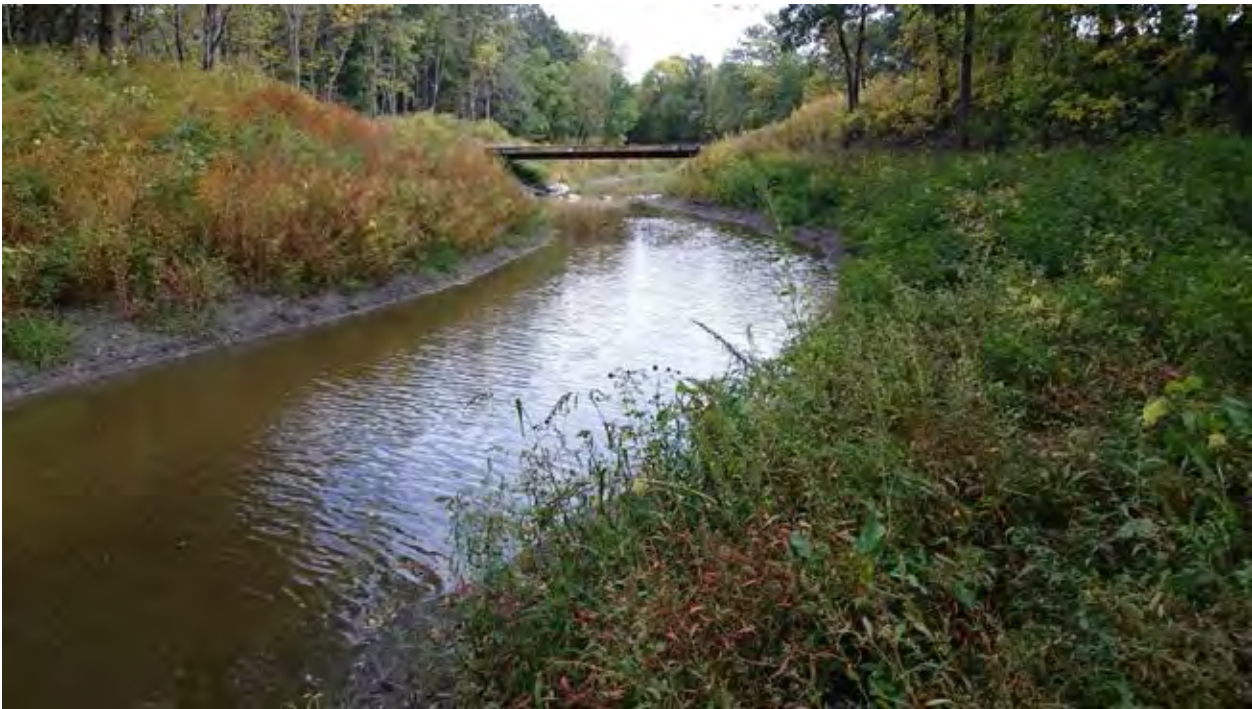
SR Photo 29: Channel graded in cleared woods.

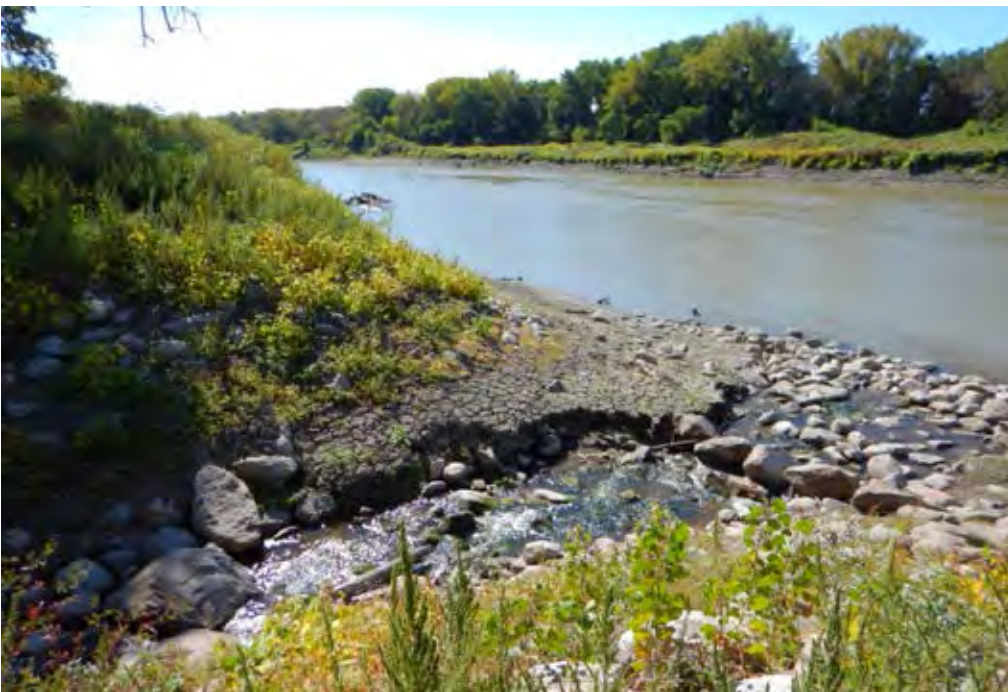
SR Photo 38: Outlet to Red River. Sediment above constructed rock outlet assumed to be material deposited by Red River Floods in spring and scoured by Grand Marais Creek after coming on-line. Note change in water clarity between Grand Marais Creek and Red River at confluence.

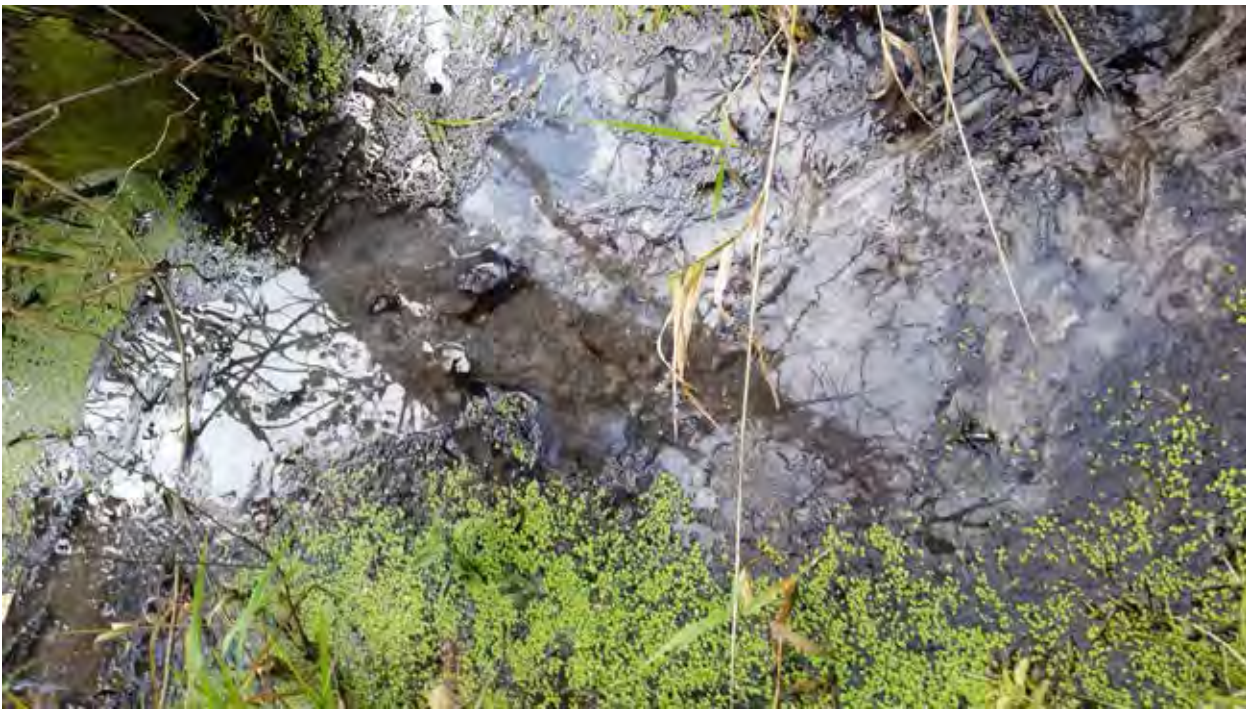
Figure 9 - Calcareous seepage at GPS point 476
