ARCHITECTURAL  
ASSESSMENT FOR  
PRAIRIE CORRECTIONAL  
FACILITY

Appleton, Minnesota

Final Report

January 5, 2018

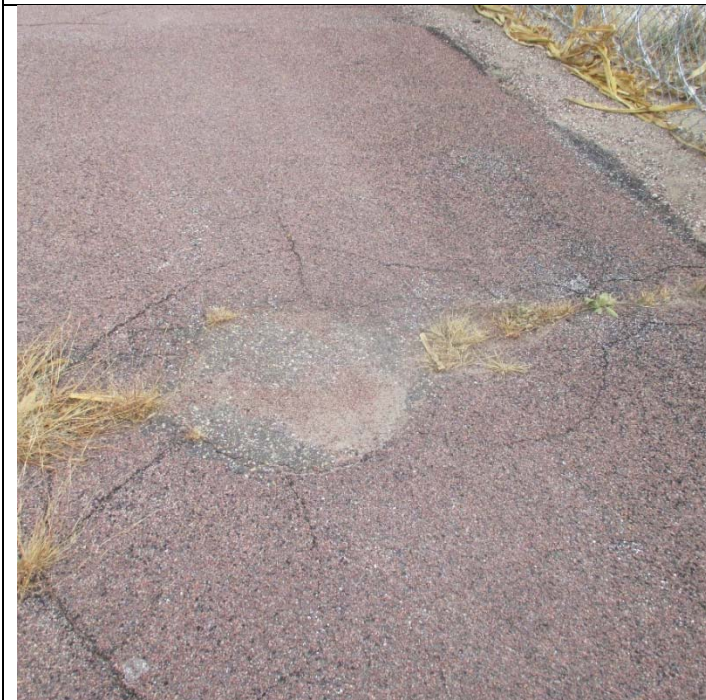
**Photograph No. 10**  
Pothole on 15-foot perimeter  
road close to guard tower

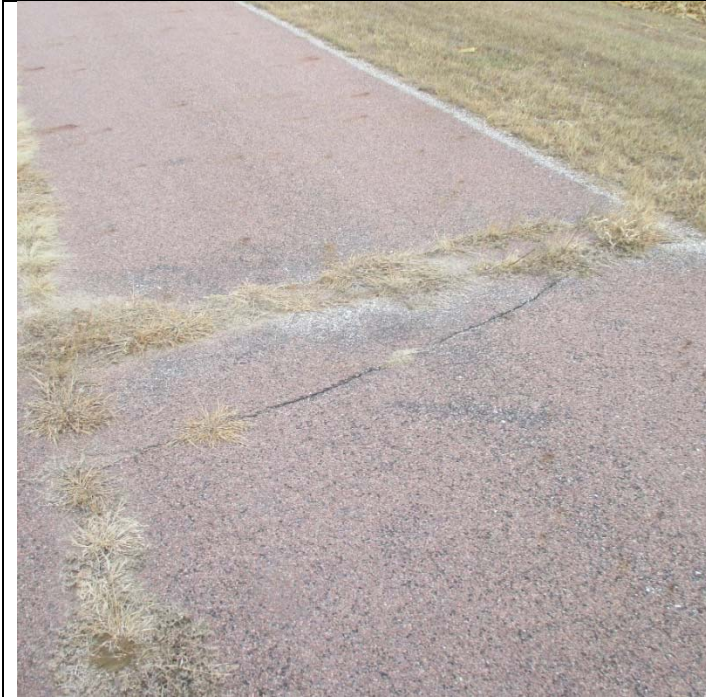
**Photograph No. 11**  
24-foot perimeter road

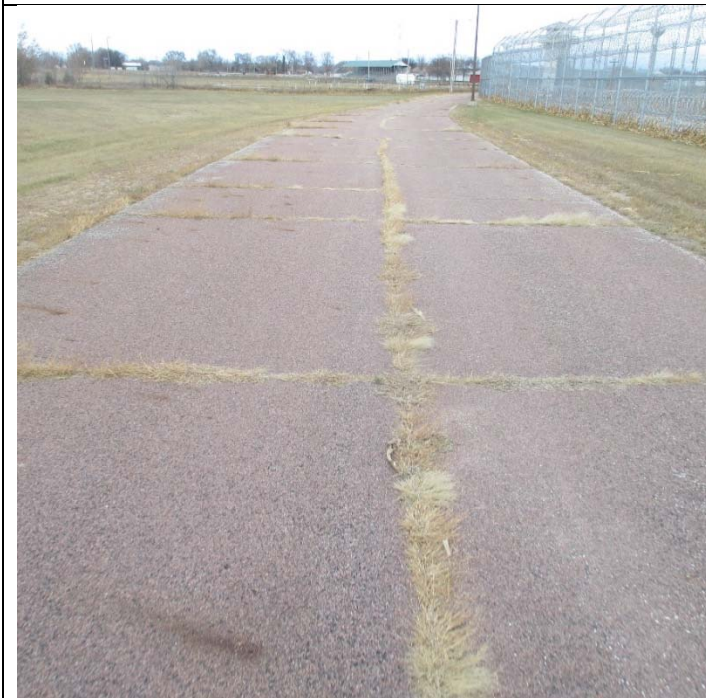
**Photograph No. 12**  
24-foot perimeter road
