Minnesota Department of Natural Resources Minnesota Board of Water and Soil Resources

Appendix A: 2020 Legacy Fund Restoration Evaluation Report

April 2020

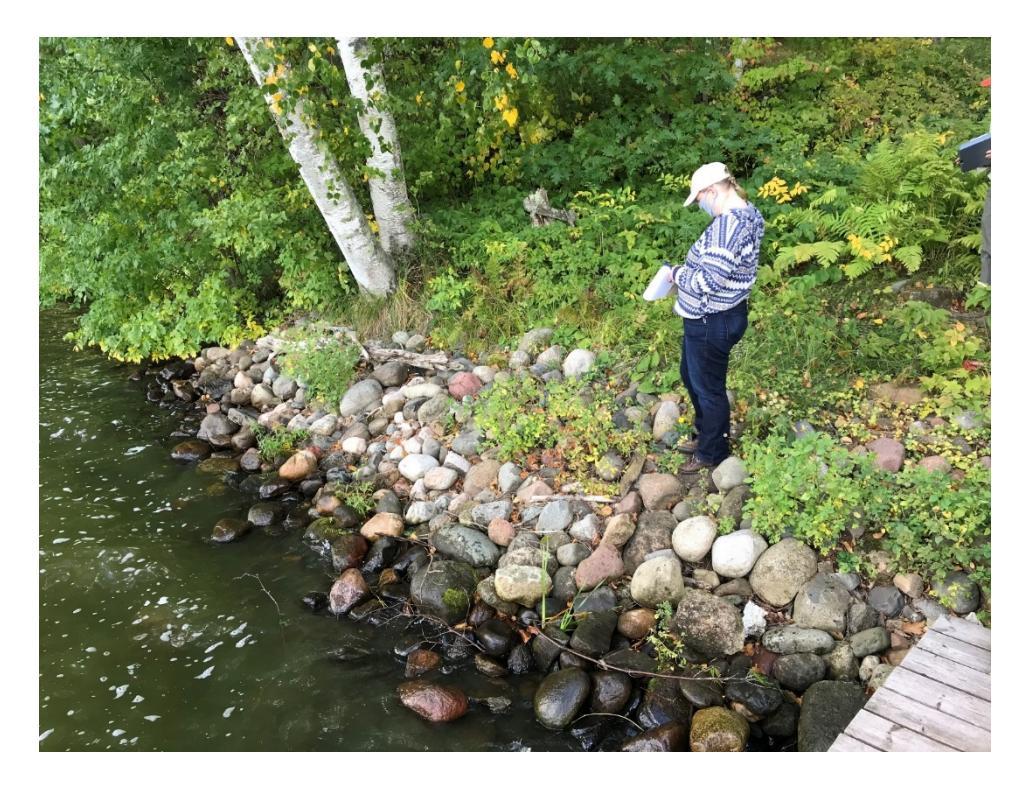
- **22.** *Provide explanation of reason(s) for determination.* The lakeshore is stable and no erosion was observed during the site visit. The upper banks were well vegetated and contained a diversity of native species.
- 23. Site Assessor(s) Conducting Review: Mike Majeski

Photo 1-1 Schroeder shoreline stabilization, photo taken during site visit 09/16/2020.

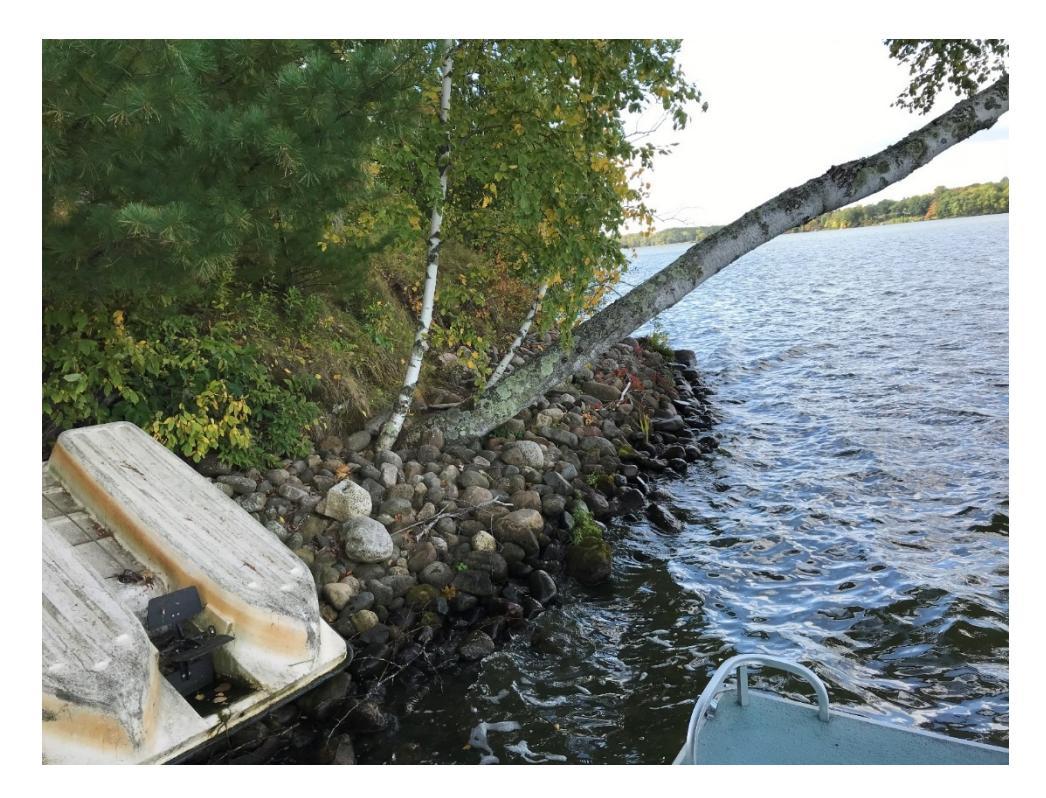
Photo 1-2 Schroeder shoreline stabilization, photo taken during site visit 09/16/2020.

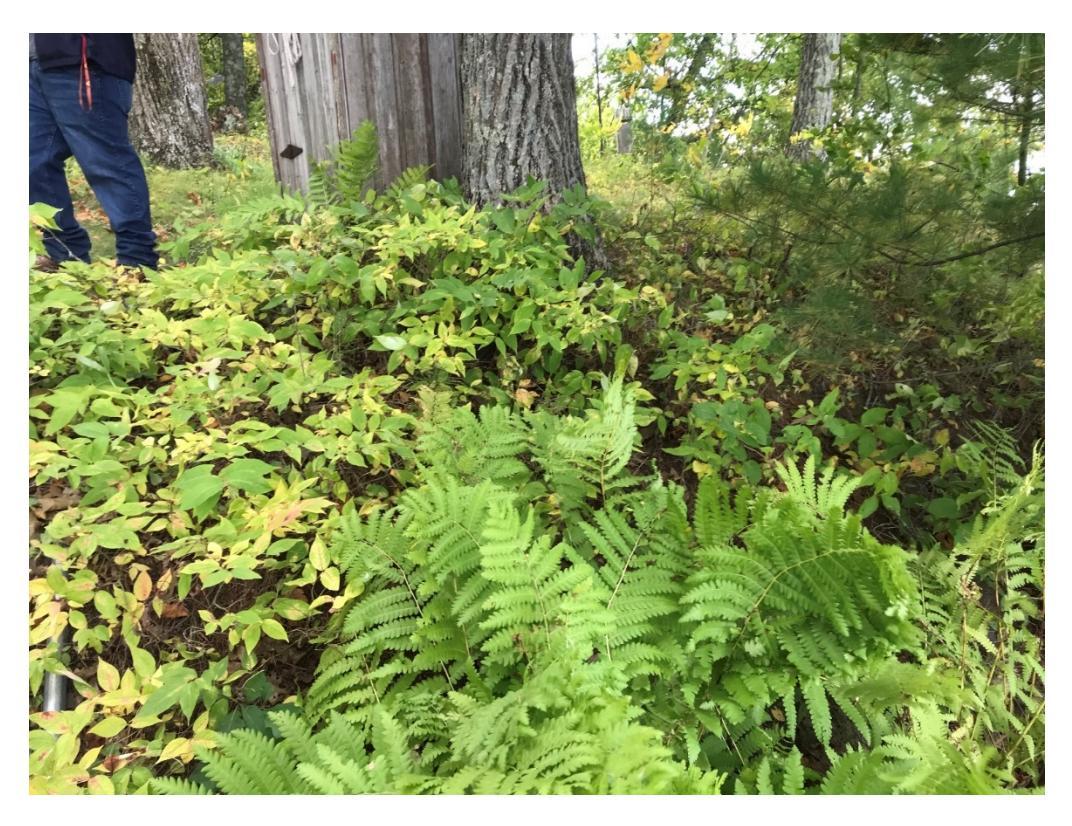
Photo 1-3 Close-up image of the Schroeder shoreline upper bank vegetation. Photo taken during site visit 09/16/2020.

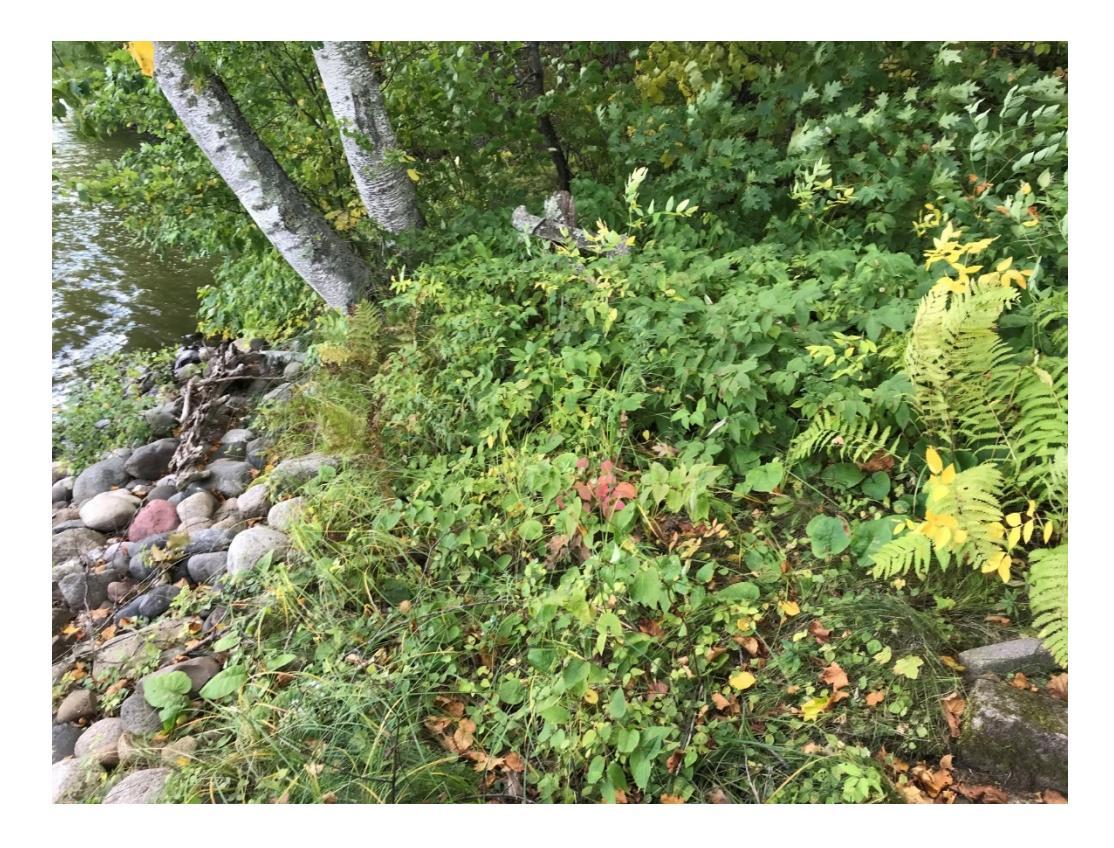
Photo 1-4 Rock to vegetation transition zone, Schroeder shoreline. Photo taken during site visit 09/16/2020.

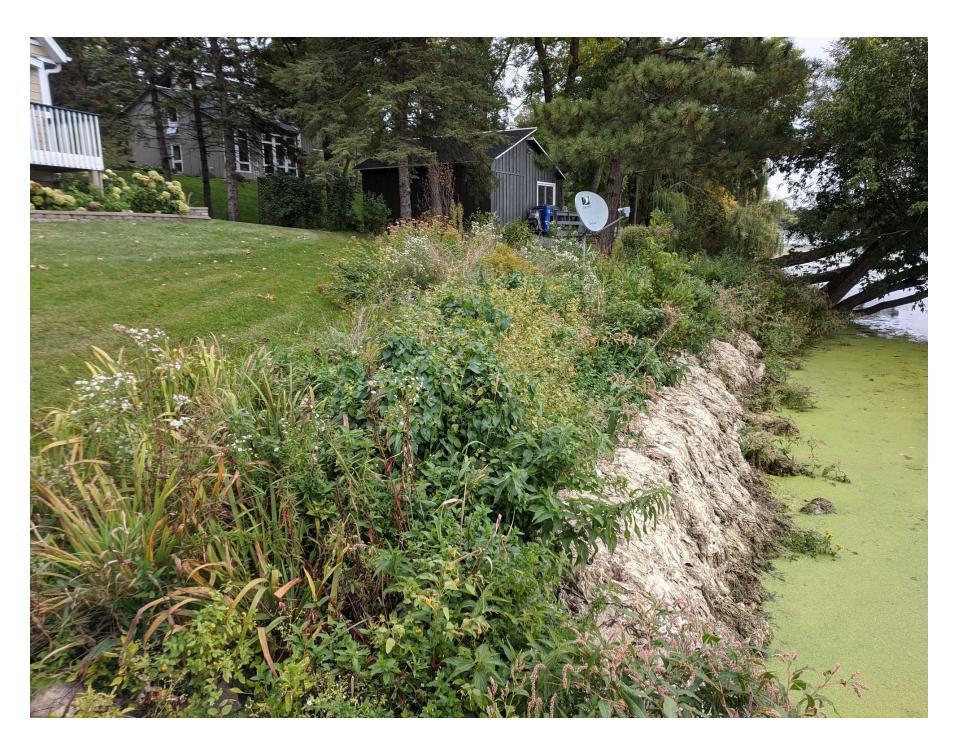
Photo 2-1 East facing view of the vegetated bank and riprap with accumulations of dried algae. Photo taken by Seth Bossert during site visit September 17, 2020.

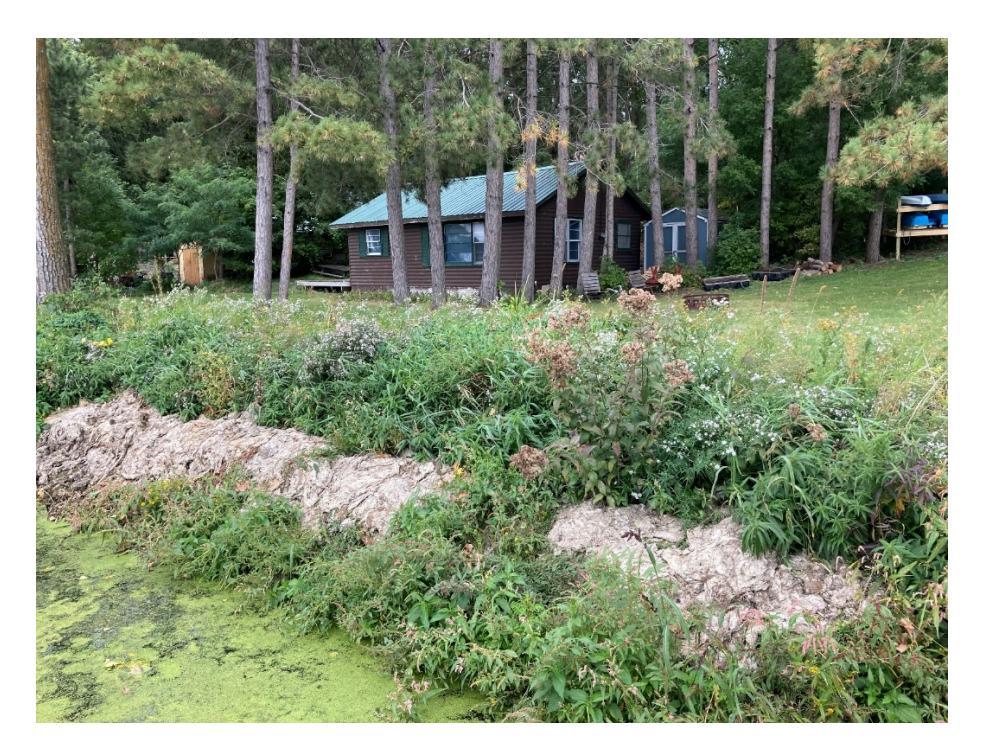
Photo 2-2 Northwest facing view of the vegetated bank and riprap with accumulations of dried algae. Photo taken during site visit September 17, 2020.

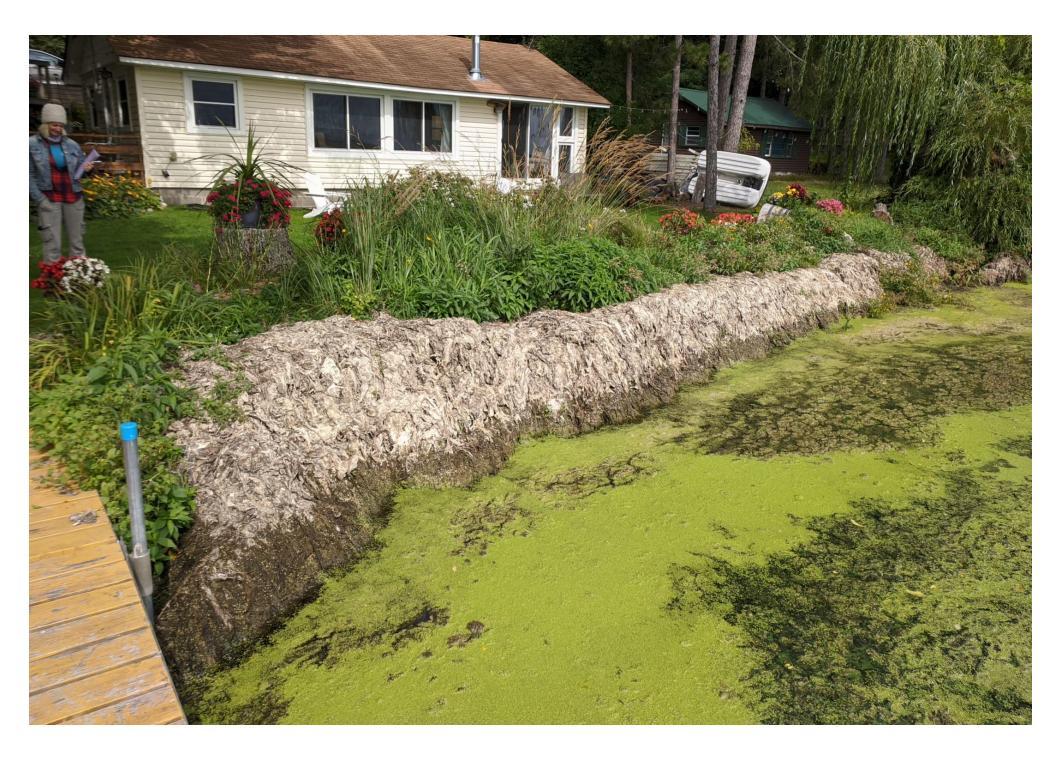
Photo 3-1 View of eastern shoreline, with vegetated bank and accumulations of dried algae on riprap present. Photo taken by Seth Bossert during site visit September 17, 2020.

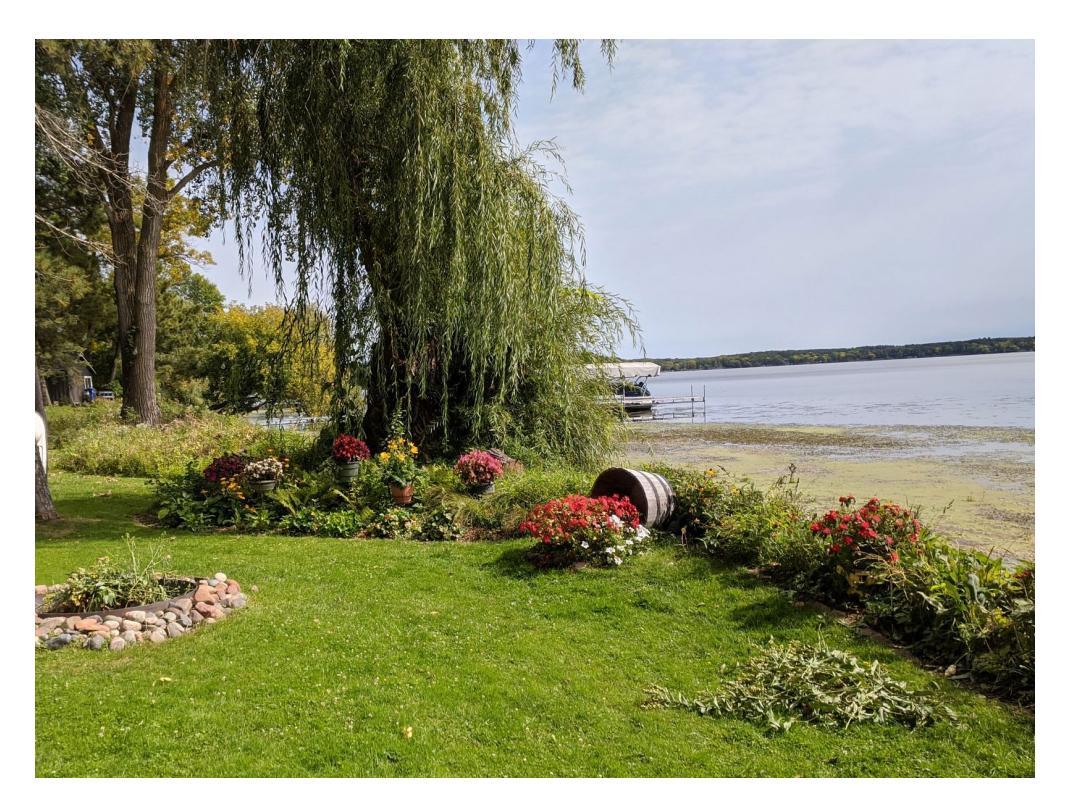
Photo 3-2 View of bank above shoreline, vegetated with grass. Photo taken by Seth Bossert during site visit September 17, 2020.

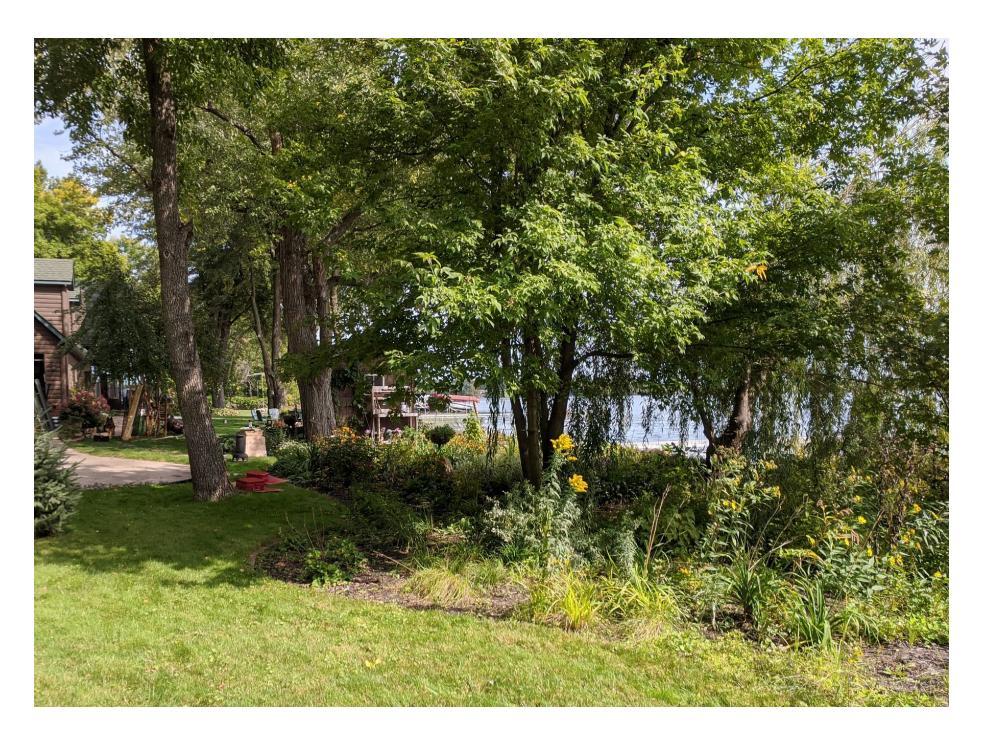
Photo 4-1 A view of the vegetated bank on the project site above the shoreline. Photo taken by Seth Bossert during site visit September 17, 2020.

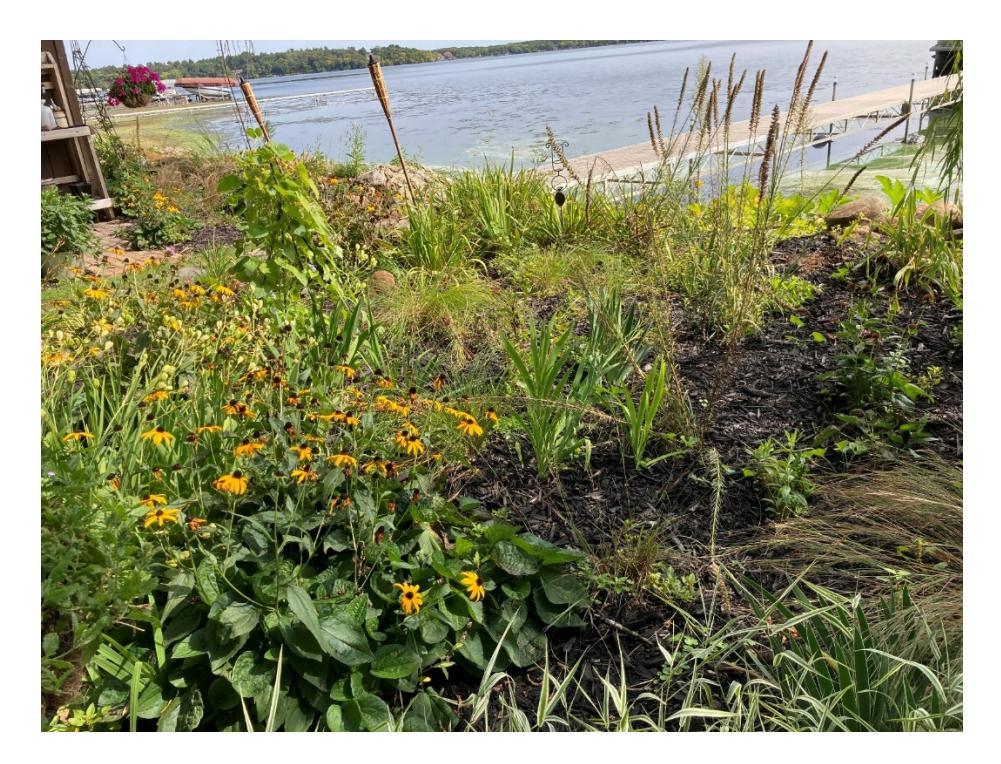
Photo 4-2 Well maintained forbs and grasses in the shoreline planting. Photo taken during site visit September 17, 2020.

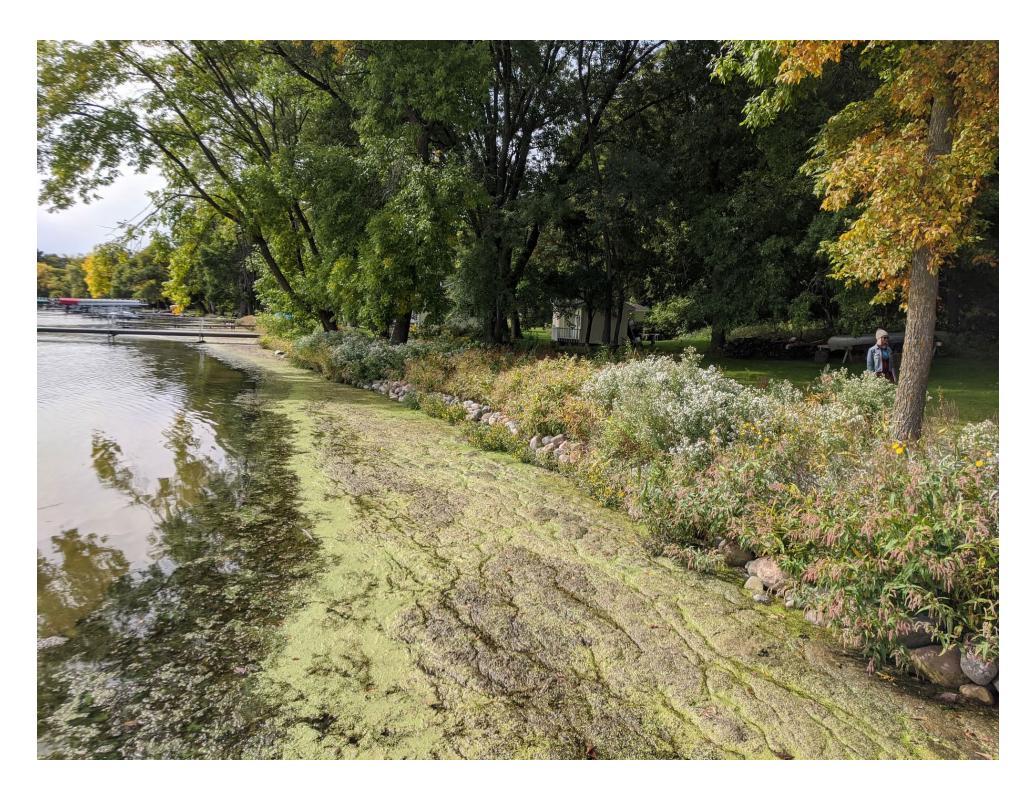
Photo 5-1 View of western beach with riprap and vegetation installed. Photo taken during site visit September 17, 2021.

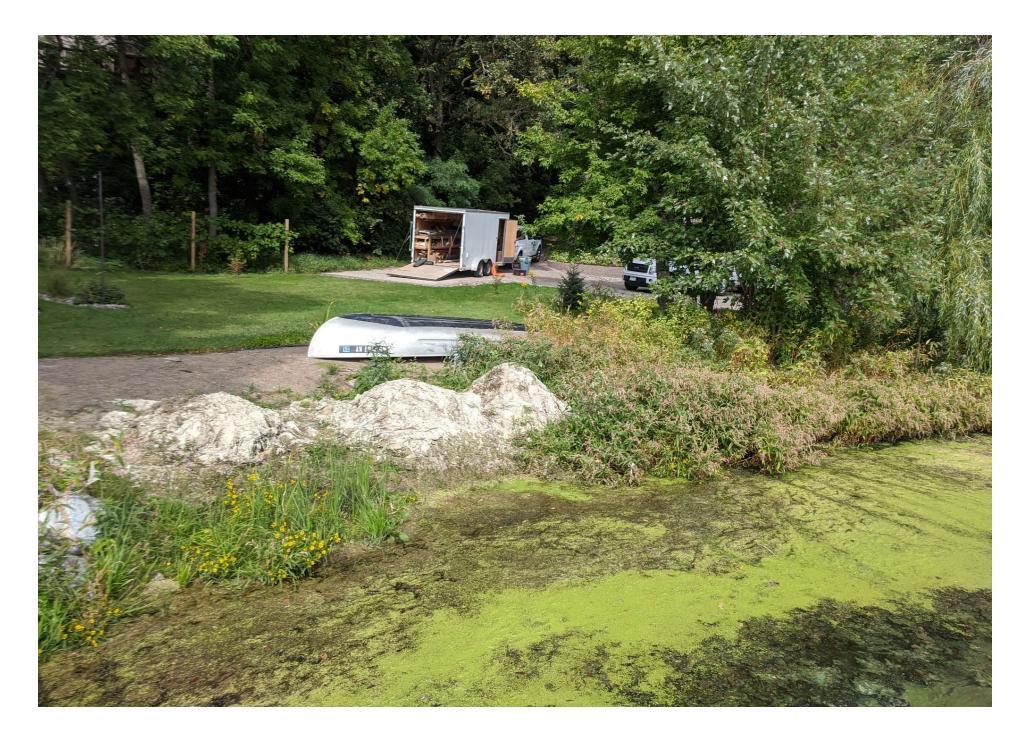
Photo 5-2 View of eastern beach. Shoreline is vegetated, with no riprap is visible. Dried algae is visible collected on the shore. Photo taken by Seth Bossert during site visit September 17, 2021.

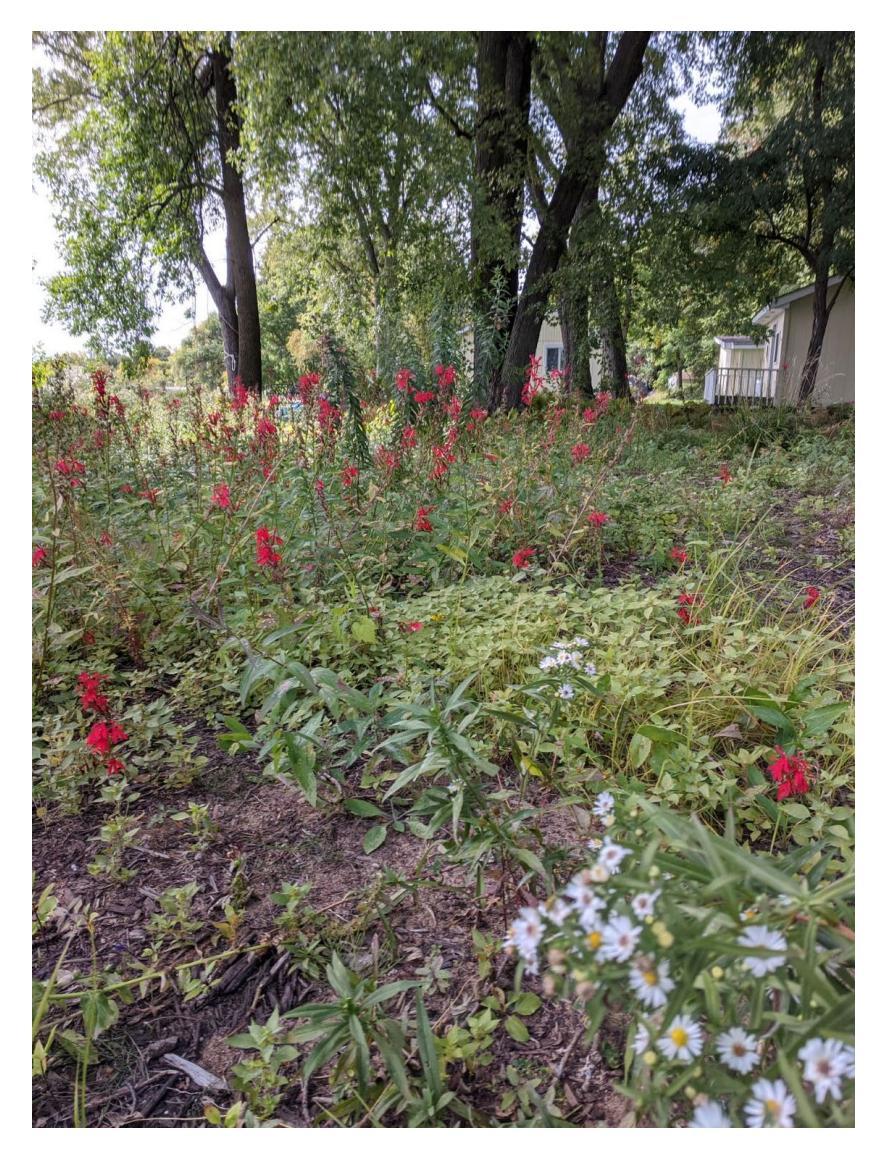
The long-term maintenance for this project will be provided by the landowners as agreed upon in the operation and maintenance plan for the Chilson Green Lakeshore Restoration—developed with the Isanti SWCD. Several undesirable species were observed in the vegetation along the banks. This was not observed to be currently causing any outstanding issues.

Photo 5-3 View of vegetation on shore, with gaps in cover visible. Photo taken during site visit September 17, 2021.

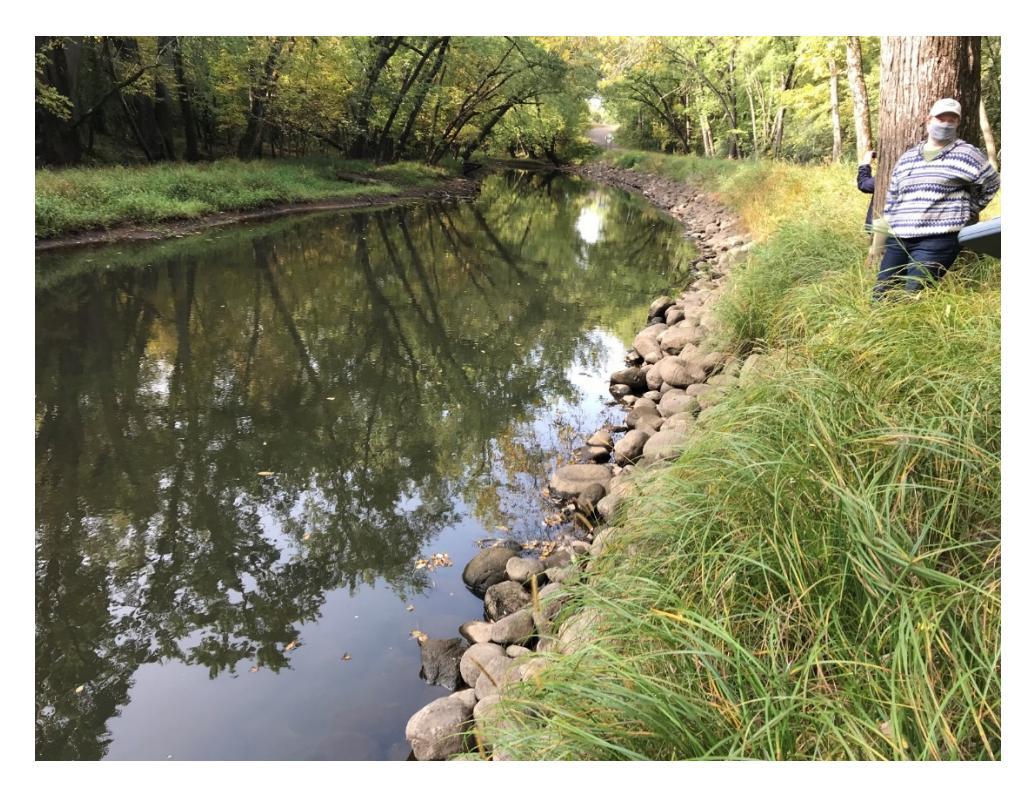
Yes, the installed rock achieved the goal to stabilize the eroding riverbank and the native vegetation seeded along the upper banks has become well-established. No recent erosion was observed within the project site.

Photo 6-1 Brunswick township riverbank stabilization, photo taken during site visit 09/16/2020.

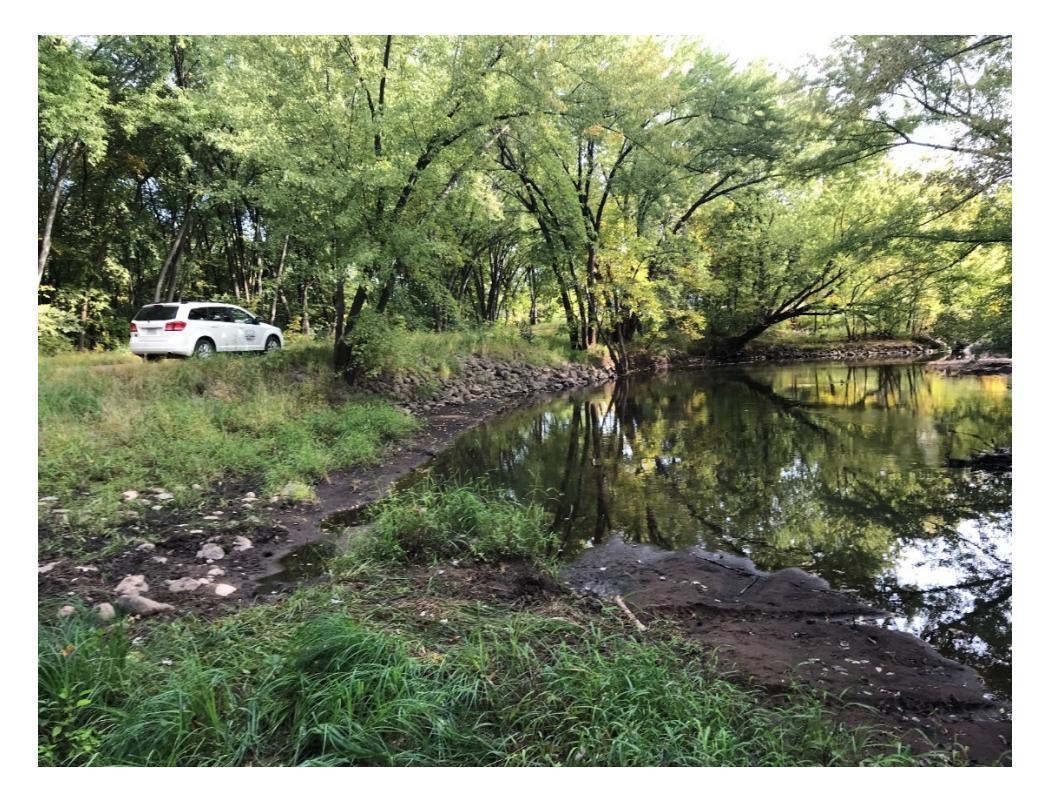
Photo 6-2 Brunswick township riverbank stabilization, photo taken during site visit 09/16/2020.

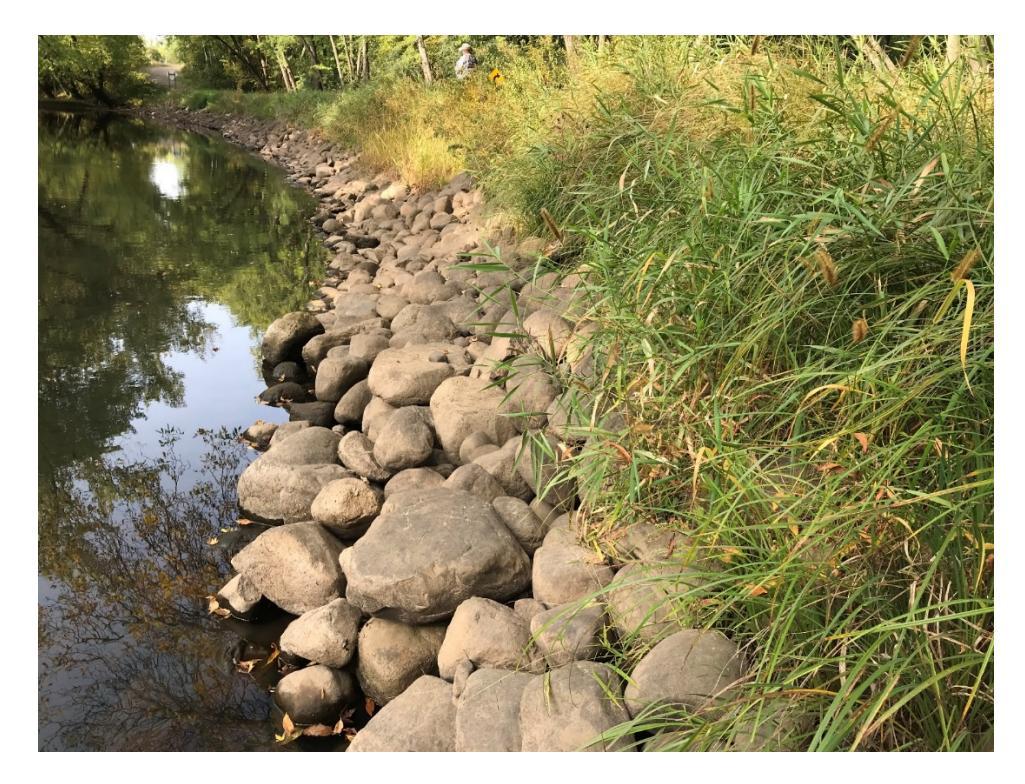
Photo 6-4. Brunswick township riverbank stabilization, photo taken during site visit 09/16/2020.

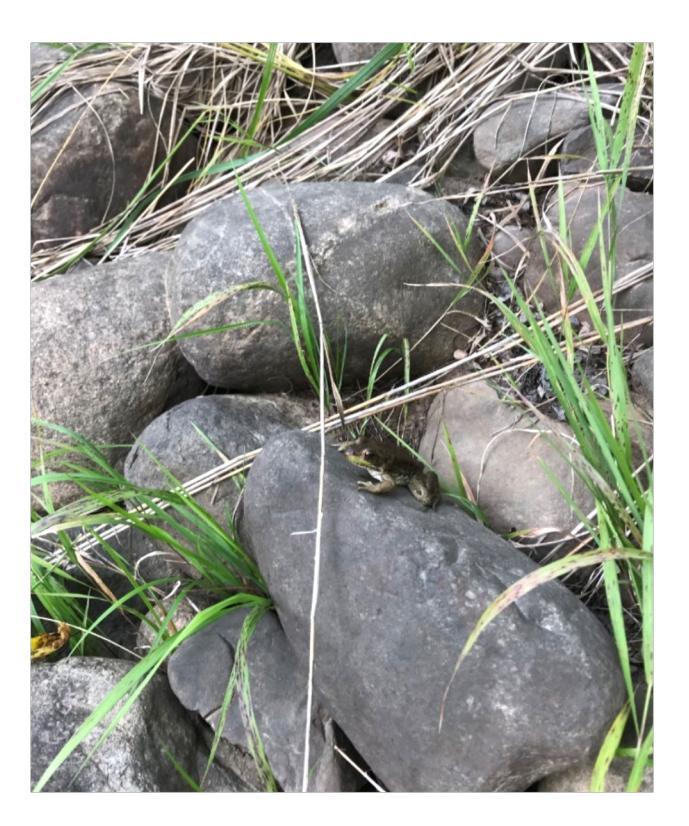
Photo 6-5. Brunswick township riverbank stabilization. Close-up image of field stone boulder toe with lake sedge growing between the rocks. A green frog was sitting on one of the exposed rocks. Photo taken during site visit 09/16/2020.

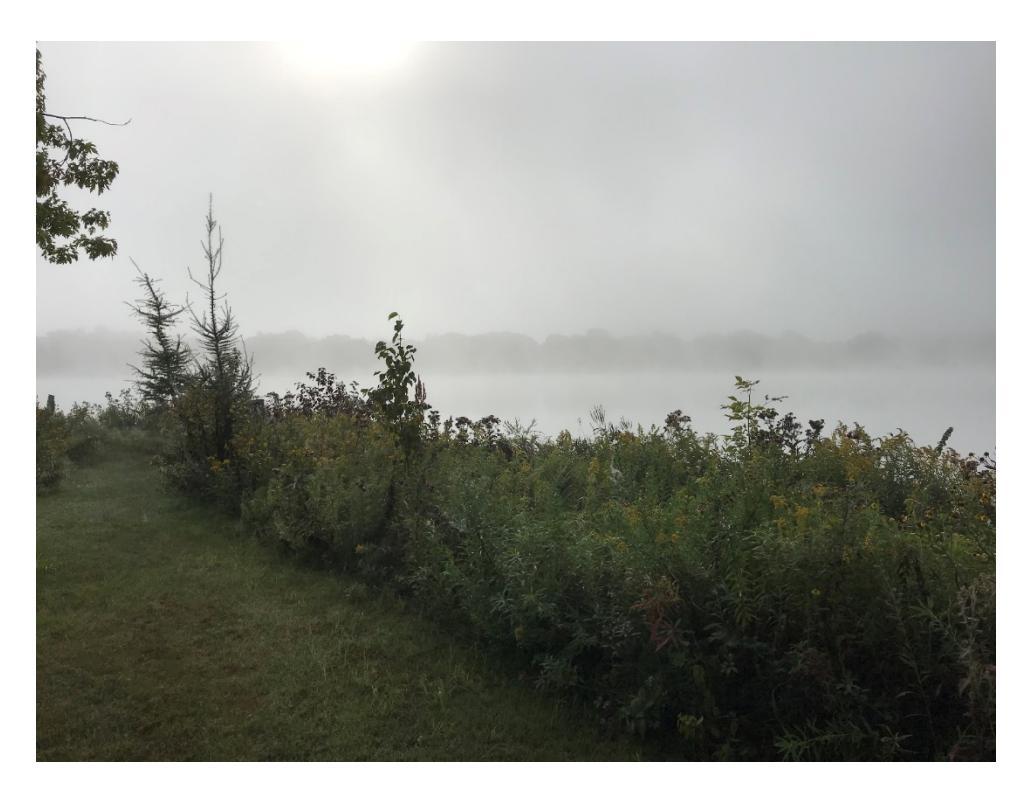
Yes, the bio-rolls and established lakeshore vegetation have stabilized the lakeshore, no erosion was observed.

Photo 7-1 Madson shoreline restoration, photo taken during site visit 09/10/2020.

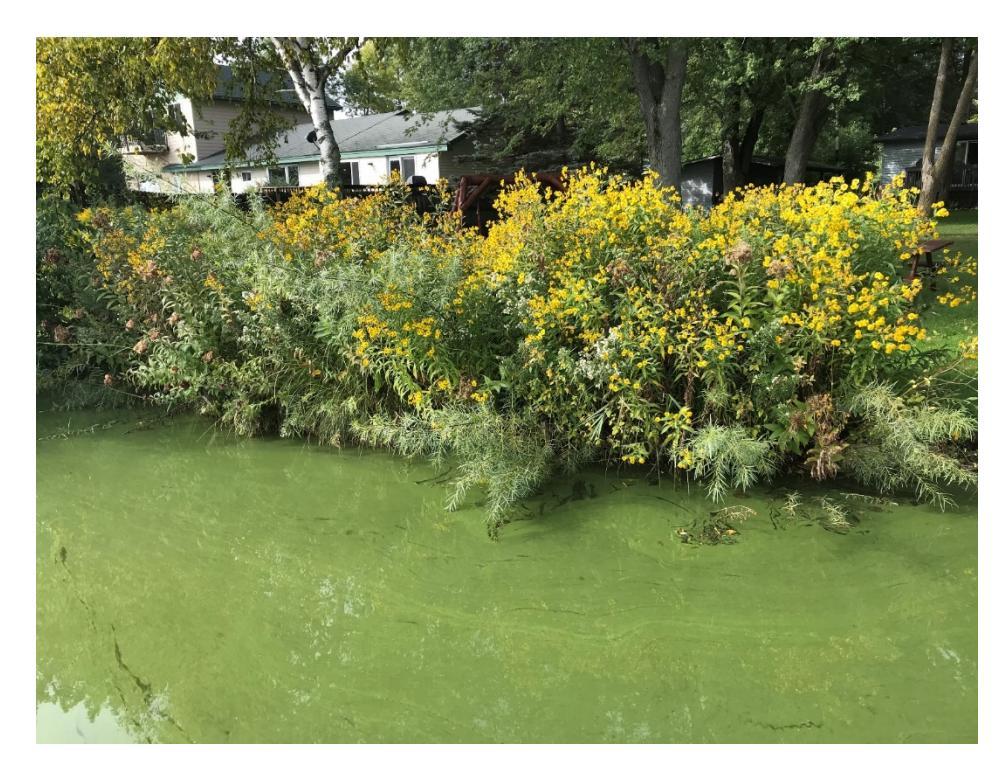
Yes, the wattles and established lakeshore vegetation have stabilized the lakeshore, no erosion was observed.

Photo 8-1 Preekett shoreline restoration, photo taken during site visit 09/10/2020.

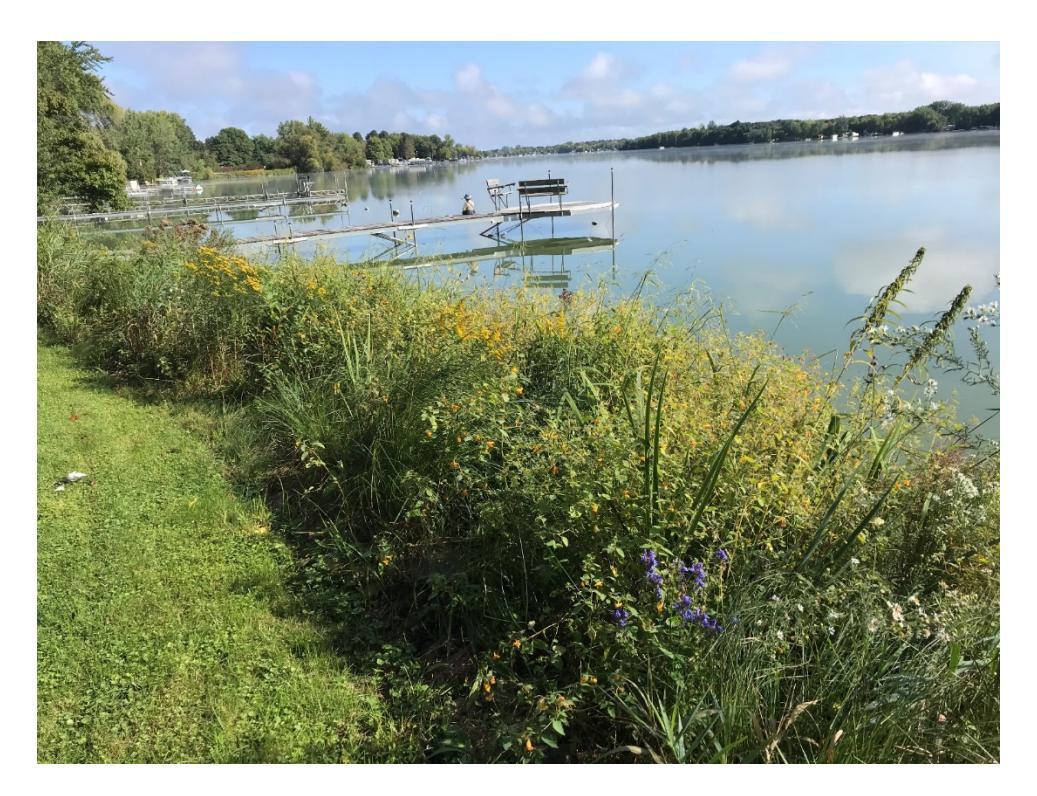
Yes, the wattles and established lakeshore vegetation have stabilized the lakeshore, no erosion was observed. The existing rock toe was incorporated into the shoreline restoration as evident by the exposed rock along the edge of the water.

Photo 9-1 Nelson shoreline restoration, photo taken during site visit 09/10/2020.

This project established significant perennial lakeshore vegetation to replace mowed turf grass. The buffer width will certainly help slow & infiltrate runoff from the adjacent lawn. Vegetation maintenance is recommended to reduce or eliminate existing invasive species.

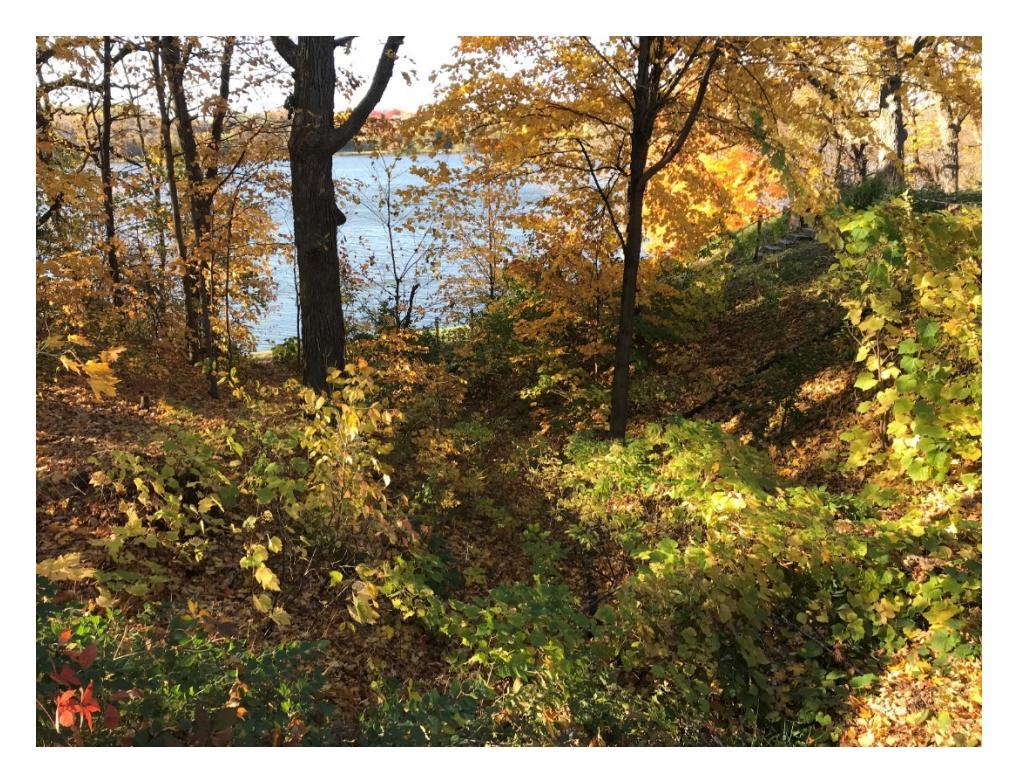
Well established vegetation along the gully bottom and side slopes, no erosion was observed within the gully. The rock grade control check appeared stable and functional without any signs of undercutting or settling.

Photo 11-1 Upslope end of restored gully at 8715 Reitz Lake Road, photo taken during site visit 10/13/2020.

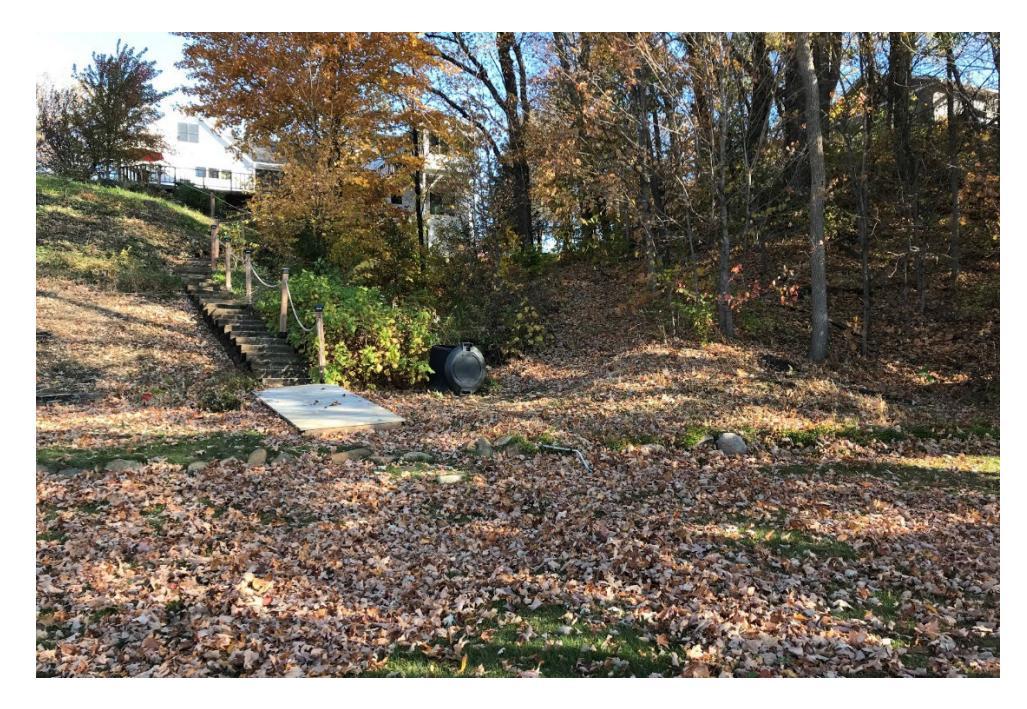
The installation of native vegetation has stabilized the gully soils; however, the removal of the rain garden/ native planting buffer at the bottom end of the gully has reduced the potential for capturing stormwater nutrients and has decreased pollinator & lakeshore habitat. The landowner has re-graded the upper drainage swale and modified a retaining wall to slow & dissipate stormwater runoff at the top of the gully. The landowner also relocated downspouts to reduce the volume of water that reaches the gully. In addition, project managers noted that runoff from the road way has since been diverted to remain on the roadway ditch. These efforts have reduced the volume of concentrated runoff through the gully.

Photo 11-2 Downslope end of restored gully at 8715 Reitz Lake Road. Note the mowed native plantings upslope of the rock toe and turf grass in the foreground that was previously planted in native vegetation (rain garden/ buffer). Photo taken during site visit 10/13/2020.

The removal of the rain garden/ native planting buffer is in direct conflict with the project goal to reduce nutrient loading to Reitz Lake. It is recommended the native planting buffer be replanted; however, the landowner has a strong desire for shorter vegetation along the shoreline.

The project site in its current state is stable and the landowner does not plan to remove vegetation in the gully. However, follow up is needed to determine the course of action regarding the removal of the rain garden/ native planting buffer. If a new rain garden is proposed, it is recommended native short grass & forb species be planted as a compromise with the landowner's desire for "managed" vegetation.

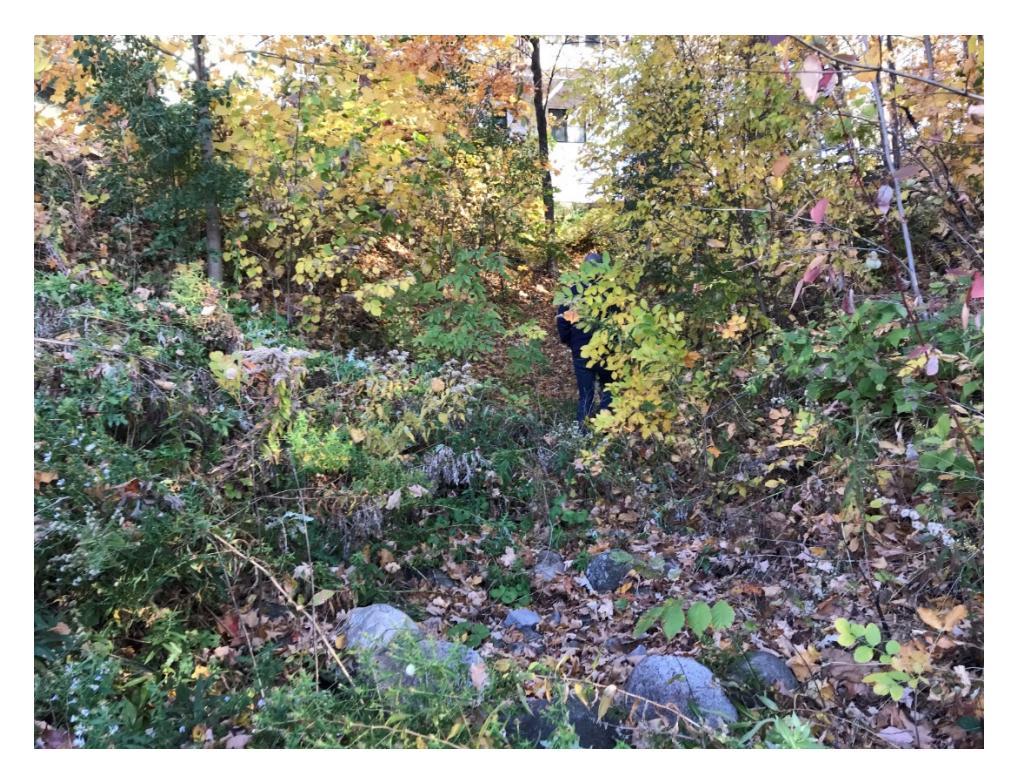
Photo 11-3 Mid-point along wooded gully showing established vegetation, photo taken during site visit 10/13/2020.

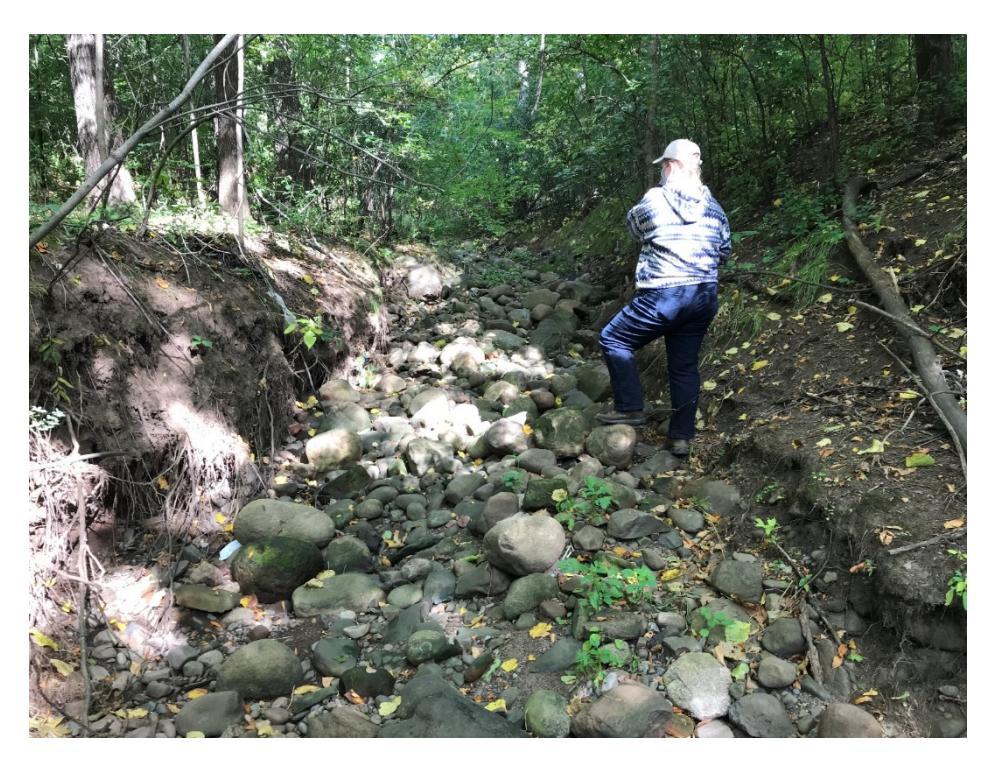
Photo 12-1 Lowest reach of Mora ravine stabilization looking up channel. Photo taken during site visit 09/16/2020.

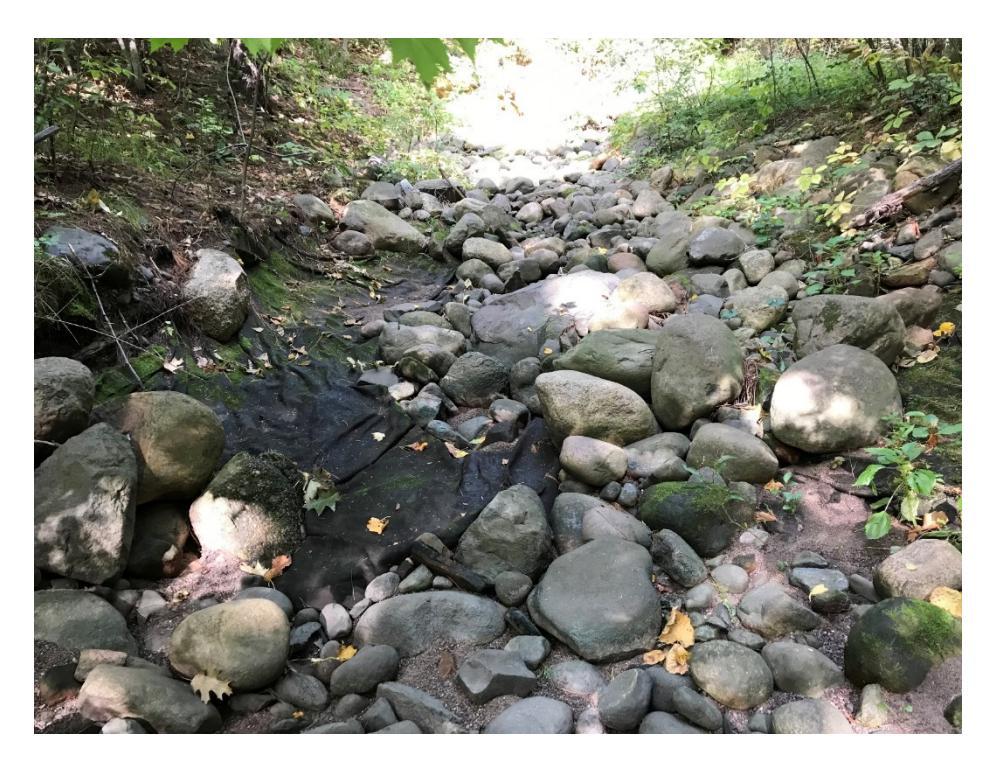
The alterations listed above did not negatively impact the project outcome. The rock as it was installed is mostly stable with minor toe erosion observed despite significant flooding events over the last several years.

Photo 12-2 Mora ravine stabilization. Note the exposed filter fabric from the displaced field stone boulders. Photo taken during site visit 09/16/2020.

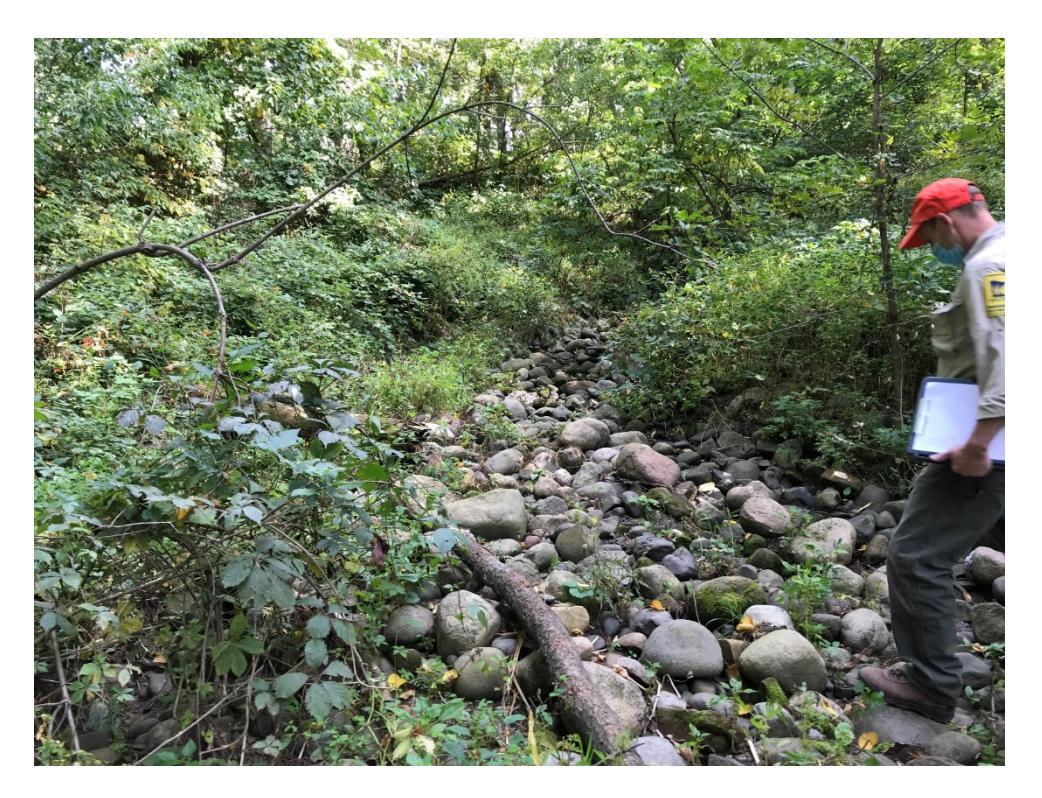
Photo 12-3 Mora ravine stabilization showing installed field stone boulders and surrounding vegetation. Photo taken during site visit 09/16/2020.
