Minnesota Department of Natural Resources Minnesota Board of Water and Soil Resources

Appendix A: 2020 Legacy Fund Restoration Evaluation Report

April 2020

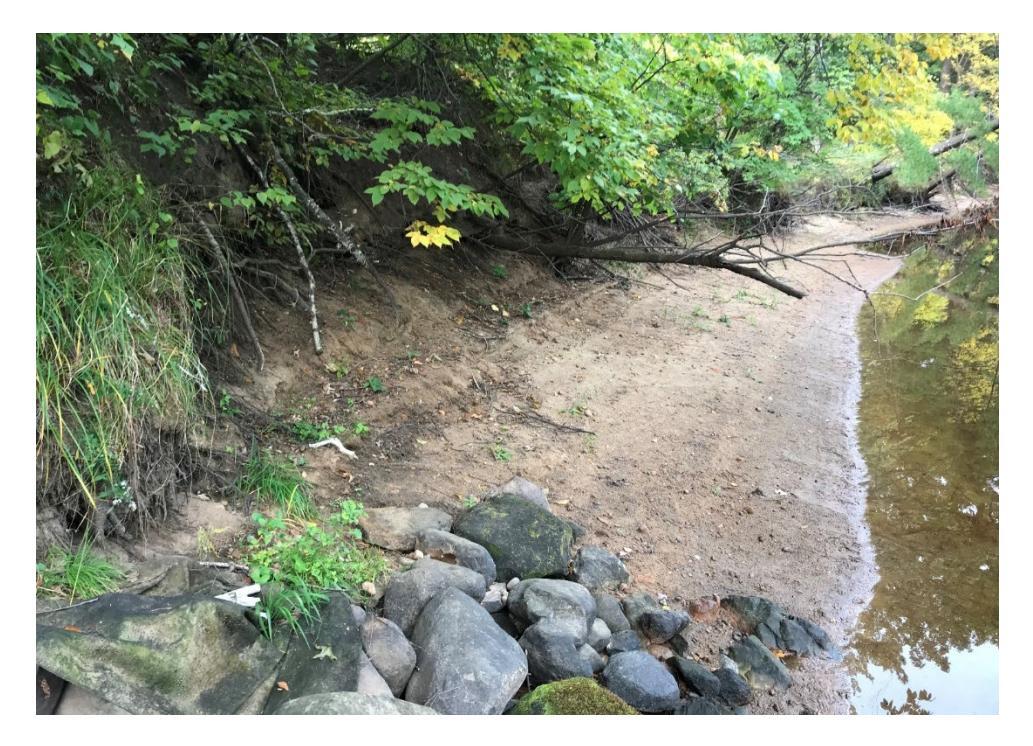
Photo 13-3 Upstream end of stabilized shoreline that transitions to a natural riverbank. Photo taken 09/16/2020.

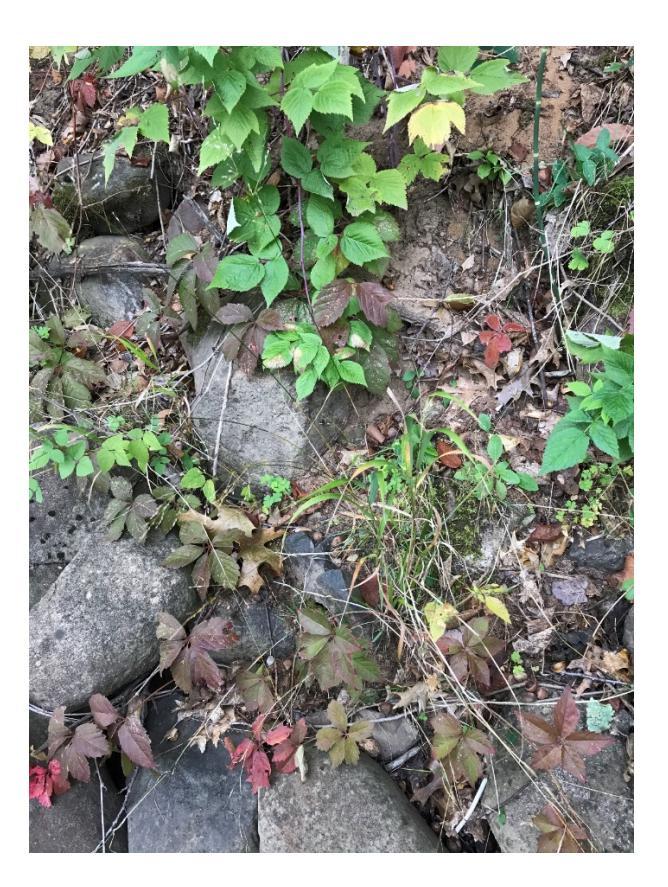
Photo 13-4 Close up image of transition zone between field stone boulders and upper slope vegetation. Photo taken 09/16/2020.

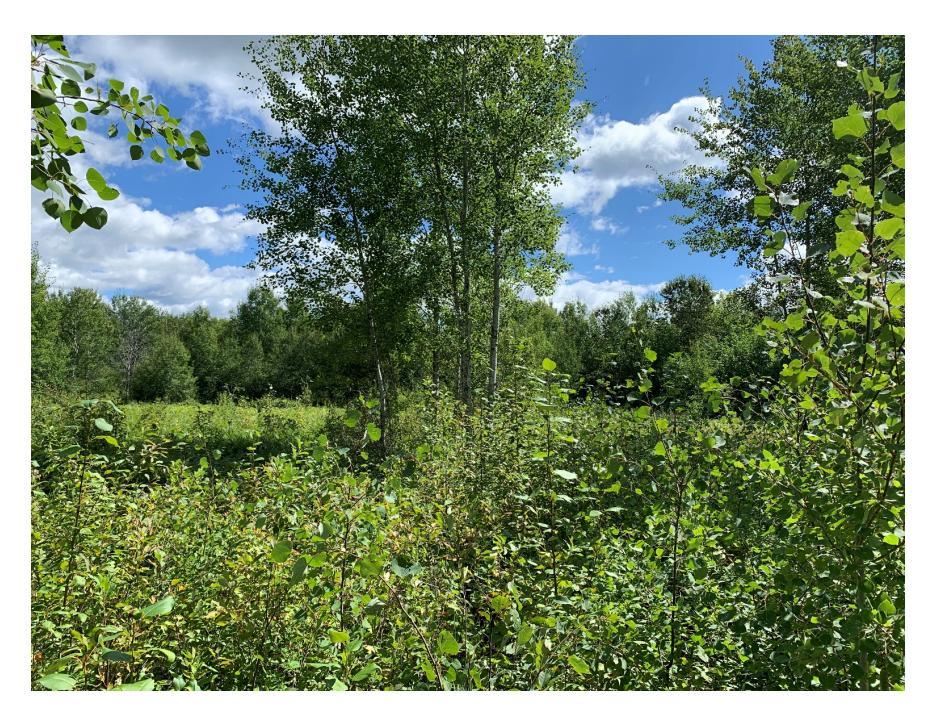
Photo 14-1 View of area that was mowed with tractor and rotary cutter in foreground and herbaceous-dominated opening in background (8.17.20).

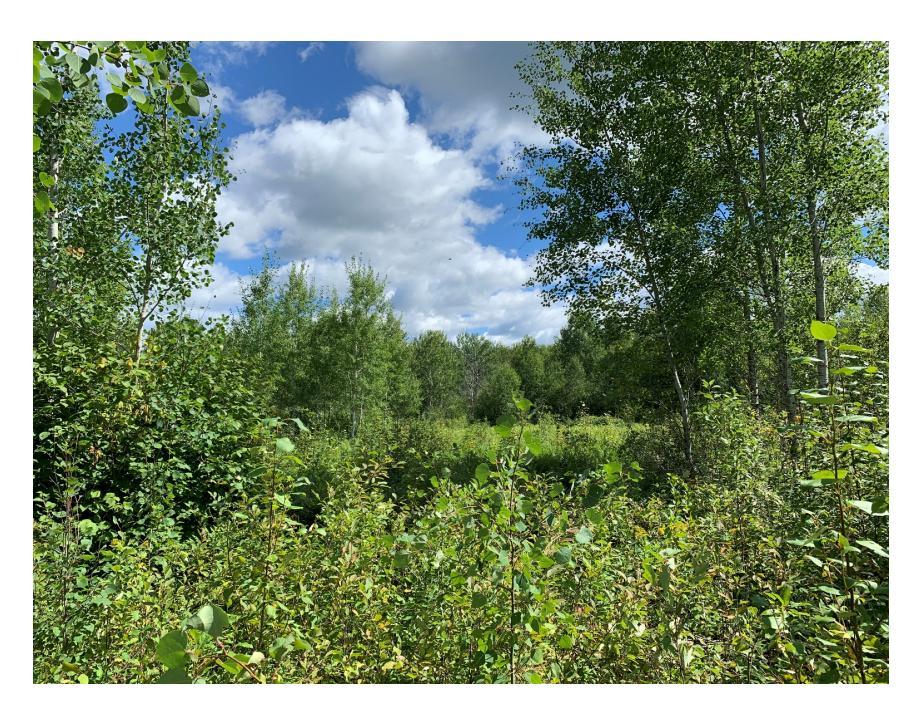
Photo 14-2 Area illustrating rotary cutting in the foreground and resulting aspen resprouts, with adjacent quaking aspen trees and unmowed beaked hazel (8.17.20).

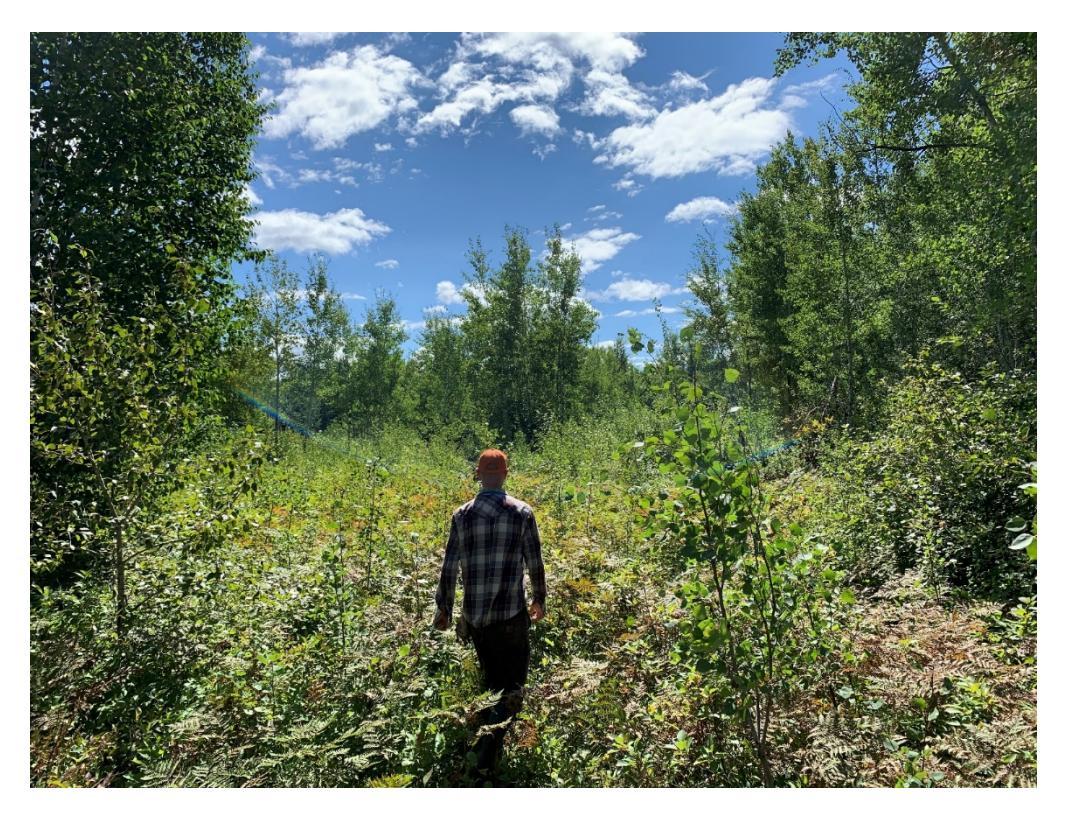
Photo 14-3 Area that was cut with a Davco mower exhibiting good regrowth of herbaceous cover, including bracken fern. The area on the right-hand side of the photo is where cutting was accomplished under more mature aspen in an attempt to soften edge effect (8.17.20).

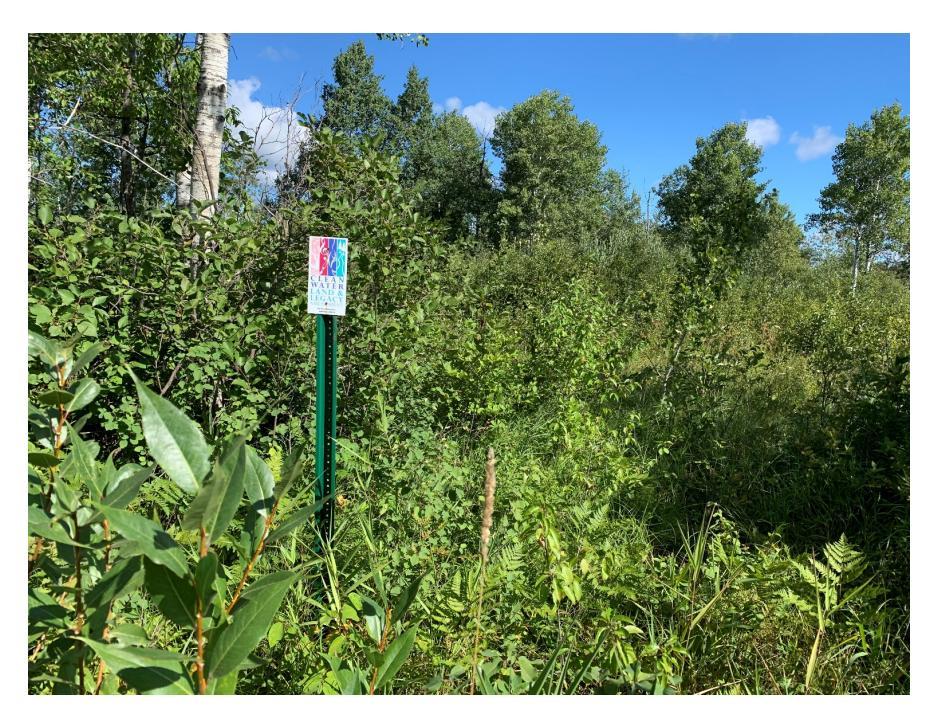
Photo 15-1 View from roadside on south side of project site with forestry mowed brush and small trees resprouting, with matrix of grasses, sedges, forbs and ferns (8.17.20).

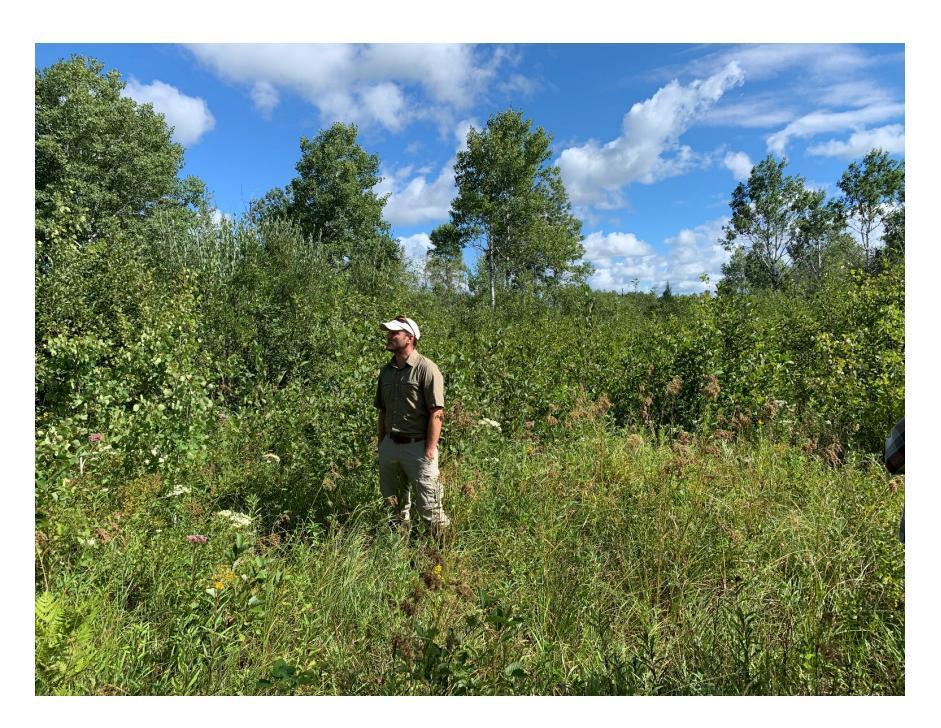
Photo 15-2 Pete Drieser of American Bird Conservancy in wet meadow opening that is surrounded by brush that is resprouting after forestry mowing (8.17.20).

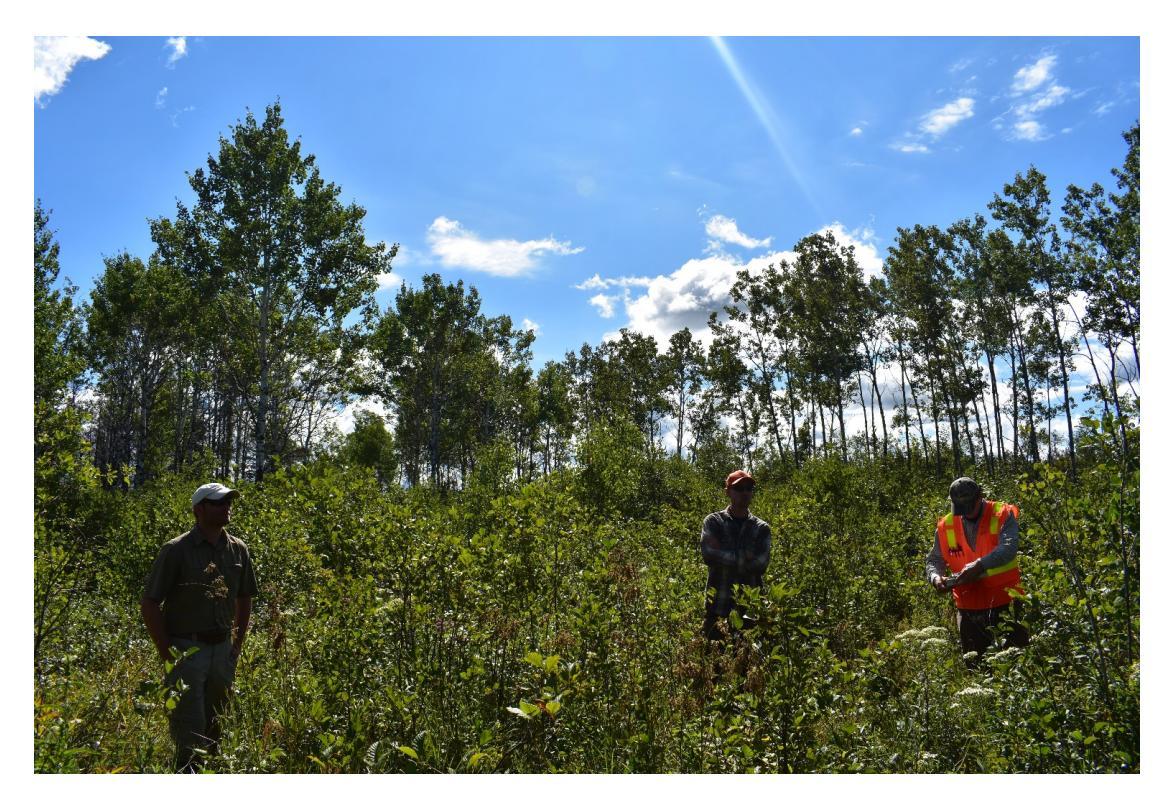
Photo 15-3 Large opening that was mowed with tractor and rotary cutter. The relatively slow regrowth of woody resprouts is helping sustain the benefits of the management (8.17.20).

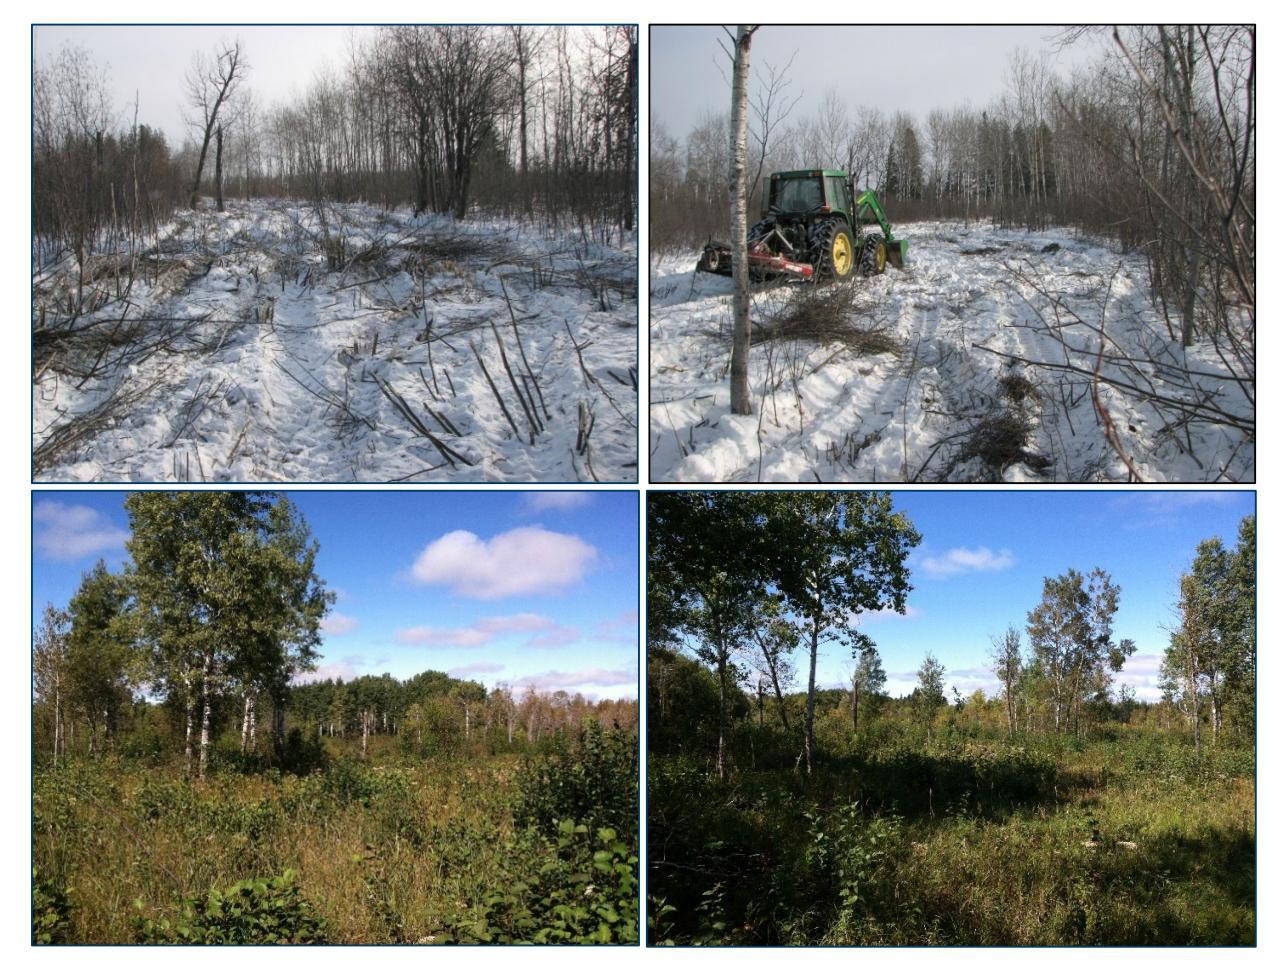
Photo 15-4 Top site immediately post treatment. Bottom

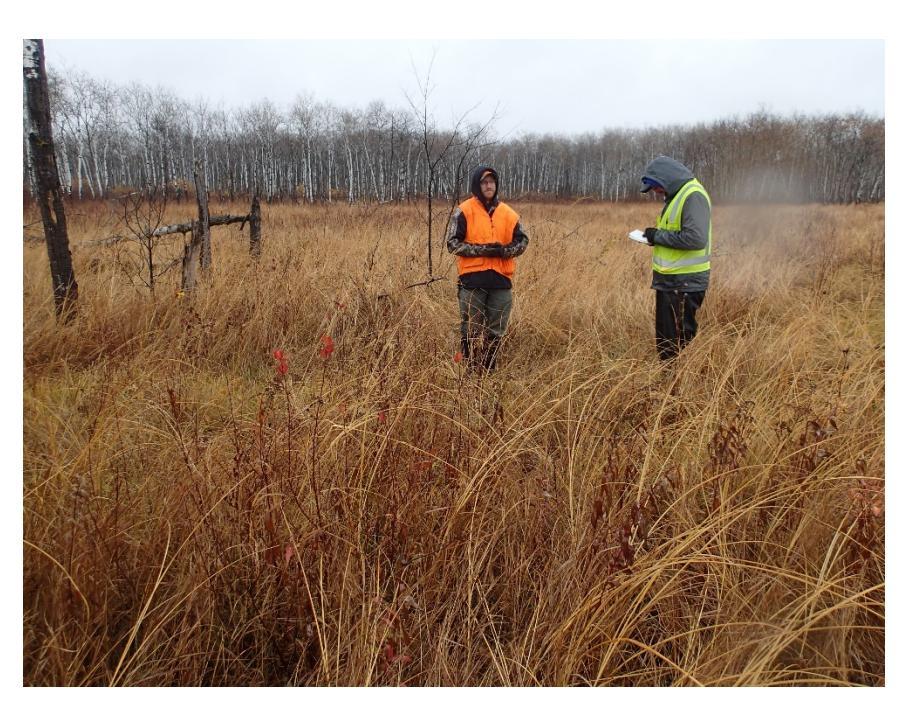
Photo 16-1 Example of vegetation in project area. Cattle grazed in this area in July for approximately seven days. (Caribou Wildlife Management Area, photo taken during site visit 10/14/2020).

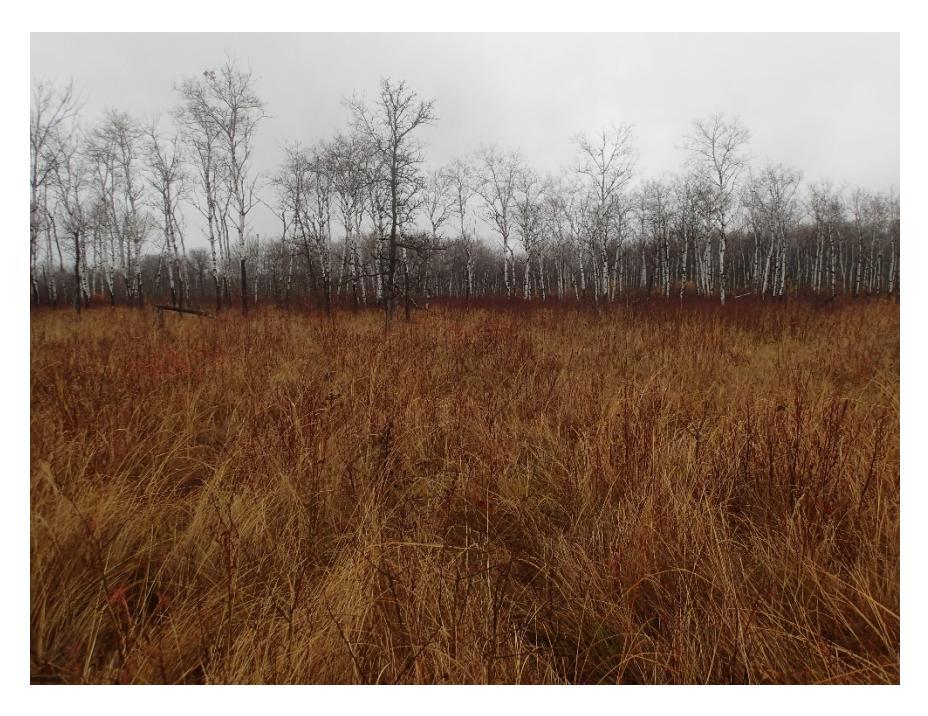
Photo 16-2 Example of the existing vegetation in the project area. Shrubs are scattered shrubs are present within the grassland cover. Aspen patches are scattered throughout the unit. (Caribou Wildlife Management Area, photo taken during site visit 10/14/2020).

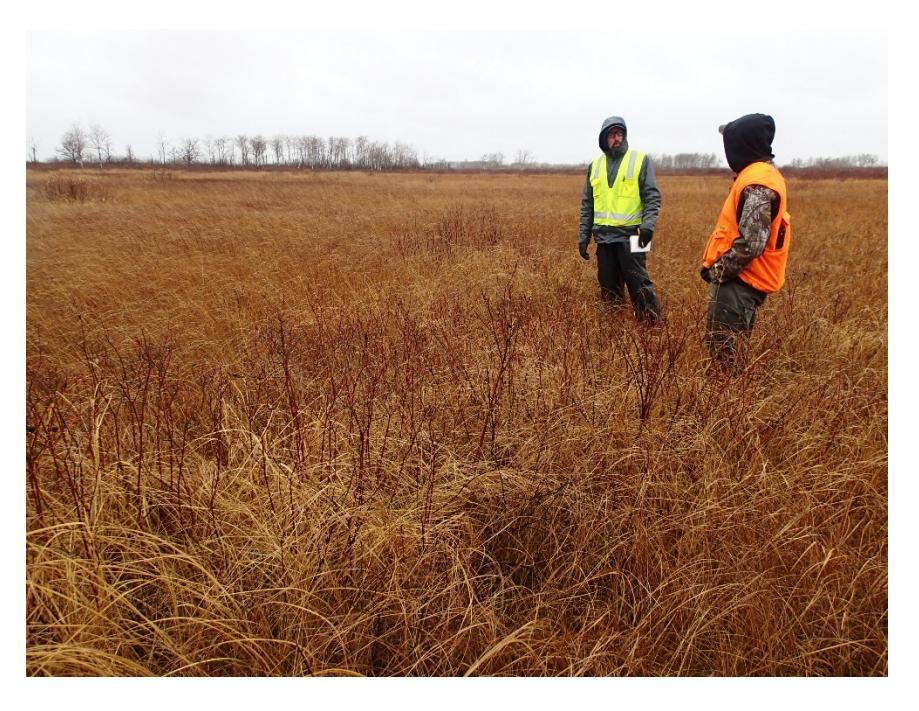
Photo 17-1 Example of vegetation in project area. (Caribou Wildlife Management Area, photo taken during site visit 10/14/2020).

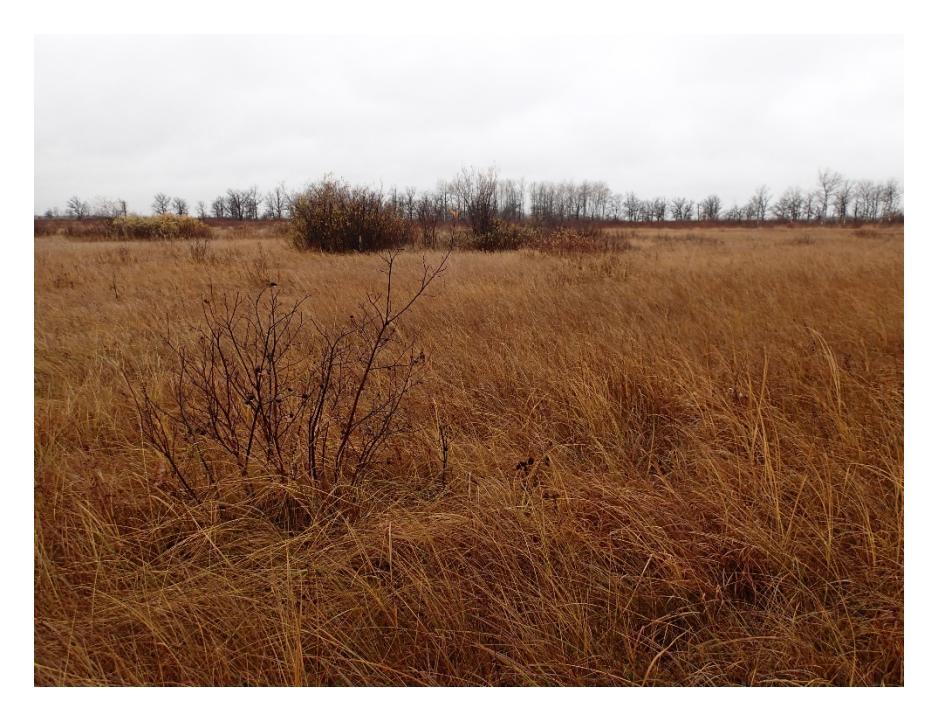
Photo 17-2 Example of the existing vegetation in the project area. Shrubs are scattered shrubs are present within the grassland cover. Aspen patches are scattered throughout the unit. (Caribou Wildlife Management Area, photo taken during site visit 10/14/2020).

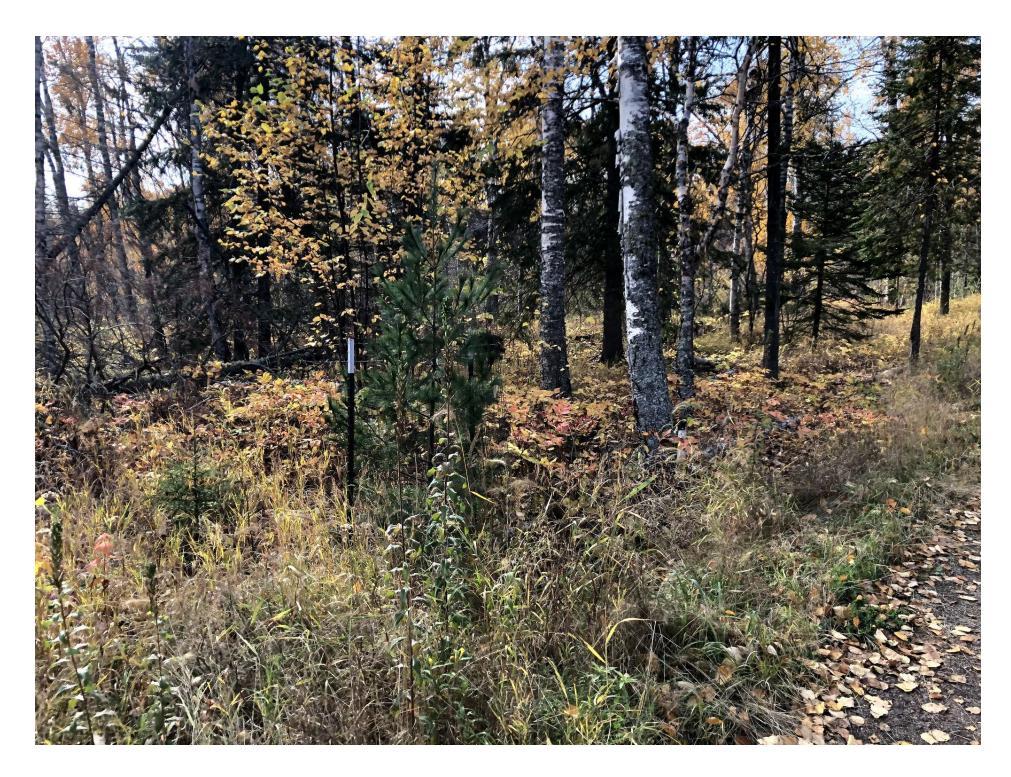
Photo 18-1 Replanted pine trees and installed fencing at the Caribou Falls Wayside site.

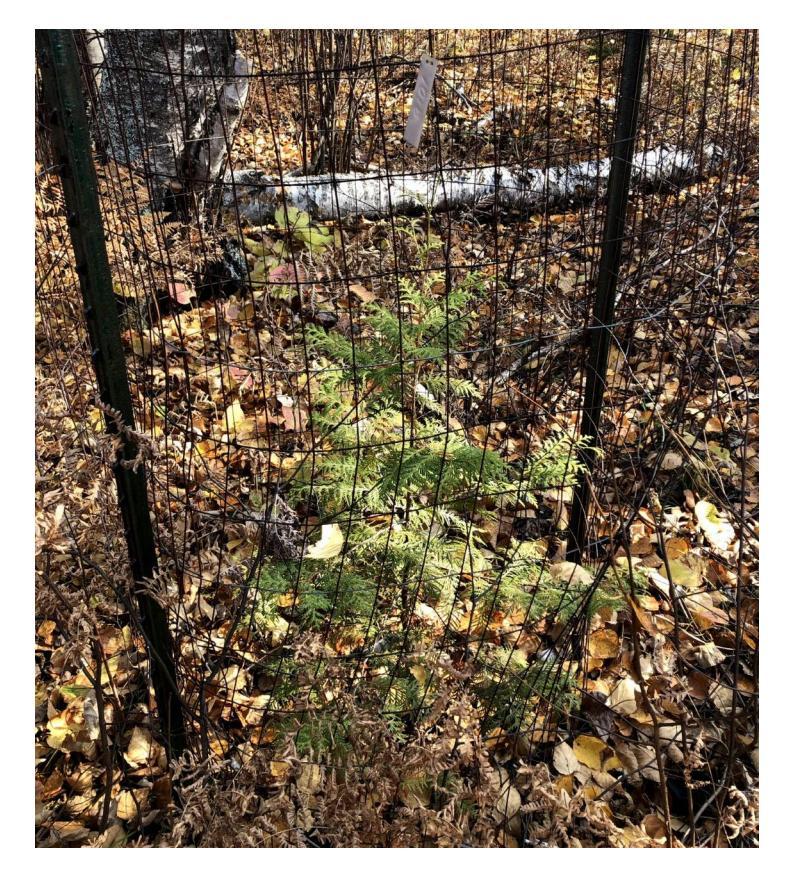
Photo 18-2 A planted cedar tree and protective tree cage.

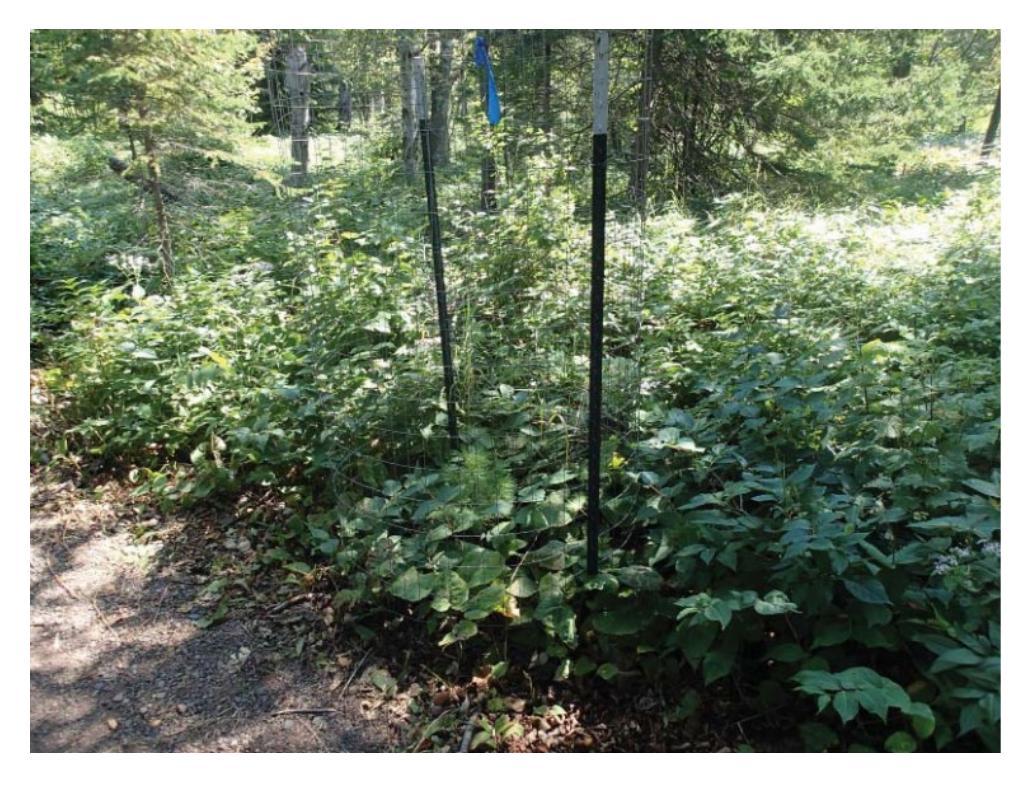
Photo 18-3 A white Pine planted in a tree cage at Caribou Falls Wayside site.

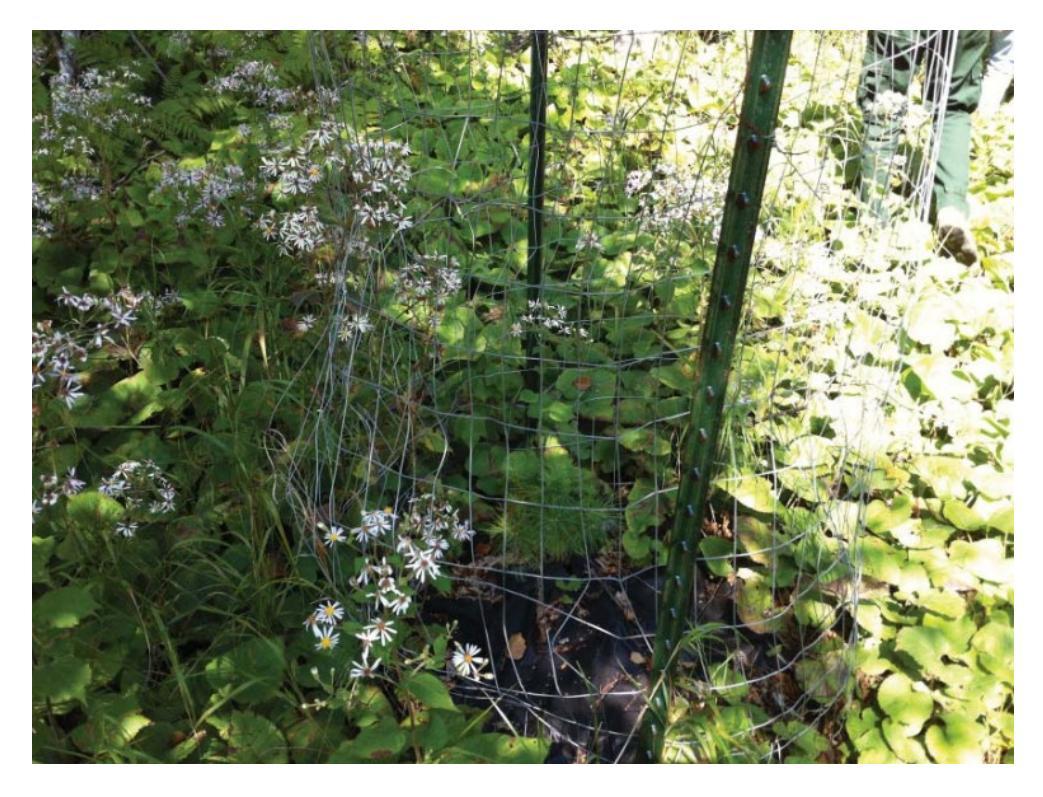
Photo 18-4 A tree cage with geotextile ground cover at the Caribou Falls Wayside project site.

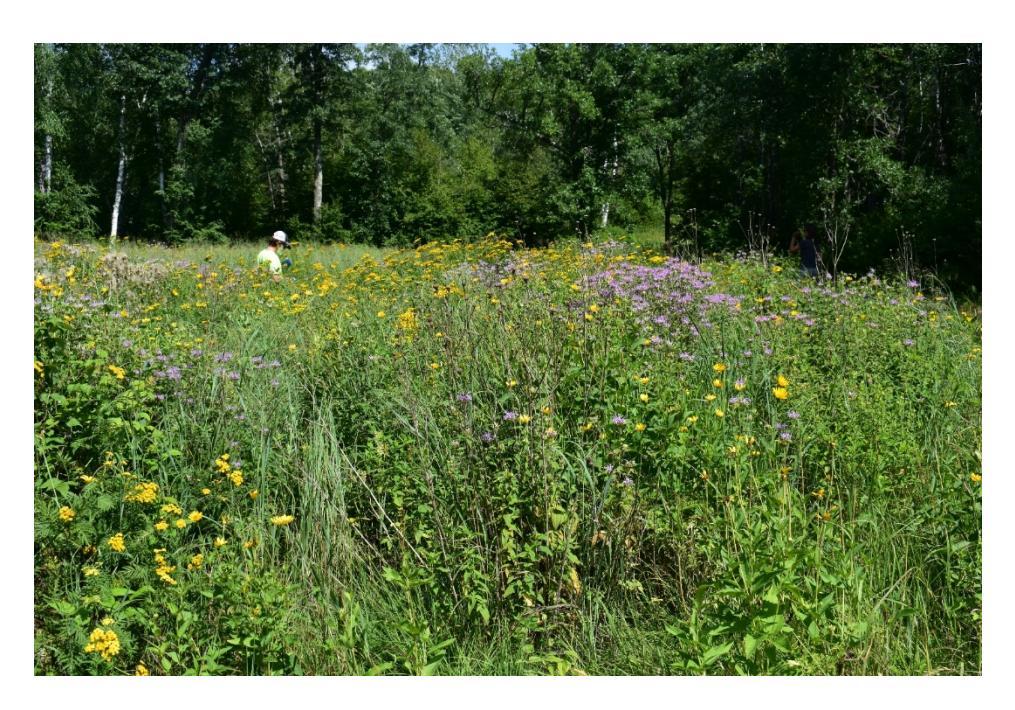
Photo 19-2 Site 1, pictured here, shows dense establishment of native grasses and blooming forbs, with pockets of Tansy visible as well. (photo taken during site visit 8/6/2020).

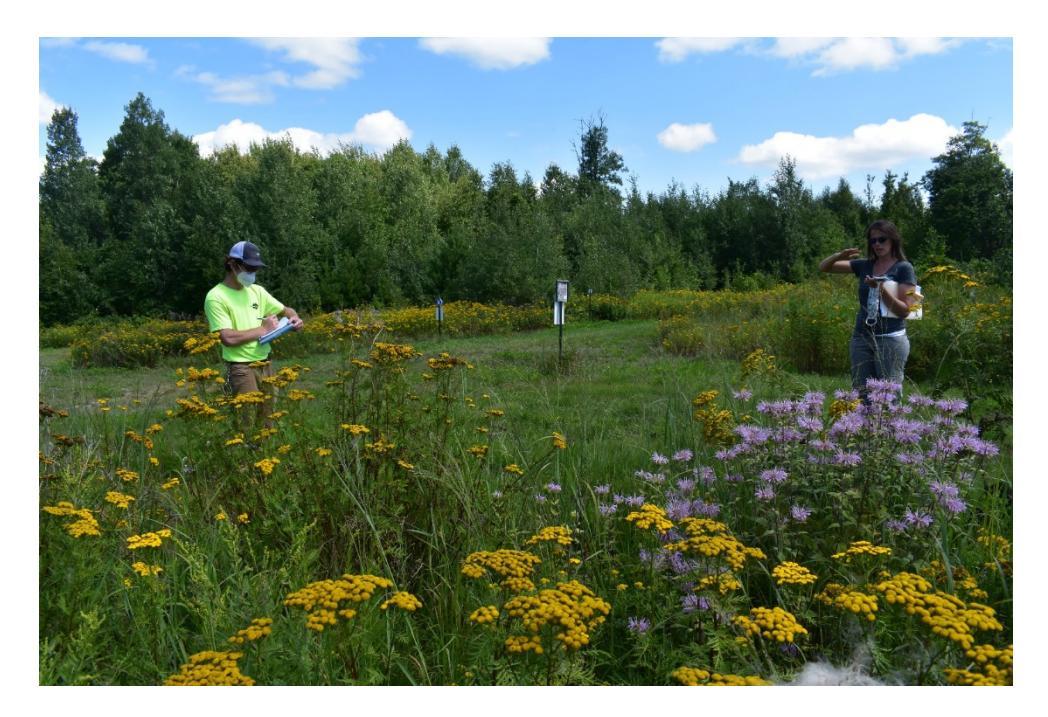
Photo 19-3 Photo showing site 2. Abundant floral resources are evident, although tansy is becoming dominant (photo taken during site visit 8/6/2020).

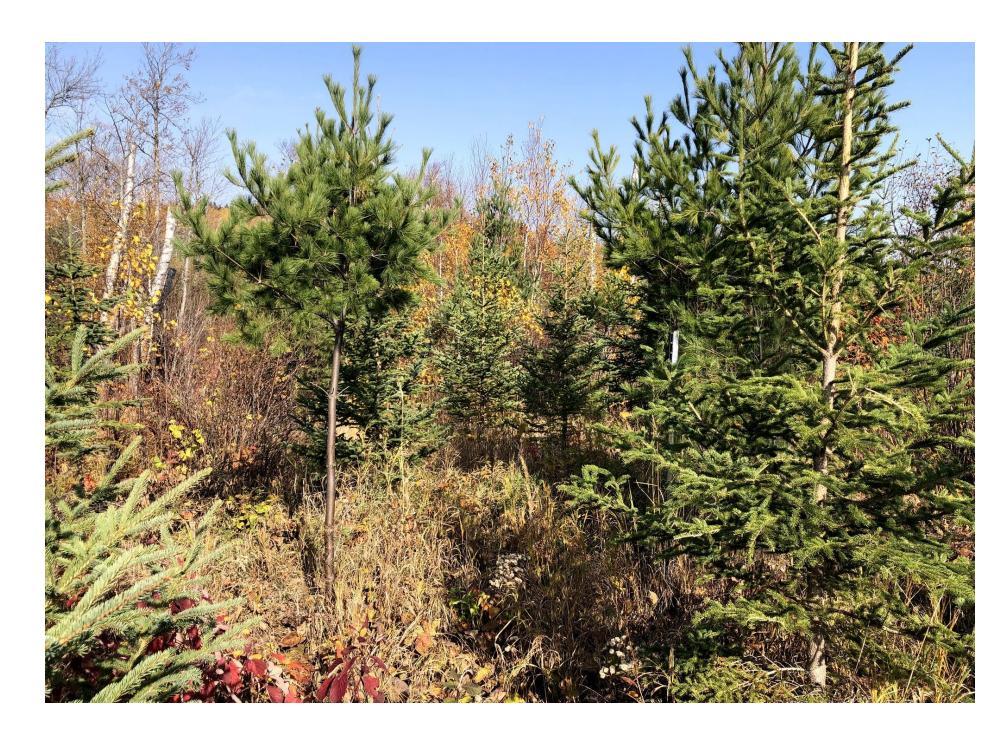
Photo 20-2 Pruned white pines, spruce, and tree fence at the Wolf Ridge site.

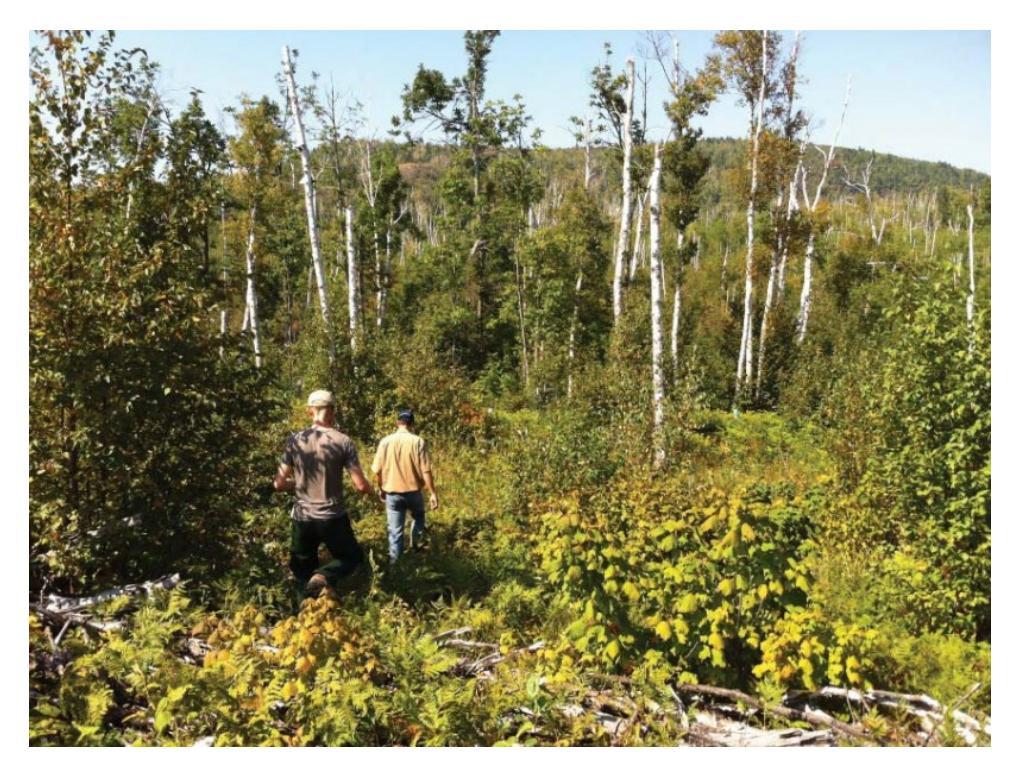
Photo 20-2 A thinned area with birch dieback.

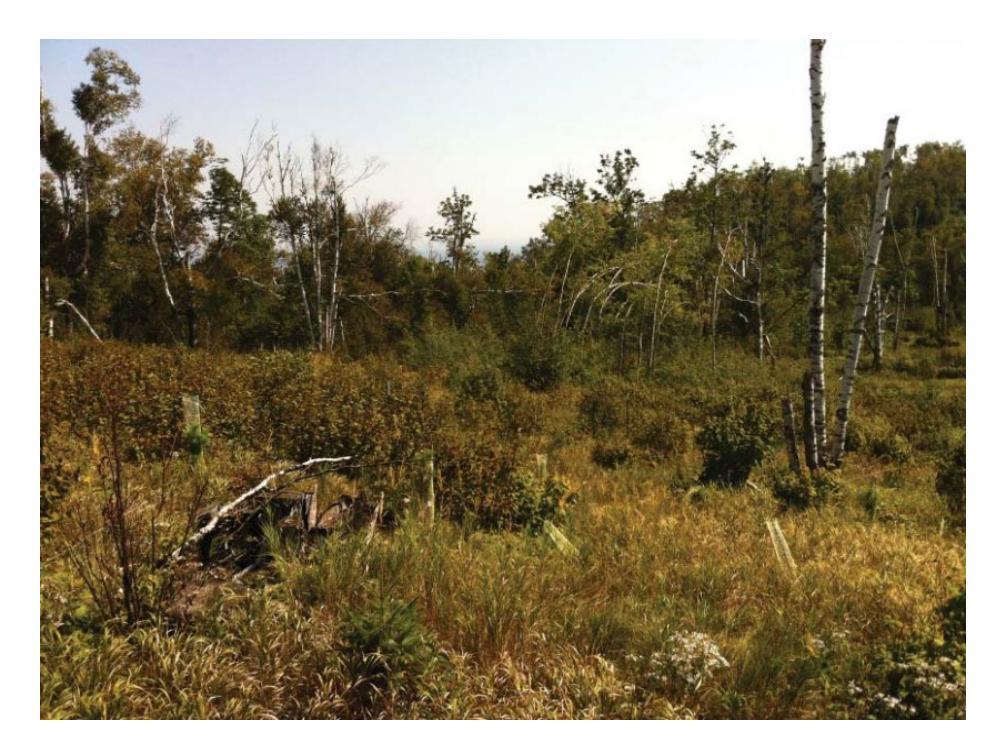
Photo 20-4 A thinned area with birch dieback.

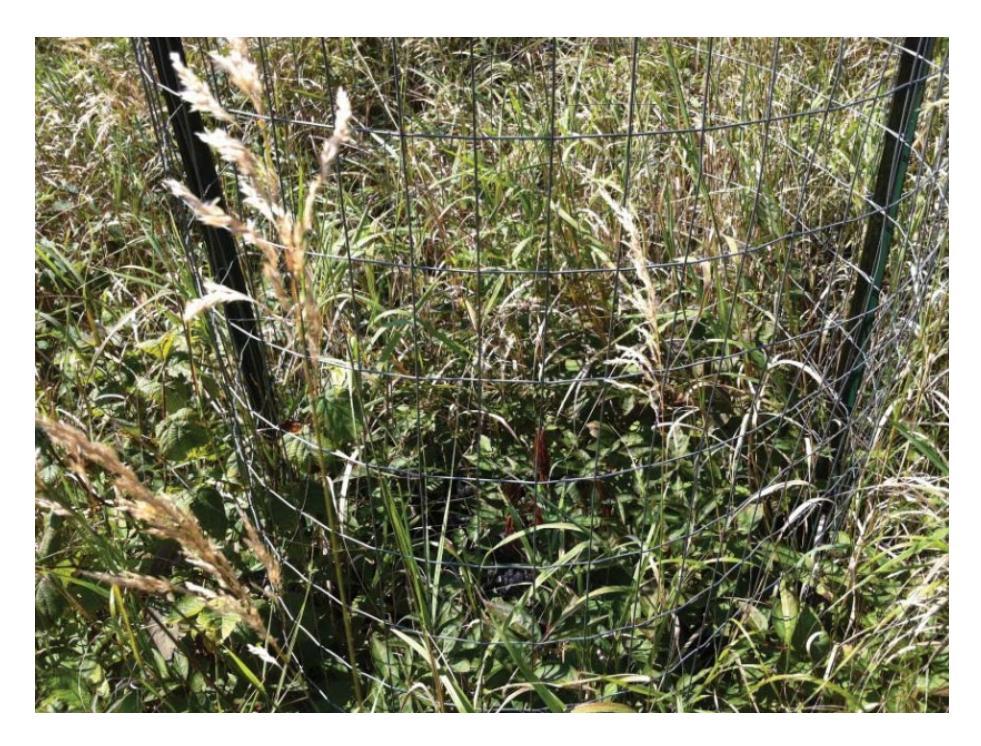
Photo 20-6 Seedling mortality.

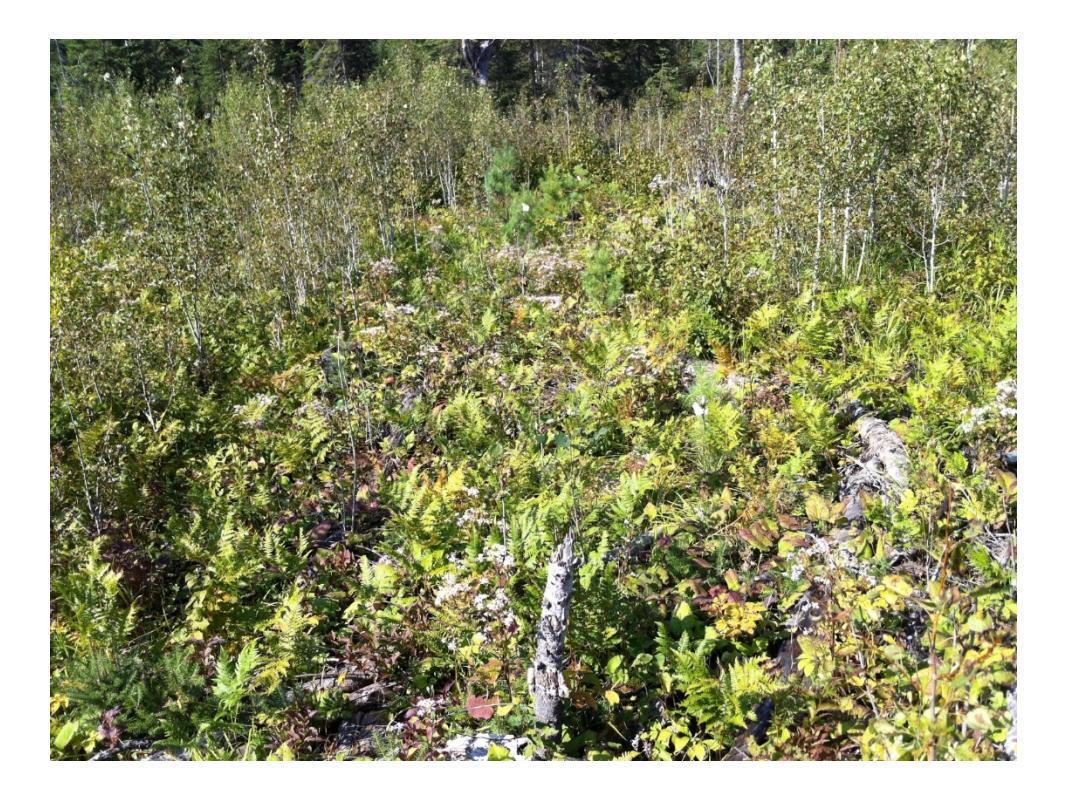
Photo 21-3 The Hut Two site is still very open post logging in 2012. Planted White Pine and White Spruce will need to be released during future management to compete with Balsam Fir, Aspen and other shrubs and forbs.

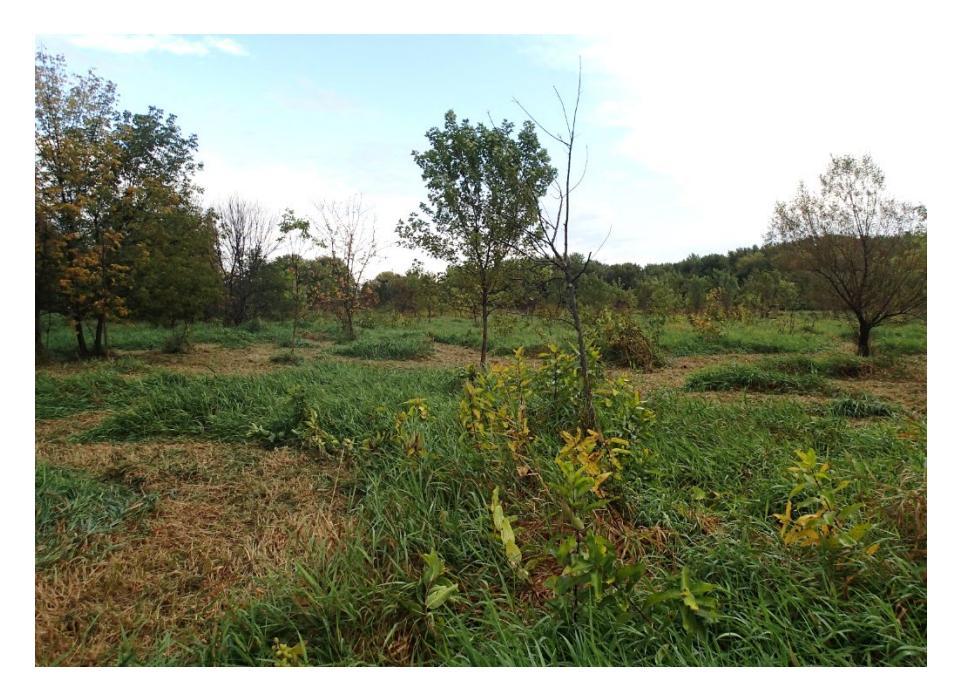
Photo 22-1 Representative vegetative structure of the planting site. In the background, one of the denser stands of surviving trees can be seen. In the foreground are an example of a live Silver Maple and one that has not survived. Reed Canary Grass dominates the ground layer vegetation throughout the site, interspersed with forbs such as common milkweed in this photo. Photo from site visit September 24, 2020.

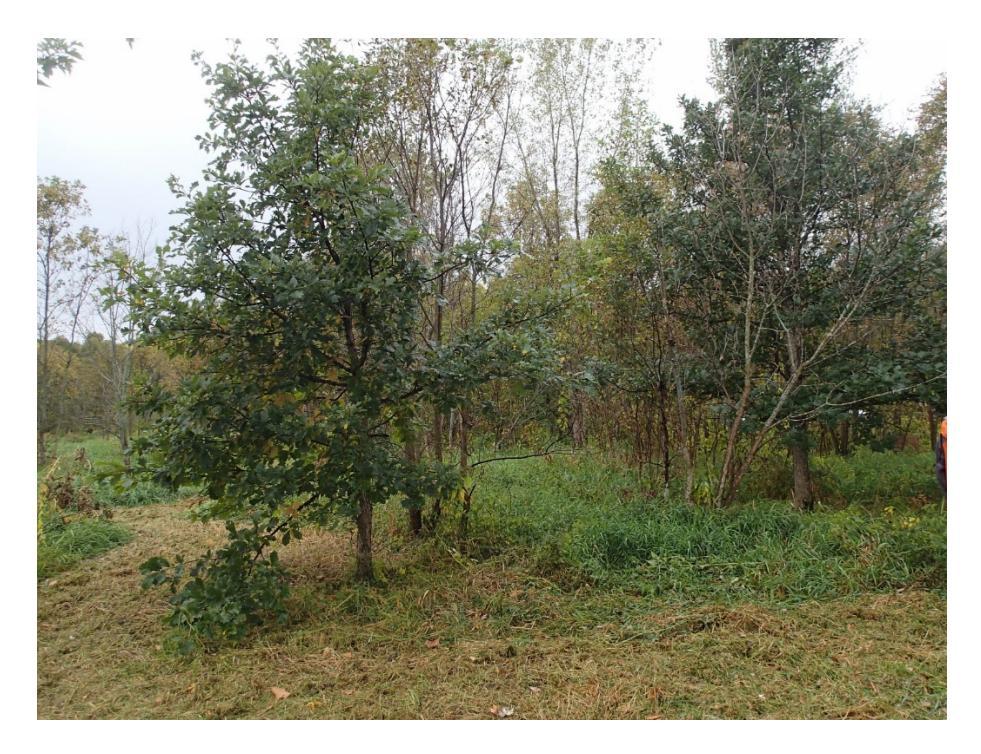
Photo 22-3 These swamp white oaks are adjacent to the planting area, and their presence on site indicates that the species was an appropriate choice for the planting, despite their struggles in establishment. Periodic mowing of the reed canary grass on site should help promote the volunteer trees on the site as well as those that were planted. Photo from site visit September 24, 2020.

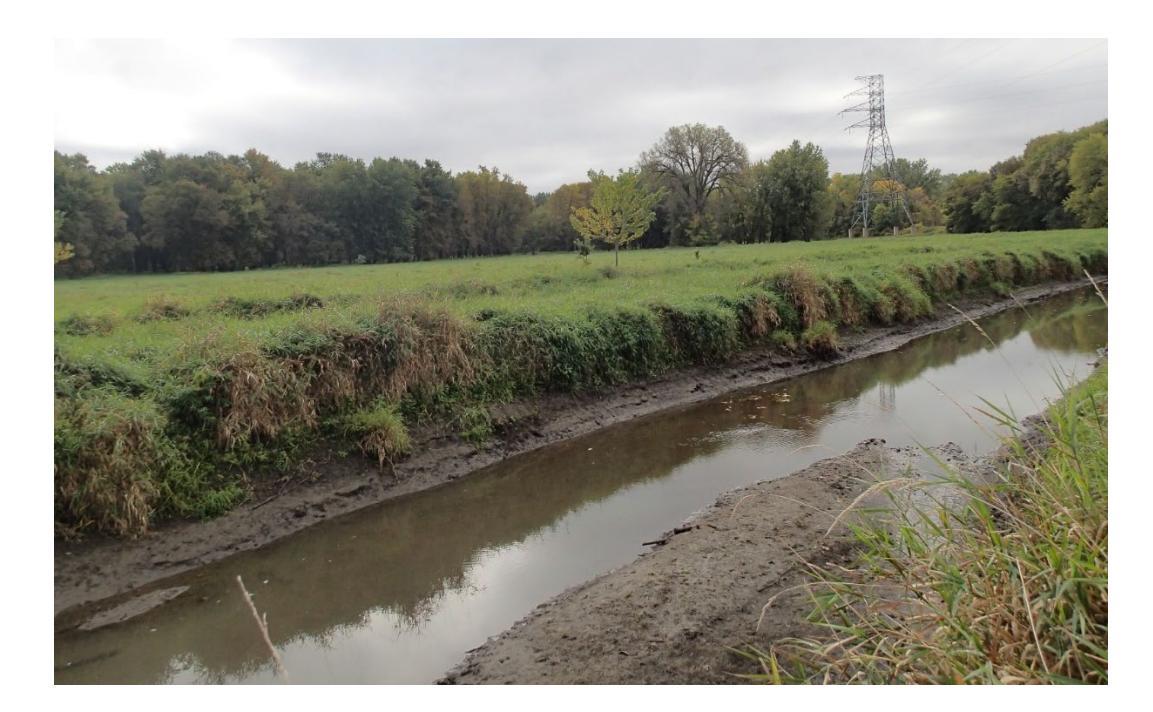
Flooding caused mortality of a significant percentage of the trees. The areas of lowest elevation appear to have the lowest success rate, and of the planted species, only Silver Maple and Swamp White Oak have survived. In addition, the deer protection installation was completely wiped out due to flooding. Despite the setback due to high water in 2014, the surviving trees and those which were planted after the high water of 2014 have grown quickly and appear to be well-established enough to survive future challenges to the site.

Photo 22-6 The eastern side of the planting area has a much lower survival rate, as can be seen here. Only widely scattered trees remain. Photo from site visit September 24, 2020.

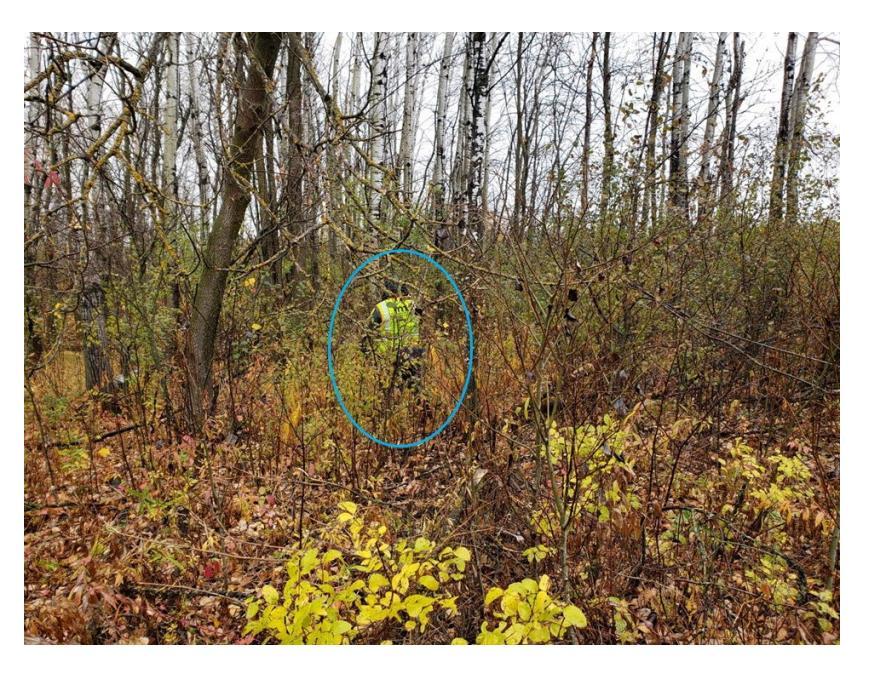
- 22. Provide explanation of reason(s) for determination.Buckthorn is fairly dense on this site and will likely dominate the shrub layer within several years without further management actions.
- 23. Site Assessor(s) Conducting Review: Mark Pranckus, Cardno

Photo 23-1 Example of buckthorn re-growth at the site. Most shrub vegetation with green and yellow leaves is buckthorn. MN DNR staff in blue circle to demonstrate vegetation density and height. (Halma Swamp Wildlife Management Area, photo taken during site visit 10/14/2020 by Mark Pranckus, Cardno).
