Minnesota Department of Natural Resources Minnesota Board of Water and Soil Resources

Appendix A: 2020 Legacy Fund Restoration Evaluation Report

April 2020

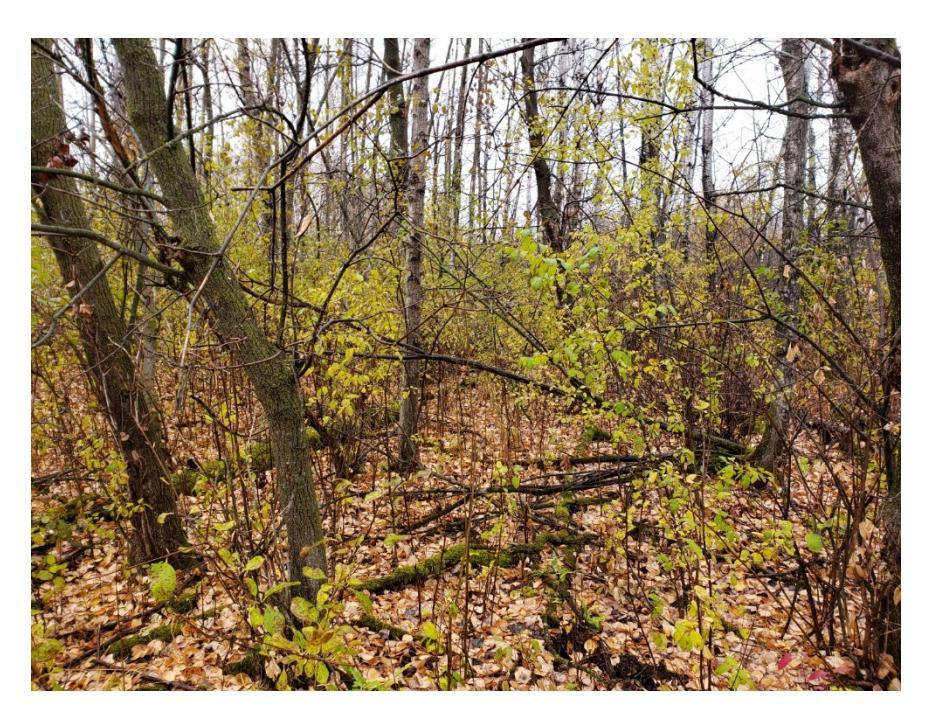
Photo 23-2 Example of the existing vegetation in the project area. Dense buckthorn dominates the understory (Halma Swamp Wildlife Management Area, photo taken during site visit 10/14/2020 by Mark Pranckus, Cardno).

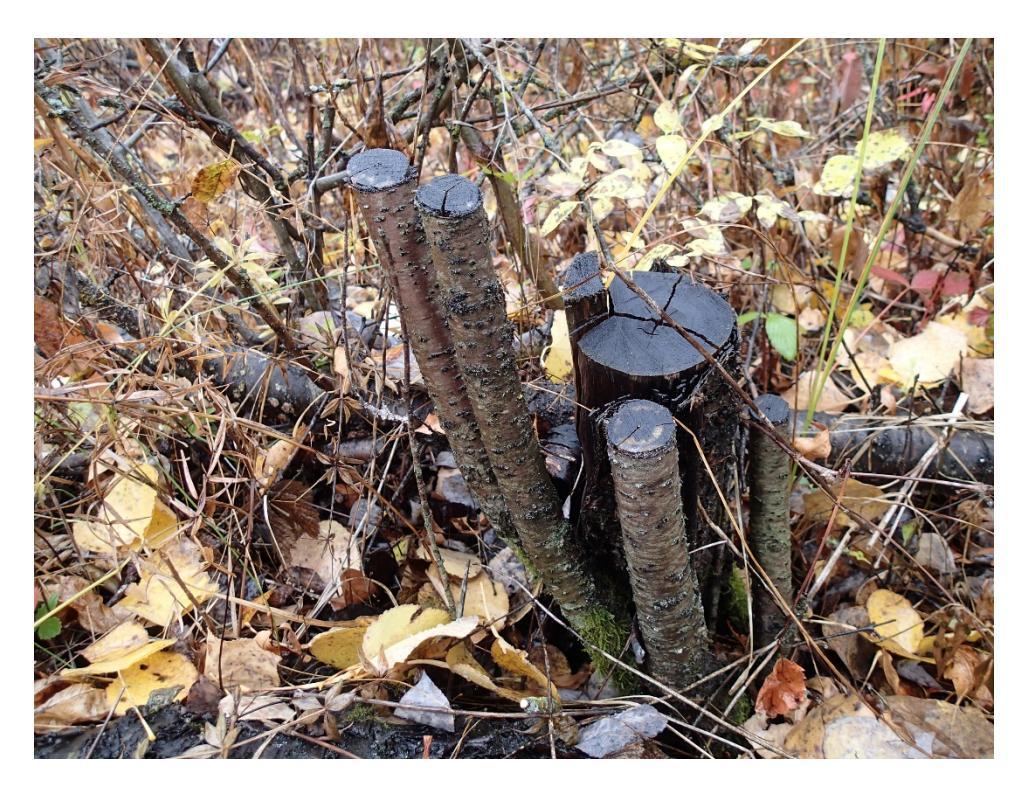
Photo 23-3. Example of a mature buckthorn that was cut and stumped treated with herbicide in 2015. Treated stumps are not resprouting. (Halma Swamp Wildlife Management Area, photo taken during site visit 10/14/2020).

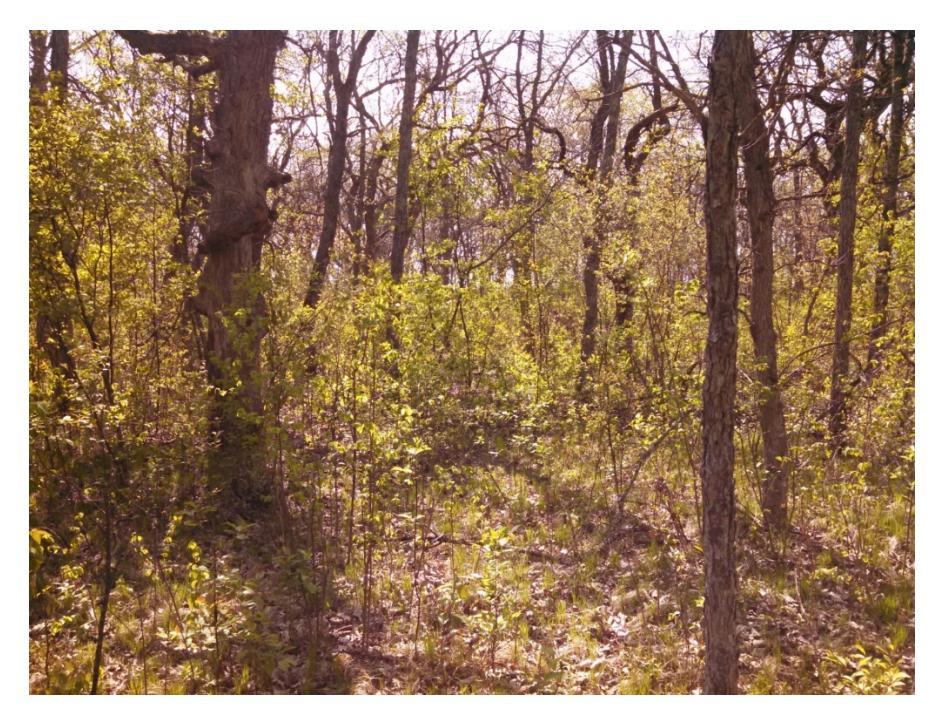
Photo 24-1 This photo shows the condition of the site prior to treatment. Notable is the height and density of the brush layer. (photo taken 5/15)

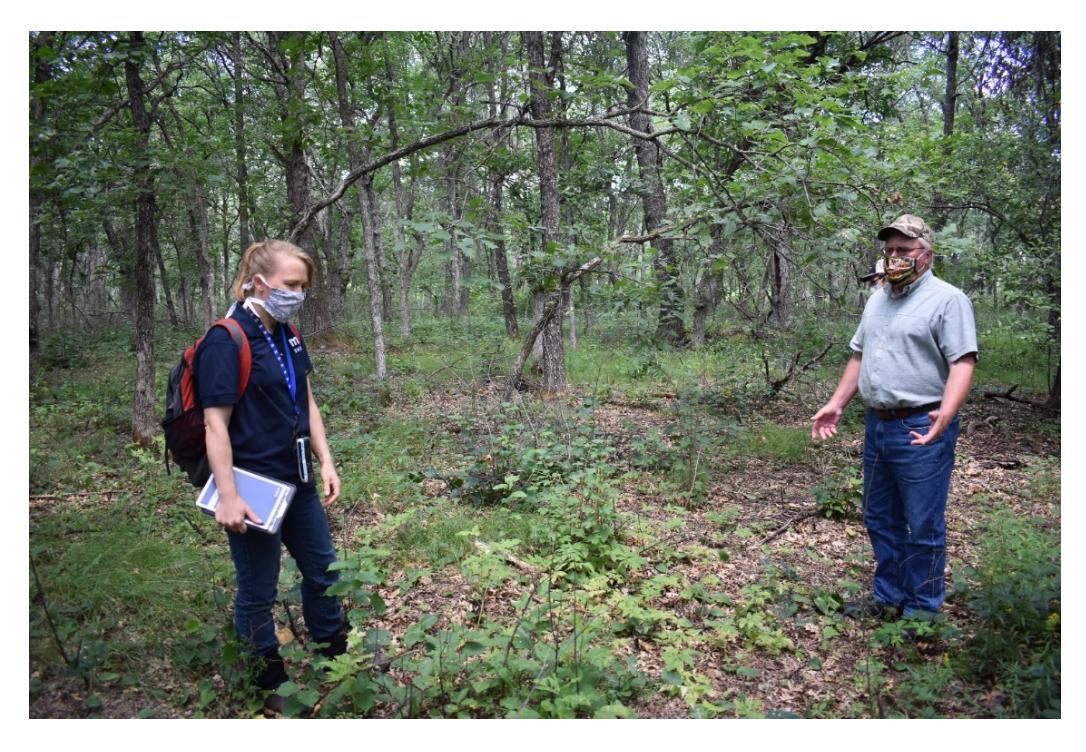
Photo 24-5 In the growing season following the burn, many open pockets remain clear of overabundant woody brush, and ground layer herbaceous vegetation is filling in. (photo taken 8/3/20)

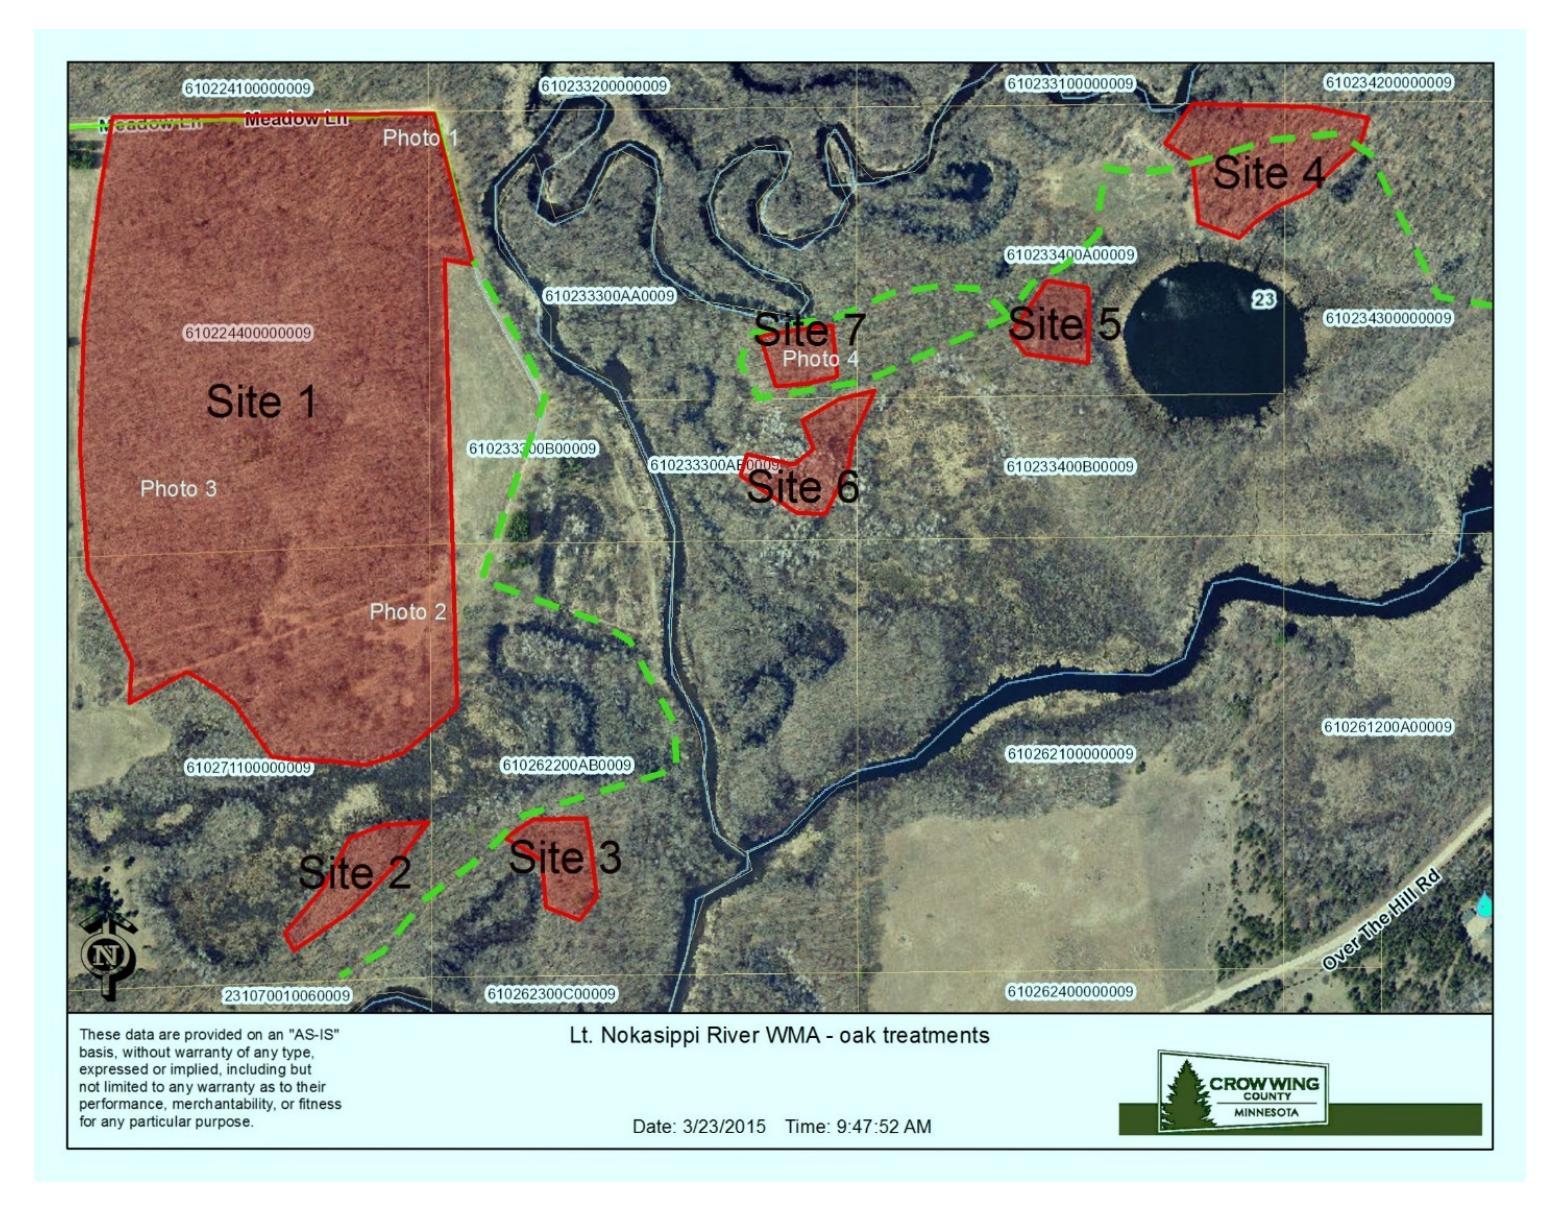
Figure 25-1 Sites 4-7 received forestry mowing, herbicide follow up.

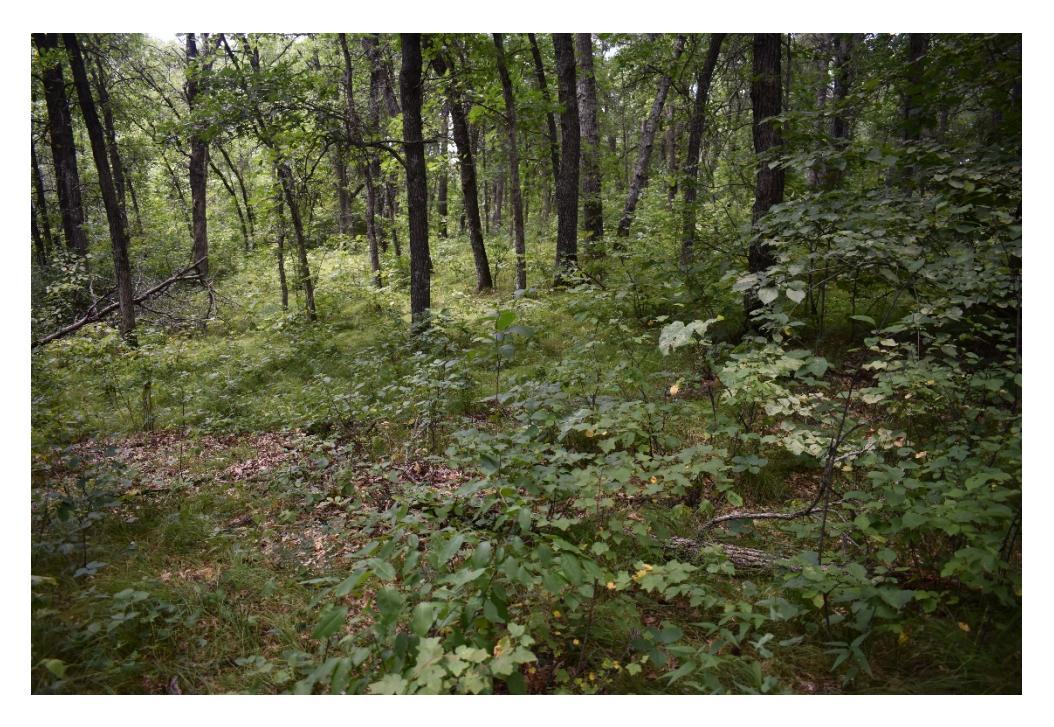
As compared with the density prior to treatment, there has been roughly a 50 percent reduction in the brush layer density, as well as a 35 percent reduction in height of the brush—specifically prickly ash and hazel. Within Site 4, young oak seedlings were observed. This indicates that the treatment area benefited from additional sunlight created by the forestry mowing.

Photo 25-1 Area of brush removal in Site 4 showing a mix of remaining openings and resprouting brush (photo taken during site visit on 8/3/2020).

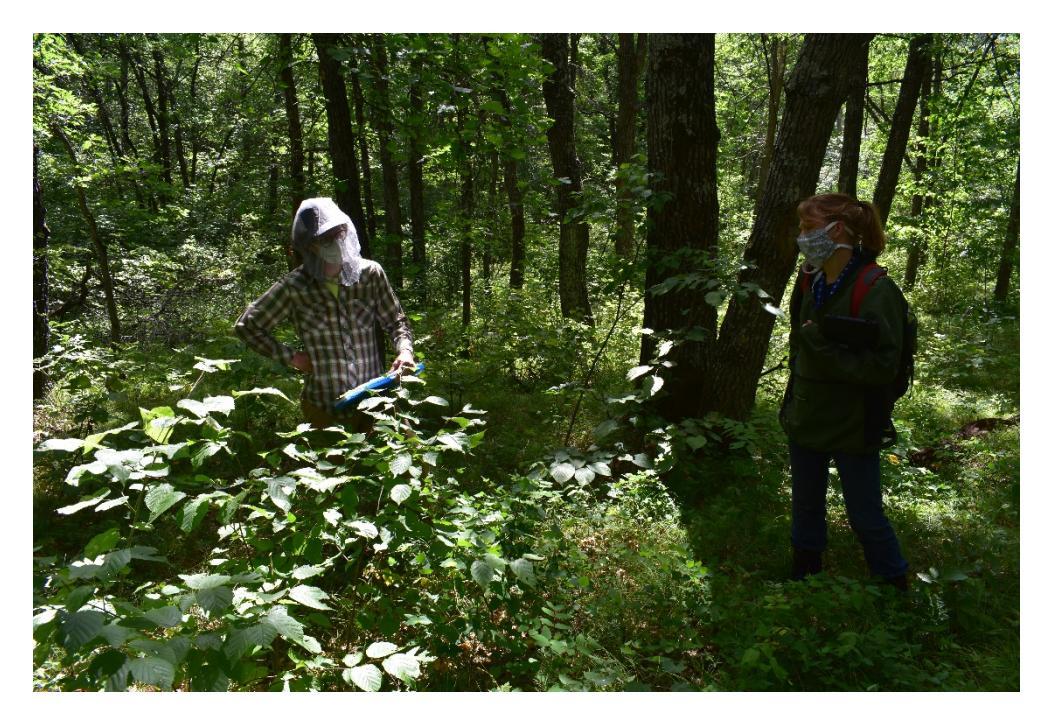
Photo 25-2 Area characteristic of where more regrowth has happened on the site following brush removal (photo taken during the site visit on 8/3/2020).

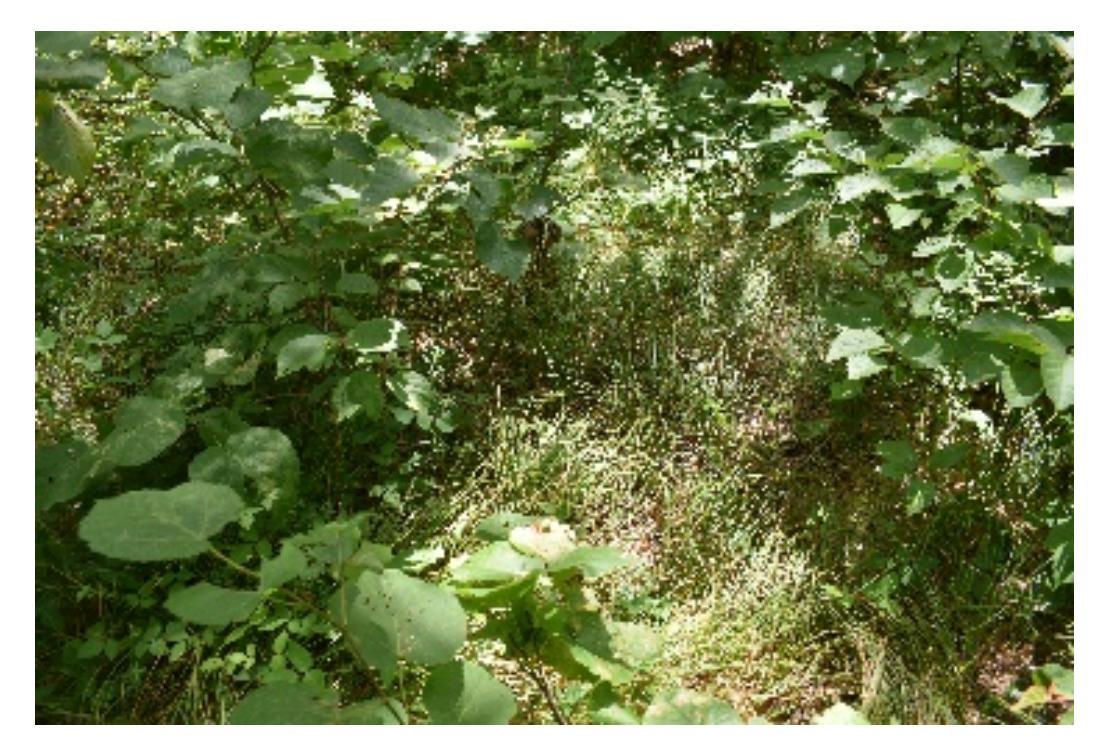
Photo 25-3 Photo characteristic of the understory vegetation in Site 4 (phot taken during site visit on 8/3/2020).

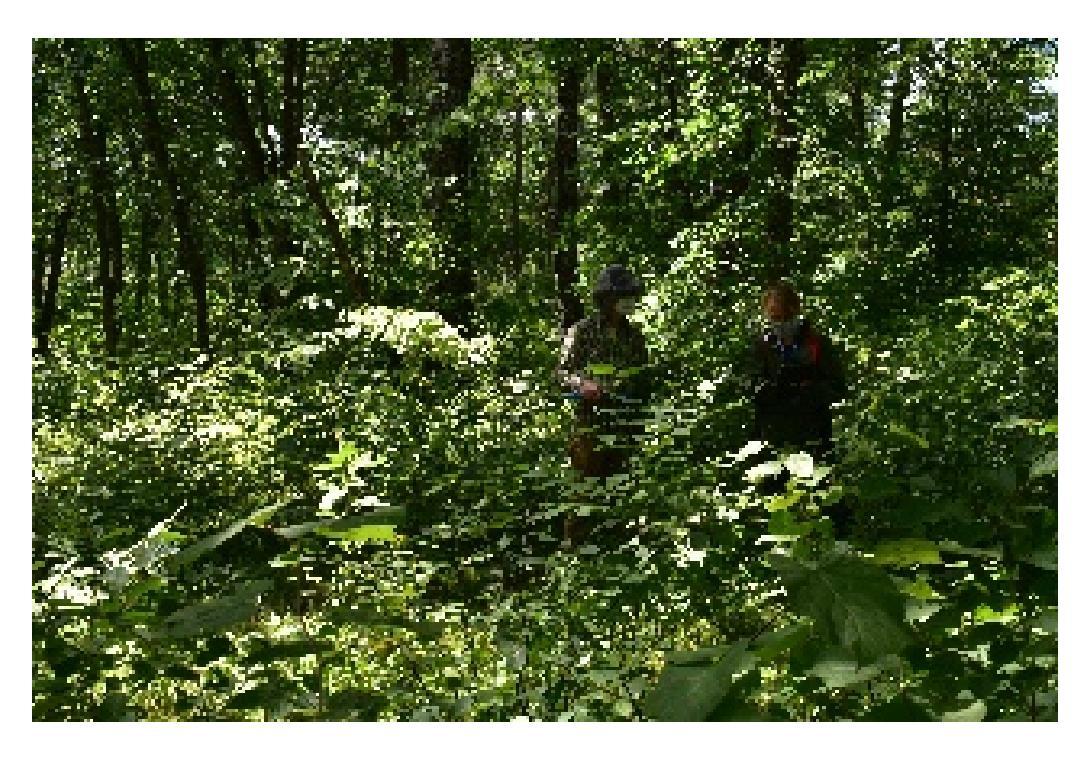
Photo 25-4 Untreated area NE of site 4. Untreated areas were covered pretty consistently by 3-5 ft brush with few to no openings (photo taken during site visit 8/3/2020).

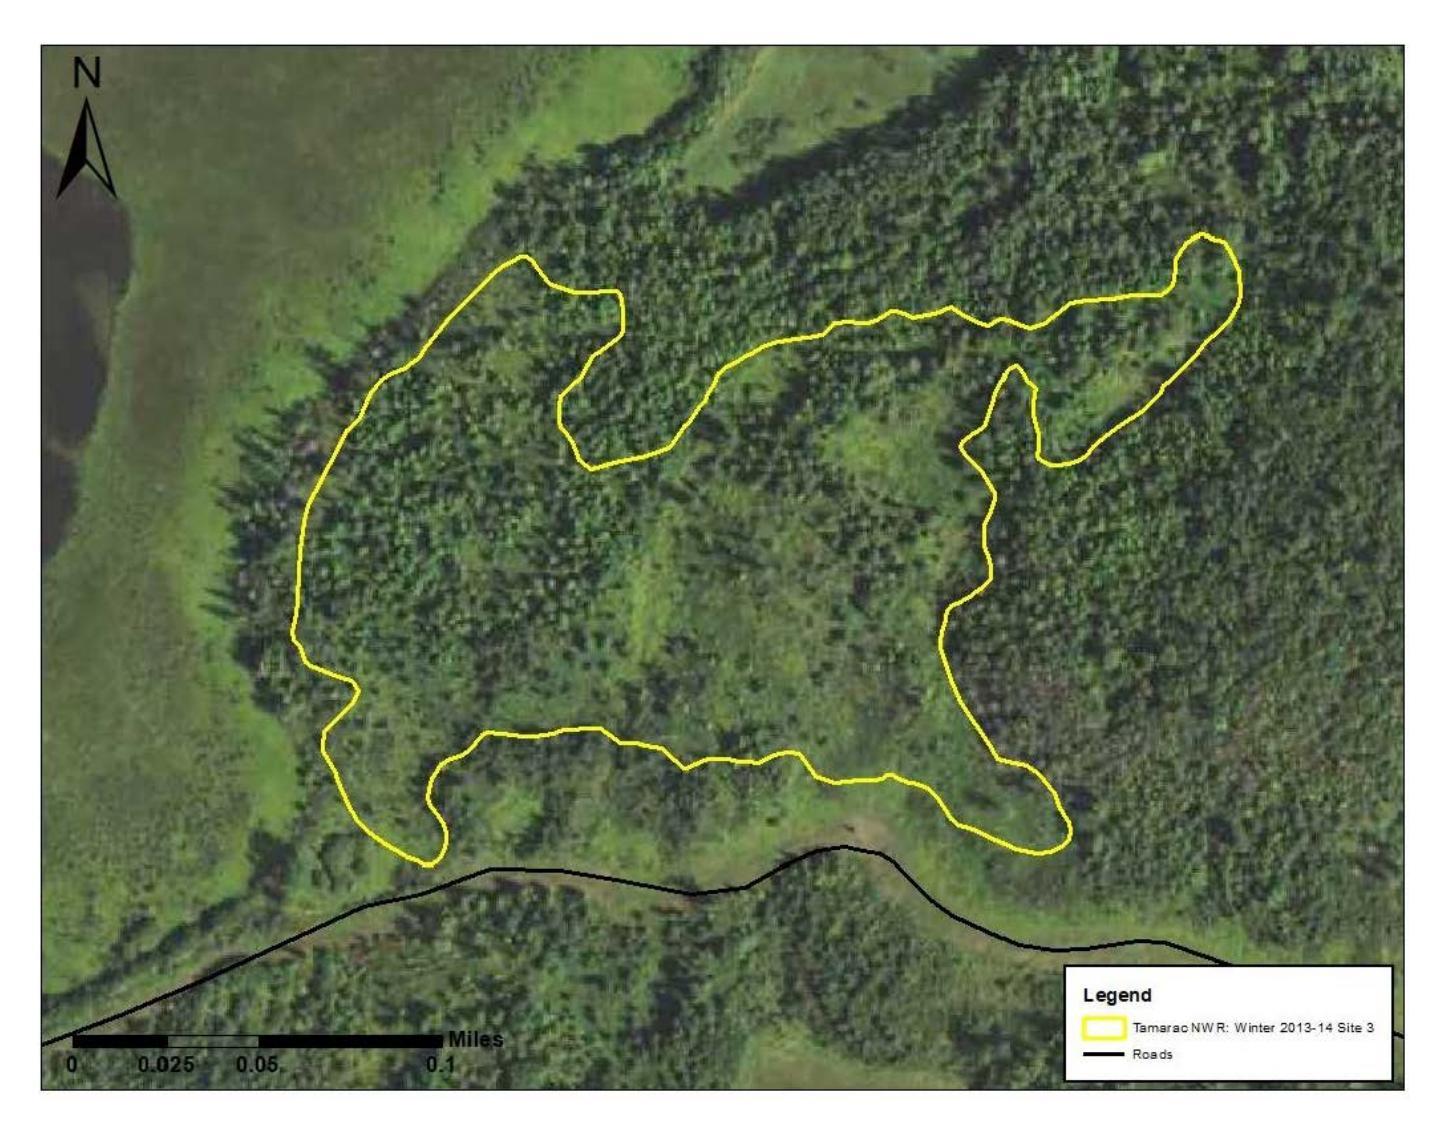
Figure 26-1 Pre-treatment aerial imagery of project site dominated by dense hazel from 1-3" DBH, completed in Winter 2016-17 (2015 True Color).

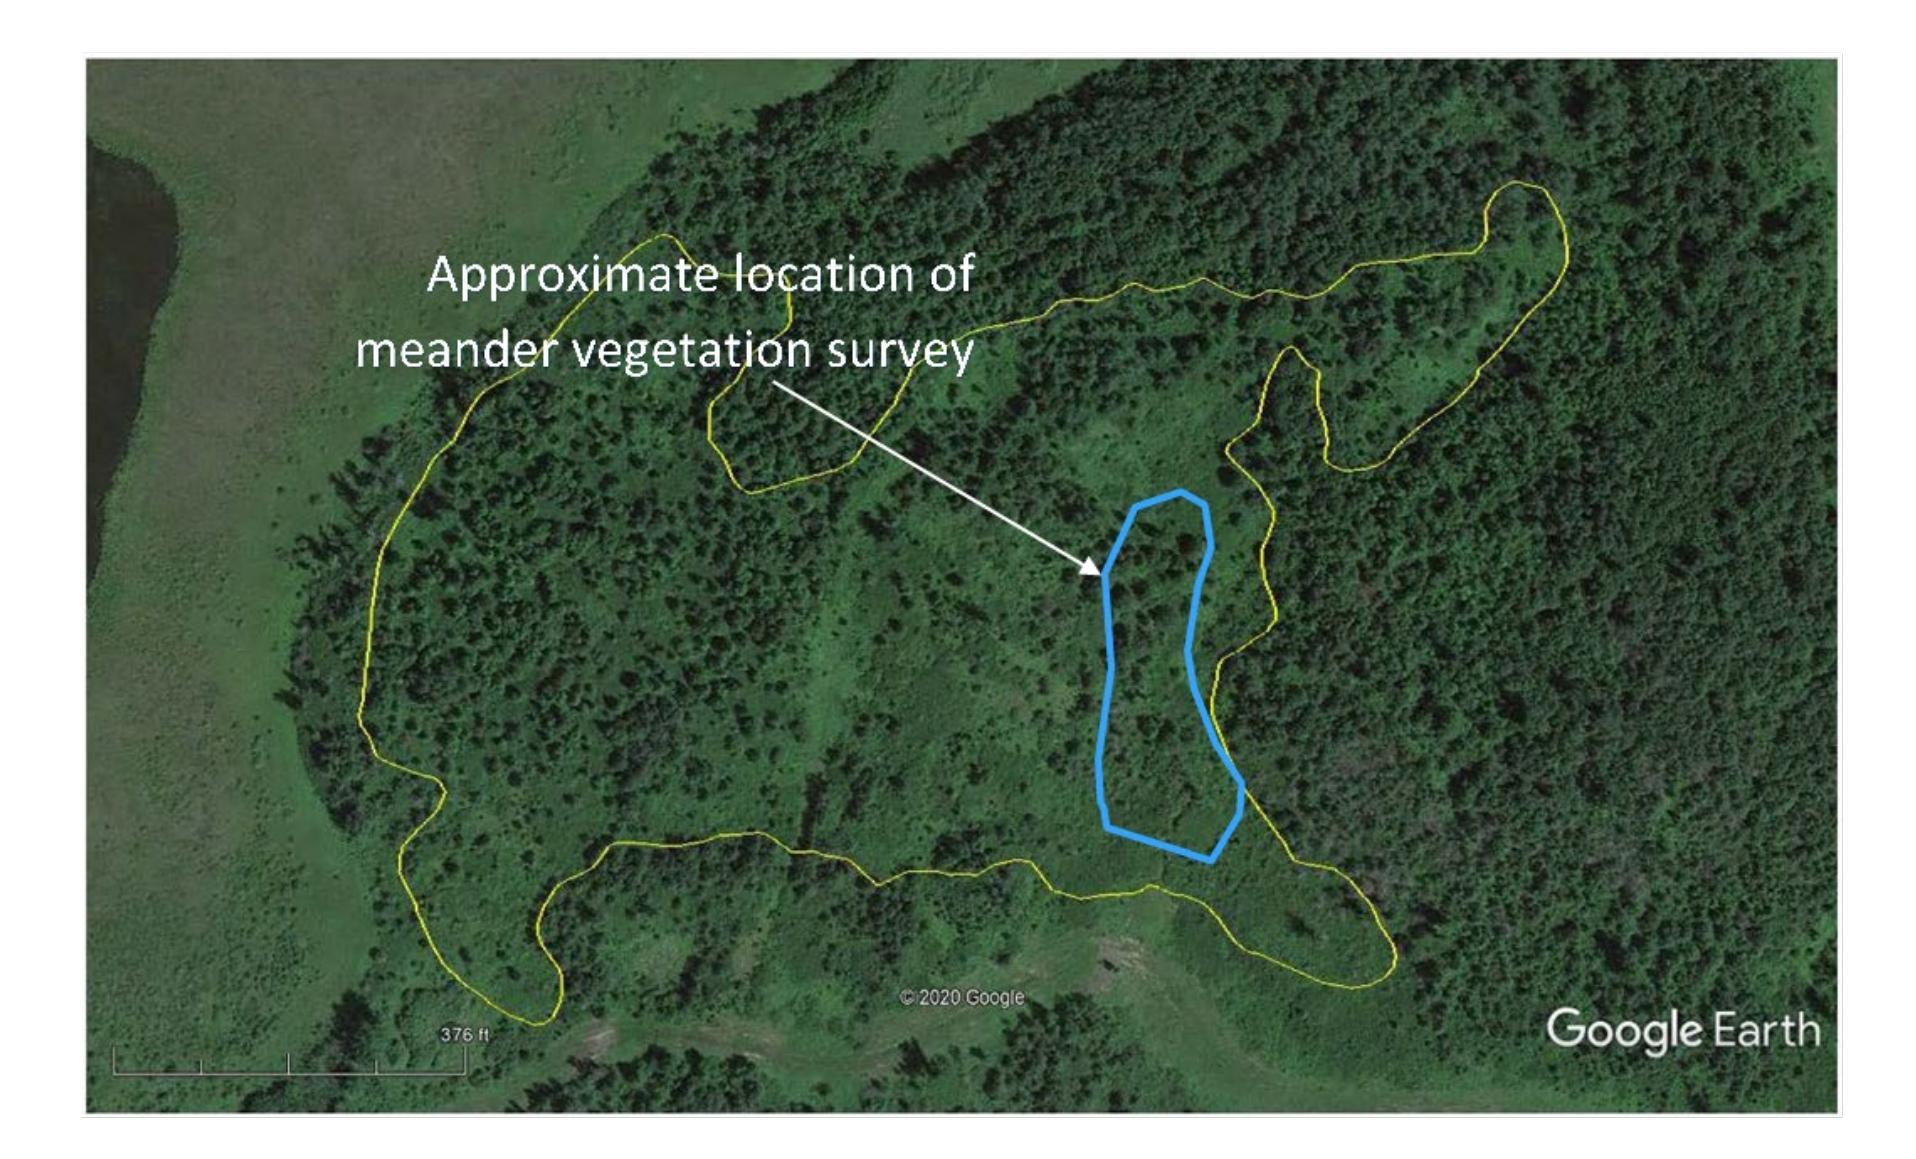
Figure 26-2 Post-treatment aerial imagery of project site includes more aspen and oak regeneration, though still robust hazel component, (Google Earth 2020).

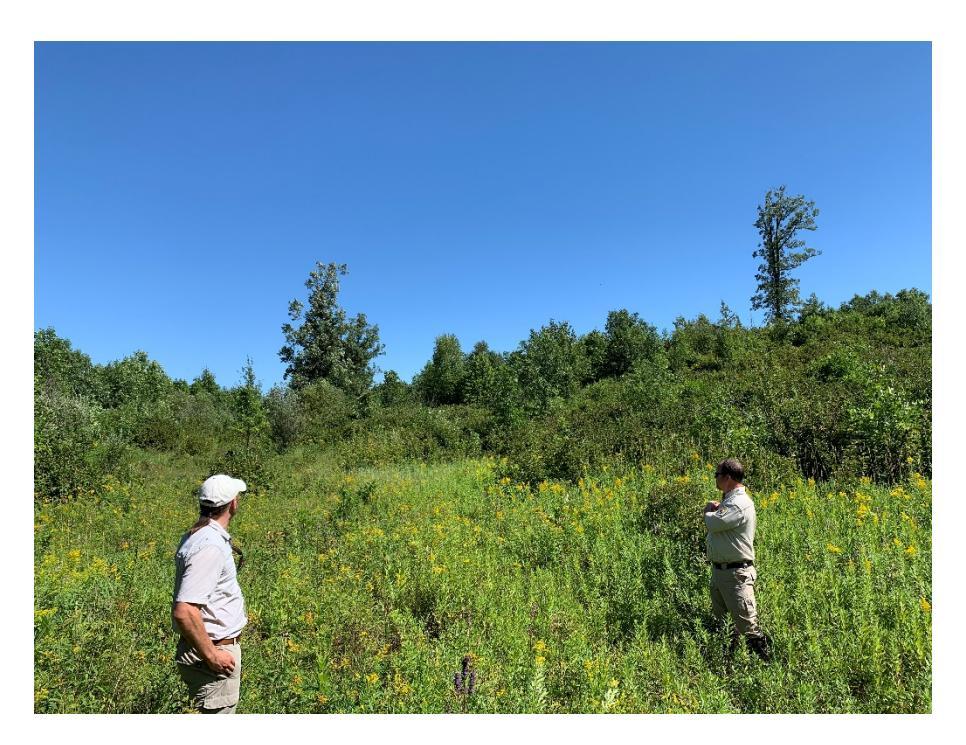
Photo 26-1 Treatment area illustrating open meadows that are interspersed with dense regrowth of beaked hazel and other brush after forestry mowing in 2017 (photo taken 8.18.20).

Accepted practice for long-term management of early-successional (woody regrowth and herbaceous) habitat requires periodic mowing and/or fire. The long-term challenge for maintaining early successional habitats such as the ones in this project is the need to periodically re-mow or burn every 6-10 years.

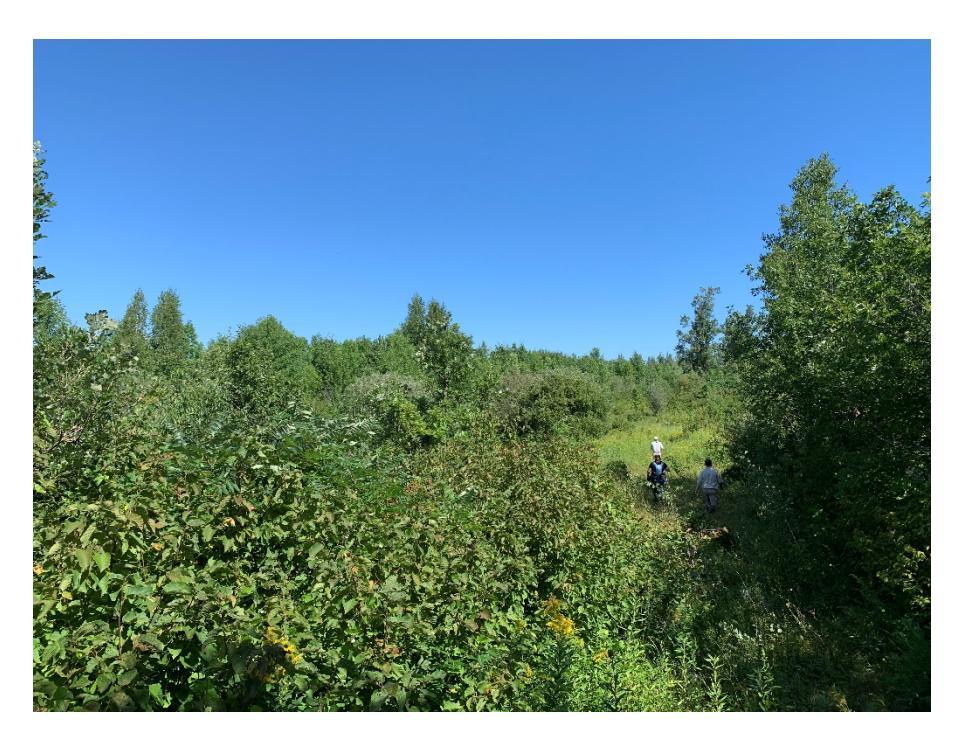
Photo 26-2 View from hillside, showing regrowth of mowed woody vegetation and scattered taller trees that were retained during the treatment (8.18.20).

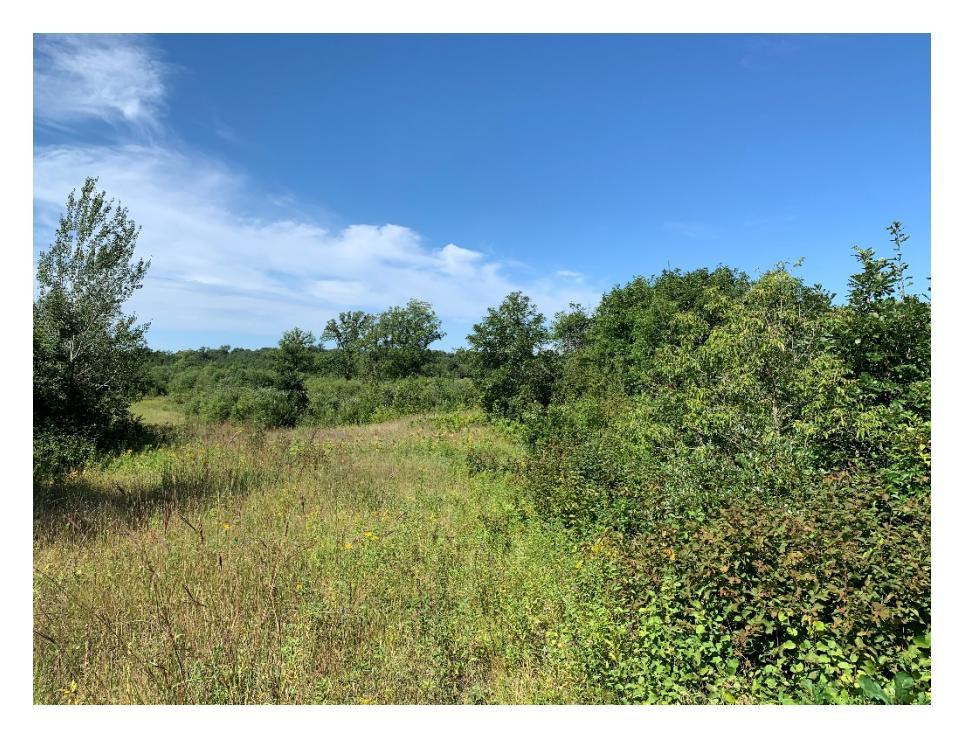
Photo 26-3 Portion of treatment area that had pre-existing native grasses and flowers, surrounded by regrowth of brush following forestry mowing (8.18.20).

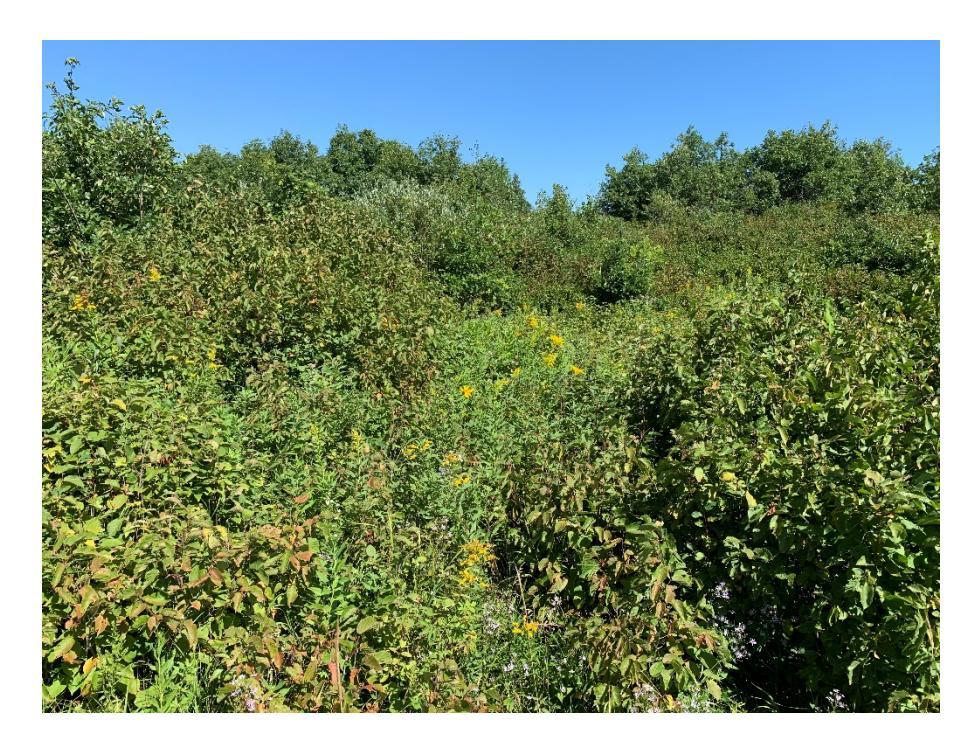
Photo 26-4 Portion of treatment area with dense brush regrowth following forestry mowing (8.18.20).

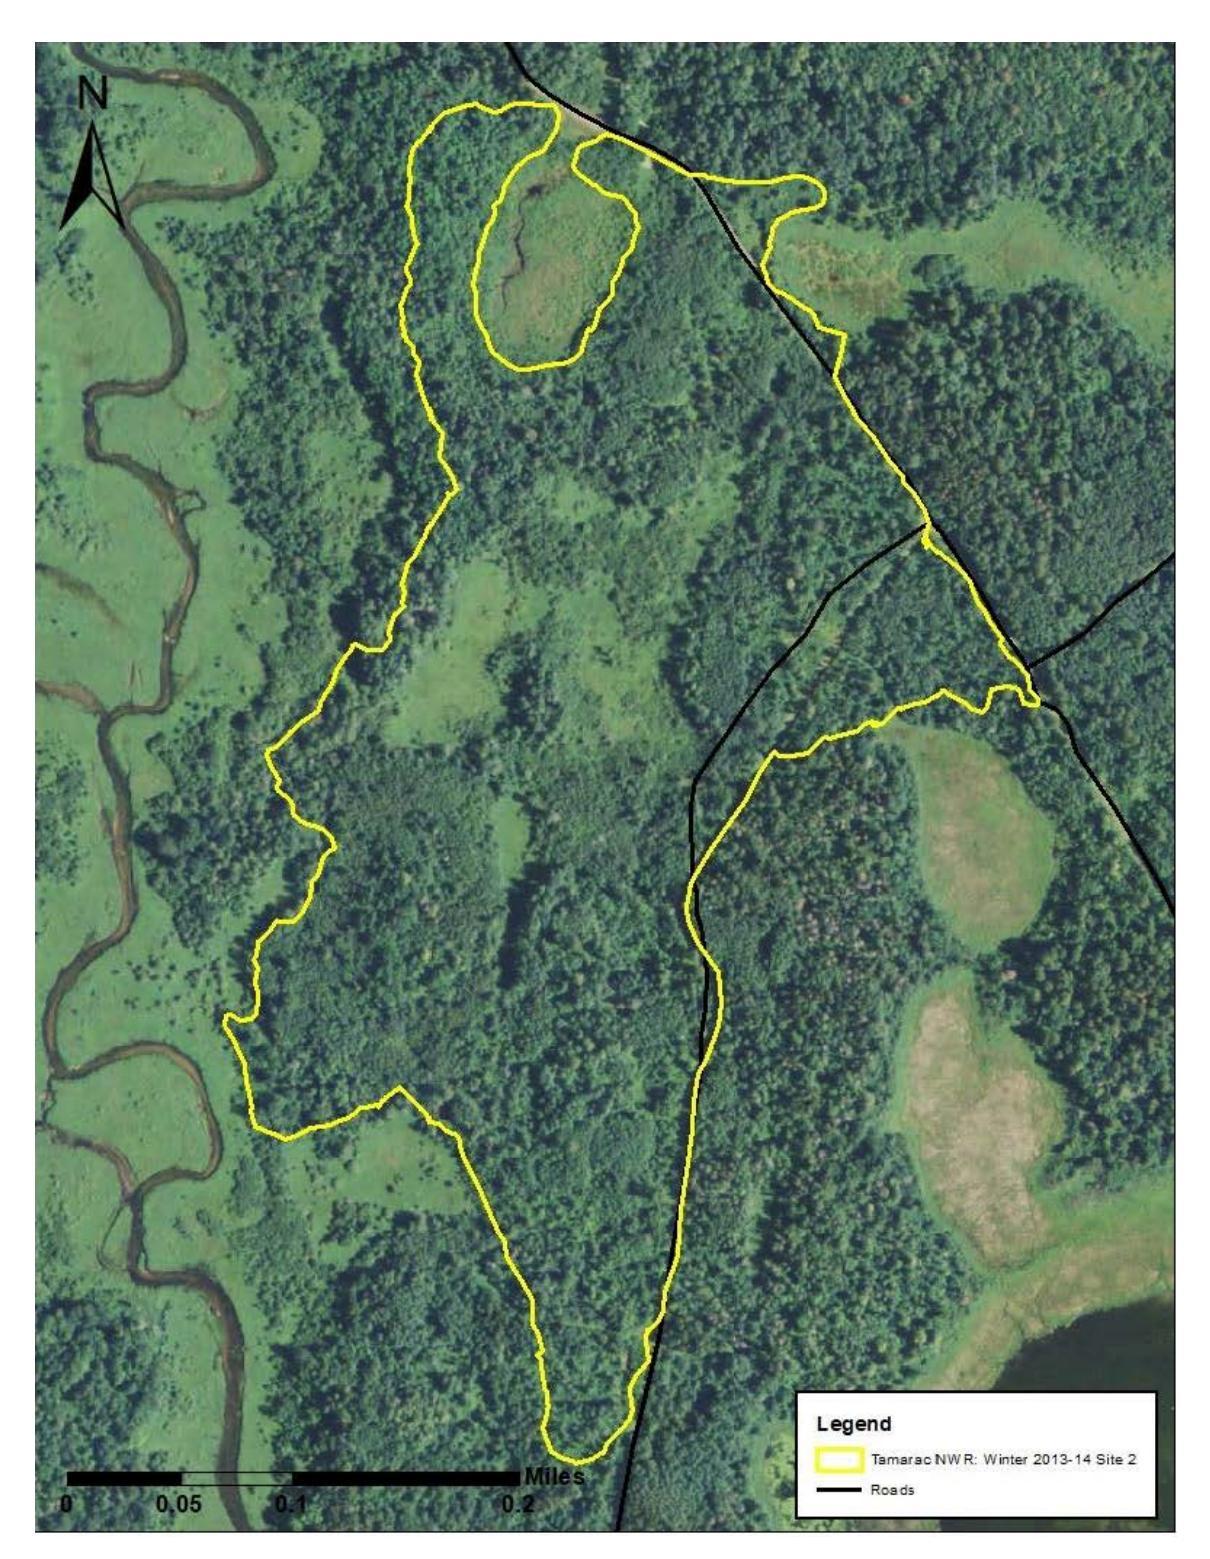
Figure 27-1 Pre-treatment aerial imagery of project site dominated by illustrating dense willow, alder and aspen species from 1-3" DBH within a matrix of singly dispersed and clumped mature tree species, (2010 True Color).

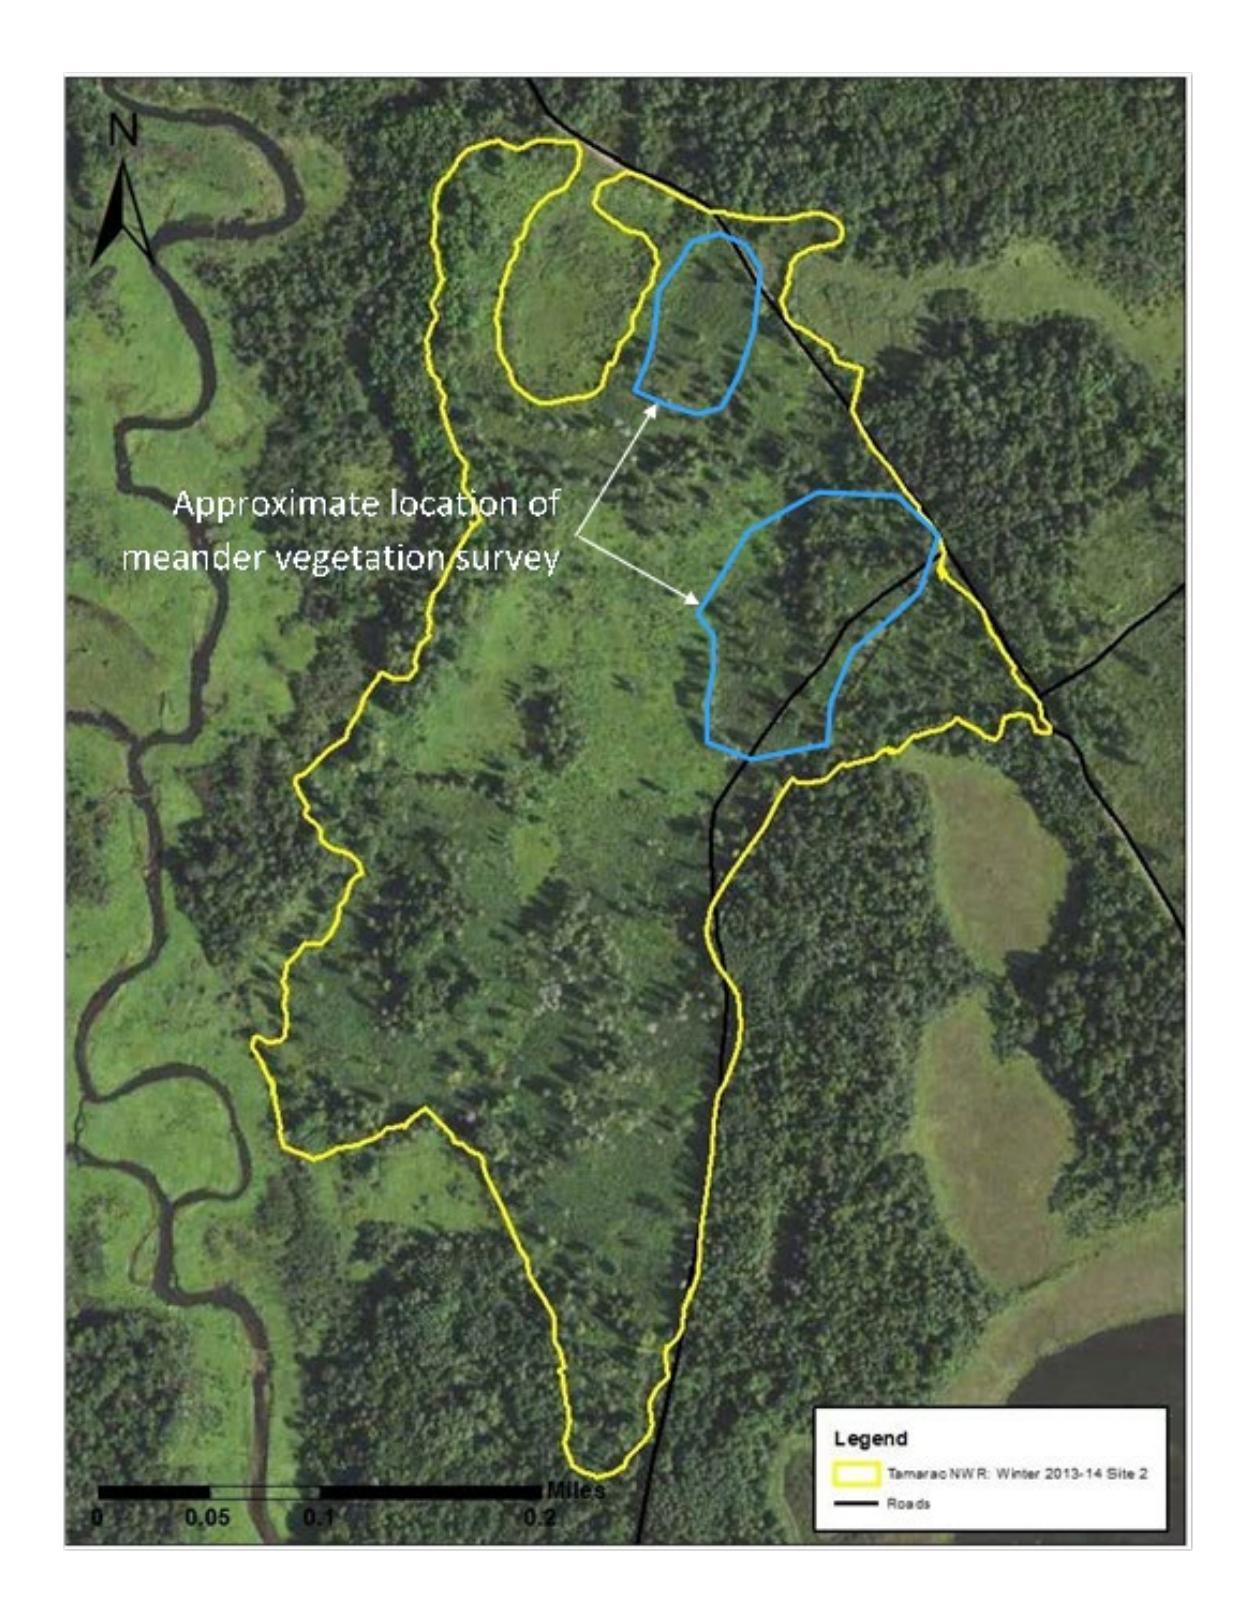
Figure 27-2 Post-treatment aerial image of project illustrating the increase in shorter stature vegetation following brush mowing. Site treatment focused on dense willow, alder and aspen species from 1-3" DBH, completed in Winter 2013-14 (2016 True Color).

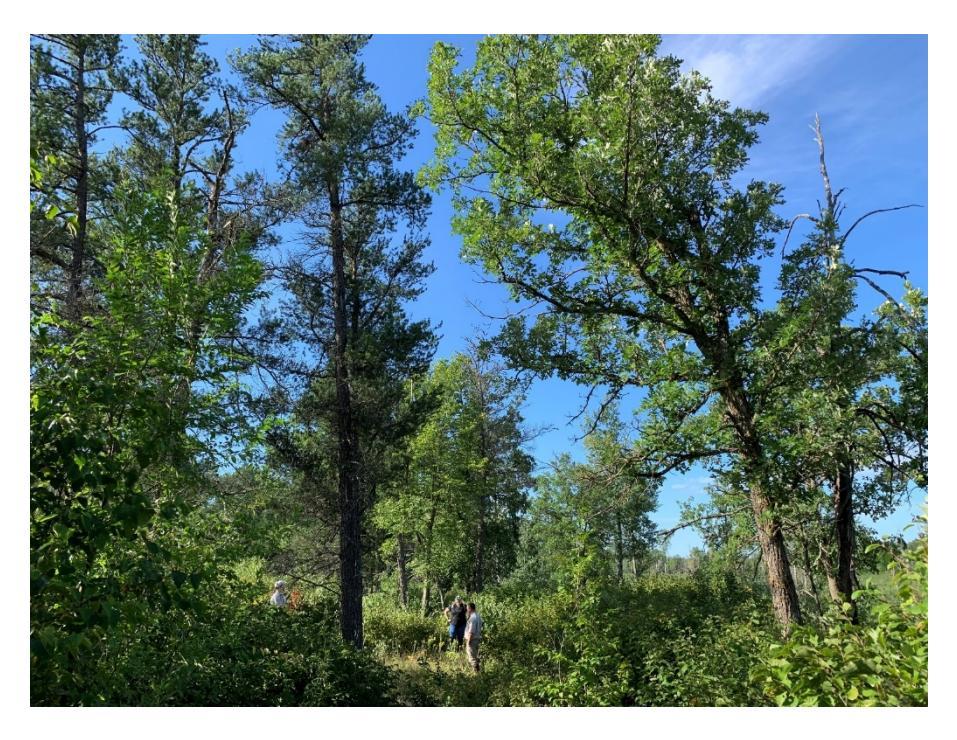
Photo 27-1 Upland portion of site project area illustrating relatively even, short herbaceous and woody resprout growth following brush mowing. Mature trees in photo include Jack pine and bur oak (8.18.20).

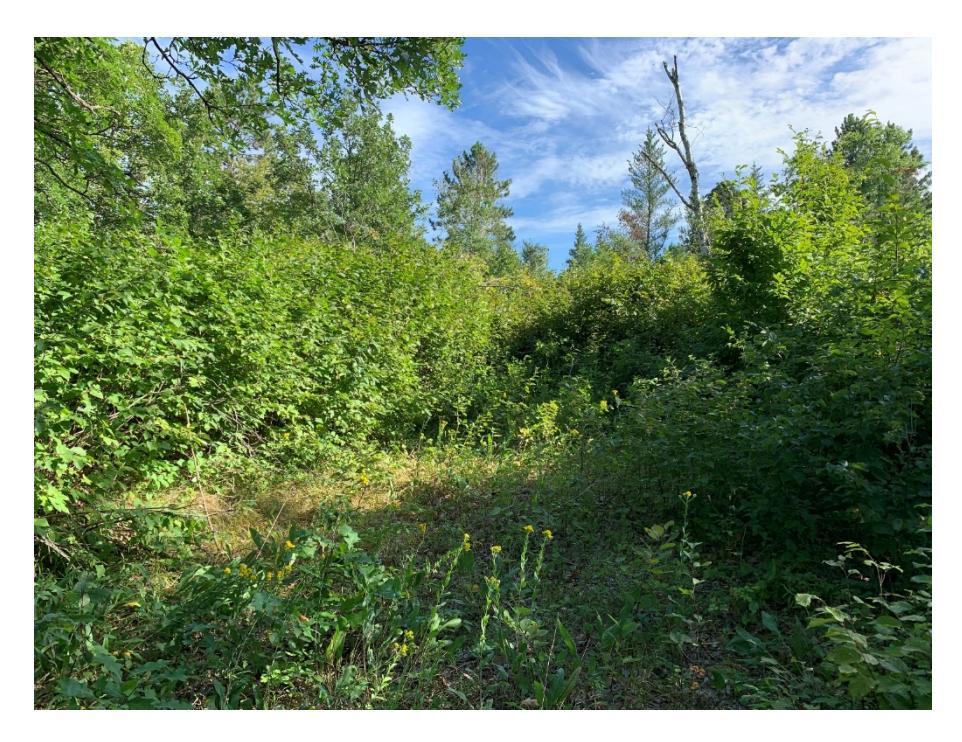
Photo 27-2 Forestry mowed areas include small, pre-existing openings characterized as having thin, droughty soils dominated by dry-mesic prairie/savanna graminoids and forbs (8.18.20).

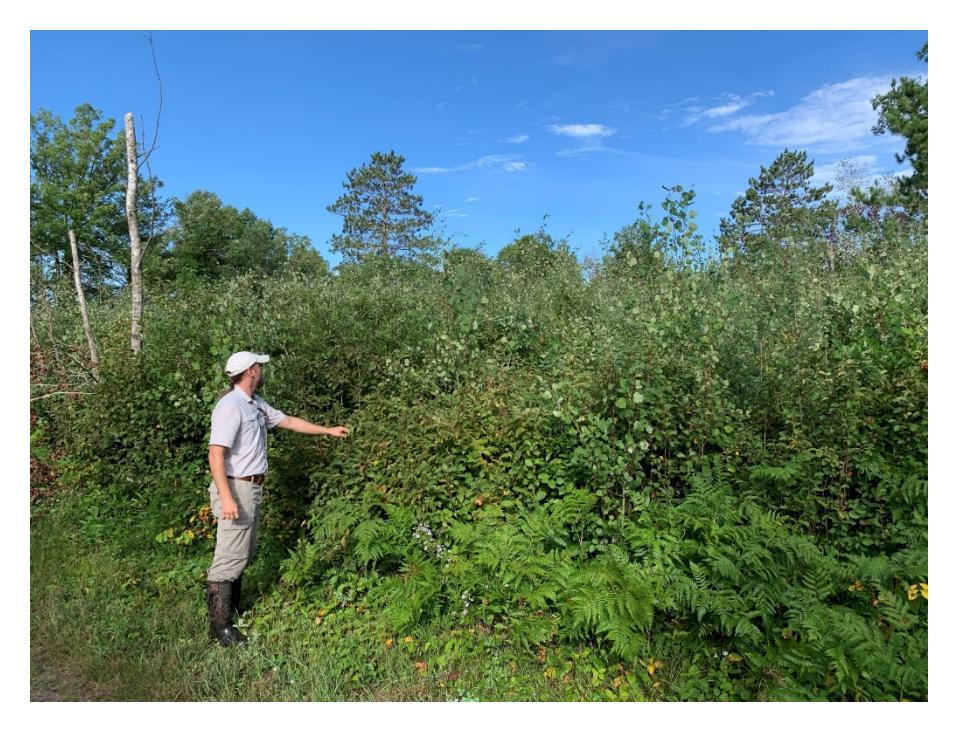
Photo 27-3 Peter Dieser of American Bird Conservancy standing on a maintained trail, next to an area of dense woody regrowth (8.18.20).

Accepted practice for long-term management of early-successional (woody regrowth and herbaceous) habitat requires periodic mowing and/or fire. The long-term challenge for maintaining early successional habitats such as the ones in this project is the need to periodically re-mow or burn approximately every 6-10 years.
