Minnesota Department of Natural Resources Minnesota Board of Water and Soil Resources

Appendix A: 2020 Legacy Fund Restoration Evaluation Report

April 2020

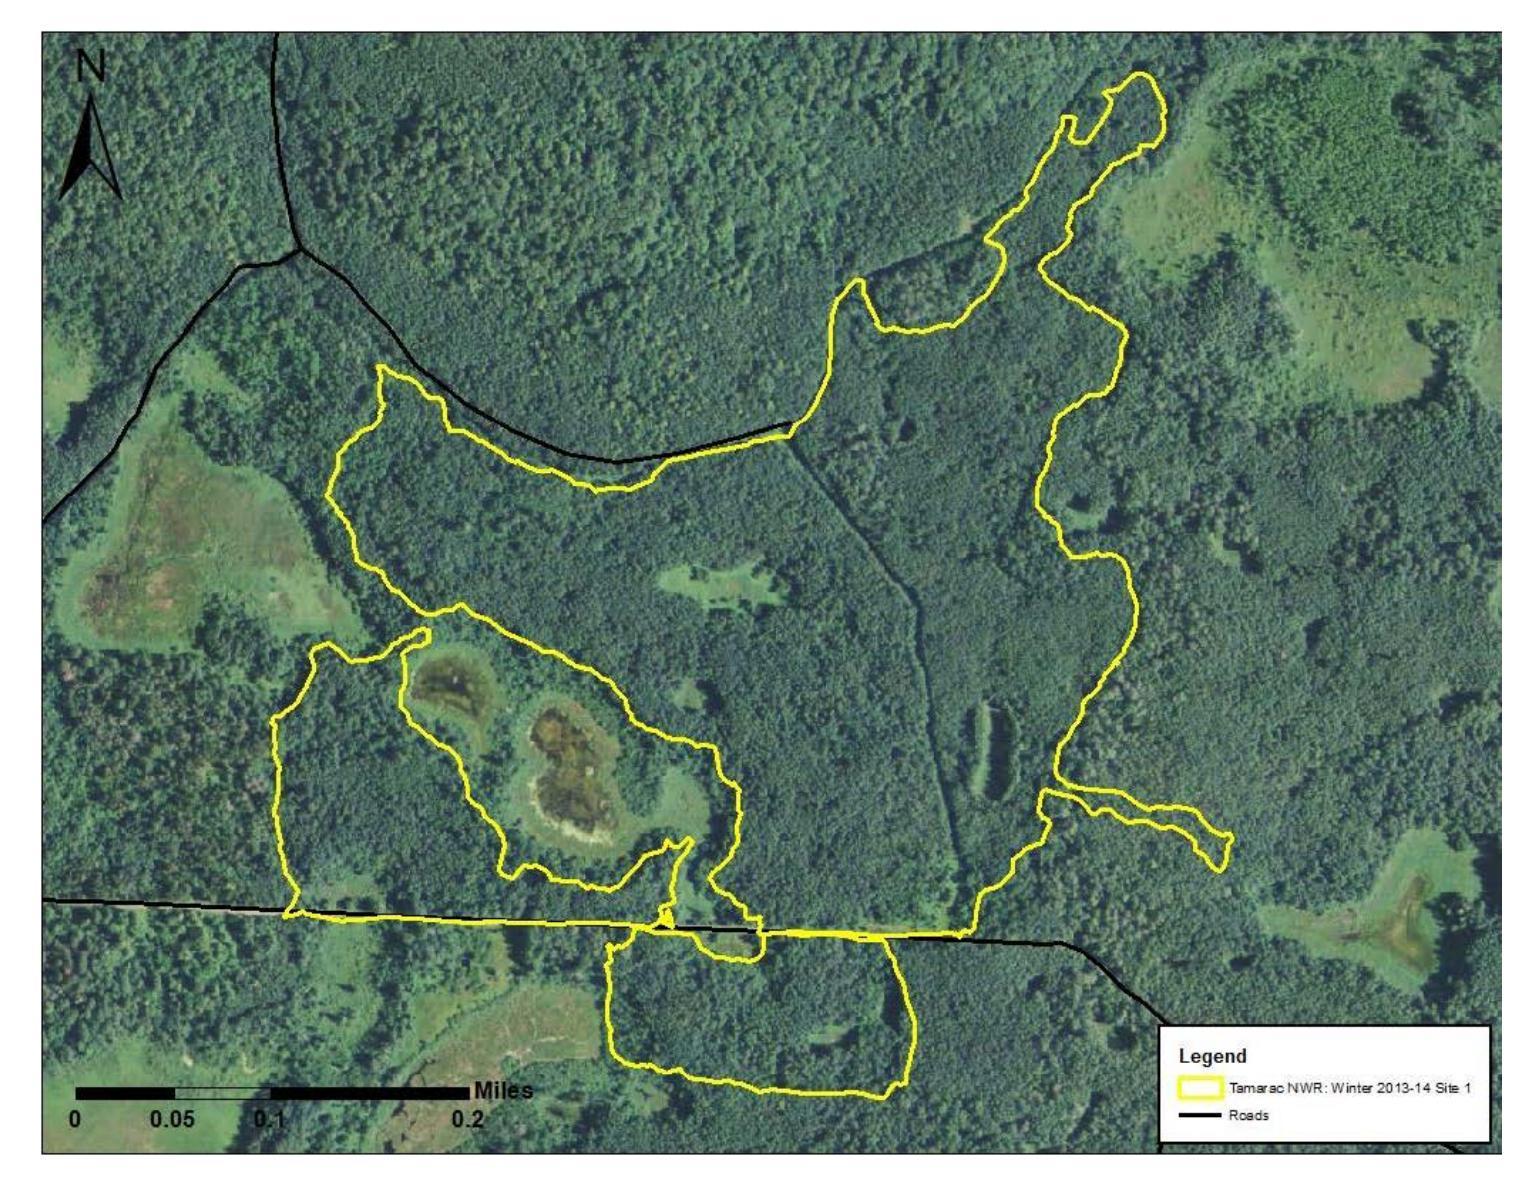
Figure 28-1 Pre-treatment aerial imagery of site dominated by 3-4" DBH Aspen (2010 True Color).

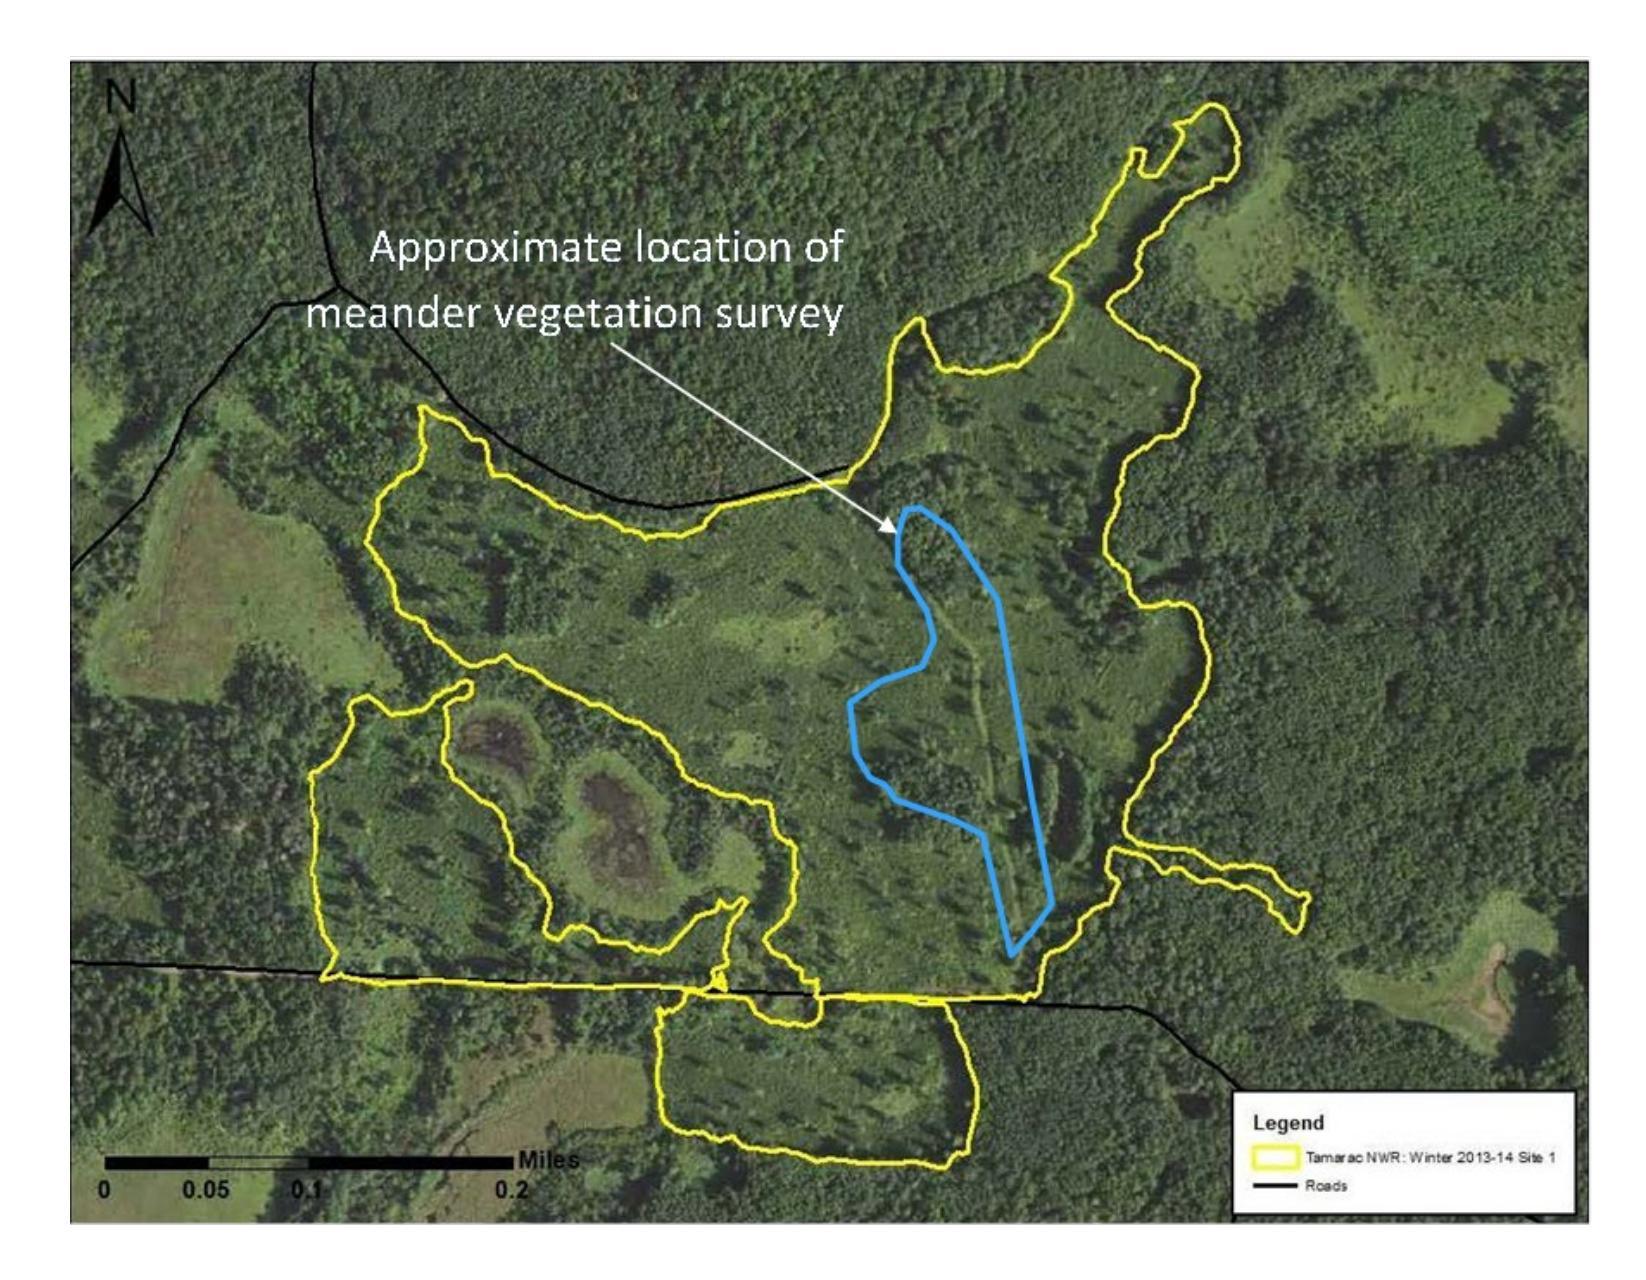
Figure 28-2 Post-treatment aerial imagery, 3-4" DBH aspen cut w/ reserved and legacy patches, completed in Winter 2013-14 (2016 True Color).

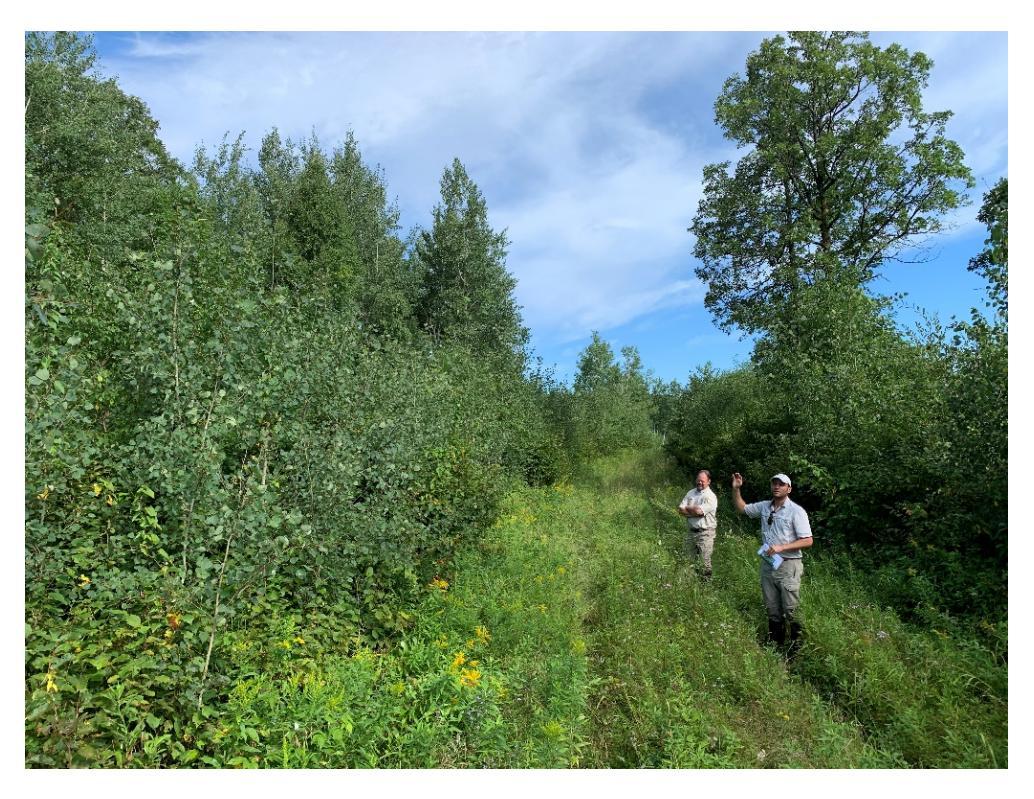
Photo 28-1 Treatment area illustrating dense regrowth of quaking aspen six years after forestry mowing (8.19.20).

Accepted practice for long-term management of early-successional (woody regrowth and herbaceous) habitat requires periodic mowing and/or fire. The long-term challenge for maintaining early successional habitats such as the ones in this project is the need to periodically re-mow or burn every 6-10 years.

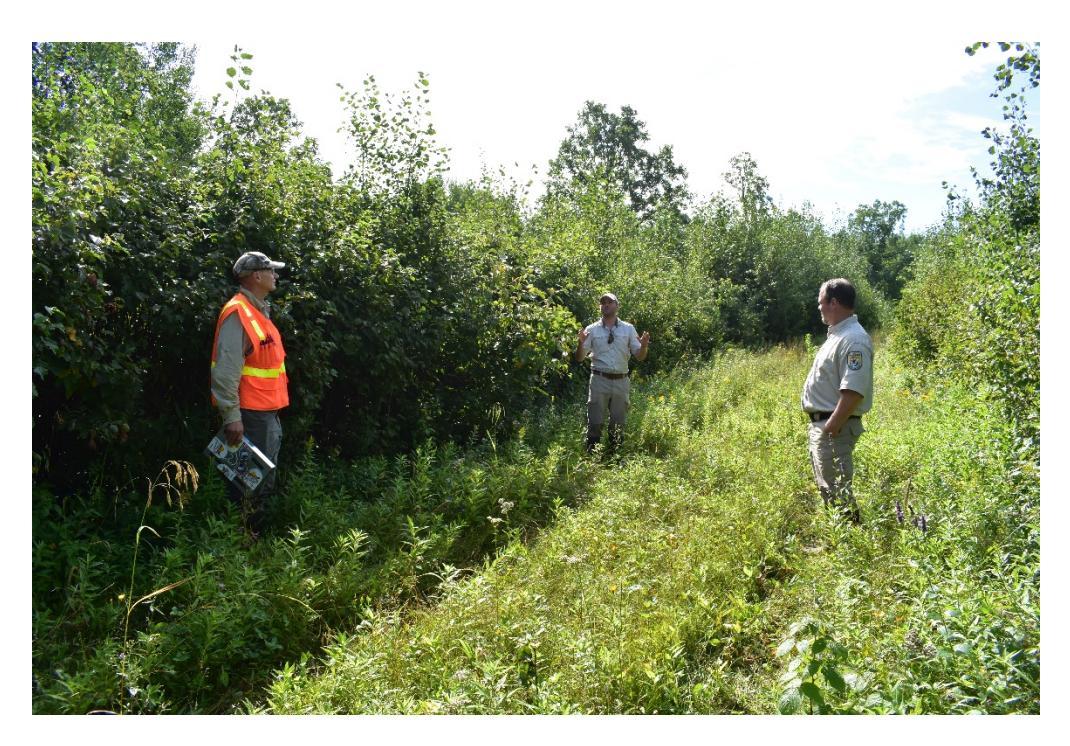
Photo 28-2 Portion of treatment area that also shows dense, but somewhat shorter, regrowth of woody vegetation (8.18.20).

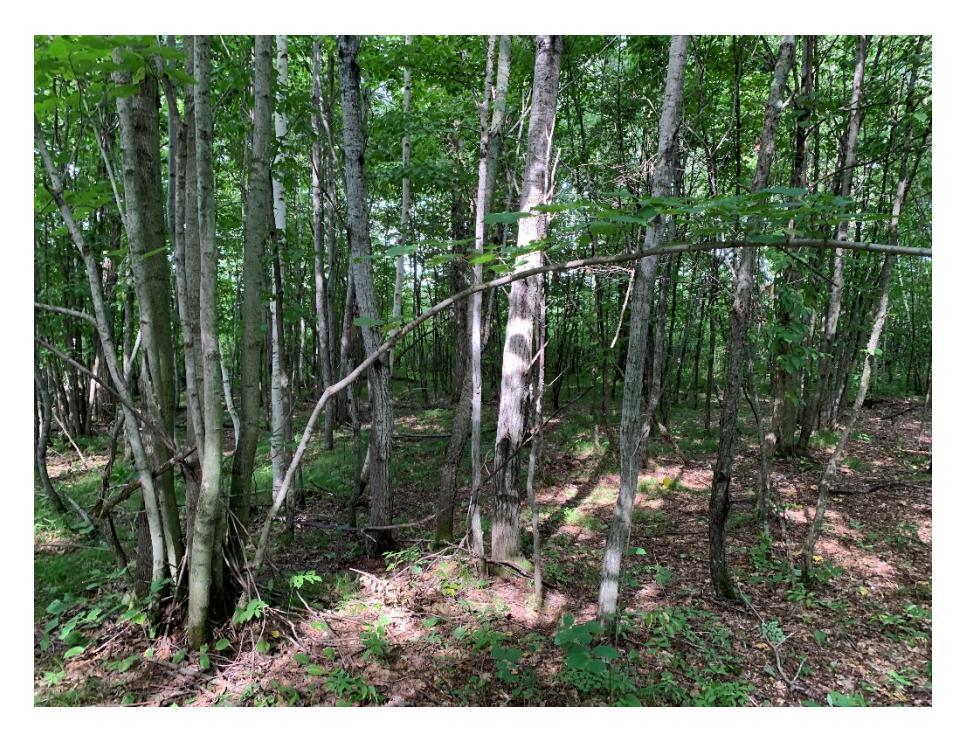
Photo 28-3 Photo of tree island in broader forestry mowed area with quaking aspen common (8.18.20).

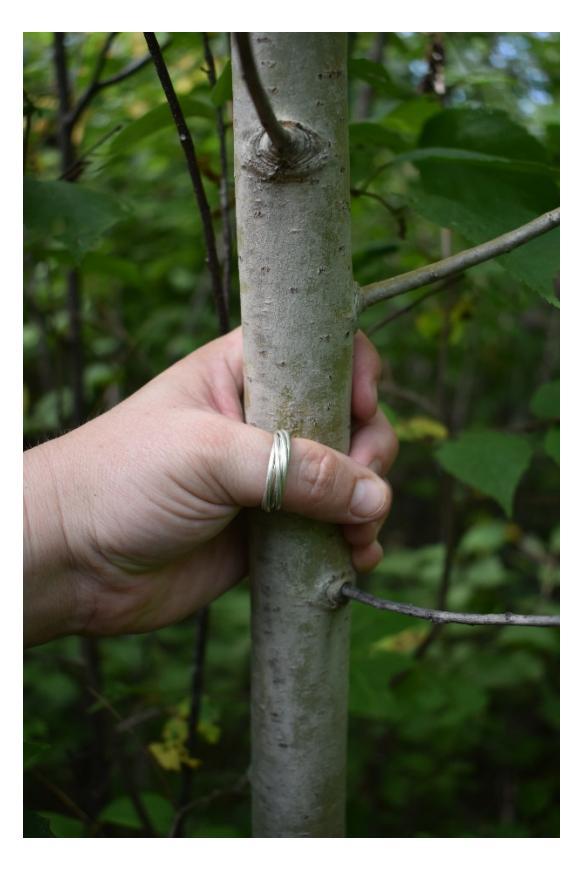
Photo 28-4 Regrowth of quaking aspen has been substantial in the six years since forestry mowing (8.18.20).

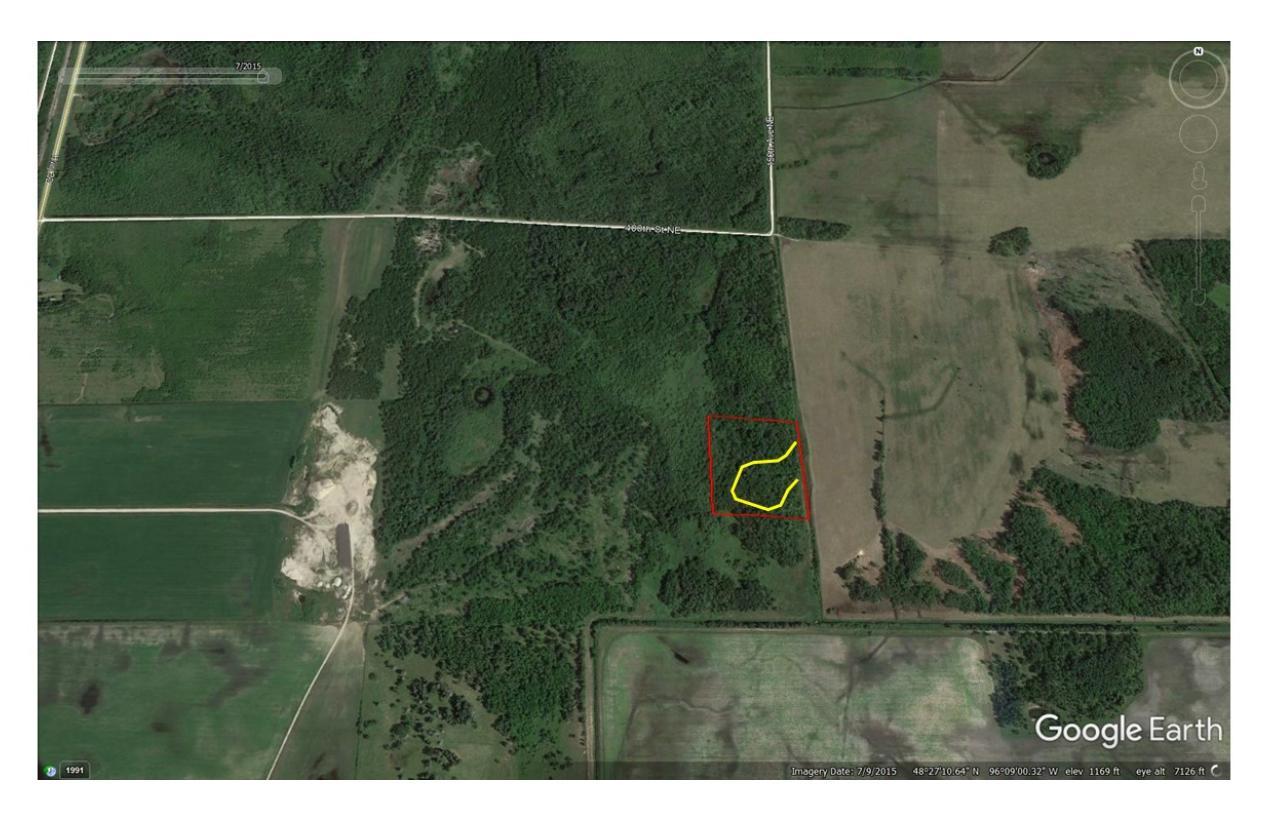
Figure 29-1 Aerial photograph of the 8 acre project site from 2015. The yellow line represents the meander survey path taken to assess the plant community. (Source: Google Earth, accessed October 30, 2020, <u>https://www.google.com/earth</u>).

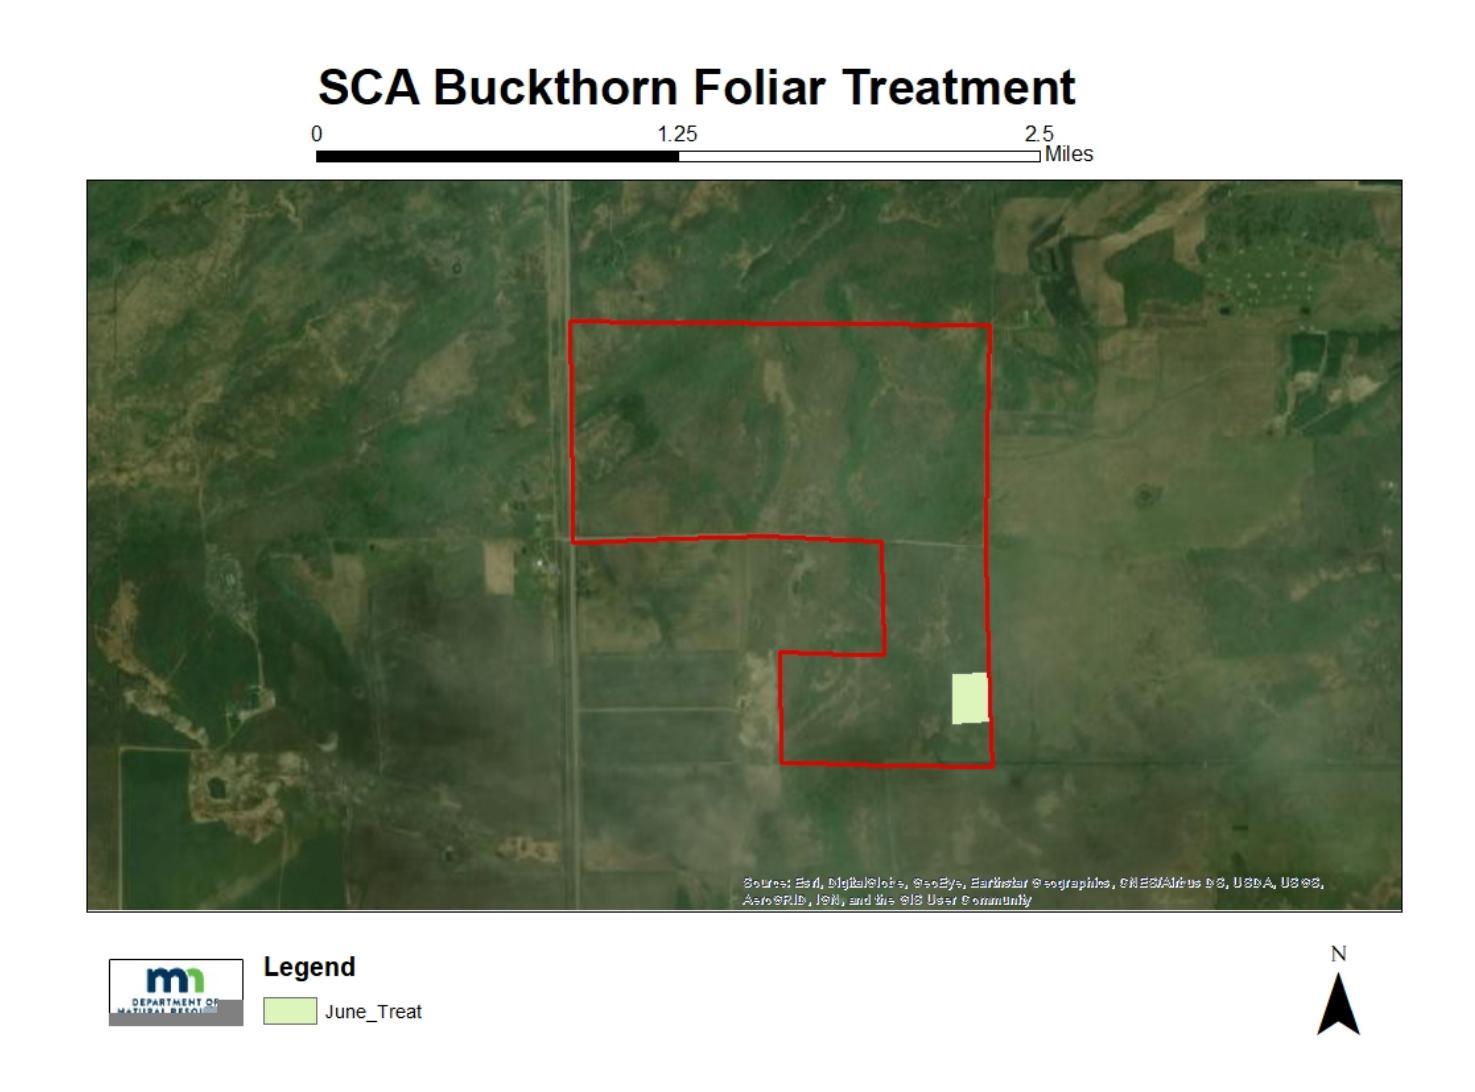
Figure 29-2 Aerial photograph of the project site showing the buckthorn control unit on a portion of Thief Lake WMA. Map provided by MN DNR Thief Lake Area office staff.

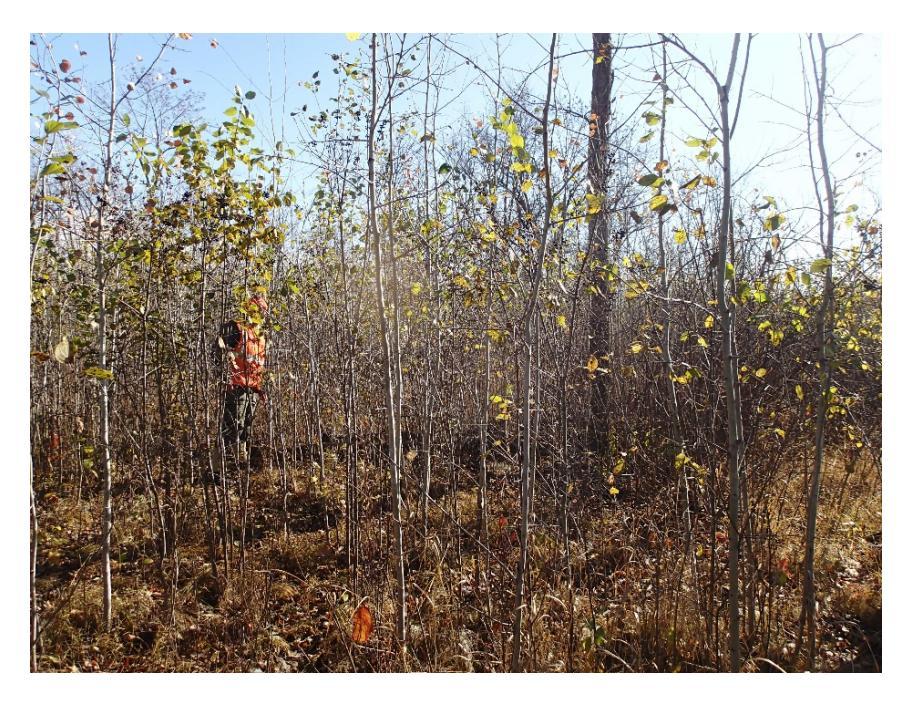
Photo 29-1 Example of buckthorn re-growth at the site. Most shrub vegetation with green and yellow leaves is buckthorn. Aspen saplings are re-growing and competing with the buckthorn for resources. (Thief Lake Wildlife Management Area, photo taken during site visit 10/15/2020).

Yes. Buckthorn needs to be controlled at the site to prevent spread throughout the management unit and onto private lands. Potential management actions include: fall foliar application to treat seedlings and saplings. Forestry mowing to reduce sapling growth followed by a stump treatment. Developing the management unit into a prescribed burn unit. All follow up actions should include a multi-year component.

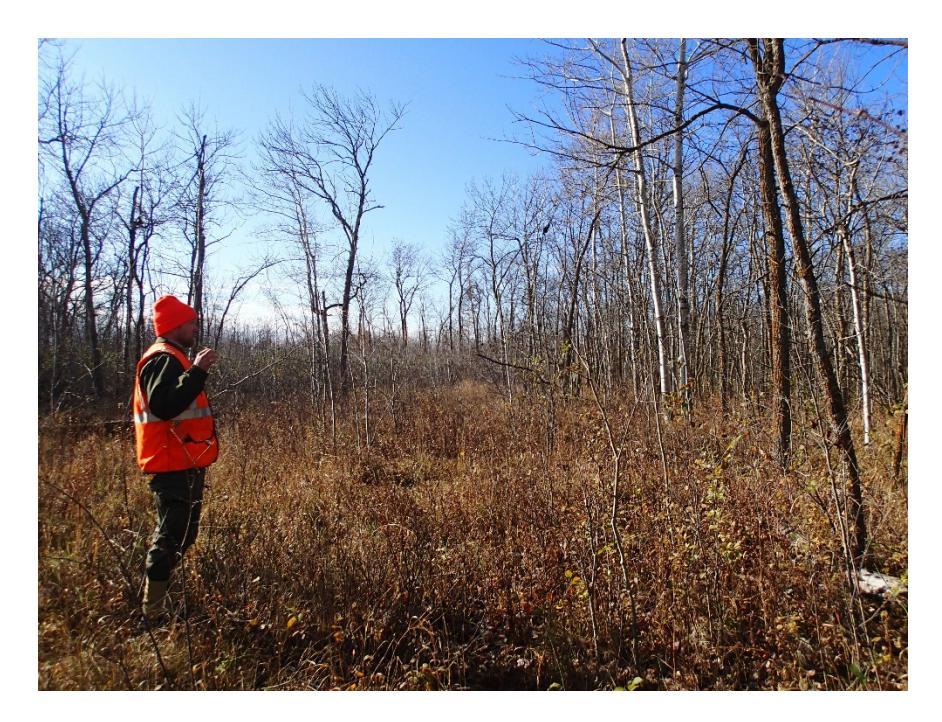
Photo 29-2 Example of the existing vegetation in the project area where buckthorn has not established yet (Thief Lake Wildlife Management Area, photo taken during site visit 10/15/2020).

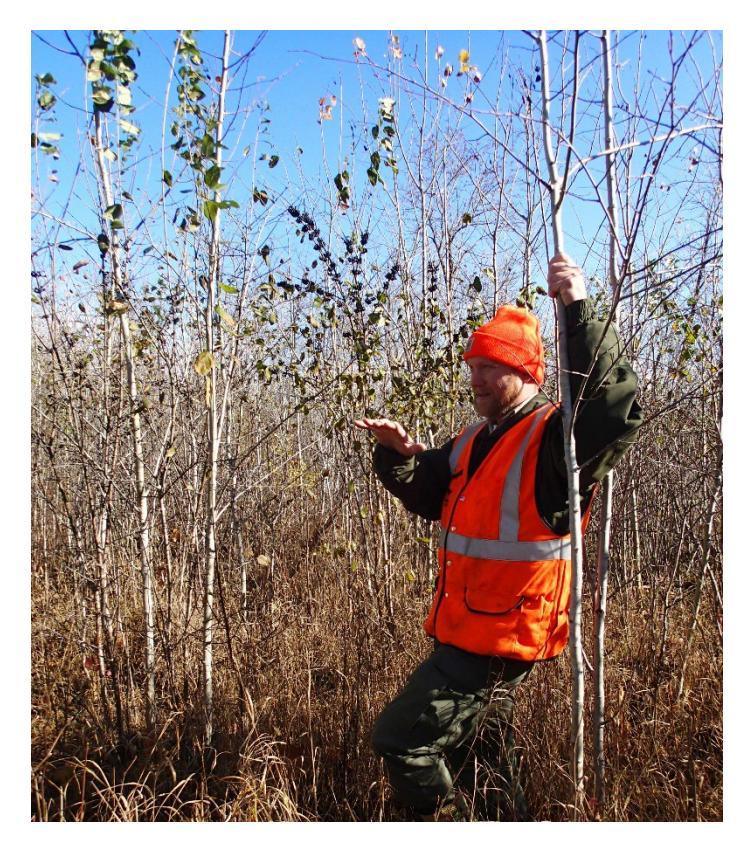
Photo 29-3 Example of the existing fruiting buckthorn in the project area (Thief Lake Wildlife Management Area, photo taken during site visit 10/15/2020).

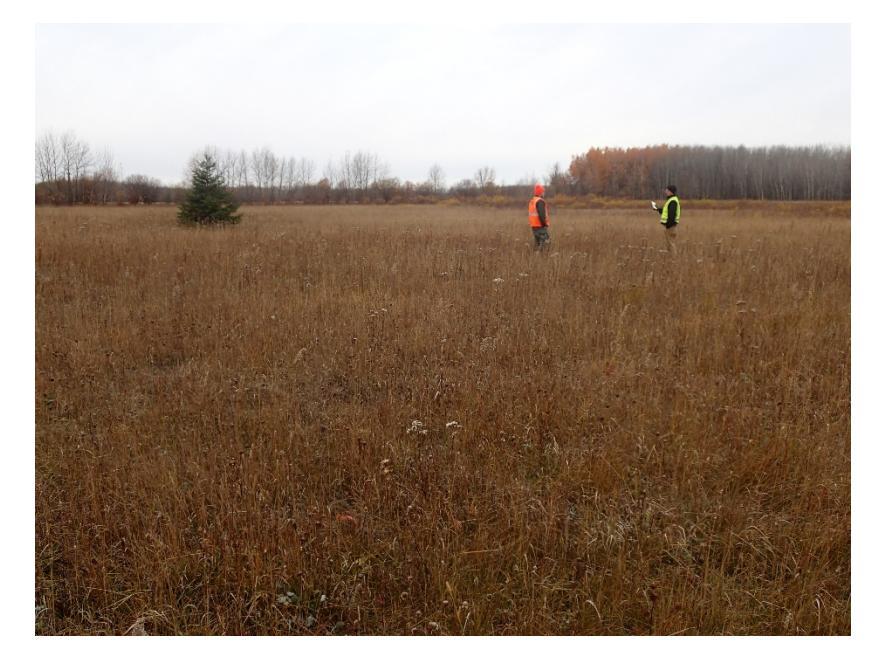
Burnet saxifrage is still present on the site, but has been reduced from 30 to 40% cover to less than 10%. Common tansy abundance has been reduced by 90%.

Photo 30-1 Example of the site where burnet saxifrage was controlled. (Thief Lake Wildlife Management Area, photo taken during site visit 10/15/2020).

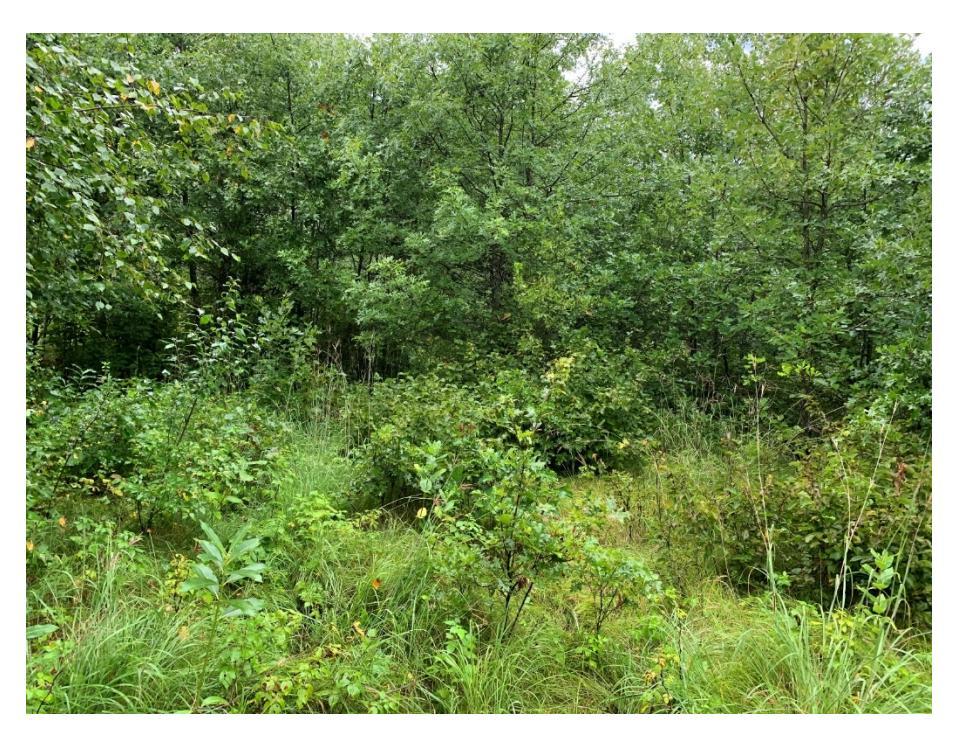
Photo 31-1 Site photo taken 8.19.20 illustrating are that was forestry mowed (foreground) as well as area that was untreated.

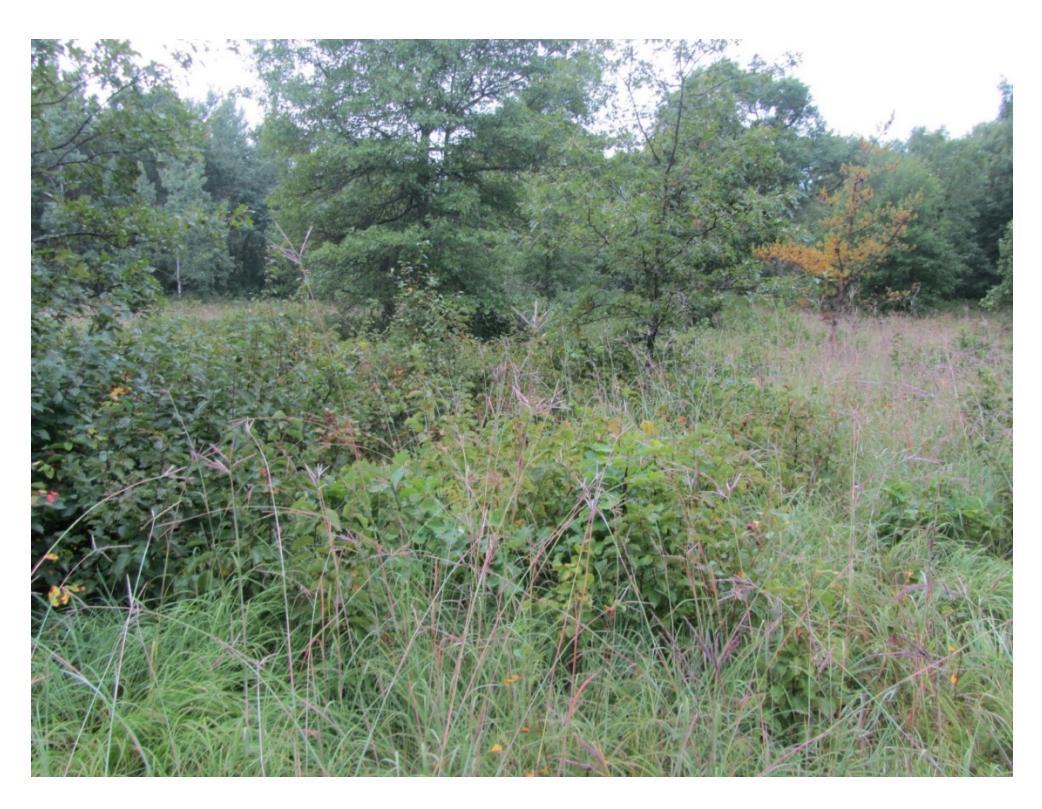
Photo 31-2 Portion of project area that includes areas where brush and small trees were forestry mowed (center-left) surrounded by areas that were likely relatively open prior to treatment, dominated by big bluestem grass (8.19.20).

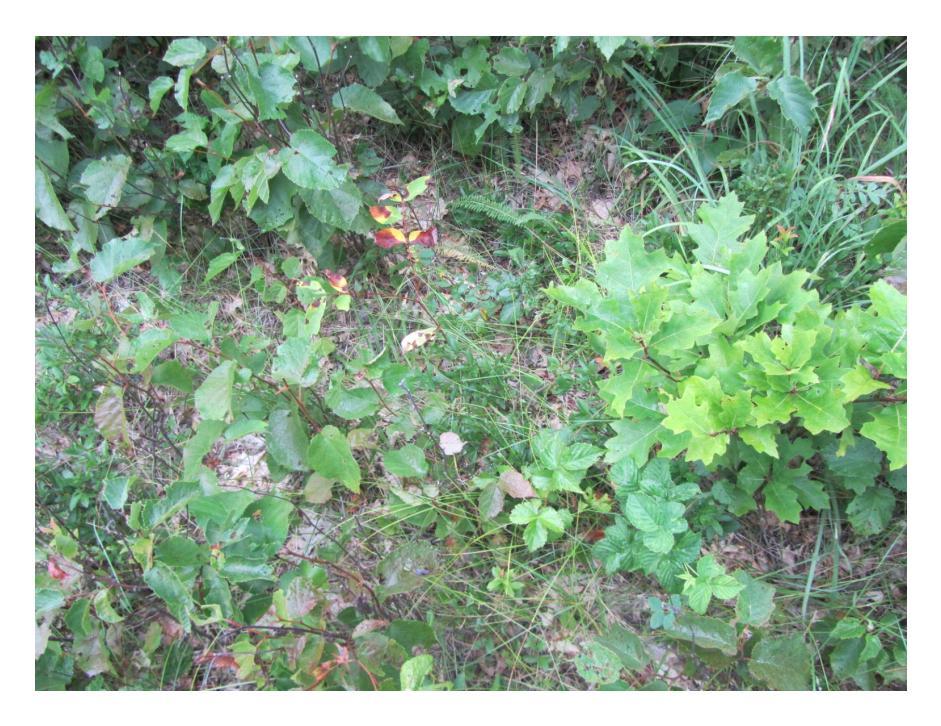
Photo 31-3 Overhead view of area that was forestry mowed showing resprouts of beaked hazel, raspberry, and pin oak and herbaceous graminids big bluestem and sedge species (8.19.20).

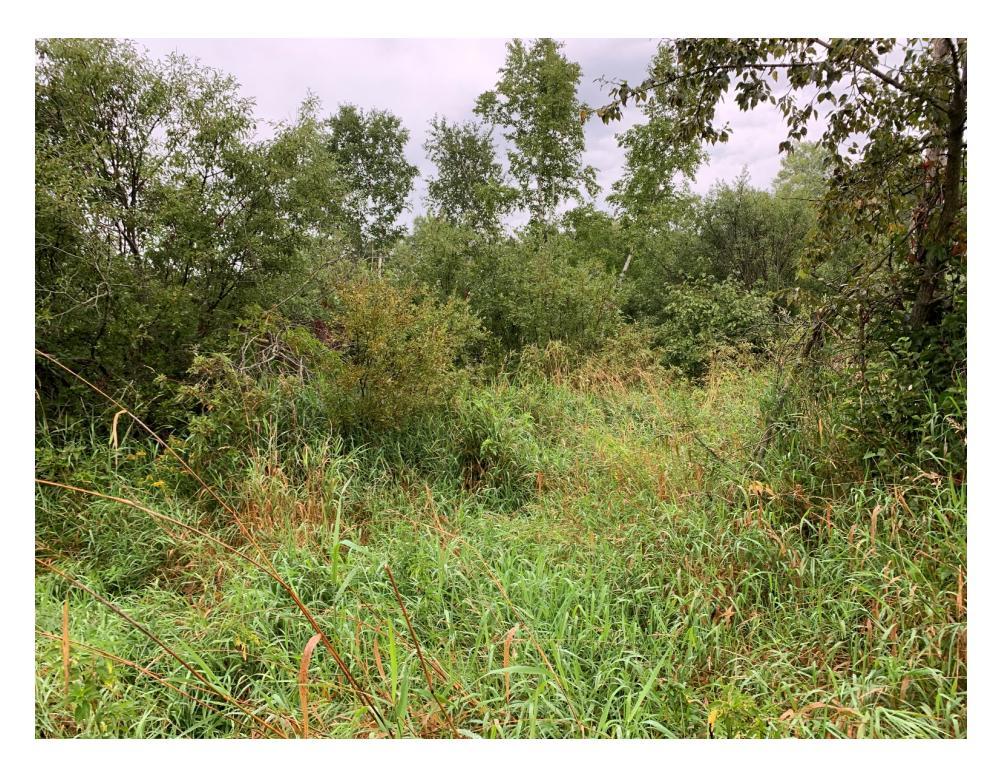
Photo 31-4 View of shrub carr area that was forestry mowed to improve structural diversity of habitat illustrating mix of herbaceous, shrub and young tree cover (8.19.20).

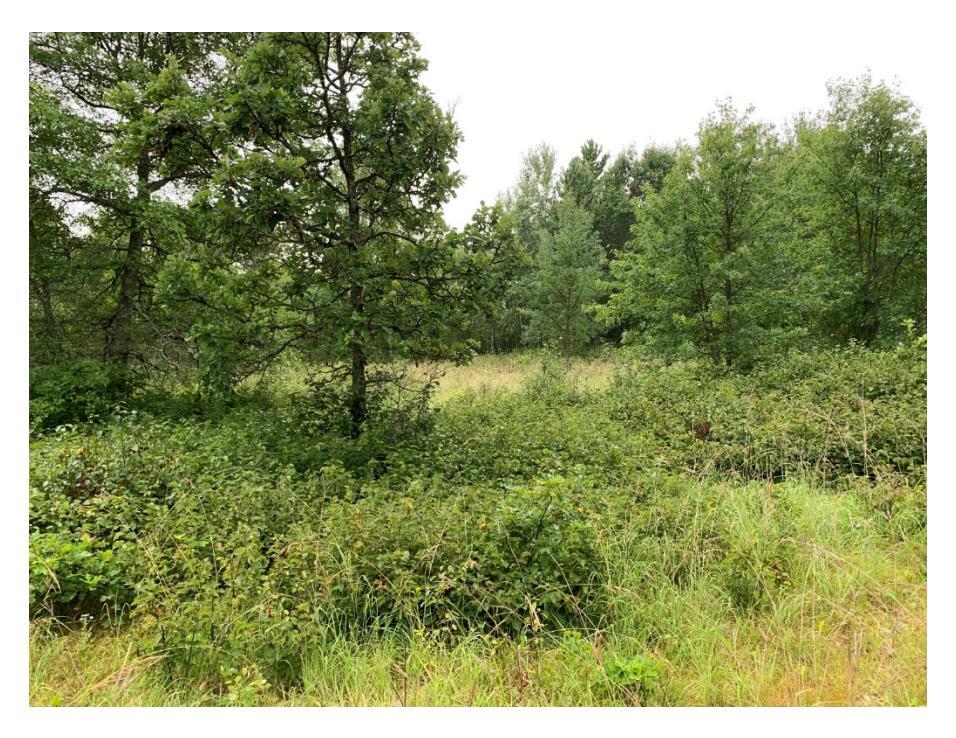
Photo 32-1 Area at Yaeger Lake #2 site illustrating areas of brush that were forestry mowed in center of photo, bracketed by pre-existing areas of native dry woodland/prairie grasses and forbs (lighter green vegetation) (8.19.20).

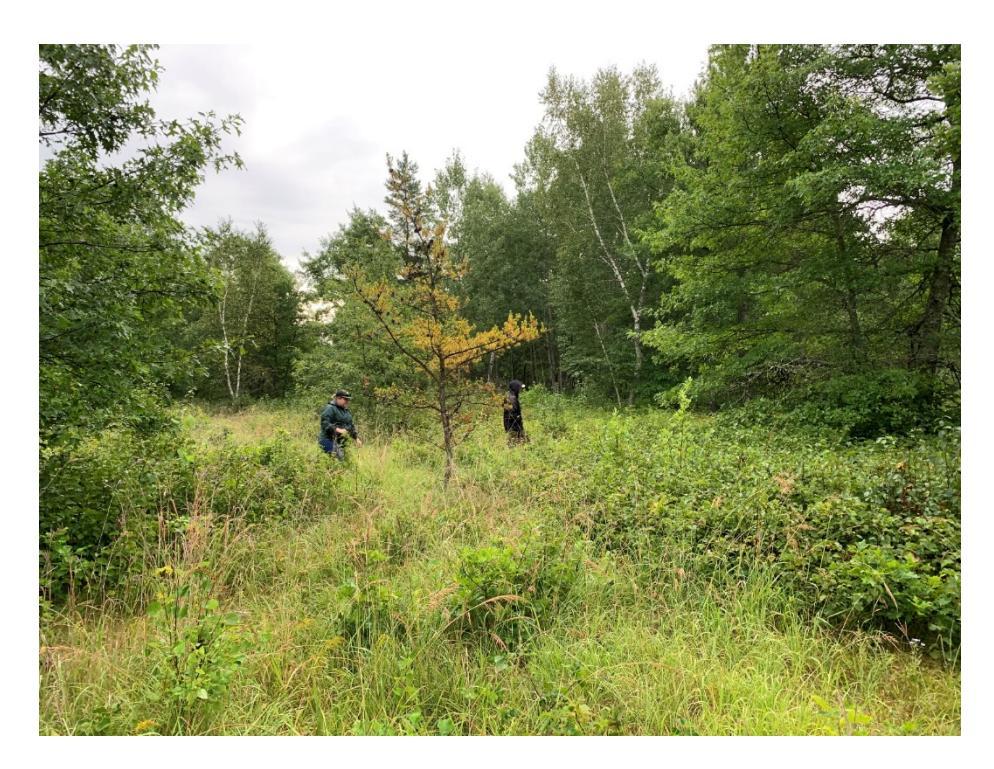
Photo 32-2 Areas of brush that were forestry mowed on left and right sides of photo, with pre-existing areas of native dry woodland/prairie grasses and forbs (lighter green in center of photo) (8.19.20).

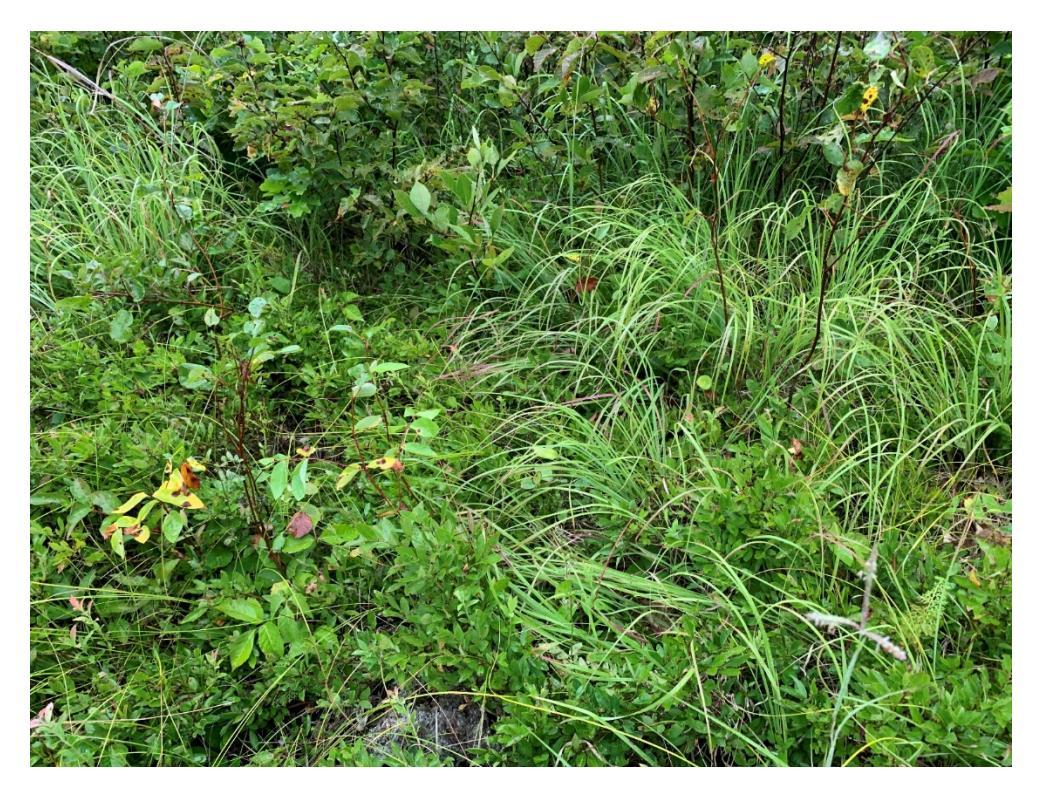
Photo 32-3 Ground cover in forestry mowed area, with regrowth of big bluestem grass, blueberry and others (8-19-20).

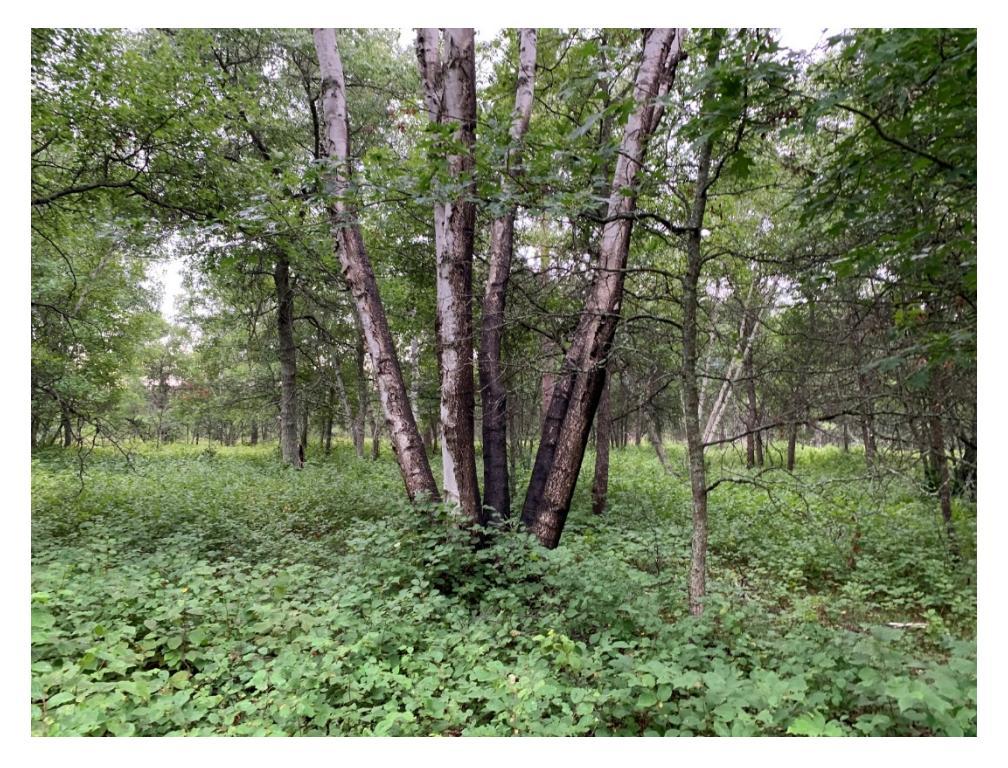
Photo 32-4 Area that was forestry mowed with multi-stem white birch exhibiting fire scars from a previously conducted prescribed burn (8.19.20).

Project Notes: There is evidence of prescribed fire on this site, though it is unlikely it has been burned since this project was completed. The hazel brush has grown back vigorously and will continue limit fire spread if not burned at regular intervals within the next couple years.

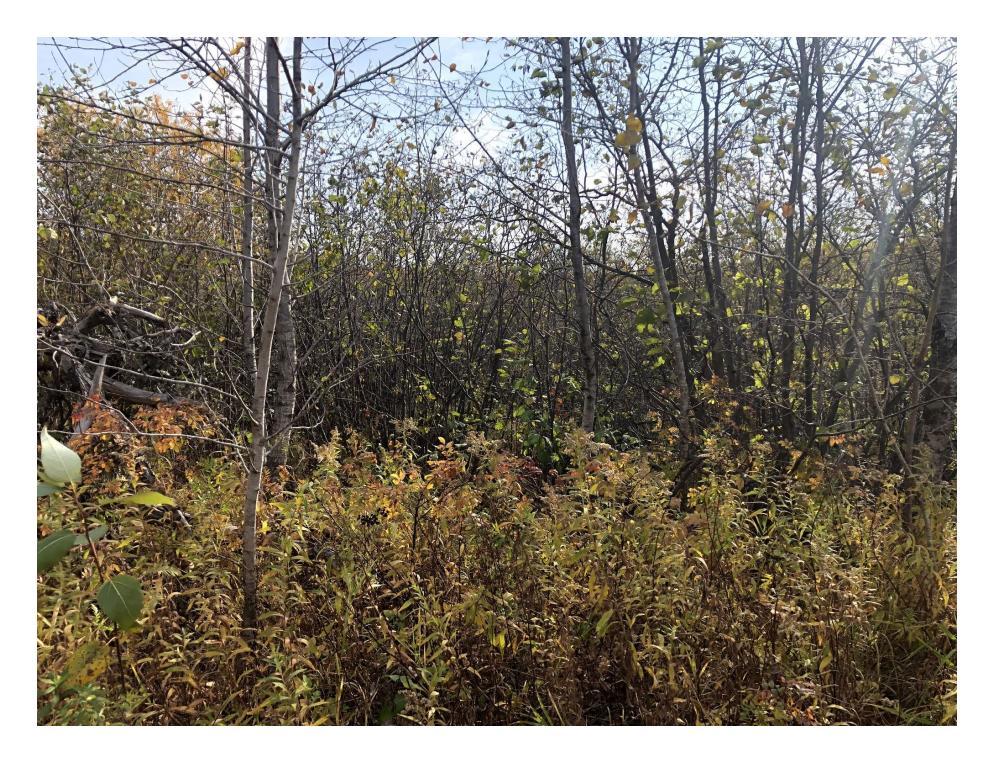
Photo 33-2 Glossy buckthorn present in project area (in background)—average height around 6 to 8 ft. It appeared that 6-8 ft. was the average height/age of the buckthorn throughout the park. This is the revegetated buckthorn from the first removal in 2017.

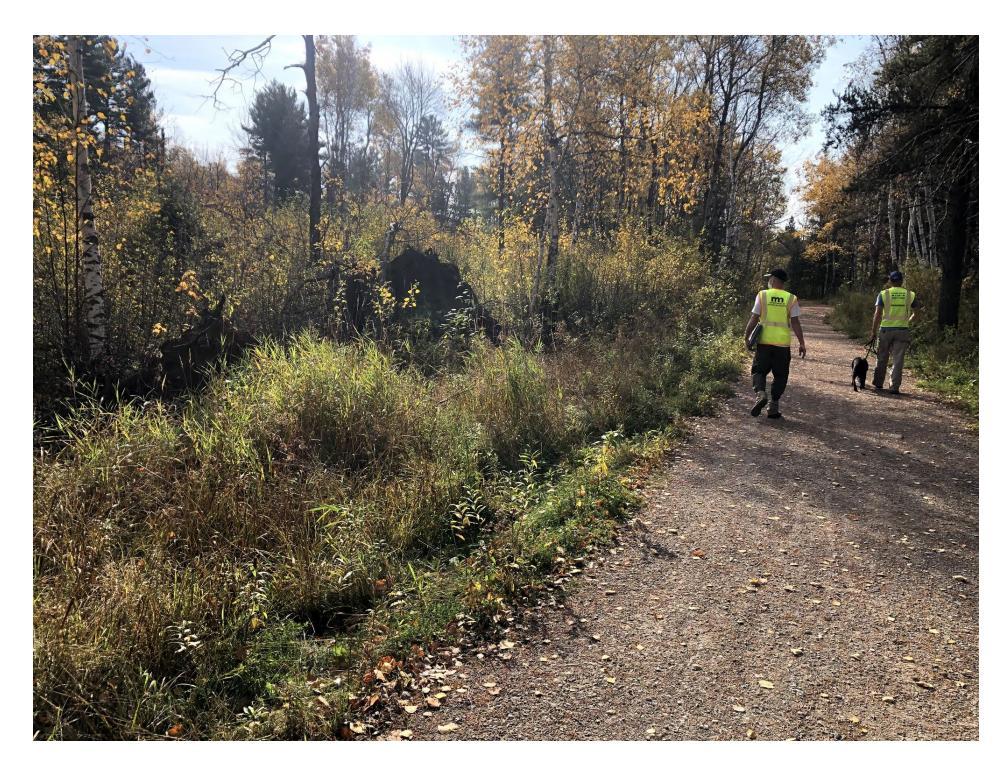
Photo 33-3 A view of the trail, with buckthorn management more successful on the left side of the photo.

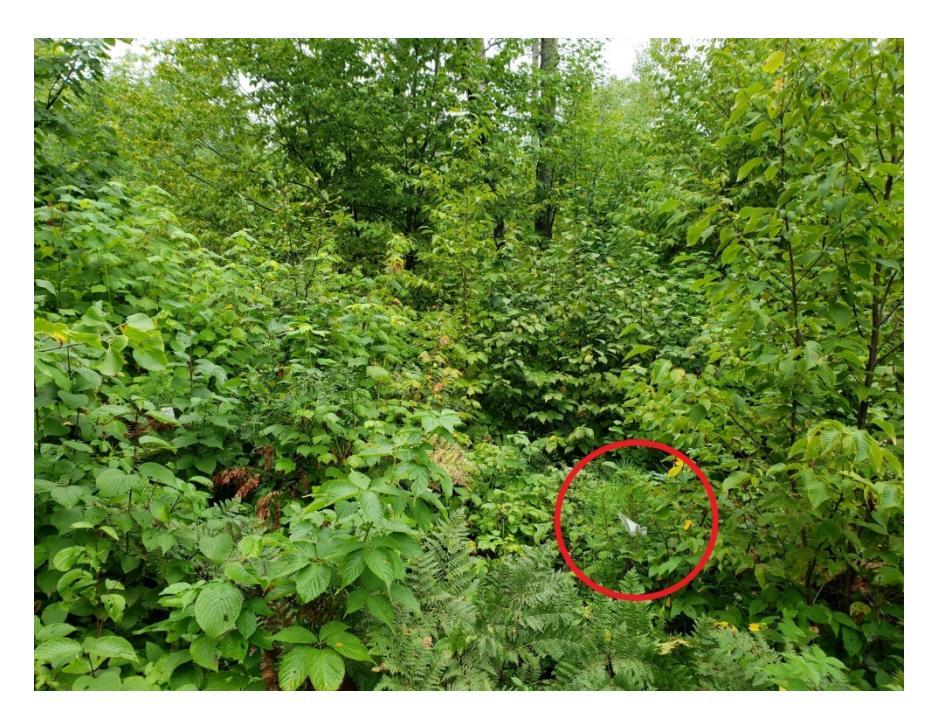
Photo 34-2 Example of the pine planting in an area with more dense herbaceous and woody vegetation that provides competition for the planted pine tree, which is barely above the 3 to 4 feet tall vegetation. Red circle indicates a small pine that was previously budcapped. (Itasca State Park, photo taken during site visit 8/26/2020 by Mark Pranckus, Cardno).

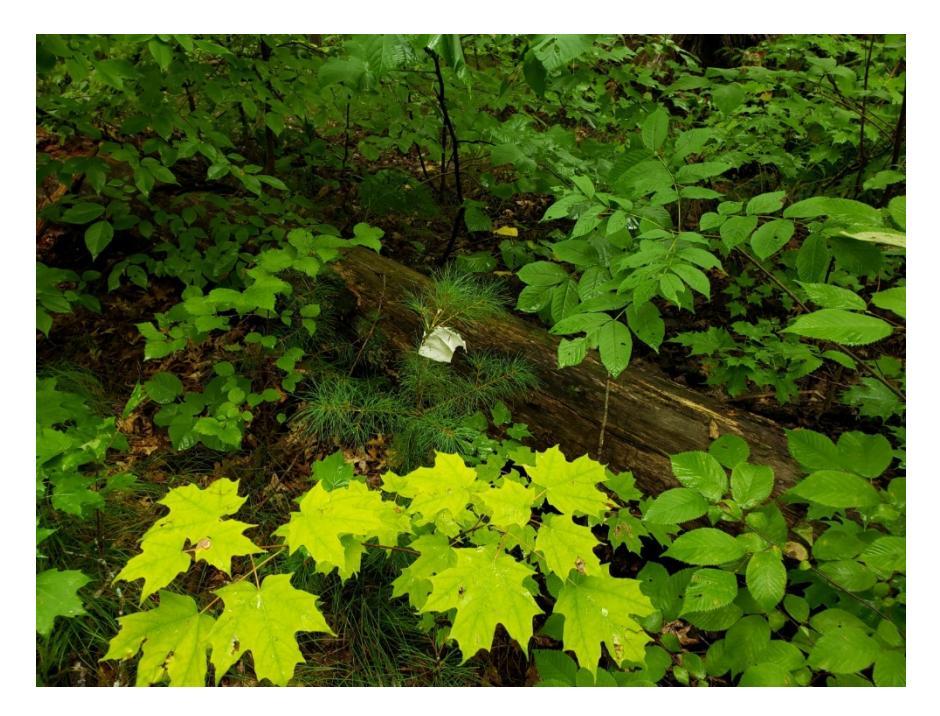
Photo 34-3 Example of a small pine seeding that was previously budcapped. The paper material around the terminal buds prevents deer browse. The tree is growing next to a large pine tree that died and fell down. (Itasca State Park, photo taken during site visit 8/26/2020 by Mark Pranckus, Cardno).

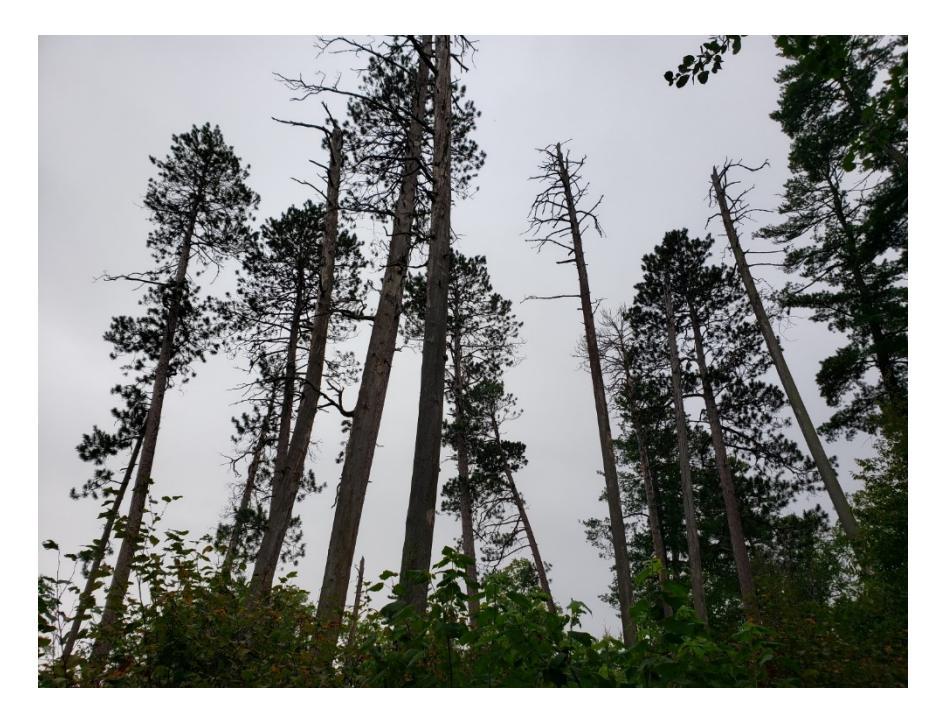
Photo 34-5 Example of remaining mature pine trees following the blowdown of 2012 and 2016. Most of the site does not have a closed canopy due to the blowdowns. (Itasca State Park, photo taken during site visit 8/26/2020 by Mark Pranckus, Cardno).
