Minnesota Department of Natural Resources Minnesota Board of Water and Soil Resources

Appendix A: 2020 Legacy Fund Restoration Evaluation Report

April 2020

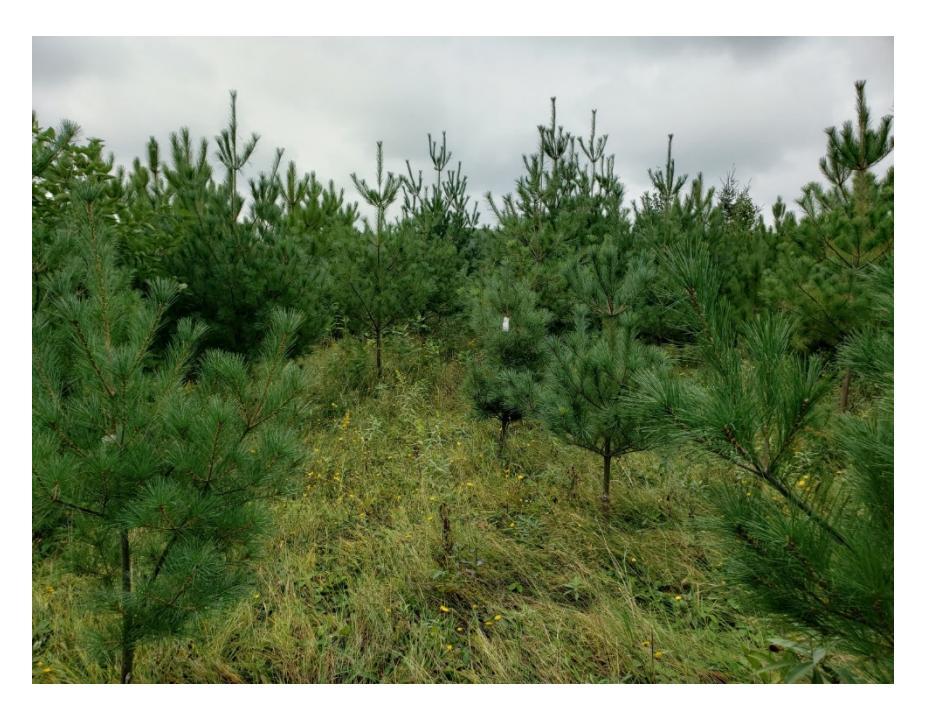
Photo 35-1 Example of pine plantings from 2011. Most trees have grown to a height of at least 8 to 10 feet and appear to be resistant to deer browse. Note the smaller tree with a previous bud cap. (Itasca State Park, photo taken during site visit 8/26/2020 by Mark Pranckus, Cardno).

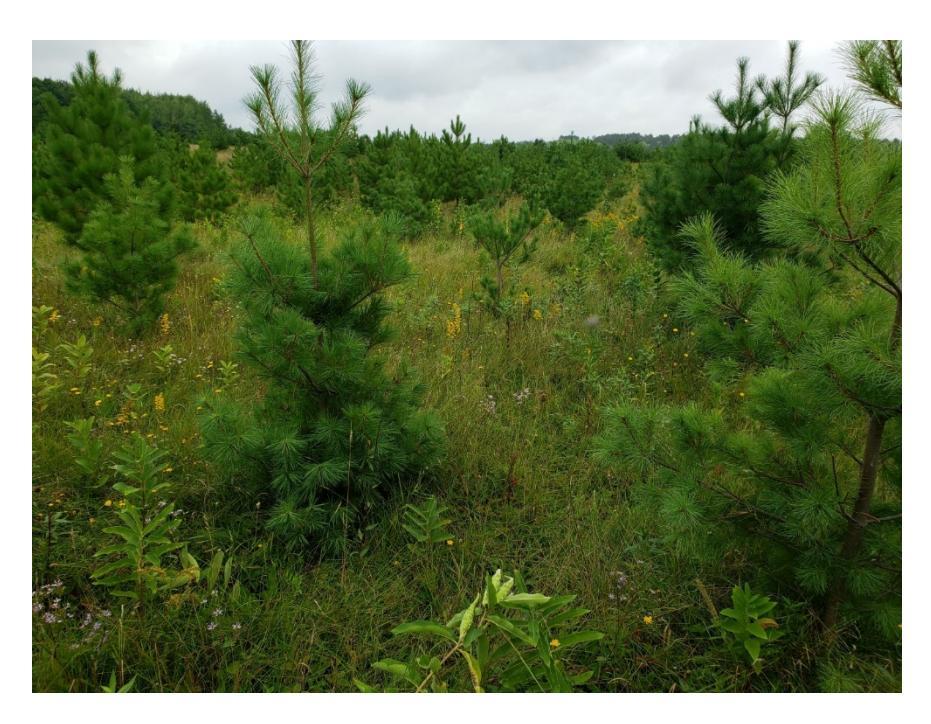
Photo 35-2 Example of the pine planting in an area of the site with reduced density. There was a good mixture of tree density throughout the site that added to the "naturalness" of the planting, instead of trees planted in rows. (Itasca State Park, photo taken during site visit 8/26/2020 by Mark Pranckus, Cardno).

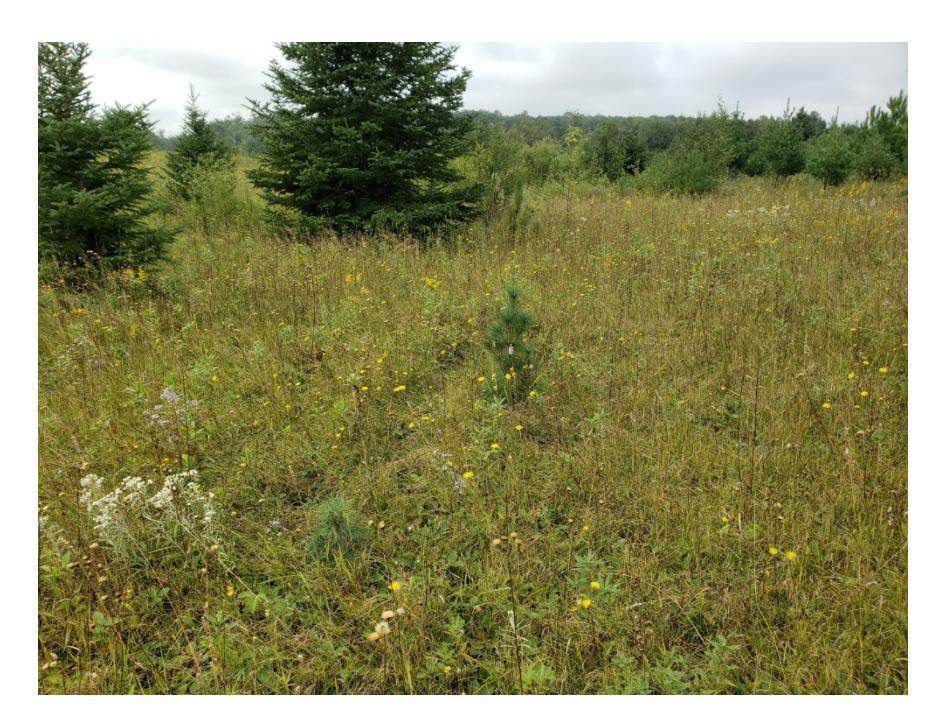
Photo 35-3 Example of a small pine seeding that was previously budcapped. The paper material around the terminal buds prevents deer browse. (Itasca State Park, photo taken during site visit 8/26/2020 by Mark Pranckus, Cardno).

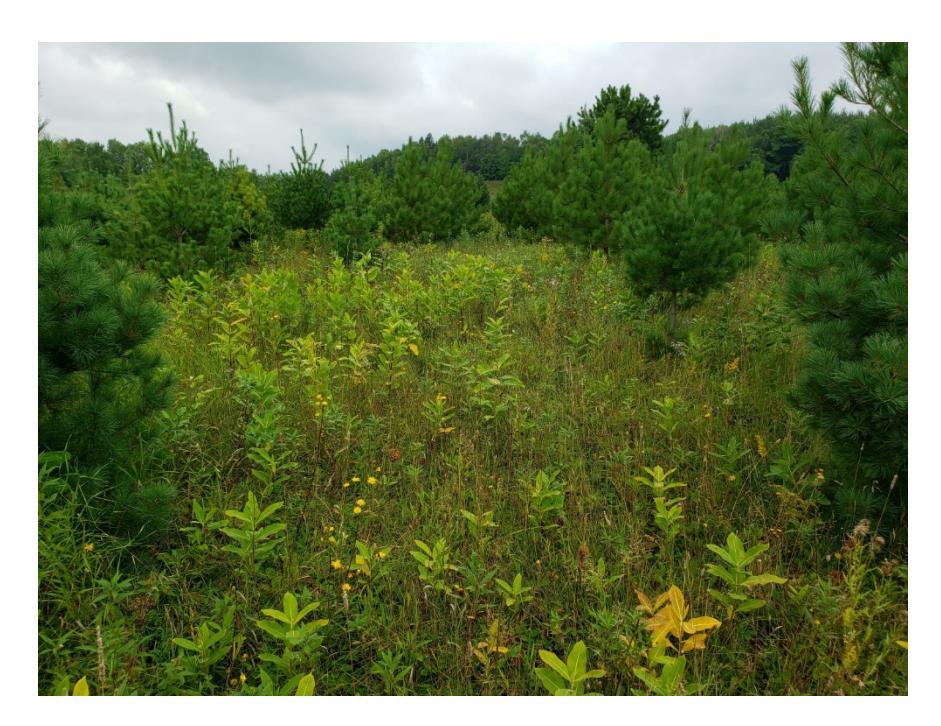
Photo 35-4 Example of the grass and forb community scattered among the trees. The old field vegetation is still present on the side, but will likely decrease as shading from mature trees increases (Itasca State Park, photo taken during site visit 8/26/2020 by Mark Pranckus, Cardno).

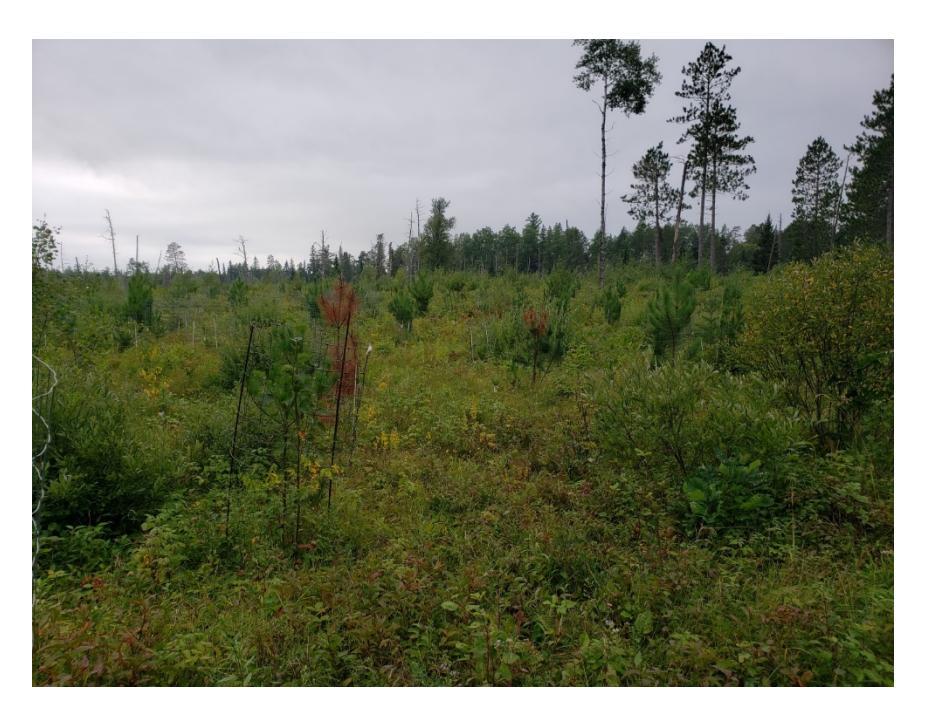
Photo 36-1 Example of pine plantings, approximately 4 to 8 feet in height, that have been released through a brush saw cut, protected with tree cages, and/or bud capped (Itasca State Park, photo taken during site visit 8/26/2020 by Mark Pranckus, Cardno).

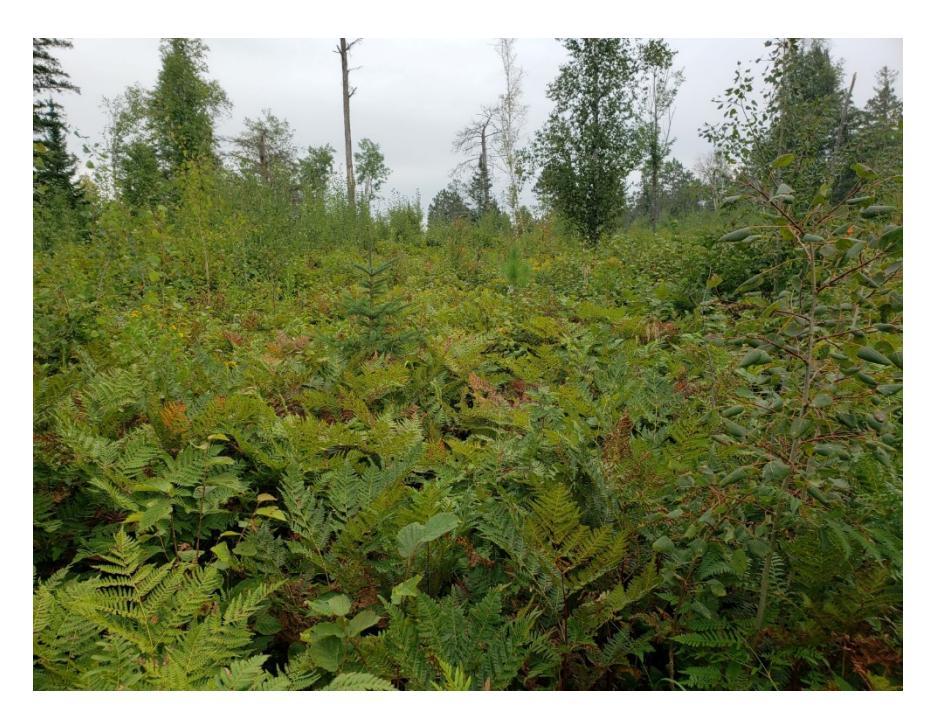
Photo 36-2 Example of the pine planting in an area with more dense herbaceous and woody vegetation that provides competition for the planted pine tree, which is barely above the 3 to 4 feet tall vegetation (Itasca State Park, photo taken during site visit 8/26/2020 by Mark Pranckus, Cardno).

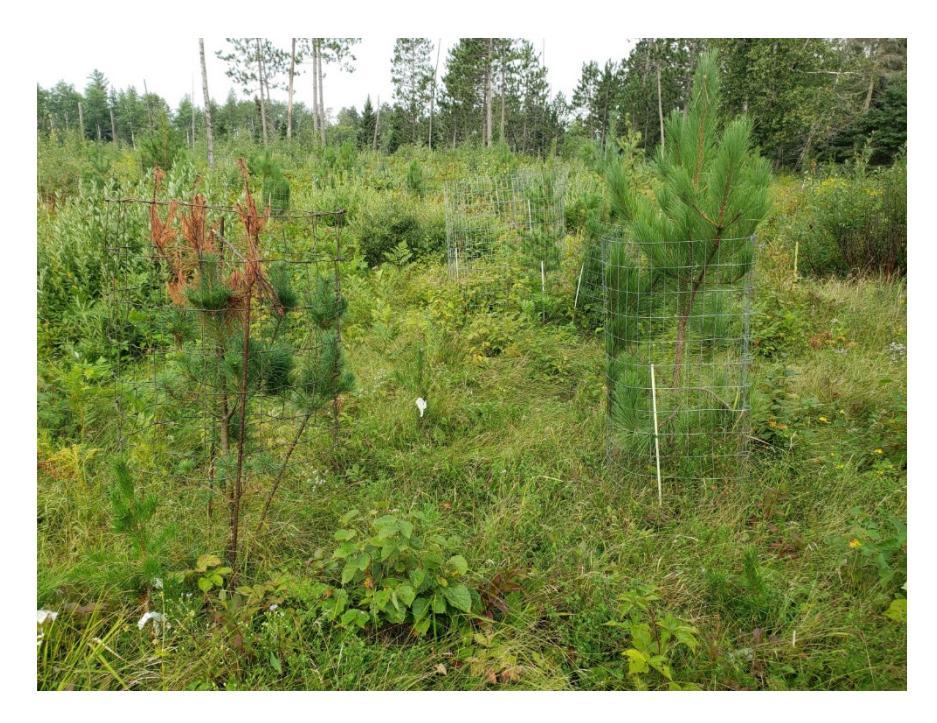
Photo 36-3 Example of two different types of tree cages used to protect pine seedlings from deer browse. The one on the left is an earlier version using heavier gauge wire with large gaps and rebar stakes. The one on the right is a newer version using lighter fencing with tighter gaps and lightweight step-in fence posts (Itasca State Park, photo taken during site visit 8/26/2020 by Mark Pranckus, Cardno).

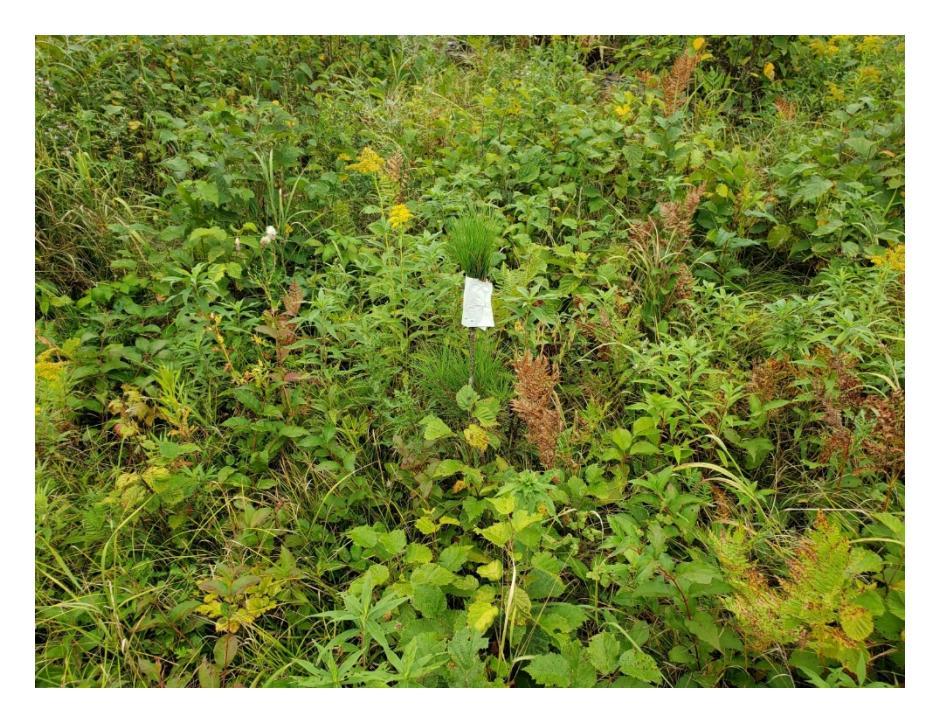
Photo 36-4 Example of pine seedling that was been bud capped (white paper material stapled around the terminal buds of seedlings) to protect deer browse and allow the tree to grow vertically (Itasca State Park, photo taken during site visit 8/26/2020 by Mark Pranckus, Cardno).
