# ***Study Memorials / Monuments Capitol Complex***

***August 2013  
RECS #: 02CP0034***

**Consultant's Report**

Re: Study Memorials / Monuments, Capitol Complex  
RECS # : 02CP0034

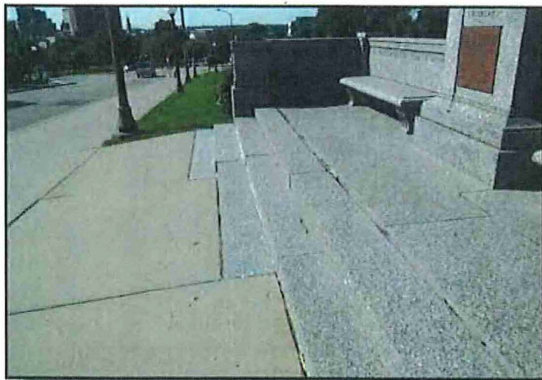
*Only stairs need resetting.*

Number one priority since it is so close in proximity to the Capitol and one of the earliest installations (1931). The bronze sculpture has a dark chocolate brown patina that has discoloration of the coating. The wax is separating and very distracting. The granite base at the steps is coming apart and the mortar and caulking have failed.

- 2.Reset loose granite stair pieces only including adding pinning to prevent separation.\*  
The rest of the stone monument base does not need reassembly.(\$45,000)
- 3.Tuckpoint all mortar joints.
- 4.Remove all caulking and caulk all sealant joints.
- 5.Clean stone when complete.(\$26,000 for 3,4,5)
6. Landscape shrub replacement at perimeter of Monument.(\$19,000)

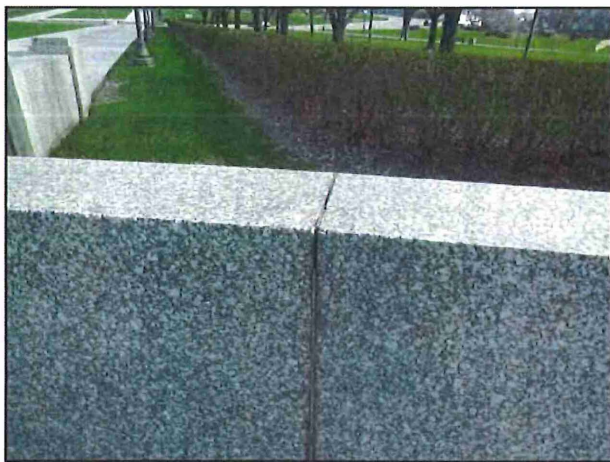
*Grout joints need to be reworked along  
with conservation of all plaques.*

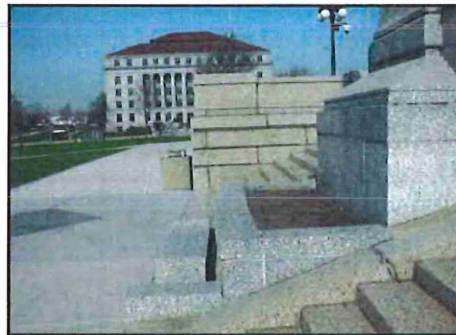
*Stone needs to be reset.*

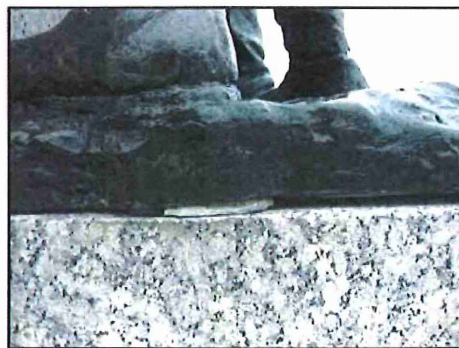
*Grout needs to be redone at base of sculpture.*

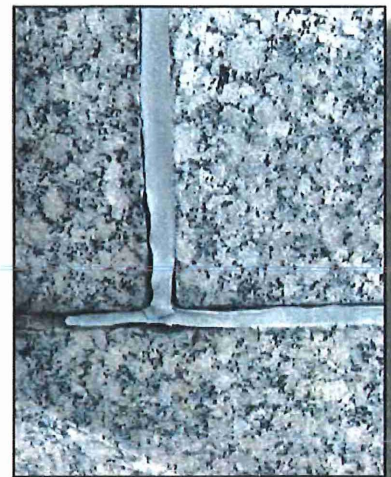
*Joints need to be reworked.*

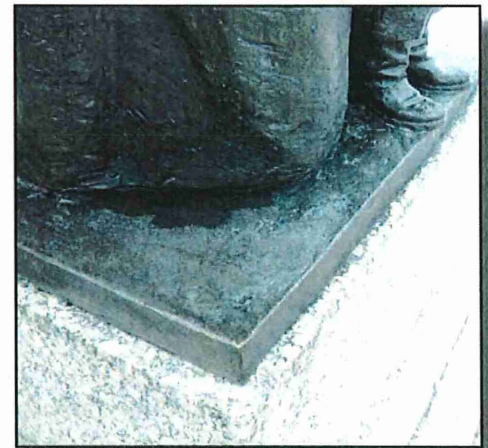
***Sculpture requires conservation treatment  
and work at stone joints.***

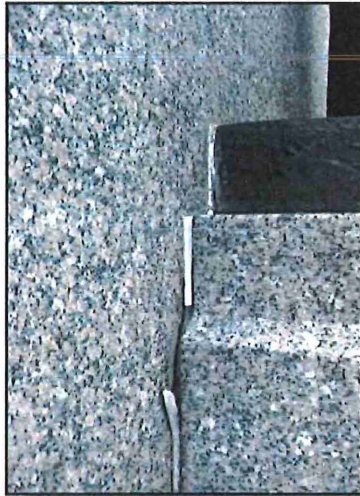
*Joints need to be reworked.*

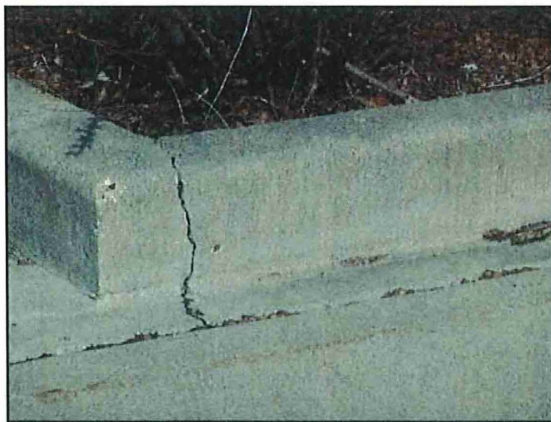
***New concrete curb surround should be constructed.***
