LEGACY FUND RESTORATION EVALUATION REPORT

Technical Panel Findings and Recommendations—2022

REPORT TO THE MINNESOTA LEGISLATURE

Date of Report: August 2023

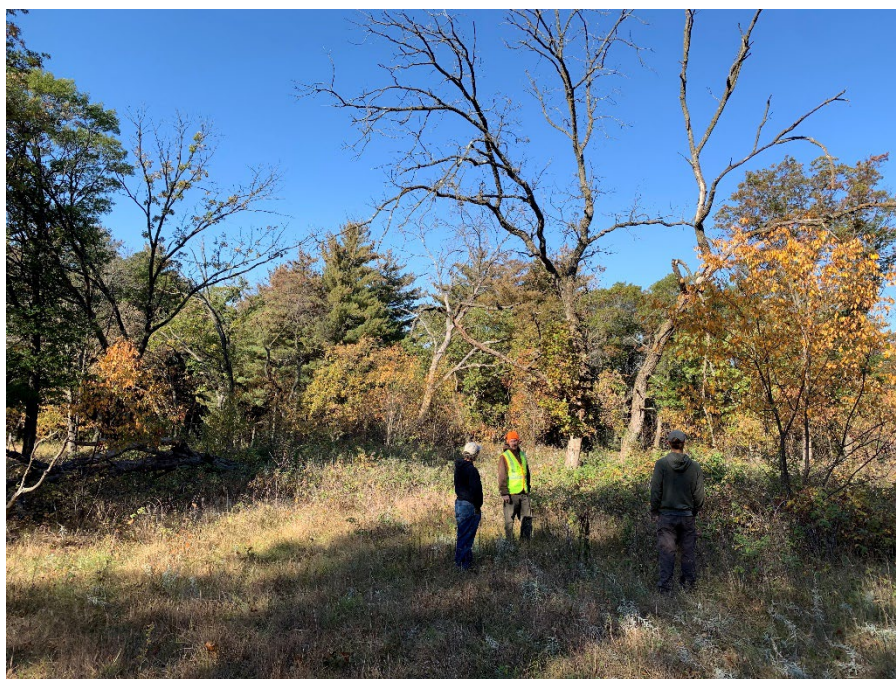
Photo 1 – View of Ups14 Southern Dry Savanna area looking north where invasive, nonnative woody removal occurred. This area illustrates the positive recovery of native herbaceous prairie/savanna vegetation (surrounding people in the photo).

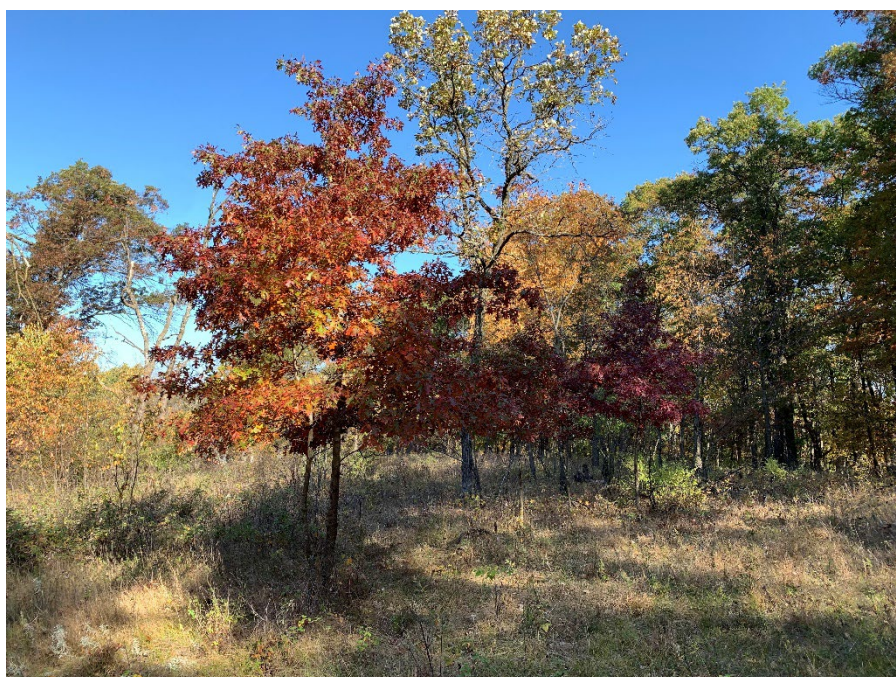
Photo 2 – View of prairie/savanna opening area with good recovery of the herbaceous layer, as well as recruitment of pin oak and bur oak.

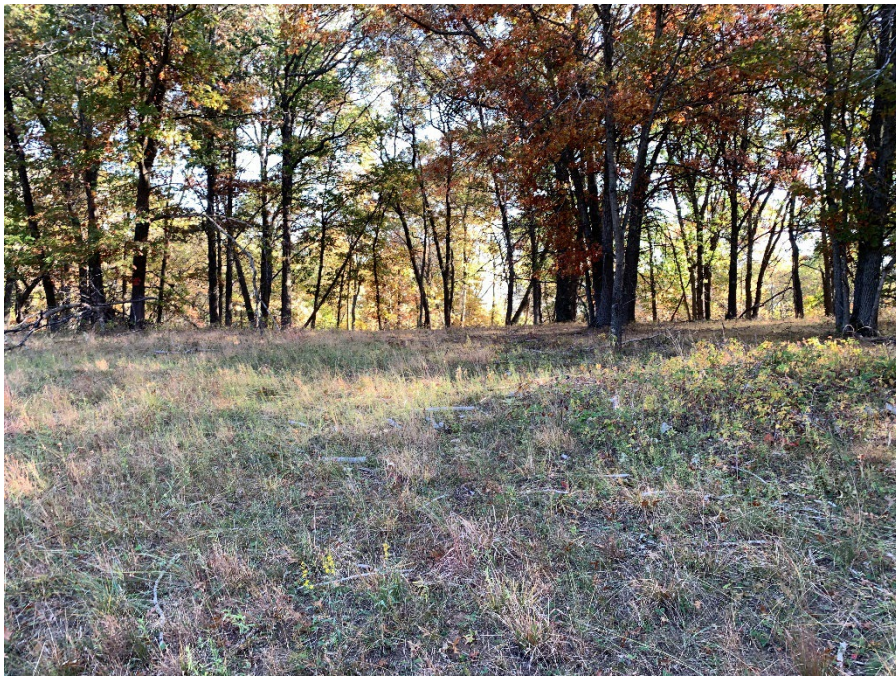
Photo 3 – View of an opening/canopy gap with abundant small native warm season bunch grasses (tan- and russet-colored tufts).

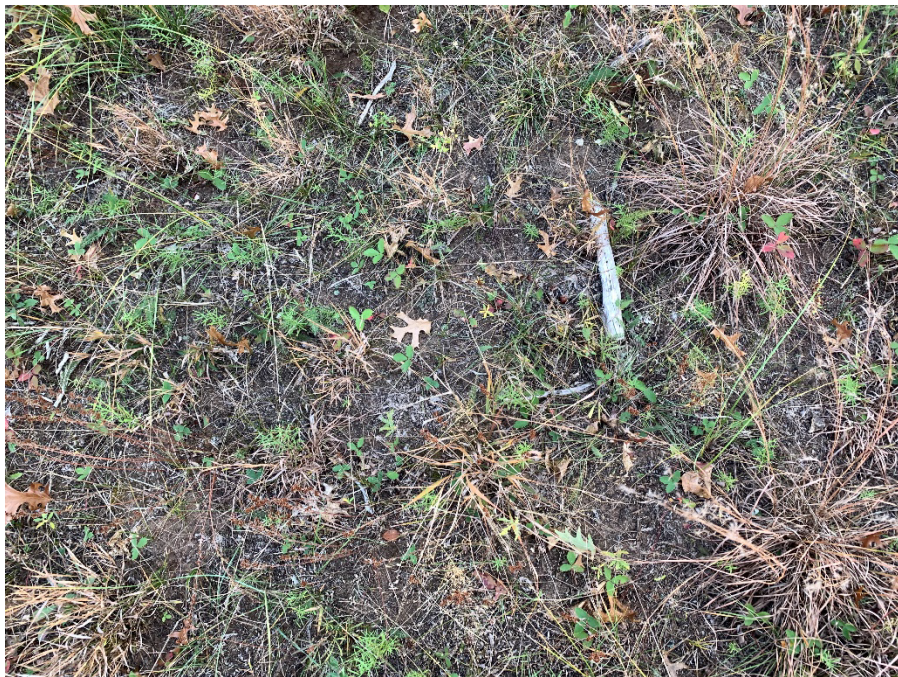
Photo 4 – View of prairie/savanna restoration looking down at the ground surface. Native grasses are evident as tan tufts, with forbs interspersed.

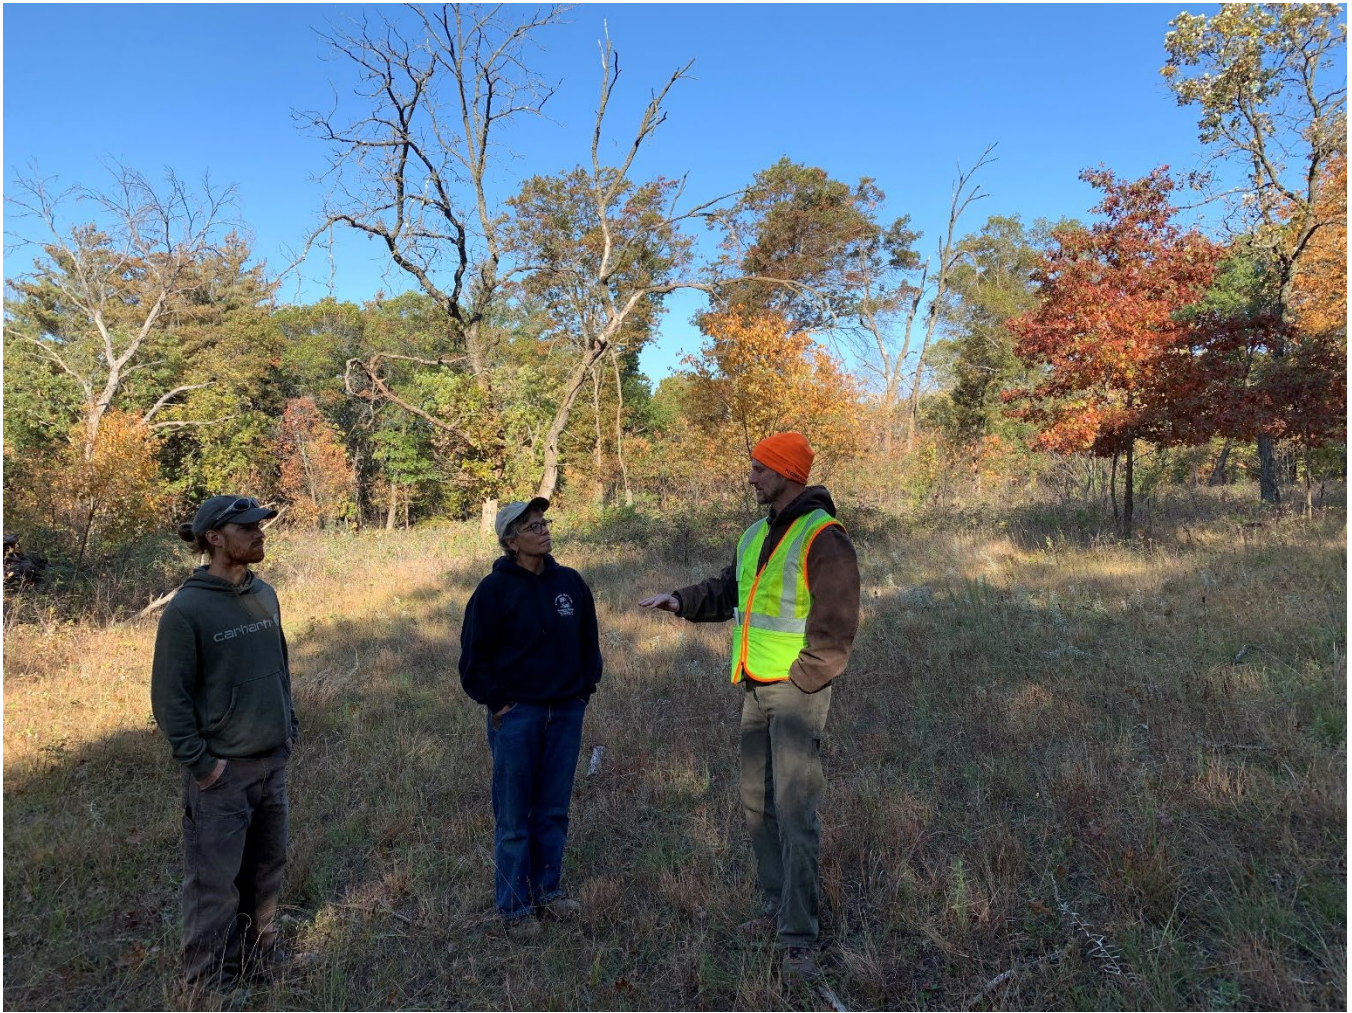
Photo 5 – Cooper Crose (left) and Lynette Anderson (center) of Belwin Conservancy, along with Wade Johnson of MNDNR discuss work completed in the surrounding area. Recovery of the native herbaceous layer in this particular area was very good following invasive woody removal.

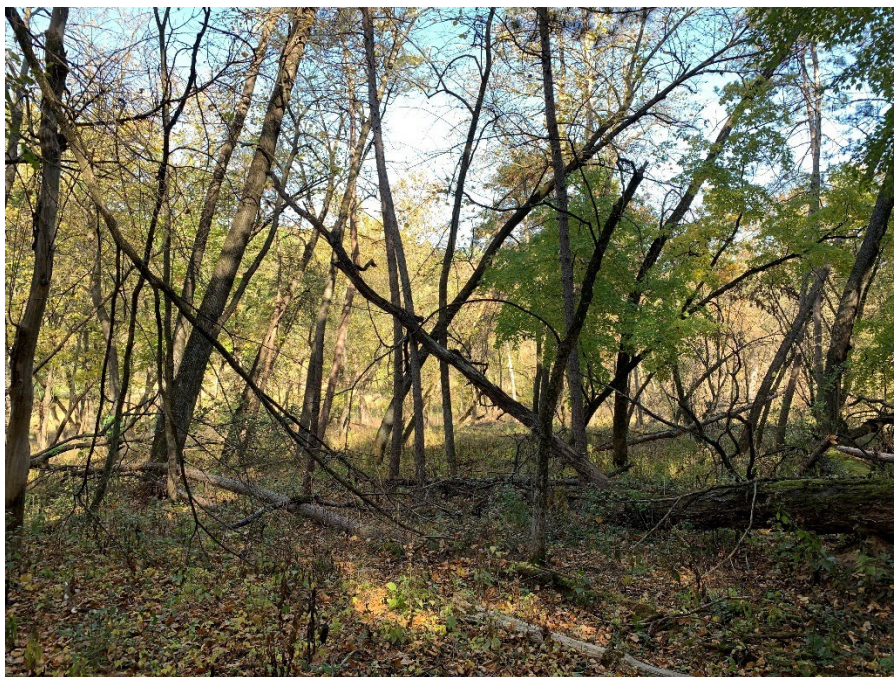
Photo 6 – View of forest along Valley Creek, looking northeast illustrating the open character of the shrub layer following invasive woody removal.

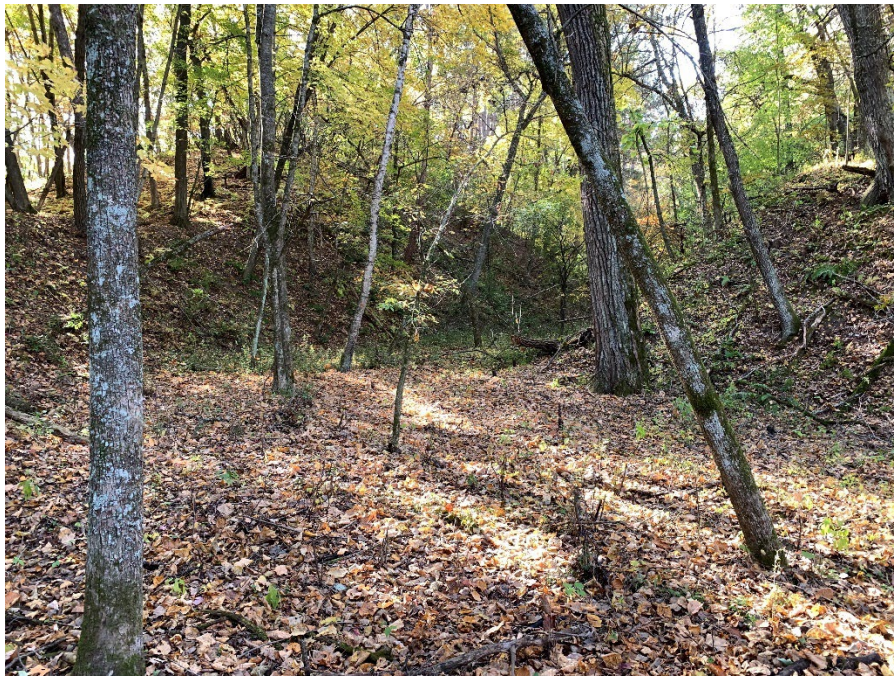
Photo 8 – Looking south and upslope in southern dry-mesic oak (maple) forest. Common trees in the picture include red maple, oak, and paper birch. A few cut stumps of buckthorn are evident in the bottom center part of the photo.

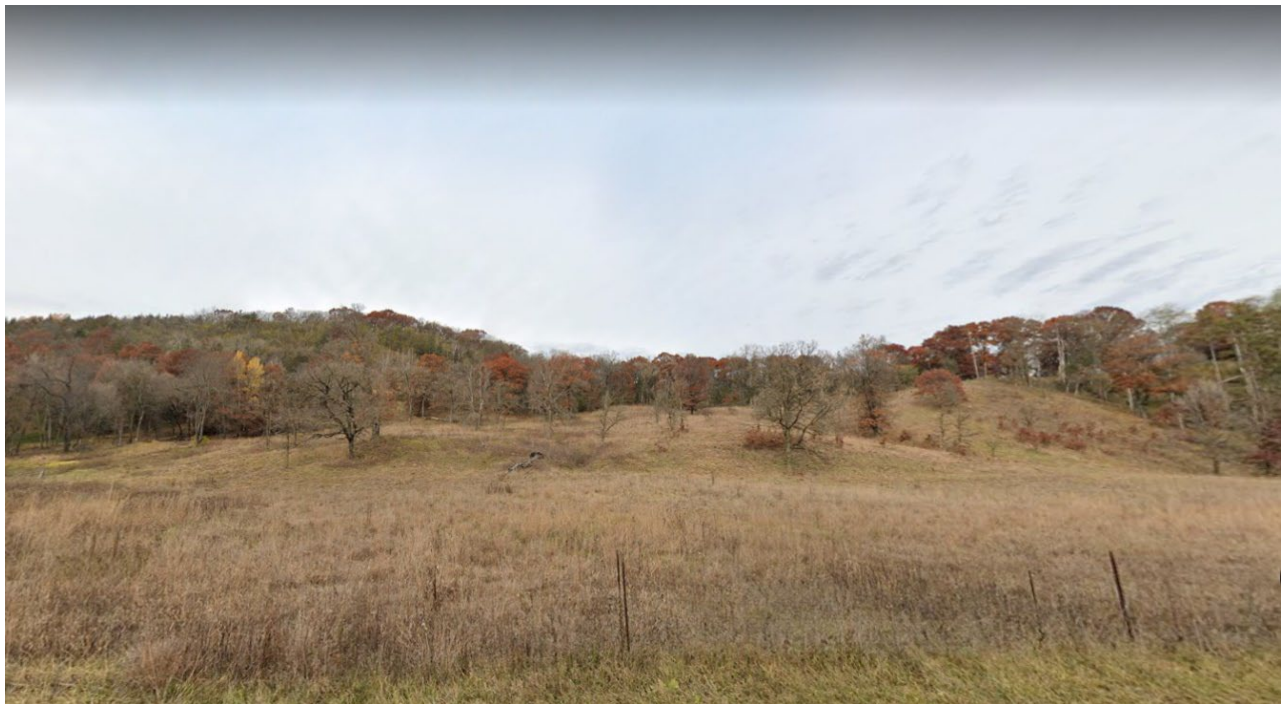
Photo 9 – View of prairie/savanna restoration looking south from Valley Creek Trail. In a 1947 aerial photograph, the area in the foreground appeared to be plowed. Invasive brush/trees were removed from the savanna area upslope in this photo. Patchiness of native, weedy, and nonnative vegetation is evident at left-center of photo (Source: Google Maps, image November 2021)

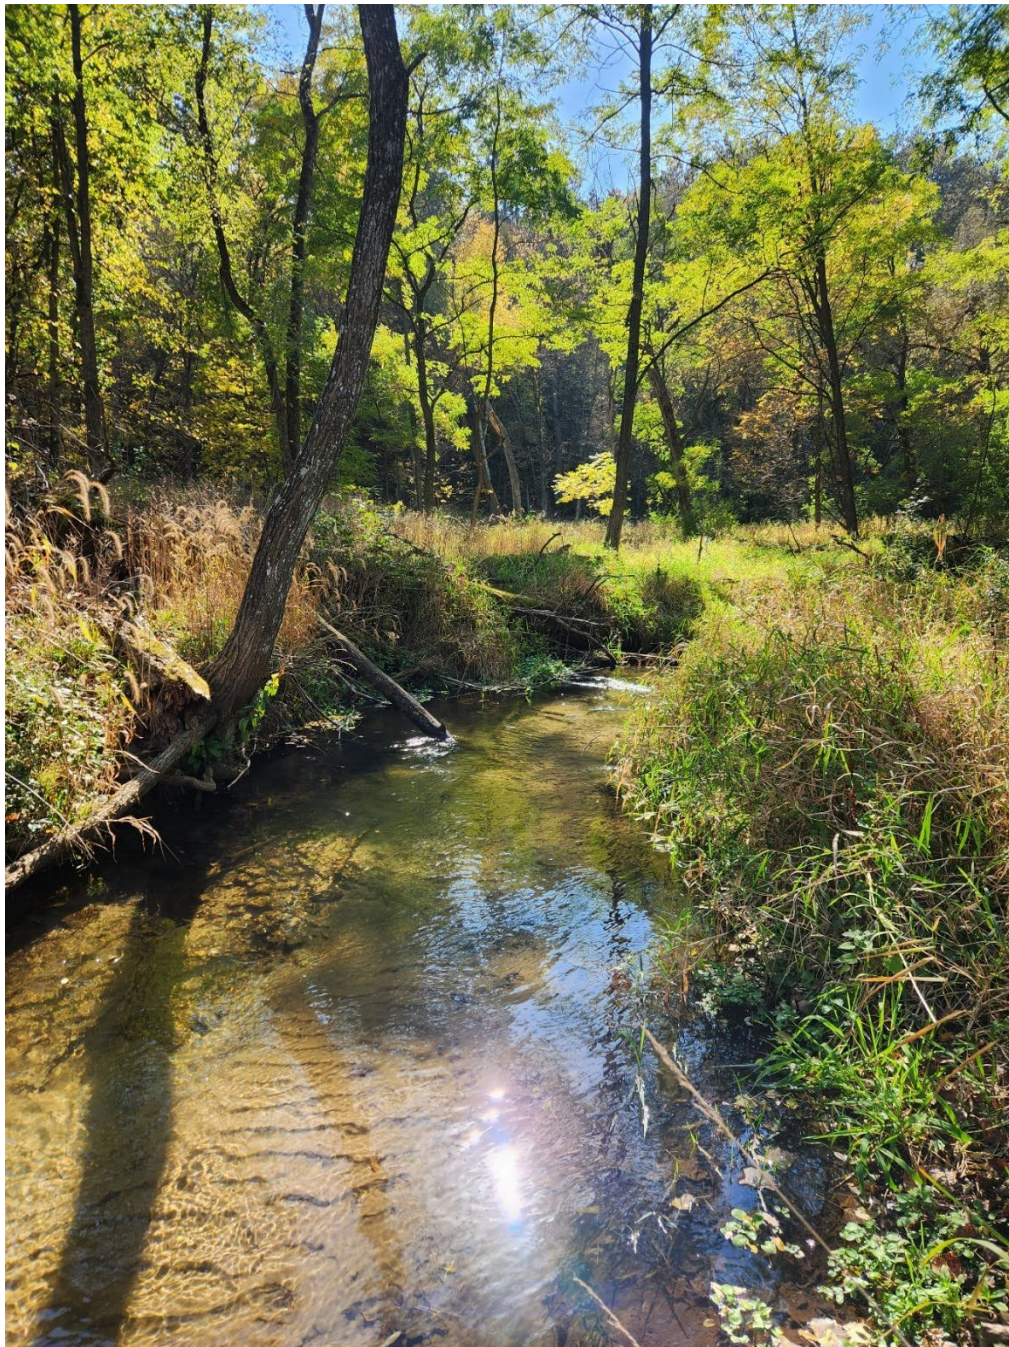
Photo 6 – View of Valley Creek in the southern terrace forest looking south towards the southern dry-mesic oak (maple) forest. Invasive brush/trees were removed from the riparian area and planted with native trees species.

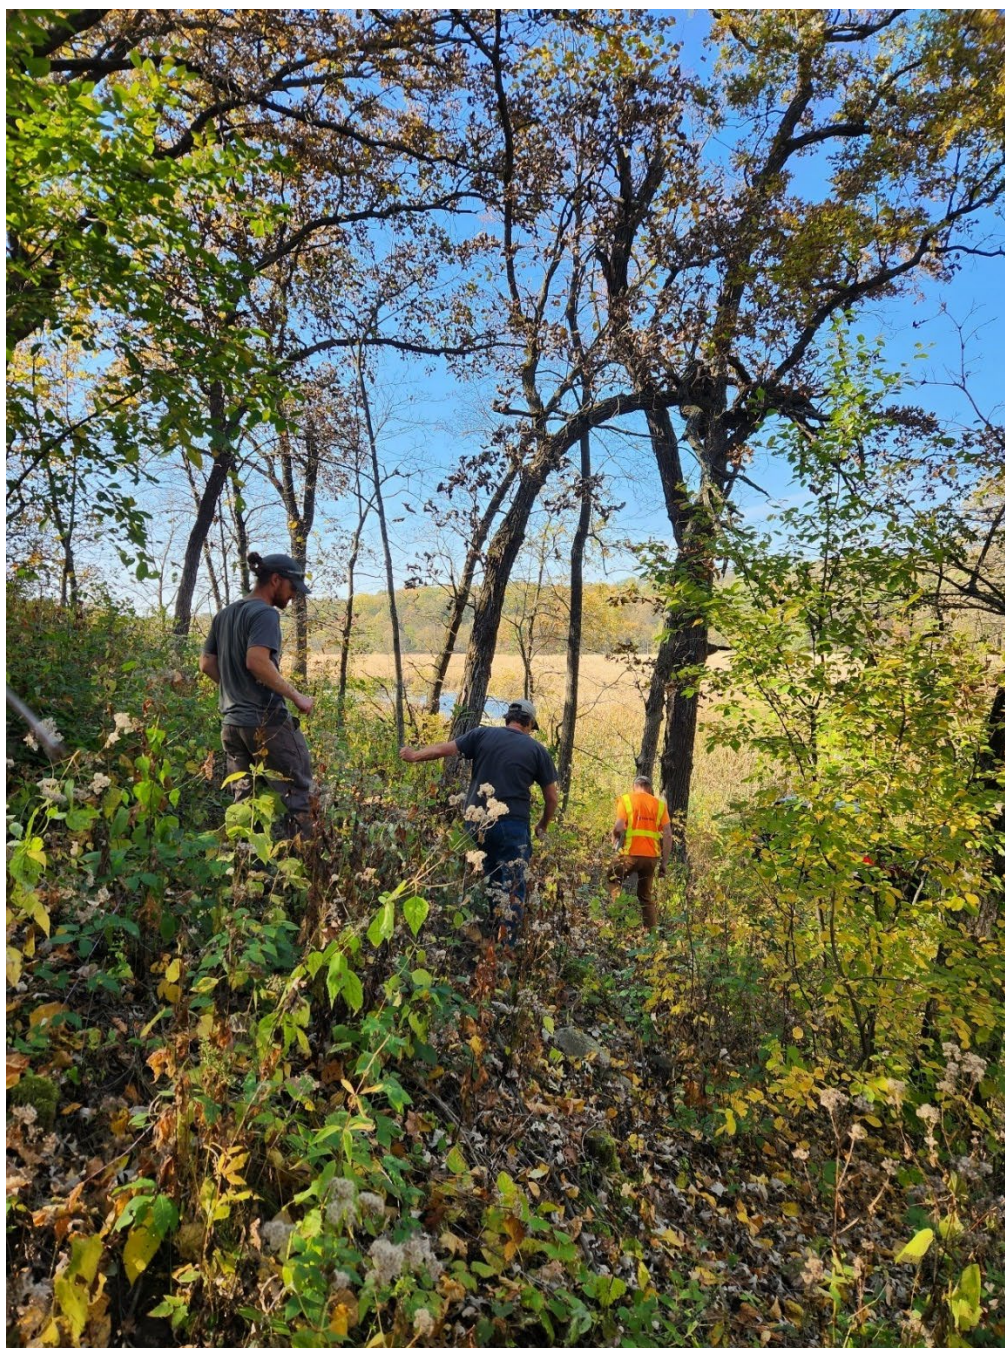
Photo 10 – Picture looking northwest on the east side of the project area near the outlet from the large cattail marsh (that flows into Lake Edit to the east). This photo illustrates the open shrub layer following invasive brush removal following work that occurred 2020-2022.

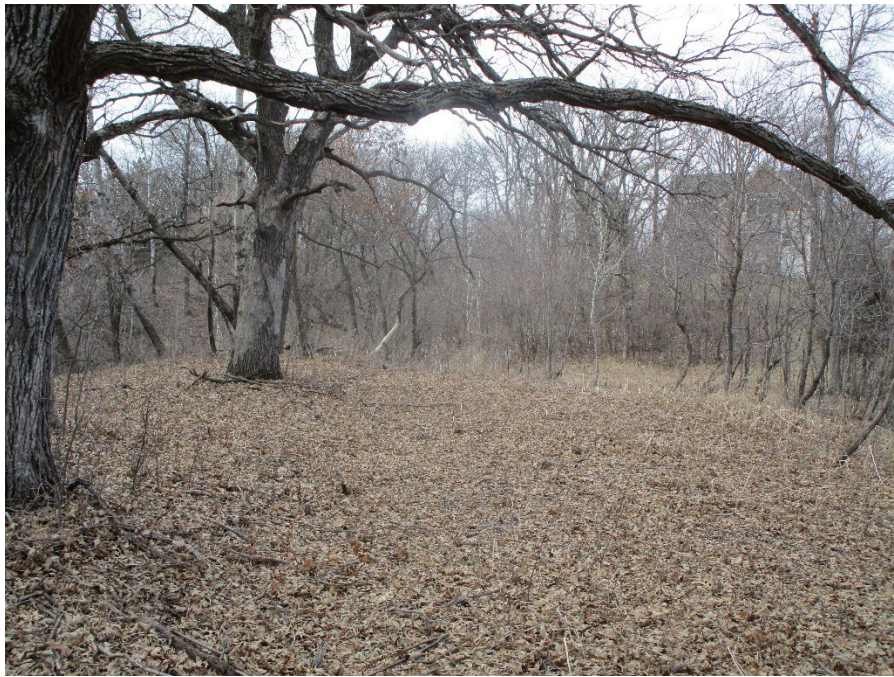
Photo 11 – Photo taken in 2019 by Belwin Conservancy staff, following initial invasive woody management. Photo is believed to have been taken on the north side of the project site.

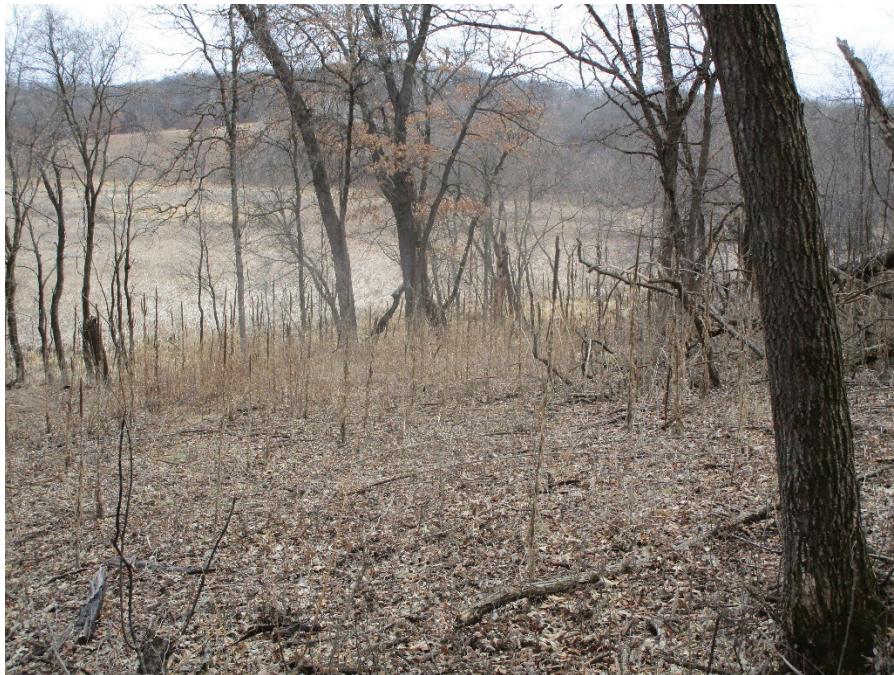
Photo 12 – Photo reportedly taken in 2019 by Belwin Conservancy staff, following initial invasive woody management. Photo is on the north side of the project site, looking south across the large cattail marsh.

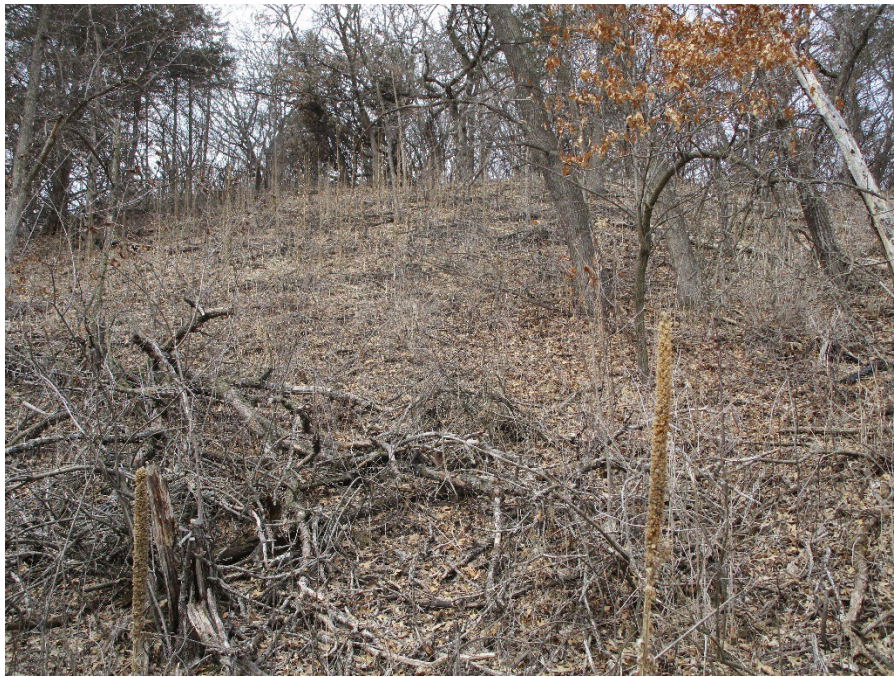
Photo 13 – Photo taken in 2019 by Belwin Conservancy staff, following initial invasive woody management. Photo is believed to have been taken on the north side of the project site, on the south-facing slope above a large cattail marsh.

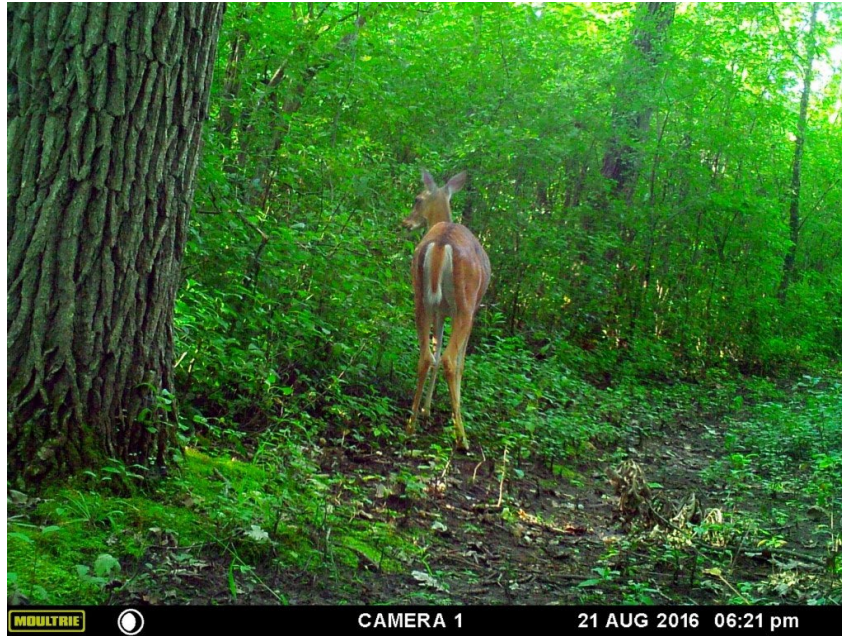
Photo 14. Trail camera image along trail within SCWRS project area prior to project (SCWRS project area, photo taken 8/21/2016).

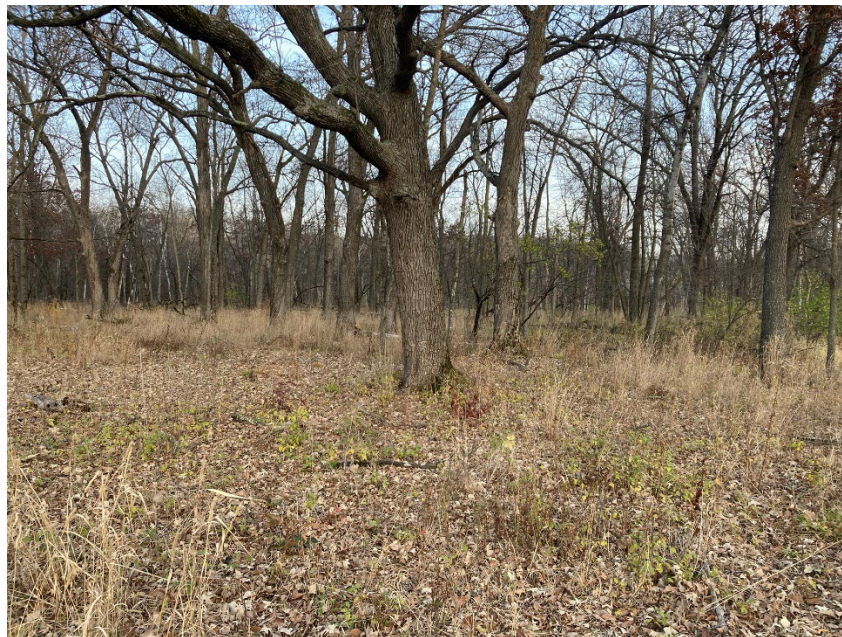
Photo 15. Representative overview of SCWRS oak woodland project area with 25-50% cover of native seeded grasses and 5% cover of 2-foot tall buckthorn resprouts. (SCWRS project area, photo taken 11/3/2021).

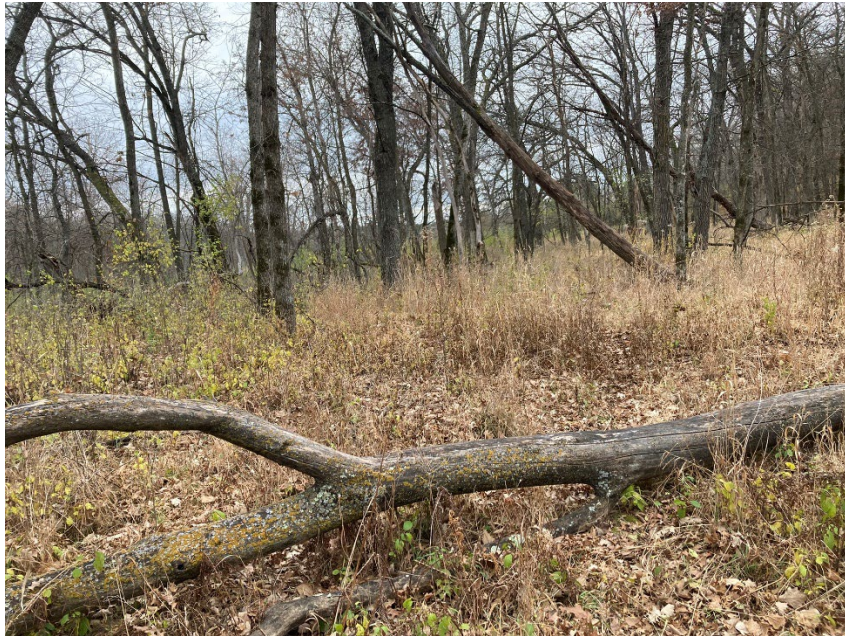
Photo 16. Overview of SCWRS oak woodland project area border with wetter seepage area to the left. Transition to from native grass understory to buckthorn resprouts is clearly visible from right to left. (SCWRS project area, photo taken 11/3/2021).

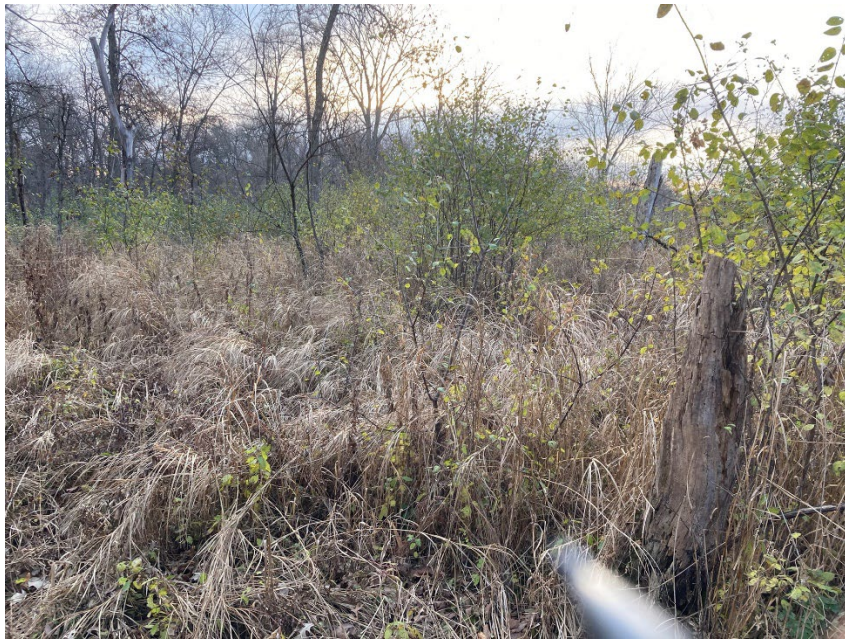
Photo 17. Overview of SCWRS seepage project area with some 5-25% buckthorn cover and understory of lake sedge. (SCWRS project area, photo taken 11/3/2021).

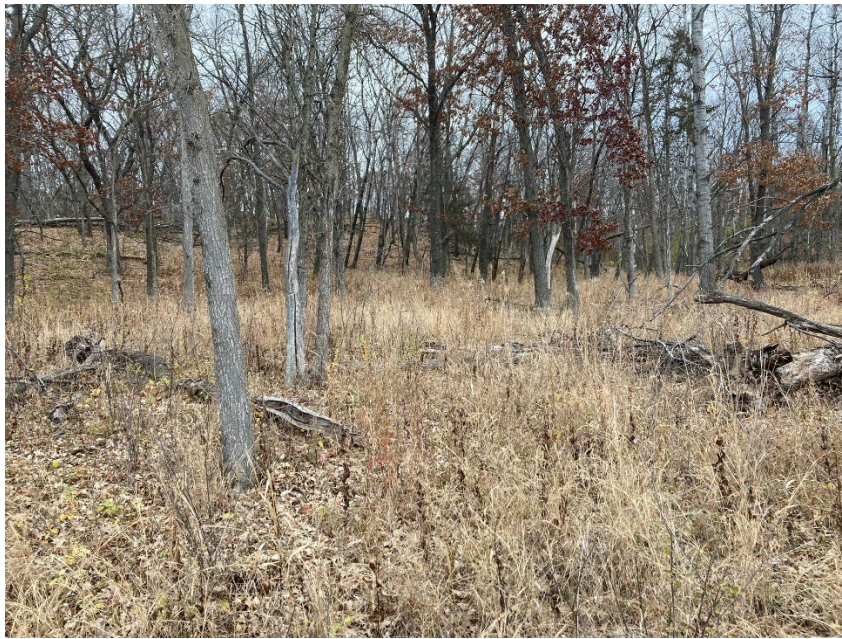
Buckthorn cover has been significantly reduced throughout the project area to less than 5% cover. Pre-project photos indicate the project areas were often 100% cover of mature buckthorn. Native vegetation cover has increased through combination of seeding, buckthorn removal, and prescribed burning.

Photo 18. Representative overview of Tanglewood project area with canopy of oak and aspen and understory of seeded native grasses with white snakeroot. Buckthorn cover is less than 5%. (Tanglewood project area, photo taken 11/3/2021).

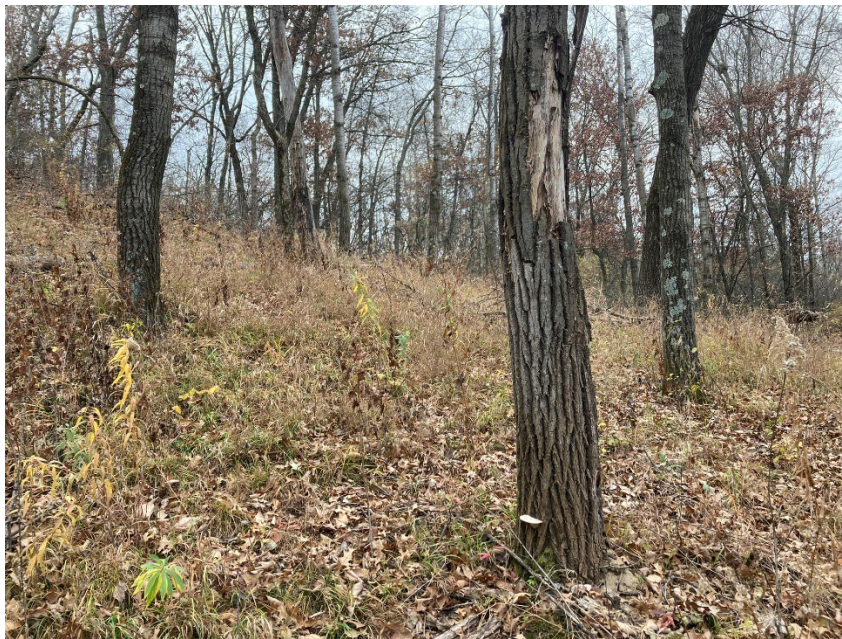
Photo 19. Overview of Tanglewood project area along a steeper slope with similar understory establishment and buckthorn reduction to more level areas. (Tanglewood project area, photo taken 11/3/2021).

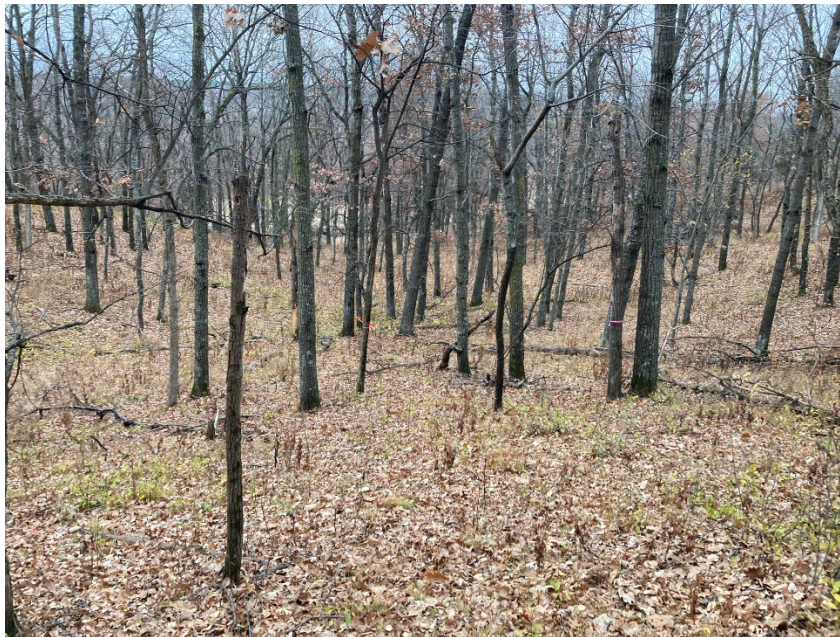
Photo 20. Overview of Tanglewood project area with younger age class of trees and less established native seeded grasses. (Tanglewood project area, photo taken 11/3/2021).

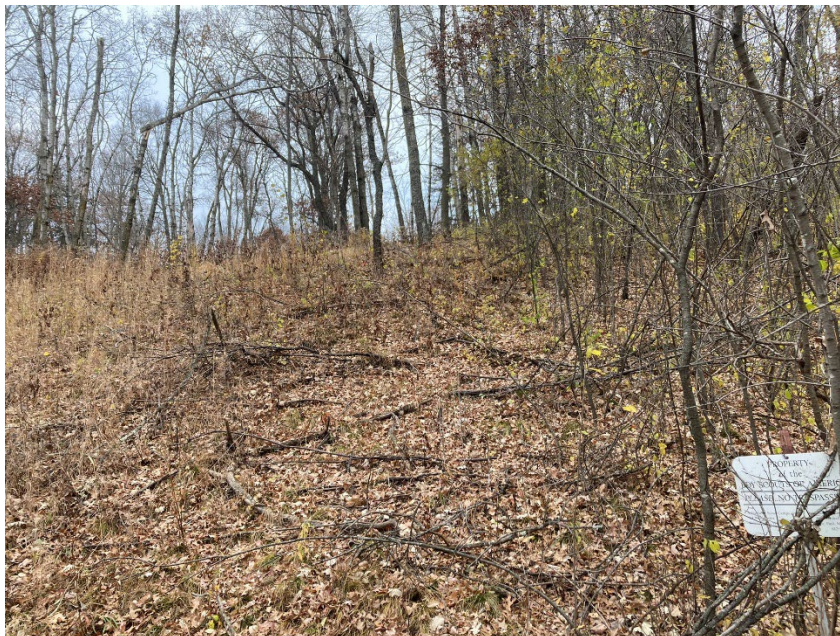
Photo 21. Overview of Tanglewood project area along parcel boundary. The right half of the image received no buckthorn treatment. The left half the image includes the proposed project. (Tanglewood project area, photo taken 11/3/2021).

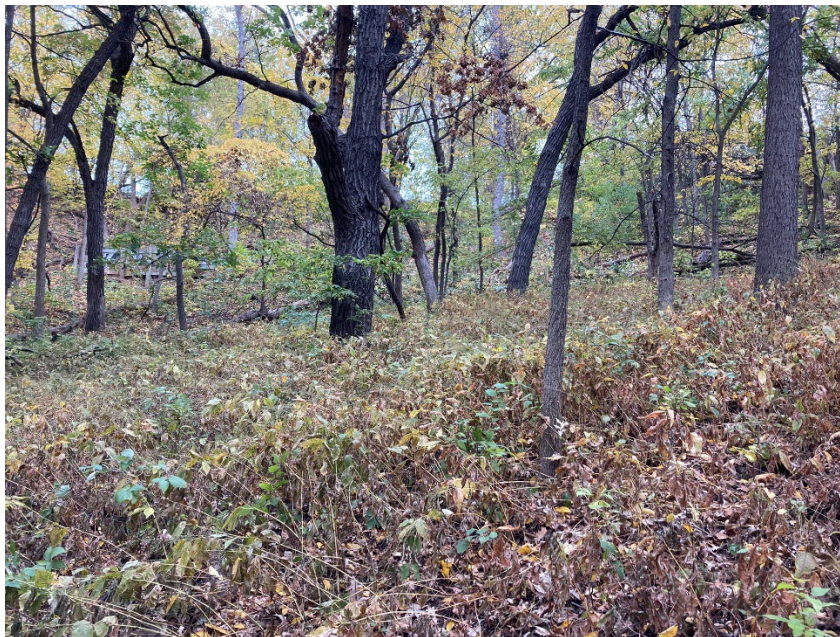
Photo 23 Small area within west goat grazing area with understory dominated by jumpseed (*Persicaria virginiana*). (Indian Mounds Regional Park, photo taken during site visit 10/17/2022).

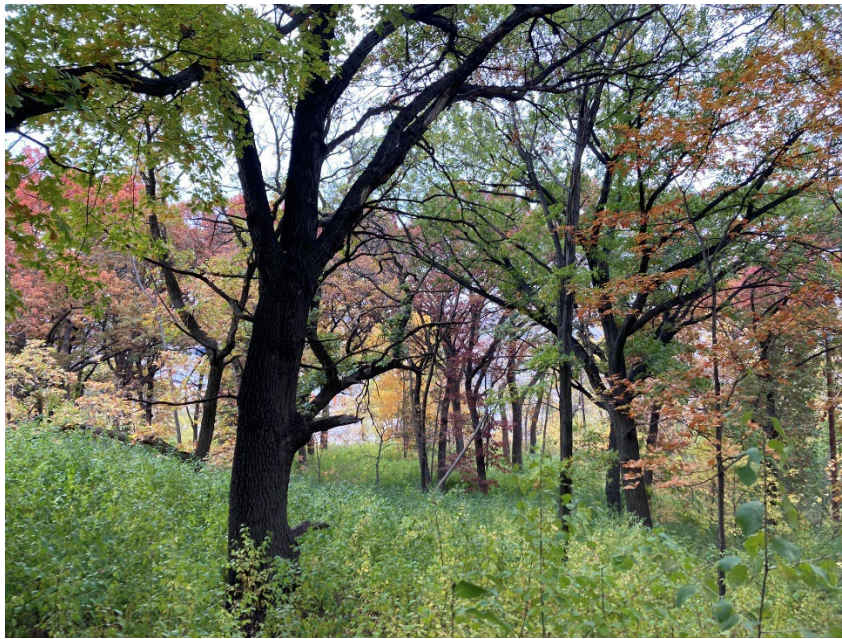
Photo 24 West goat grazing area where re-sprouted buckthorn cover is 100%. (Indian Mounds Regional Park, photo taken during site visit 10/17/2022).

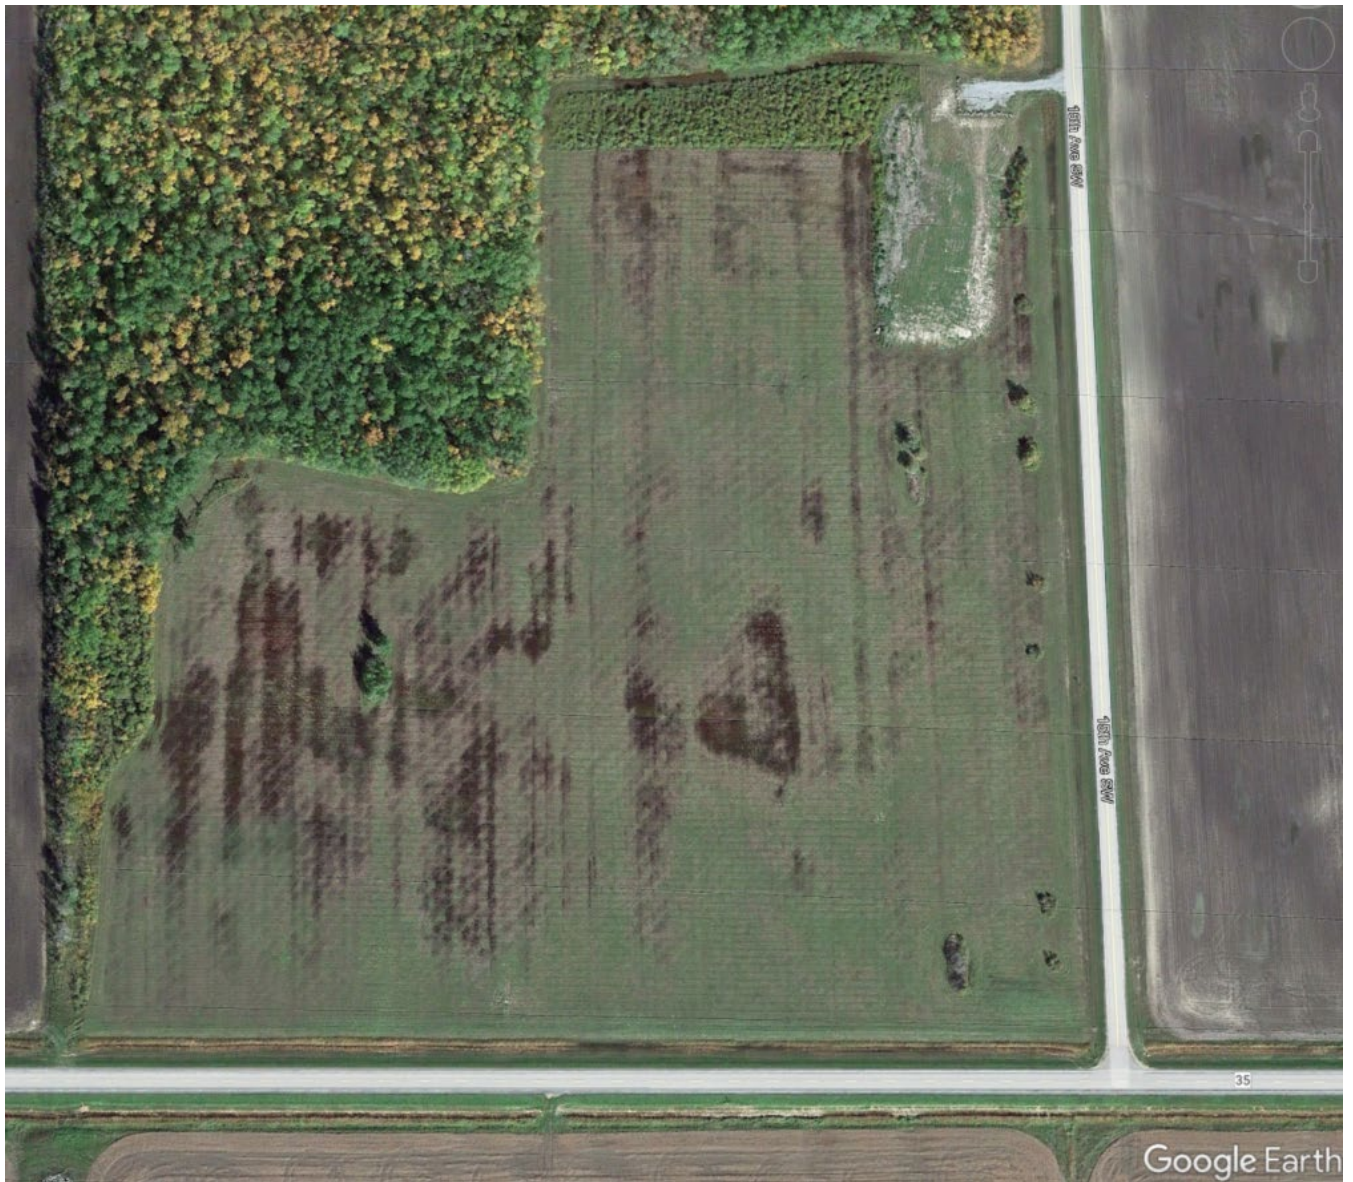
Figure 3. Google Earth image (dated 9/2014) showing site *after* second brush shearing event. Note the site is open and largely devoid of woody species (Agassiz Lowlands Grassland Enhancement).

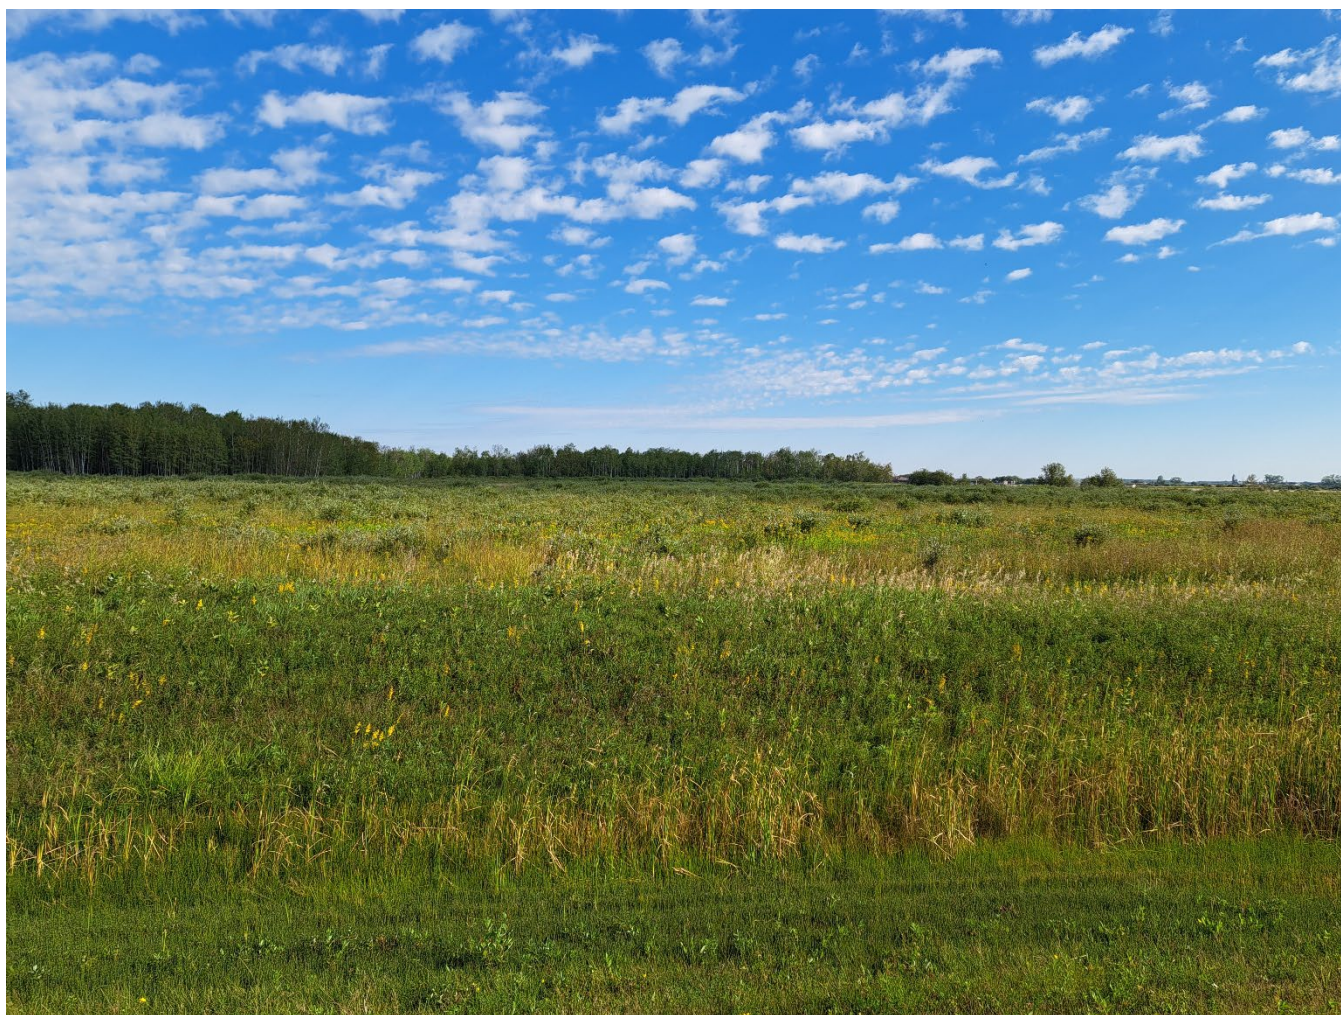
Photo 1. Looking north from County Hwy 35 at the project site showing largely 50-75% grassland cover (Agassiz Lowlands Grassland Enhancement, photo taken during site visit 8/30/2022).

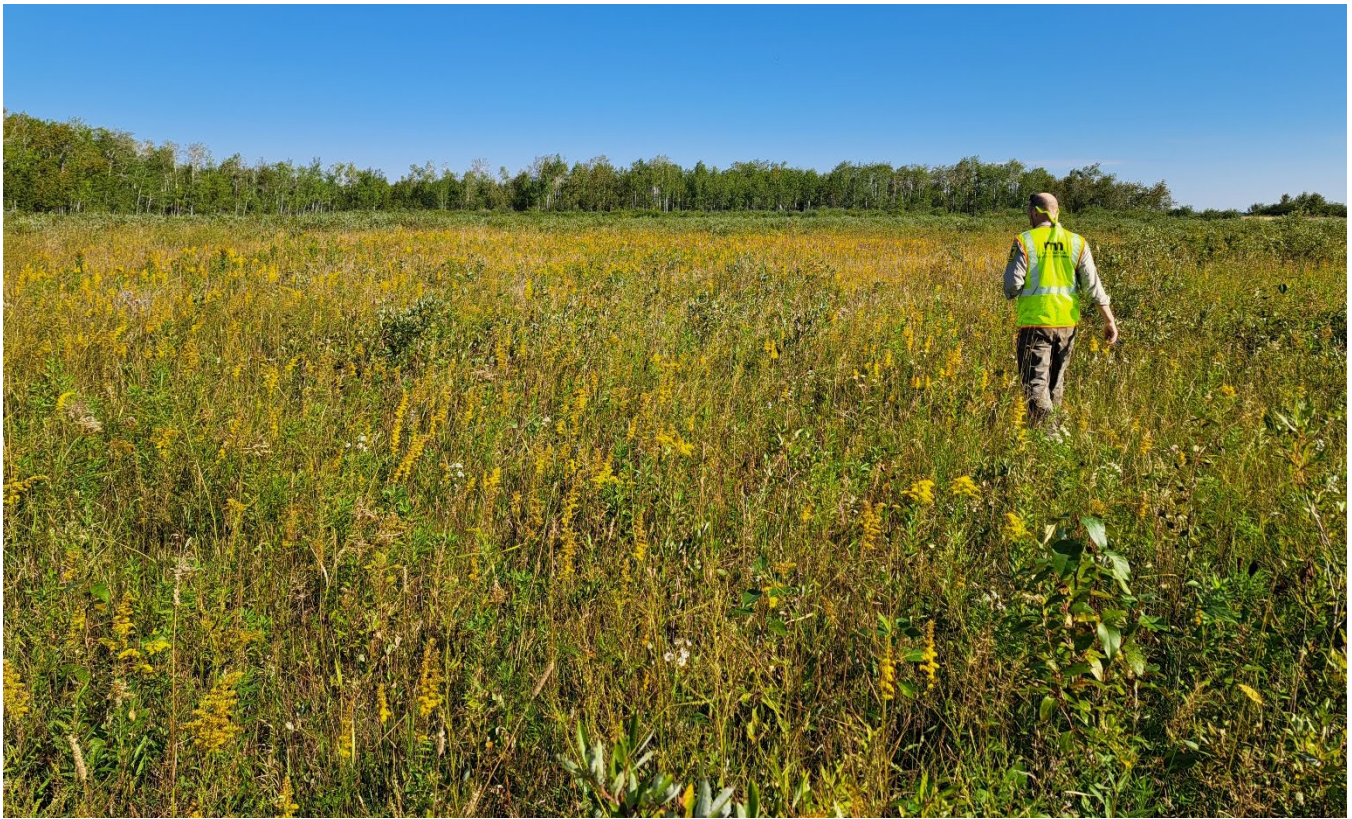
Photo 2. Looking north midway through the site meander survey showing 75-100% grassland cover, indicating high success in this area from the brush shearing (Agassiz Lowlands Grassland Enhancement, photo taken during site visit 8/30/2022).

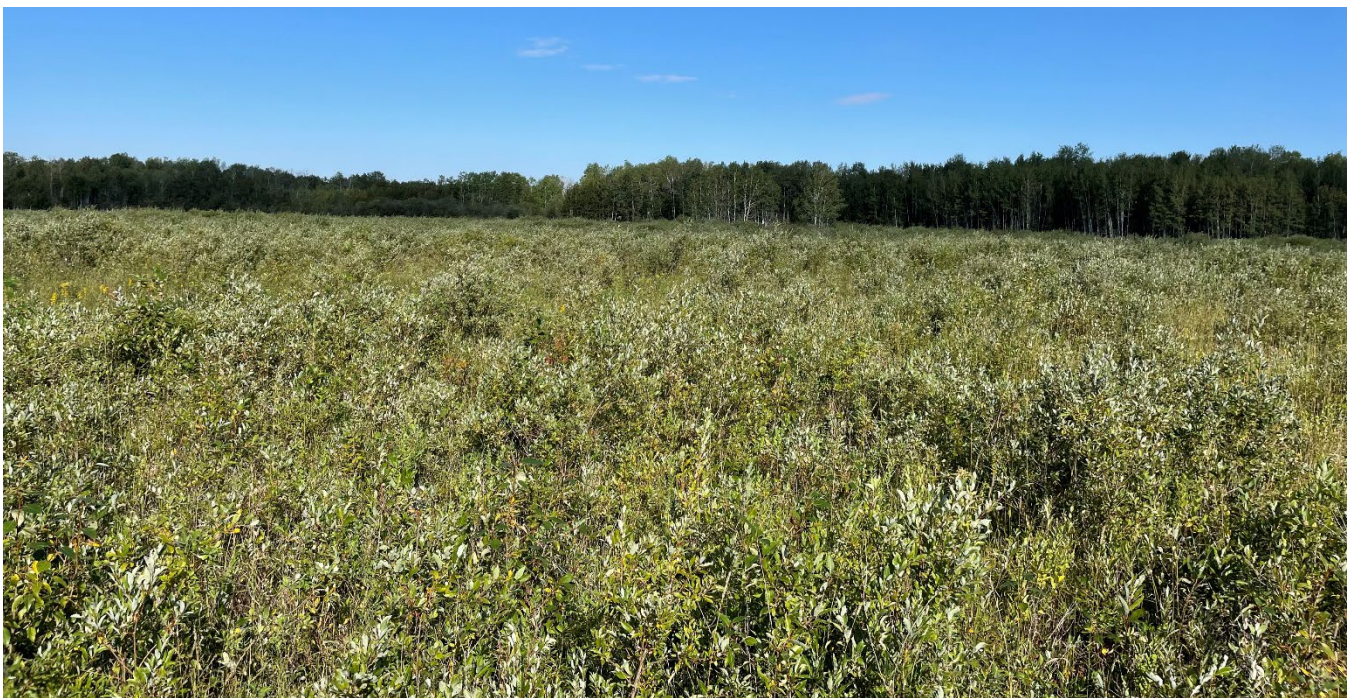
Photo 3. Looking northeast at the end of the site meander survey showing 25-50% grassland cover but dominated by willow species (Agassiz Lowlands Grassland Enhancement, photo taken during site visit 8/30/2022).
