LEGACY FUND RESTORATION EVALUATION REPORT

Technical Panel Findings and Recommendations—2022

REPORT TO THE MINNESOTA LEGISLATURE

Date of Report: August 2023

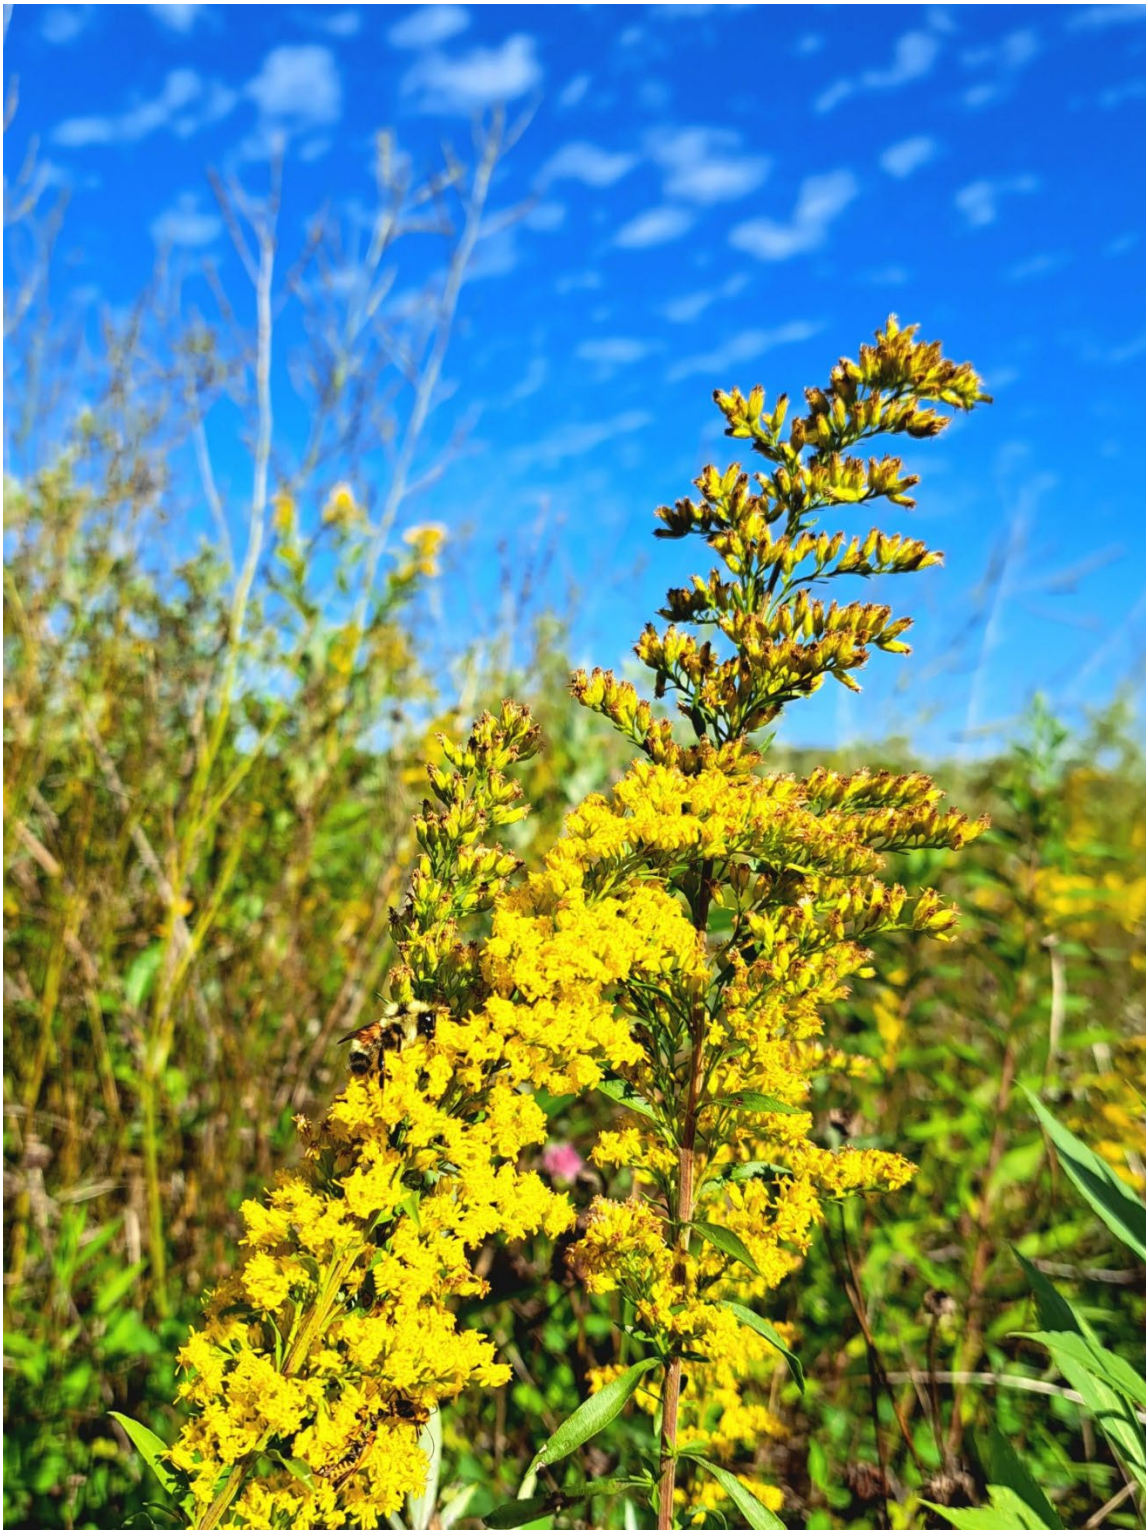
Photo 4. Close-up photo of goldenrods. Approximately 30 different grass and forb species identified during the vegetation meander survey including 11 nonnative species (Agassiz Lowlands Grassland Enhancement, photo taken during site visit 8/30/2022).

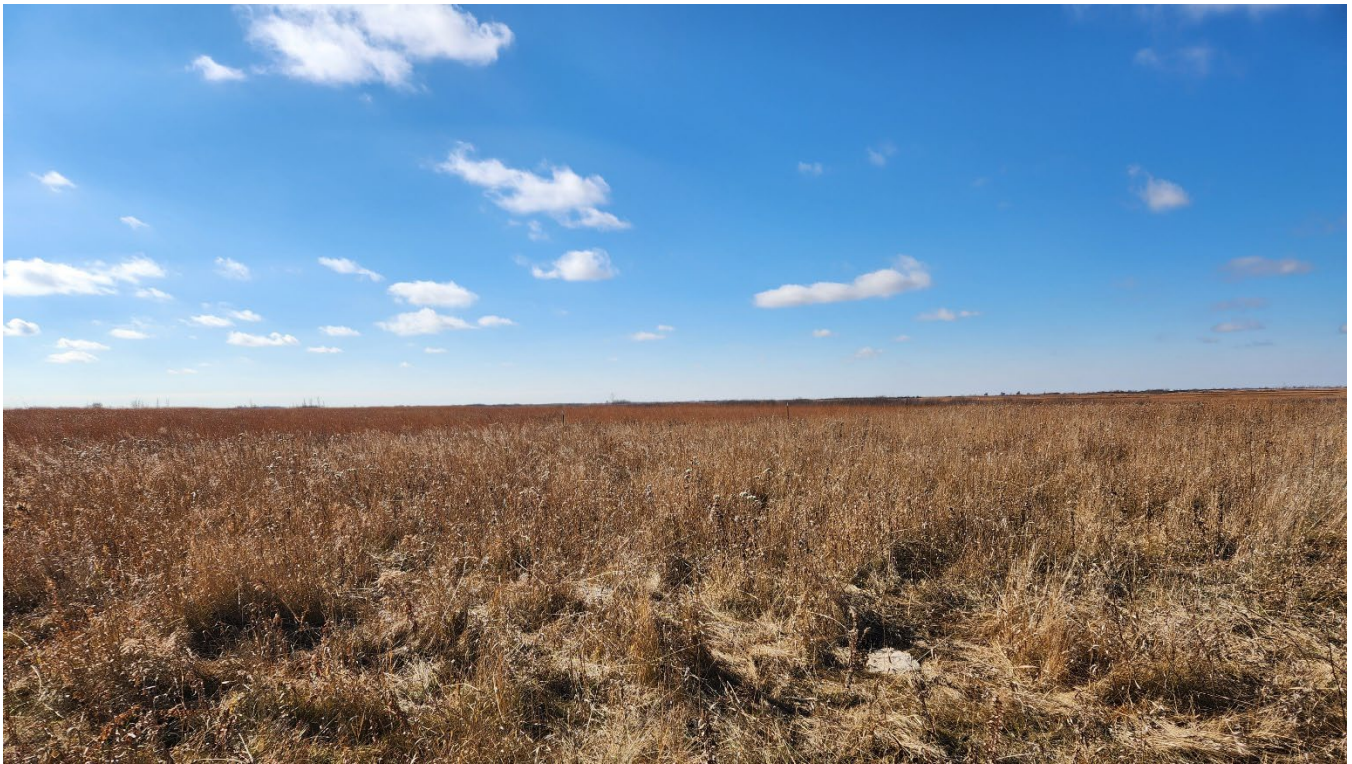
Photo 30. Grassland after one season of grazing (Oxcart Unit – 10/26/2022)

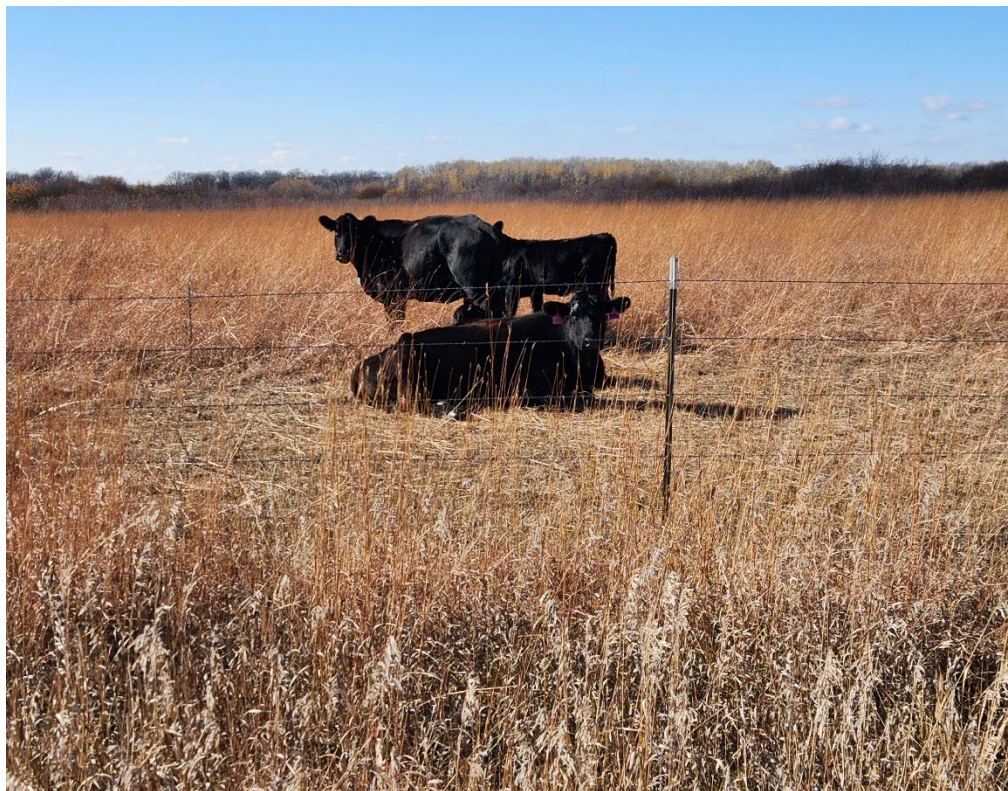
Photo 31. Livestock utilized for conservation grazing summer 2022 on both Oxcart and East Haul Units (10/26/2022).

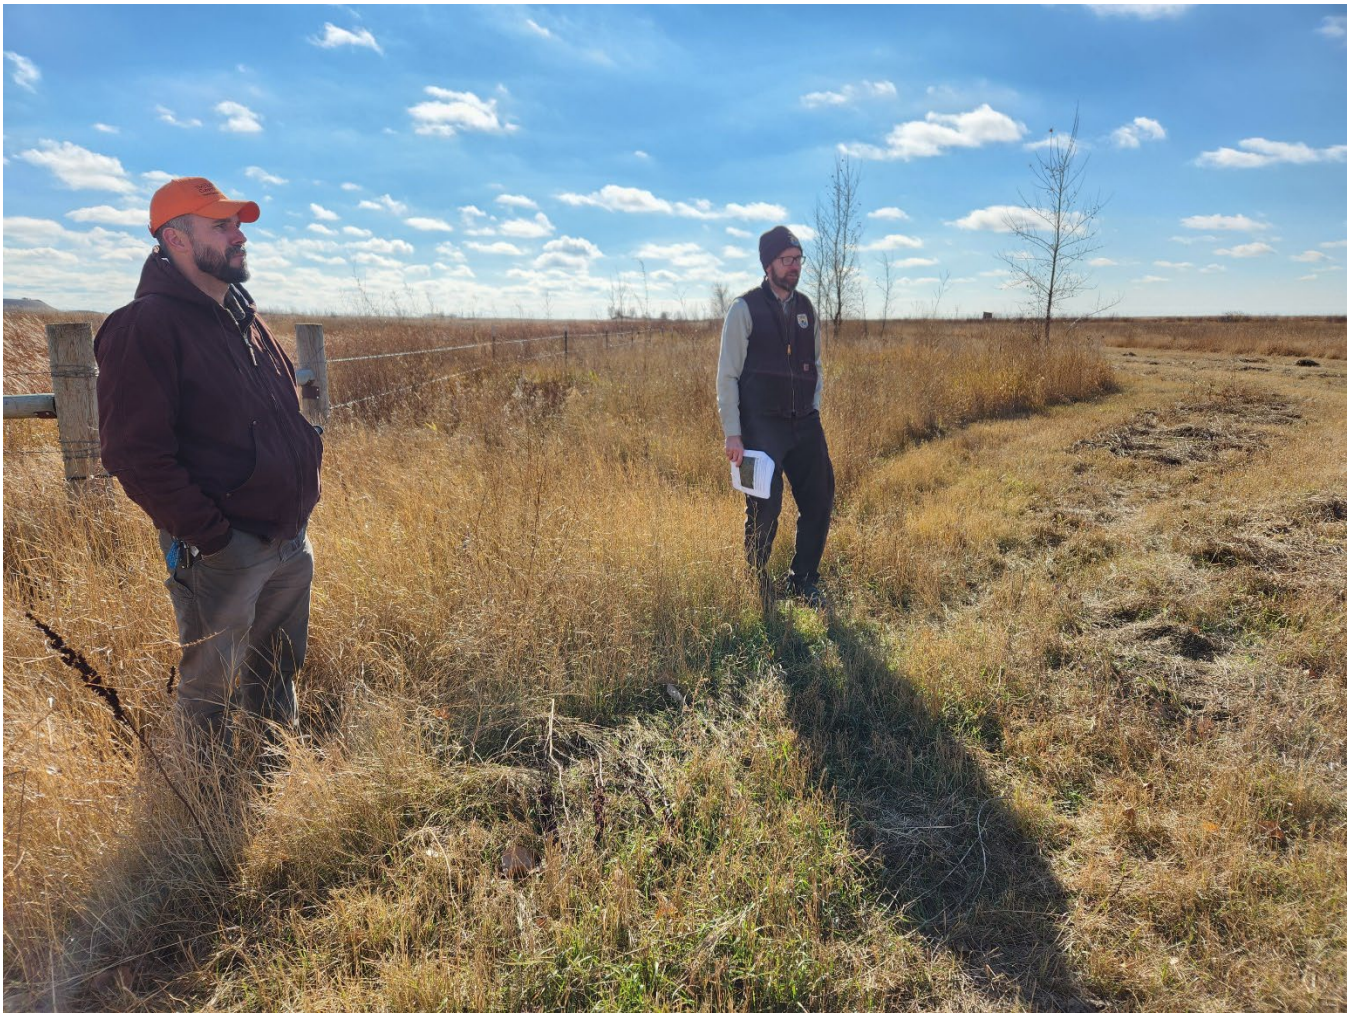
Photo 32. Project Hosts Travis Issendorf (TNC) and Ben Walker (USFWS) from site visit (10-26/2022). Note the mowed burn break for the coming 2023 prescribed burn season.

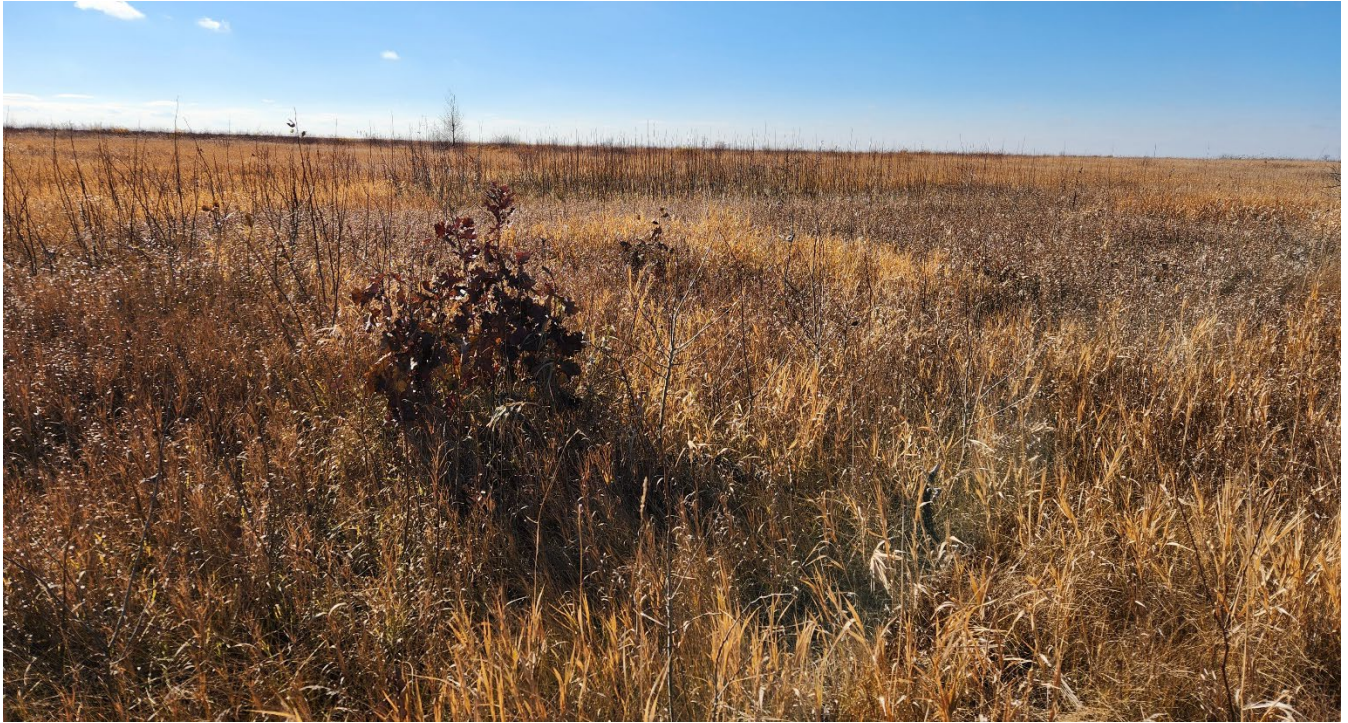
Photo 33. Prairie following woody tree removal. In this project area, trees were removed from the prairie and the stumps were chemically treated (Four Square Mile Unit - 10/26/2022).

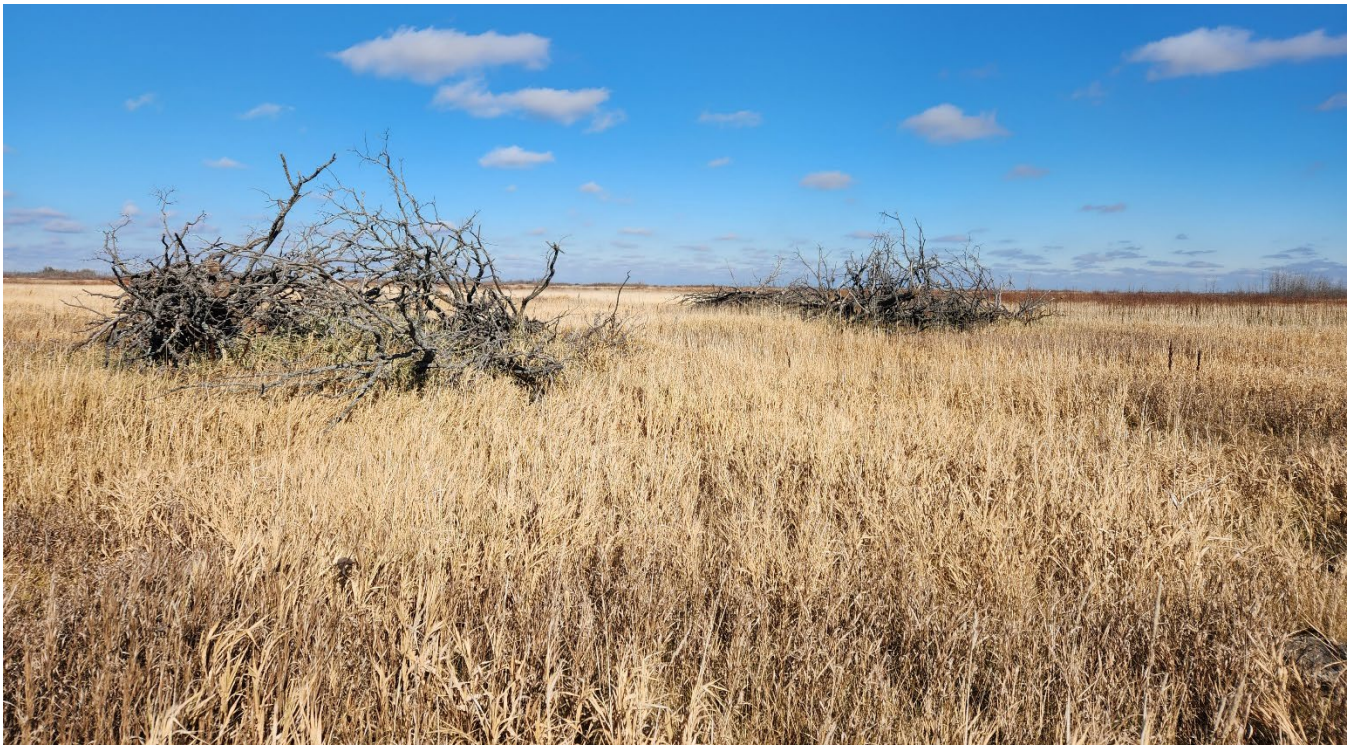
Photo 34. Woody debris piles post prairie enhancement and restoration efforts slated for burning (Four Square Mile Unit - 10/26/2022).

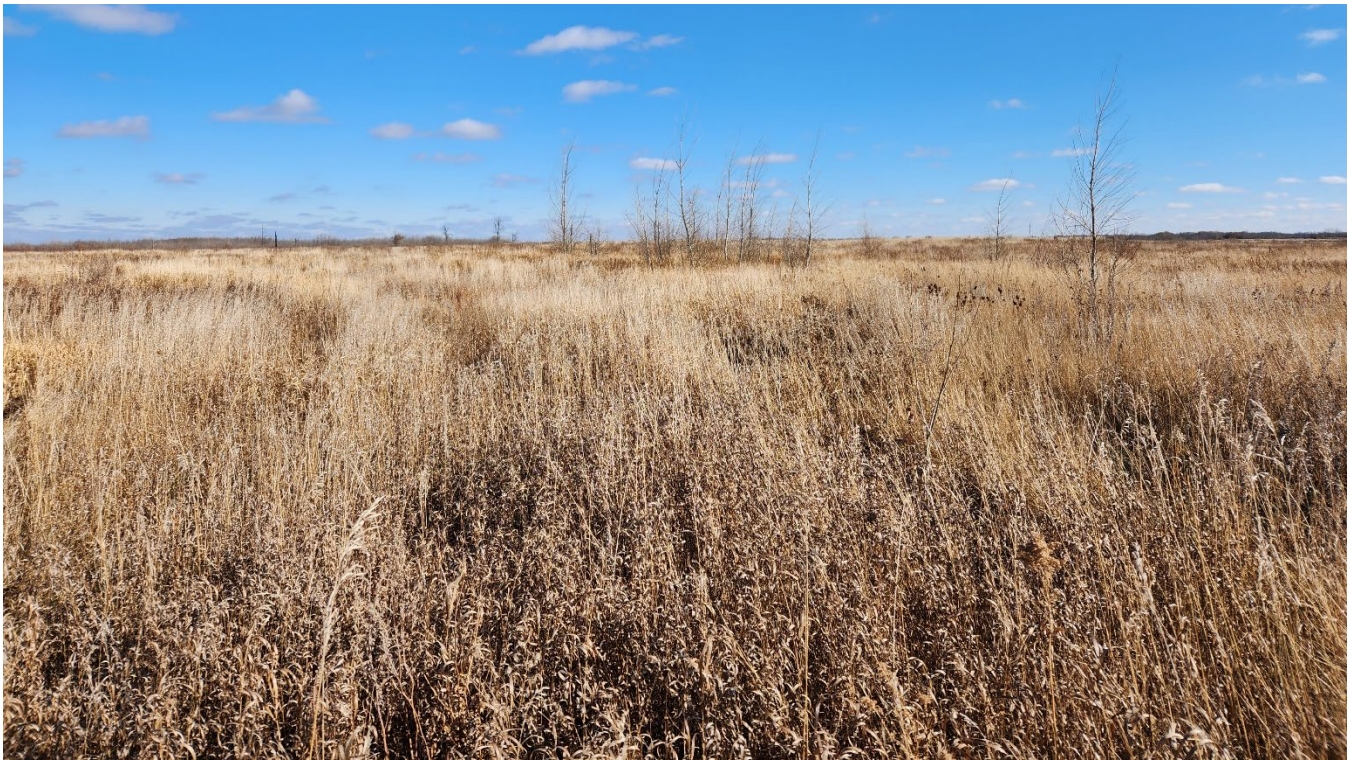
Photo 36. The prairie community in this enhancement area is still largely dominated by cool-season invasive grasses since it was not restored but enhanced. Smooth brome stands will require future restoration efforts (Four Square Mile Unit - 10/26/2022).

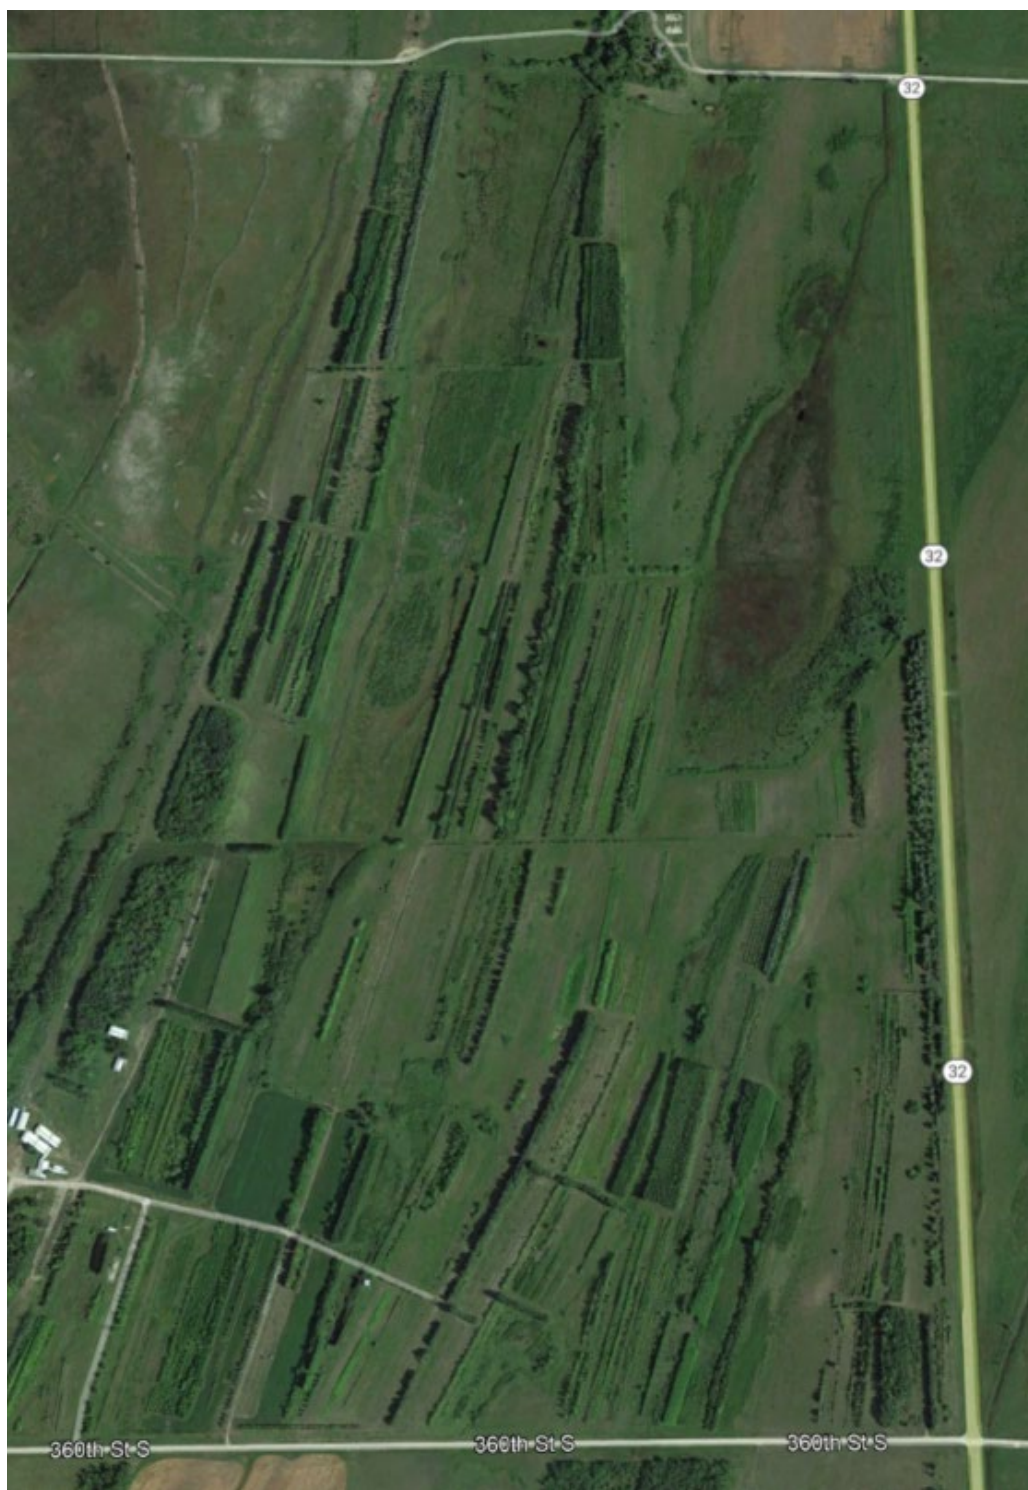
Figure 27. Aerial imagery from Google Earth (2015) before restoration efforts had taken place. Note the presence of rowed tree crops throughout much of the former tree nursery area.

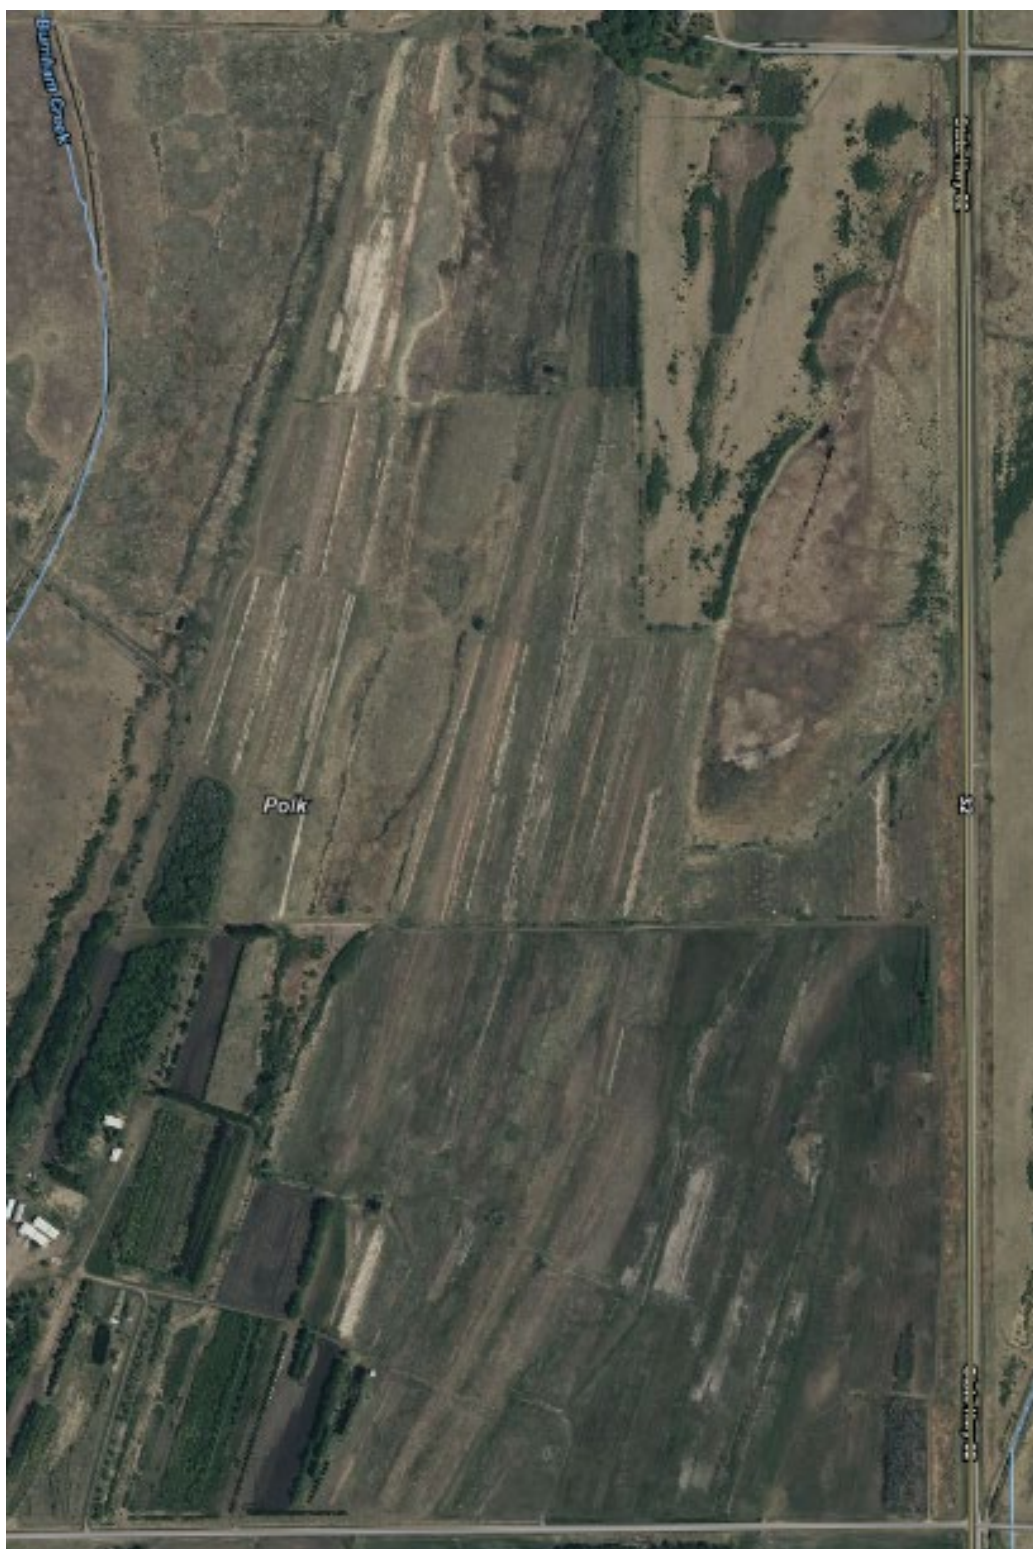
Figure 28. Aerial imagery from NRCS Web Soil Survey (image from September 6, 2022) post tree and shrub removal. Note the absence of rowed tree crops throughout much of the former tree nursery area. The farmstead in the lower left corner of the image is still owned privately and is not part of the Lee Unit Prairie Restoration and Enhancement project area.

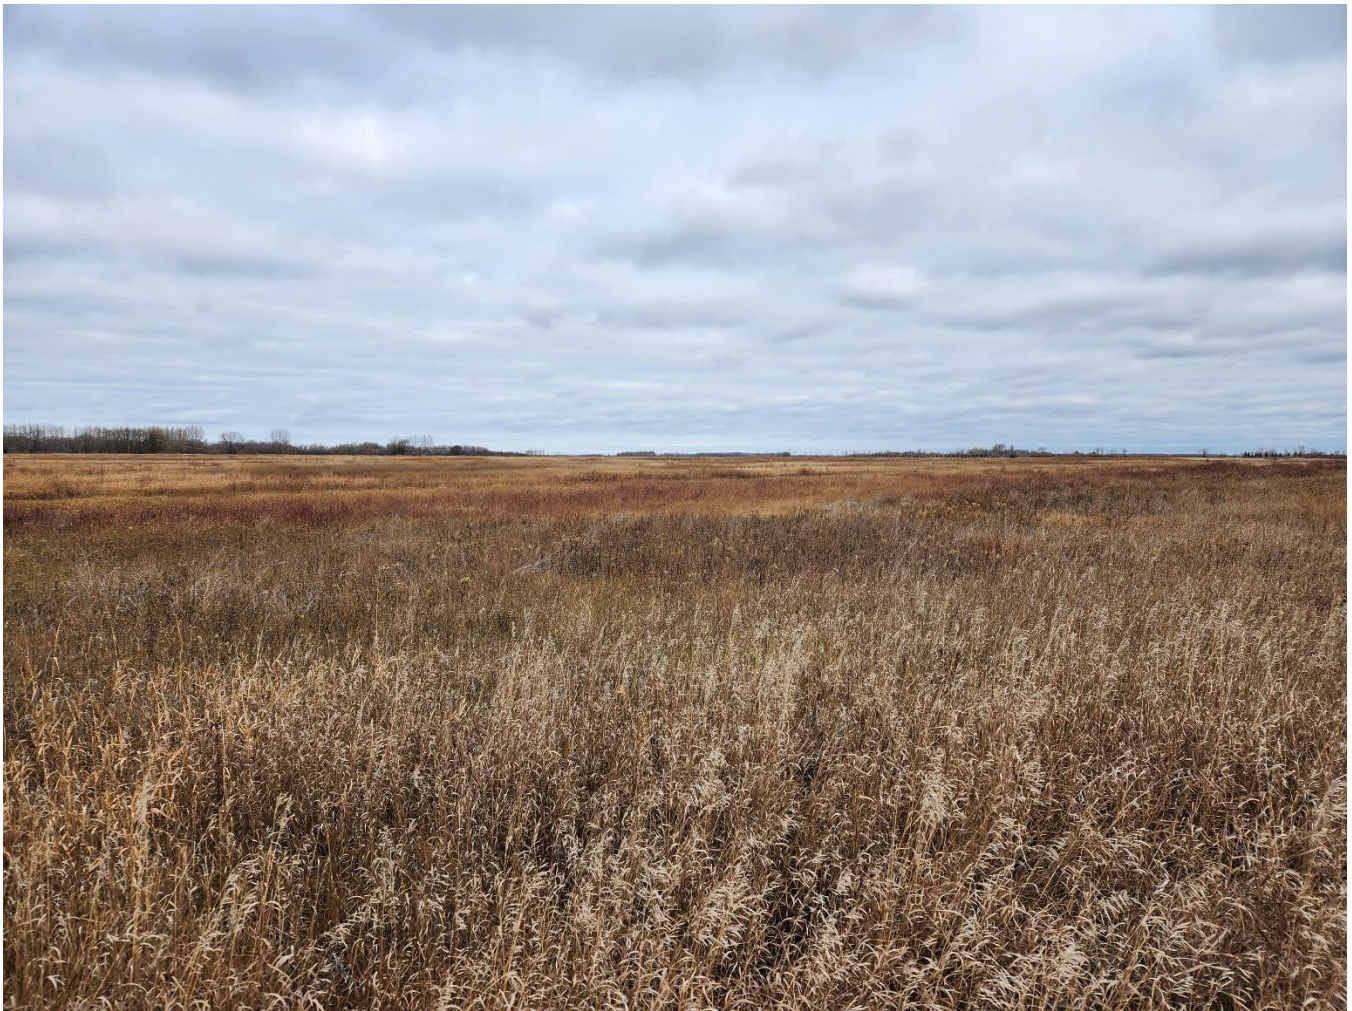
Photo 40. Photo looking northwest outside the restoration area. Note the abundance of smooth brome, an invasive grass, demonstrating the need for additional prairie restoration efforts (Lee Unit Prairie Restoration and Enhancement, photo taken during the site visit on 10/26/2022).

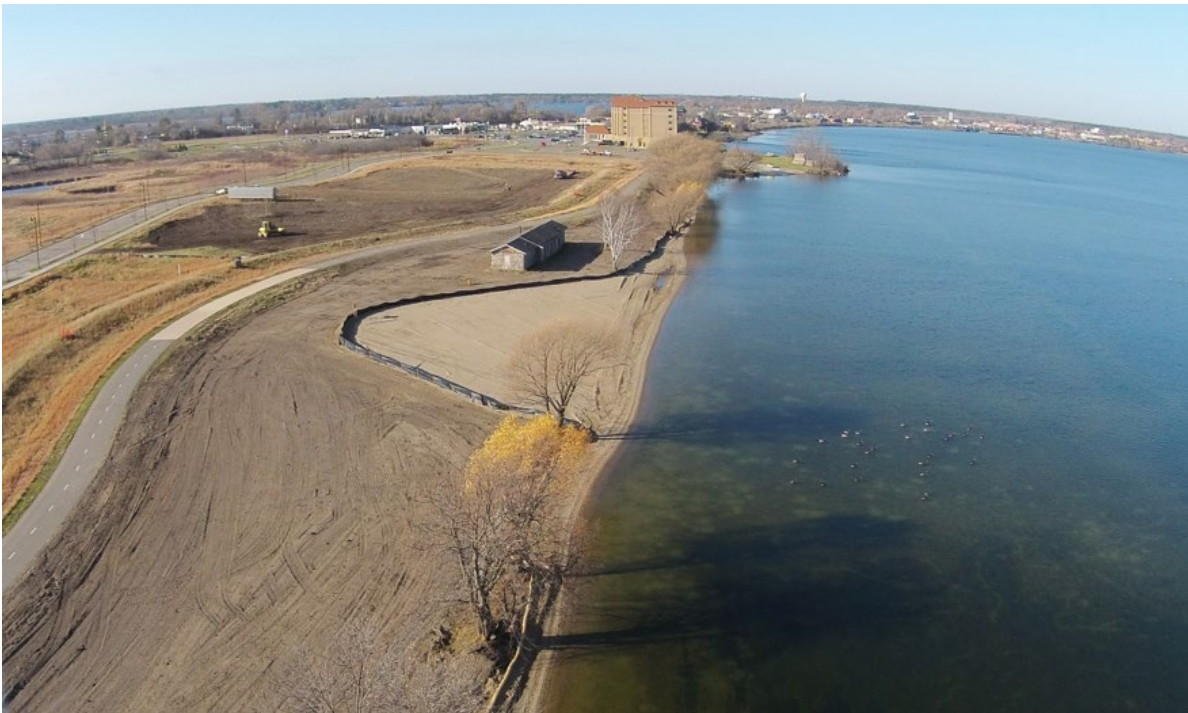
Photo 45. Aerial photo looking west along shore after grading was completed (Lake Bemidji South Shore Enhancement – photo from City of Bemidji).

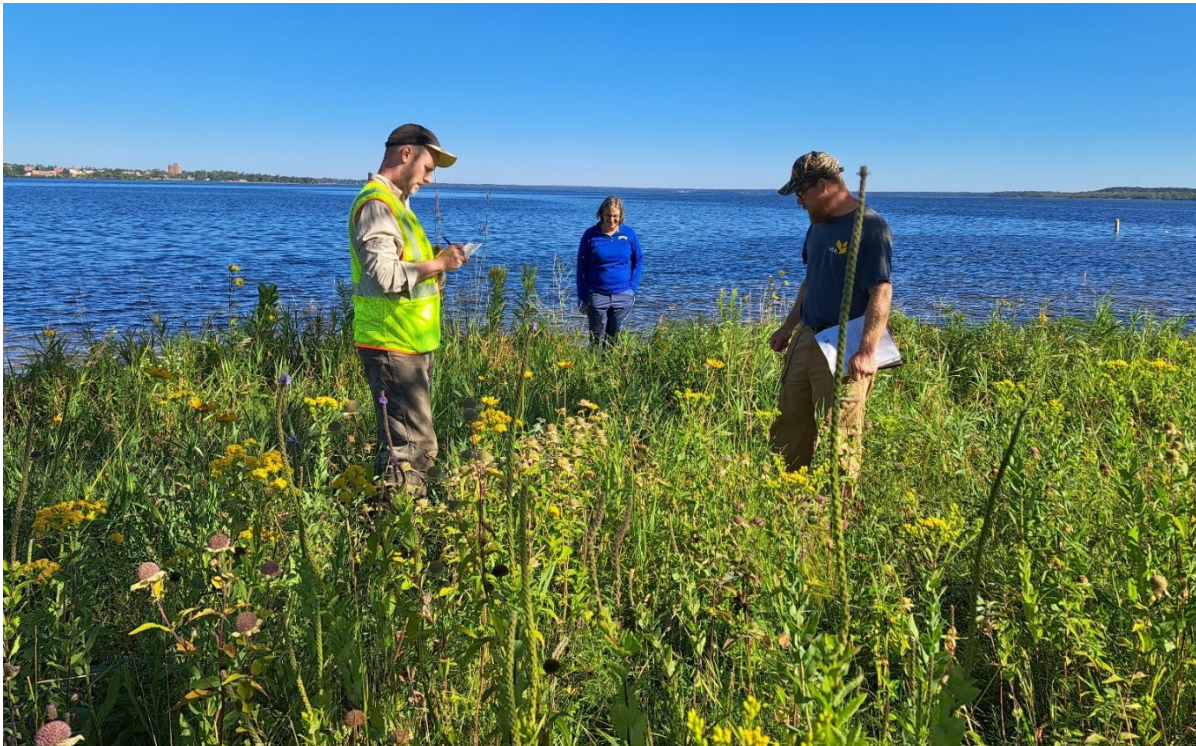
Photo 46. Site visit on 8/31/2022 (Lake Bemidji South Shore Enhancement).

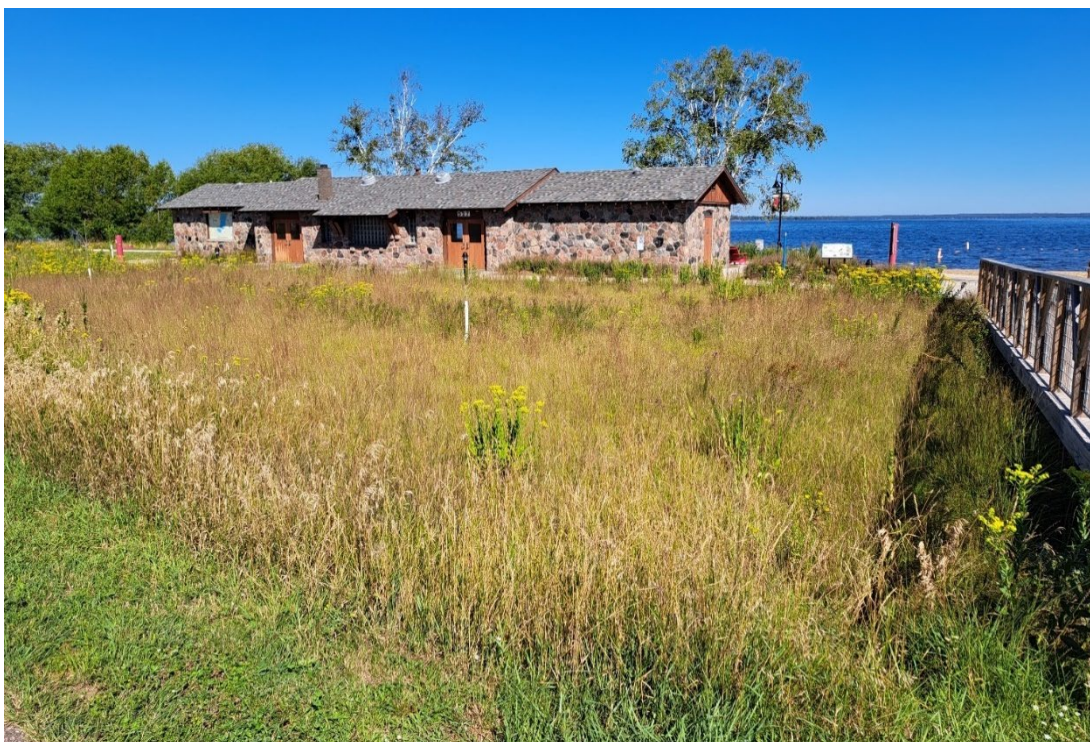
Photo 47. Site visit on 8/31/2022 (Lake Bemidji South Shore Enhancement).

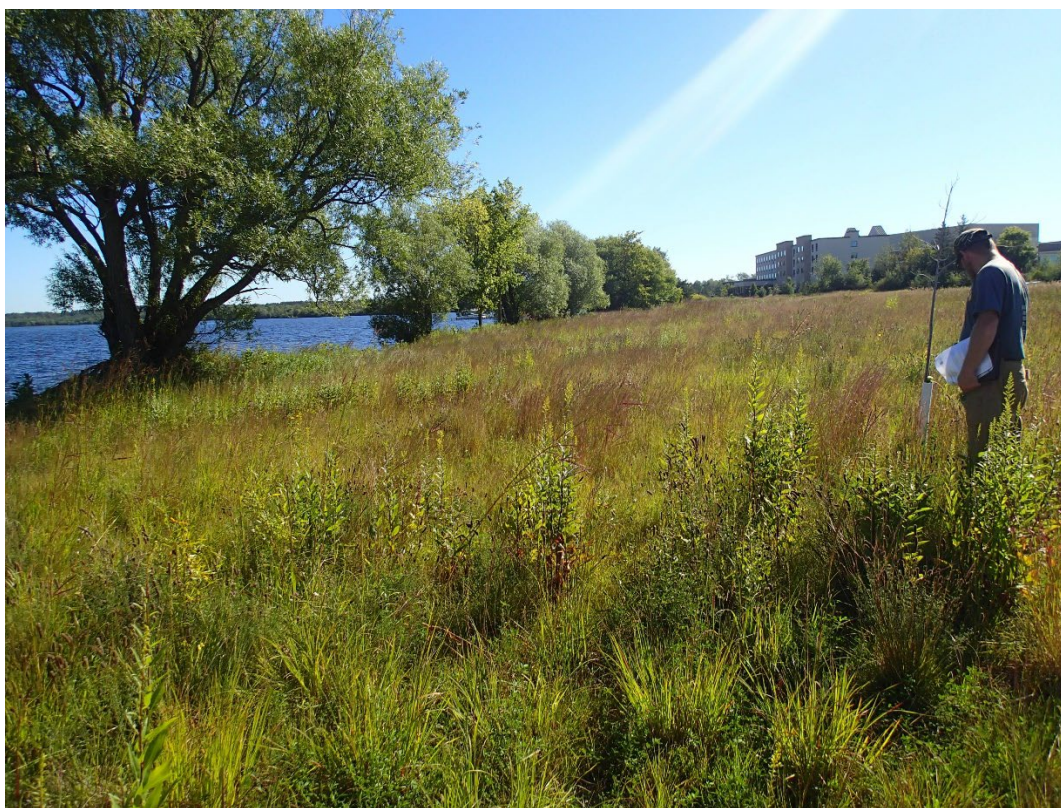
Photo 48. Site visit on 8/31/2022 showing upland prairie planting (Lake Bemidji South Shore Enhancement).

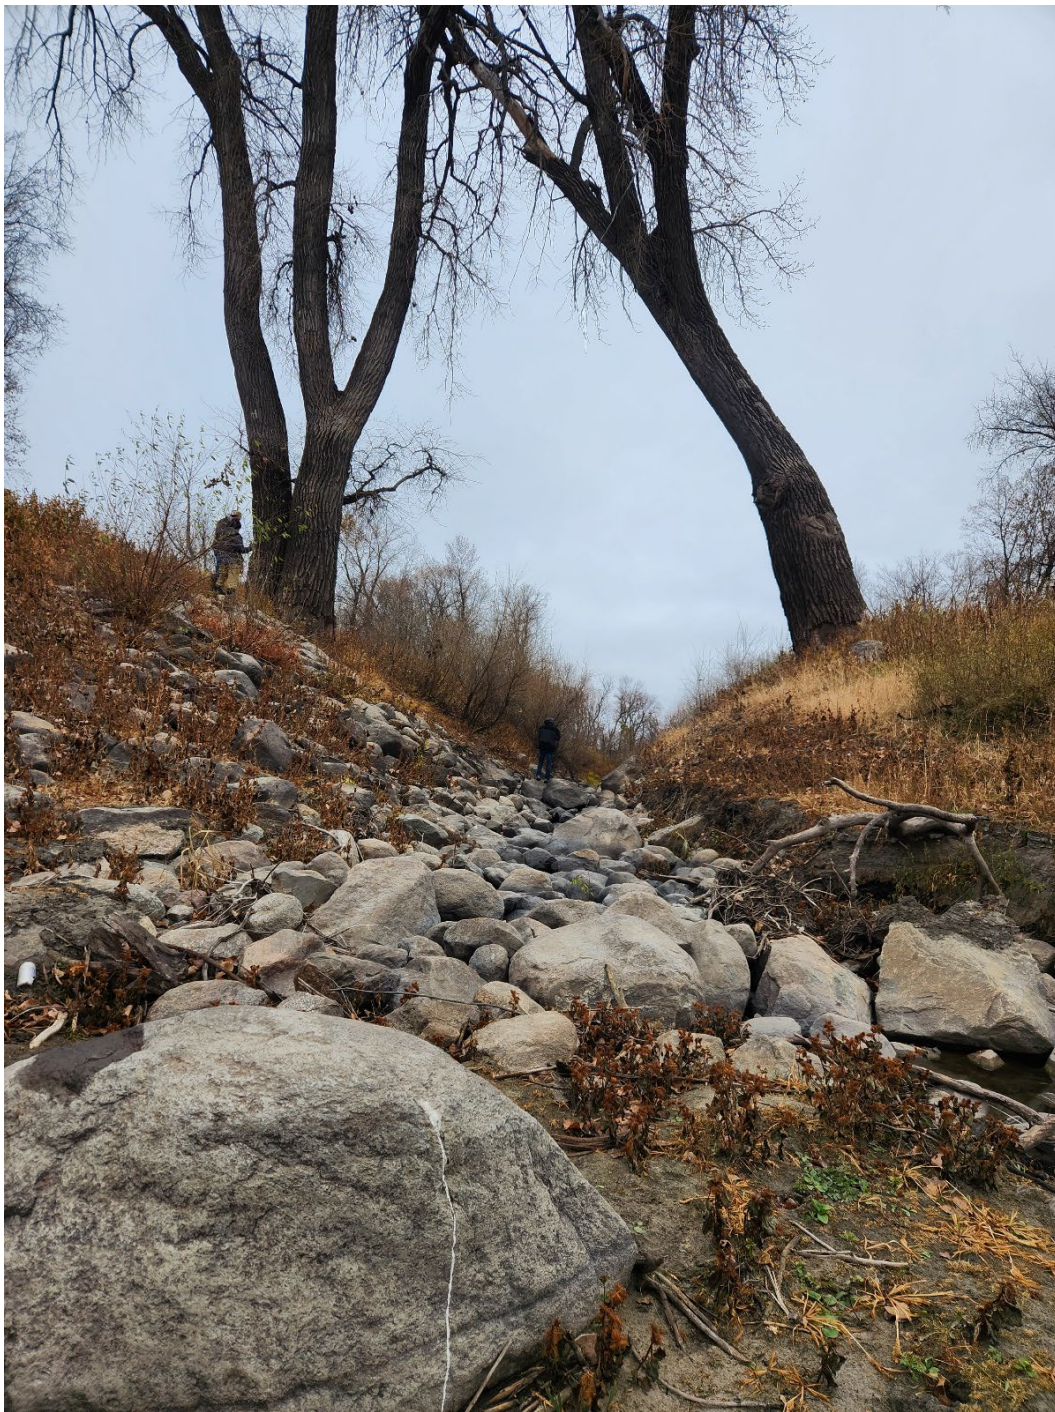
Photo 49. Riprap outflow area of Grand Marais Creek at the Red River. Photo taken on 10/25/2022.

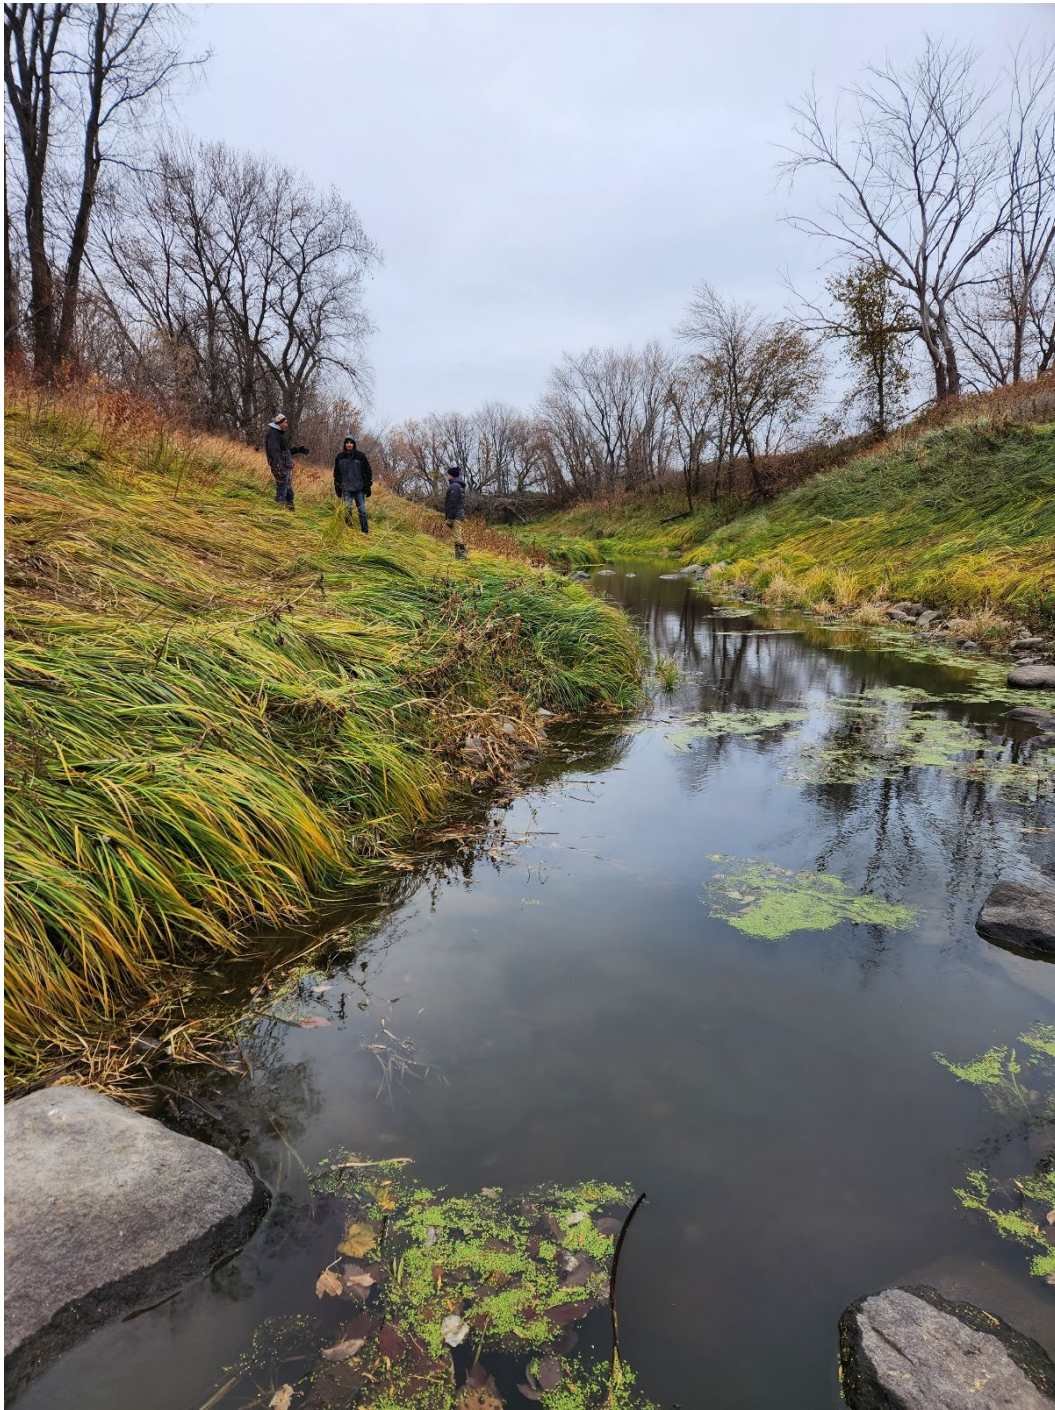
Photo 50. Densely vegetated riparian area and rock installations along toe approximately 500 feet upstream from the outlet to the Red River. Photo taken on 10/25/2022 and is looking east.

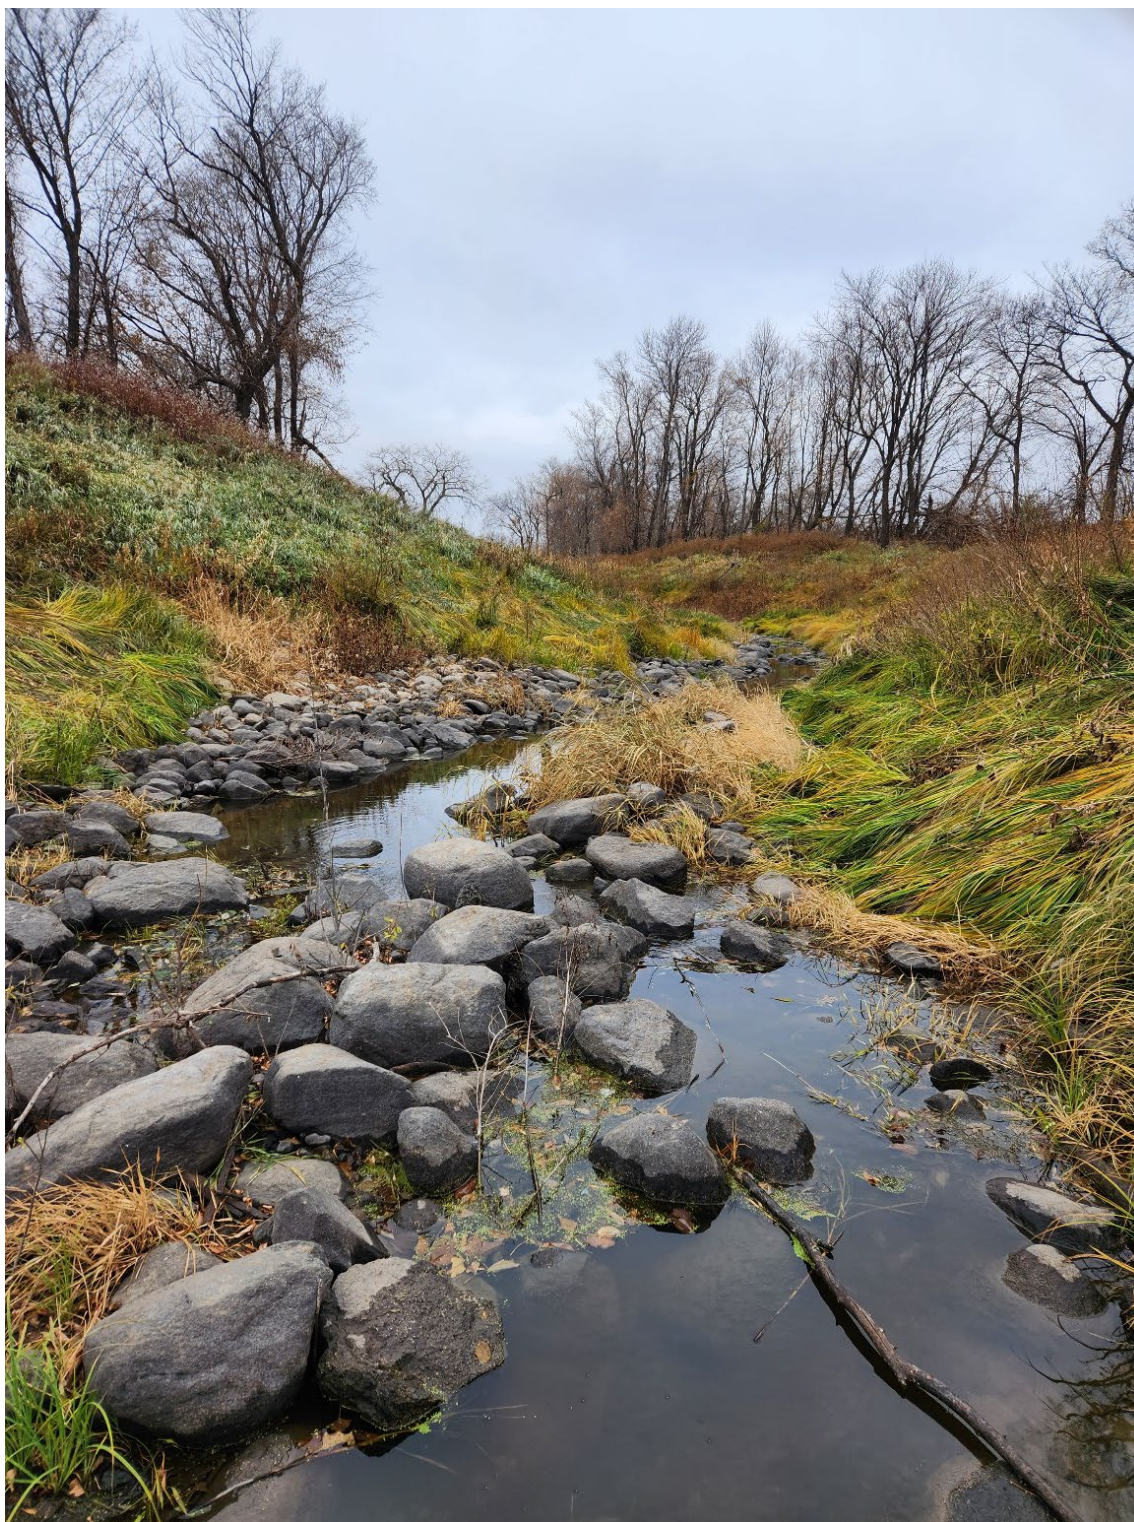
Photo 51. Rock bars along Grand Marais Creek approximately 500 feet upstream from the outlet to the Red River.

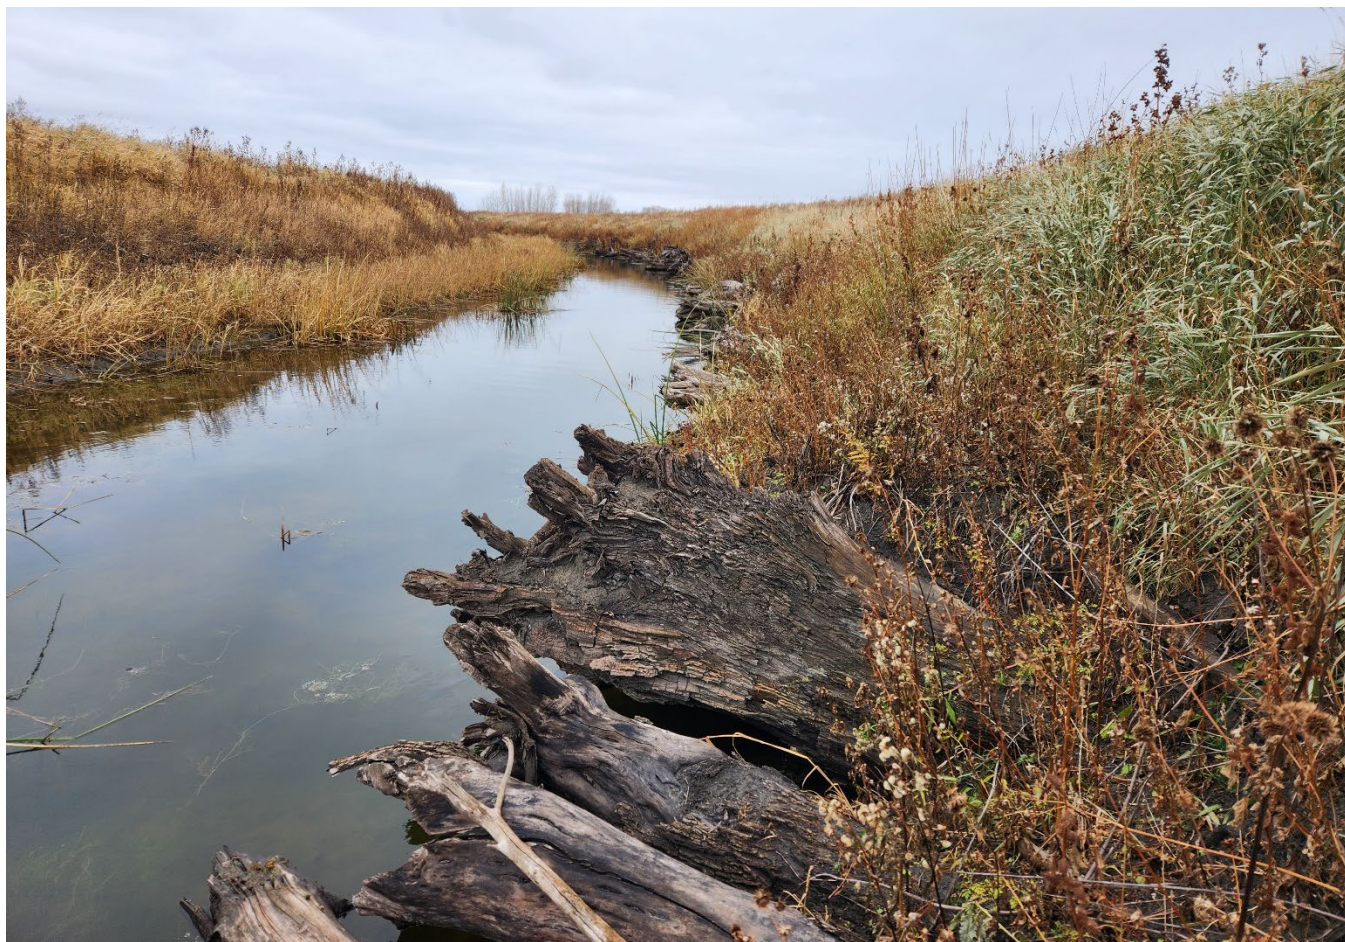
Photo 58. Toe wood installations along Grand Marais Creek. Photo taken on 10/25/2022.
