LEGACY FUND RESTORATION EVALUATION REPORT

Technical Panel Findings and Recommendations—2022

REPORT TO THE MINNESOTA LEGISLATURE

Date of Report: August 2023

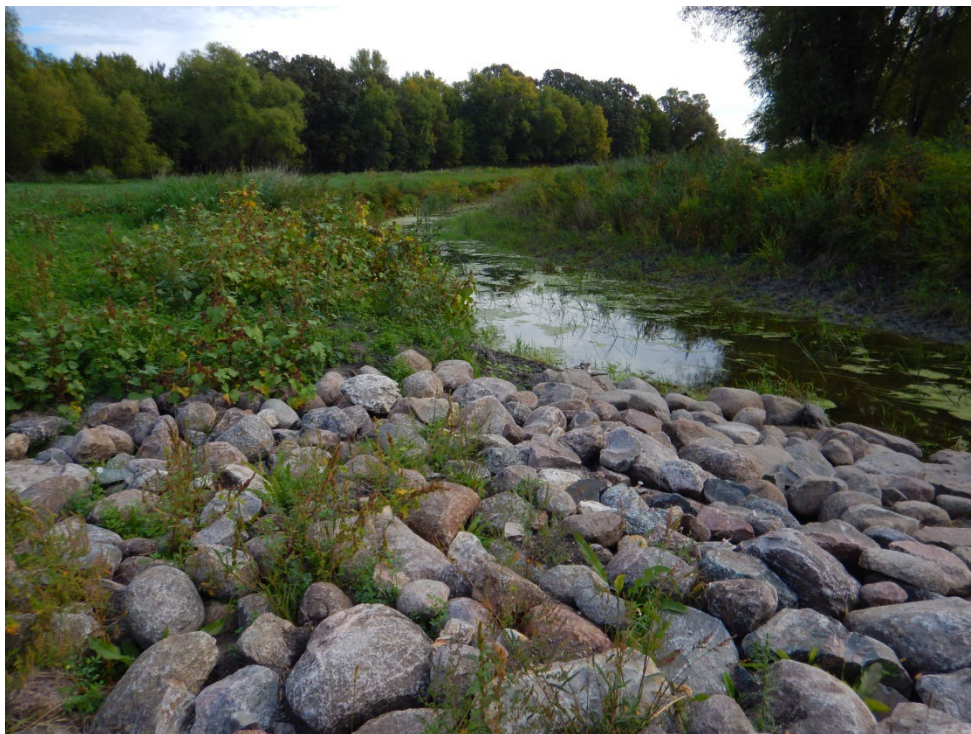
SR Photo 1: Grand Marais Creek at location of Diversion Structure.

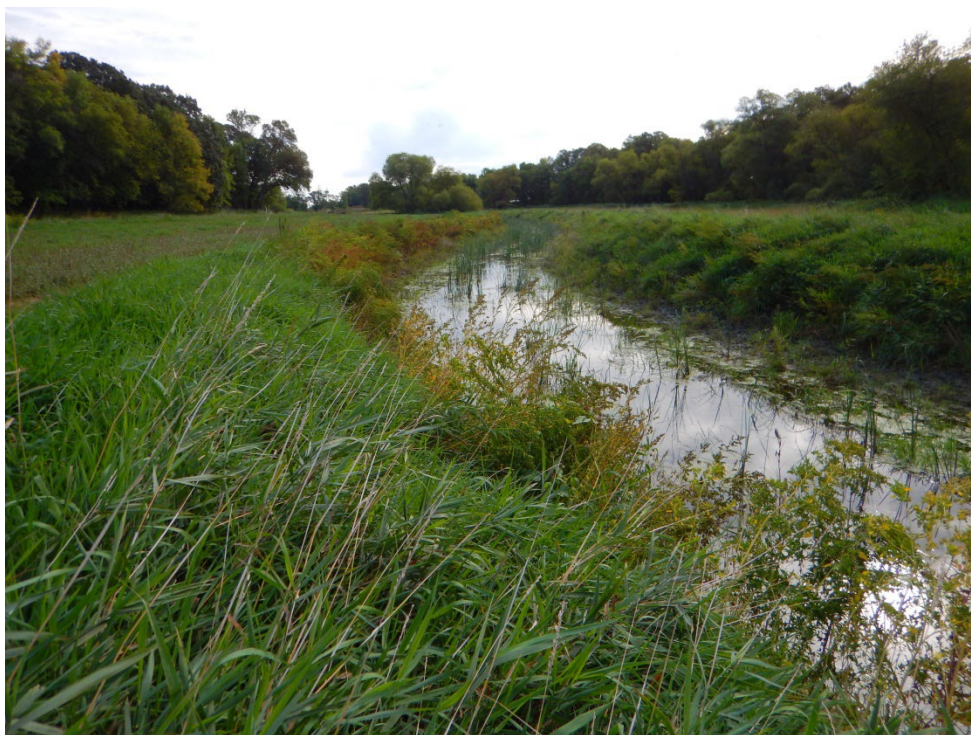
SR Photo 2: Vegetated slopes in upper project area immediately downstream of Diversion Structure.

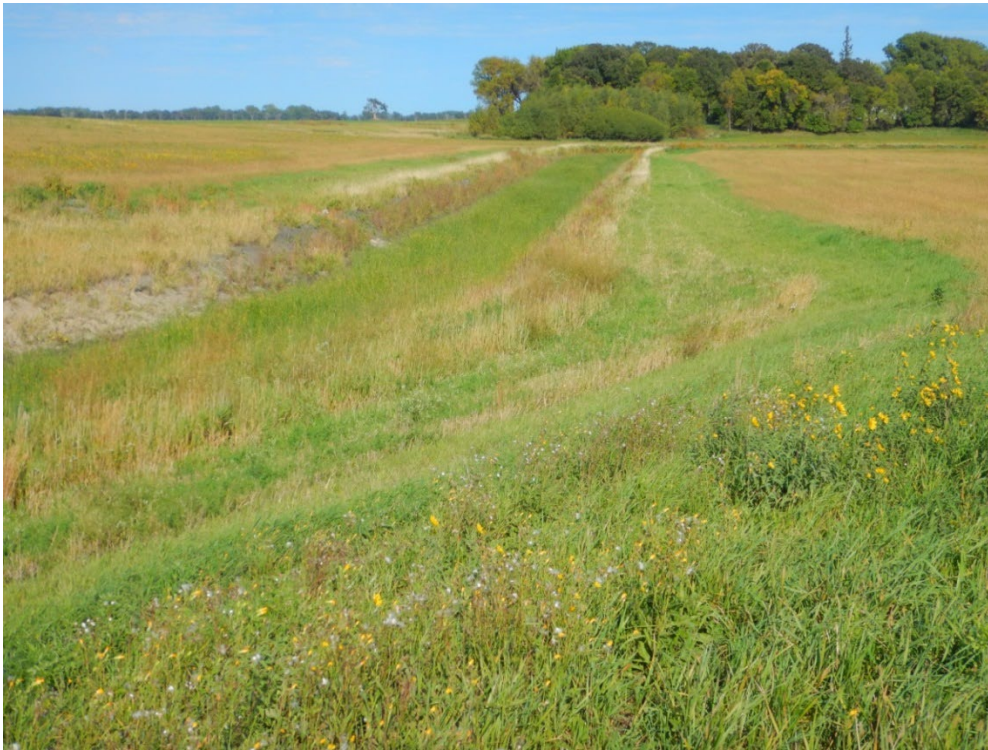
SR Photo 6: Constructed Channel. Upper areas seeded to "Special Seed Mix". Lower slopes not seeded, channel dominated by Hybrid Cattail.

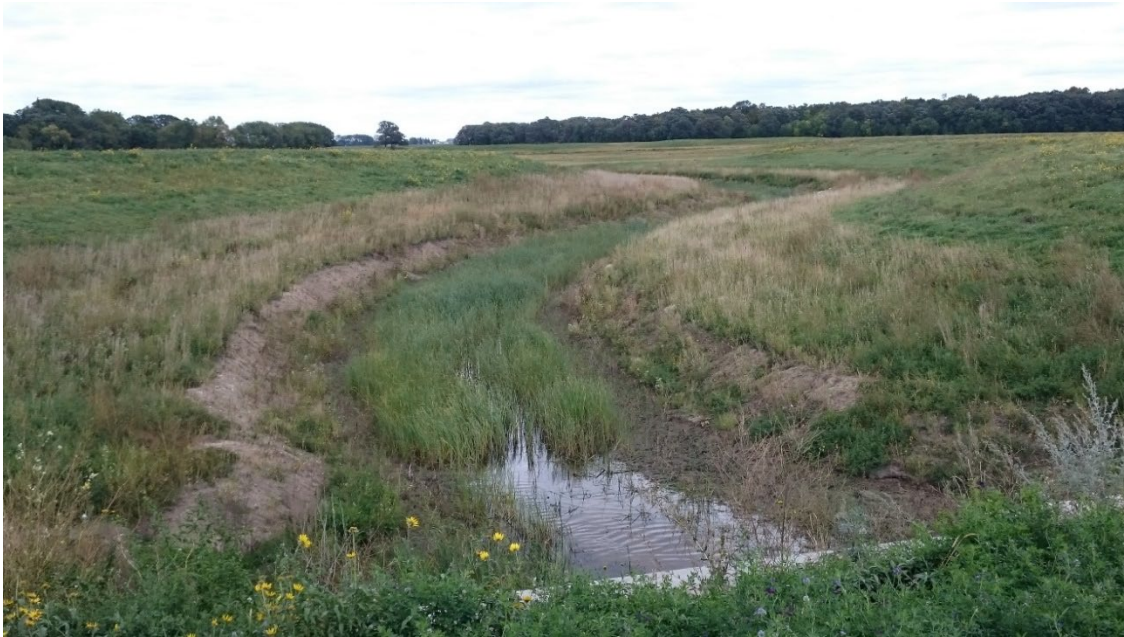
SR Photo 8: Constructed Channel looking east from 470th Avenue NW. Seeded upland, unseeded channel.

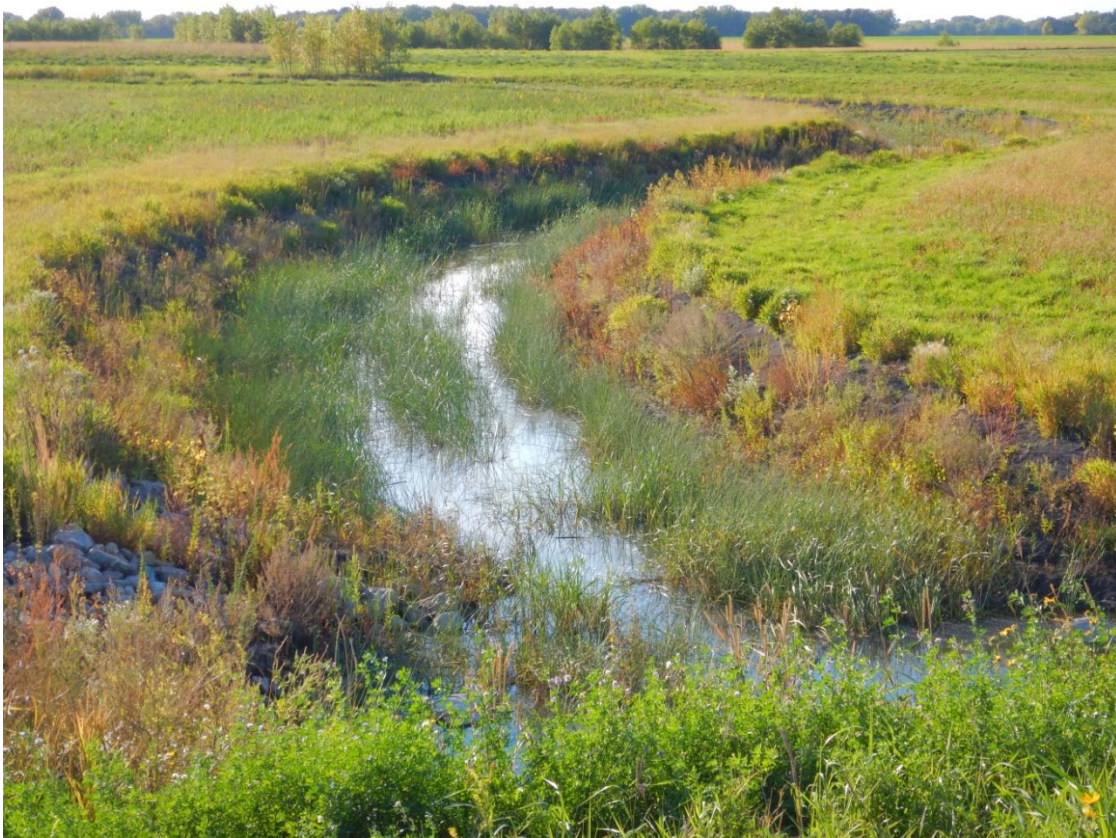
SR Photo 9: Constructed channel looking west from 470th Avenue NW. Channel dominated by Softstem Bulrush.

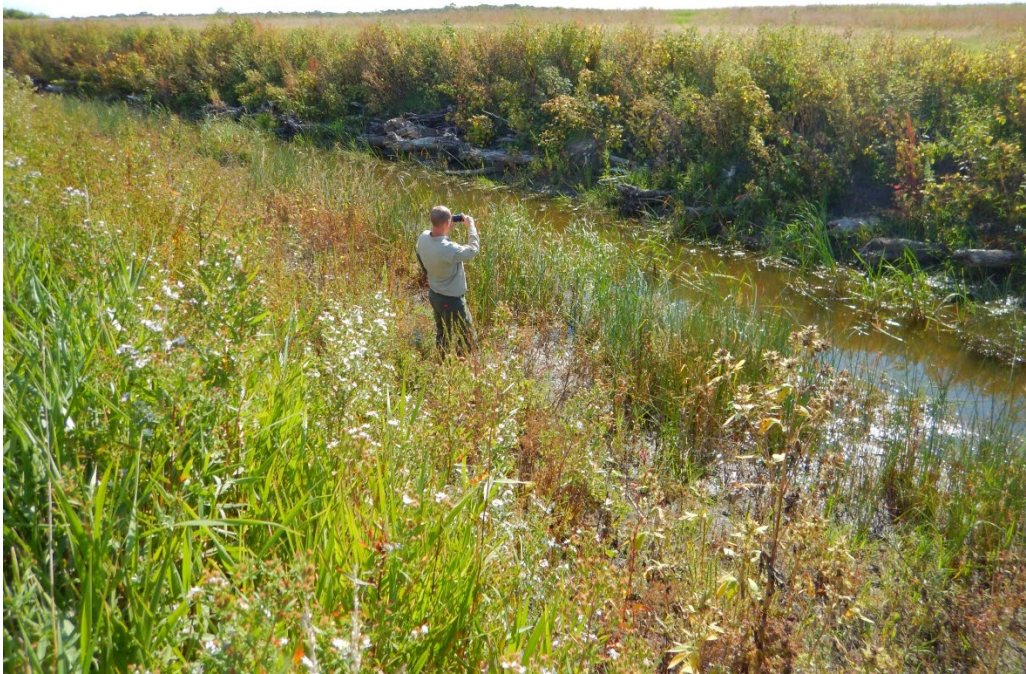
SR Photo 10: Constructed Channel. Toe wood treatment on opposite bank.

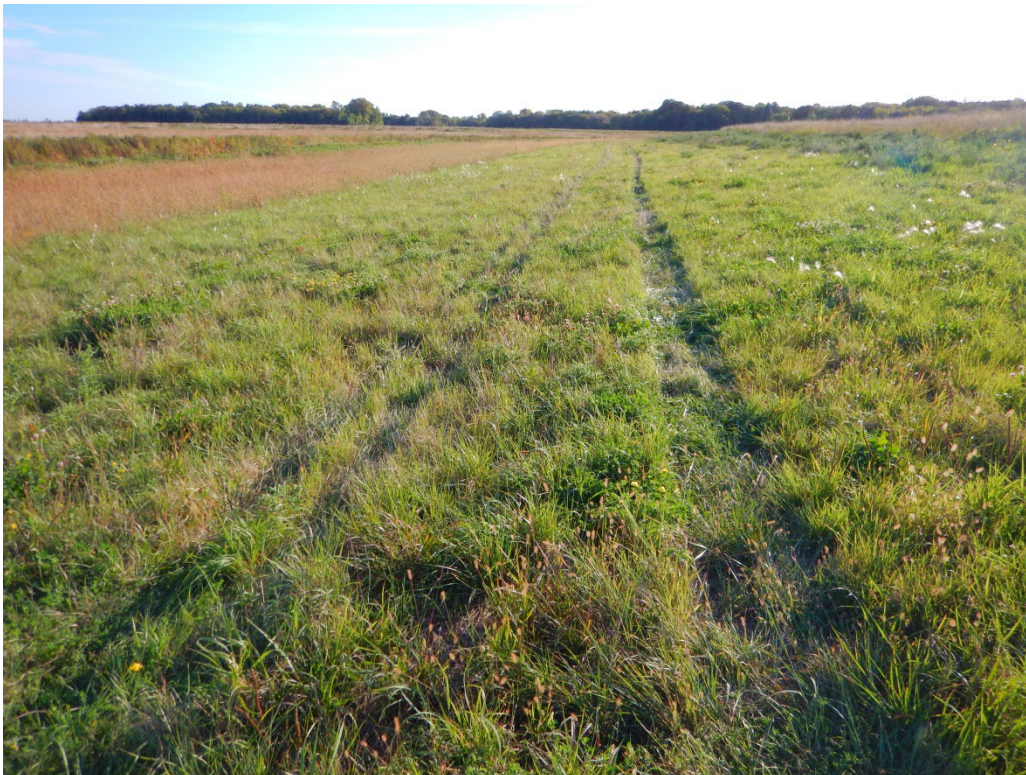
SR Photo 11: Seeding areas above the channel restoration. Note three zones of seeding. Appears to have been seeded at different times with very different species composition.

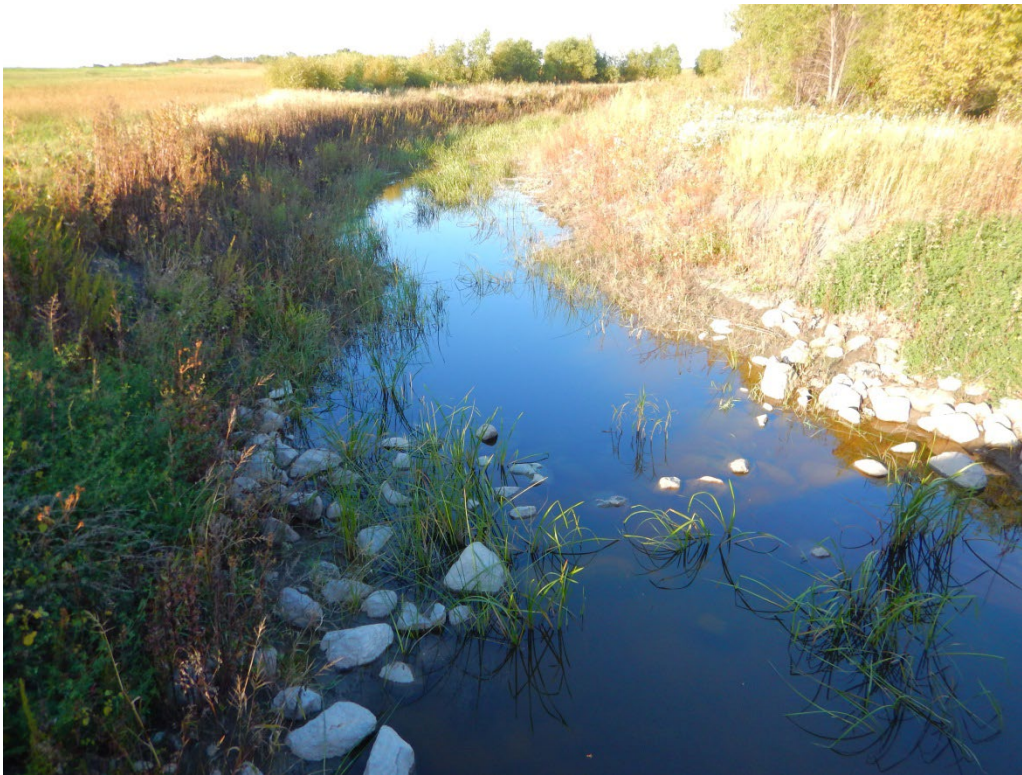
SR Photo 12: Ellipse Channel Riffle at 171+25. Vegetation is volunteer.

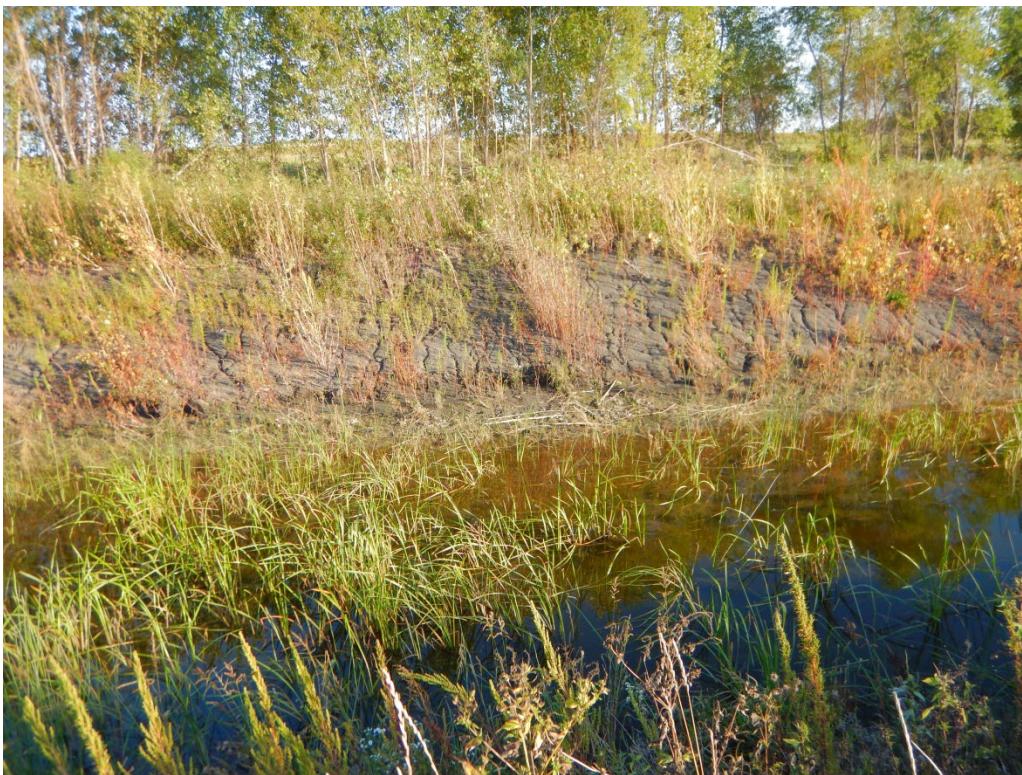
SR Photo 13: Unseeded slope at excavated channel.

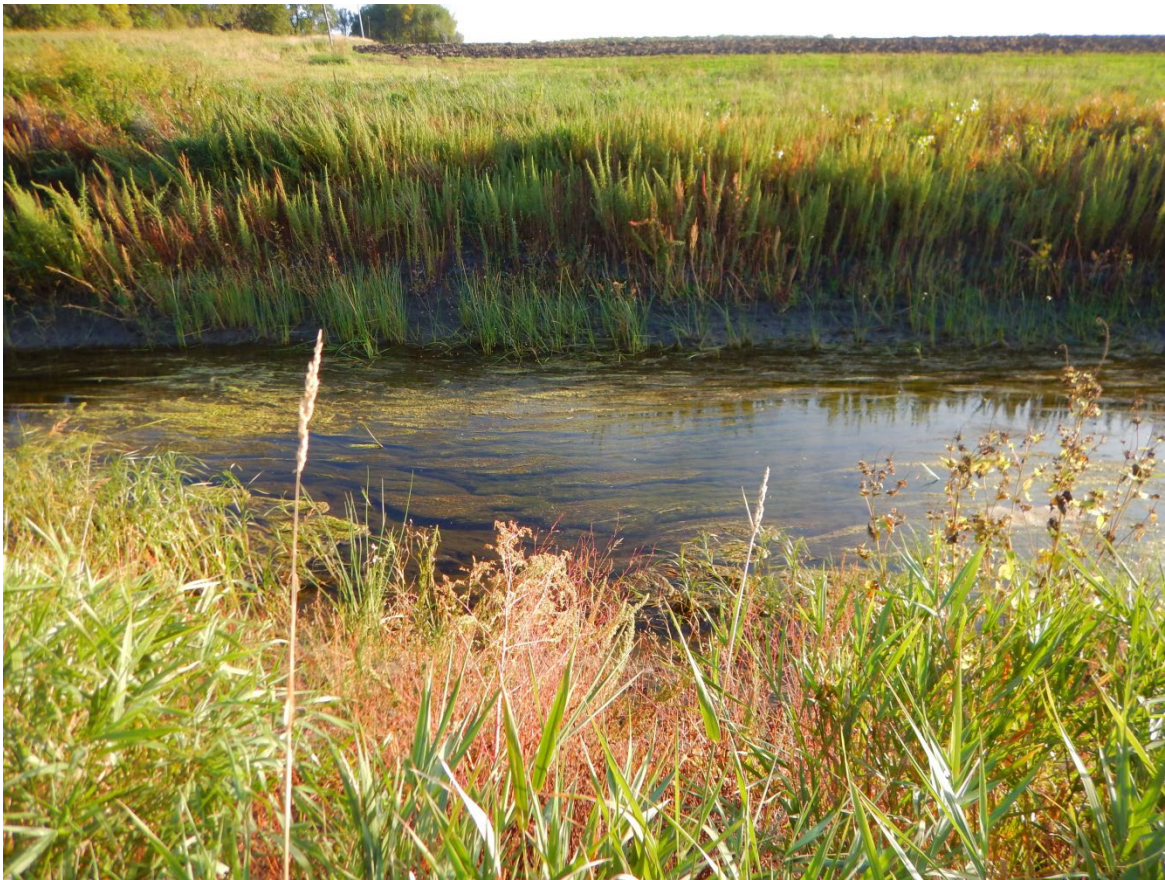
SR Photo 14: Unseeded slopes revegetating with predominantly annual weedy species.

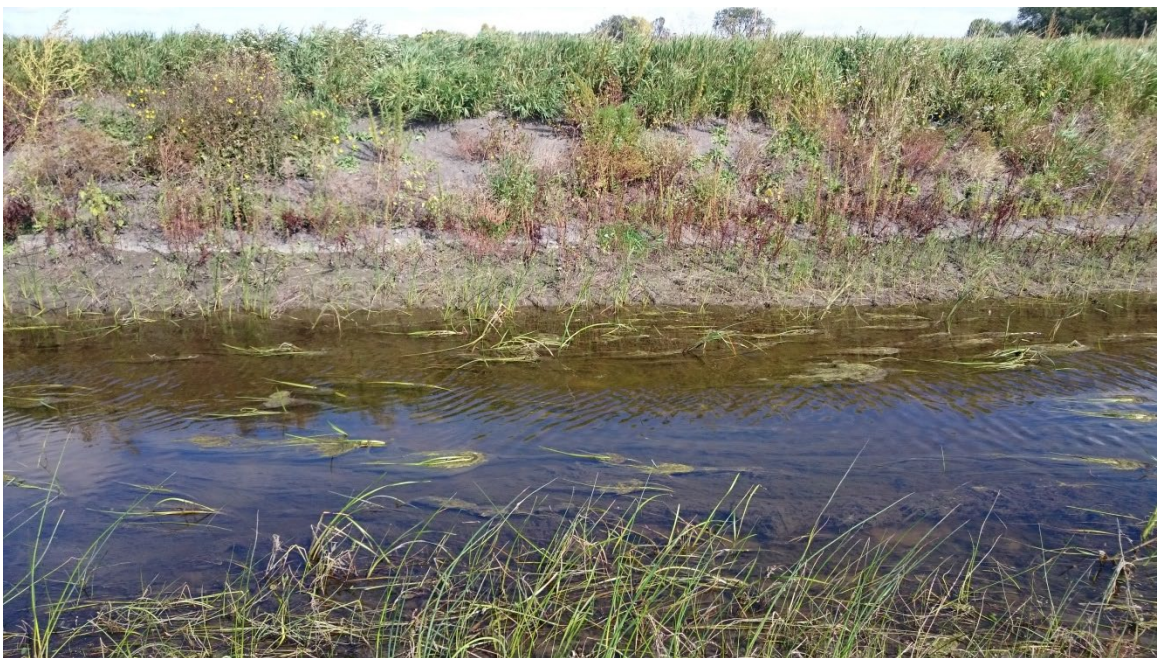
SR Photo 15: Bare slopes where unseeded.

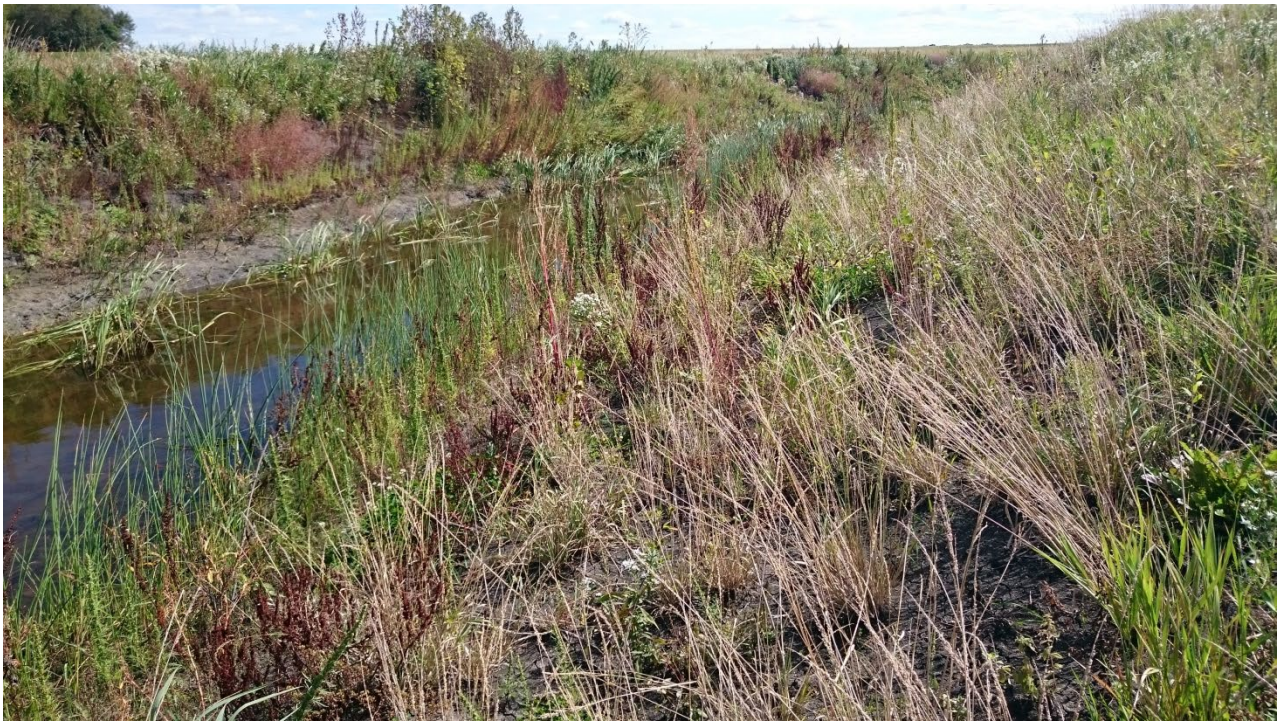
SR Photo 16: American Sloughgrass *Beckmannia syzigachne* dominates the lower unseeded slope in this location.

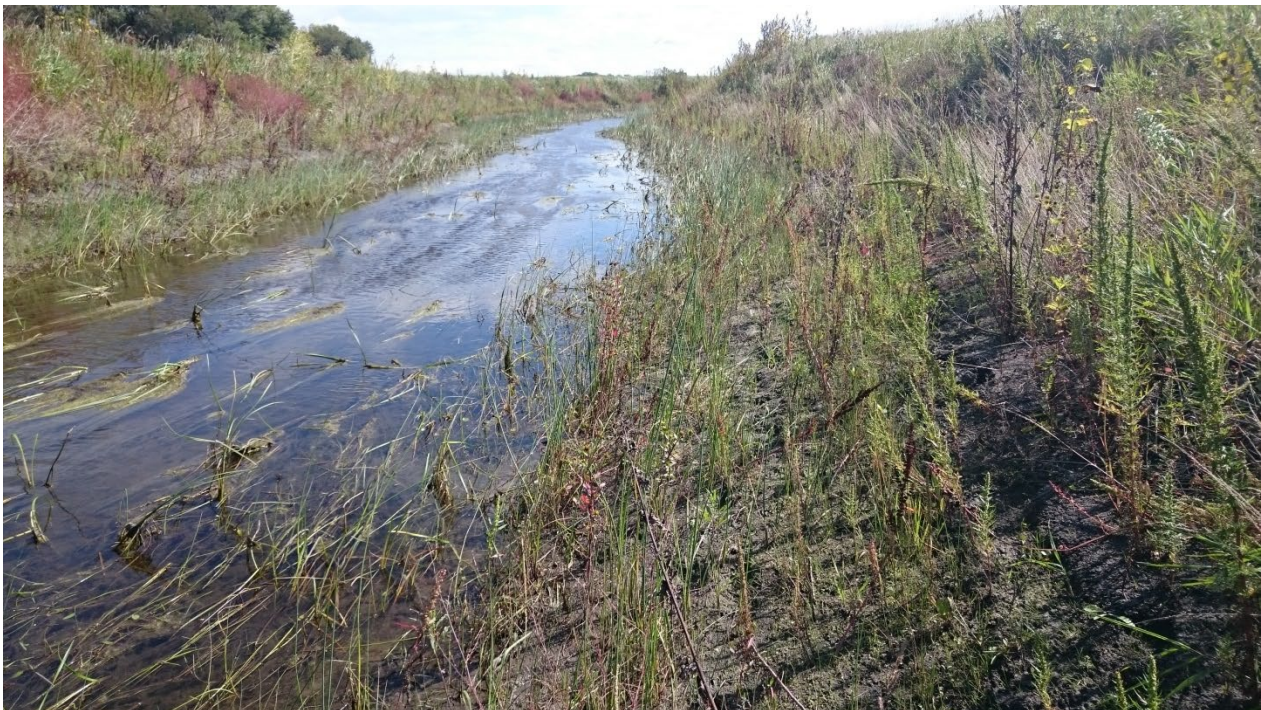
SR Photo 17: Softstem Bulrush in channel and saturated zone. Mostly annual weedy species inhabit the zone above.

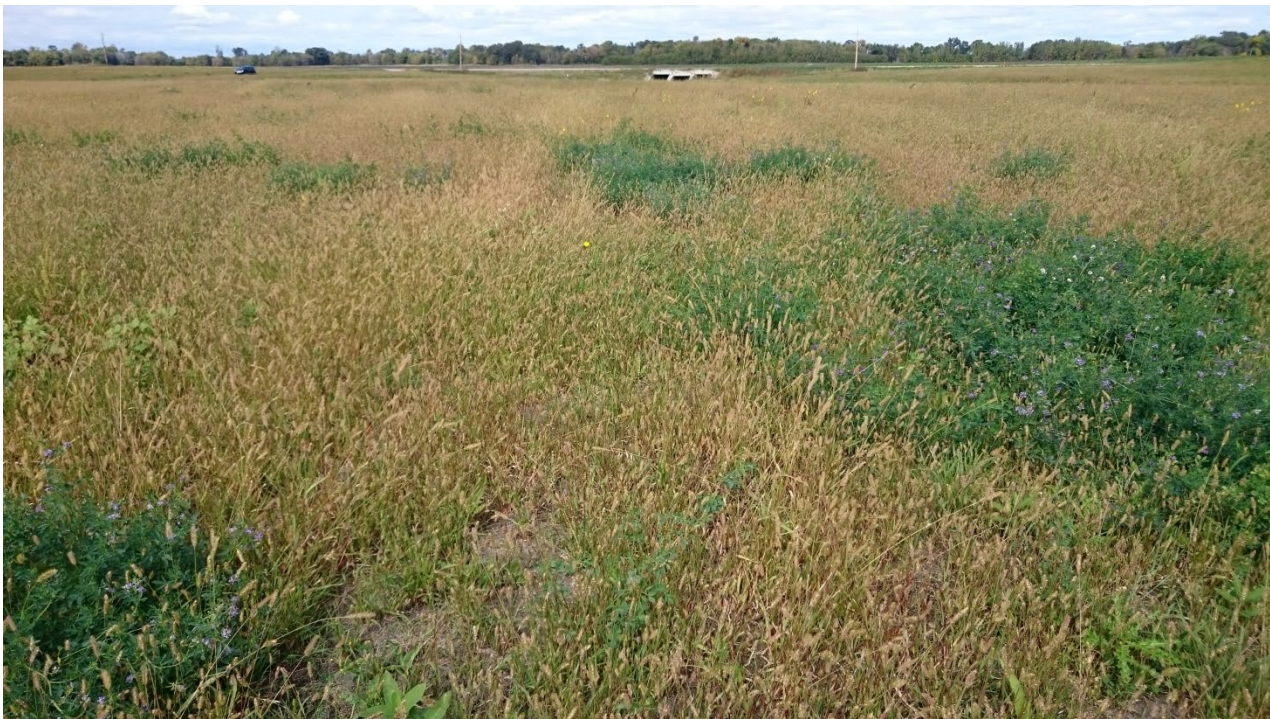
SR Photo 19: Upland area south of 130th St. NW. Appears to be seeded to CP-23A, similar to adjacent areas seeded to this mix, and not areas seeded to “Mixture Special Mix”. *Setaria glauca* dominates.

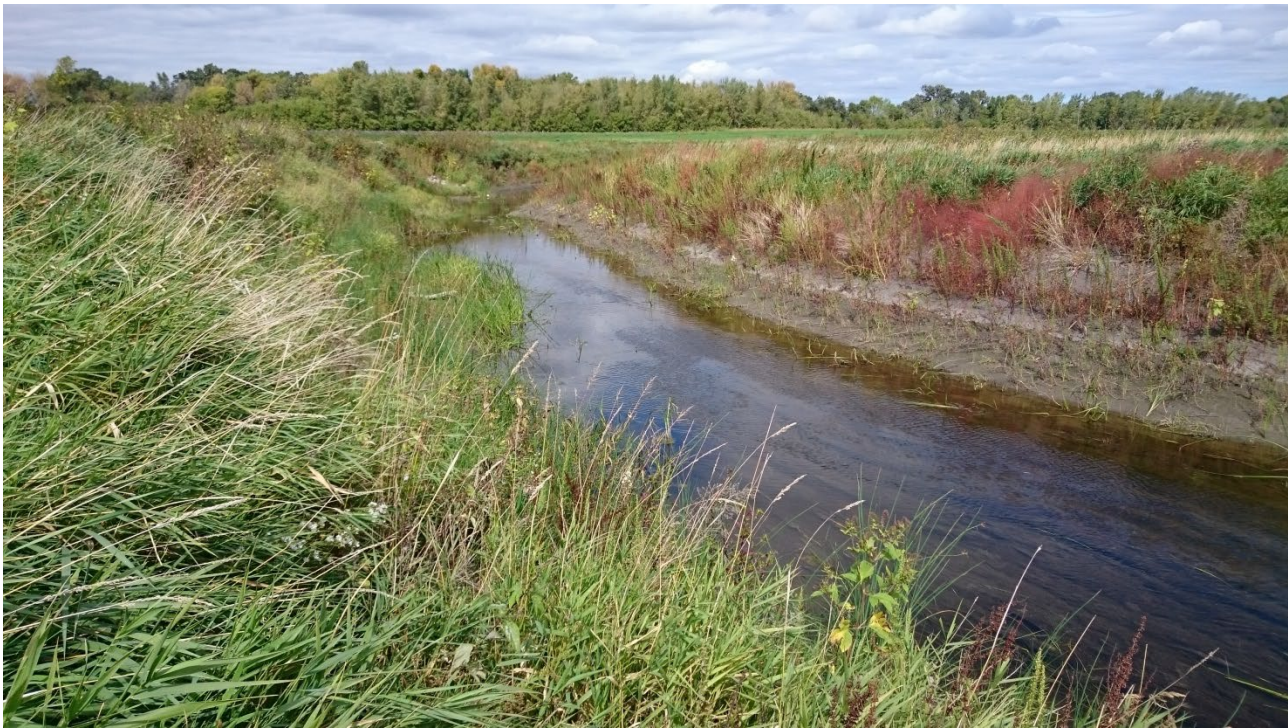
SR Photo 20: Restored Channel north of 130th Street NW. Above the channel, Seed Mix MnDOT 250 was used. Uplands largely dominated by Smooth Brome with Reed Canary grass common near/in channel.

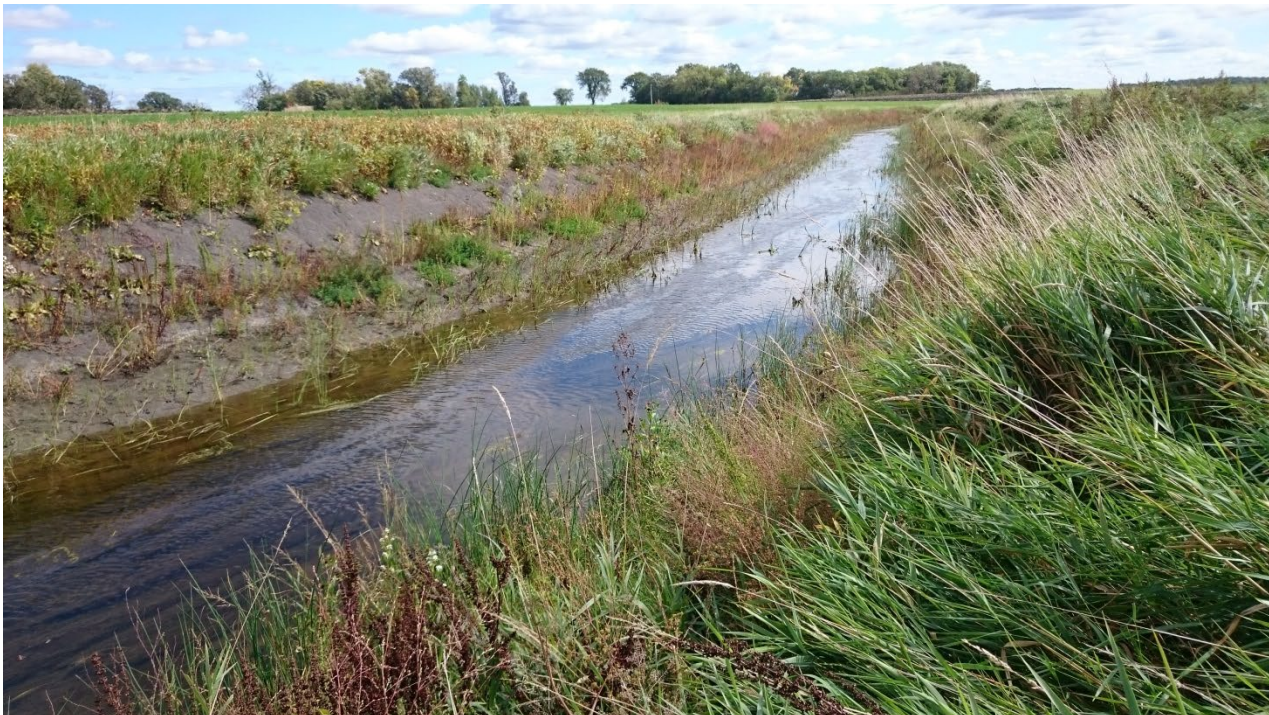
SR Photo 21: Dense Smooth Brome above channel with bare soils below.

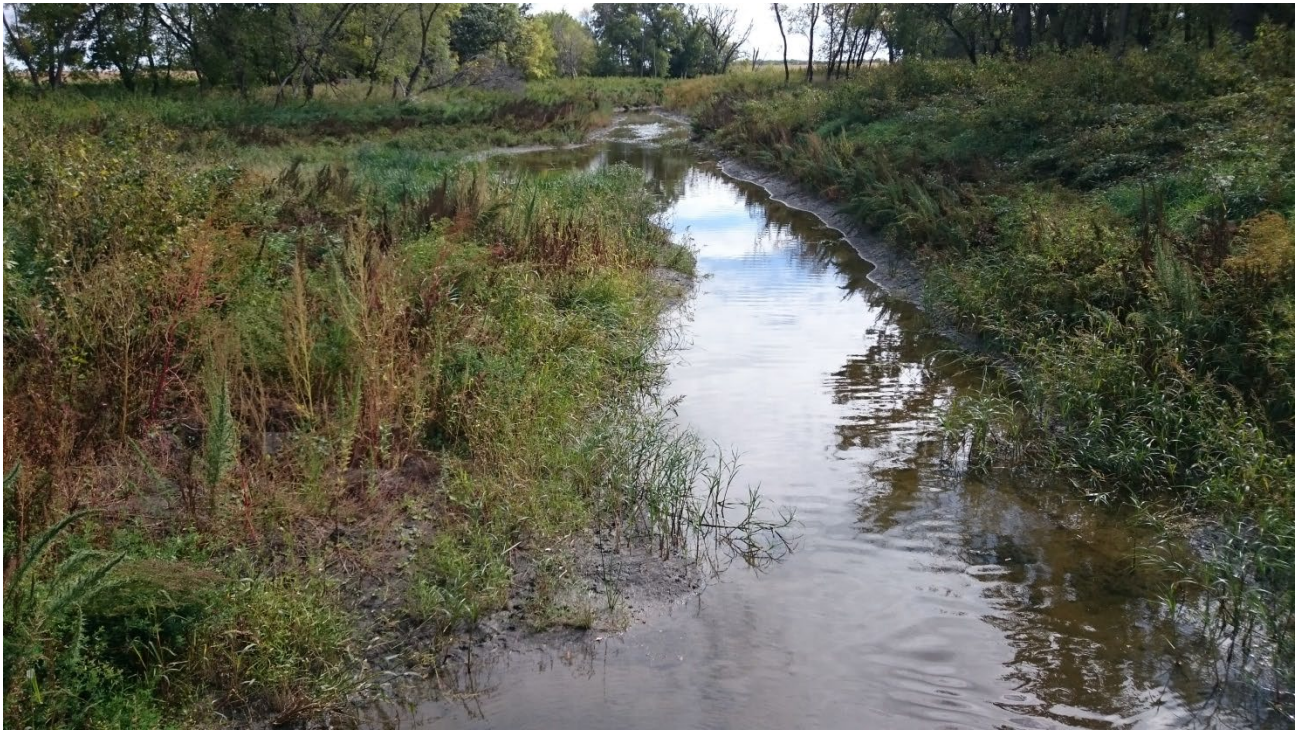
SR Photo 22: Excavated channel in cleared woodlands. Immediately above water, annual weedy species dominate. River bulrush is common in channel.

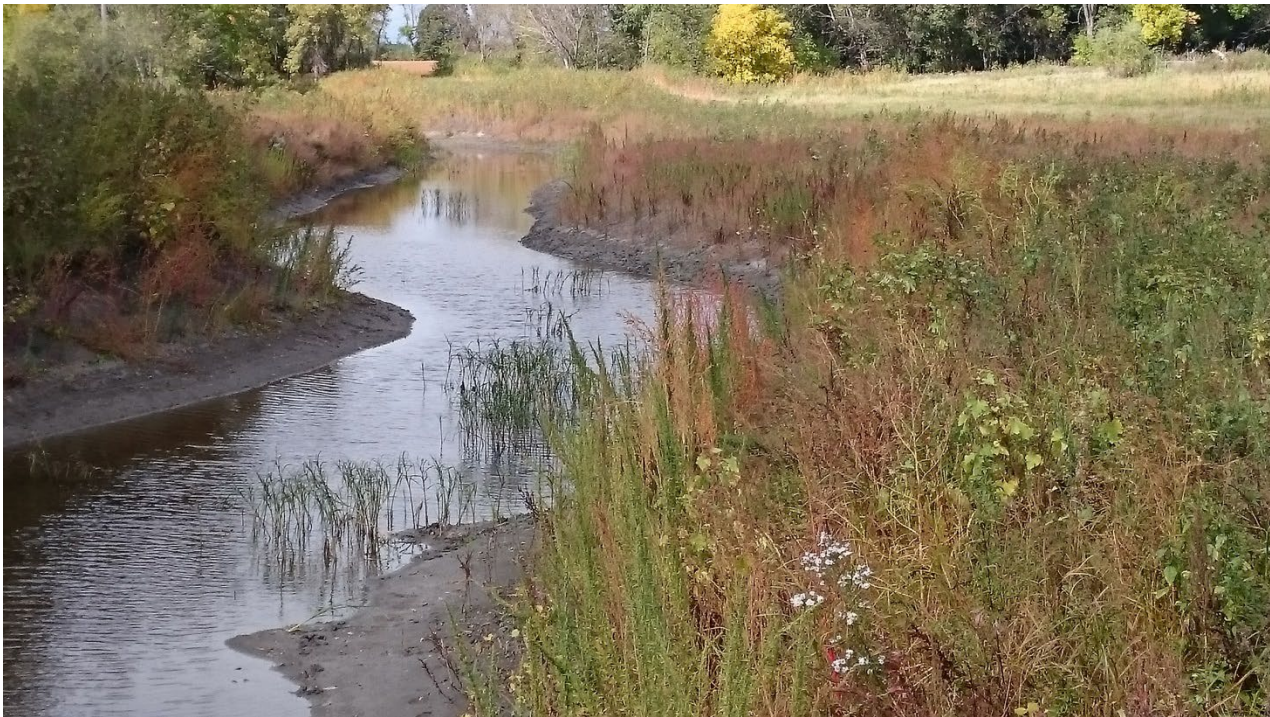
SR Photo 24: Vegetating slopes dominated by annual forbs.

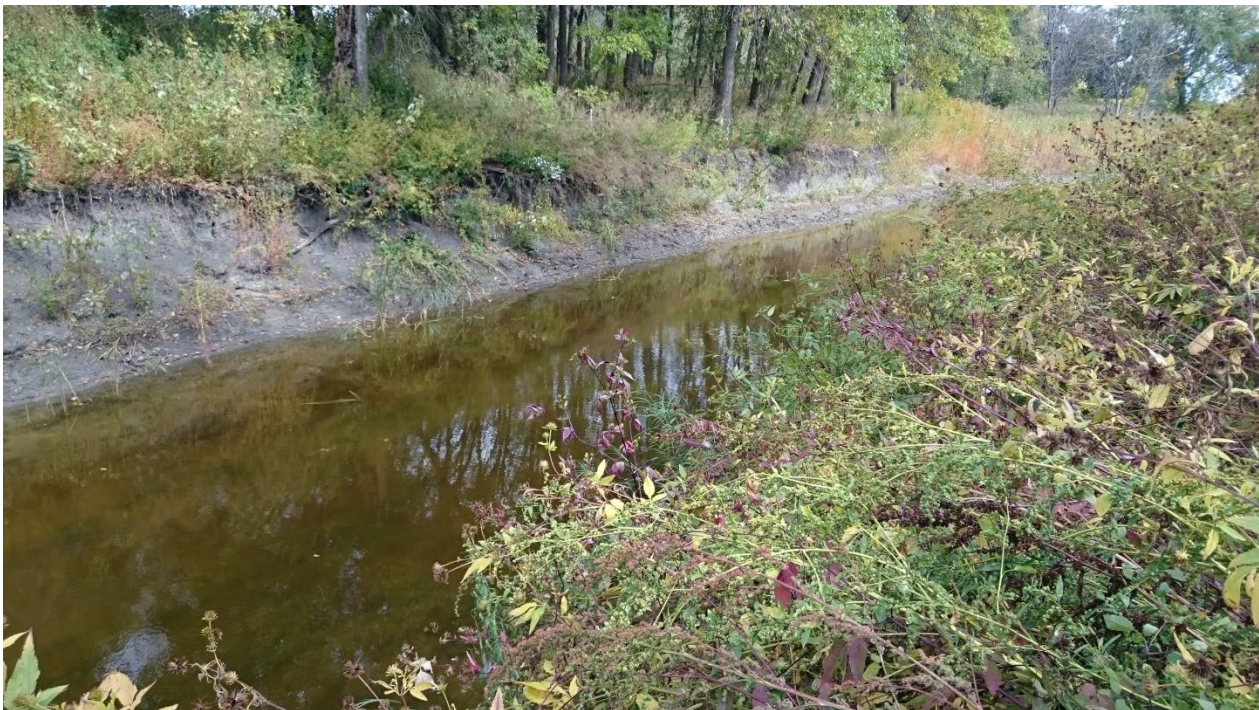
SR Photo 25: Exposed banks where channel was excavated in forested areas.

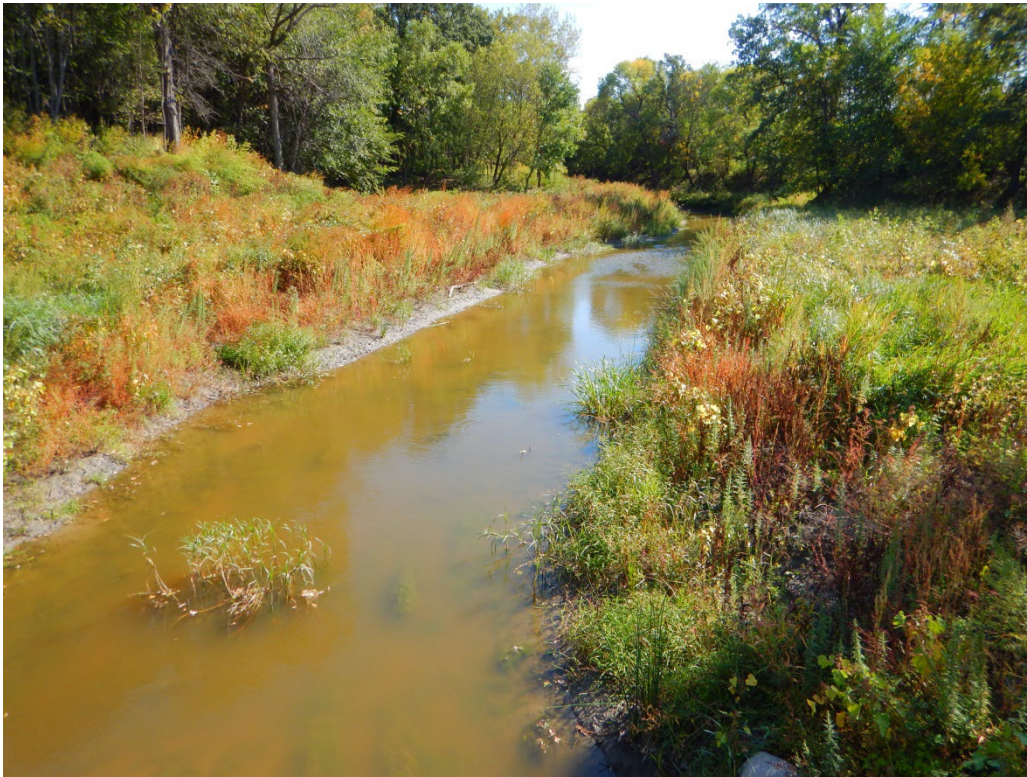
SR Photo 26: Graded channel in cleared woods. Annual pioneer species dominate.

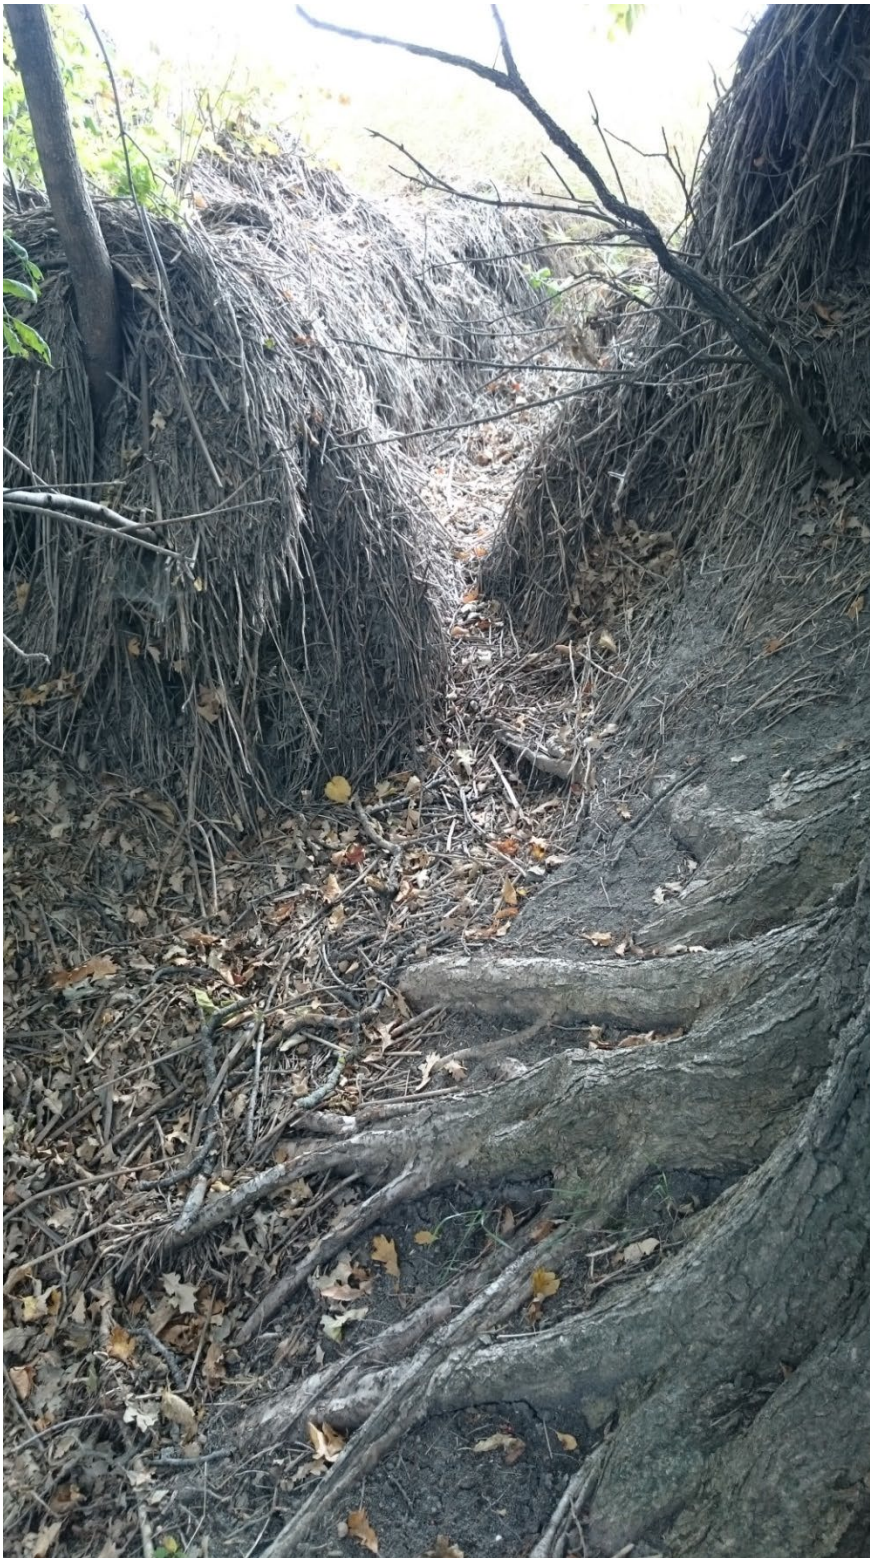
SR Photo 28: Gully above construction area in wooded area. Likely predates project as it is above existing exposed roots.

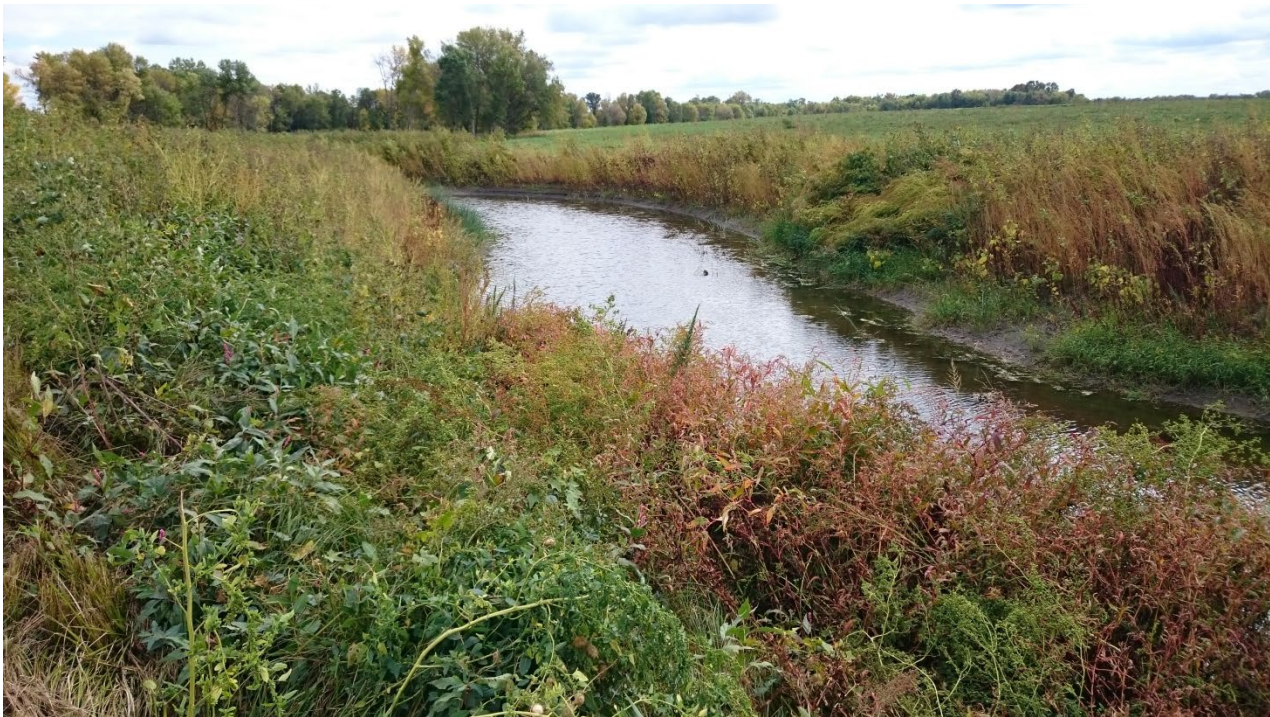
SR Photo 31: Heavily vegetated banks in the openings below cleared woods. Annuals dominate.

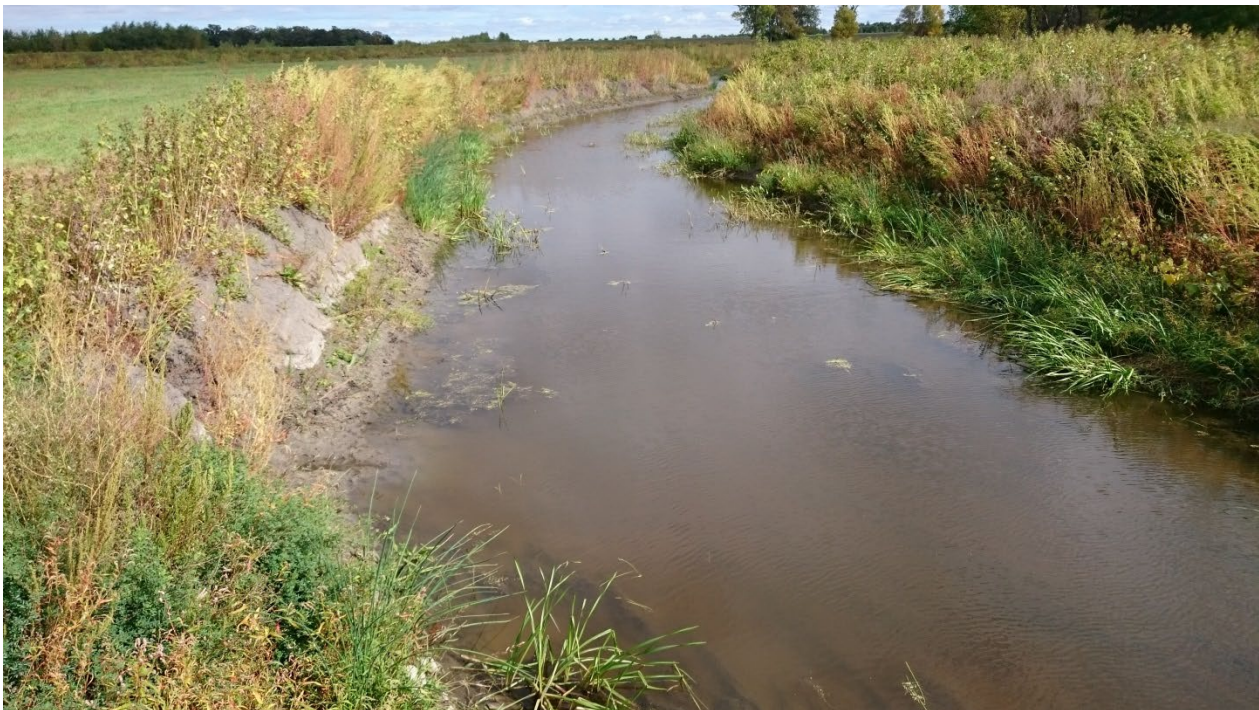
SR Photo 32: Exposed banks along slopes downstream of cleared woods.

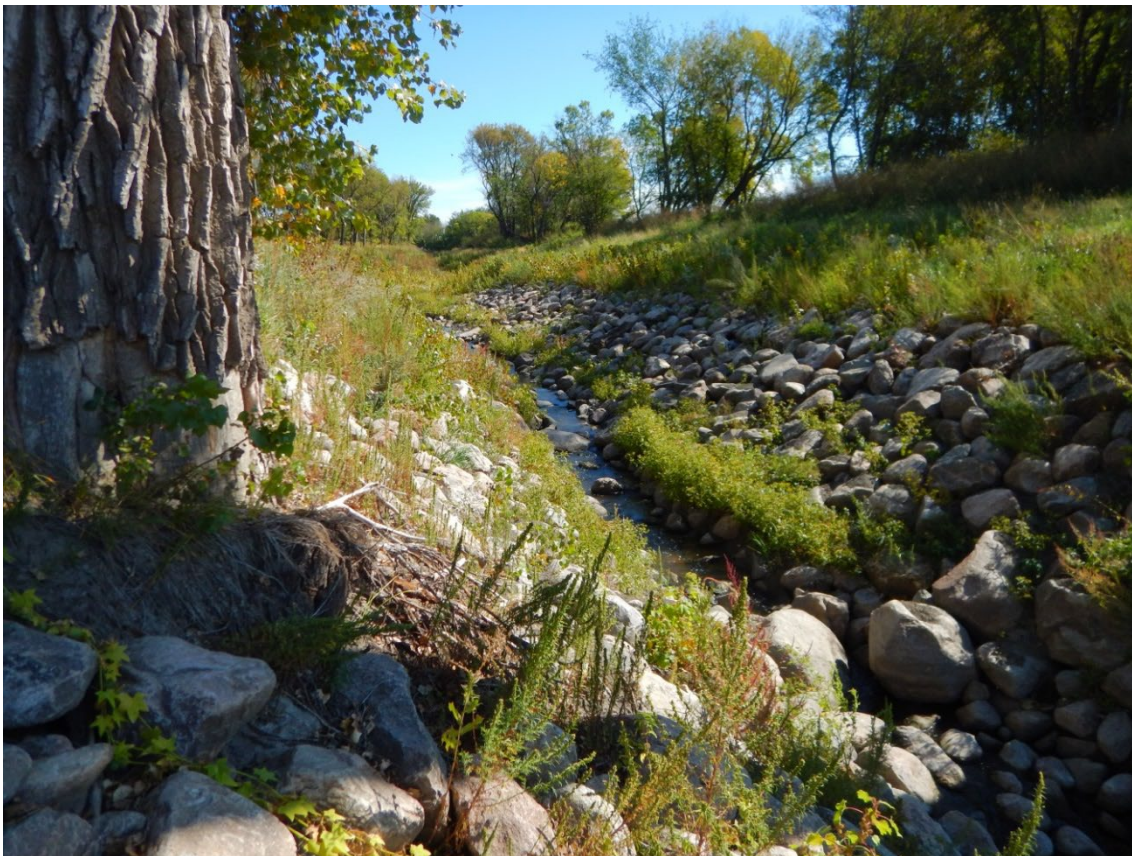
SR Photo 36: V Channel immediately upstream of confluence with the Red River. Note scour at base of cottonwood tree at top of slope.

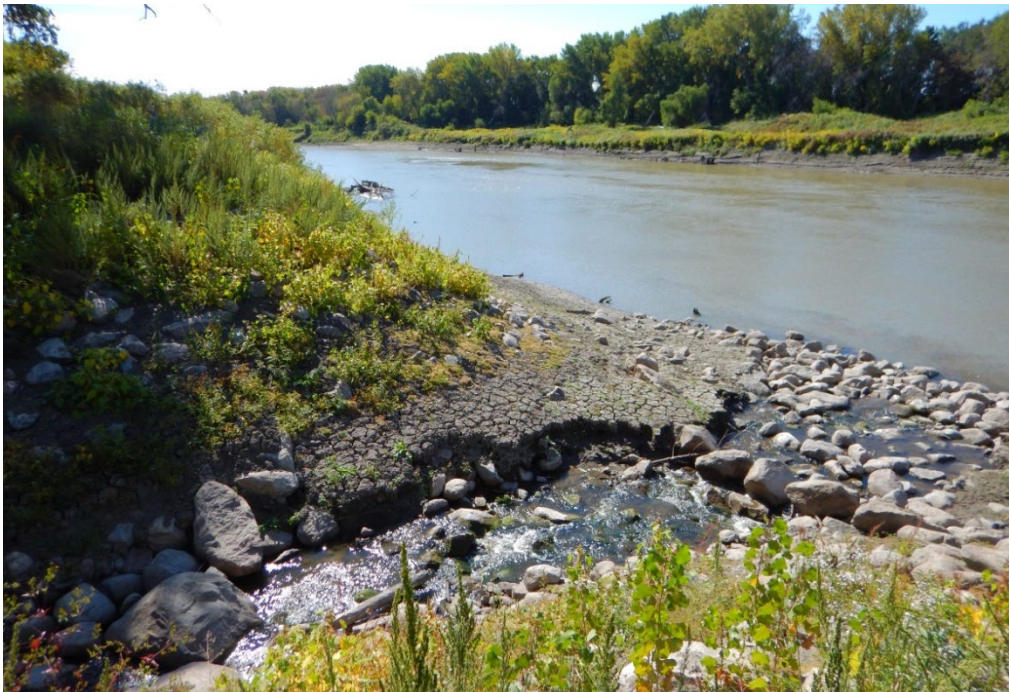
SR Photo 38: Outlet to Red River. Sediment above constructed rock outlet assumed to be material deposited by Red River Floods in spring and scoured by Grand Marais Creek after coming on-line. Note change in water clarity between Grand Marais Creek and Red River at confluence.

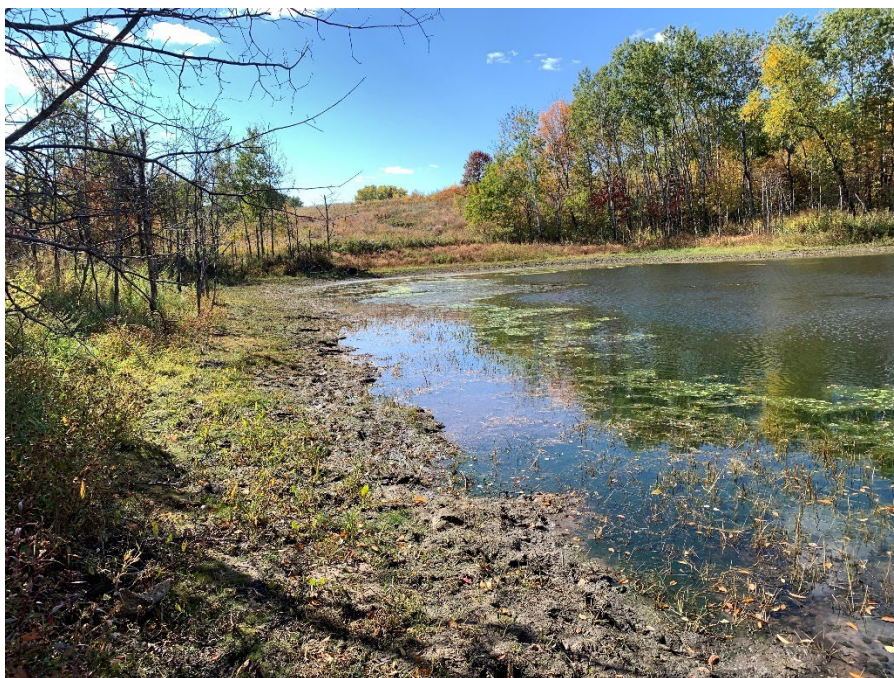
Photo 62 – Photo of east side of Buck Pond wetland edge where deposited sediment was removed. Mud flat area includes abundant cover by spike rushes, while the emergent zone has a large amount of rigid arrowhead.
