LEGACY FUND RESTORATION EVALUATION REPORT

Technical Panel Findings and Recommendations—2022

REPORT TO THE MINNESOTA LEGISLATURE

Date of Report: August 2023

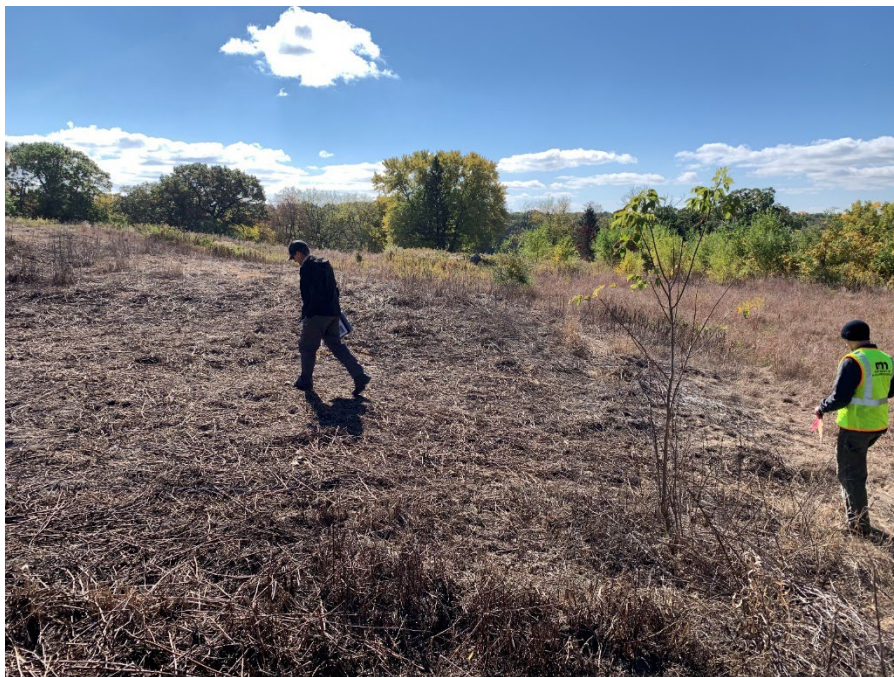
Photo 64 – Former barrow area that was filled with sediment excavated from the fringes of Buck Pond. Dakota County continues to treat reed canary grass that volunteers from this sediment with the long-term goal of establishing desirable native vegetation in this area.

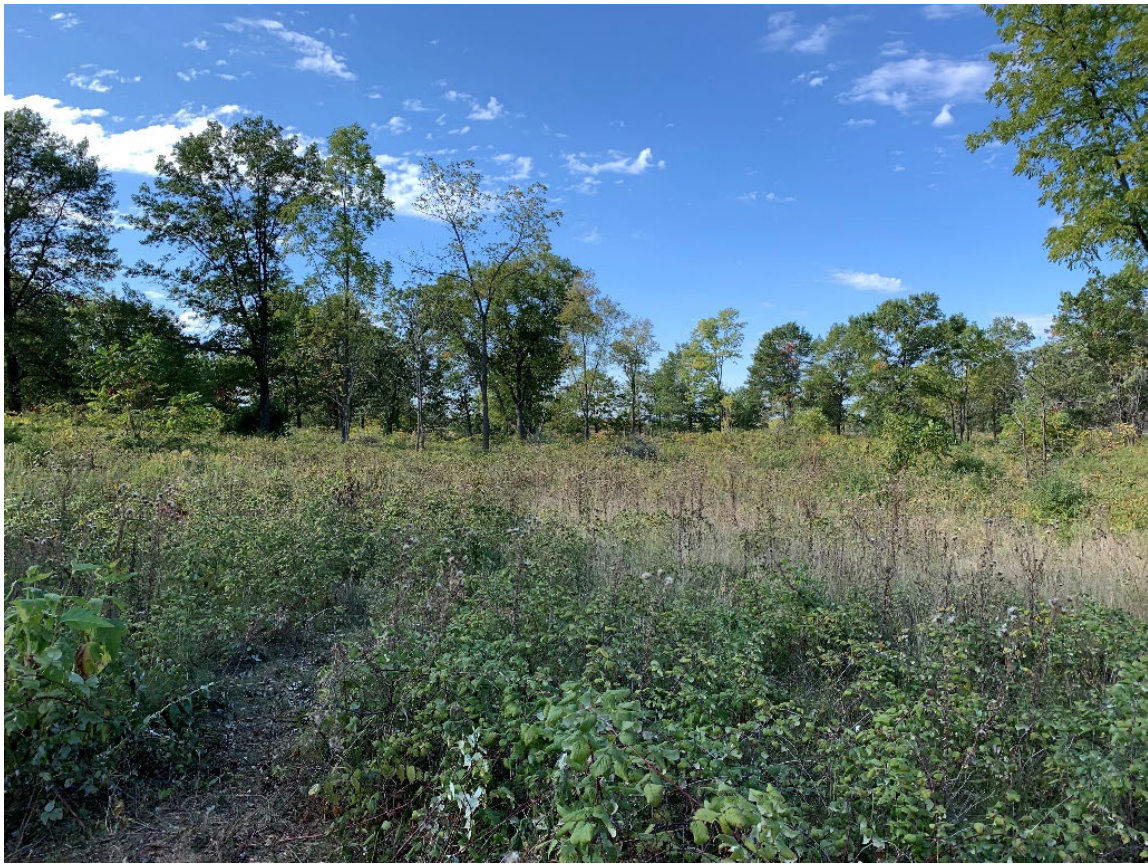
Photo 67 – View of an area on the east side of the “Unit 4” area where trees and brush were removed. This particular area has residual woody resprouts and new tree/brush volunteers. This area is inside of the bison paddock.

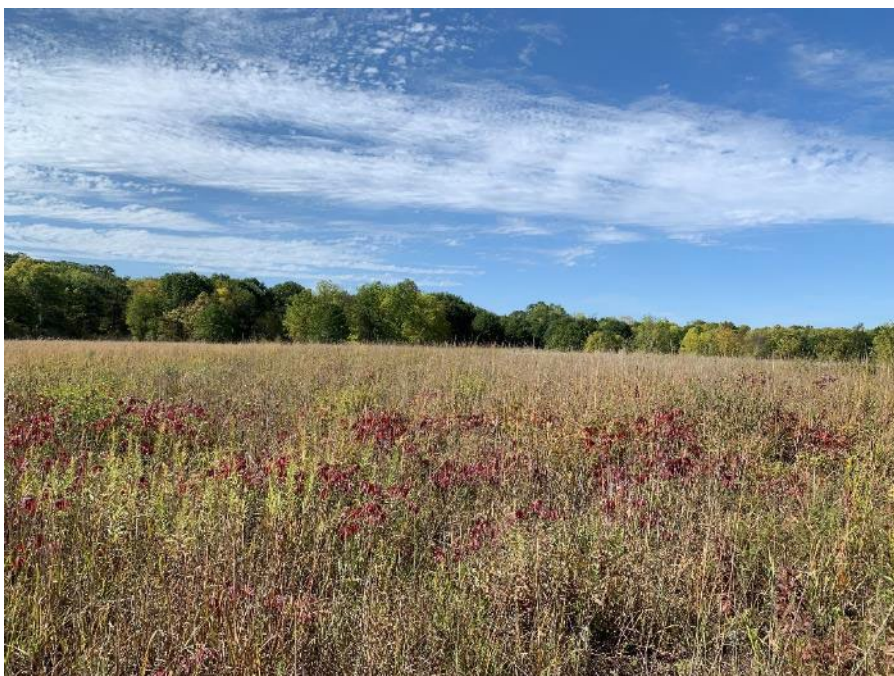
Photo 69 – Additional view of restored prairie looking north northeast toward parking area. Photo illustrates the limited regrowth of invasive woody growth, in this case smooth sumac.

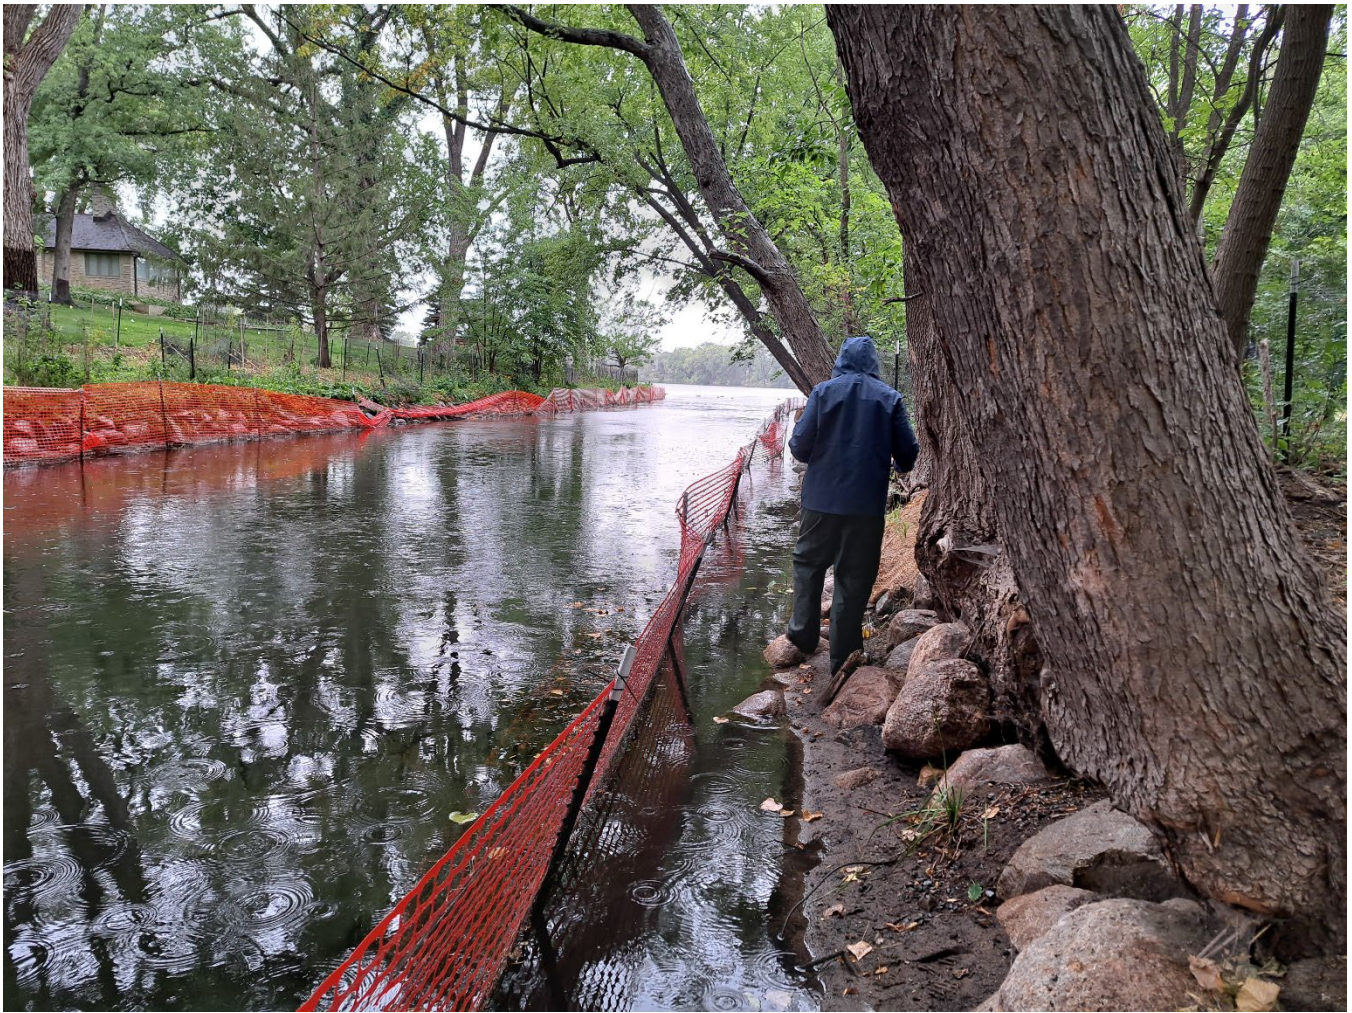
Photo 72. Looking to the northwest along Kenilworth Channel towards Cedar Lake outlet. Note the project goal of maintaining significant canopy cover of mature silver maples and cottonwoods throughout construction (Kenilworth Channel Shoreline Stabilization, photo taken during site visit 9/23/2022).

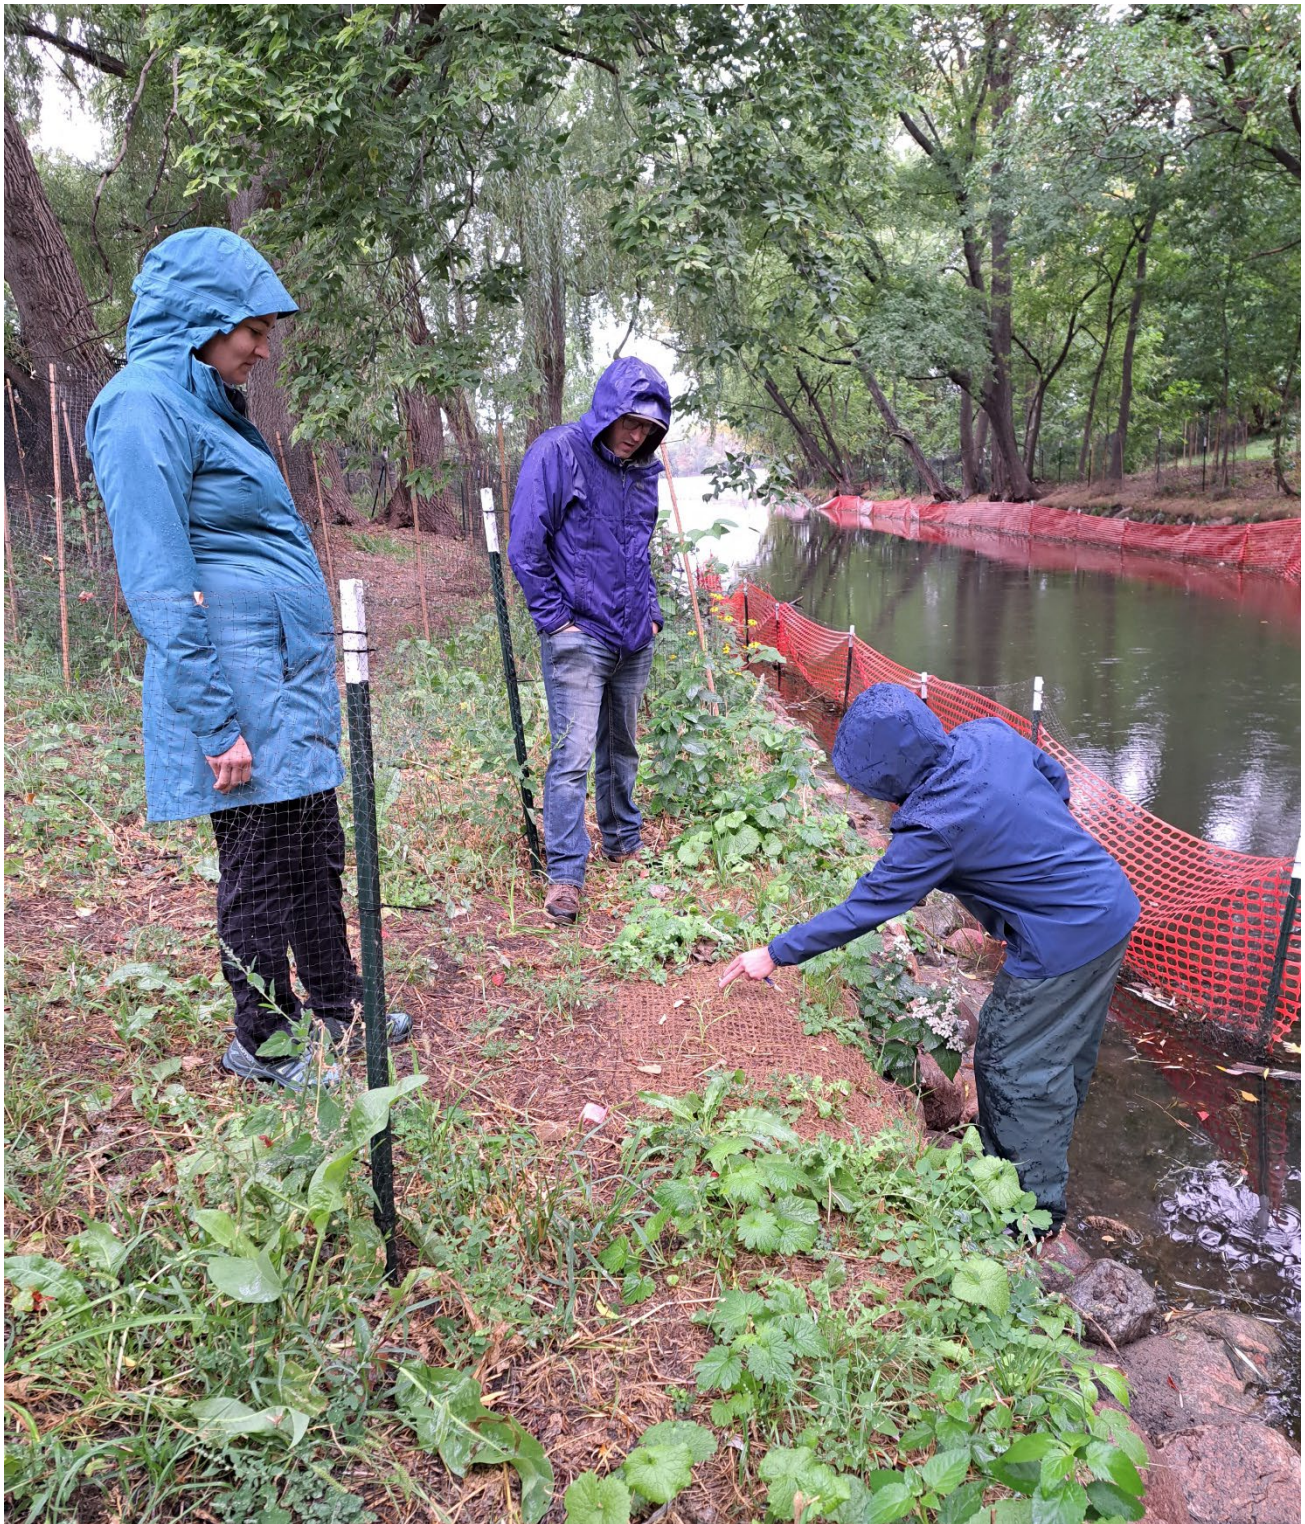
Photo 73. Site visit photo with projects hosts Maren Hancock (Interfluve) and Dan Elias (MPRB) alongside Wade Johnson from the Restoration Evaluation Program. During the site visit there appeared to be substantial mortality of planted plugs potentially due to drought and/or geese herbivory (Kenilworth Channel Shoreline Stabilization, photo taken during site visit 9/23/2022).

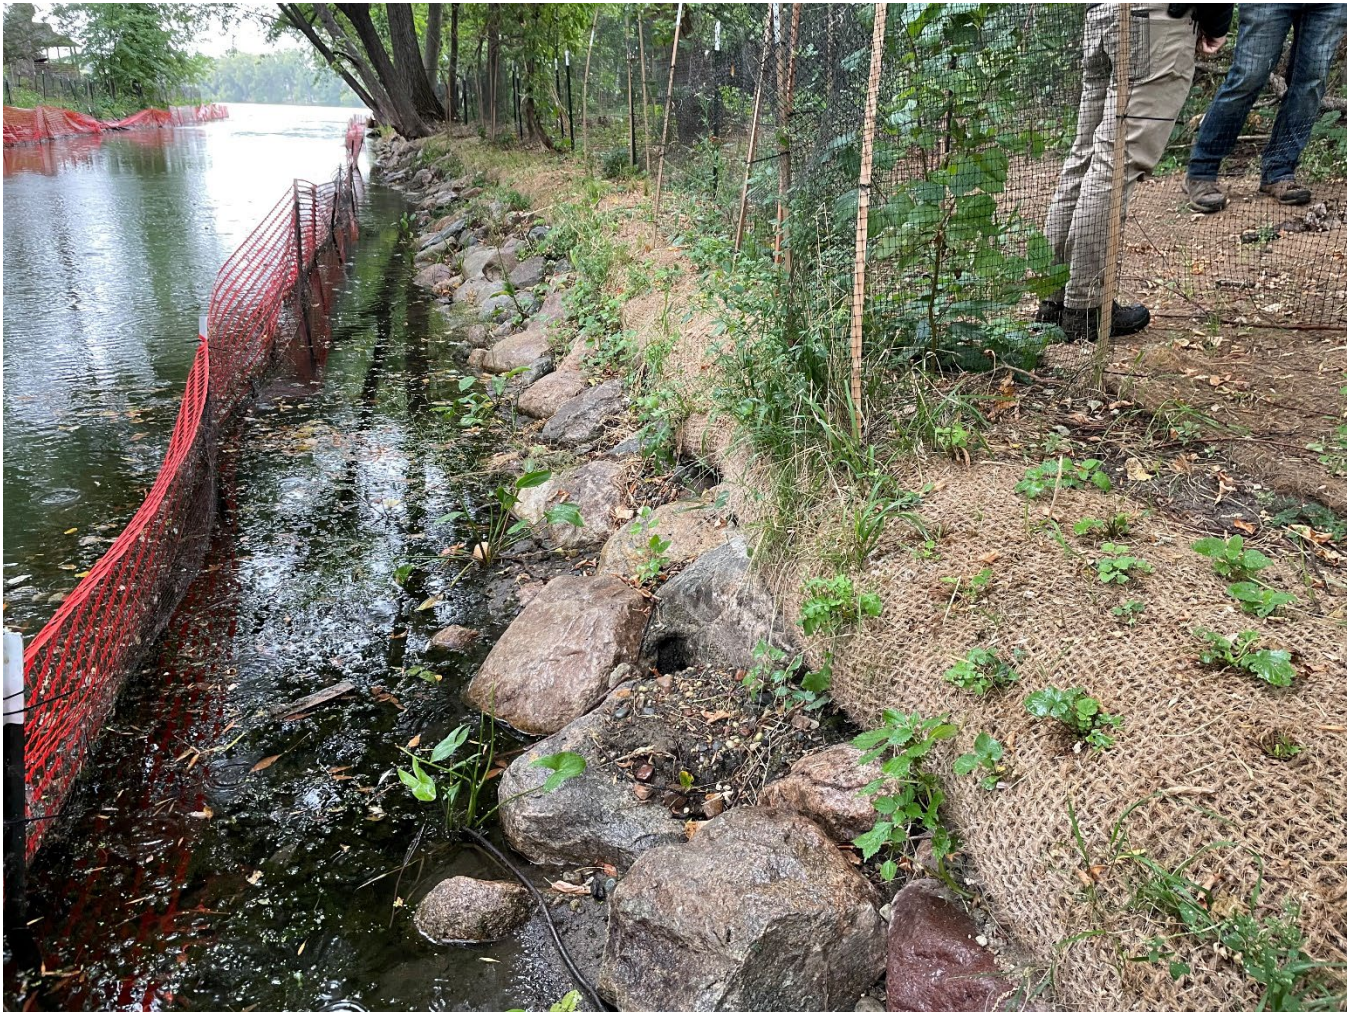
No appreciable erosion to the slope or the immediate shoreline was observed during the site visit and the FES lifts were completely intact. In addition, the rock toe was vegetated by a variety of emergent plugs that were thriving (see *Photos 4 & 5*). During the site visit, project hosts identified challenges with more upland native plant survivorship due to drought and herbivory by geese. Additional protection measures were put in place in the form of added fencing. These measures appeared to be protecting the native plants we observed during this establishment phase.

Photo 75. Looking to the northwest along Kenilworth Channel towards Cedar Lake outlet. Note the rocked toe as well as the FES (Fabric Encapsulated Soil) lifts alongside the channel (Kenilworth Channel Shoreline Stabilization, photo taken during site visit 9/23/2022).

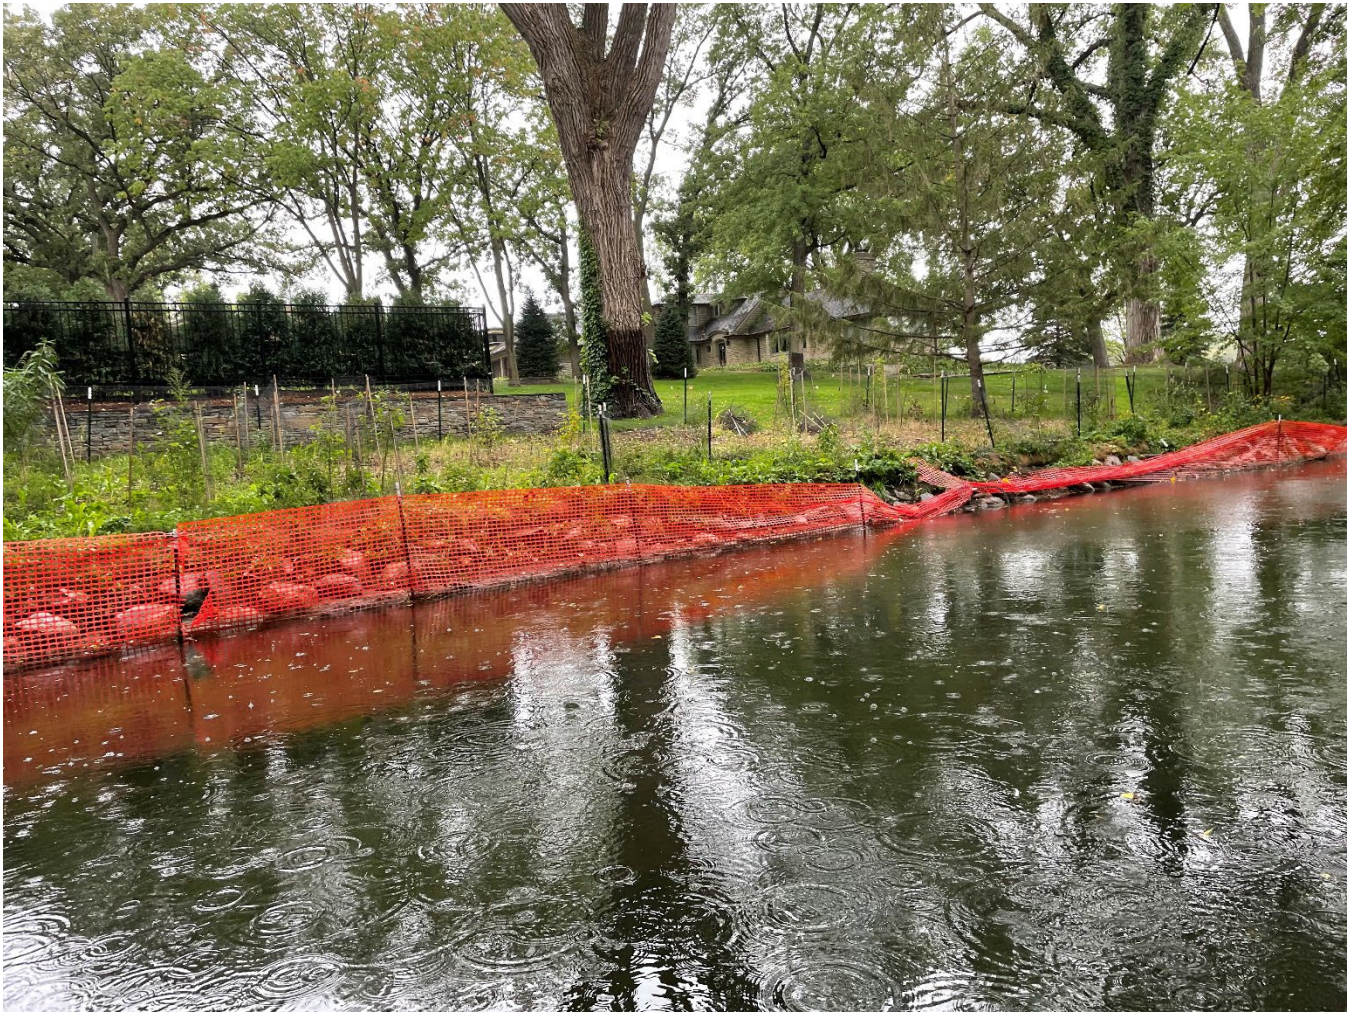
Photo 76. Looking to the southwest along Kenilworth Channel near the Cedar Lake outlet. Significant efforts by the project managers were undertaken to protect the native plantings including snow fencing along the channel as well as netting surrounding the trees and shrub planting (Kenilworth Channel Shoreline Stabilization, photo taken during site visit 9/23/2022).

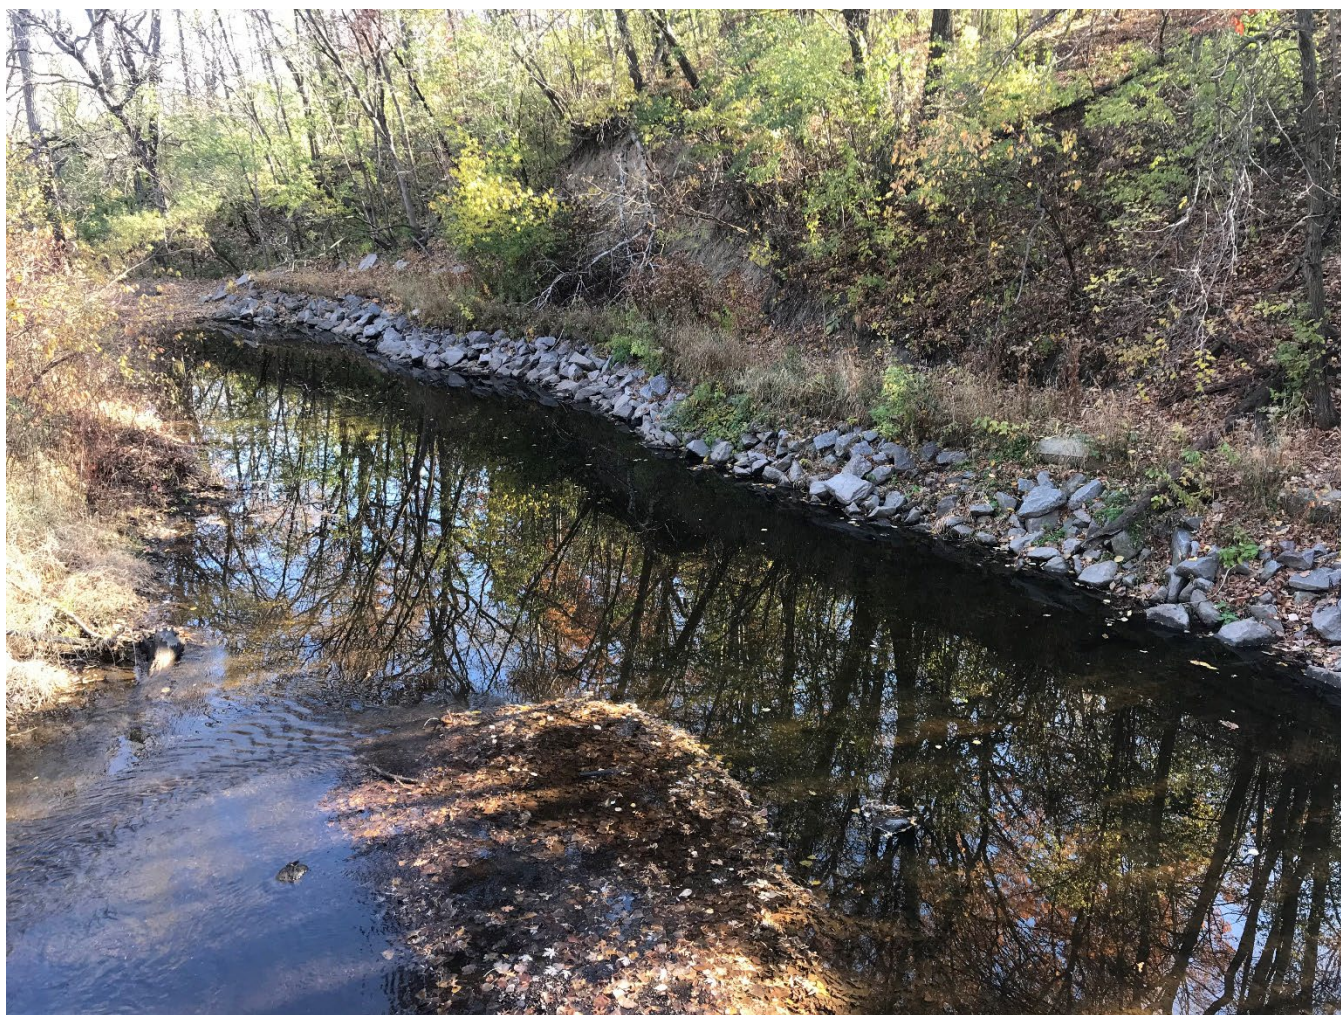
Figure 56. Stabilization Area 9 showing riprap toe and vegetated bench upstream of trail bridge. Photo taken on 10/28/2022.

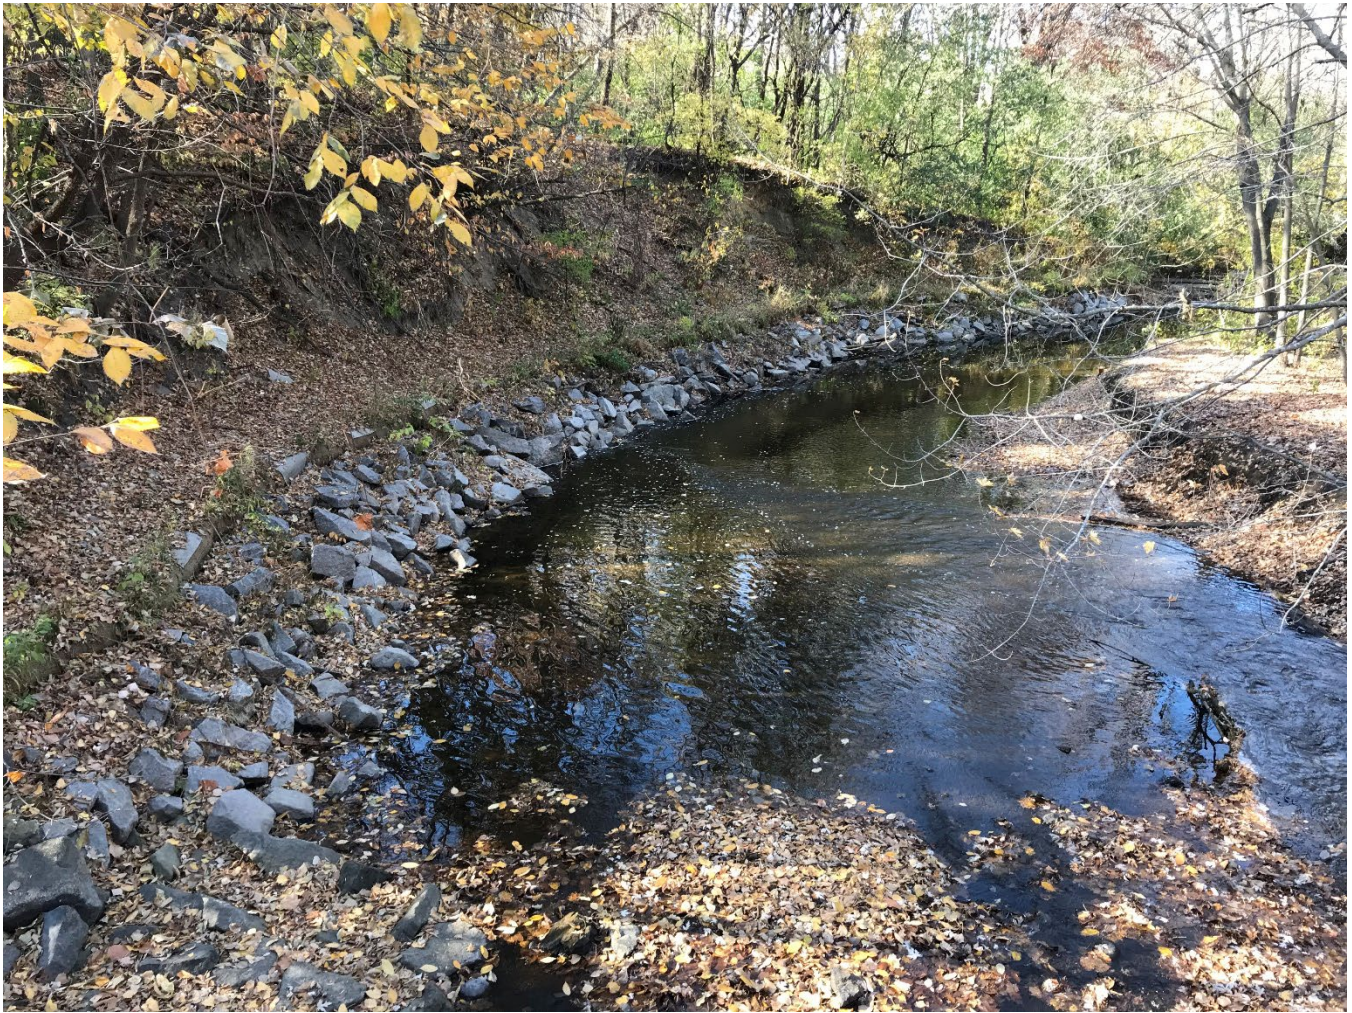
Figure 57. Stabilization Area 9 showing riprap toe and vegetated bench along cutbank downstream of trail bridge. Photo taken on 10/28/2022.

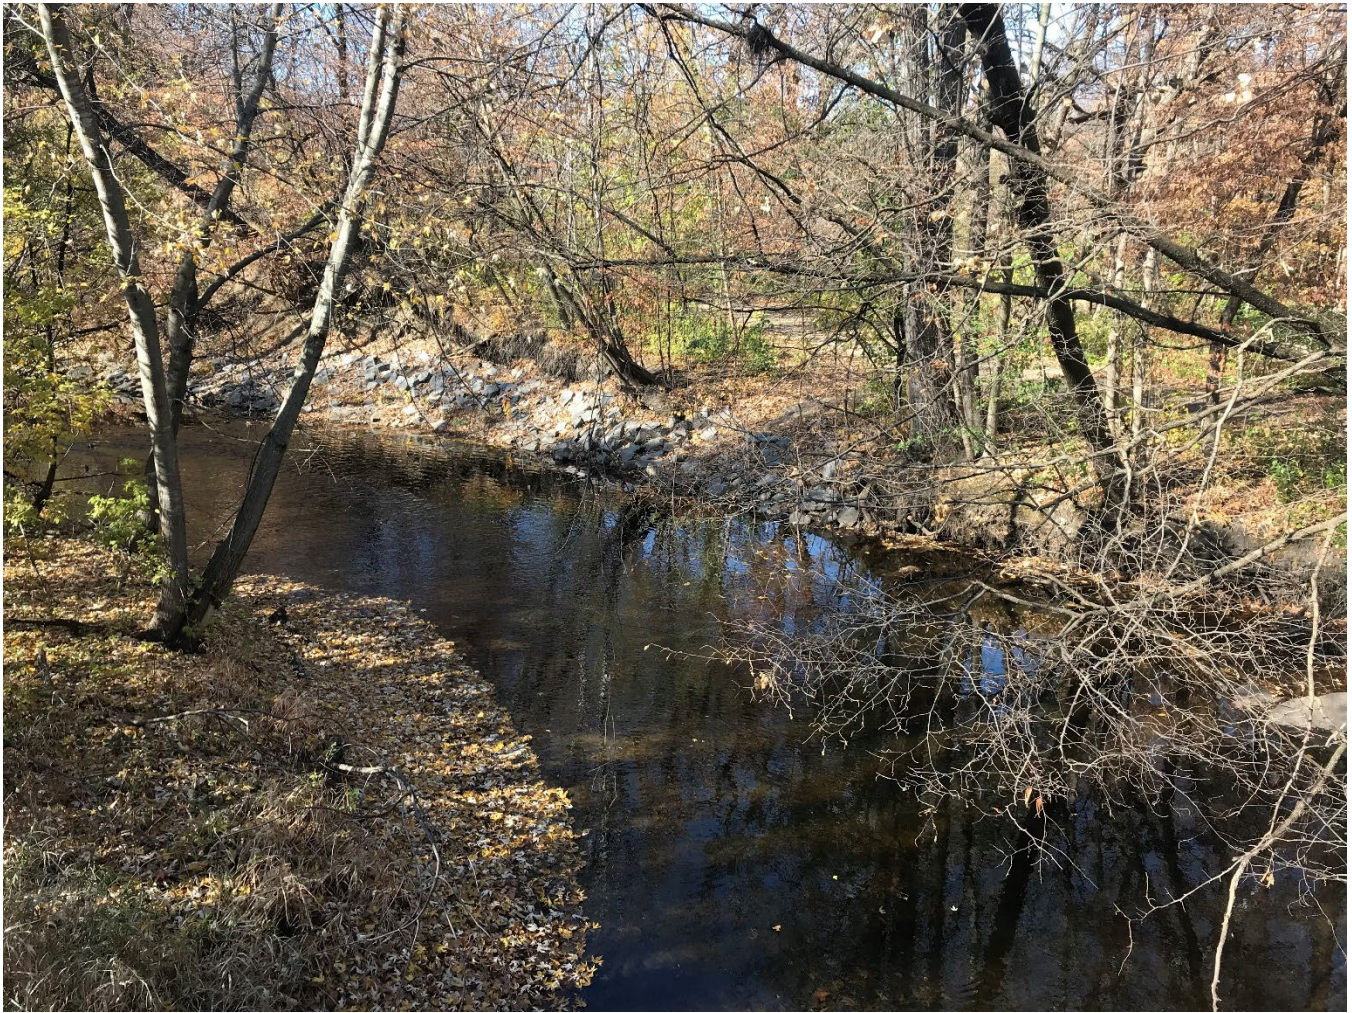
Figure 58. Stabilization Area 3 showing riprap along a previous cutbank. Photo taken on 10/28/2022.

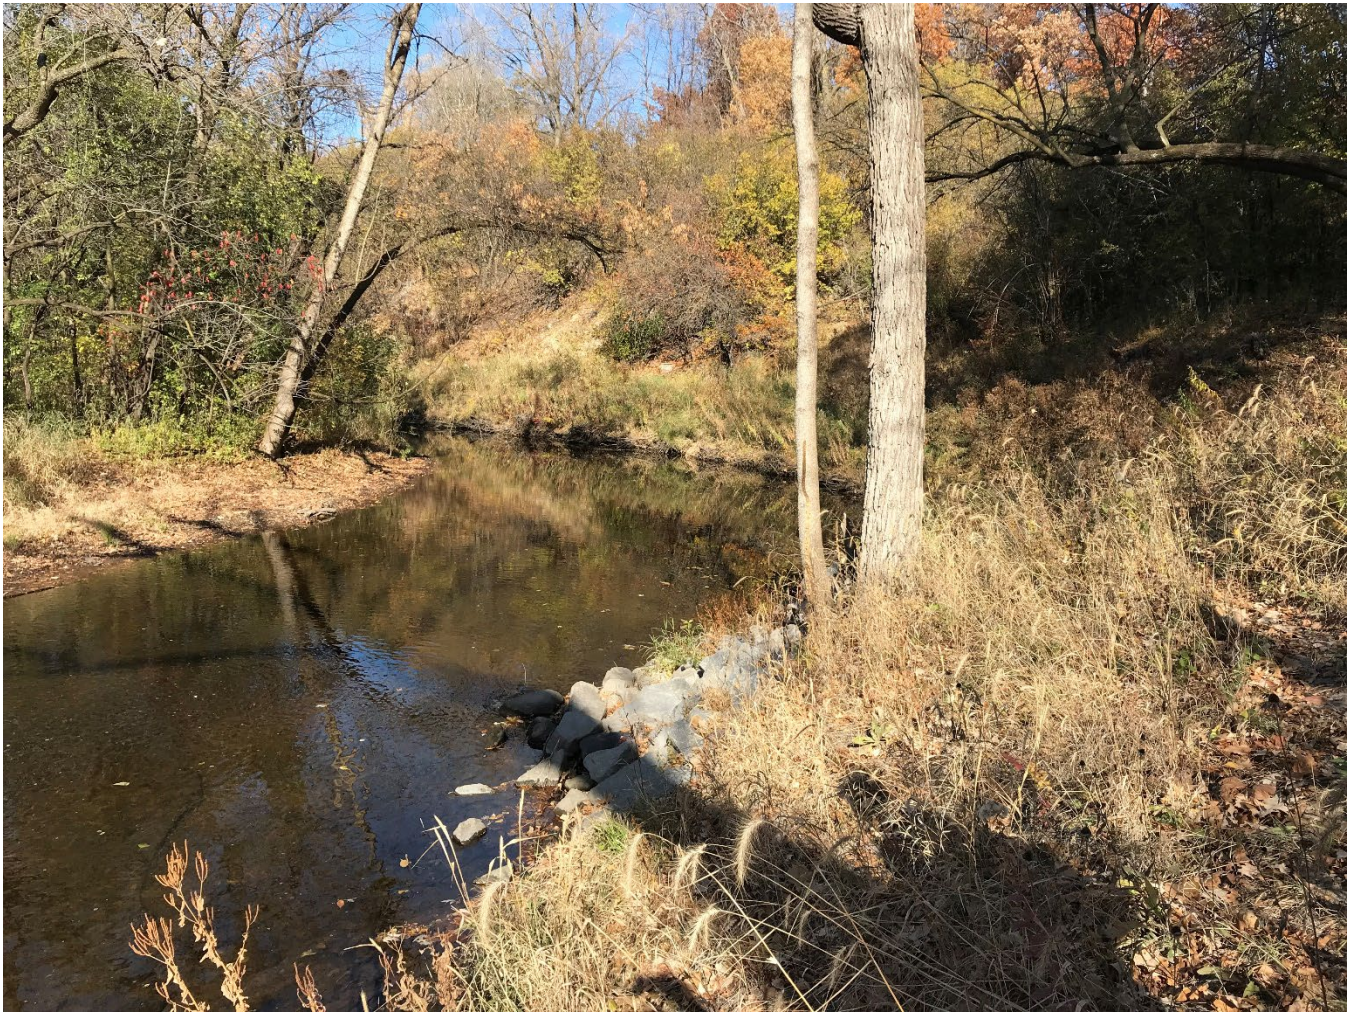
Figure 59. Stabilization Area 4 showing toewood and boulder rock vane at upstream terminus of the toewood structure. Photo taken on 10/28/2022.

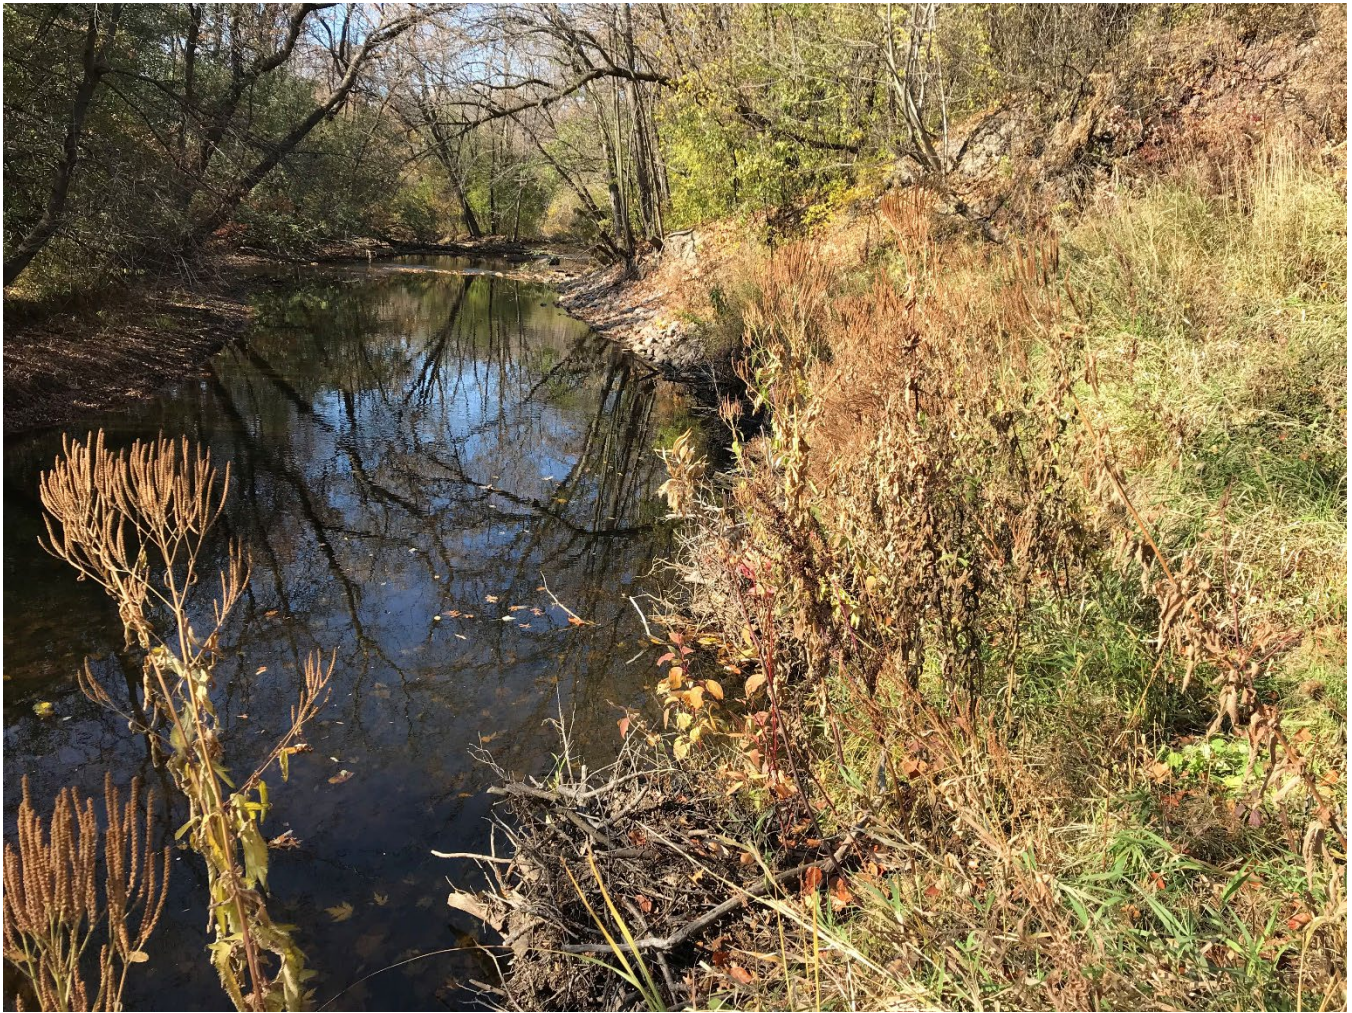
Figure 60. Stabilization Area 4 close-up of toewood and native vegetation. Photo taken on 10/28/2022.

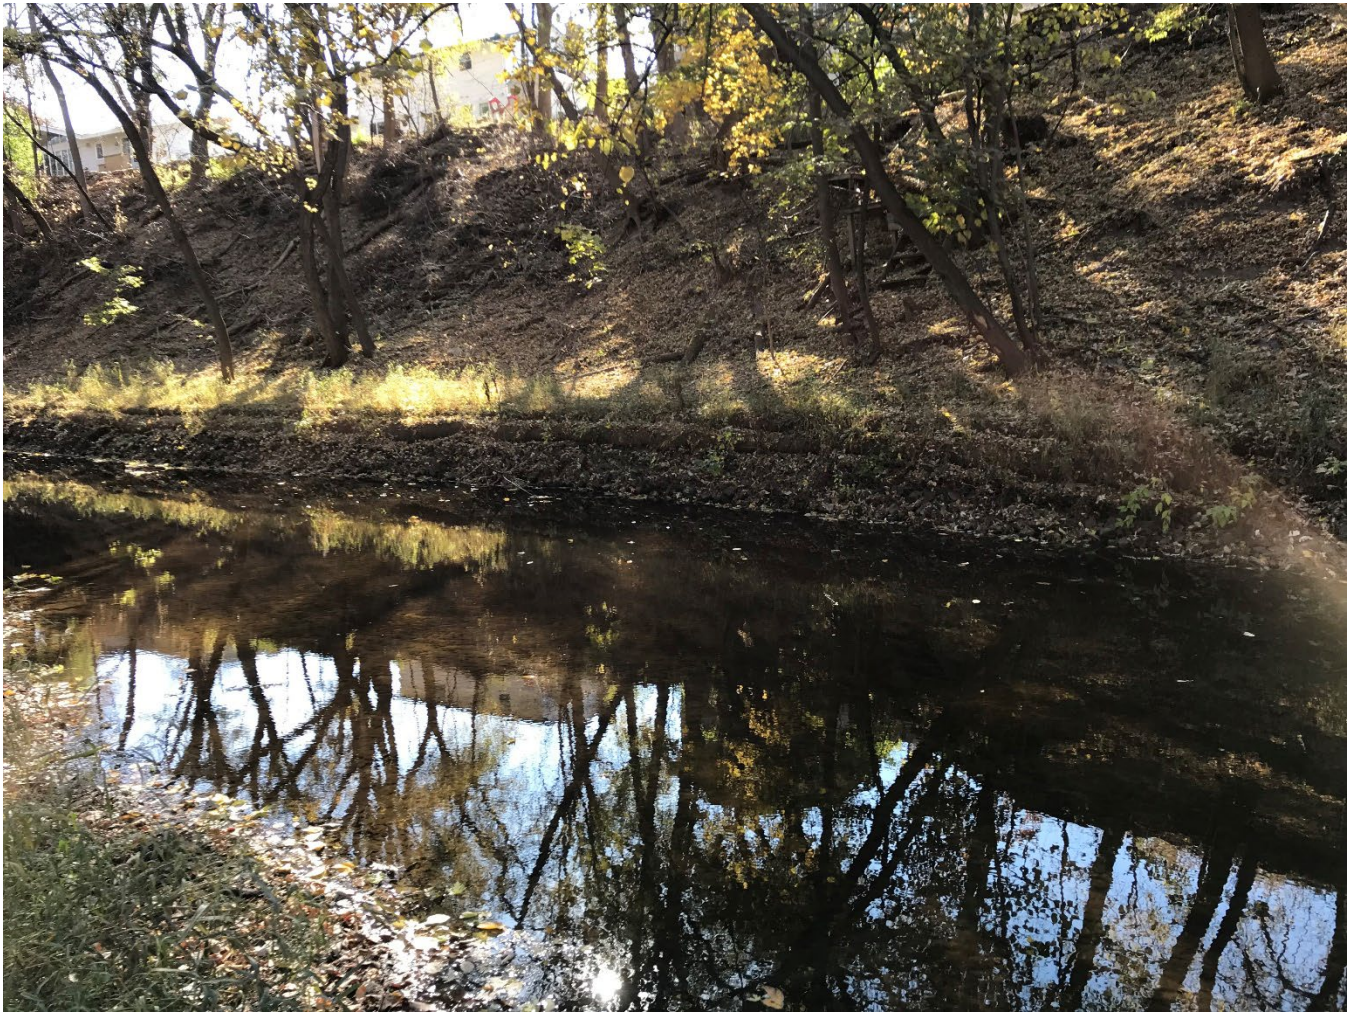
Figure 61. Stabilization Area 2 showing existing rock gabions along the base of a steep bank and vegetated soil lifts placed above the rock gabions. Photo taken on 10/28/2022.

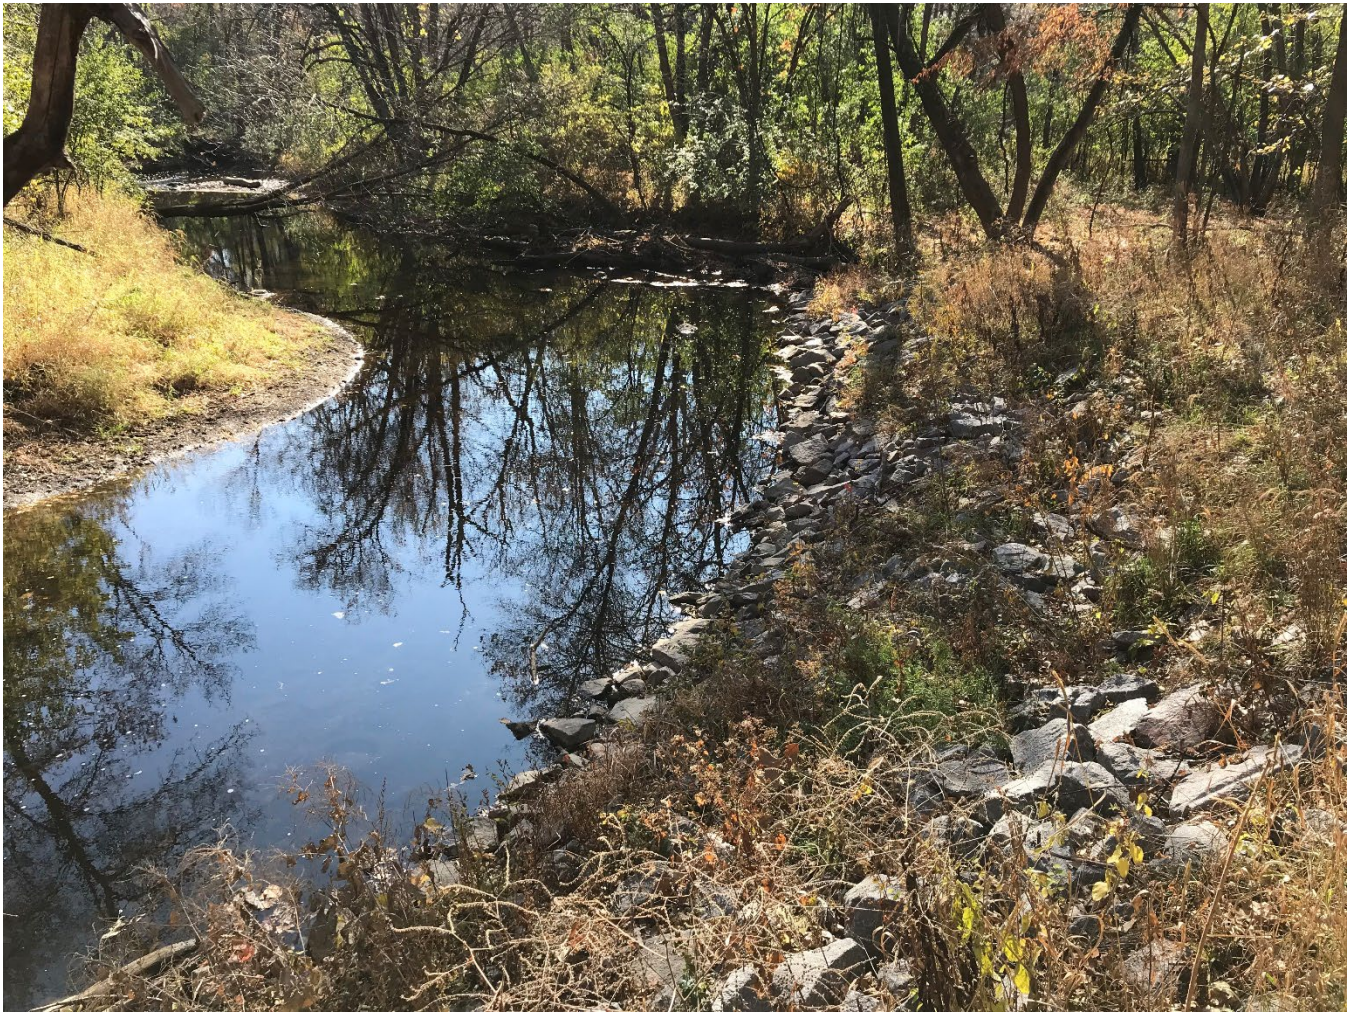
Figure 62. Stabilization Area 1 showing riprap toe and vegetated floodplain bench. Photo taken on 10/28/2022.

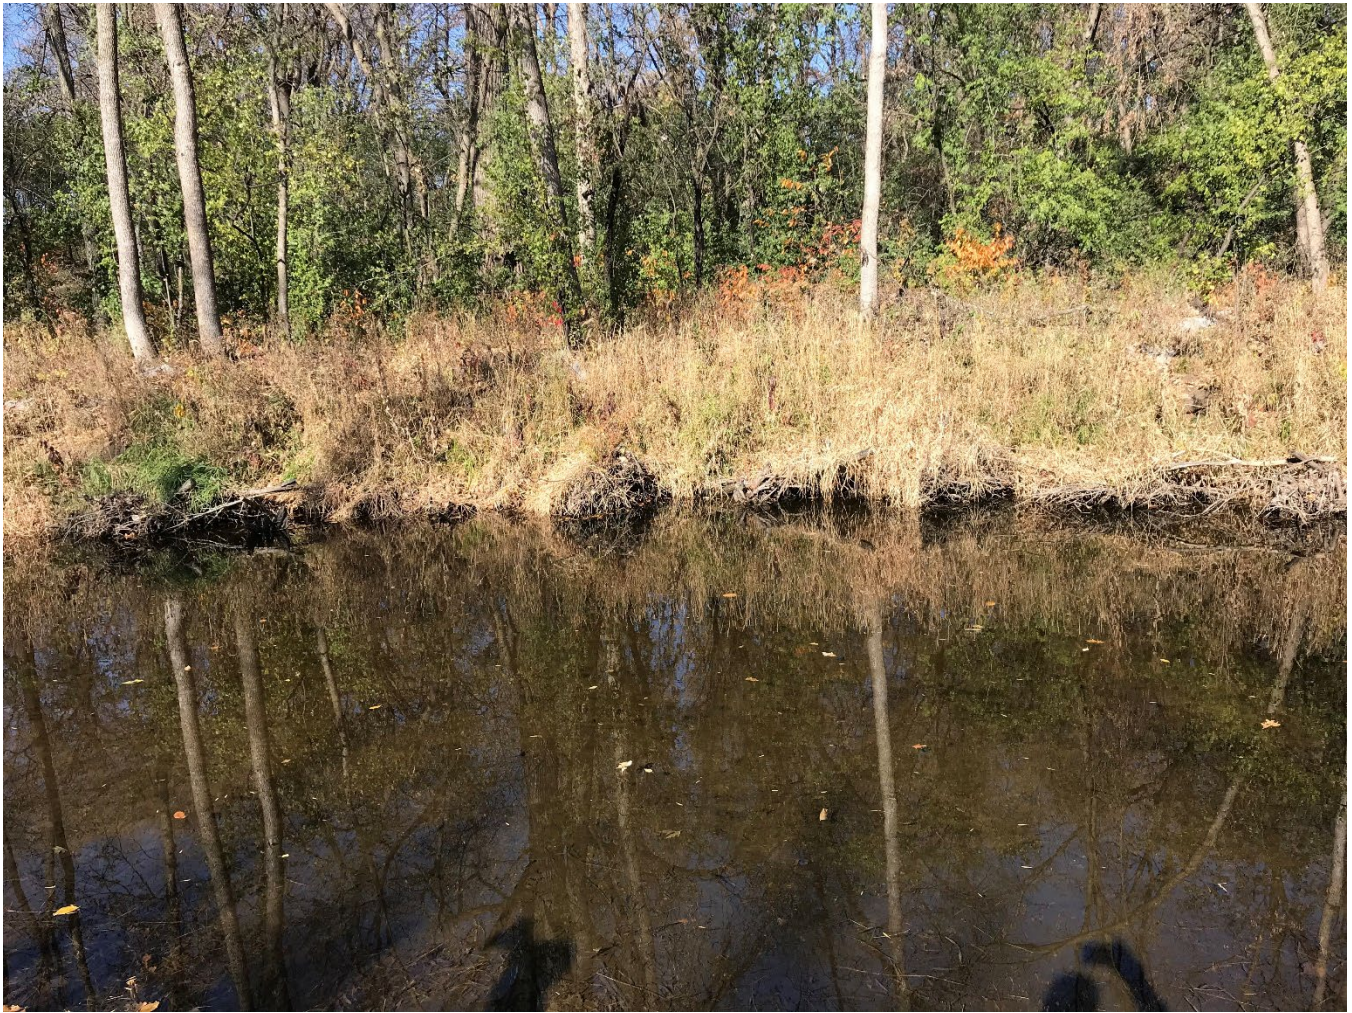
Figure 63. Stabilization Area 12 showing toewood and three soil lifts installed above the toewood structure. Photo taken on 10/28/2022.

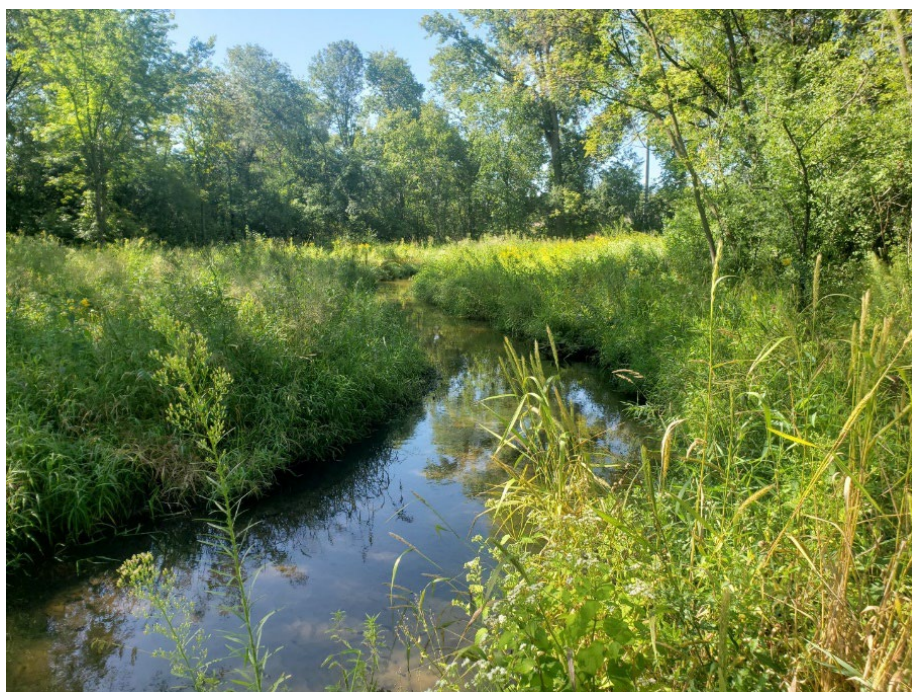
Photo 77. Looking upstream along Sand Creek. Banks are well-vegetated. (Photo taken by Mark Prankus, Cardno now Stantec, on 9/1/22).

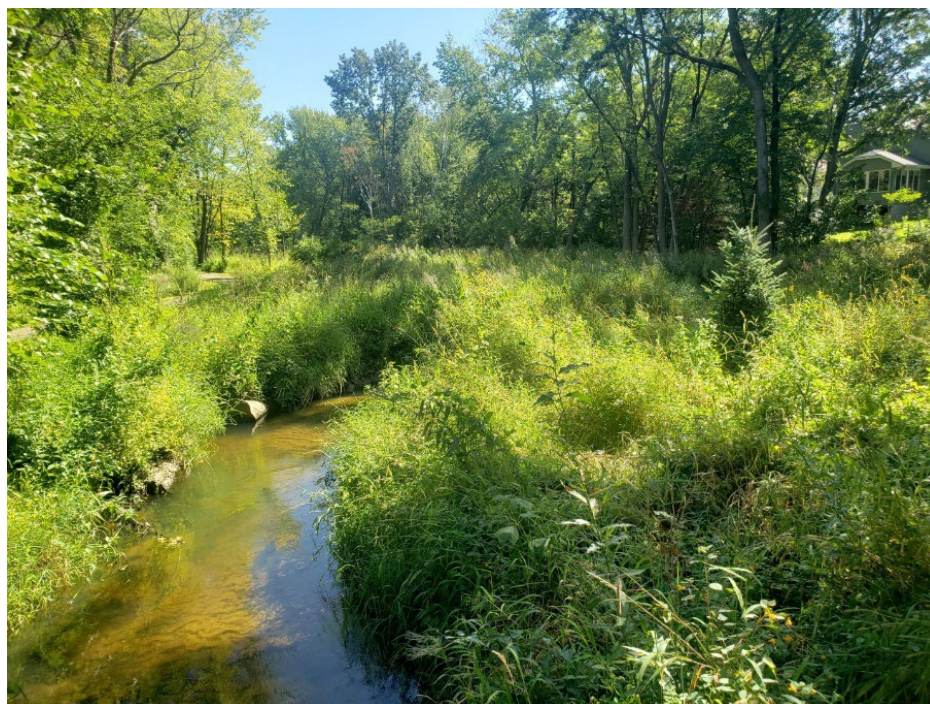
Photo 78. Looking upstream along Sand Creek. Banks are well-vegetated. (Photo taken by Mark Prankus, Cardno now Stantec, on 9/1/22).

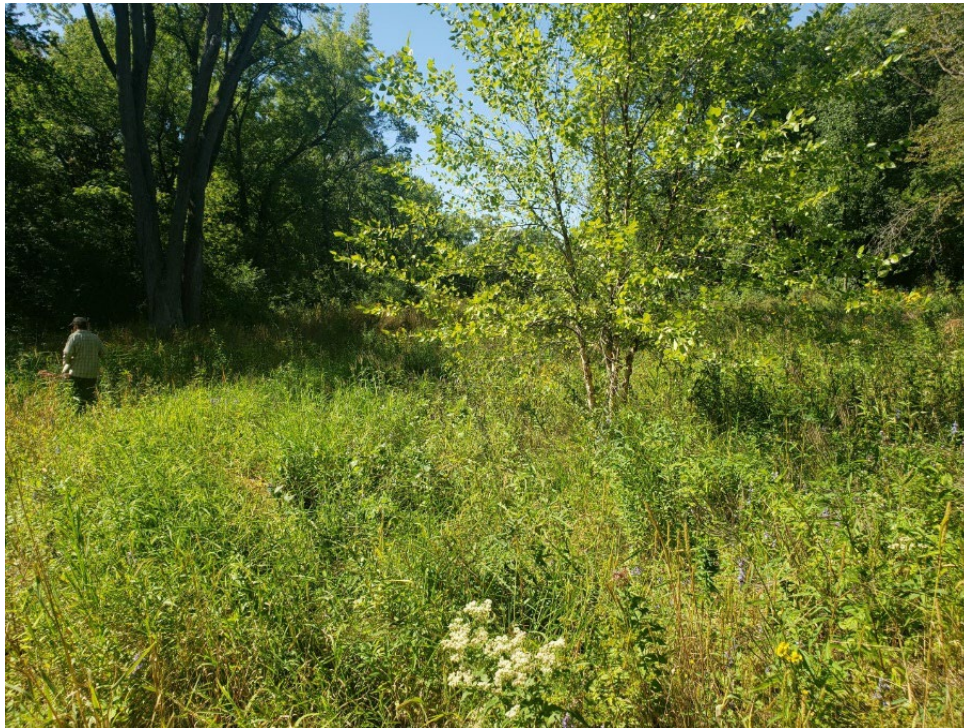
Photo 79. Example of trees planted post-construction in the riparian corridor. Resources were spent on fewer, but larger trees, which may have a higher survival rate. (Photo taken by Mark Prancus, Cardno now Stantec, on 9/1/22).

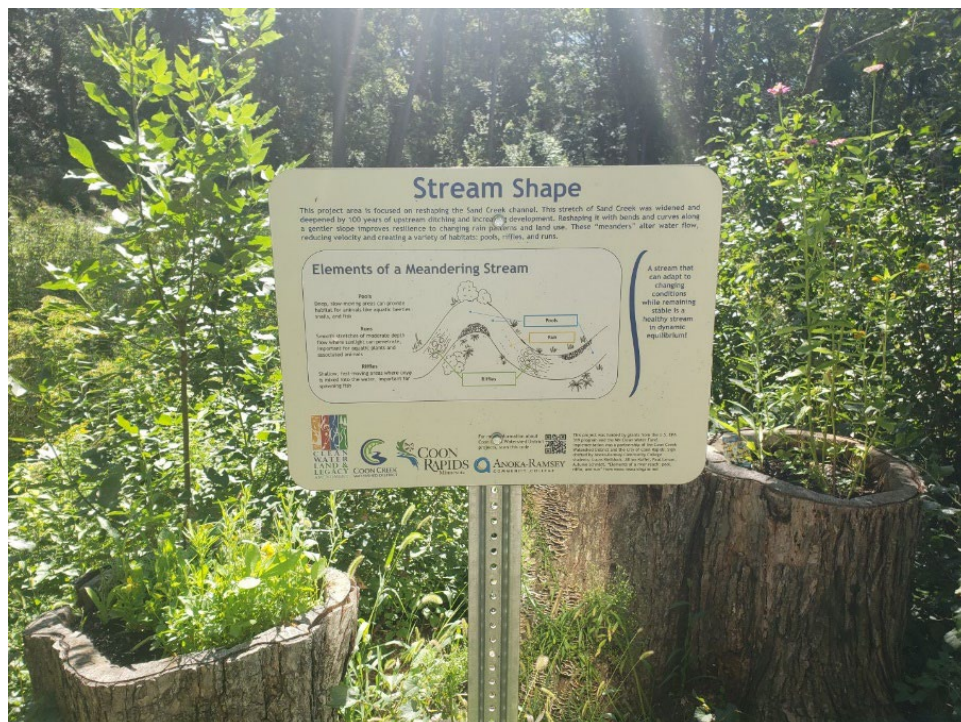
Photo 80. Example of the education signage placed along the Middle Sand Creek Corridor Restoration project area to tell the story of the project and promote awareness for water quality and naturalized bank stabilization practices. (Photo taken by Mark Prancus, Cardno now Stantec, on 9/1/22).
